Fire-resistance test on fire collars protecting a plasterboard wall penetrated by services

Test Report

Report number: FSP 1960

Date: 5 February 2019

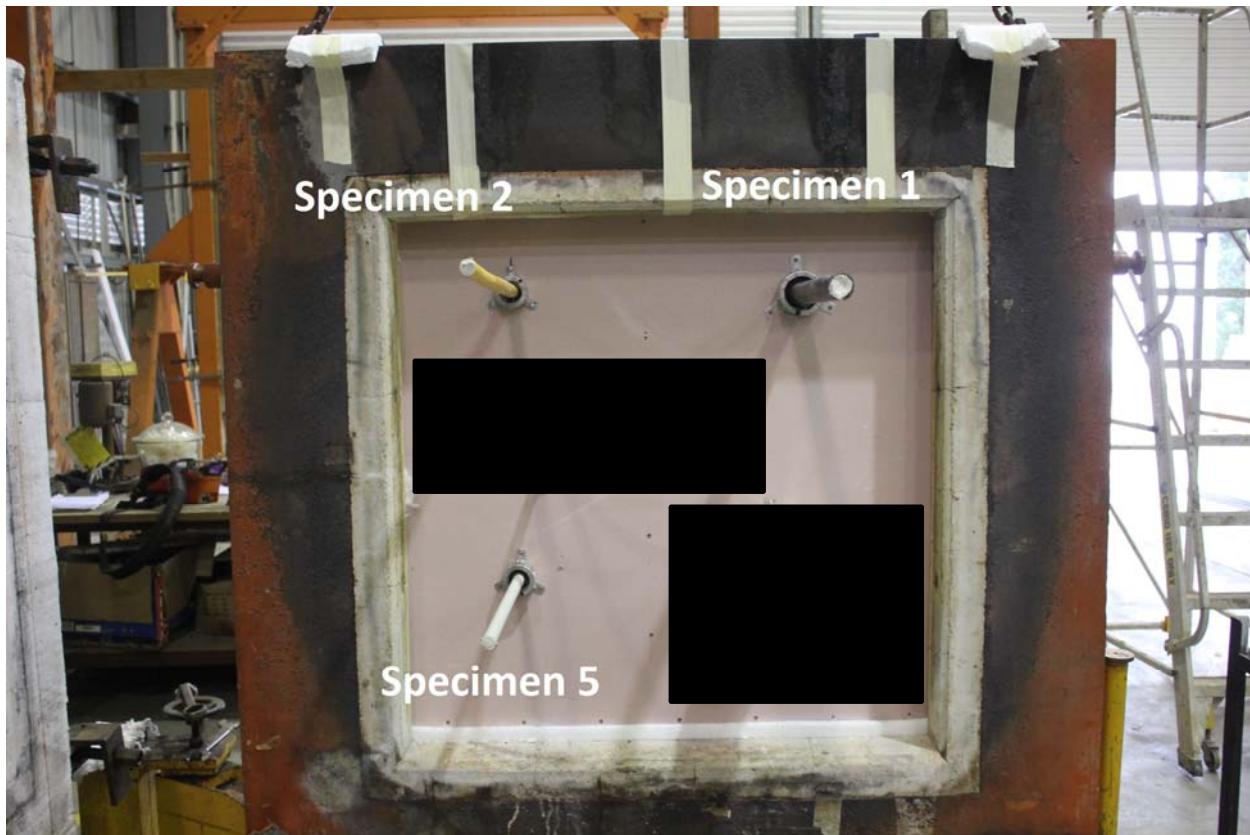
PHOTOGRAPH 1 – EXPOSED FACE OF SPECIMENS PRIOR TO TESTING

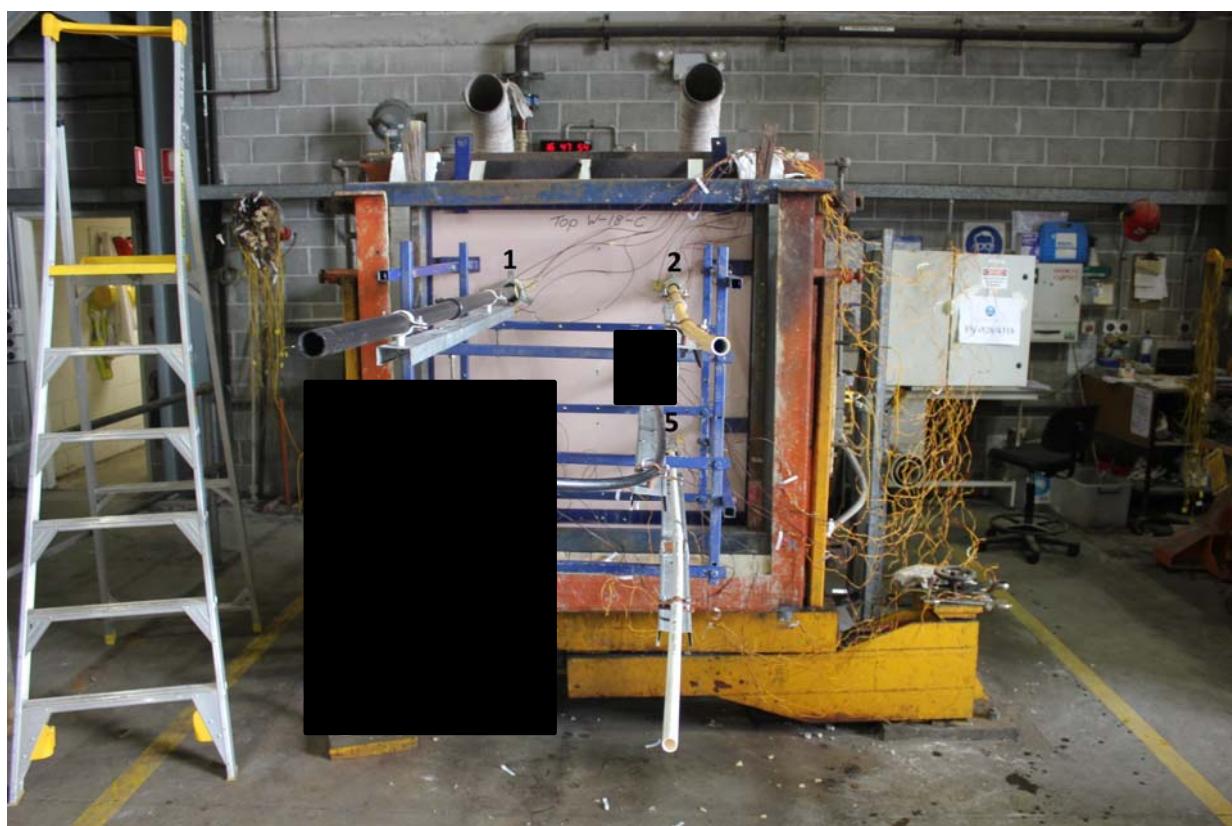
PHOTOGRAPH 2 – UNEXPOSED FACE OF SPECIMENS PRIOR TO TESTING

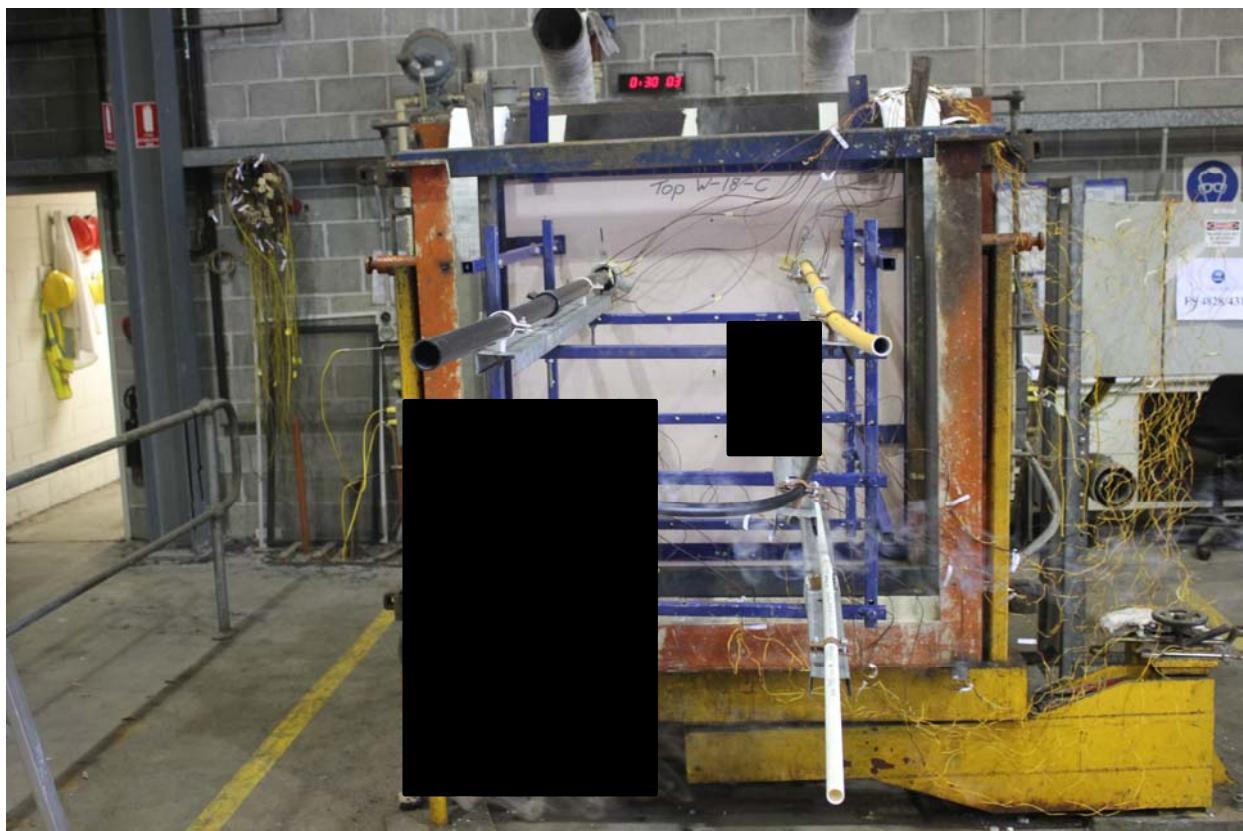
PHOTOGRAPH 3 – SPECIMENS AFTER 30 MINUTES OF TESTING

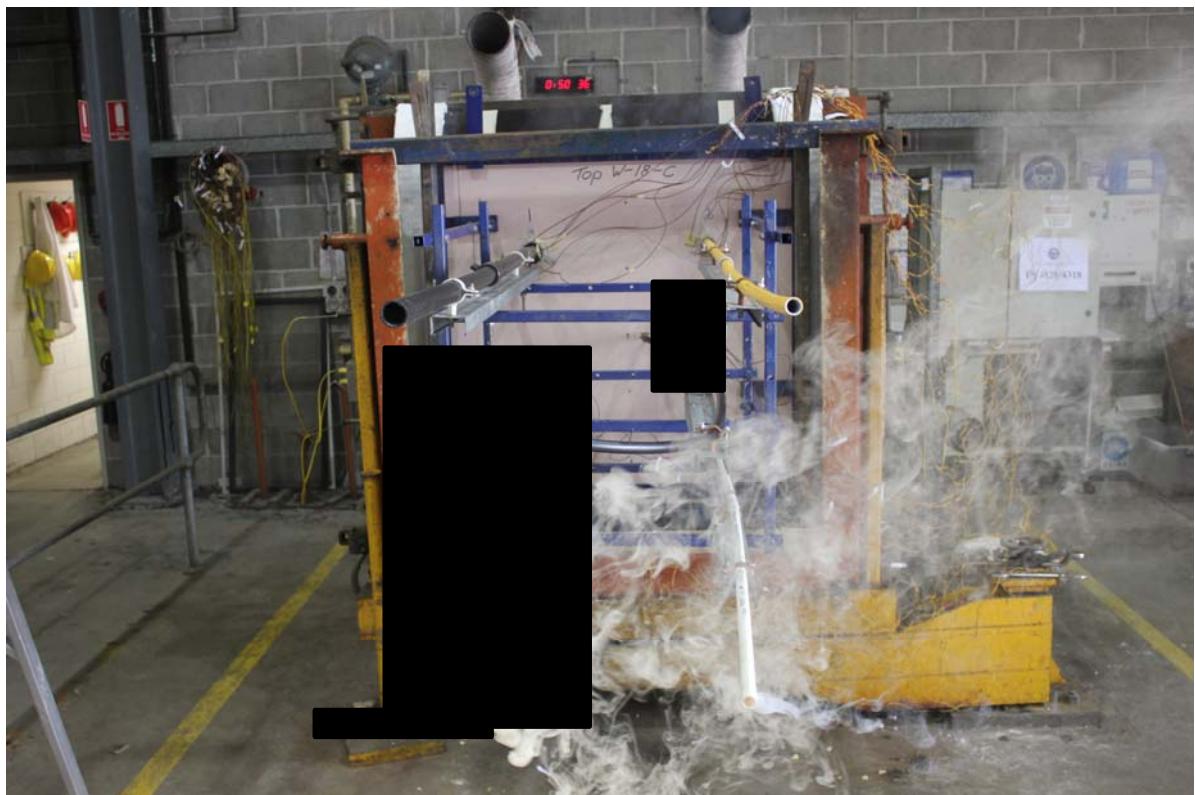
PHOTOGRAPH 4 – SPECIMENS AFTER 50 MINUTES OF TESTING

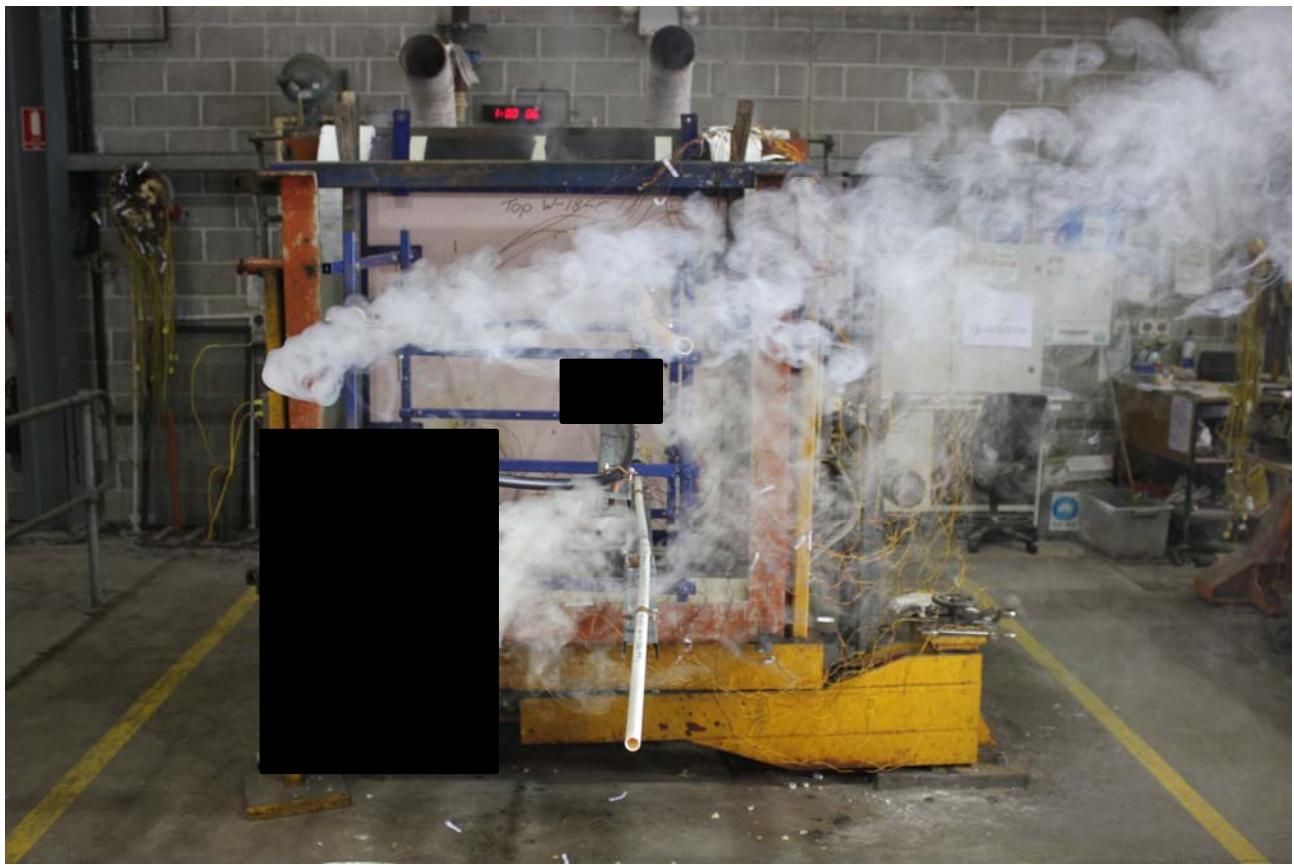
PHOTOGRAPH 5 – SPECIMENS AFTER 60 MINUTES OF TESTING

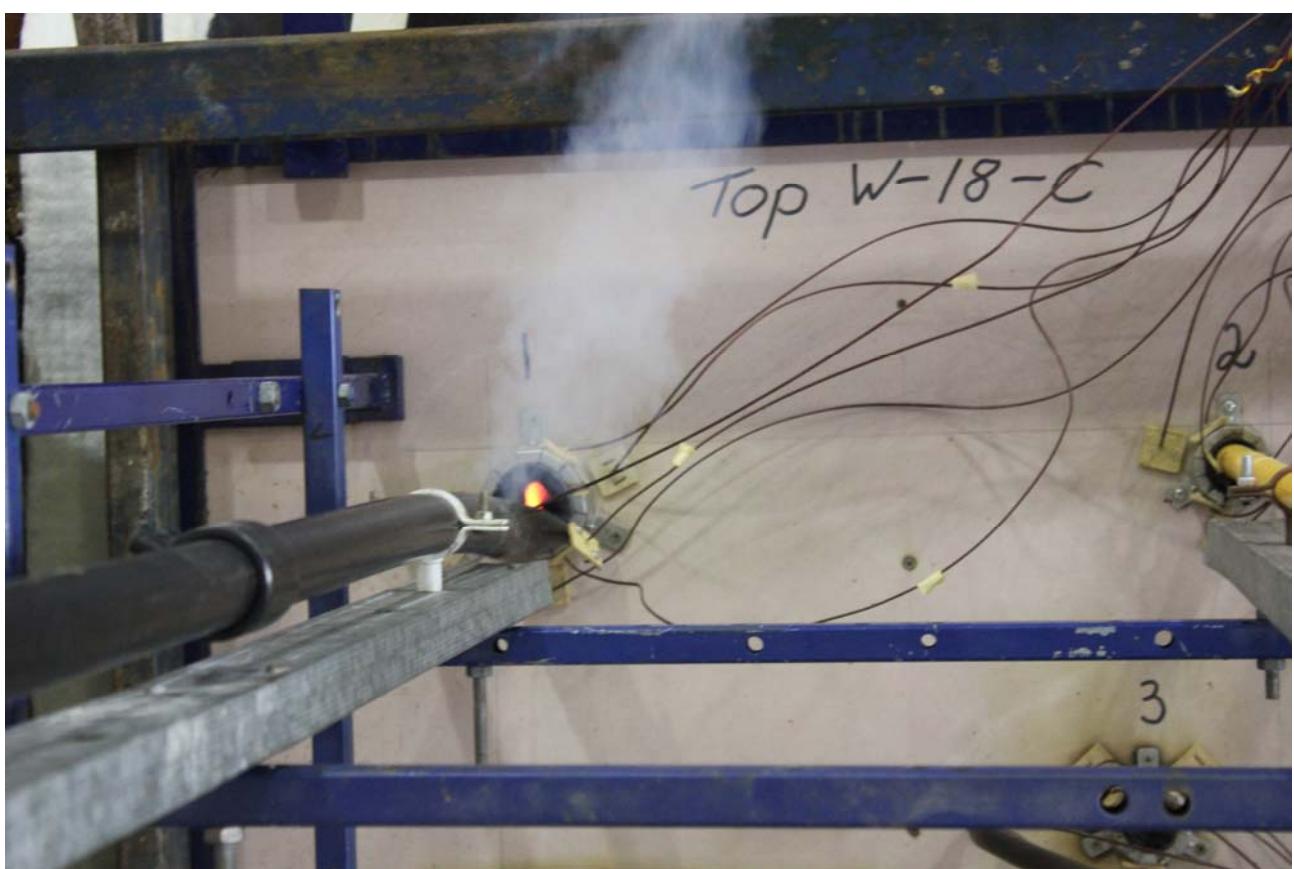
Time	Observation
2 minutes -	Smoke is fluing from Specimens 1.
4 minutes -	Smoke no longer fluing from Specimen 1.
11 minutes -	Smoke is being emitted from inside the collar of Specimen 2.
38 minutes -	Smoke is fluing from Specimen 5.
45 minutes -	The pipe of Specimen 5 has sagged between the wall and supports.
50 minutes -	The amount of smoke fluing from Specimen 5 has increased.
60 minutes -	The pipe of Specimen 1 has started to deform at the based near collar
63 minutes -	Smoke is being emitted from inside the collar of Specimen 1; a red glow is now visible through the gap between the sagged pipe and collar. Cotton wool pad applied over the collar of Specimen 1 - no ignition noted.
65 minutes -	<u>Insulation Failure Specimen 5</u> – maximum temperature rise of 180K is exceeded on the plasterboard 25-mm from the collar of Specimen 5.
65 minutes -	Face of wall is starting to discolour.
67 minutes -	<u>Insulation Failure Specimen 1</u> – maximum temperature rise of 180K is exceeded on the plasterboard 25-mm from the collar of Specimen 1.

Structural adequacy	-	not applicable
Integrity	-	no failure at 75 minutes
Insulation	-	67 minutes

PHOTOGRAPH 6 – SPECIMEN 1 AFTER 63 MINUTES OF TESTING

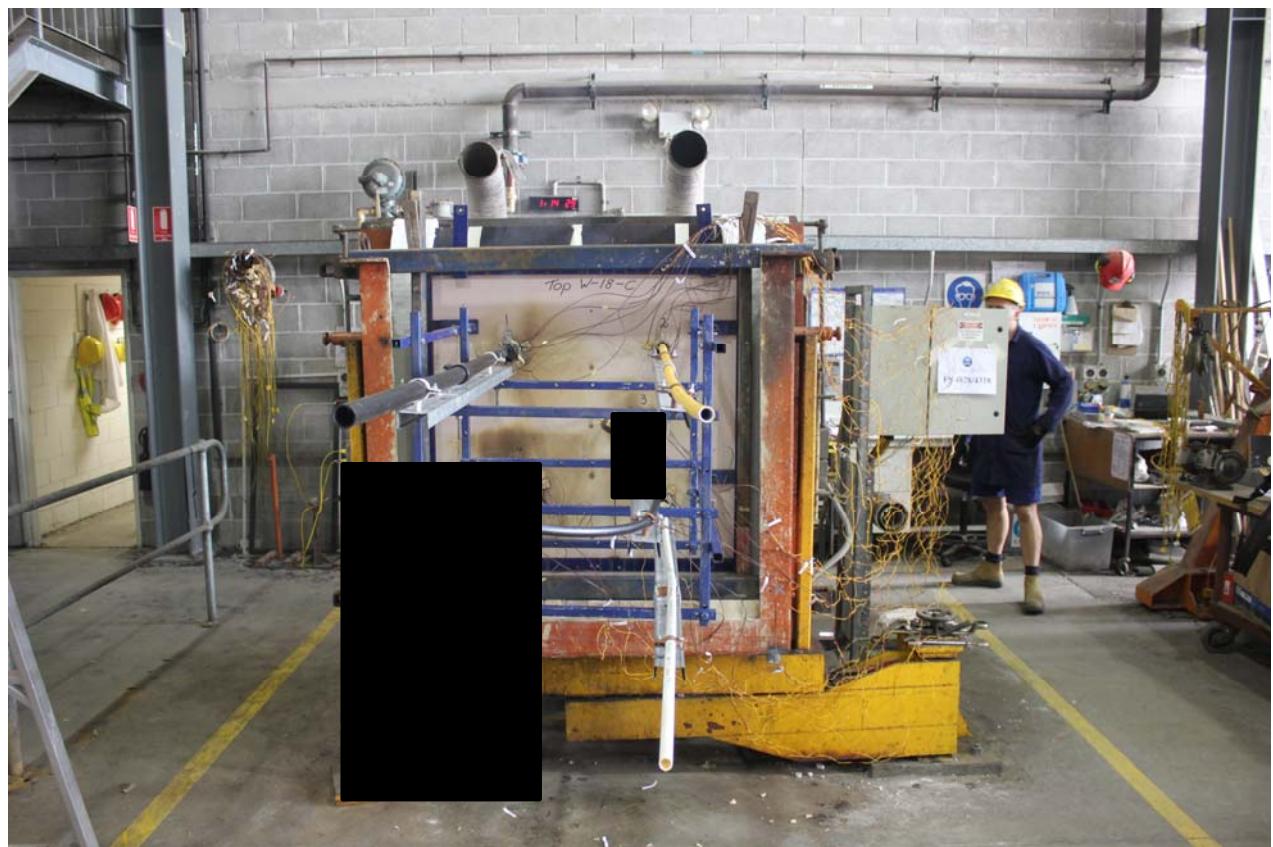
PHOTOGRAPH 7 – SPECIMENS AFTER 74 MINUTES OF TESTING

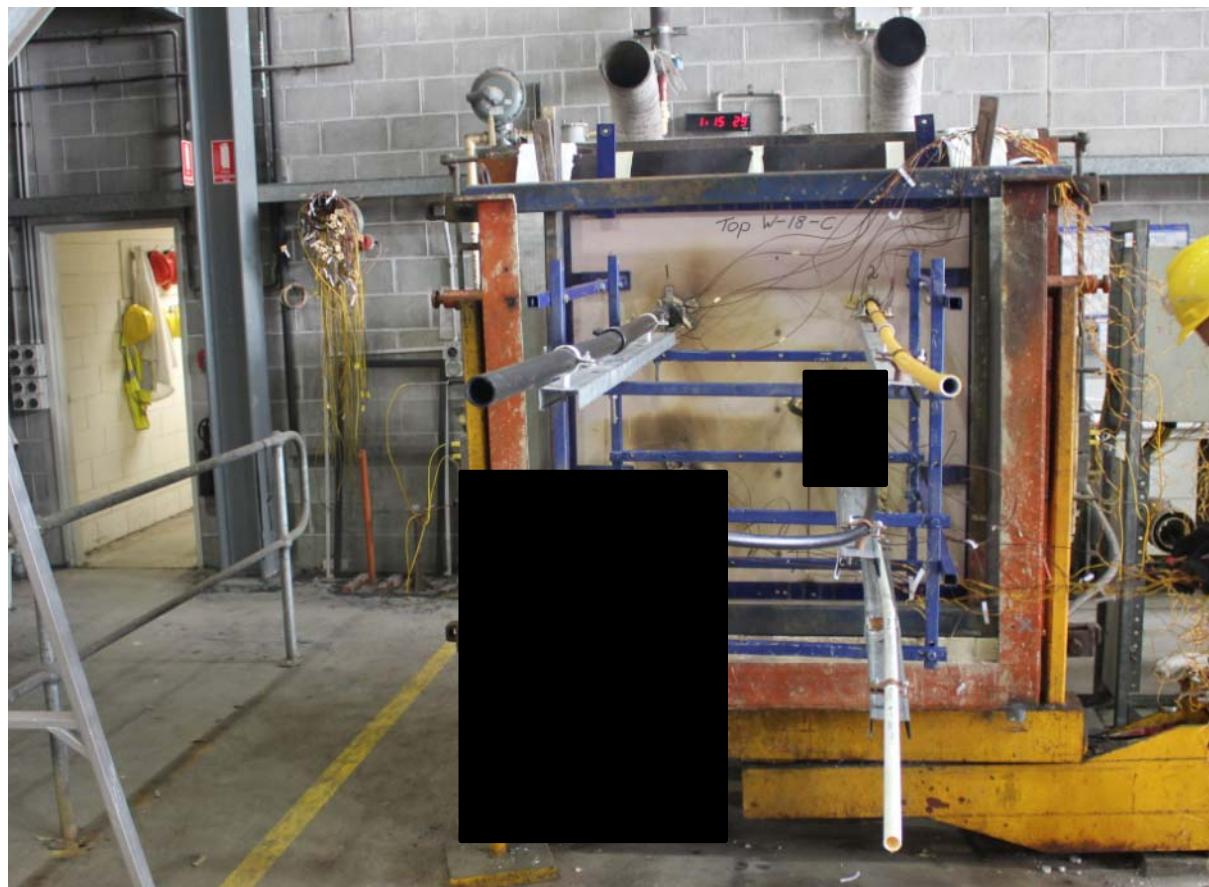
75 minutes -	<u>Insulation Failure Specimen 2</u> – maximum temperature rise of 180K is exceeded on the plasterboard 25-mm from the collar of Specimen 2. Test terminated

PHOTOGRAPH 8 – SPECIMENS AT CONCLUSION OF TESTING

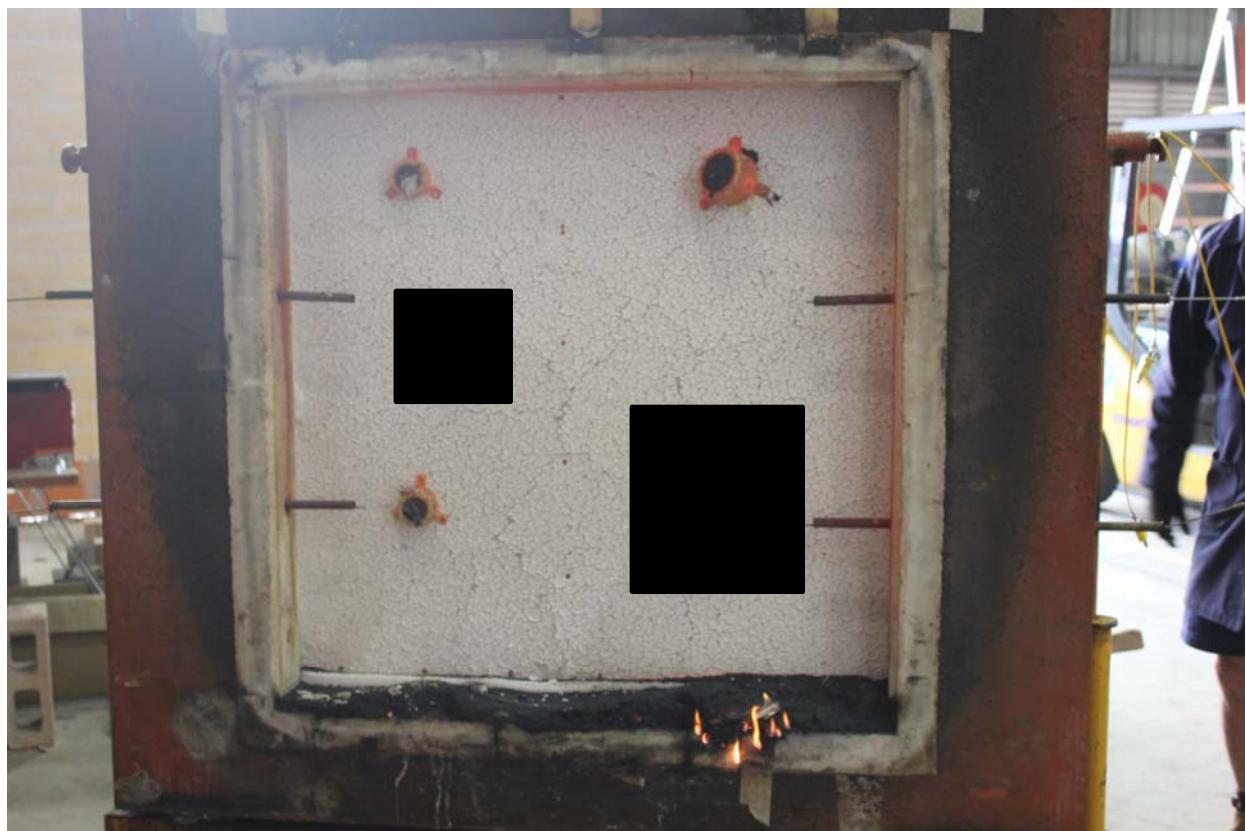
PHOTOGRAPH 9 – EXPOSED FACE OF SPECIMENS AT CONCLUSION OF TESTING

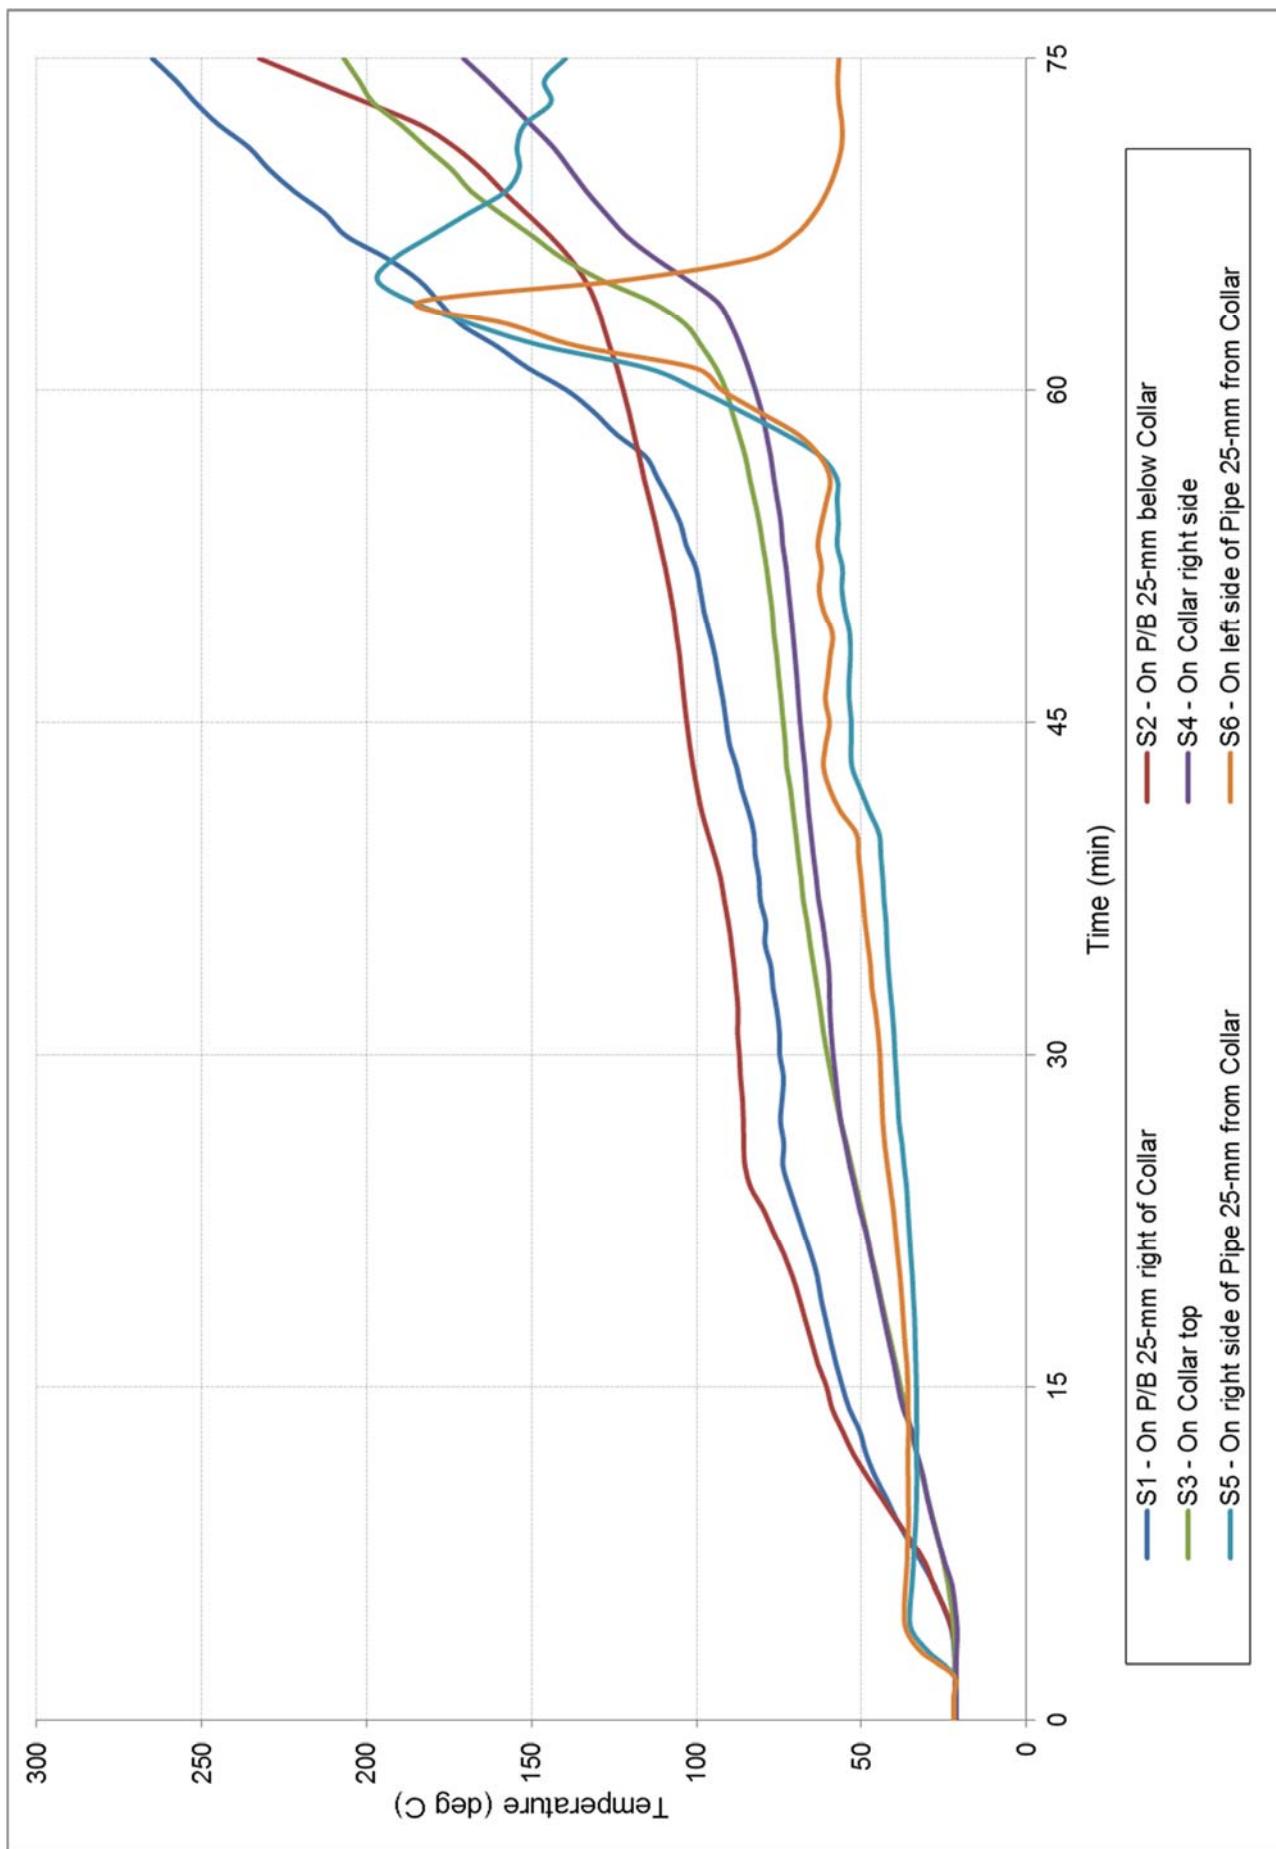
FIGURE 3 - TEMPERATURE VERSUS TIME ASSOCIATED WITH SPECIMEN #1

Figure 3 shows the curve of temperature versus time associated with Specimen 1.

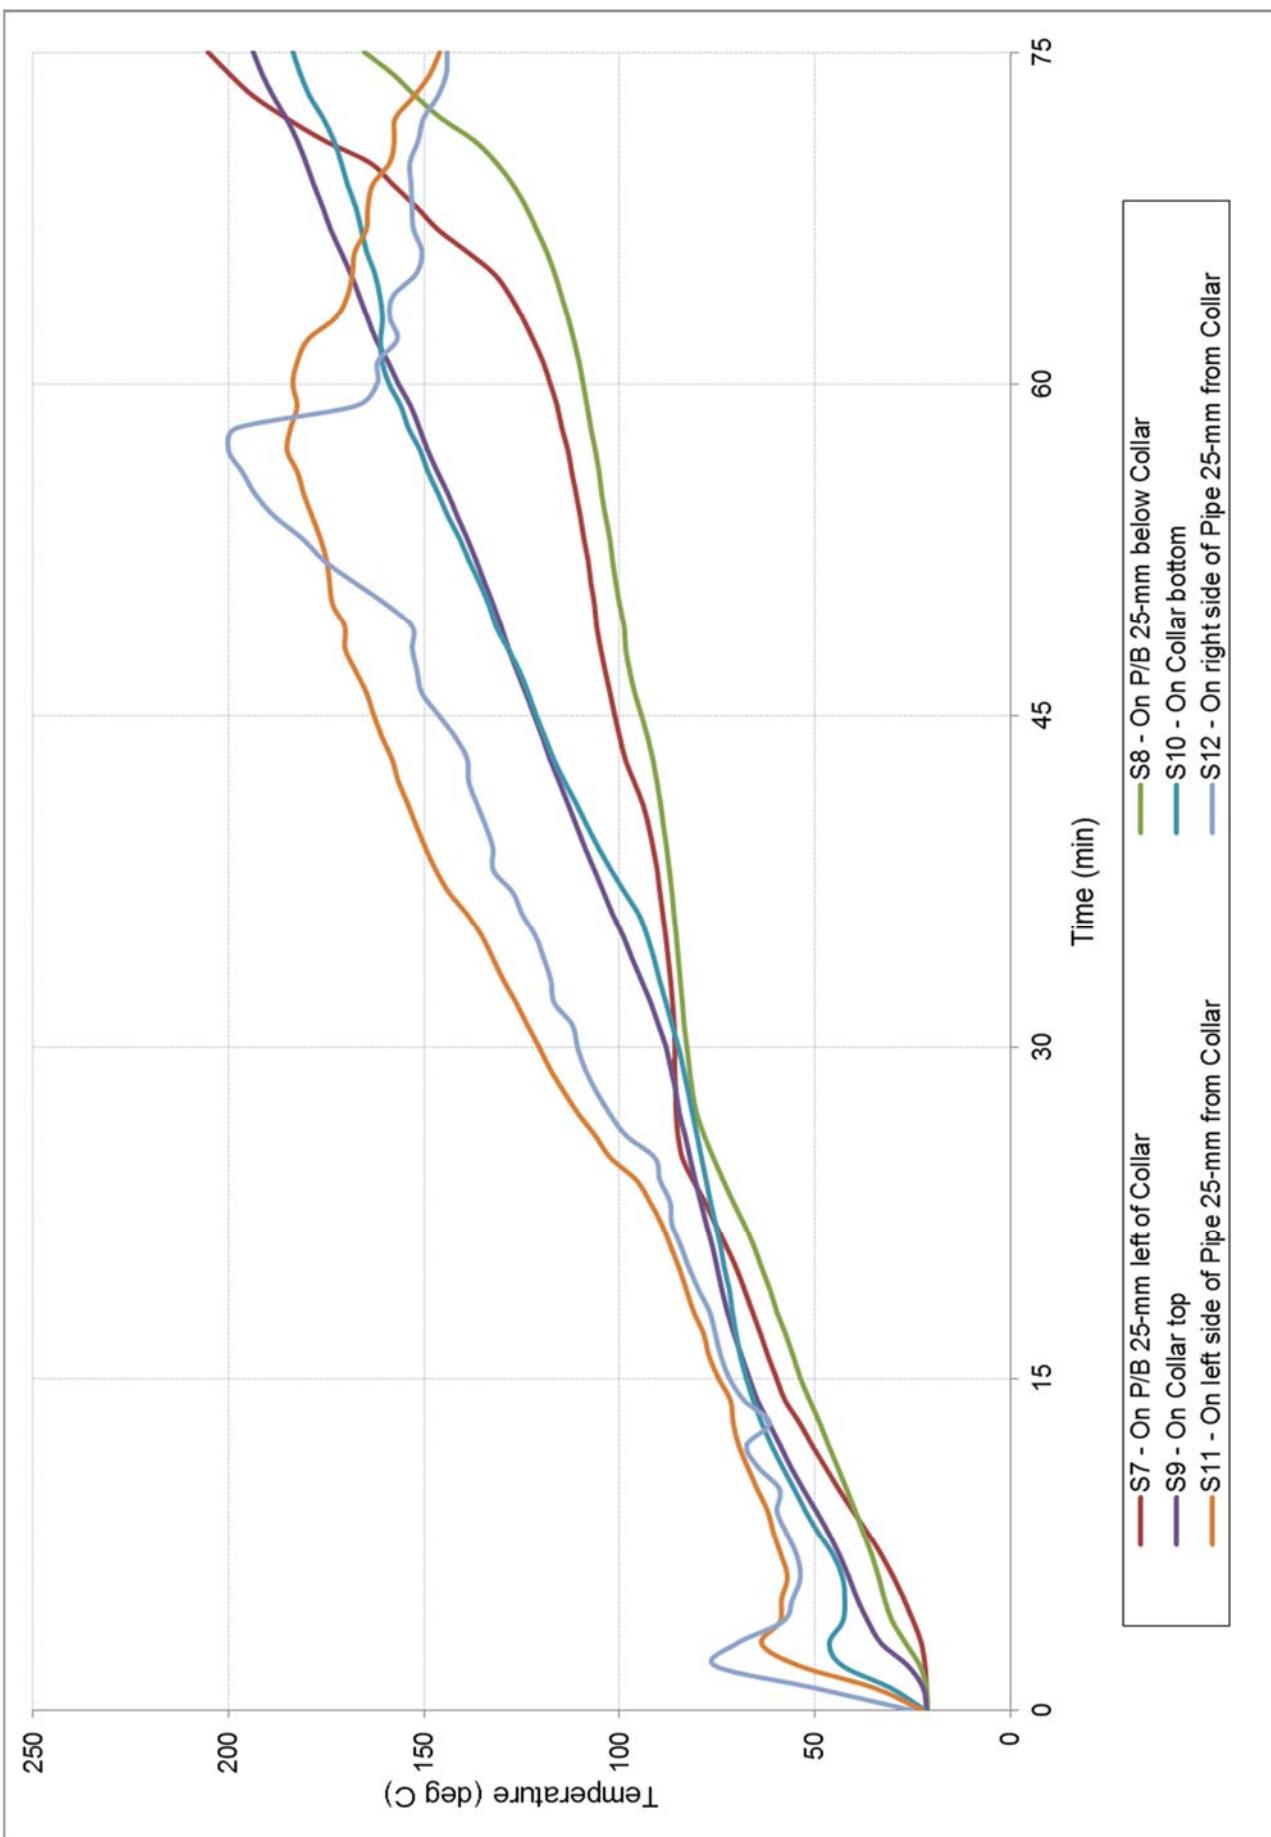
FIGURE 4 - TEMPERATURE VERSUS TIME ASSOCIATED WITH SPECIMEN #2

Figure 4 shows the curve of temperature versus time associated with Specimen 2.

Structural adequacy	-	not applicable
Integrity	-	no failure at 75 minutes
Insulation	-	75 minutes

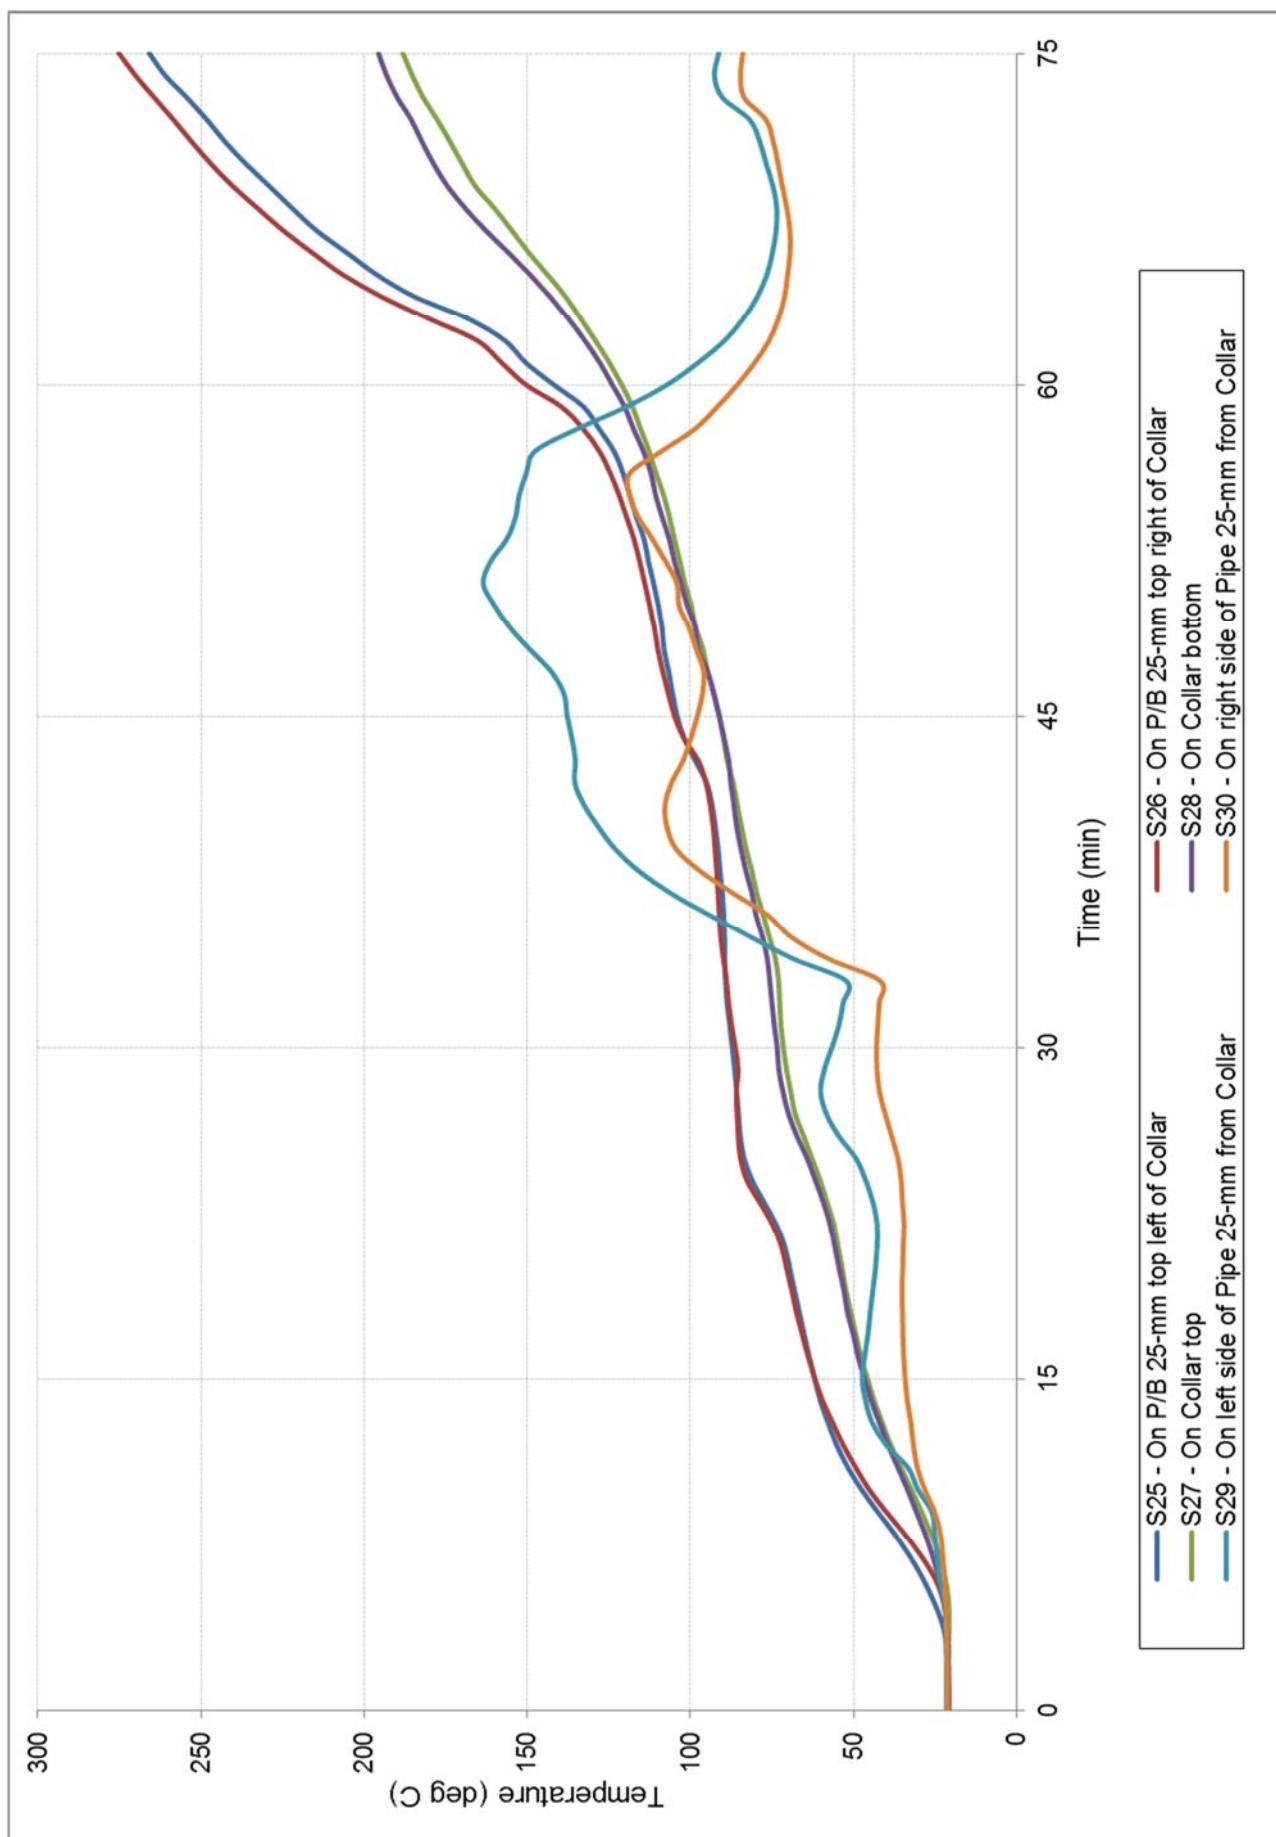
FIGURE 5 - TEMPERATURE VERSUS TIME ASSOCIATED WITH SPECIMEN #5

Figure 5 shows the curve of temperature versus time associated with Specimen 5.

Structural adequacy	-	not applicable
Integrity	-	no failure at 75 minutes
Insulation	-	66 minutes
