# Fire-resistance test on fire collars protecting a plasterboard wall penetrated by a single service

## Test Report

**Author:** Peter Gordon  
**Report number:** FSP 2040  
**Date:** 23 September 2019

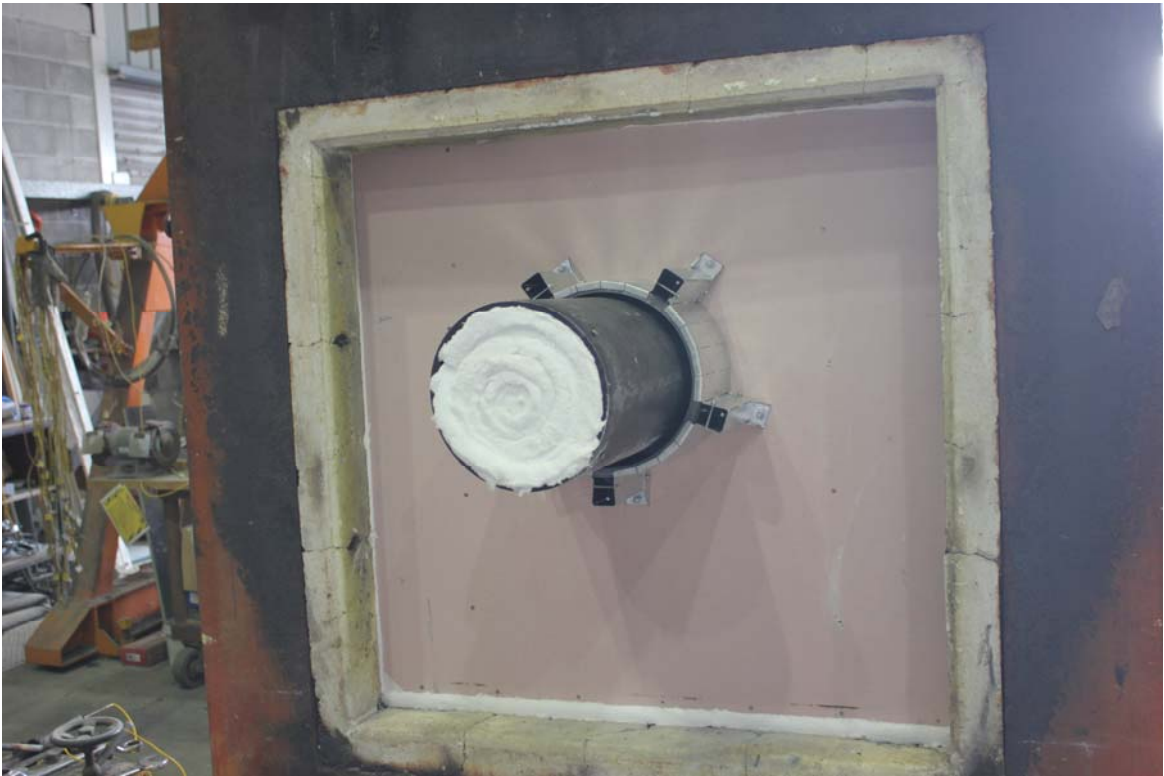
**PHOTOGRAPH 1 – EXPOSED FACE OF SPECIMEN 1 PRIOR TO TESTING**

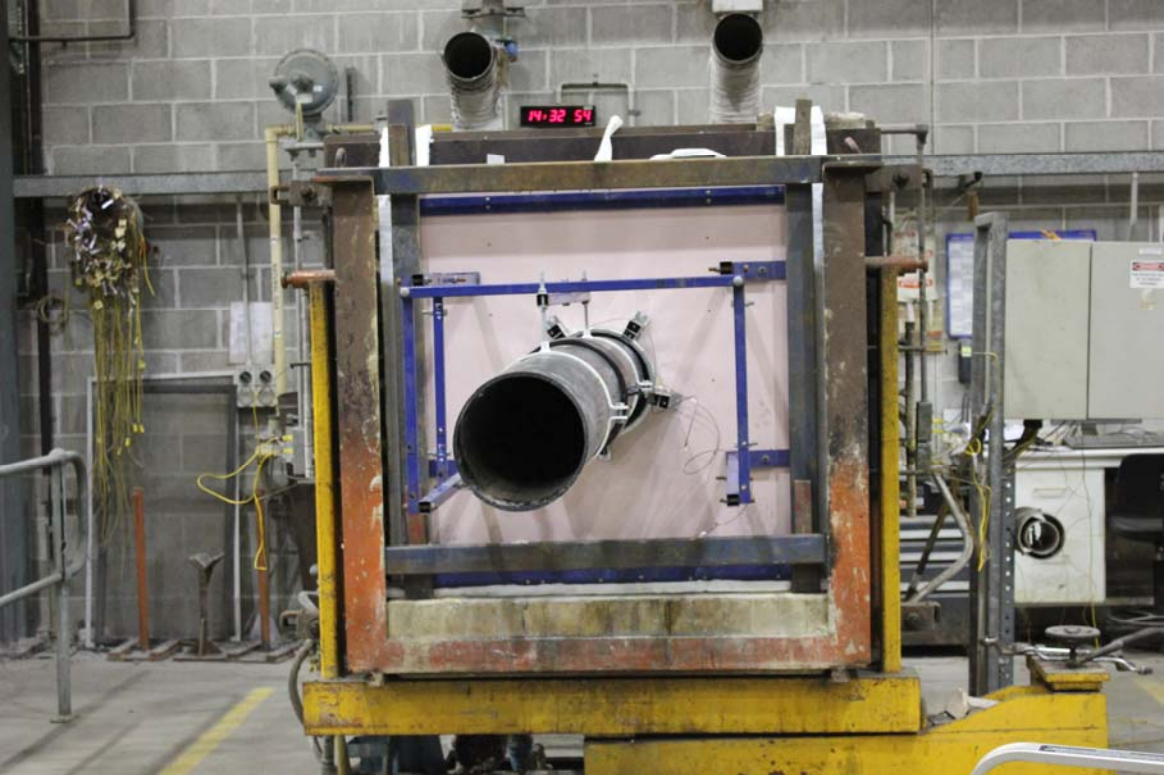
**PHOTOGRAPH 2 – UNEXPOSED FACE OF SPECIMEN 1 PRIOR TO TESTING**

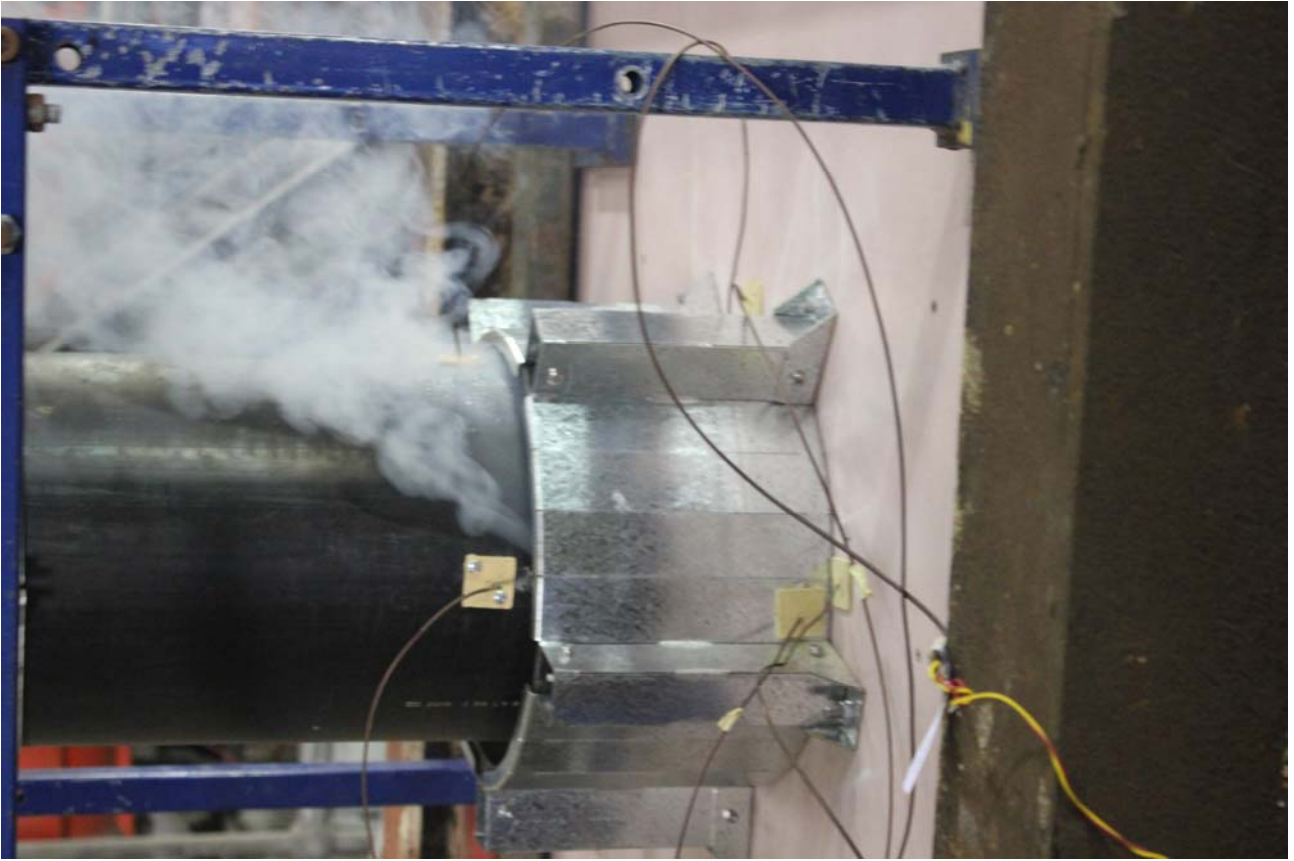
**PHOTOGRAPH 3 – SPECIMEN 1 AFTER 3 MINUTES OF TESTING**

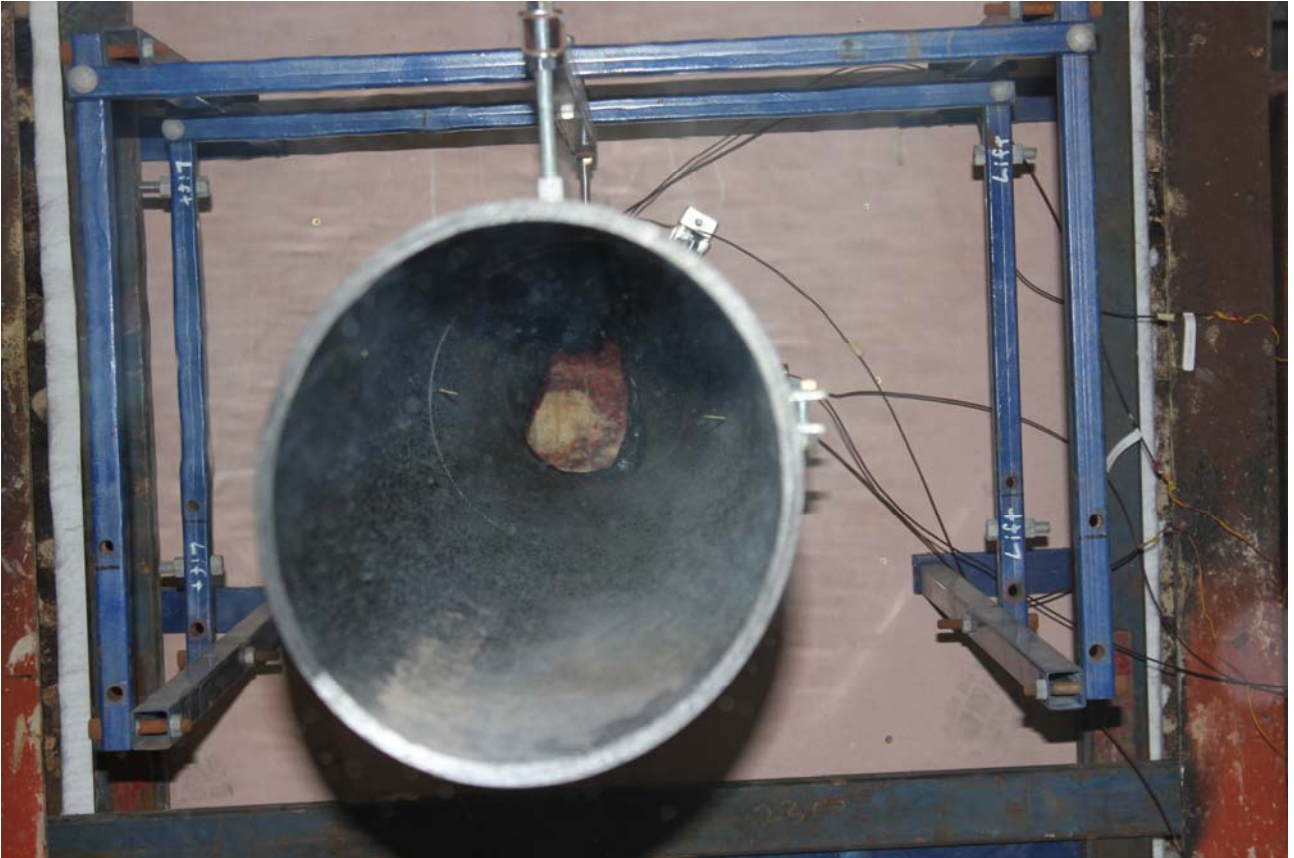
**PHOTOGRAPH 4 – SPECIMEN 1 AFTER 7 MINUTES OF TESTING**

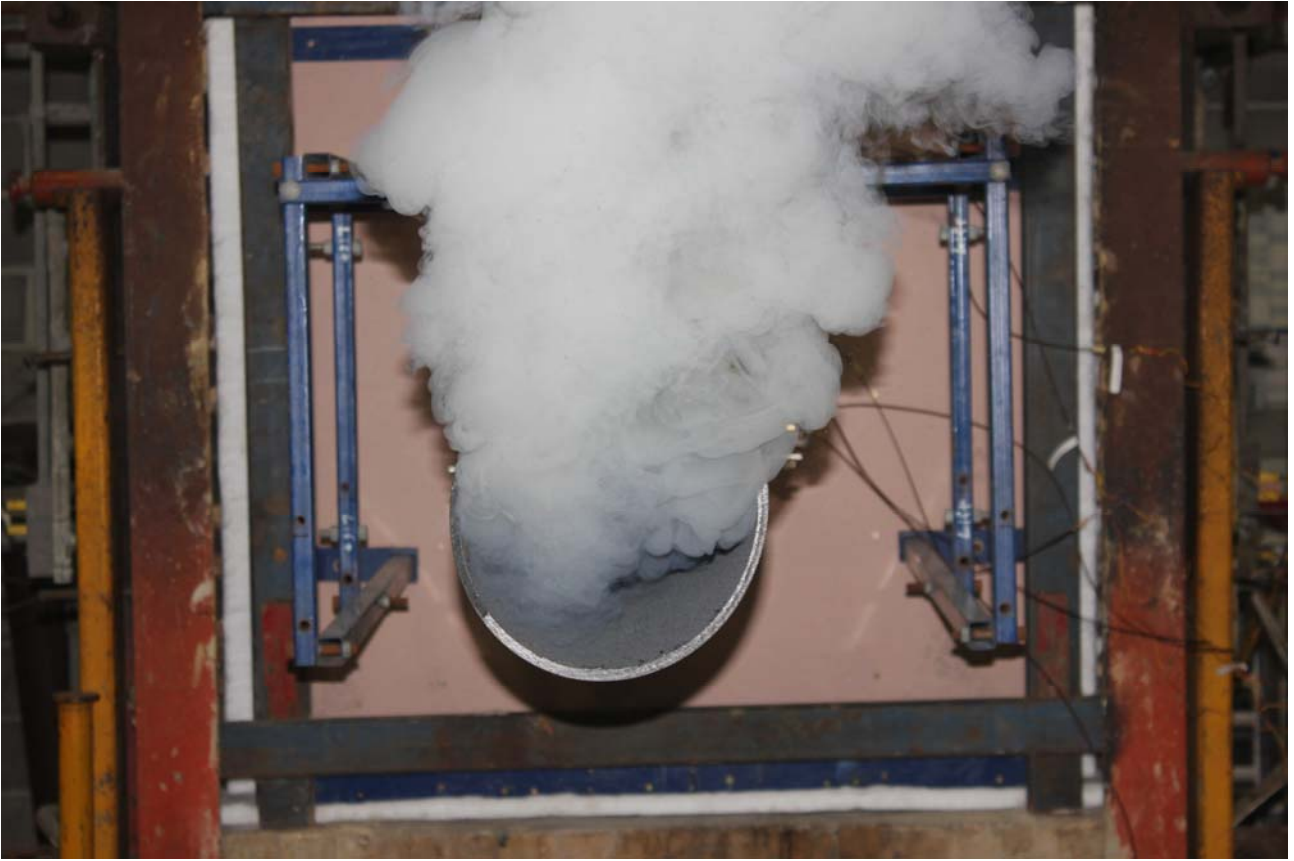
**PHOTOGRAPH 5 – SPECIMEN 1 AFTER 9 MINUTES OF TESTING**

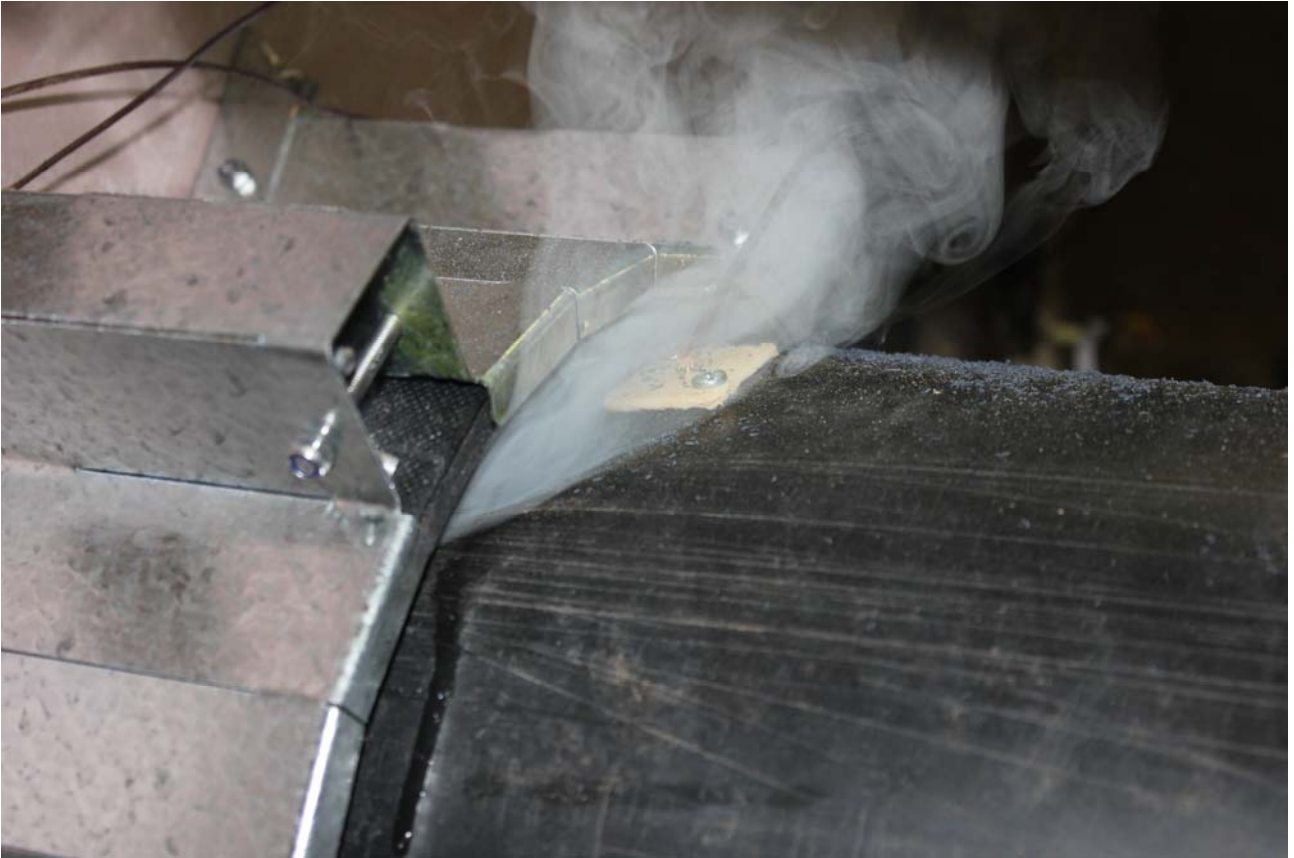
14 minutes -	The level of smoke emitted between the collar and the pipe has increased
16 minutes -	A large gap has begun to form between the top of pipe and the inside of the collar where the pipe has deformed and begun to collapse. The pipe has moved inwards towards the furnace approximately 7-mm. Cotton pad applied over the gap. No ignition noted at this time.
17 minutes -	Smoke has ceased fluing from the end of the pipe of Specimen 1.
20 minutes -	Cotton pad applied over the gap. No ignition noted at that time.
23 minutes -	Intumescent material has filled the large gap inside the collar where the pipe had collapsed.

**PHOTOGRAPH 6 – SPECIMEN 1 AFTER 16 MINUTES OF TESTING**

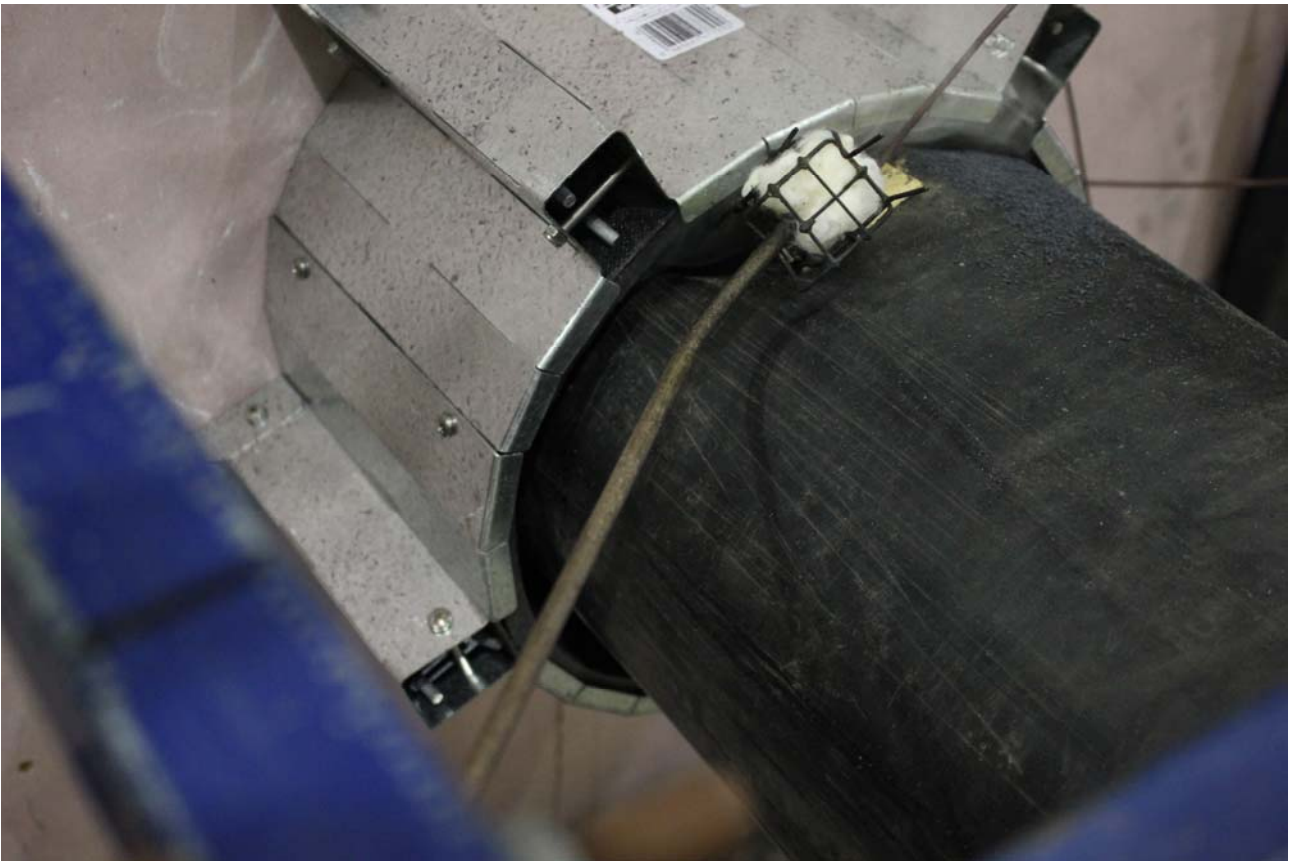
**PHOTOGRAPH 7 – SPECIMEN 1 AFTER 20 MINUTES OF TESTING**

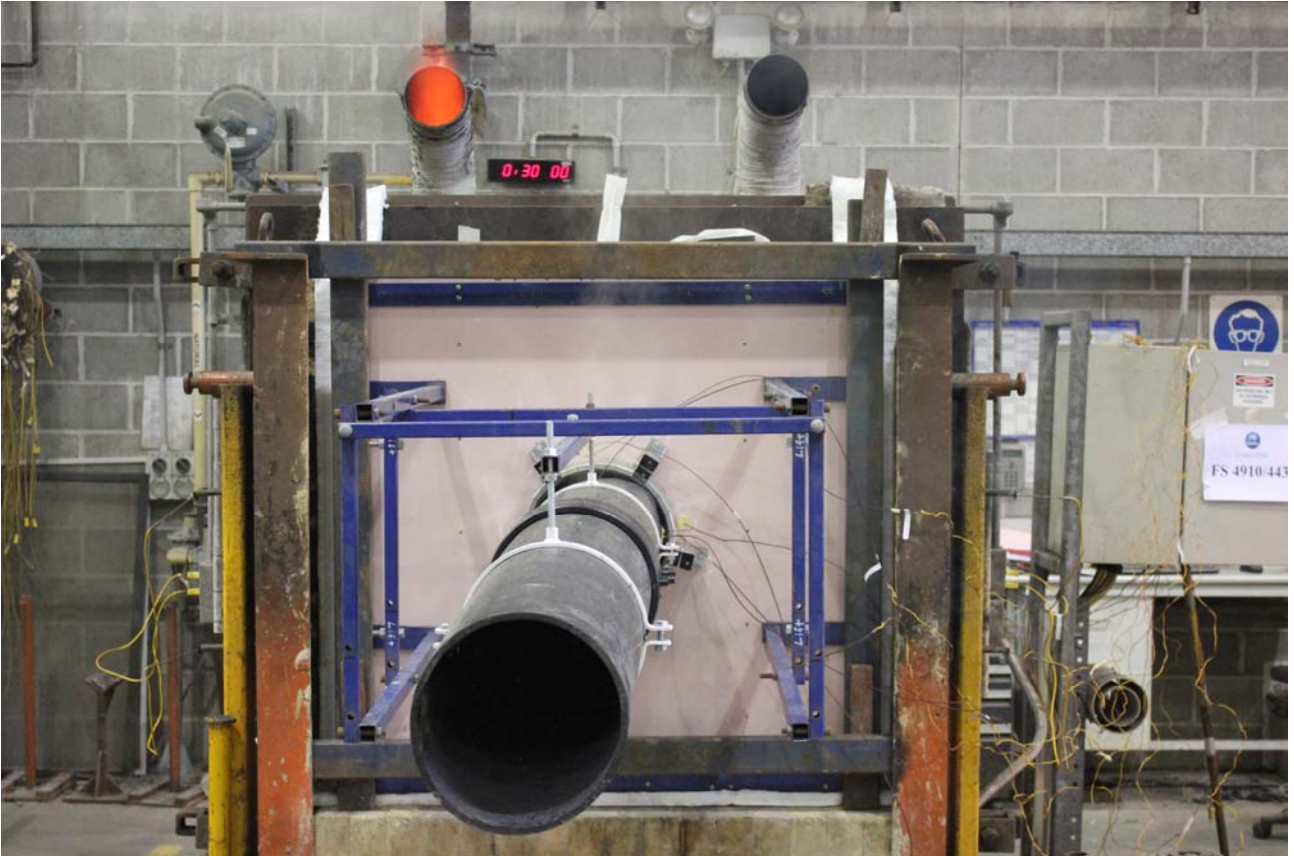
**PHOTOGRAPH 8 – SPECIMEN 1 AFTER 30 MINUTES OF TESTING**

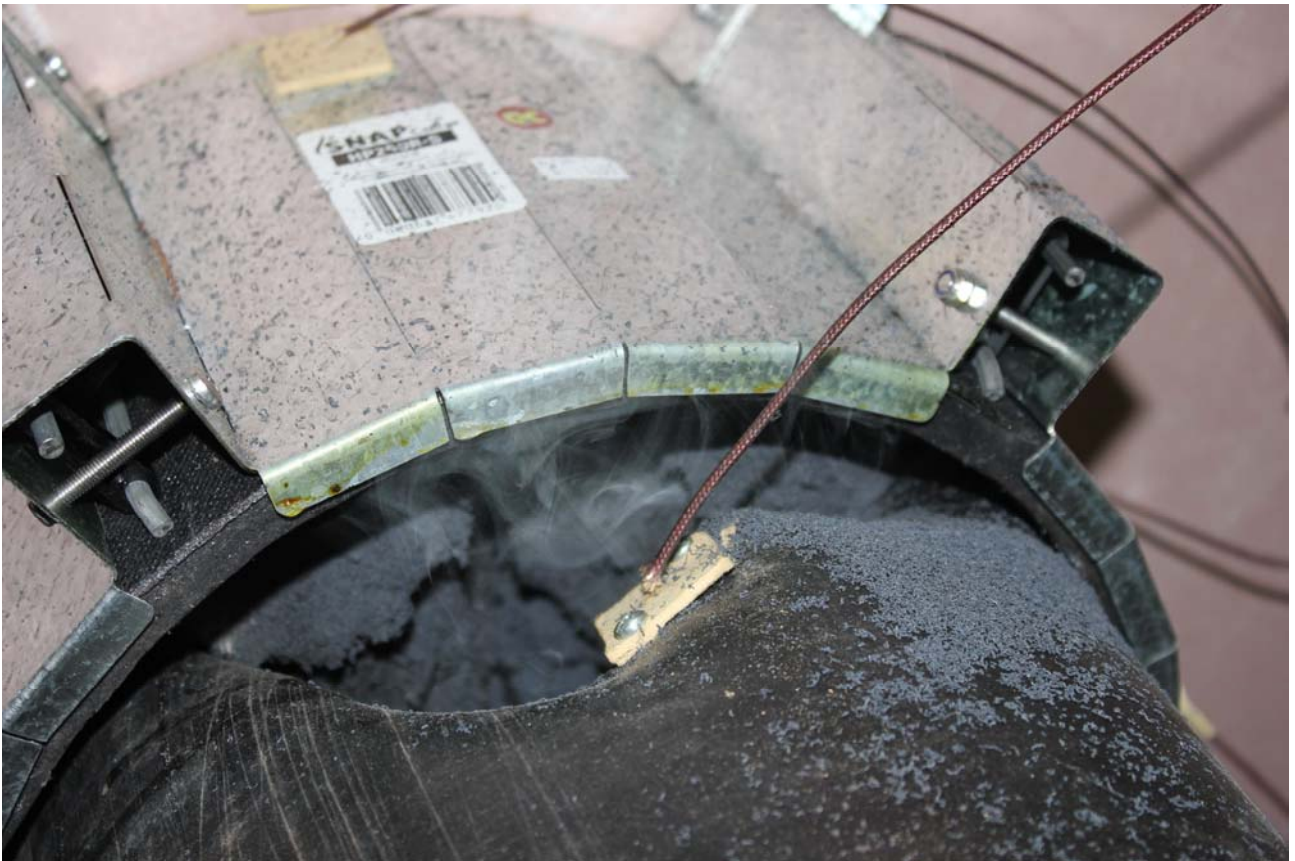
- 35 minutes - Light smoke is being emitted between the collar and the pipe of Specimen 1.
- 40 minutes - Intumescent material continues to fill the large gap inside the collar.
- 60 minutes - No further visible change to specimen.
- 121 minutes - Test terminated.

**PHOTOGRAPH 9 – SPECIMEN 1 AFTER 40 MINUTES OF TESTING**

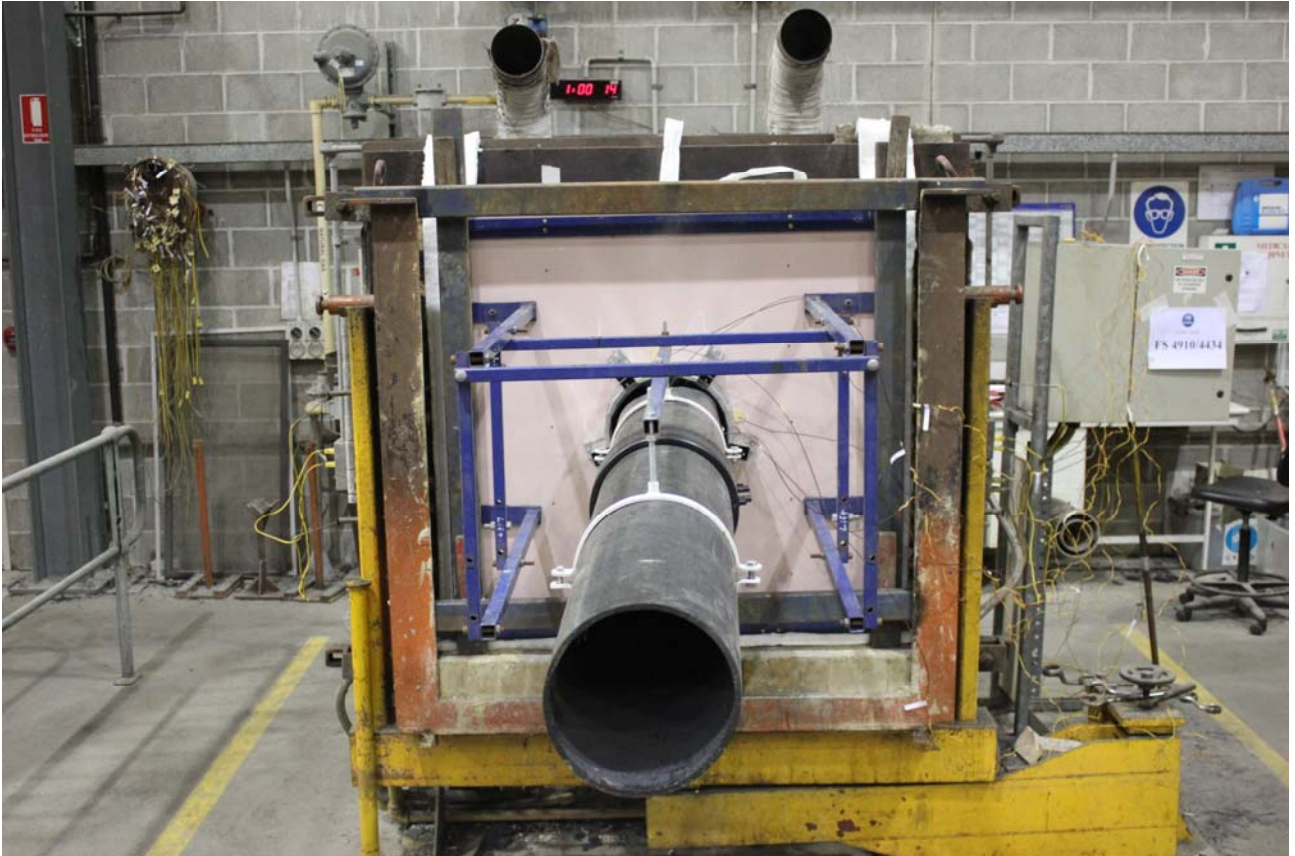
**PHOTOGRAPH 10 – SPECIMEN 1 AFTER 60 MINUTES OF TESTING**

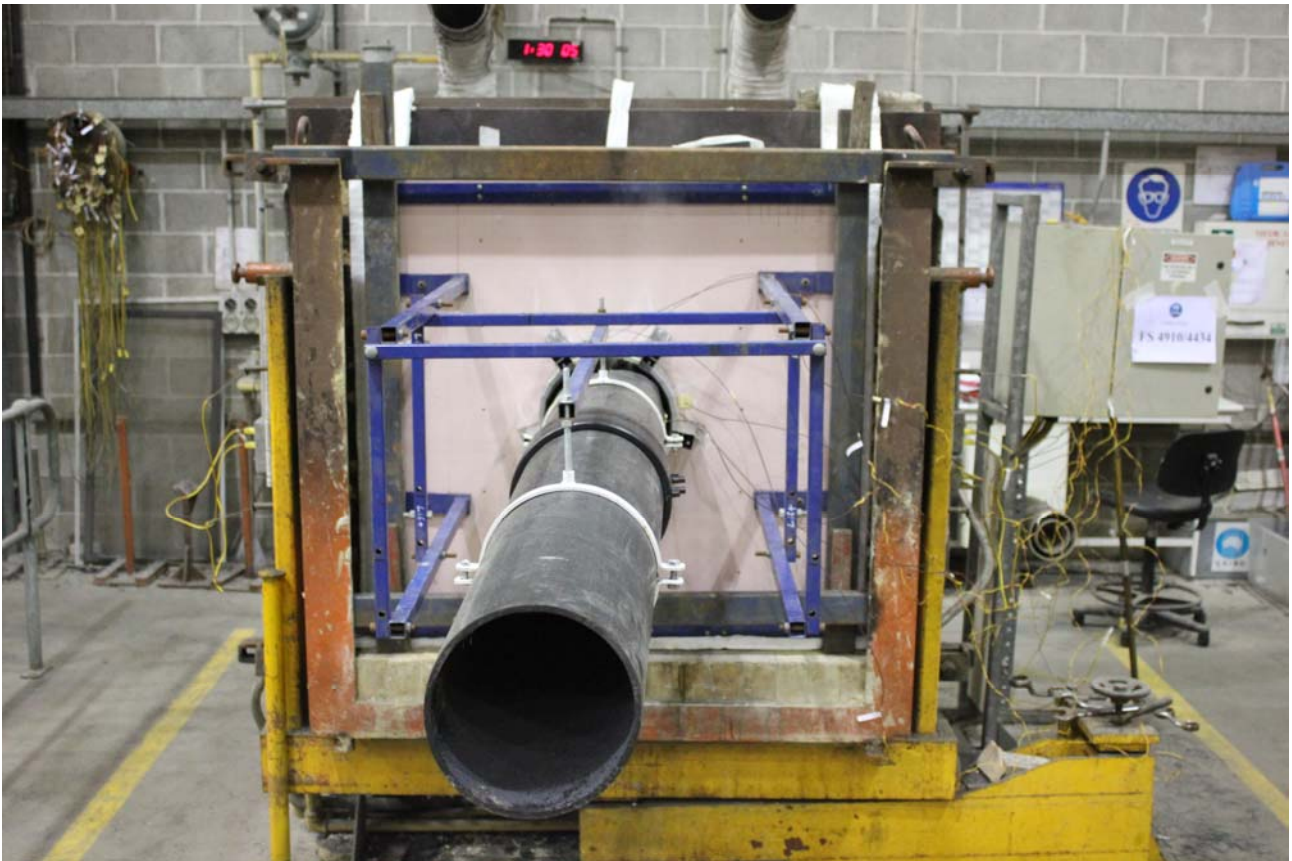
**PHOTOGRAPH 11 – SPECIMEN 1 AFTER 90 MINUTES OF TESTING**

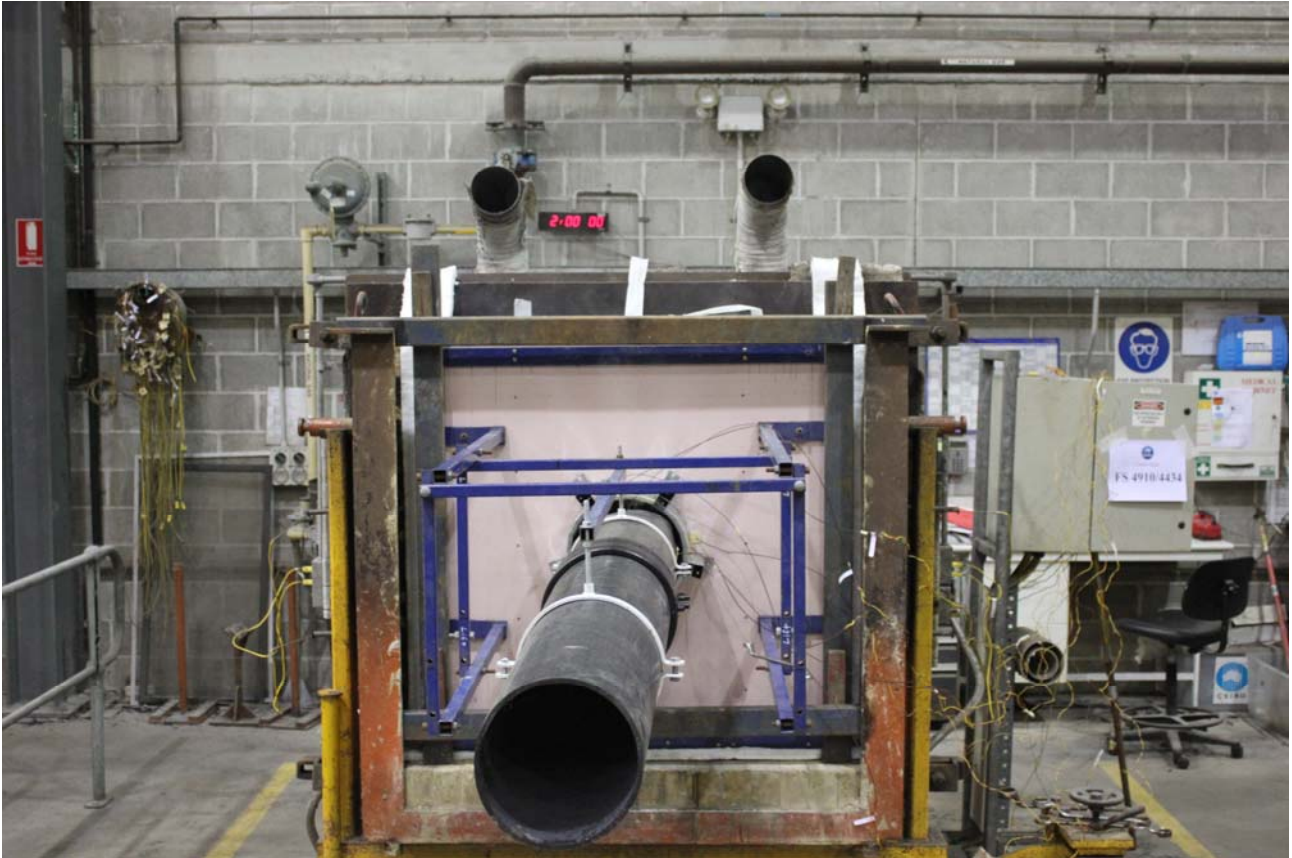
**PHOTOGRAPH 12 – SPECIMEN 1 AFTER 120 MINUTES OF TESTING**

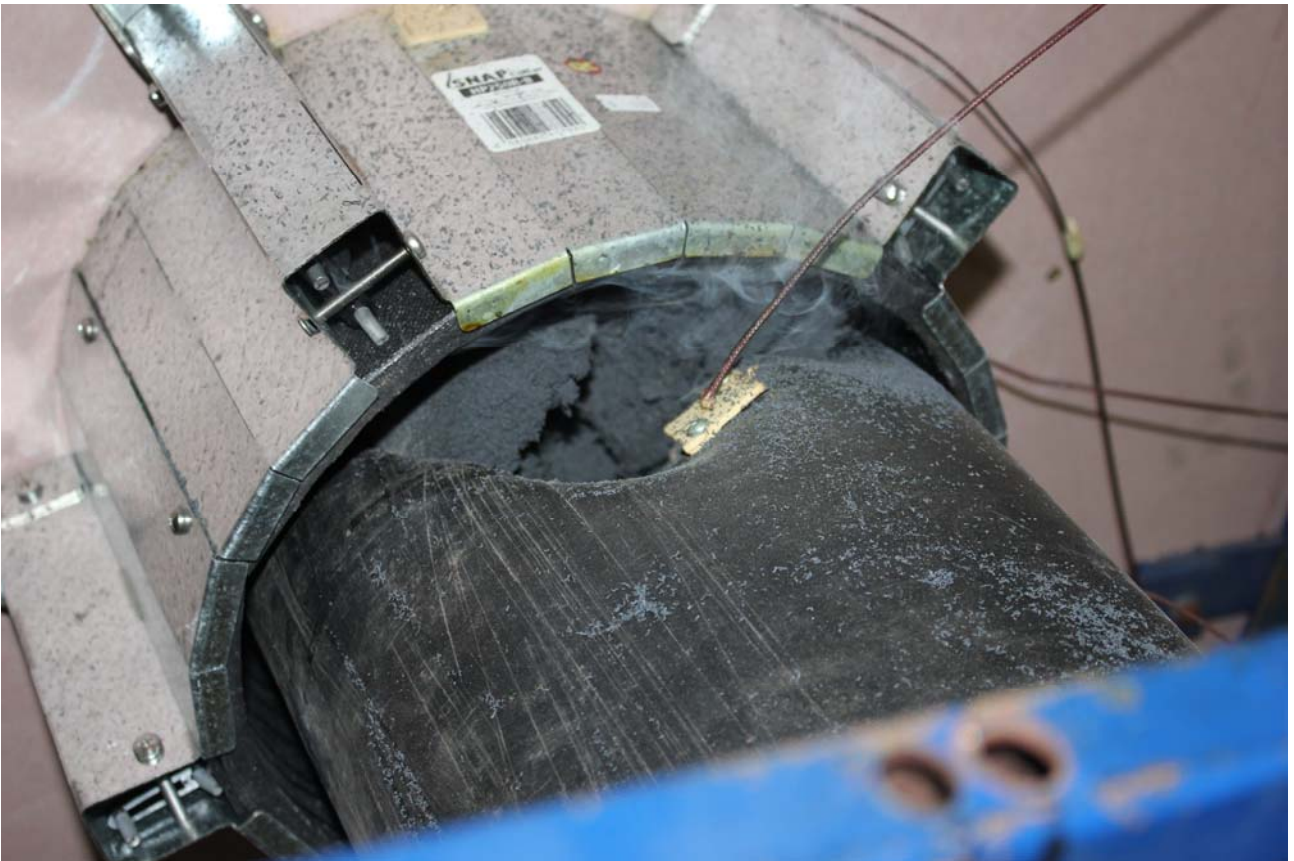
**PHOTOGRAPH 13 – SPECIMEN 1 AFTER 120 MINUTES OF TESTING**

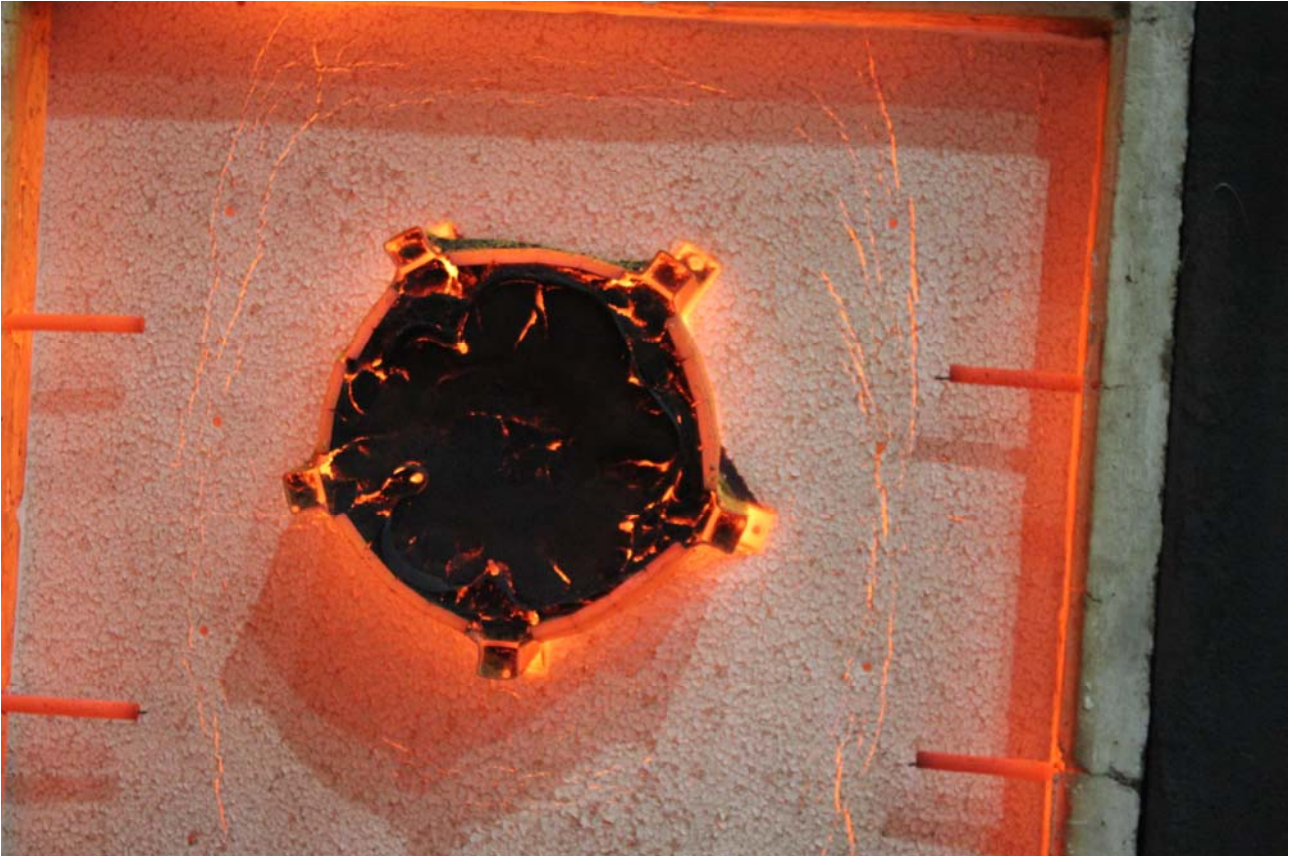
**PHOTOGRAPH 14 – EXPOSED FACE OF SPECIMEN 1 AT CONCLUSION OF TESTING**

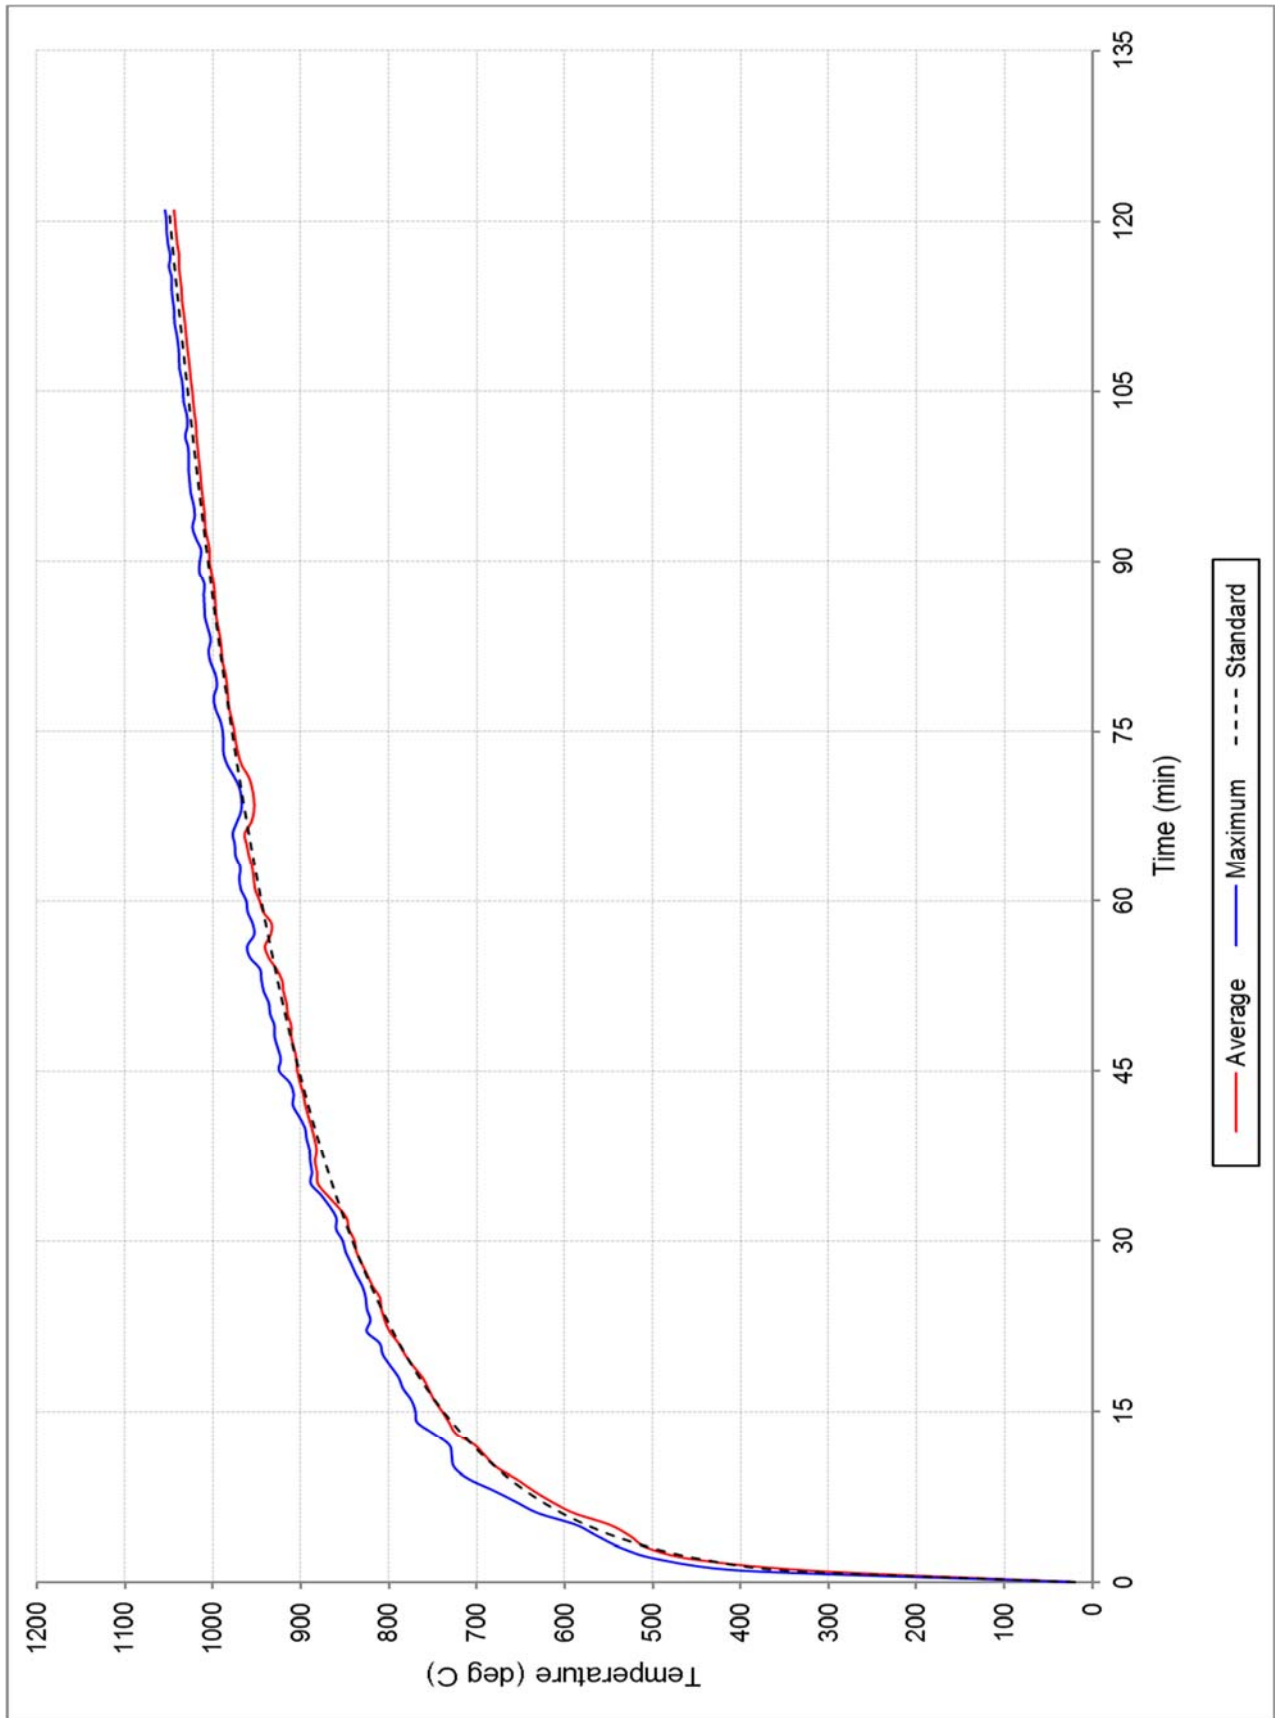
FIGURE 1 – FURNACE TEMPERATURE

Figure 1 shows the standard curves of temperature versus time for heating the furnace chamber and the actual curves of average and maximum temperature versus time recorded during the heating period.

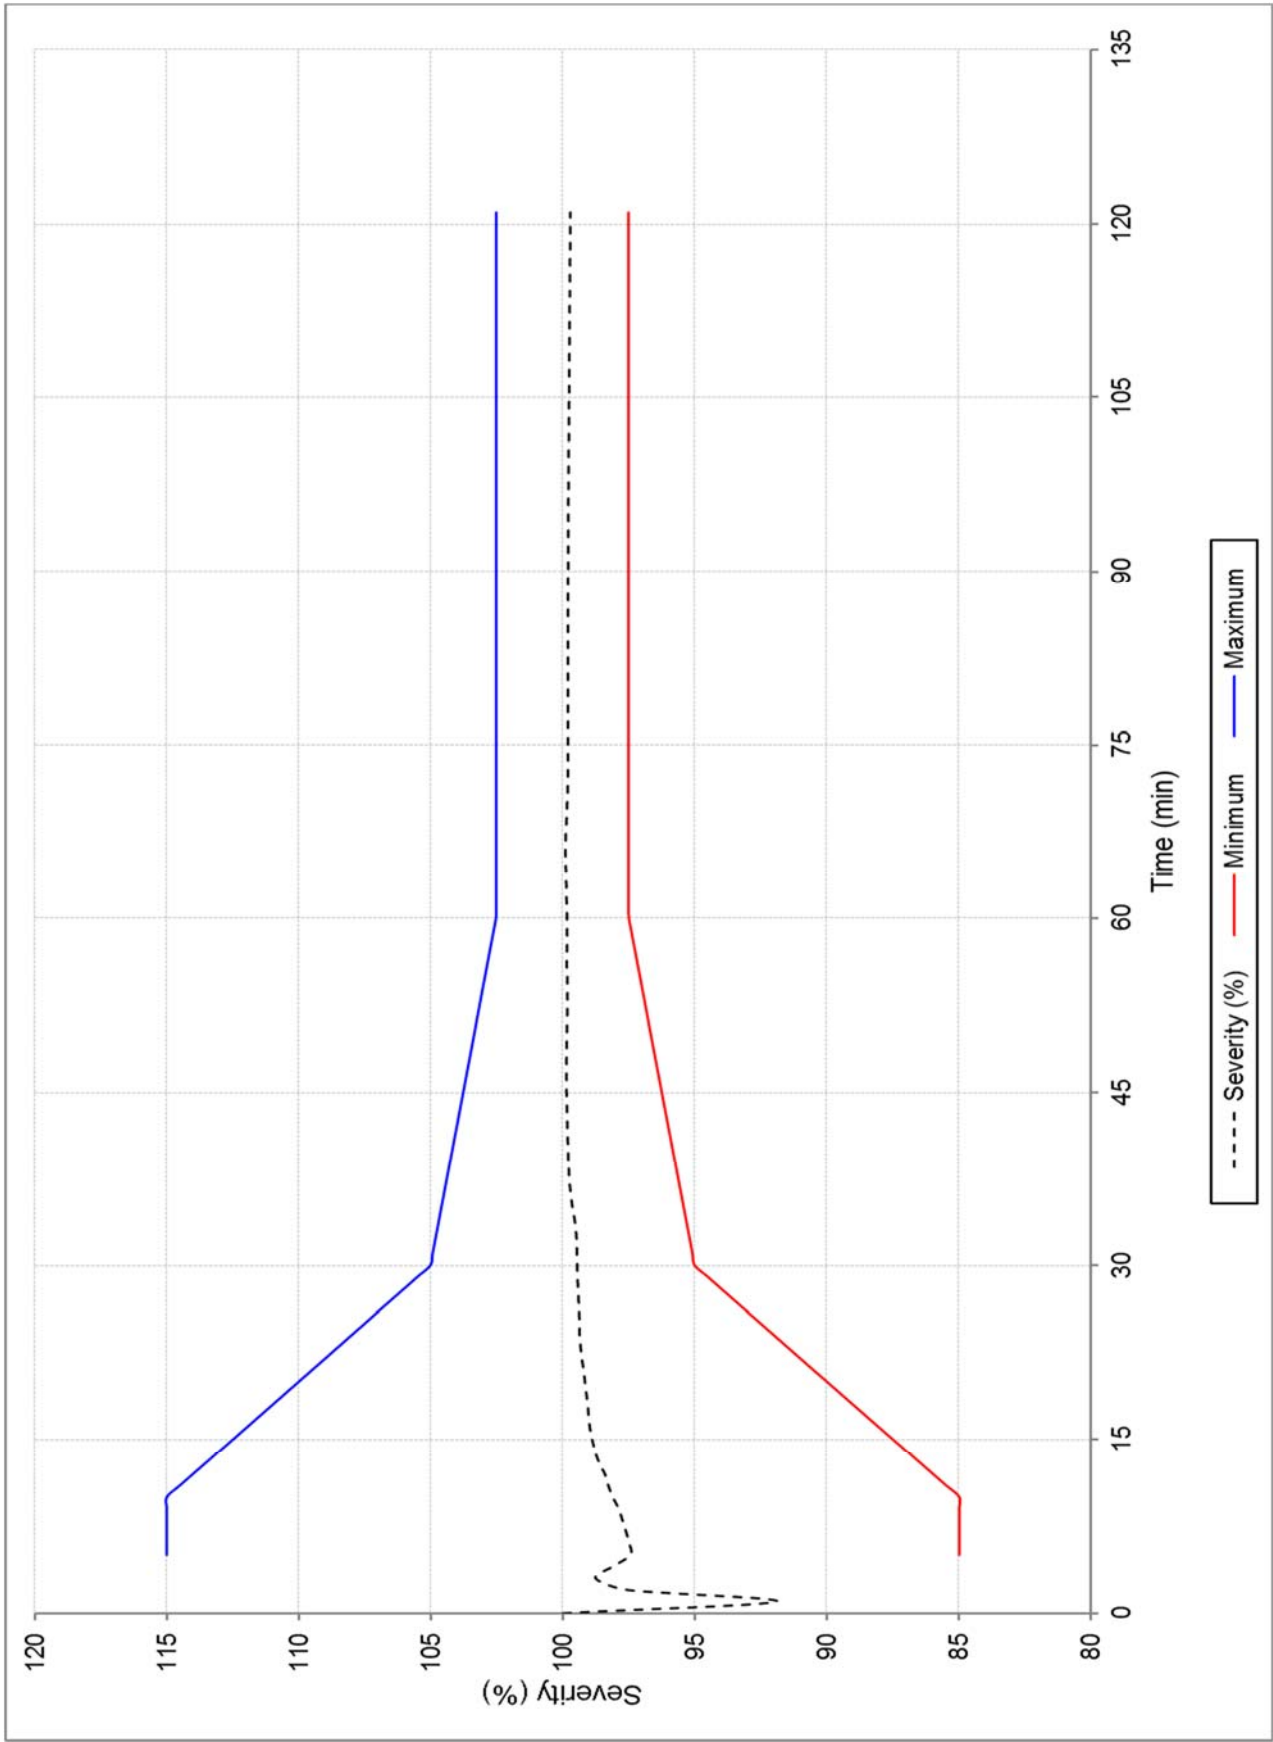
FIGURE 2 – FURNACE SEVERITY

Figure 2 shows the curve of furnace severity versus time during the heating period.

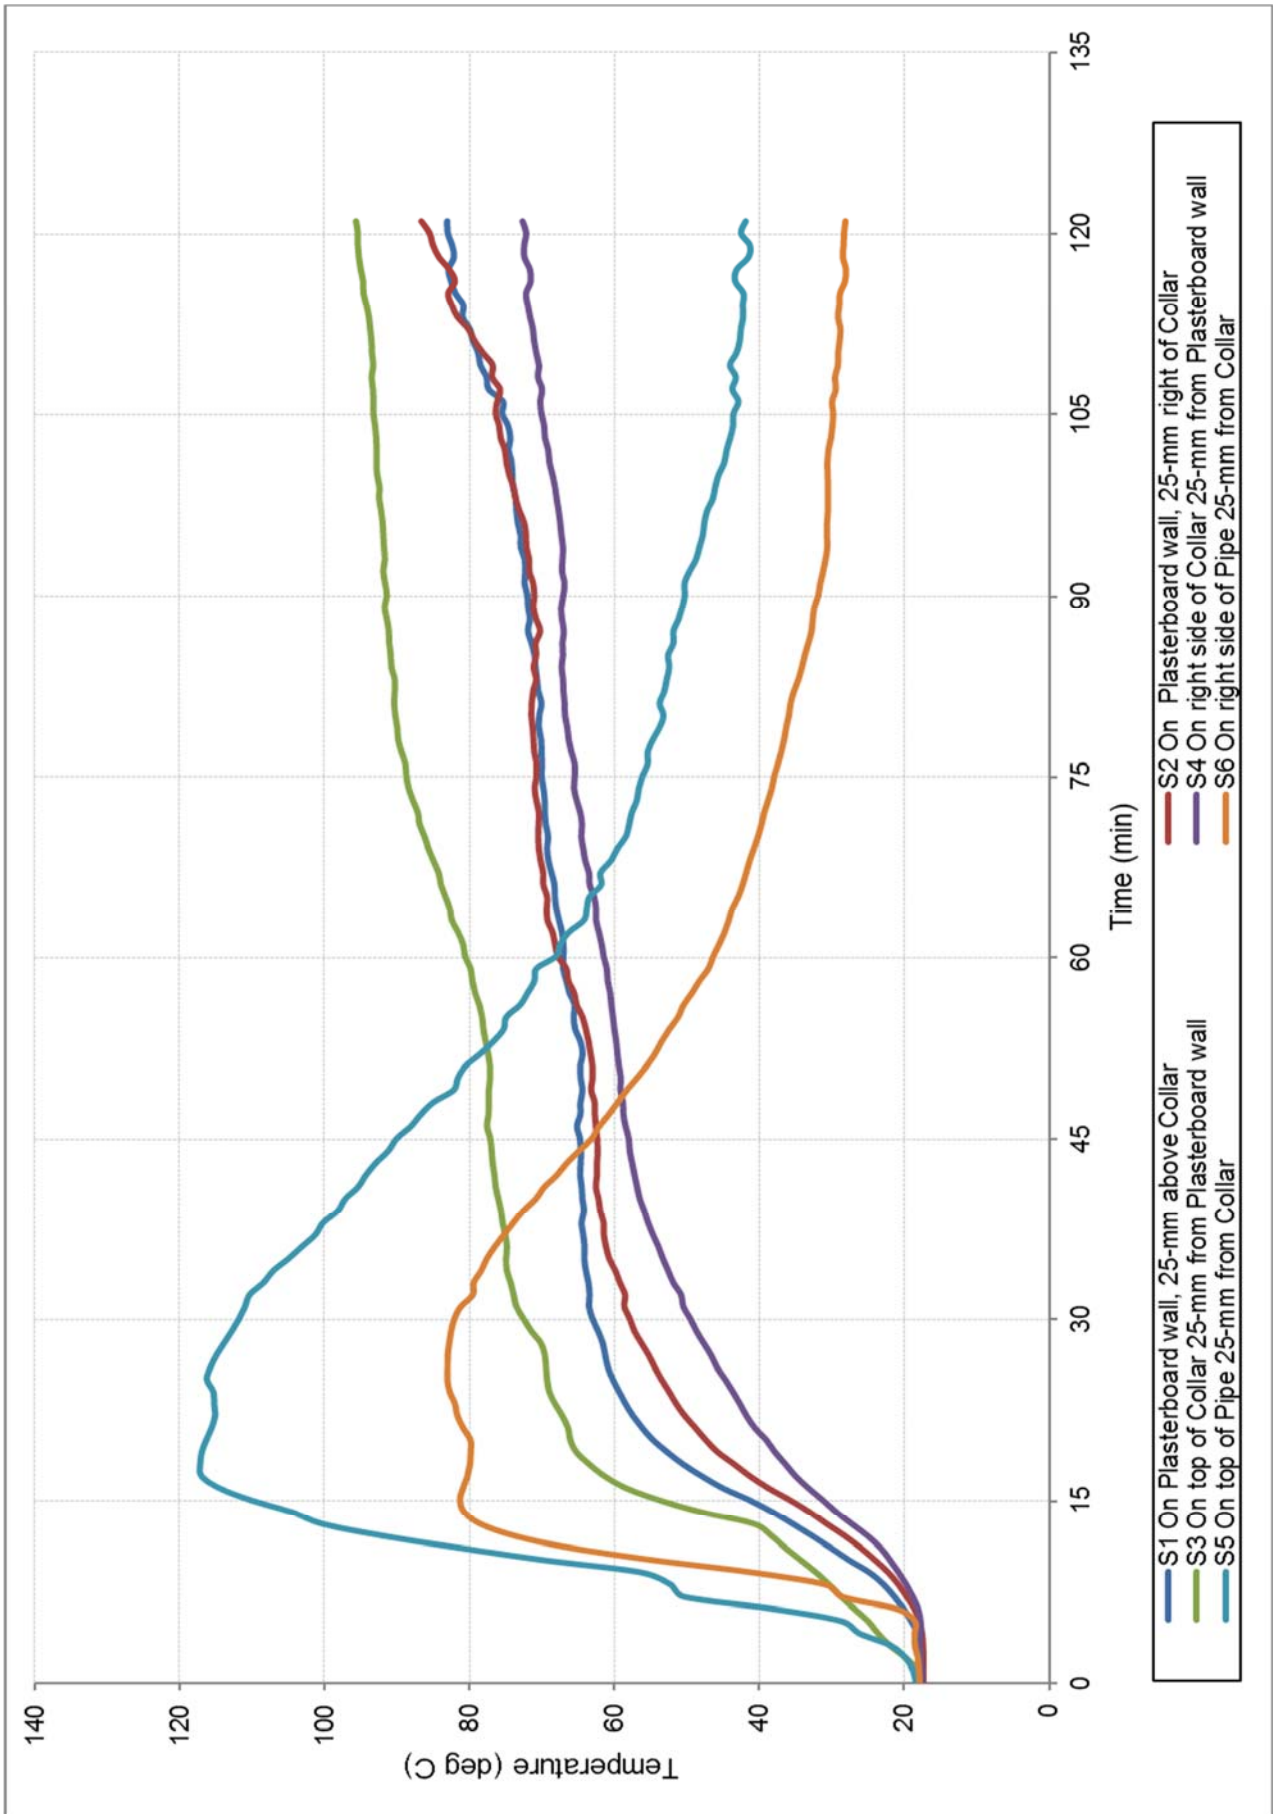
FIGURE 3 - SPECIMEN 1 TEMPERATURE

Figure 3 shows the curve of temperature versus time associated with Specimen 1.
