Fire-resistance test on fire collars protecting a concrete slab penetrated by services

Test Report

Author: Peter Gordon
Report number: FSP 2231
Date: 2 November 2021

Sponsored Investigation No. FSP 2231

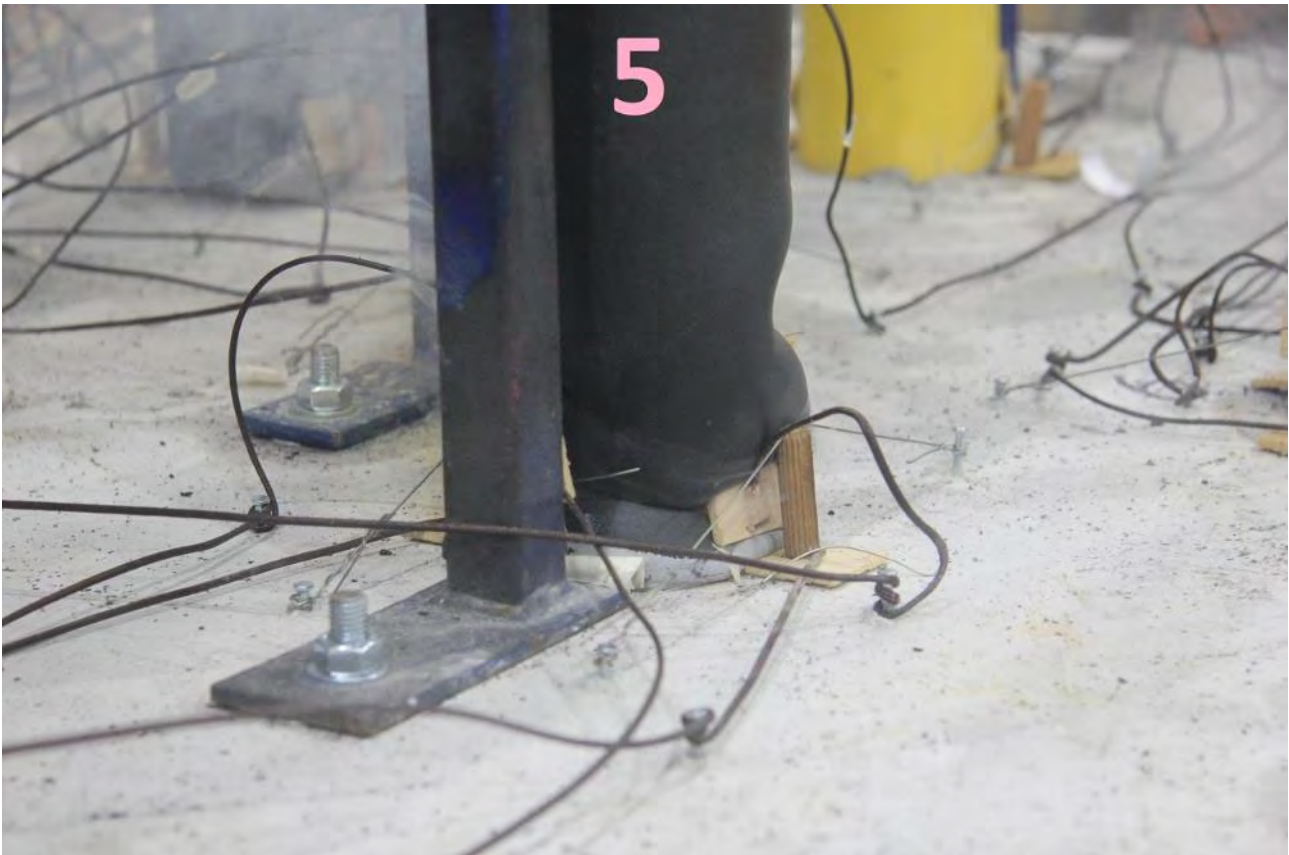
85 minutes -	<u>Insulation failure of Specimen 5</u> - maximum temperature rise of 180K is on the exposed pipe lagging (Thermocouple #29), 25-mm above the mastic.
91 minutes -	Roving thermocouple applied to the sealant at the base of Specimen 3. A temperature 52°C degrees was recorded at this time.
99 minutes -	Roving thermocouple applied to pipe lagging at the base of Specimen 5 approximately 25-mm above the slab. A temperature 145°C degrees was recorded at this time.

PHOTOGRAPH 15 – SPECIMEN 5 AT 86 MINUTES INTO THE TEST

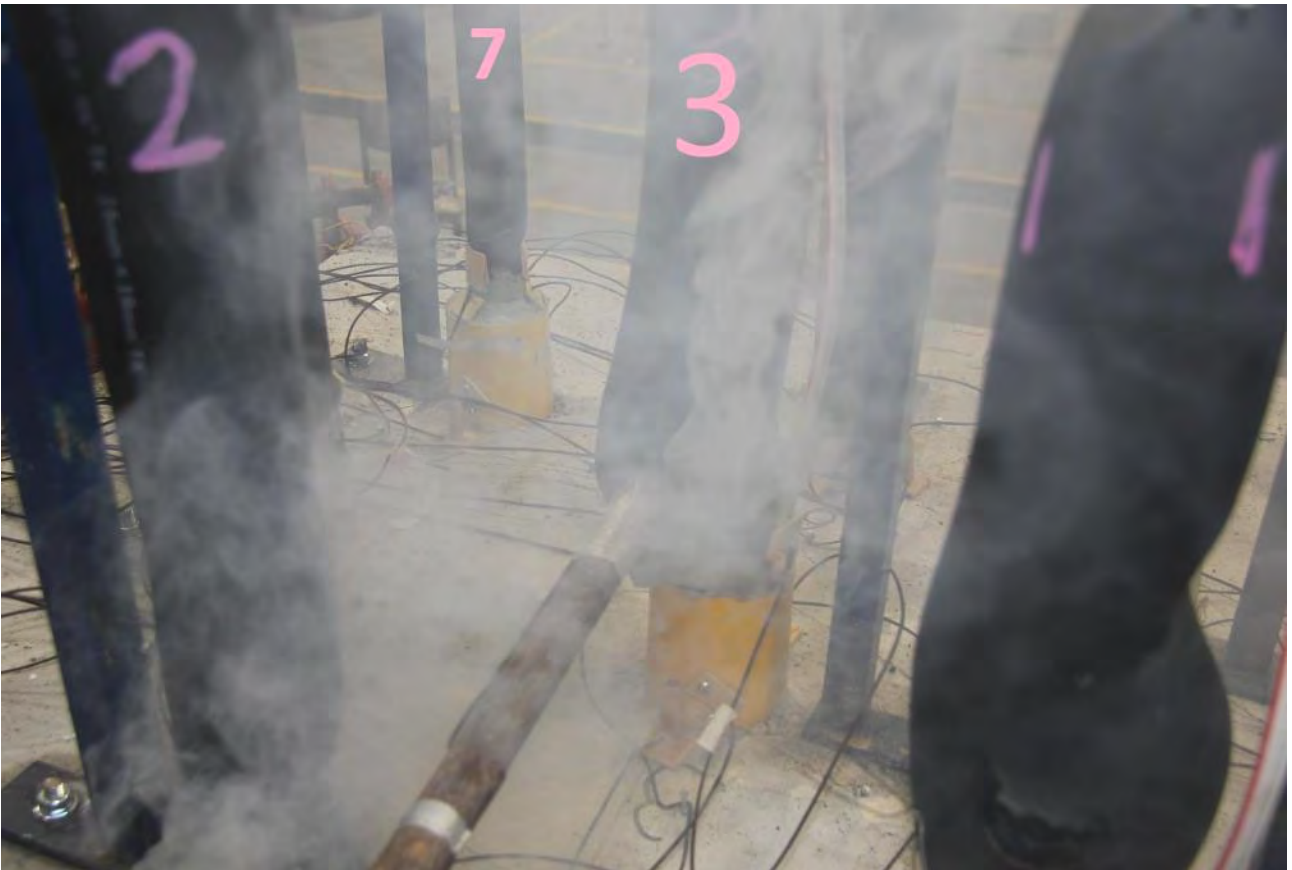
- 118 minutes - The pipe lagging of Specimen 3 has ruptured with hot gases and smoke venting through a hole approximately 30-mm above the collar casing is visible.

- 119 minutes - The pipe lagging at the base of Specimen 3 has begun to split. Rover applied to the split surface of the lagging, with a maximum temperature of 119°C noted at this time.

PHOTOGRAPH 19 –SPECIMEN 3 AT 119 MINUTES INTO THE TEST

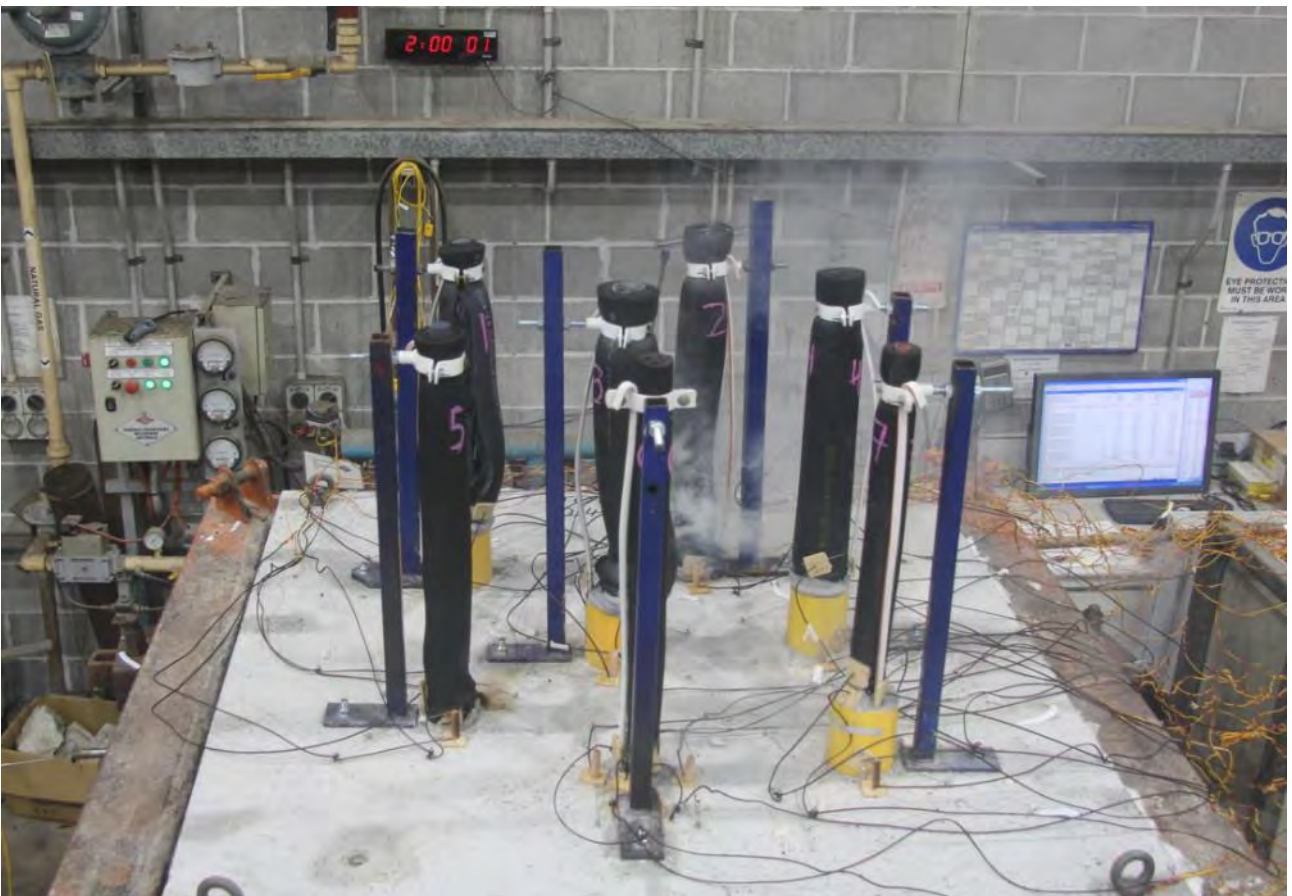
- 120 minutes - Insulation failure of Specimen 2 - maximum temperature rise of 180K is exceeded on the lagging – north side, 25-mm above the collar casing.
Insulation failure of Specimen 3 - maximum temperature rise of 180K is exceeded on the lagging – north side, 25-mm above the collar casing.

PHOTOGRAPH 20 – SPECIMENS AT 120 MINUTES INTO THE TEST

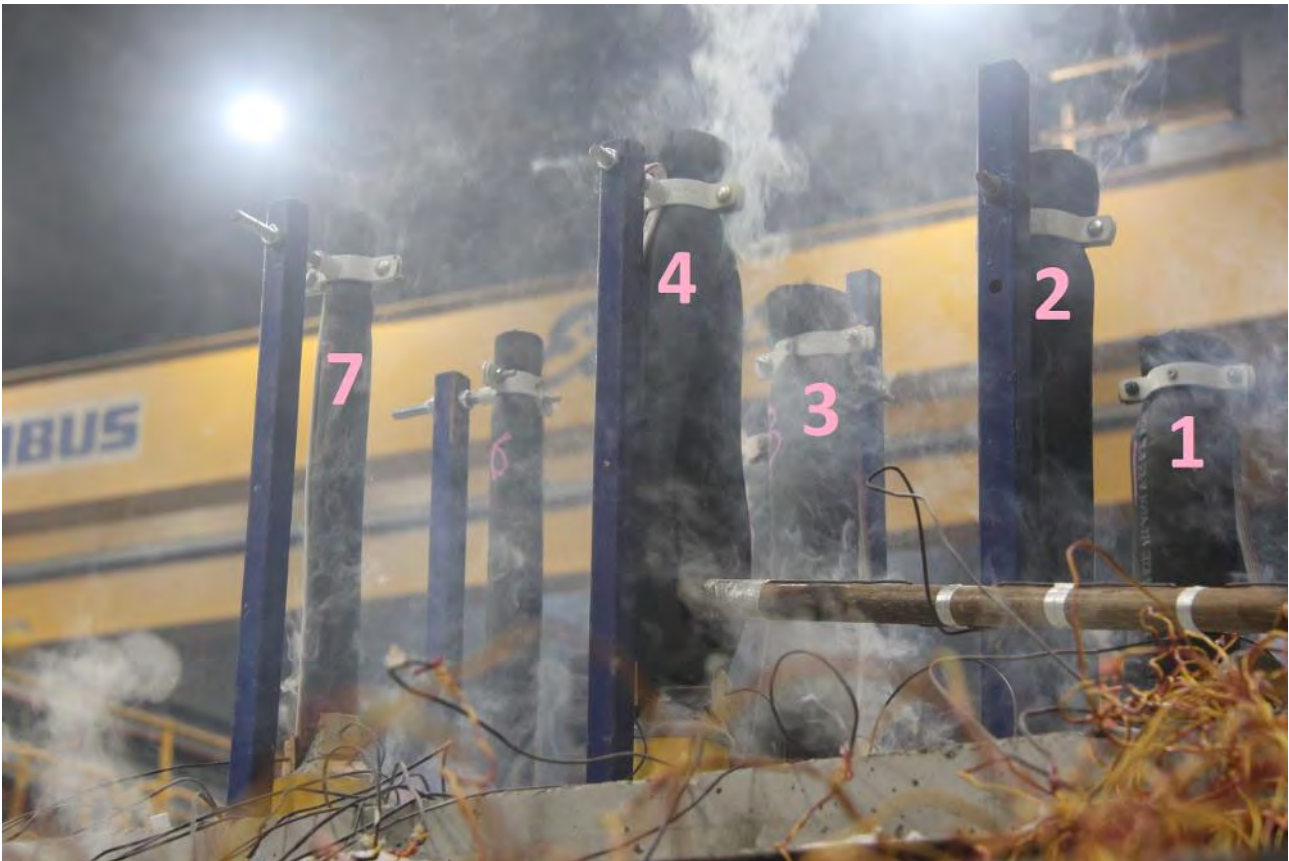
- 134 minutes - Roving thermocouple applied to the split pipe lagging at the base of Specimen 4 above the collar. A temperature of 352°C degrees was recorded at this time.
Insulation failure of Specimen 4 - maximum temperature rise of 180K is exceeded (roving thermocouple recorded a temperature of 352°C) on the split pipe lagging of the specimen above the collar (photograph 21).

PHOTOGRAPH 21 –SPECIMEN 4 AT 134 MINUTES INTO THE TEST

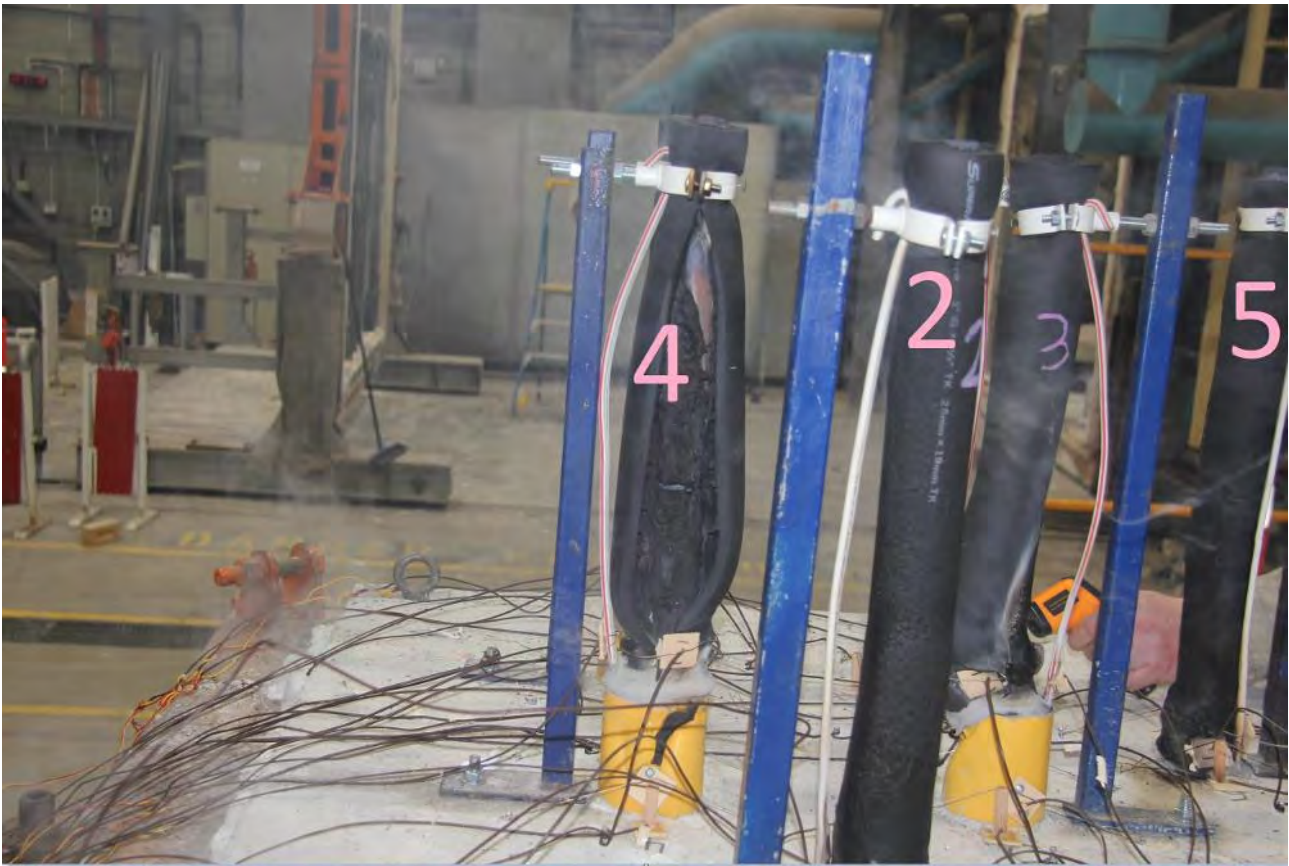
- 152 minutes - The collar sleeve above the concrete slab of Specimen 4 has begun to melt leaving a hole on the north side (photograph 23).
- 189 minutes - Insulation failure of Specimen 6 - maximum temperature rise of 180K is exceeded on the pipe lagging, 25-mm above the concrete slab (north side).

PHOTOGRAPH 23 – SPECIMENS AT 152 MINUTES INTO THE TEST

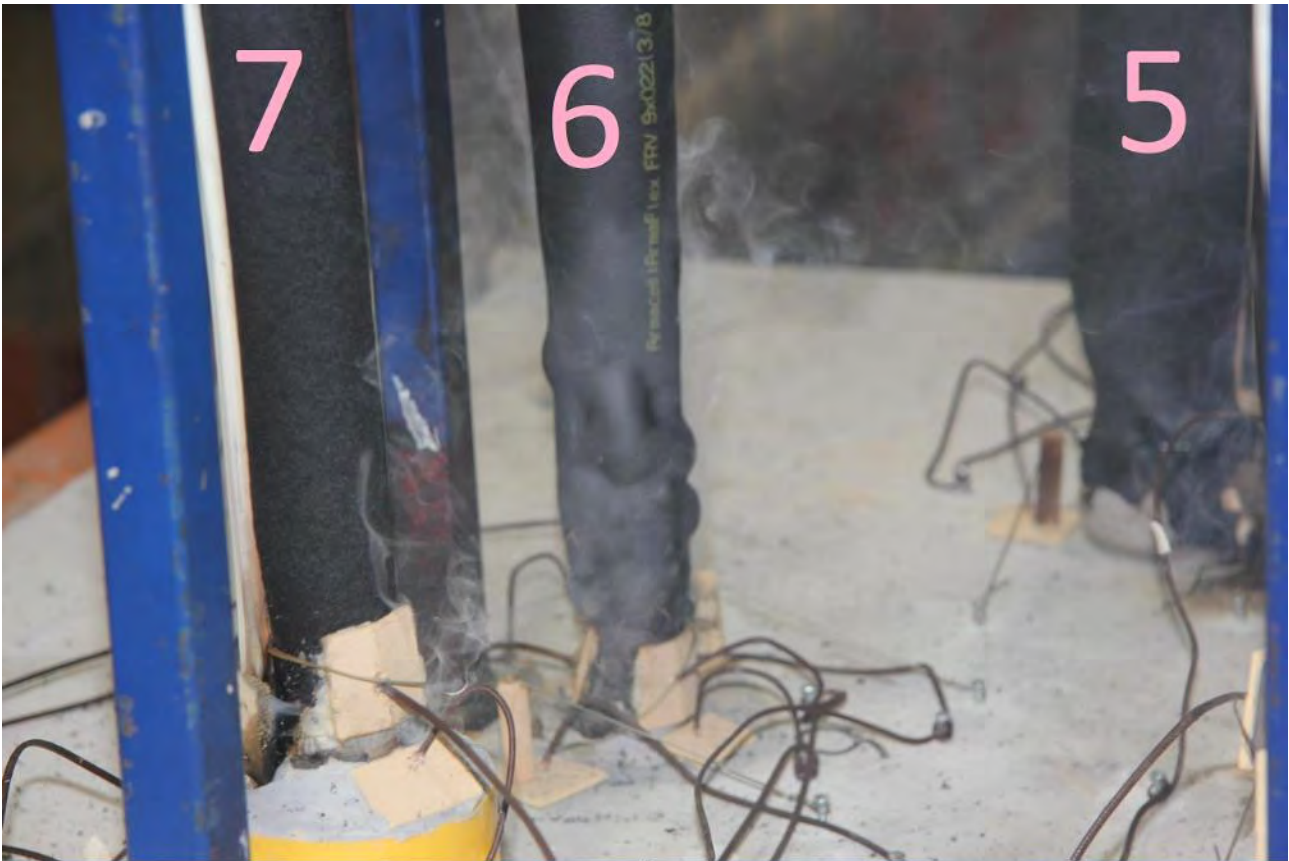
PHOTOGRAPH 25 – SPECIMENS 5, 6 AND 7 AT 191 MINUTES INTO THE TEST

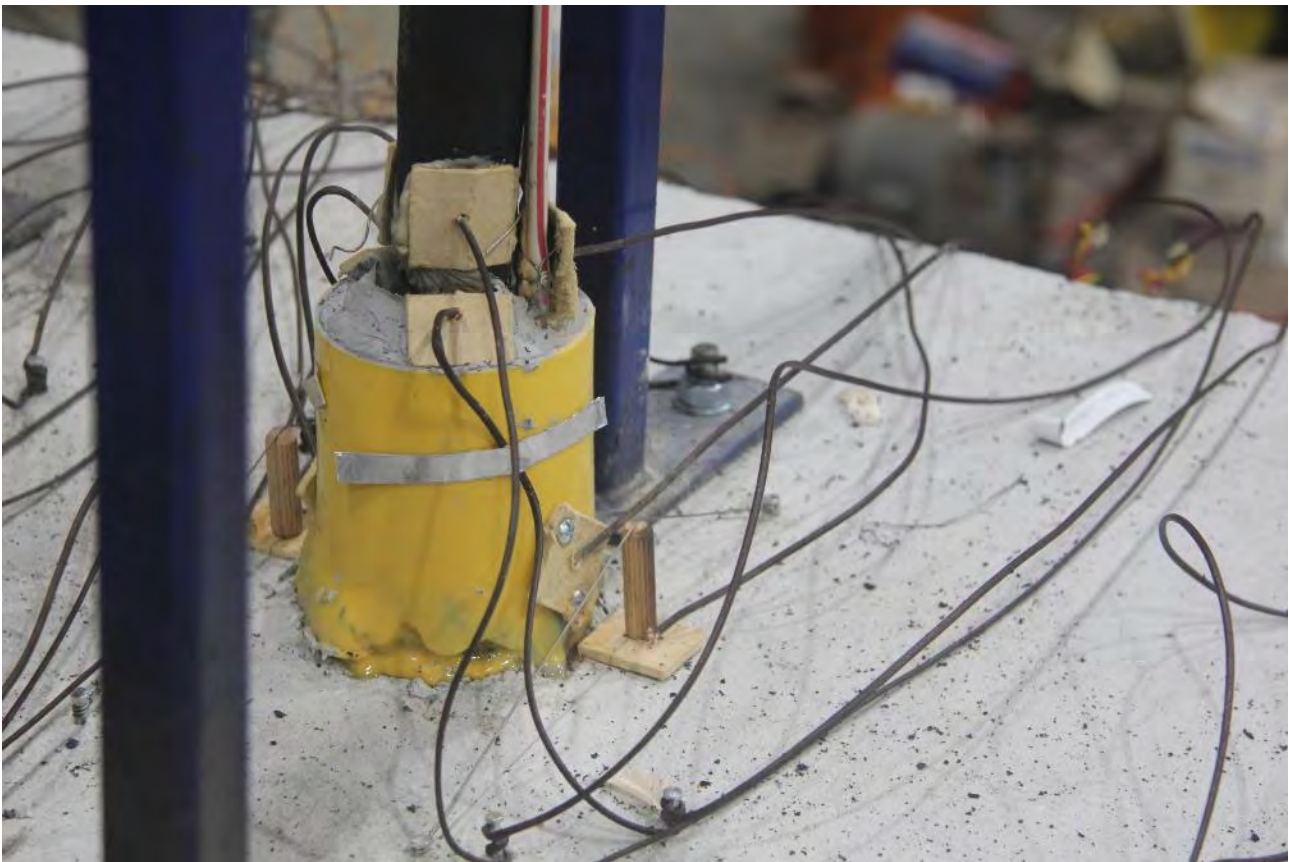
- 199 minutes - A large amount of smoke is now being emitted from the pipe lagging of Specimens 6 and 7.
- 219 minutes - Insulation failure of Specimen 7 - maximum temperature rise of 180K is exceeded on the pipe lagging, 25-mm above the concrete slab (north side).

PHOTOGRAPH 26 – SPECIMEN 7 AT 197 MINUTES INTO THE TEST
