# Fire-resistance test on fire collars protecting a concrete slab penetrated by services and a blank penetration seal

### **Test Report**

Author:Peter GordonReport number:FSP 2277Date:28 June 2022

Client: IG6 Pty Ltd

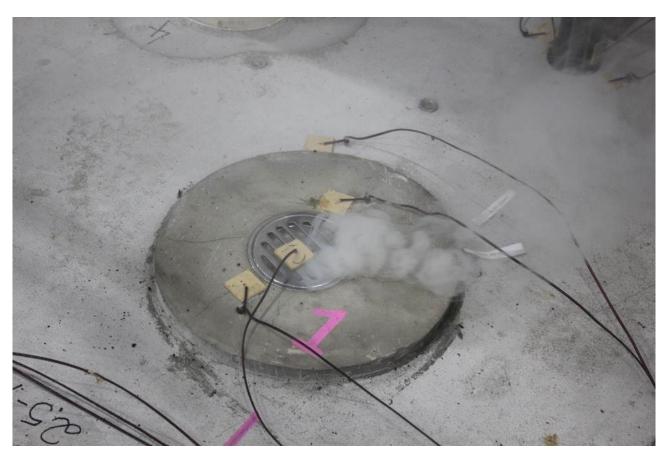
PHOTOGRAPH 4 – SPECIMEN 1 AT 2½ MINUTES INTO THE TEST

37 minutes -	Light smoke continues to flue from the floor waste grate of specimen 1.
82 minutes -	The level of smoke fluing from the floor waste grate of specimen 1 has intensified.
91 minutes -	The white-collar casing below the slab of specimen 4 has started to melt.
121 minutes -	The collar casing below the slab of specimen 4 continues to melt.  Light venting of smoke between the pipes and the slab of specimens 2 and 3 continues.
135 minutes -	The base of the PVC south side of specimen 4 has started to discolour to a light pink colour.
148 minutes -	The temperature on the grate of specimen 1 has risen above 160°C, with smoke fluing, cotton pad test applied over the grate, no ignition of the cotton pad noted at this time.
163 minutes -	Smoke intermittently fluing from the end of the pipe of specimen 2.
182 minutes -	The level of smoke fluing from the floor waste grate of specimen 1 has reduced.

225 minutes -	The level of smoke fluing from the floor waste grate of specimen 1 has increased
235 minutes -	The temperature on the grate of specimen 1 has risen above 180°C, with smoke fluing, cotton pad test applied over the grate, no ignition of the cotton pad noted at this time
239 minutes -	Insulation failure of specimen 4: Maximum temperature rise of 180K is exceeded on the unexposed face of concrete slab 25-mm from the core hole.
241 minutes -	Test terminated.

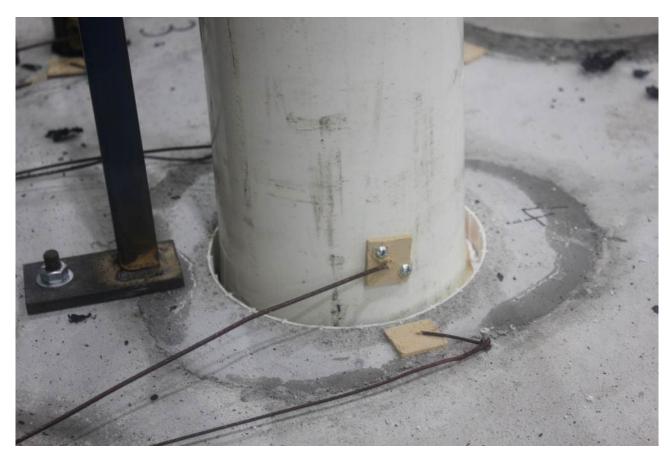
PHOTOGRAPH 8 – SPECIMEN 4 AT 90 MINUTES INTO THE TEST

The following ob.	servations were made during the me resistance test.
Time	Observation
1 minute -	Smoke is being emitted between the concrete slab and the pipes of specimens 2 and 3.
2½ minutes -	Smoke has started to flu from the floor waste grate of specimen 1.
3 minutes -	Smoke is fluing from the end of the pipe of specimen 4.
4½ minutes -	Smoke is fluing from the end of the pipes of specimens 2 and 3. The level of smoke fluing from the floor waste grate of specimen 1 has intensified.
6 minutes -	The level of smoke fluing from end of the pipe of specimen 4 has reduced. Smoke has ceased fluing from the end of the pipe of specimens 2 and 3
12 minutes -	Smoke has ceased fluing from the end of the pipe of specimen 4.
20 minutes -	The level of smoke fluing from the floor waste grate of specimen 1 has reduced with discolouration (smoke staining) visible on the eastern side of the screed. Light venting of smoke between the pipes and slab of specimens 2 and 3. Light smoke has resumed fluing from the end of the pipe of specimen 4.

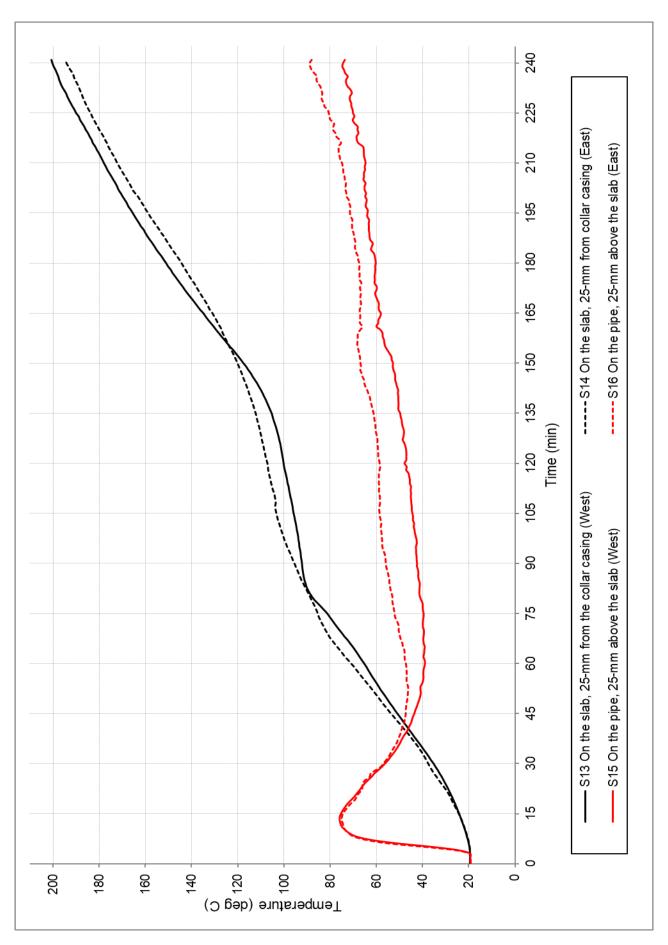
FIGURE 7 – SPECIMEN TEMPERATURE – ASSOCIATED WITH SPECIMEN 4

Structural Adequacy - not applicable Integrity - no failure at 241 minutes Insulation - 239 minutes
