Fire-resistance test on fire collars protecting a plasterboard wall penetrated by services

Test Report

Author: Mario Lara
Report number: FSP 1634
Date: 9 July 2014

Sponsored Investigation No. FSP 1634

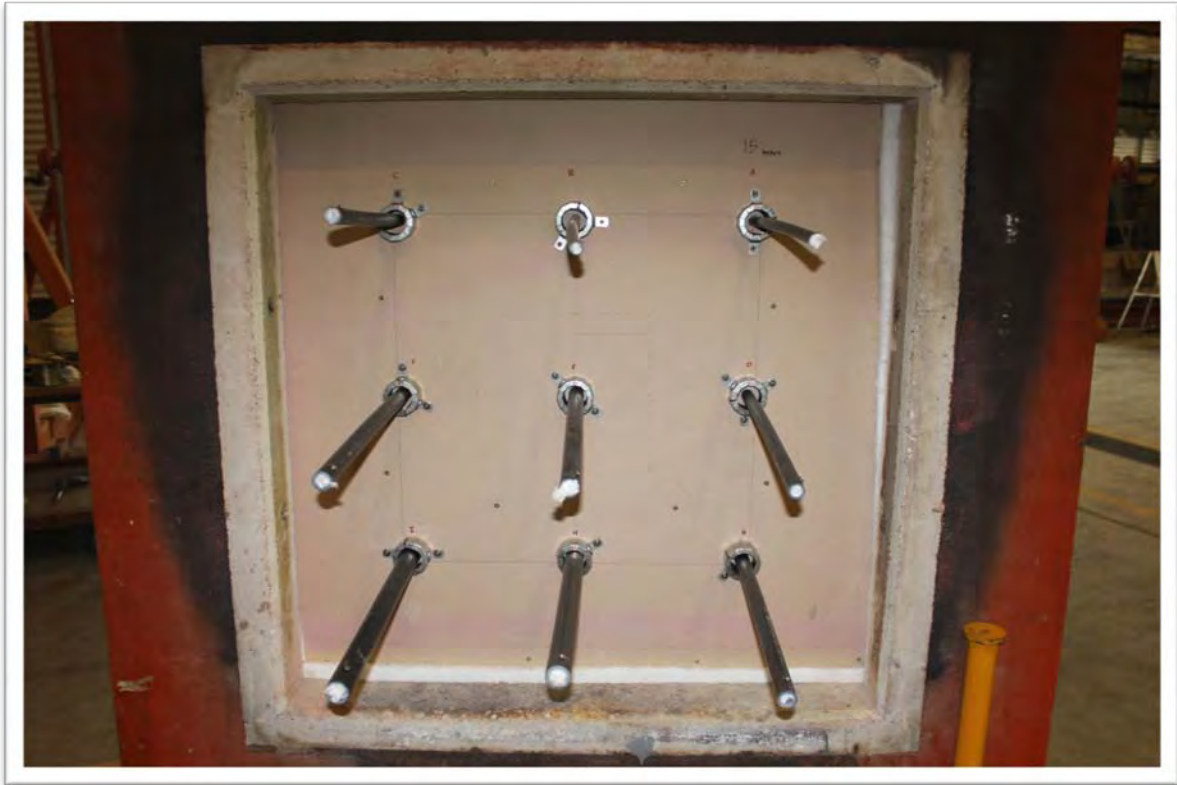
PHOTOGRAPH 1 – EXPOSED FACE OF SPECIMENS PRIOR TO TESTING

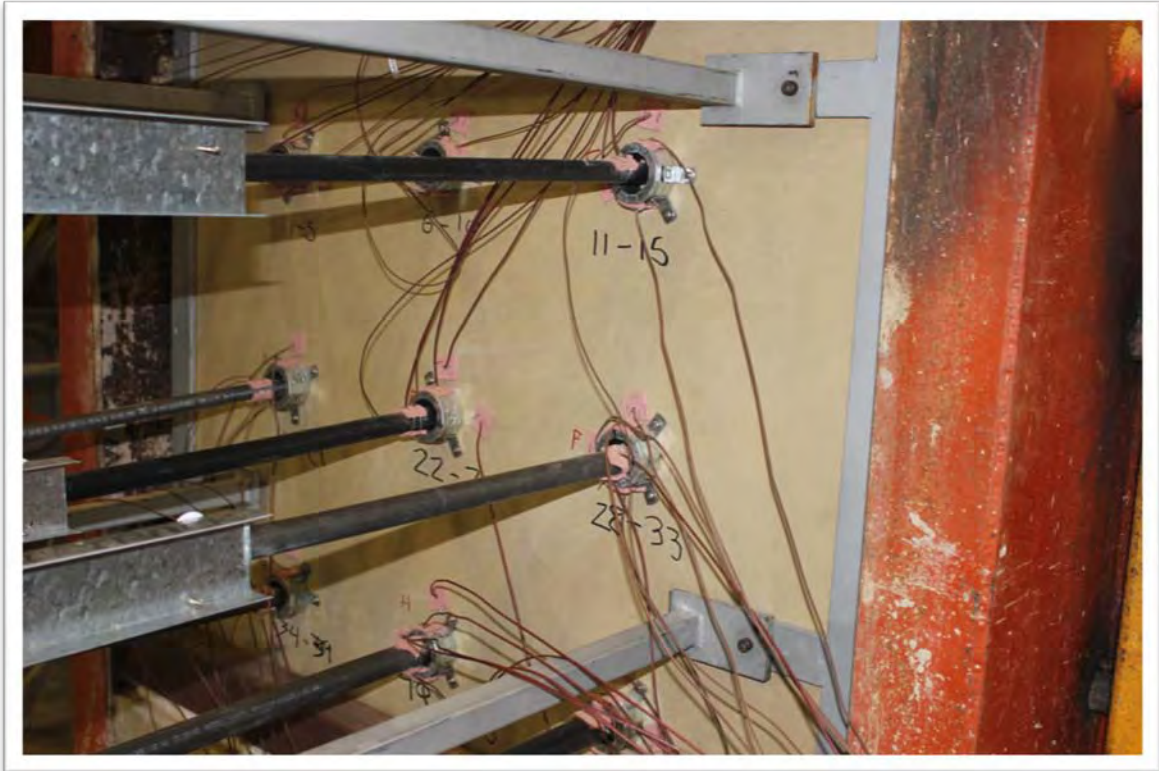
PHOTOGRAPH 2 – UNEXPOSED FACE OF SPECIMENS PRIOR TO TESTING

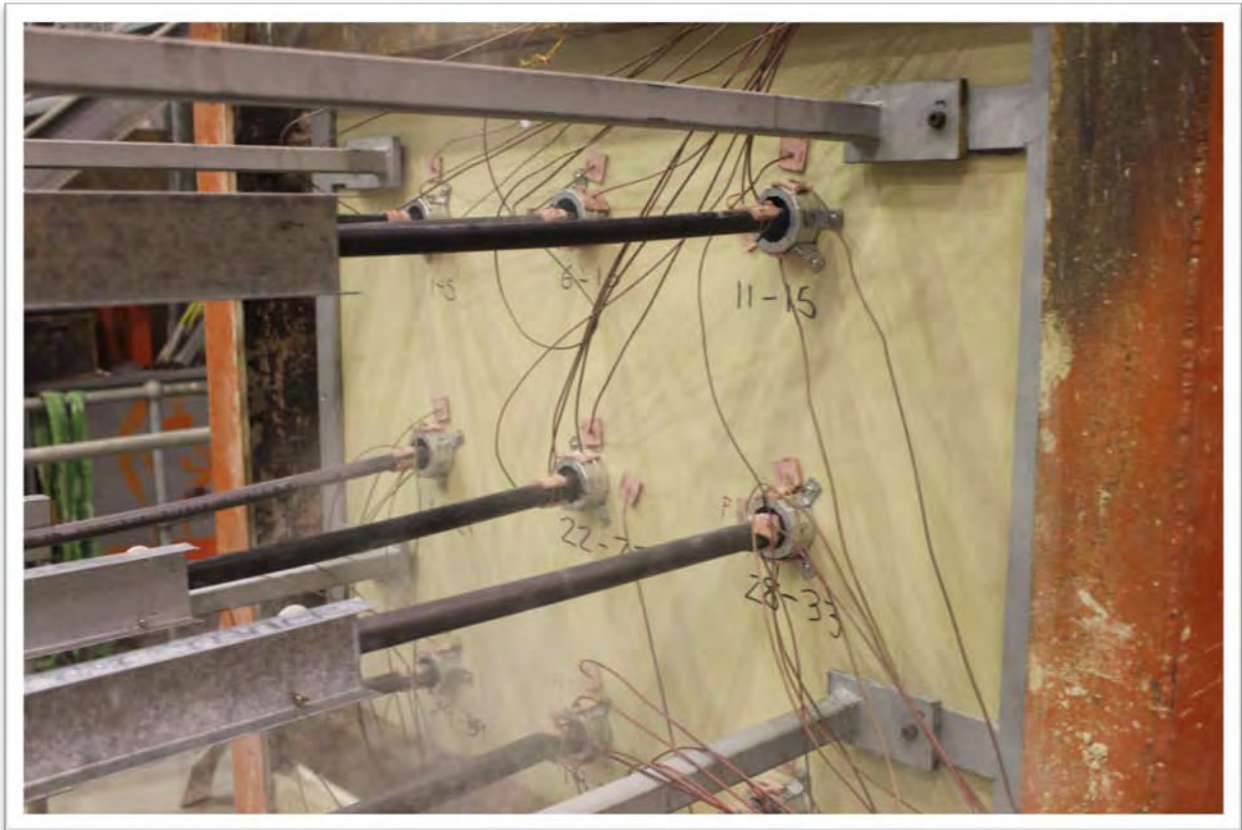
PHOTOGRAPH 3 – SPECIMENS AFTER 60 MINUTES OF TESTING

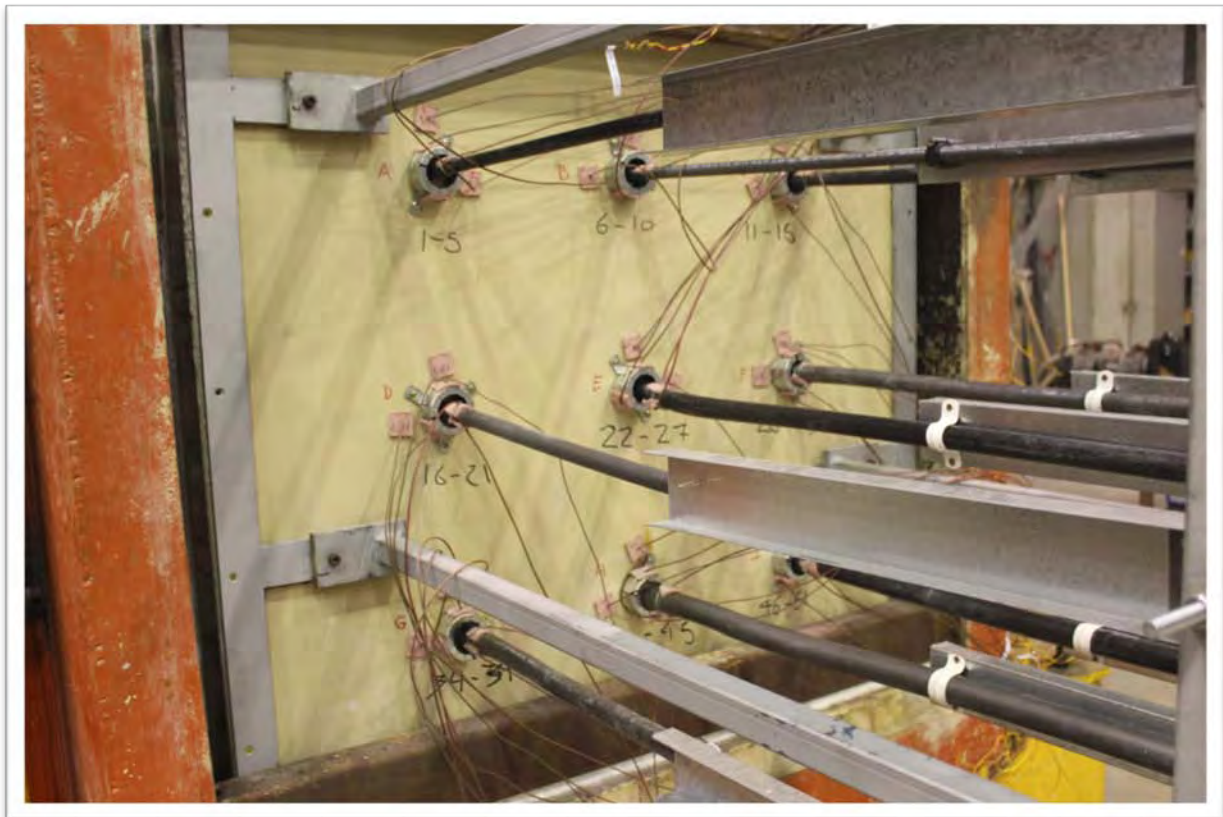
PHOTOGRAPH 4 – SPECIMENS AFTER 120 MINUTES OF TESTING

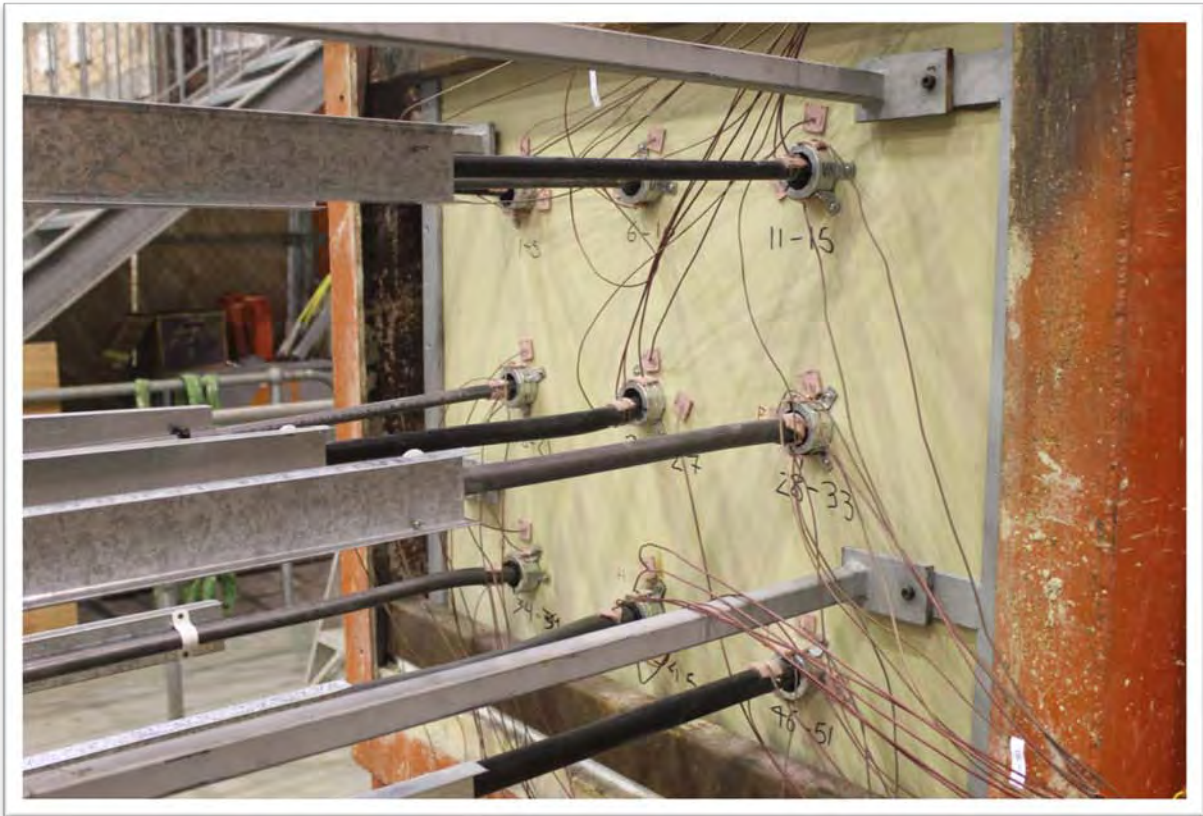
PHOTOGRAPH 5 – SPECIMENS AFTER 180 MINUTES OF TESTING

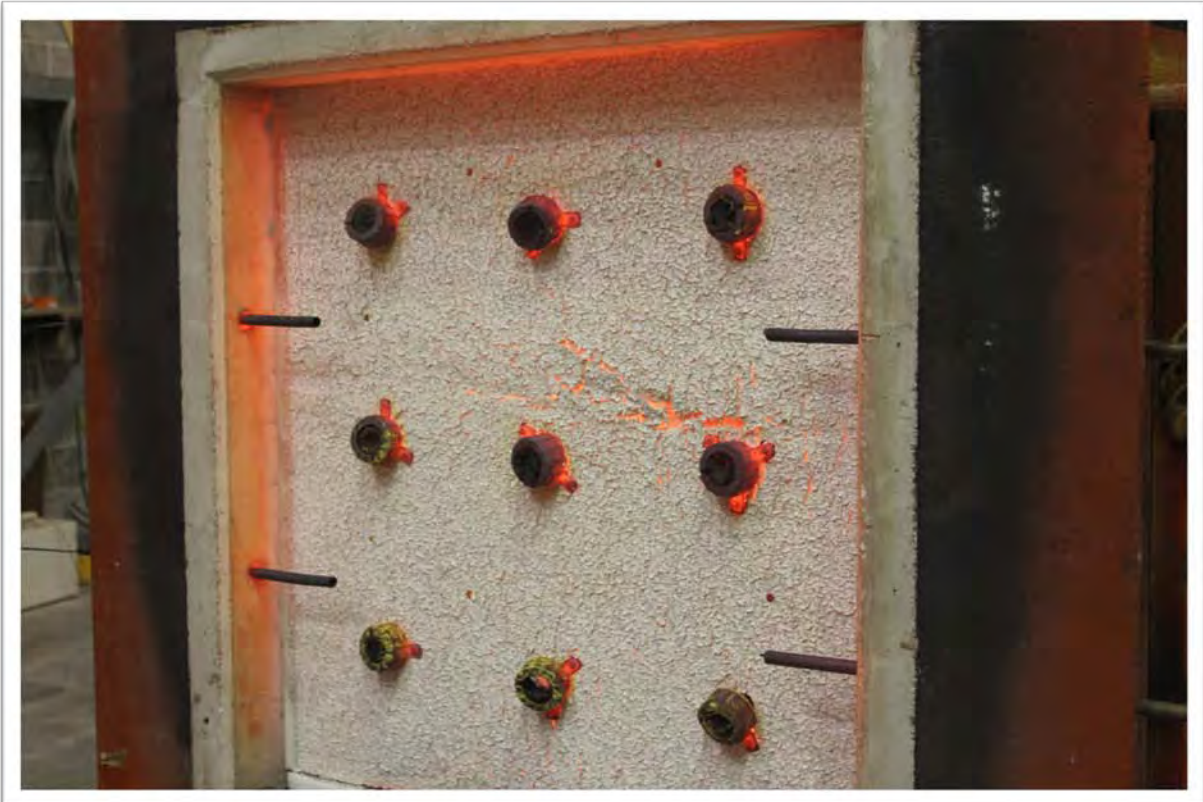
PHOTOGRAPH 6 – EXPOSED FACE OF SPECIMENS AT CONCLUSION OF TESTING

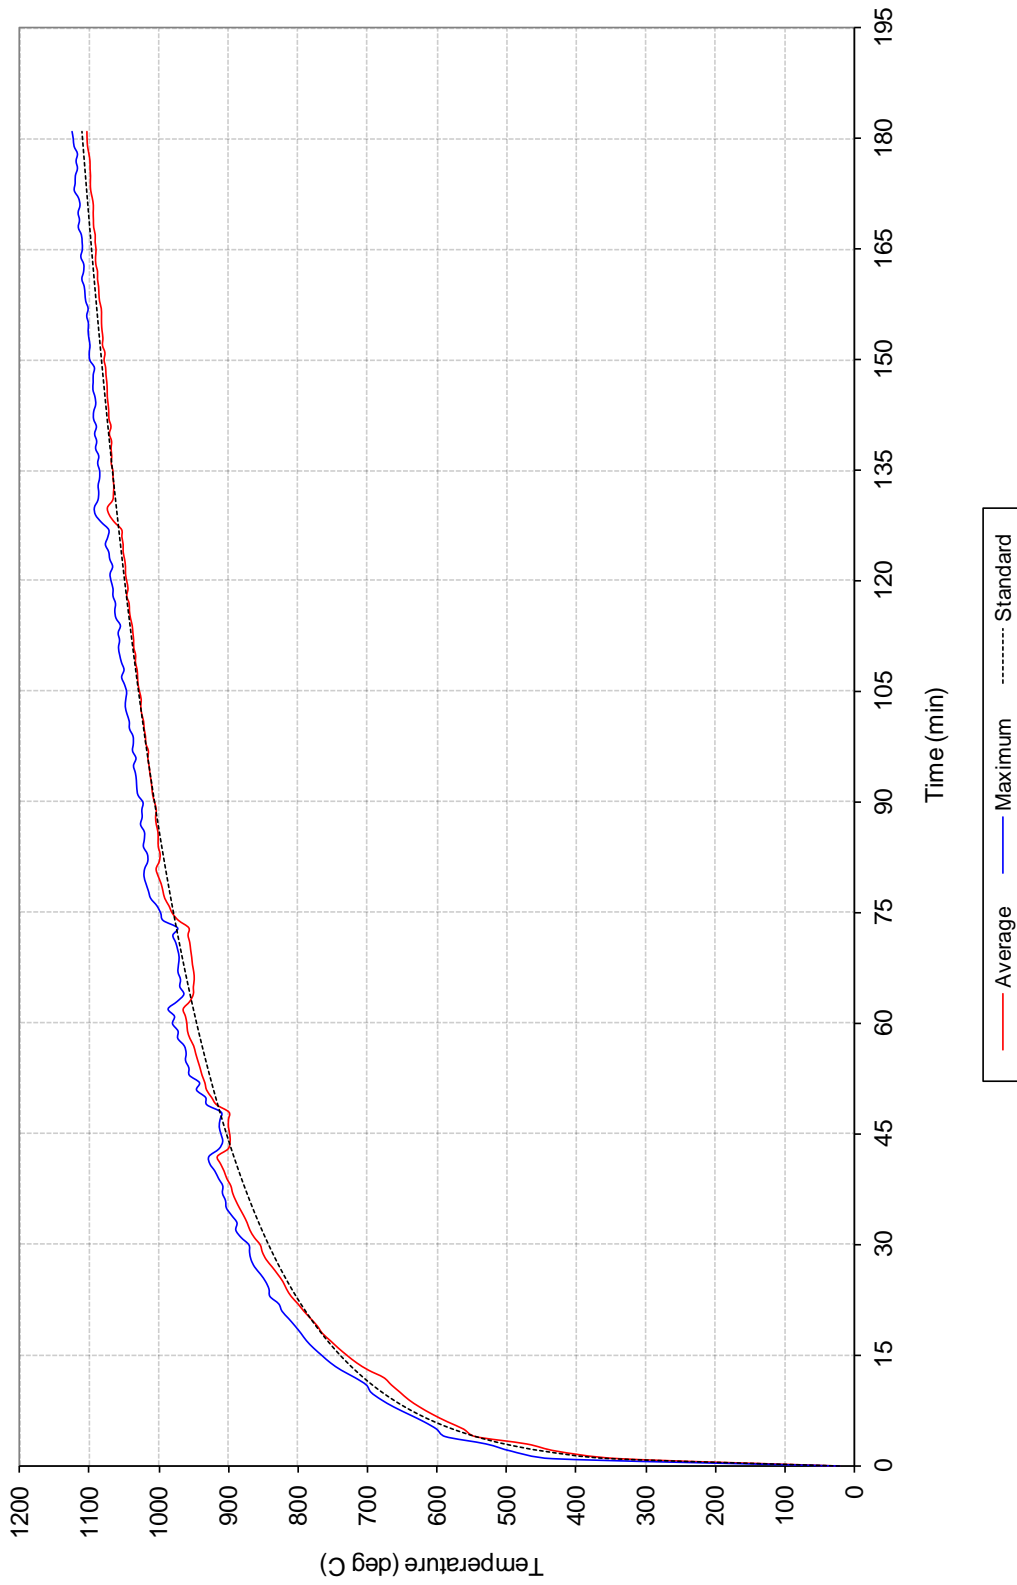
FIGURE 1 – FURNACE TEMPERATURE

The temperature in the furnace chamber was measured by four type K, 3-mm diameter, and 310 stainless steel Mineral Insulated Metal Sheathed (MIMS) thermocouples. Each thermocouple was housed in high-nickel steel tubes opened at the exposed end.

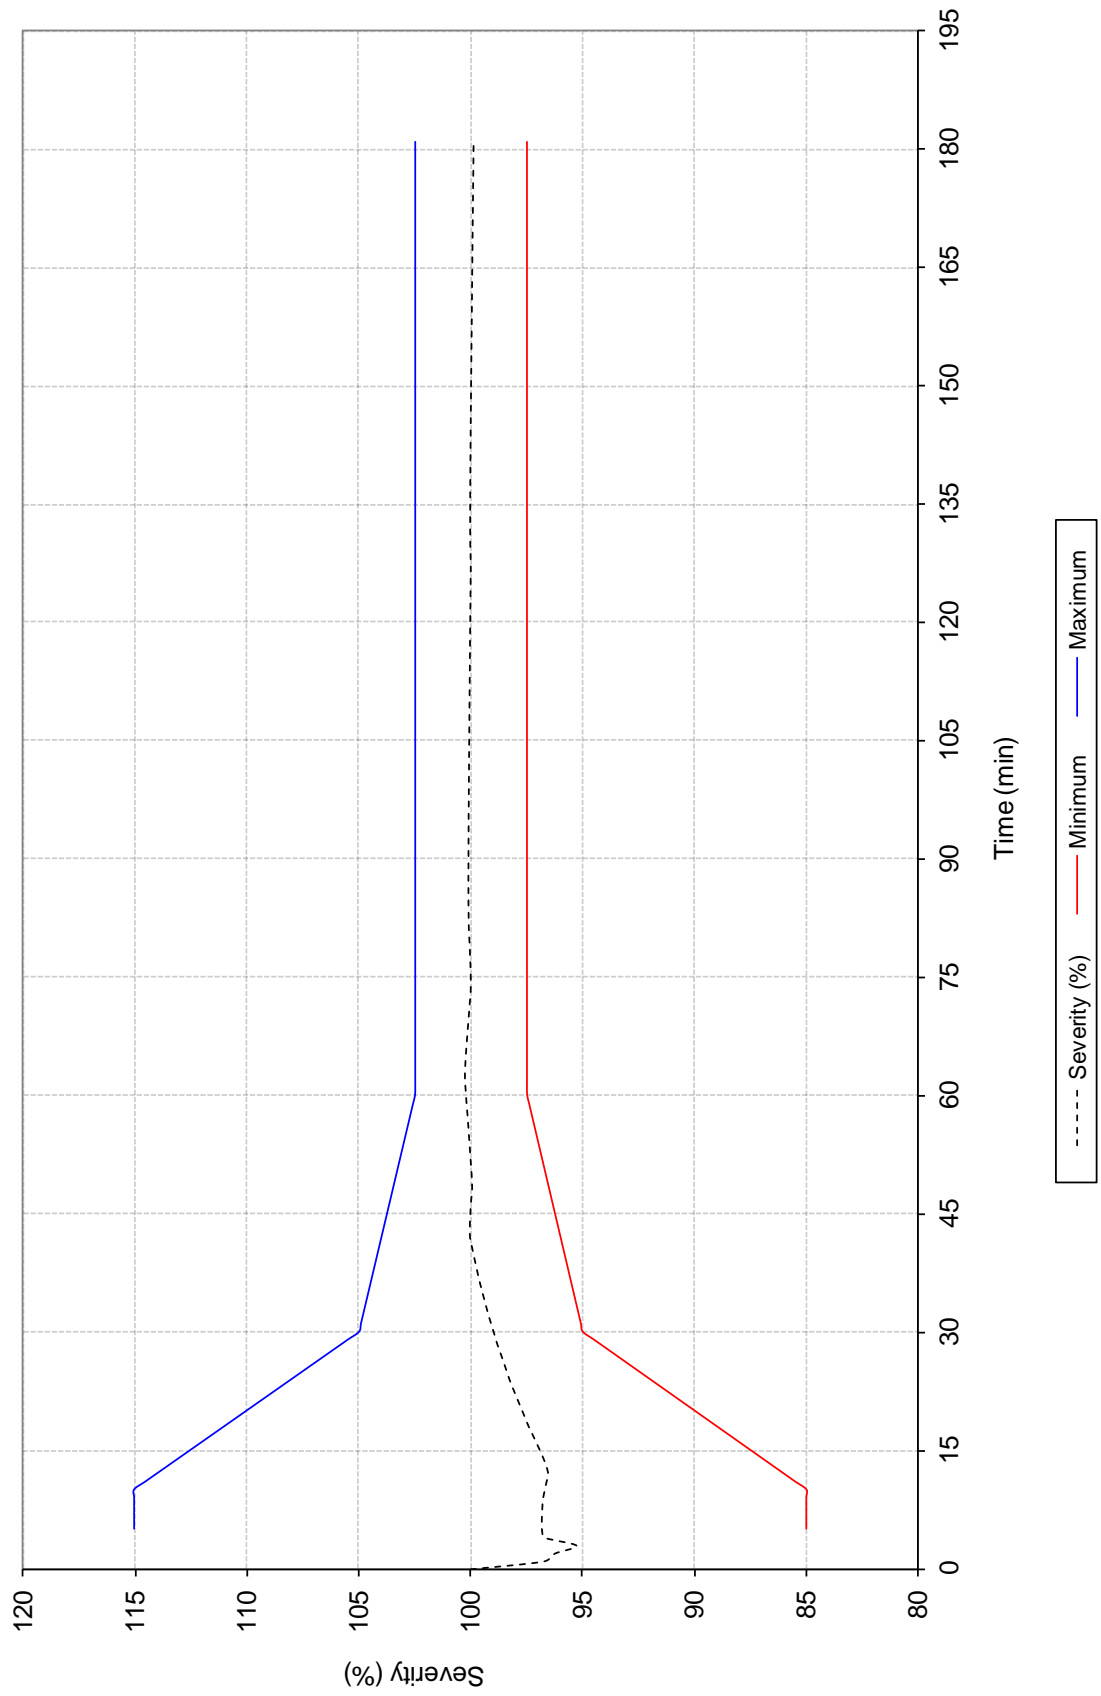
FIGURE 2 – FURNACE SEVERITY

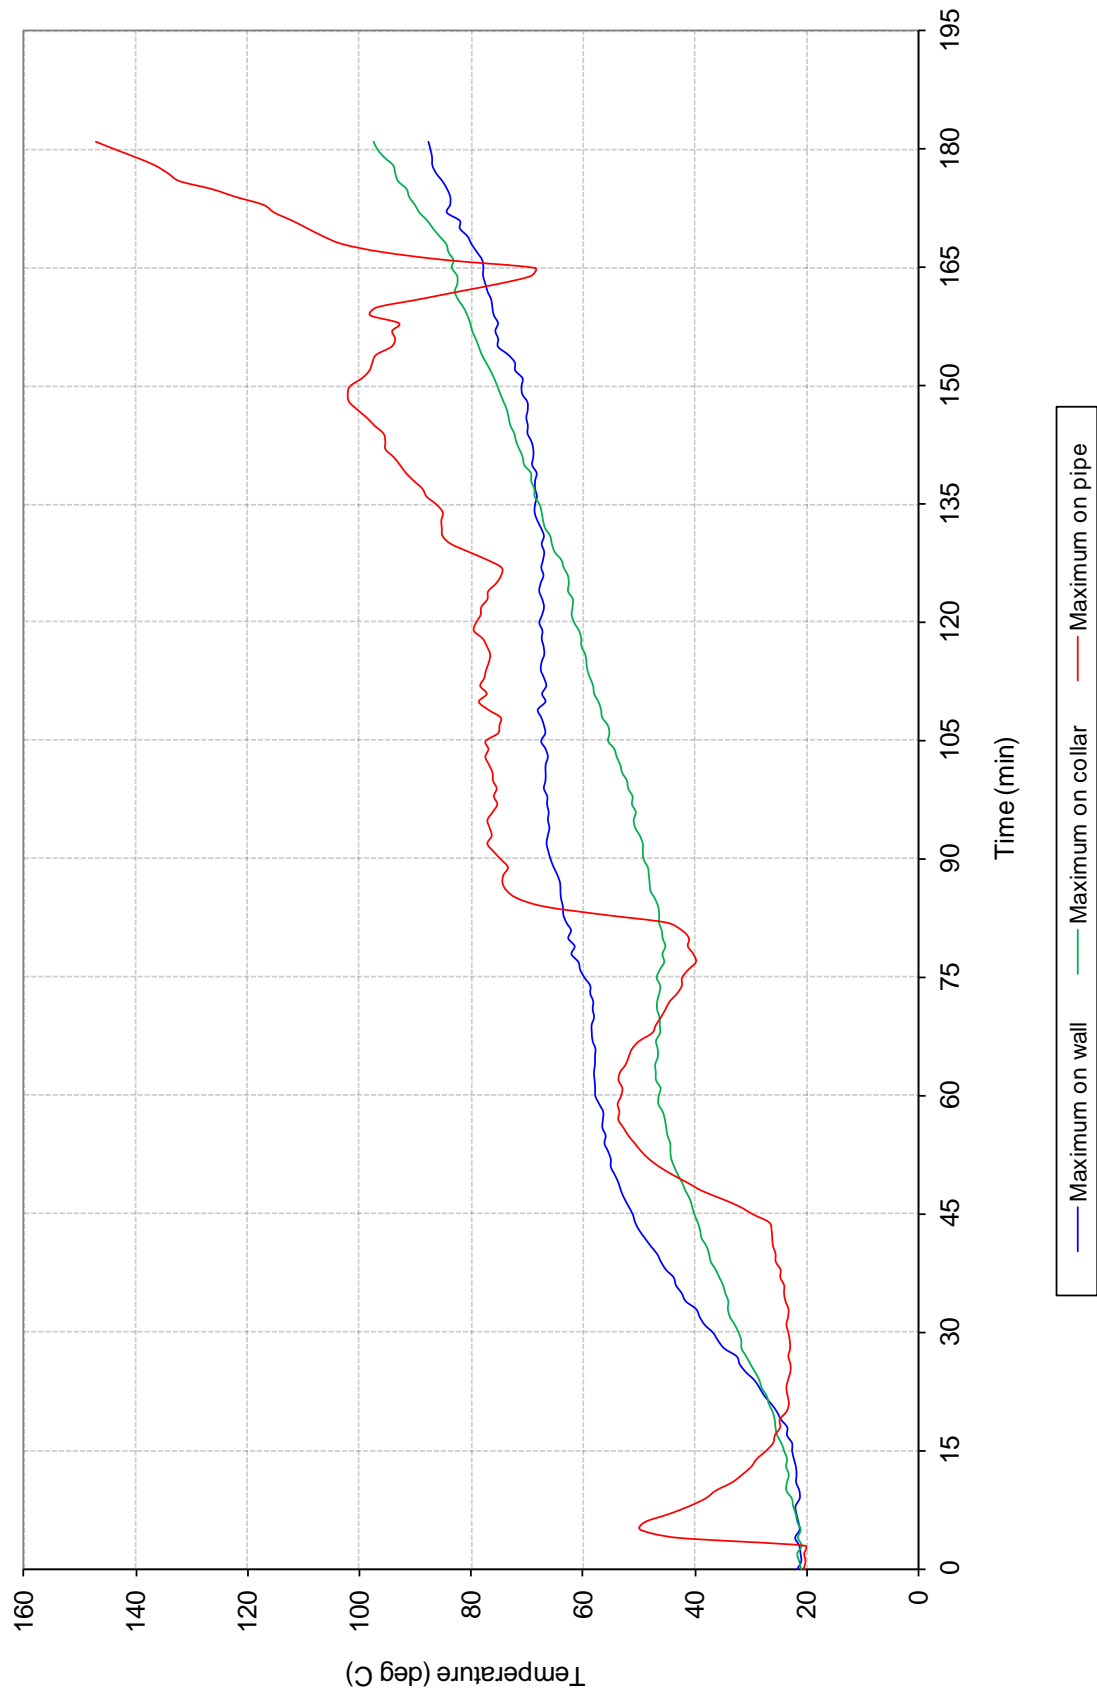
FIGURE 3 – SPECIMEN TEMPERATURE – ASSOCIATED WITH PENETRATION A

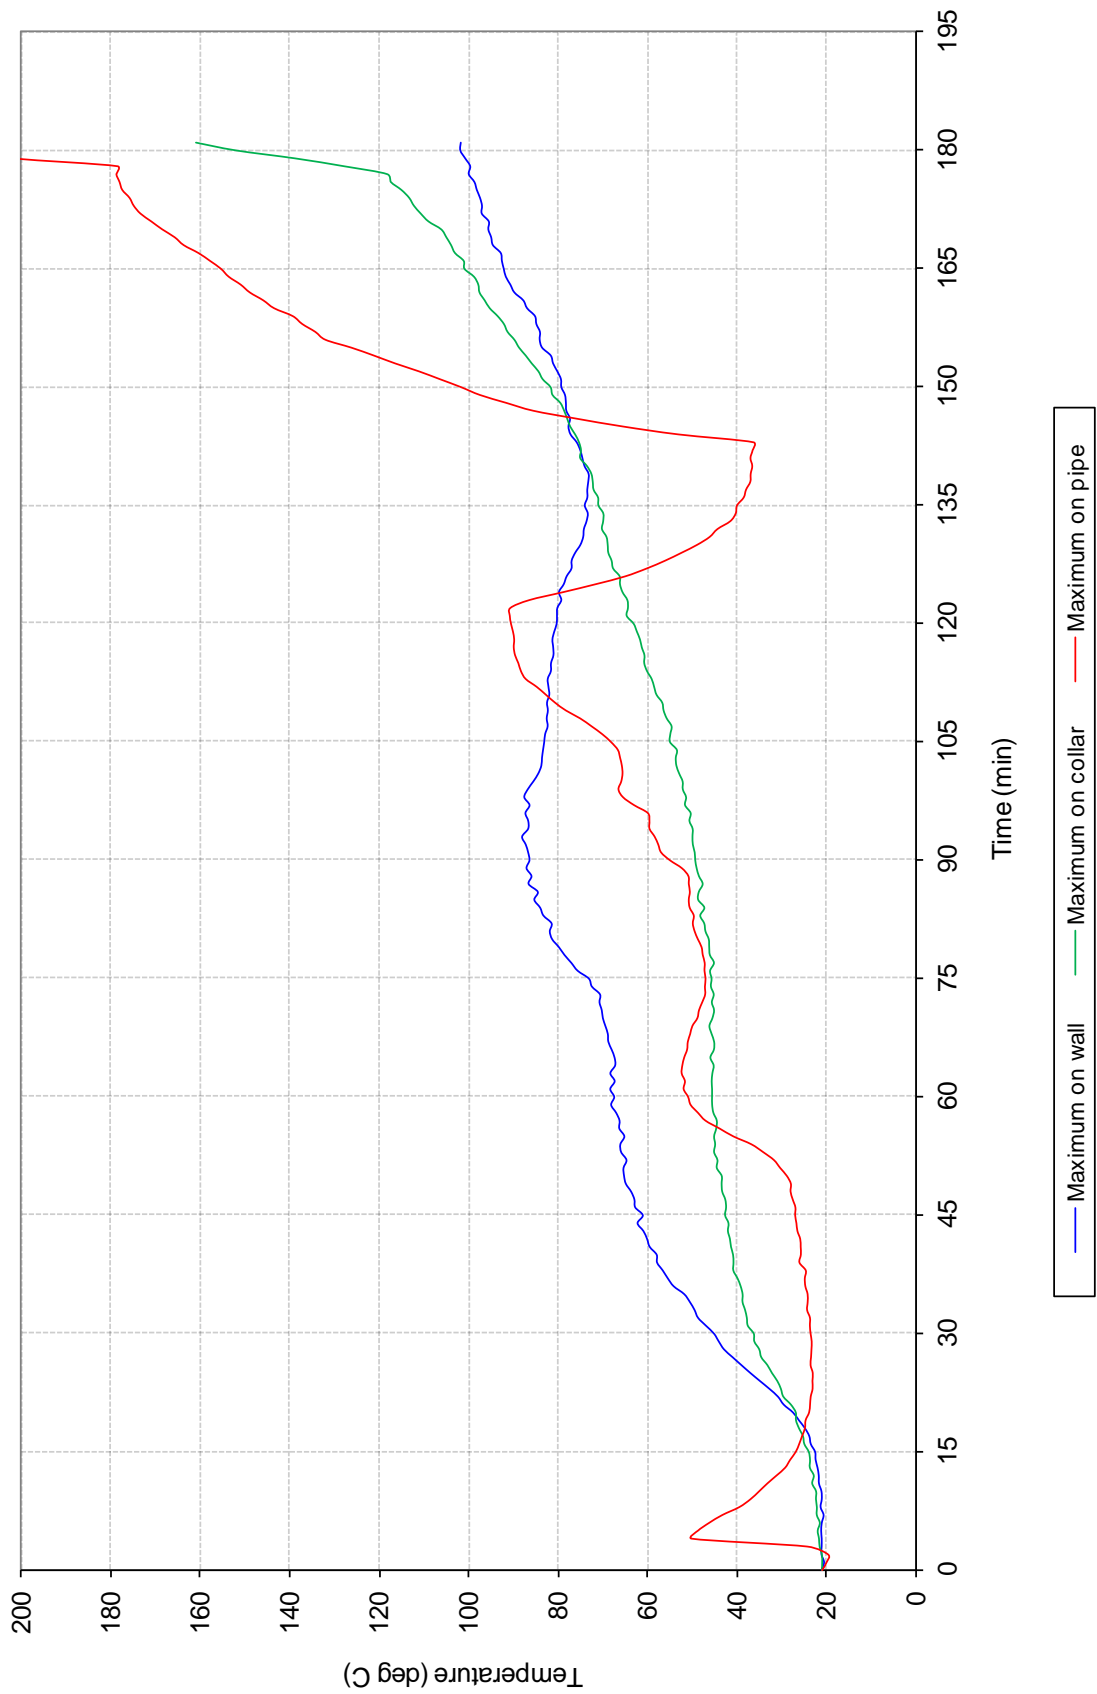
FIGURE 4 – SPECIMEN TEMPERATURE – ASSOCIATED WITH PENETRATION B

- 2:58:00 - Penetration B – the pipe has melted away exposing a hole. Cotton pad test applied, no ignition.
- 2:59:00 - Insulation failure of penetration B – maximum temperature rise of 180 deg C is exceeded on the pipe.

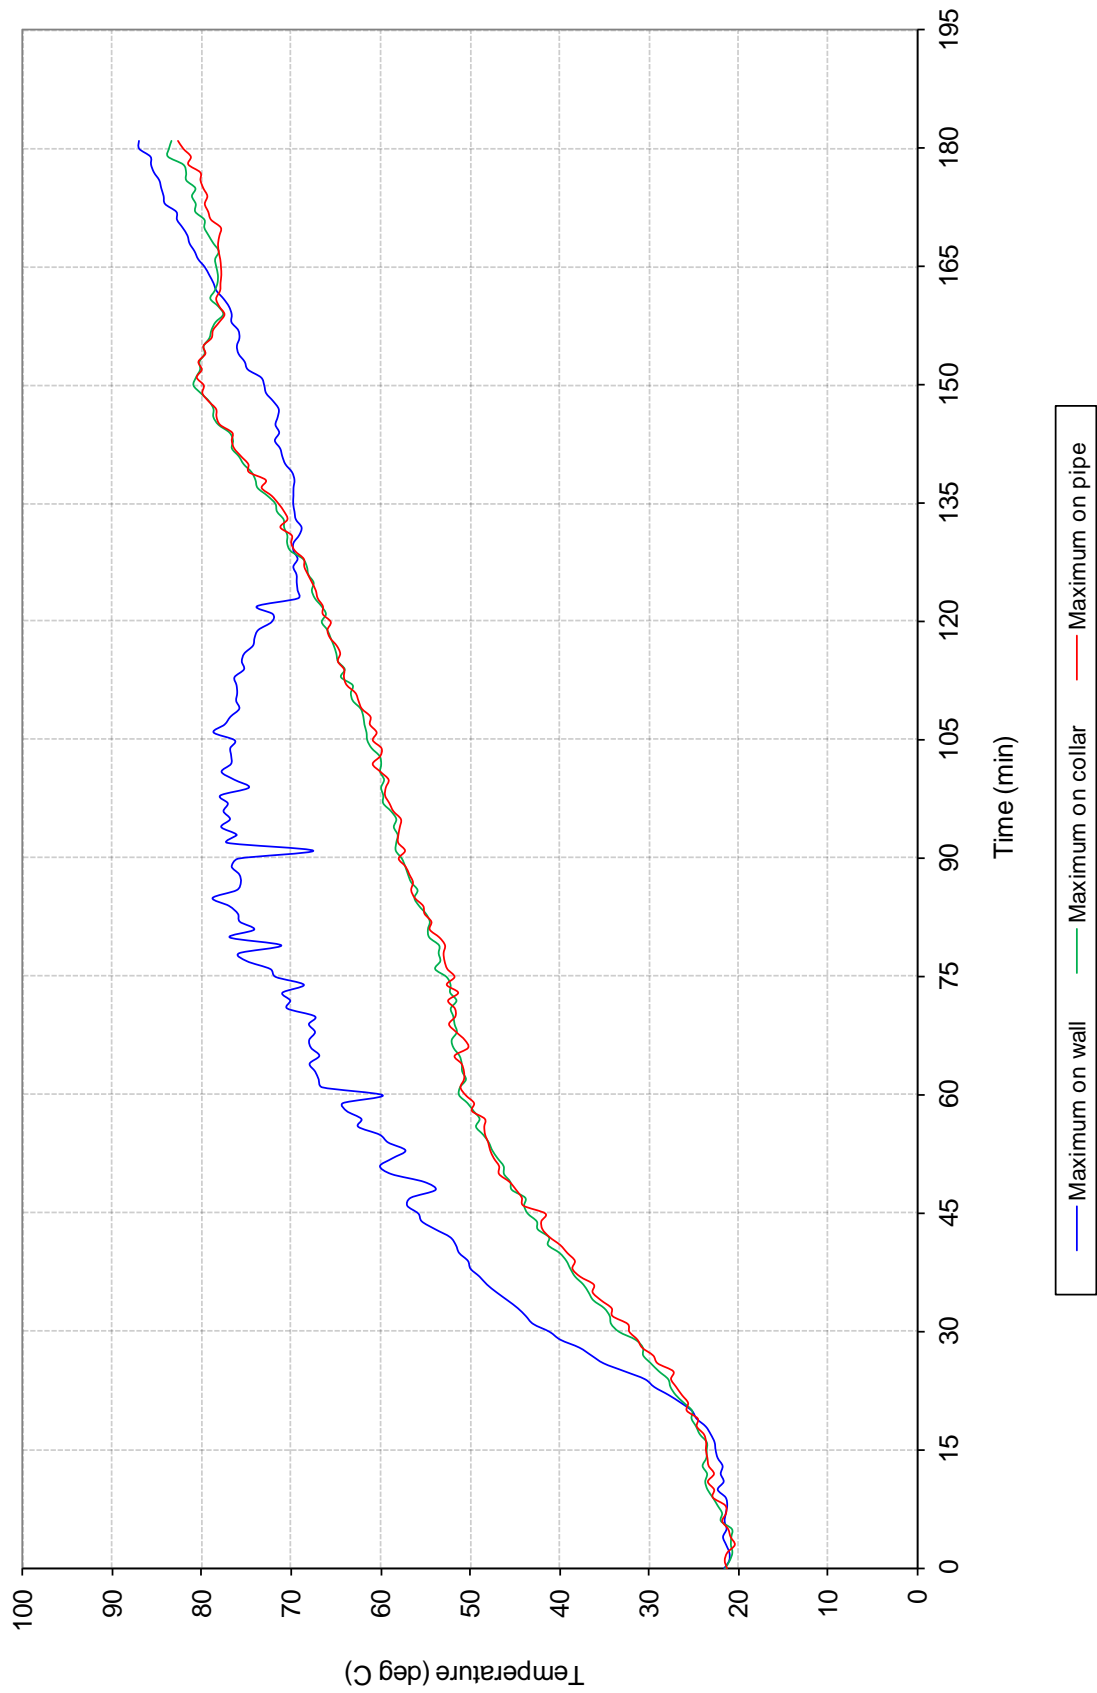
FIGURE 5 – SPECIMEN TEMPERATURE – ASSOCIATED WITH PENETRATION C

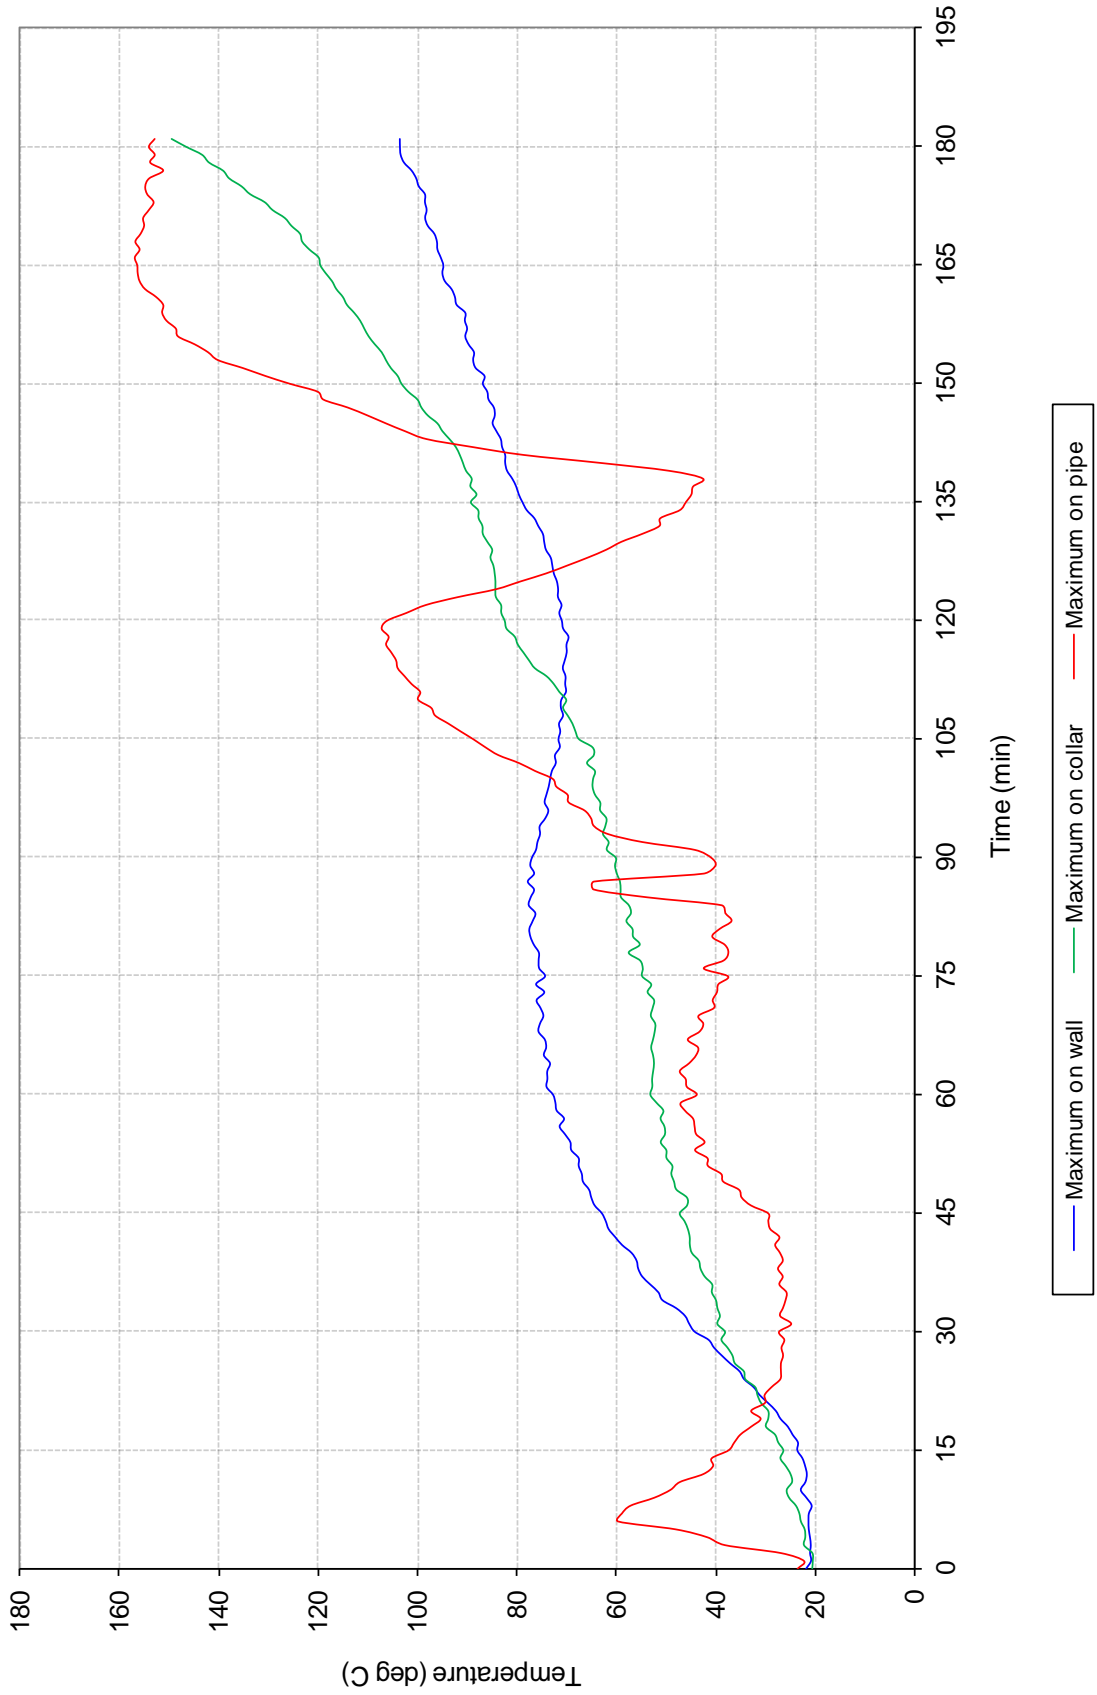
FIGURE 6 – SPECIMEN TEMPERATURE – ASSOCIATED WITH PENETRATION D

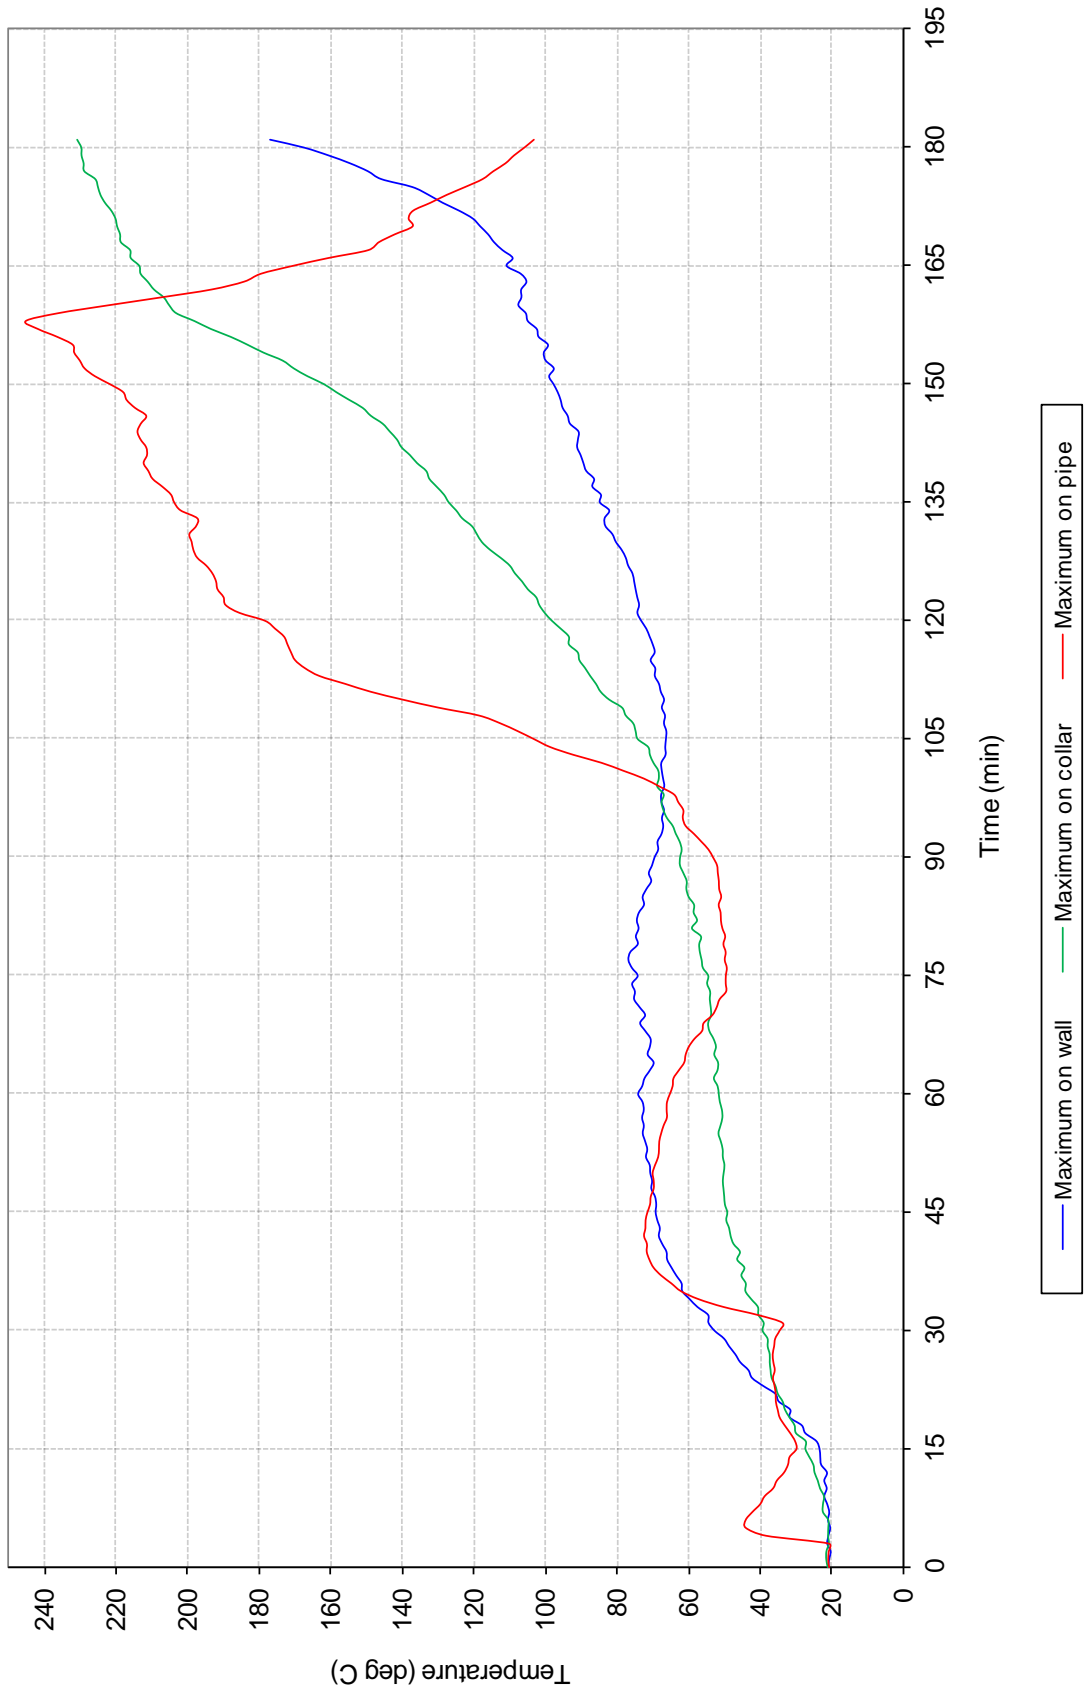
FIGURE 7 – SPECIMEN TEMPERATURE – ASSOCIATED WITH PENETRATION E

- 1:37:00 - Insulation failure of penetration G – maximum temperature rise of 180 deg C is exceeded on the pipe.
- 2:14:00 - Insulation failure of penetration E – maximum temperature rise of 180 deg C is exceeded on the pipe.

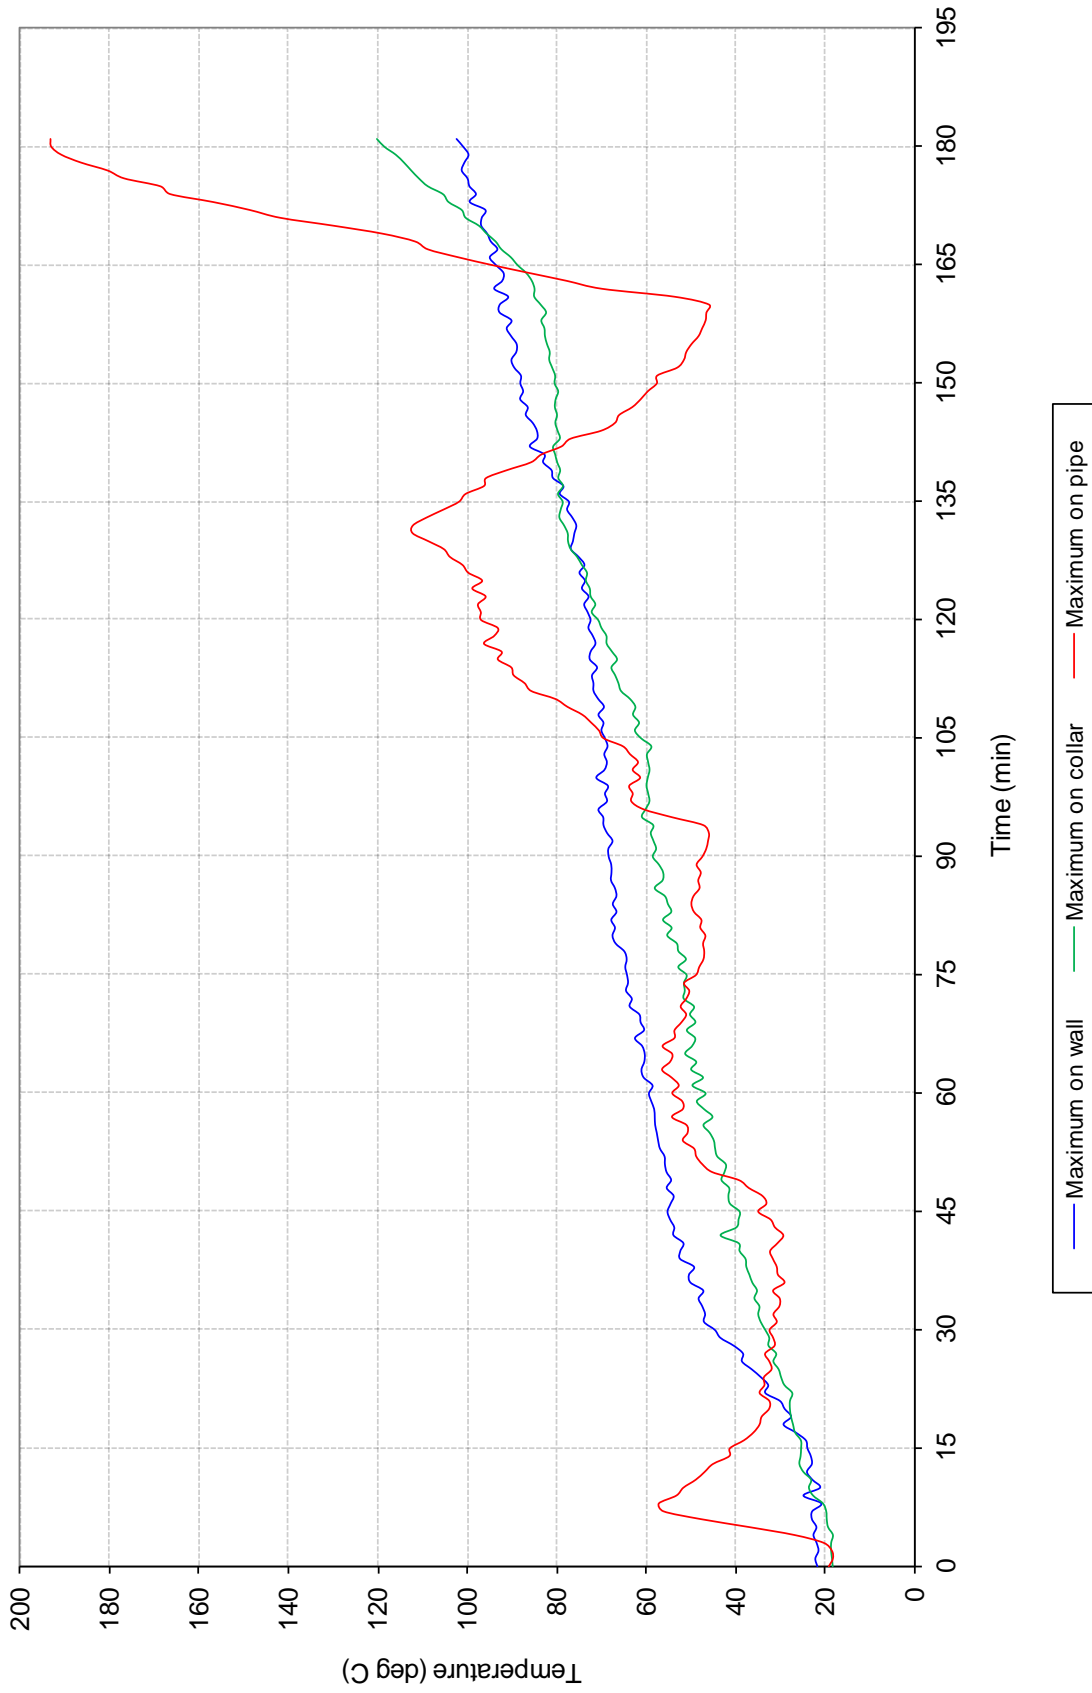
FIGURE 8 – SPECIMEN TEMPERATURE – ASSOCIATED WITH PENETRATION F

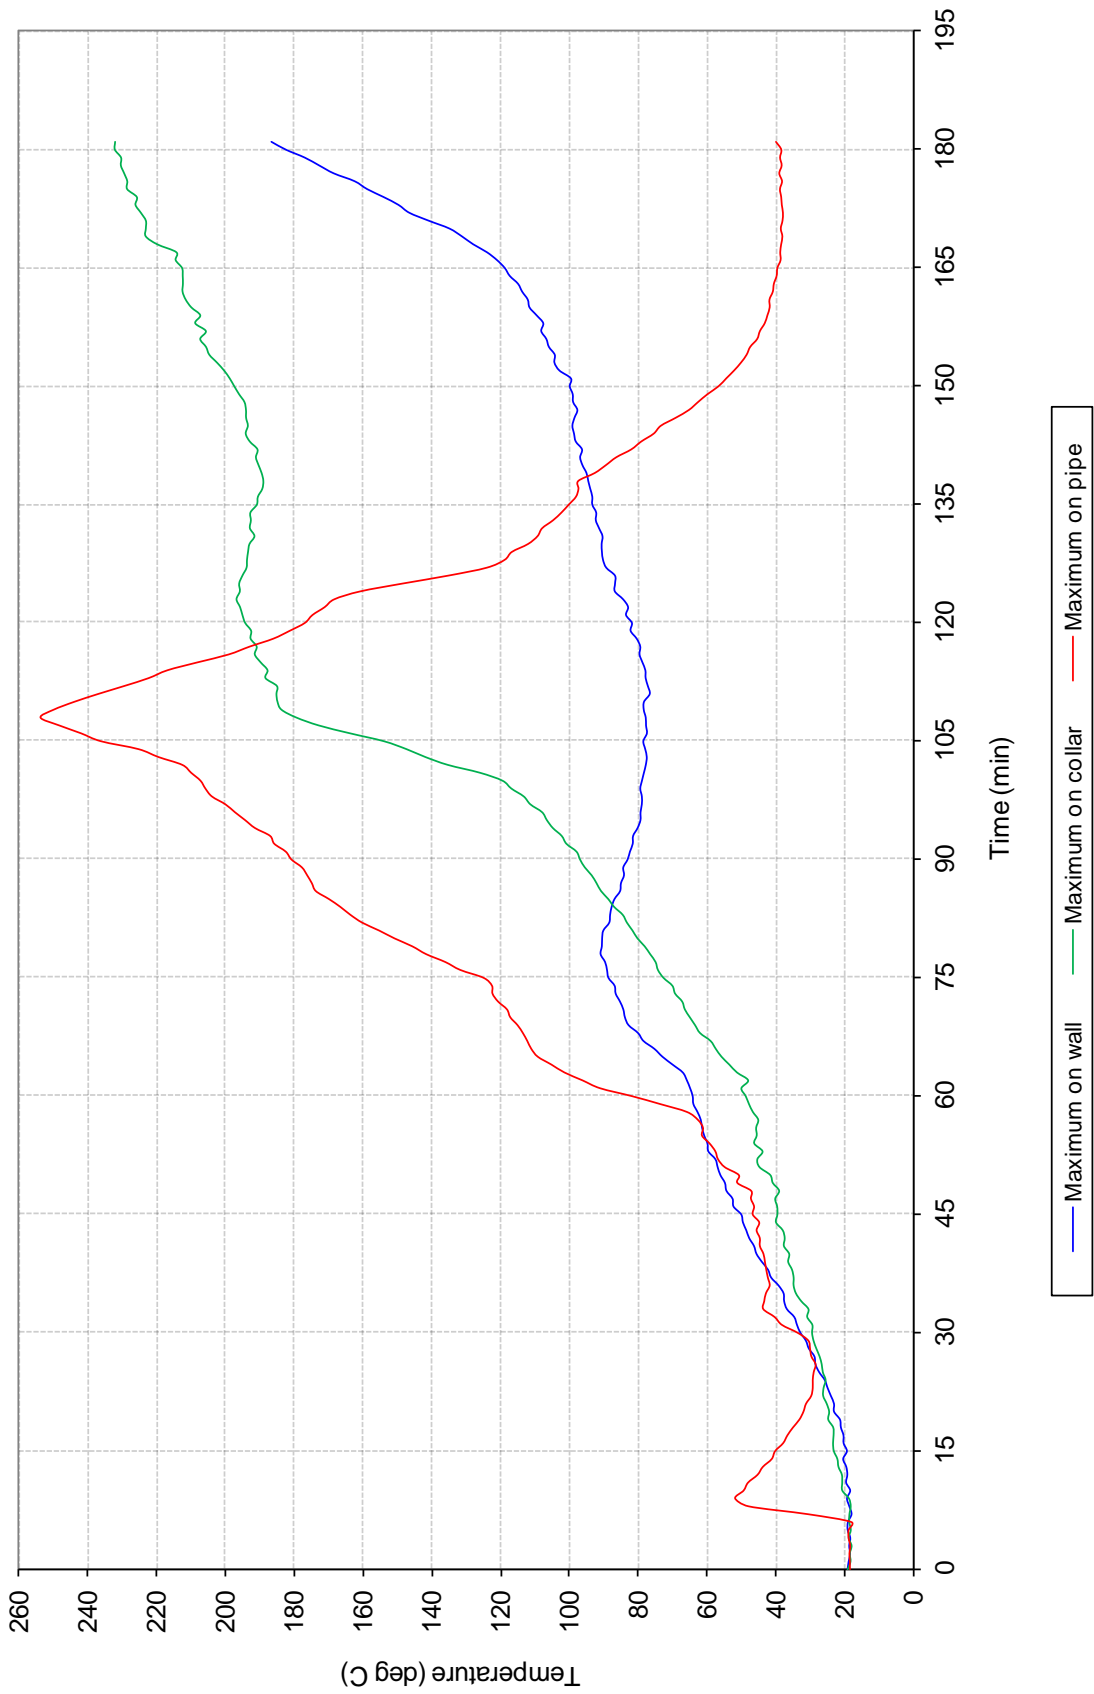
FIGURE 9 – SPECIMEN TEMPERATURE – ASSOCIATED WITH PENETRATION G
