Fire-resistance test on fire collars protecting a plasterboard wall penetrated by services

Test Report

Author: Mario Lara
Report number: FSP 1634
Date: 9 July 2014

Sponsored Investigation No. FSP 1634

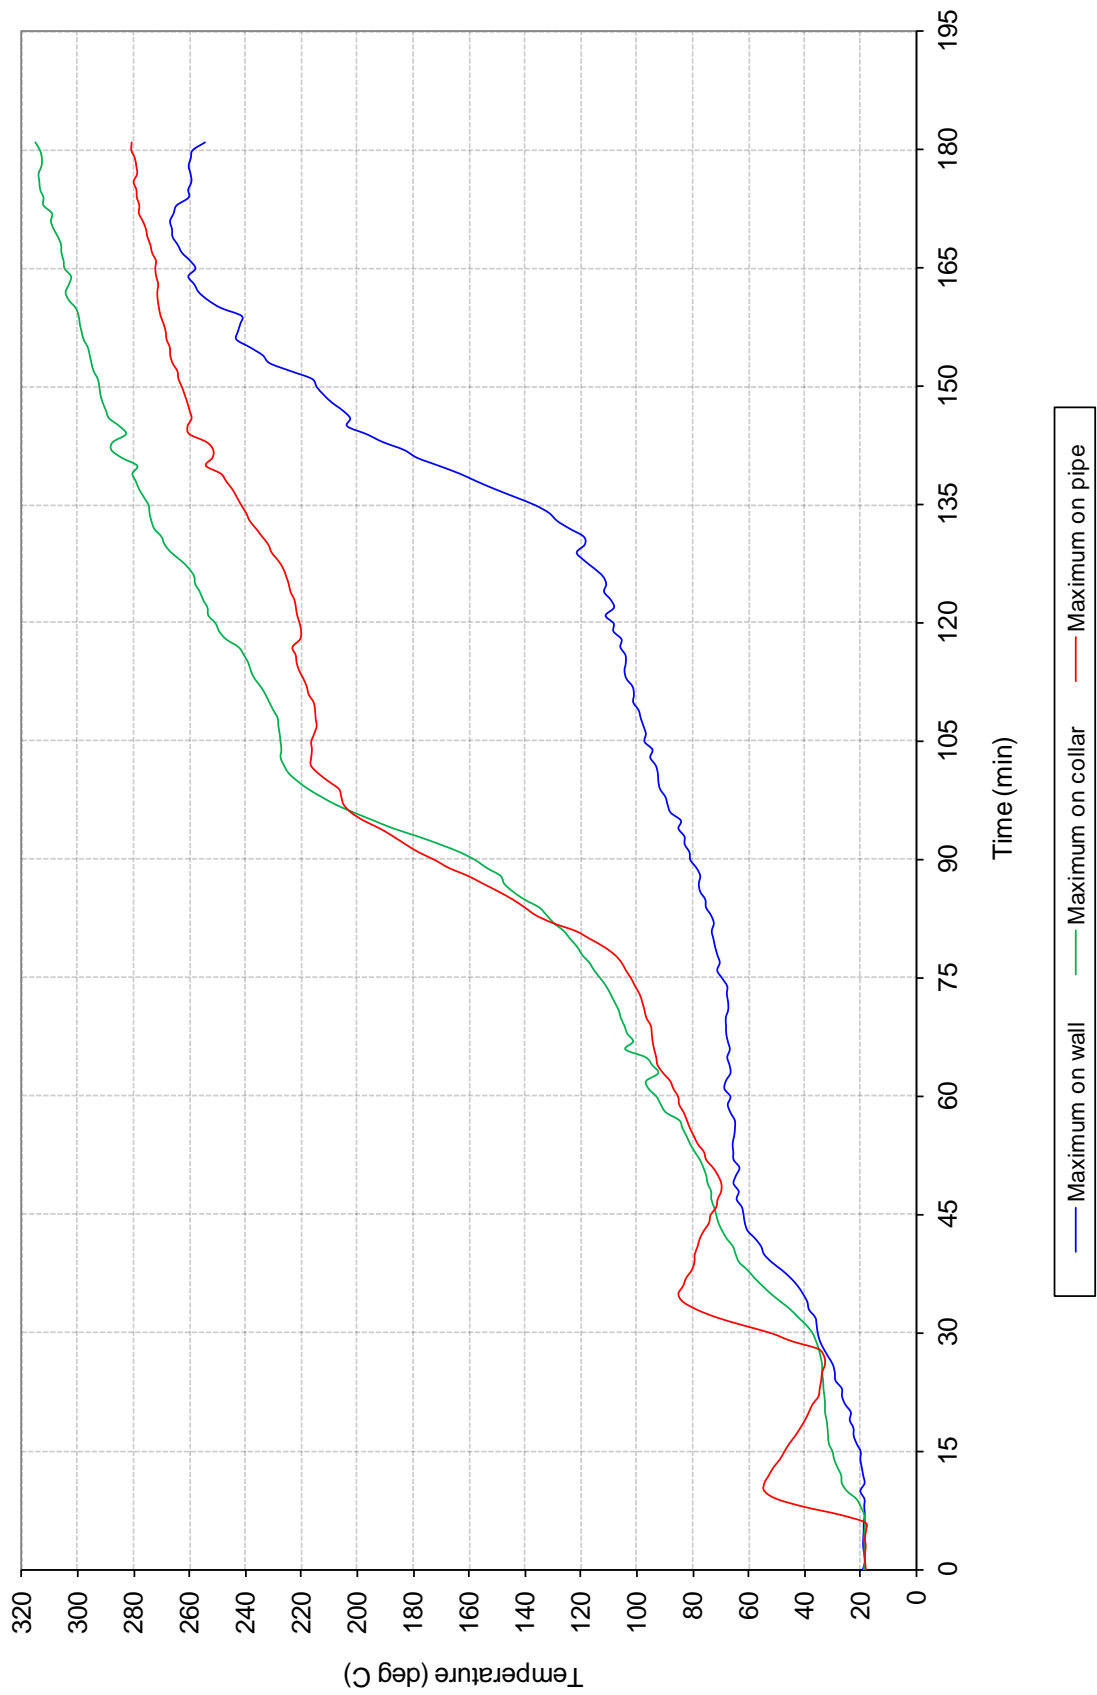
FIGURE 10 – SPECIMEN TEMPERATURE – ASSOCIATED WITH PENETRATION H

0:54:00	- Fluing visible again from Penetration H
0:57:00	- Fluing visible again from Penetration G.
1:36:00	- <u>Insulation failure of penetration H</u> – maximum temperature rise of 180 deg C is exceeded on the pipe.

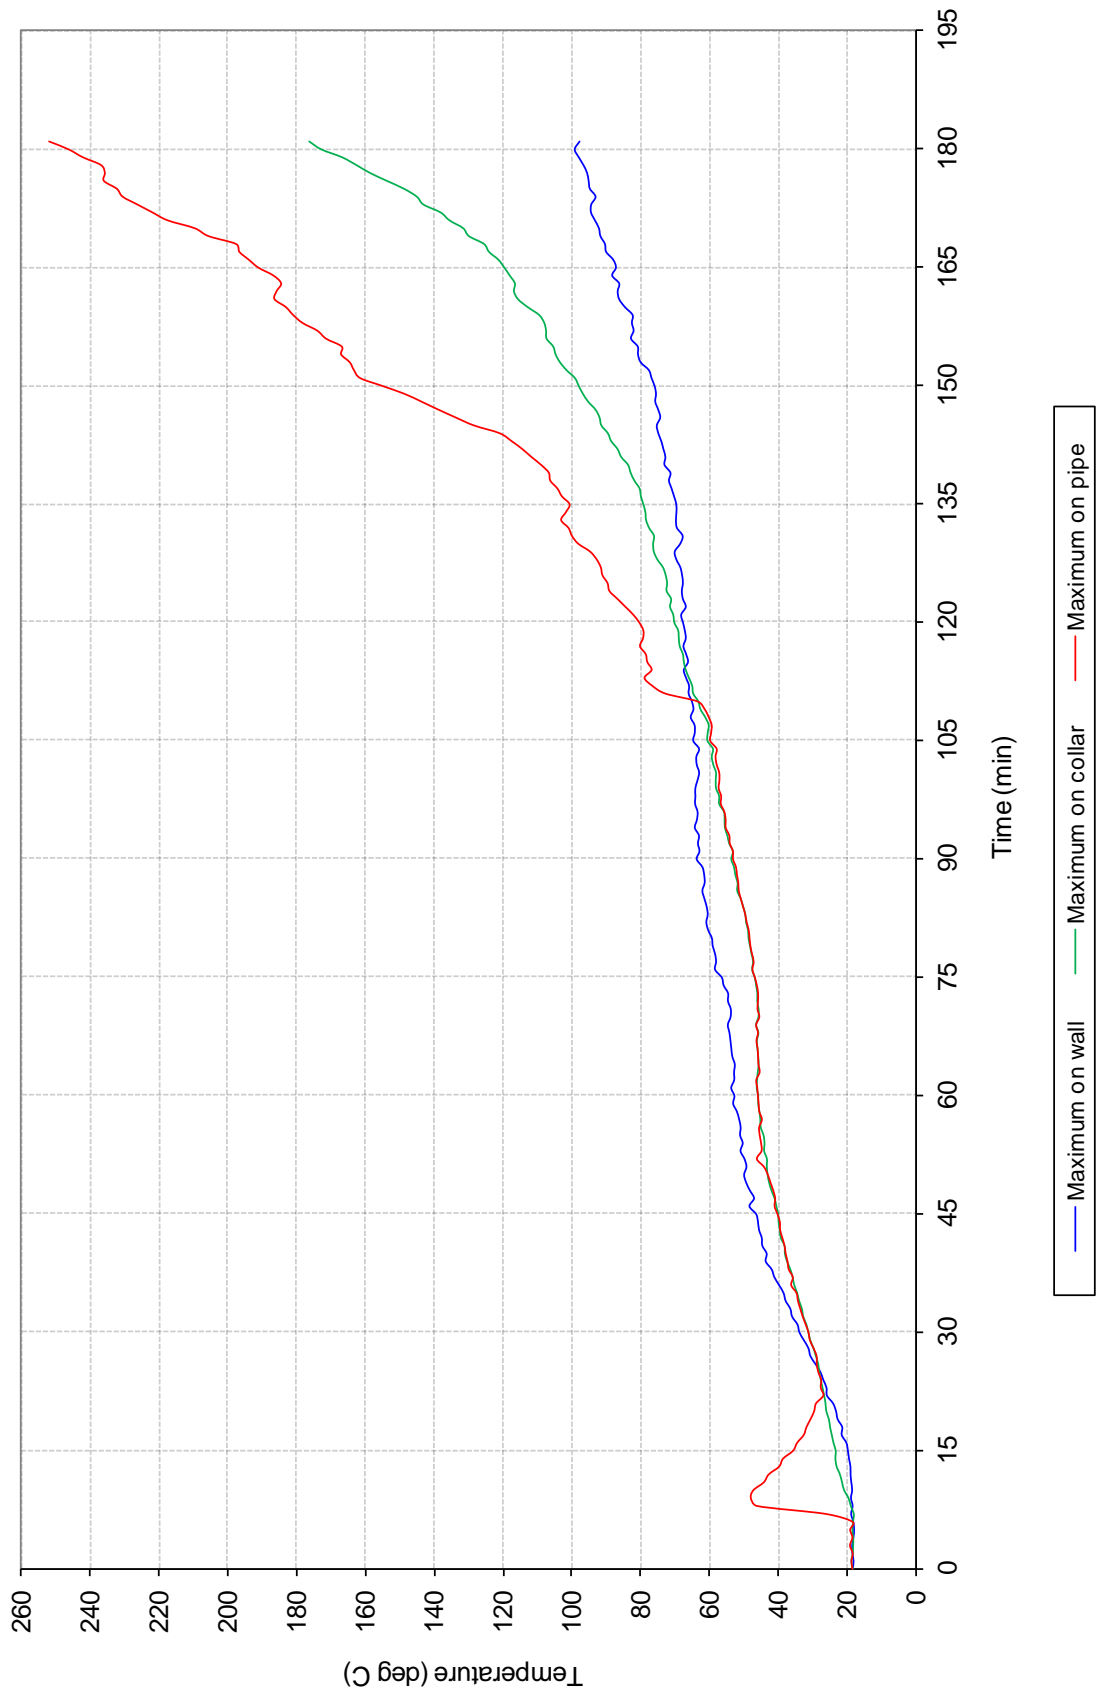
FIGURE 11 – SPECIMEN TEMPERATURE – ASSOCIATED WITH PENETRATION I

- 2:49:00 - The opening on Penetration G has been blocked by intumescent material.
Insulation failure of penetration I – maximum temperature rise of 180 deg C is exceeded on the pipe.

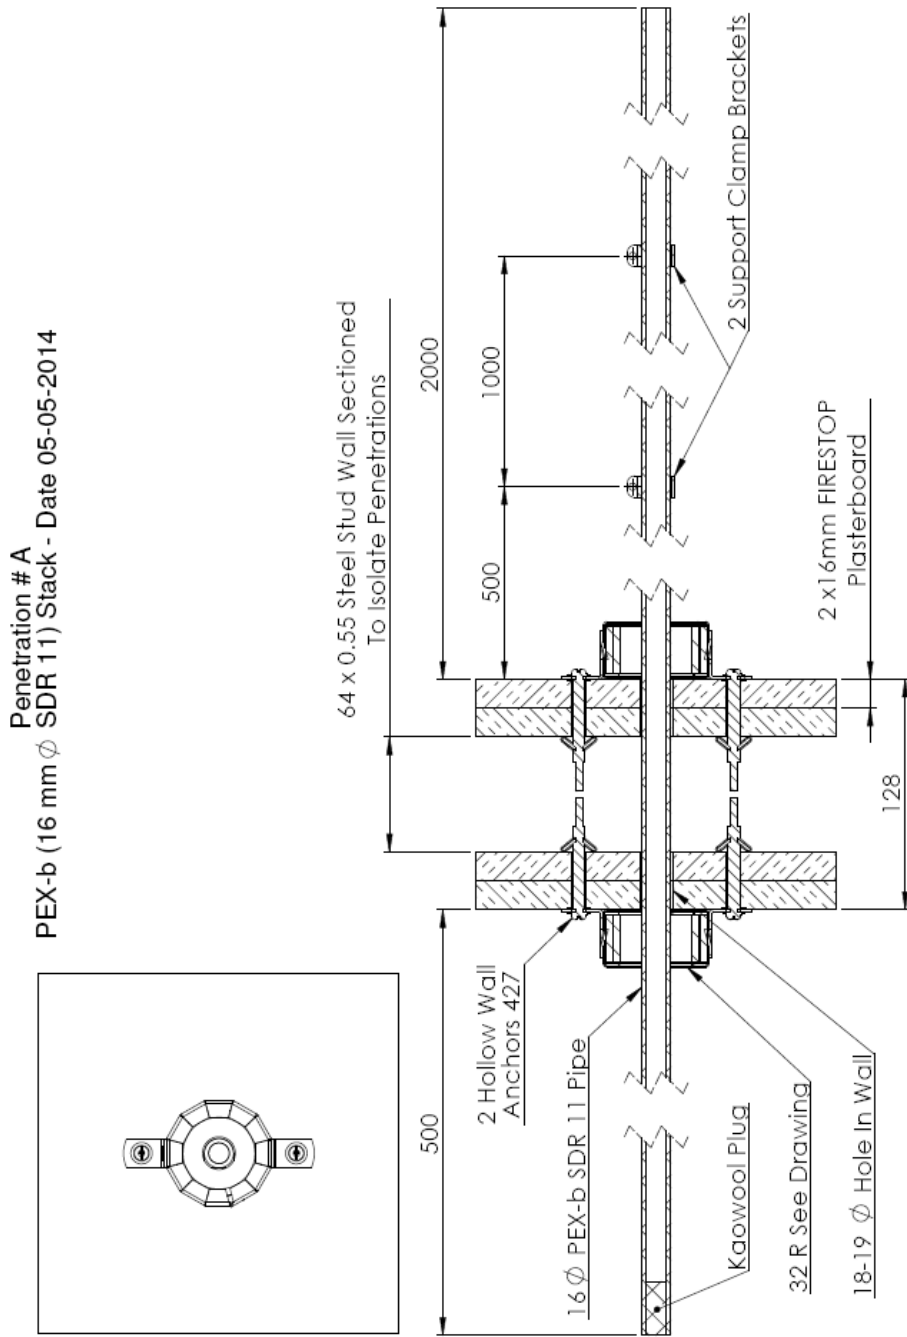
DRAWING TITLED “PENETRATION #A – PEX-B (16-MM SDR 11) STACK” DATED 5 MAY 2104, BY SNAP FIRE SYSTEMS PTY LTD.

Penetration A – 32R retrofitted fire collar protecting a PEX-b (16-mm SDR 11) stack pipe (80° brackets)

The SNAP retrofitted 32R fire collar comprised a 0.75-mm steel case with a 40-mm inner diameter and a 60-mm outside diameter. The 32-mm high collar casing comprised two layers of 4-mm thick Intumesh and a 135-mm x 25-mm stainless steel mesh as shown in drawing numbered 32R-T, dated 13 May 2014, by SNAP Fire Systems. Two collars were fixed to the wall by 180° brackets with Hollow Wall Anchors 427.

The penetrating service comprised a 16-mm cross-linked polyethylene (PEX-b) pipe, with a measured wall thickness of 3.1-mm fitted through a 19-mm diameter hole in the wall. The pipe projected horizontally 2000-mm through the plasterboard and 500-mm into the furnace chamber. The pipe was supported at 500-mm and 1000-mm from the unexposed face of the plasterboard wall. The pipe was open at the unexposed end and capped with kaowool plug on the exposed end.

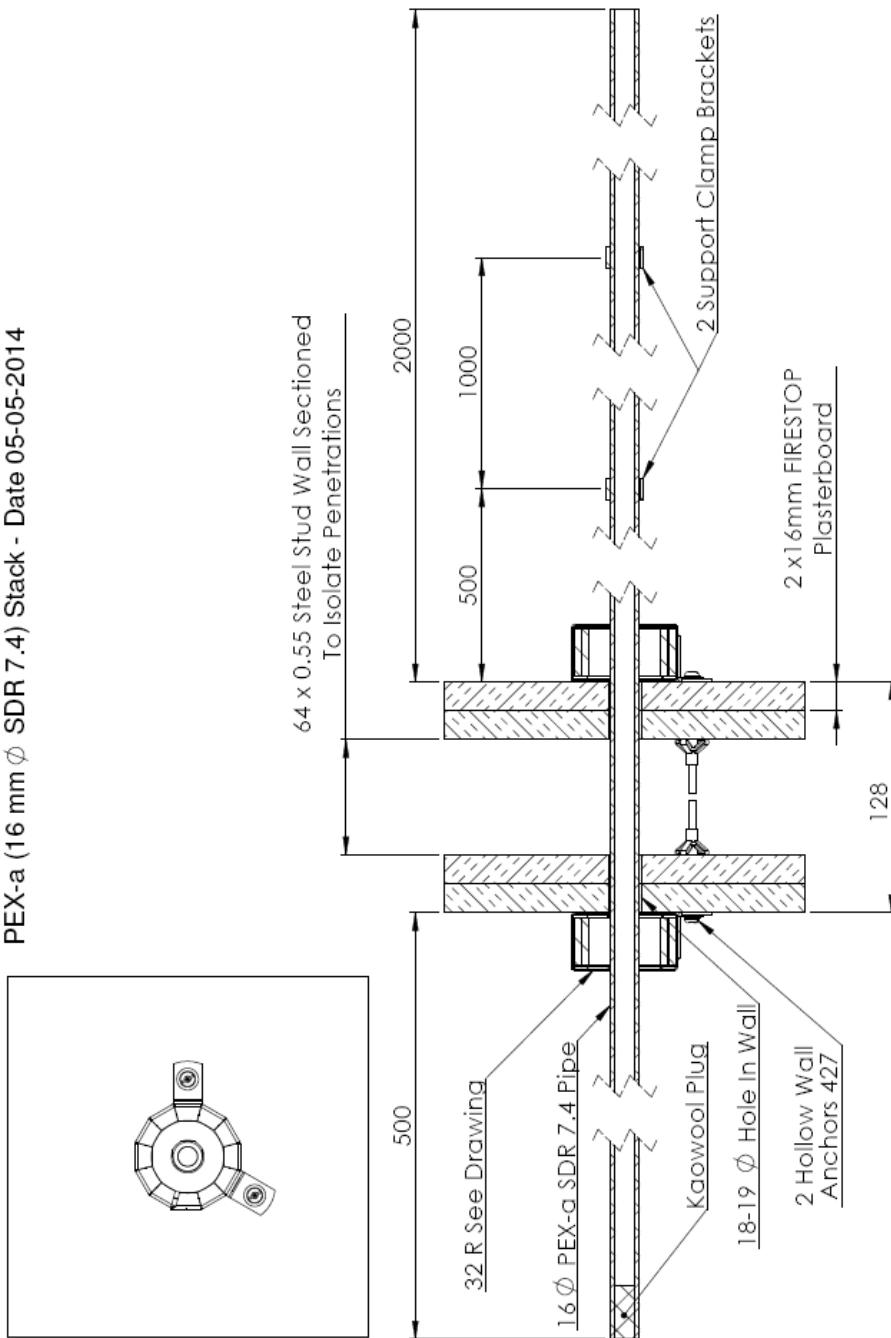
Penetration # B
 PEX-a (16 mm ϕ SDR 7.4) Stack - Date 05-05-2014

DRAWING TITLED "PENETRATION #B – PEX-A (16-MM SDR 7.4) STACK" DATED 5 MAY 2014, BY SNAP FIRE SYSTEMS PTY LTD.

Penetration B – 32R retrofitted fire collar protecting a PEX-a (16-mm SDR 7.4) stack pipe (120° brackets)

The SNAP retrofitted 32R fire collar comprised a 0.75-mm steel case with a 40-mm inner diameter and a 60-mm outside diameter. The 32-mm high collar casing comprised two layers of 4-mm thick Intumesh and a 135-mm x 25-mm stainless steel mesh as shown in drawing numbered 32R-T, dated 13 May 2014, by SNAP Fire Systems. Two collars were fixed to the wall by 120° brackets with Hollow Wall Anchors 427.

The penetrating service comprised a 16-mm cross-linked polyethylene (PEX-a) pipe, with a measured wall thickness of 2.3-mm fitted through a 19-mm diameter hole in the wall. The pipe projected horizontally 2000-mm through the plasterboard and 500-mm into the furnace chamber. The pipe was supported at 500-mm and 1000-mm from the unexposed face of the plasterboard

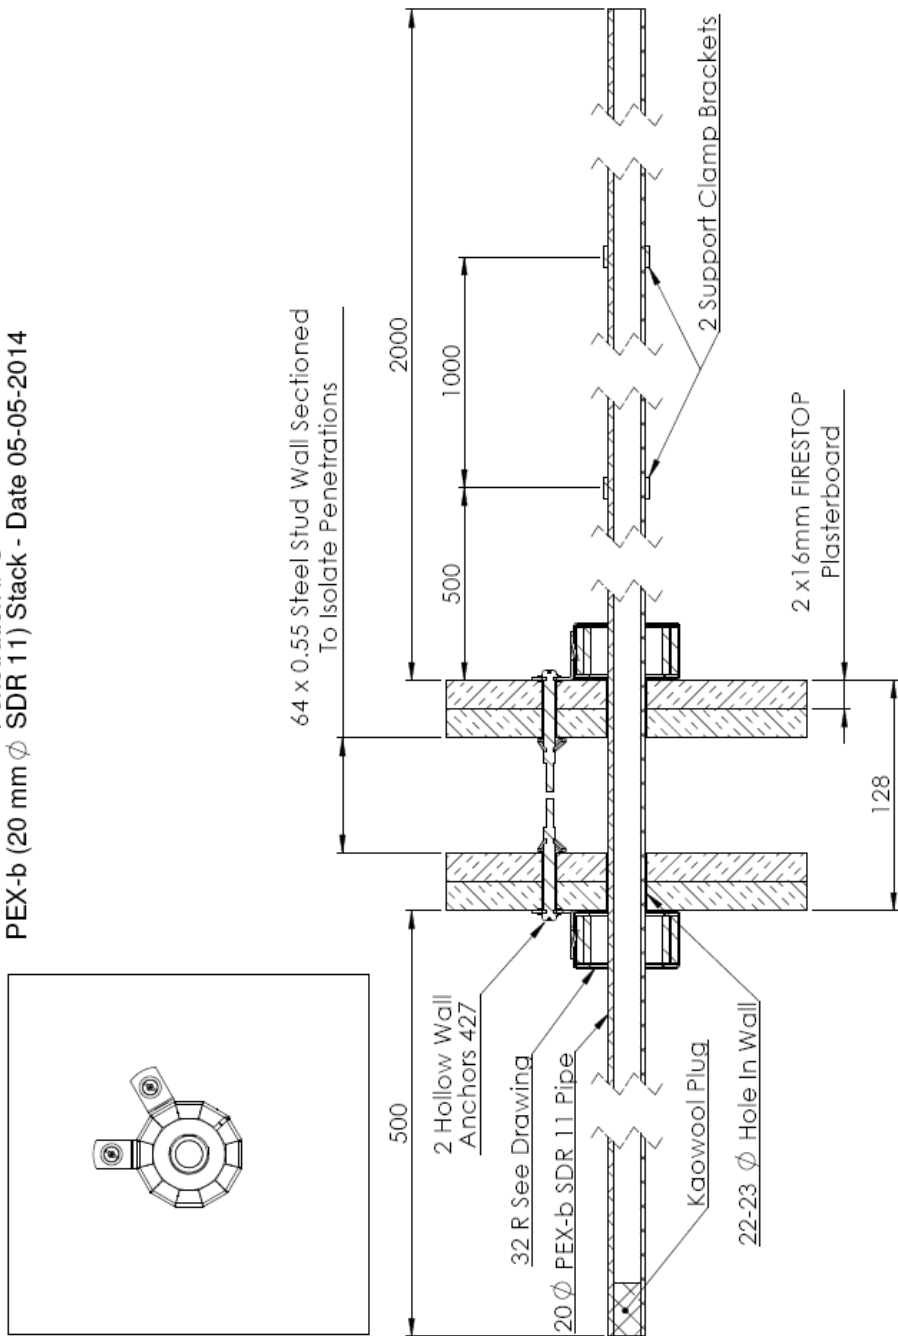
Penetration # C
 PEX-b (20 mm ϕ SDR 11) Stack - Date 05-05-2014

DRAWING TITLED "PENETRATION #C – PEX-B (20-MM SDR 11) STACK" DATED 5 MAY 2014, BY SNAP FIRE SYSTEMS PTY LTD.

Penetration C – 32R retrofitted fire collar protecting a PEX-b (20-mm SDR 11) stack pipe (60° brackets)

The SNAP retrofitted 32R fire collar comprised a 0.75-mm steel case with a 40-mm inner diameter and a 60-mm outside diameter. The 32-mm high collar casing comprised two layers of 4-mm thick Intumesh and a 135-mm x 25-mm stainless steel mesh as shown in drawing numbered 32R-T, dated 13 May 2014, by SNAP Fire Systems. Two collars were fixed to the wall by two 60° brackets with Hollow Wall Anchors 427.

The penetrating service comprised a 20-mm cross-linked polyethylene (PEX-b) pipe, with a measured wall thickness of 2.1-mm fitted through a 23-mm diameter hole in the wall. The pipe projected horizontally 2000-mm through the plasterboard and 500-mm into the furnace chamber. The pipe was supported at 500-mm and 1000-mm from the unexposed face of the plasterboard wall. The pipe was open at the unexposed end and capped with kaowool plug on the exposed end.

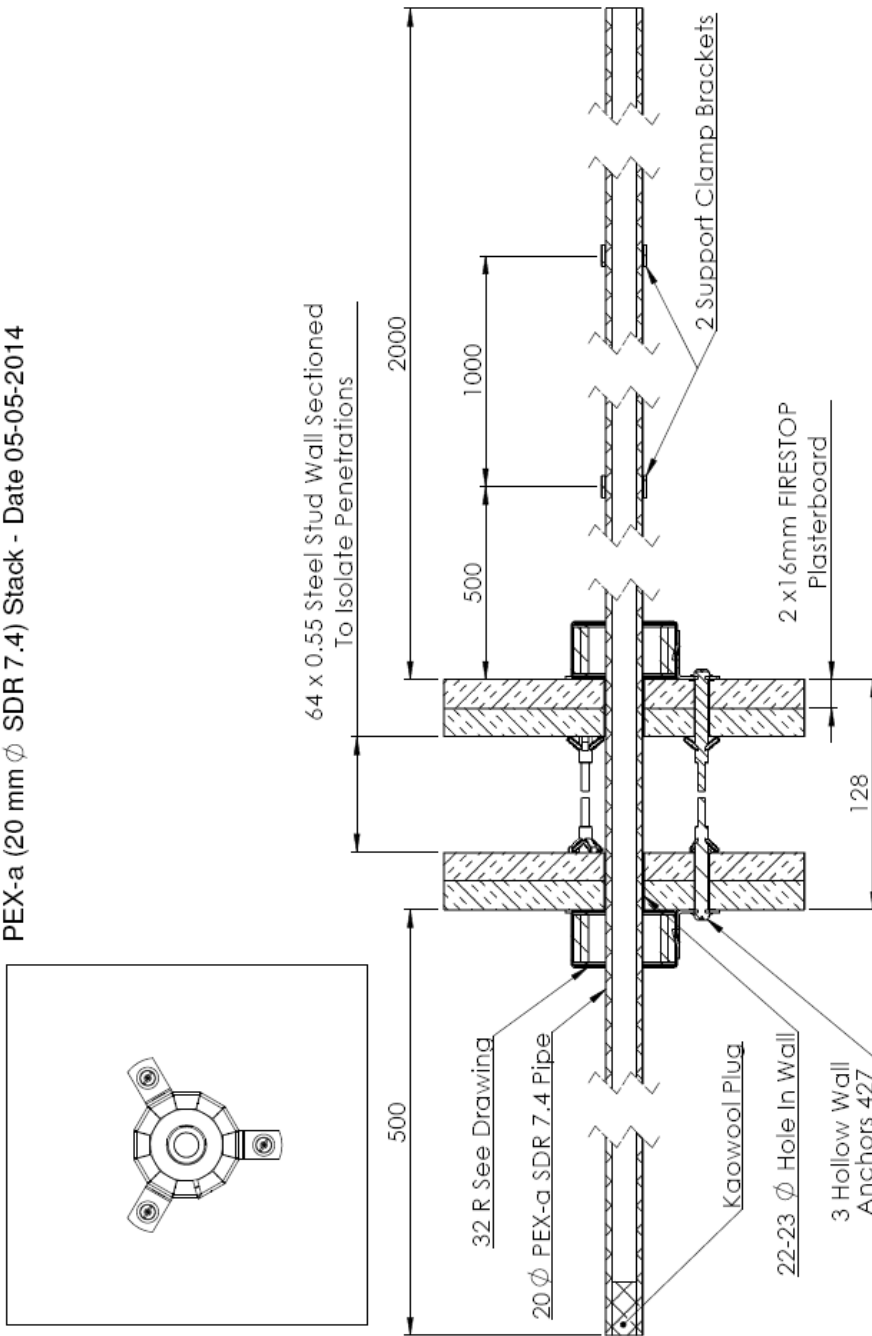
Penetration # D
 PEX-a (20 mm ϕ SDR 7.4) Stack - Date 05-05-2014

DRAWING TITLED "PENETRATION #D – PEX-A (20-MM SDR 7.4) STACK" DATED 5 MAY 2014, BY SNAP FIRE SYSTEMS PTY LTD.

Penetration D – 32R retrofitted fire collar protecting a PEX-a (20-mm SDR 7.4) stack pipe (120° brackets)

The SNAP retrofitted 32R fire collar comprised a 0.75-mm steel case with a 40-mm inner diameter and a 60-mm outside diameter. The 32-mm high collar casing comprised two layers of 4-mm thick Intumesh and a 135-mm x 25-mm stainless steel mesh as shown in drawing numbered 32R-T, dated 13 May 2014, by SNAP Fire Systems. Two collars were fixed to the wall by three 120° brackets with Hollow Wall Anchors 427.

The penetrating service comprised a 20-mm cross-linked polyethylene (PEX-a) pipe, with a measured wall thickness of 3.9-mm fitted through a 23-mm diameter hole in the wall. The pipe projected horizontally 2000-mm through the plasterboard and 500-mm into the furnace chamber. The pipe was supported at 500-mm and 1000-mm from the unexposed face of the plasterboard wall. The pipe was open at the unexposed end and capped with kaowool plug on the exposed end.

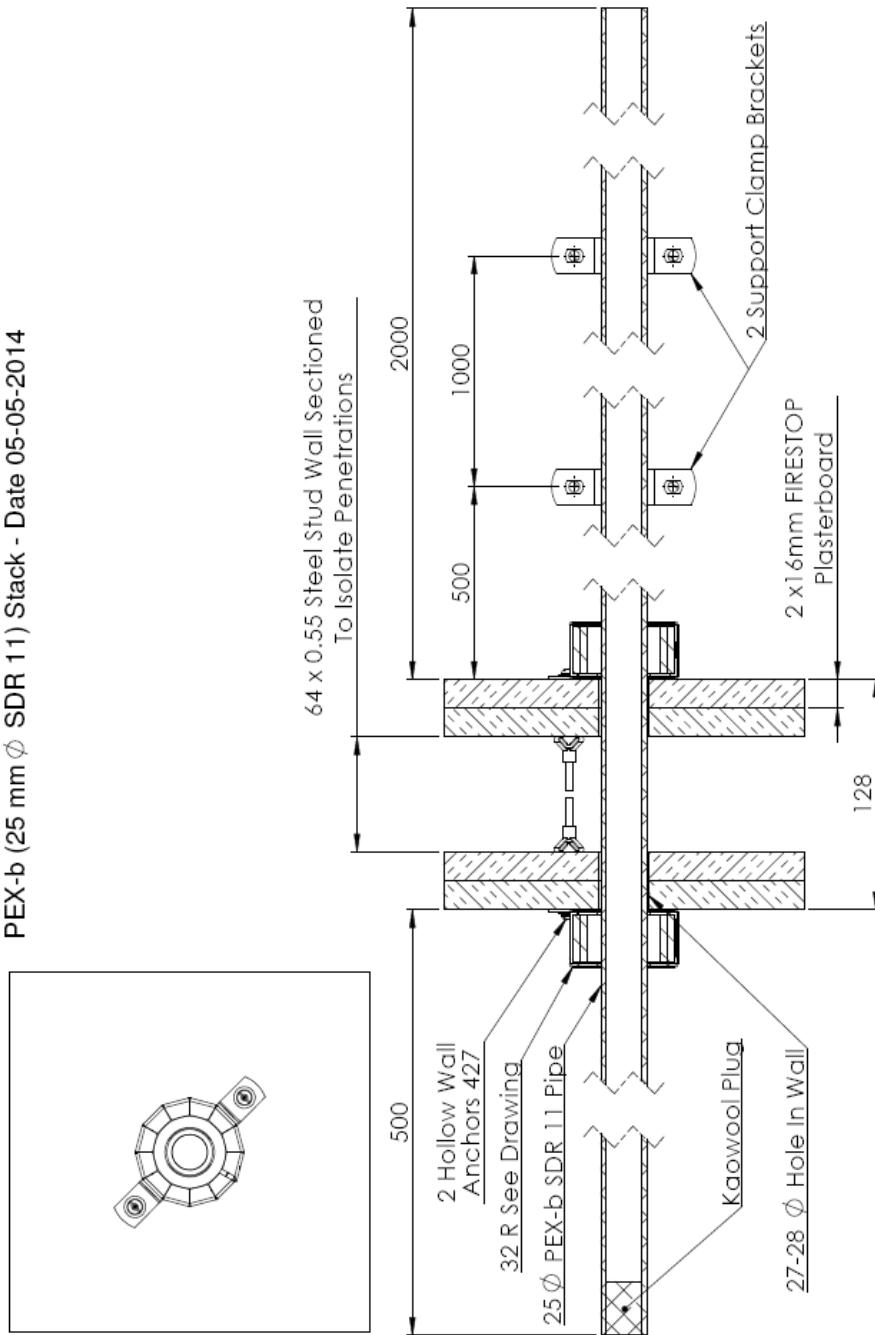
Penetration # E
 PEX-b (25 mm ϕ SDR 11) Stack - Date 05-05-2014

DRAWING TITLED "PENETRATION #E – PEX-B (25-MM SDR 11) STACK" DATED 5 MAY 2014, BY SNAP FIRE SYSTEMS PTY LTD.

Penetration E – 32R retrofitted fire collar protecting a PEX-b (25-mm SDR 11) stack pipe (180° brackets)

The SNAP retrofitted 32R fire collar comprised a 0.75-mm steel case with a 40-mm inner diameter and a 60-mm outside diameter. The 32-mm high collar casing comprised two layers of 4-mm thick Intumesh and a 135-mm x 25-mm stainless steel mesh as shown in drawing numbered 32R-T, dated 13 May 2014, by SNAP Fire Systems. Two collars were fixed to the wall by two 180° brackets with Hollow Wall Anchors 427.

The penetrating service comprised a 25-mm cross-linked polyethylene (PEX-b) pipe, with a measured wall thickness of 2.6-mm fitted through the collar's sleeve. The pipe projected horizontally 2000-mm through the plasterboard and 500-mm into the furnace chamber. The pipe was supported at 500-mm and 1000-mm from the unexposed face of the plasterboard wall. The pipe was open at the unexposed end and capped with kaowool plug on the exposed end.

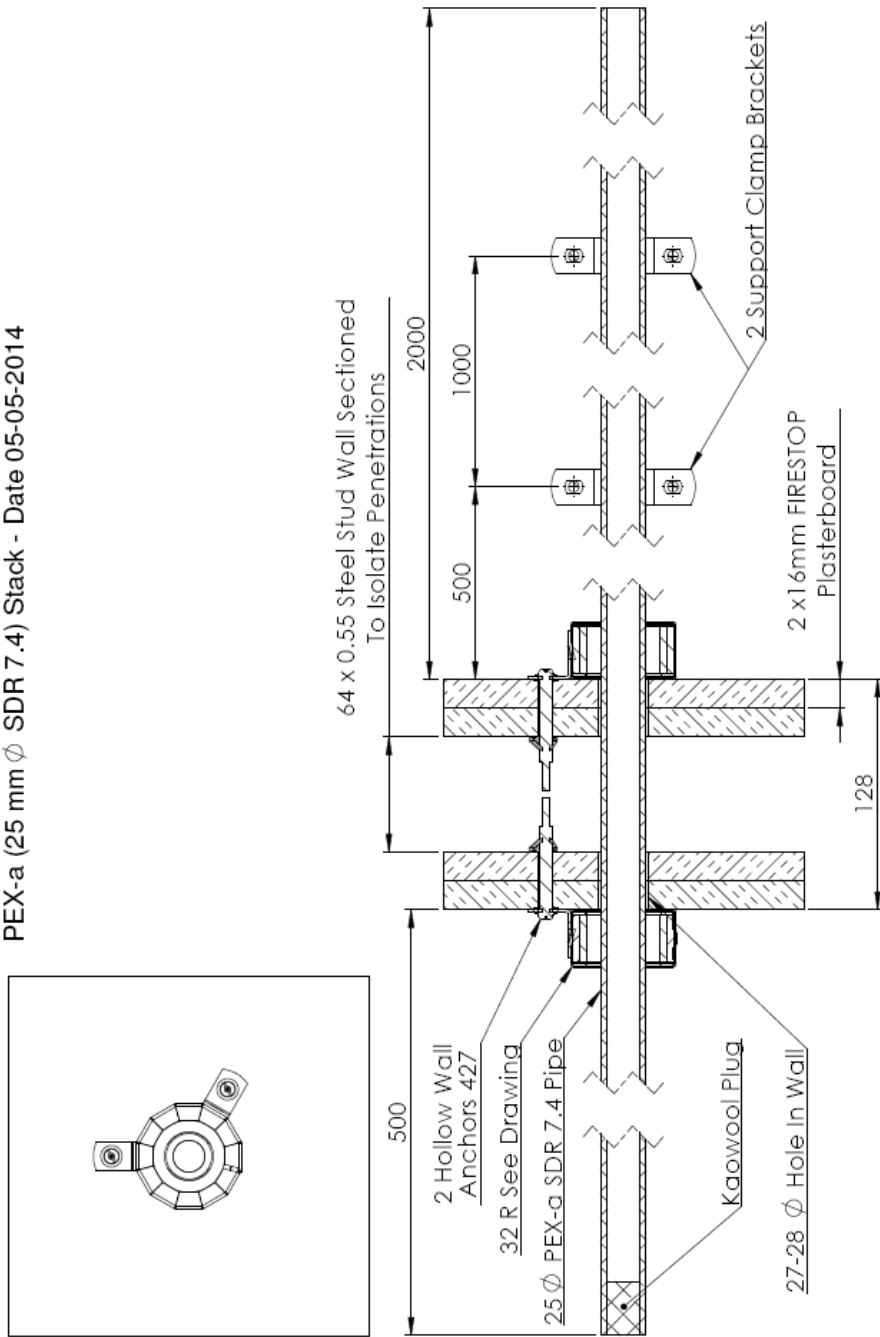
Penetration # F
 PEX-a (25 mm ϕ SDR 7.4) Stack - Date 05-05-2014

DRAWING TITLED "PENETRATION # F – PEX-A (25-MM SDR 7.4) STACK" DATED 5 MAY 2014, BY SNAP FIRE SYSTEMS PTY LTD.

Penetration F – 32R retrofitted fire collar protecting a PEX-a (25-mm SDR 7.4) stack pipe (120° brackets)

The SNAP retrofitted 32R fire collar comprised a 0.75-mm steel case with a 40-mm inner diameter and a 60-mm outside diameter. The 32-mm high collar casing comprised two layers of 4-mm thick Intumesh and a 135-mm x 25-mm stainless steel mesh as shown in drawing numbered 32R-T, dated 13 May 2014, by SNAP Fire Systems. Two collars were fixed to the wall by three 120° brackets with Hollow Wall Anchors 427.

The penetrating service comprised a 25-mm cross-linked polyethylene (PEX-a) pipe, with a measured wall thickness of 4-mm fitted through a 28-mm diameter hole in the wall. The pipe projected horizontally 2000-mm through the plasterboard and 500-mm into the furnace chamber. The pipe was supported at 500-mm and 1000-mm from the unexposed face of the plasterboard wall. The pipe was open at the unexposed end and capped with kaowool plug on the exposed end.

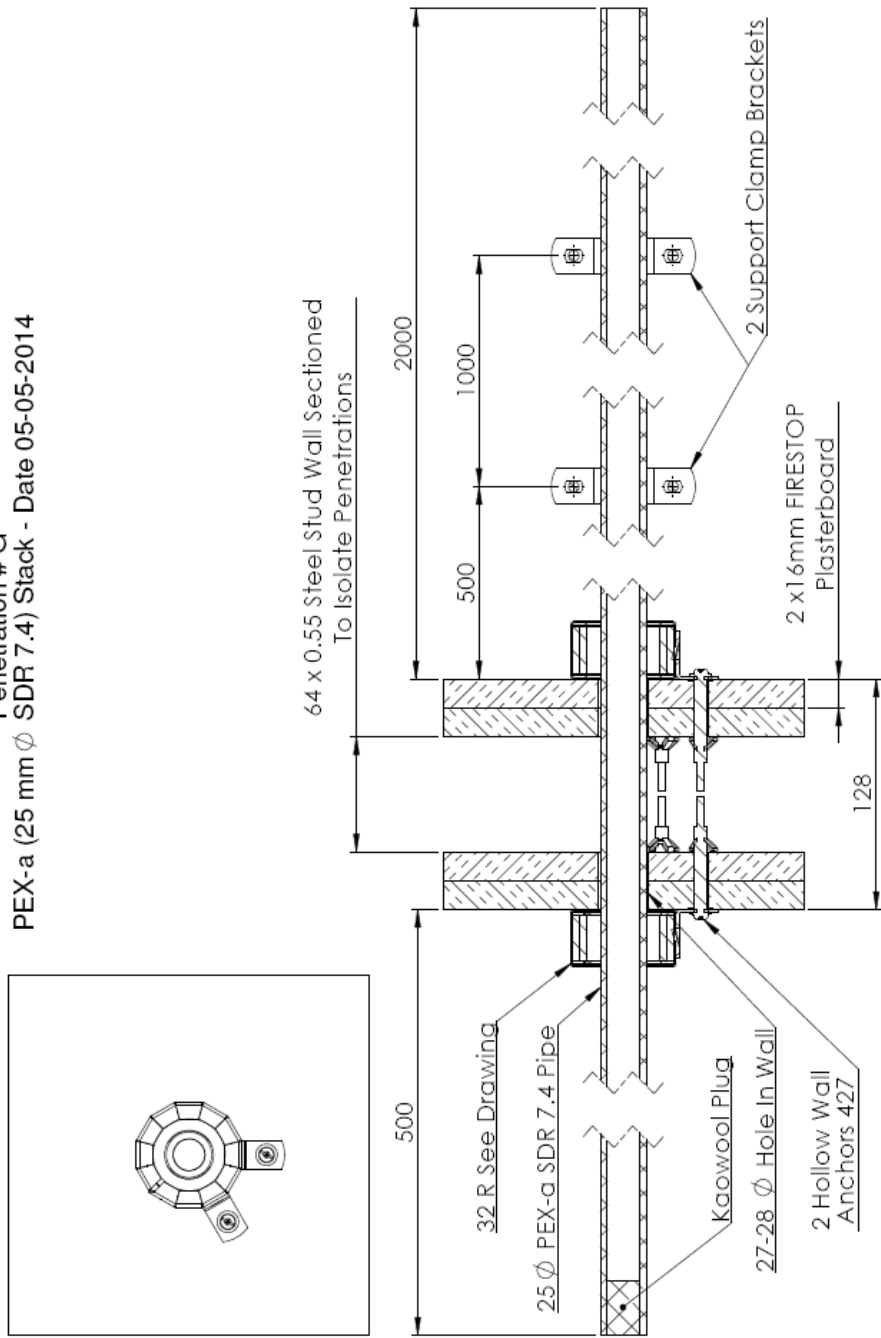
Penetration # G
 PEX-a (25 mm ϕ SDR 7.4) Stack - Date 05-05-2014

DRAWING TITLED "PENETRATION #G – PEX-A (25-MM SDR 7.4) STACK" DATED 5 MAY 2014, BY SNAP FIRE SYSTEMS PTY LTD.

Penetration G – 32R retrofitted fire collar protecting a PEX-a (25-mm SDR 7.4) stack pipe (60° brackets)

The SNAP retrofitted 32R fire collar comprised a 0.75-mm steel case with a 40-mm inner diameter and a 60-mm outside diameter. The 32-mm high collar casing comprised two layers of 4-mm thick Intumesh and a 135-mm x 25-mm stainless steel mesh as shown in drawing numbered 32R-T, dated 13 May 2014, by SNAP Fire Systems. Two collars were fixed to the wall by two 60° brackets with Hollow Wall Anchors 427.

The penetrating service comprised a 25-mm cross-linked polyethylene (PEX-a) pipe, with a measured wall thickness of 4-mm fitted through the a 28-mm diameter hole in the wall. The pipe projected horizontally 2000-mm through the plasterboard and 500-mm into the furnace chamber. The pipe was supported at 500-mm and 1000-mm from the unexposed face of the plasterboard wall. The pipe was open at the unexposed end and capped with kaowool plug on the exposed end.

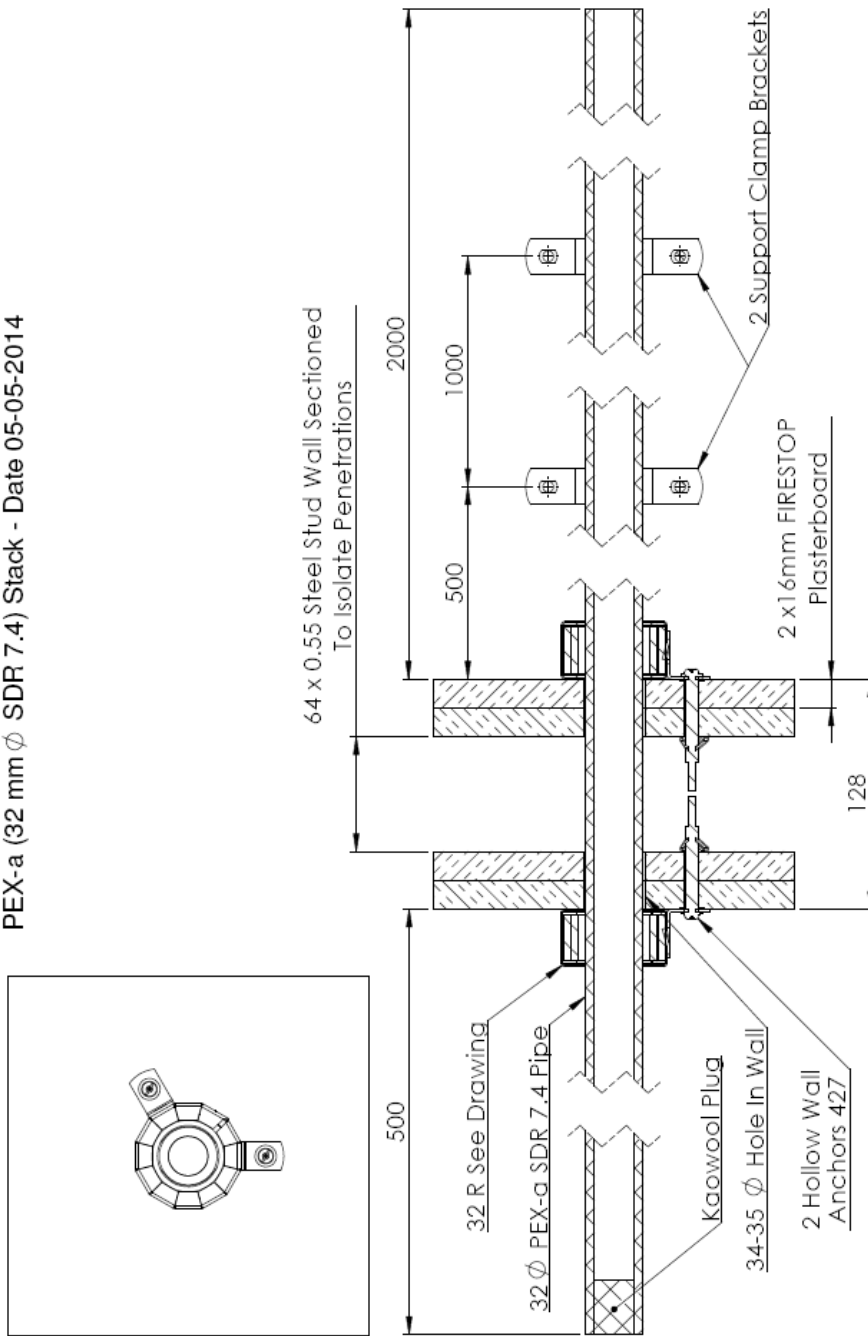
Penetration # H
 PEX-a (32 mm ϕ SDR 7.4) Stack - Date 05-05-2014

DRAWING TITLED "PENETRATION #H – PEX-A (32-MM SDR 7.4) STACK" DATED 5 MAY 2014, BY SNAP FIRE SYSTEMS PTY LTD.

Penetration H – 32R retrofitted fire collar protecting a PEX-a (32-mm SDR 7.4) stack pipe (120° brackets)

The SNAP retrofitted 32R fire collar comprised a 0.75-mm steel case with a 40-mm inner diameter and a 60-mm outside diameter. The 32-mm high collar casing comprised two layers of 4-mm thick Intumesh and a 135-mm x 25-mm stainless steel mesh as shown in drawing numbered 32R-T, dated 13 May 2014, by SNAP Fire Systems. Two collars were fixed to the wall by two 120° brackets with Hollow Wall Anchors 427.

The penetrating service comprised a 32-mm cross-linked polyethylene (PEX-a) pipe, with a measured wall thickness of 4.5-mm fitted through a 35-mm diameter hole in the wall. The pipe projected horizontally 2000-mm through the plasterboard and 500-mm into the furnace chamber. The pipe was supported at 500-mm and 1000-mm from the unexposed face of the plasterboard wall. The pipe was open at the unexposed end and capped with kaowool plug on the exposed end.

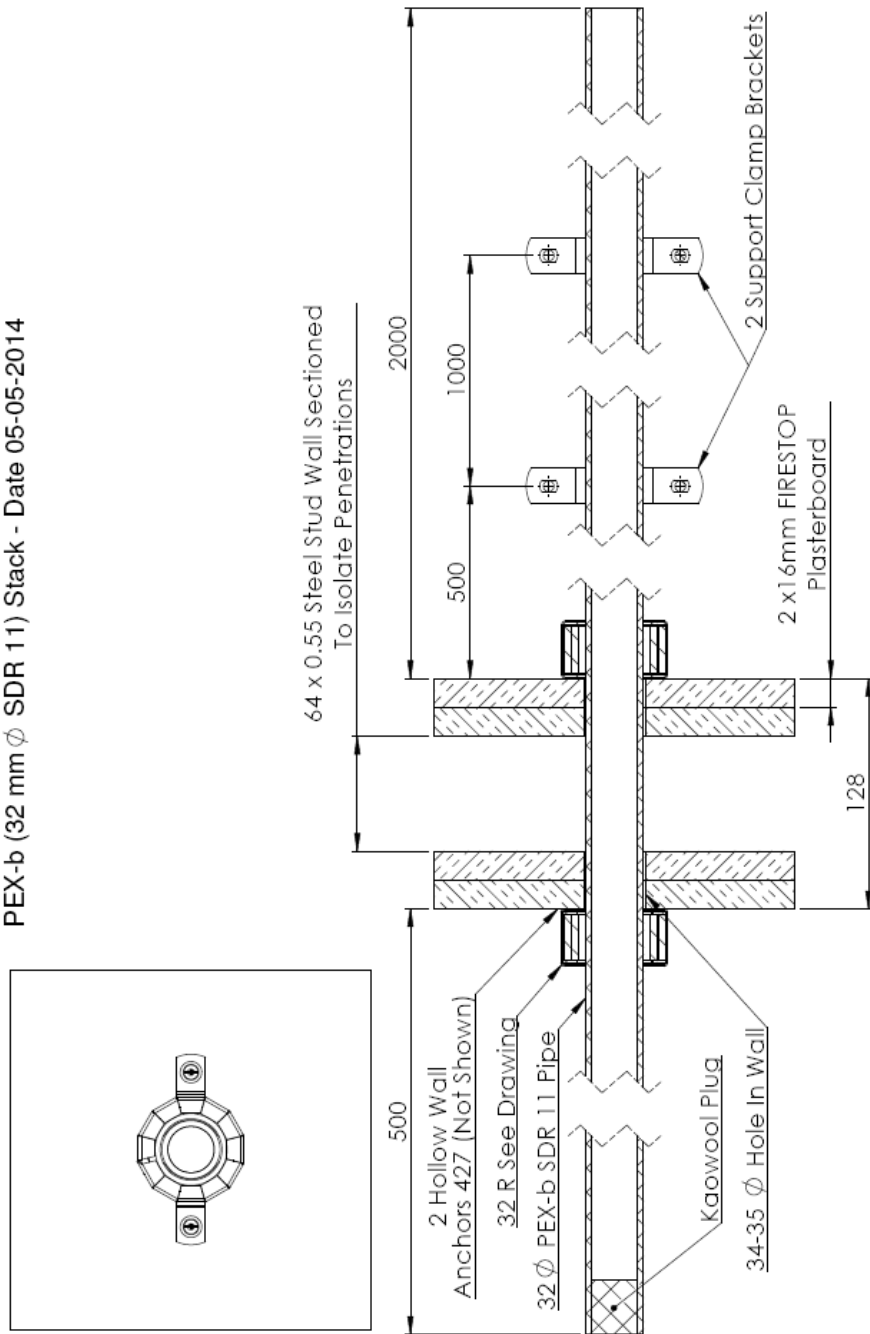
Penetration # 1
 PEX-b (32 mm ϕ SDR 11) Stack - Date 05-05-2014

DRAWING TITLED "PENETRATION #1 – PEX-B (32-MM SDR 11) STACK" DATED 5 MAY 2014, BY SNAP FIRE SYSTEMS PTY LTD.

Penetration I – 32R retrofitted fire collar protecting a PEX-b (32-mm SDR 11) stack pipe (180° brackets)

The SNAP retrofitted 32R fire collar comprised a 0.75-mm steel case with a 40-mm inner diameter and a 60-mm outside diameter. The 32-mm high collar casing comprised two layers of 4-mm thick Intumesh and a 135-mm x 25-mm stainless steel mesh as shown in drawing numbered 32R-T, dated 13 May 2014, by SNAP Fire Systems. Two collars were fixed to the wall by two 180° brackets with Hollow Wall Anchors 427.

The penetrating service comprised a 32-mm cross-linked polyethylene (PEX-b) pipe, with a measured wall thickness of 3.5-mm fitted through a 35-mm diameter hole in the wall. The pipe projected horizontally 2000-mm through the plasterboard and 500-mm into the furnace chamber. The pipe was supported at 500-mm and 1000-mm from the unexposed face of the plasterboard wall. The pipe was open at the unexposed end and capped with kaowool plug on the exposed end.
