Fire-resistance test on fire collars protecting a concrete slab penetrated by services

Test Report

Author: Chris Wojcik
Report number: FSP 1758
Date: 1 November 2016

Client: Snap Fire Systems Pty Ltd

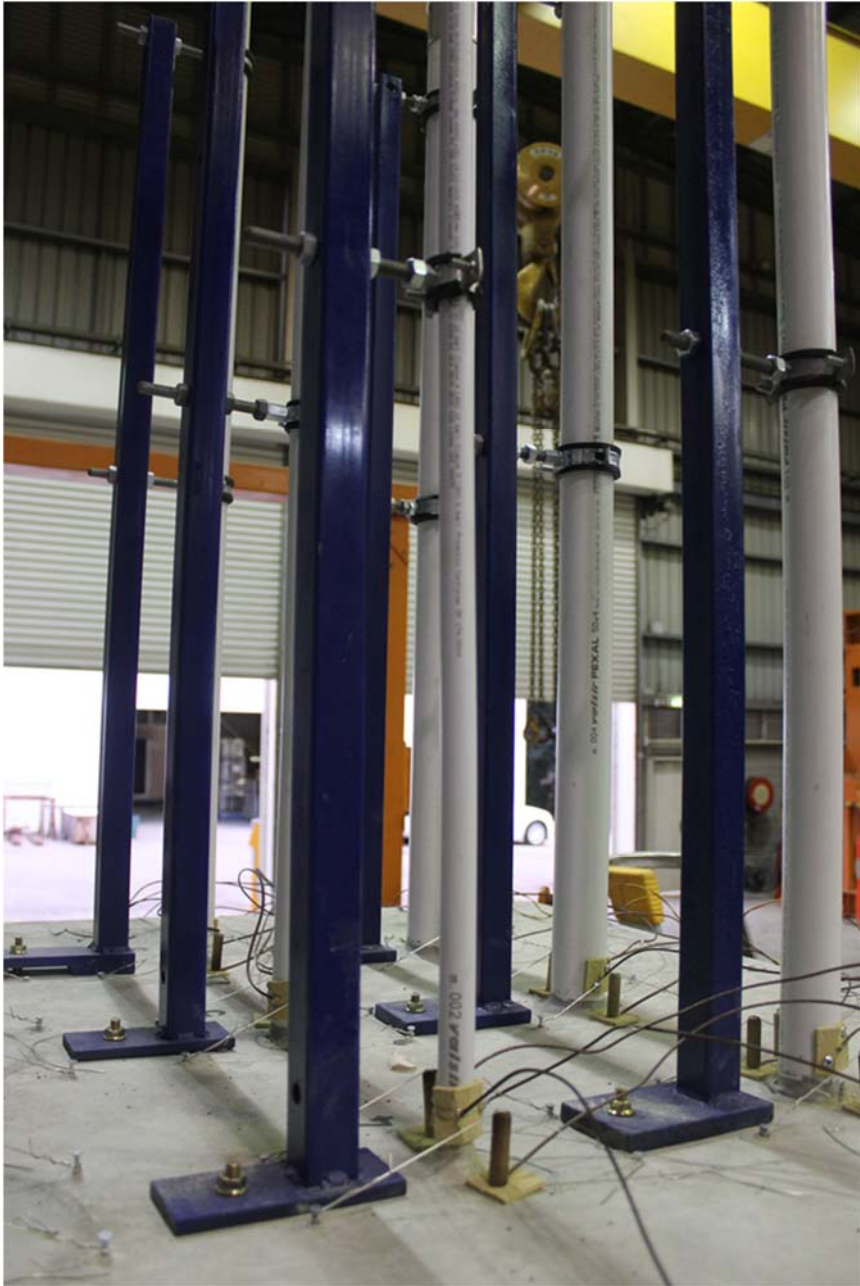
PHOTOGRAPH 1 – UNEXPOSED FACE OF SPECIMENS PRIOR TO TESTING

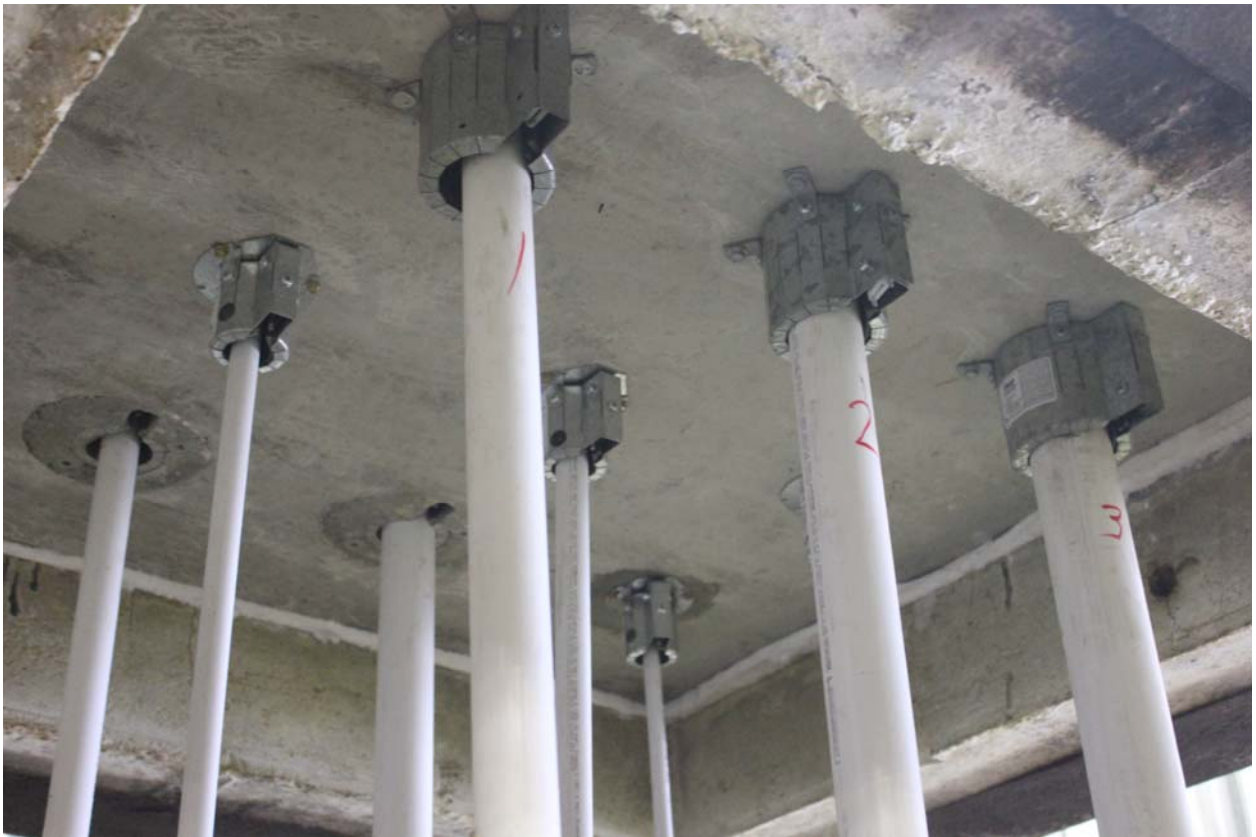
PHOTOGRAPH 2 – EXPOSED FACE OF SPECIMEN PRIOR TO TESTING

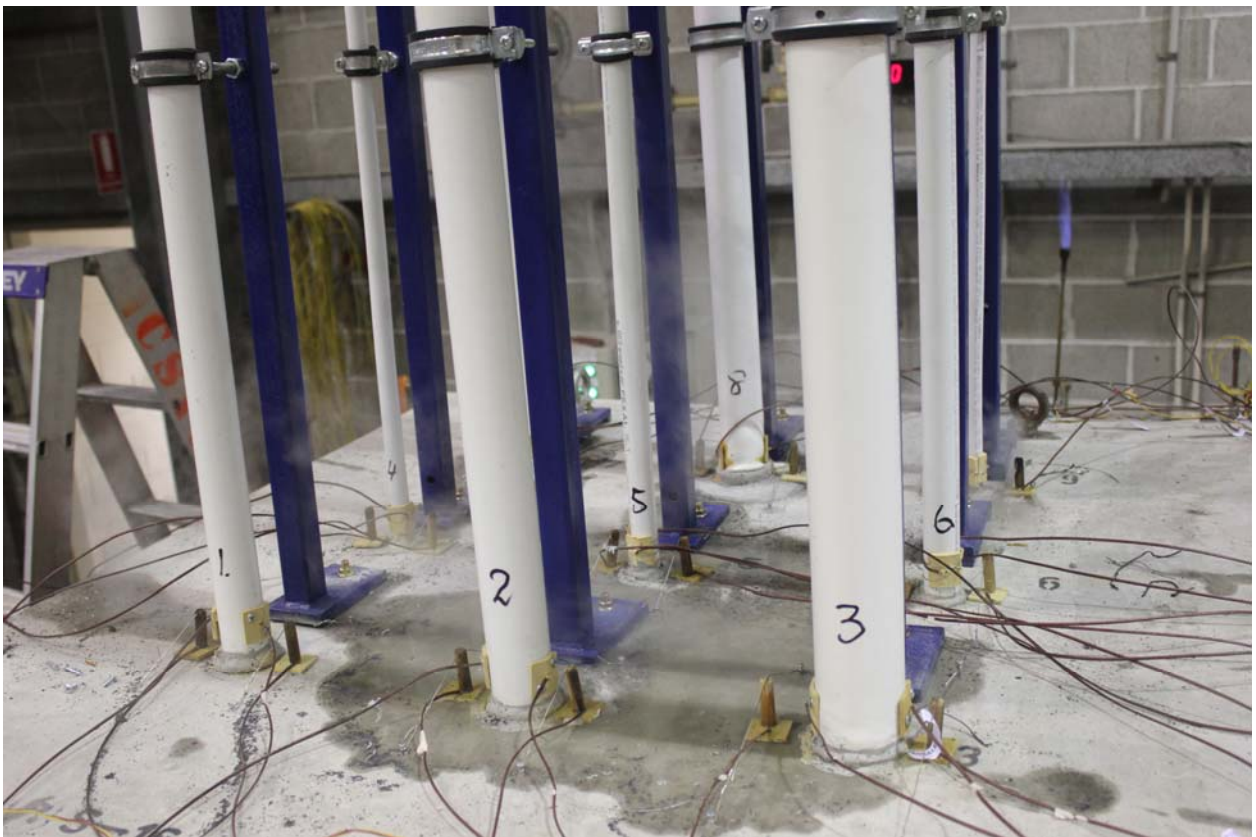
PHOTOGRAPH 3 – SPECIMENS AFTER 60 MINUTES OF TESTING

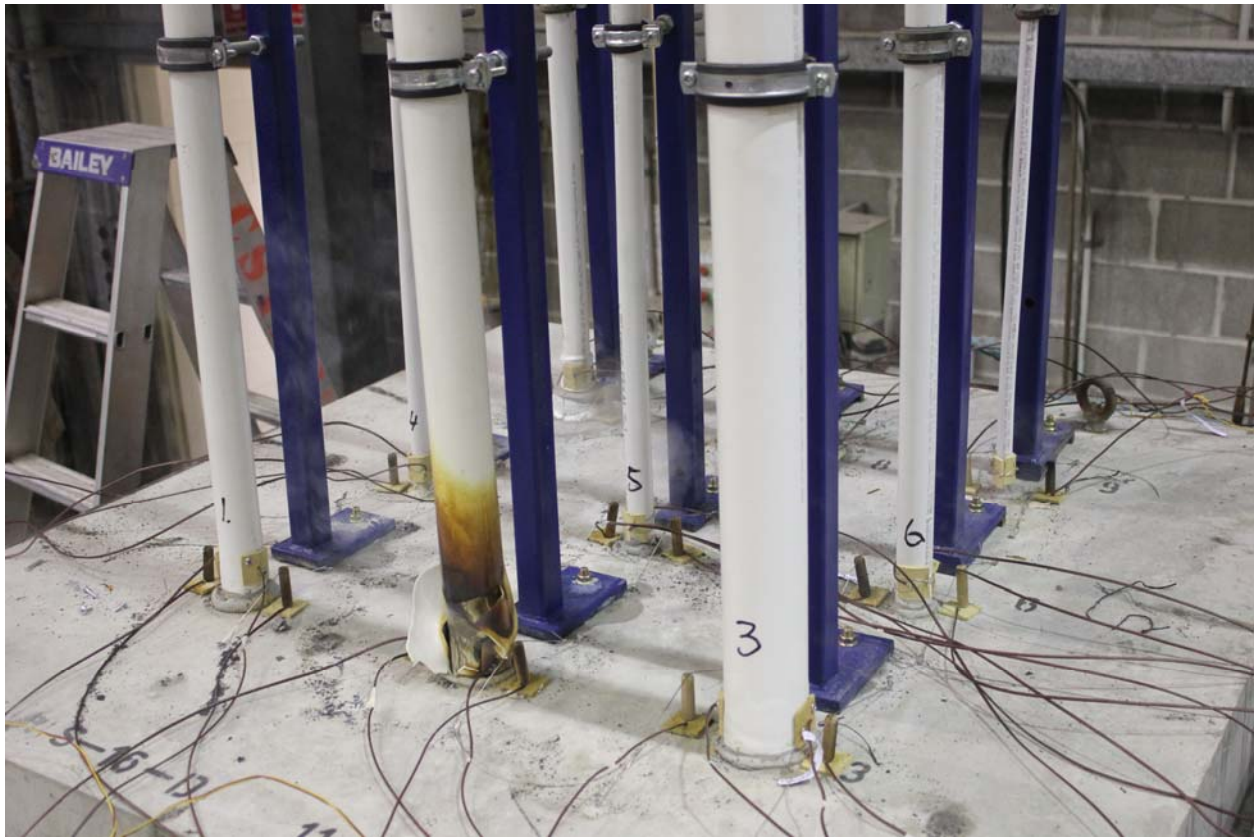
PHOTOGRAPH 4 – SPECIMENS AFTER 120 MINUTES OF TESTING

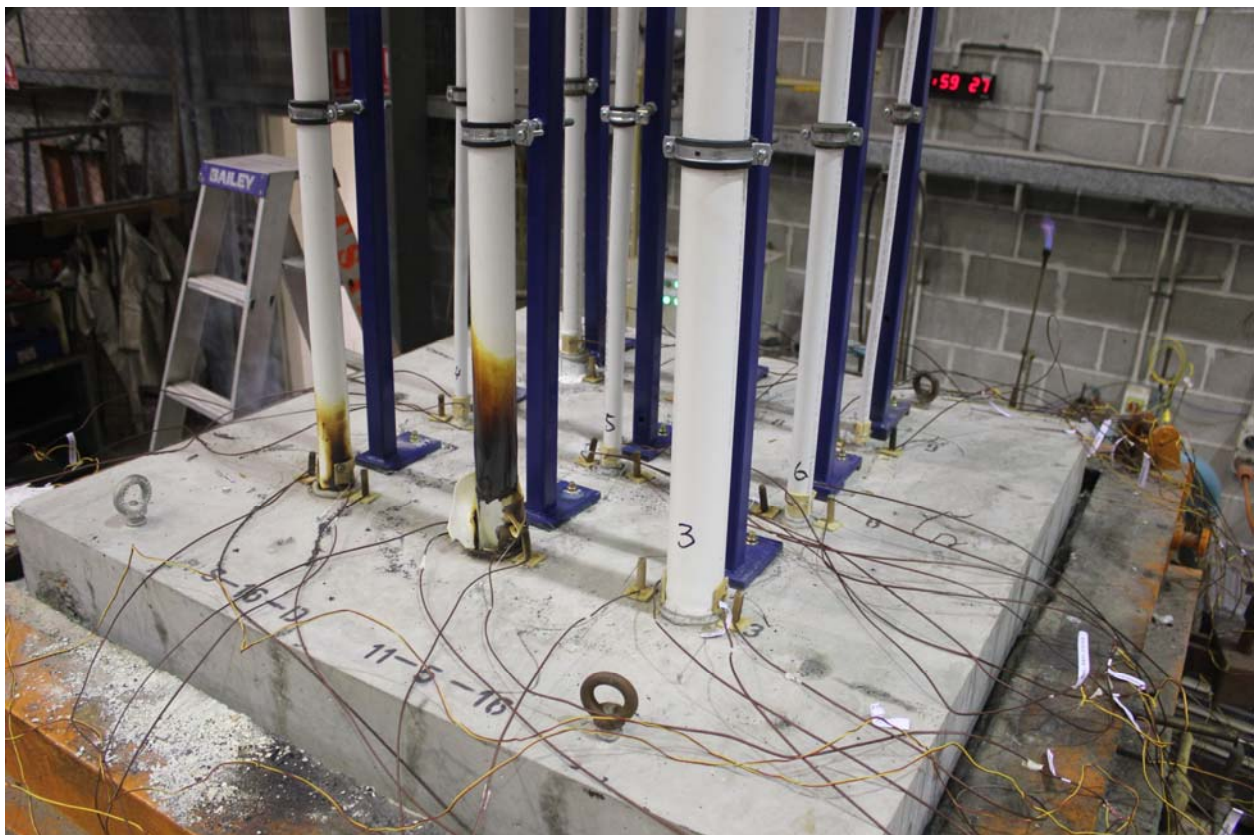
PHOTOGRAPH 5 – SPECIMENS AFTER 180 MINUTES OF TESTING

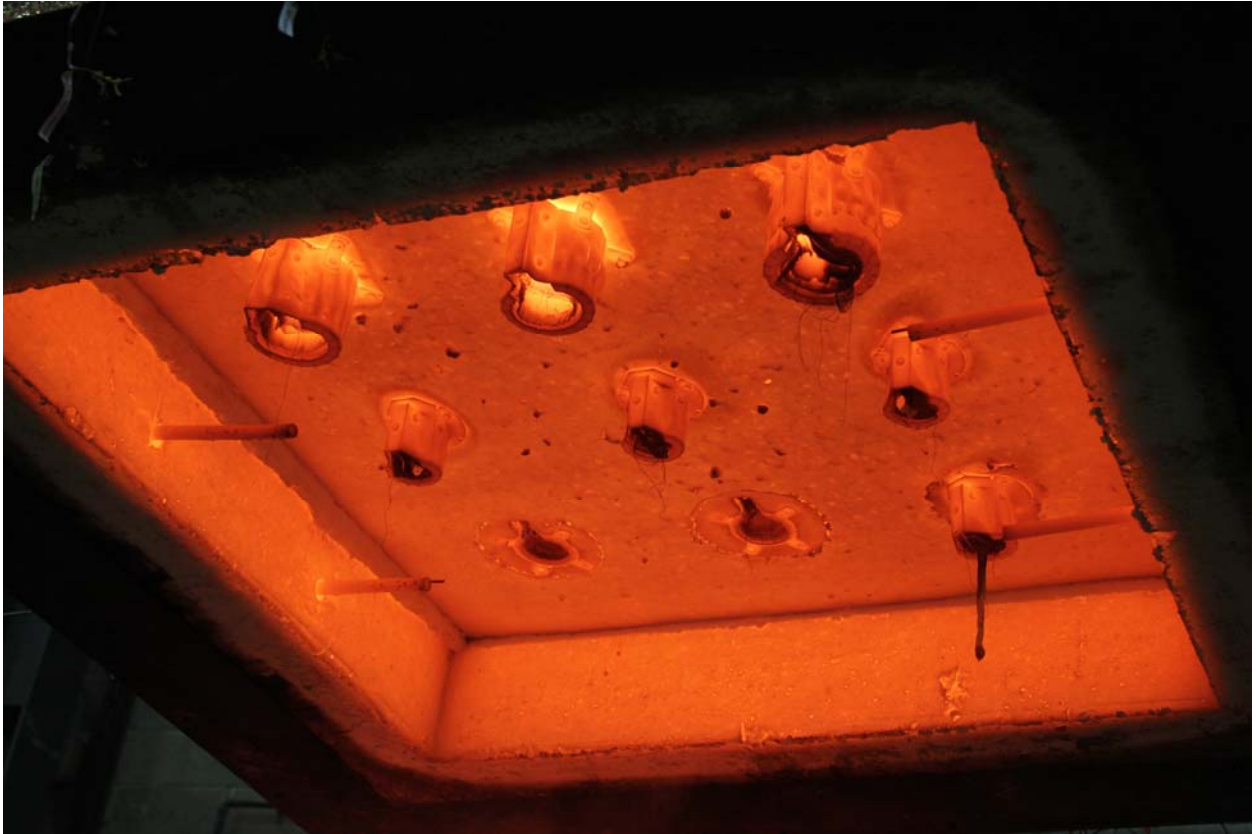
PHOTOGRAPH 6 – EXPOSED FACE OF SPECIMENS AT CONCLUSION OF TESTING

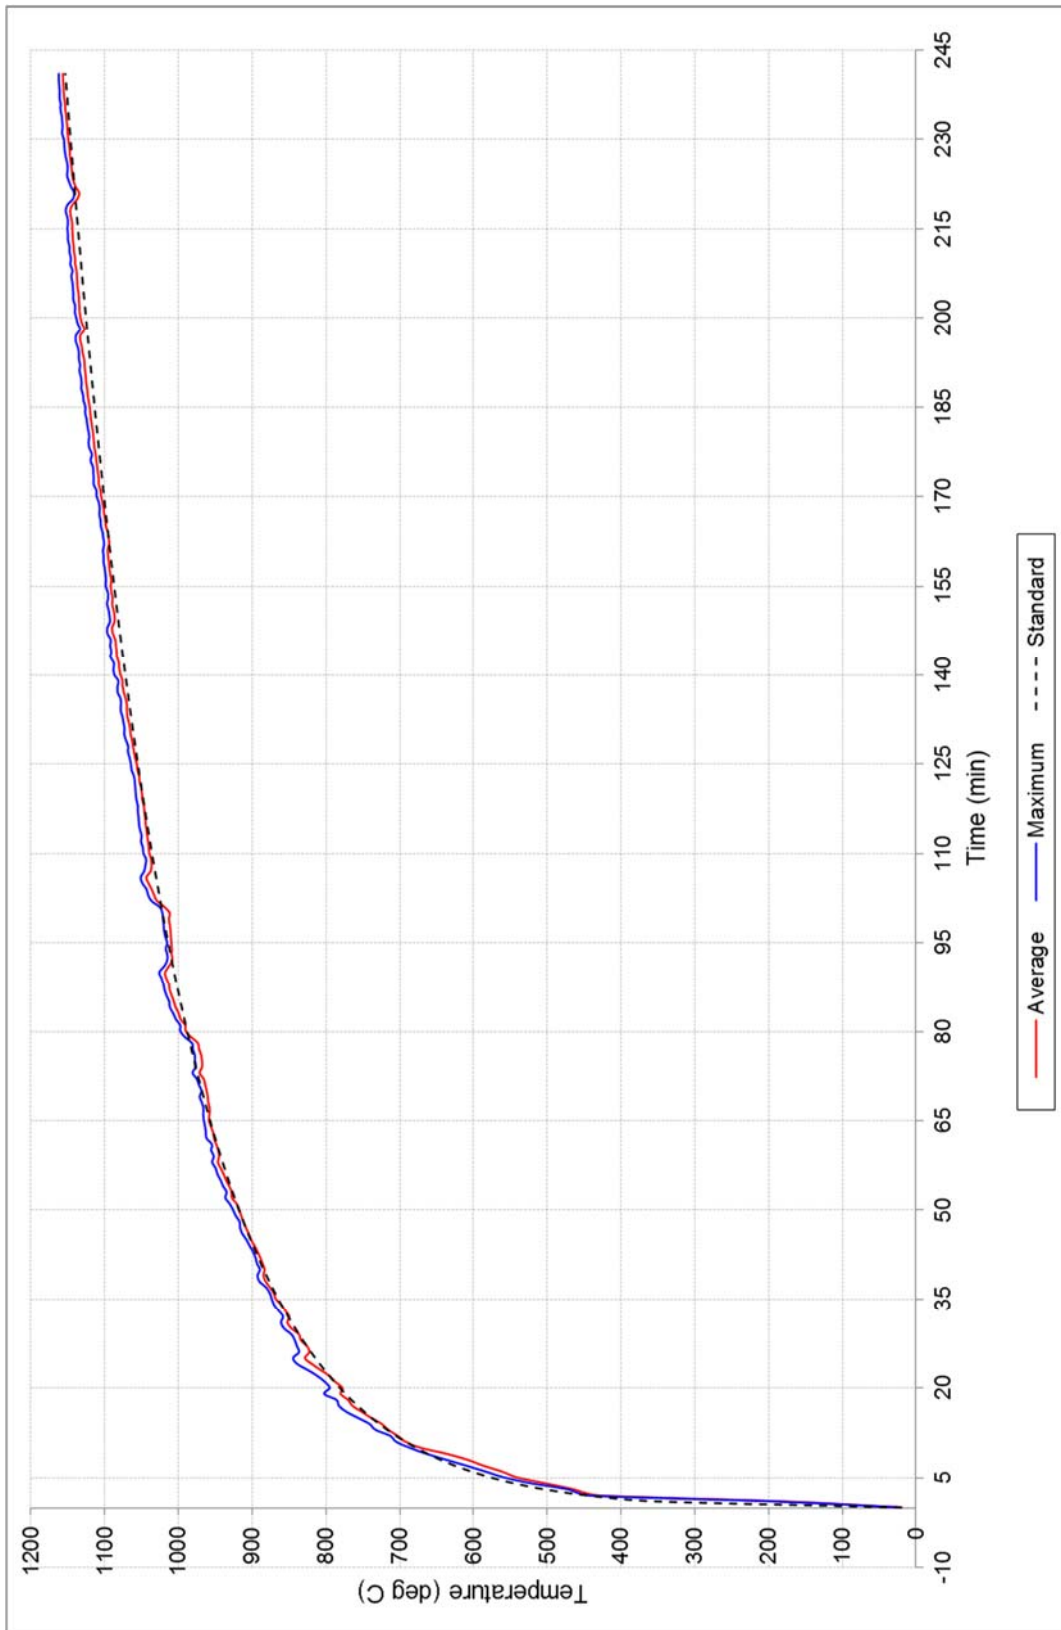
FIGURE 1 – FURNACE TEMPERATURE

Figure 1 shows the standard curves of temperature versus time for heating the furnace chamber and the actual curves of average and maximum temperature versus time recorded during the heating period.

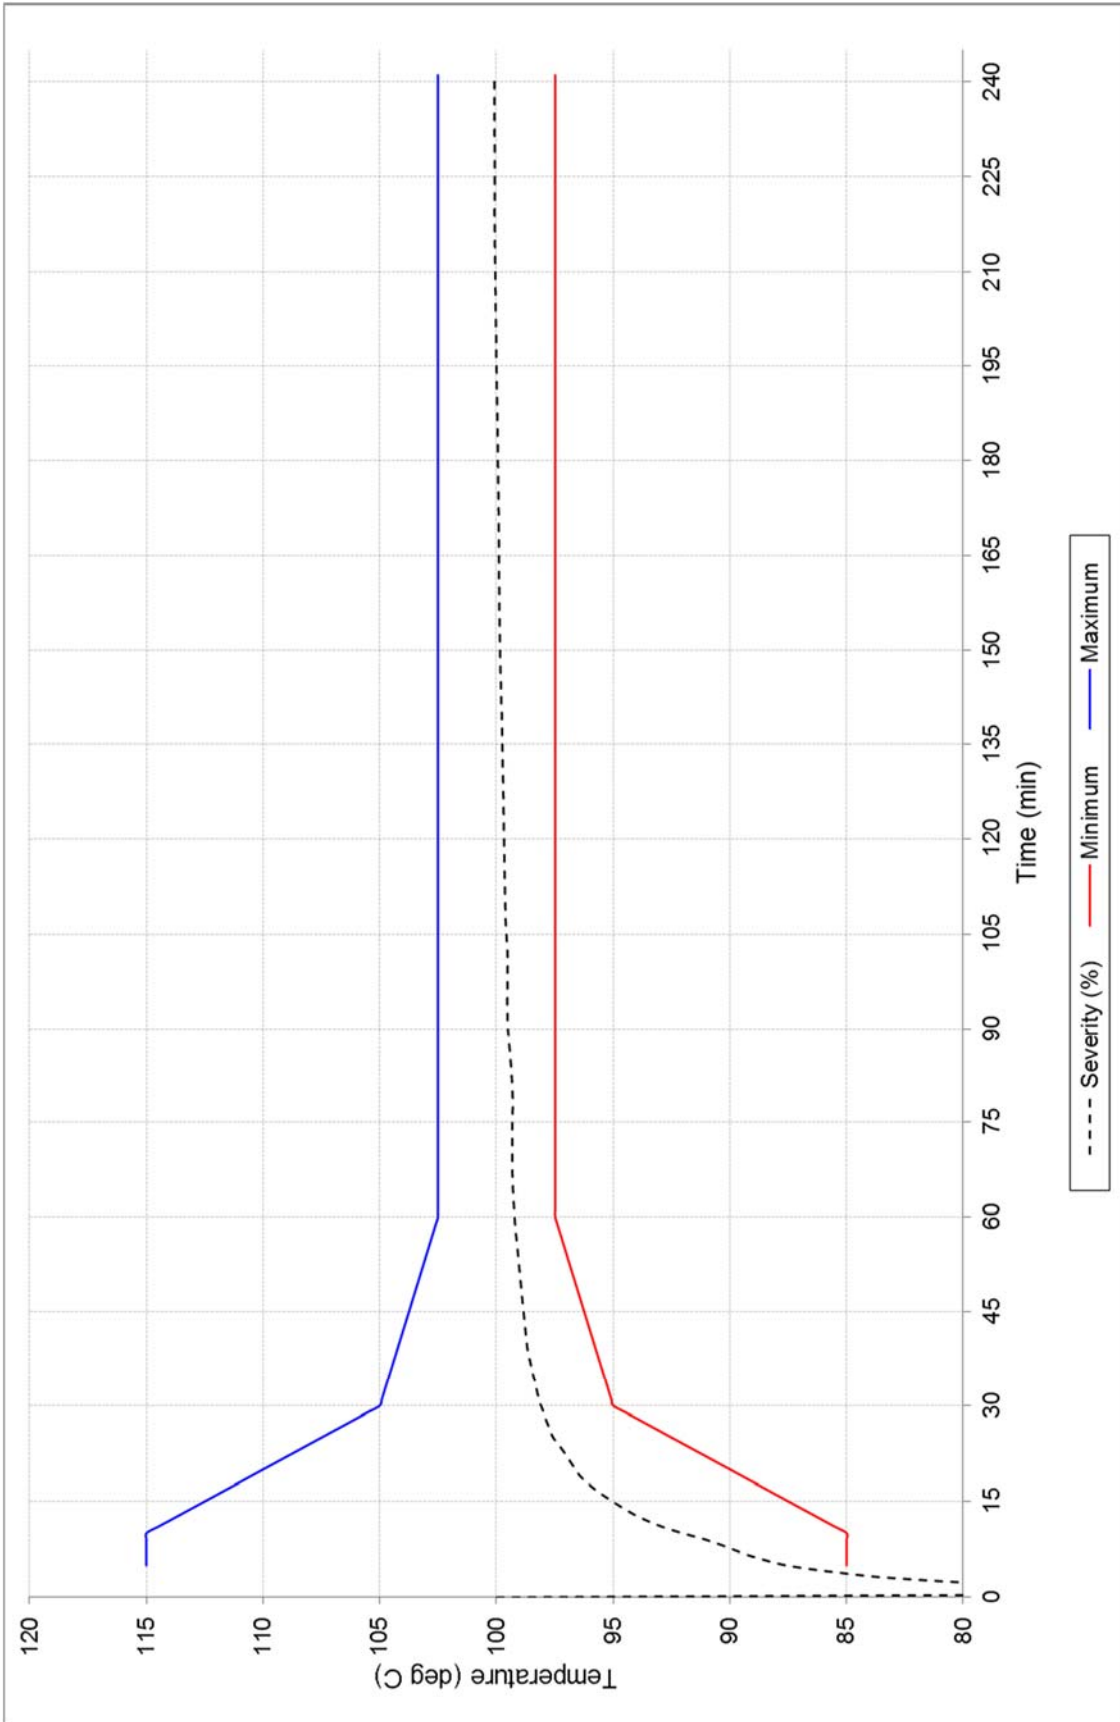
FIGURE 2 – FURNACE SEVERITY

Figure 2 shows the curve of furnace severity versus time during the heating period.

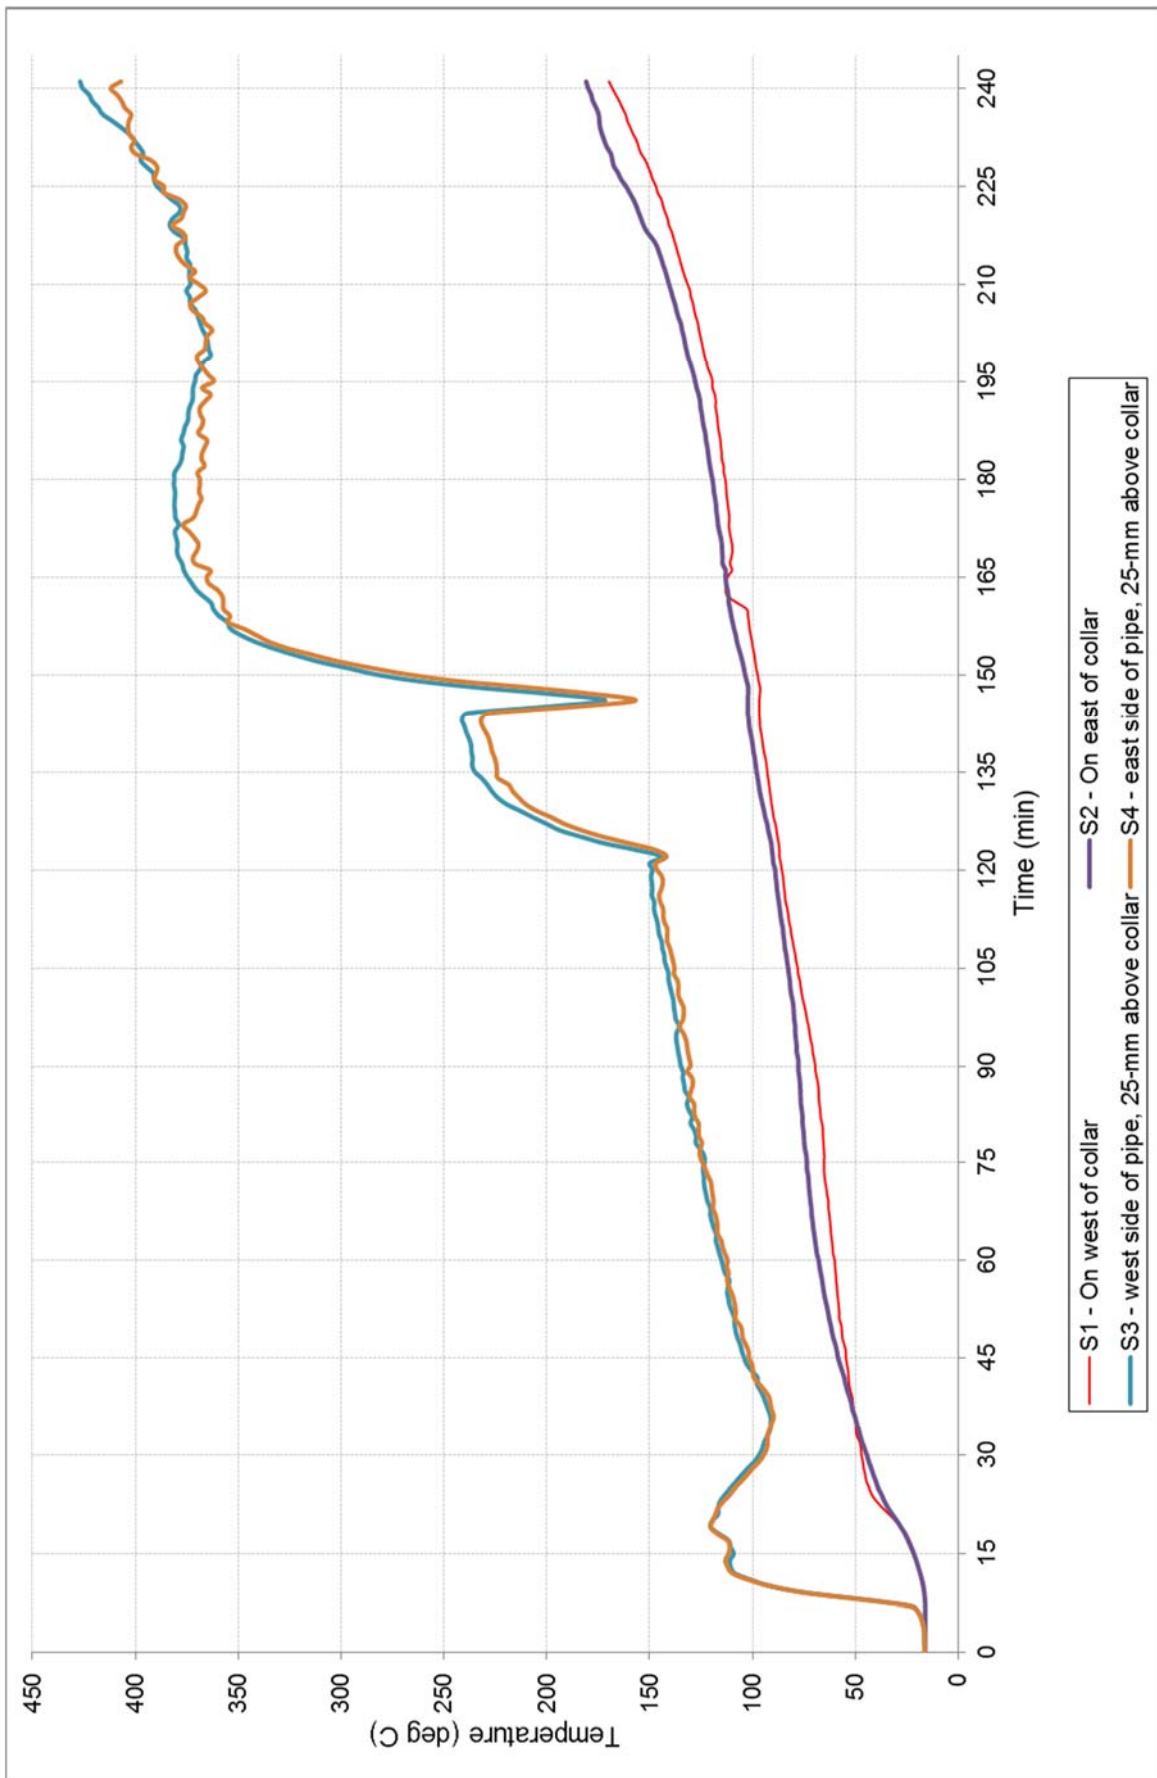
FIGURE 3 – SPECIMEN TEMPERATURE – ASSOCIATED WITH PENETRATION 1

Figure 3 shows the curve of maximum temperature versus time associated with Penetration 1.

Structural adequacy	-	not applicable
Integrity	-	No failure 241 minutes
Insulation	-	127 minutes

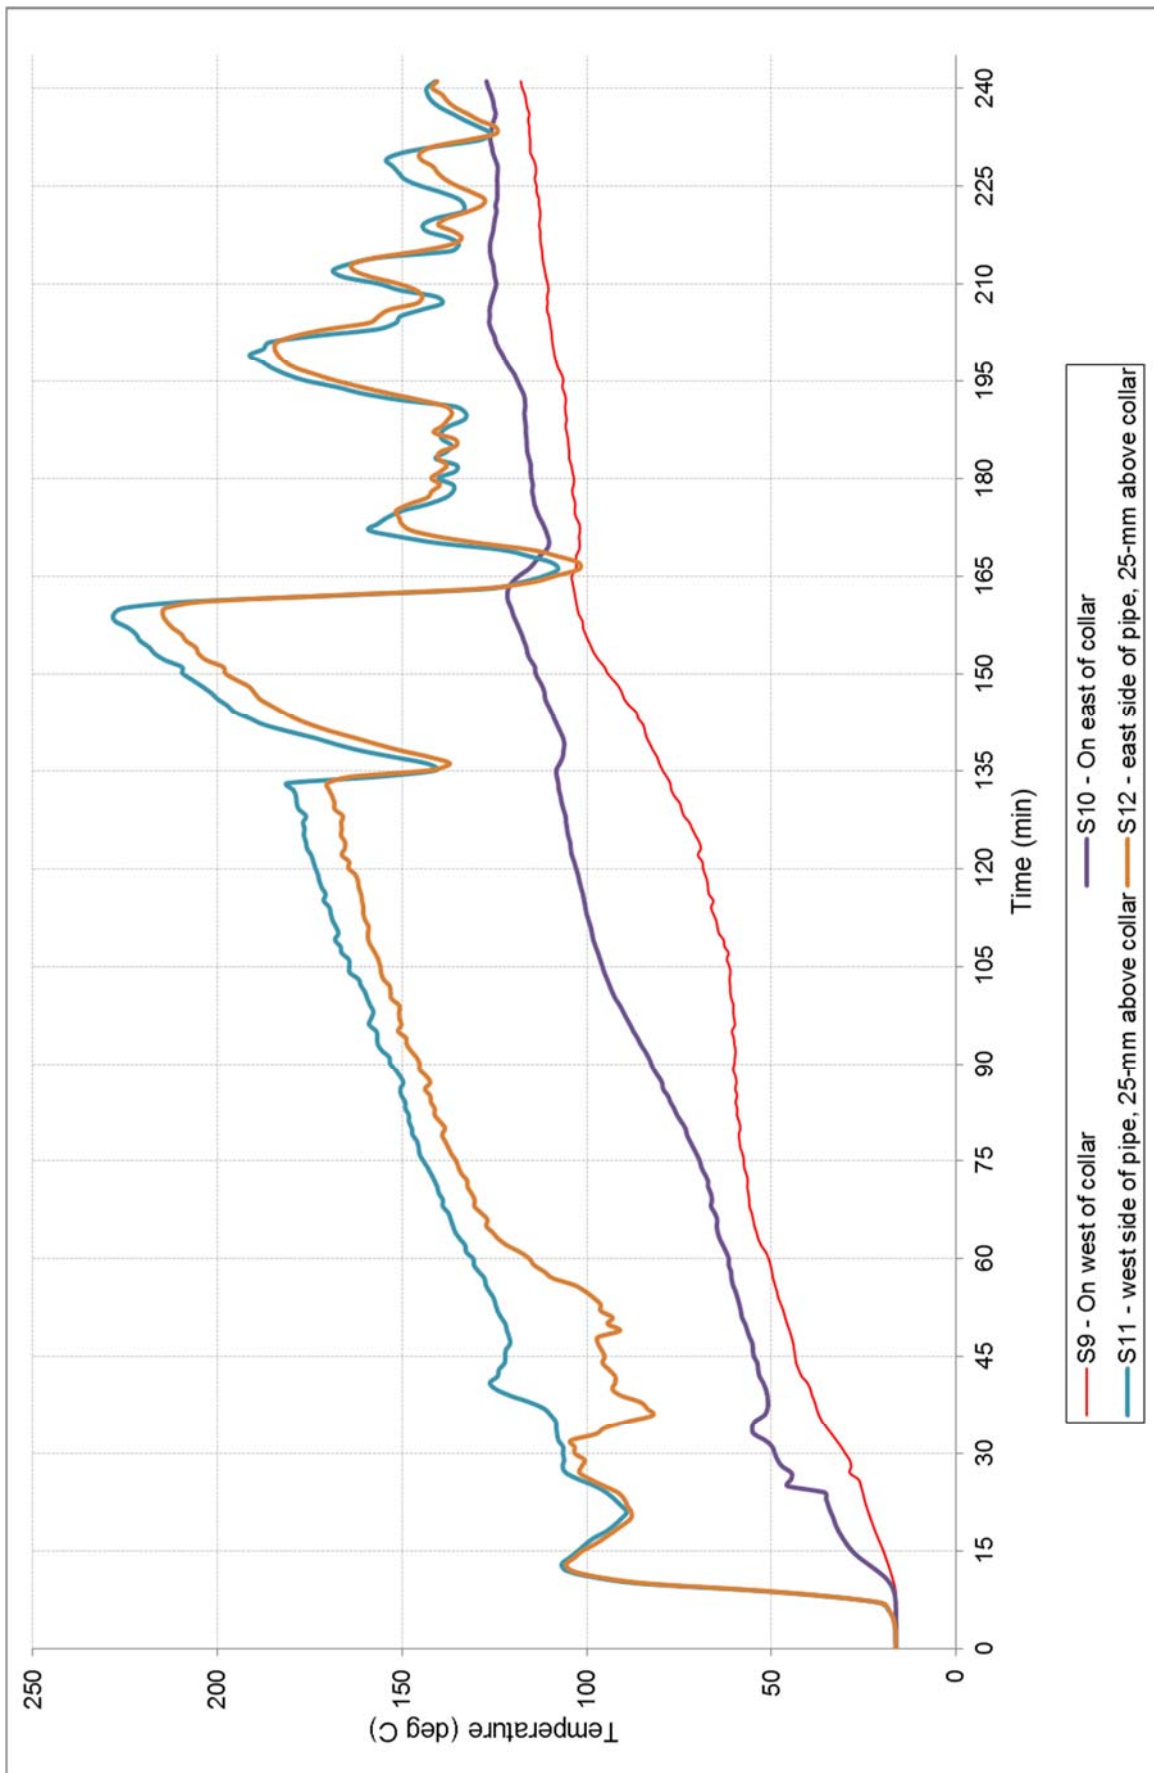
FIGURE 4 – SPECIMEN TEMPERATURE – ASSOCIATED WITH PENETRATION 3

Figure 4 shows the curve of maximum temperature versus time associated with Penetration 3.

Structural adequacy	-	not applicable
Integrity	-	No failure 241 minutes
Insulation	-	145 minutes

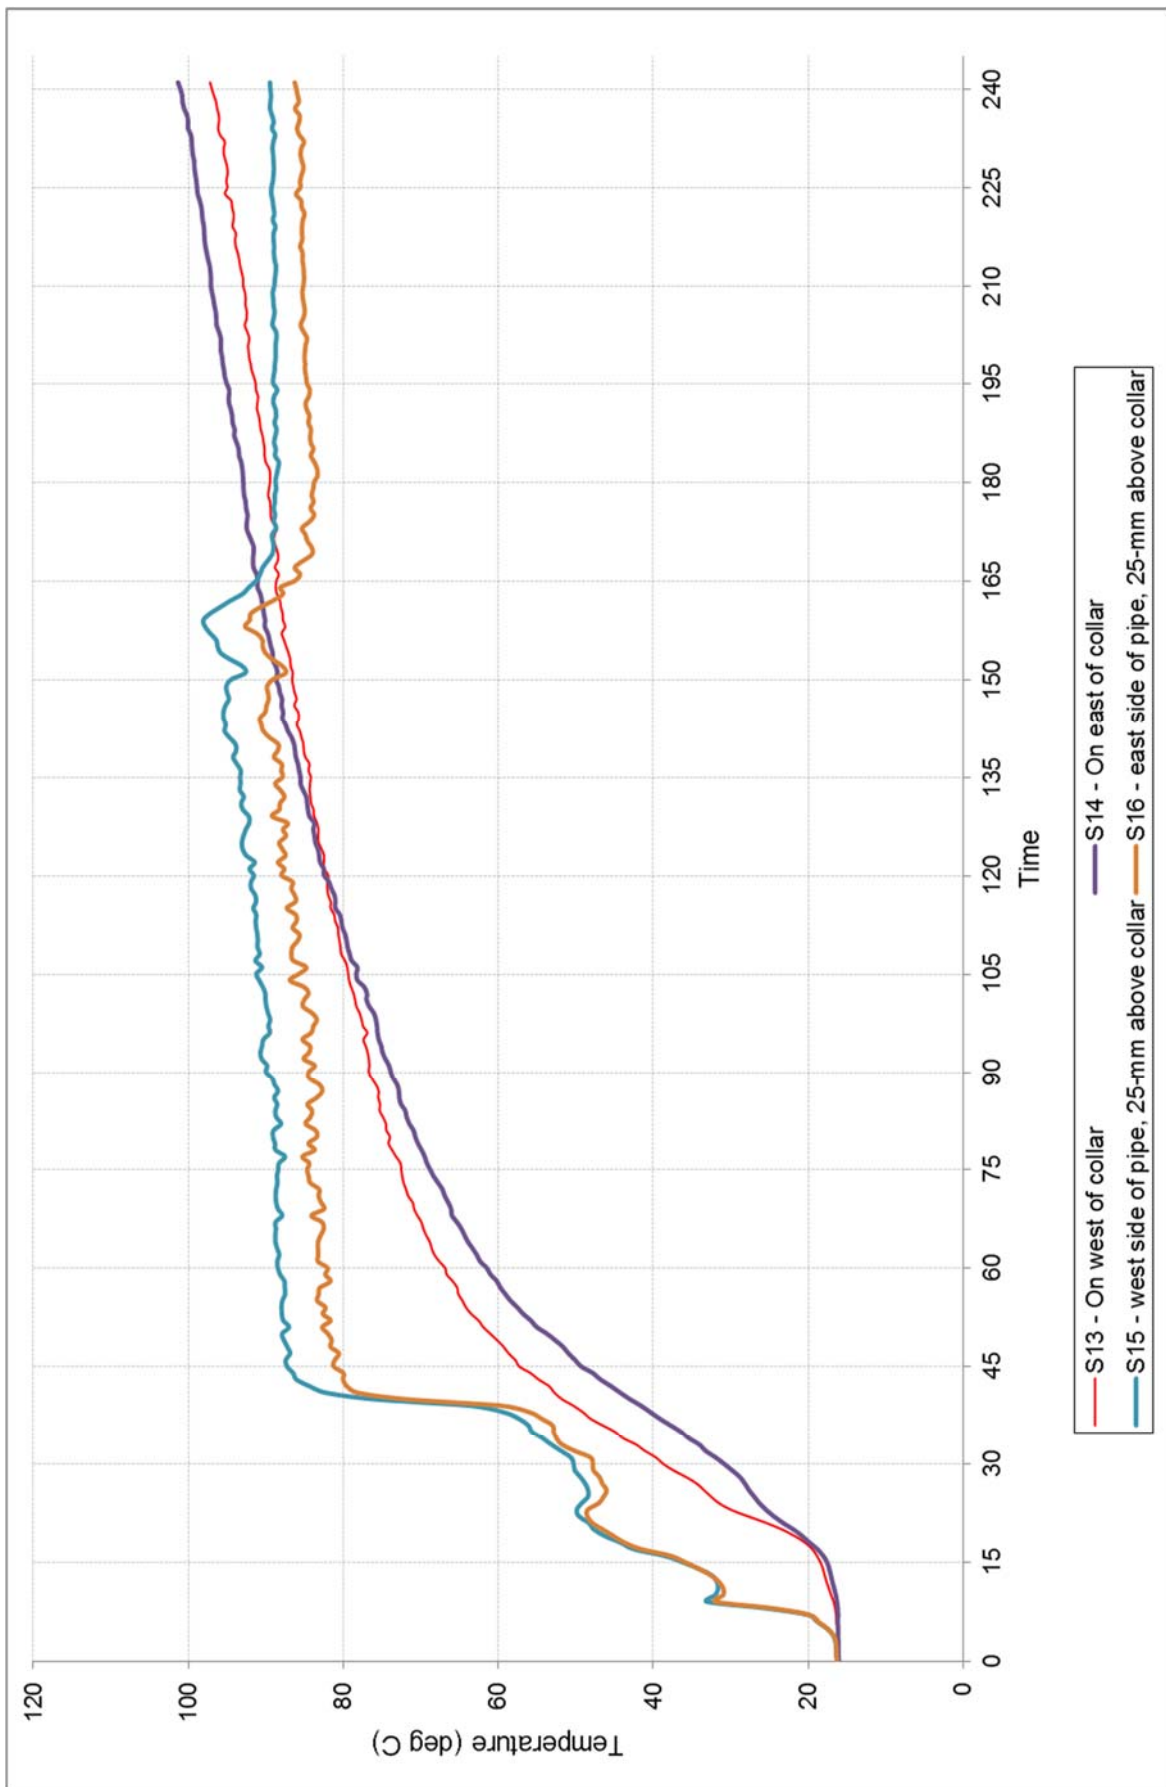
FIGURE 5 – SPECIMEN TEMPERATURE – ASSOCIATED WITH PENETRATION 4

Figure 5 shows the curve of maximum temperature versus time associated with Penetration 4.

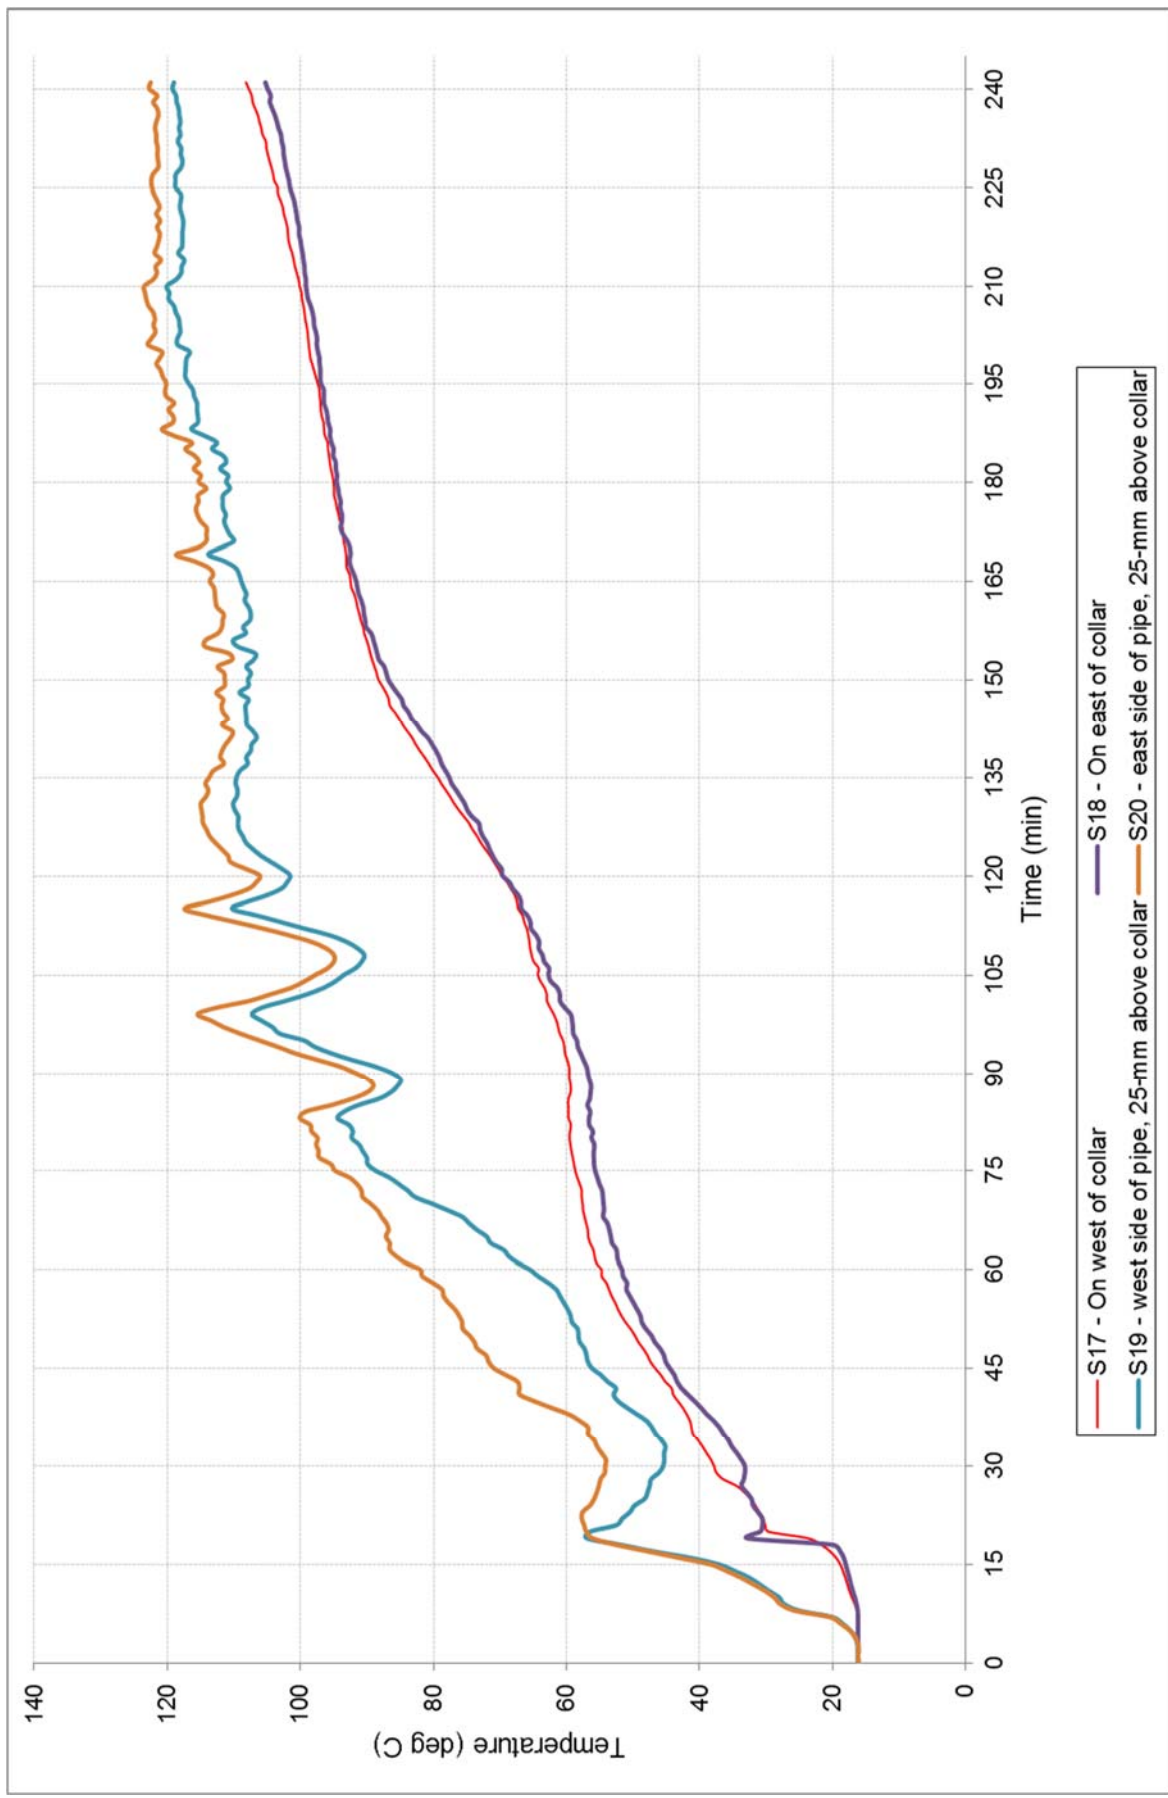
FIGURE 6 – SPECIMEN TEMPERATURE – ASSOCIATED WITH PENETRATION 5

Figure 6 shows the curve of maximum temperature versus time associated with Penetration 5.

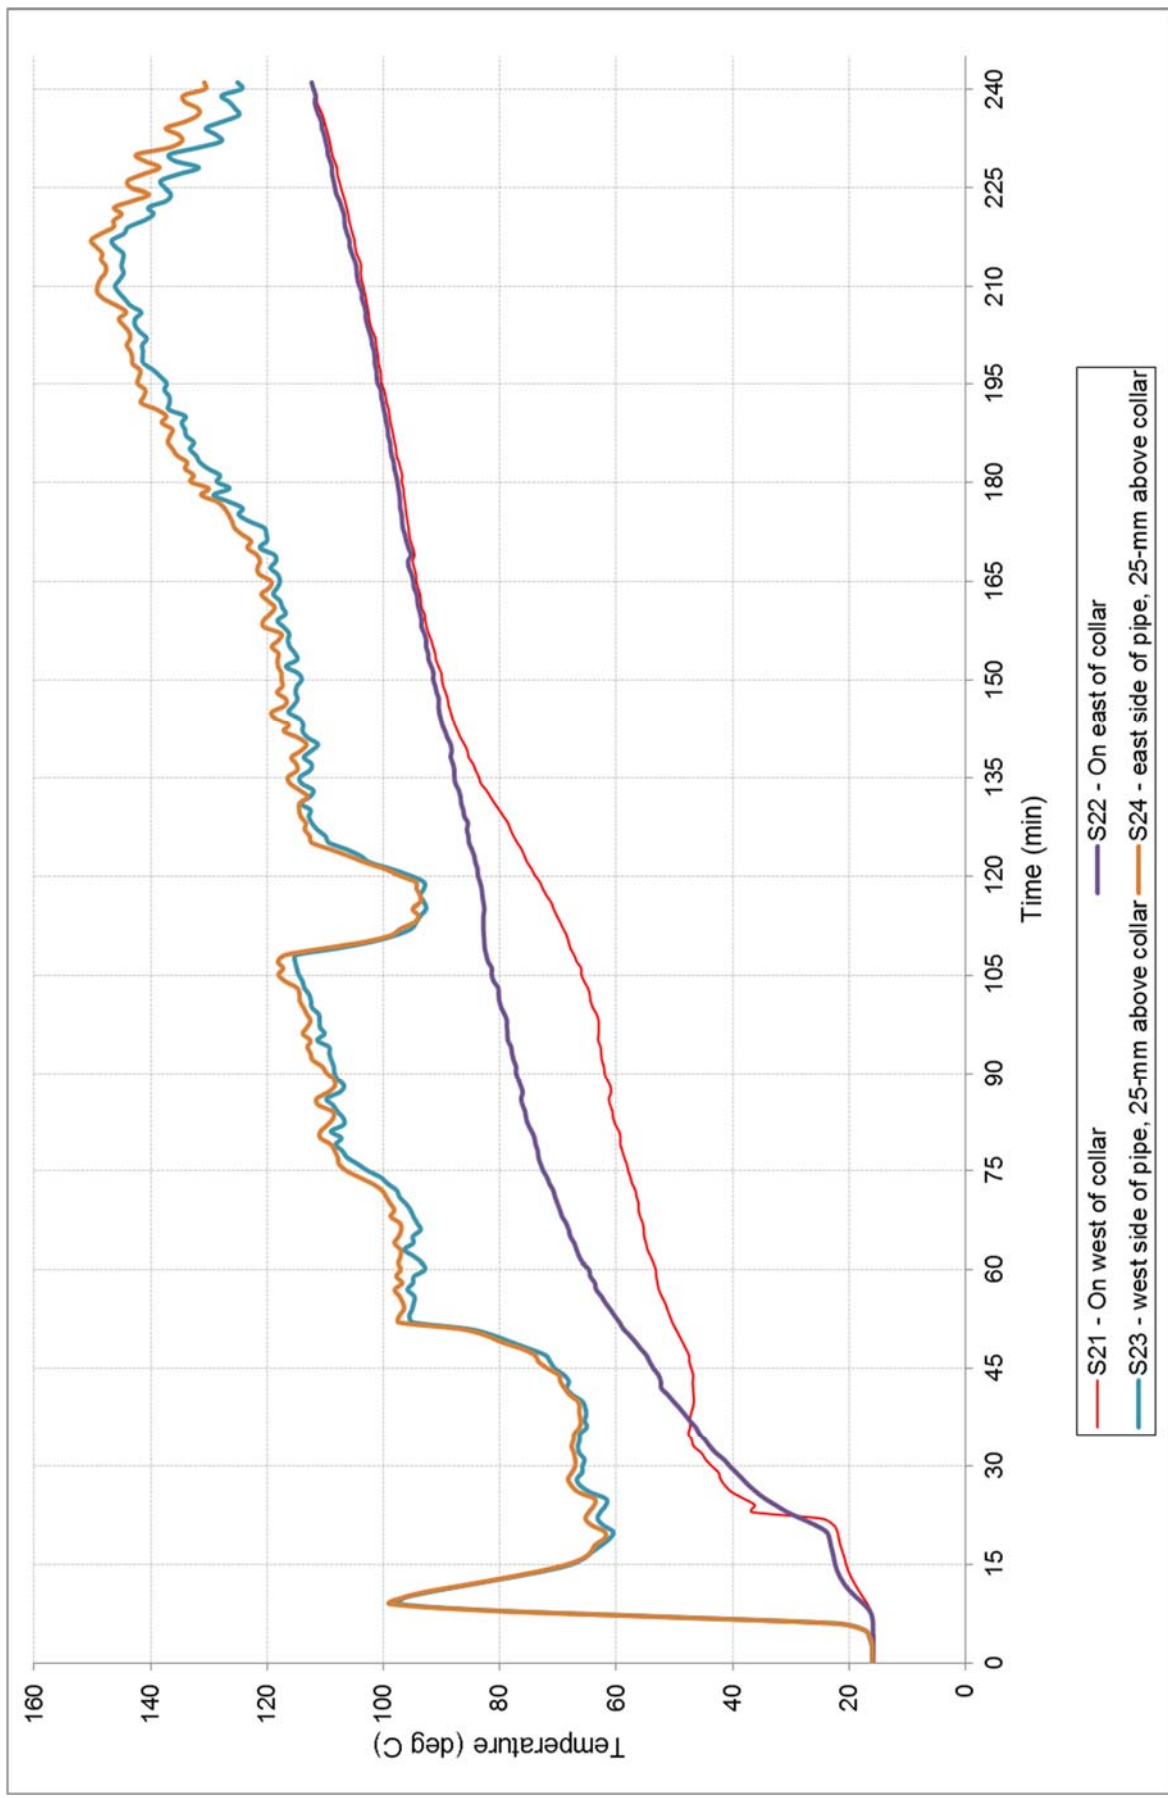
FIGURE 7 – SPECIMEN TEMPERATURE – ASSOCIATED WITH PENETRATION 6

Figure 7 shows the curve of maximum temperature versus time associated with Penetration 6.

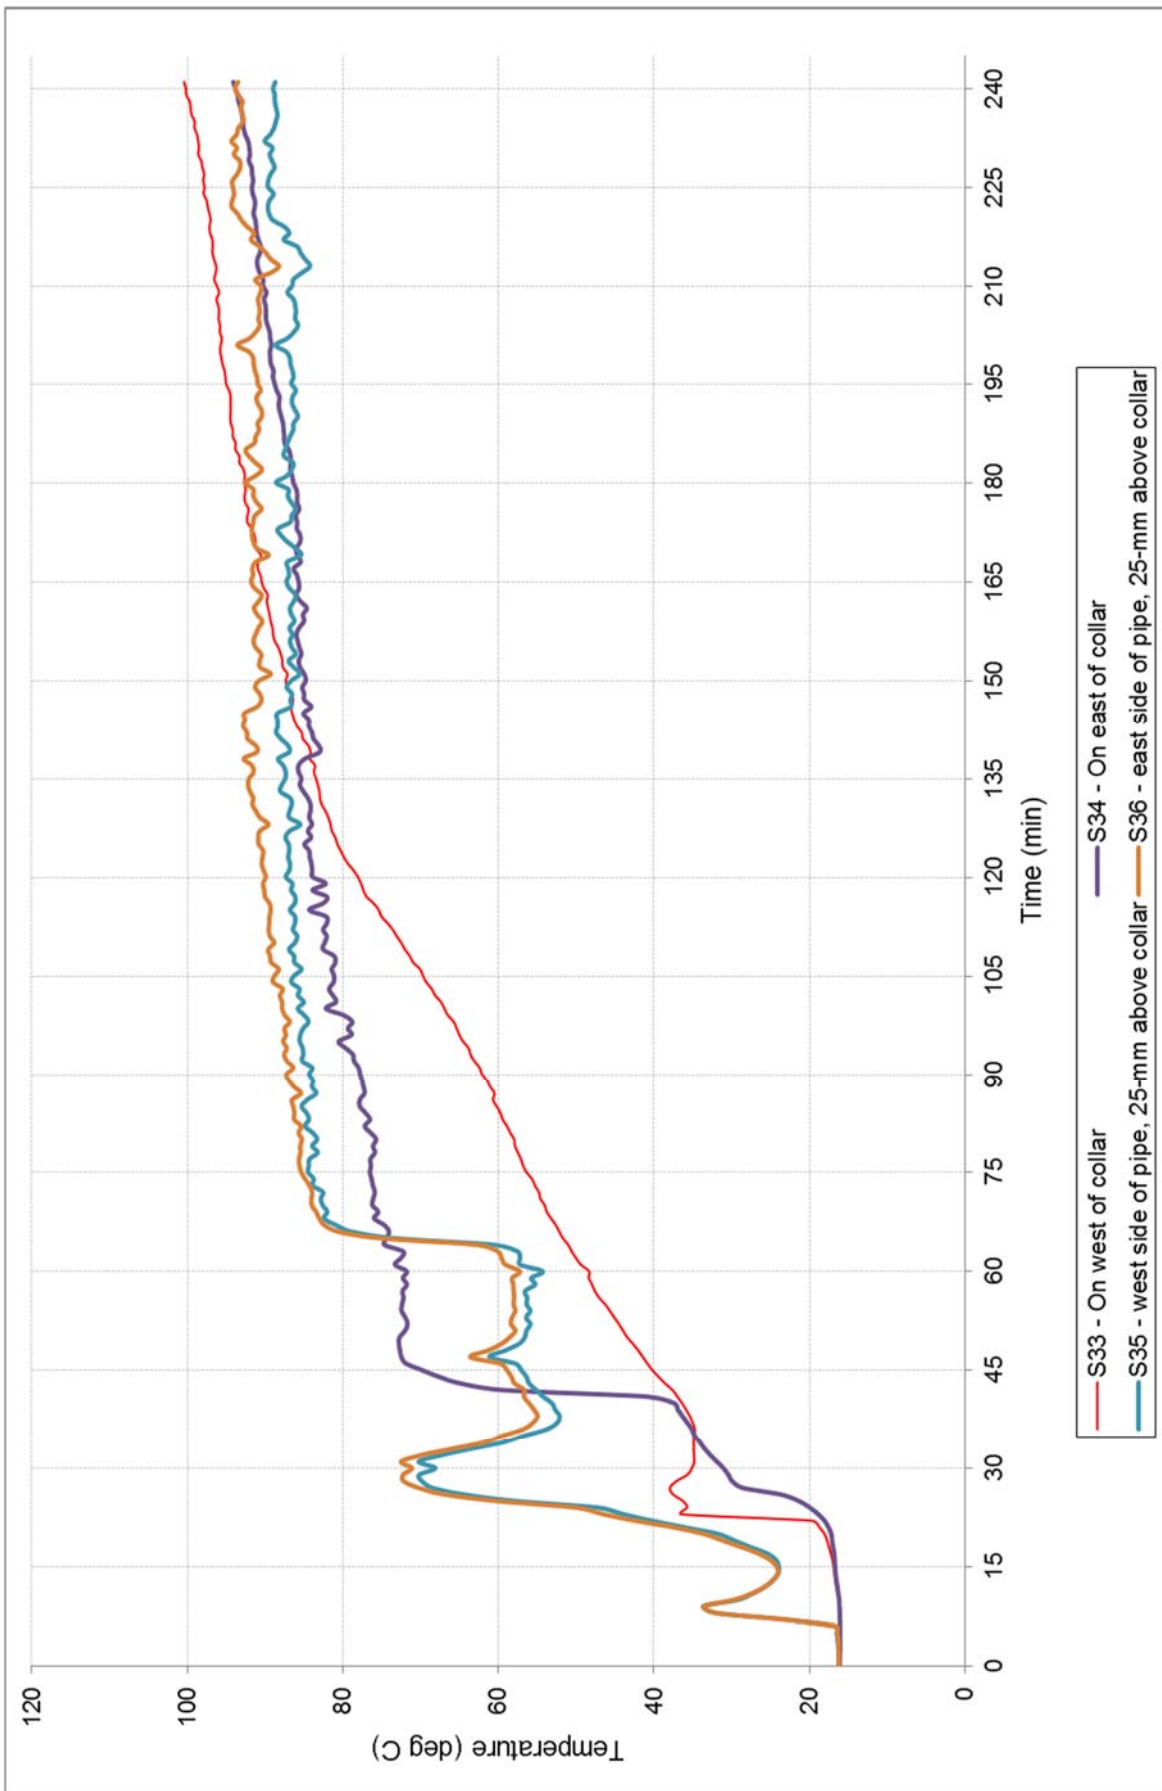
FIGURE 8 – SPECIMEN TEMPERATURE – ASSOCIATED WITH PENETRATION 9

Figure 8 shows the curve of maximum temperature versus time associated with Penetration 9.
