Fire-resistance test on fire collars protecting a concrete slab penetrated by services

Test Report

Author: Chris Wojcik
Report number: FSP 1758
Date: 1 November 2016

Client: Snap Fire Systems Pty Ltd

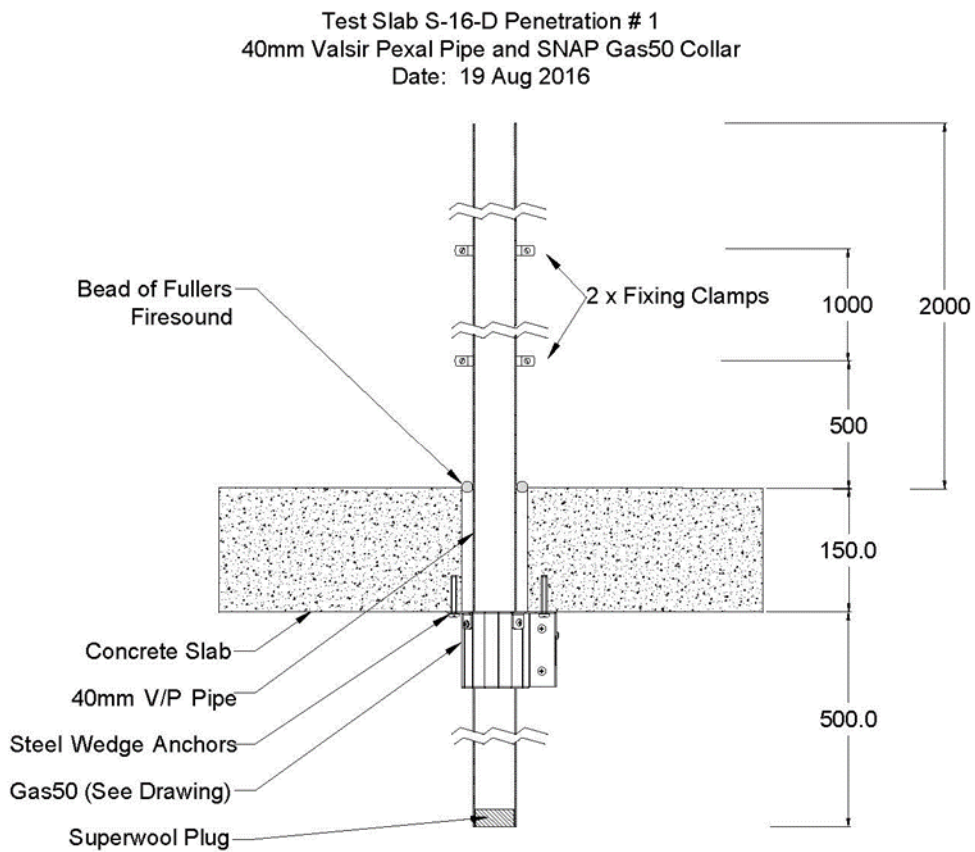
DRAWING TITLED "TEST SLAB S-16-D PENETRATION # 1 – 40MM VALSIR PEXAL PIPE AND SNAP GAS50 COLLAR" DATED 19 AUGUST 2016, BY SNAP FIRE SYSTEMS PTY LTD.

The SNAP Retrofit GAS50 collar comprised a 0.95-mm thick steel casing with a 57-mm inner diameter and a 127-mm diameter base flange. The 91-mm high collar casing incorporated a layer of 215-mm x 85-mm x 4-mm thick Intumescent material and a layer of 190-mm x 85-mm x 4-mm thick Intumescent material. The closing mechanism comprised 1 x 304 stainless steel spring bound with a black nylon fuse link and a 316 stainless steel mesh measuring 190 x 84-mm as shown in drawing numbered GAS50-B-T dated 16 September 2016, by Snap Fire Systems Pty Ltd.

The penetrating service comprised a 40-mm Valsir Pexal stack pipe, with a wall thickness of 3.5-mm fitted through the collar's sleeve. The pipe projected vertically 2000-mm above the concrete and 500-mm into the furnace chamber. The pipe was supported at 500-mm and 1500-mm from the unexposed face of the concrete slab as shown in drawing titled "Test Slab S-16-D Penetration # 1 – 40mm Valsir Pexal Pipe and SNAP Gas50 Collar" dated 19 August 2016, by Snap Fire Systems Pty Ltd. On the exposed end, the pipe was capped with a Superwool Plug.

On the unexposed face, the annular gap between the pipe and slab was sealed with a bead of Fullers Firesound.

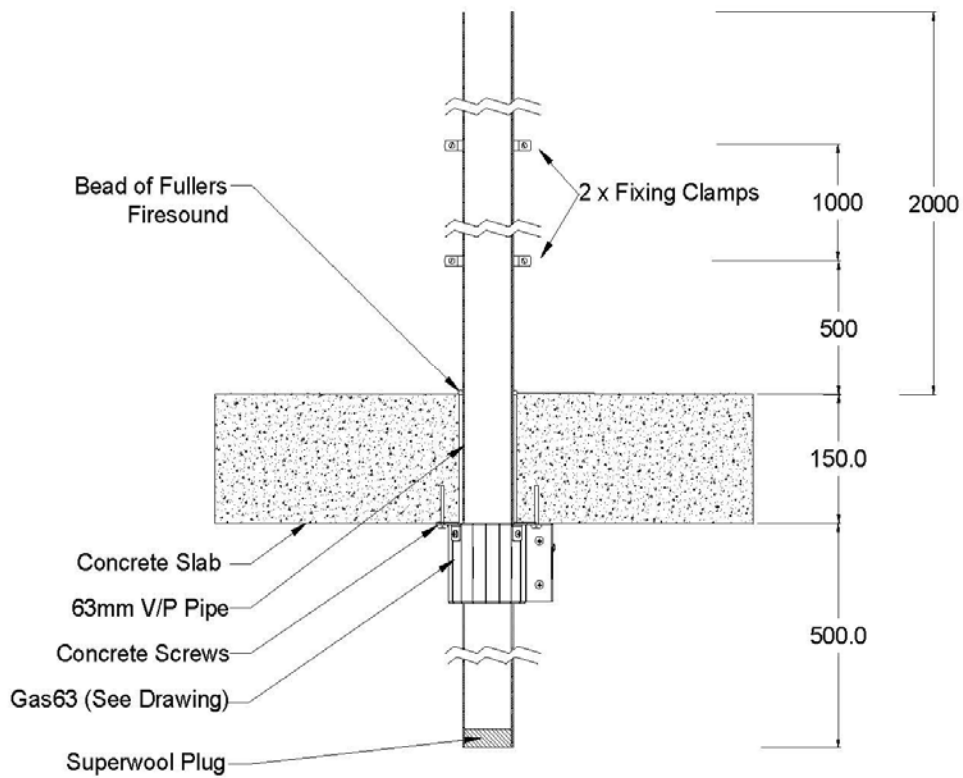
DRAWING TITLED "TEST SLAB S-16-D PENETRATION # 3 – 63MM VALSIR PEXAL PIPE AND SNAP GAS63 COLLAR" DATED 19 AUGUST 2016, BY SNAP FIRE SYSTEMS PTY LTD.

The SNAP Retrofit GAS63 collar comprised a 0.95-mm thick steel casing with a 67-mm inner diameter and a 121-mm diameter base flange. The 91-mm high collar casing incorporated a layer of 265-mm x 85-mm x 4-mm thick Intumescent material and a layer of 235-mm x 85-mm x 4-mm thick Intumescent material. The closing mechanism comprised 1 x 304 stainless steel spring bound with a black nylon fuse link and a 316 stainless steel mesh measuring 230 x 84-mm as shown in drawing numbered GAS63-B-T dated 20 September 2016, by Snap Fire Systems Pty Ltd.

The penetrating service comprised a 63-mm Valsir Pexal stack pipe, with a wall thickness of 5-mm fitted through the collar's sleeve. The pipe projected vertically 2000-mm above the concrete and 500-mm into the furnace chamber. The pipe was supported at 500-mm and 1500-mm from the unexposed face of the concrete slab as shown in drawing titled "Test Slab S-16-D Penetration # 3 – 63mm Valsir Pexal Pipe and SNAP Gas63 Collar" dated 19 August 2016, by Snap Fire Systems Pty Ltd. On the exposed end, the pipe was capped with a Superwool Plug.

On the unexposed face, the annular gap between the pipe and slab was sealed with a bead of Fullers Firesound.

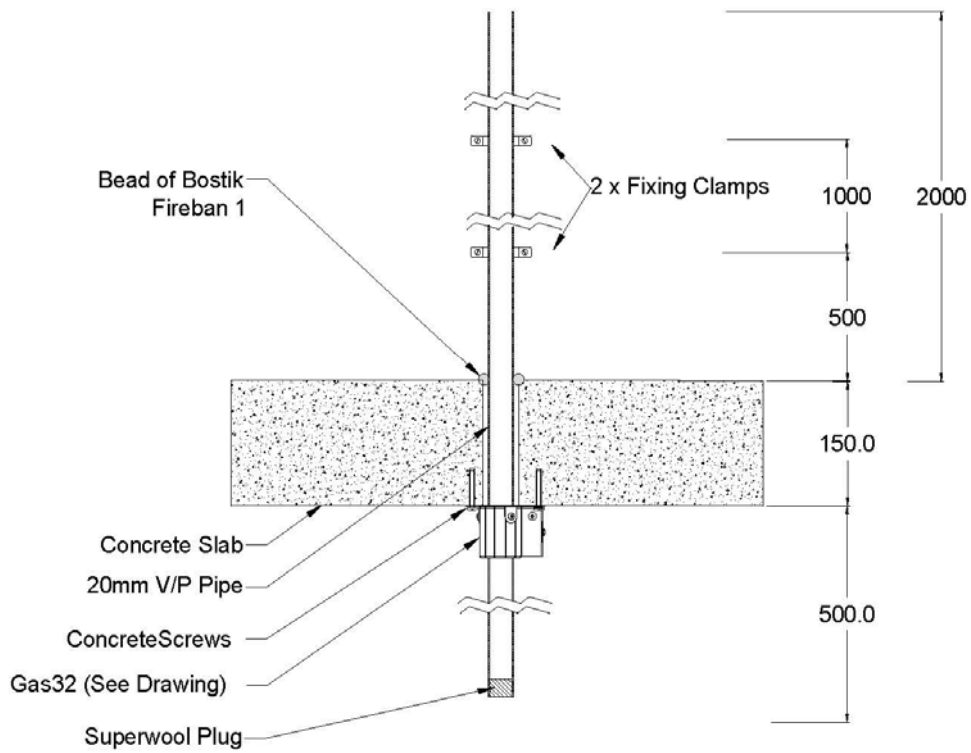
DRAWING TITLED "TEST SLAB S-16-D PENETRATION # 4 – 20MM VALSIR PEXAL PIPE AND SNAP GAS32 COLLAR" DATED 19 AUGUST 2016, BY SNAP FIRE SYSTEMS PTY LTD.

The GAS32 Retrofit collar comprised a 0.95-mm thick galvanised steel casing with a 35-mm inner diameter and a 100-mm diameter base flange. The 63-mm high collar casing incorporated a layer of 140-mm x 55-mm x 4-mm thick Intumescent material and a layer of 120-mm x 55-mm x 4-mm thick Intumescent material. The closing mechanism comprised 1 x 304 stainless steel spring bound with a black nylon fuse link and a 316 stainless steel mesh measuring 120 x 54-mm as shown in drawing numbered GAS32-T dated 14 September 2016, by Snap Fire Systems Pty Ltd.

The penetrating service comprised a 20-mm Valsir Pexal stack pipe, with a wall thickness of 2-mm fitted through the collar's sleeve. The pipe projected vertically 2000-mm above the concrete and 500-mm into the furnace chamber. The pipe was supported at 500-mm and 1000-mm from the unexposed face of the concrete slab as shown in drawing titled "Test Slab S-16-D Penetration # 4 – 20mm Valsir Pexal Pipe and SNAP Gas32 Collar" dated 19 August 2016, by Snap Fire Systems Pty Ltd. On the exposed end, the pipe was capped with a Superwool Plug.

On the unexposed face, the annular gap between the pipe and slab was sealed with a bead of Bostik Fireban 1.

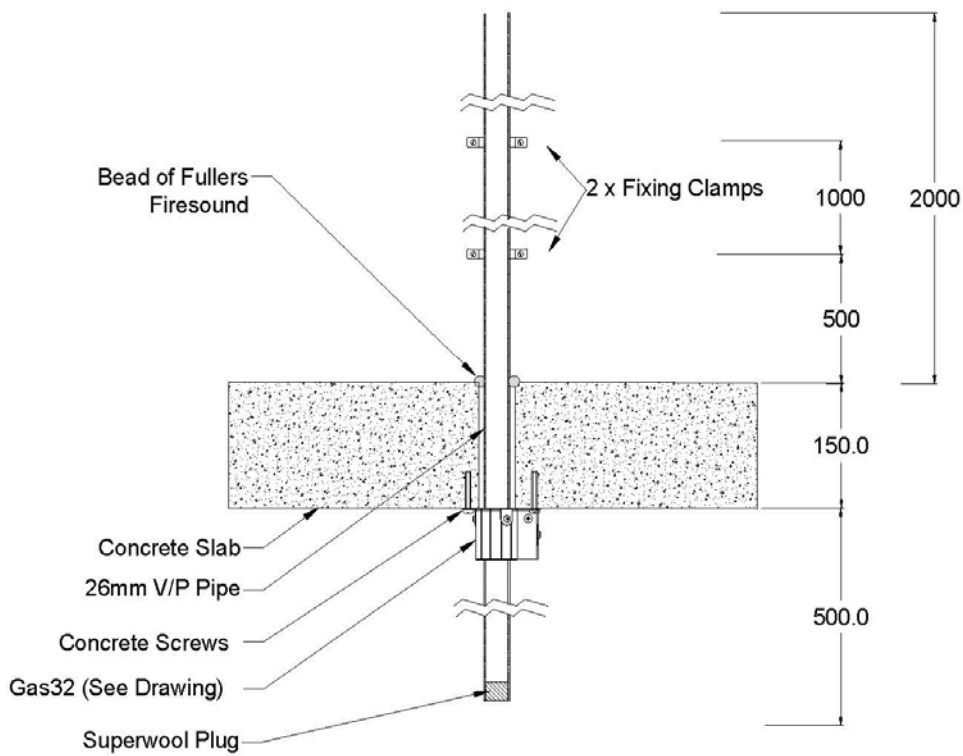
DRAWING TITLED "TEST SLAB S-16-D PENETRATION # 5 – 26MM VALSIR PEXAL PIPE AND SNAP GAS32 COLLAR" DATED 19 AUGUST 2016, BY SNAP FIRE SYSTEMS PTY LTD.

The GAS32 Retrofit collar comprised a 0.95-mm thick galvanised steel casing with a 35-mm inner diameter and a 100-mm diameter base flange. The 63-mm high collar casing incorporated a layer of 140-mm x 55-mm x 4-mm thick Intumescent material and a layer of 120-mm x 55-mm x 4-mm thick Intumescent material. The closing mechanism comprised 1 x 304 stainless steel spring bound with a black nylon fuse link and a 316 stainless steel mesh measuring 120 x 54-mm as shown in drawing numbered GAS32-T dated 14 September 2016, by Snap Fire Systems Pty Ltd.

The penetrating service comprised a 26-mm Valsir Pexal stack pipe, with a wall thickness of 3-mm fitted through the collar's sleeve. The pipe projected vertically 2000-mm above the concrete and 500-mm into the furnace chamber. The pipe was supported at 500-mm and 1000-mm from the unexposed face of the concrete slab as shown in drawing titled "Test Slab S-16-D Penetration # 5 – 26mm Valsir Pexal Pipe and SNAP Gas32 Collar" dated 19 August 2016, by Snap Fire Systems Pty Ltd. On the exposed end, the pipe was capped with a Superwool Plug.

On the unexposed face, the annular gap between the pipe and slab was sealed with a bead of Fullers Firesound.

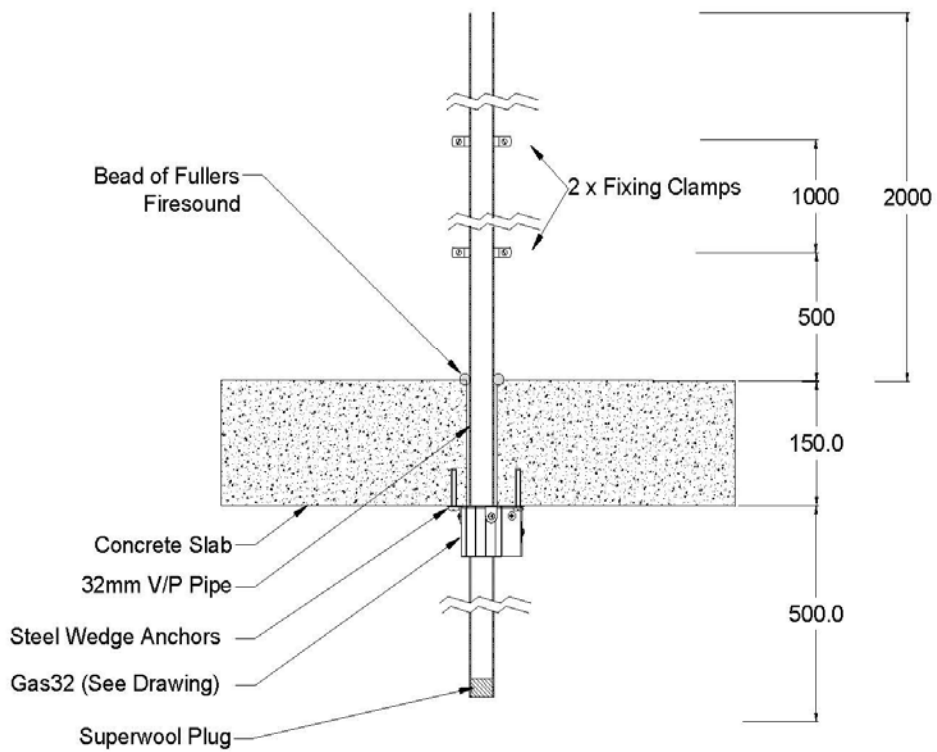
DRAWING TITLED "TEST SLAB S-16-D PENETRATION # 6 – 32MM VALSIR PEXAL PIPE AND SNAP GAS32 COLLAR" DATED 19 AUGUST 2016, BY SNAP FIRE SYSTEMS PTY LTD.

The GAS32 Retrofit collar comprised a 0.95-mm thick galvanised steel casing with a 35-mm inner diameter and a 100-mm diameter base flange. The 63-mm high collar casing incorporated a layer of 140-mm x 55-mm x 4-mm thick Intumescent material and a layer of 120-mm x 55-mm x 4-mm thick Intumescent material. The closing mechanism comprised 1 x 304 stainless steel spring bound with a black nylon fuse link and a 316 stainless steel mesh measuring 120 x 54-mm as shown in drawing numbered GAS32-T dated 14 September 2016, by Snap Fire Systems Pty Ltd.

The penetrating service comprised a 32-mm Valsir Pexal stack pipe, with a wall thickness of 3-mm fitted through the collar's sleeve. The pipe projected vertically 2000-mm above the concrete and 500-mm into the furnace chamber. The pipe was supported at 500-mm and 1500-mm from the unexposed face of the concrete slab as shown in drawing titled "Test Slab S-16-D Penetration # 6 – 32mm Valsir Pexal Pipe and SNAP Gas32 Collar" dated 19 August 2016, by Snap Fire Systems Pty Ltd. On the exposed end, the pipe was capped with a Superwool Plug.

On the unexposed face, the annular gap between the pipe and slab was sealed with a bead of Fullers Firesound.

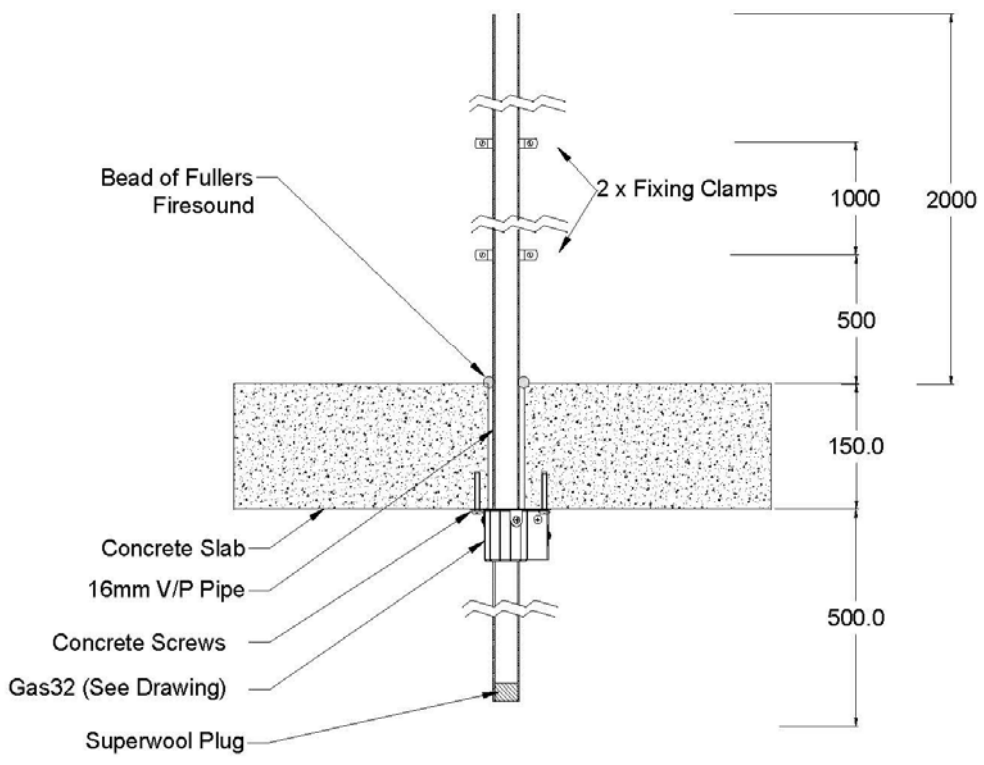
DRAWING TITLED "TEST SLAB S-16-D PENETRATION # 9 – 16MM VALSIR PEXAL PIPE AND SNAP GAS32 COLLAR" DATED 19 AUGUST 2016, BY SNAP FIRE SYSTEMS PTY LTD.

The GAS32 Retrofit collar comprised a 0.95-mm thick galvanised steel casing with a 35-mm inner diameter and a 100-mm diameter base flange. The 63-mm high collar casing incorporated a layer of 140-mm x 55-mm x 4-mm thick Intumescent material and a layer of 120-mm x 55-mm x 4-mm thick Intumescent material. The closing mechanism comprised 1 x 304 stainless steel spring bound with a black nylon fuse link and a 316 stainless steel mesh measuring 120 x 54-mm as shown in drawing numbered GAS32-T dated 14 September 2016, by Snap Fire Systems Pty Ltd.

The penetrating service comprised a 16-mm Valsir Pexal stack pipe, with a wall thickness of 2-mm fitted through the collar's sleeve. The pipe projected vertically 2000-mm above the concrete and 500-mm into the furnace chamber. The pipe was supported at 500-mm and 1500-mm from the unexposed face of the concrete slab as shown in drawing titled "Test Slab S-16-D Penetration # 9 – 16mm Valsir Pexal Pipe and SNAP Gas32 Collar" dated 19 August 2016, by Snap Fire Systems Pty Ltd. On the exposed end, the pipe was capped with a Superwool Plug.

On the unexposed face, the annular gap between the pipe and slab was sealed with a bead of Fullers Firesound.
