# Fire-resistance test on fire collars protecting a plasterboard wall penetrated by services

## Test Report

**Author:** Russell Collins  
**Report number:** FSP 1759  
**Date:** 15 November 2016

## Sponsored Investigation No. FSP 1759

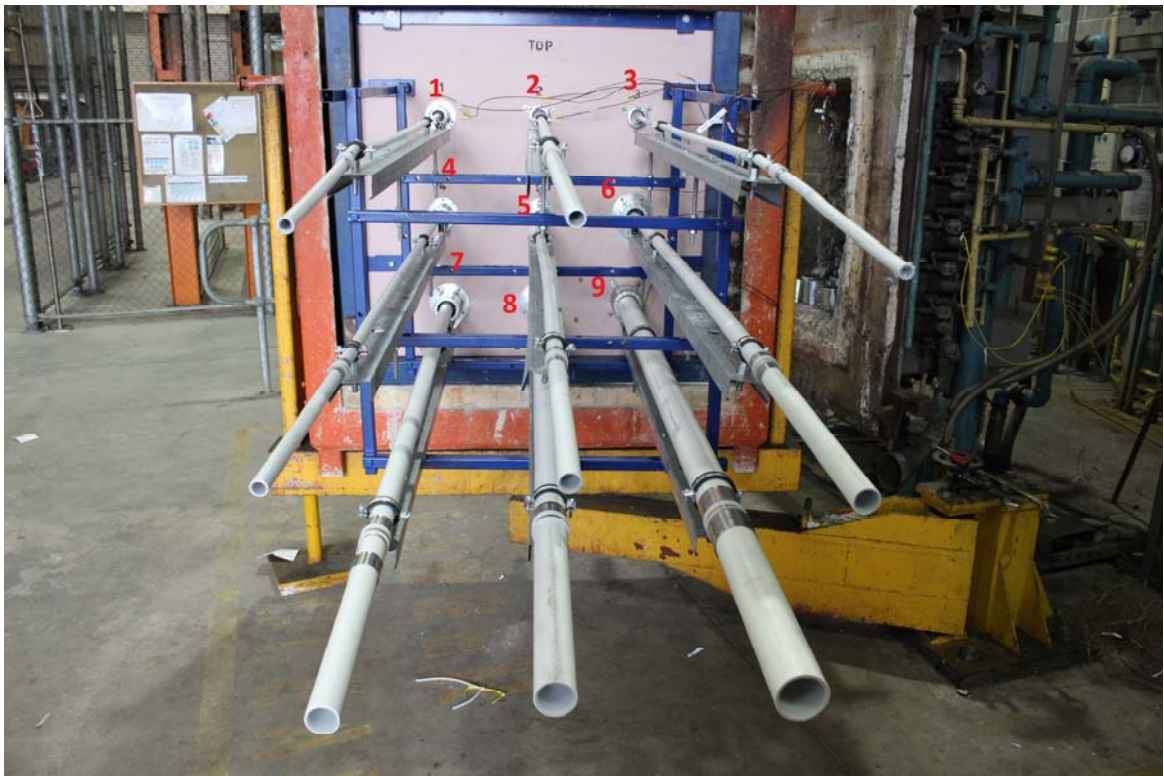
**PHOTOGRAPH 1 – UNEXPOSED FACE OF SPECIMENS PRIOR TO TESTING**

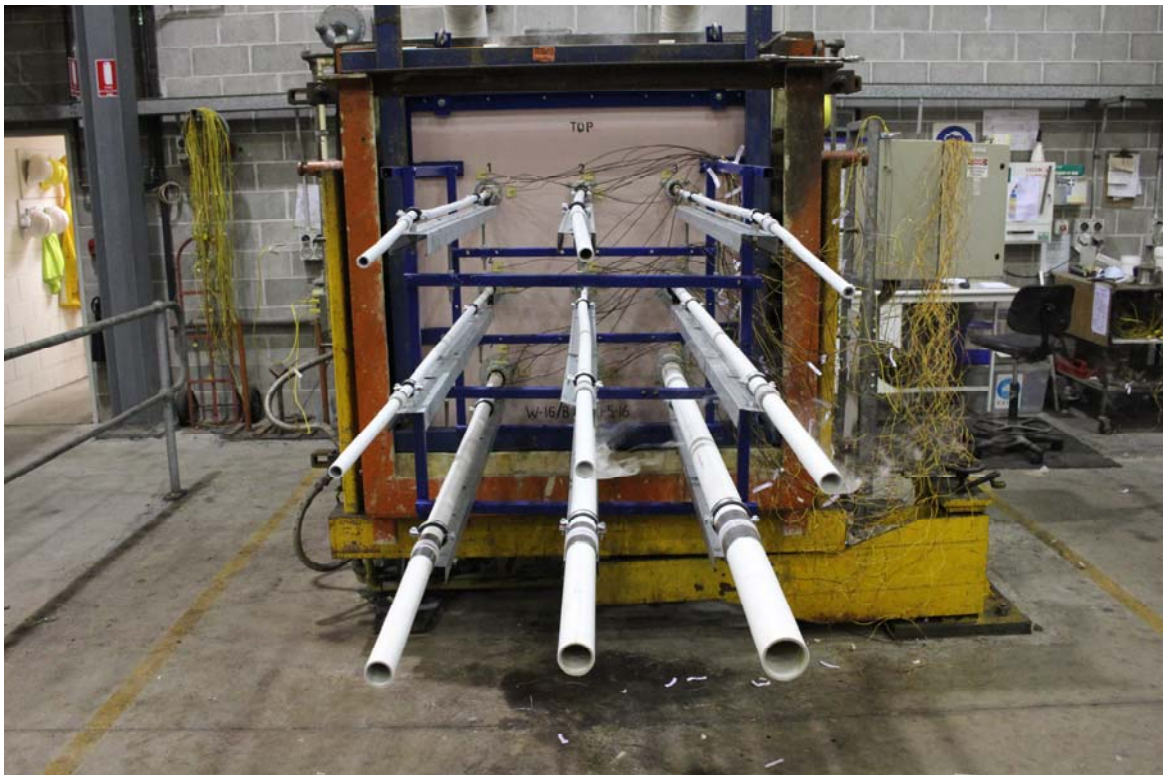
**PHOTOGRAPH 2 – SPECIMENS AFTER 60 MINUTES OF TESTING**

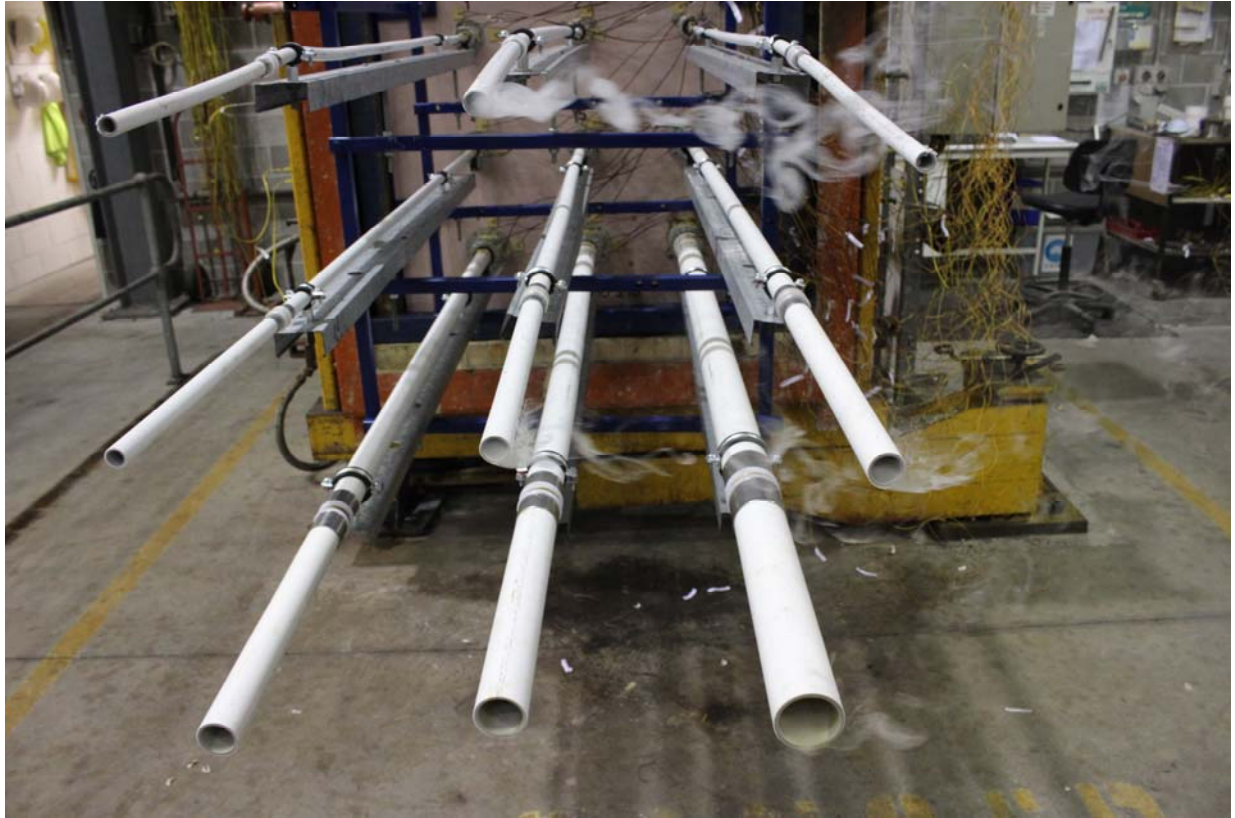
**PHOTOGRAPH 3 – SPECIMENS AFTER 120 MINUTES OF TESTING**

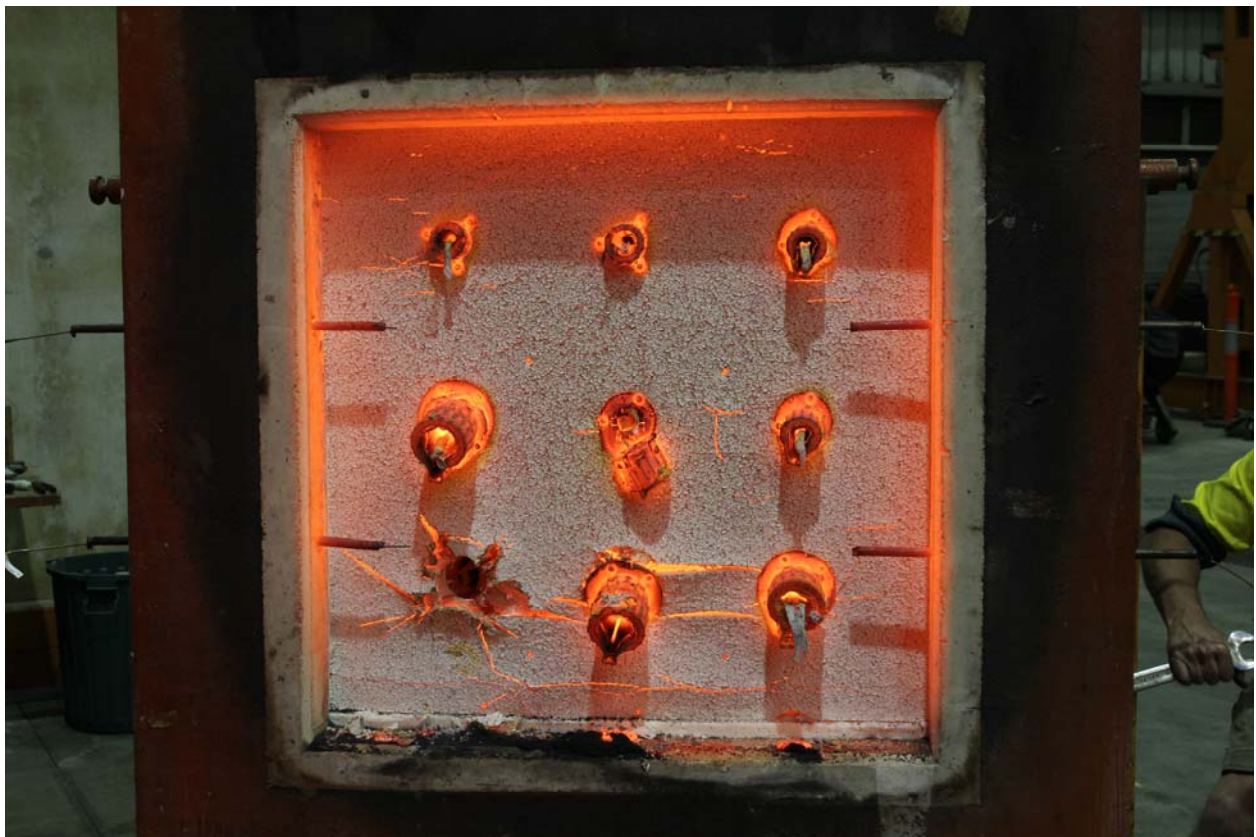
**PHOTOGRAPH 4 – EXPOSED FACE OF SPECIMENS AT CONCLUSION OF TESTING**

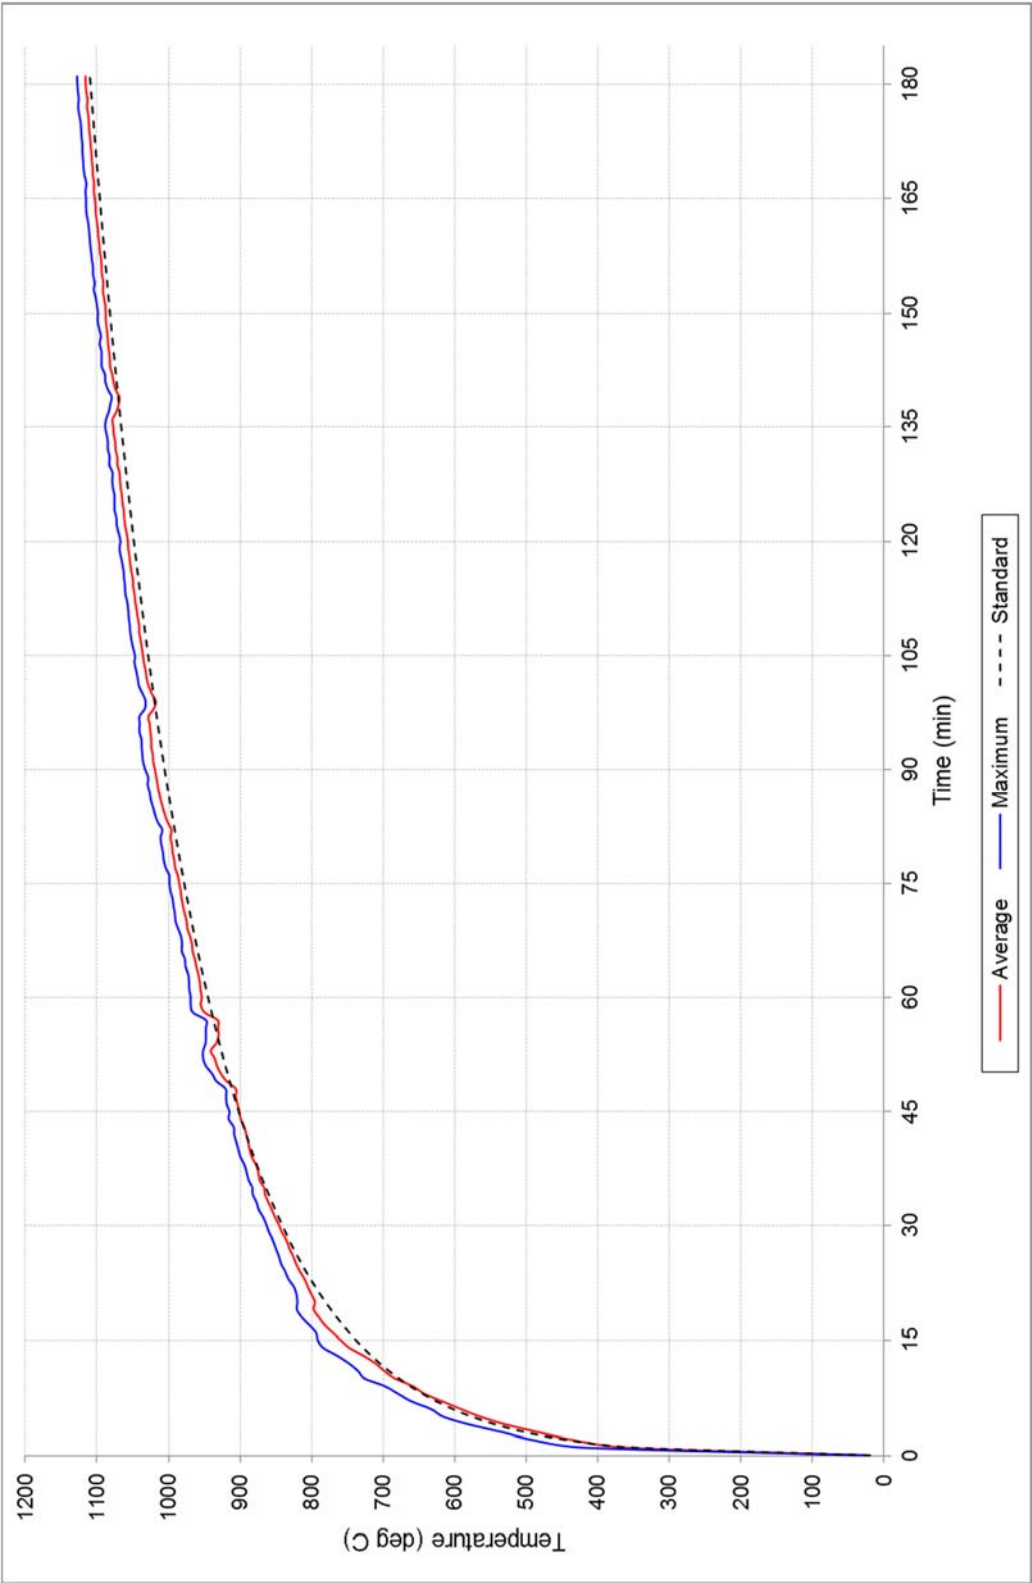
FIGURE 1 – FURNACE TEMPERATURE

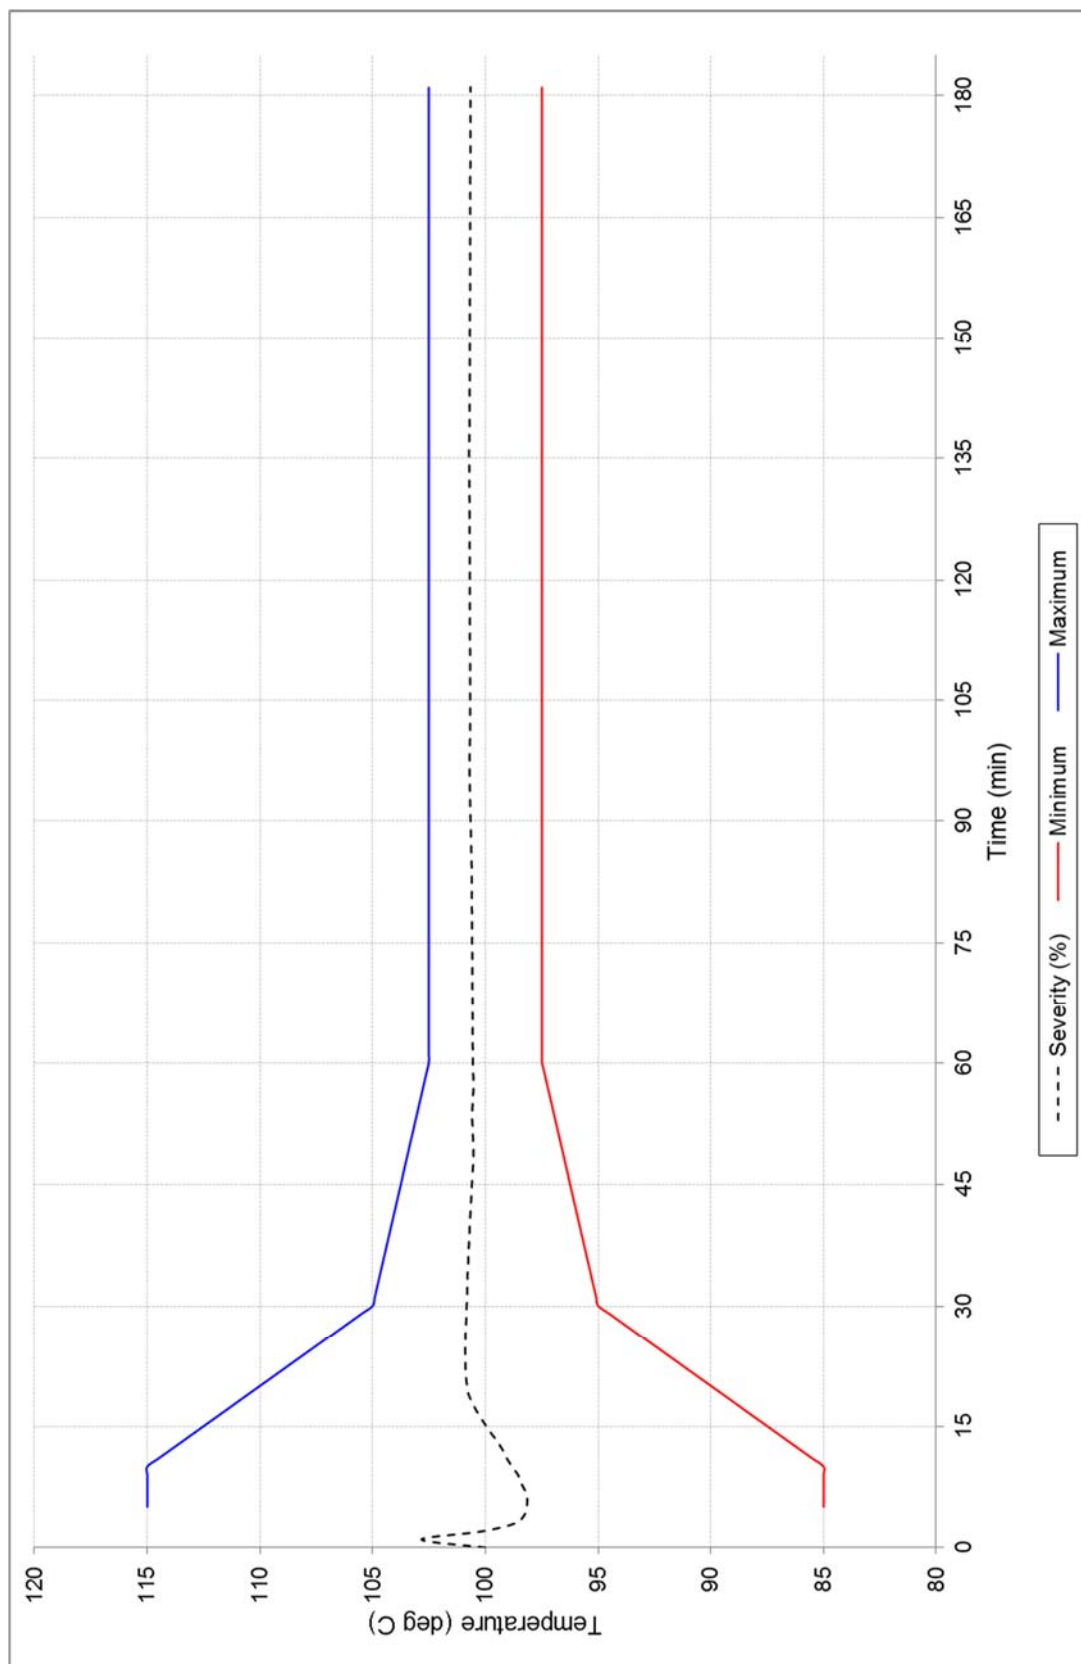
FIGURE 2 – FURNACE SEVERITY

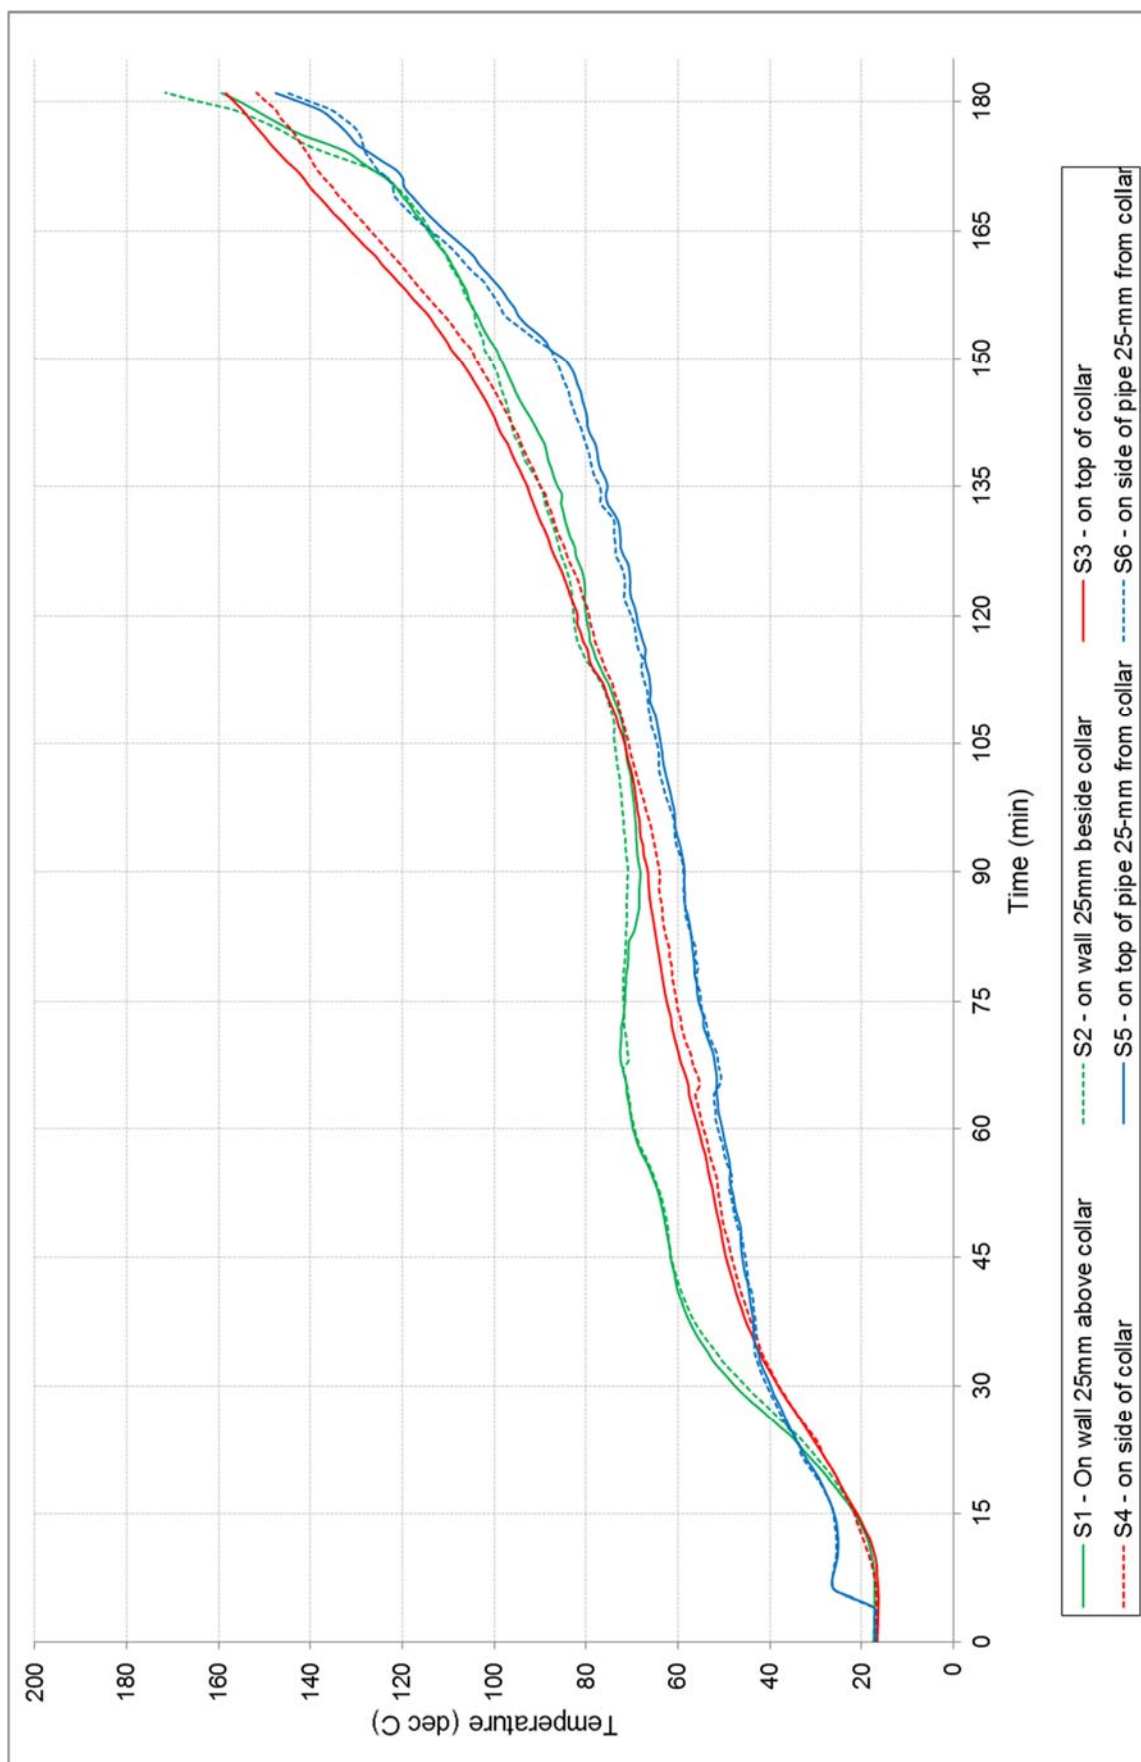
FIGURE 3 – SPECIMEN TEMPERATURE – ASSOCIATED WITH PENETRATION # 1

Structural adequacy	-	not applicable
Integrity	-	no failure at 181 minutes
Insulation	-	no failure at 181 minutes

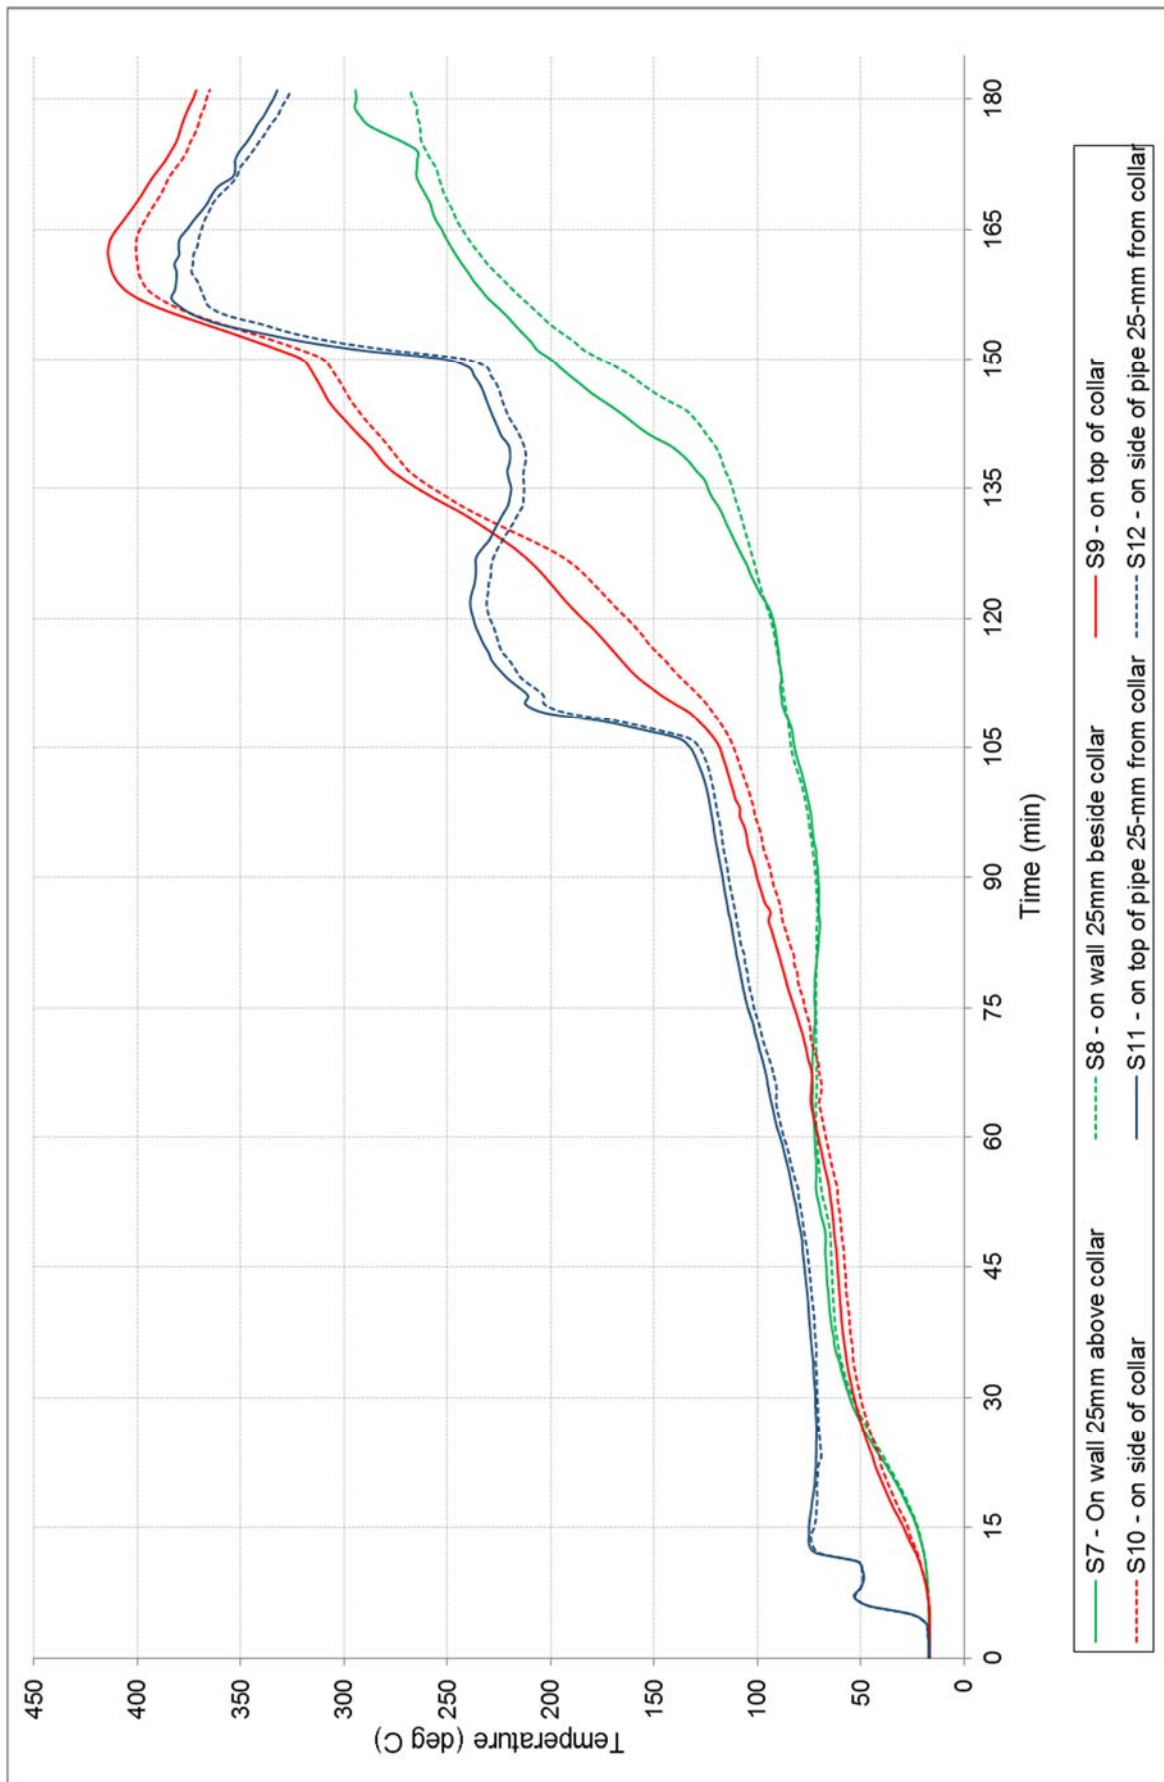
FIGURE 4 – SPECIMEN TEMPERATURE – ASSOCIATED WITH PENETRATION # 2

Structural adequacy	-	not applicable
Integrity	-	no failure at 181 minutes
Insulation	-	109 minutes

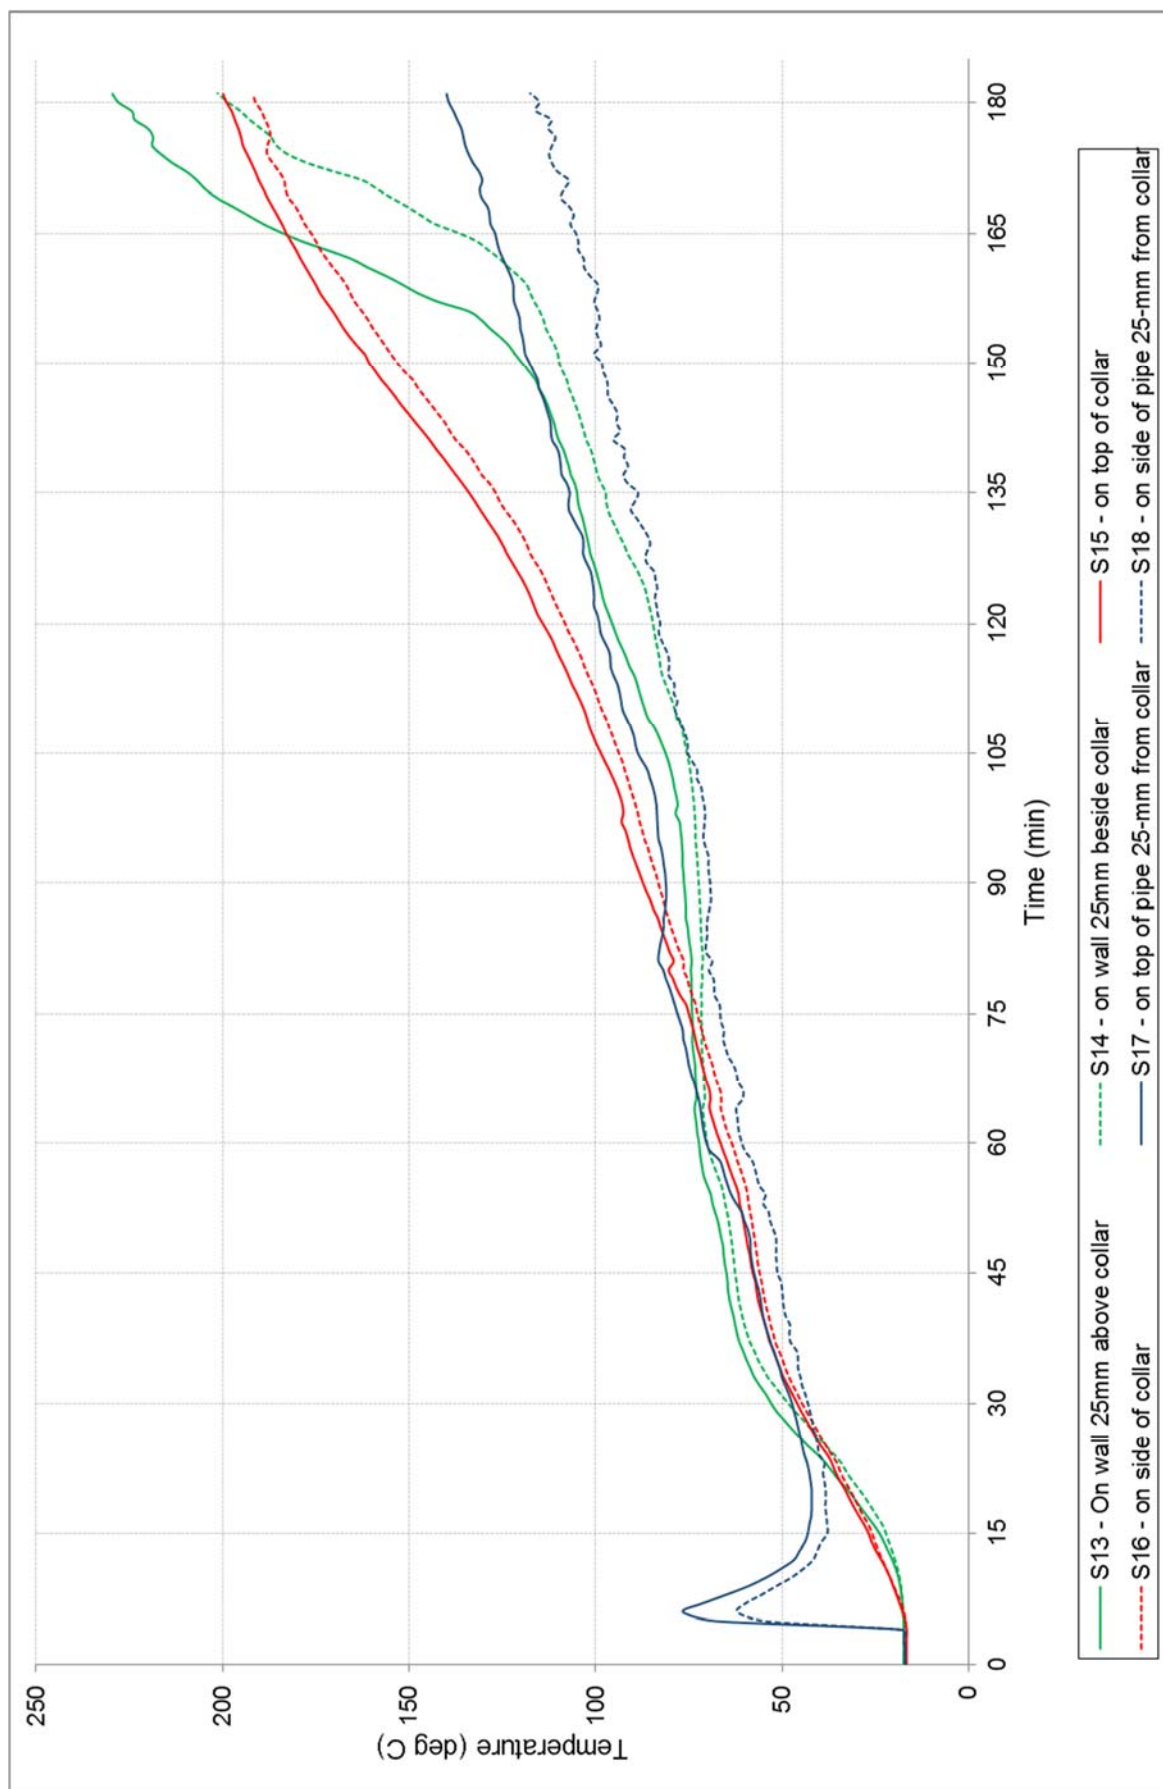
FIGURE 5 – SPECIMEN TEMPERATURE – ASSOCIATED WITH PENETRATION # 3

Structural adequacy	-	not applicable
Integrity	-	no failure at 181 minutes
Insulation	-	169 minutes

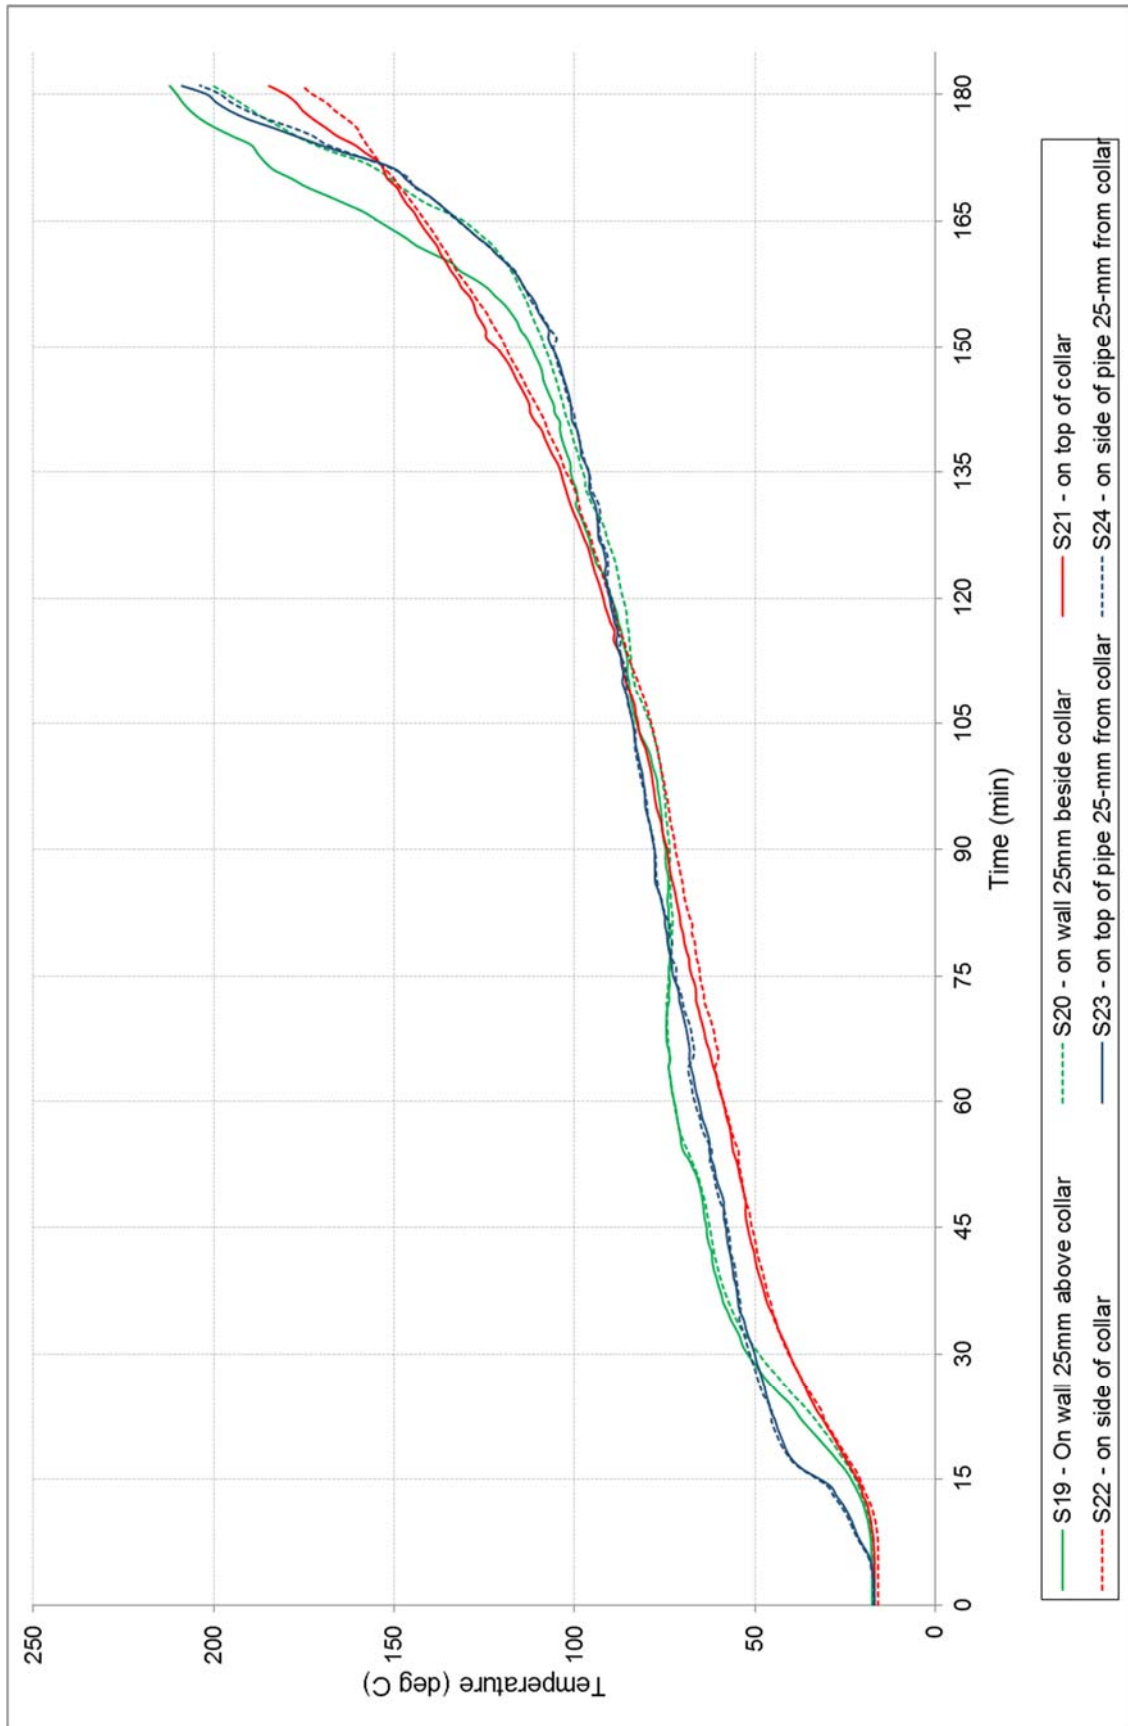
FIGURE 6 – SPECIMEN TEMPERATURE – ASSOCIATED WITH PENETRATION # 4

Structural adequacy	-	not applicable
Integrity	-	no failure at 181 minutes
Insulation	-	176 minutes

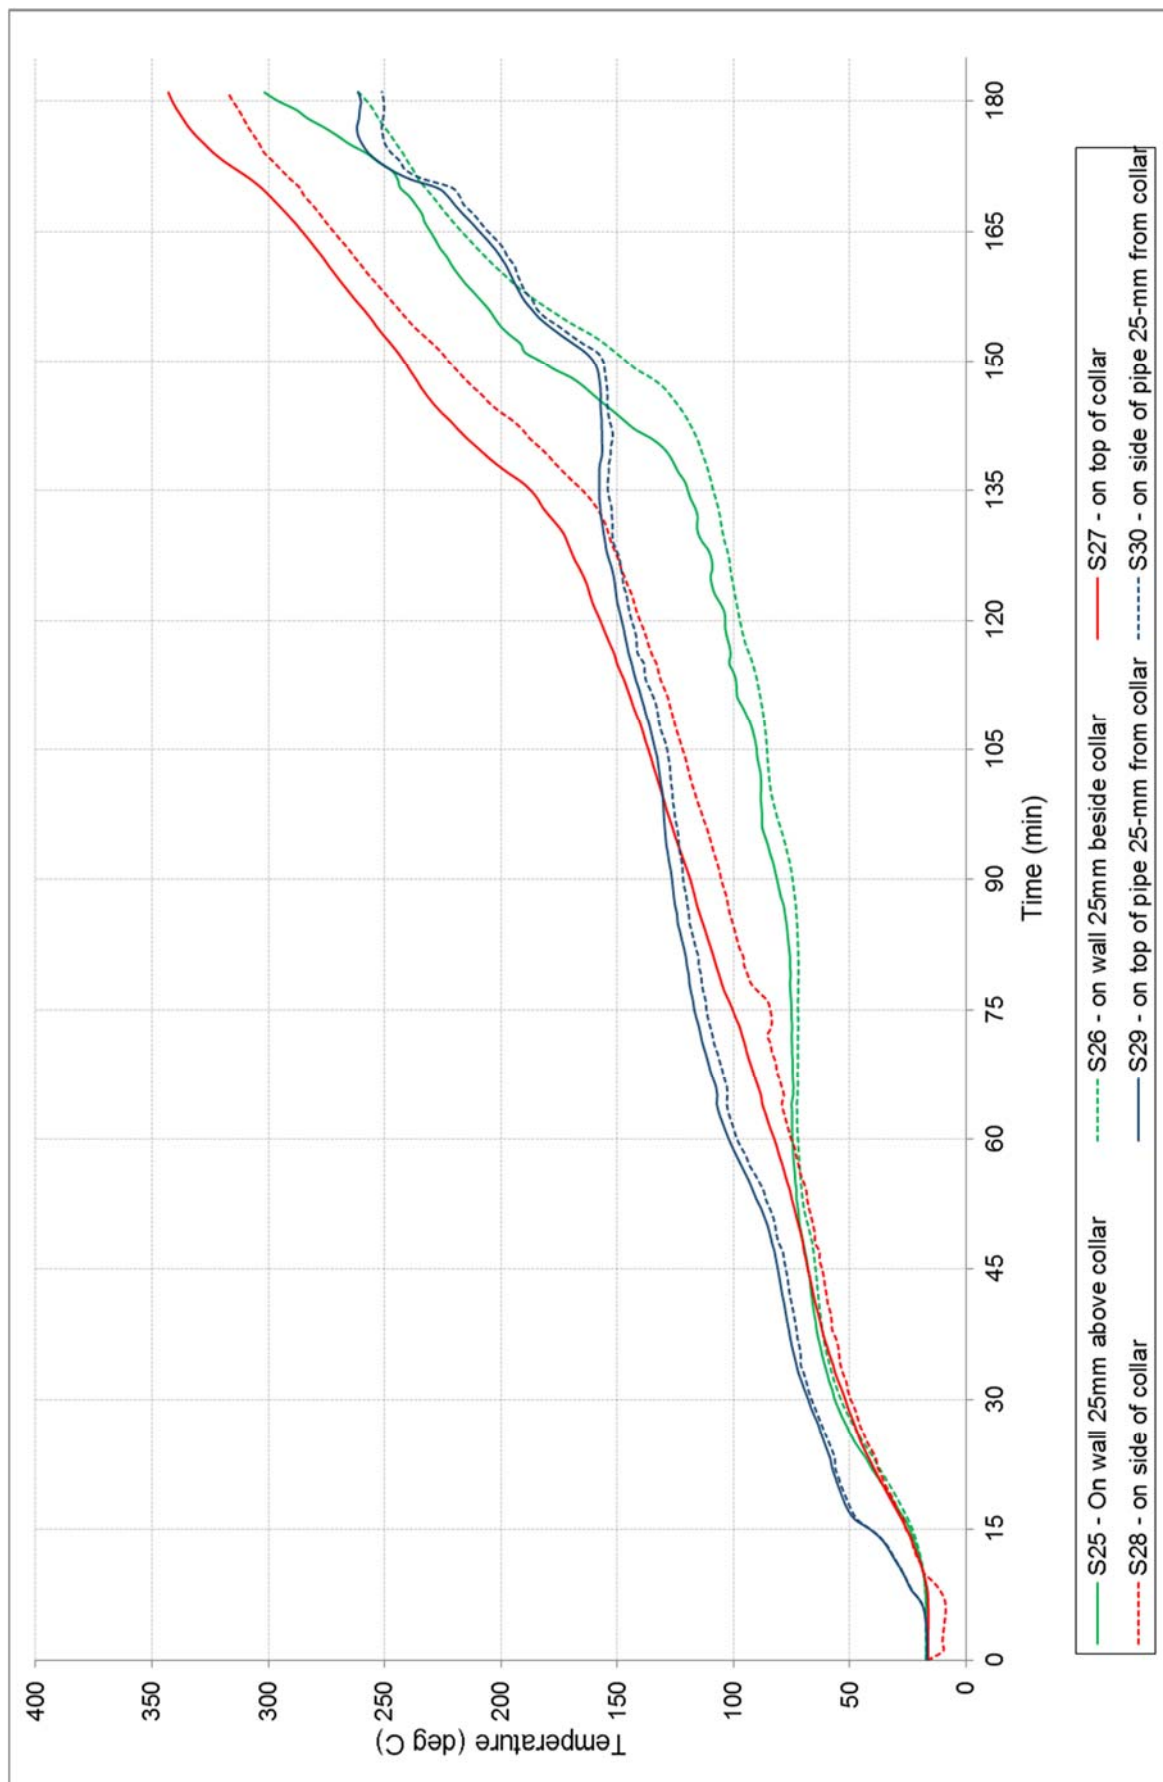
FIGURE 7 – SPECIMEN TEMPERATURE – ASSOCIATED WITH PENETRATION # 5

Structural adequacy	-	not applicable
Integrity	-	no failure at 181 minutes
Insulation	-	138 minutes

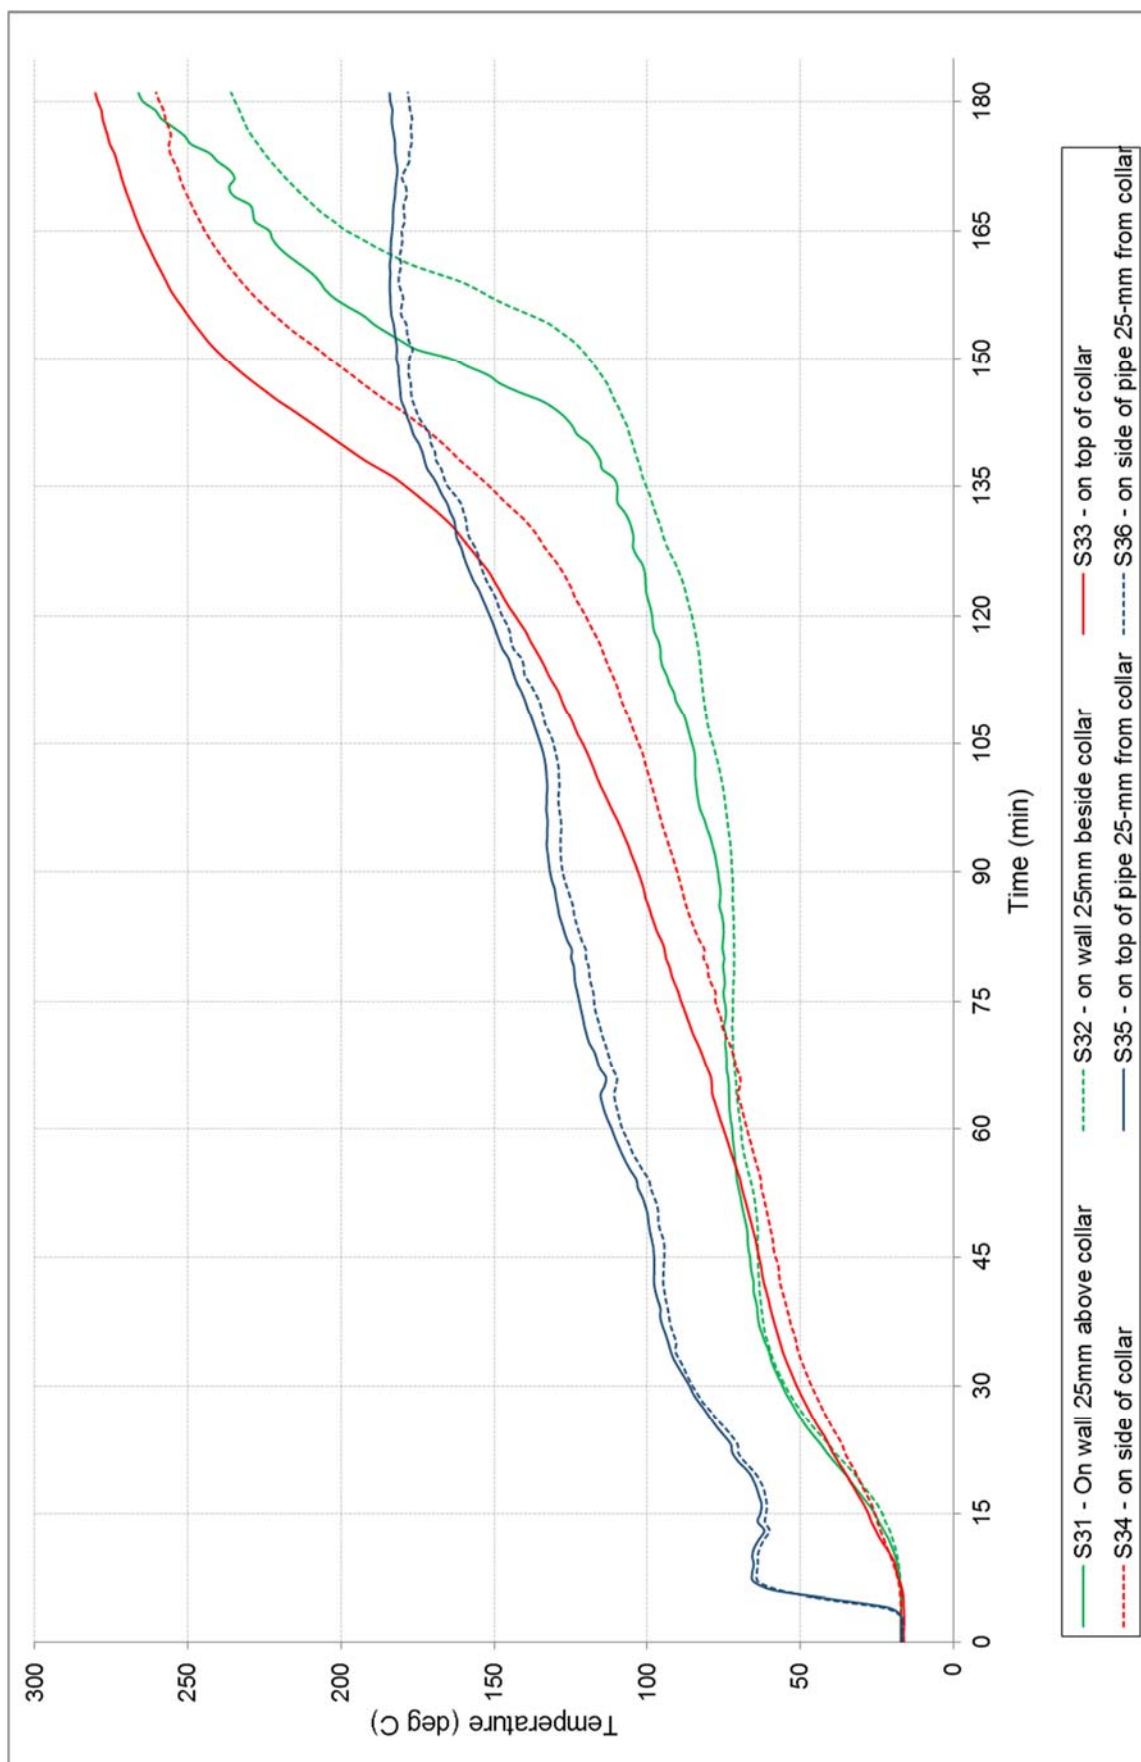
FIGURE 8 – SPECIMEN TEMPERATURE – ASSOCIATED WITH PENETRATION # 6

Structural adequacy	-	not applicable
Integrity	-	no failure at 181 minutes
Insulation	-	140 minutes

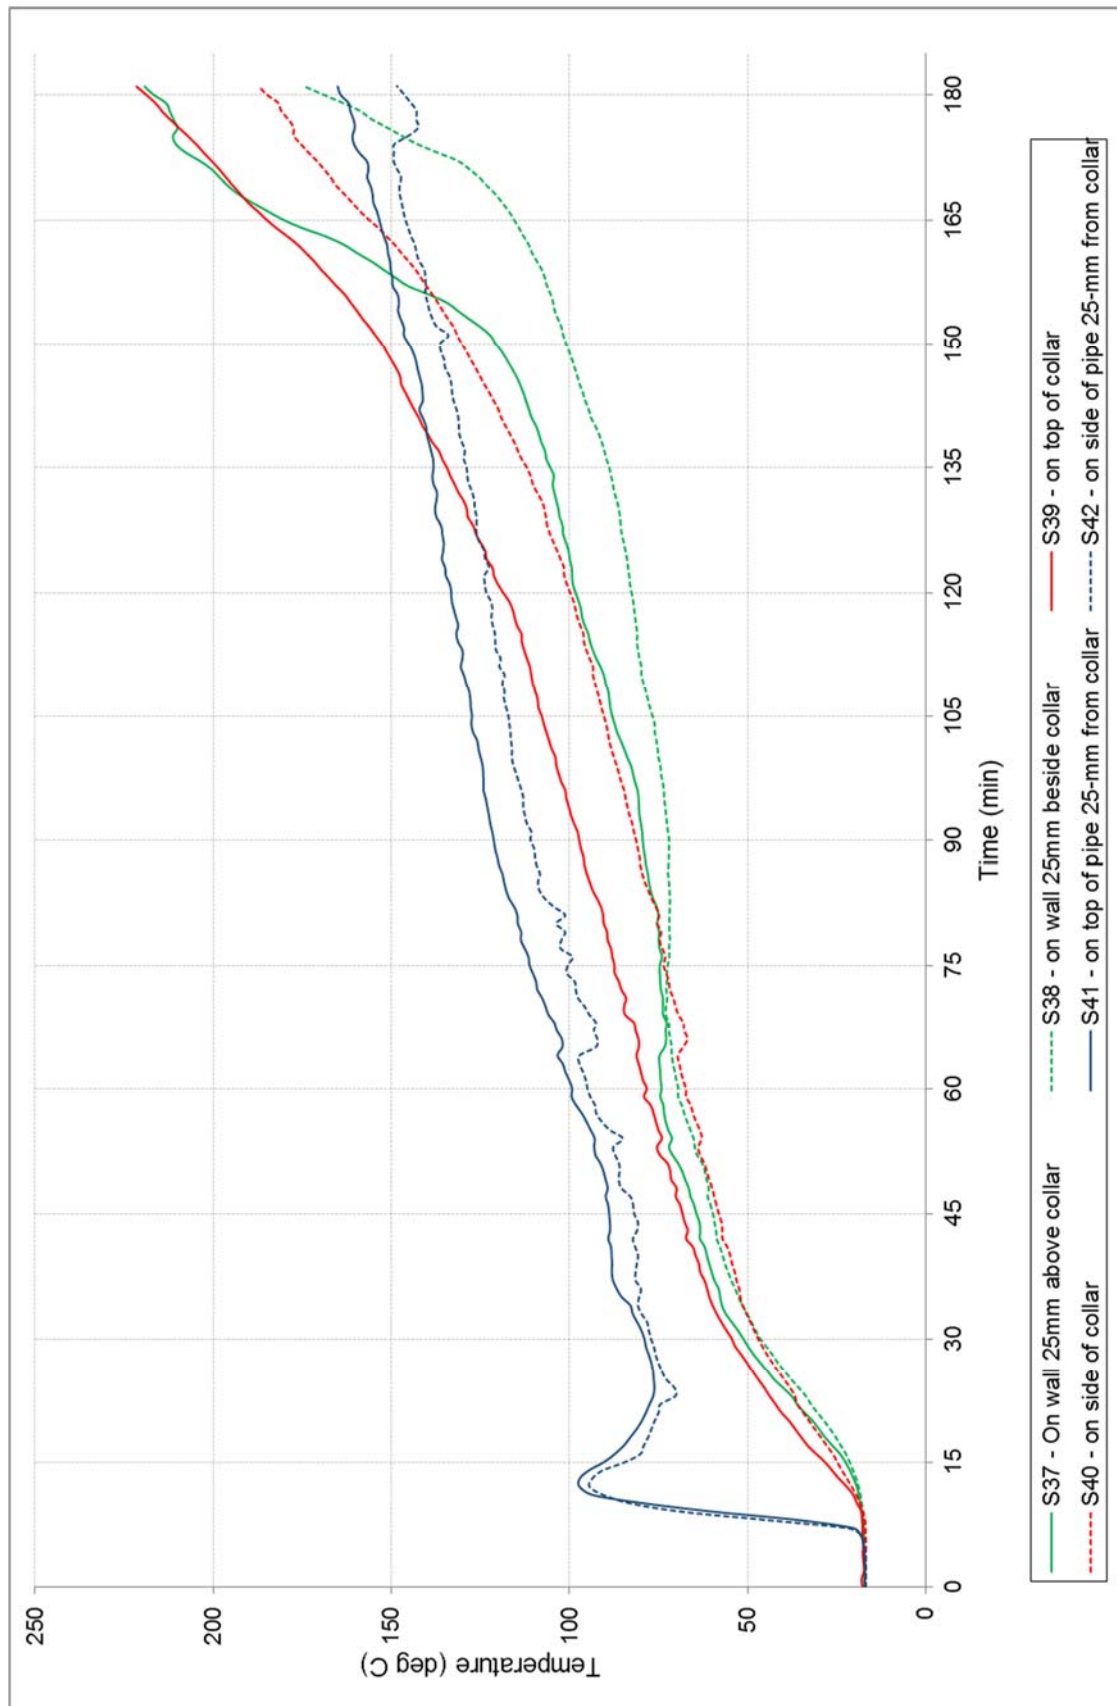
FIGURE 9 – SPECIMEN TEMPERATURE – ASSOCIATED WITH PENETRATION # 7

Structural adequacy	-	not applicable
Integrity	-	no failure at 181 minutes
Insulation	-	170 minutes
