# Fire-resistance test on fire collars protecting a plasterboard wall penetrated by services

## Test Report

**Author:** Russell Collins  
**Report number:** FSP 1759  
**Date:** 15 November 2016

## Sponsored Investigation No. FSP 1759

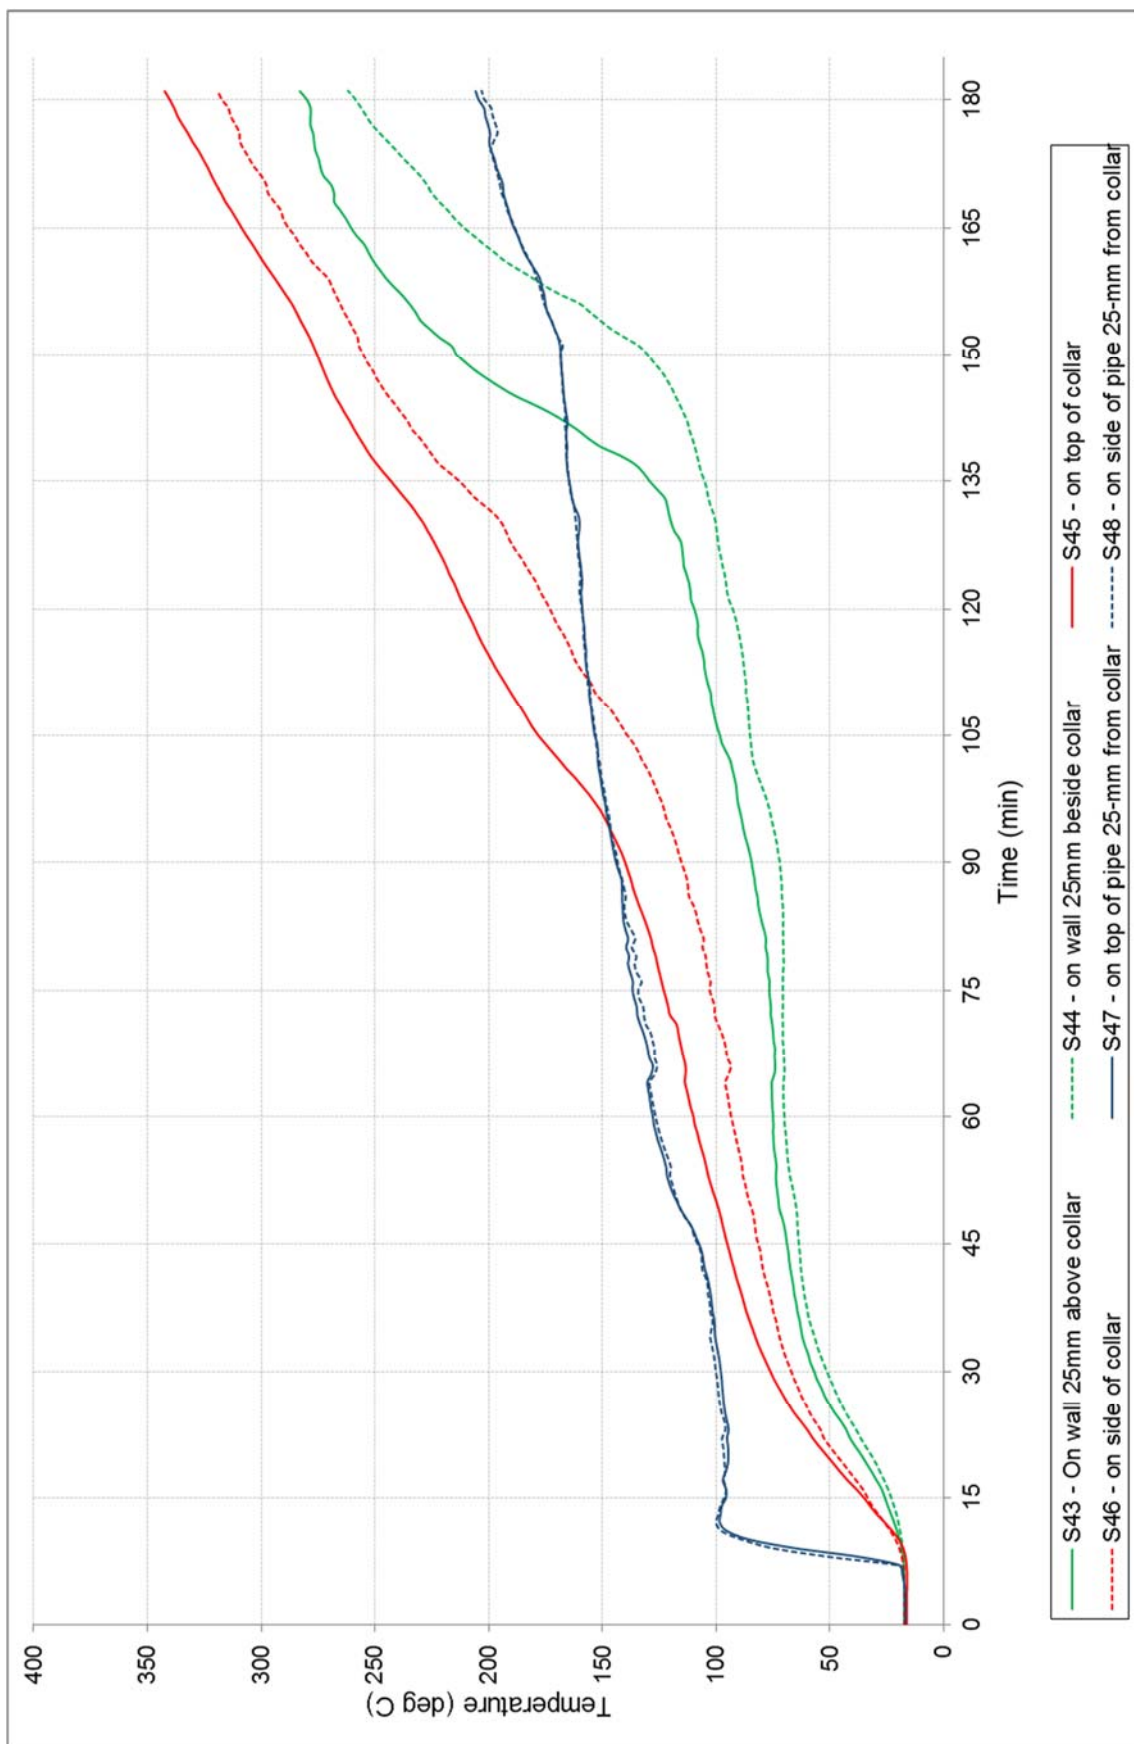
FIGURE 10 – SPECIMEN TEMPERATURE – ASSOCIATED WITH PENETRATION # 8

Structural adequacy	-	not applicable
Integrity	-	no failure at 181 minutes
Insulation	-	114 minutes

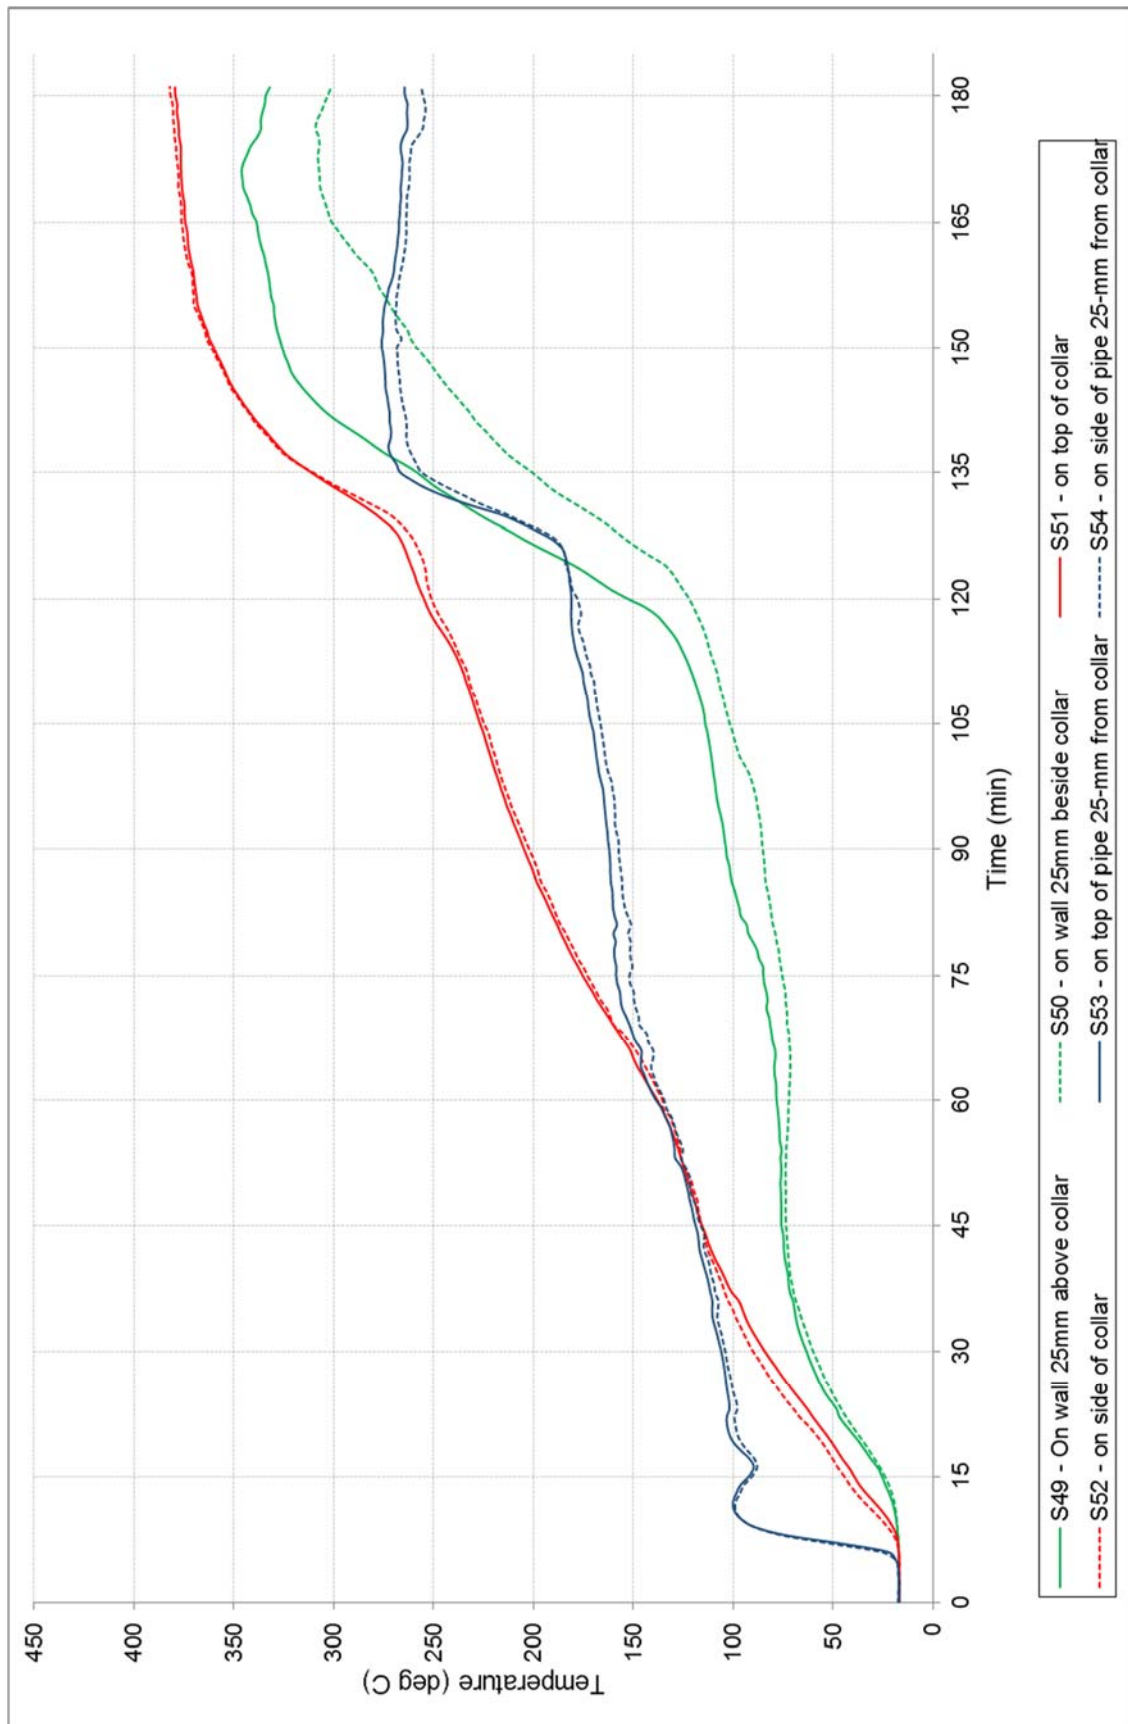
FIGURE 11 – SPECIMEN TEMPERATURE – ASSOCIATED WITH PENETRATION # 9

Structural adequacy	-	not applicable
Integrity	-	no failure at 181 minutes
Insulation	-	86 minutes

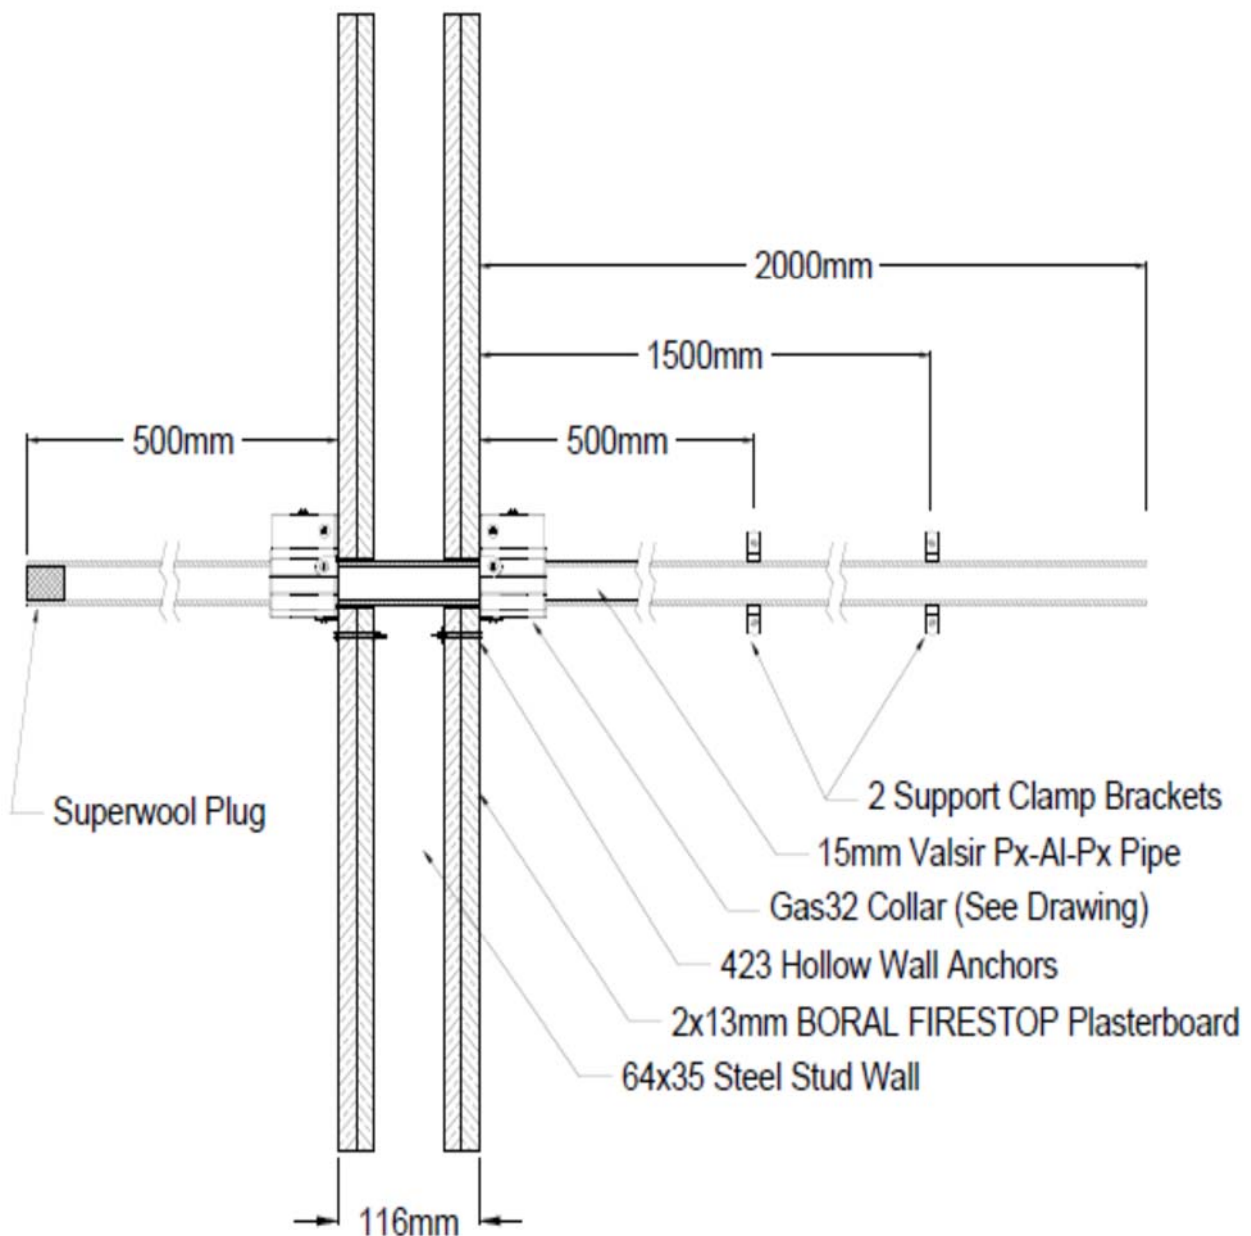
Test Wall W-16-B Penetration #1  
15mm Valsir Px-Al-Px Pipe – Gas32 Collar  
19 AUG 2016

DRAWING TITLED "TEST WALL W-16-B PENETRATION #1, 15-MM VALSIR PX-AL-PX PIPE – GAS32 COLLAR, DATED 19 AUGUST 2016".

The GAS32 Retrofit collar comprised a 0.95-mm thick galvanised steel casing with a 35-mm inner diameter and a 90-mm diameter base flange. The 63-mm high collar casing incorporated a layer of 140-mm x 55-mm x 4-mm thick Intumescent material and a layer of 120-mm x 55-mm x 4-mm thick Intumescent material. The closing mechanism comprised 1 x 304 stainless steel spring bound with a black nylon fuse link and a 316 stainless steel mesh measuring 120 x 54-mm as shown in drawing numbered GAS32-T dated 14 September 2016, by Snap Fire Systems Pty Ltd.

The penetrating service comprised a 15-mm Valsir Px-Al-Px stack pipe, with a wall thickness of 2-mm fitted through the collar's sleeve and penetrating the plasterboard wall through a 19-mm diameter cut-out hole as shown in drawing titled "Test Wall W-16-B Penetration # 1, 15-mm Valsir Px-Al-Px Pipe – Gas32 Collar, dated 19 August 2016". The pipe projected horizontally, 2000-mm away from the unexposed face of the plasterboard wall and approximately 500-mm into the furnace chamber. The pipe was supported at nominally 500-mm and 1500-mm from the unexposed face of the plasterboard wall by two support clamps spaced apart at nominally 1000-mm. The pipe was open at the unexposed end and capped on the exposed end with a ceramic fibre (Superwool) plug.

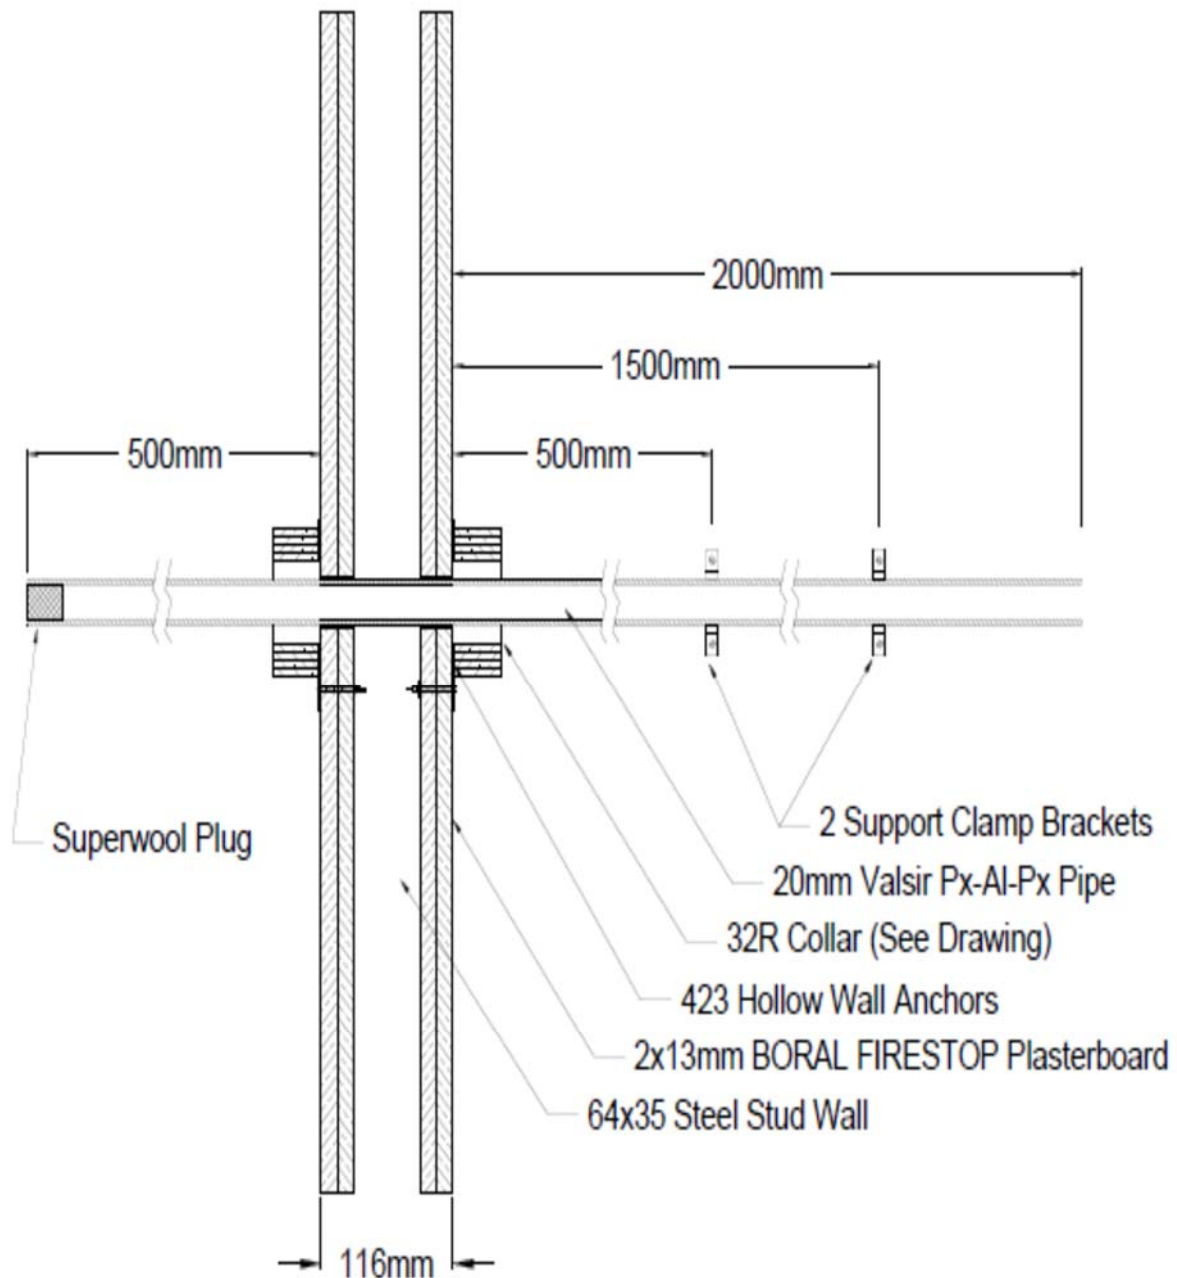
Test Wall W-16-B Penetration #2  
20mm Valsir Px-Al-Px Pipe – 32R Retrofit Collar  
19 AUG 2016

**DRAWING TITLED "TEST WALL W-16-B PENETRATION #2, 20-MM VALSIR PX-AL-PX PIPE – 32R COLLAR, DATED 19 AUGUST 2016".**

The 32R Retrofit collar comprised a 0.75-mm steel casing with a 40-mm inner diameter and a 106-mm diameter base flange. The 32-mm high collar casing incorporated a closing mechanism that was comprised of two soft Intumesh intumescent strips lined within the internal circumference of the collar. The inner and outer strips were 4-mm thick x 26-mm wide x 135-mm long, and 4-mm thick x 26-mm wide x 154-mm long, respectively. Between the strips was a layer of 304 stainless steel mesh 135 mm long x 25-mm wide with wire mesh diameter of 0.15-mm, as shown in drawing numbered 32R-T dated 12 February 2015, by Snap Fire Systems Pty Ltd. One collar was fixed to each side of the plasterboard wall in a back-to-back configuration using three hollow wall anchors.

The penetrating service comprised a 20-mm Valsir Px-Al-Px stack pipe, with a wall thickness of 2.8-mm fitted through the collar's sleeve and penetrating the plasterboard wall through a 22-mm diameter cut-out hole as shown in drawing titled "Test Wall W-16-B Penetration # 2, 20-mm Valsir Px-Al-Px Pipe – 32R Collar, dated 19 August 2016". The pipe projected horizontally, 2000-mm away from the unexposed face of the plasterboard wall and approximately 500-mm into the furnace chamber. The pipe was supported at nominally 500-mm and 1500-mm from the unexposed face of the plasterboard wall by two support clamps spaced apart at nominally 1000-mm. The pipe was open at the unexposed end and capped on the exposed end with a ceramic fibre (Superwool) plug.

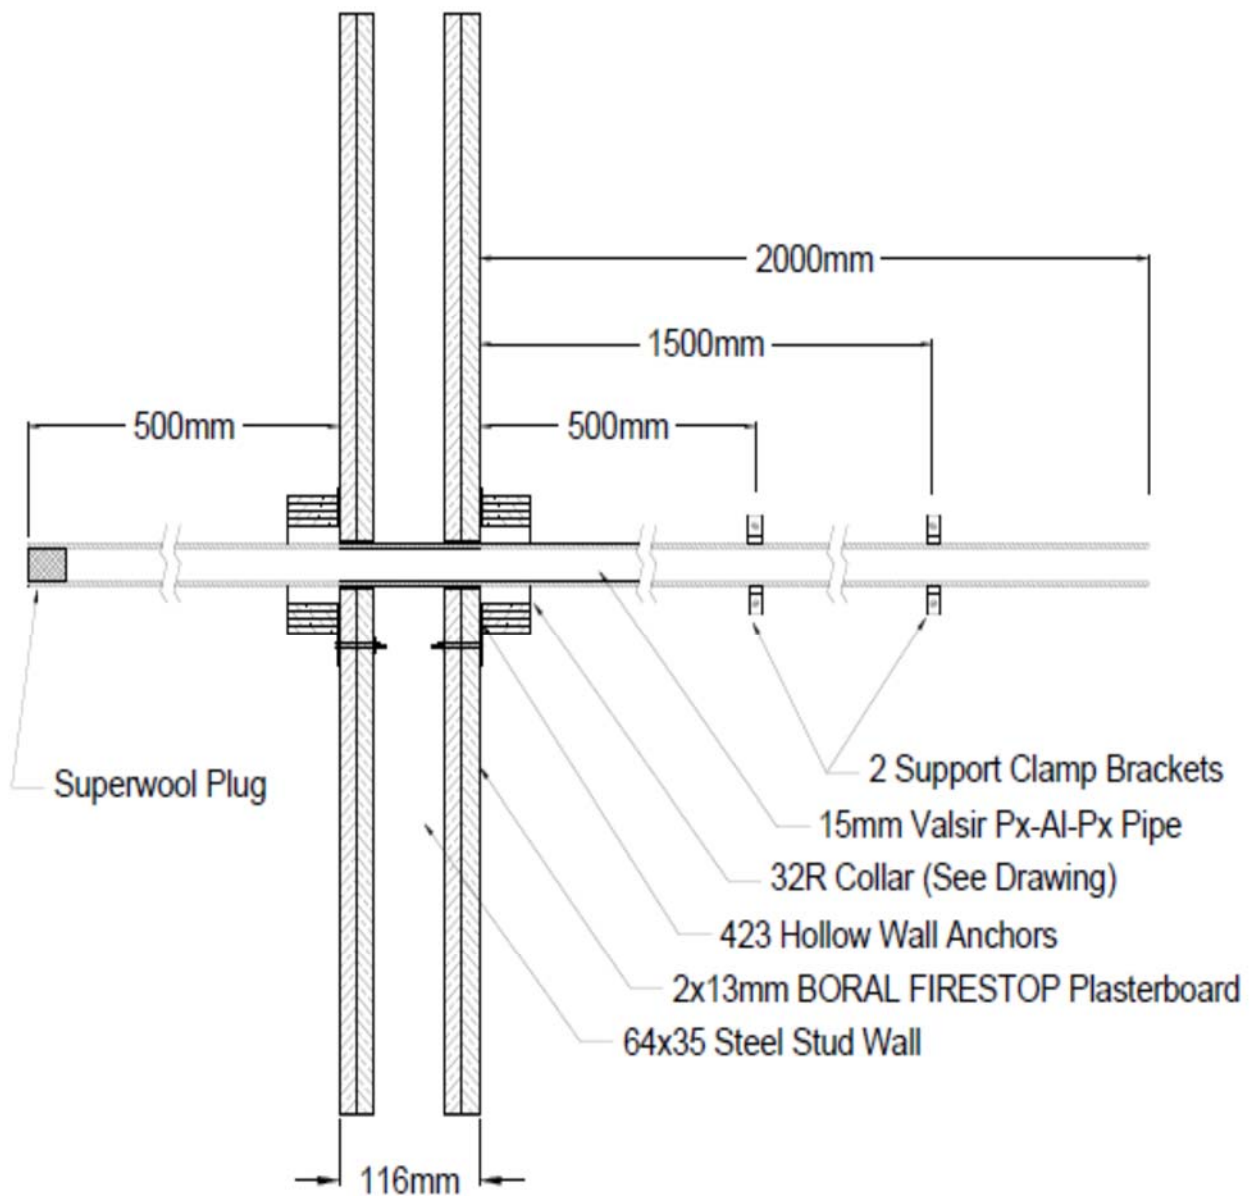
Test Wall W-16-B Penetration #3  
15mm Valsir Px-Al-Px Pipe – 32R Collar  
19 AUG 2016

**DRAWING TITLED "TEST WALL W-16-B PENETRATION #3, 15-MM VALSIR PX-AL-PX PIPE – 32R COLLAR, DATED 19 AUGUST 2016".**

The 32R Retrofit collar comprised a 0.75-mm steel casing with a 40-mm inner diameter and a 106-mm diameter base flange. The 32-mm high collar casing incorporated a closing mechanism that was comprised of two soft Intumesh intumescent strips lined within the internal circumference of the collar. The inner and outer strips were 4-mm thick x 26-mm wide x 135-mm long, and 4-mm thick x 26-mm wide x 154-mm long, respectively. Between the strips was a layer of 304 stainless steel mesh 135 mm long x 25-mm wide with wire mesh diameter of 0.15-mm, as shown in drawing numbered 32R-T dated 12 February 2015, by Snap Fire Systems Pty Ltd. One collar was fixed to each side of the plasterboard wall in a back-to-back configuration using three hollow wall anchors.

The penetrating service comprised a 15-mm Valsir Px-Al-Px stack pipe, with a wall thickness of 2.3-mm fitted through the collar's sleeve and penetrating the plasterboard wall through a 19-mm diameter cut-out hole as shown in drawing titled "Test Wall W-16-B Penetration # 3, 15-mm Valsir Px-Al-Px Pipe – 32R Collar, dated 19 August 2016". The pipe projected horizontally, 2000-mm away from the unexposed face of the plasterboard wall and approximately 500-mm into the furnace chamber. The pipe was supported at nominally 500-mm and 1500-mm from the unexposed face of the plasterboard wall by two support clamps spaced apart at nominally 1000-mm. The pipe was open at the unexposed end and capped on the exposed end with a ceramic fibre (Superwool) plug.

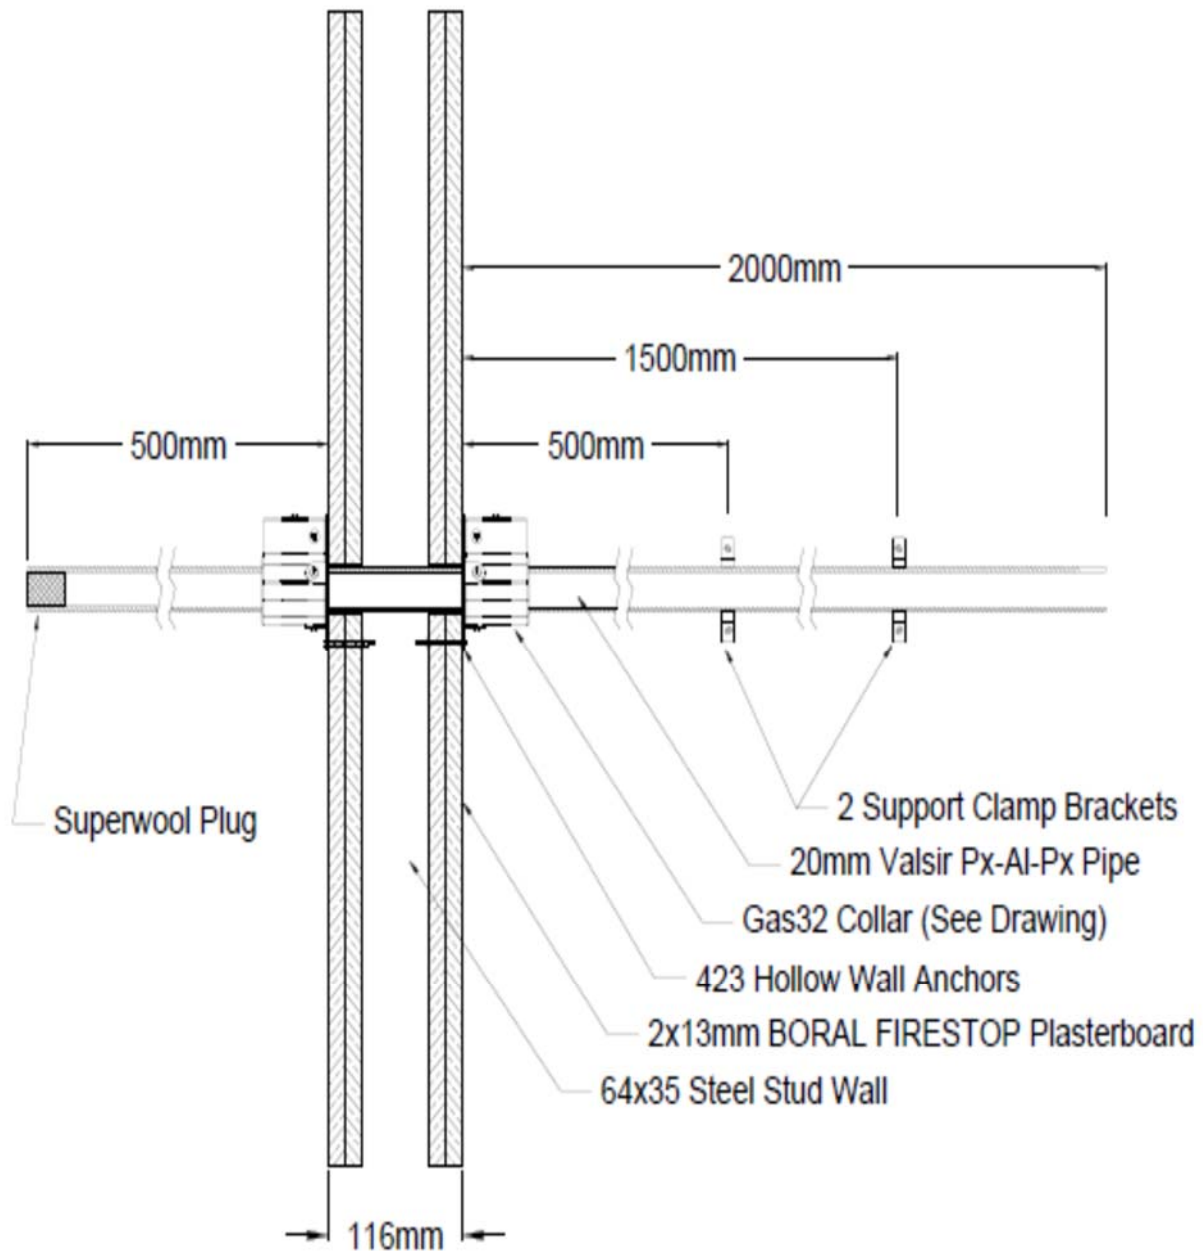
Test Wall W-16-B Penetration # 4  
20mm Valsir Px-Al-Px Pipe – Gas32 Collar  
19 AUG 2016

DRAWING TITLED "TEST WALL W-16-B PENETRATION #4, 20-MM VALSIR PX-AL-PX PIPE – GAS32 COLLAR, DATED 19 AUGUST 2016".

The GAS32 Retrofit collar comprised a 0.95-mm thick galvanised steel casing with a 35-mm inner diameter and a 90-mm diameter base flange. The 63-mm high collar casing incorporated a layer of 140-mm x 55-mm x 4-mm thick Intumescent material and a layer of 120-mm x 55-mm x 4-mm thick Intumescent material. The closing mechanism comprised 1 x 304 stainless steel spring bound with a black nylon fuse link and a 316 stainless steel mesh measuring 120 x 54-mm as shown in drawing numbered GAS32-T dated 14 September 2016, by Snap Fire Systems Pty Ltd.

The penetrating service comprised a 20-mm Valsir Px-Al-Px stack pipe, with a wall thickness of 2.9-mm fitted through the collar's sleeve and penetrating the plasterboard wall through a 22-mm diameter cut-out hole as shown in drawing titled "Test Wall W-16-B Penetration # 4, 20-mm Valsir Px-Al-Px Pipe – Gas32 Collar, dated 19 August 2016". The pipe projected horizontally, 2000-mm away from the unexposed face of the plasterboard wall and approximately 500-mm into the furnace chamber. The pipe was supported at nominally 500-mm and 1500-mm from the unexposed face of the plasterboard wall by two support clamps spaced apart at nominally 1000-mm. The pipe was open at the unexposed end and capped on the exposed end with a ceramic fibre (Superwool) plug.

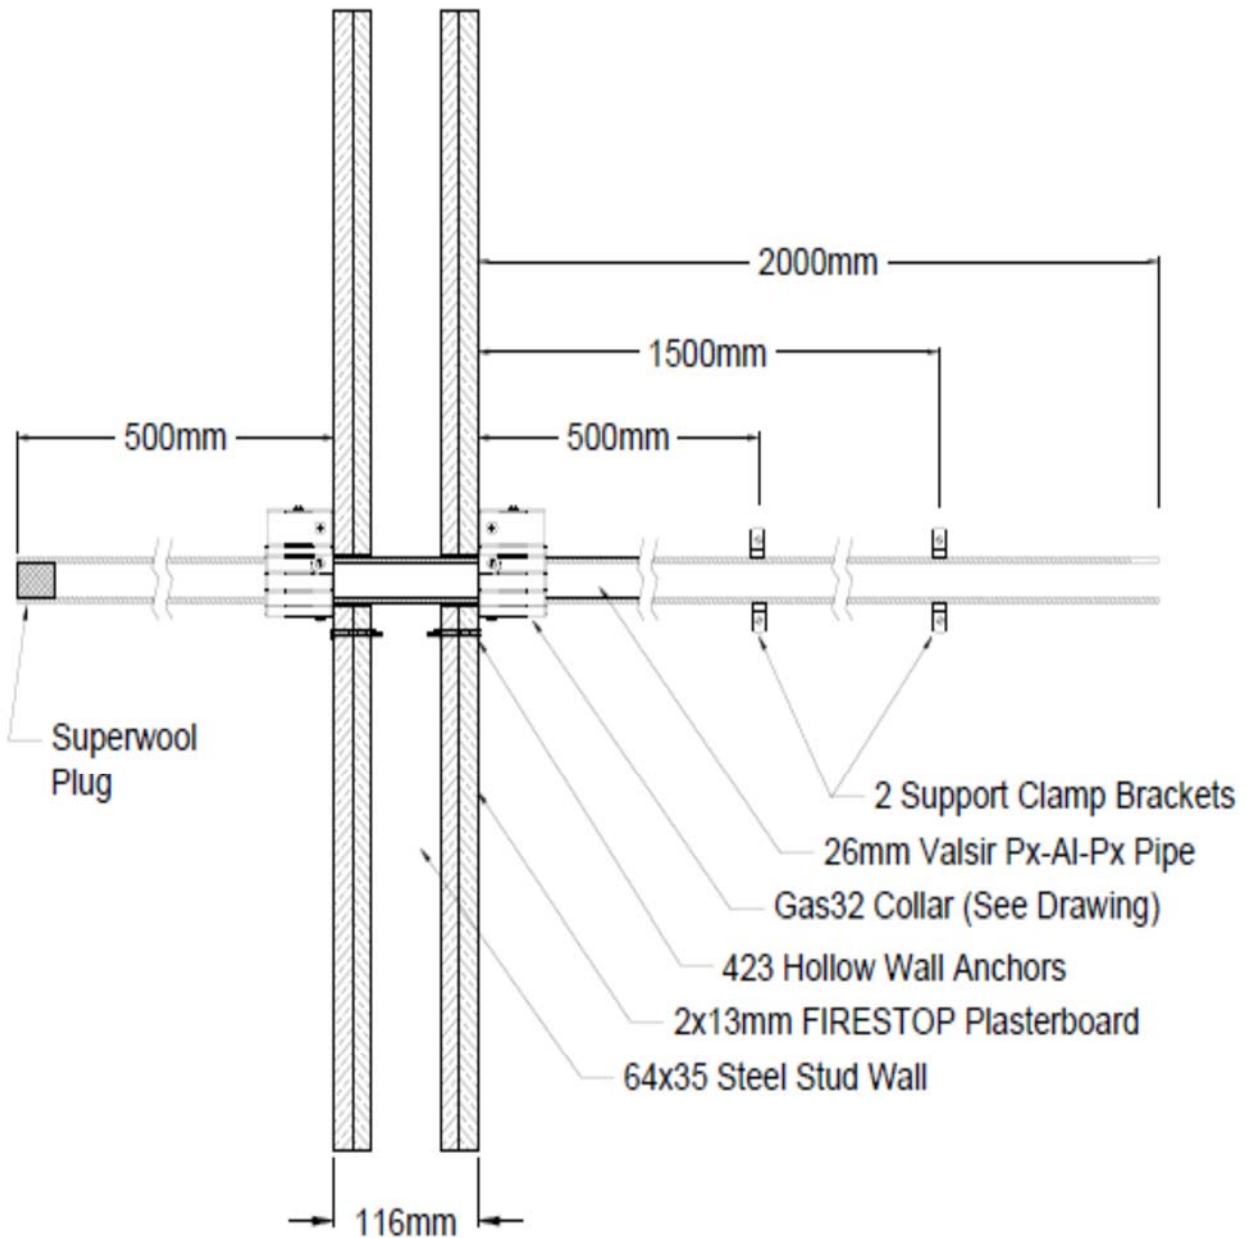
Test Wall W-16-B Penetration #5  
 26mm Valsir Px-Al-Px Pipe – Gas32 Collars  
 19 AUG 2016

DRAWING TITLED "TEST WALL W-16-B PENETRATION #5, 26-MM VALSIR PX-AL-PX PIPE – GAS32 COLLAR, DATED 19 AUGUST 2016".

The GAS32 Retrofit collar comprised a 0.95-mm thick galvanised steel casing with a 35-mm inner diameter and a 90-mm diameter base flange. The 63-mm high collar casing incorporated a layer of 140-mm x 55-mm x 4-mm thick Intumescent material and a layer of 120-mm x 55-mm x 4-mm thick Intumescent material. The closing mechanism comprised 1 x 304 stainless steel spring bound with a black nylon fuse link and a 316 stainless steel mesh measuring 120 x 54-mm as shown in drawing numbered GAS32-T dated 14 September 2016, by Snap Fire Systems Pty Ltd.

The penetrating service comprised a 26-mm Valsir Px-Al-Px stack pipe, with a wall thickness of 3.4-mm fitted through the collar's sleeve and penetrating the plasterboard wall through a 29-mm diameter cut-out hole as shown in drawing titled "Test Wall W-16-B Penetration # 5, 26-mm Valsir Px-Al-Px Pipe – Gas32 Collar, dated 19 August 2016". The pipe projected horizontally, 2000-mm away from the unexposed face of the plasterboard wall and approximately 500-mm into the furnace chamber. The pipe was supported at nominally 500-mm and 1500-mm from the unexposed face of the plasterboard wall by two support clamps spaced apart at nominally 1000-mm. The pipe was open at the unexposed end and capped on the exposed end with a ceramic fibre (Superwool) plug.

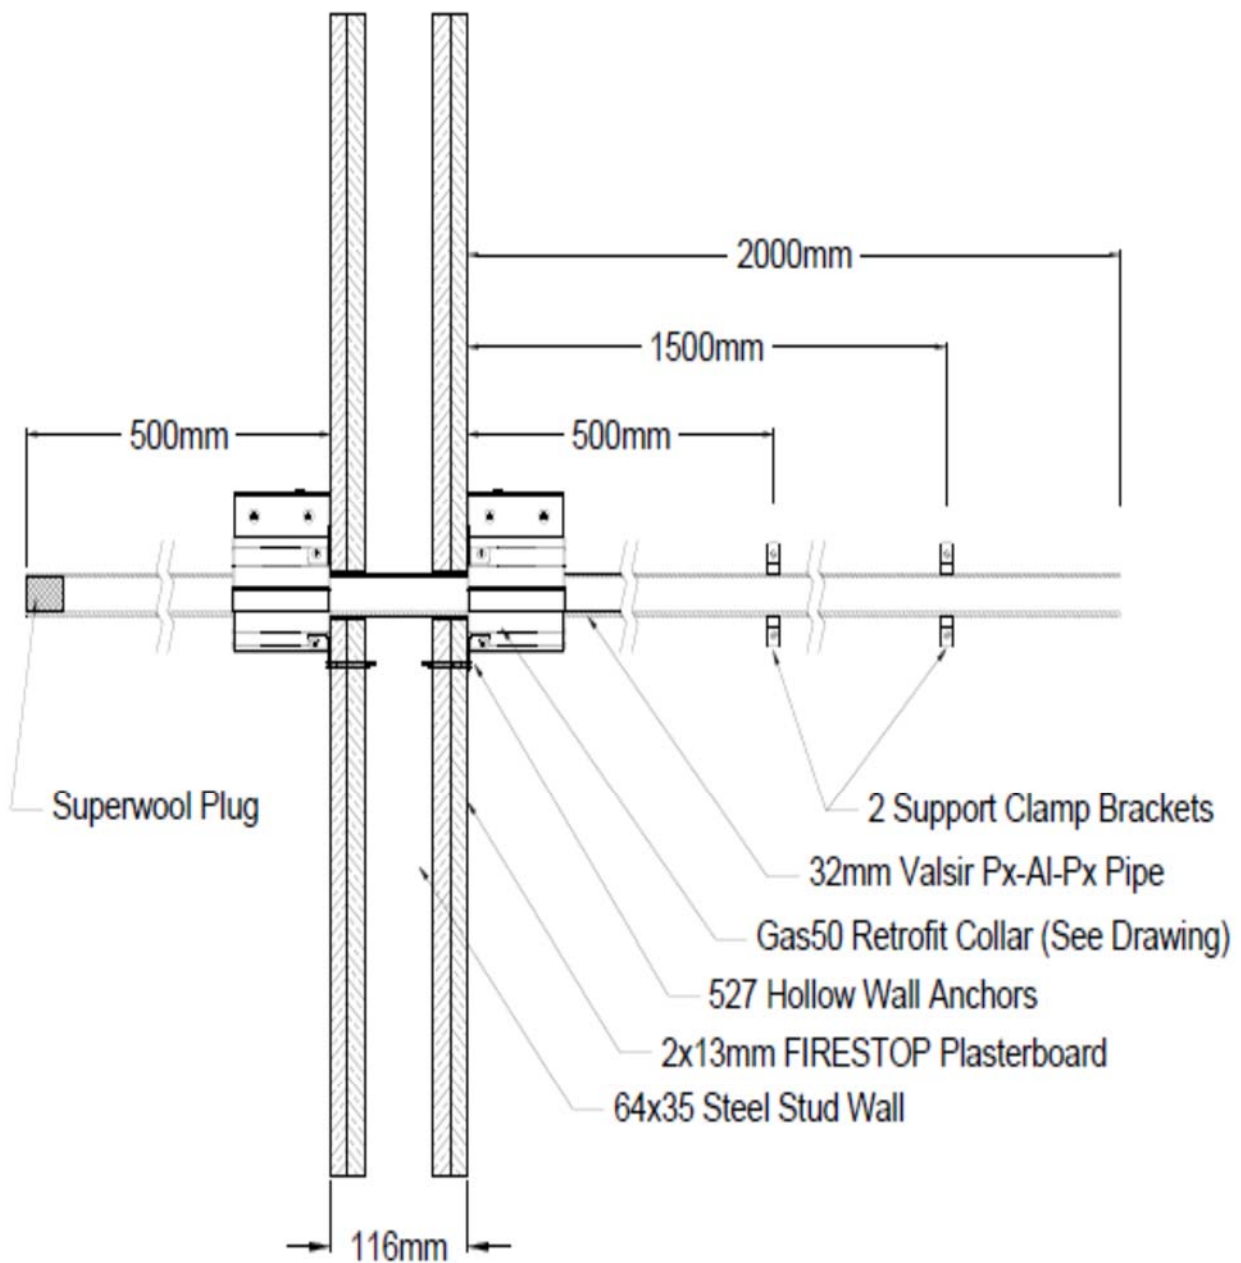
Test Wall W-16-B Penetration #6  
32mm Valsir Px-Al-Px Pipe – Gas50 Collar  
19 AUG 2016

**DRAWING TITLED "TEST WALL W-16-B PENETRATION #6, 32-MM VALSIR PX-AL-PX PIPE – GAS50 COLLAR, DATED 19 AUGUST 2016".**

The GAS50 Retrofit collar comprised a 0.95-mm thick galvanised steel casing with a 57-mm inner diameter and a 115-mm diameter base flange. The 92-mm high collar casing incorporated a layer of 215-mm x 85-mm x 4-mm thick Intumescent material and a layer of 190-mm x 85-mm x 4-mm thick Intumescent material. The closing mechanism comprised 1 x 304 stainless steel spring bound with a black nylon fuse link and a 316 stainless steel mesh measuring 190 x 84-mm as shown in drawing numbered GAS50-T dated 16 September 2016, by Snap Fire Systems Pty Ltd.

The penetrating service comprised a 32-mm Valsir Px-Al-Px stack pipe, with a wall thickness of 3.6-mm fitted through the collar's sleeve and penetrating the plasterboard wall through a 35-mm diameter cut-out hole as shown in drawing titled "Test Wall W-16-B Penetration # 6, 32-mm Valsir Px-Al-Px Pipe – Gas50 Collar, dated 19 August 2016". The pipe projected horizontally, 2000-mm away from the unexposed face of the plasterboard wall and approximately 500-mm into the furnace chamber. The pipe was supported at nominally 500-mm and 1500-mm from the unexposed face of the plasterboard wall by two support clamps spaced apart at nominally 1000-mm. The pipe was open at the unexposed end and capped on the exposed end with a ceramic fibre (Superwool) plug.

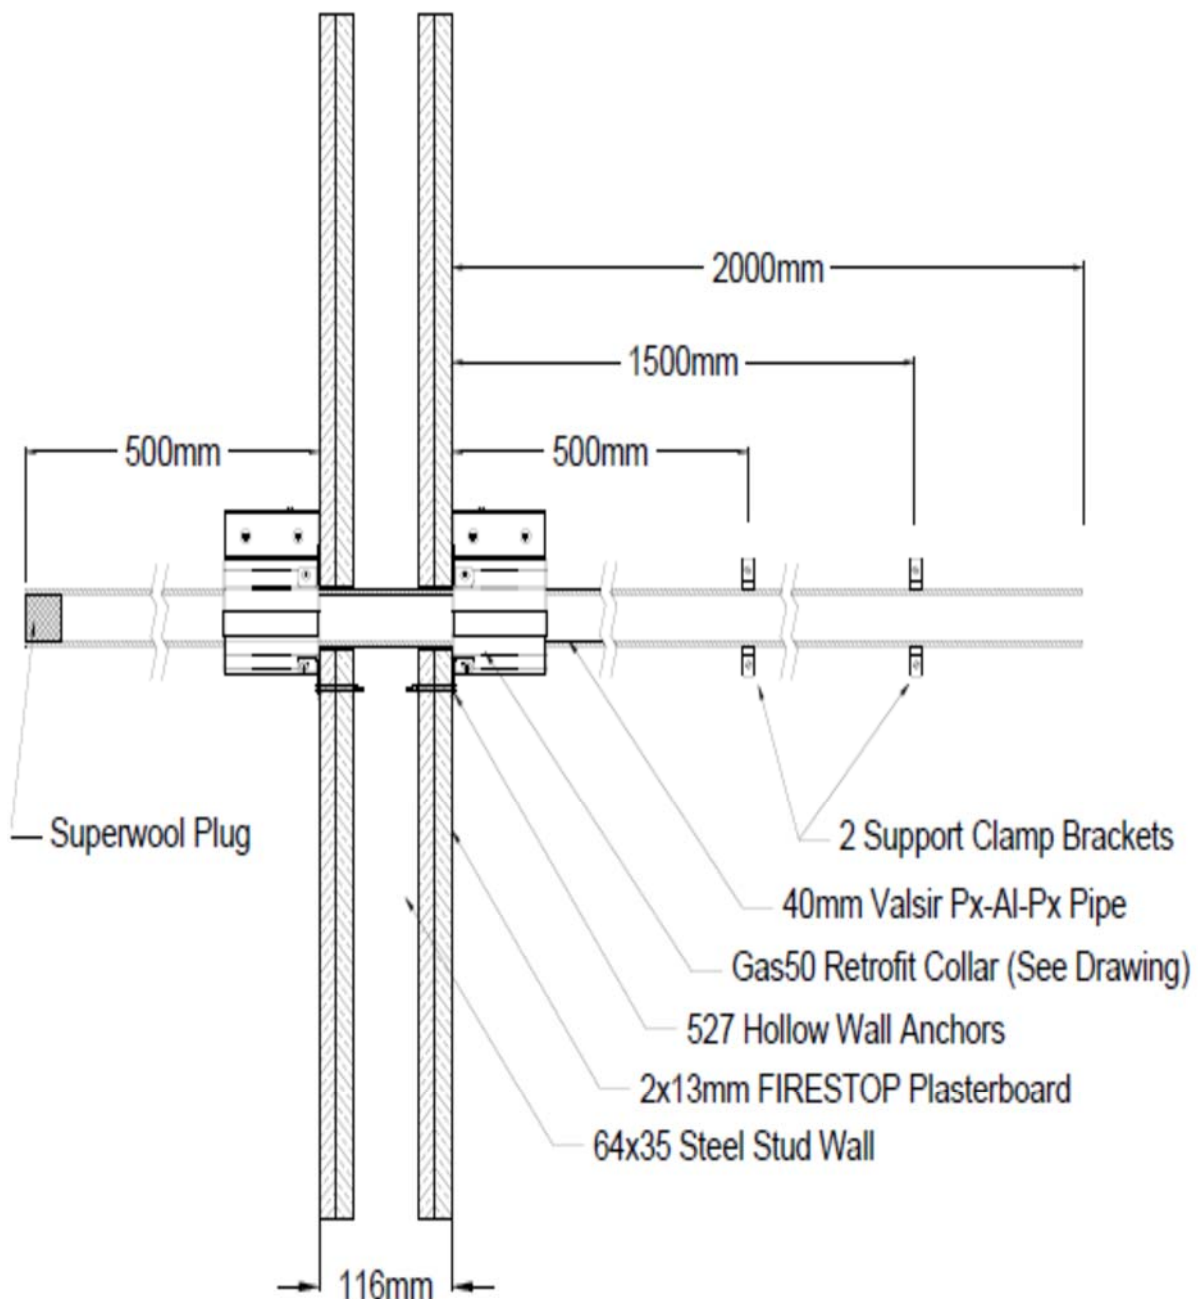
Test Wall W-16-B Penetration #7  
 40mm Valsir Px-Al-Px Pipe – Gas50 Collar  
 19 AUG 2016

**DRAWING TITLED “TEST WALL W-16-B PENETRATION #7, 40-MM VALSIR PX-AL-PX PIPE – GAS50 COLLAR, DATED 19 AUGUST 2016”.**

The GAS50 Retrofit collar comprised a 0.95-mm thick galvanised steel casing with a 57-mm inner diameter and a 115-mm diameter base flange. The 92-mm high collar casing incorporated a layer of 215-mm x 85-mm x 4-mm thick Intumescent material and a layer of 190-mm x 85-mm x 4-mm thick Intumescent material. The closing mechanism comprised 1 x 304 stainless steel spring bound with a black nylon fuse link and a 316 stainless steel mesh measuring 190 x 84-mm as shown in drawing numbered GAS50-T dated 16 September 2016, by Snap Fire Systems Pty Ltd.

The penetrating service comprised a 40-mm Valsir Px-Al-Px stack pipe, with a wall thickness of 4-mm fitted through the collar's sleeve and penetrating the plasterboard wall through a 44-mm diameter cut-out hole as shown in drawing titled "Test Wall W-16-B Penetration # 7, 40-mm Valsir Px-Al-Px Pipe – Gas50 Collar, dated 19 August 2016". The pipe projected horizontally, 2000-mm away from the unexposed face of the plasterboard wall and approximately 500-mm into the furnace chamber. The pipe was supported at nominally 500-mm and 1500-mm from the unexposed face of the plasterboard wall by two support clamps spaced apart at nominally 1000-mm. The pipe was open at the unexposed end and capped on the exposed end with a ceramic fibre (Superwool) plug.

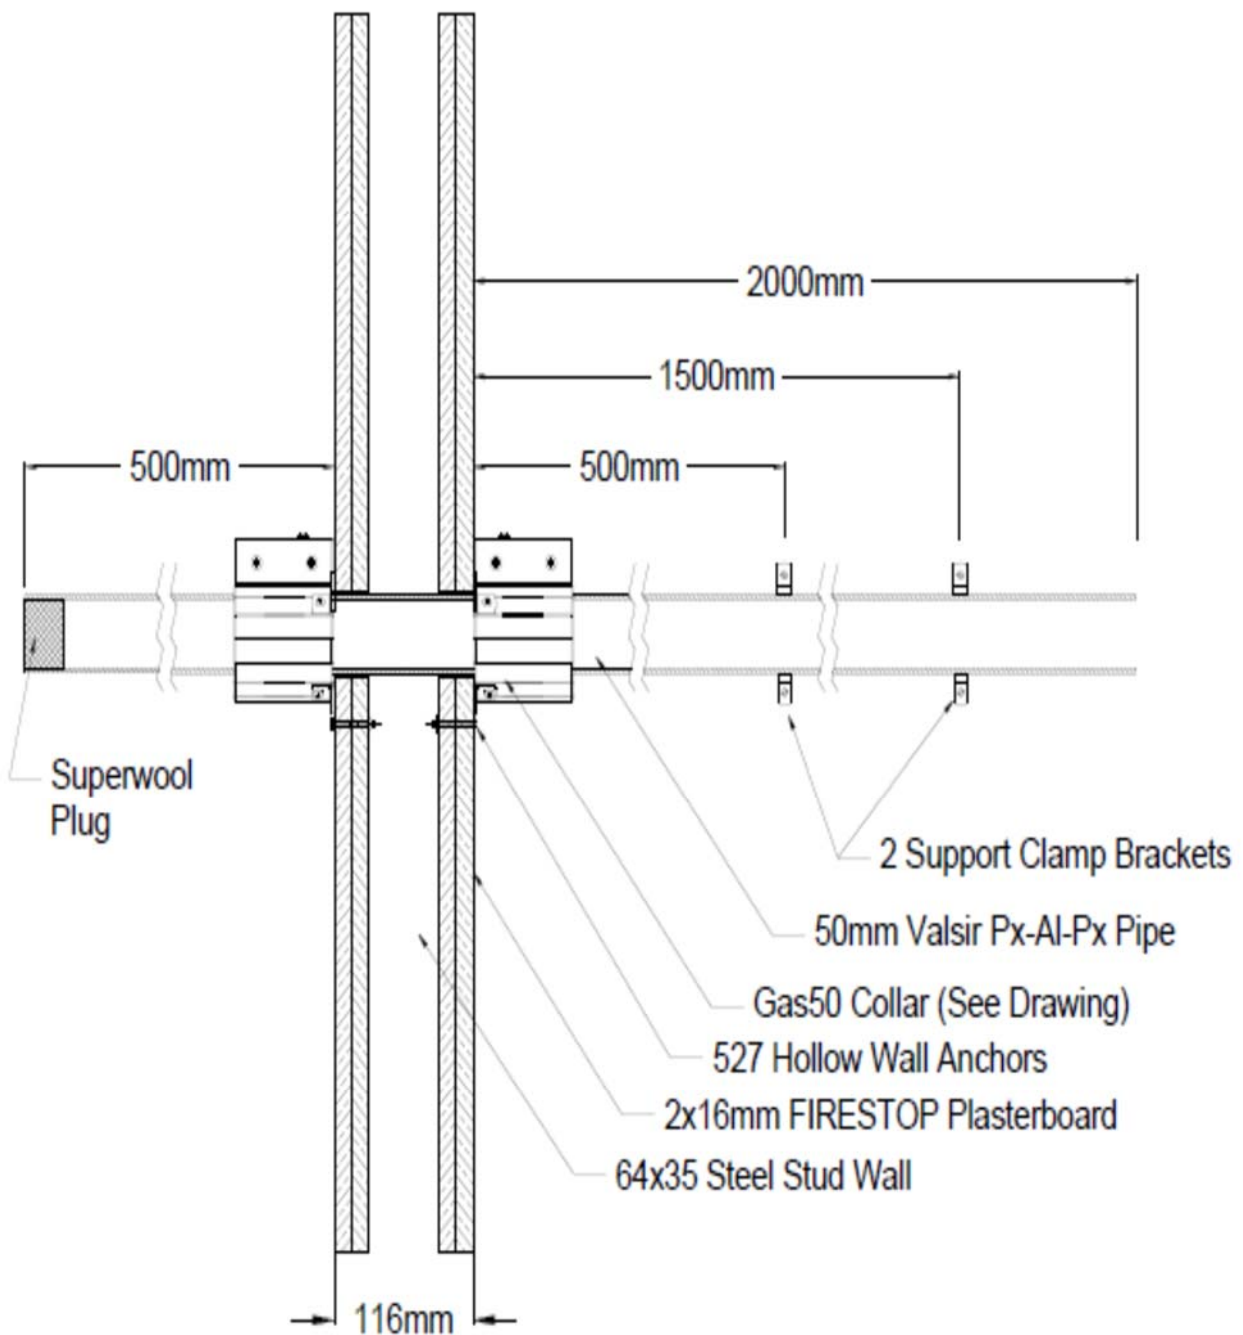
Test Wall W-16-B Penetration #8  
50mm Valsir Px-Al-Px Pipe – Gas50 Collar  
19 AUG 2016

DRAWING TITLED "TEST WALL W-16-B PENETRATION #8, 50-MM VALSIR PX-AL-PX PIPE – GAS50 COLLAR, DATED 19 AUGUST 2016".

The GAS50 Retrofit collar comprised a 0.95-mm thick galvanised steel casing with a 57-mm inner diameter and a 115-mm diameter base flange. The 92-mm high collar casing incorporated a layer of 215-mm x 85-mm x 4-mm thick Intumescent material and a layer of 190-mm x 85-mm x 4-mm thick Intumescent material. The closing mechanism comprised 1 x 304 stainless steel spring bound with a black nylon fuse link and a 316 stainless steel mesh measuring 190 x 84-mm as shown in drawing numbered GAS50-T dated 16 September 2016, by Snap Fire Systems Pty Ltd.

The penetrating service comprised a 50-mm Valsir Px-Al-Px stack pipe, with a wall thickness of 4.4-mm fitted through the collar's sleeve and penetrating the plasterboard wall through a 57-mm diameter cut-out hole as shown in drawing titled "Test Wall W-16-B Penetration # 8, 50-mm Valsir Px-Al-Px Pipe – Gas50 Collar, dated 19 August 2016". The pipe projected horizontally, 2000-mm away from the unexposed face of the plasterboard wall and approximately 500-mm into the furnace chamber. The pipe was supported at nominally 500-mm and 1500-mm from the unexposed face of the plasterboard wall by two support clamps spaced apart at nominally 1000-mm. The pipe was open at the unexposed end and capped on the exposed end with a ceramic fibre (Superwool) plug.

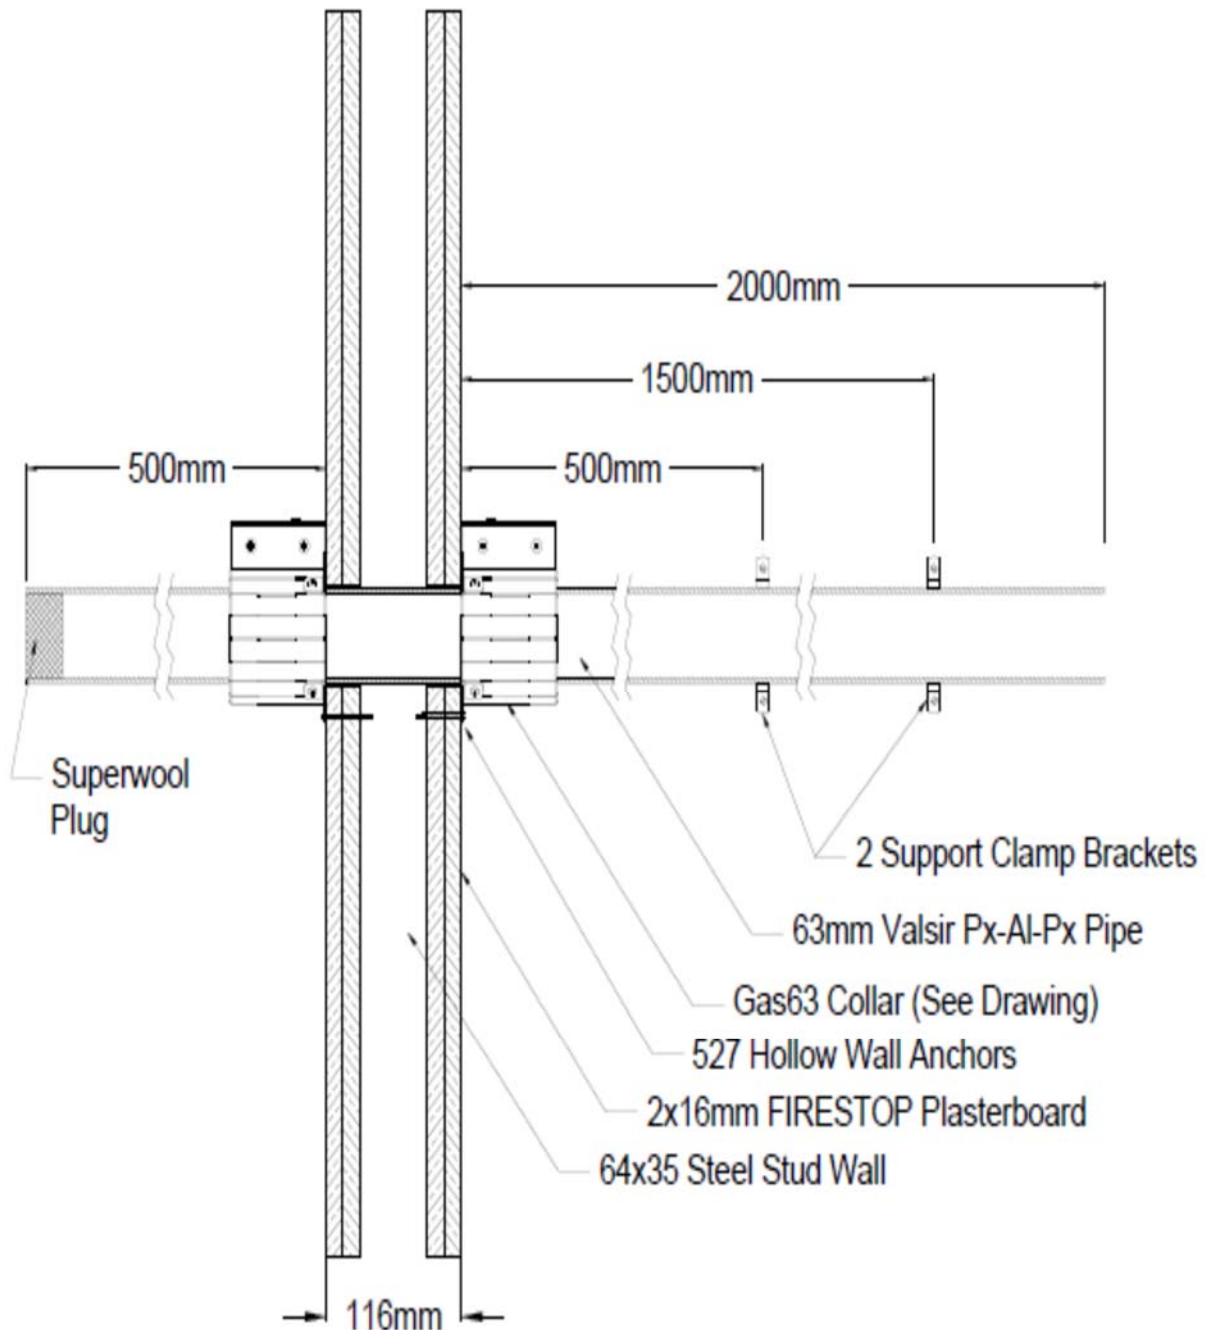
Test Wall W-16-B Penetration #9  
63mm Valsir Px-Al-Px Pipe – Gas63 Collar  
19 AUG 2016

DRAWING TITLED "TEST WALL W-16-B PENETRATION #9, 63-MM VALSIR PX-AL-PX PIPE – GAS63 COLLAR, DATED 19 AUGUST 2016".

The GAS63 Retrofit collar comprised a 0.95-mm thick galvanised steel casing with a 67-mm inner diameter and a 121-mm diameter base flange. The 91-mm high collar casing incorporated a layer of 265-mm x 85-mm x 4-mm thick Intumescent material, a layer of 235-mm x 85-mm x 4-mm thick Intumescent material and a layer of 200-mm x 85-mm x 4-mm thick Intumescent material. The closing mechanism comprised 1 x 304 stainless steel spring bound with a black nylon fuse link, one layer of 316 stainless steel mesh measuring 230 x 84-mm, and one layer of 316 stainless steel mesh measuring 200 x 84-mm as shown in drawing numbered GAS63-B-T dated 20 September 2016, by Snap Fire Systems Pty Ltd.

The penetrating service comprised a 63-mm Valsir Px-Al-Px stack pipe, with a wall thickness of 5.4-mm fitted through the collar's sleeve and penetrating the plasterboard wall through a 67-mm diameter cut-out hole as shown in drawing titled "Test Wall W-16-B Penetration # 9, 63-mm Valsir Px-Al-Px Pipe – Gas63 Collar, dated 19 August 2016". The pipe projected horizontally, 2000-mm away from the unexposed face of the plasterboard wall and approximately 500-mm into the furnace chamber. The pipe was supported at nominally 500-mm and 1500-mm from the unexposed face of the plasterboard wall by two support clamps spaced apart at nominally 1000-mm. The pipe was open at the unexposed end and capped on the exposed end with a ceramic fibre (Superwool) plug.
