Fire-resistance test on a fire collar protecting a concrete floor slab penetrated by a pipe

Test Report

Author: Peter Gordon
Report number: FSP 1924
Date: 3 September 2018

Sponsored Investigation No. FSP 1924

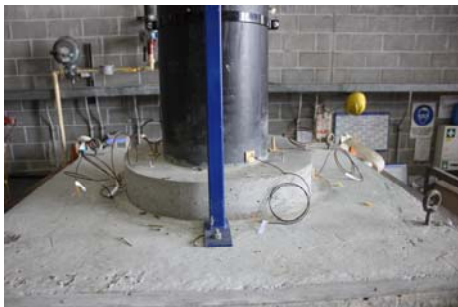
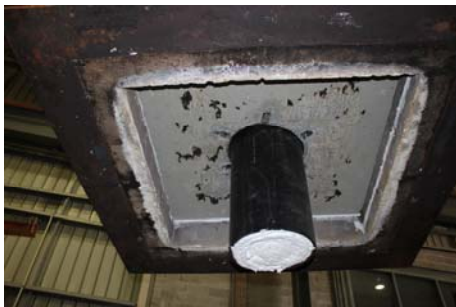
Application	The Snap collar was cast face down on exposed face of the slab.
Photograph	<div style="display: flex; justify-content: space-around; align-items: center;">

</div> <div style="display: flex; justify-content: space-around; margin-top: 10px;"> Unexposed face Exposed face </div>

SEPARATING ELEMENT	
150-mm thick reinforced concrete slab including a 100-mm high x 100-mm wide concrete hob.	
TYPE AND SIZE OF CONSTRUCTION	
Cast in fire collar	
PENETRATING SERVICE	
Description	315-mm OD PE100 Pipe
Size	A 315-mm OD, HDPE pipe with a wall thickness of 10.45-mm. The pipe extended 2000-mm from the unexposed side and 500-mm from the exposed face.
End conditions	Plugged on the exposed end with a Superwool plug and left open on the unexposed end.
Supports	Approximately 500-mm and 1500-mm away from the wall on the unexposed face.
FIRE STOPPING SYSTEM	
Trade name	SNAP 315C Cast-in fire collar
Manufacturer	SNAP Fire Systems Pty Ltd
Description	The SNAP 315C Cast-in fire collar comprised a plastic casing with a 318-mm inner diameter and a 489-mm external diameter base flange. The 204-mm high collar casing incorporated a layer of Intumescent and a 316 stainless steel mesh, as shown in drawing titled 315C, undated, by Snap Fire Systems Pty Ltd.

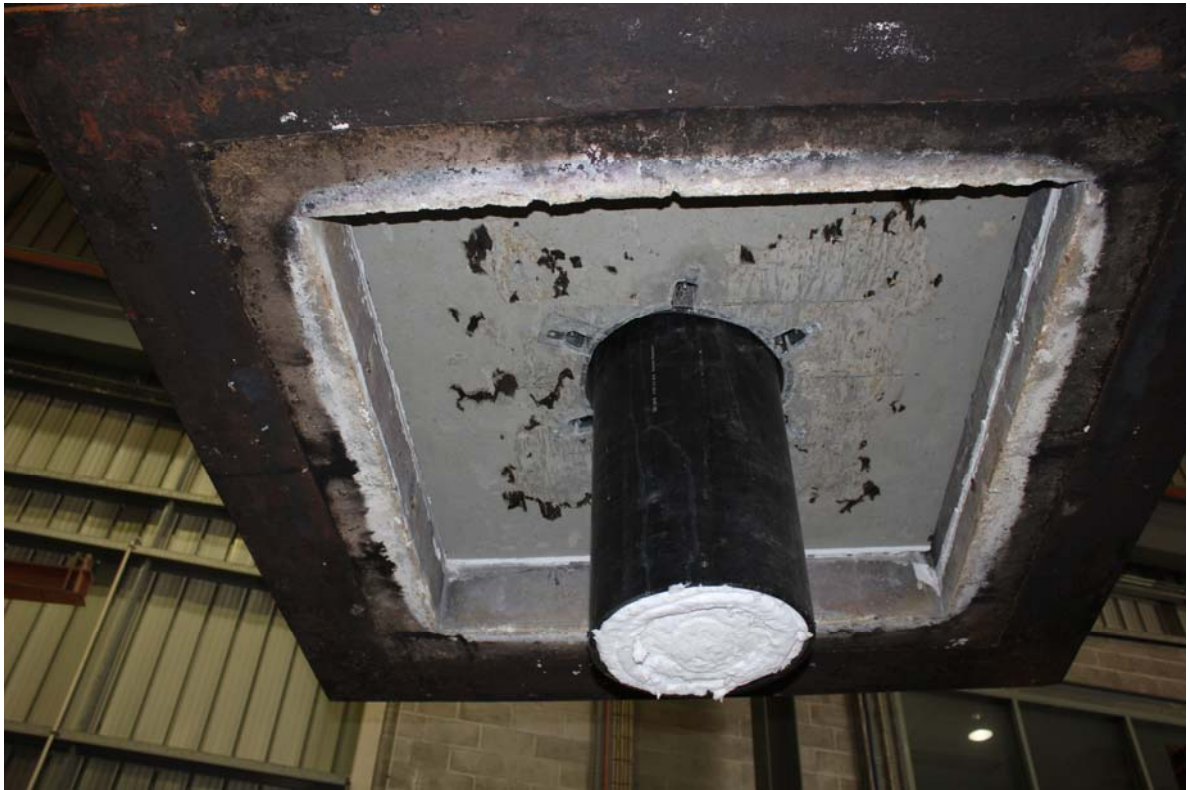
PHOTOGRAPH 1 – EXPOSED FACE OF SPECIMEN PRIOR TO TESTING

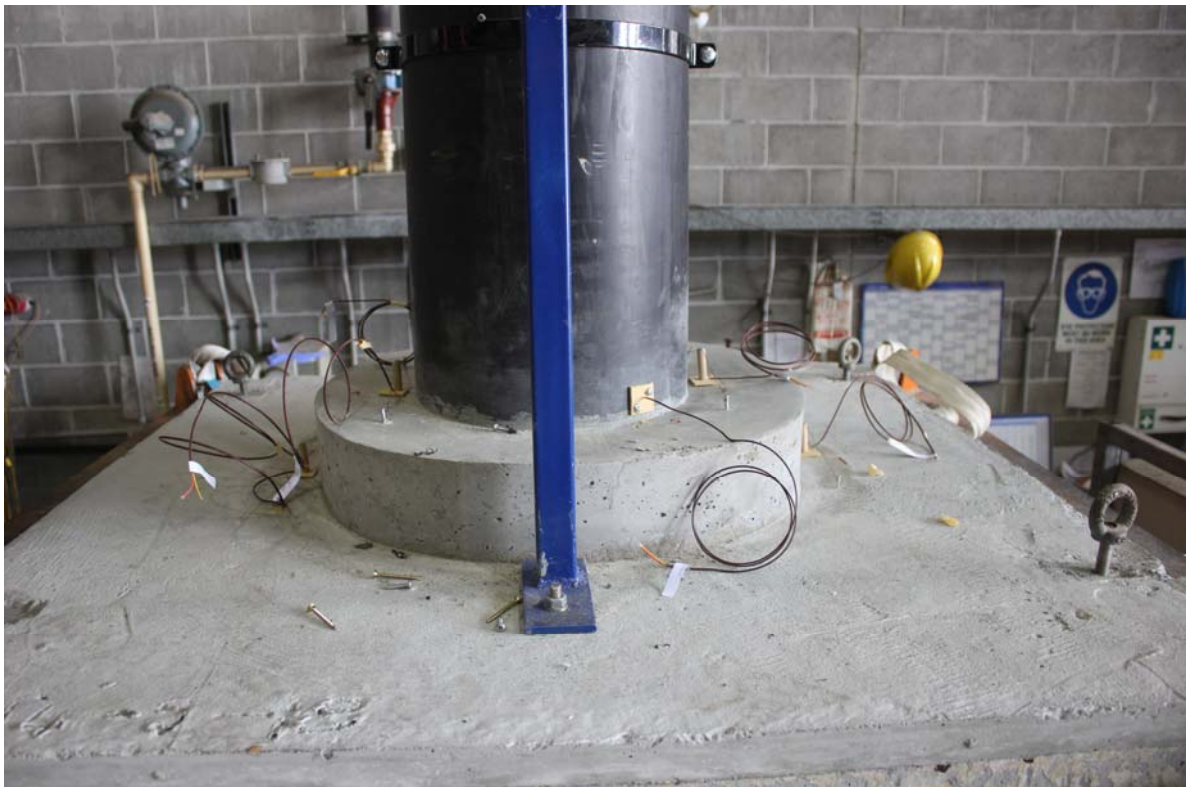
PHOTOGRAPH 2 – UNEXPOSED FACE OF SPECIMEN PRIOR TO TESTING

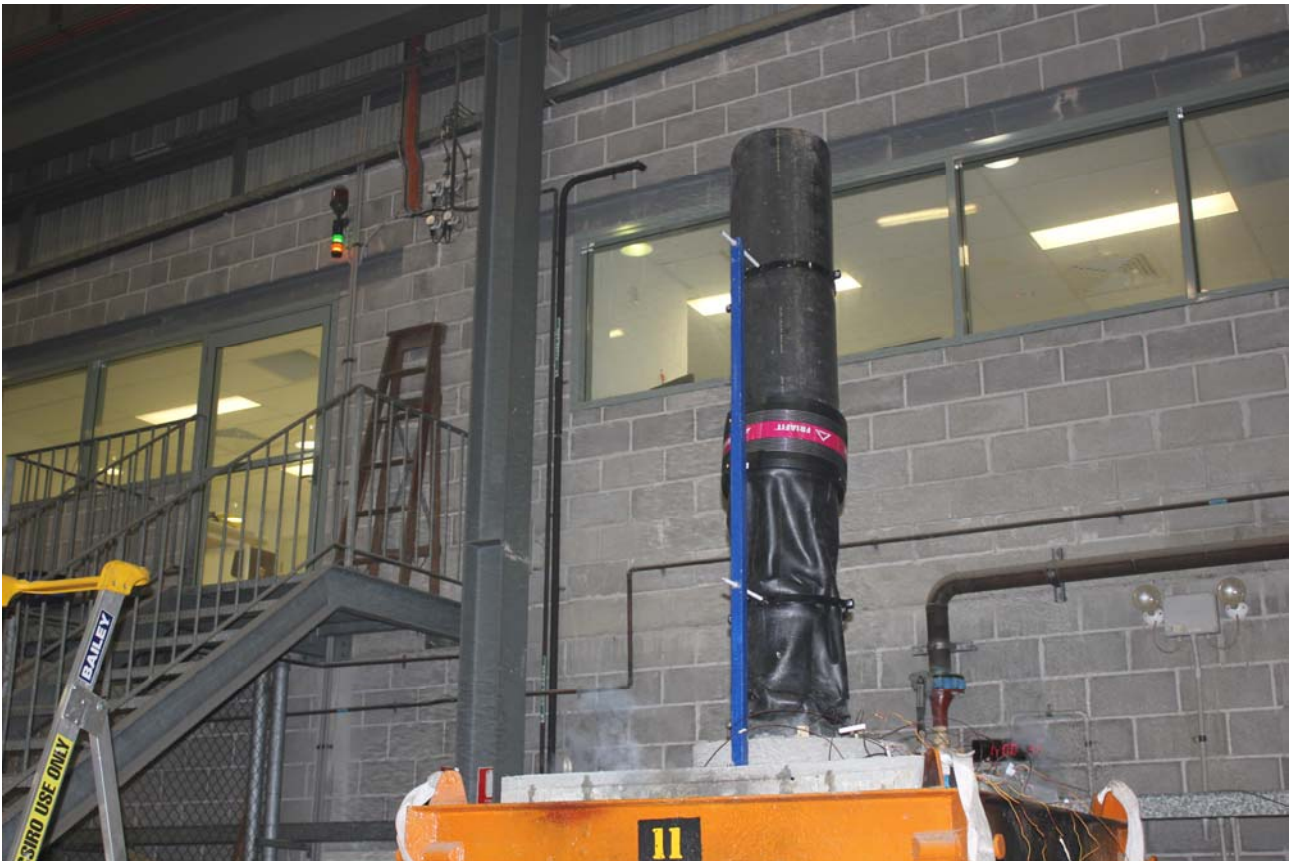
PHOTOGRAPH 3 – SPECIMEN AFTER 60 MINUTES OF TESTING

Time	Observation
4 minutes -	Smoke is being emitted from the furnace flues. A smaller amount of smoke is fluing from the pipe.
7 minutes -	A steady stream of smoke is fluing from the pipe. Smoke is continuing to be emitted from the flue.
12 minutes -	Noises are audible from the specimen.
13 minutes -	Cracking noises are continuing. Red glow in flue visible.
14 minutes -	Furnace gases are fluing straight from the pipe.
15 minutes -	Furnace gases are replaced by smoke. Smoke from flues has ceased.
16 minutes -	Pipe is beginning to distort at the base. Smoke from the pipe is diminishing.
30 minutes -	Smoke levels have diminished considerably. The lower pipe section is heavily distorted. Condensation has formed small puddles on the unexposed face of the slab.
60 minutes -	A small amount of smoke is continuing to flue from the pipe. Water has continued to accumulate on the slab with steam being emitted. The pipe appears to be pushed up by the intumescent material.

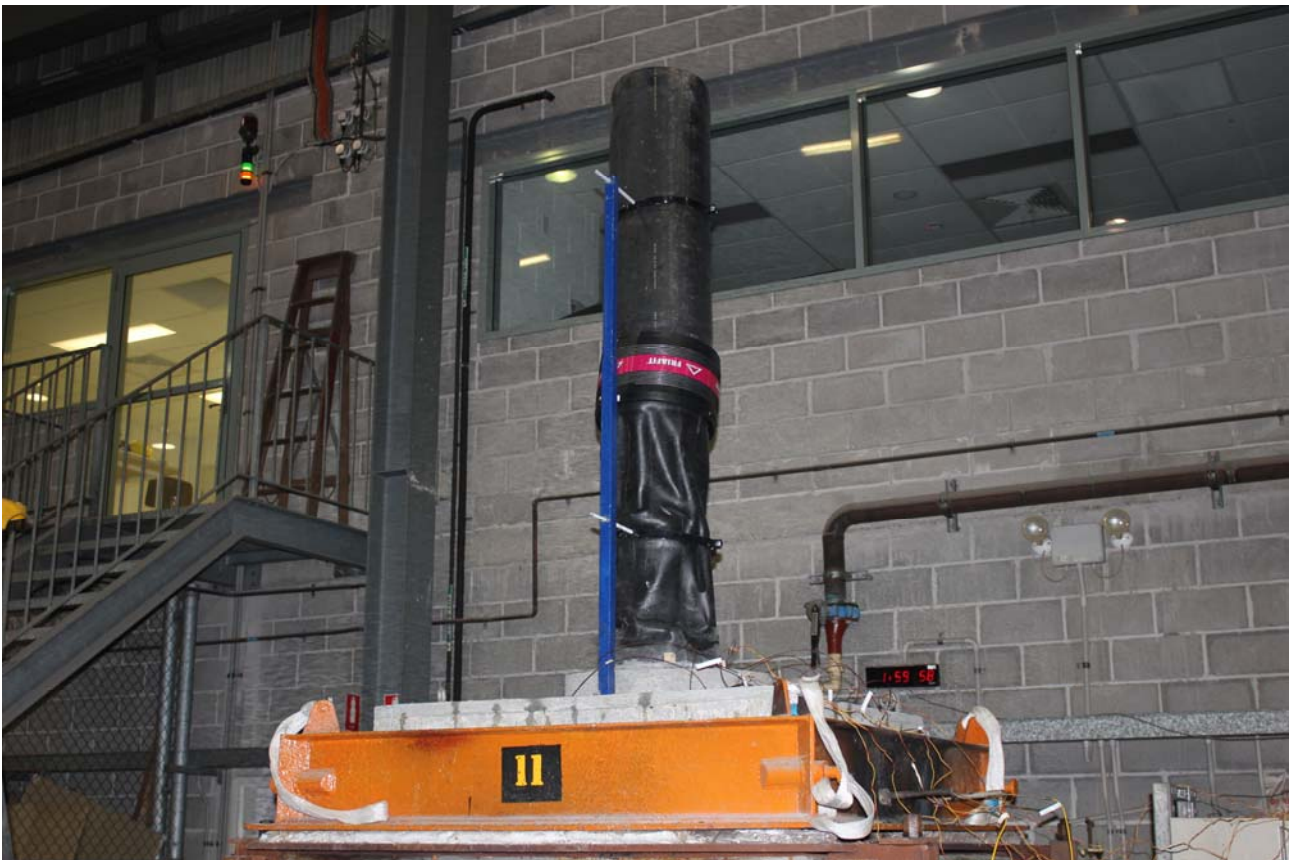
PHOTOGRAPH 4 – SPECIMEN AFTER 120 MINUTES OF TESTING

- 90 minutes - The moisture noted on the slab is beginning to dry off. Steam continuing to be emitted. Minimal fluing is noted from the pipe.
- 120 minutes - The pipe has continued to be pushed up from the slab surface.
- 180 minutes - The majority of water has been driven from the concrete. Slight bellying of pipe at the concrete junction. A small amount of smoke is continuing to flue from the pipe.
- 217 minutes - Insulation failure of Specimen 1 – maximum temperature rise of 180 deg Celsius is exceeded on the concrete hob.
- 234 minutes - The base of the pipe has continued to distort and is venting a small amount of smoke. A small amount of smoke is bring emitted from the top of the pipe.
- 241 minutes - Test terminated.

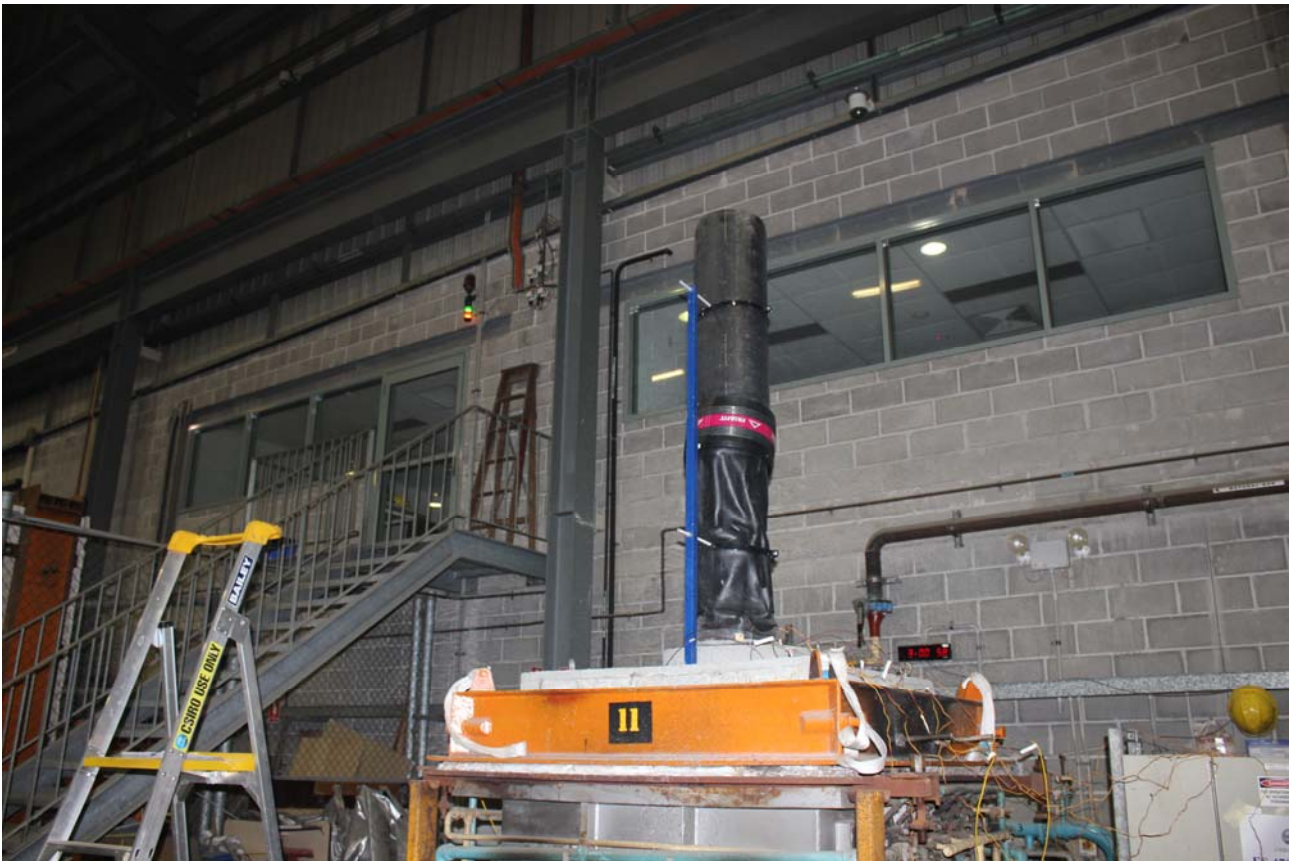
PHOTOGRAPH 5 – SPECIMEN AFTER 180 MINUTES OF TESTING

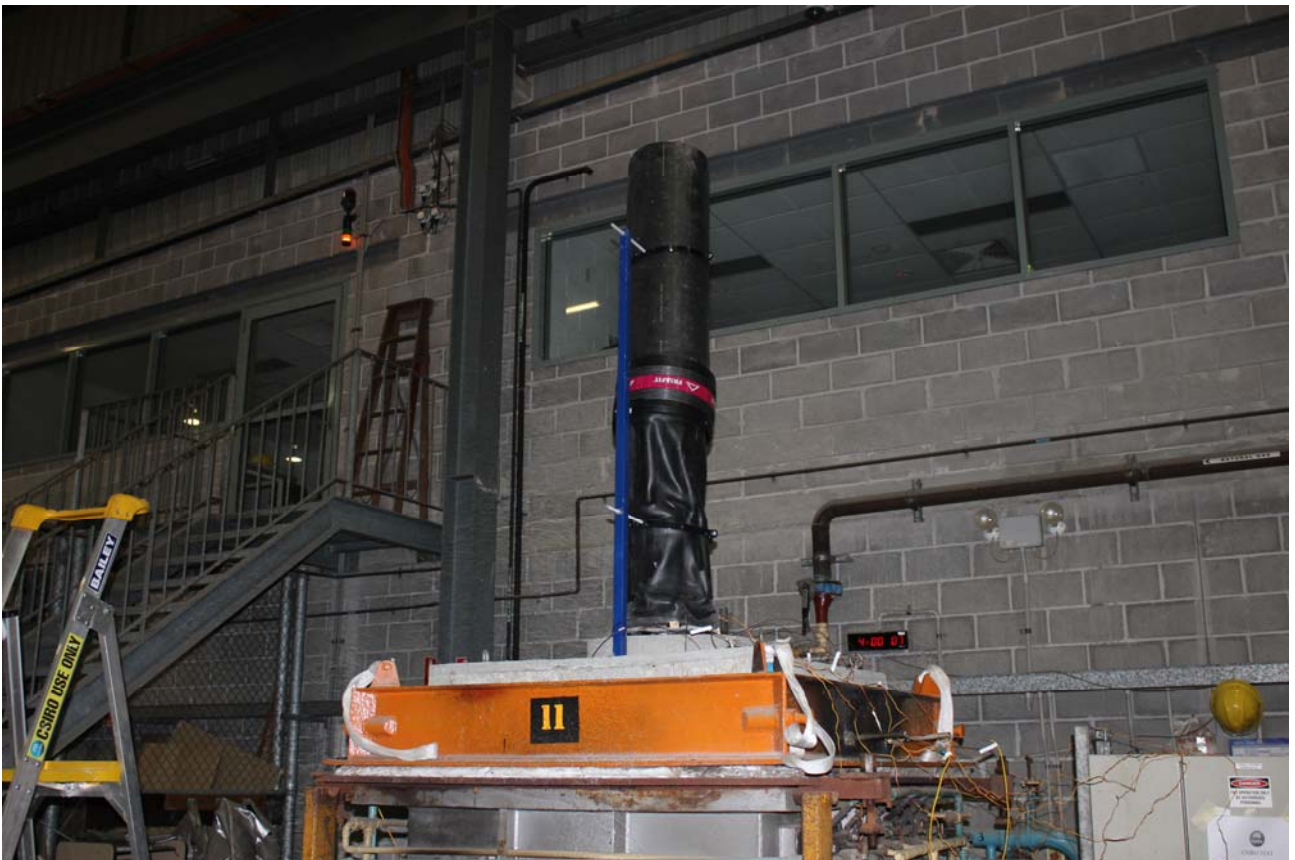
PHOTOGRAPH 6 – UNEXPOSED FACE OF SPECIMEN AT THE CONCLUSION OF TESTING
