Fire-resistance test on fire collars protecting a plasterboard wall penetrated by services

Test Report

Author: Peter Gordon
Report number: FSP 1996
Date: 9 May 2019

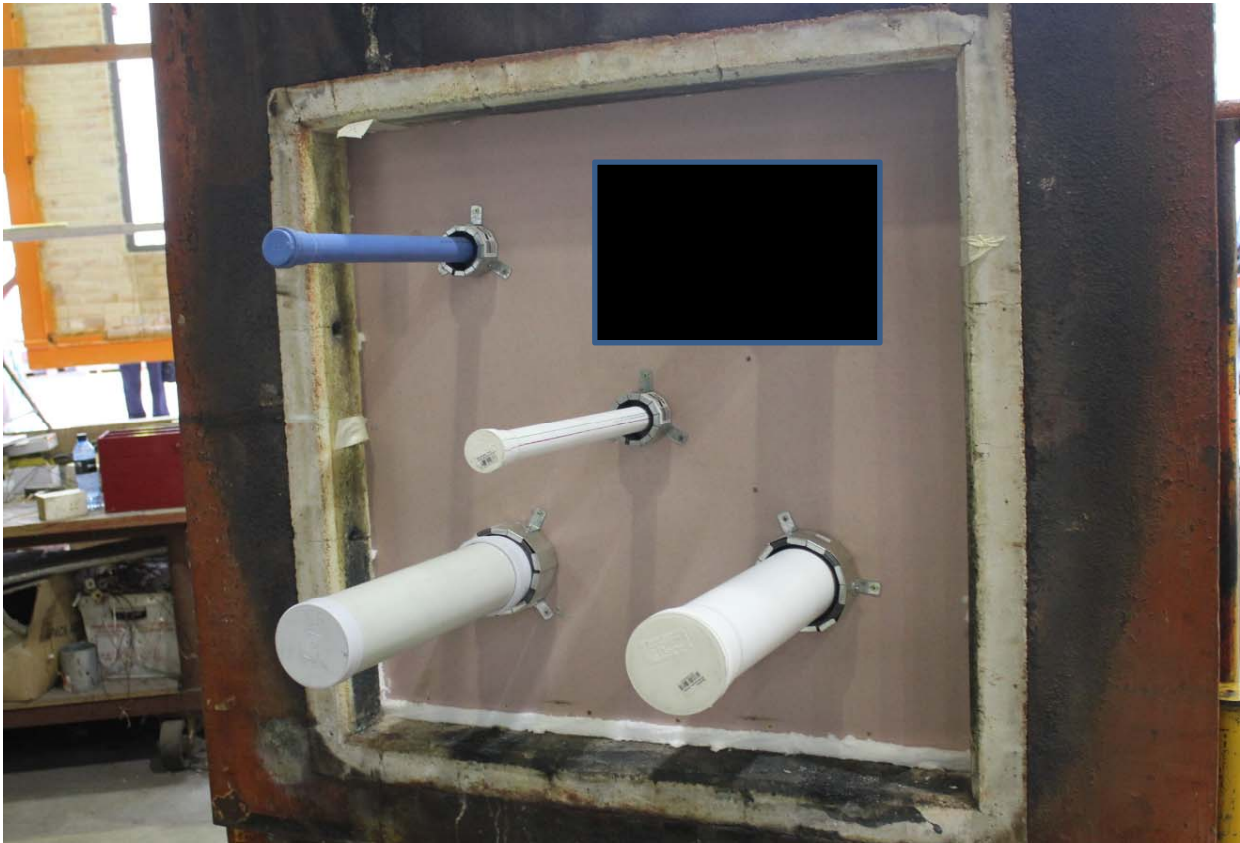
PHOTOGRAPH 1 – EXPOSED FACE OF SPECIMENS PRIOR TO TESTING

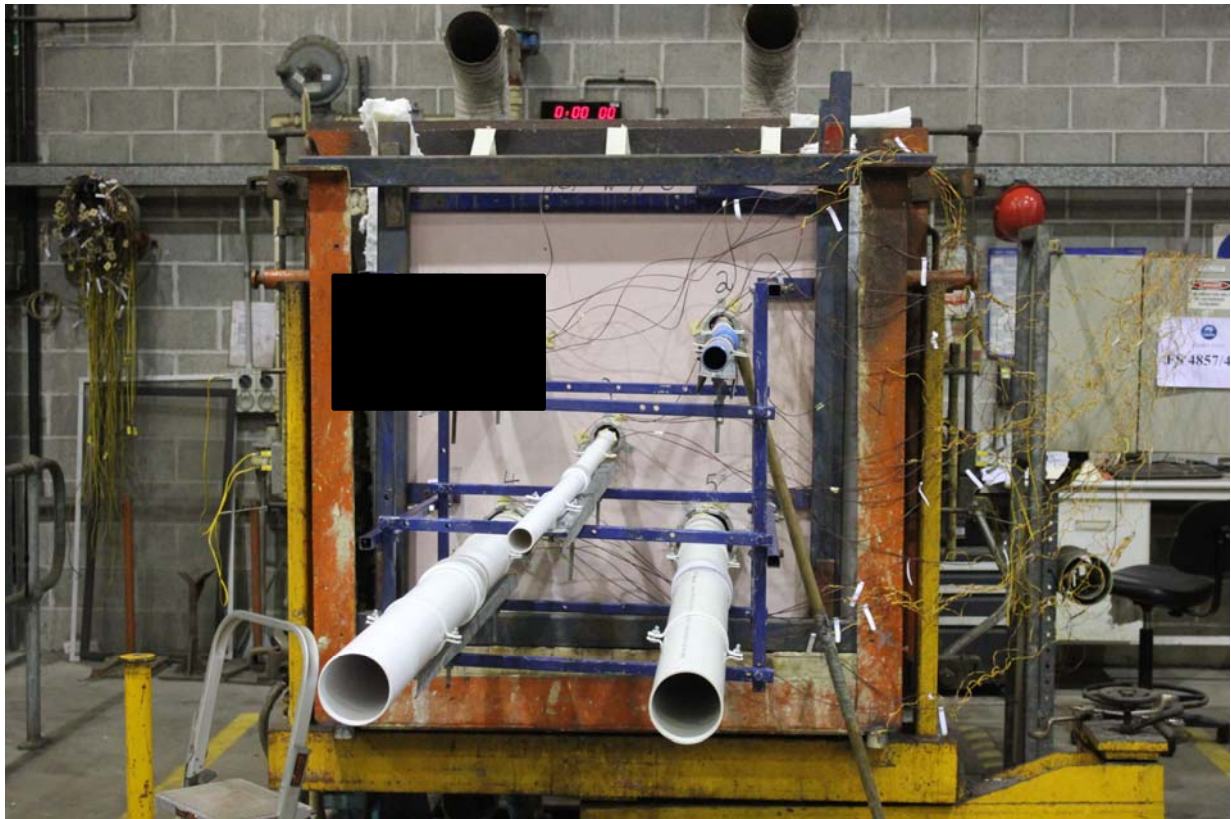
PHOTOGRAPH 2 – UNEXPOSED FACE OF SPECIMENS PRIOR TO TESTING

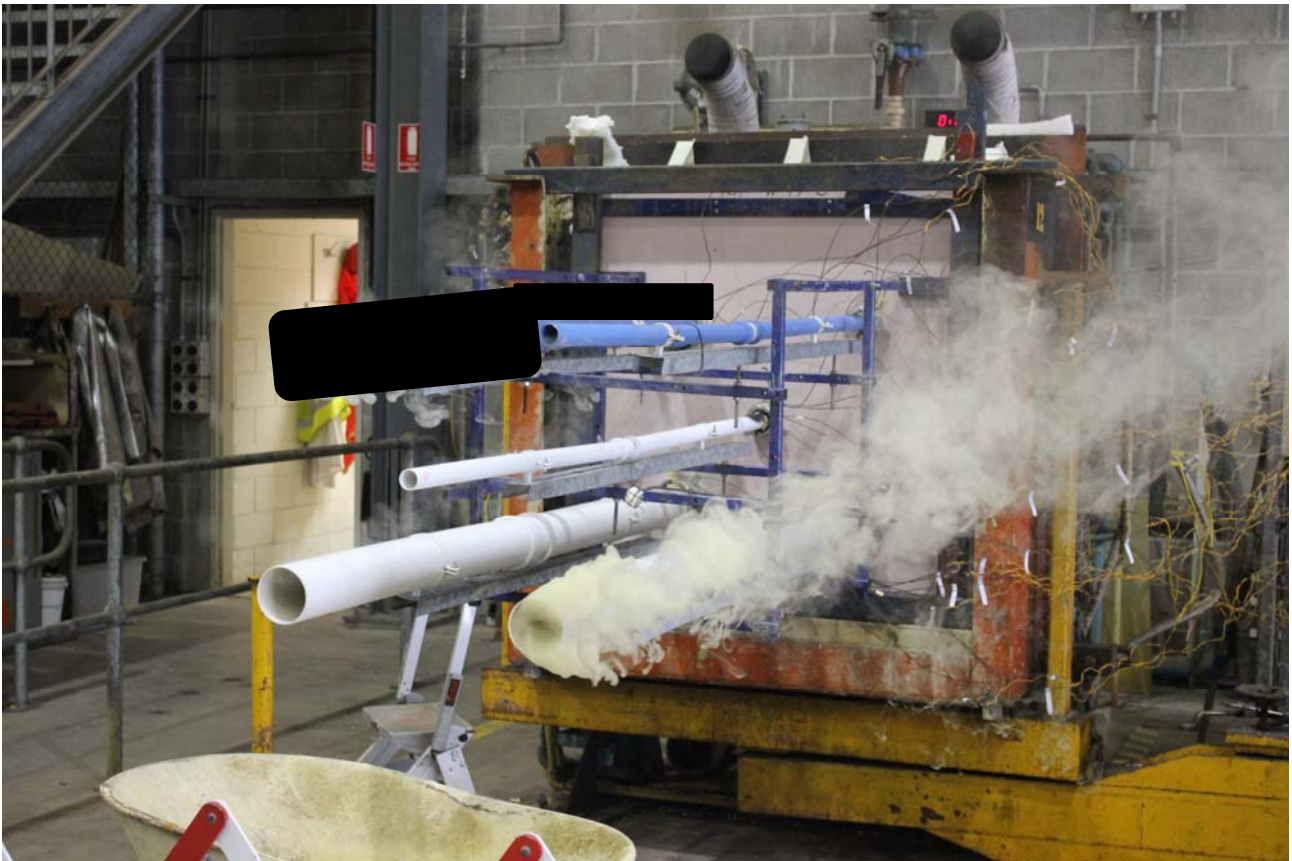
PHOTOGRAPH 3 – SPECIMENS AFTER 7 MINUTES OF TESTING

2:30 minutes -	Intumescent material emitted from the collars of Specimens 2 and 3.
4 minutes -	Smoke fluing from the end of pipe of Specimens 2 and 4.
5 minutes -	The amount of smoke fluing from of Specimens 2 and 5 has reduced.
8 minutes -	Specimens 4 and 5 continue to flue from the end of pipes.
10 minutes -	Smoke fluing from the end of pipe of Specimens 2, 3 has ceased. Smoke emitted from the collars of Specimens 2, 4, and 5 has ceased, with limited smoke emitted from the collar of specimen 3.
20 minutes -	Specimens 4 has ceased fluing, the amount of smoke fluing from Specimen 5 has reduced.
30 minutes -	Smoke continues to be emitted from the collar of Specimen 3. (Photograph 4)
60 minutes -	Smoke continues be emitted from the collar of Specimen 3. (Photograph 5)
61 minutes -	Smoke resumes fluing from the end of pipe of Specimens 2 and 4.
64 minutes -	Light smoke is being emitted between the collar and pipes of Specimen 4.

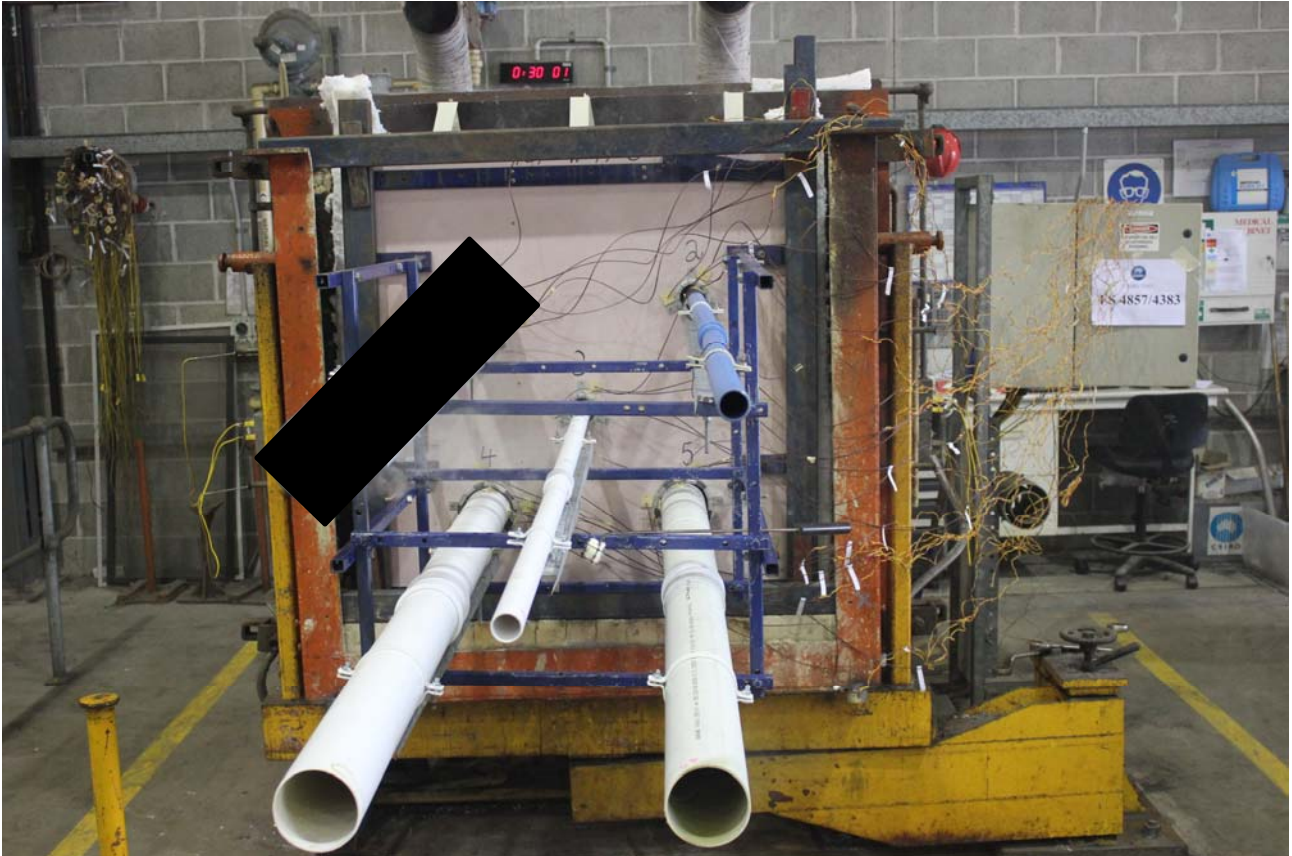
PHOTOGRAPH 4 – SPECIMENS AFTER 30 MINUTES OF TESTING

Time	Observation
30 seconds -	Smoke being emitted from the base of pipe and collar of Specimen 4.
60 seconds -	Smoke being emitted from the base of pipe and collar of Specimen 5.
90 seconds -	Smoke fluing from the end of pipe of Specimen 5 and between the collar and pipe on the unexposed side.
2 minutes -	Smoke being emitted from the collar of Specimen 5 has increased.

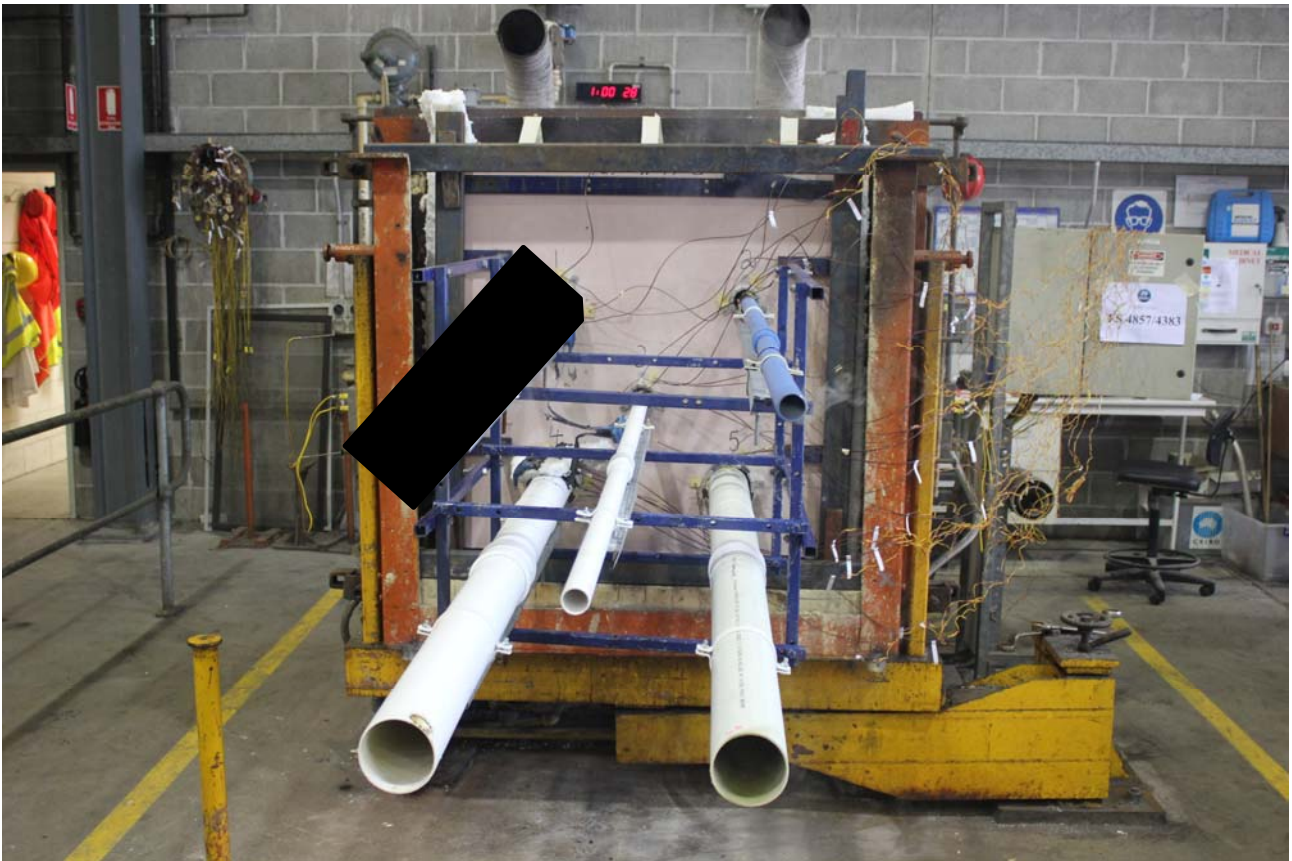
PHOTOGRAPH 5 – SPECIMENS AFTER 60 MINUTES OF TESTING

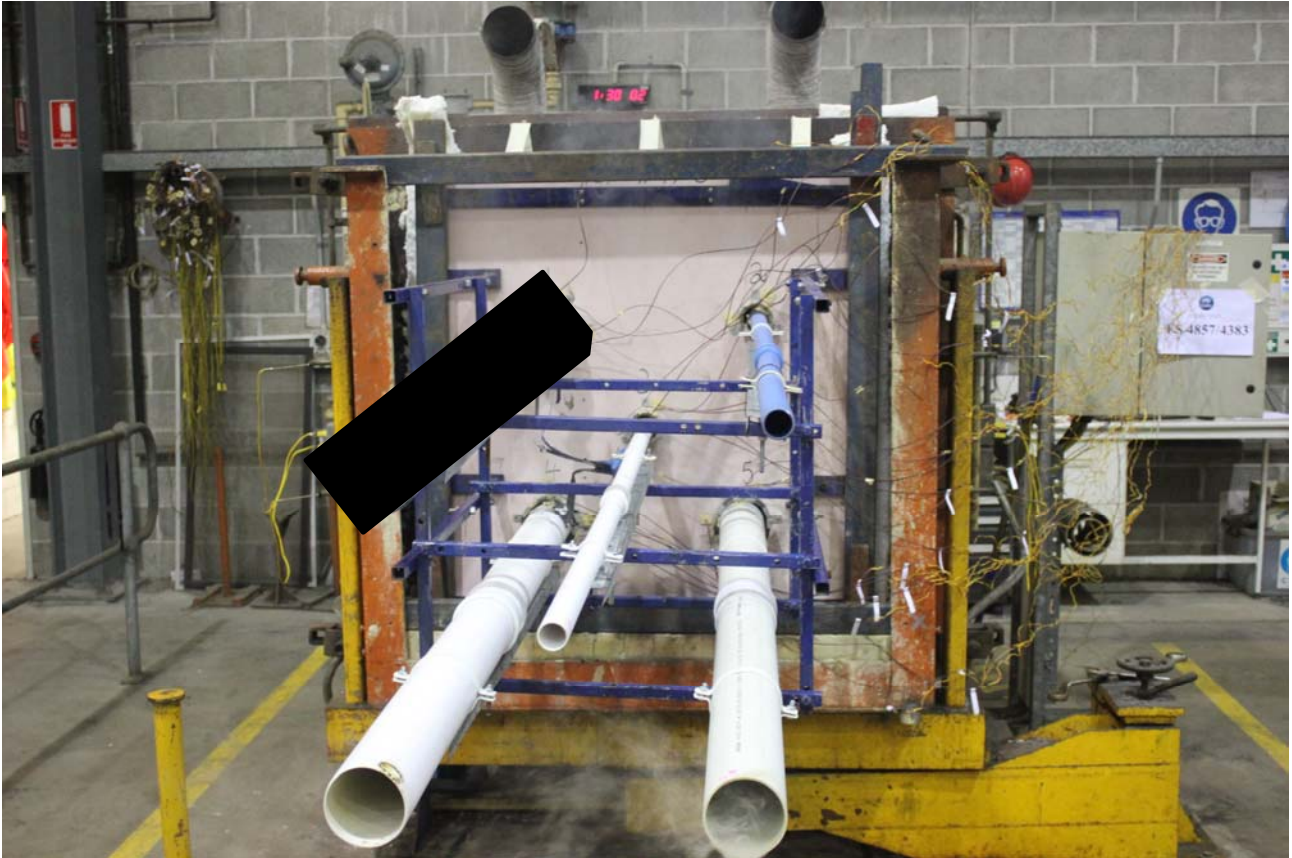
PHOTOGRAPH 6 – SPECIMENS AFTER 90 MINUTES OF TESTING

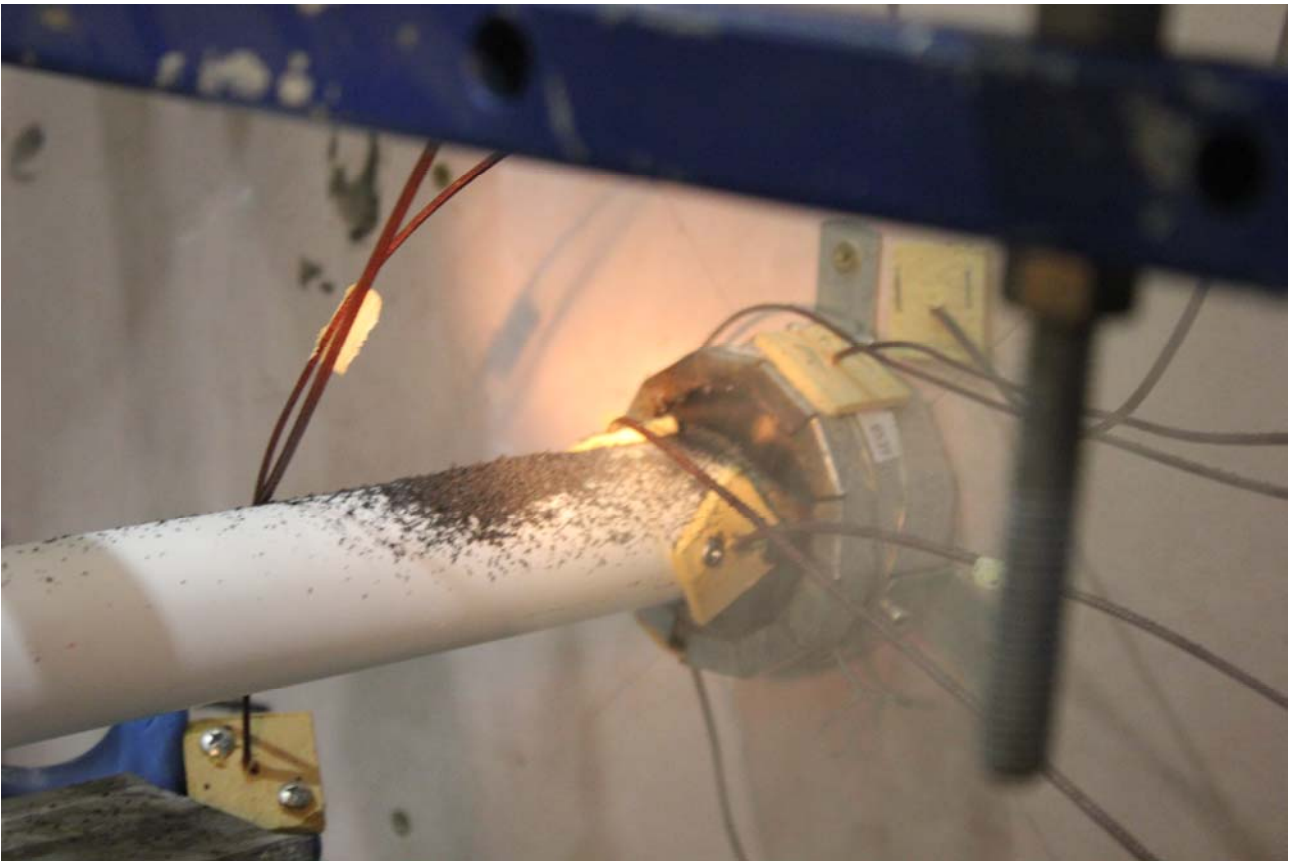
PHOTOGRAPH 7 – SPECIMEN 3 AFTER 100 MINUTES OF TESTING

- 98 minutes - The base of pipe inside the collar of Specimen 3 has softened and collapsed. Cotton pad applied at the base of pipe next to collar no ignition noted.

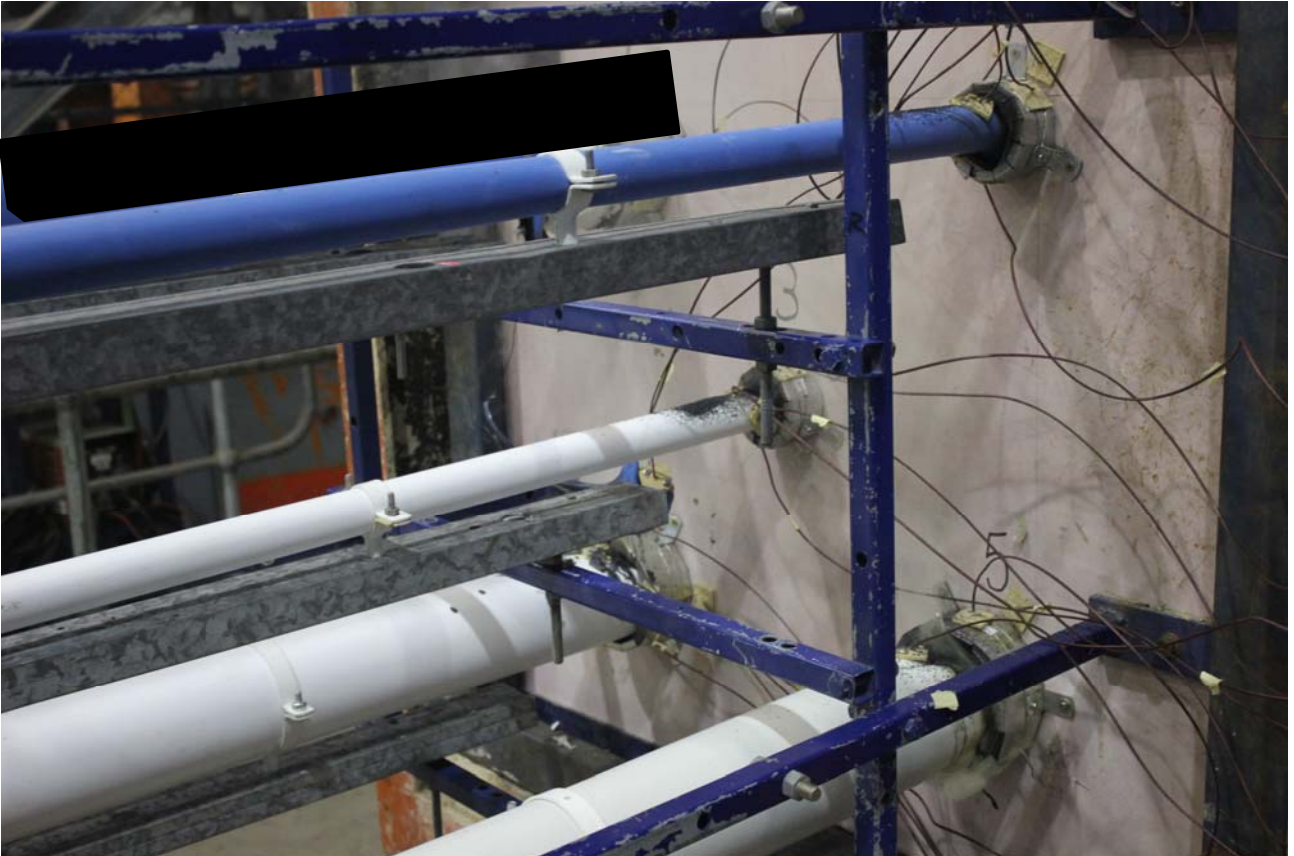
PHOTOGRAPH 8 – SPECIMENS AFTER 120 MINUTES OF TESTING

- 117 minutes - The base of pipe inside the collar of Specimen 5 has softened and collapsed. Cotton pad applied at the base of pipe next to collar no ignition noted.

- 118 minutes - The base of pipe inside the collar of Specimen 4 has softened and collapsed. Cotton pad applied at the base of pipe and collar no ignition noted.

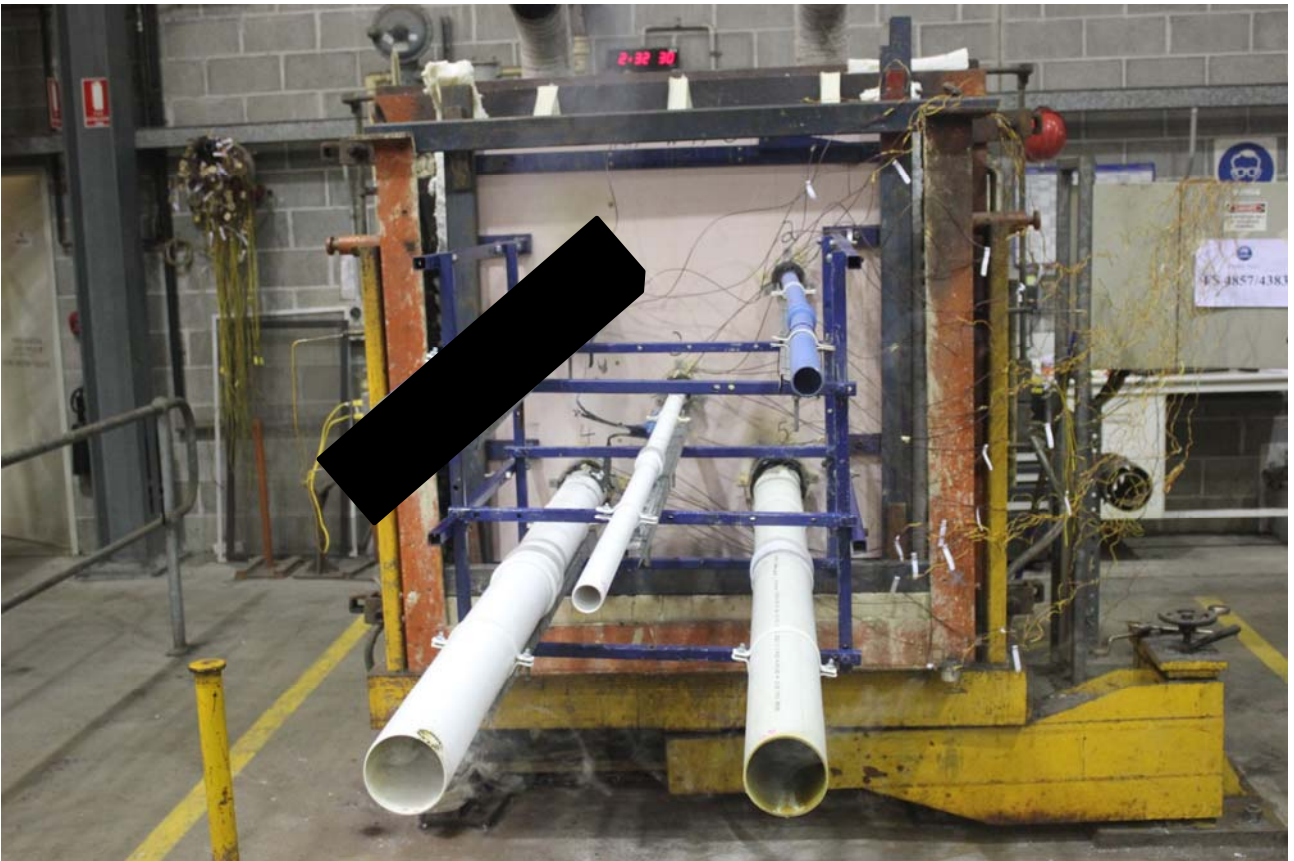
PHOTOGRAPH 9 – SPECIMENS AFTER 152 MINUTES OF TESTING

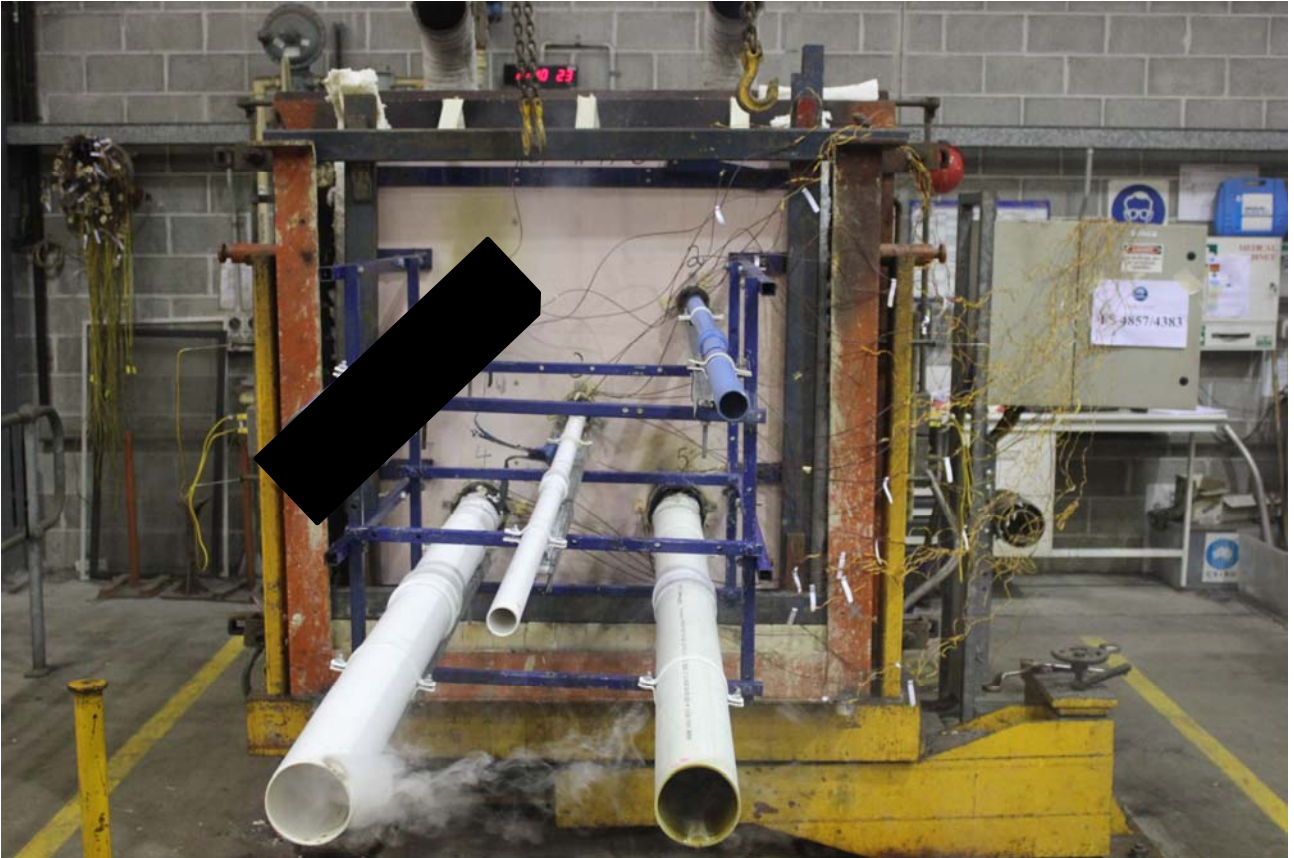
PHOTOGRAPH 10 – SPECIMENS AT THE CONCLUSION OF TESTING

- 161 minutes - Test terminated.

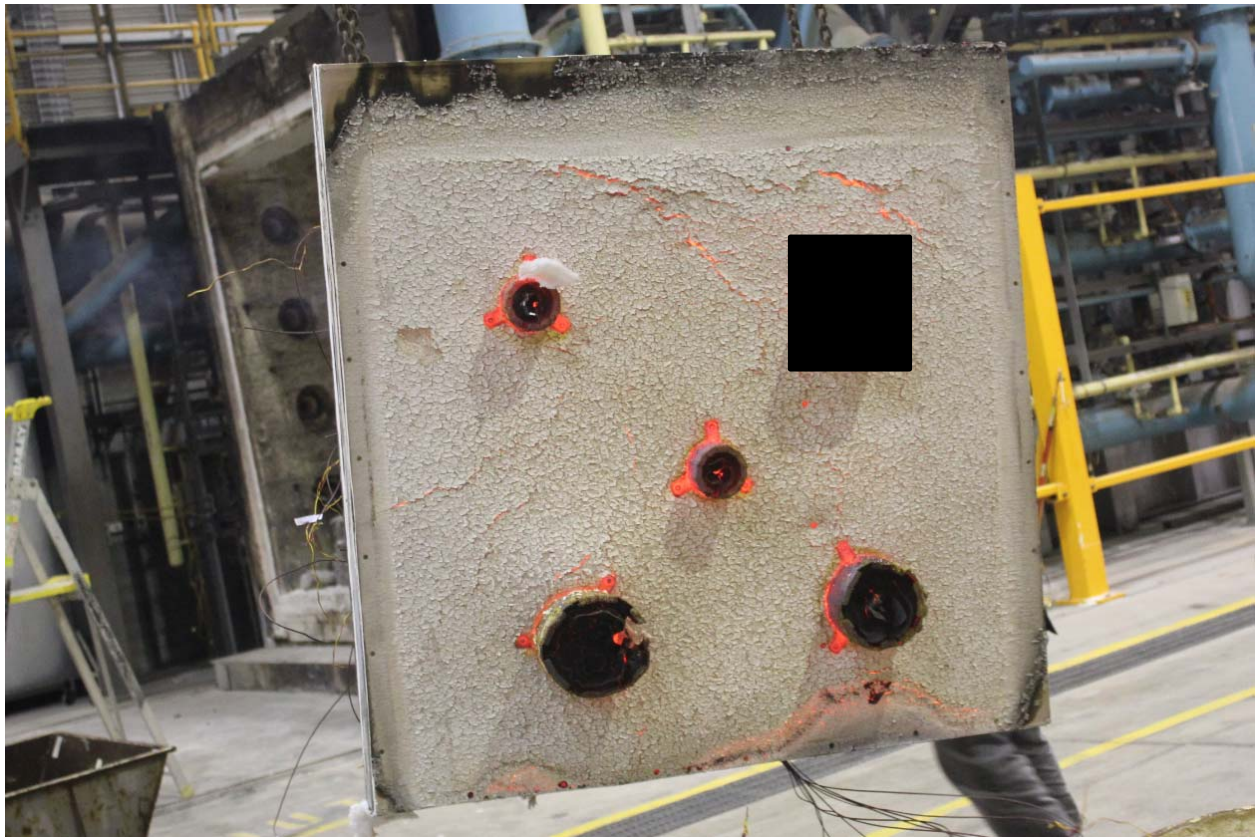
PHOTOGRAPH 11 – EXPOSED FACE OF SPECIMENS AT THE CONCLUSION OF TESTING

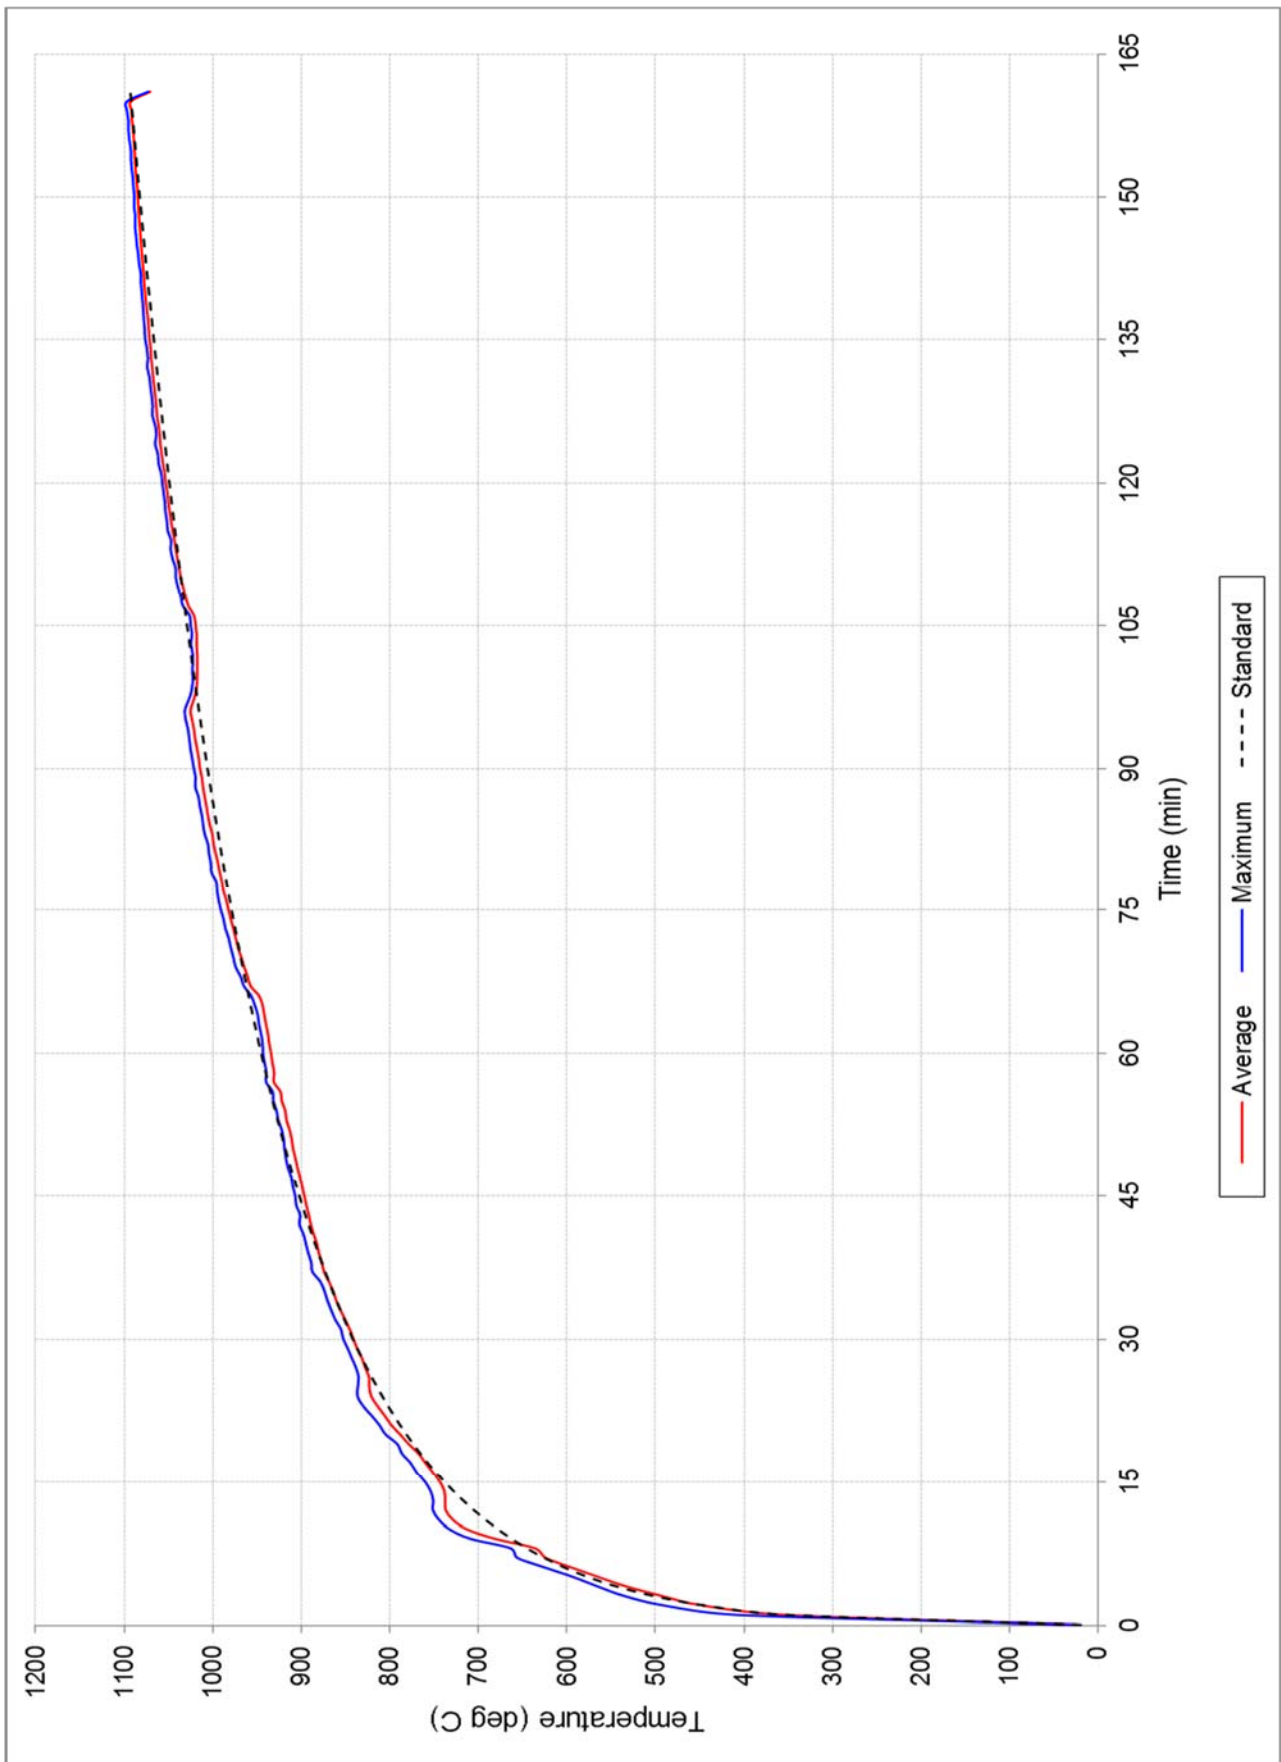
FIGURE 1 – FURNACE TEMPERATURE

Figure 1 shows the standard curves of temperature versus time for heating the furnace chamber and the actual curves of average and maximum temperature versus time recorded during the heating period.

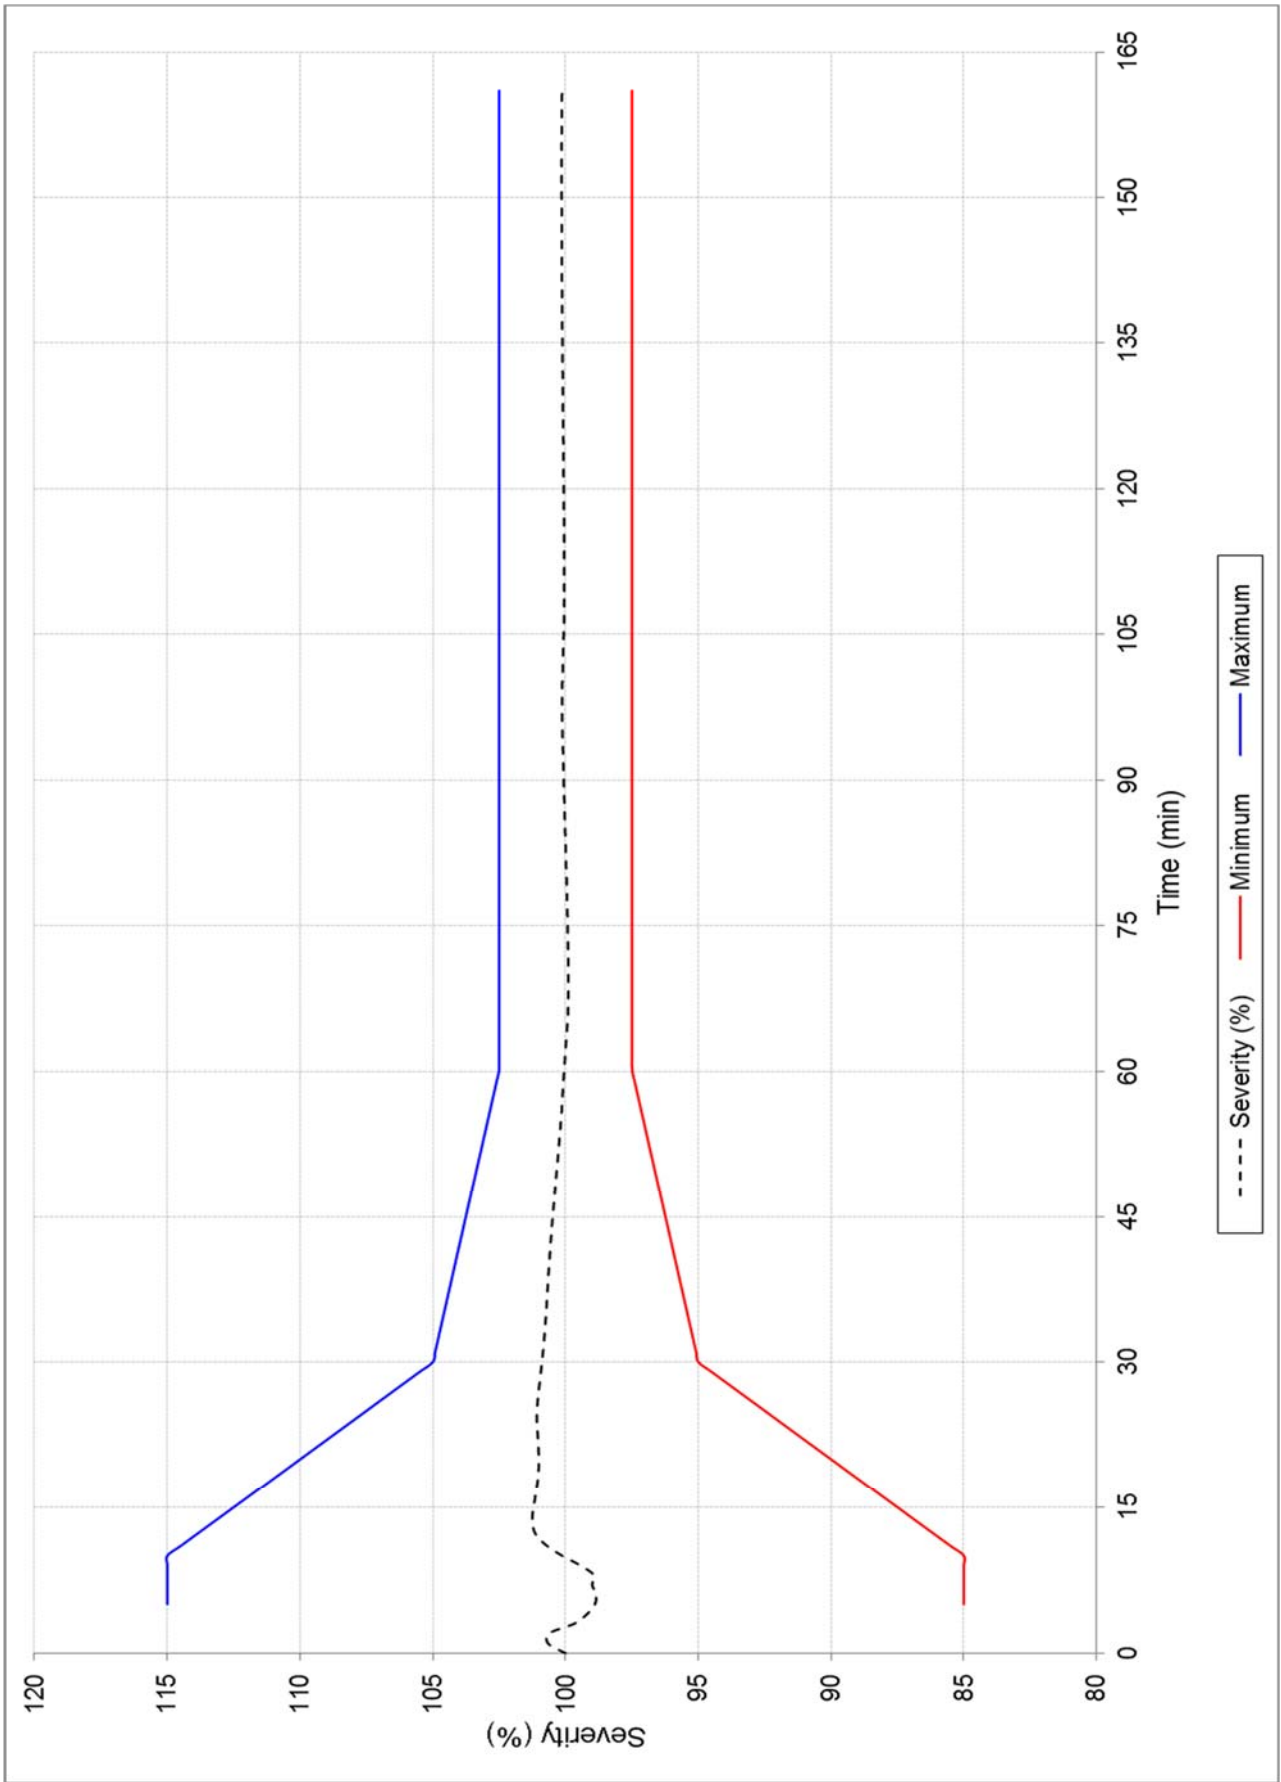
FIGURE 2 – FURNACE SEVERITY

Figure 2 shows the curve of furnace severity versus time during the heating period.

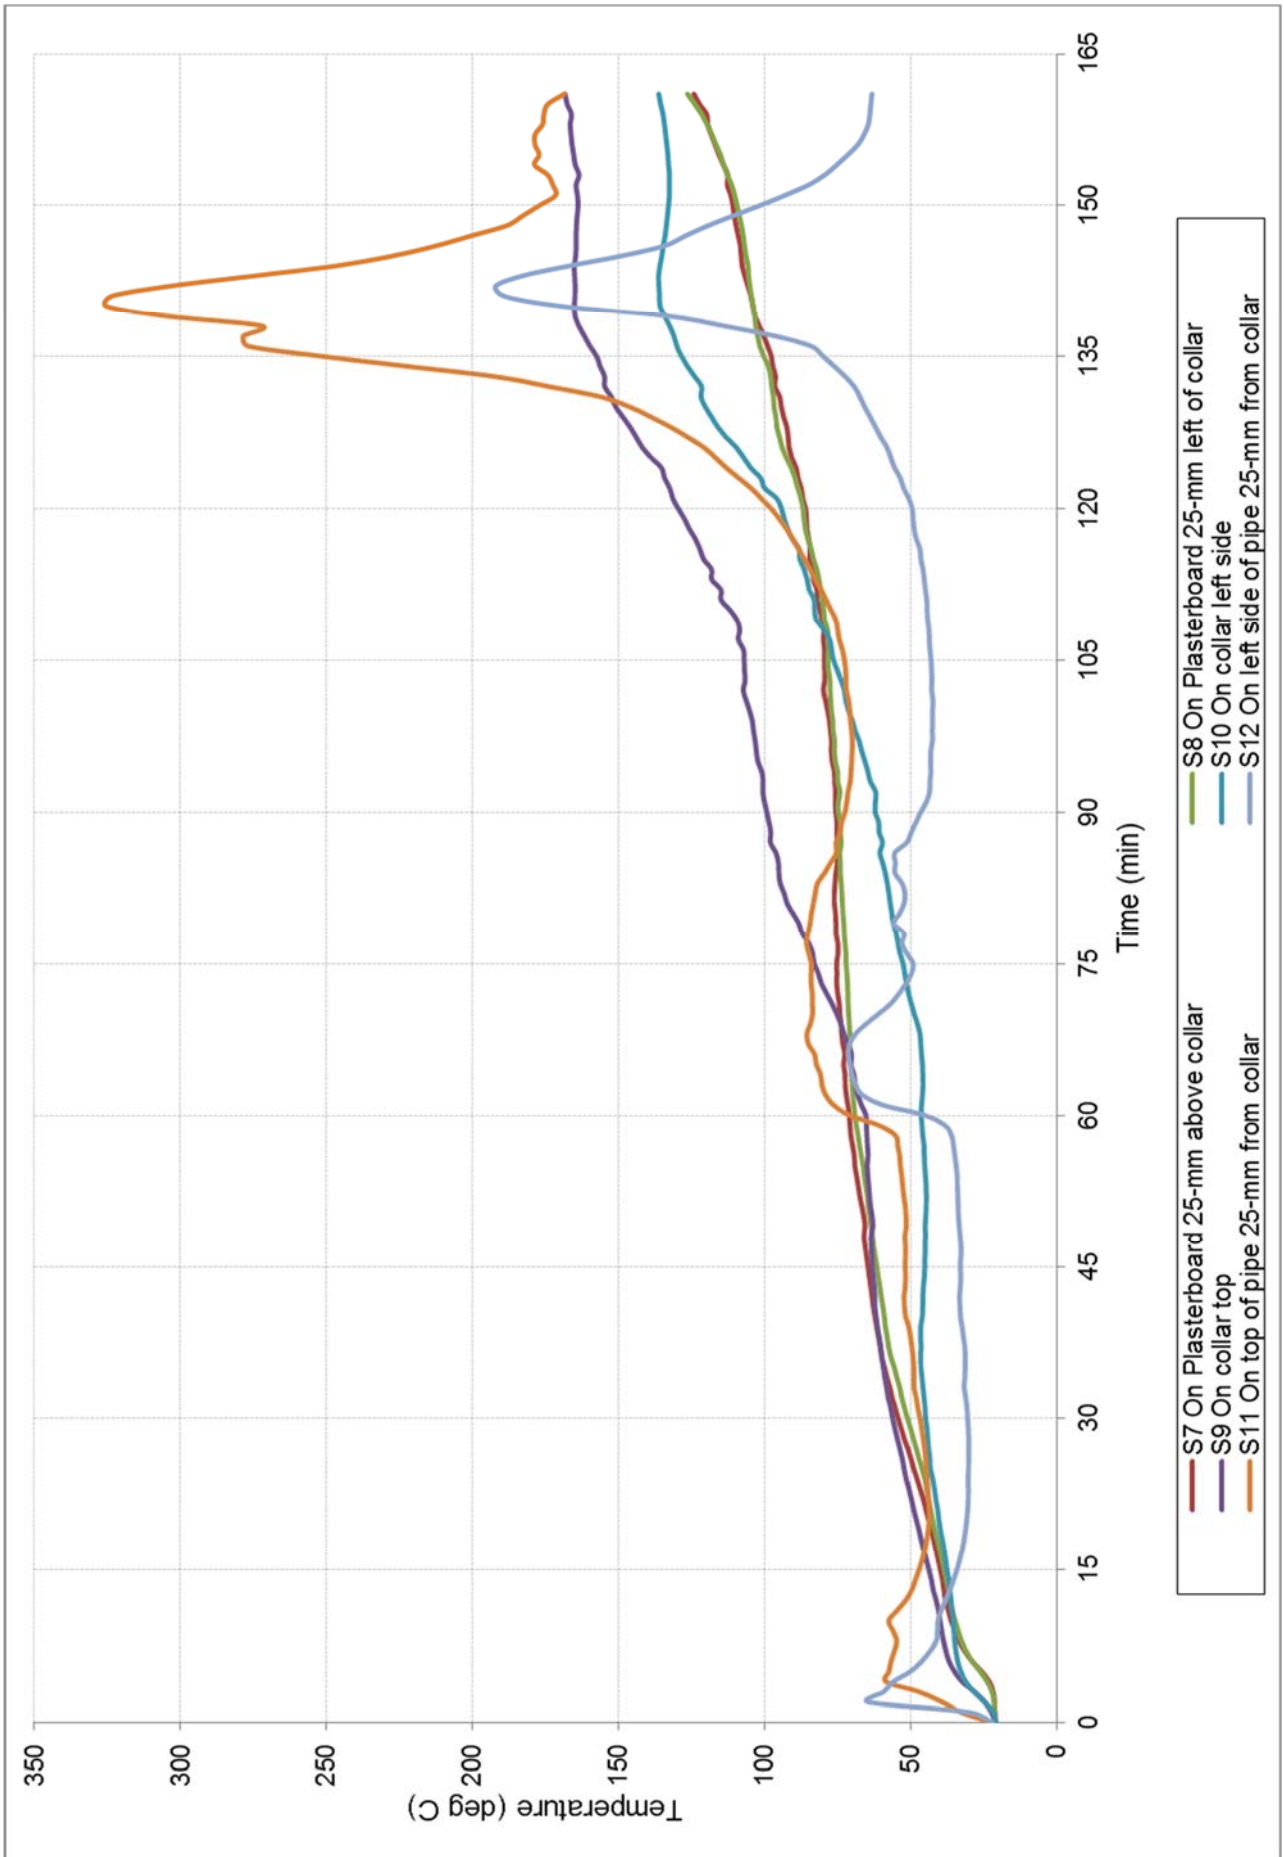
FIGURE 3 - SPECIMEN 2 TEMPERATURE

- 134 minutes - Insulation Failure of Specimen 2 - maximum temperature rise of 180K is exceeded from the top of pipe 25-mm from collar on the unexposed face. (Thermocouple #11)

Figure 3 shows the curve of temperature versus time associated with Specimen 2.

Structural adequacy	-	not applicable
Integrity	-	no failure at 161 minutes
Insulation	-	134 minutes

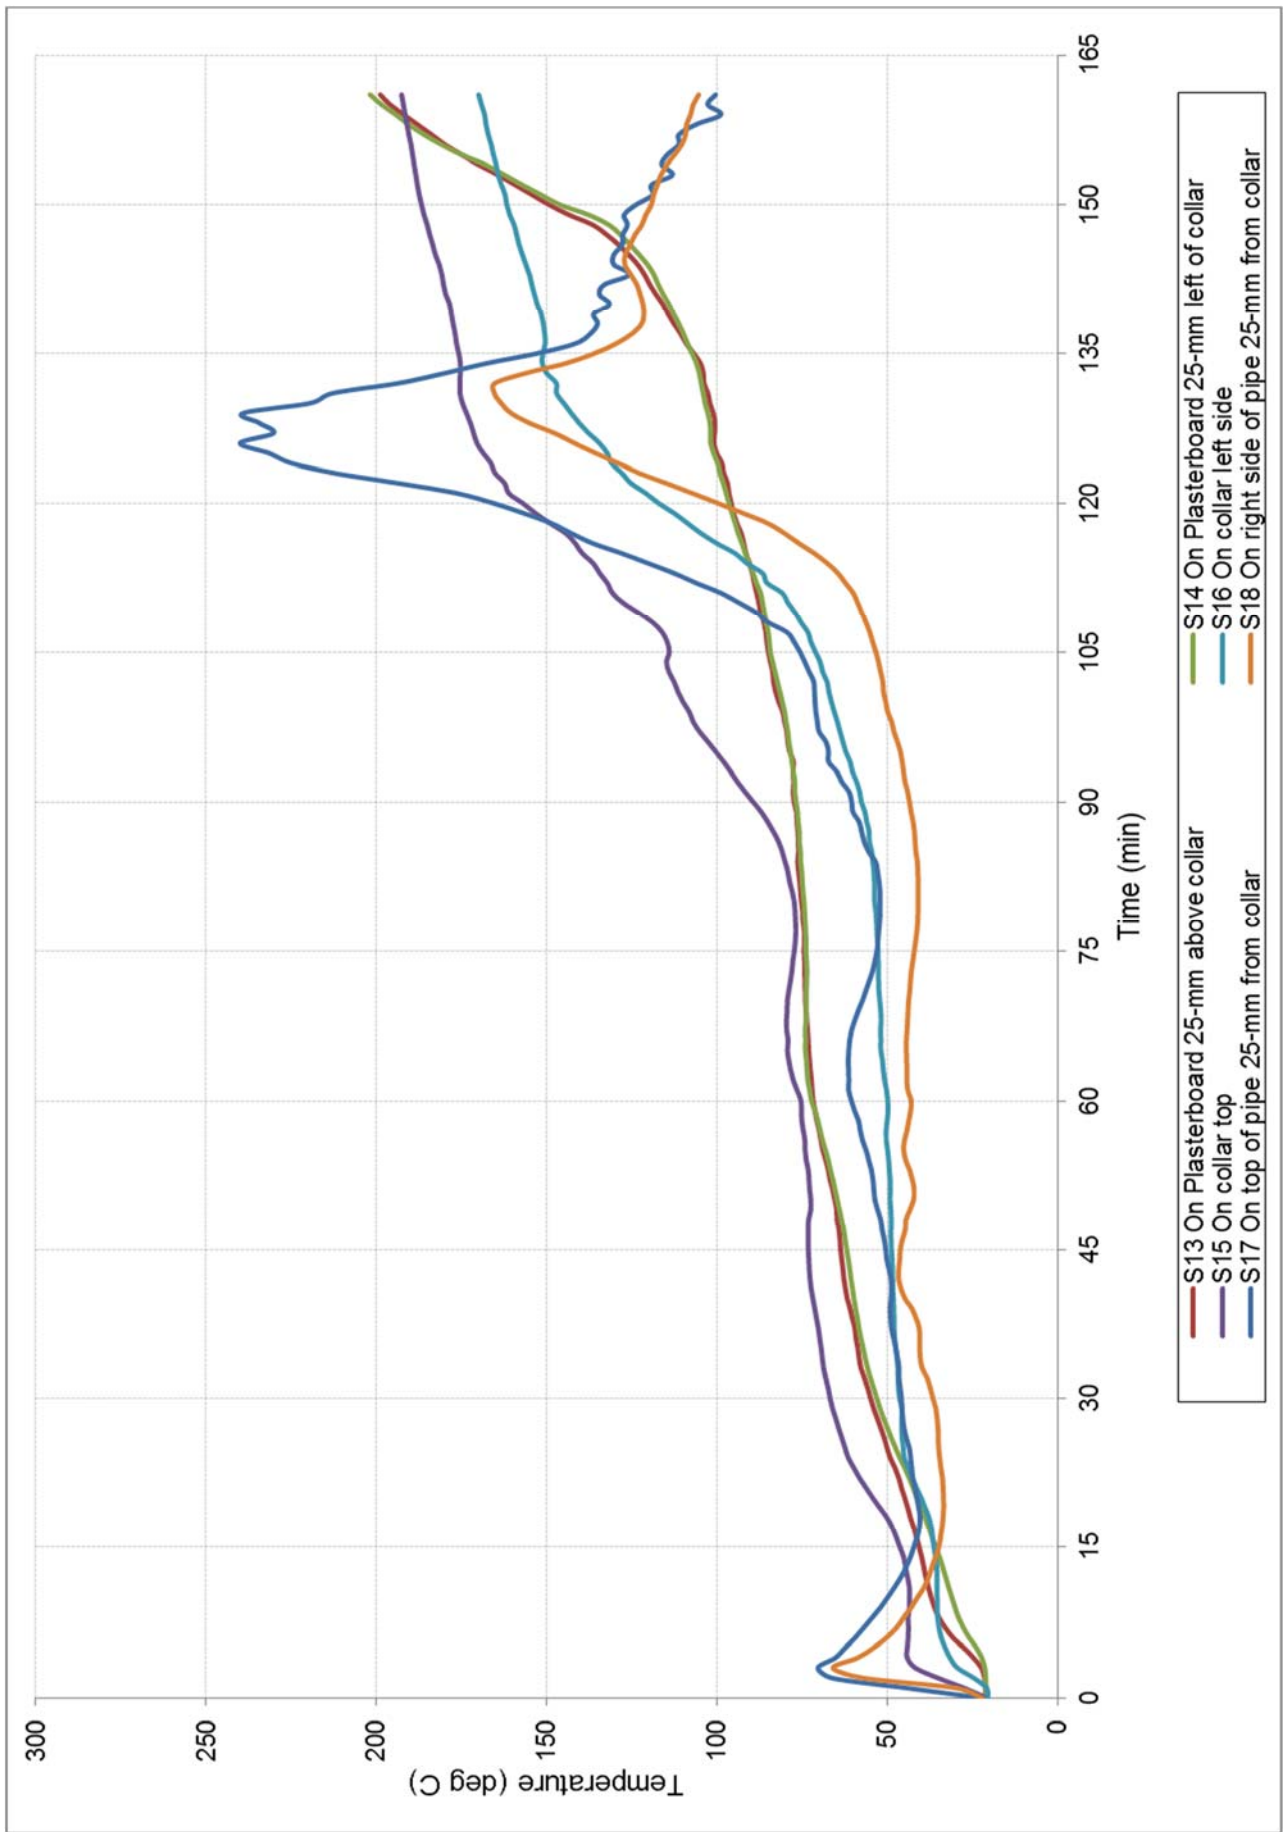
FIGURE 4 - SPECIMEN 3 TEMPERATURE

- 123 minutes - Insulation Failure of Specimen 3 - maximum temperature rise of 180K is exceeded from the top of pipe 25-mm from collar on the unexposed face. (Thermocouple #11)

Figure 4 shows the curve of temperature versus time associated with Specimen 3.

Structural adequacy	-	not applicable
Integrity	-	no failure at 161 minutes
Insulation	-	123 minutes
