Fire-resistance test on fire collars protecting a plasterboard wall penetrated by services

Test Report

Author: Peter Gordon
Report number: FSP 1996
Date: 9 May 2019

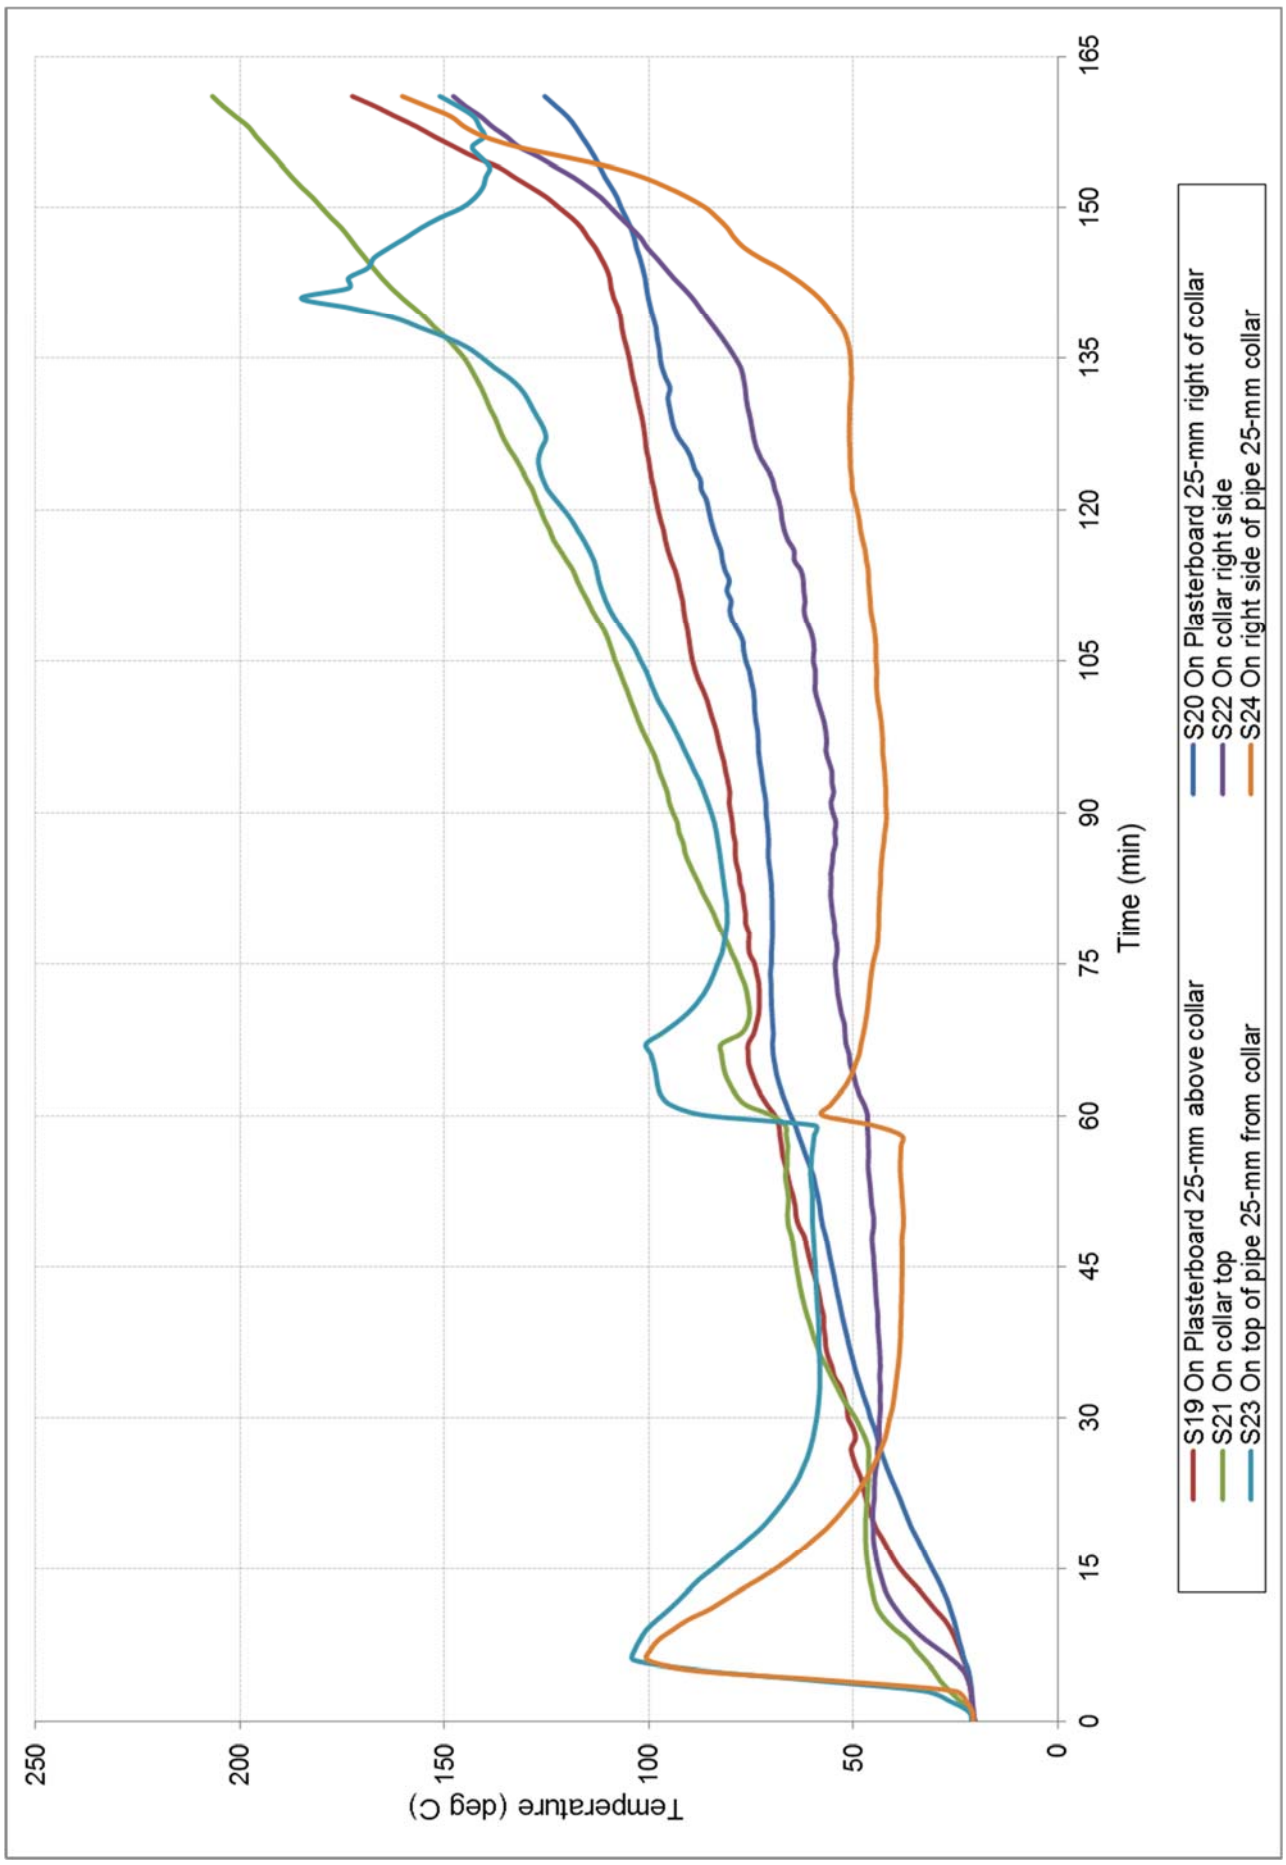
FIGURE 5 - SPECIMEN 4 TEMPERATURE

- 159 minutes - Insulation Failure of Specimen 4 – maximum temperature rise of 180K is exceeded from the top of collar on the exposed. (Thermocouple #21)

Figure 5 shows the curve of temperature versus time associated with Specimen 4.

Structural adequacy	-	not applicable
Integrity	-	no failure at 161 minutes
Insulation	-	159 minutes

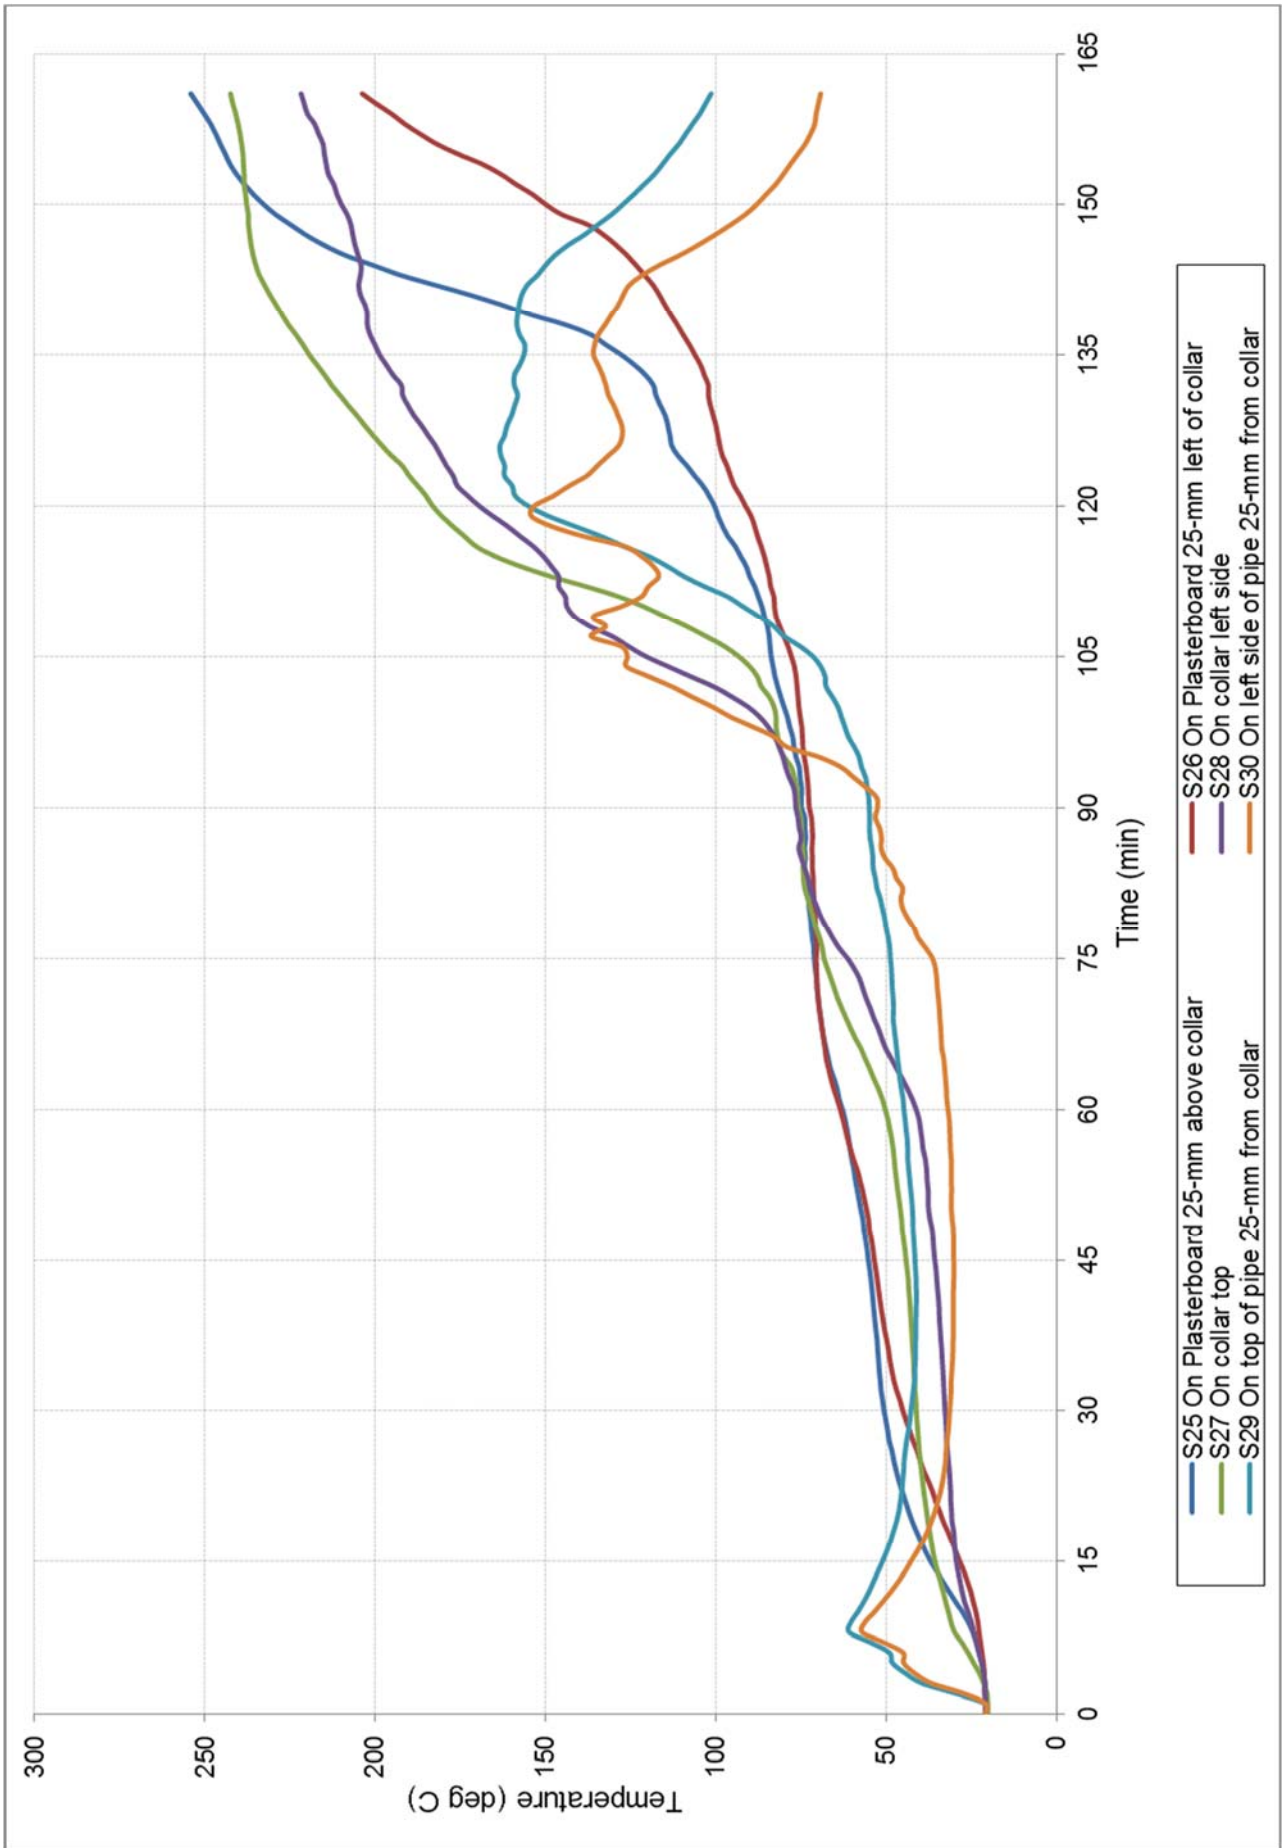
FIGURE 6 - SPECIMEN 5 TEMPERATURE

- 128 minutes - Insulation Failure of Specimen 5 - maximum temperature rise of 180K is exceeded from the top of collar on the unexposed face. (Thermocouple #27)
The base of pipe inside the collar of Specimen 1 has softened and collapsed.

Figure 6 shows the curve of temperature versus time associated with Specimen 5.

Structural adequacy	-	not applicable
Integrity	-	no failure at 161 minutes
Insulation	-	128 minutes

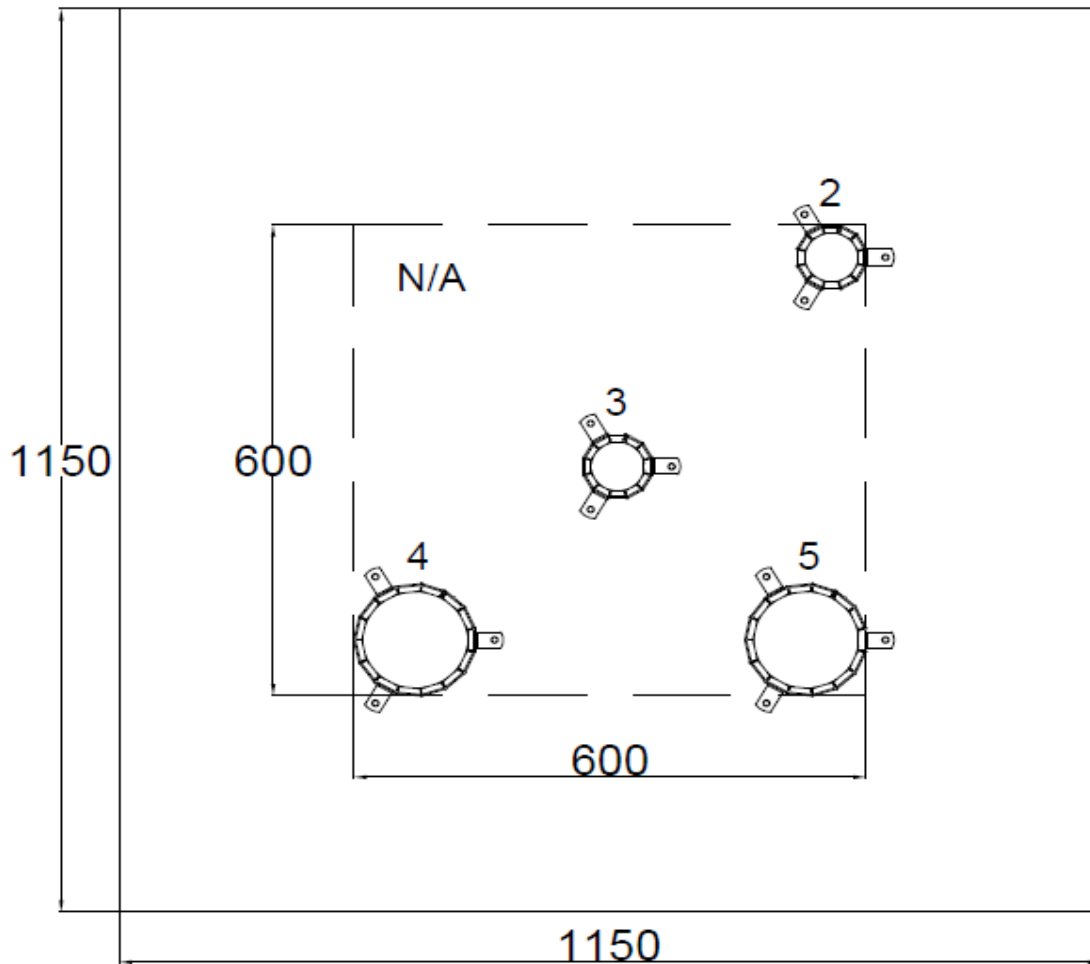
Test Wall W-19-C Layout

Penetration	Collar Code	Pipe Type	Pipe Diameter (mm)	Sealant
2	50R	Triplus	40	
3	50R	Raupiano	40	
4	110R	Raupiano	110	
5	110R	PVC-SC	110

DRAWING TITLED "TEST WALL W-19-C LAYOUT" DATED 19 MARCH 2019, BY SNAP FIRE SYSTEMS PTY LTD.

The specimen comprised an 1160-mm x 1160-mm x 116-mm thick wall penetrated by five (5) pipes protected by retrofitted Snap Fire Systems fire collars.

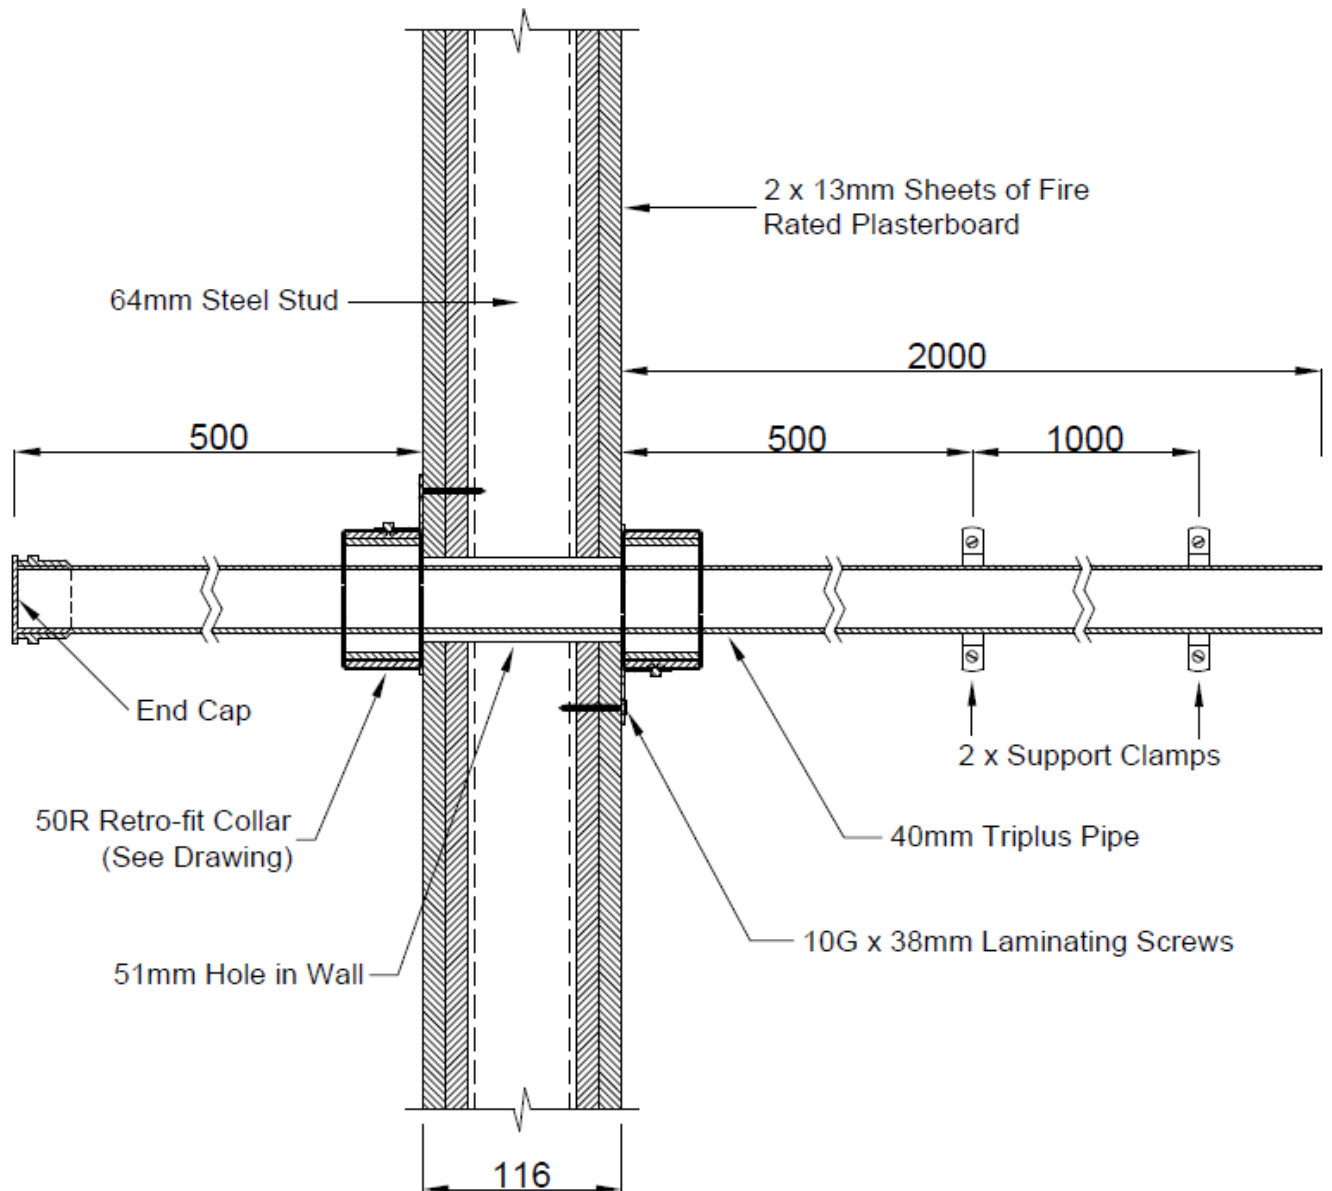
Specimen #2

40 Triplus Stack & 50R

DRAWING TITLED "SPECIMEN #2, 40 TRIPLUS STACK & 50R", DATED 20 MARCH 2019, PROVIDED BY SNAP FIRE SYSTEMS PTY LTD.

The SNAP Retrofit 50R fire collar comprised a 0.75-mm steel casing with a 62-mm inner diameter and a 147-mm diameter base flange. The 47-mm high collar casing incorporated a closing mechanism which comprised two soft Intumesh intumescent wraps lined within the internal circumference of the collar. Intumescent A was 4-mm thick x 43-mm wide x 220-mm long, and Intumescent B was 4-mm thick x 43-mm wide x 200-mm long. Between the strips was a layer of 316 grade stainless steel mesh 210-mm long x 42-mm wide with wire mesh diameter of 0.15-mm, as shown in drawing titled "SNAP 50 Retro", dated 18 January 2019, by Snap Fire Systems Pty Ltd. The Snap collars were surface mounted around the pipe on both the exposed and unexposed face of the wall and fixed through 3 mounting brackets using 38-mm (10g) coarse thread laminating screws.

The penetrating service comprised a 40-mm outside diameter polypropylene pipe, with a wall thickness of 2-mm which penetrated the wall through a 51-mm diameter cut-out hole as shown in drawing titled "Specimen #2, 40 Triplus Stack & 50R", dated 20 March 2019, provided by Snap Fire Systems Pty Ltd. The pipe projected horizontally, 2000-mm away from the unexposed face of the wall and approximately 500-mm into the furnace chamber. The pipe was supported at nominally 500-mm and 1500-mm from the unexposed face of the plasterboard wall. The pipe was open at the unexposed end and capped with polypropylene end cap on the exposed end.

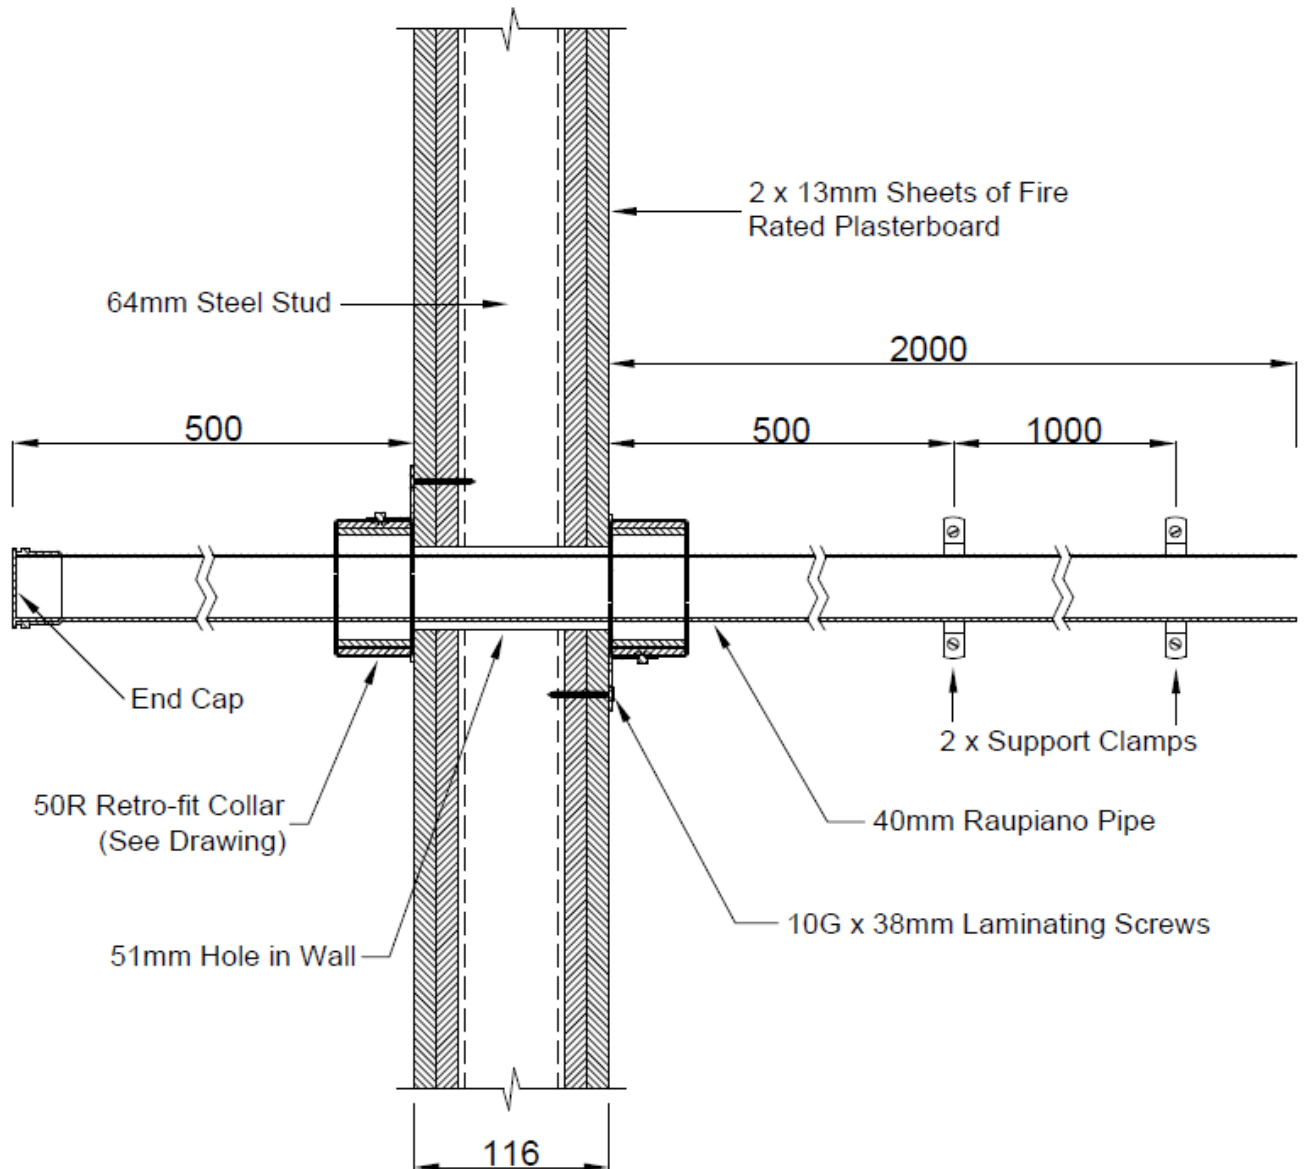
Specimen #3

40 Raupiano Stack & 50R

DRAWING TITLED "SPECIMEN #3, 40 RAUPIANO STACK & 50R", DATED 20 MARCH 2019, PROVIDED BY SNAP FIRE SYSTEMS PTY LTD.

The SNAP Retrofit 50R fire collar comprised a 0.75-mm steel casing with a 62-mm inner diameter and a 147-mm diameter base flange. The 47-mm high collar casing incorporated a closing mechanism which comprised two soft Intumesh intumescent wraps lined within the internal circumference of the collar. Intumescent A was 4-mm thick x 43-mm wide x 220-mm long, and Intumescent B was 4-mm thick x 43-mm wide x 200-mm long. Between the strips was a layer of 316 grade stainless steel mesh 210-mm long x 42-mm wide with wire mesh diameter of 0.15-mm, as shown in drawing titled "SNAP 50 Retro", dated 18 January 2019, by Snap Fire Systems Pty Ltd. The Snap collars were surface mounted around the pipe on both the exposed and unexposed face of the wall and fixed through 3 mounting brackets using 38-mm (10g) course thread laminating screws.

The penetrating service comprised a 40-mm outside diameter polypropylene pipe, with a wall thickness of 2.12-mm which penetrated the wall through a 51-mm diameter cut-out hole as shown in drawing titled "Specimen #3, 40 Raupiano Stack & 50R", dated 20 March 2019, provided by Snap Fire Systems Pty Ltd. The pipe projected horizontally, 2000-mm away from the unexposed face of the wall and approximately 500-mm into the furnace chamber. The pipe was supported at nominally 500-mm and 1500-mm from the unexposed face of the plasterboard wall. The pipe was open at the unexposed end and capped with polypropylene end cap on the exposed end.

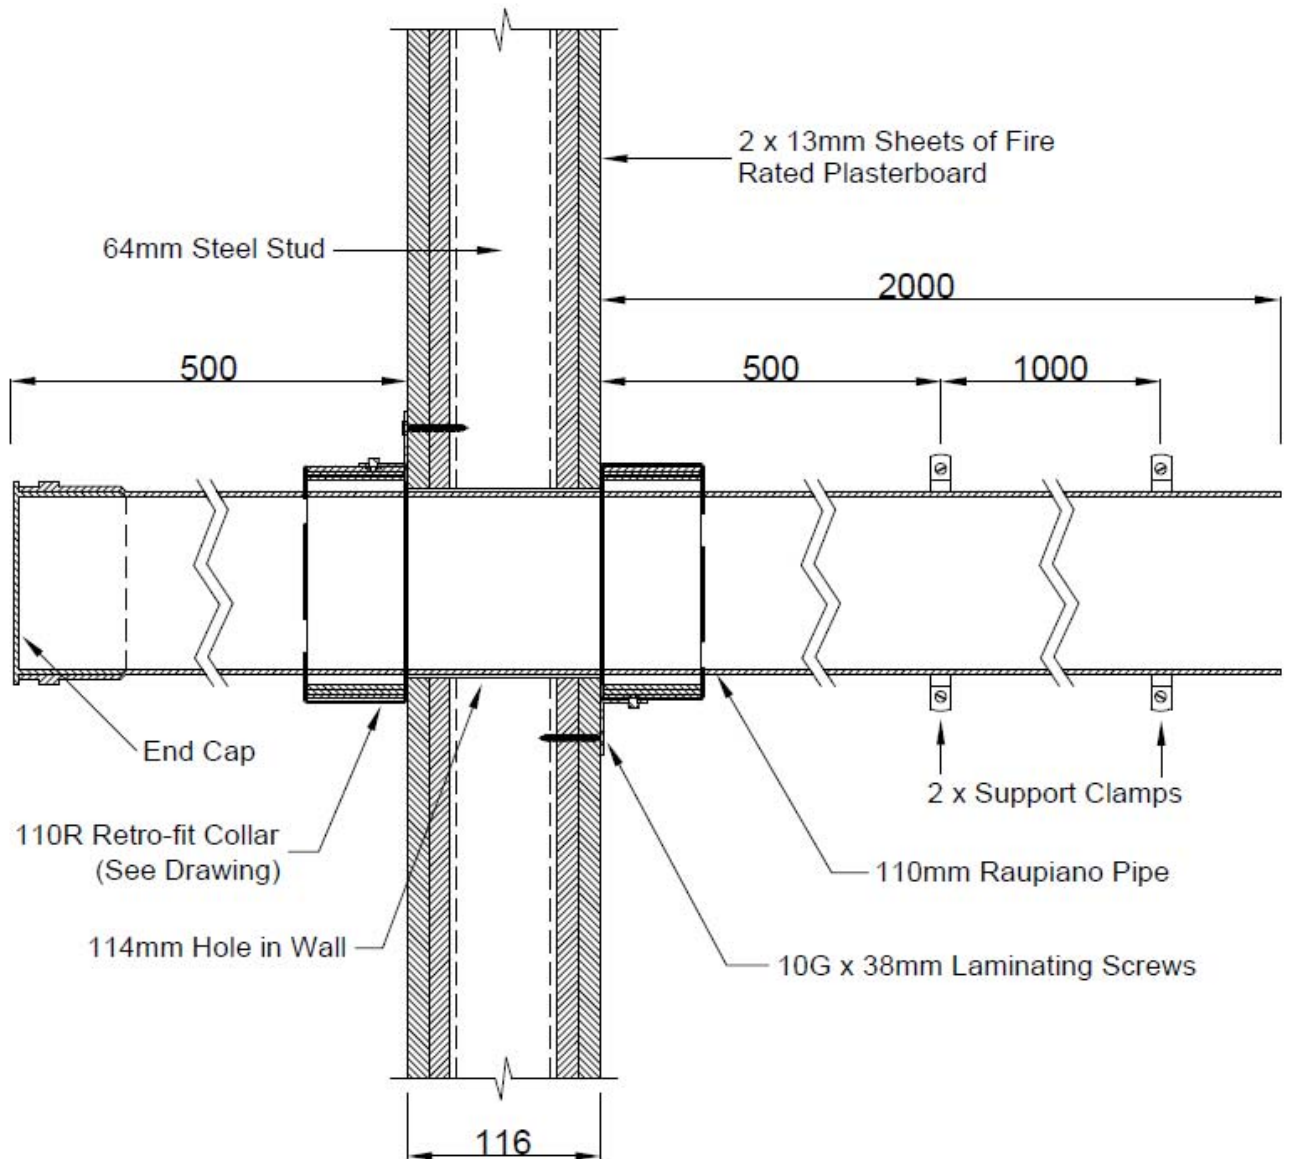
Specimen #4

110 Raupiano Stack & 110R

DRAWING TITLED "SPECIMEN #4, 110 RAUPIANO STACK & 110R", DATED 20 MARCH 2019, PROVIDED BY SNAP FIRE SYSTEMS PTY LTD.

The SNAP Retrofit 110R fire collar comprised a 0.75-mm steel casing with a 122-mm inner diameter and a 206-mm diameter base flange. The 62-mm high collar casing incorporated a closing mechanism that was comprised of three soft Intumesh intumescent wraps and wire meshes lined within the internal circumference of the collar. Intumescent A was 2.5-mm thick x 58-mm wide x 424-mm long, Intumescent B was 2.5-mm thick x 58-mm wide x 407-mm long and Intumescent C was 2.5-mm thick x 58-mm wide x 389-mm long. Between intumescent strips A and B was a layer of 316 stainless steel mesh 415-mm long x 58-mm wide and between intumescent strips B and C was a layer of 316 stainless steel mesh 398-mm long x 58-mm wide both had wire mesh diameters of 0.15-mm, as shown in drawing titled "SNAP 110 Retro", dated 16 January 2019, by Snap Fire Systems Pty Ltd. The Snap collars were surface mounted around the pipe on both the exposed and unexposed face of the wall and fixed through 3 mounting brackets using 38-mm (10g) course thread laminating screws.

The penetrating service comprised a 110-mm outside diameter polypropylene pipe, with a wall thickness of 3.13-mm fitted through the collar's sleeve. The pipe penetrated the wall through a 114-mm diameter opening and projected horizontally 2000-mm away from the unexposed face of the wall and approximately 500 mm into the furnace chamber. The pipe was supported at nominally 500-mm, and 1500-mm from the unexposed face of the plasterboard wall, as shown in drawing titled "Specimen #4, 110 Raupiano Stack & 110R", dated 20 March 2019, provided by Snap Fire Systems Pty Ltd. The pipe was open on the unexposed end and capped on the exposed end with a polypropylene end cap.

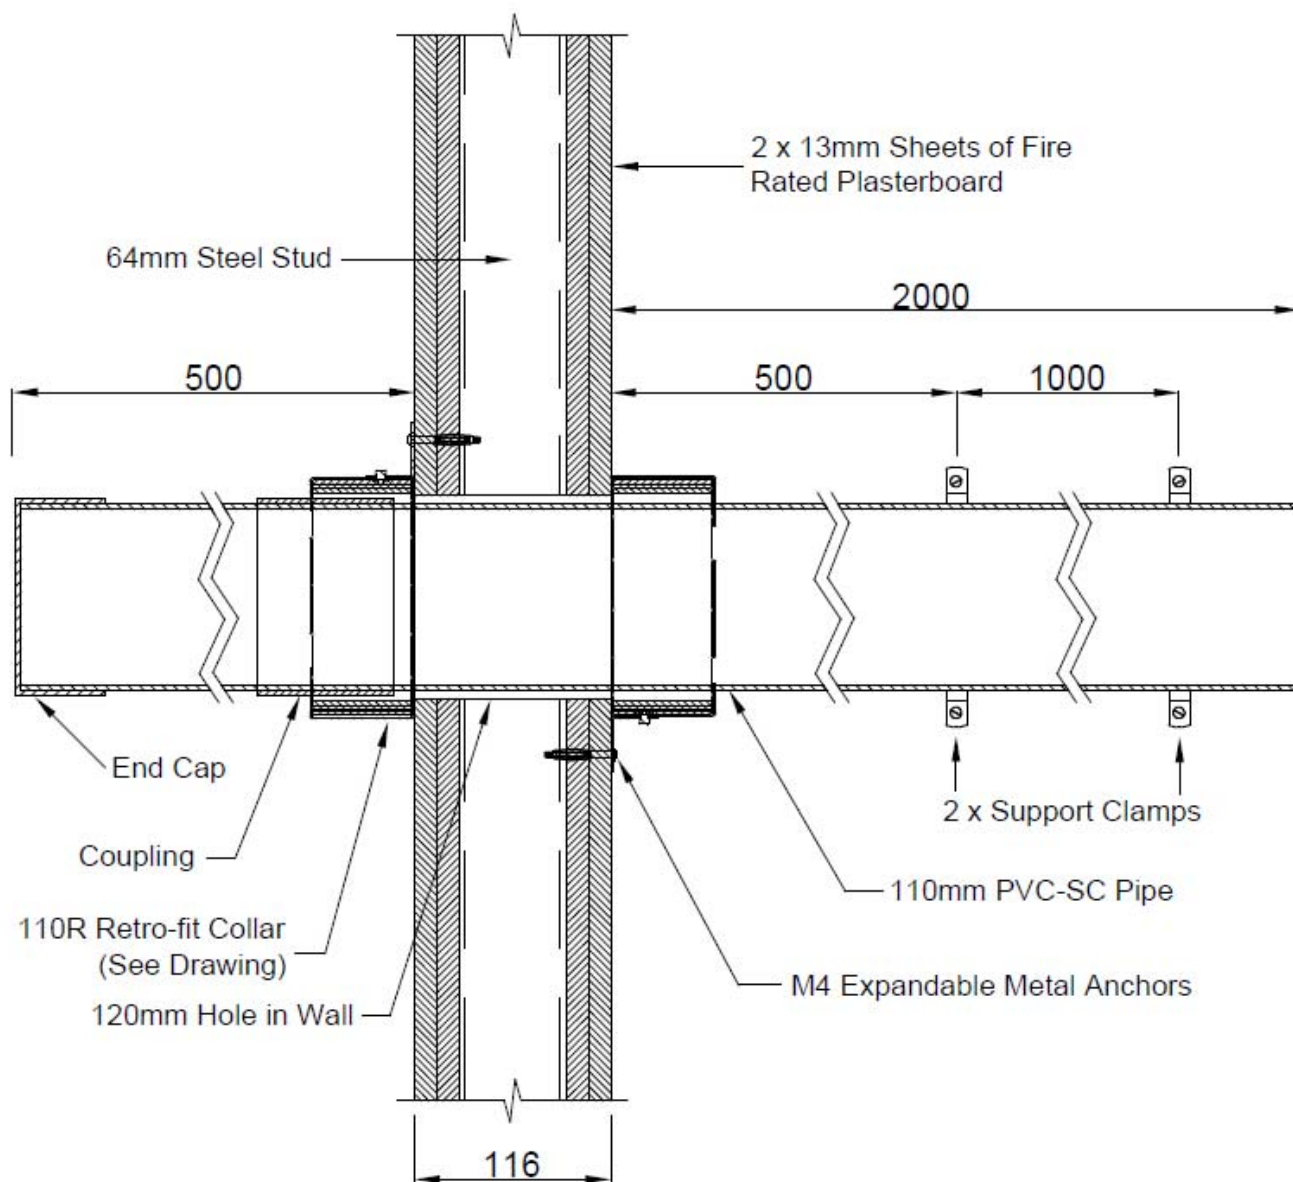
Specimen #5

100 PVC-SC Stack & 110R

DRAWING TITLED "SPECIMEN #5, 100 PVC-SC STACK & 110R", DATED 20 MARCH 2019, PROVIDED BY SNAP FIRE SYSTEMS PTY LTD.

The SNAP Retrofit 110R fire collar comprised a 0.75-mm steel casing with a 122-mm inner diameter and a 206-mm diameter base flange. The 62-mm high collar casing incorporated a closing mechanism that was comprised of three soft Intumesh intumescent wraps and wire meshes lined within the internal circumference of the collar. Intumescent A was 2.5-mm thick x 58-mm wide x 424-mm long, Intumescent B was 2.5-mm thick x 58-mm wide x 407-mm long and Intumescent C was 2.5-mm thick x 58-mm wide x 389-mm long. Between intumescent strips A and B was a layer of 316 stainless steel mesh 415-mm long x 58-mm wide and between intumescent strips B and C was a layer of 316 stainless steel mesh 398-mm long x 58-mm wide both had wire mesh diameters of 0.15-mm, as shown in drawing titled “SNAP 110 Retro”, dated 16 January 2019, by Snap Fire Systems Pty Ltd. The Snap collars were surface mounted around the pipe on both the exposed and unexposed face of the wall and fixed through 3 mounting brackets using M4 expandable steel anchors.

The penetrating service comprised a 110-mm outside diameter PVC-SC pipe with a wall thickness of 3.58-mm and a PVC coupling with a wall thickness of 2.8-mm (with a total wall thickness of 6.38-mm fitted through the collar’s sleeve on the exposed side only) penetrating the plasterboard wall through a 120-mm diameter opening and projected horizontally 2000-mm away from the unexposed face of the wall and approximately 500 mm into the furnace chamber. The pipe was supported at nominally 500-mm, and 1500-mm from the unexposed face of the plasterboard wall, as shown in drawing titled “Specimen #5, 100 PVC-SC Stack & 110R”, dated 20 March 2019, provided by Snap Fire Systems Pty Ltd. The pipe was open on the unexposed end and capped on the exposed end with a PVC end cap.

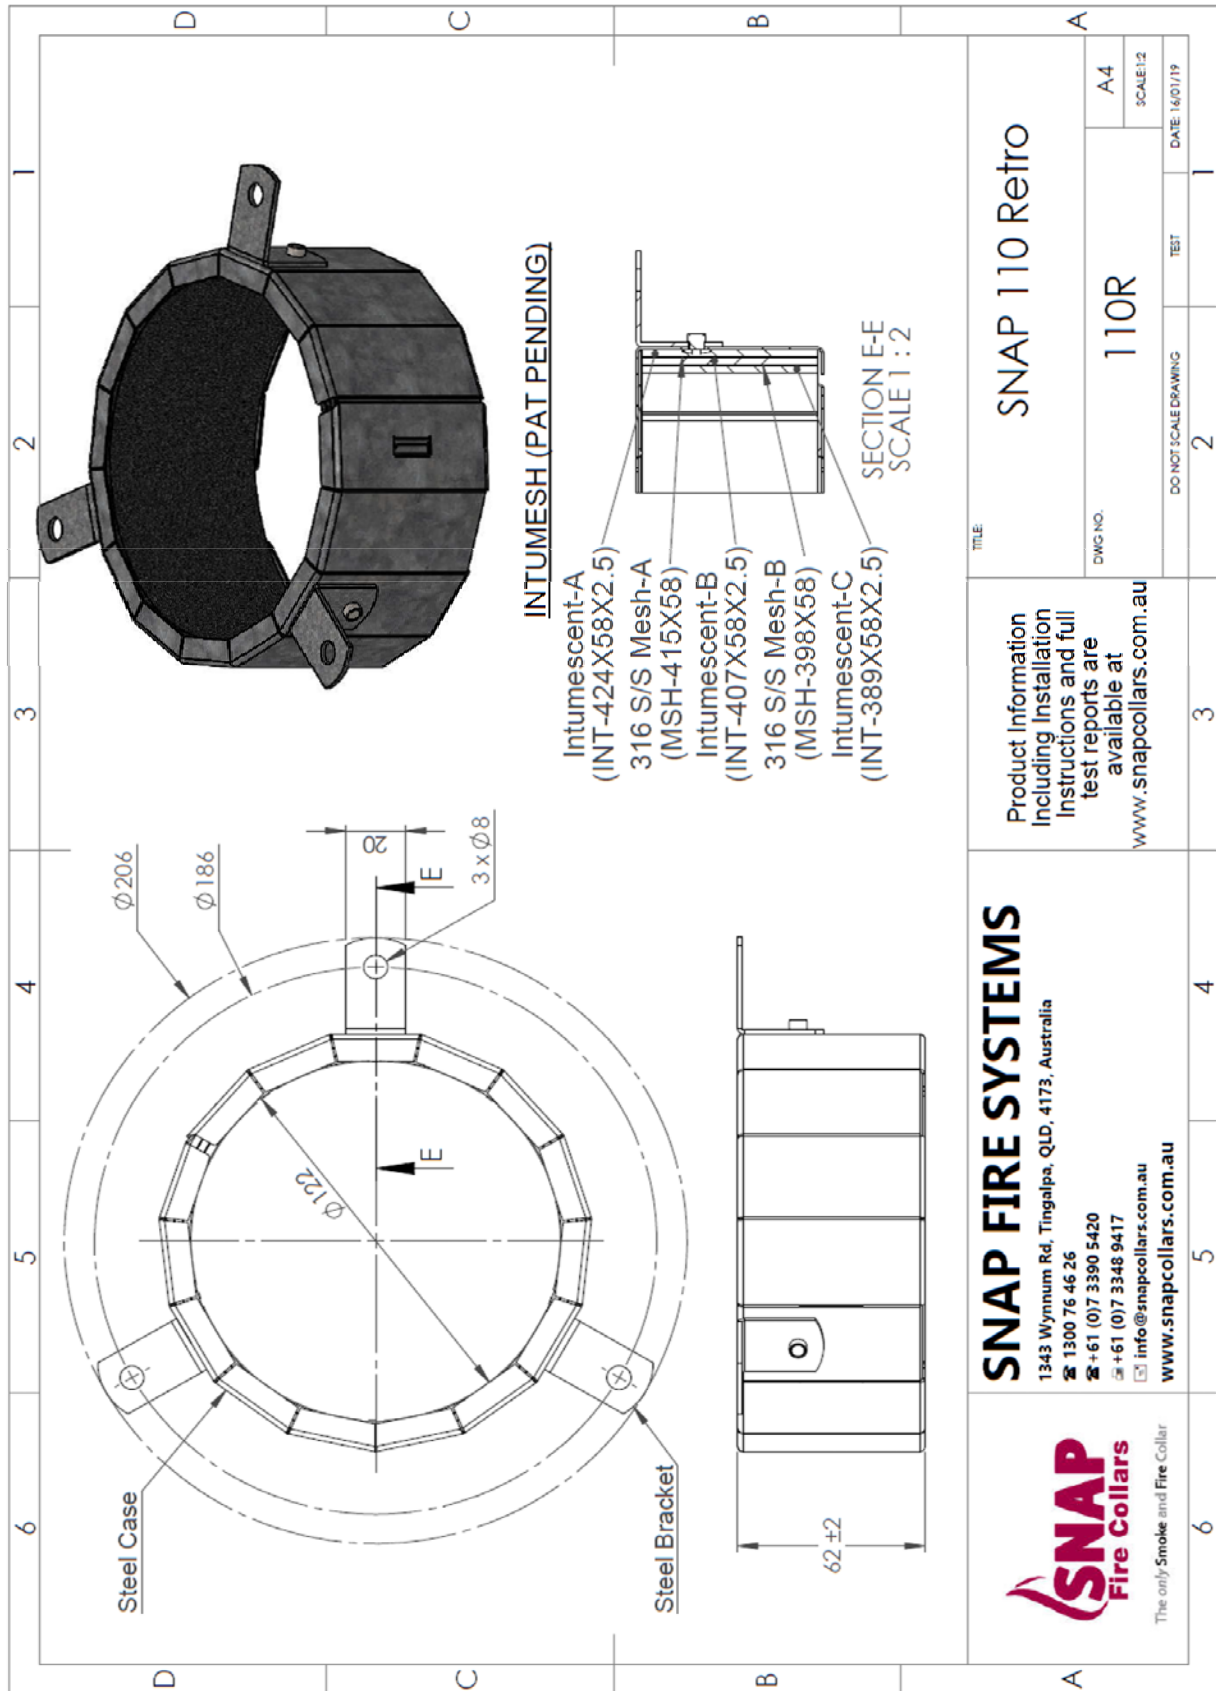
DRAWING NUMBERED 110R, SNAP 110 RETRO, DATED 16 JANUARY 2019, BY SNAP FIRE SYSTEMS PTY LTD.

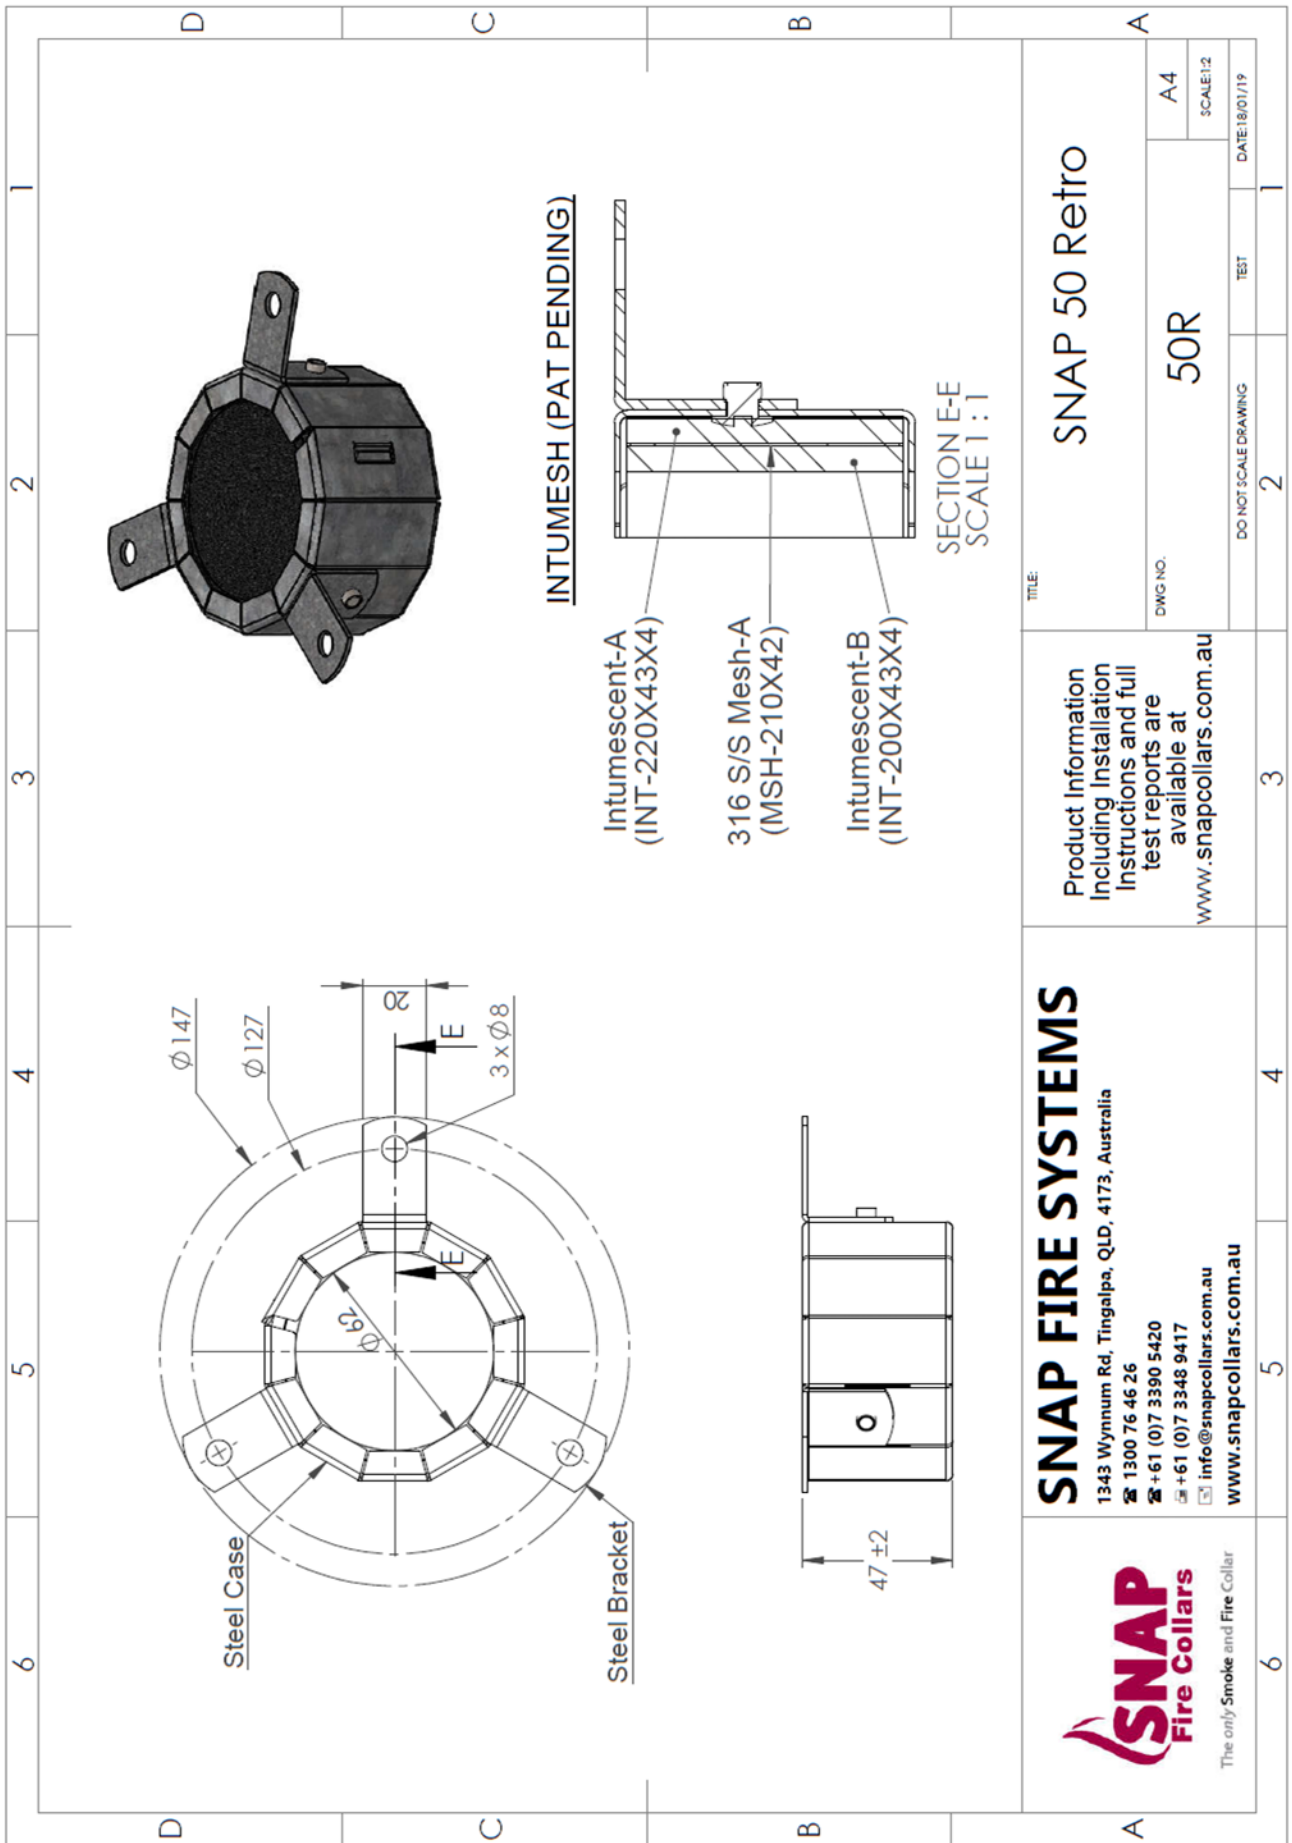
DRAWING NUMBERED 50R, SNAP 50 RETRO, DATED 18 JANUARY 2019, BY SNAP FIRE SYSTEMS PTY LTD.
