# Fire-resistance test on fire collars protecting a concrete slab penetrated by services

## Test Report

**Author:** Mario Lara-Ledermann  
**Report number:** FSP 1652a  
**Date:** 23 December 2014 (This report supersedes issue dated 10 September 2014)  
**Client:** Snap Fire Systems Pty Ltd

## Sponsored Investigation No. FSP 1652a

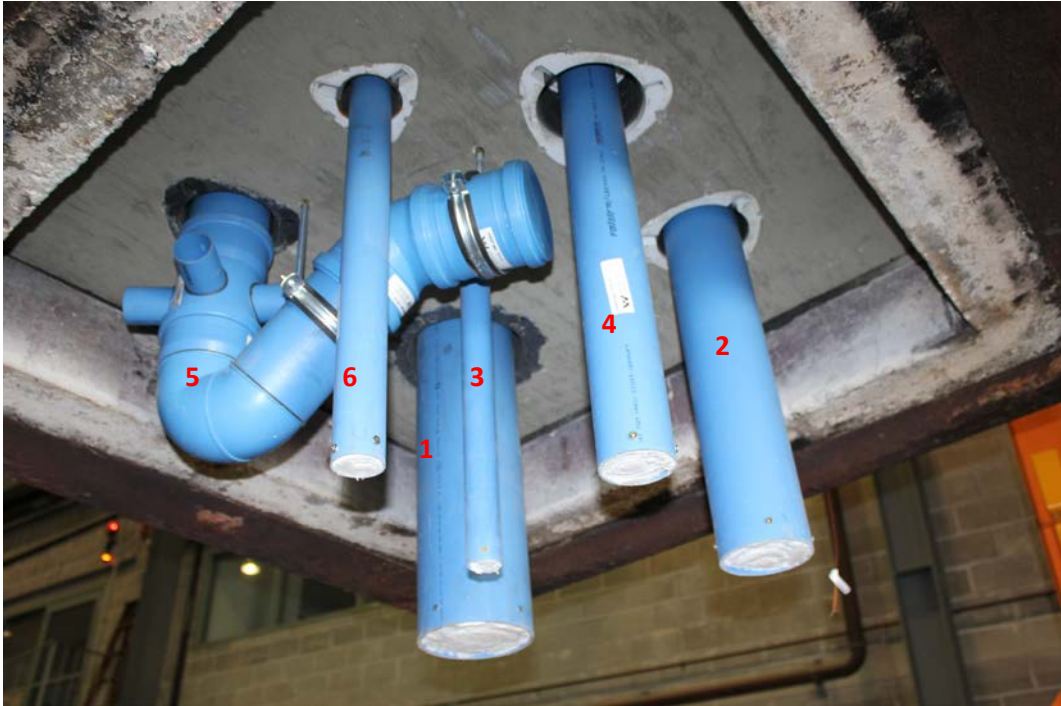
PHOTOGRAPH 1 – EXPOSED FACE OF SPECIMENS PRIOR TO TESTING

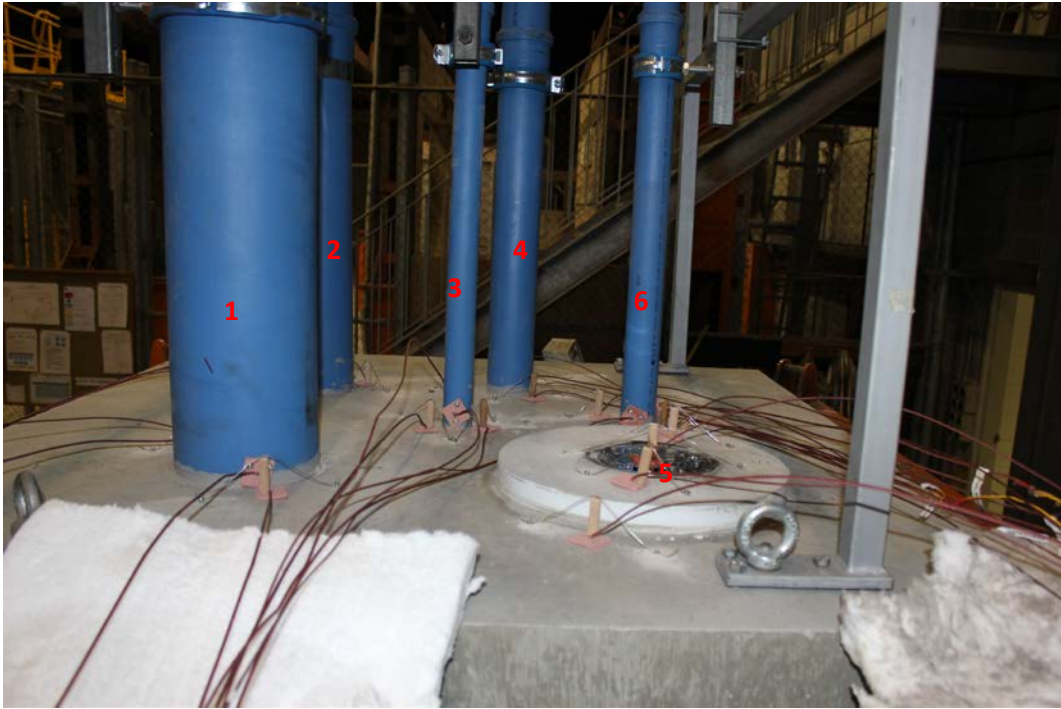
PHOTOGRAPH 2 – UNEXPOSED FACE OF SPECIMENS PRIOR TO TESTING

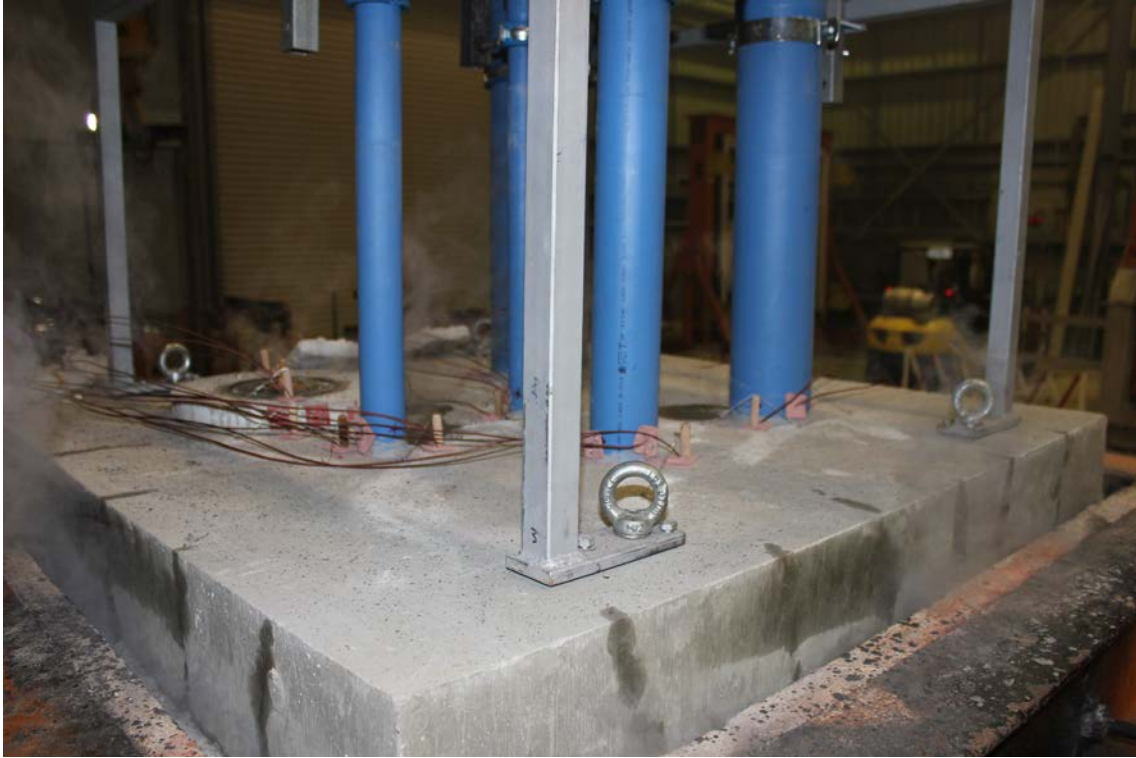
**PHOTOGRAPH 3 – SPECIMENS AFTER 60 MINUTES OF TESTING**

<b>Time</b>	<b>Observation</b>
3 minutes	- Smoke is visible from Penetration 2 and Penetration 4.
4 minutes	- Smoke is visible from Penetration 5 (floor waste). - Cotton wool pad applied over Penetration 5 (floor waste) – No ignition.
5 minutes	- Smoke is visible from Penetrations 1 and 2. Penetration 4 has ceased fluing.
11 minutes	- Light smoke is visible from Penetration 1.
12 minutes	- Spalling noises can be heard from the specimen.
15 minutes	- Smoke is fluing from Penetration 5.
44 minutes	- Penetrations are no longer fluing.
48 minutes	- Smoke is being emitted from Penetrations 3 and 5.
57 minutes	- Water is pooling on the unexposed face of the slab.
183 minutes	- <u>Insulation failure of Penetration 1</u> : maximum temperature rise limit of 180°C measured on the slab.
241 minutes	- Test terminated

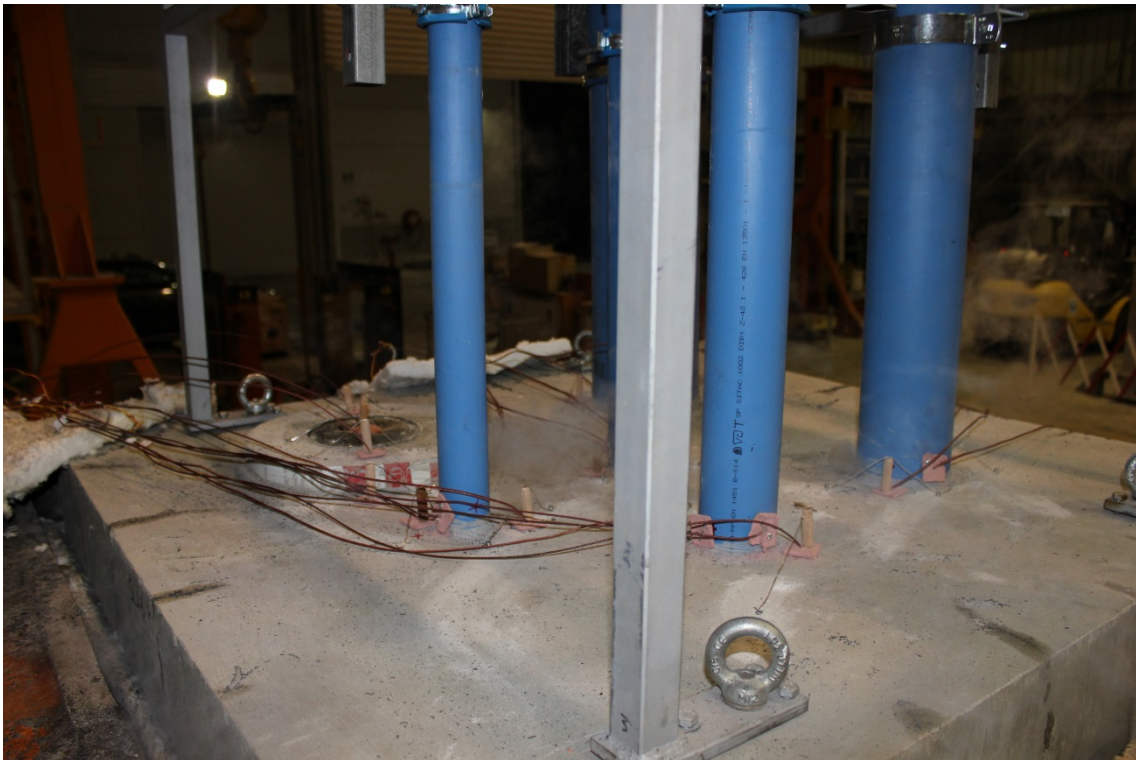
**PHOTOGRAPH 4 – SPECIMENS AFTER 120 MINUTES OF TESTING**

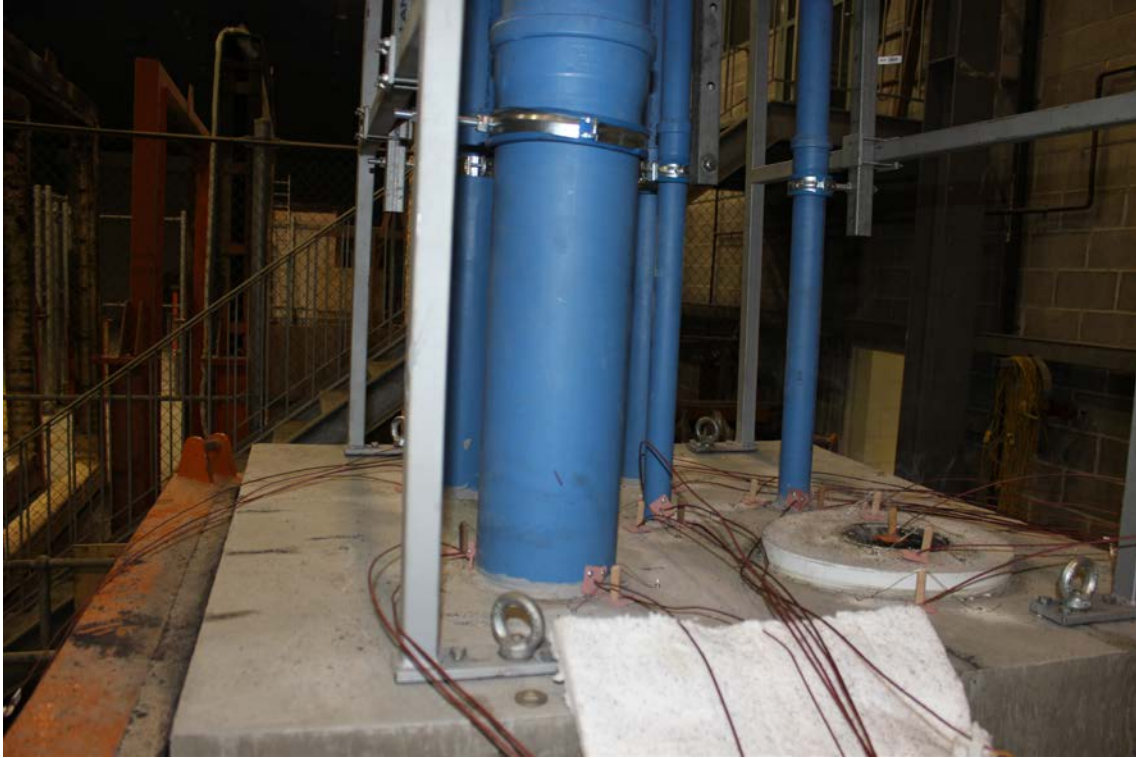
**PHOTOGRAPH 5 – SPECIMENS AFTER 180 MINUTES OF TESTING**

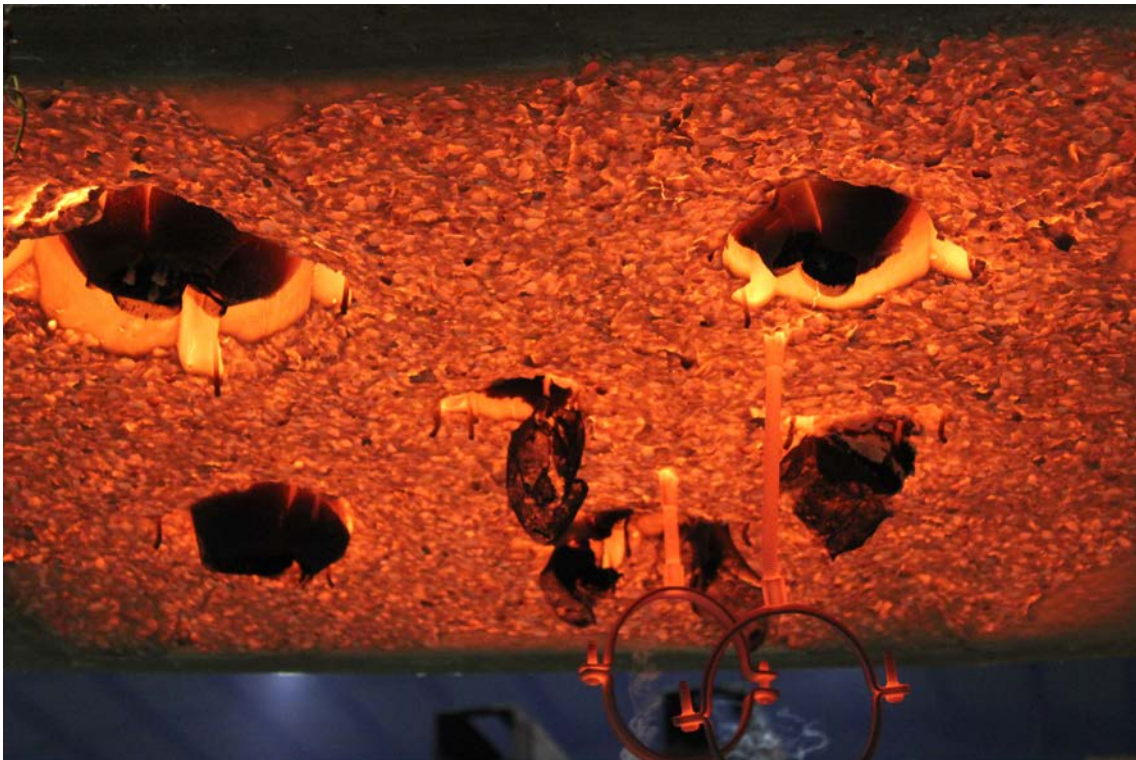
**PHOTOGRAPH 6 – EXPOSED FACE OF SPECIMENS AT CONCLUSION OF TESTING**
