Fire-resistance test on fire collars protecting a concrete floor slab penetrated by services

Test Report

Author: Peter Gordon
Report number: FSP 1949
Date: 7 December 2018

Sponsored Investigation No. FSP 1949

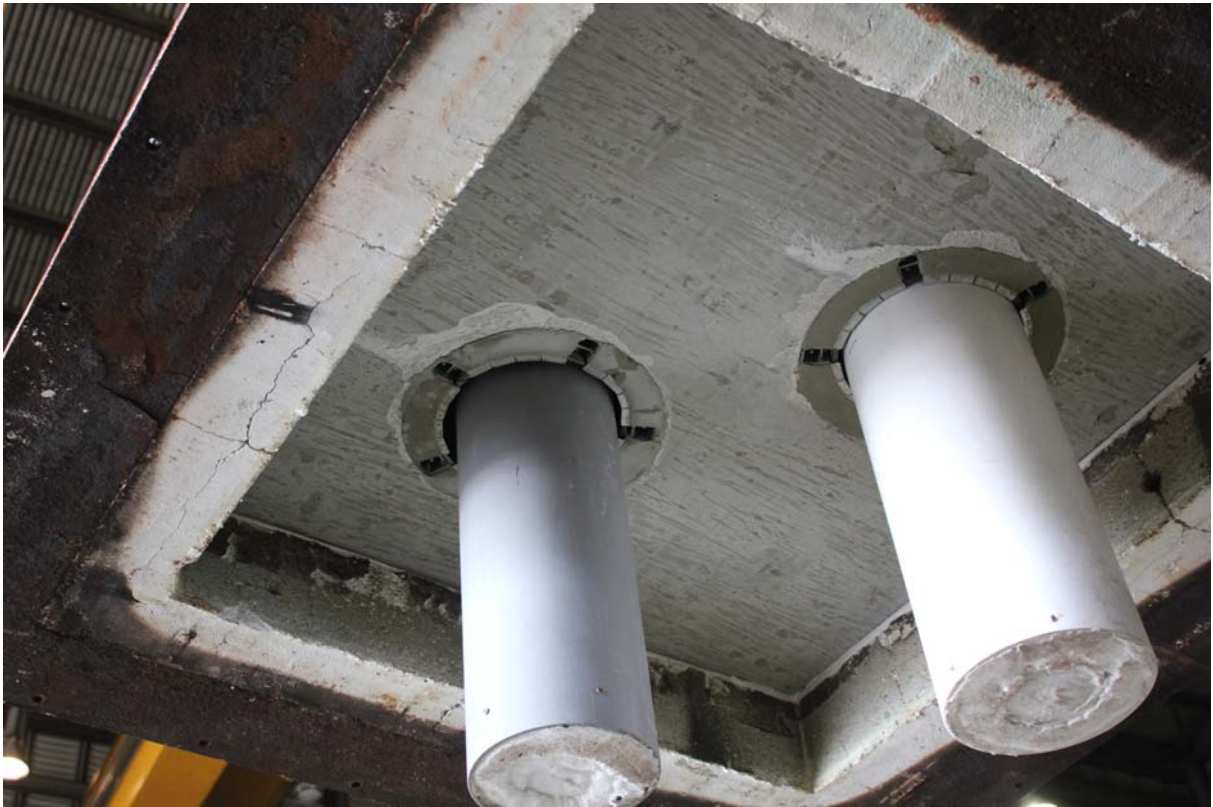
PHOTOGRAPH 2 – EXPOSED FACE OF SPECIMENS PRIOR TO TESTING

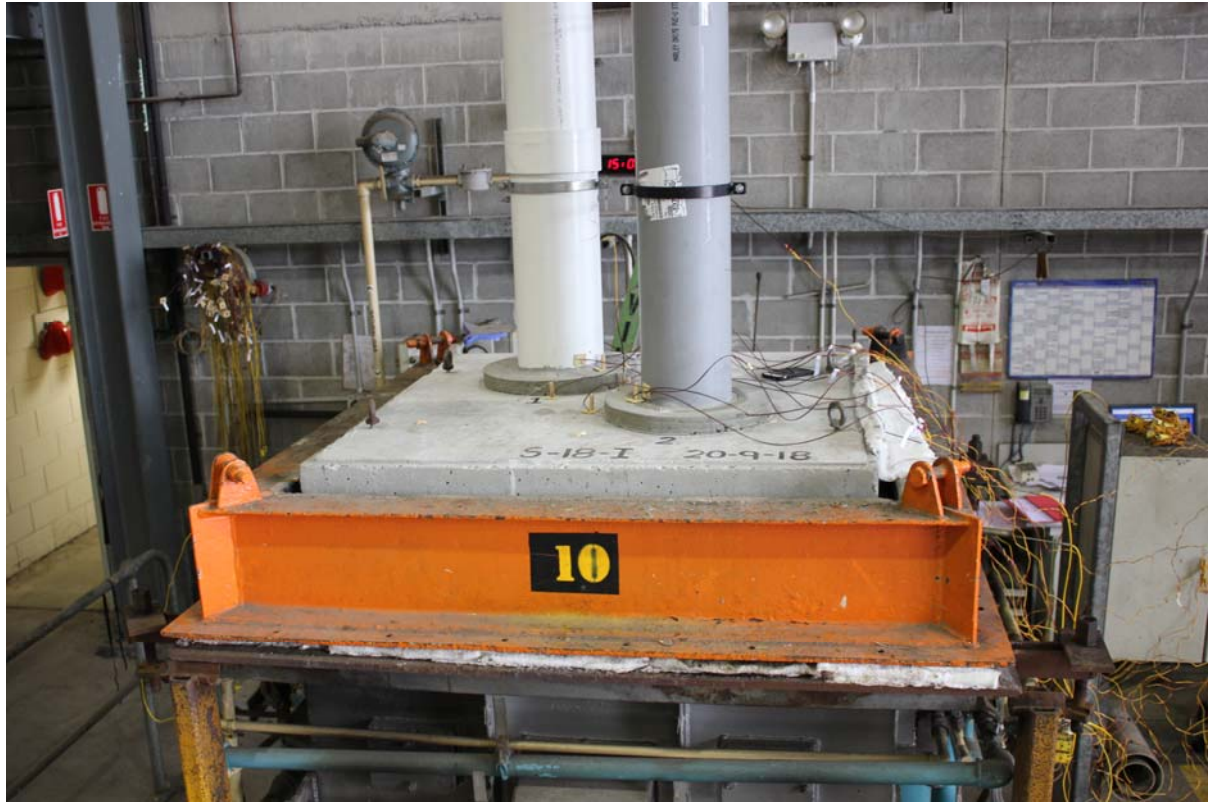
PHOTOGRAPH 3 – UNEXPOSED FACE OF SPECIMENS PRIOR TO TESTING

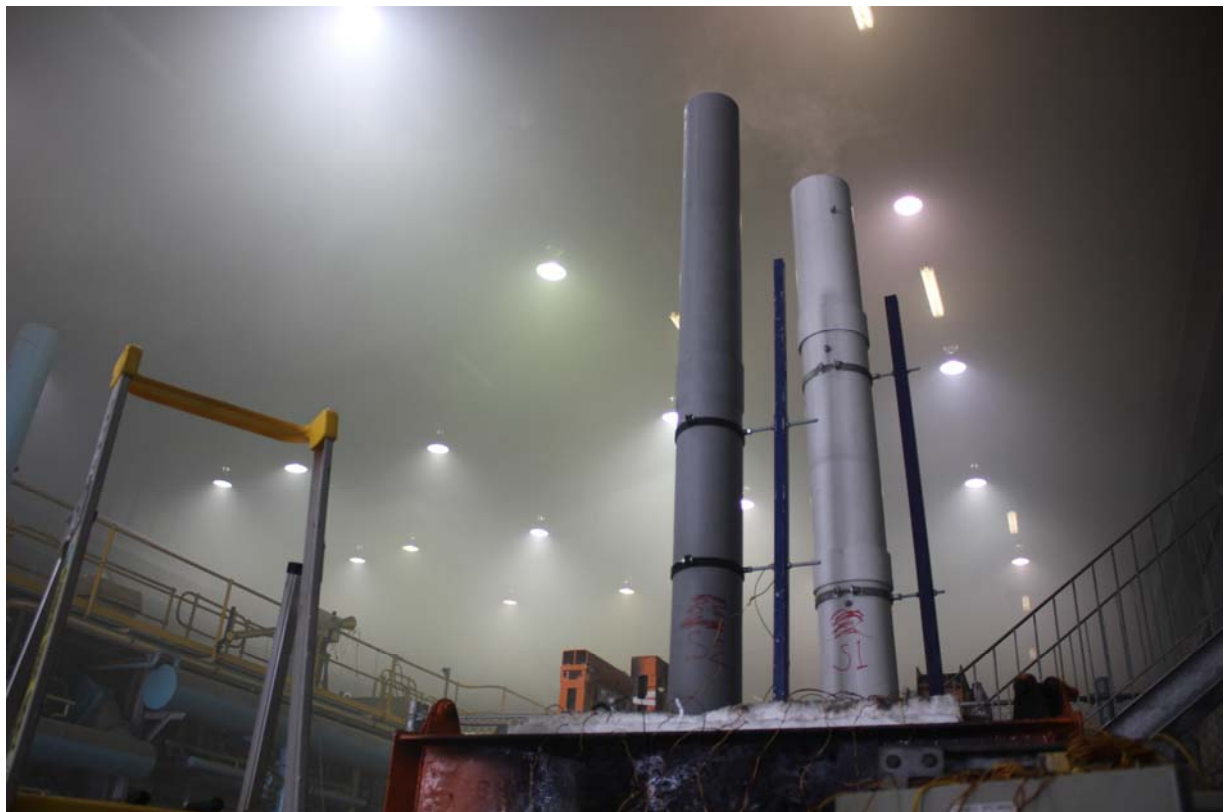
PHOTOGRAPH 4 – SPECIMENS AFTER 88 MINUTES OF TESTING

88 minutes -	A yellow liquid has condensed at the base of pipe of Specimen 2 near TC#8
119 minutes -	Light smoke continues to be emitted from the base of Specimen 2 on grout near TC#8.
130 minutes -	The smoke level fluing from both Specimens 1 and 2 has increased.
147 minutes -	Smoke emitted from the base of Specimen 2 near TC#8 has ceased.
195 minutes -	<u>Insulation Failure Specimen 1</u> – maximum temperature rise of 180K is exceeded on the hob.
203 minutes -	Smoke level fluing from Specimen 1 continues to increase.
218 minutes -	The base of pipe of Specimen 2 near TC#8 has darkened and is emitting smoke.
224 minutes -	Mastic at the base of pipe of Specimen 1 has started to swell
227 minutes -	<u>Insulation Failure Specimen 2</u> – maximum temperature rise of 180K is exceeded on the concrete slab 25-mm from hob.
232 minutes -	Cotton wool pad applied to base of Specimen 1 near where a red glow is visible through pipe. No ignition noted.

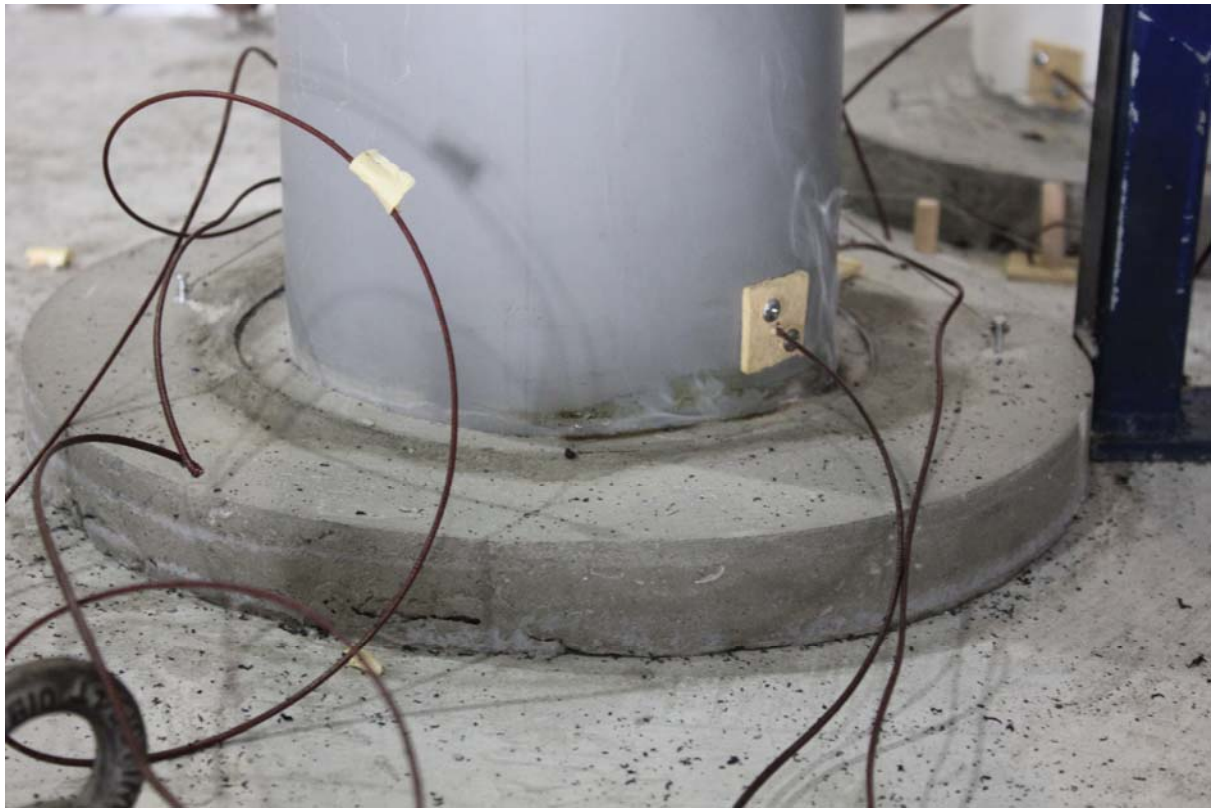
PHOTOGRAPH 5 – BASE OF SPECIMEN 2 AFTER 122 MINUTES OF TESTING

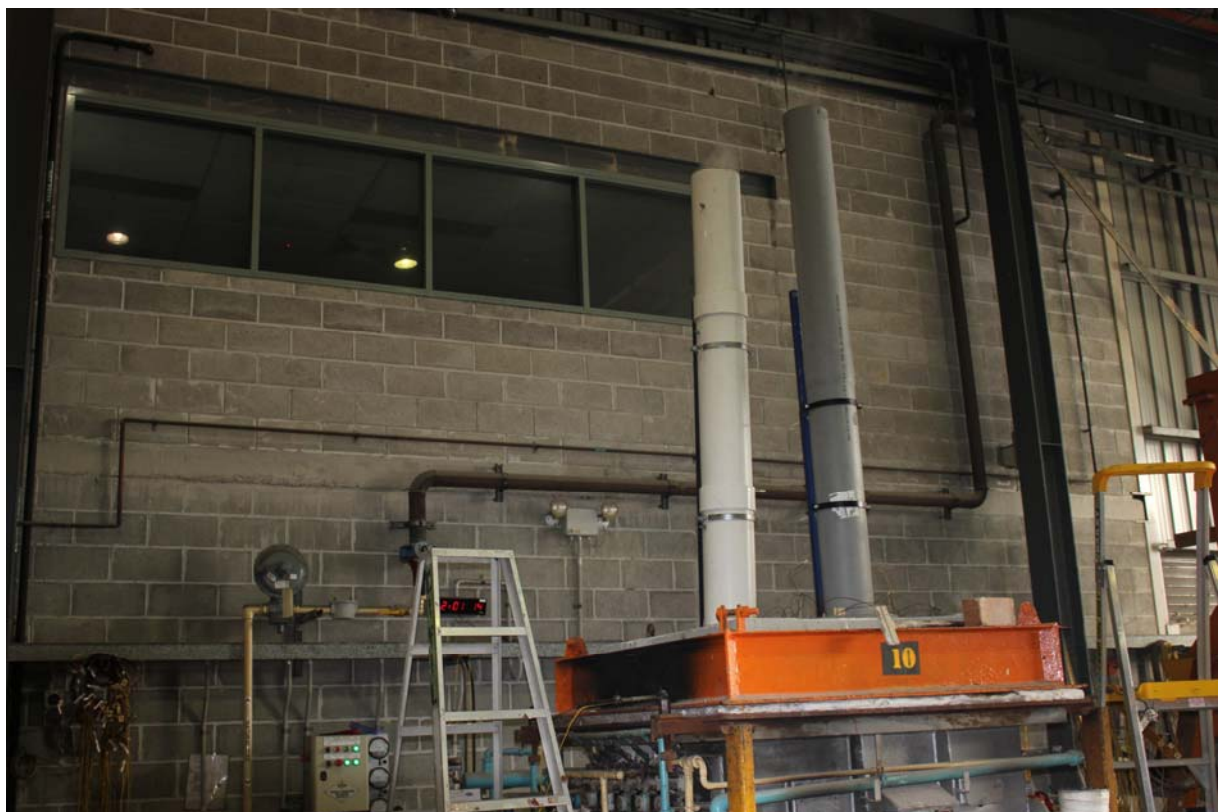
PHOTOGRAPH 6 – SPECIMENS AFTER 121 MINUTES OF TESTING

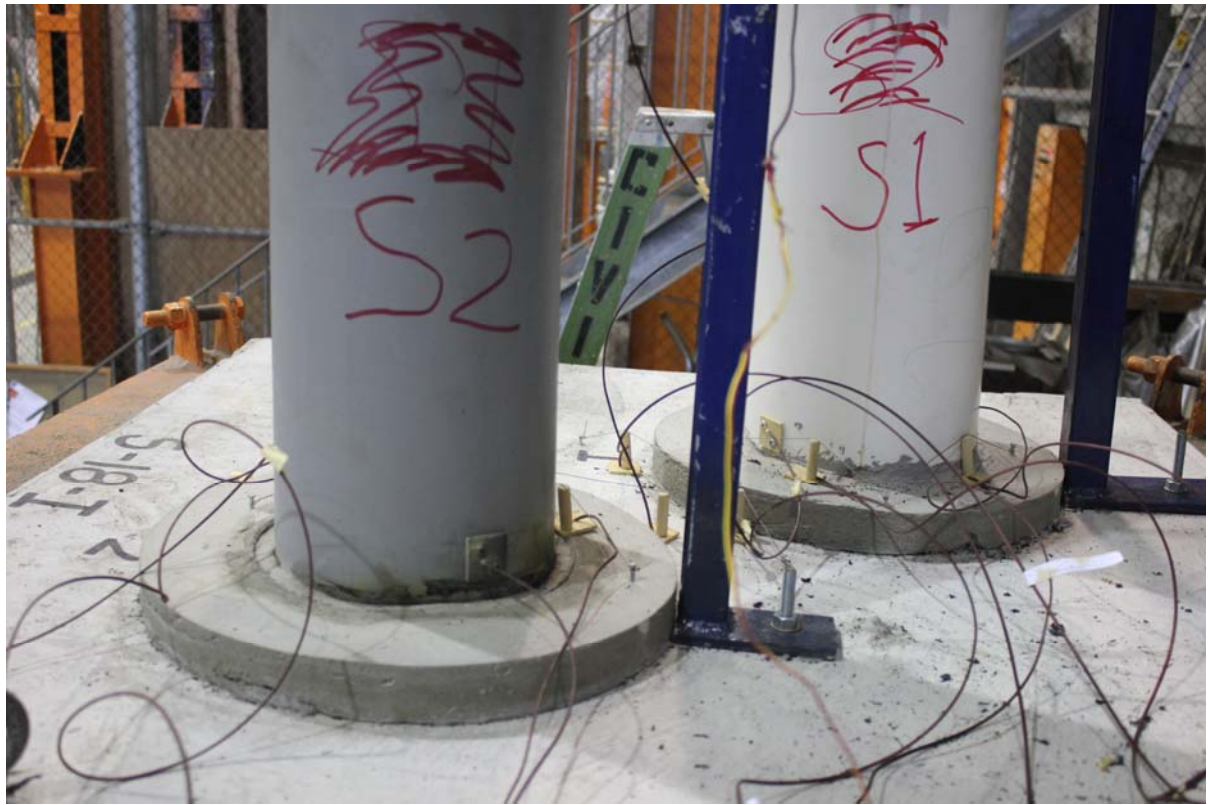
PHOTOGRAPH 7 – SPECIMENS AFTER 180 MINUTES OF TESTING

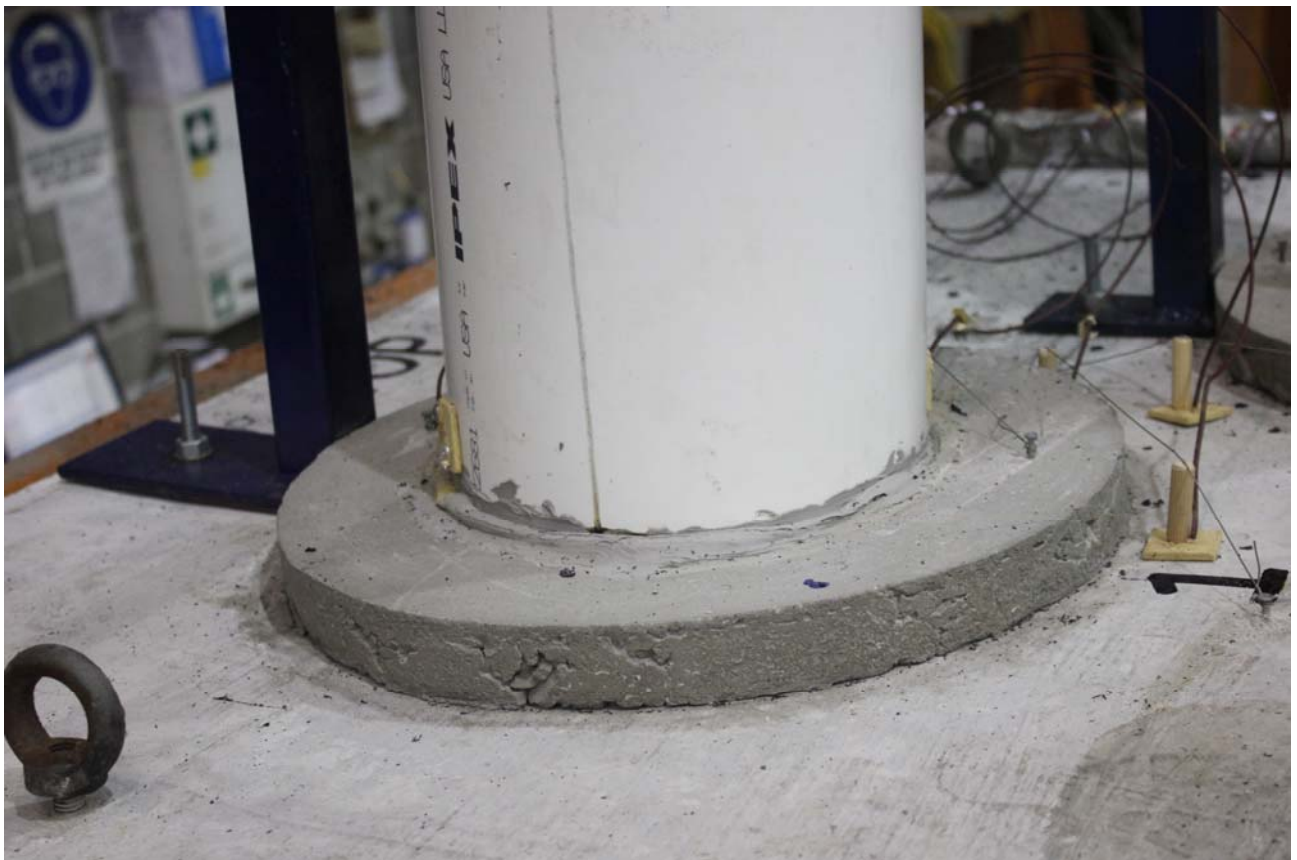
PHOTOGRAPH 8 – SPECIMEN 1 AFTER 222 MINUTES OF TESTING

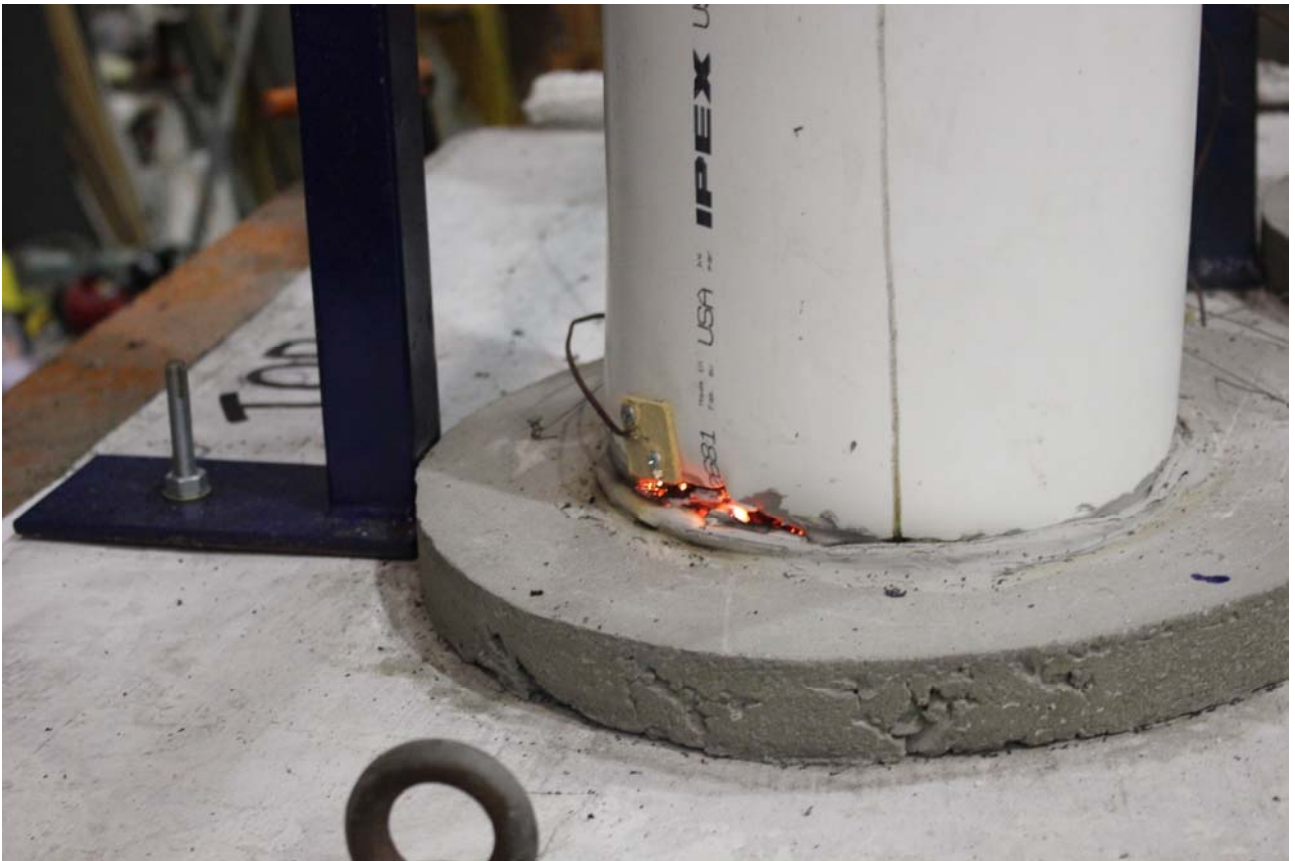
PHOTOGRAPH 9 – SPECIMEN 1 AFTER 232 MINUTES OF TESTING

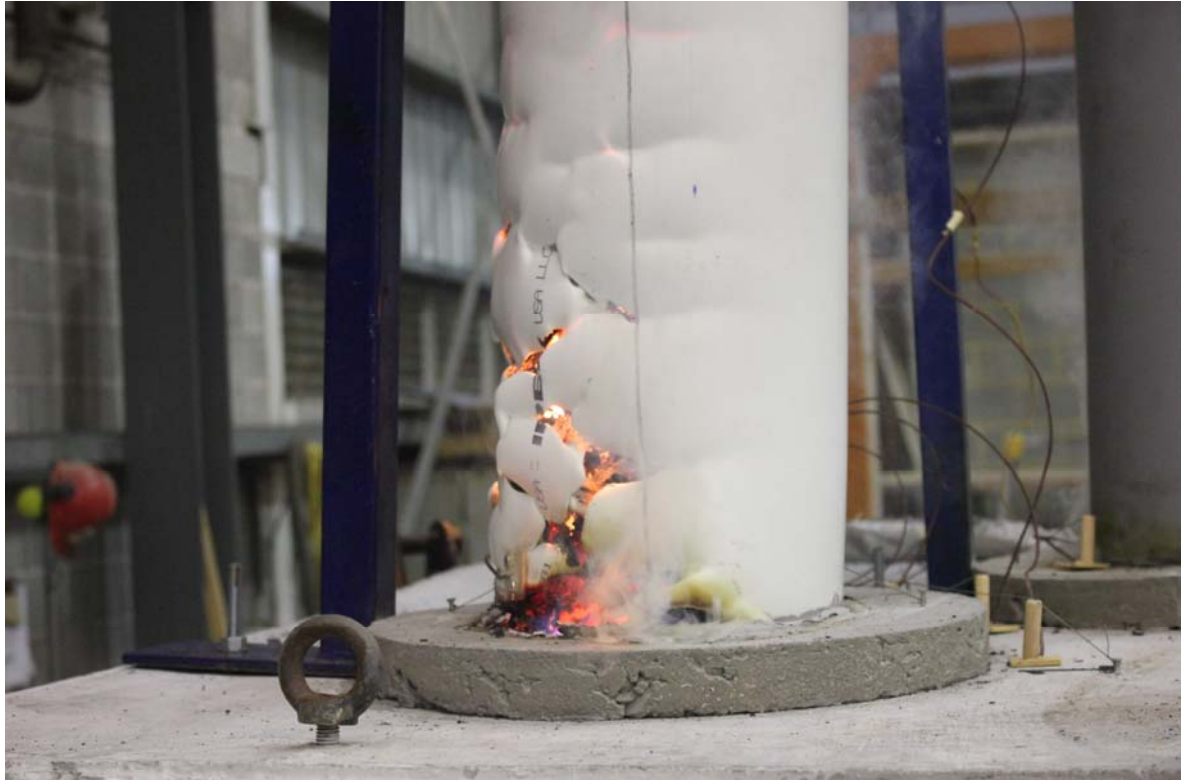
PHOTOGRAPH 10 – SPECIMEN 1 AFTER 238 MINUTES OF TESTING

- 236 minutes - Integrity failure of Specimen 1 - Cotton wool pad applied to base of Specimen 1 near where a red glow is visible through pipe. Ignition of cotton pad noted at this time.
- 237 minutes - Heavy smoke fluing from Specimen 1.
- 238 minutes - Sustained flaming at the base of Specimen 1.
- 241 minutes - Test terminated.

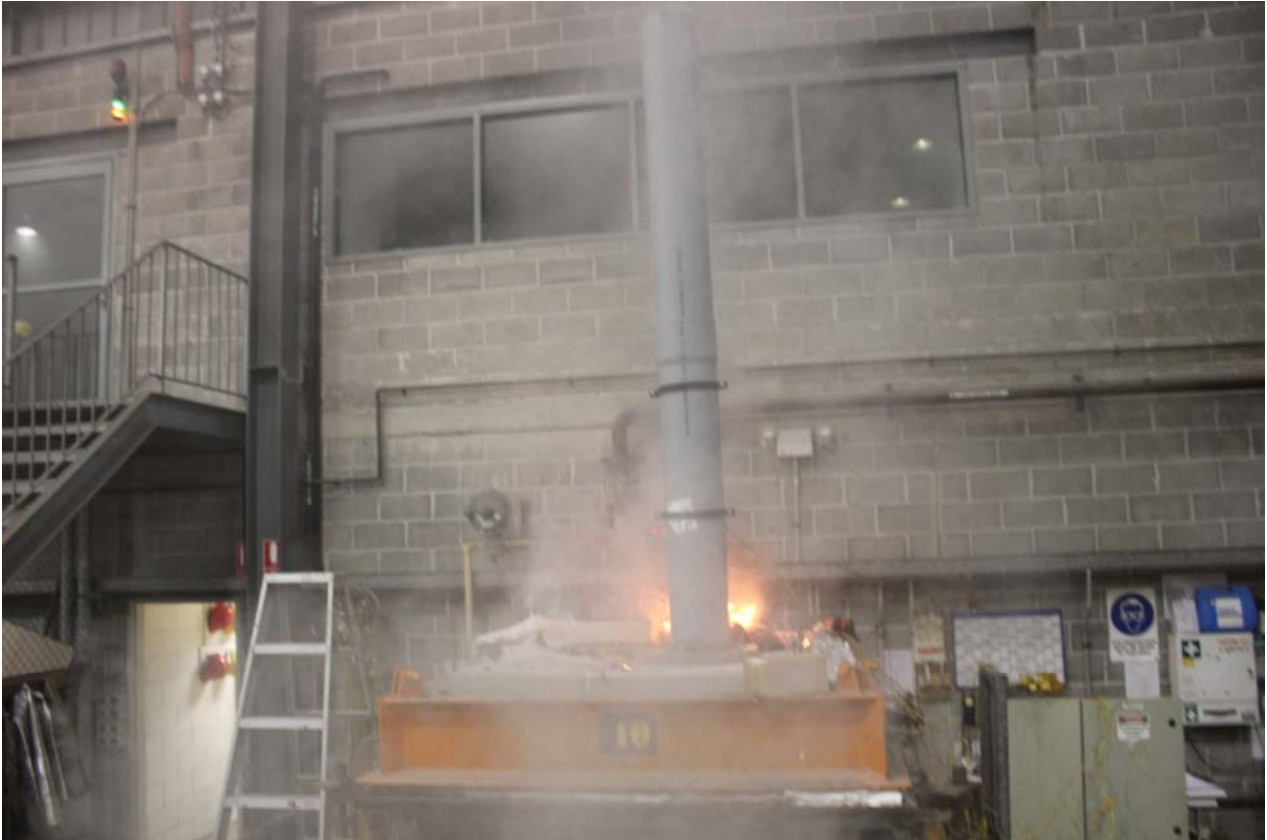
PHOTOGRAPH 11 – UNEXPOSED FACE OF SPECIMEN AT CONCLUSION OF TESTING

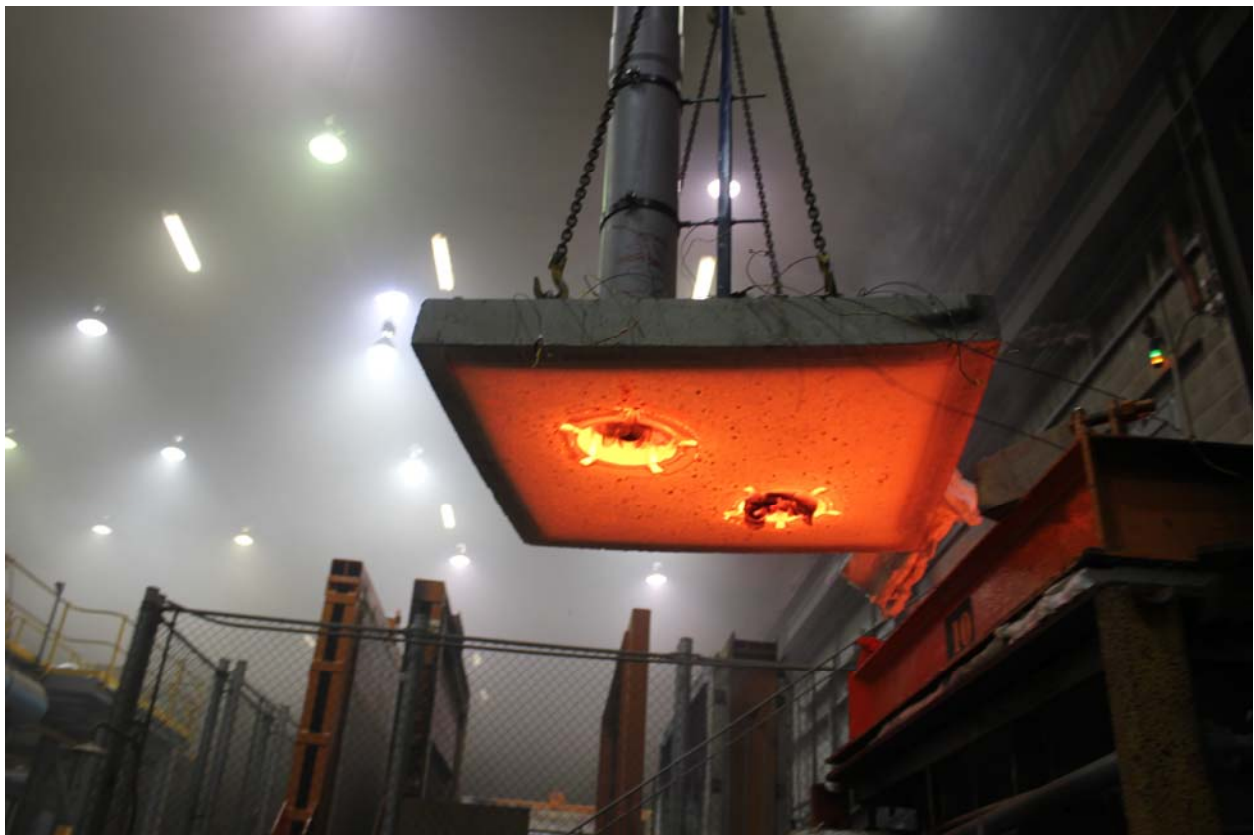
PHOTOGRAPH 12 – EXPOSED FACE OF SPECIMENS AT CONCLUSION OF TESTING
