Fire-resistance test on fire collars protecting a concrete slab penetrated by services

Test Report

Author: Peter Gordon
Report number: FSP 2072
Date: 11 May 2020

Sponsored Investigation No. FSP 2072

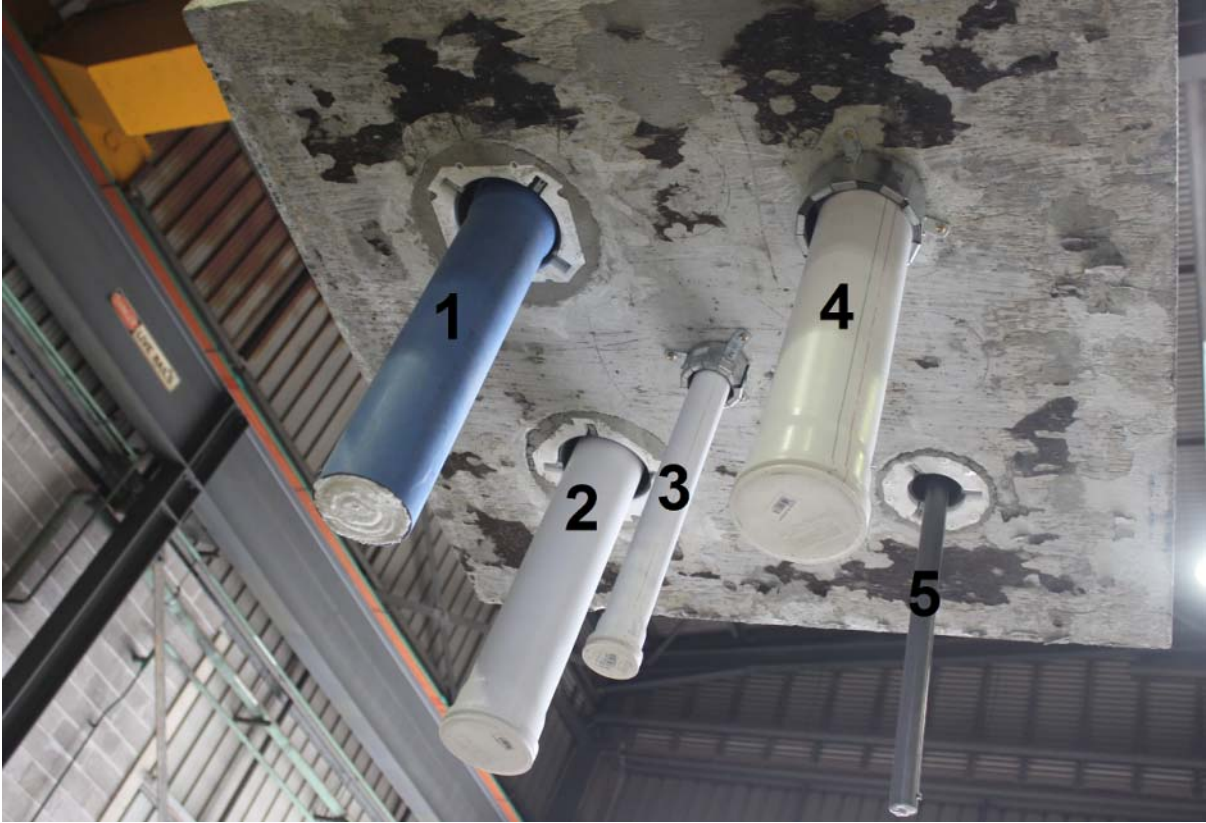
PHOTOGRAPH 1 – EXPOSED FACE OF SPECIMENS PRIOR TO TESTING

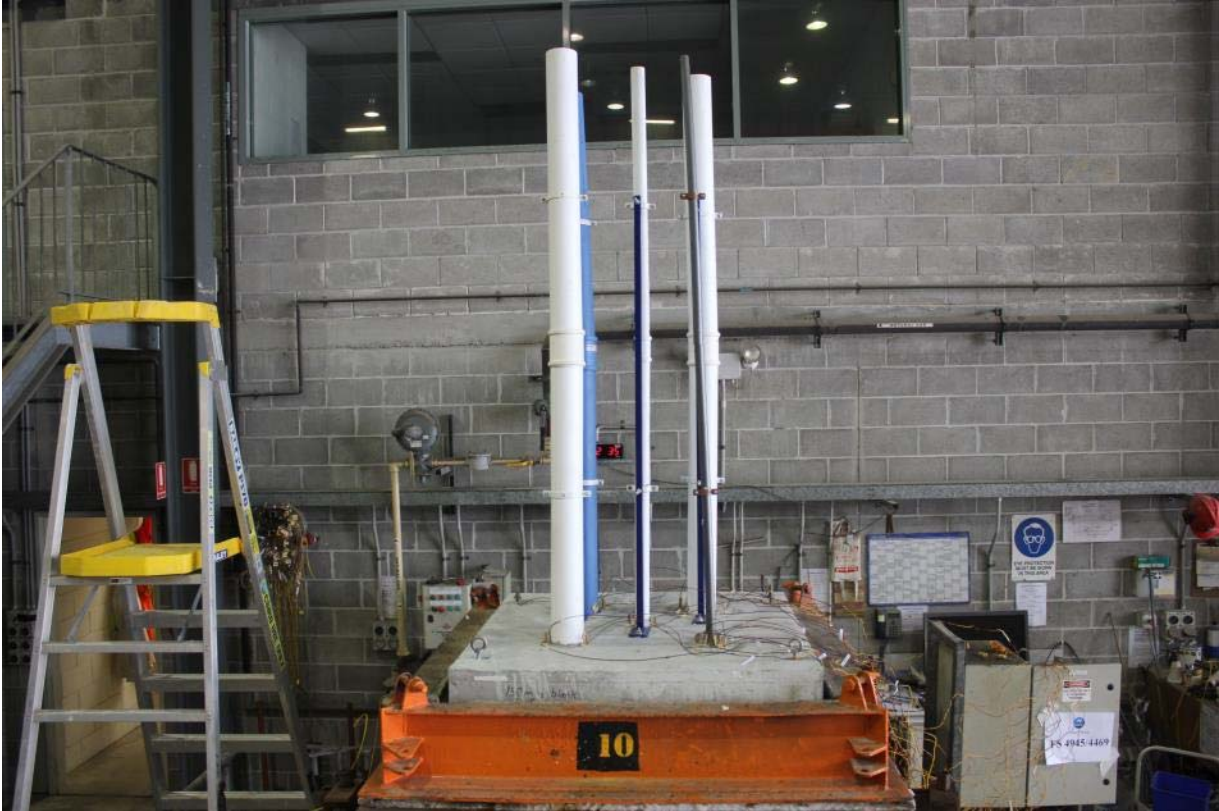
PHOTOGRAPH 2 – UNEXPOSED FACE OF SPECIMENS PRIOR TO TESTING

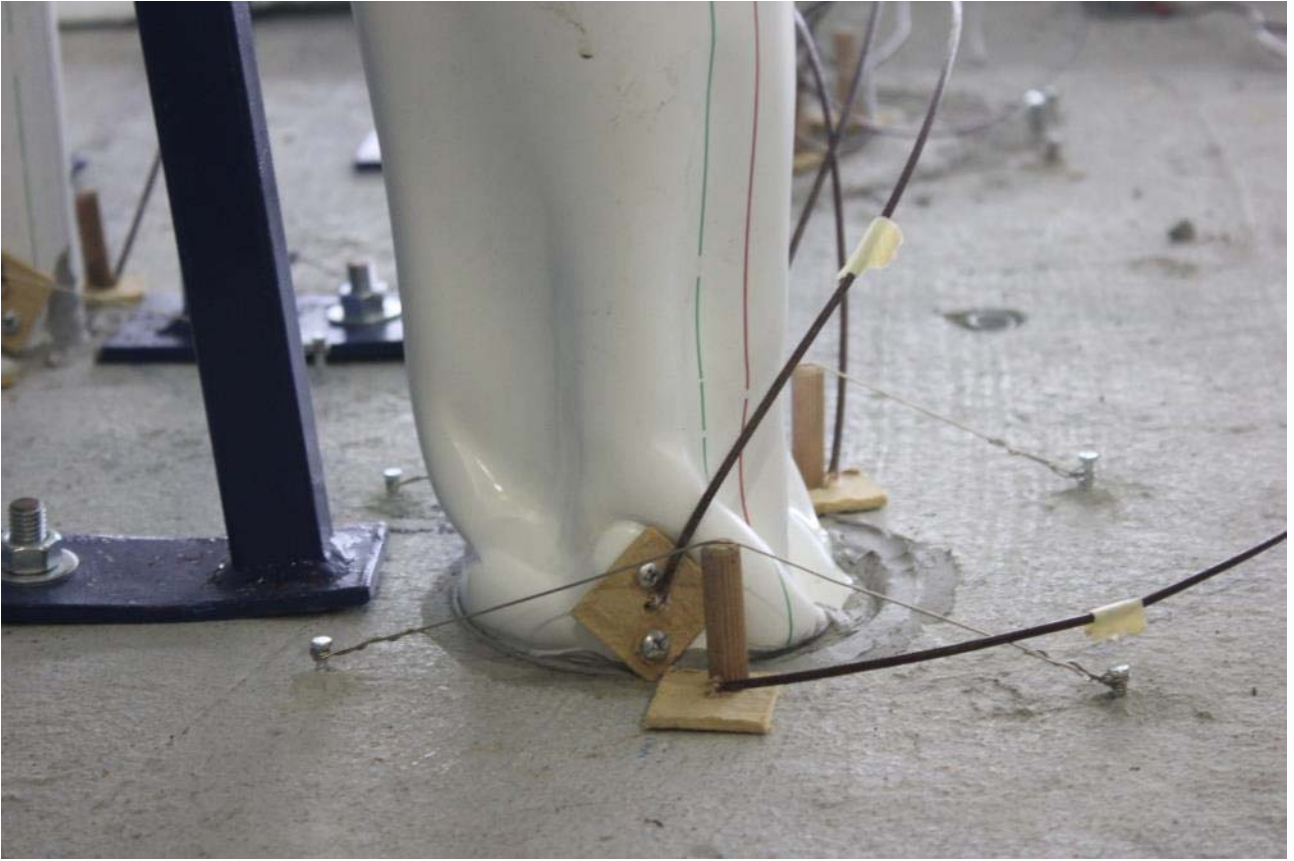
PHOTOGRAPH 3 – SPECIMEN 4 AFTER 5 MINUTES OF TESTING

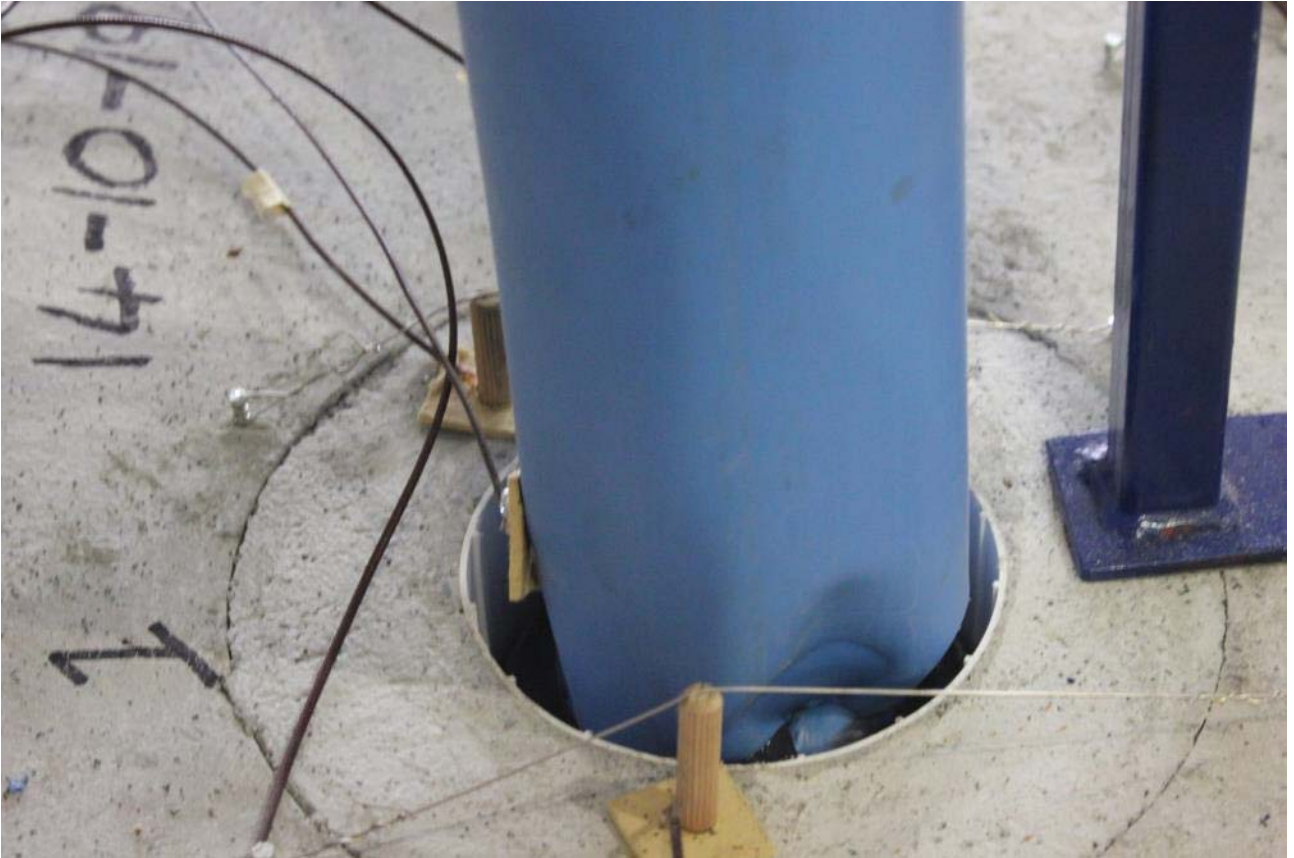
PHOTOGRAPH 4 – SPECIMEN 1 AFTER 15 MINUTES OF TESTING

- 11 minutes - Smoke has ceased fluing from the end of the pipe of Specimen 5.
- 15 minutes - Light smoke has resumed fluing from the end of the pipe of Specimen 1.

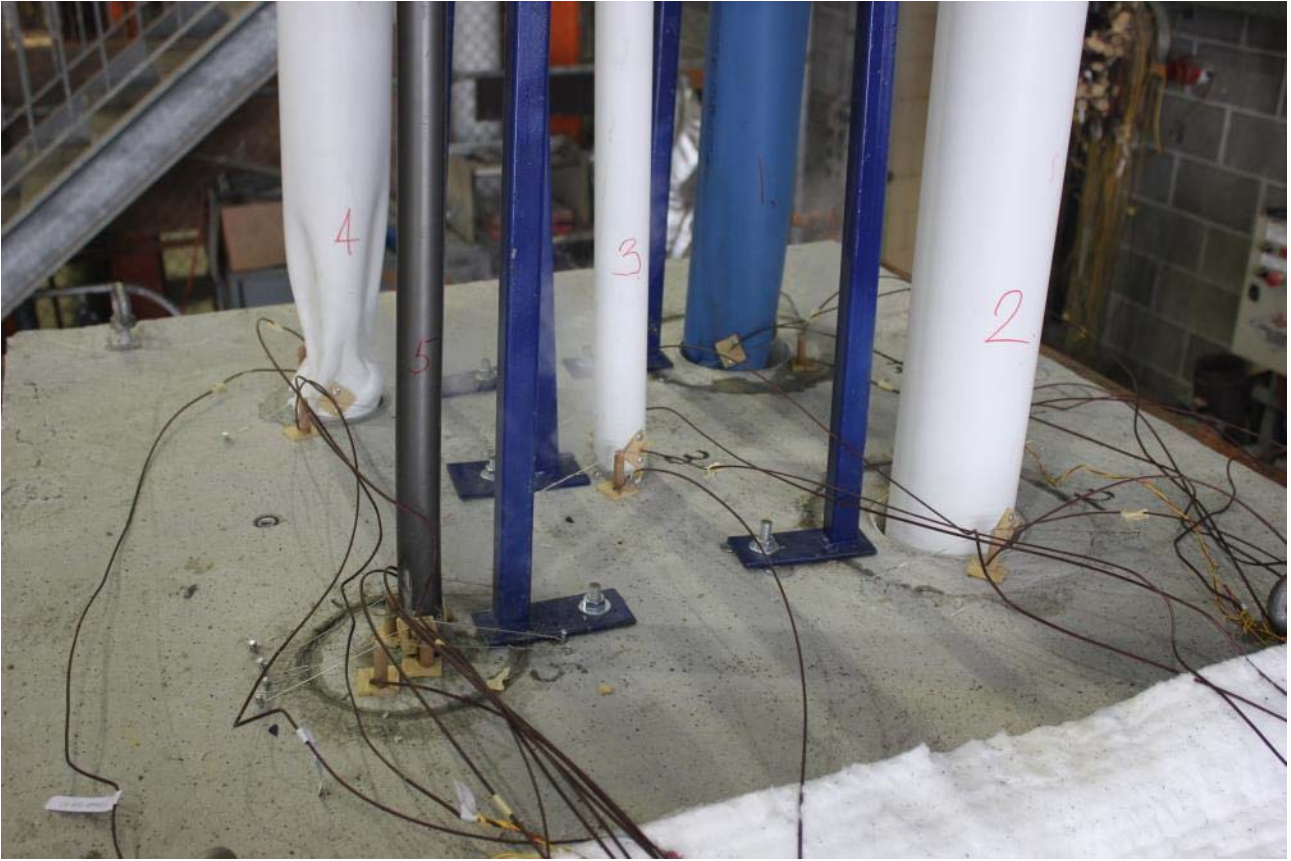
PHOTOGRAPH 5 – SPECIMENS AFTER 30 MINUTES OF TESTING

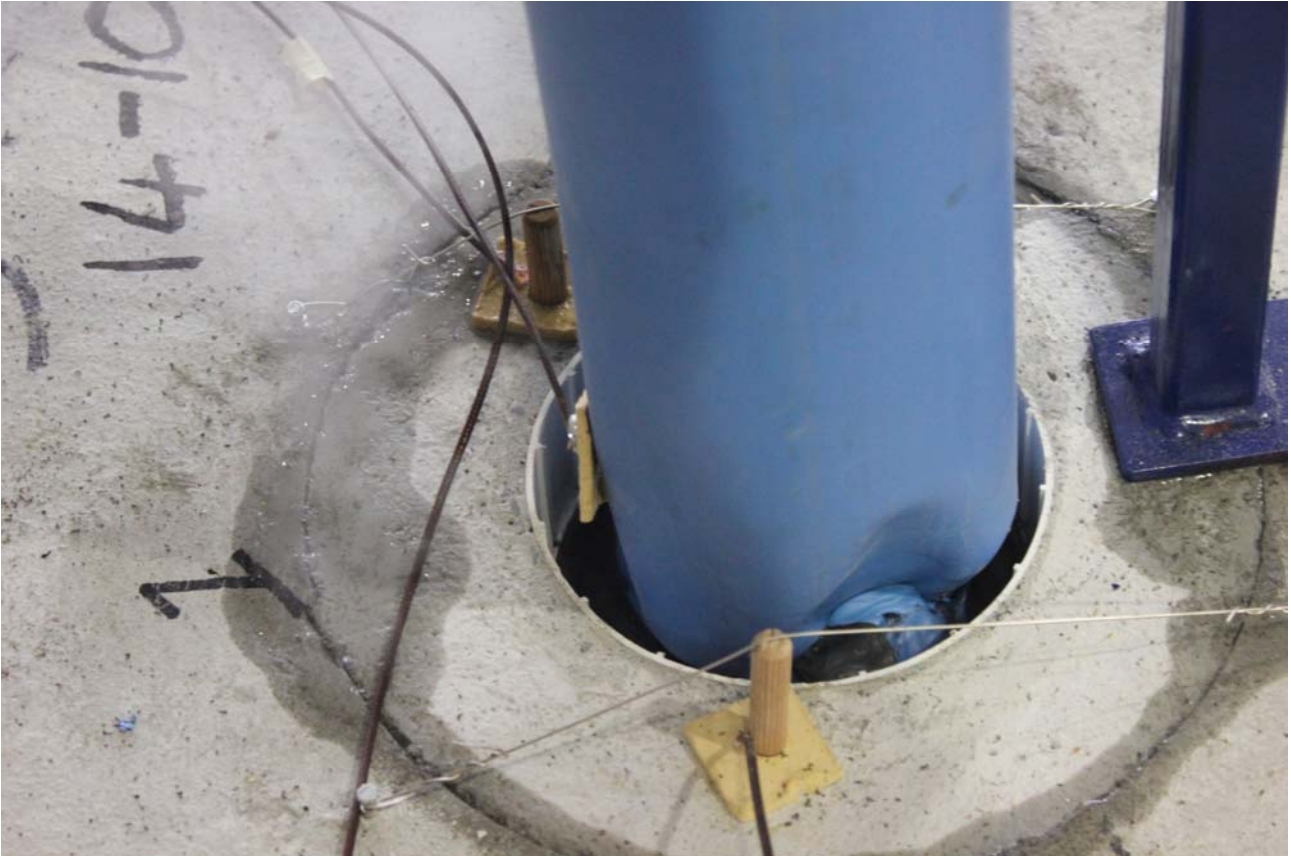
PHOTOGRAPH 6 – SPECIMEN1 AFTER 34 MINUTES OF TESTING

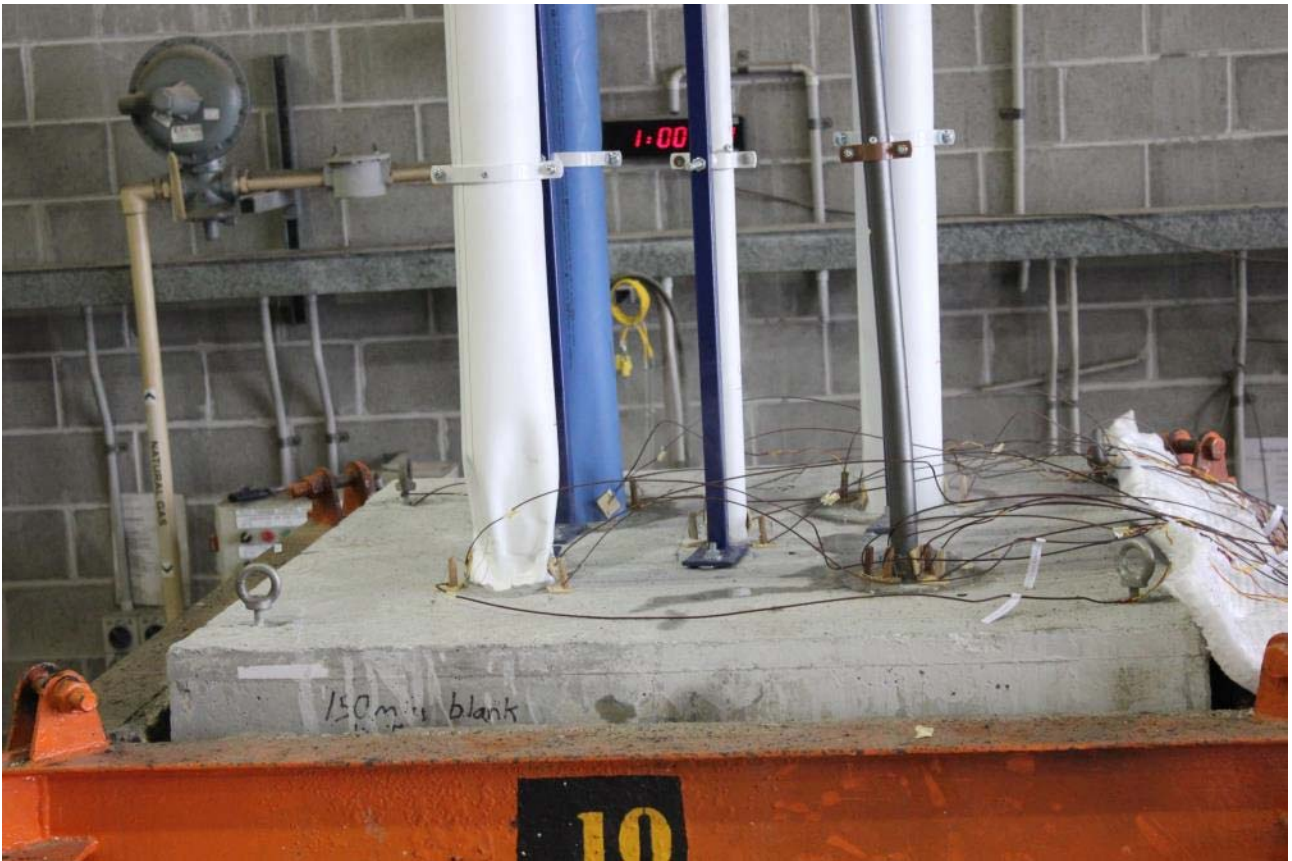
PHOTOGRAPH 7 – SPECIMENS AFTER 60 MINUTES OF TESTING

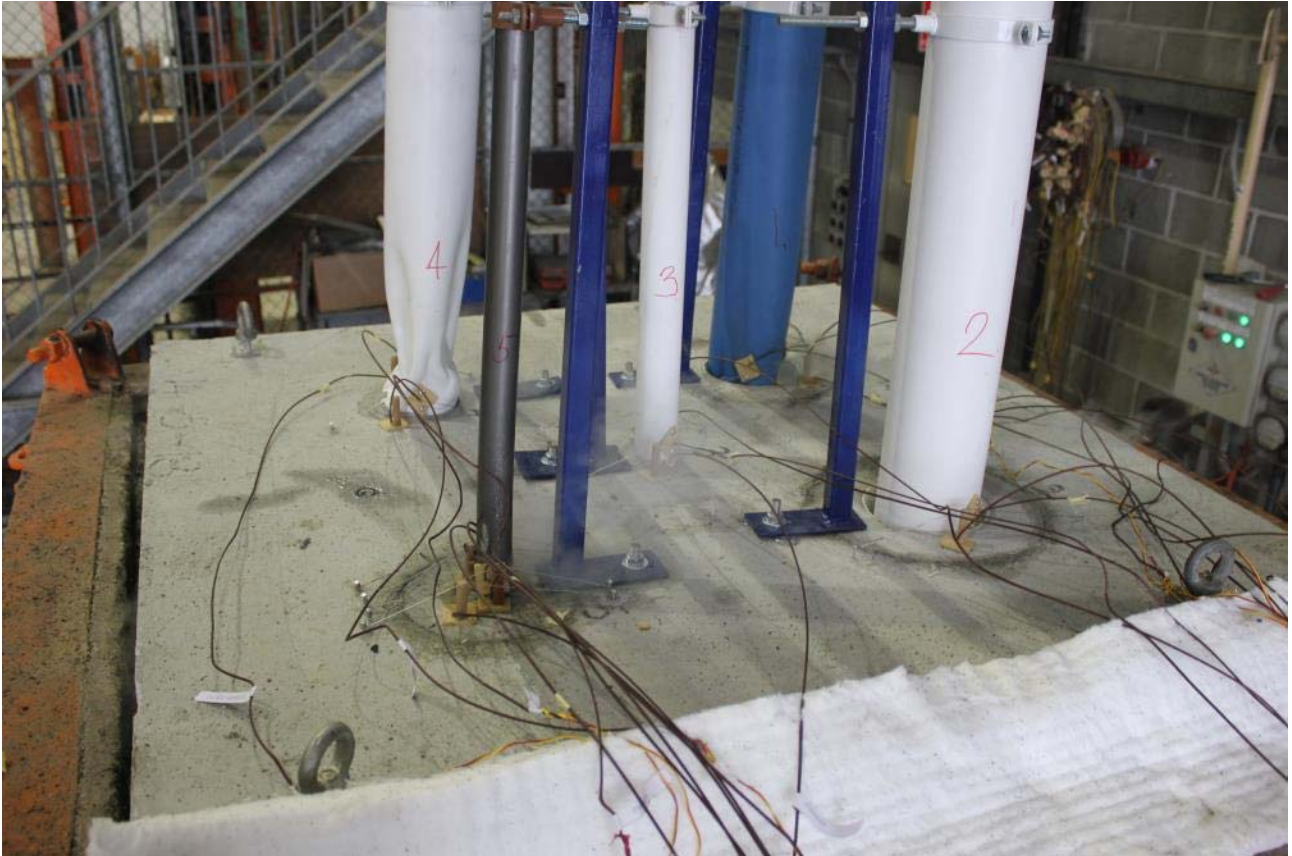
PHOTOGRAPH 8 – SPECIMENS AFTER 90 MINUTES OF TESTING

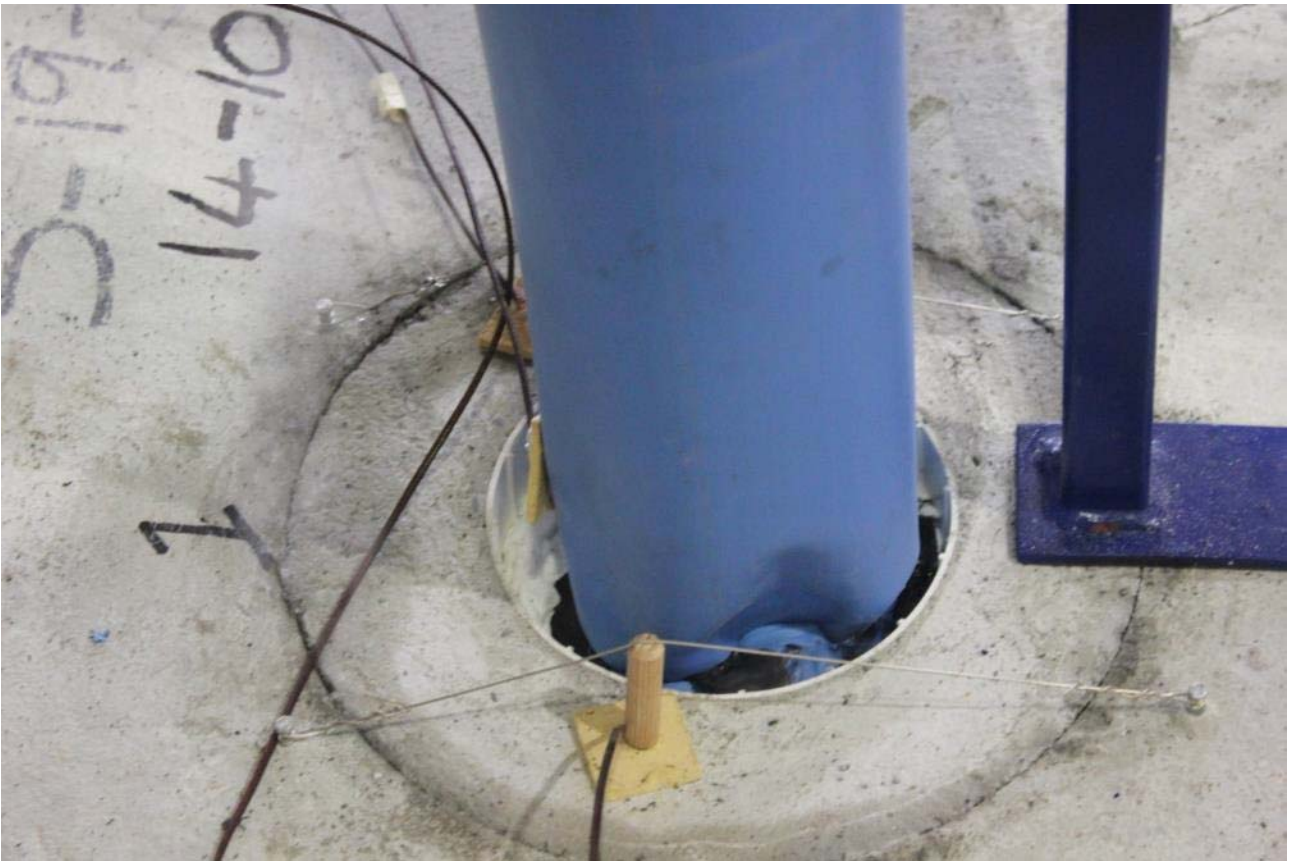
PHOTOGRAPH 9 – SPECIMEN 1 AFTER 95 MINUTES OF TESTING

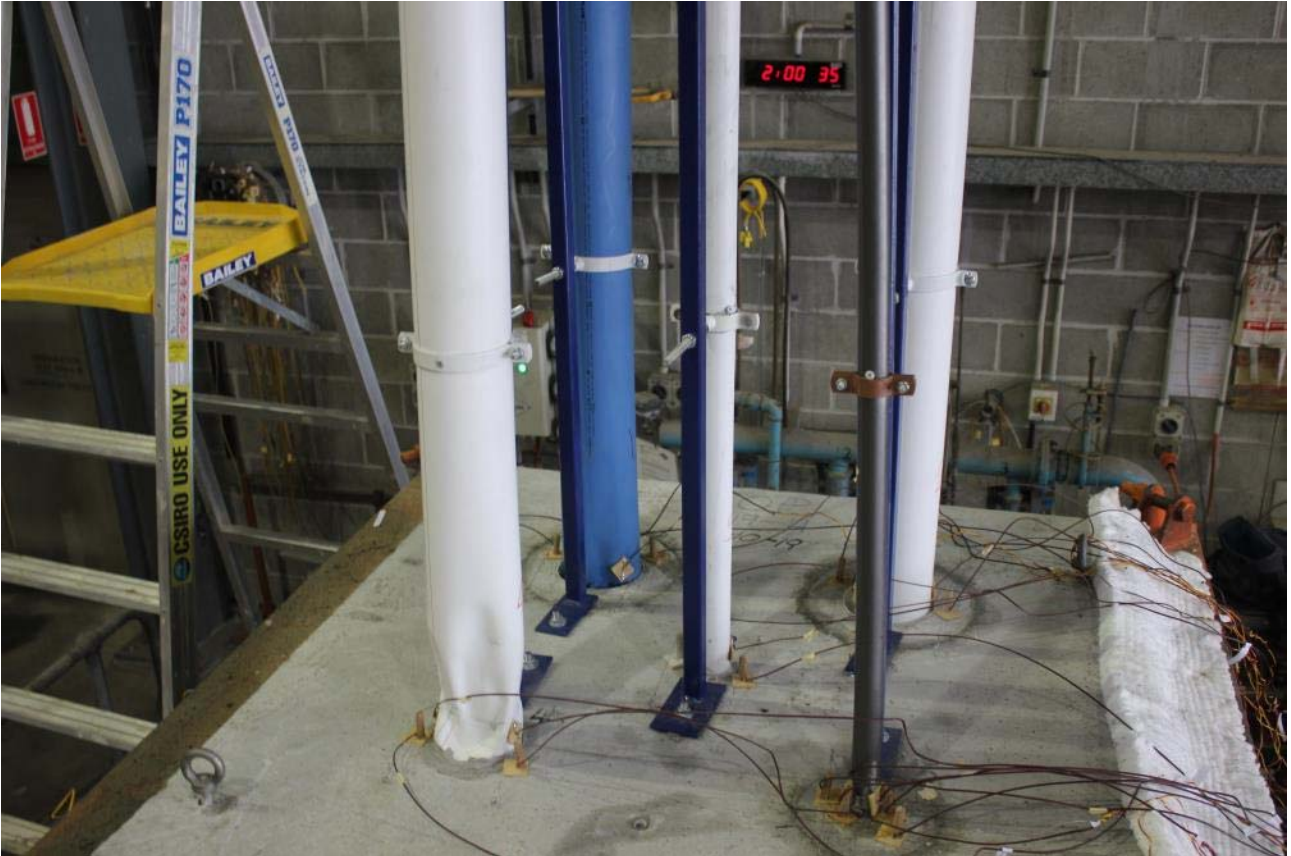
PHOTOGRAPH 10 – SPECIMENS AFTER 120 MINUTES OF TESTING

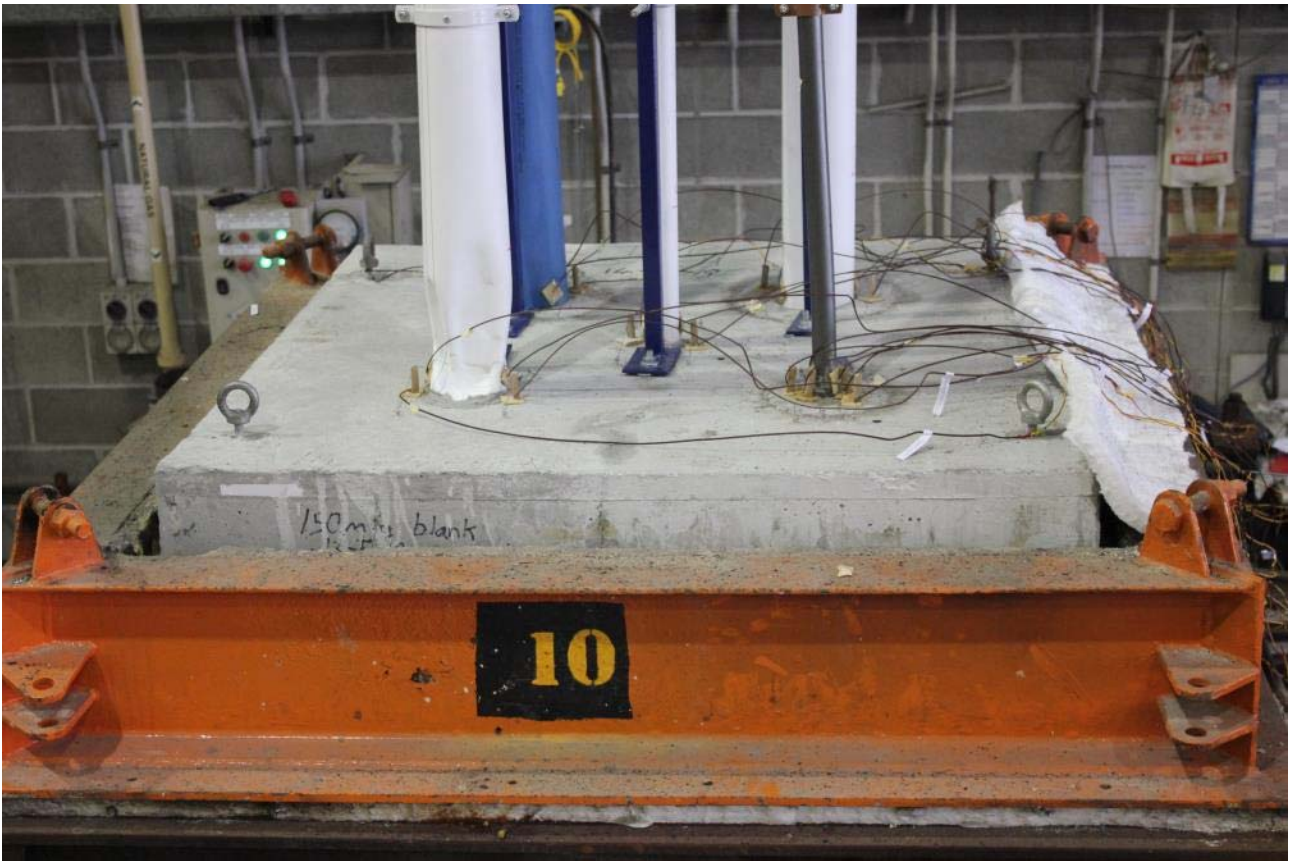
PHOTOGRAPH 11 – SPECIMENS AFTER 180 MINUTES OF TESTING

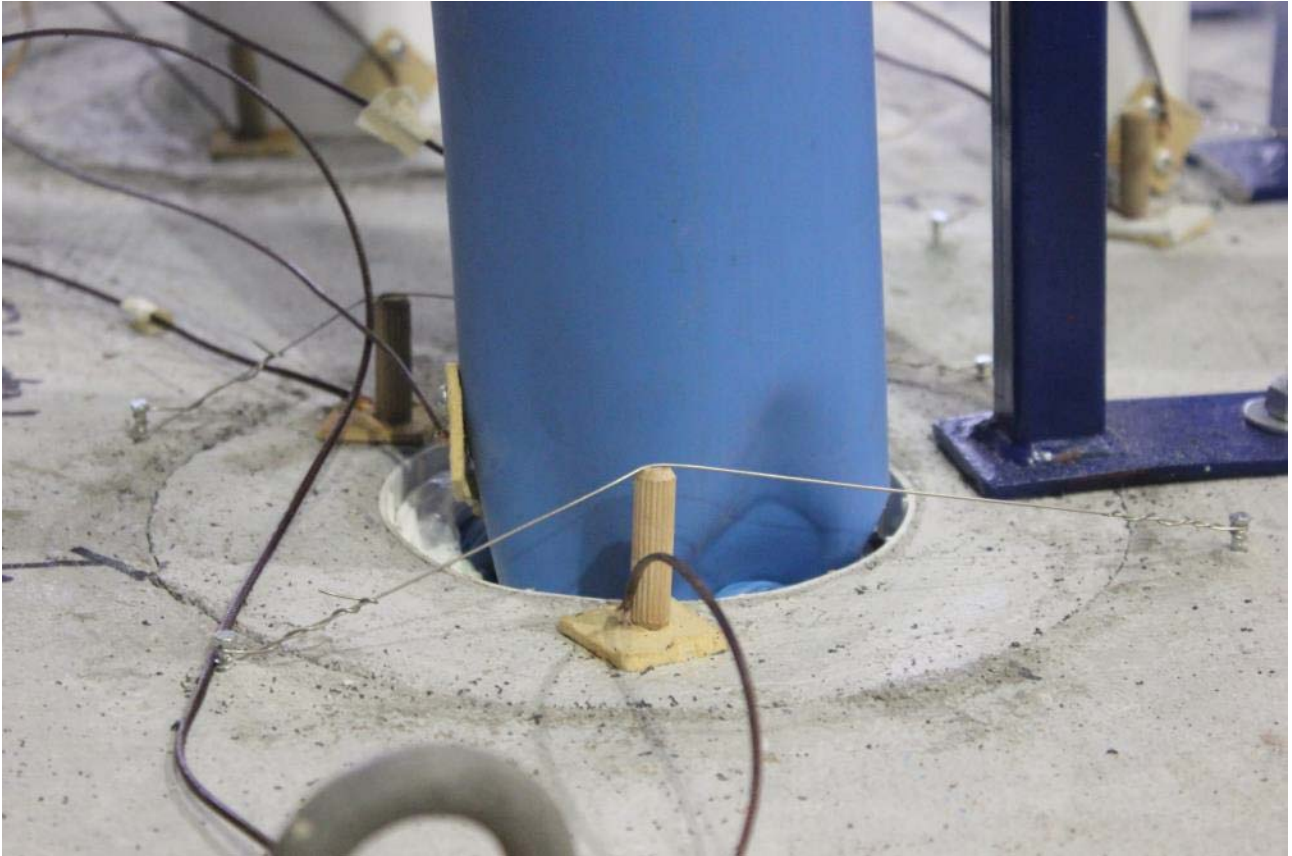
PHOTOGRAPH 12 – SPECIMEN 1 AFTER 181 MINUTES OF TESTING

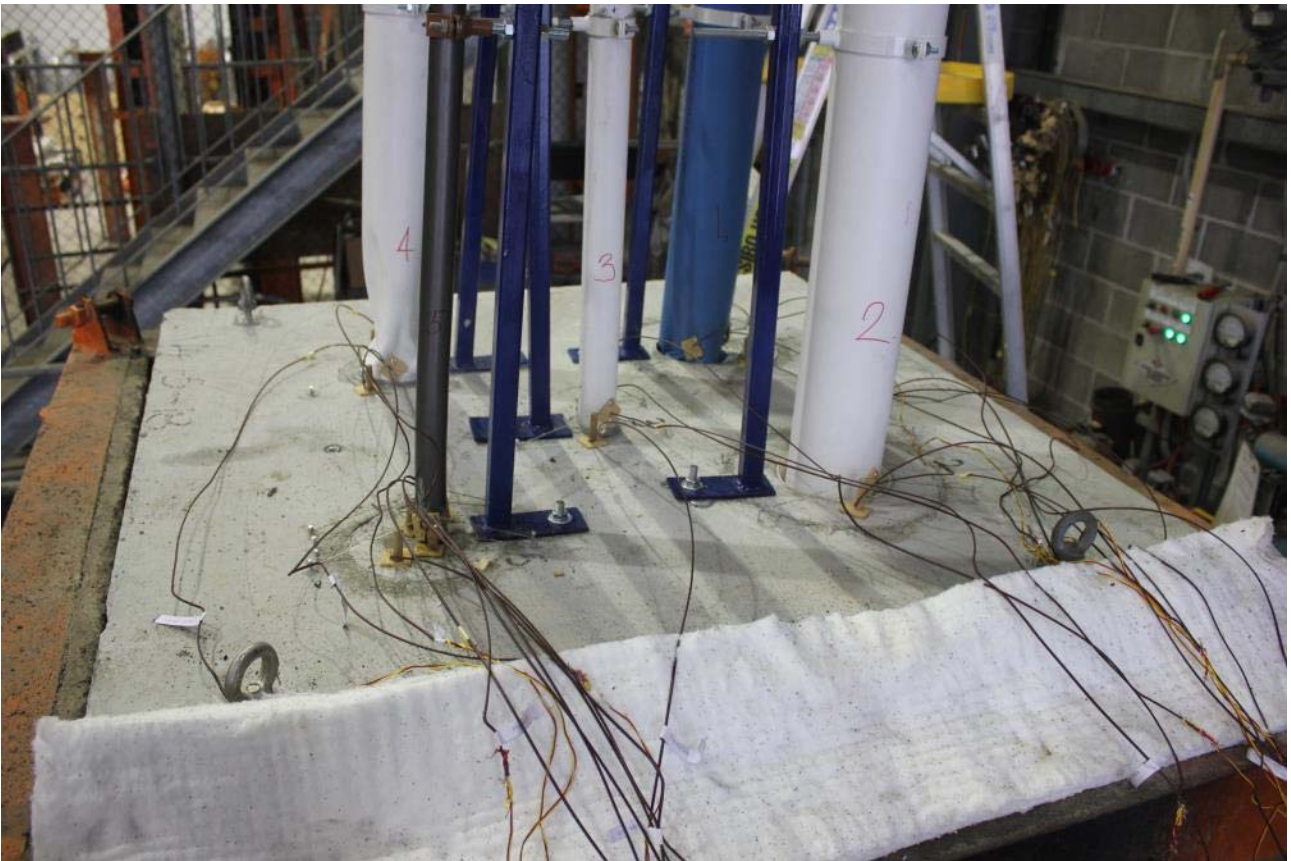
PHOTOGRAPH 13 – SPECIMENS AFTER 210 MINUTES OF TESTING

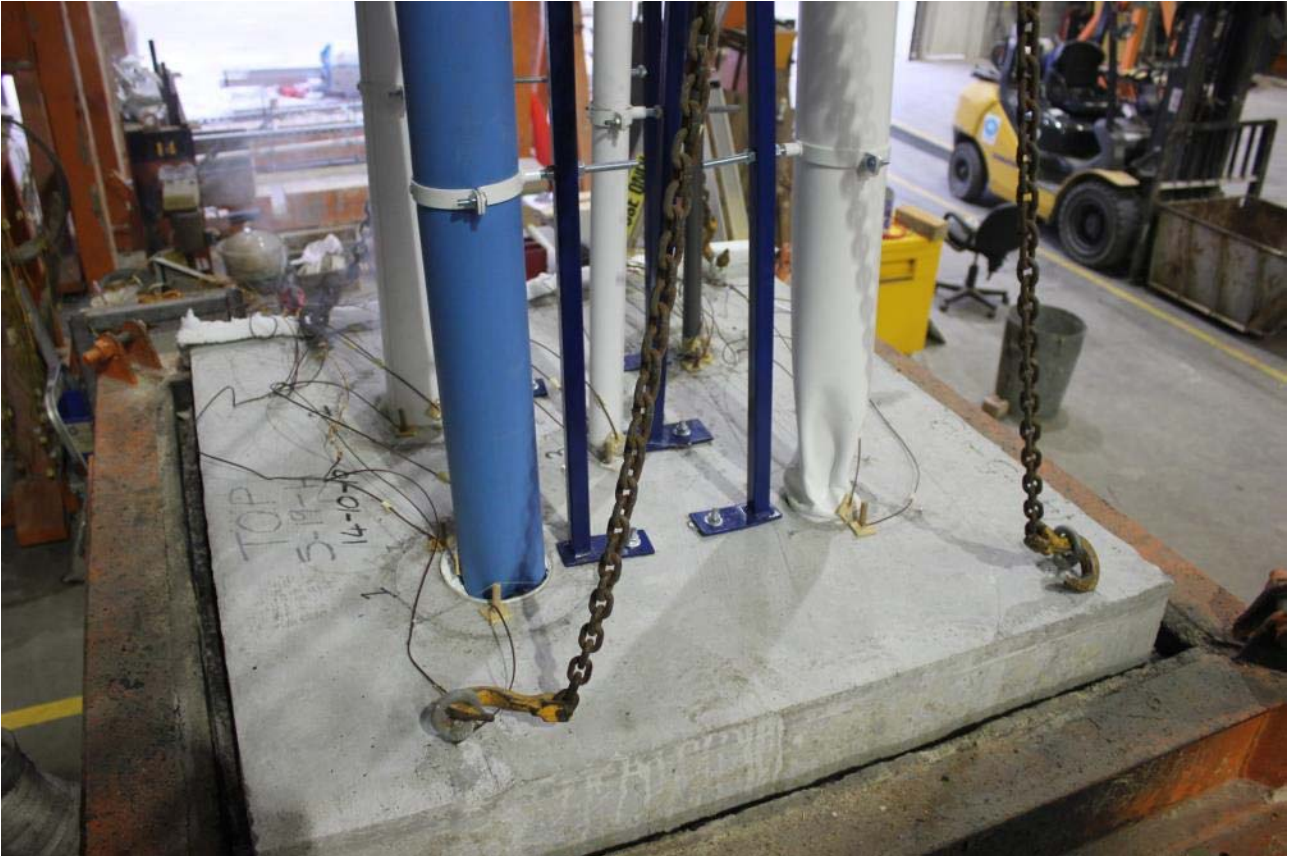
PHOTOGRAPH 14 – SPECIMENS AFTER 240 MINUTES OF TESTING

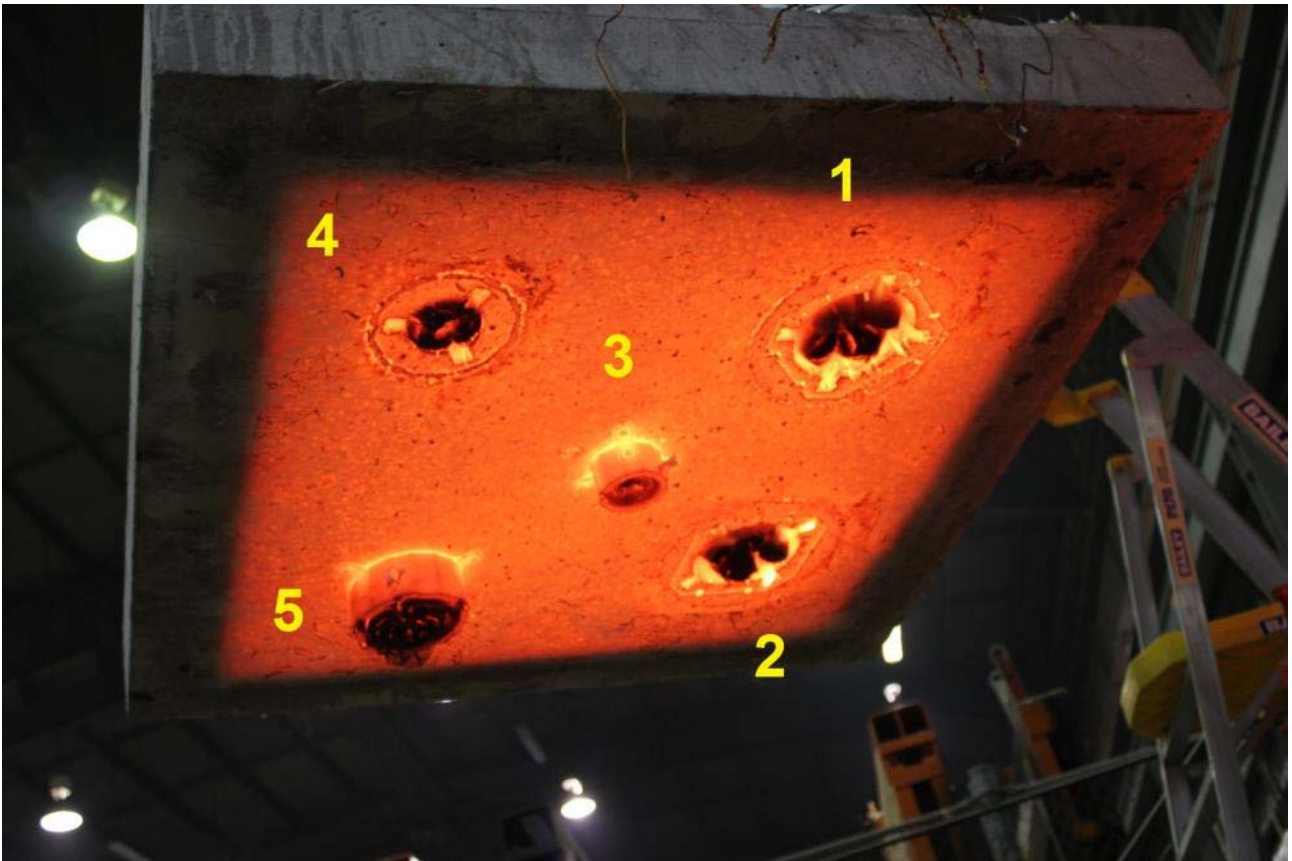
PHOTOGRAPH 15 – EXPOSED FACE OF SPECIMENS AFTER THE CONCLUSION OF TESTING

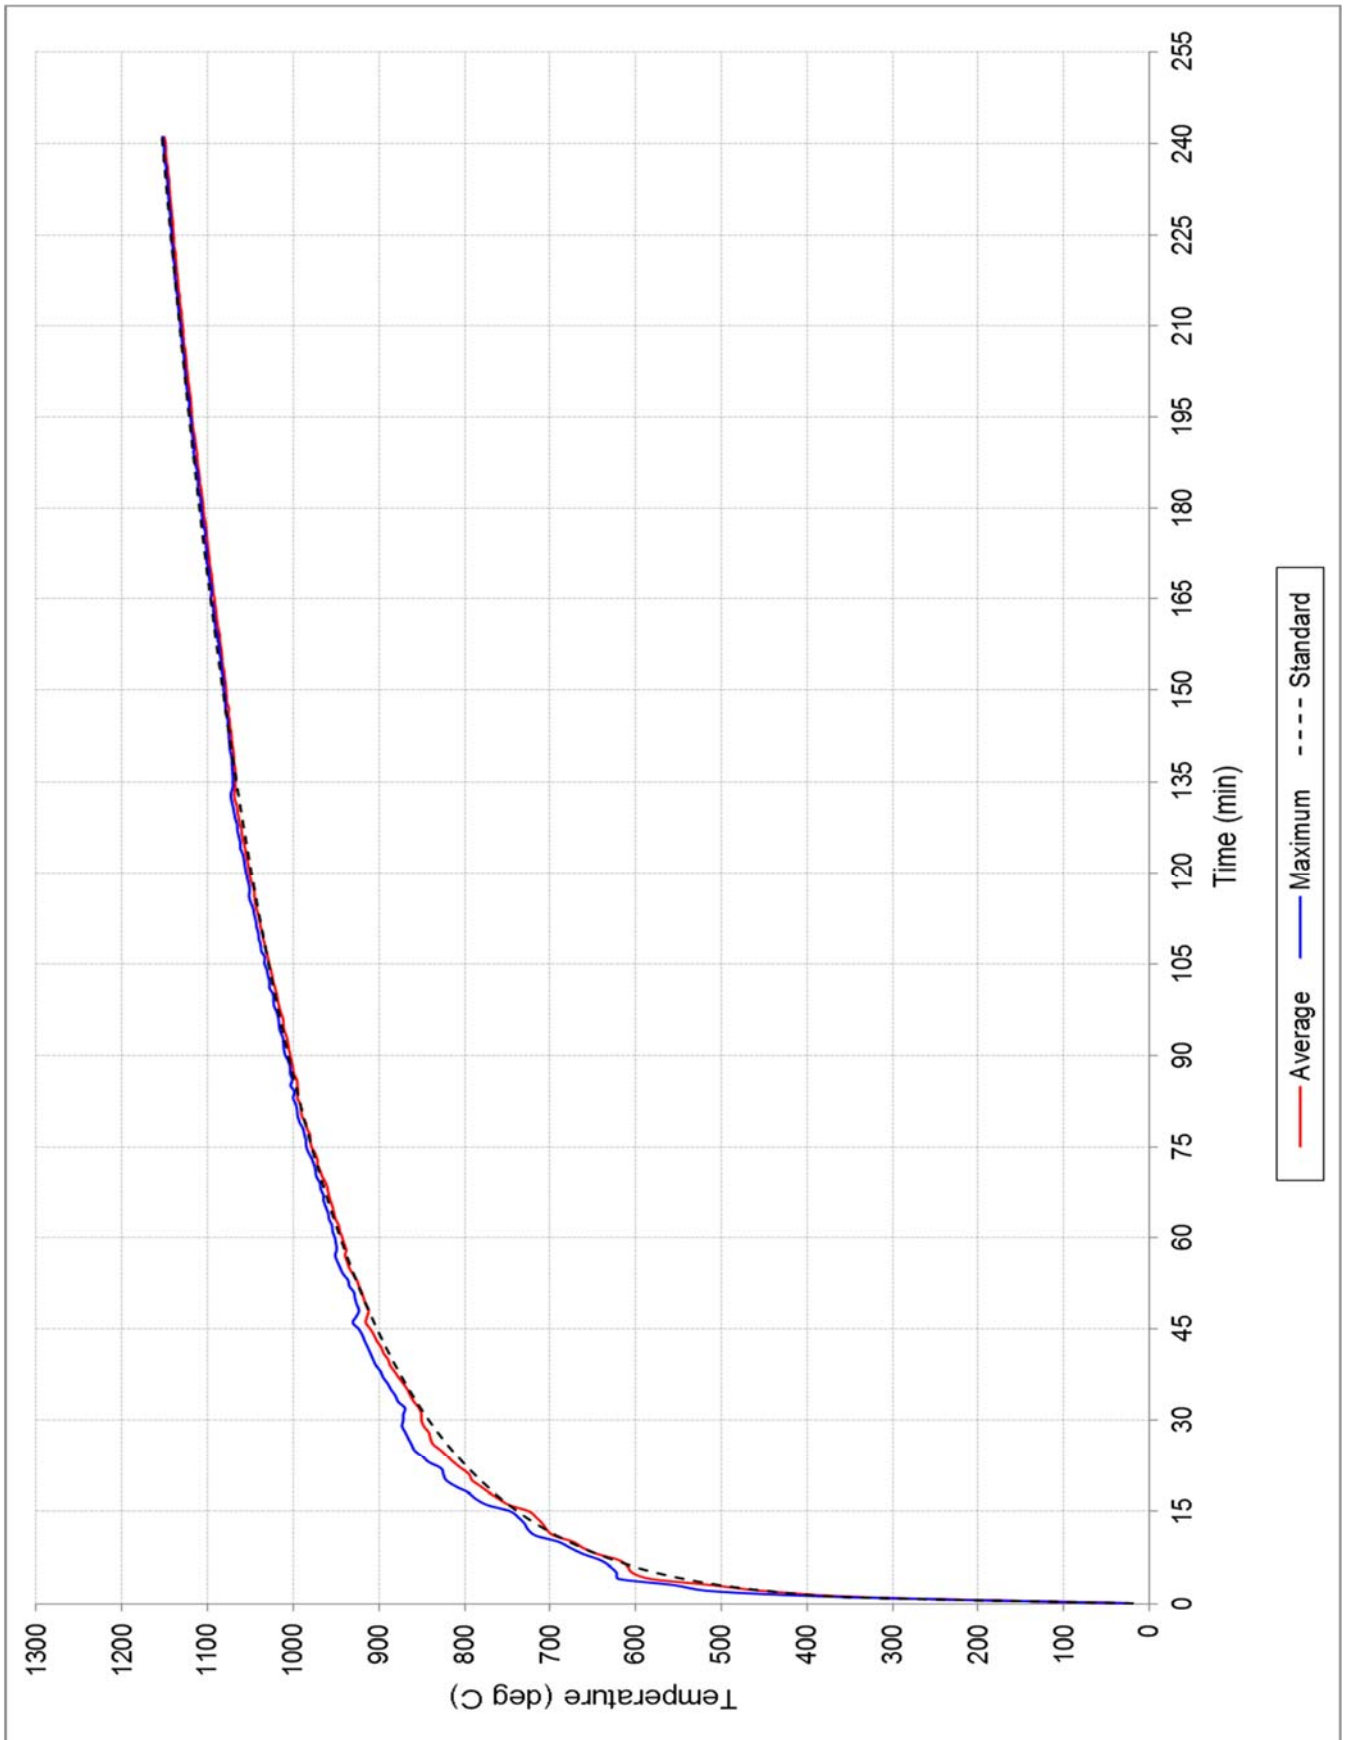
FIGURE 1 – FURNACE TEMPERATURE

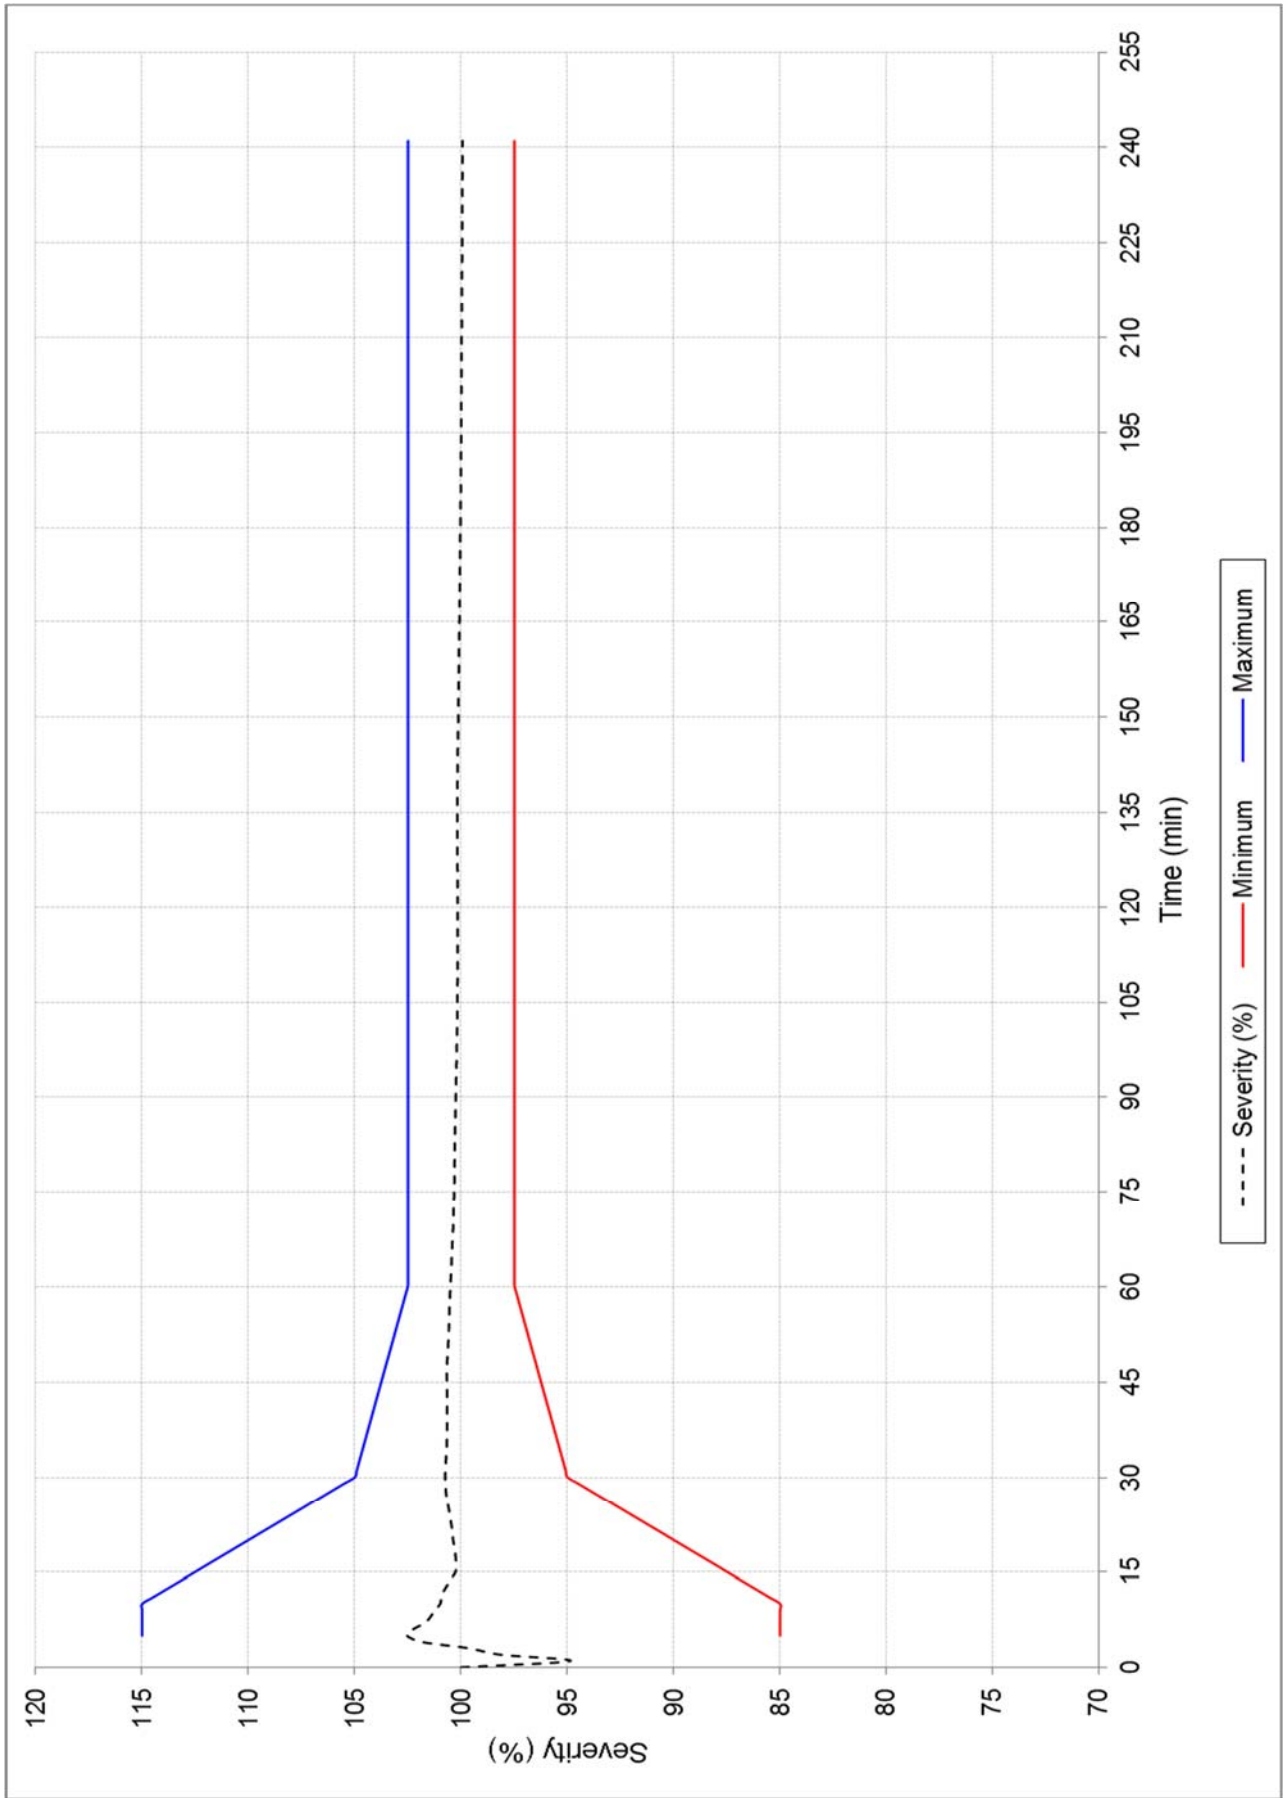
FIGURE 2 – FURNACE SEVERITY
