Fire-resistance test on fire collars protecting a concrete slab penetrated by services

Test Report

Author: Peter Gordon
Report number: FSP 2072
Date: 11 May 2020

Sponsored Investigation No. FSP 2072

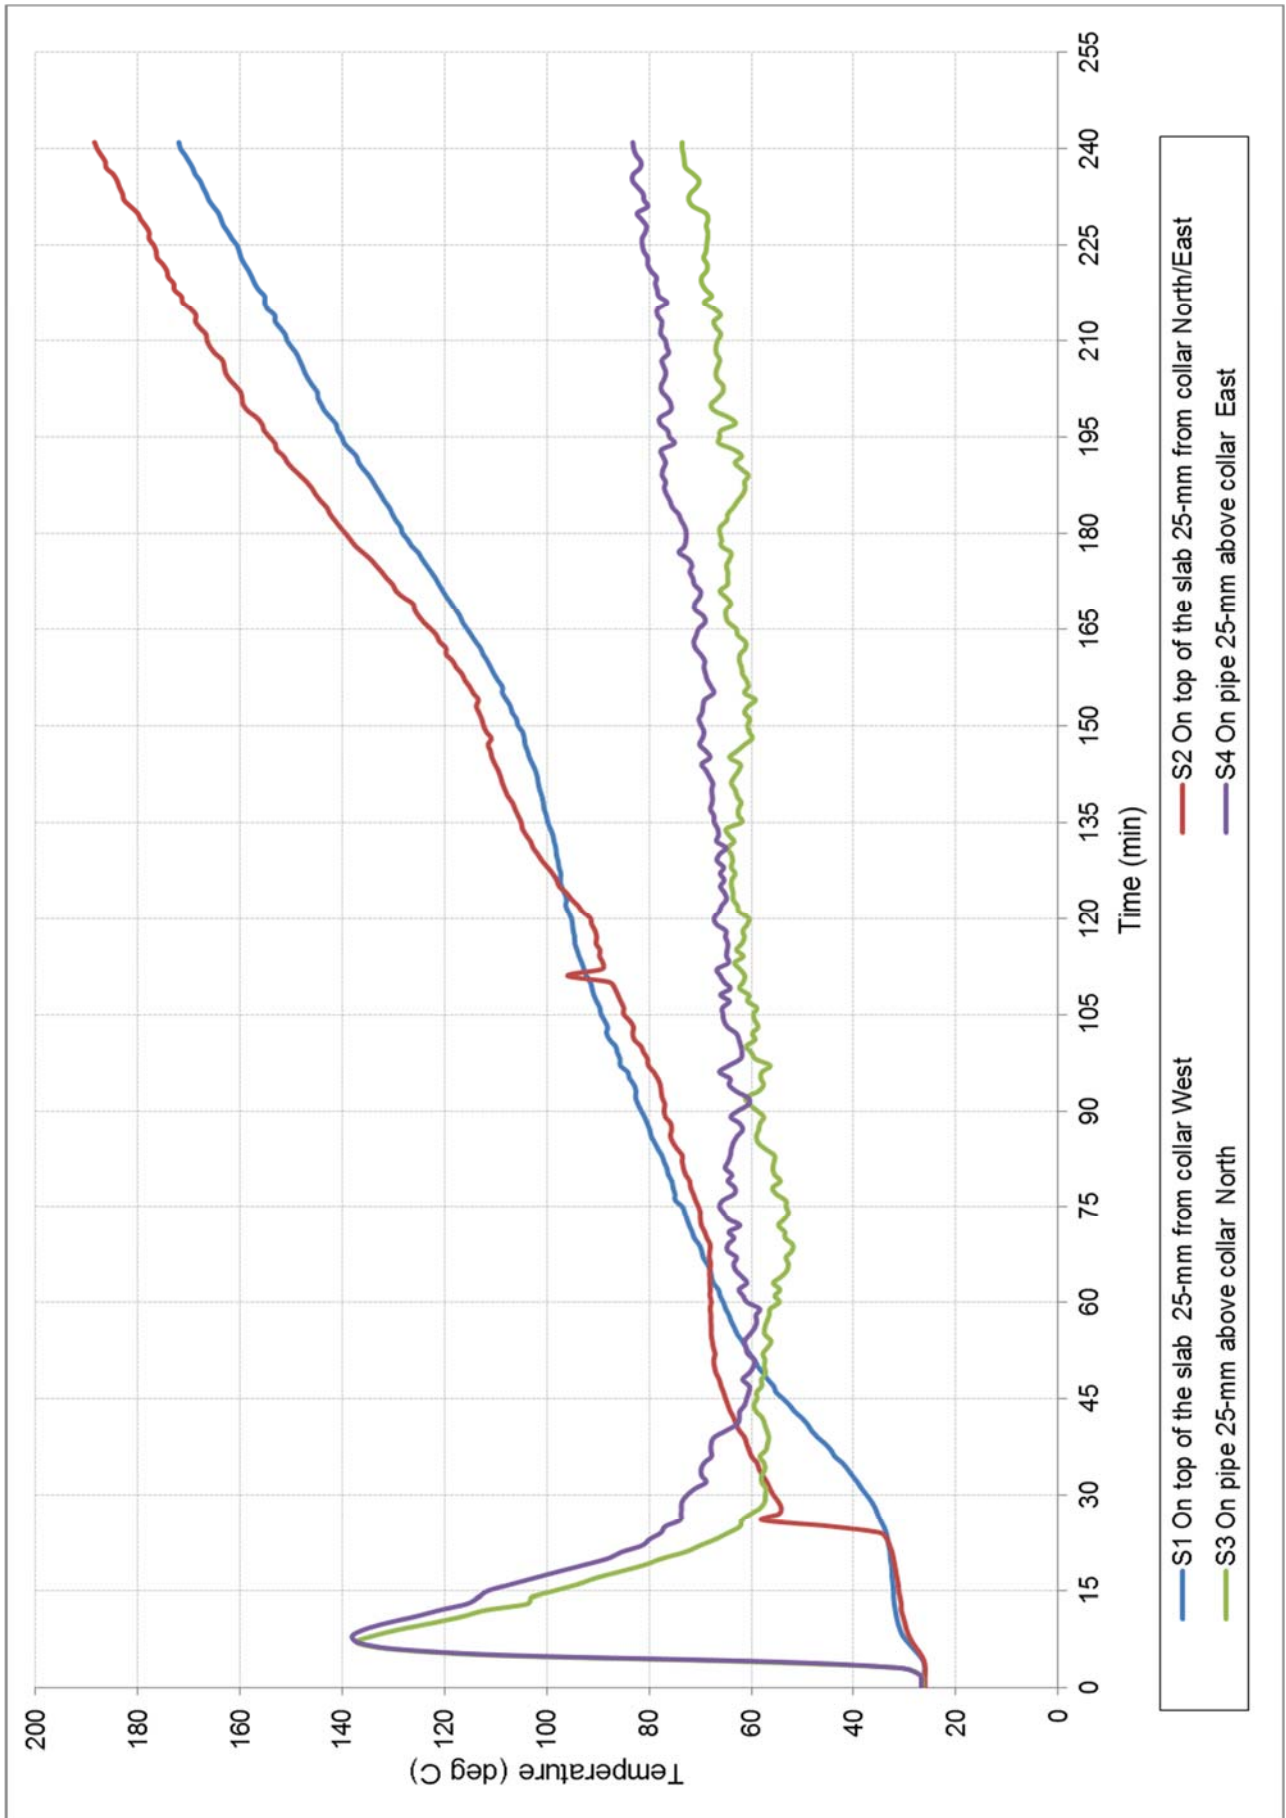
FIGURE 3 – SPECIMEN TEMPERATURE – ASSOCIATED WITH SPECIMEN 1

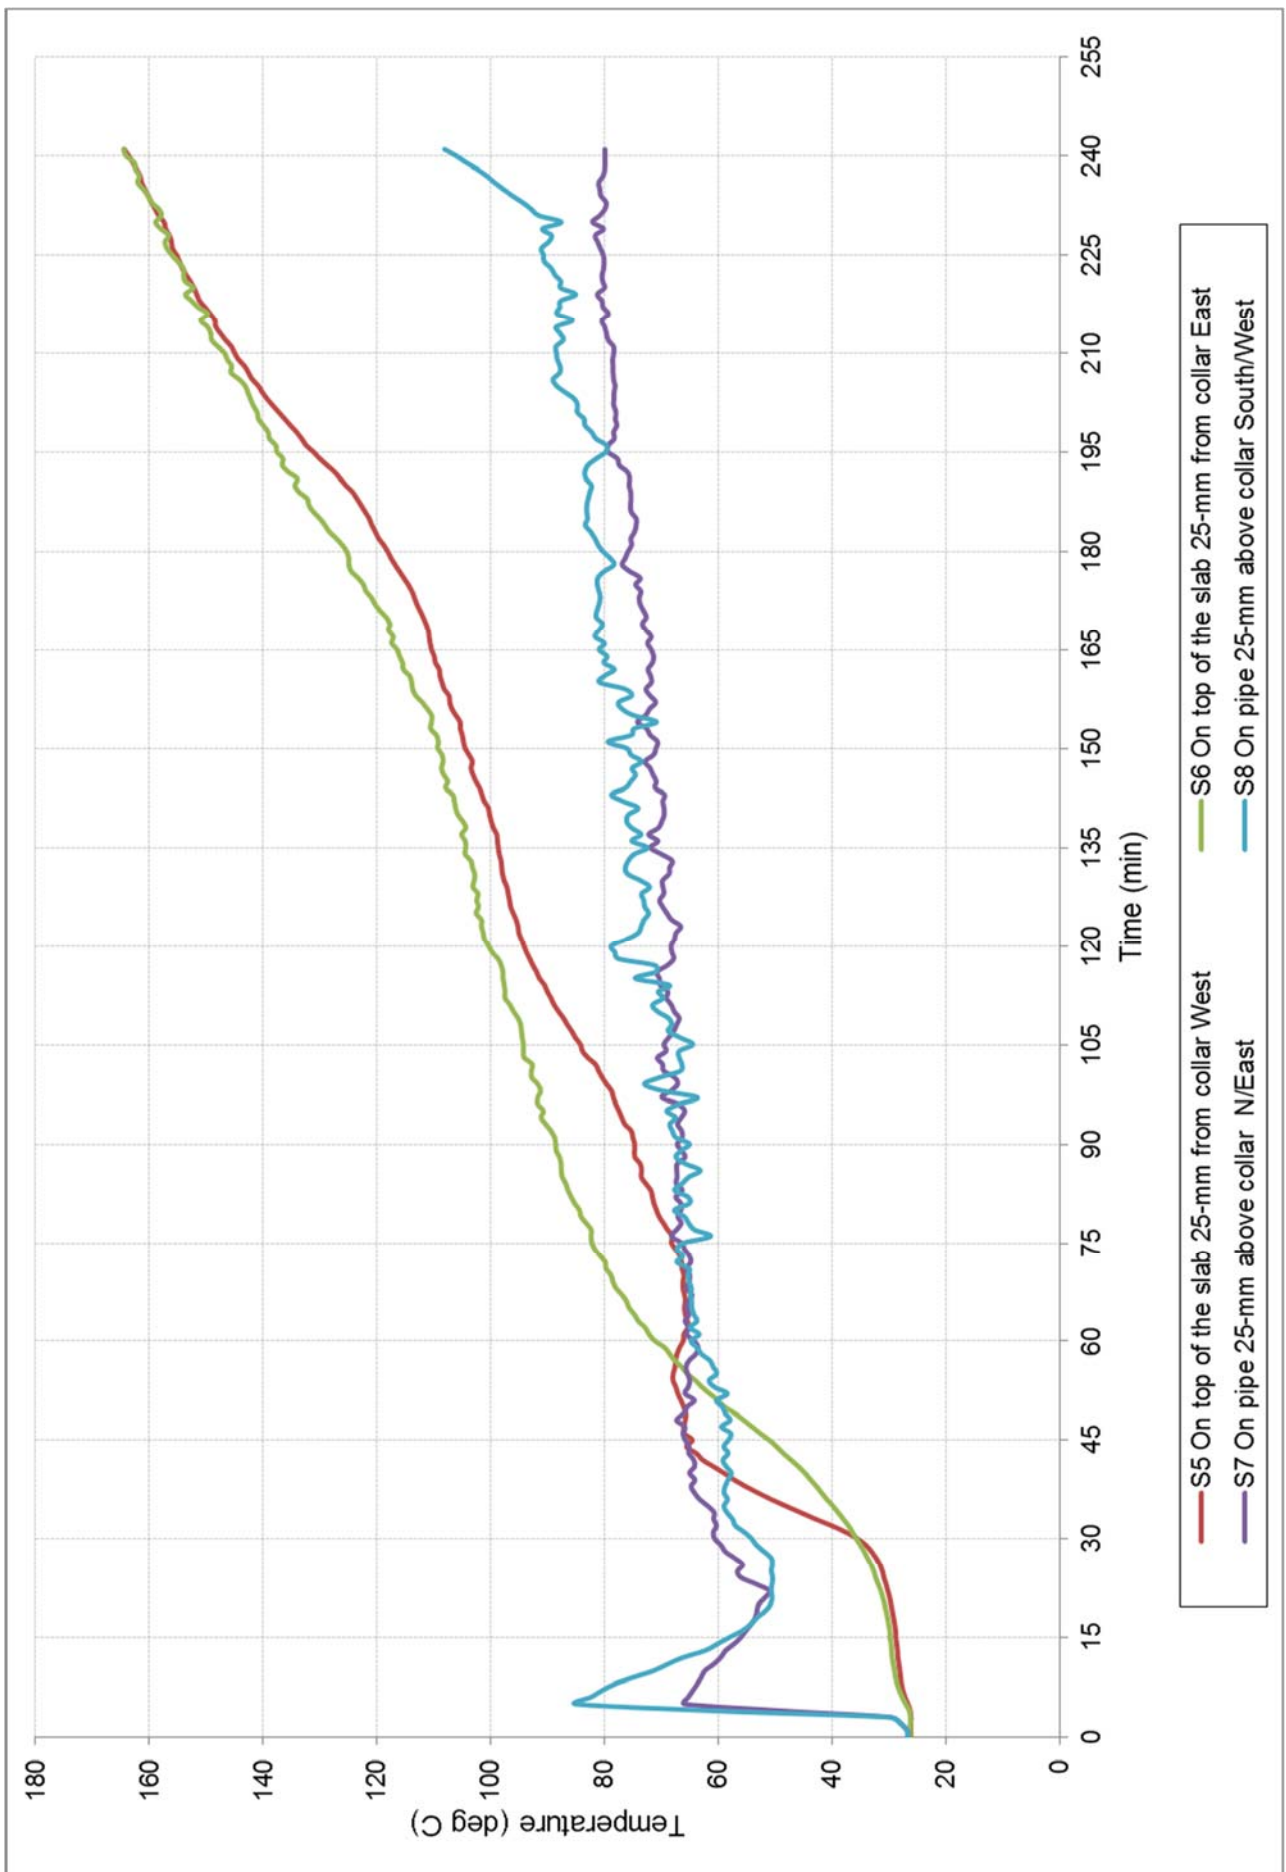
FIGURE 4 – SPECIMEN TEMPERATURE – ASSOCIATED WITH SPECIMEN 2

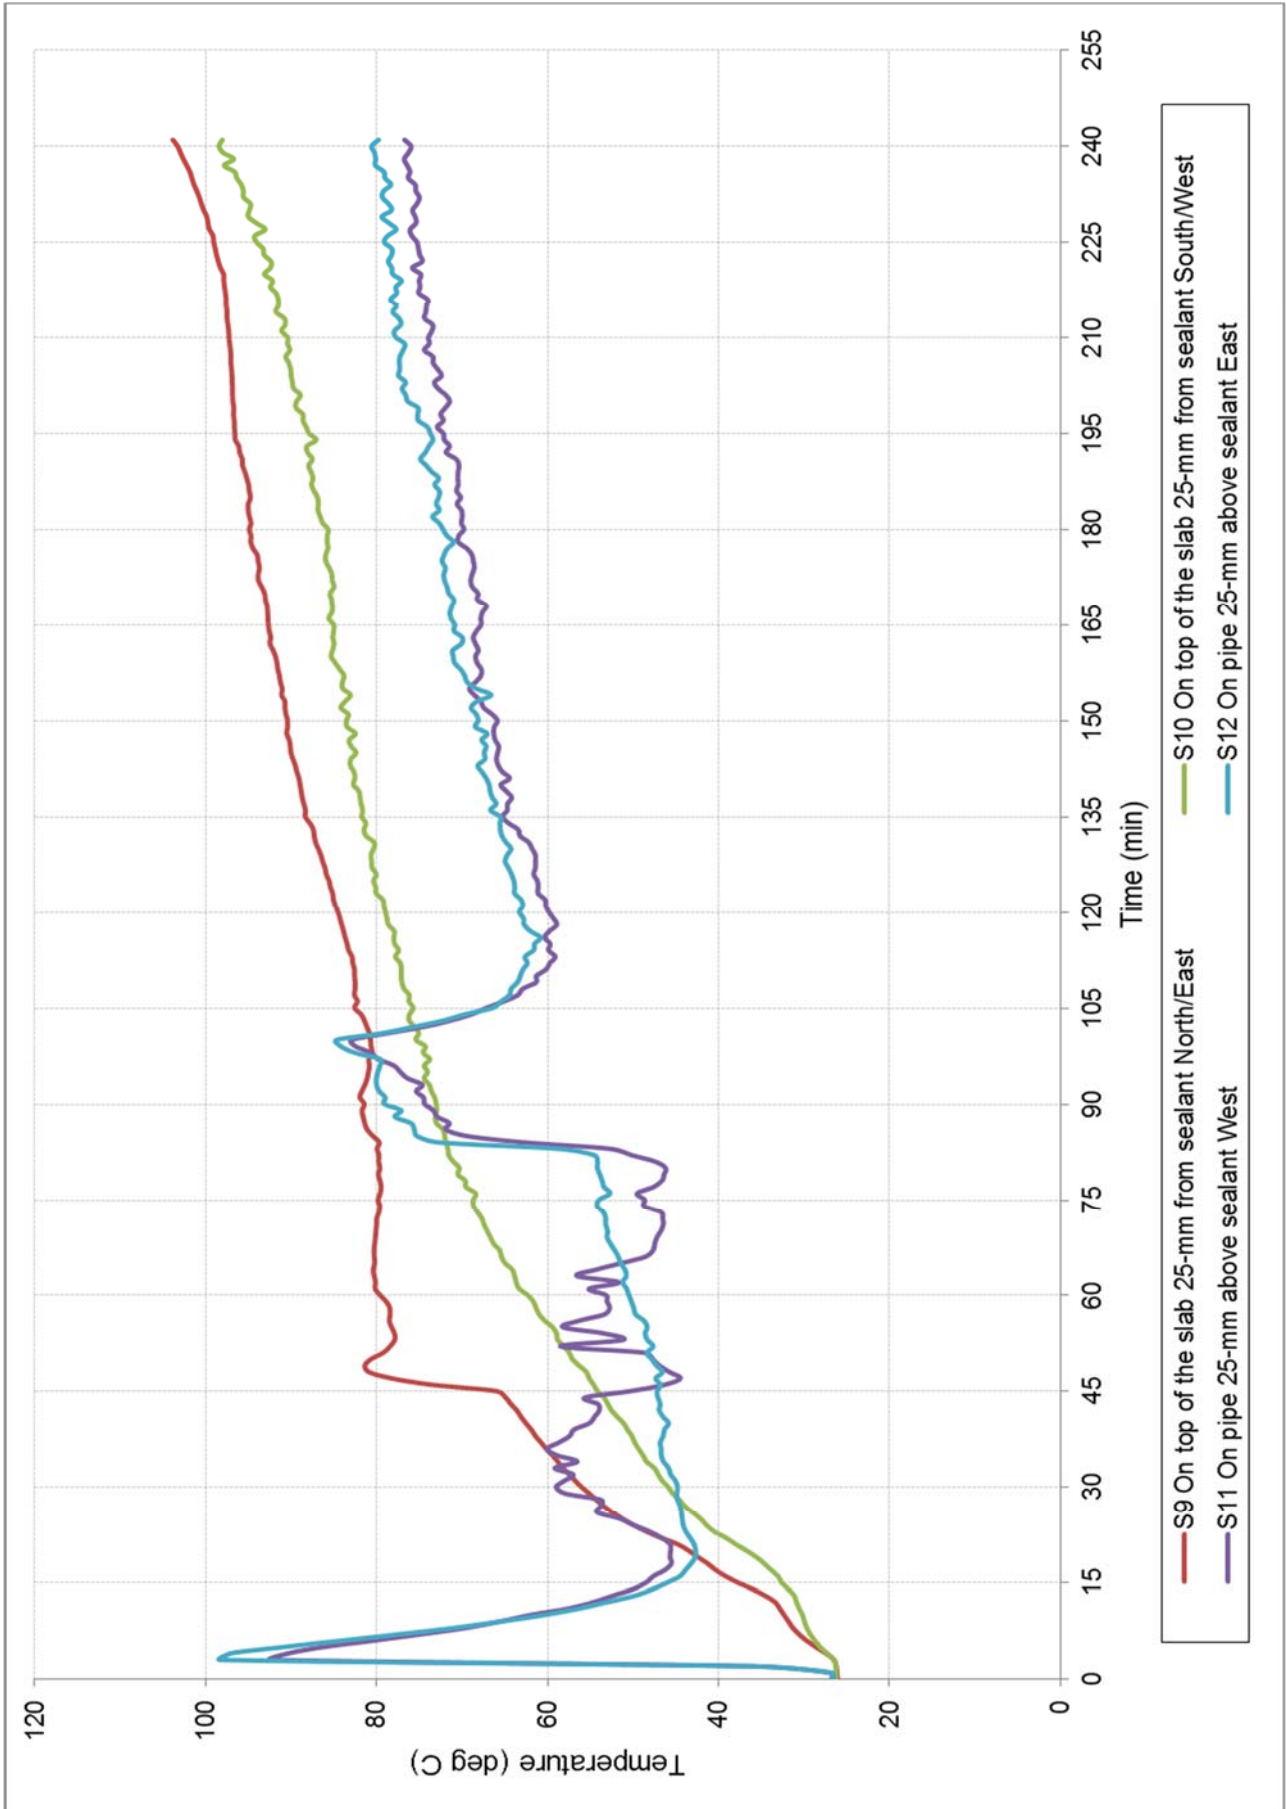
FIGURE 5 – SPECIMEN TEMPERATURE – ASSOCIATED WITH SPECIMEN 3

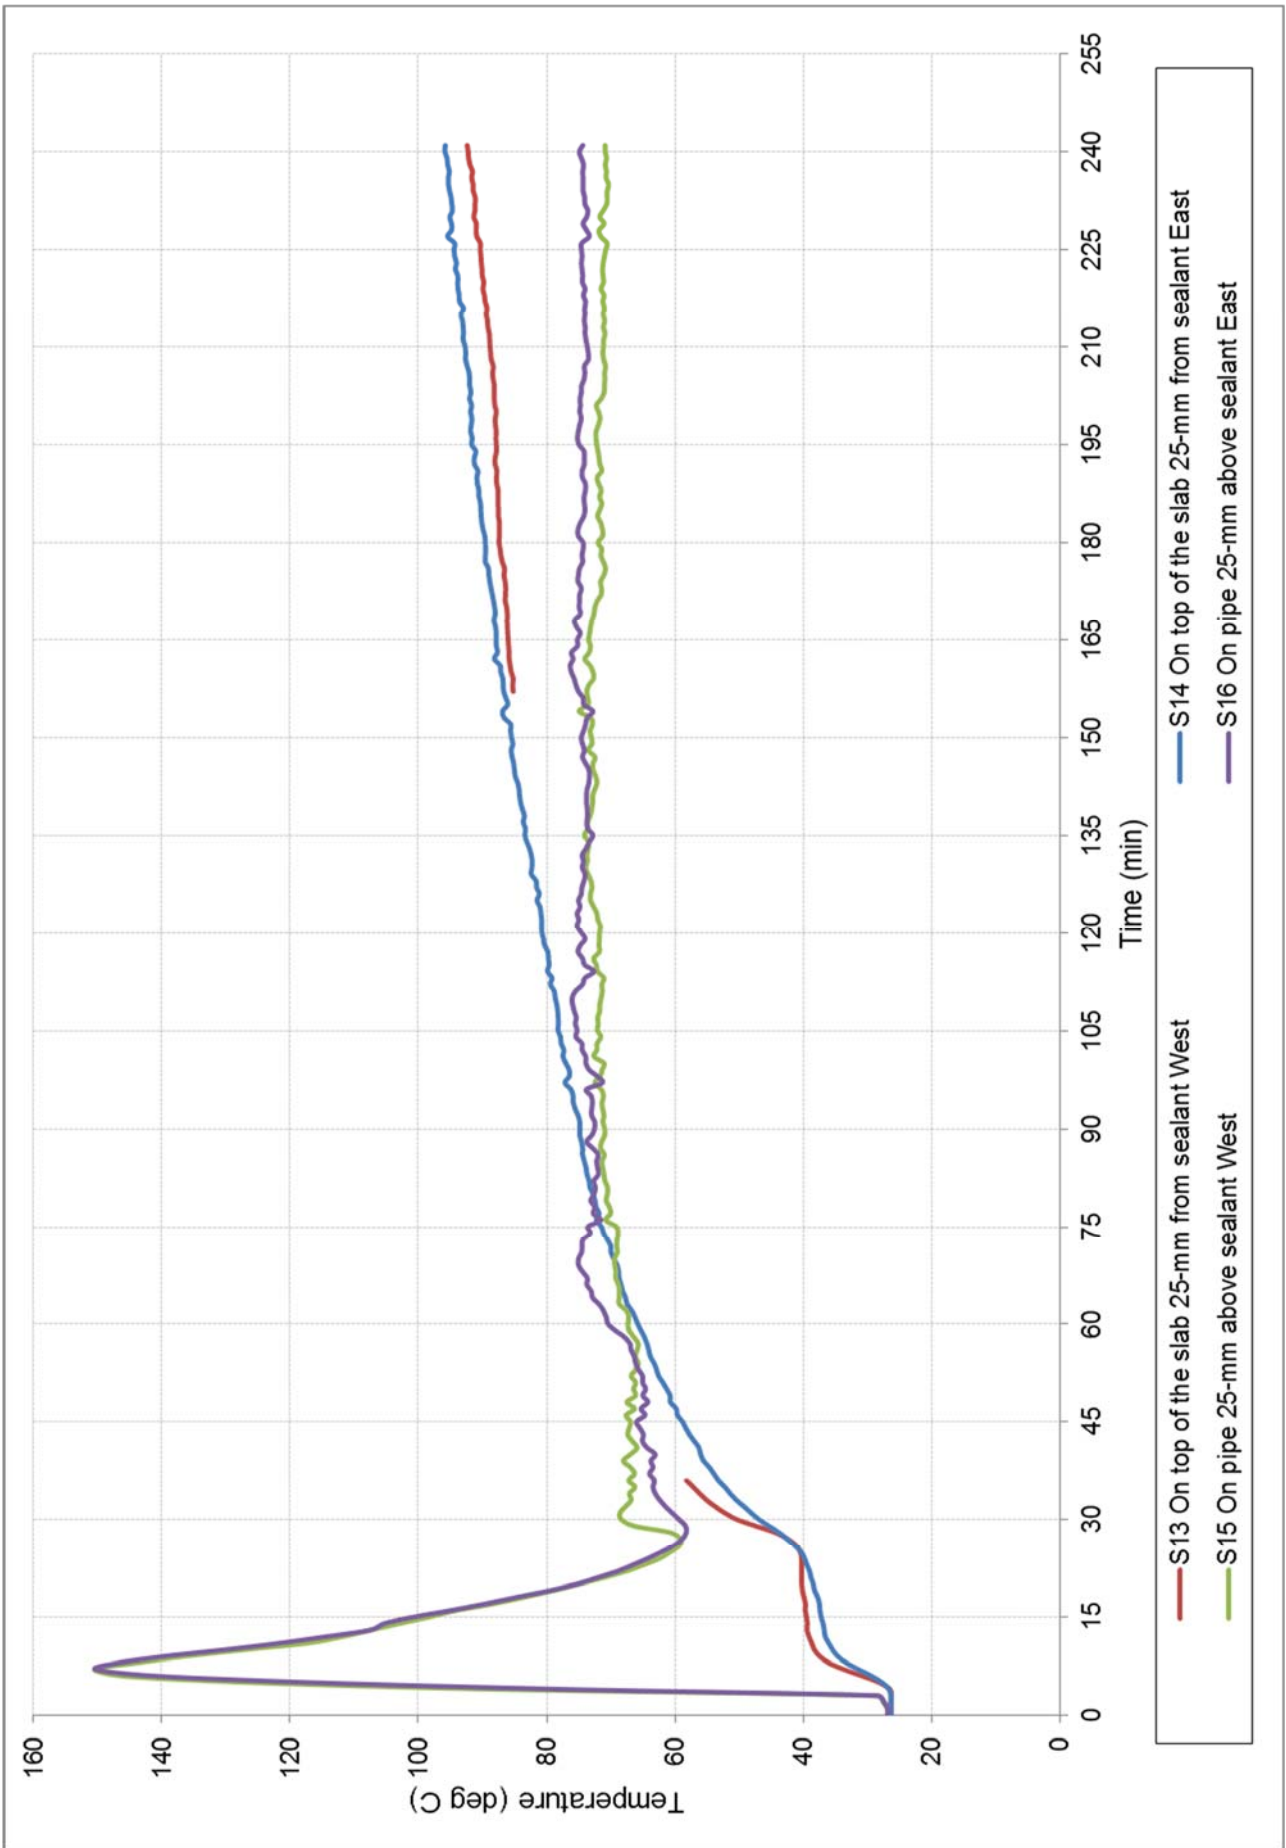
FIGURE 6 – SPECIMEN TEMPERATURE – ASSOCIATED WITH SPECIMEN 4

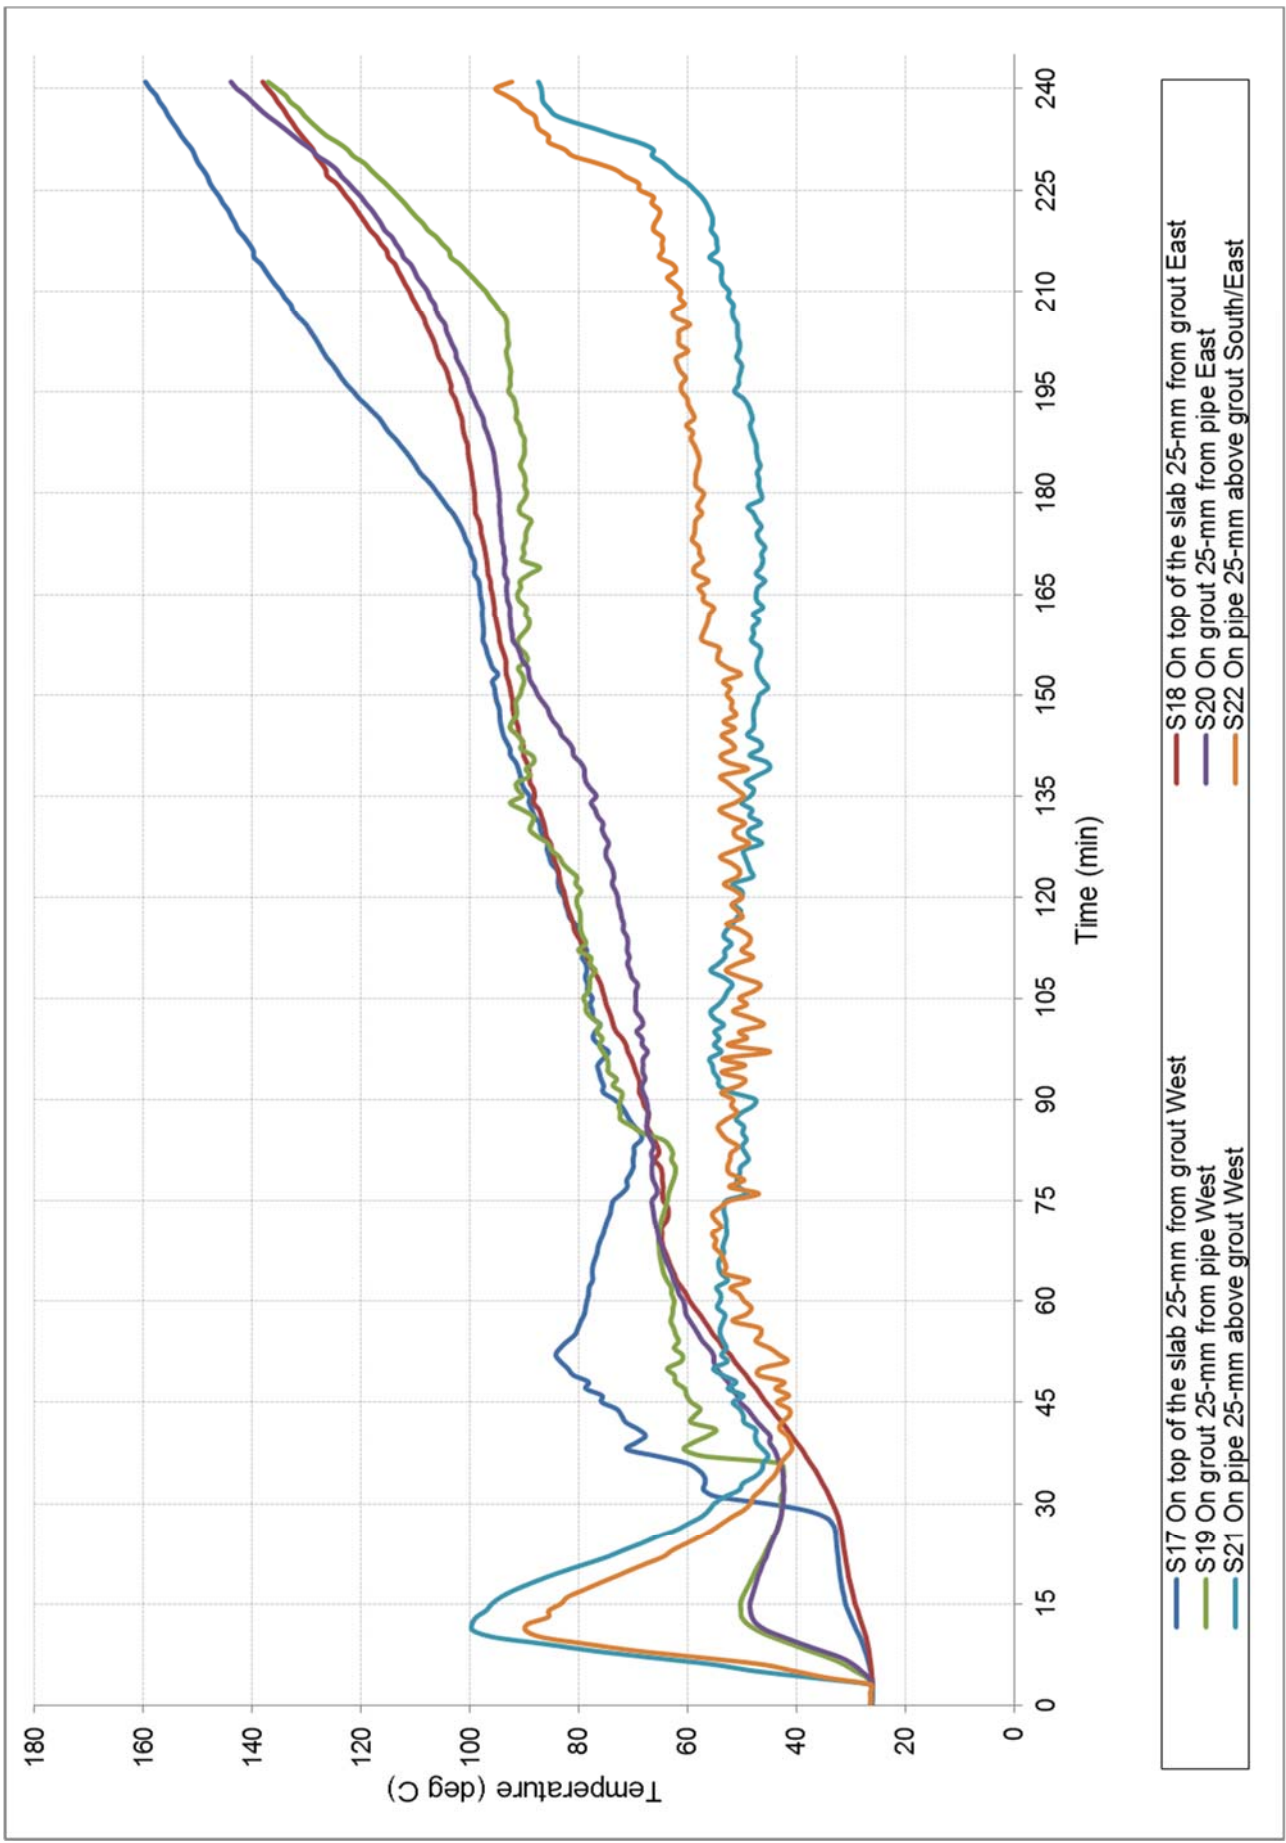
FIGURE 7 – SPECIMEN TEMPERATURE – ASSOCIATED WITH SPECIMEN 5

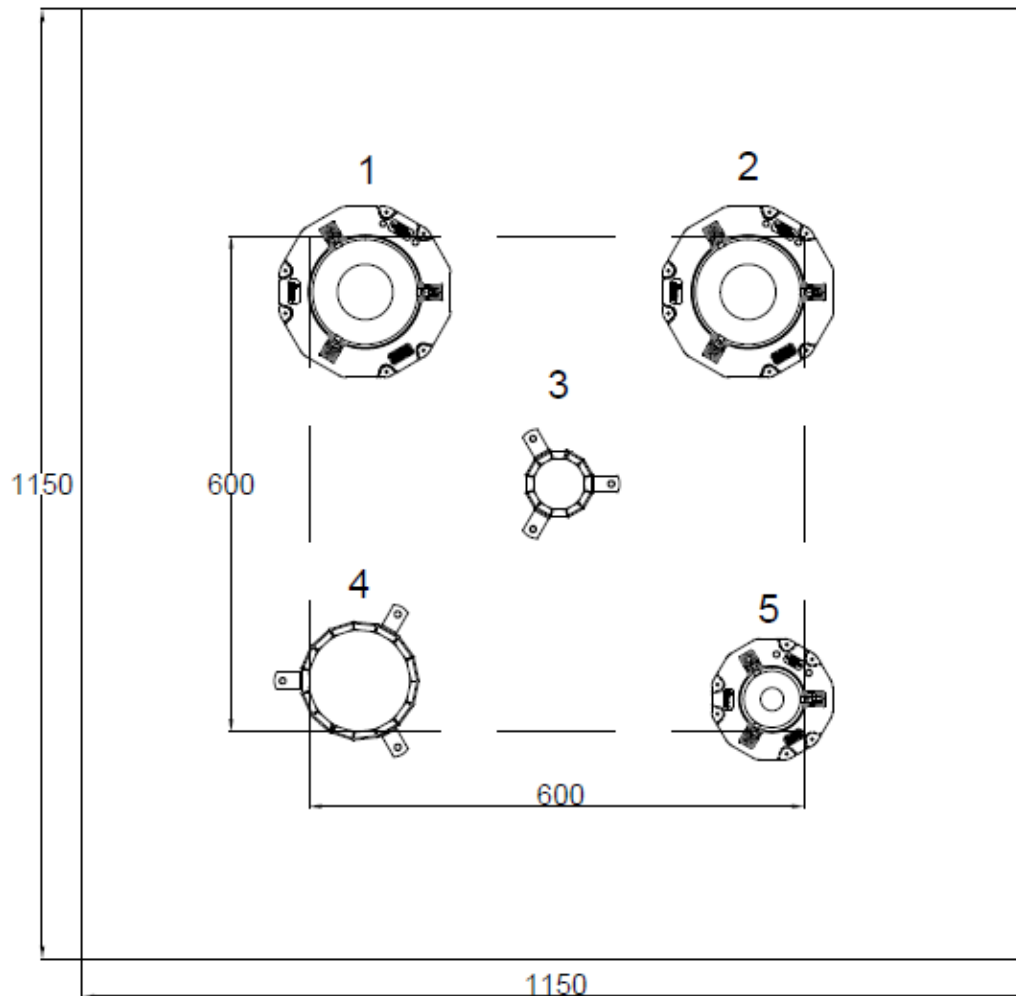
Test Slab S-19-H Layout

Penetration	Collar Code	Pipe Type	Pipe Diameter (mm)	Fitting
1	H110S-RR	Triplus	110	Yes
2	H110S-RR	Raupiano	110	N/A
3	50R	Raupiano	50	N/A
4	110R	Raupiano	110	N/A
5	H50S-RR	Pex-a	32	N/A

DRAWING TITLED "TEST SLAB S-19-H LAYOUT", DATED 2 OCTOBER 2019, PROVIDED BY SNAP FIRE SYSTEMS PTY LTD

The specimen comprised an 1150-mm x 1150-mm x 150-mm thick concrete slab penetrated by five (5) stack pipes protected by five Snap Fire Systems fire collars.

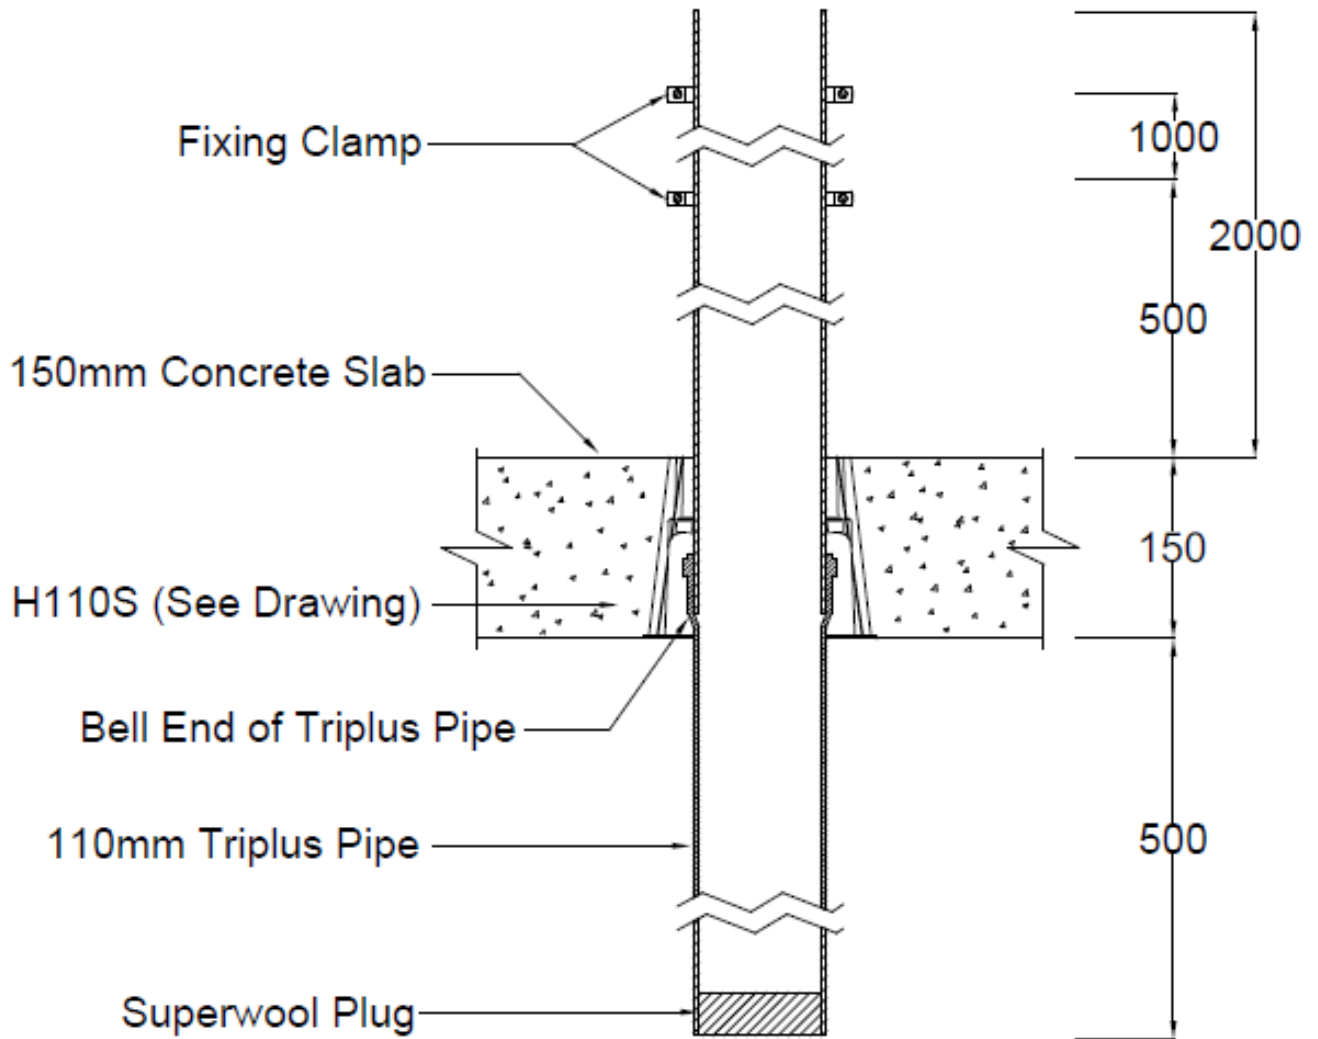
110mm Triplus Stack with Bell End in Collar & H110S

DRAWING "SPECIMEN #1, 110MM TRIPLUS STACK WITH BELL END IN COLLAR & H110S", DATED 1 NOVEMBER 2019, PROVIDED BY SNAP FIRE SYSTEMS PTY LTD

Specimen 1 – SNAP H110S Cast-in fire collar protecting a nominal 110-mm Valsir Triplus polypropylene stack pipe with bell-end joint inside collar.

The SNAP Cast-in H110S fire collar comprised a 1.6-mm thick polypropylene casing with a 140-mm inner diameter and a 194-mm x 184-mm base flange. The 248-mm high collar casing incorporated a layer of 451-mm long x 85-mm wide x 4-mm thick Intumescent material. The closing mechanism comprised four equally spaced steel springs held with nylon fuse links. The springs were fabricated using galvanised steel wire having a diameter of 3.15-mm, with the springs acting against a layer of 316 grade stainless steel mesh measuring 503-mm x 83-mm as shown in drawing number H110S, dated 15 February 2019, by Snap Fire Systems Pty Ltd.

The penetrating service comprised a 110-mm outside diameter Valsir Triplus polypropylene pipe with a wall thickness of 3.7-mm fitted through the collar's sleeve. The annular gap between the OD of the pipe and the inside collar was left unprotected as shown in drawing titled "Specimen #1, 110mm Triplus Stack with Bell End in Collar & H110S", dated 1 November 2019, provided by Snap Fire Systems Pty Ltd.

The pipe projected vertically, 2000-mm above from the unexposed face of the concrete slab and 500-mm into the furnace chamber. The pipe was supported at nominally 500-mm and 1500-mm from the unexposed face of the slab. The pipe was open at the unexposed end and closed with a ceramic fibre plug on the exposed end.

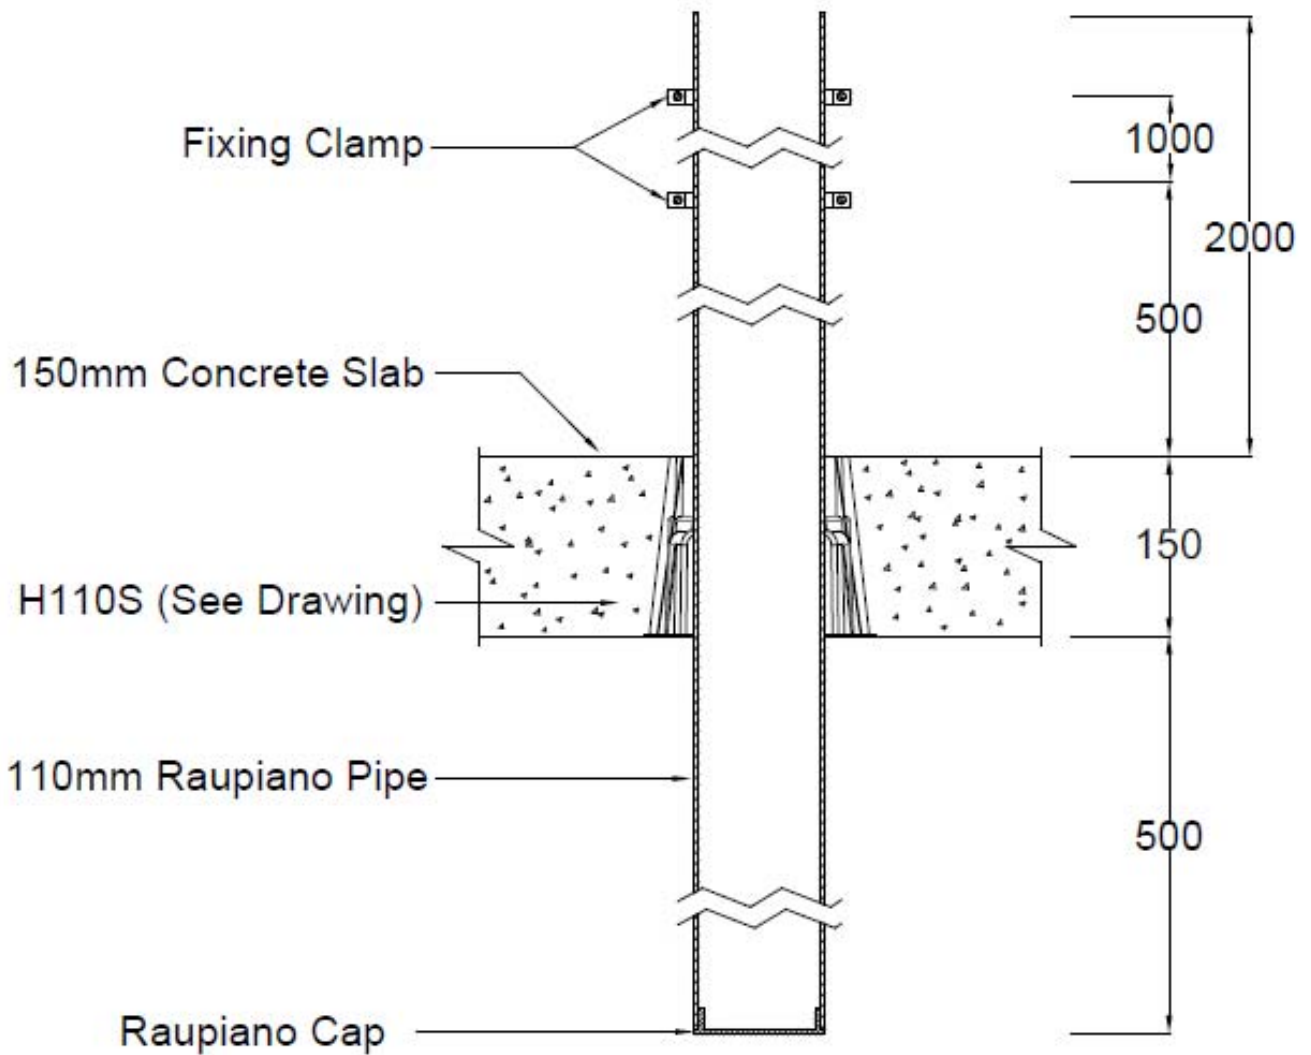
110mm Raupiano Stack & H110S

DRAWING TITLED "SPECIMEN # 2, 110MM RAUPIANO STACK & H110S", DATED 1 NOVEMBER 2019,
PROVIDED BY SNAP FIRE SYSTEMS PTY LTD

Specimen 2 – SNAP H110S Cast-in fire collar protecting a nominal 110-mm Rehau Raupiano polypropylene stack pipe.

The SNAP Cast-in H110S fire collar comprised a 1.6-mm thick polypropylene casing with a 140-mm inner diameter and a 194-mm x 184-mm base flange. The 248-mm high collar casing incorporated a layer of 451-mm long x 85-mm wide x 4-mm thick Intumescent material. The closing mechanism comprised four equally spaced steel springs held with nylon fuse links. The springs were fabricated using galvanised steel wire having a diameter of 3.15-mm, with the springs acting against a layer of 316 grade stainless steel mesh measuring 503-mm x 83-mm as shown in drawing number H110S, dated 15 February 2019, by Snap Fire Systems Pty Ltd.

The penetrating service comprised a 110.8-mm outside diameter Rehau Raupiano polypropylene pipe with a wall thickness of 2.92-mm fitted through the collar's sleeve. The annular gap between the OD of the pipe and the inside collar was left unprotected as shown in drawing titled "Specimen #2, 110mm Raupiano Stack & H110S", dated 1 November 2019, provided by Snap Fire Systems Pty Ltd.

The pipe projected vertically, 2000-mm above from the unexposed face of the concrete slab and 500-mm into the furnace chamber. The pipe was supported at nominally 500-mm and 1500-mm from the unexposed face of the slab. The pipe was open at the unexposed end and closed with a Raupiano end cap on the exposed end.

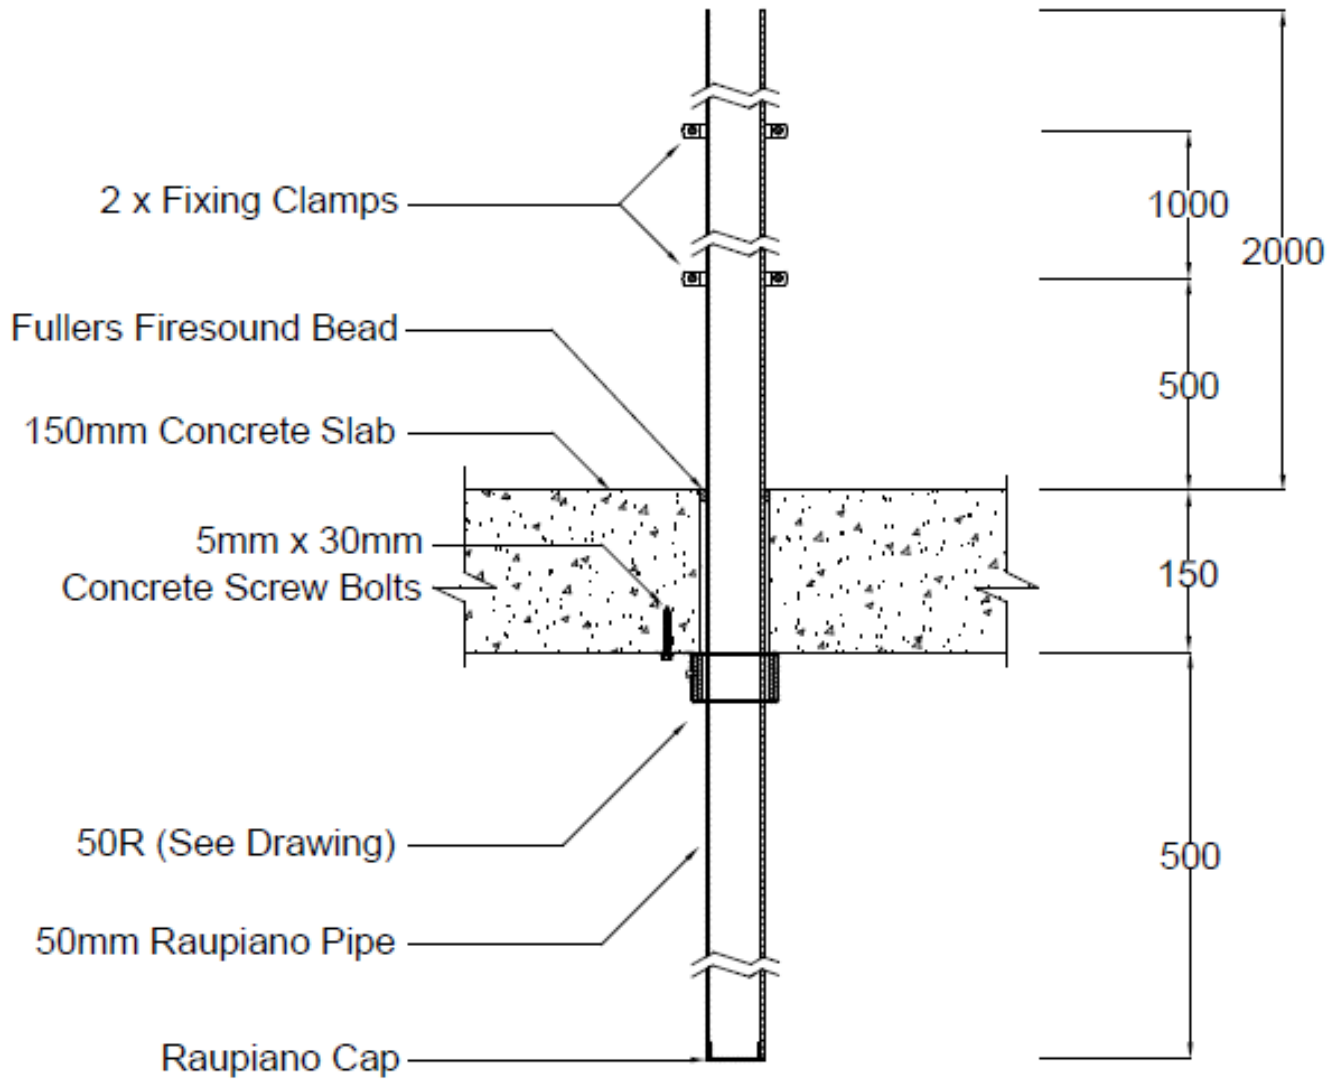
DRAWING TITLED "SPECIMEN # 3, 50MM RAUPIANO STACK & 50R", DATED 31 OCTOBER 2019, PROVIDED BY SNAP FIRE SYSTEMS PTY LTD

Specimen 3 – SNAP 50R Retrofit collar protecting a nominal 50-mm Rehau Raupiano polypropylene stack pipe.

The SNAP Retrofit 50R fire collar comprised a 0.75-mm steel casing with a 62-mm inner diameter and a 147-mm diameter base flange. The 47-mm high collar casing incorporated a closing mechanism which comprised two soft Intumesh intumescent wraps lined within the internal circumference of the collar. Intumescent A was 4-mm thick x 43-mm wide x 220-mm long and Intumescent B was 4-mm thick x 43-mm wide x 200-mm long. Between the strips was a layer of 316 grade stainless steel mesh measuring 210-mm long x 42-mm wide with a wire mesh diameter of 0.15-mm, as shown in drawing titled "SNAP 50 Retro", dated 18 January 2019, by Snap Fire Systems Pty Ltd. The Snap collar was surface mounted around the pipe on the exposed face (underside) of the slab and fixed through 3 mounting brackets using 5-mm x 30-mm concrete screw bolts.

The penetrating service comprised a 50.2-mm outside diameter Rehau Raupiano polypropylene pipe with a wall thickness of 2.06-mm fitted through the collar's sleeve. A 60-mm diameter opening was cut into slab and the collar fixed centrally over the hole as shown in drawing titled "Specimen #3, 50mm Raupiano Stack & 50R", dated 31 October 2019, provided by Snap Fire Systems Pty Ltd.

The pipe projected vertically 2000-mm above the concrete slab and 500-mm into the furnace chamber. The pipe was supported at nominally 500-mm and 1500-mm from the unexposed face of the slab. The pipe was open at the unexposed end and closed with a Raupiano polypropylene end cap on the exposed end.

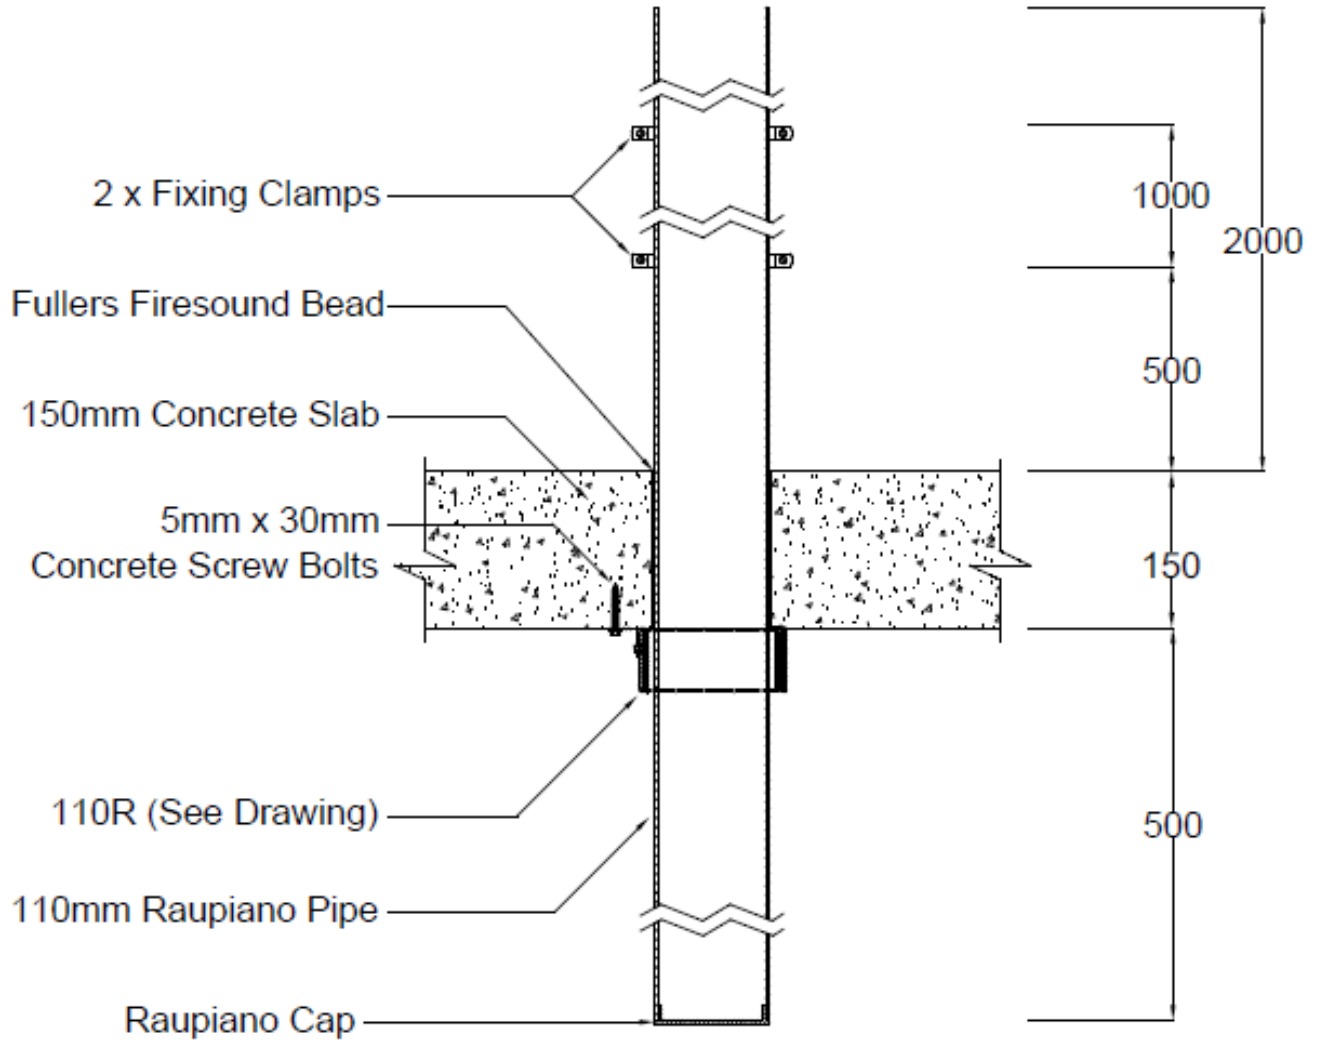
DRAWING TITLED "SPECIMEN #4, 110MM RAUPIANO STACK & 110R", DATED 31 OCTOBER 2019, PROVIDED BY SNAP FIRE SYSTEMS PTY LTD

Specimen 4 – SNAP 110R Retrofit fire collar protecting a nominal 110-mm Rehau Raupiano polypropylene pipe.

The SNAP Retrofit 110R fire collar comprised a 0.75-mm steel casing with a 122 mm inner diameter and a 206-mm diameter base flange. The 62-mm high collar casing incorporated a closing mechanism that was comprised of three soft Intumesh intumescent wraps and wire meshes lined within the internal circumference of the collar. Intumescent A was 2.5-mm thick x 58-mm wide x 424-mm long, Intumescent B was 2.5-mm thick x 58-mm wide x 407-mm long and Intumescent C was 2.5-mm thick x 58-mm wide x 389-mm long. Between intumescent strips A and B was a layer of 316 stainless steel mesh 415-mm long x 58-mm wide and between intumescent strips B and C was a layer of 316 stainless steel mesh 398-mm long x 58-mm wide both had wire mesh diameters of 0.15-mm, as shown in drawing titled “SNAP 110 Retro”, dated 16 January 2019, by Snap Fire Systems Pty Ltd. The Snap collar was surface mounted around the pipe on the exposed face of the slab and fixed through 3 mounting brackets using 5-mm x 30 mm Concrete Screws.

The penetrating service comprised a 110.8-mm outside diameter Rehau Raupiano polypropylene pipe with a wall thickness of 2.92-mm fitted through the collar’s sleeve. A 114-mm diameter opening was cut into the slab and the collar fixed centrally over the hole as shown in drawing titled “Specimen #4 110mm Raupiano Stack & 110R”, dated 31 October 2019, provided by Snap Fire Systems Pty Ltd.

The pipe projected vertically, approximately 2000-mm above from the unexposed face of the concrete floor and approximately 500-mm into the furnace chamber. The pipe was supported at nominally 500-mm and 1500-mm from the unexposed face of the slab. The pipe was open at the unexposed end and closed with a Raupiano polypropylene end cap on the exposed end.

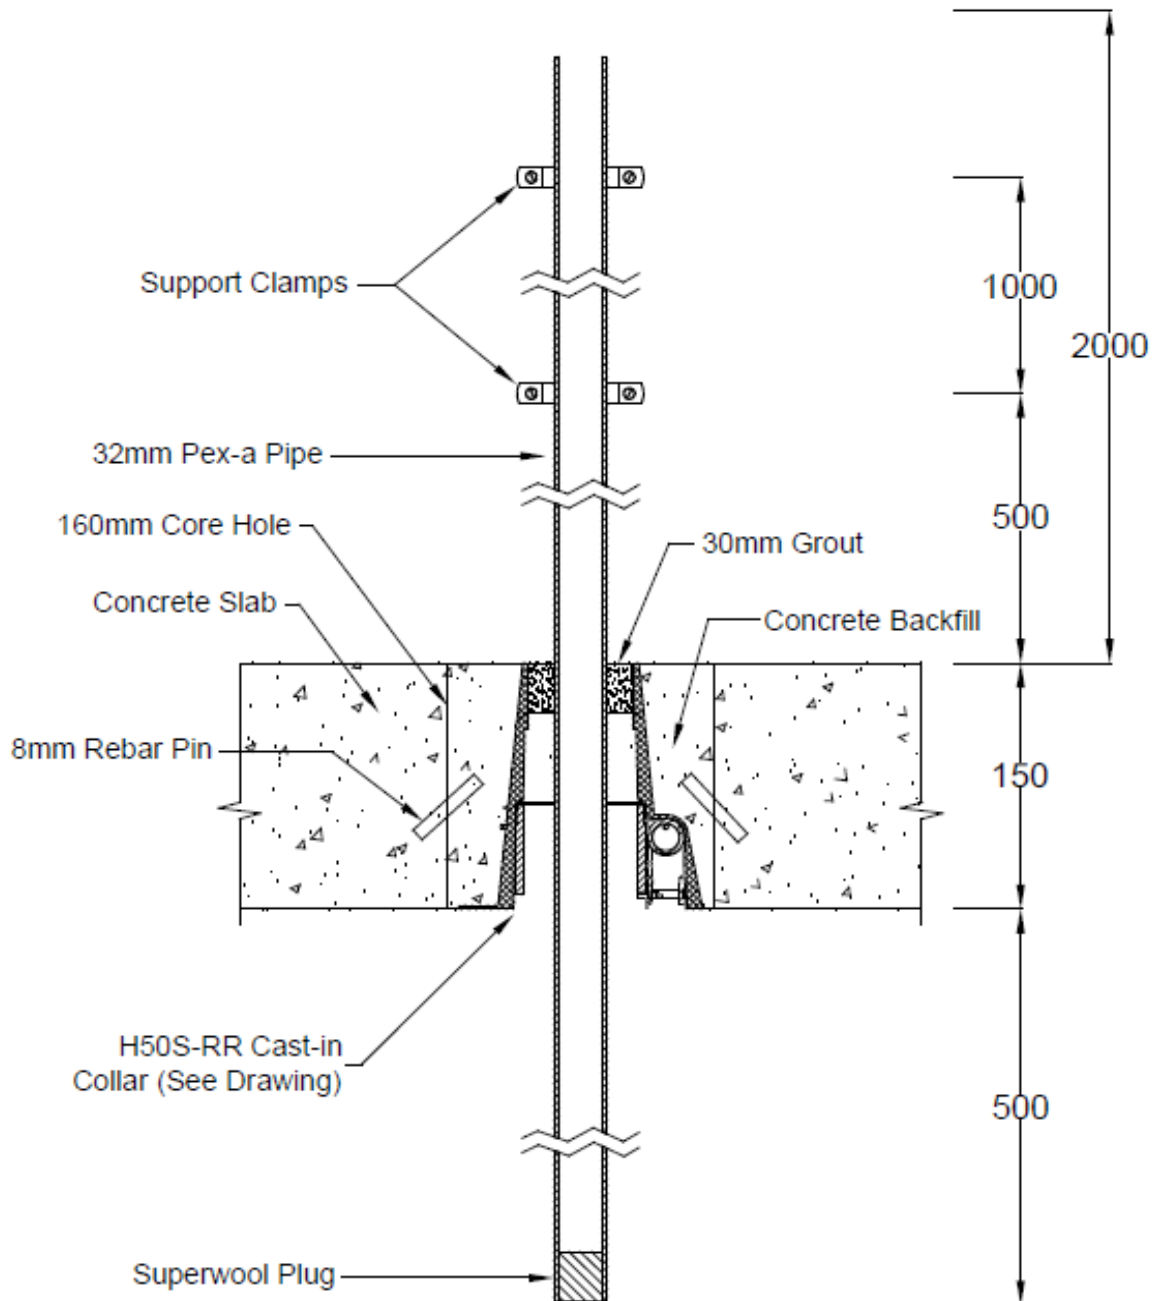
32mm Pex-a Stack & H50S-RR

DRAWING TITLED "SPECIMEN #5, 32MM PEX-A STACK & H50S-RR", DATED 31 OCTOBER 2019, PROVIDED BY SNAP FIRE SYSTEMS PTY LTD

Specimen 5 – SNAP H50S-RR Cast-in collar protecting a nominal 32-mm Rehau Rautitan PE-Xa stack pipe.

The SNAP Cast-in H50S-RR fire collar comprised a 1.6-mm thick polypropylene casing with a 67-mm inner diameter and a 150-mm diameter base flange. The 250-mm high collar casing incorporated a 230-mm x 55-mm x 5-mm thick Intumesh intumescent material and a rubber ring seal. The closing mechanism comprised three galvanised steel springs bound with nylon fuse links and a 268-mm x 53-mm 316 stainless steel mesh as shown in drawing numbered H50S-RR-T dated 29 September 2017, by Snap Fire Systems Pty Ltd.

The penetrating service comprised a 32-mm outside diameter Rehau Rautitan PE-XA pipe with a wall thickness of 4.95-mm through the collar’s sleeve. The annular gap between the pipe and the inside collar incorporated a PE backing rod, back filled with grout to a depth of 30 mm and finished flush with the slab as shown in drawing titled “Specimen #5, 32mm PE-Xa Stack & H50S-RR”, dated 31 October 2019, provided by Snap Fire Systems Pty Ltd.

The pipe projected vertically, 2000-mm above from the unexposed face of the concrete floor and 500-mm into the furnace chamber. The pipe was supported at nominally 500-mm and 1500-mm from the unexposed face of the slab. The pipe was open at the unexposed end and closed with a ceramic fibre plug on the exposed end.
