Fire-resistance test on fire collars protecting a concrete slab penetrated by services

Test Report

Author: Peter Gordon
Report number: FSP 2072
Date: 11 May 2020

Sponsored Investigation No. FSP 2072

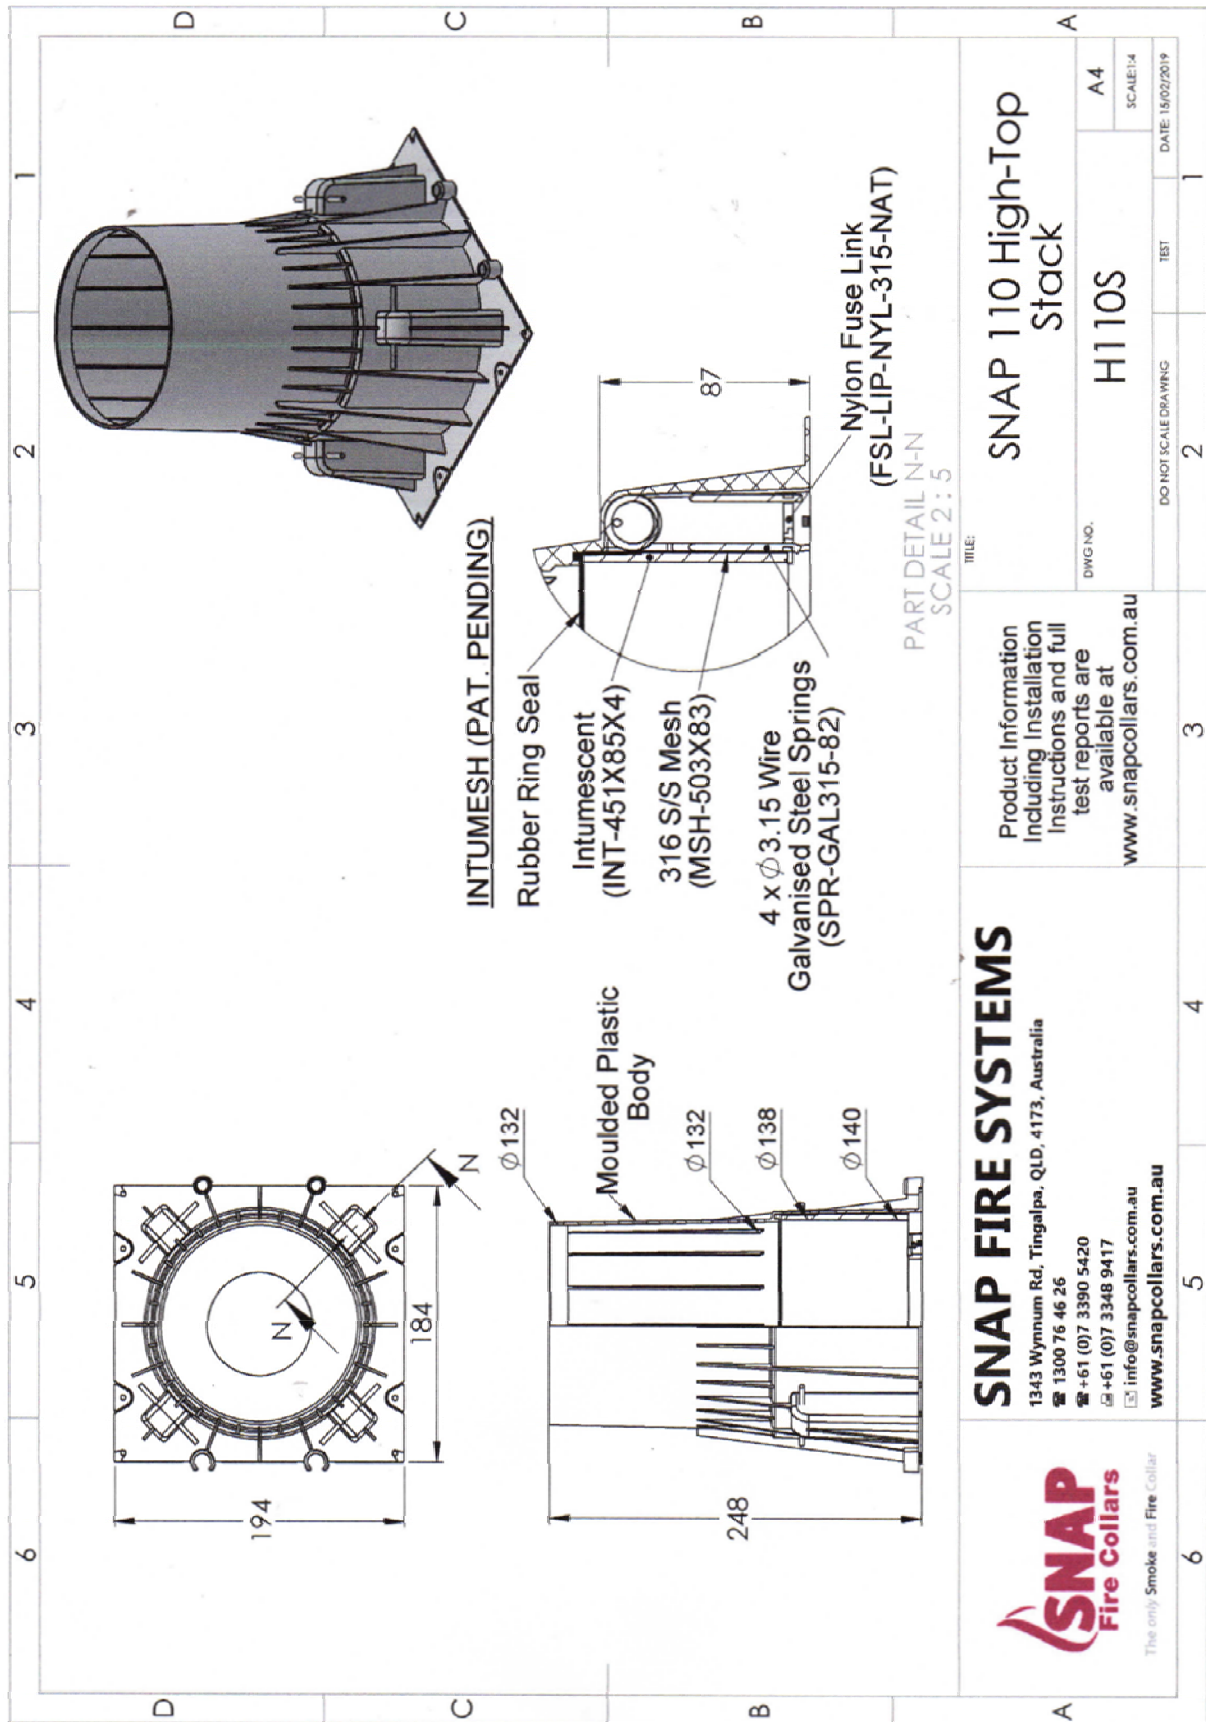
SNAP 110 High-Top Stack	
DWG NO.	H110S
SCALE	A4
DATE	15/02/2019
DO NOT SCALE DRAWING	TEST

DRAWING NUMBER H110S, DATED 15 FEBRUARY 2019, BY SNAP FIRE SYSTEMS PTY LTD

The SNAP Cast-in H110S fire collar comprised a 1.6-mm thick polypropylene casing with a 140-mm inner diameter and a 194-mm x 184-mm base flange. The 248-mm high collar casing incorporated a layer of 451-mm long x 85-mm wide x 4-mm thick Intumescent material. The closing mechanism comprised four equally spaced steel springs held with nylon fuse links. The springs were fabricated using galvanised steel wire having a diameter of 3.15-mm, with the springs acting against a layer of 316 grade stainless steel mesh measuring 503-mm x 83-mm as shown in drawing number H110S, dated 15 February 2019, by Snap Fire Systems Pty Ltd.

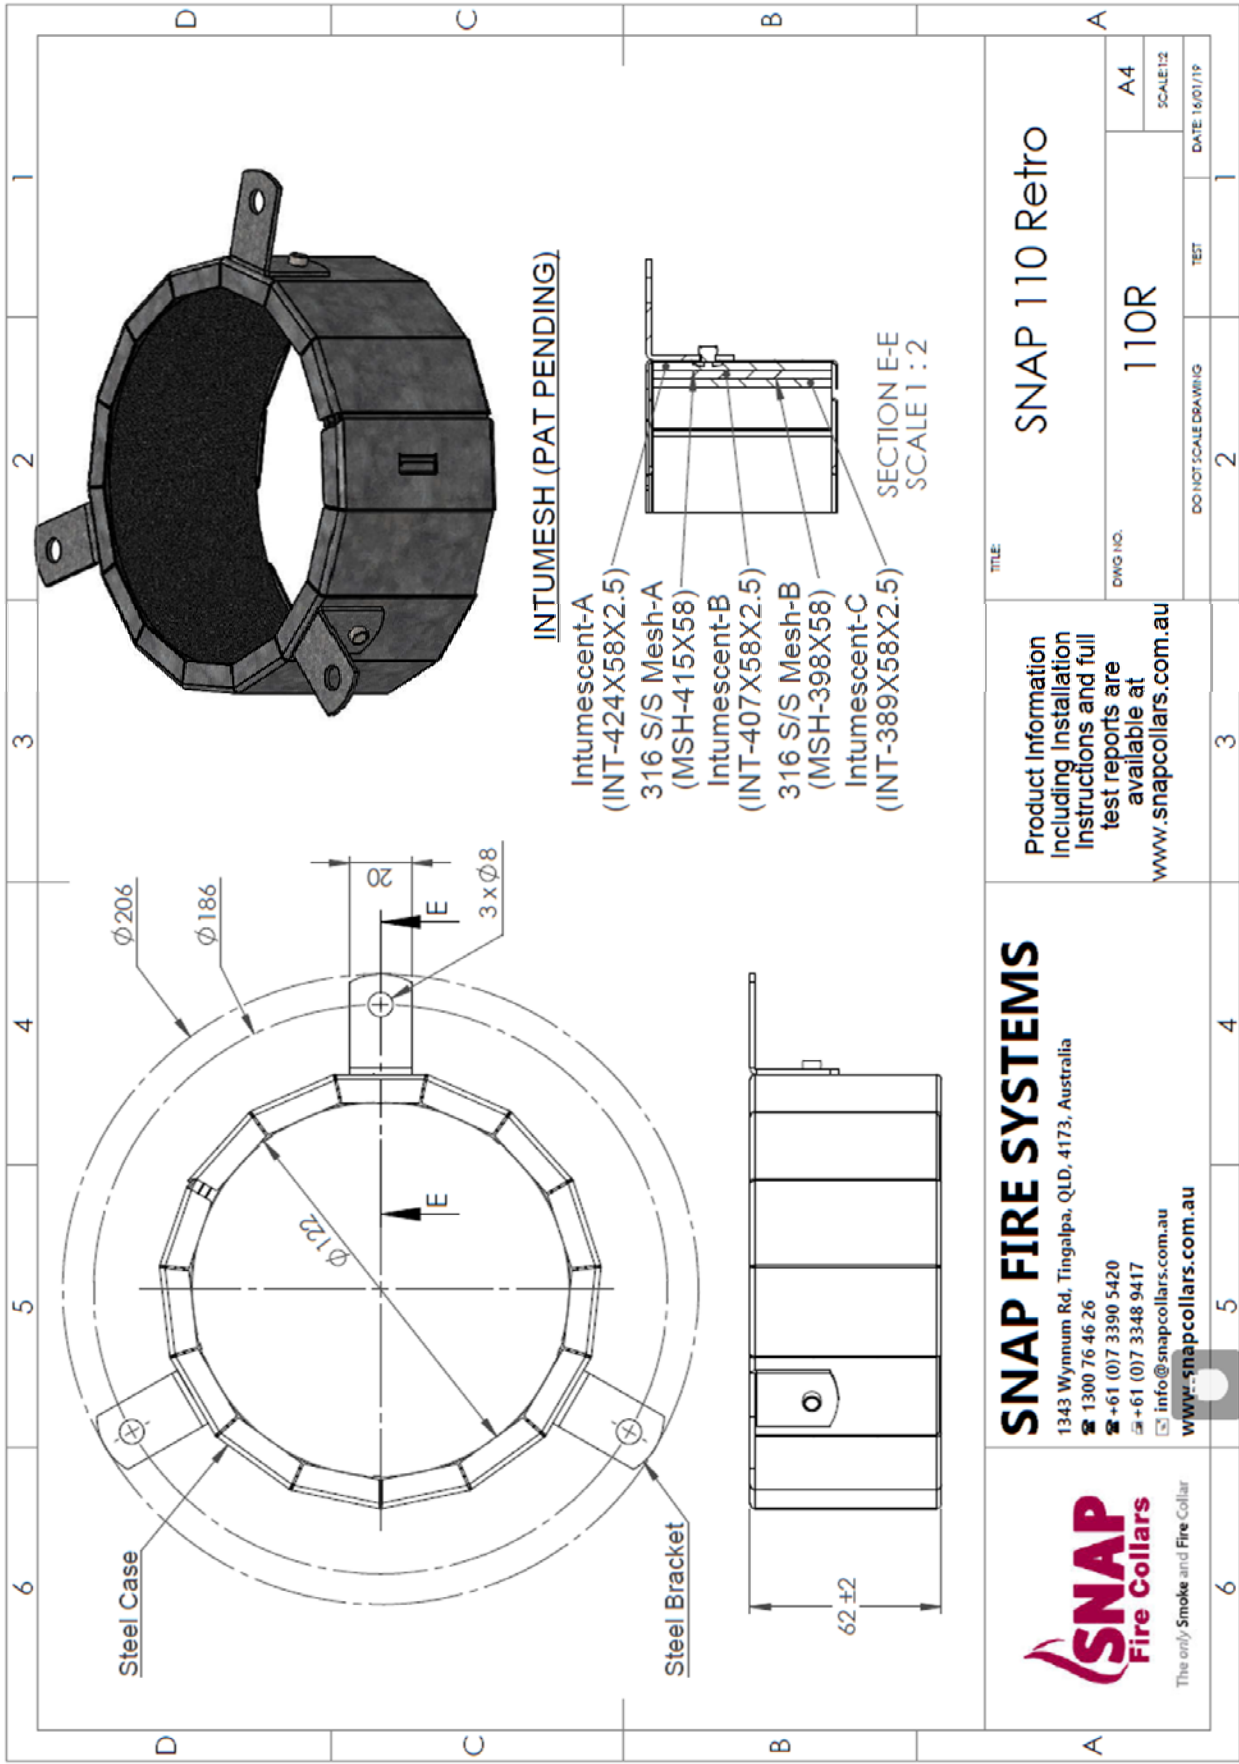
DRAWING TITLED "SNAP 110 RETRO", DATED 16 JANUARY 2019, BY SNAP FIRE SYSTEMS PTY LTD.

The SNAP Retrofit 110R fire collar comprised a 0.75-mm steel casing with a 122 mm inner diameter and a 206-mm diameter base flange. The 62-mm high collar casing incorporated a closing mechanism that was comprised of three soft Intumesh intumescent wraps and wire meshes lined within the internal circumference of the collar. Intumescent A was 2.5-mm thick x 58-mm wide x 424-mm long, Intumescent B was 2.5-mm thick x 58-mm wide x 407-mm long and Intumescent C was 2.5-mm thick x 58-mm wide x 389-mm long. Between intumescent strips A and B was a layer of 316 stainless steel mesh 415-mm long x 58-mm wide and between intumescent strips B and C was a layer of 316 stainless steel mesh 398-mm long x 58-mm wide both had wire mesh diameters of 0.15-mm, as shown in drawing titled “SNAP 110 Retro”, dated 16 January 2019, by Snap Fire Systems Pty Ltd. The Snap collar was surface mounted around the pipe on the exposed face of the slab and fixed through 3 mounting brackets using 5-mm x 30 mm Concrete Screws.

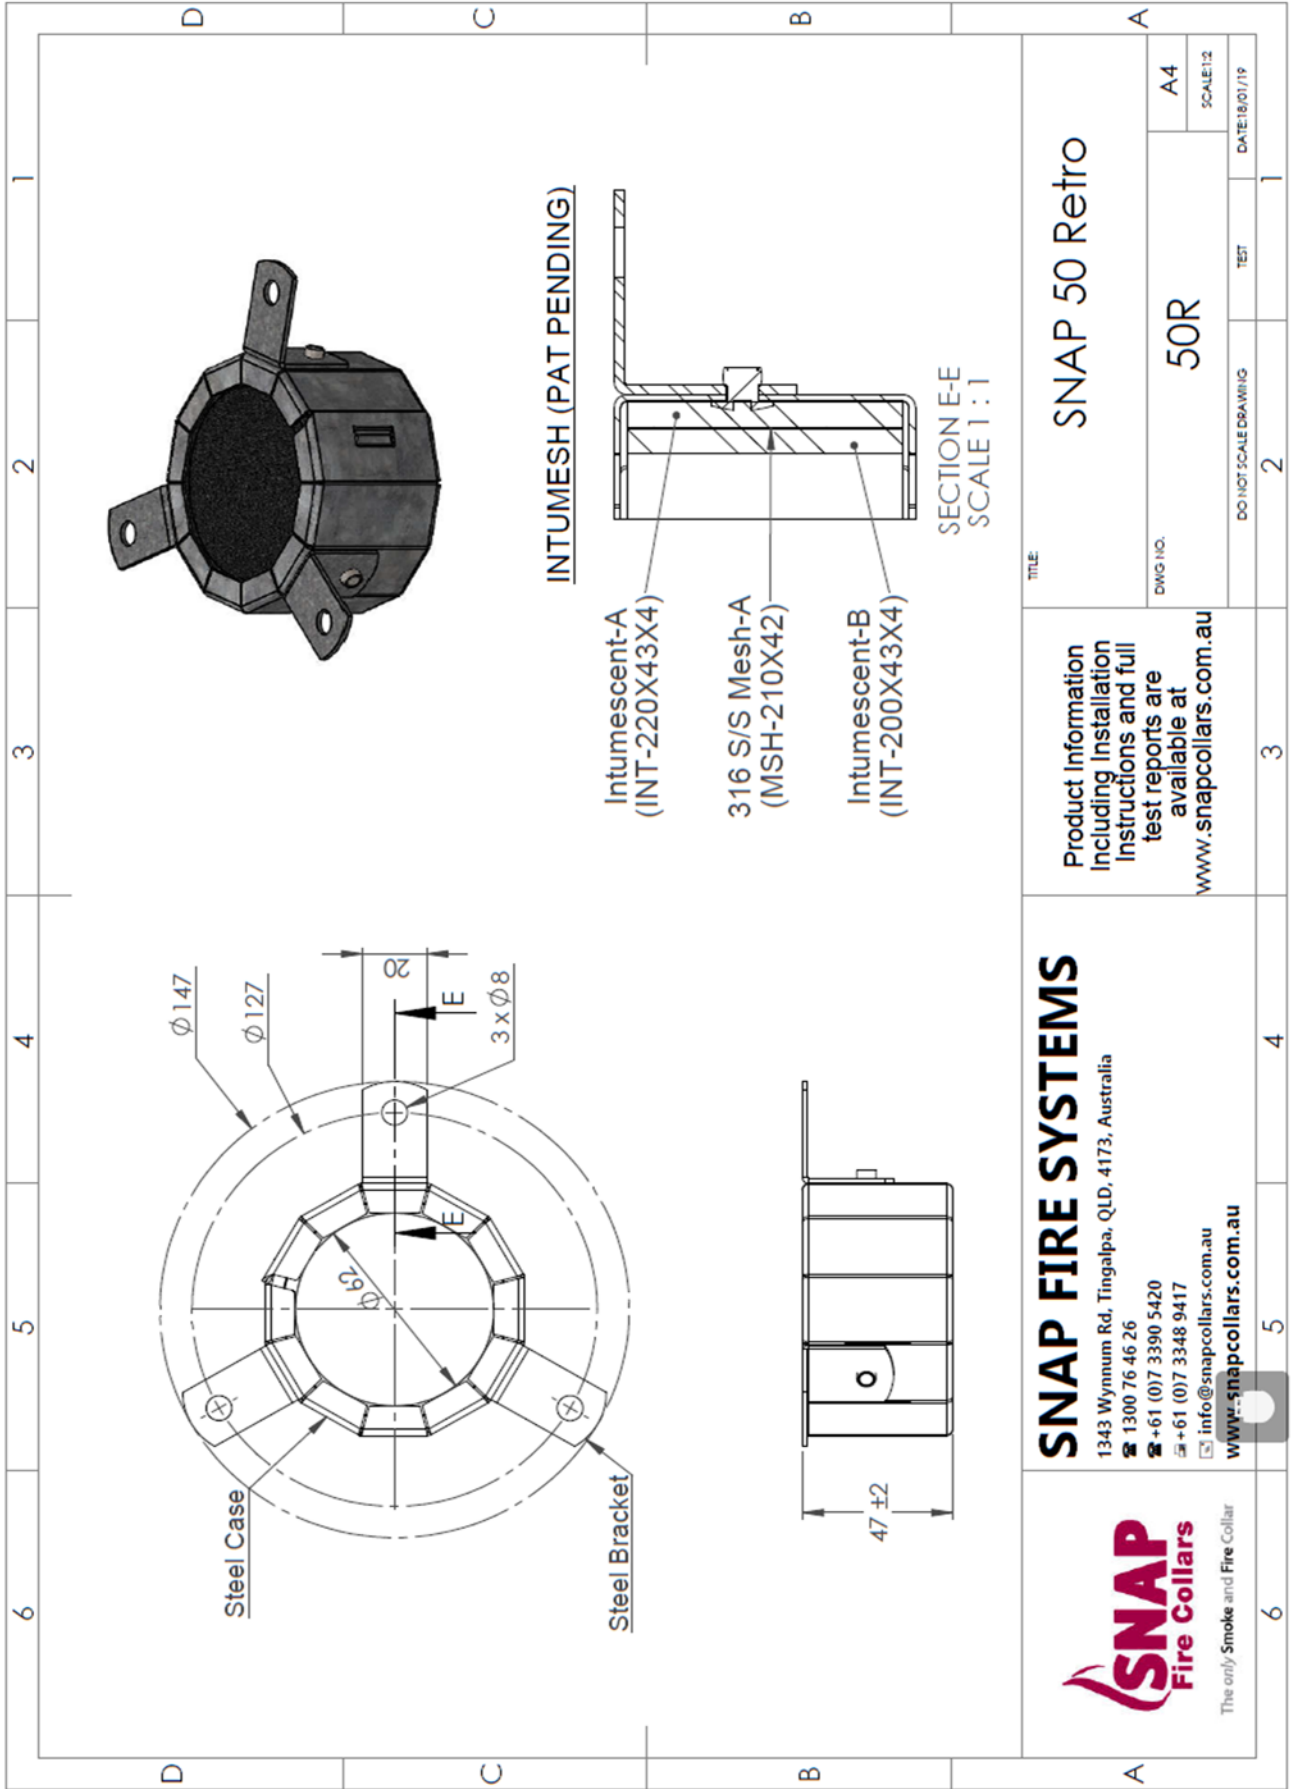
TITLE		SNAP 50 Retro	
DWG NO.		50R	
SCALE		A4	
DATE		18/01/19	
DO NOT SCALE DRAWING	TEST	2	1

DRAWING TITLED "SNAP 50 RETRO", DATED 18 JANUARY 2019, BY SNAP FIRE SYSTEMS PTY LTD.

The SNAP Retrofit 50R fire collar comprised a 0.75-mm steel casing with a 62-mm inner diameter and a 147-mm diameter base flange. The 47-mm high collar casing incorporated a closing mechanism which comprised two soft Intumesh intumescent wraps lined within the internal circumference of the collar. Intumescent A was 4-mm thick x 43-mm wide x 220-mm long and Intumescent B was 4-mm thick x 43-mm wide x 200-mm long. Between the strips was a layer of 316 grade stainless steel mesh measuring 210-mm long x 42-mm wide with a wire mesh diameter of 0.15-mm, as shown in drawing titled "SNAP 50 Retro", dated 18 January 2019, by Snap Fire Systems Pty Ltd. The Snap collar was surface mounted around the pipe on the exposed face (underside) of the slab and fixed through 3 mounting brackets using 5-mm x 30-mm concrete screw bolts.

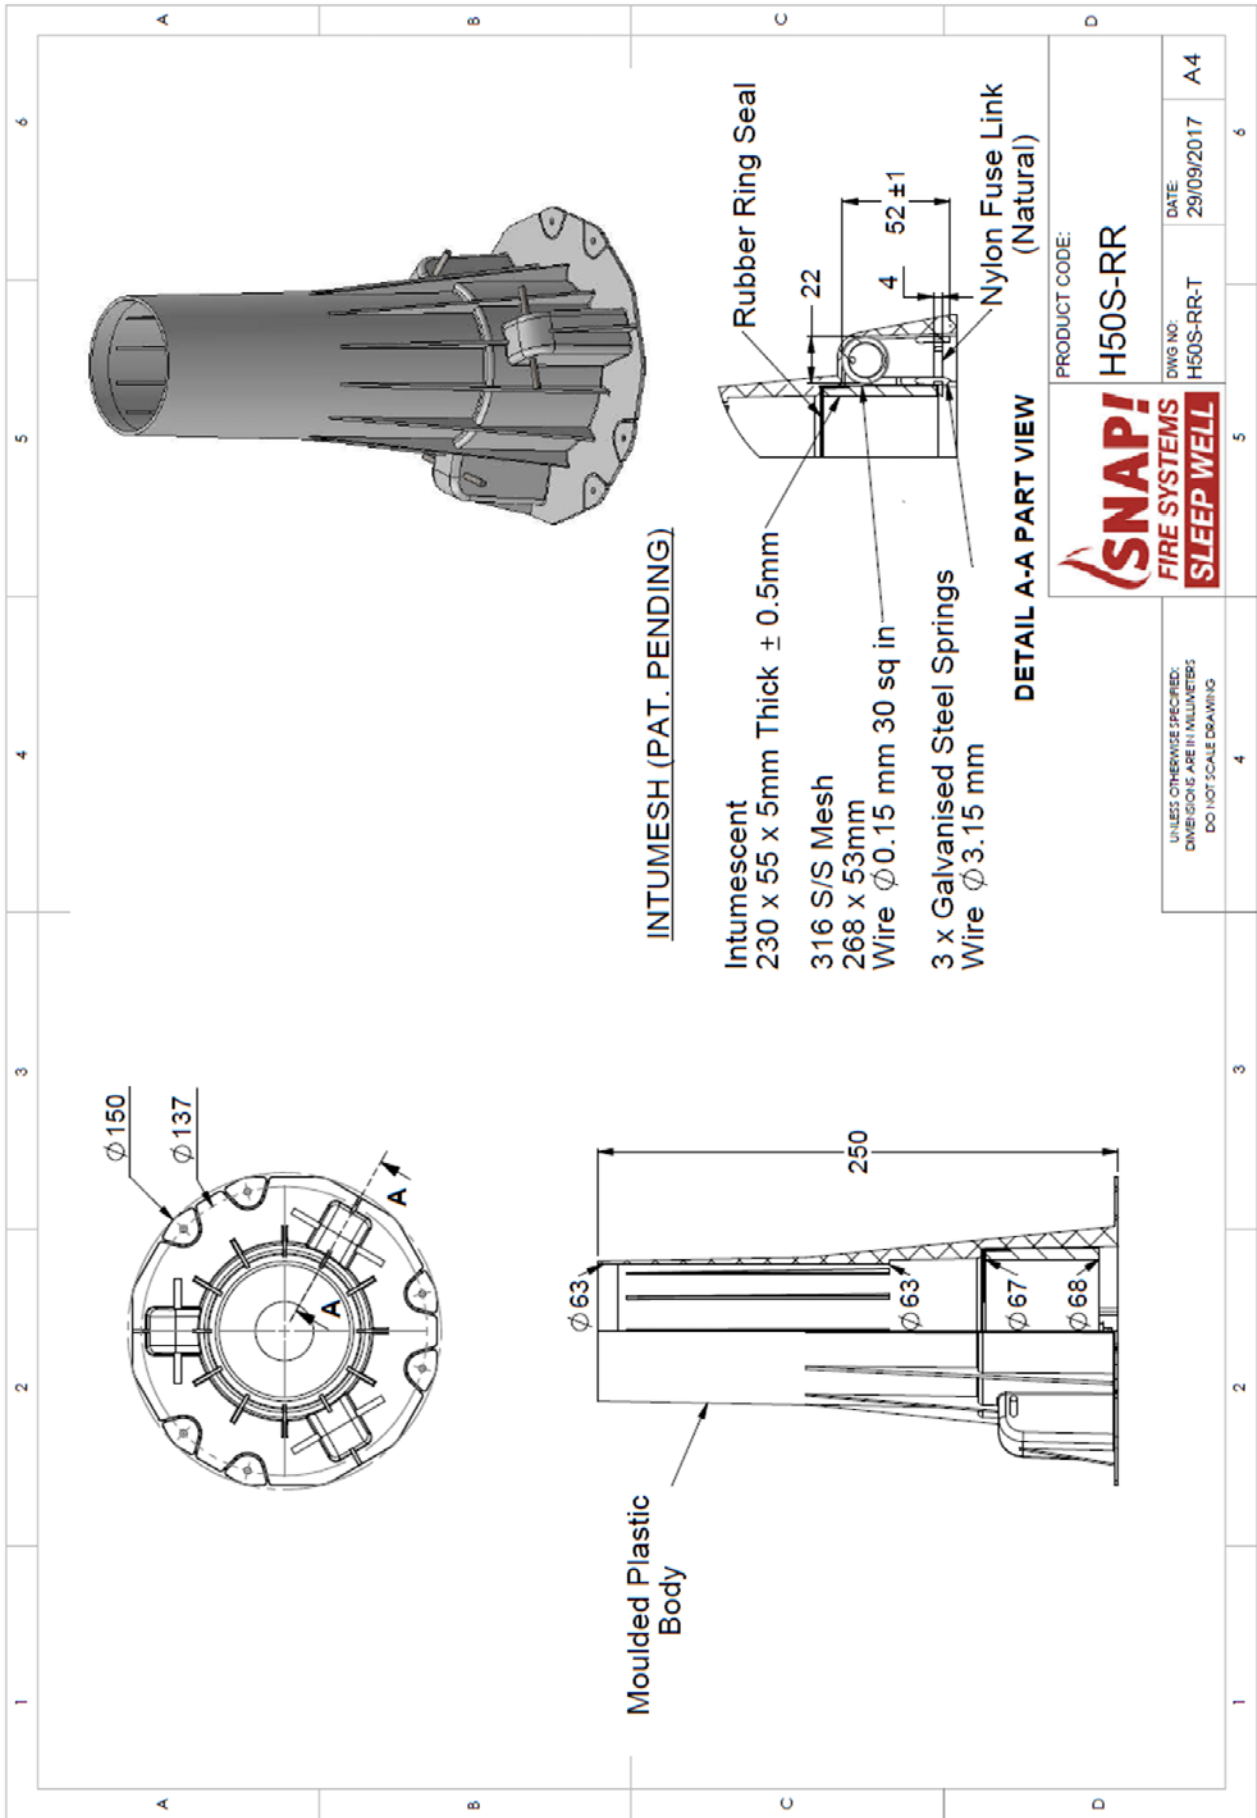
DRAWING NUMBER H50S-RR-T, DATED 29 SEPTEMBER 2017, BY SNAP FIRE SYSTEMS PTY LTD.

The SNAP Cast-in H50S-RR fire collar comprised a 1.6-mm thick polypropylene casing with a 67-mm inner diameter and a 150-mm diameter base flange. The 250-mm high collar casing incorporated a 230-mm x 55-mm x 5-mm thick Intumesh intumescent material and a rubber ring seal. The closing mechanism comprised three galvanised steel springs bound with nylon fuse links and a 268-mm x 53-mm 316 stainless steel mesh as shown in drawing numbered H50S-RR-T dated 29 September 2017, by Snap Fire Systems Pty Ltd.
