Fire-resistance test on fire collars protecting a concrete slab penetrated by services

Test Report

Author: Peter Gordon
Report number: FSP 2116
Date: 20 August 2020

Sponsored Investigation No. FSP 2116

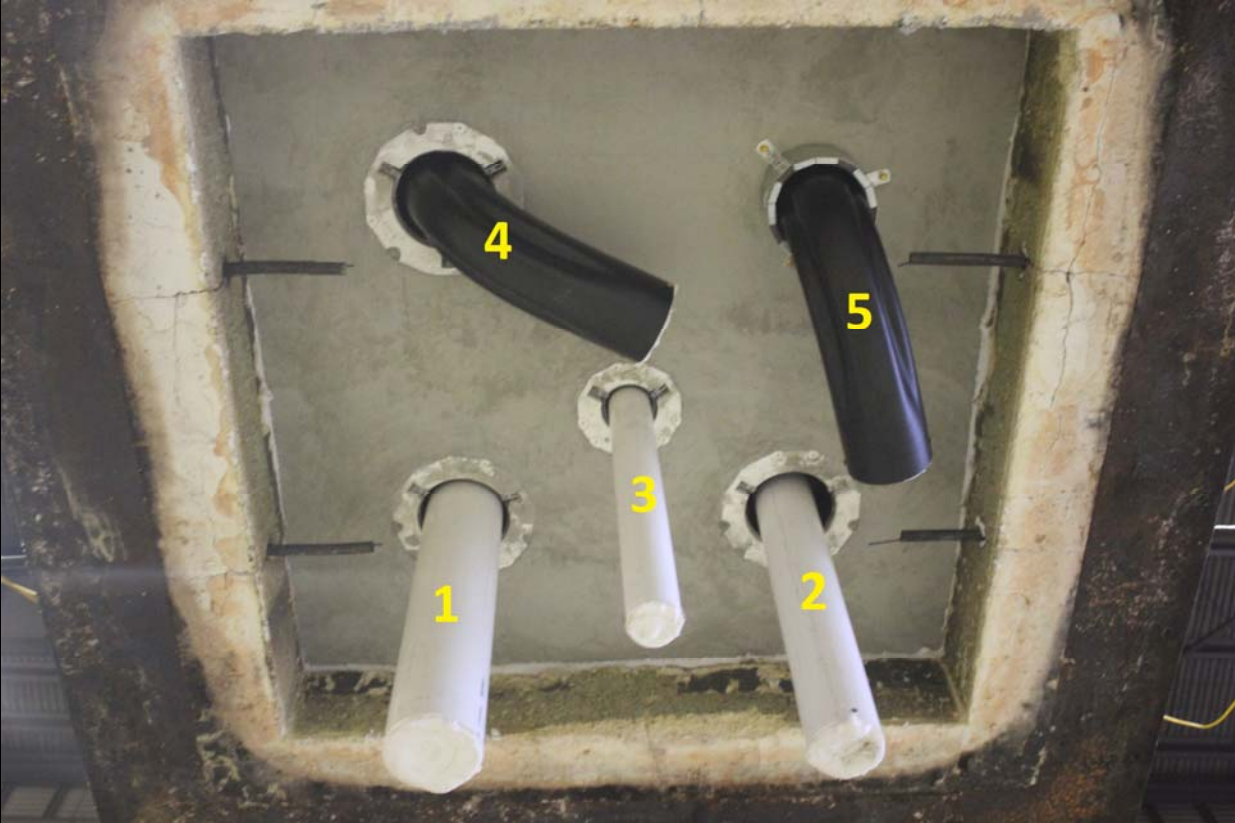
PHOTOGRAPH 1 – EXPOSED FACE OF SPECIMENS 2 AND 3 PRIOR TO TESTING

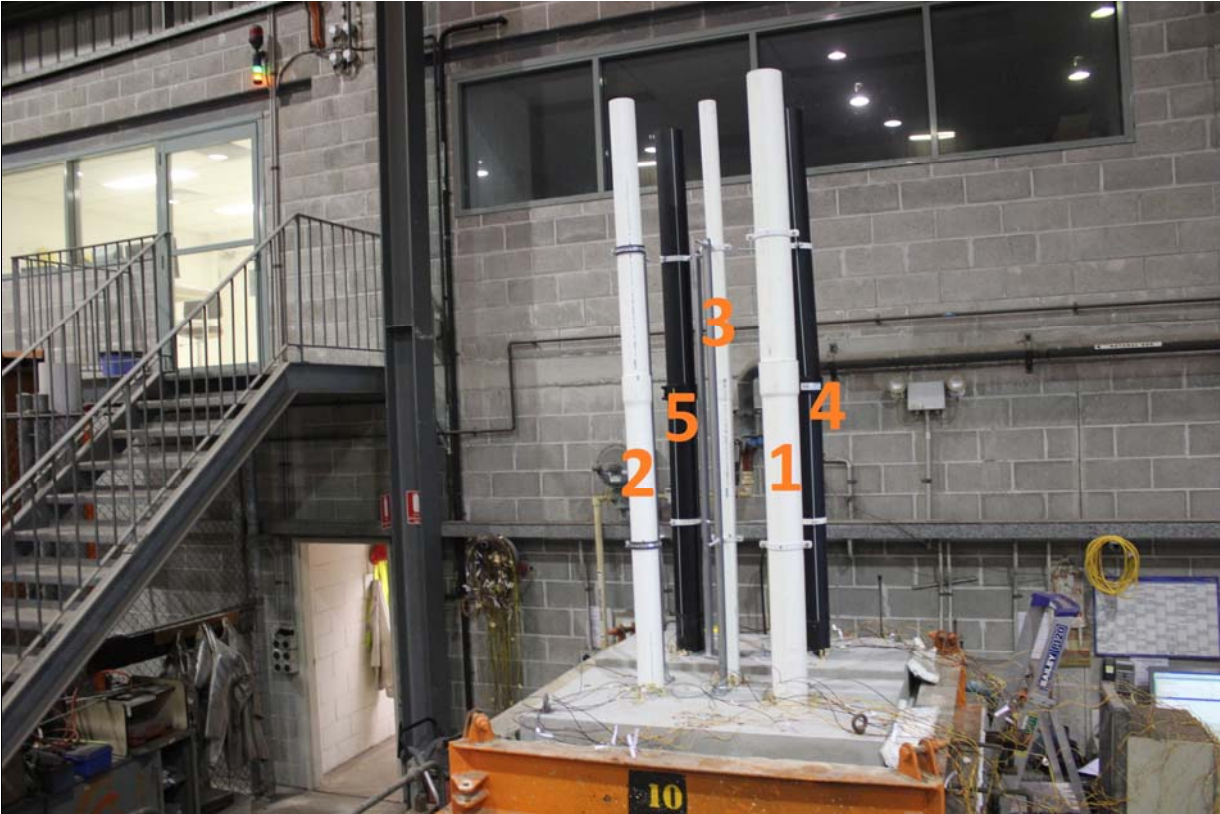
PHOTOGRAPH 2 – UNEXPOSED FACE OF SPECIMENS PRIOR TO TESTING

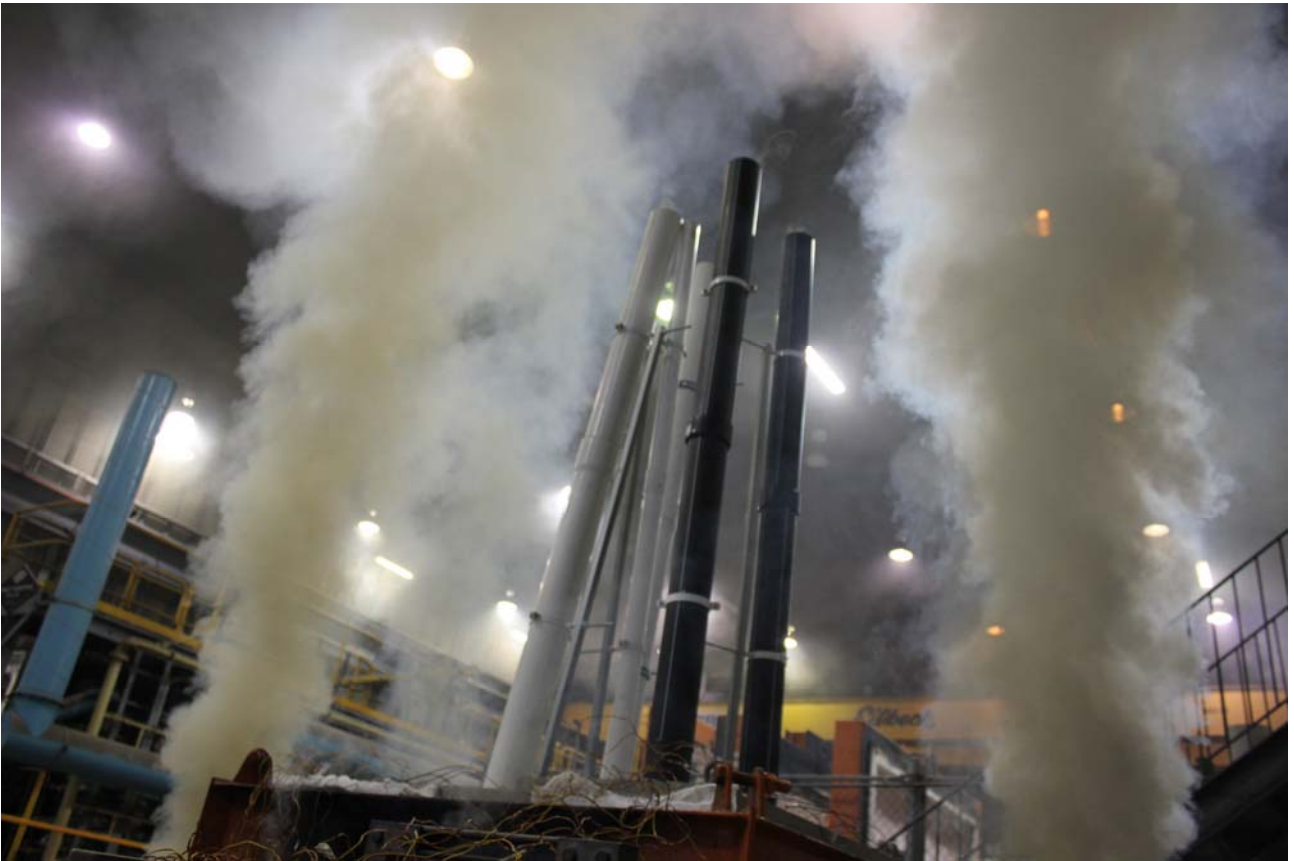
PHOTOGRAPH 3 – SPECIMENS AFTER 8 MINUTES OF TESTING

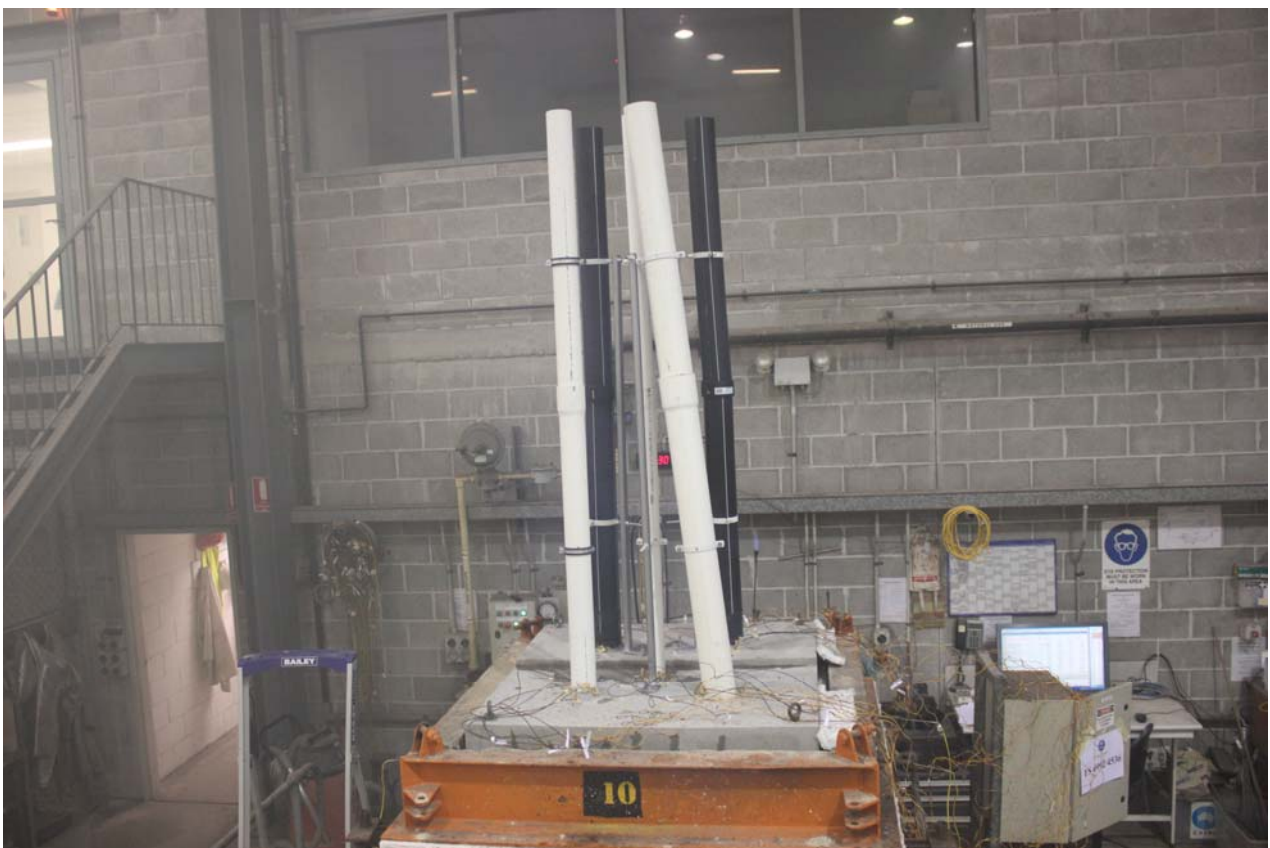
PHOTOGRAPH 4 – SPECIMENS AFTER 30 MINUTES OF TESTING

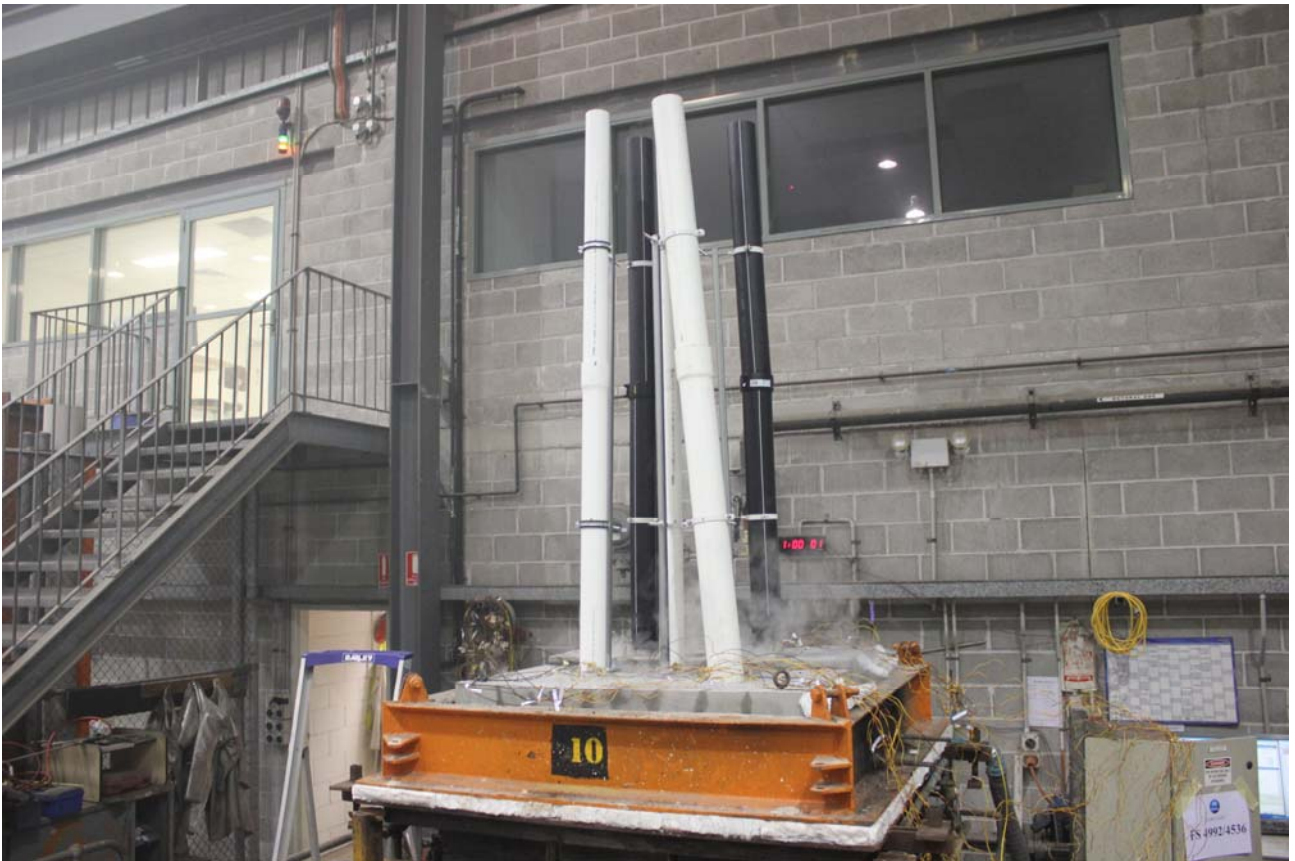
PHOTOGRAPH 5 – SPECIMENS AFTER 60 MINUTES OF TESTING

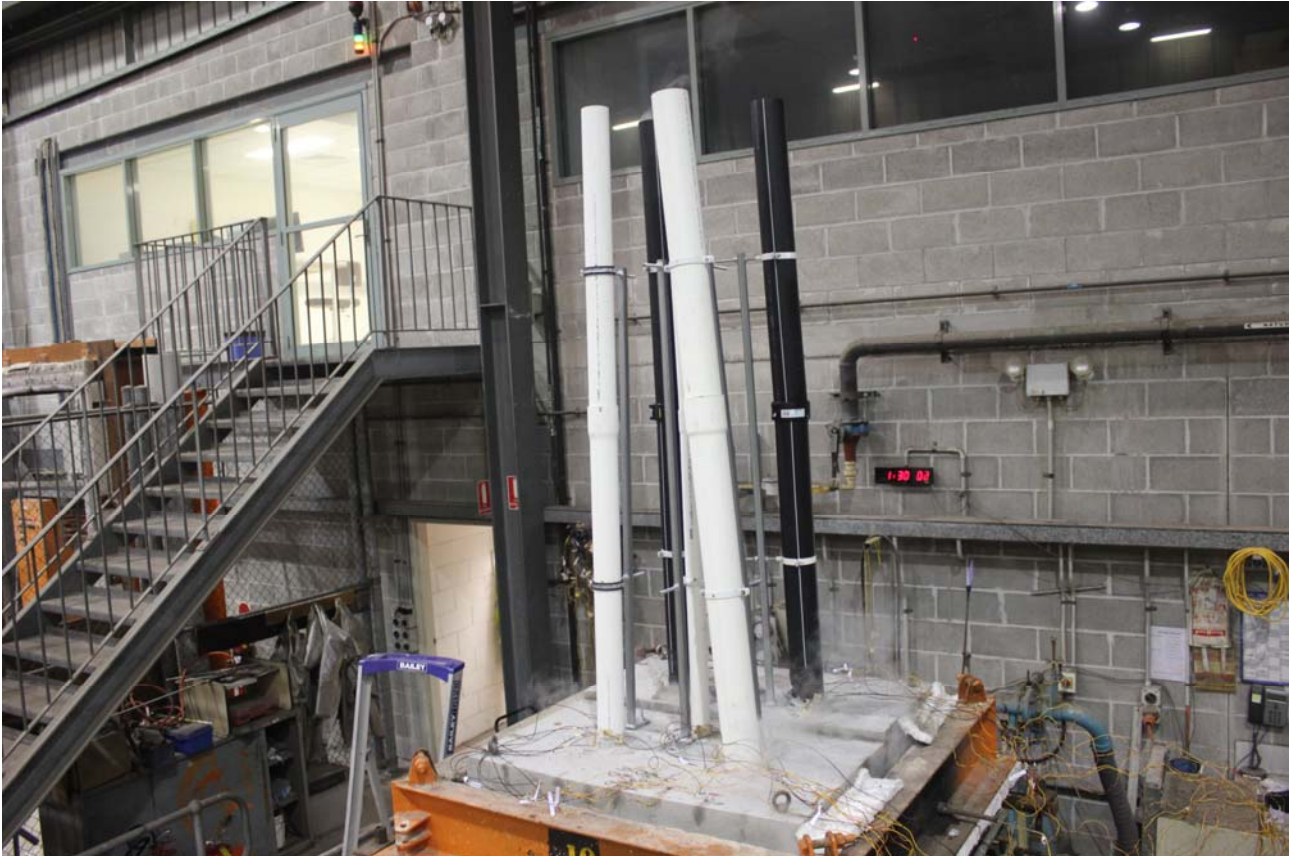
PHOTOGRAPH 6 – SPECIMENS AFTER 90 MINUTES OF TESTING

90 minutes -	Sealant around the base of the pipe of Specimen 2 has begun to swell.
105 minutes -	A small quantity of smoke is fluing from the end of the pipe of Specimen 5.

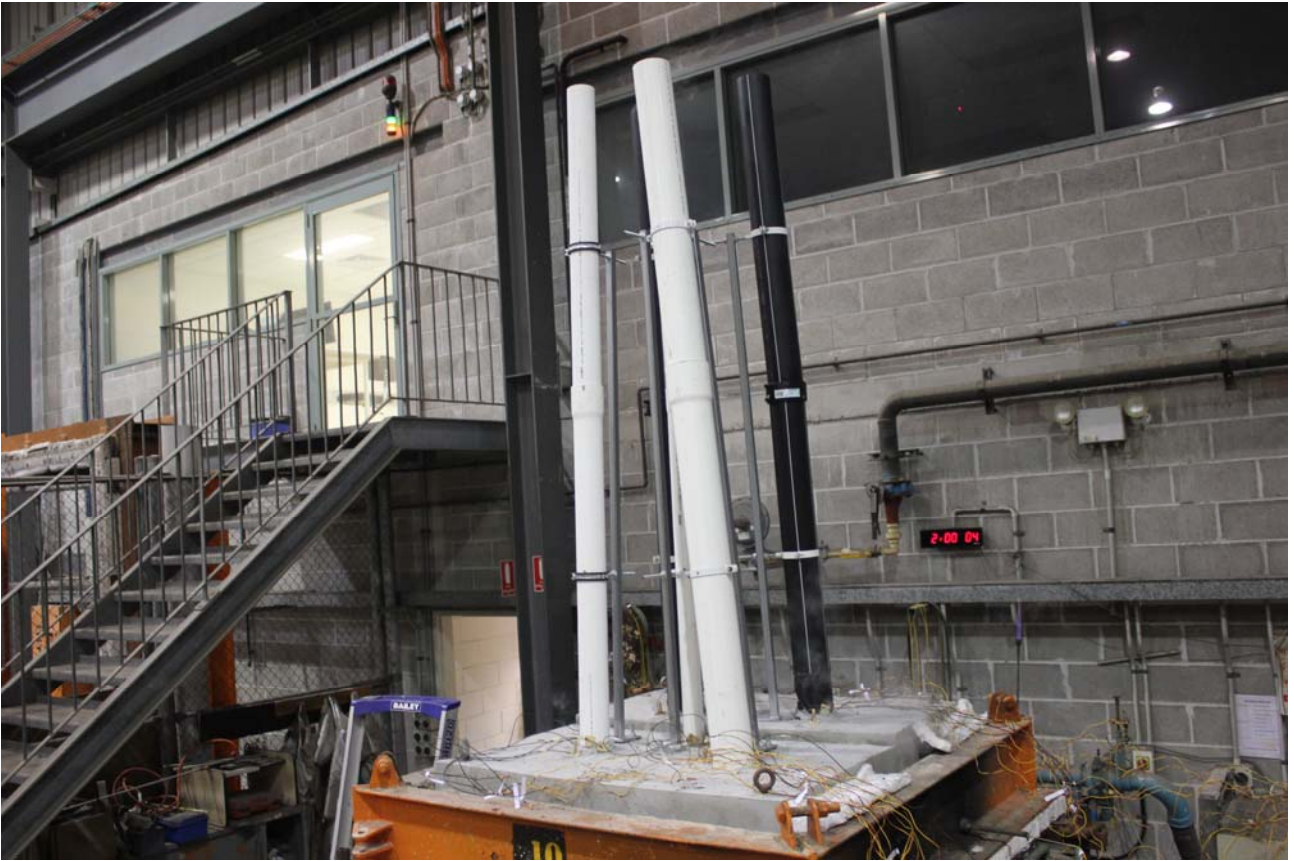
PHOTOGRAPH 7 – SPECIMENS AFTER 120 MINUTES OF TESTING

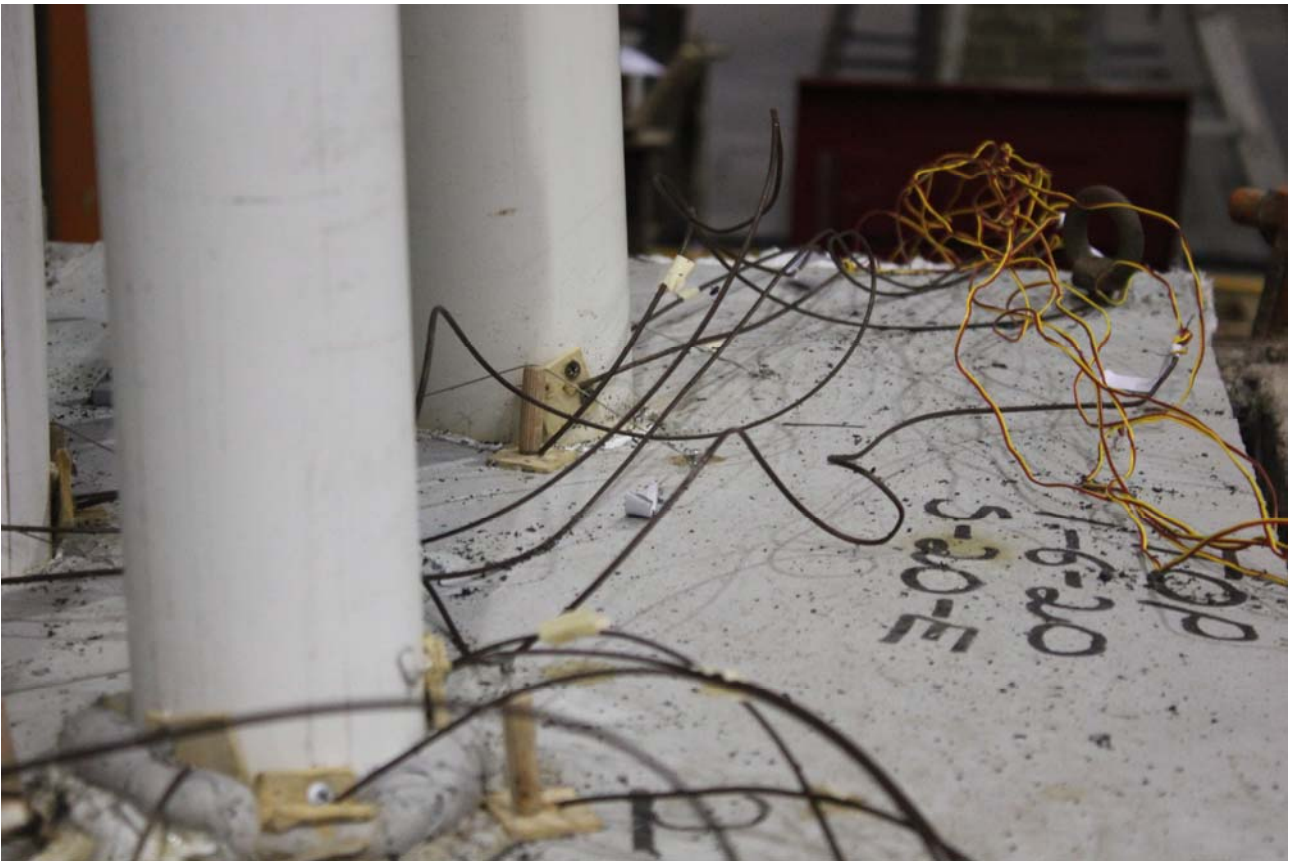
PHOTOGRAPH 9 – SPECIMENS 1 AND 2 AFTER 228 MINUTES OF TESTING

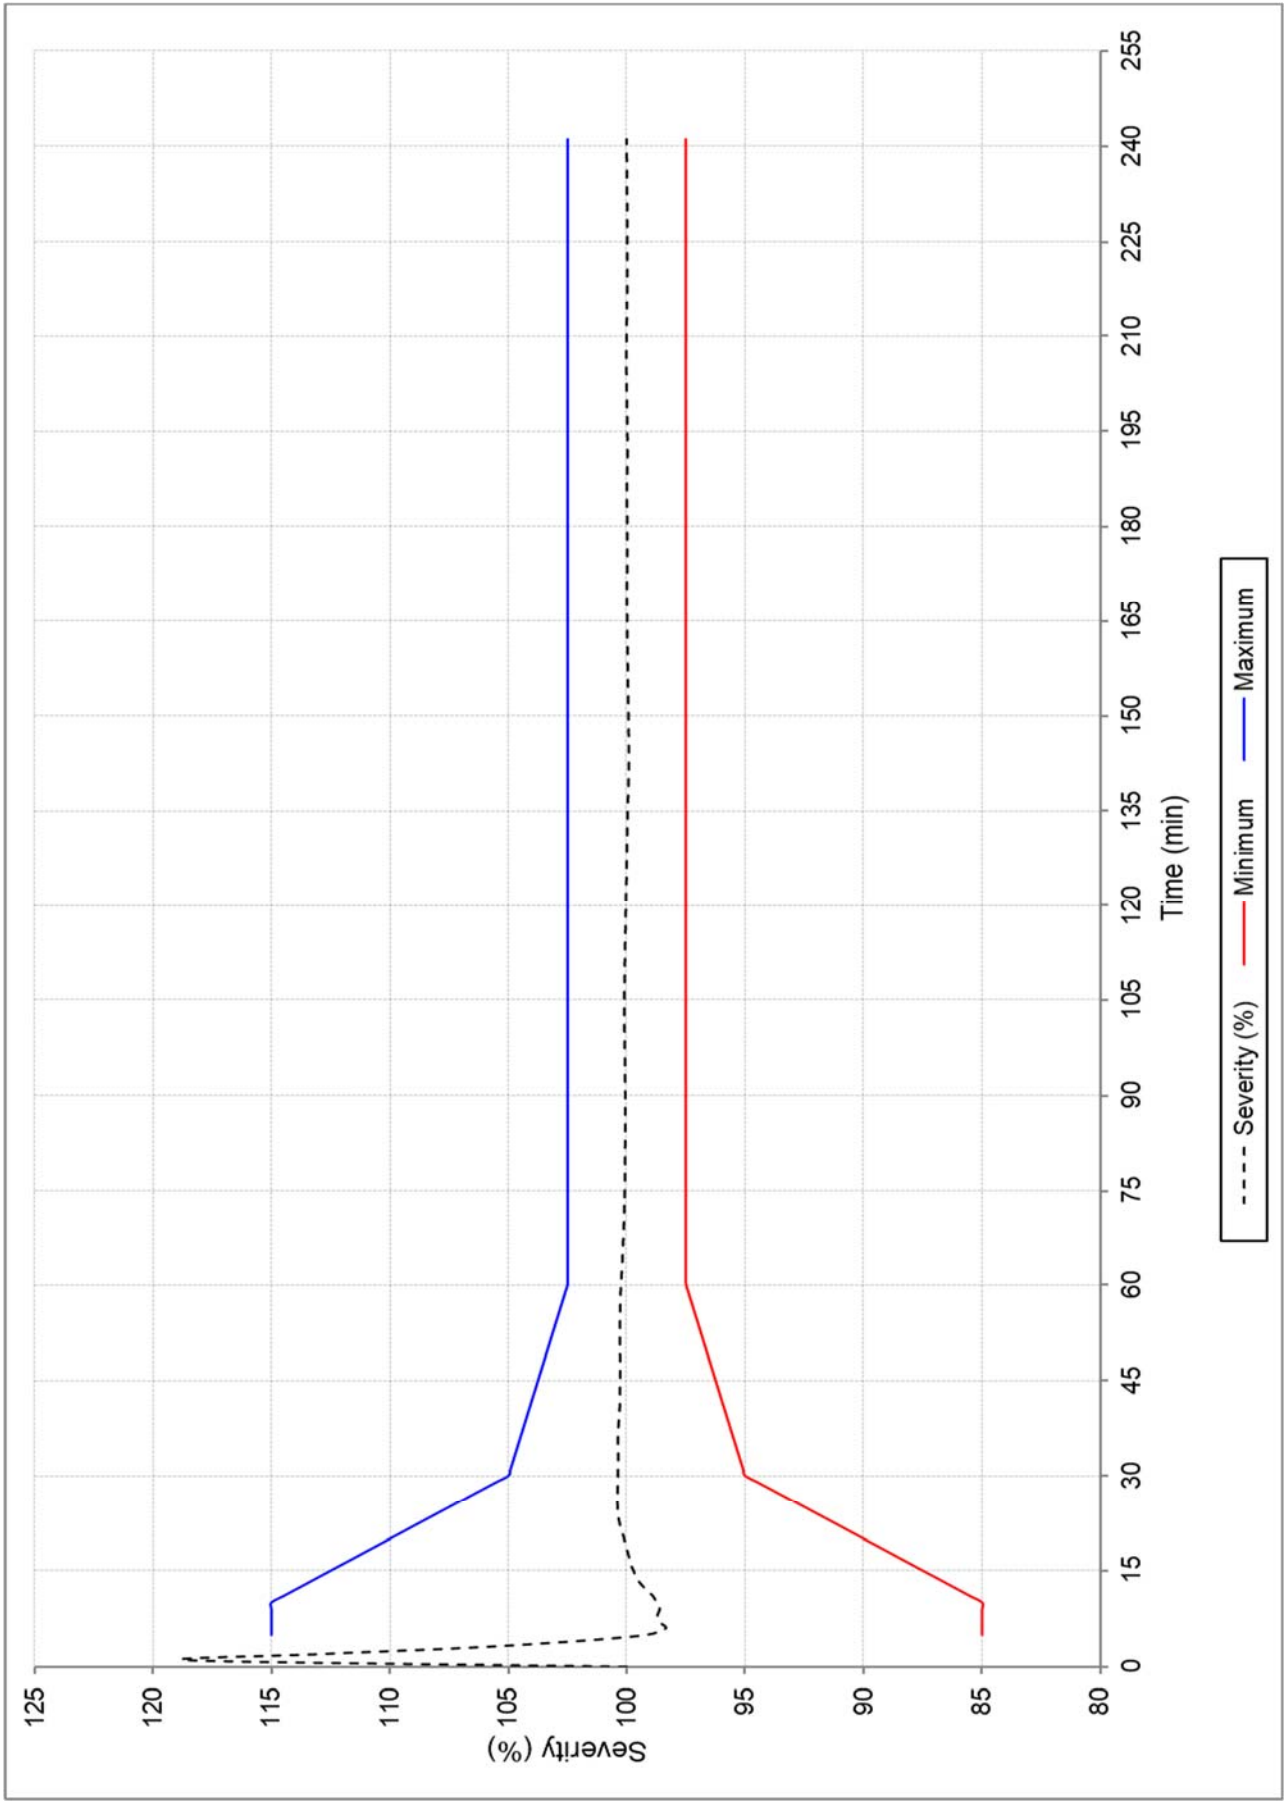
FIGURE 2 – FURNACE SEVERITY

Figure 2 shows the curve of furnace severity versus time during the heating period.
