Fire-resistance test on fire collars protecting a concrete slab penetrated by services

Test Report

Report number: FSP 2111
(Revision B)

Sponsored Investigation No. FSP 2111

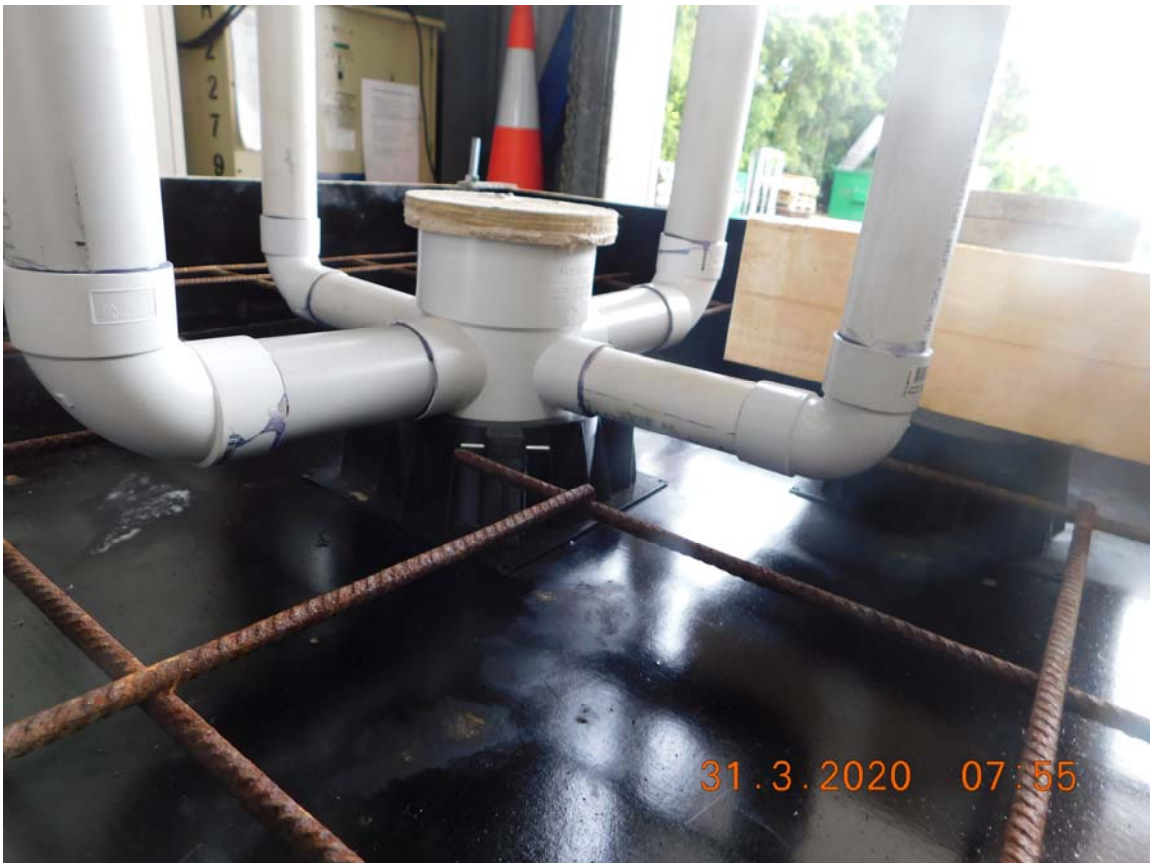
PHOTOGRAPH 1 –SPECIMENS PRIOR TO CONCRETE CASTING

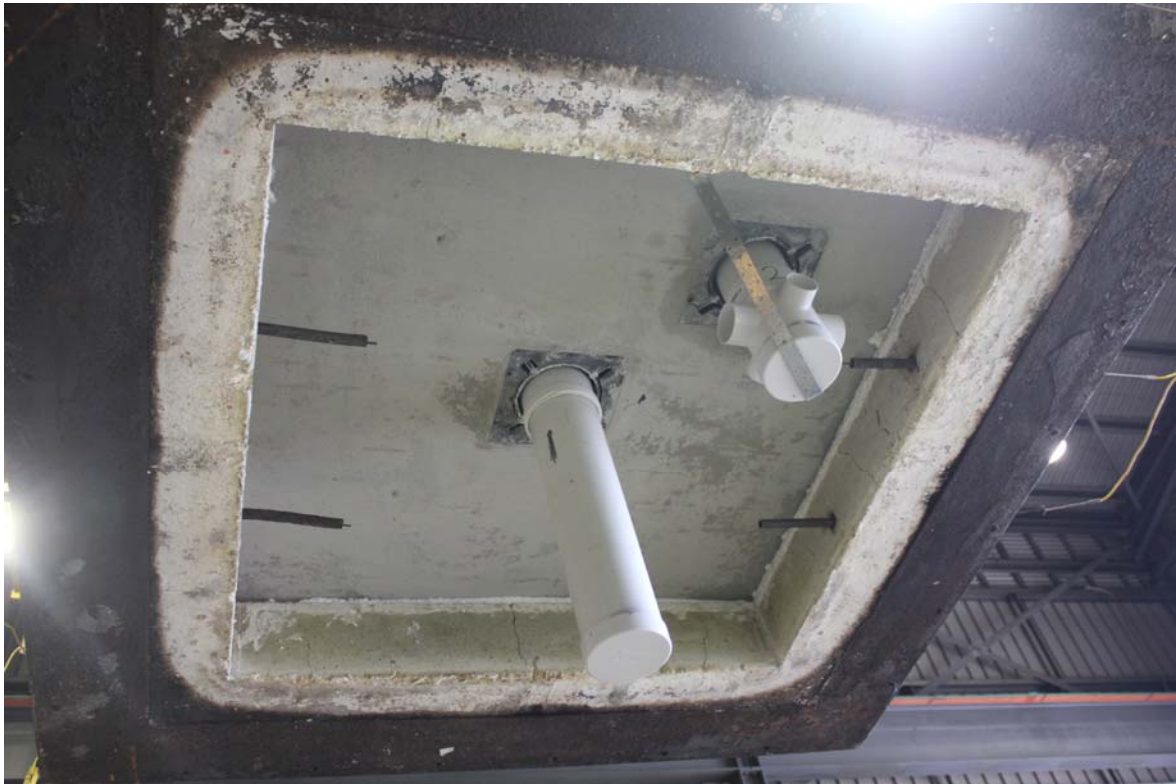
PHOTOGRAPH 2 – EXPOSED FACE OF SPECIMENS 2 AND 3 PRIOR TO TESTING

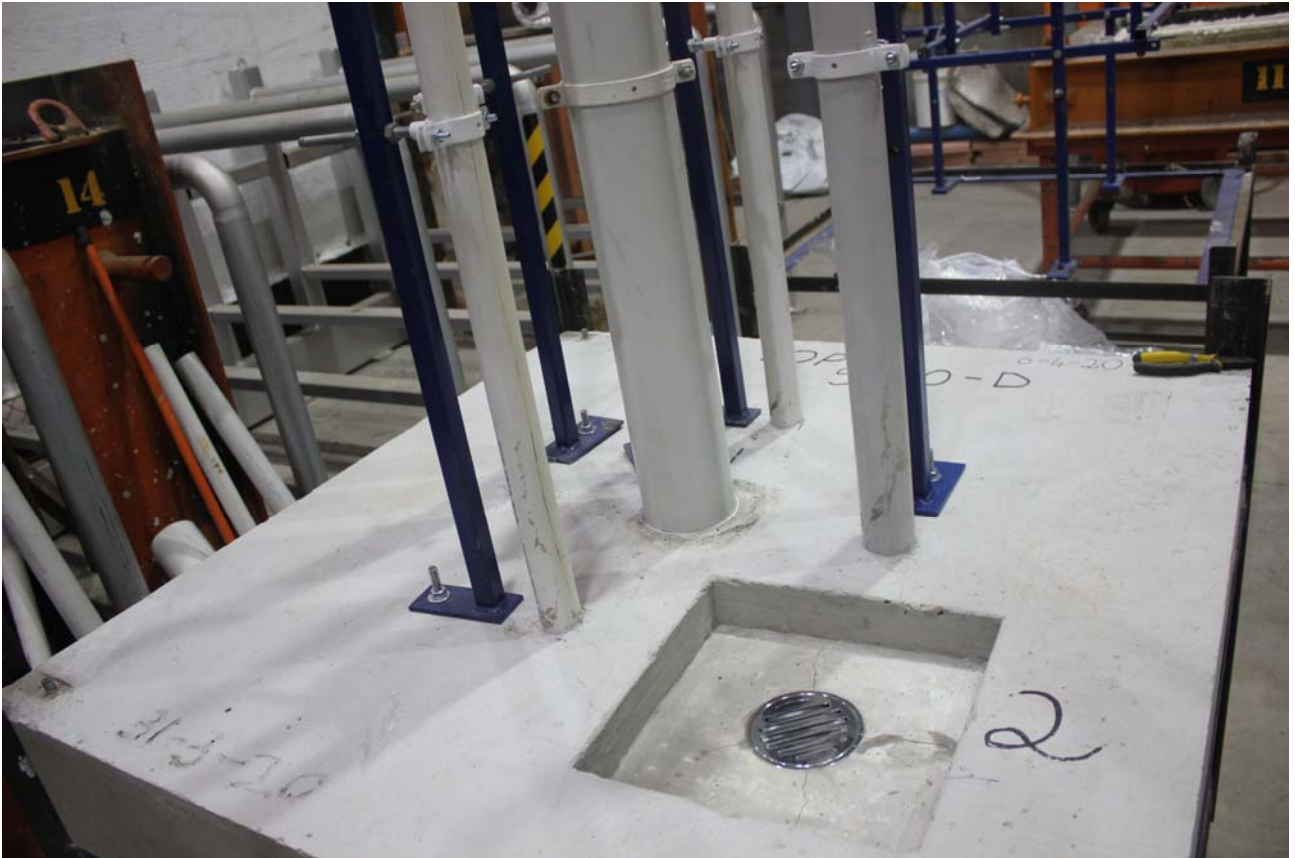
PHOTOGRAPH 3 – UNEXPOSED FACE OF SPECIMENS PRIOR TO TESTING

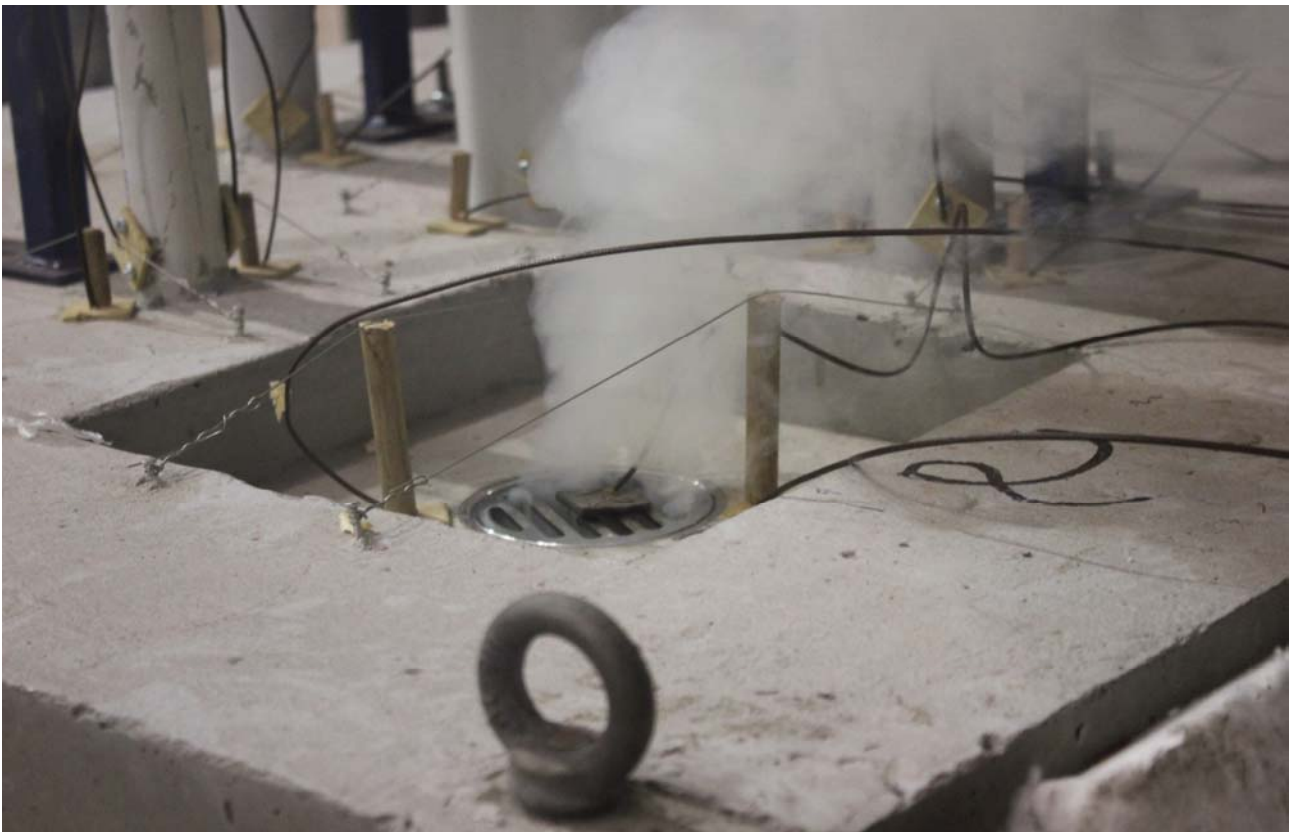
PHOTOGRAPH 4 – SPECIMEN 2 AFTER 5 MINUTES OF TESTING

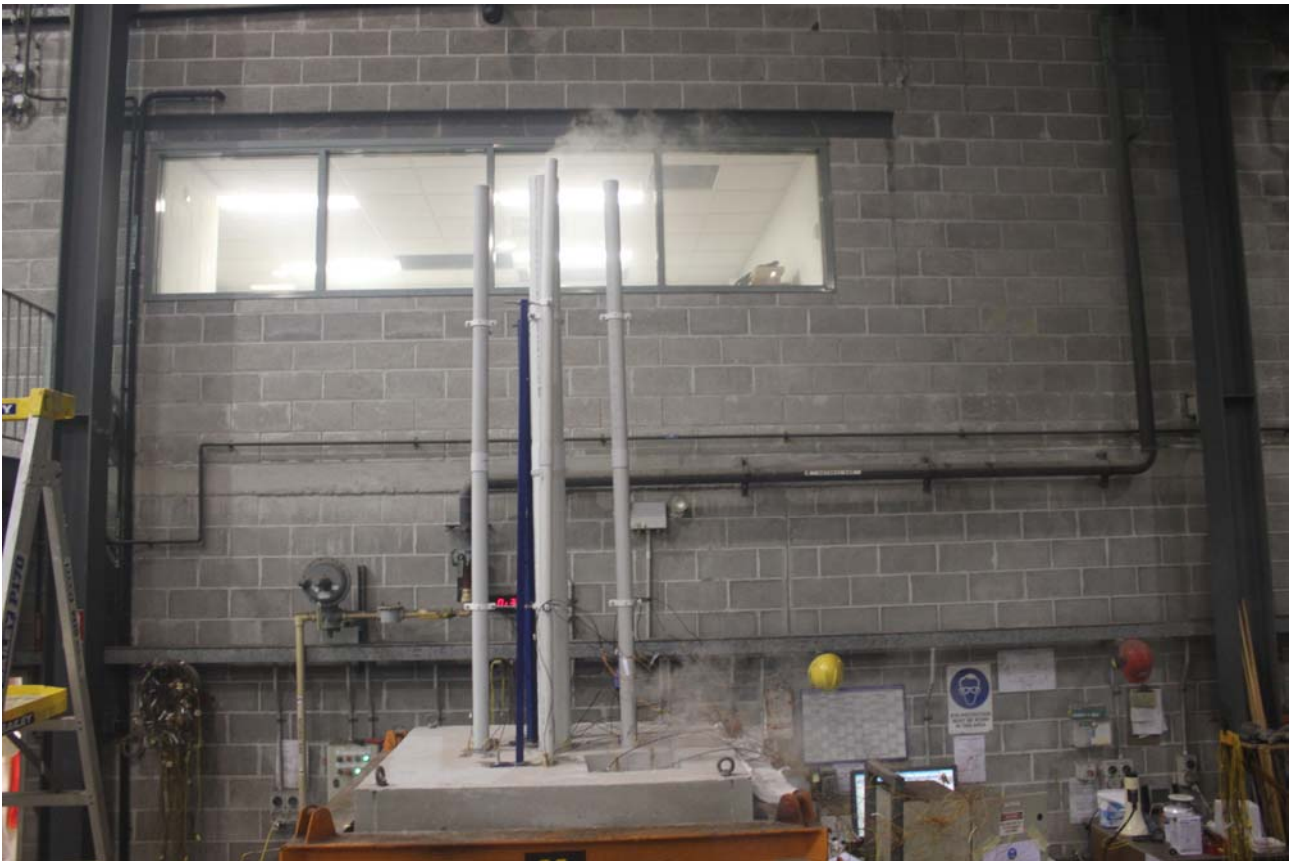
PHOTOGRAPH 5 – SPECIMENS AFTER 30 MINUTES OF TESTING

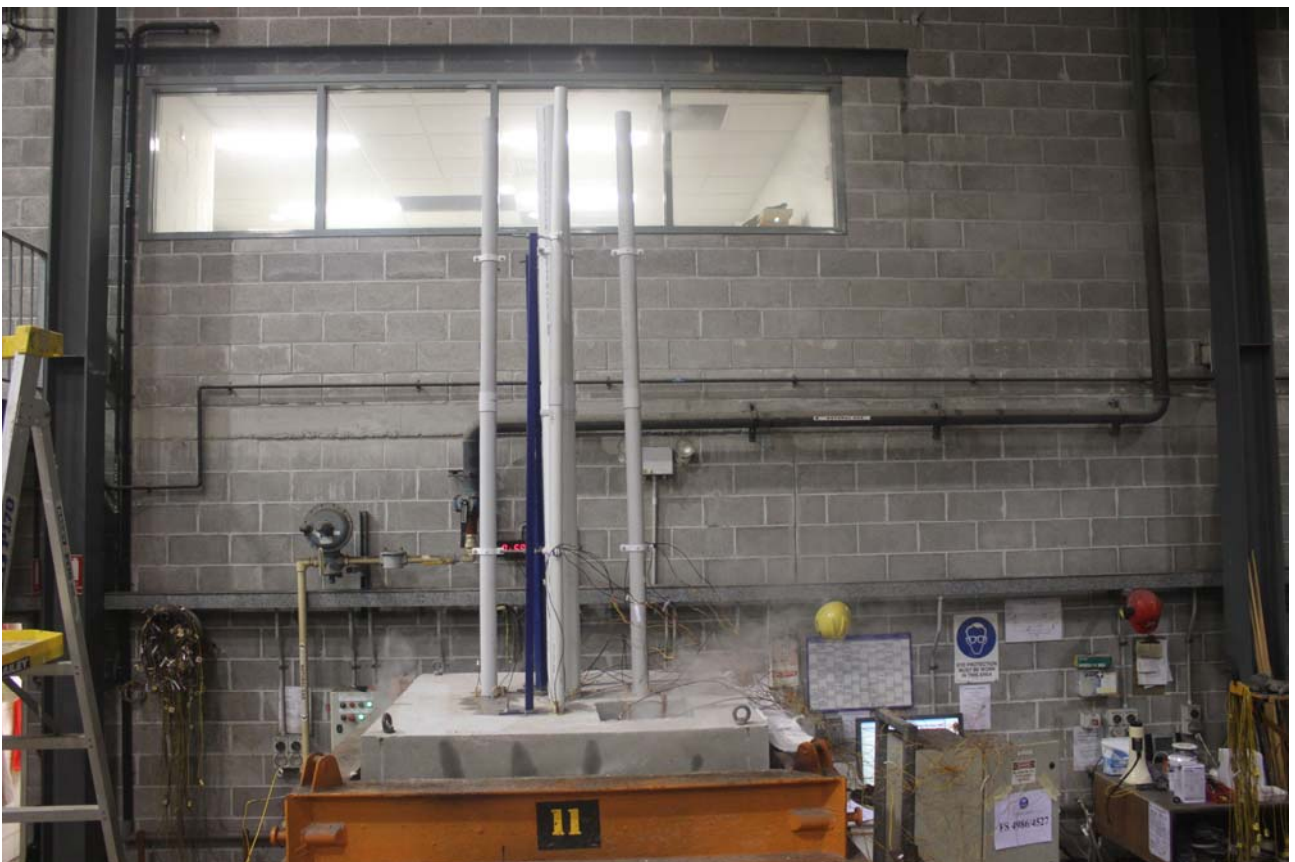
PHOTOGRAPH 6 – SPECIMENS AFTER 60 MINUTES OF TESTING

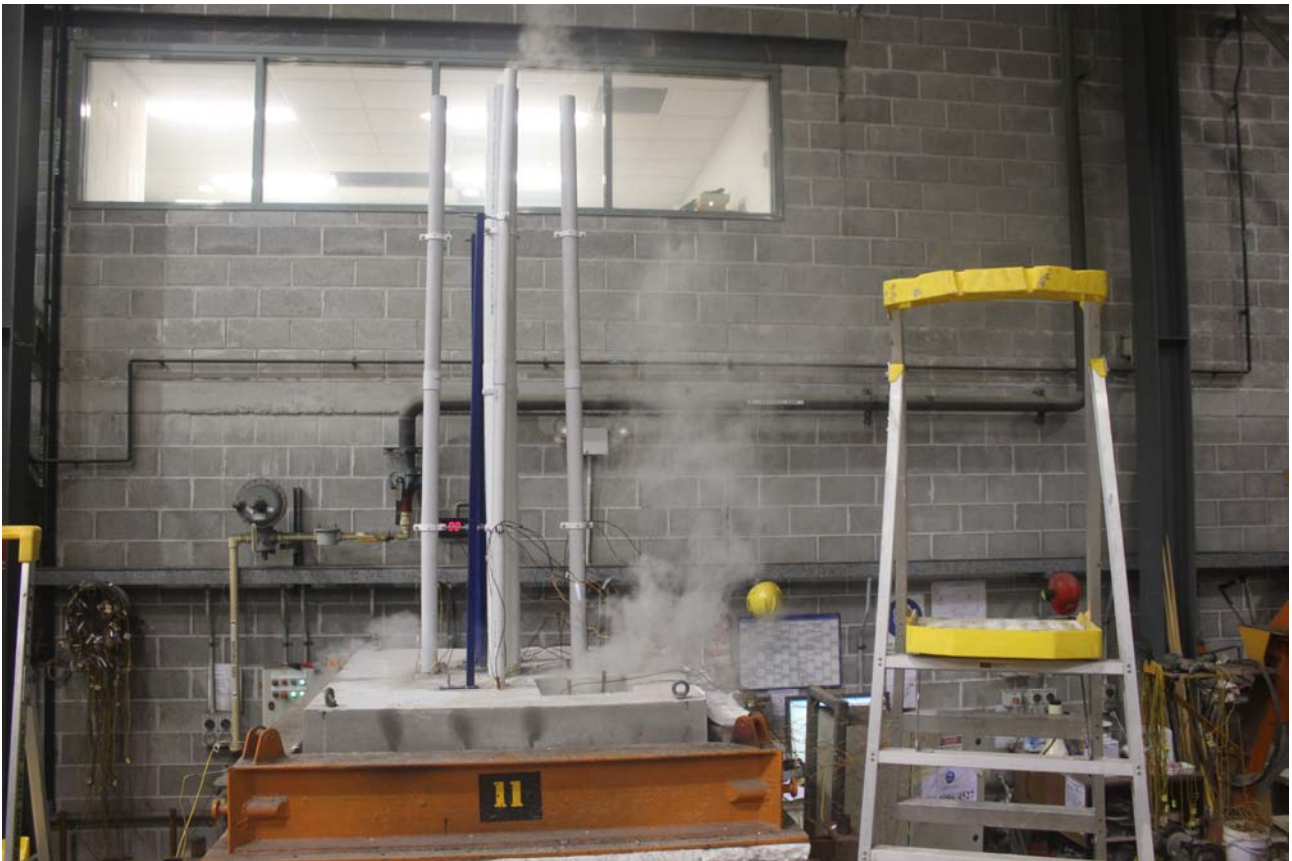
PHOTOGRAPH 7 – SPECIMENS AFTER 120 MINUTES OF TESTING

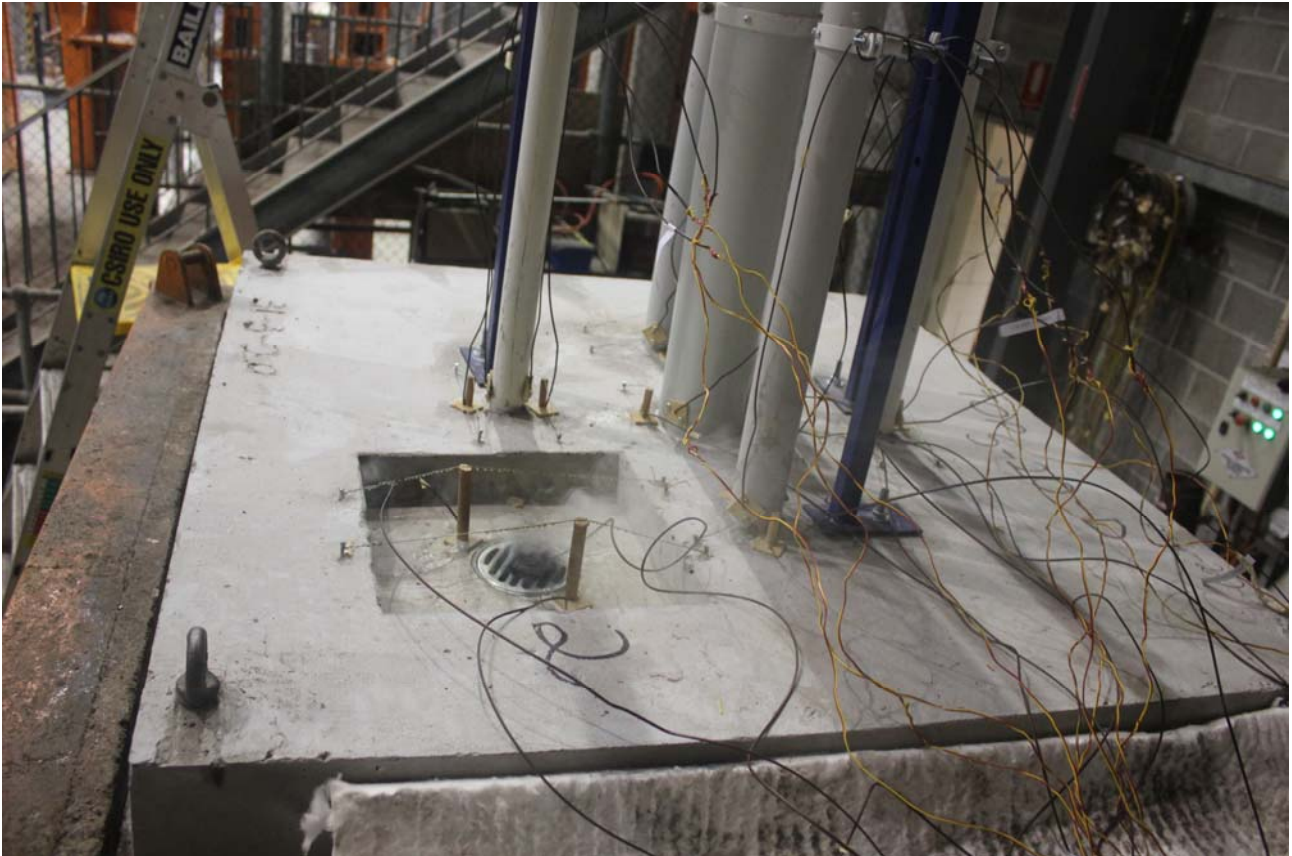
PHOTOGRAPH 8 – SPECIMENS AFTER 180 MINUTES OF TESTING

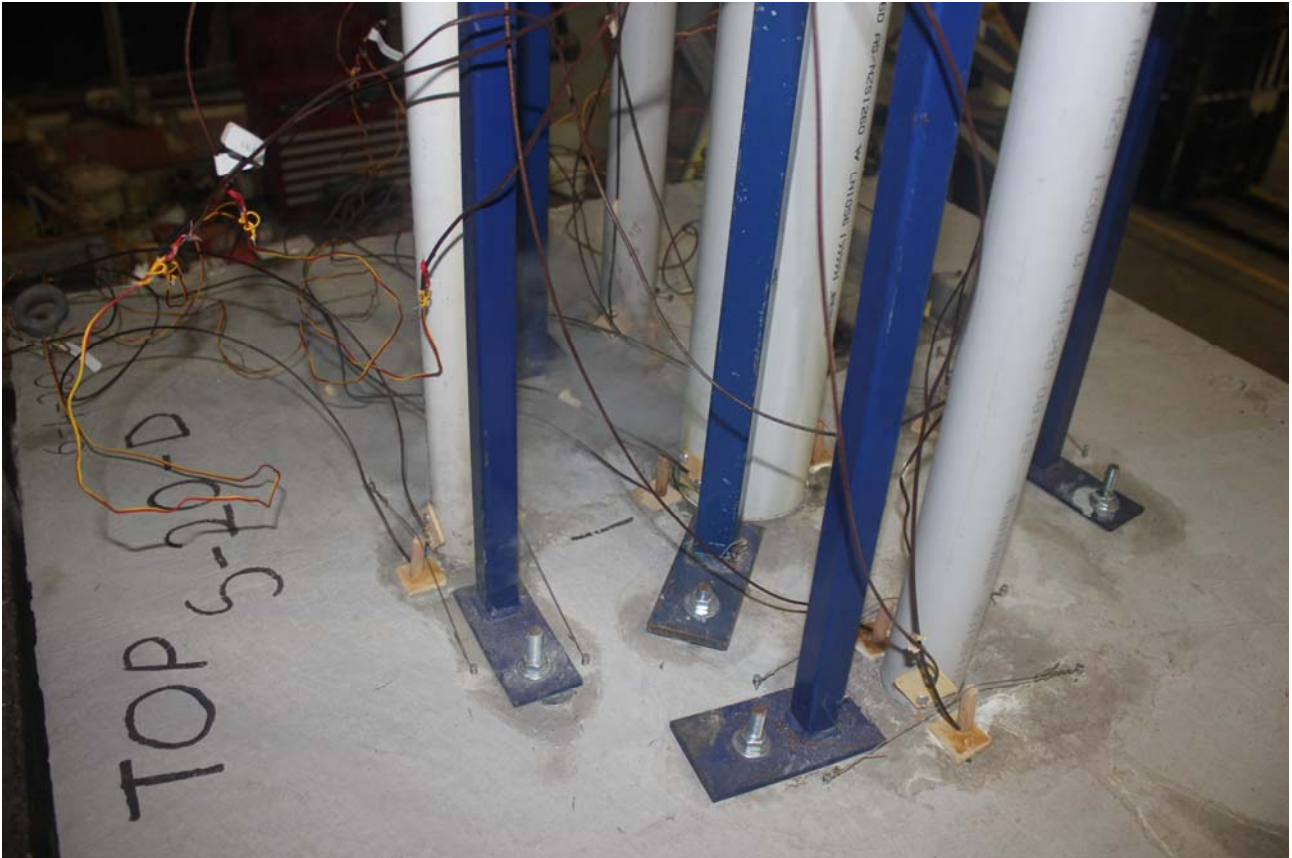
PHOTOGRAPH 9 – SPECIMEN 1 AFTER 225 MINUTES OF TESTING

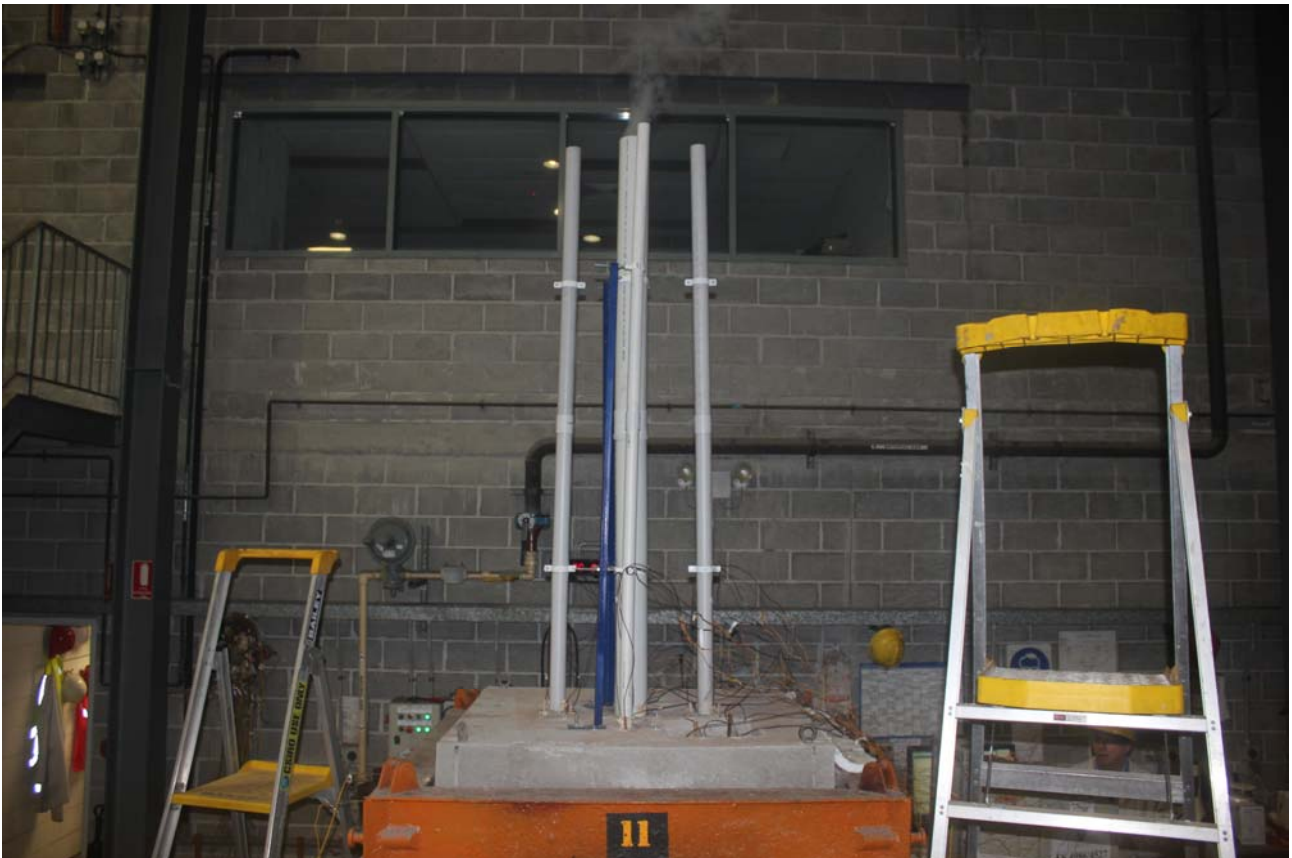
PHOTOGRAPH 10 – SPECIMENS AFTER 240 MINUTES OF TESTING

65 minutes -	Steam is being emitted from the concrete slab.
90 minutes -	Smoke has begun fluing from the grate of the Specimen 2 floor waste and the temperature has begun to rise.
102 minutes -	Cotton pad test applied above the grate of Specimen 2 – no ignition noted at this time.
120 minutes -	Smoke continues to flue from end of the 100 PVC stack pipe of Specimen 1.
179 minutes -	Cotton pad test applied above the grate of Specimen 2 – no ignition noted at this time.
184 minutes -	<u>Insulation failure of Specimen 2</u> - maximum temperature rise of 180K is exceeded on the centre of the metal grate of Specimen 2 floor waste.
203 minutes -	Smoke / steam has begun venting at the base of the 100 PVC stack pipe adjacent to thermocouples 4 and 6.
226 minutes -	Smoke / steam continues to vent at the base of the 100 PVC stack pipe adjacent to thermocouples 4 and 6. Photograph 10
241 minutes -	Test terminated.
