# Fire-resistance test on retrofit fire collars protecting a plasterboard wall penetrated by services

## Test Report

**Author:** Peter Gordon  
**Report number:** FSP 2100  
**Date:** 30 August 2020

## Sponsored Investigation No. FSP 2100

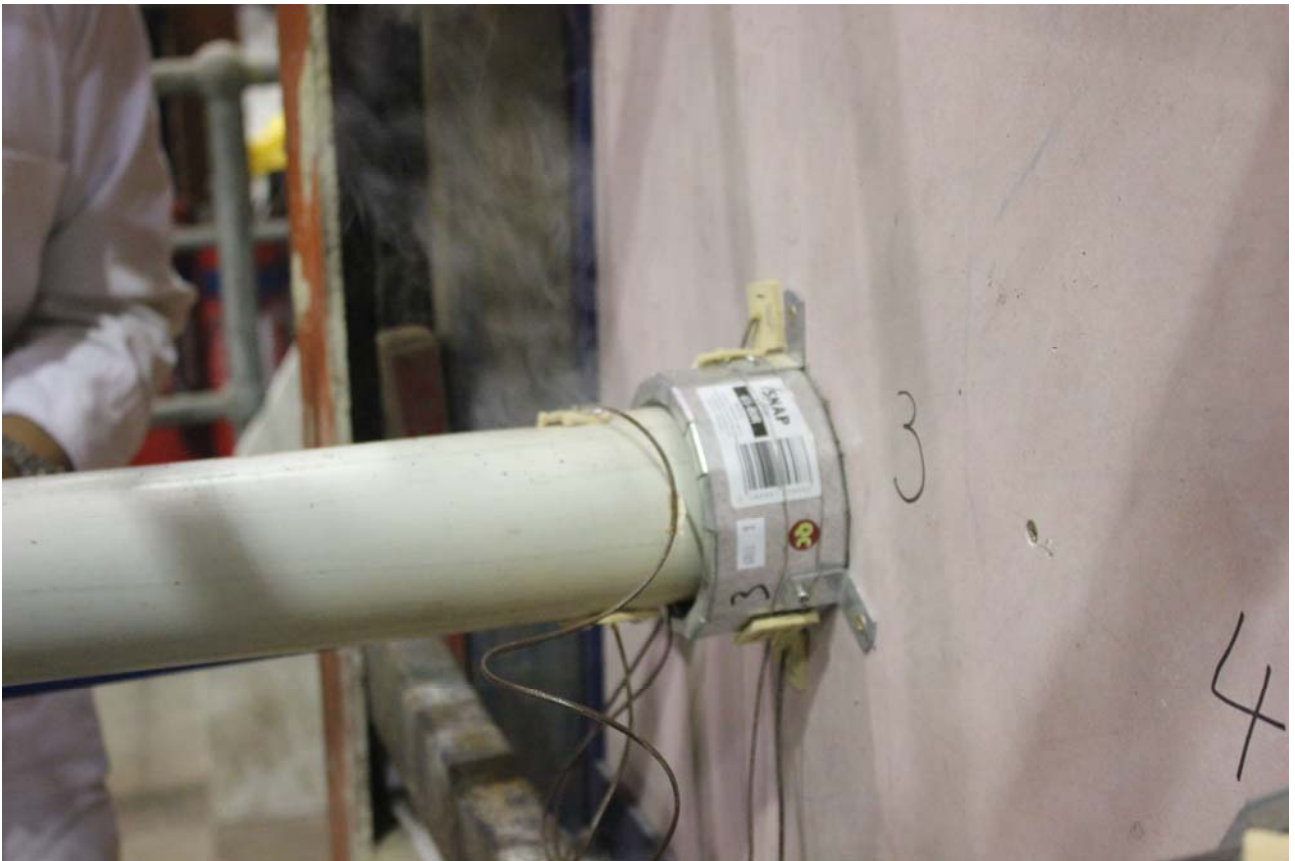
**PHOTOGRAPH 3 – SPECIMEN 3 AFTER 10 MINUTES OF TESTING**

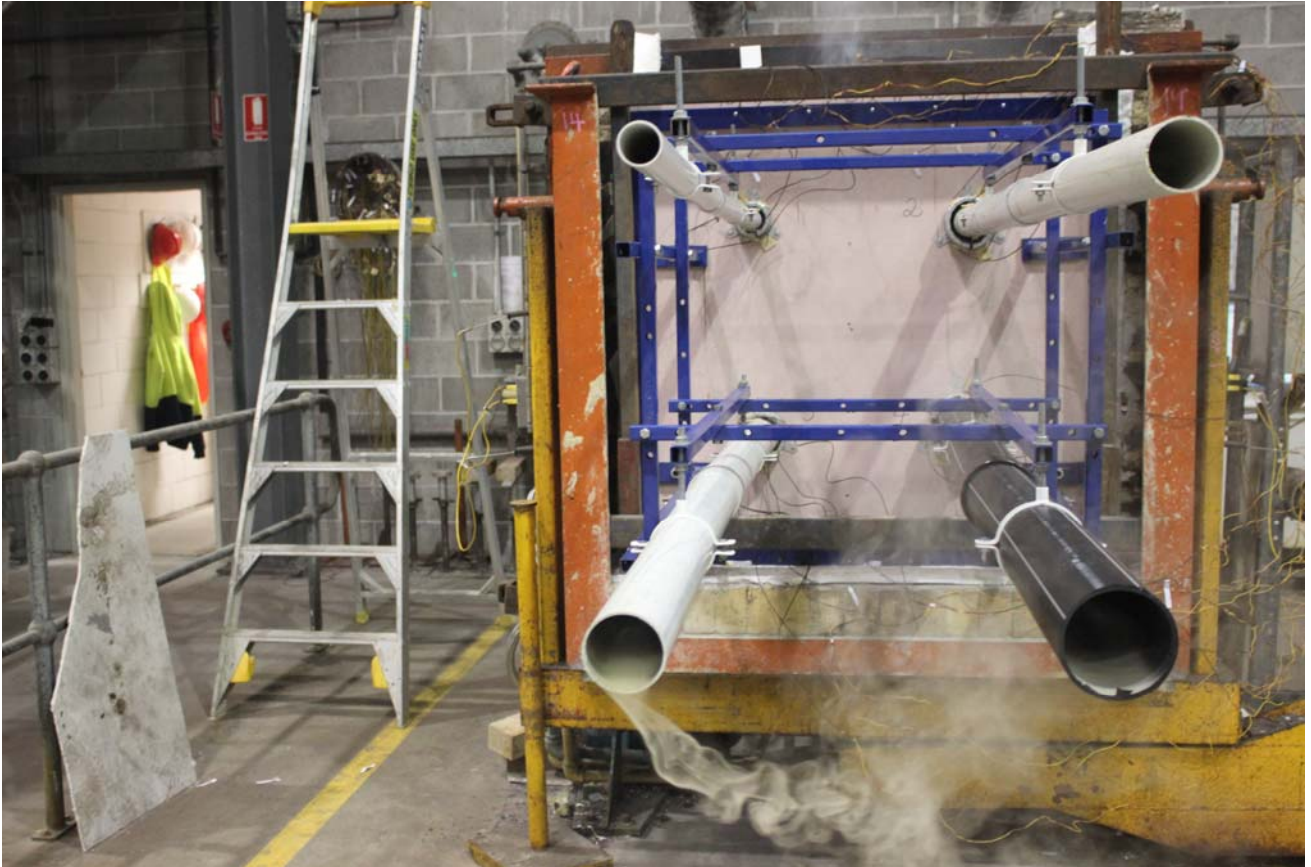
**PHOTOGRAPH 4 – SPECIMENS AFTER 30 MINUTES OF TESTING**

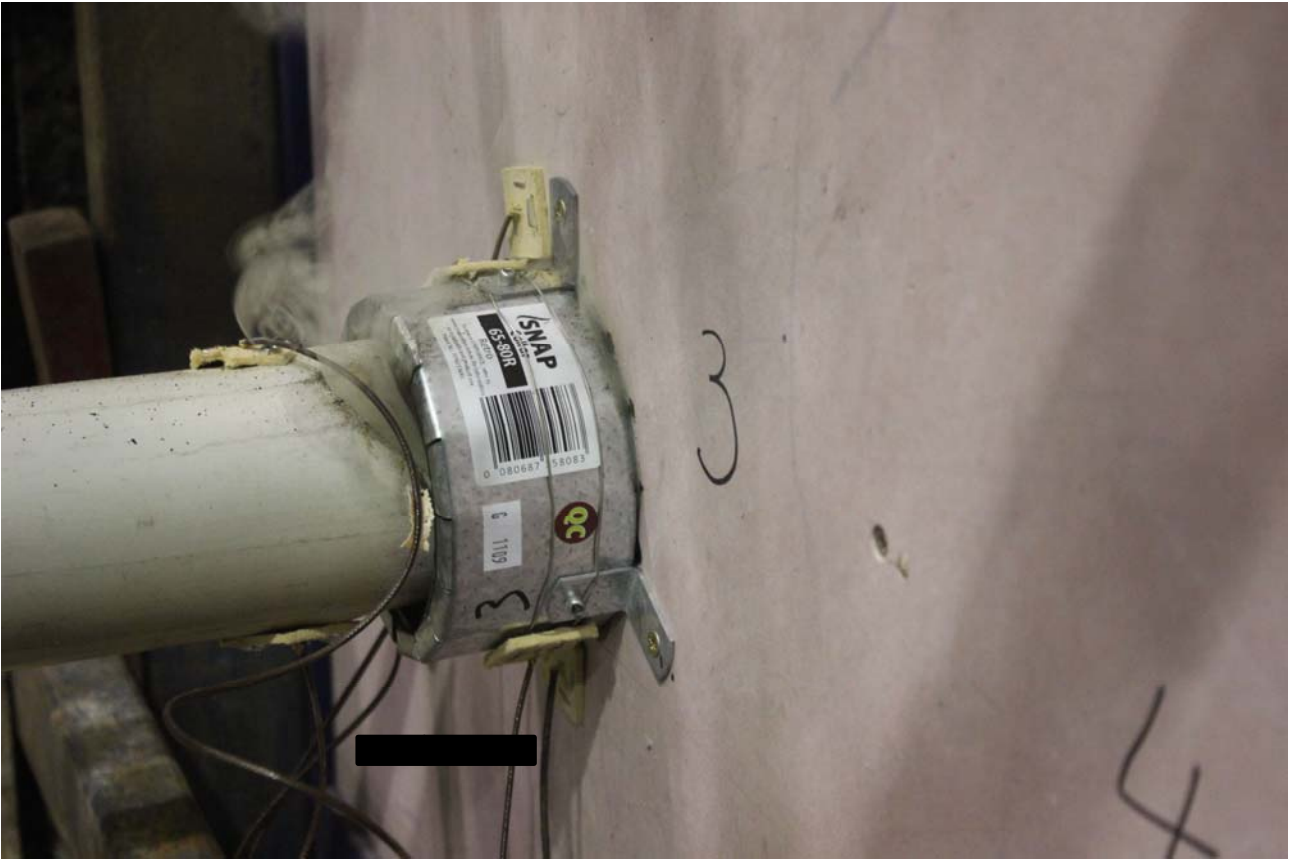
**PHOTOGRAPH 5 – SPECIMEN 3 AFTER 36 MINUTES OF TESTING**

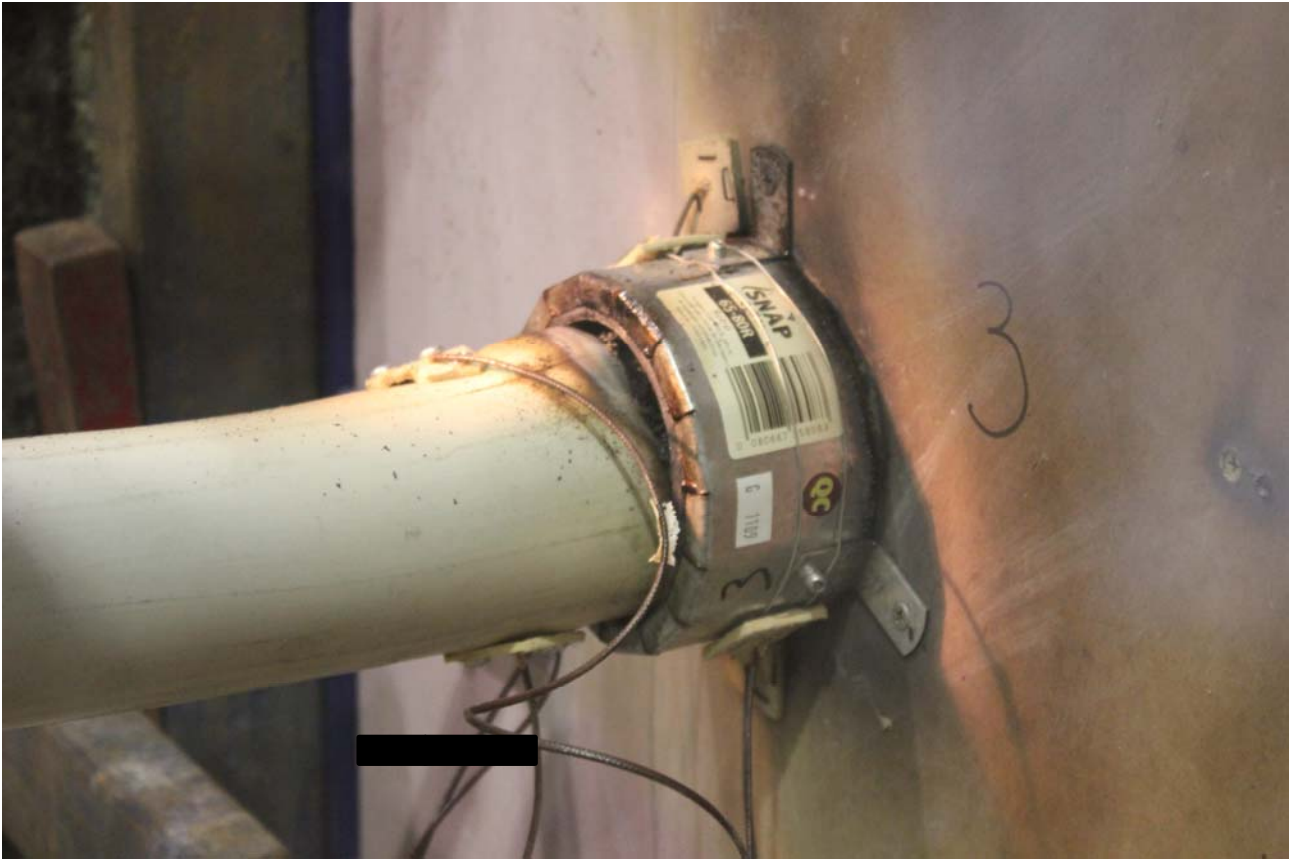
**PHOTOGRAPH 7 – SPECIMEN 3 AFTER 73 MINUTES OF TESTING**

- 70 minutes - Insulation Failure of Specimen 3 – maximum temperature rise of 180K is exceeded on the plasterboard wall 25-mm below the collar.
- 74 minutes - Insulation Failure of Specimen 1 – maximum temperature rise of 180K is exceeded on the plasterboard wall 25-mm below the collar.

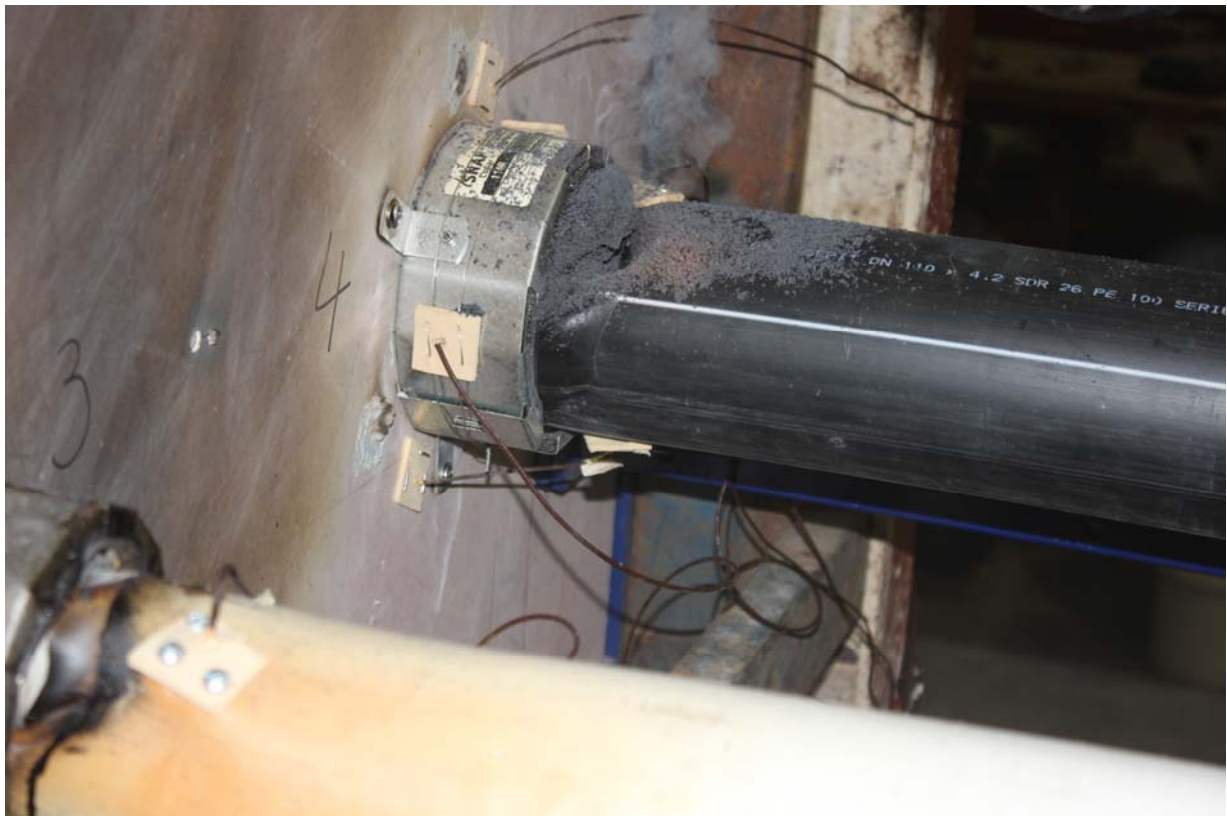
**PHOTOGRAPH 8 – SPECIMENS 3 AND 4 AFTER 80 MINUTES OF TESTING**

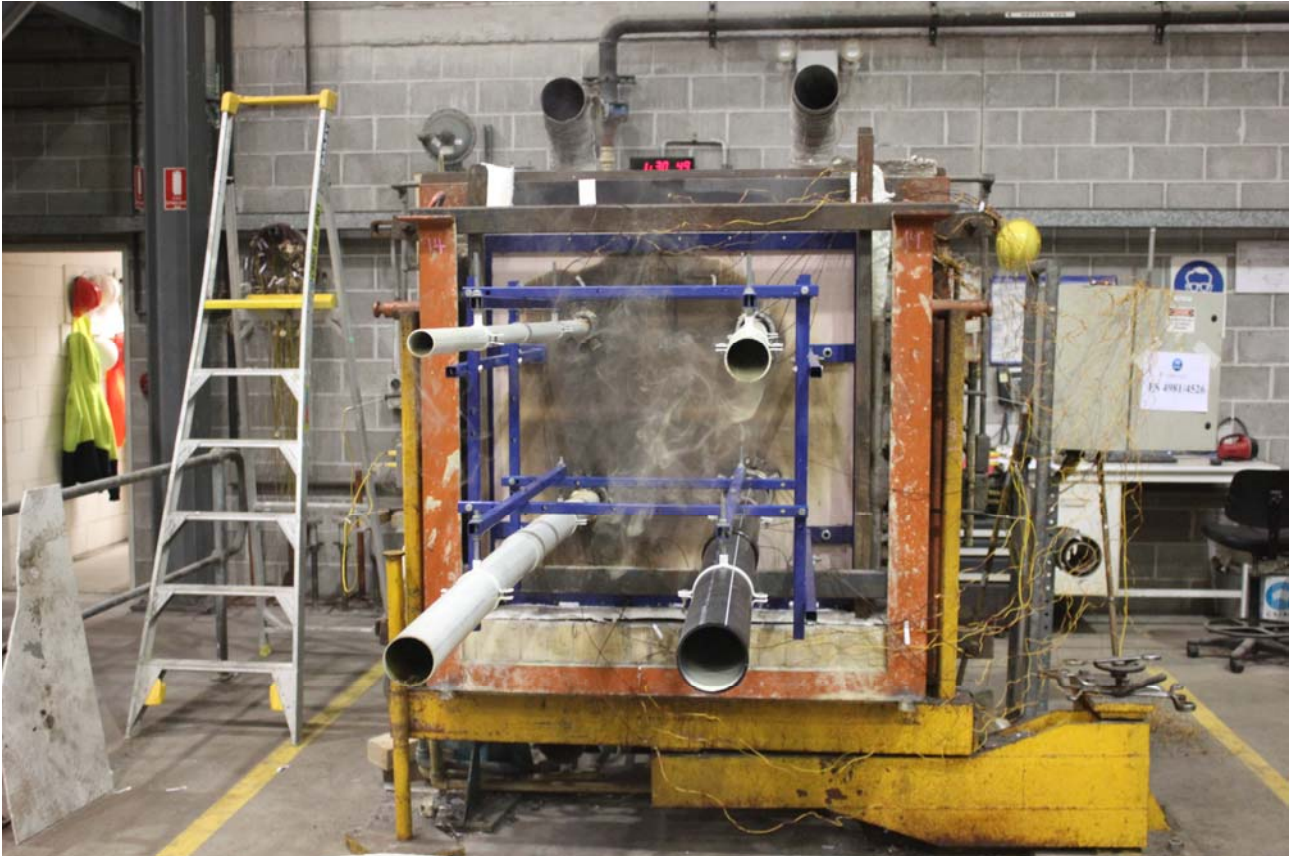
**PHOTOGRAPH 10 – SPECIMENS AT CONCLUSION OF TESTING**

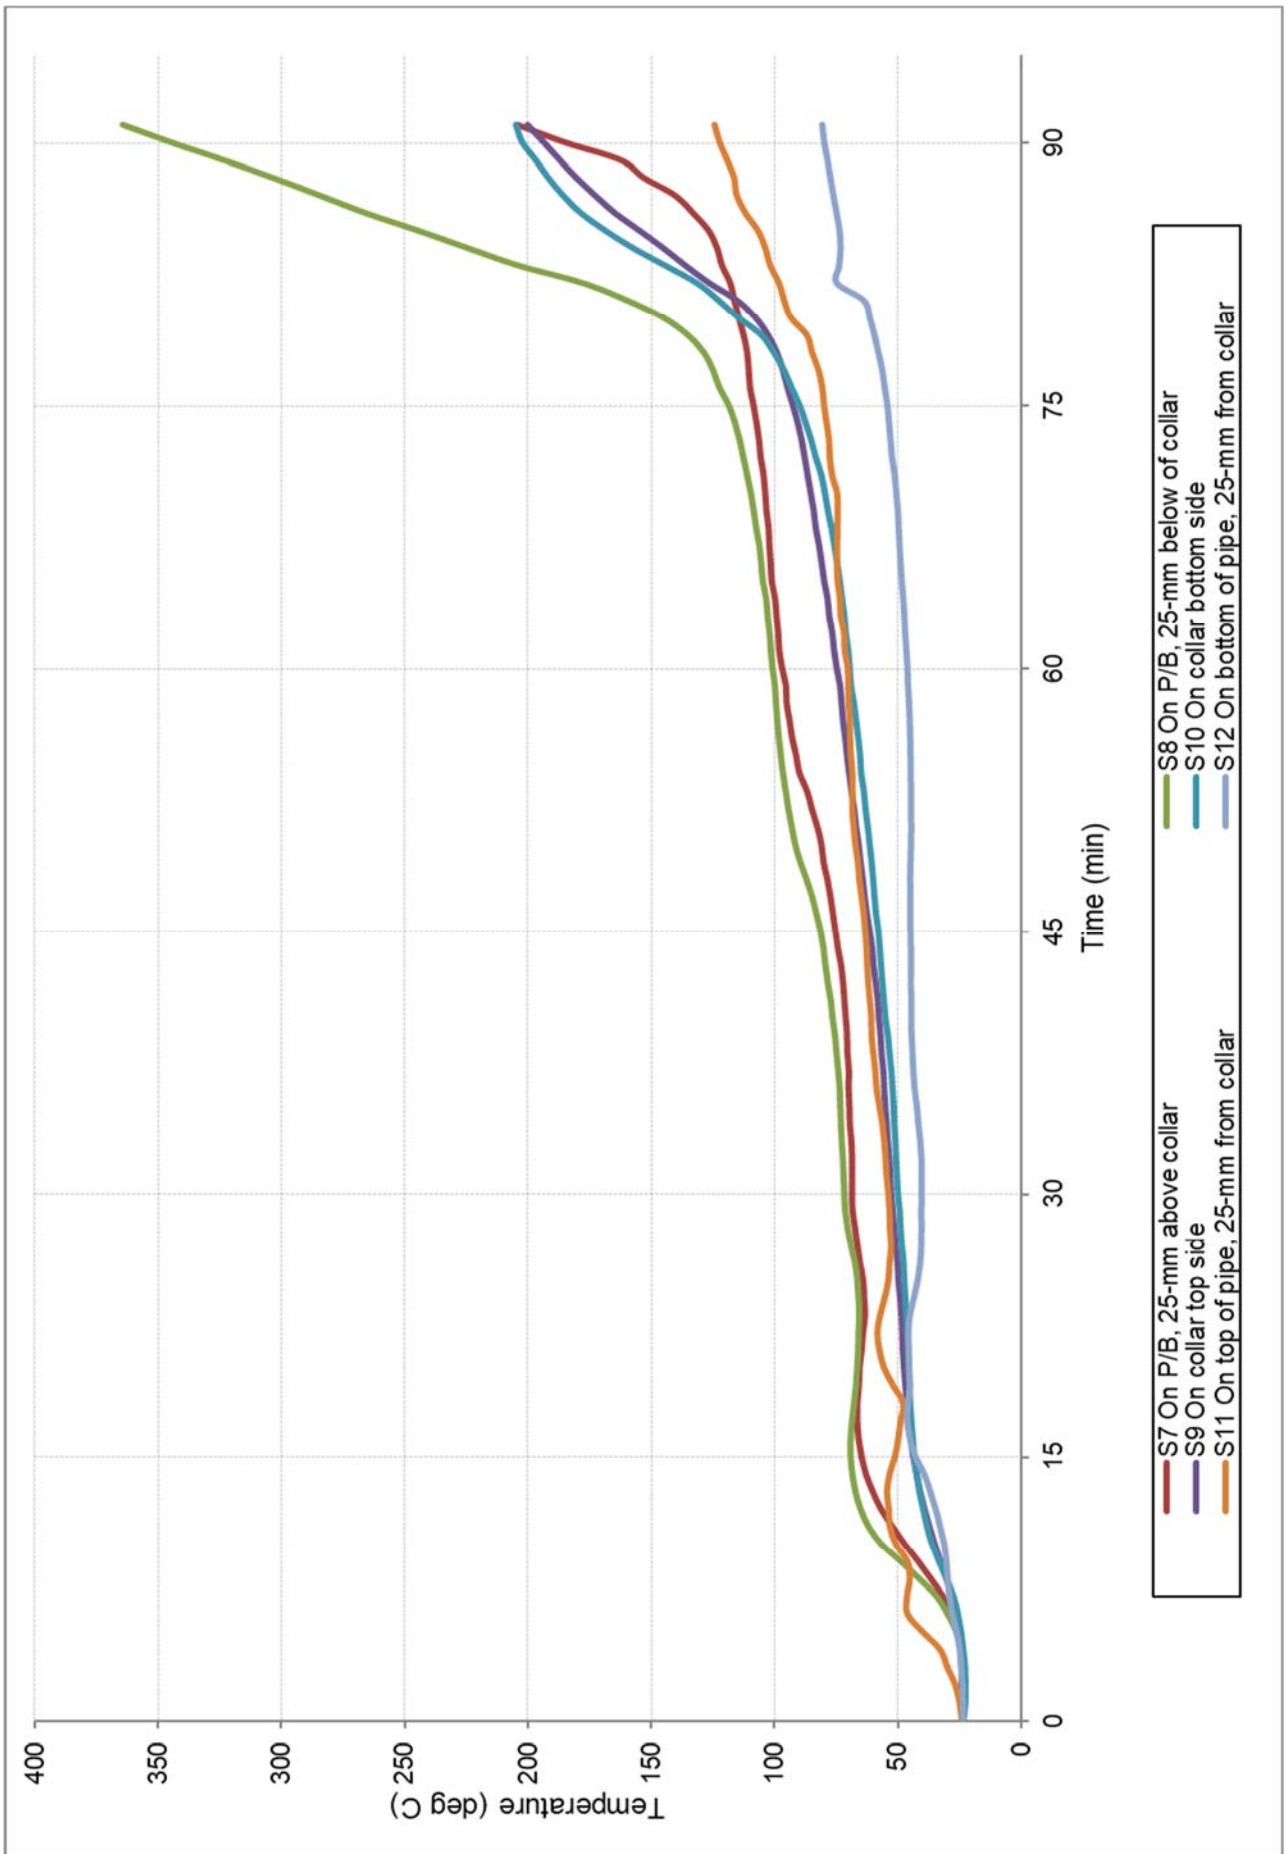
FIGURE 4 - TEMPERATURE VERSUS TIME ASSOCIATED WITH SPECIMEN # 2

Figure 4 shows the curve of temperature versus time associated with Specimen 2.

Structural adequacy	-	not applicable
Integrity	-	no failure at 91 minutes
Insulation	-	84 minutes
