Fire-resistance test on retrofit fire collars protecting a concrete wall penetrated by services

Test Report

Author: Shaw Tran
Report number: FSP 2246
Date: 23 December 2021
Client: IG6 Pty Ltd

Sponsored Investigation No. FSP 2246

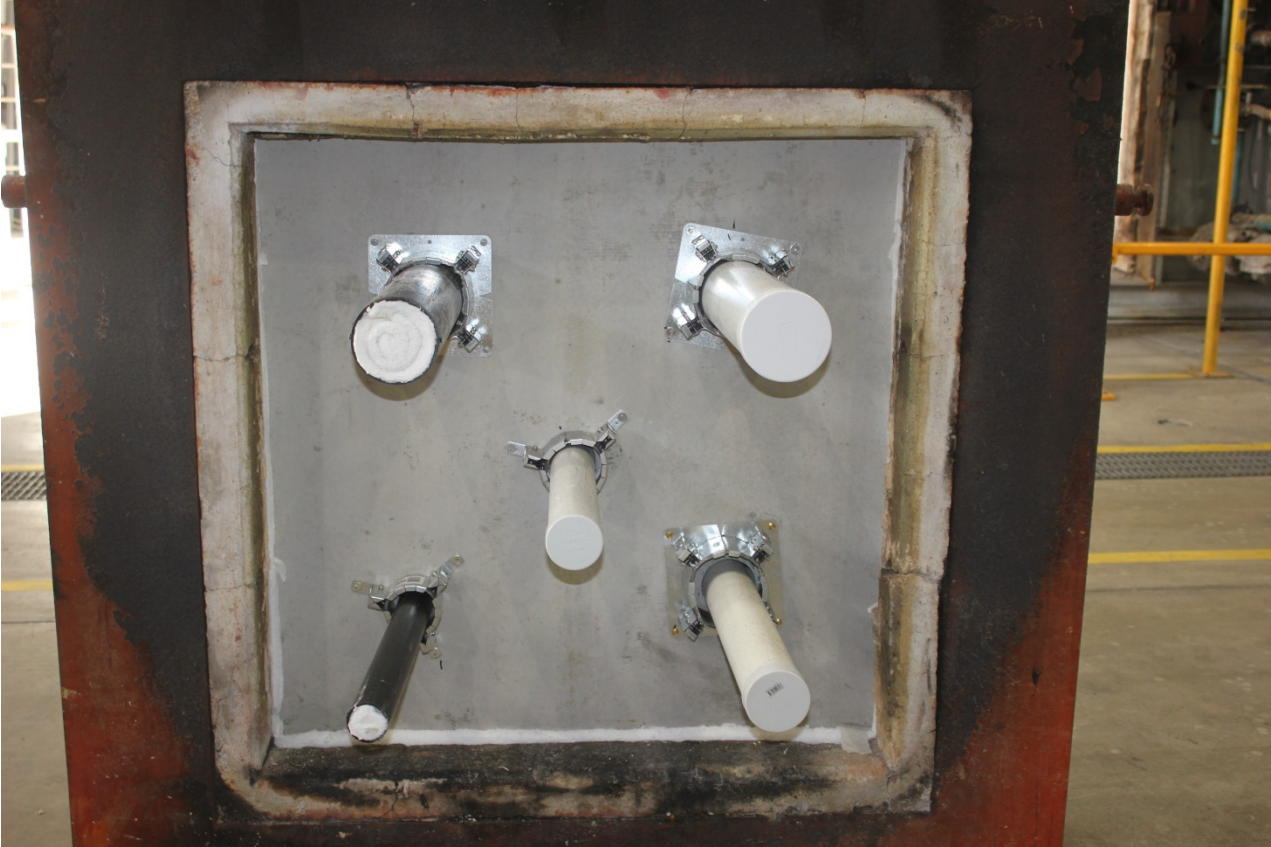
PHOTOGRAPH 1 – EXPOSED FACE OF SPECIMENS PRIOR TO TESTING

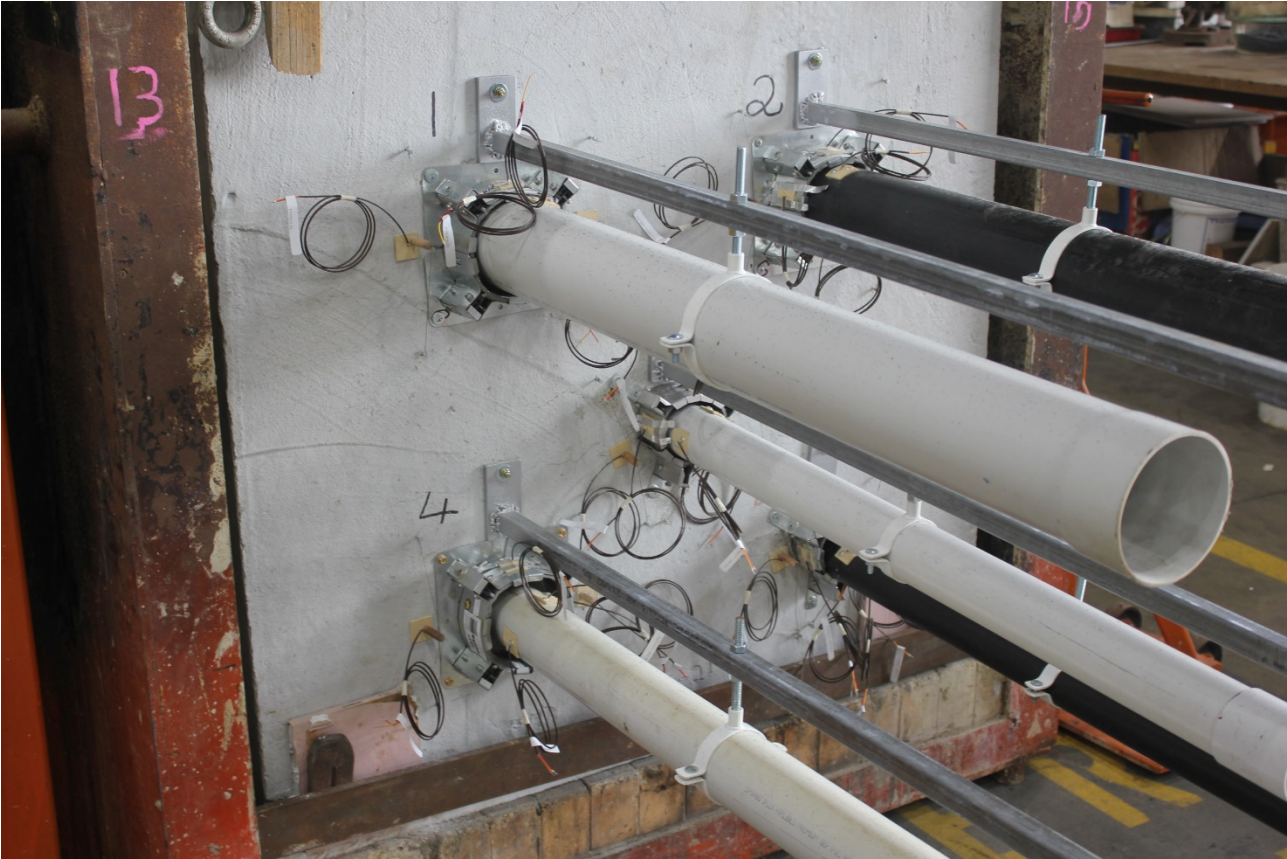
PHOTOGRAPH 2 – UNEXPOSED FACE OF SPECIMENS PRIOR TO TESTING

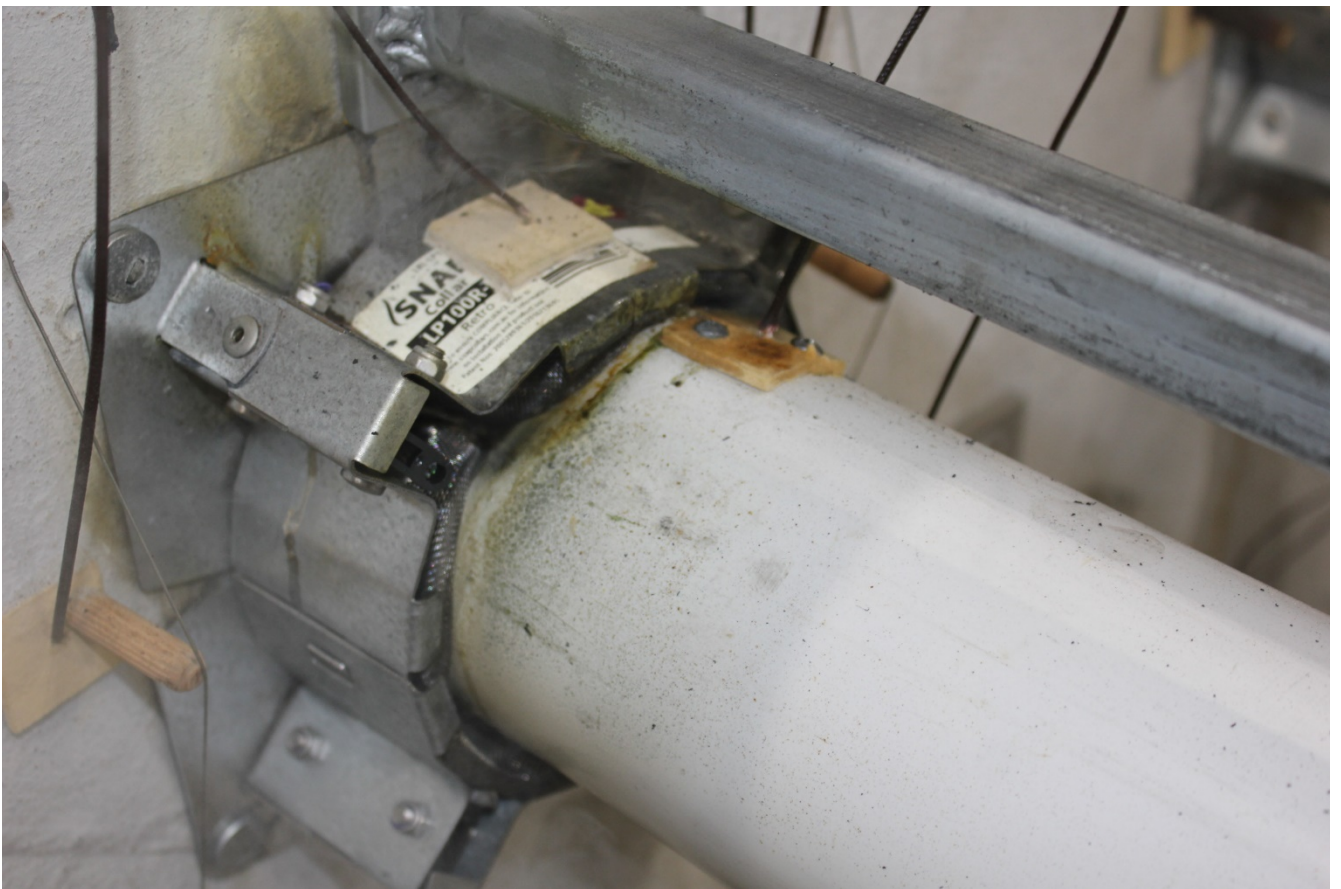
PHOTOGRAPH 6 – SPECIMEN 1 AFTER 95 MINUTES OF TESTING

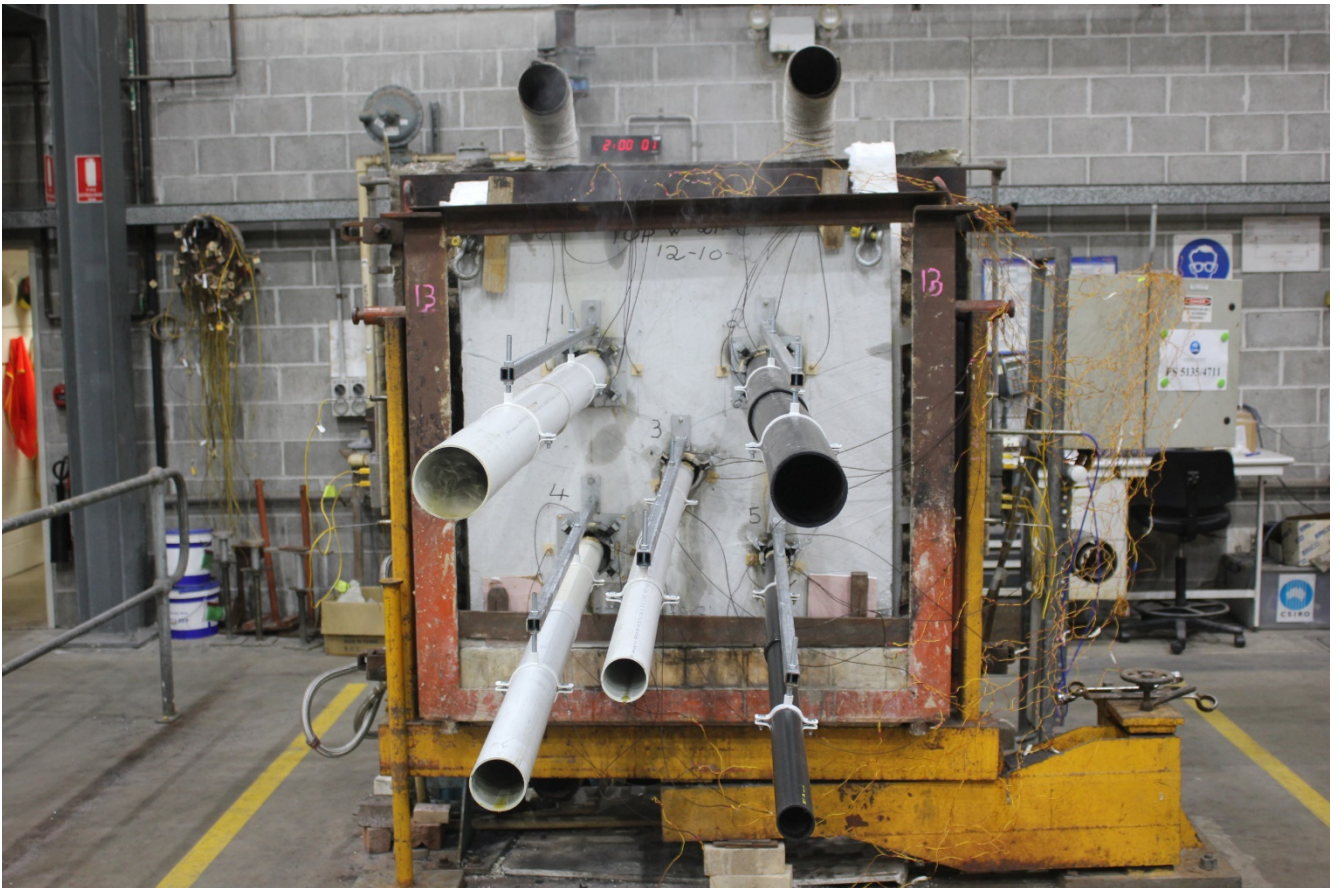
PHOTOGRAPH 7 – SPECIMENS AFTER 120 MINUTES OF TESTING

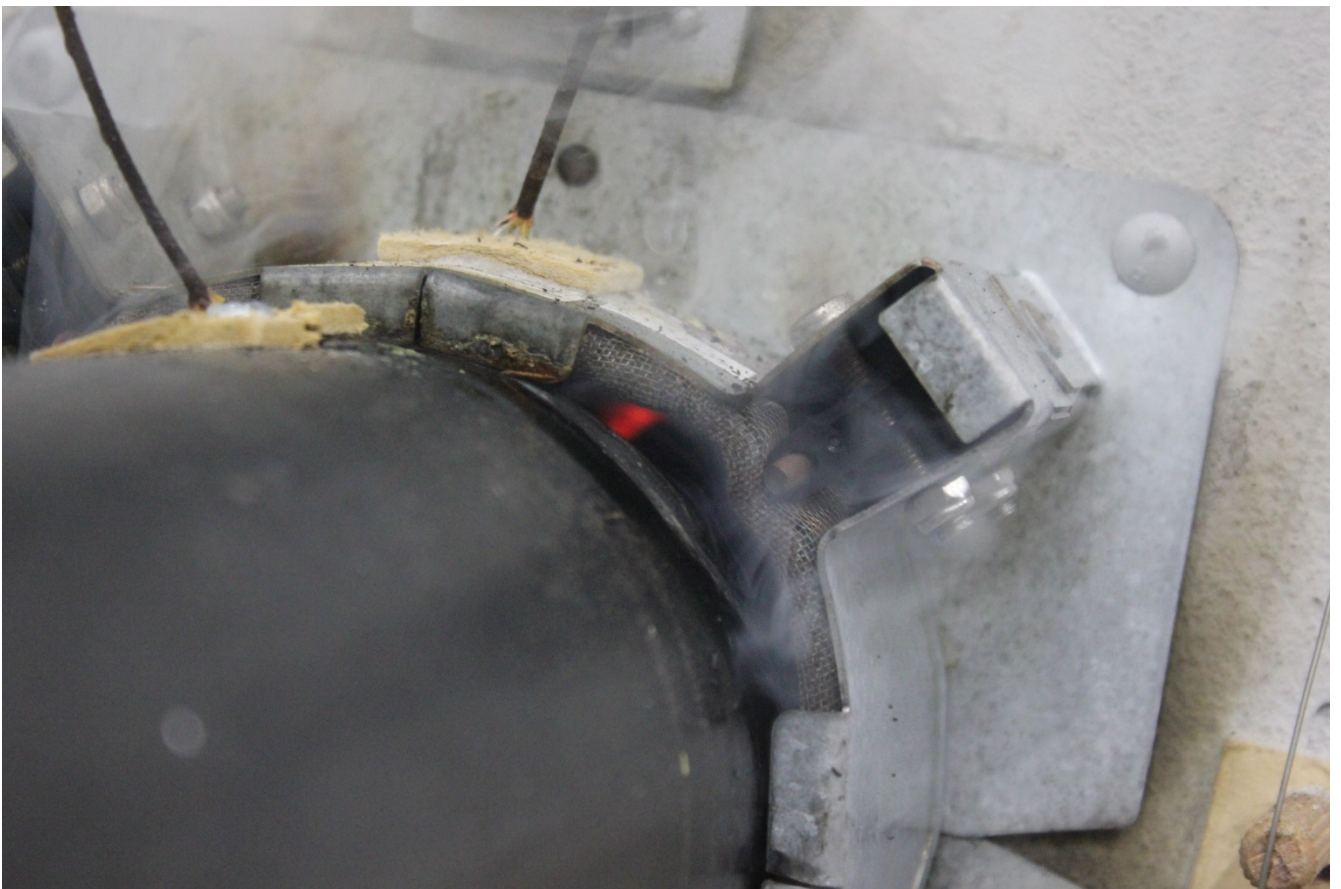
PHOTOGRAPH 8 – SPECIMEN 2 AFTER 169 MINUTES OF TESTING

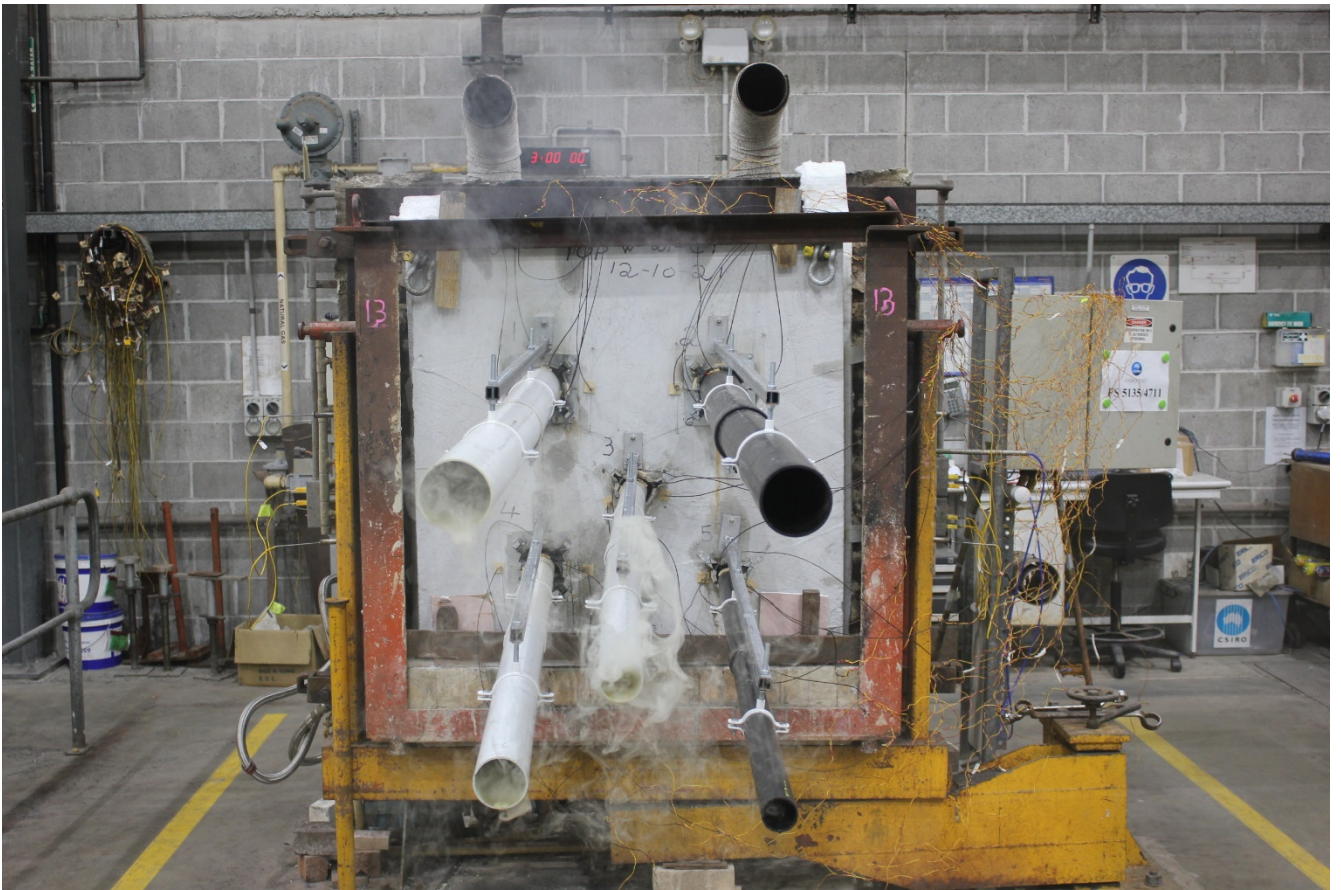
PHOTOGRAPH 9 – SPECIMENS AFTER 180 MINUTES OF TESTING

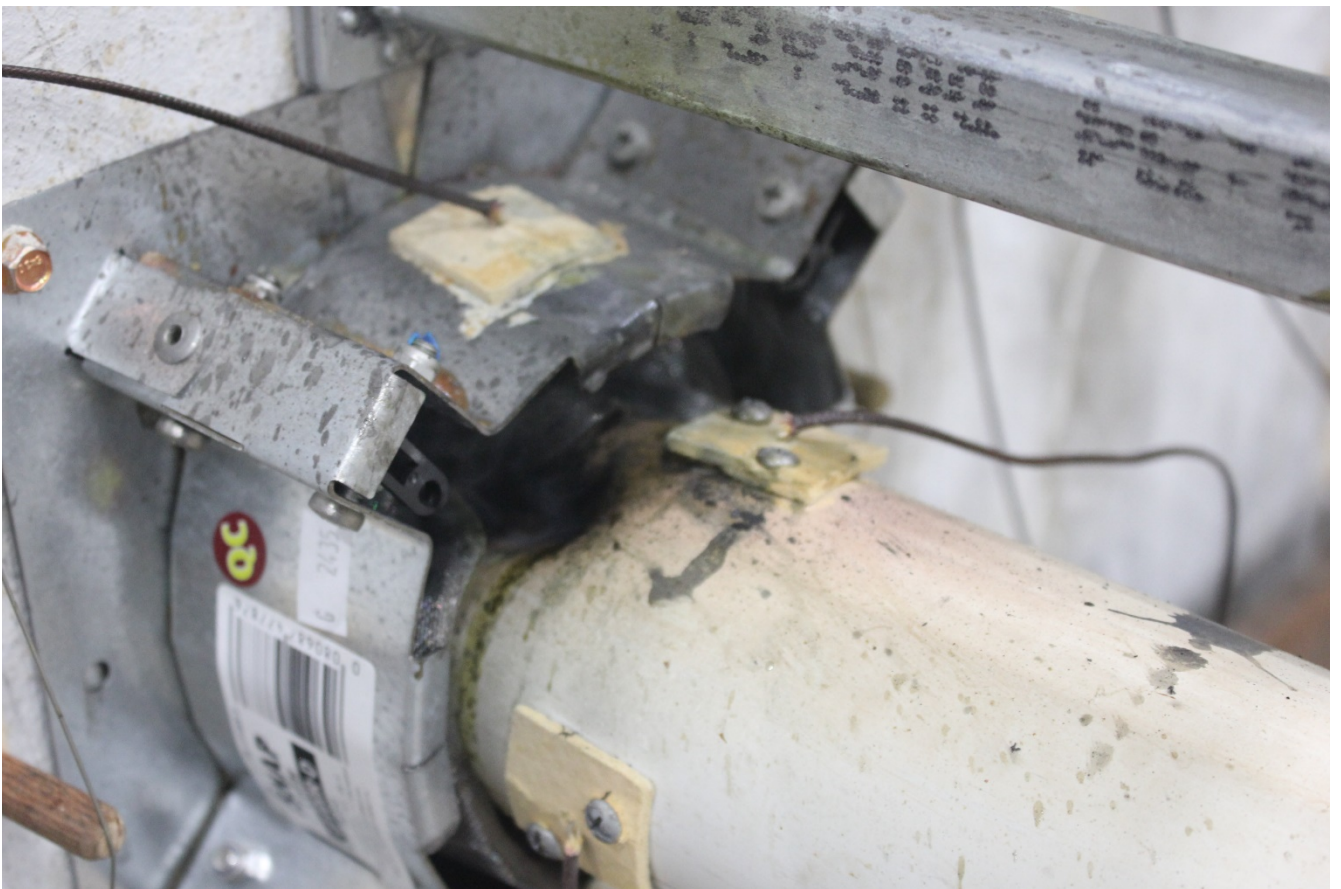
PHOTOGRAPH 10 – SPECIMEN 4 AFTER 220 MINUTES OF TESTING

38 minutes	- Smoke is being emitted from between the pipe and the collar of specimen 4.
60 minutes	- Smoke is being emitted from between the pipe and the collar of specimen 2.
75 minutes	- Discolouration is visible on the concrete wall above the collar of specimen 1.
95 minutes	- The pipe within the collar of Specimen 1 has partially collapsed (Photograph 6).
132 minutes	- Cotton pad test applied to specimen 1 on the top of the pipe near the collar – No ignition of cotton was noted.
138 minutes	- Smoke is beginning to flue from the unexposed end of specimen 4.
162 minutes	- Cotton pad test applied to specimen 2 to the top of the pipe near the collar. – No ignition of cotton was noted.
169 minutes	- A red glow is visible on specimen 2 within the collar (Photograph 8).
186 minutes	- Smoke fluing from specimen 1 between the wall and the collar.
220 minutes	- The pipe within the collar of Specimen 4 has partially collapsed (Photograph 10).

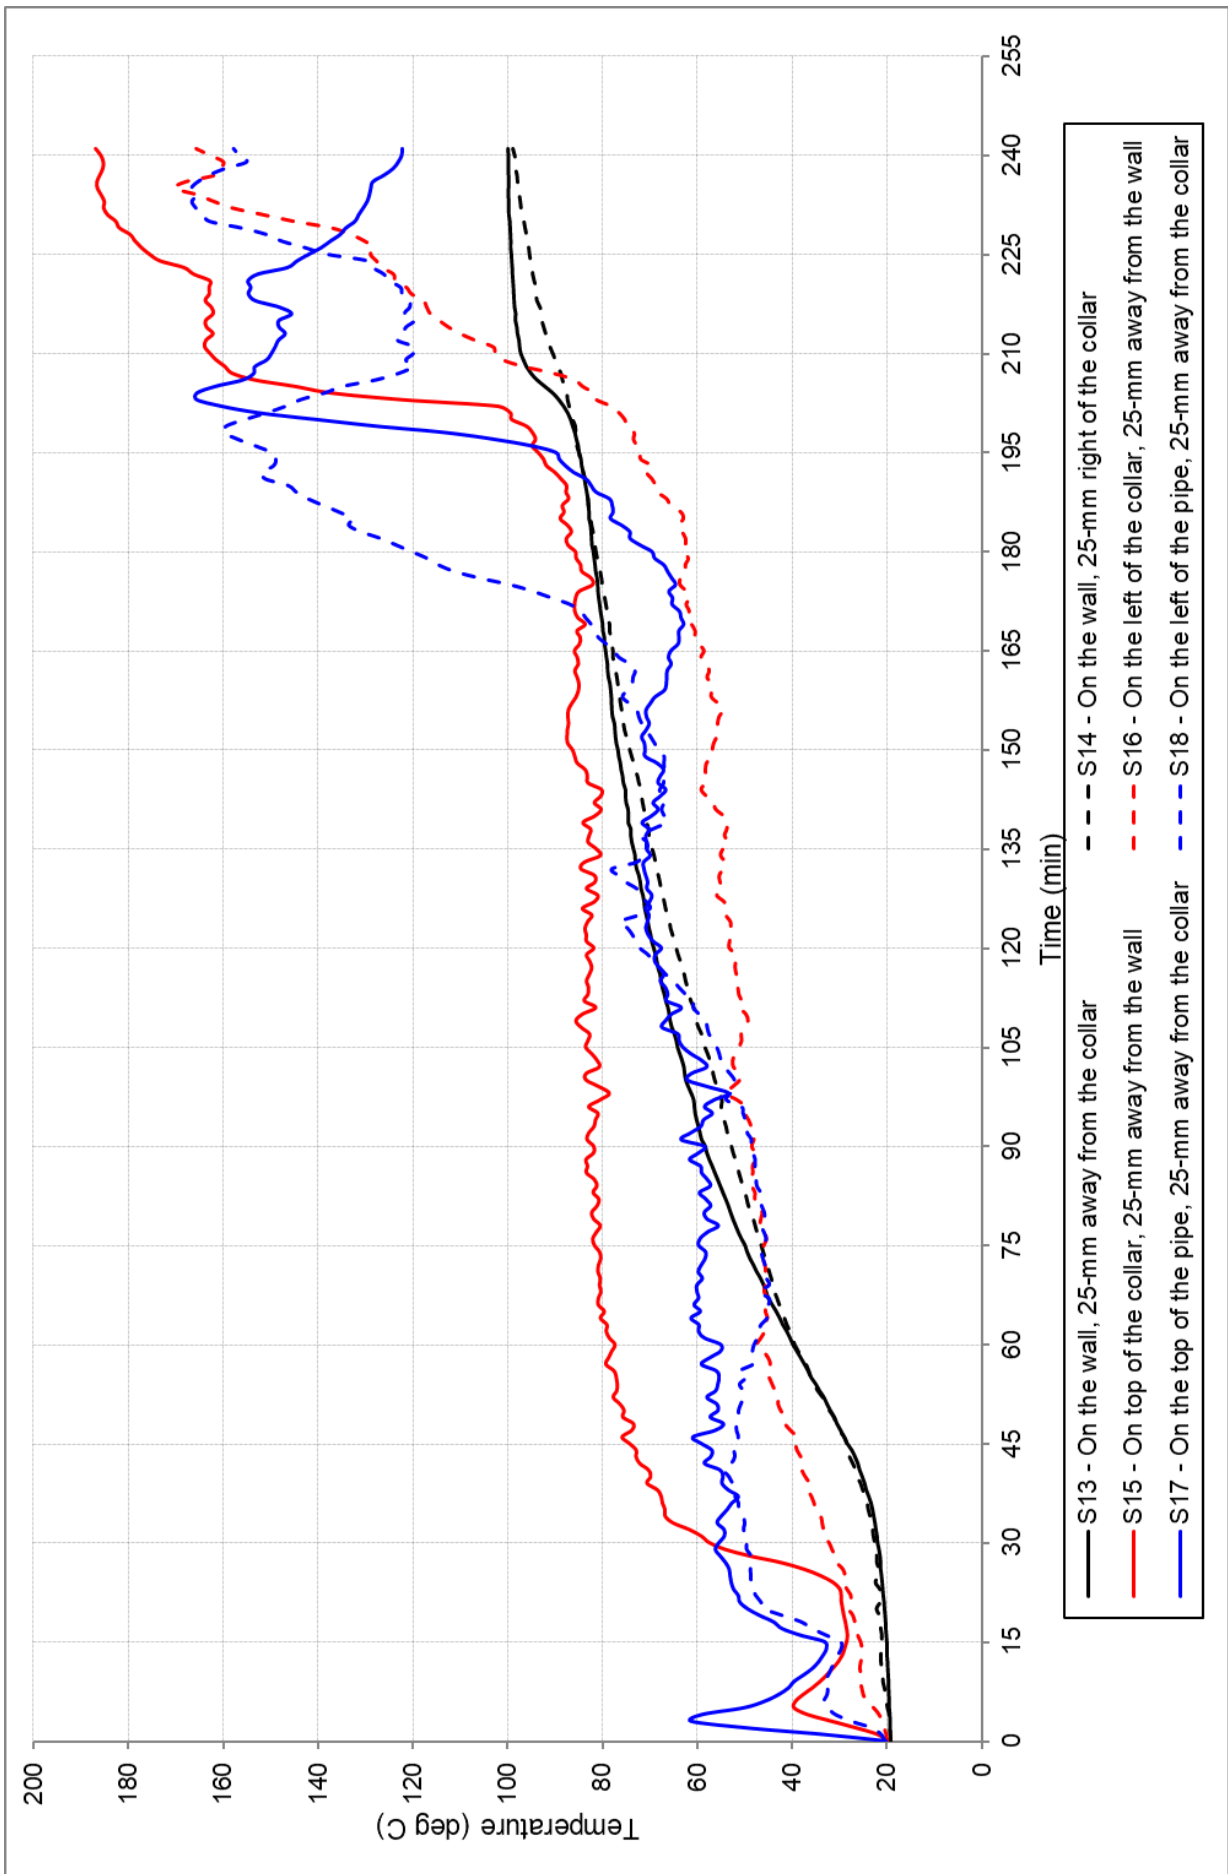
FIGURE 6 - TEMPERATURE VERSUS TIME ASSOCIATED WITH SPECIMEN #3

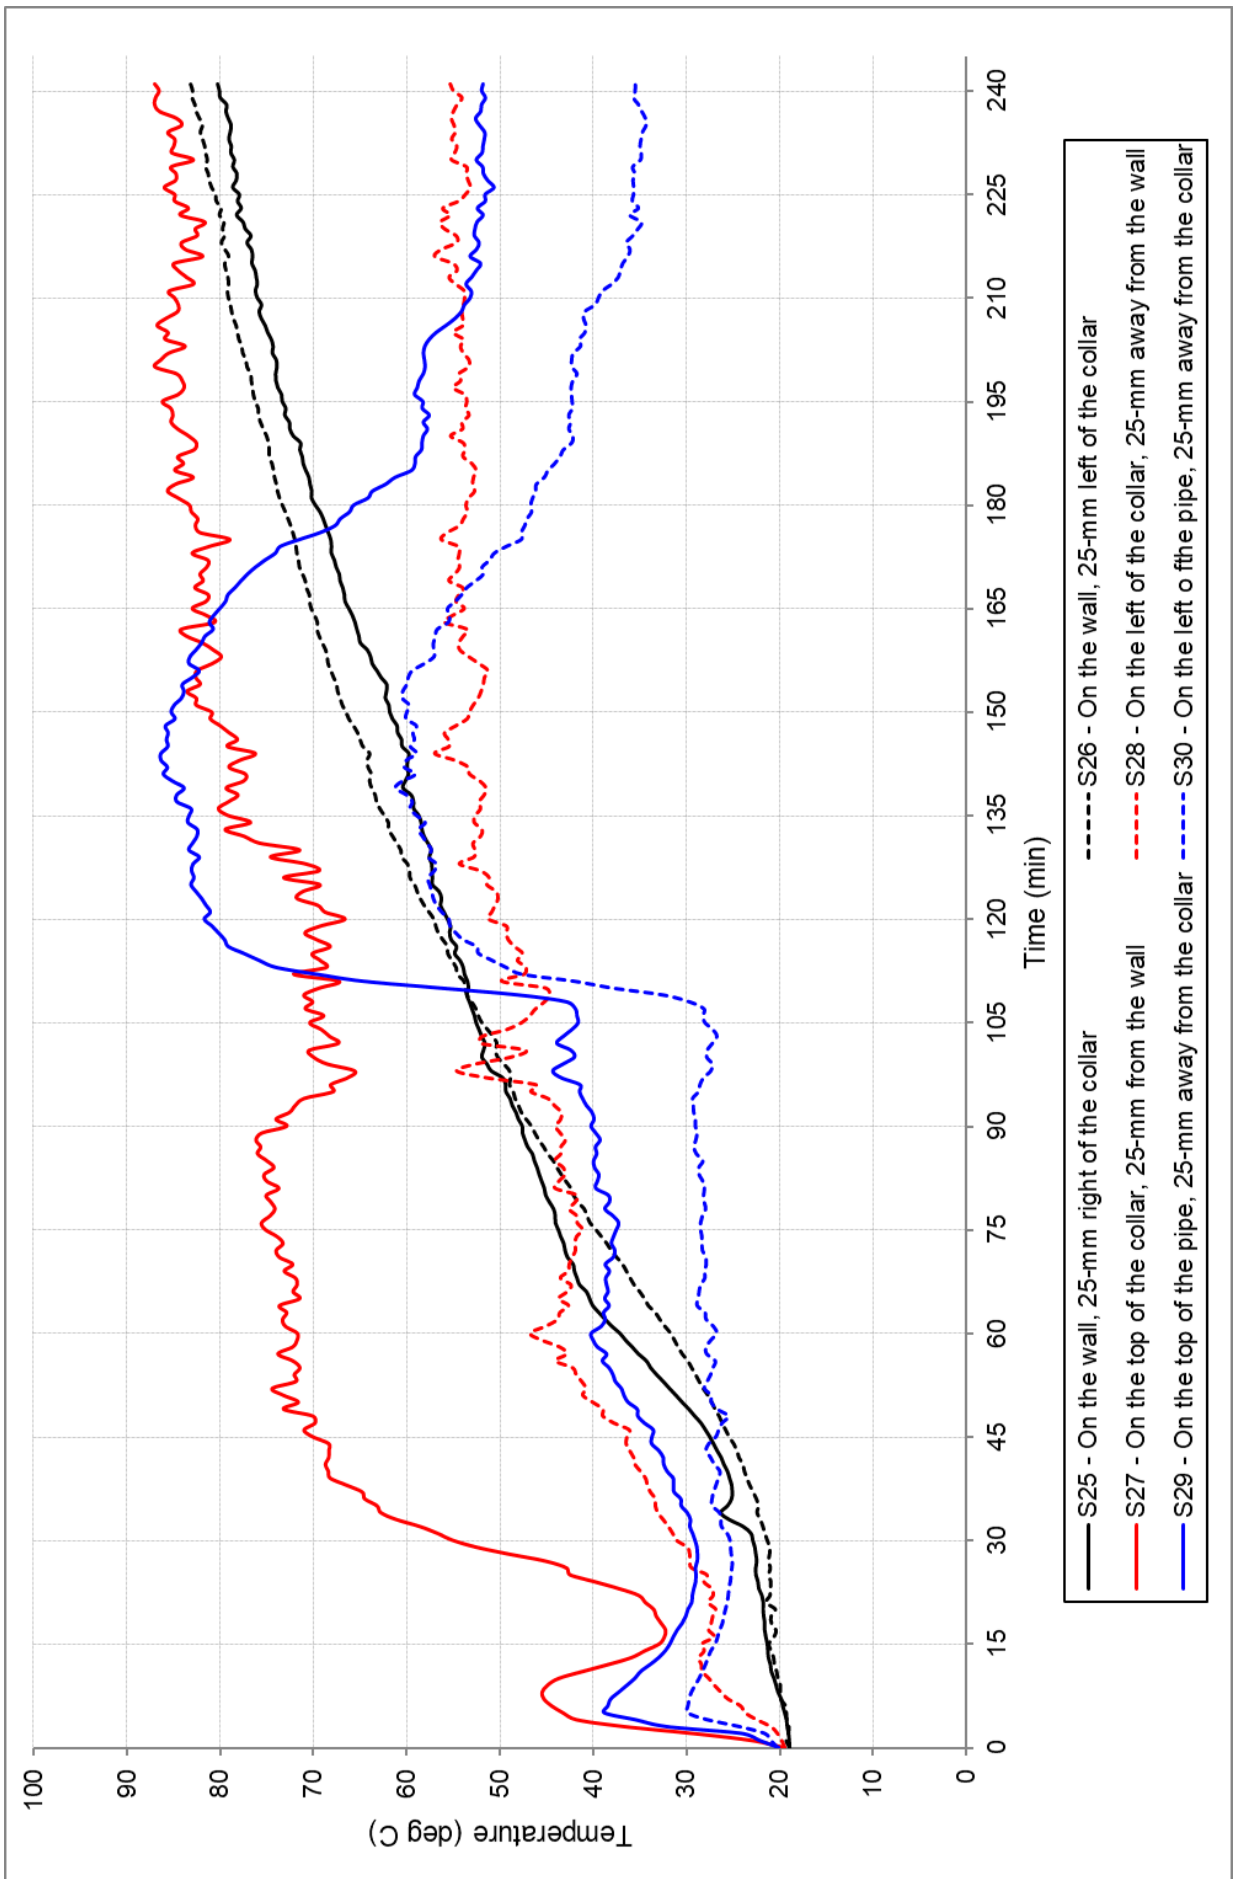
FIGURE 8 - TEMPERATURE VERSUS TIME ASSOCIATED WITH SPECIMEN #5
