Fire-resistance test on fire collars protecting a concrete slab penetrated by services

Test Report

Author: Peter Gordon
Report number: FSP 2174
Date: 30 March 2021

Sponsored Investigation No. FSP 2174

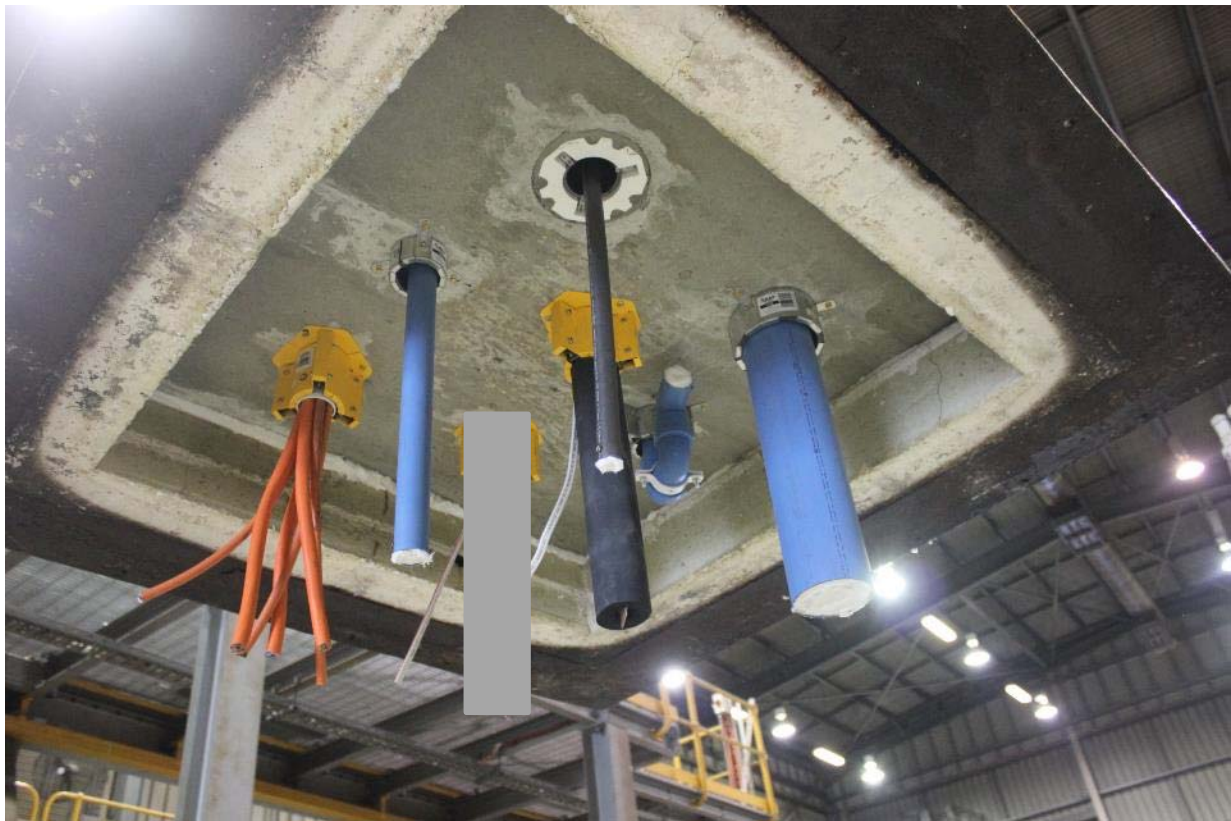
PHOTOGRAPH 1 – EXPOSED FACE OF SPECIMENS PRIOR TO TESTING

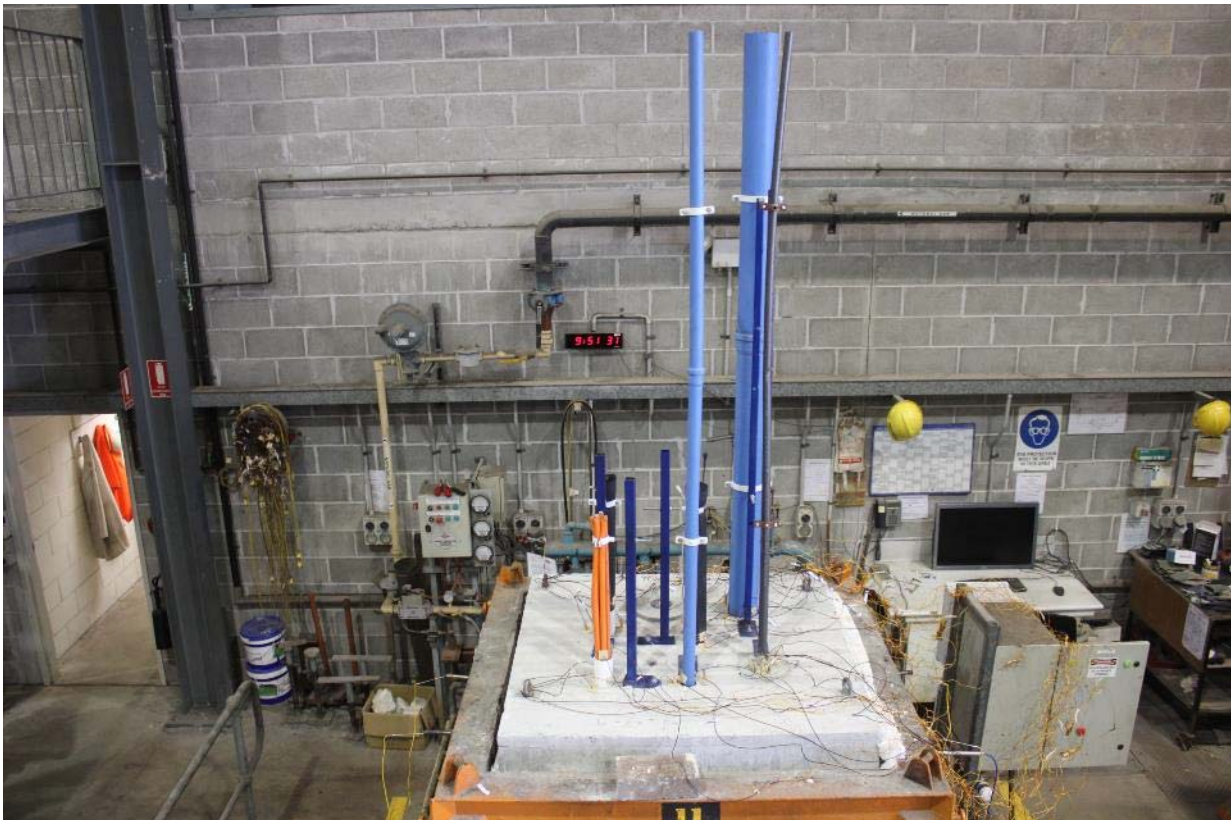
PHOTOGRAPH 2 – UNEXPOSED FACE OF SPECIMENS PRIOR TO TESTING
