Fire-resistance test on fire collars protecting a concrete slab penetrated by services

Test Report

Author: Peter Gordon
Report number: FSP 2274
Date: 2 November 2022

Sponsored Investigation No. FSP 2274

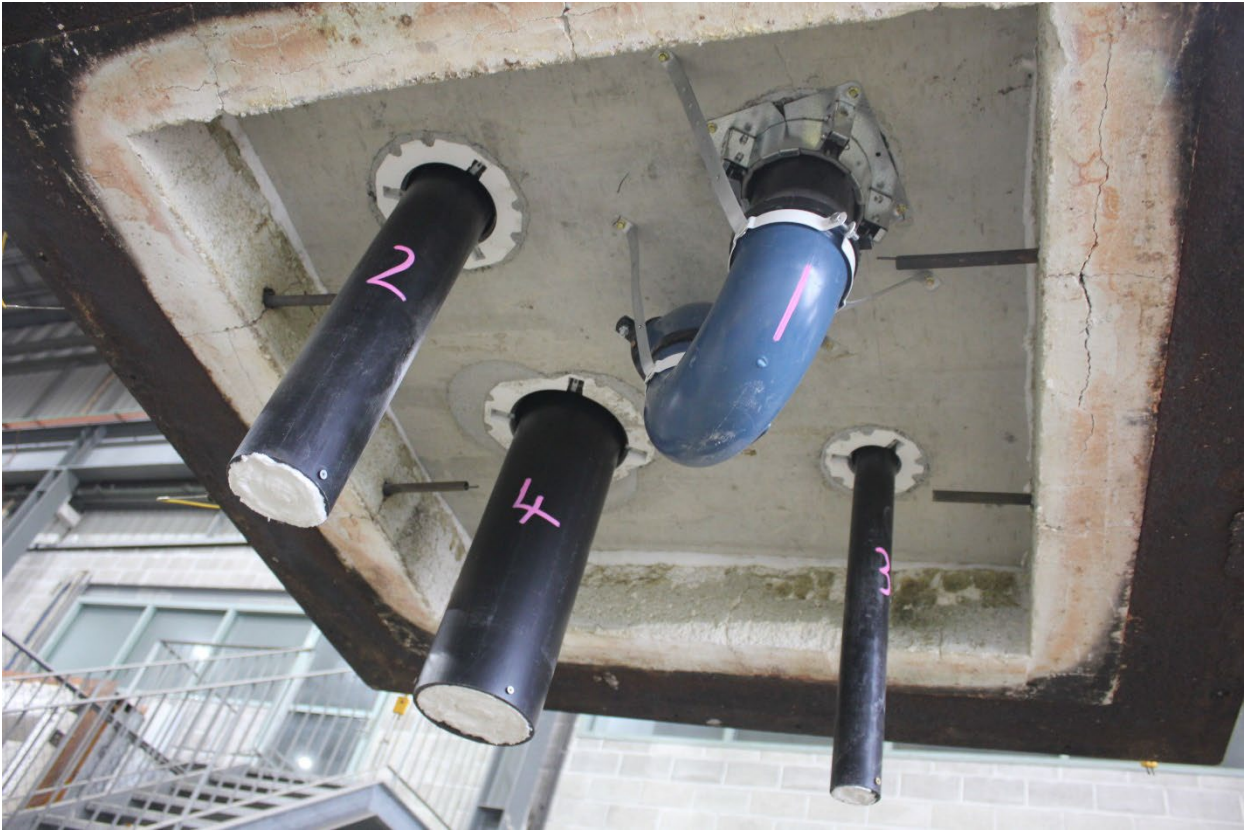
PHOTOGRAPH 1 – EXPOSED FACE OF SPECIMENS PRIOR TO TESTING

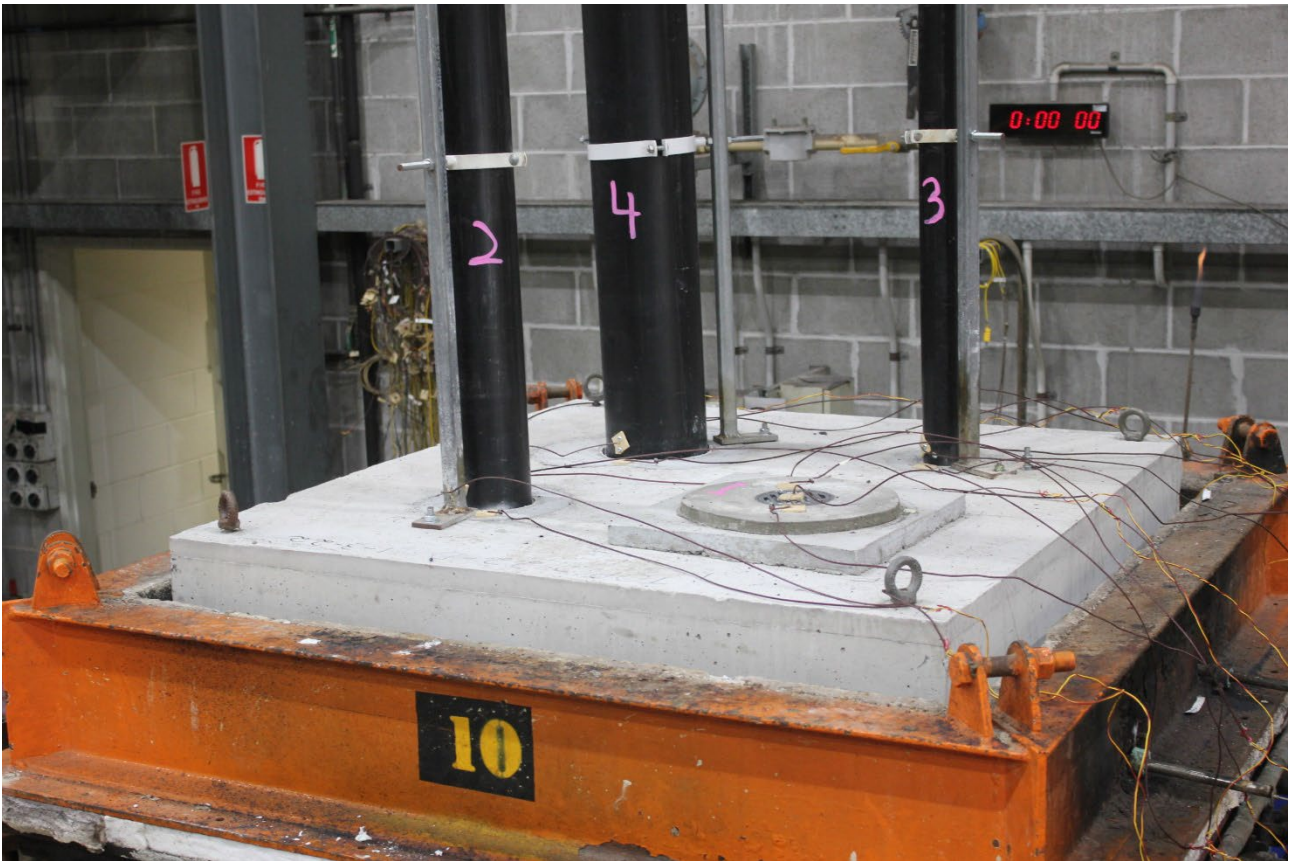
PHOTOGRAPH 3 – UNEXPOSED FACE OF SPECIMENS PRIOR TO TESTING

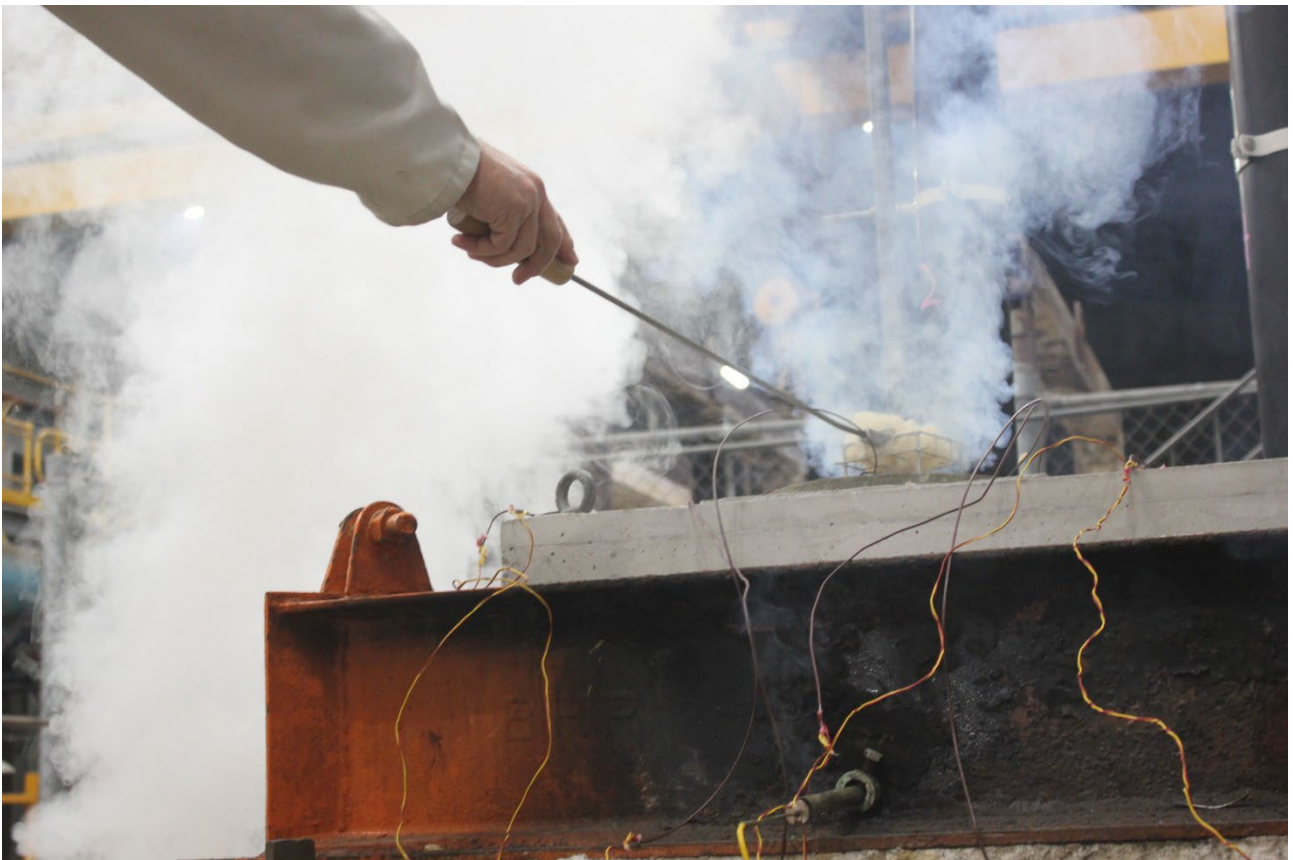
PHOTOGRAPH 4 – SPECIMENS AT 9 MINUTES INTO THE TEST

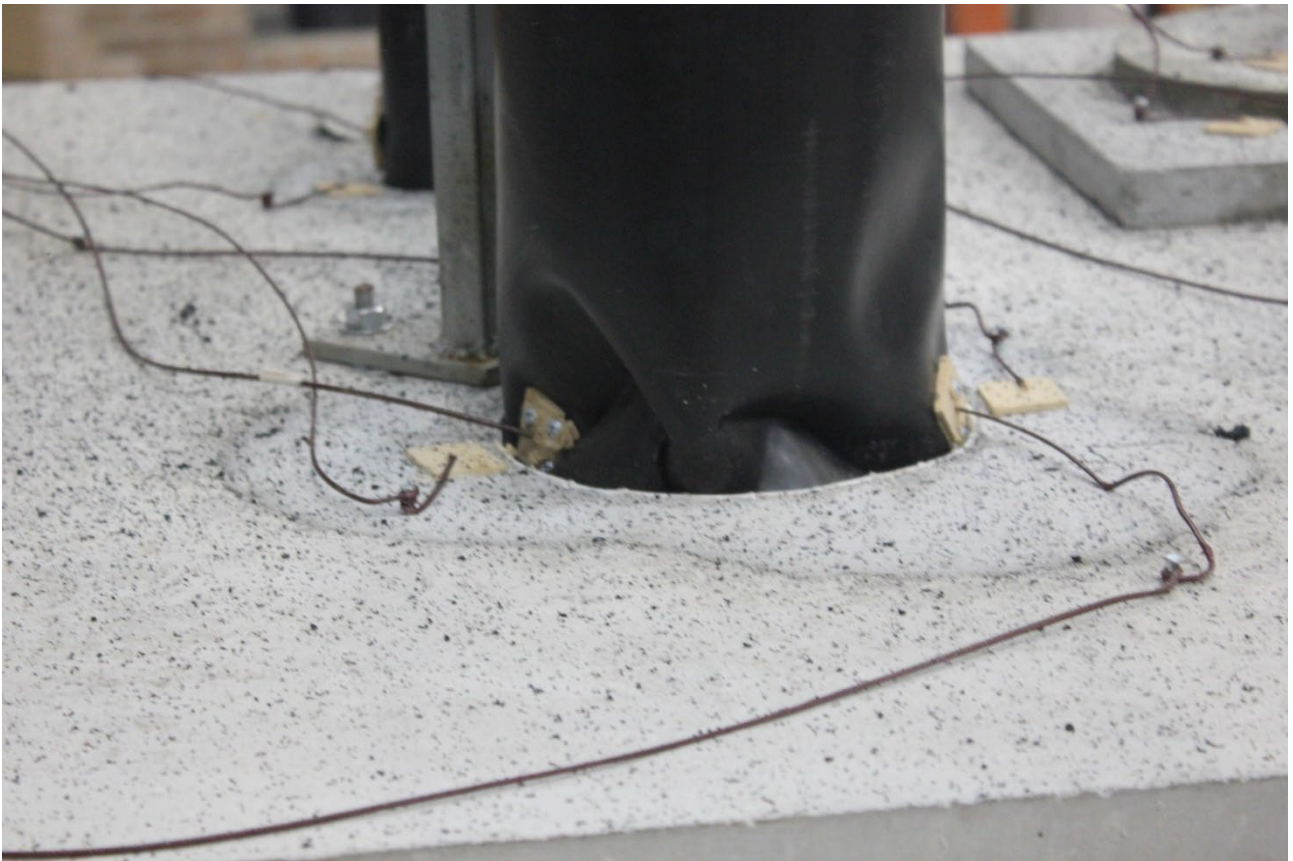
PHOTOGRAPH 5 – SPECIMEN 4 AT 14 MINUTES INTO THE TEST

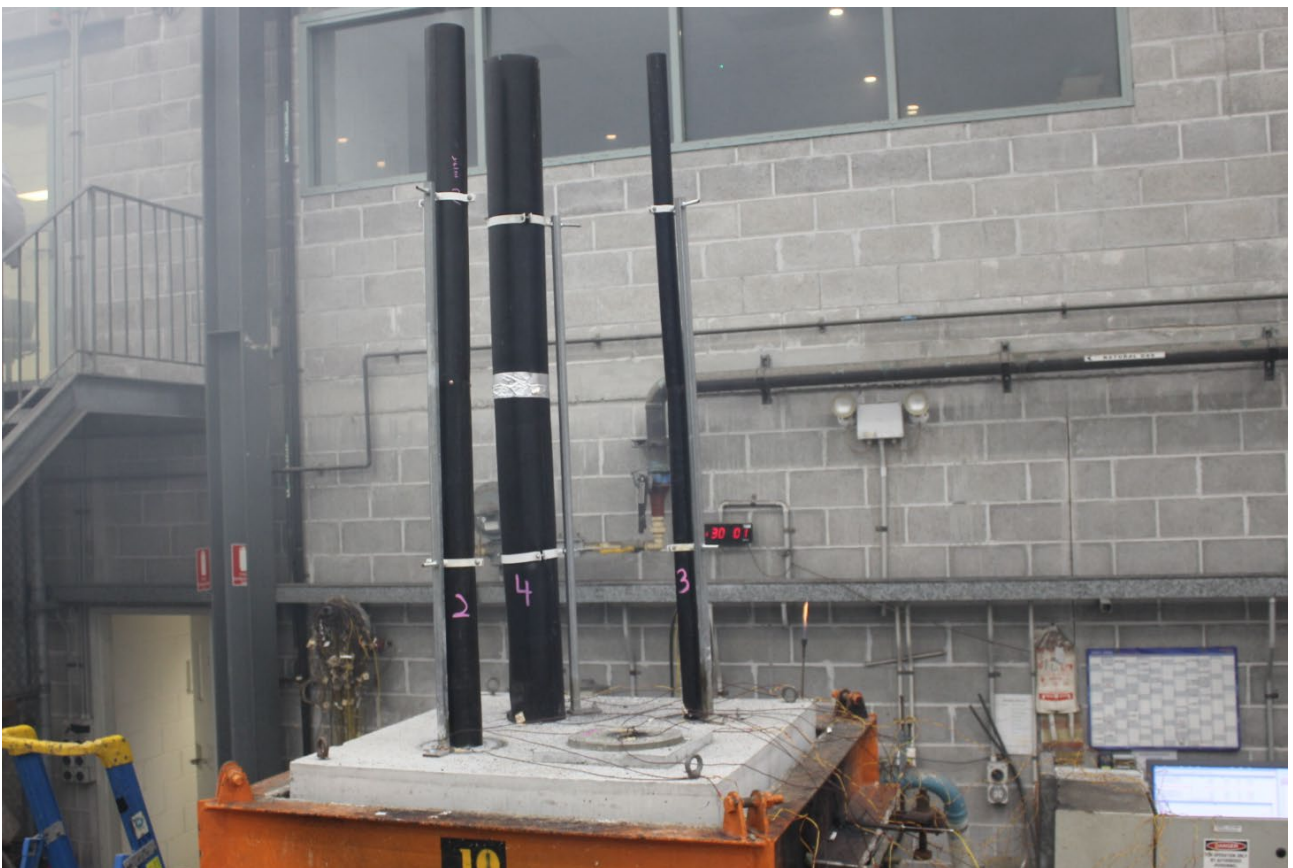
PHOTOGRAPH 6 –SPECIMENS AT 30 MINUTES INTO THE TEST

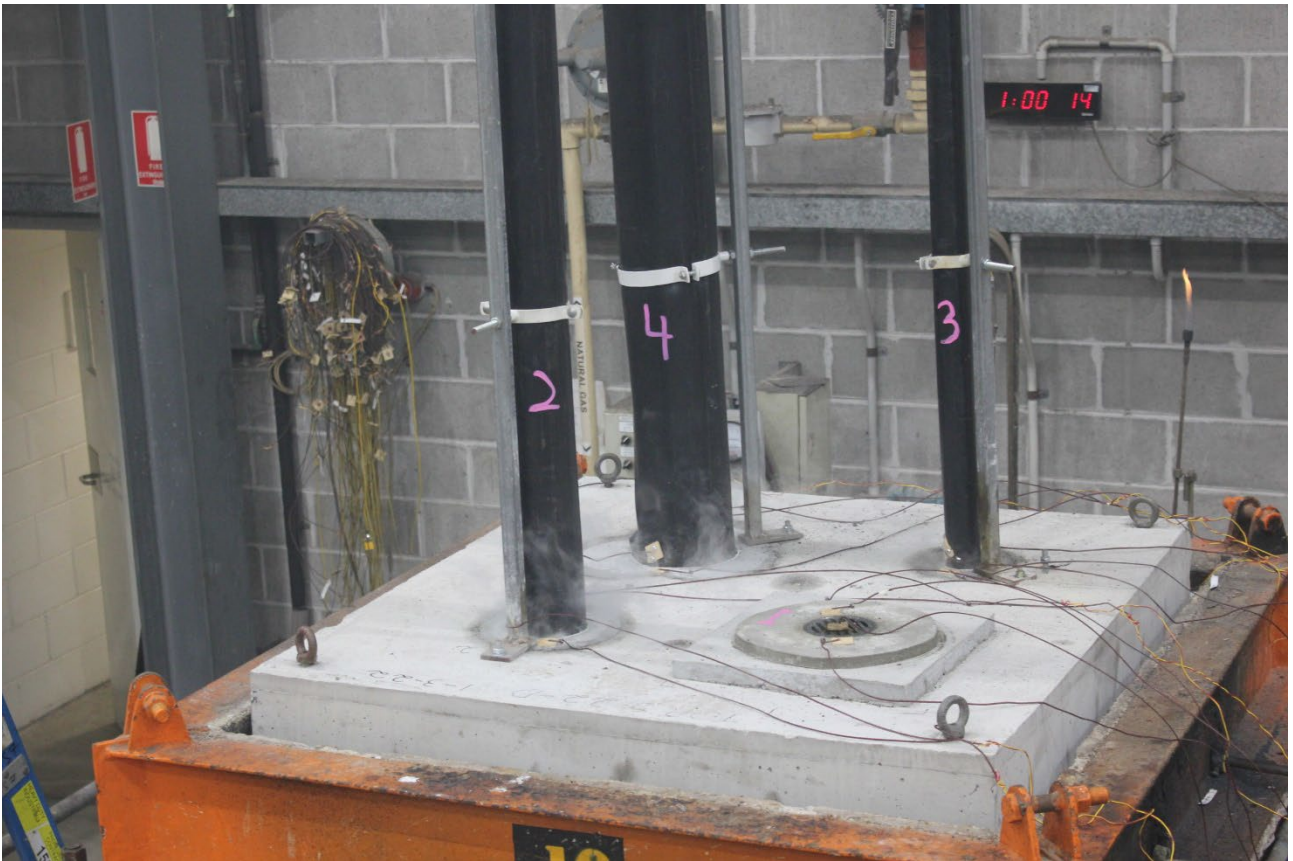
PHOTOGRAPH 7 – SPECIMENS AT 60 MINUTES INTO THE TEST

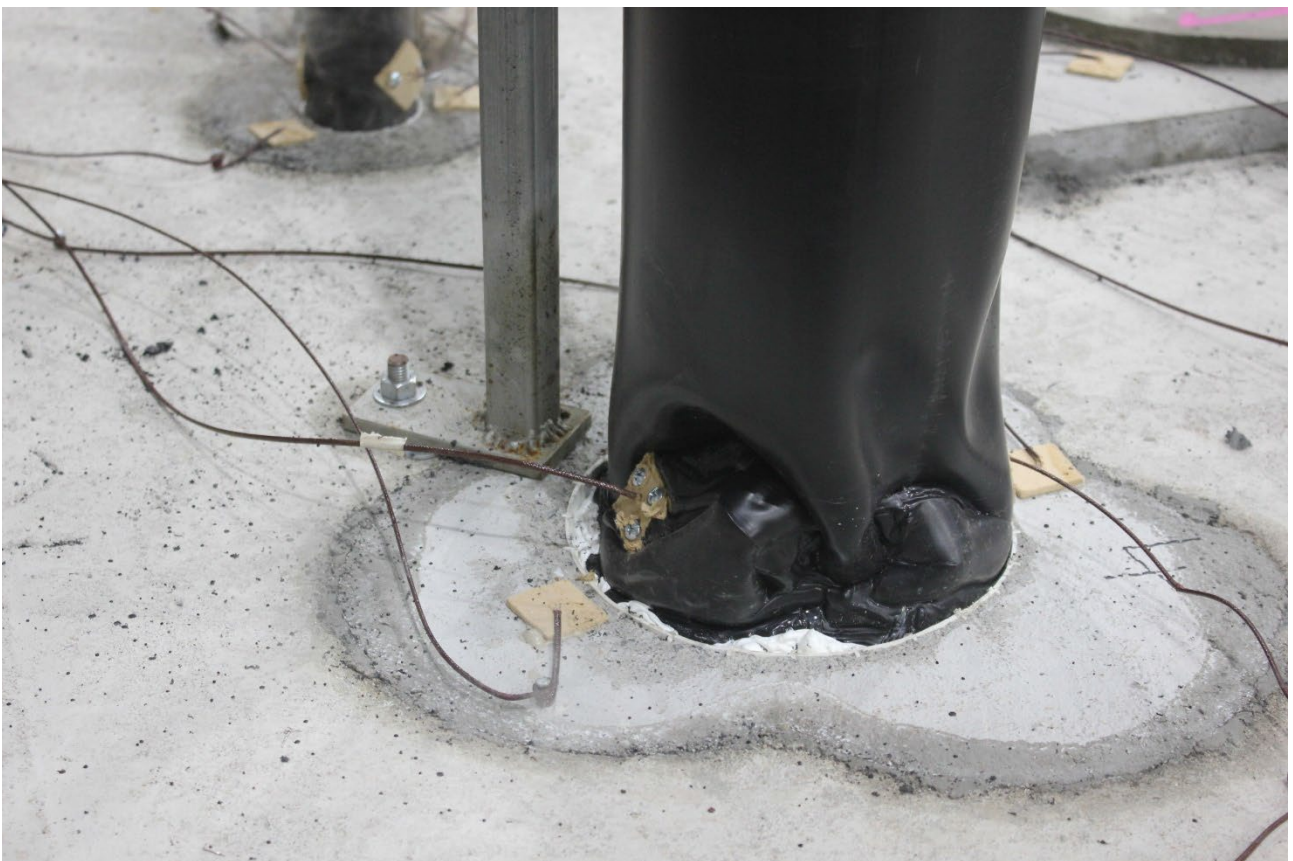
PHOTOGRAPH 8 – SPECIMEN 4 AT 88 MINUTES INTO THE TEST

45 minutes -	Smoke has ceased fluing from the pipe of specimen 3.
69 minutes -	Smoke has ceased fluing from the pipe of specimens 2 and 4.
83 minutes -	The white-collar casing at the base of specimen 4 has begun to melt, the pipe at the base of the specimen continues to deform.
124 minutes -	The white-collar casing at the base of specimen 4 has continues to melt, the pipe at the base specimen continues to deform.
151 minutes -	<u>Insulation failure of specimen 4</u> - maximum temperature rise of 180K is exceeded on the slab 25-mm from the collar case at the base (north side).
204 minutes -	The thermocouple (#13) pad at the base of specimen 4 has been covered with molten white plastic from the collar.
230 minutes -	The white-collar casing at the base of specimen 2 has been pushed up above the slab with some sections melted.
235 minutes -	The white-collar casing and black pipe at the base of specimen 4 have melted.

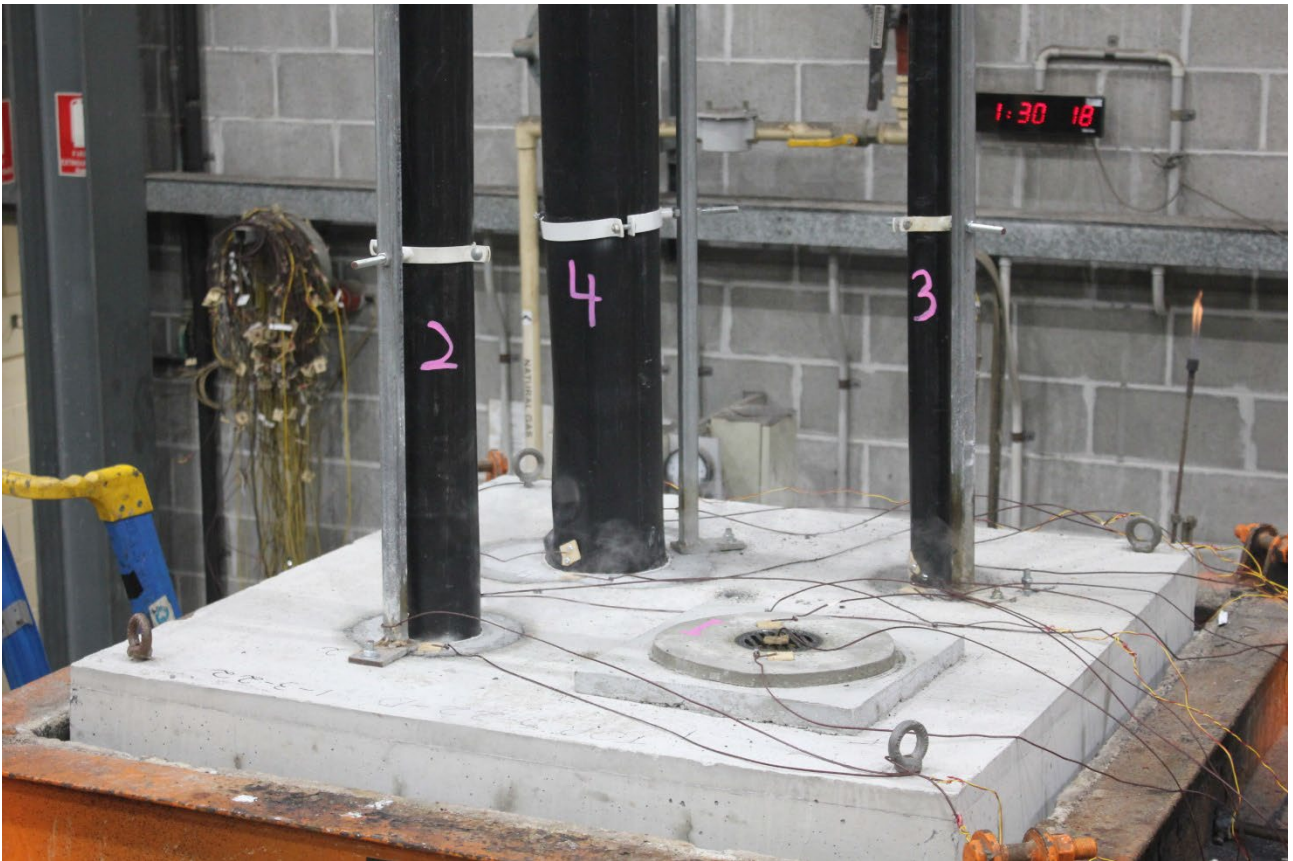
PHOTOGRAPH 9 – SPECIMENS AT 90 MINUTES INTO THE TEST

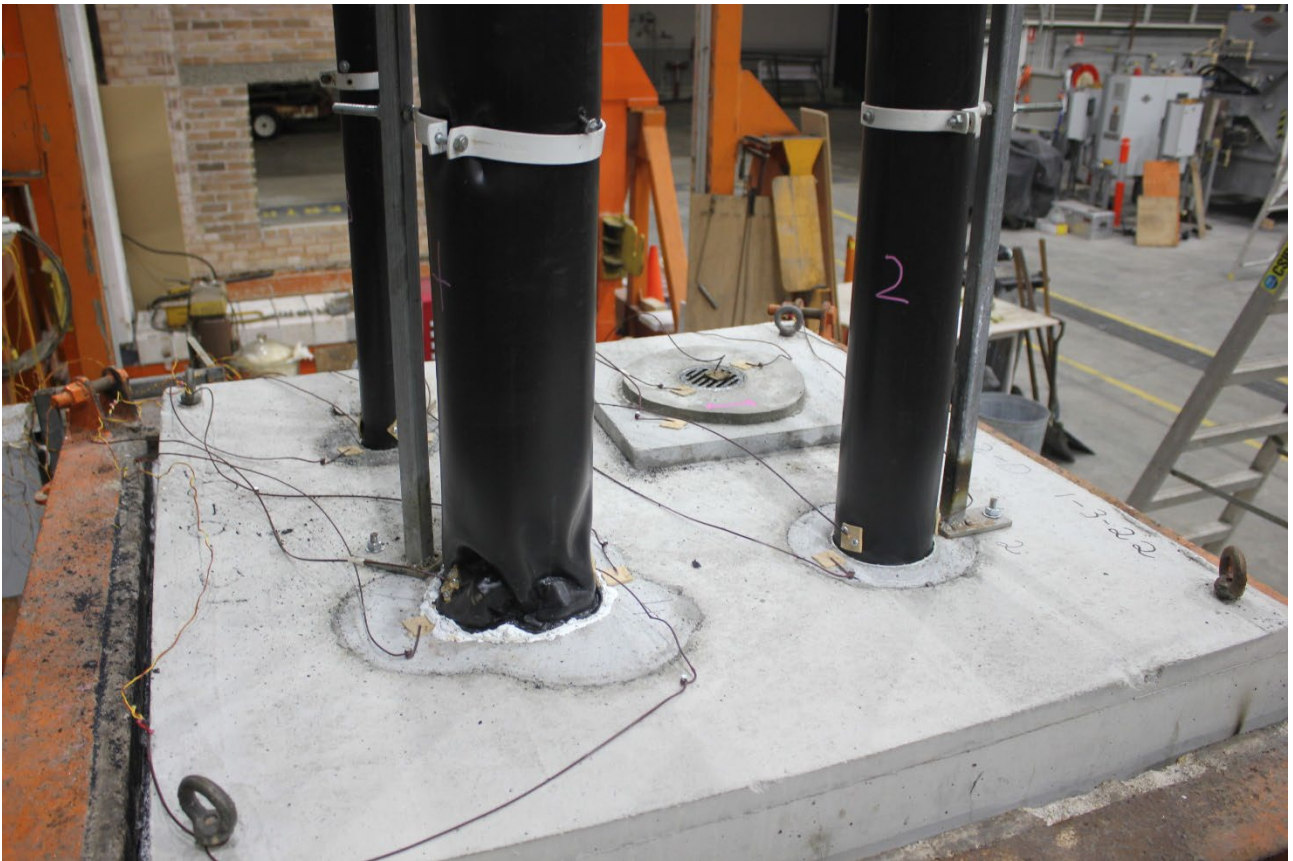
PHOTOGRAPH 11 – SPECIMENS AT 150 MINUTES INTO THE TEST

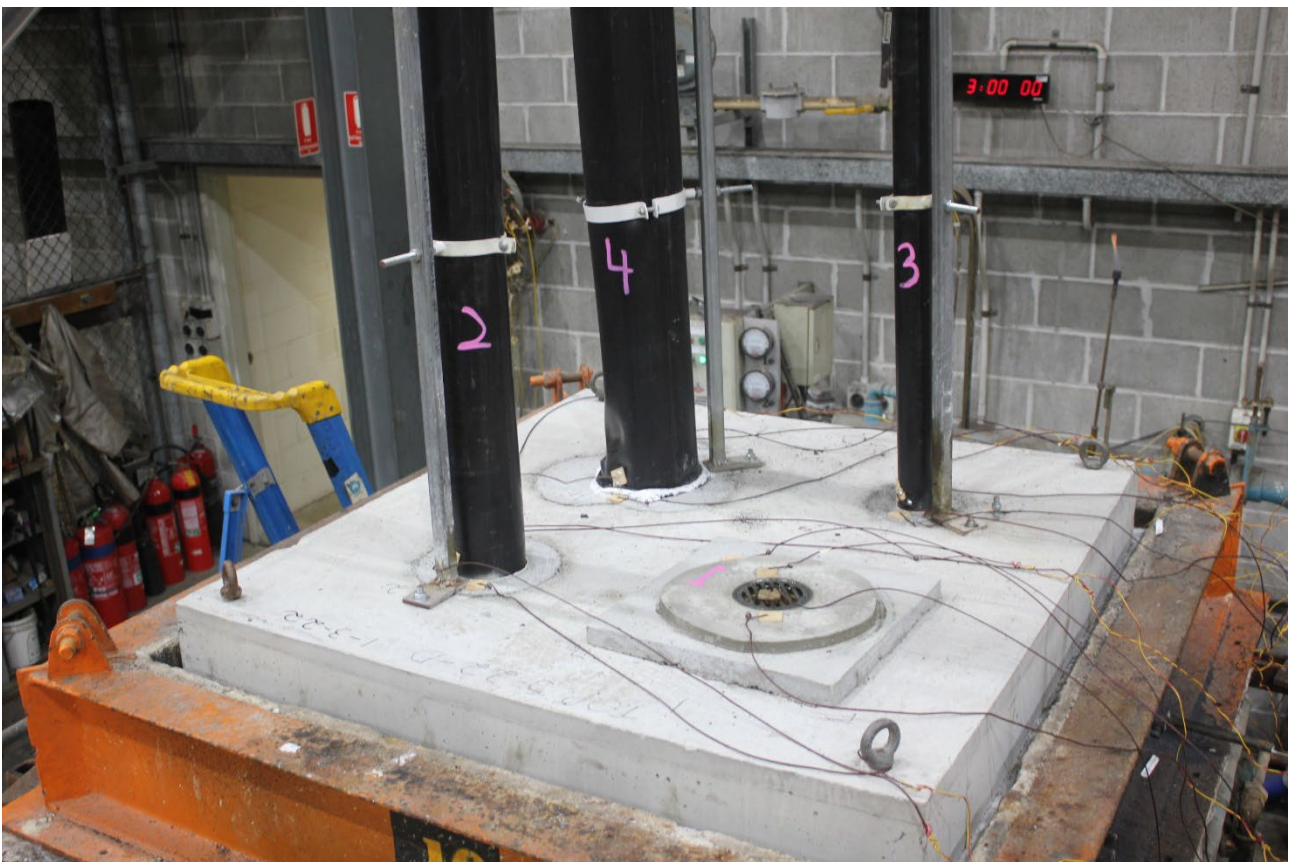
PHOTOGRAPH 12 – SPECIMENS AT 180 MINUTES INTO THE TEST

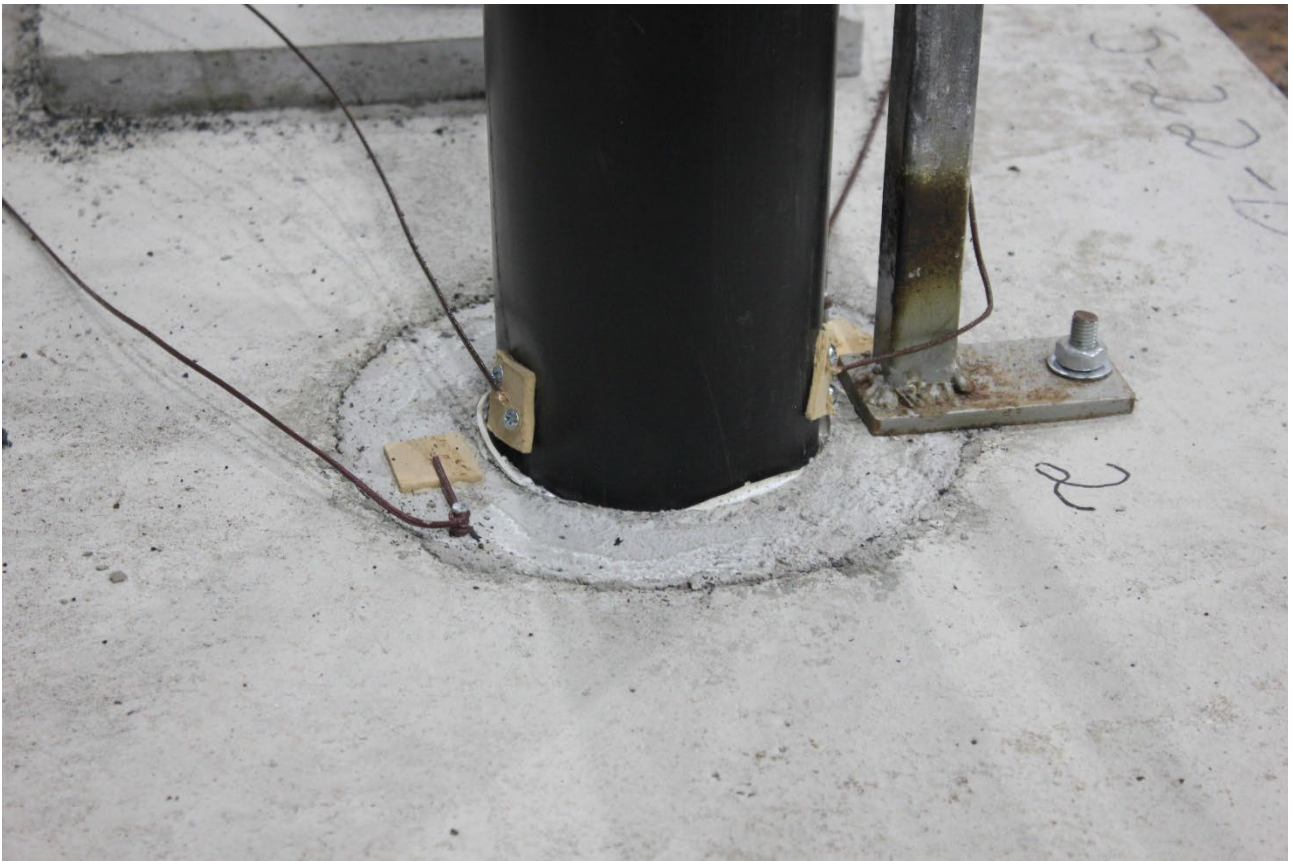
PHOTOGRAPH 13 – THE BASE OF SPECIMEN 2 AT 230 MINUTES INTO THE TEST

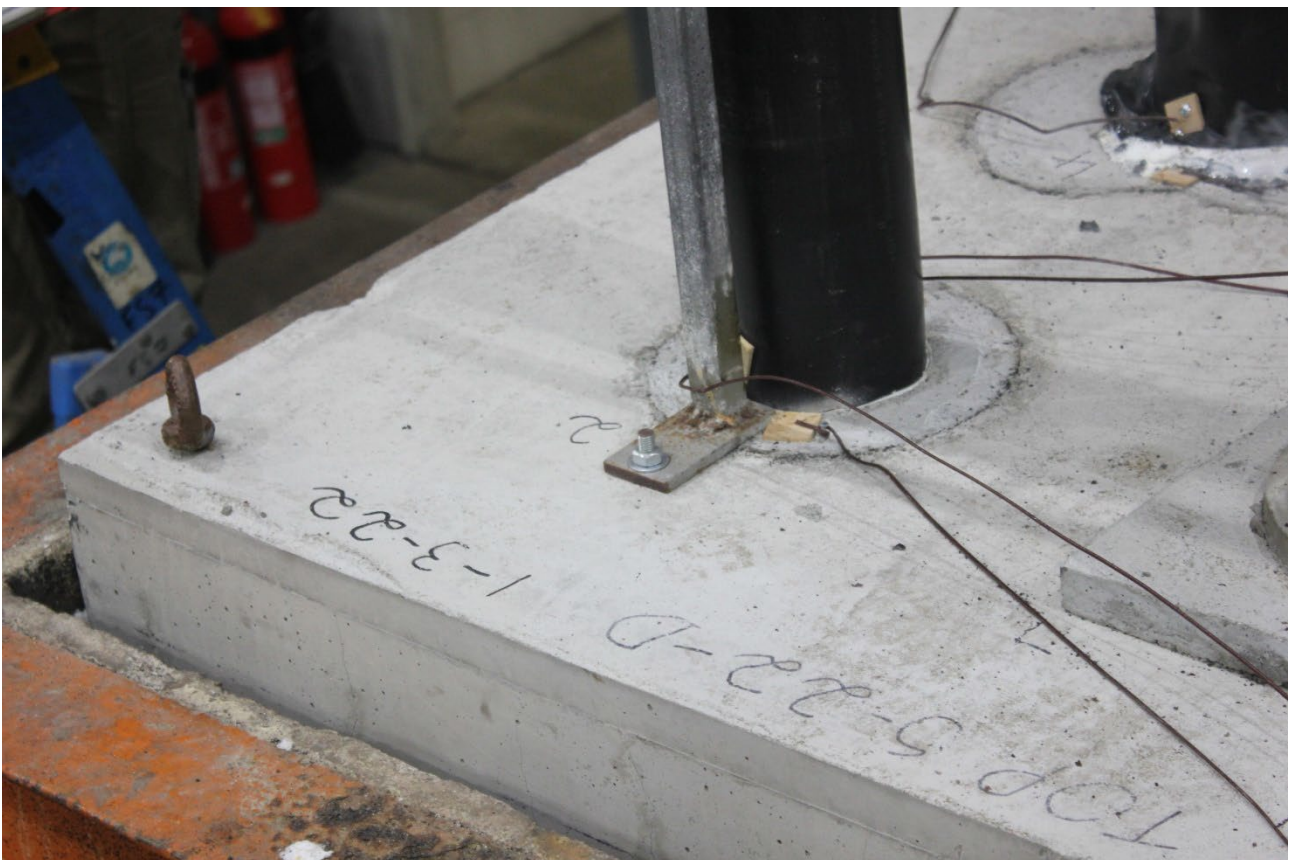
PHOTOGRAPH 16 – SPECIMEN 2 AT 240 MINUTES INTO THE TEST

236 minutes -	Intumescent material is visible through the metal grate inside the pipe of the floor waste of specimen 1.
237 minutes -	<u>Insulation failure of specimen 2</u> - maximum temperature rise of 180K is exceeded on the northern side of the slab, 25-mm from the collar.
242 minutes -	Test terminated.

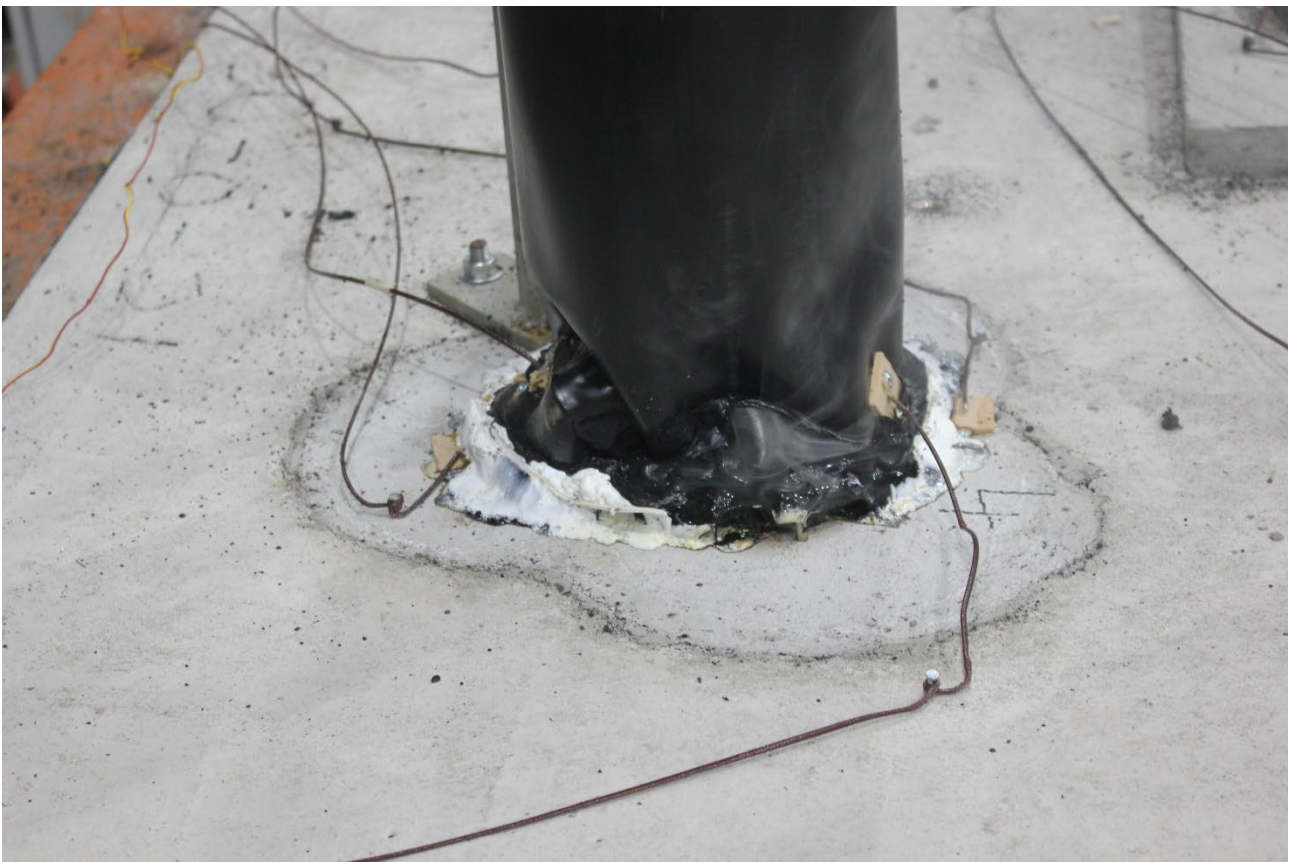
PHOTOGRAPH 18 – SPECIMEN 4 AT 240 MINUTES INTO THE TEST
