Fire-resistance test on fire collars protecting a plasterboard wall penetrated by services

Test Report

Report number: FSP 1985

Sponsored Investigation No. FSP 1985

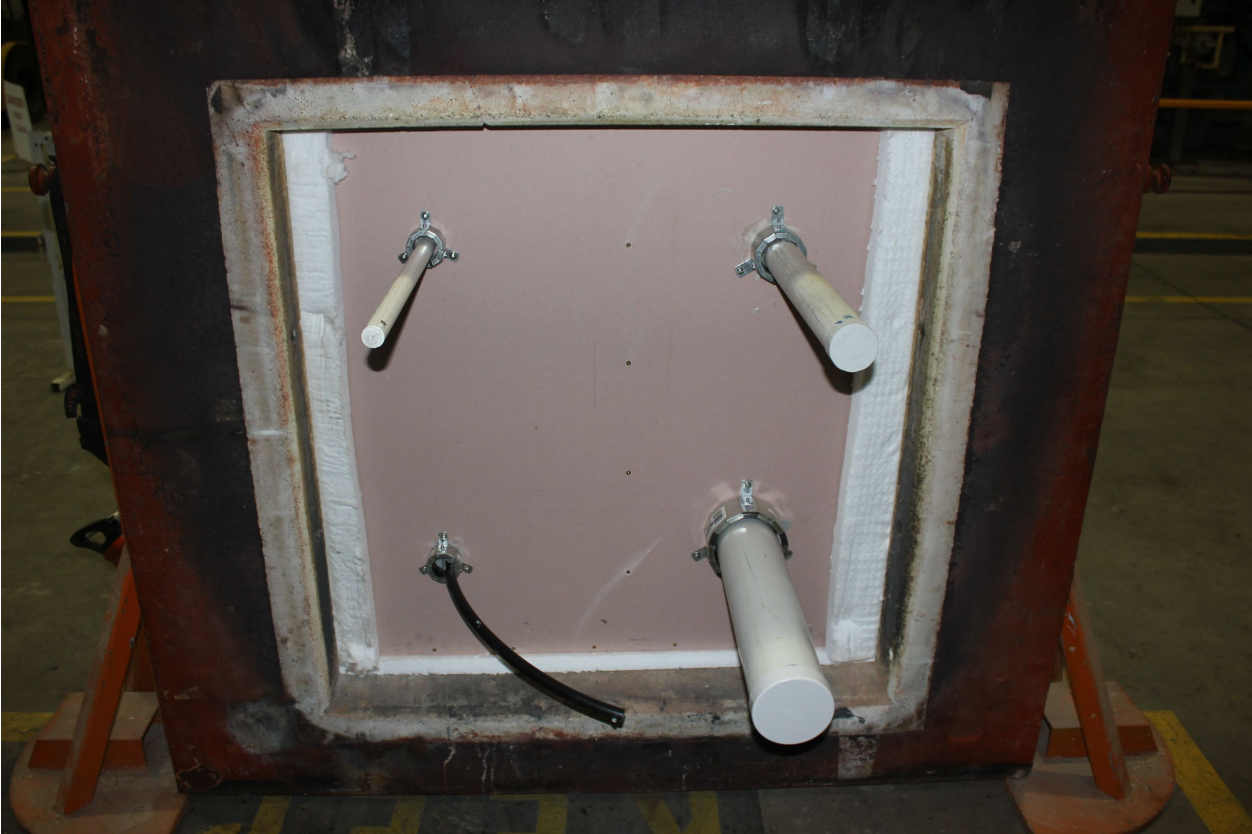
PHOTOGRAPH 1 – EXPOSED FACE OF SPECIMENS PRIOR TO TESTING

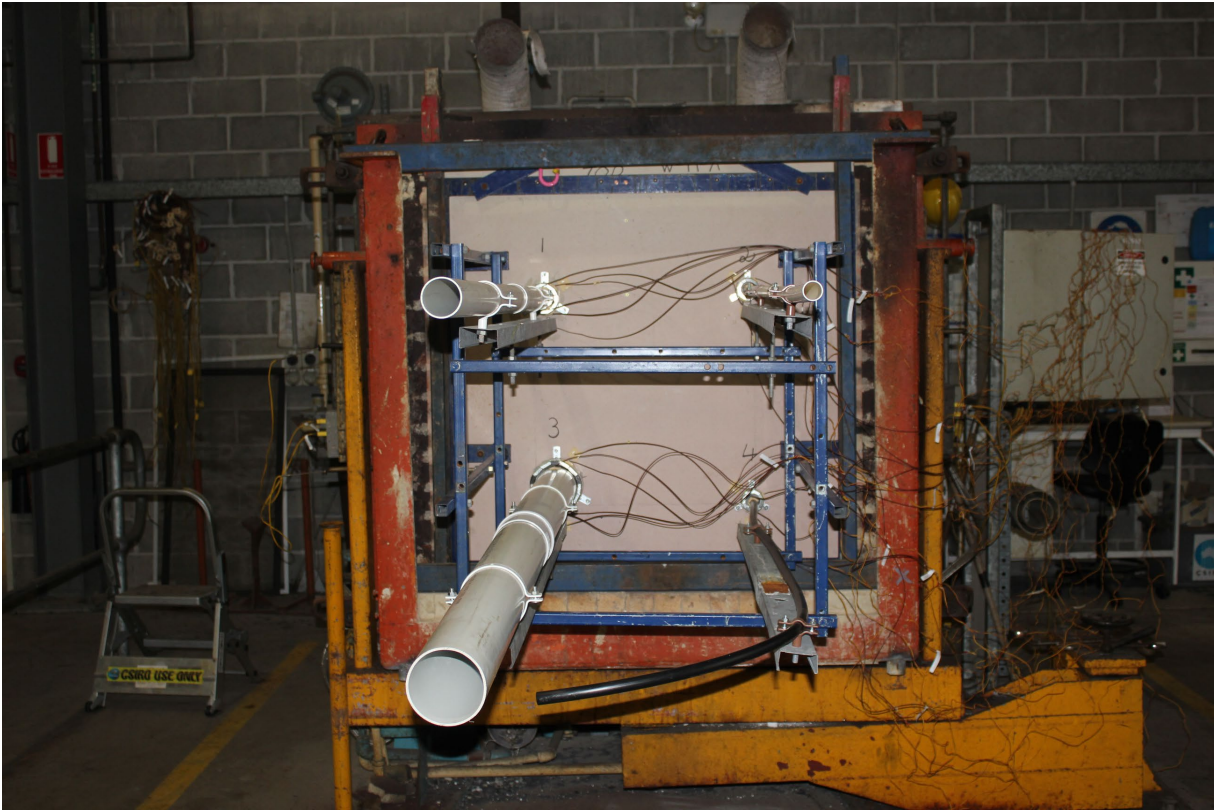
PHOTOGRAPH 2 – UNEXPOSED FACE OF SPECIMENS PRIOR TO TESTING

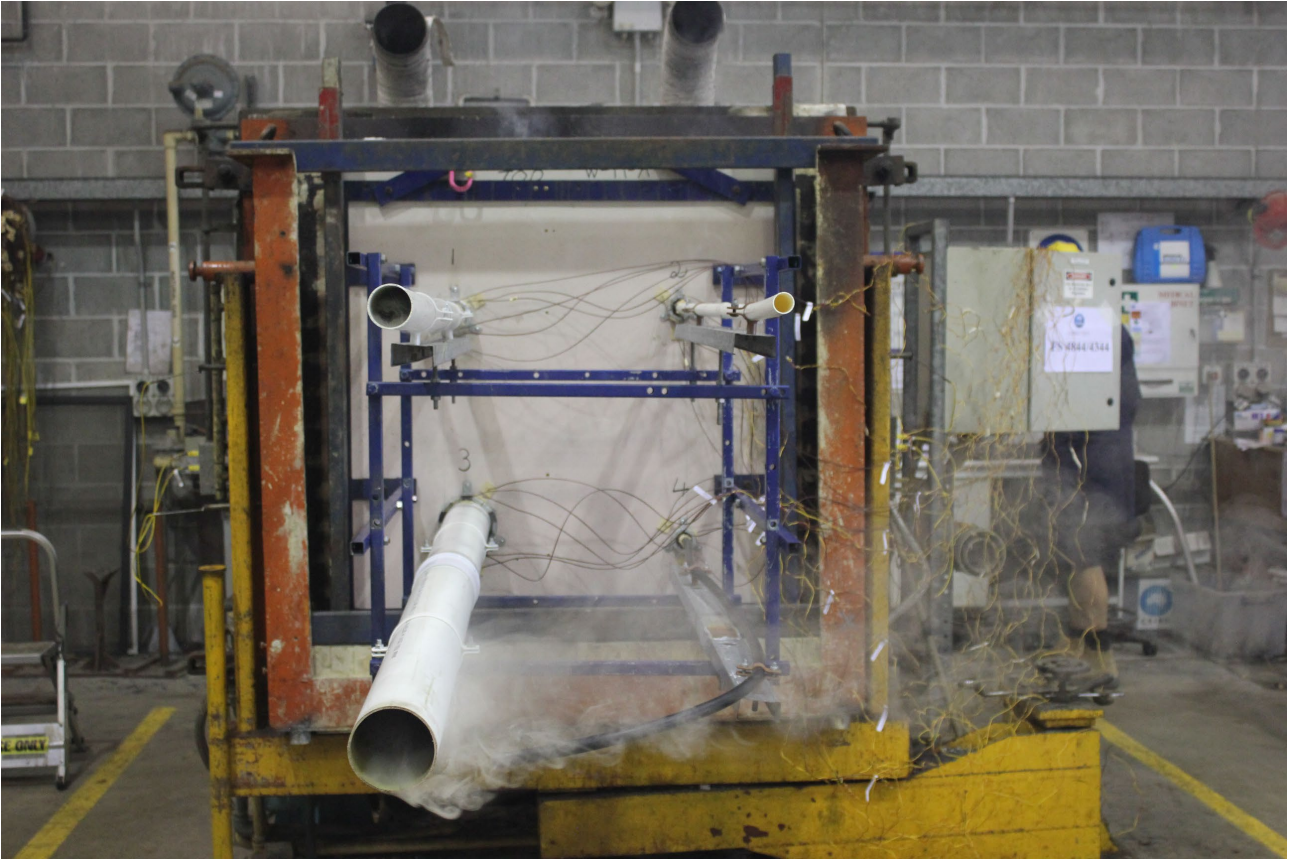
PHOTOGRAPH 3 – SPECIMENS AFTER 30 MINUTES OF TESTING

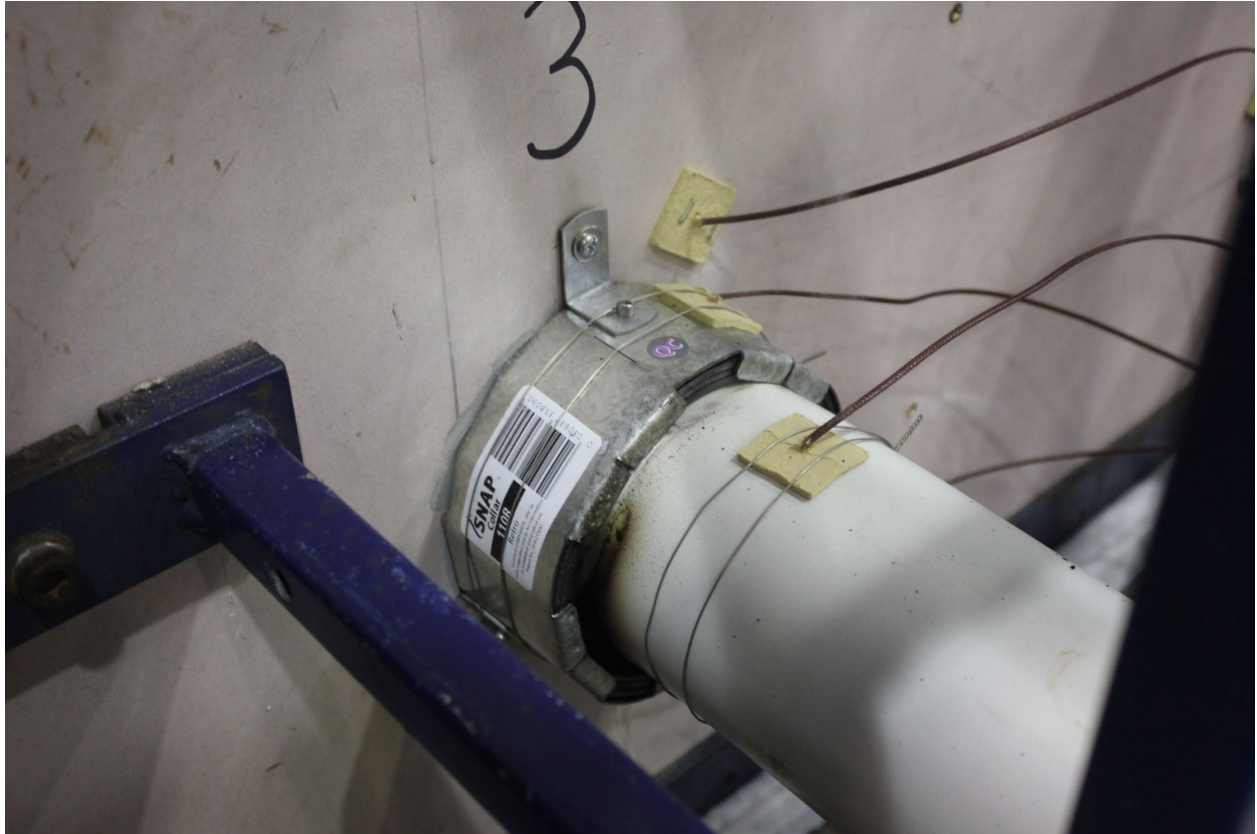
PHOTOGRAPH 4 – SPECIMEN 3 AFTER 31 MINUTES OF TESTING

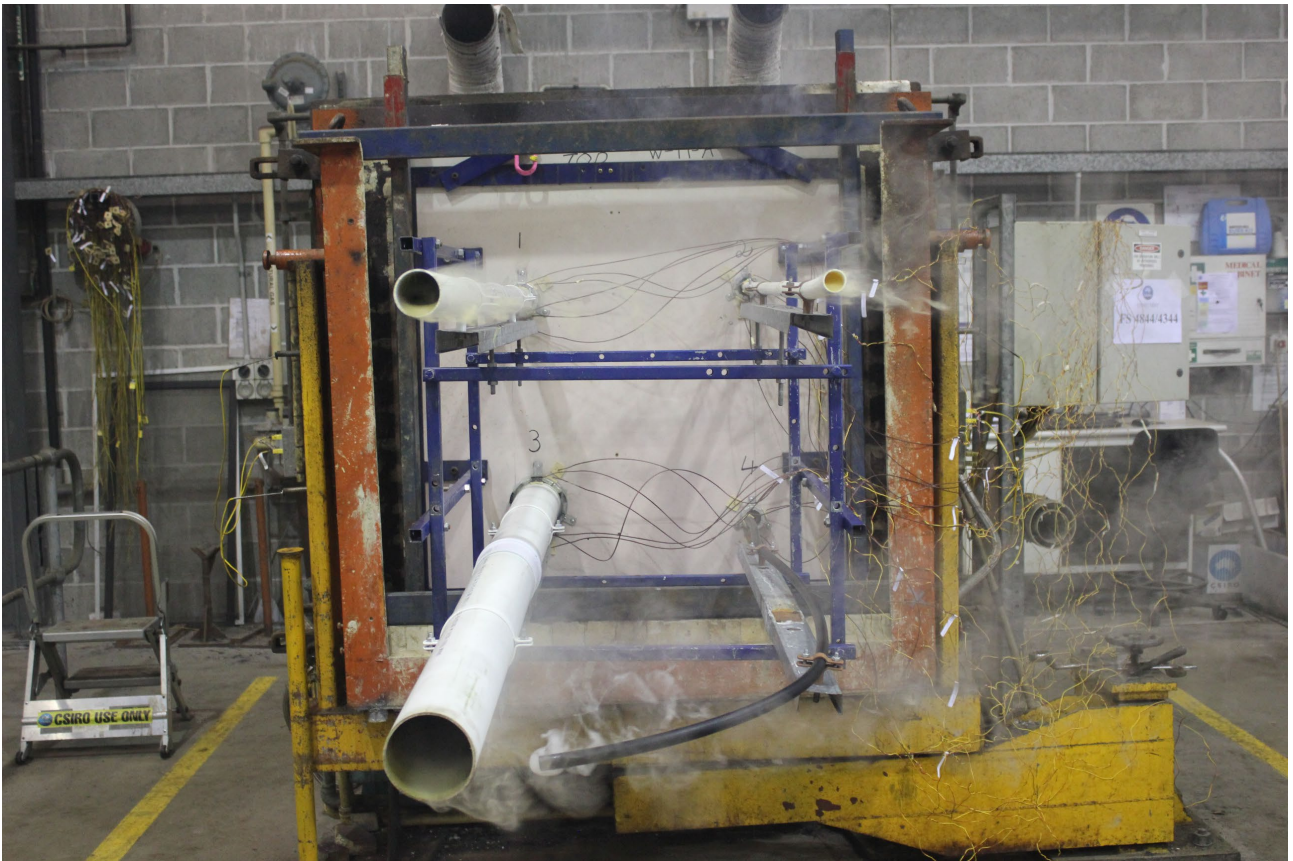
PHOTOGRAPH 5 – SPECIMENS AFTER 39 MINUTES OF TESTING

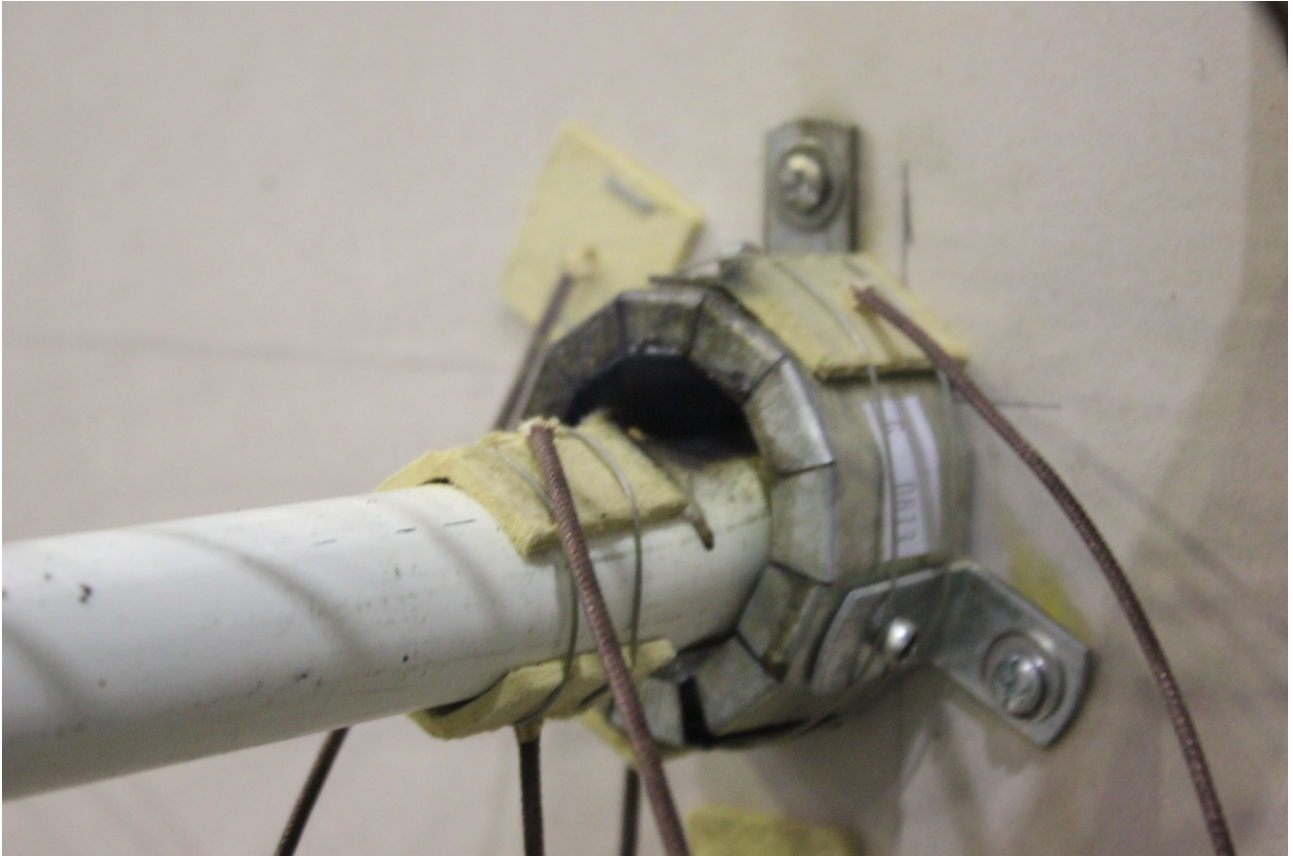
PHOTOGRAPH 6 – SPECIMEN 2 AFTER 54 MINUTES OF TESTING

Time	Observation
2 minutes	- Smoke is fluing from Specimen 1.
3 minutes	- Smoke is being emitted from the collars of Specimens 3 and 4.
4 minutes	- Smoke is fluing from the end of Specimen 3.
5 minutes	- Smoke is fluing from the end of Specimen 4.
7 minutes	- Smoke has ceased fluing from the end of Specimens 1 and 4.
8 minutes	- Smoke is being emitted from the furnace flues.
9 minutes	- Smoke has ceased fluing from the end of Specimen 3.
10 minutes	- Smoke is being emitted from the furnace flues.
15 minutes	- A small amount of smoke is fluing from the collars of Specimens 2 and 3.
17 minutes	- A small amount of smoke is fluing from Specimen 3.
25 minutes	- A small amount of smoke is fluing from Specimens 1, 3 and 4.
31 minutes	- Discolouration at the base of pipe of Specimen 3.
39 minutes	- Smoke now fluing from the end of all specimens.
40 minutes	- Smoke fluing from the collars of all specimens.
53 minutes	- The pipe of Specimen 2 near collar has started charring.

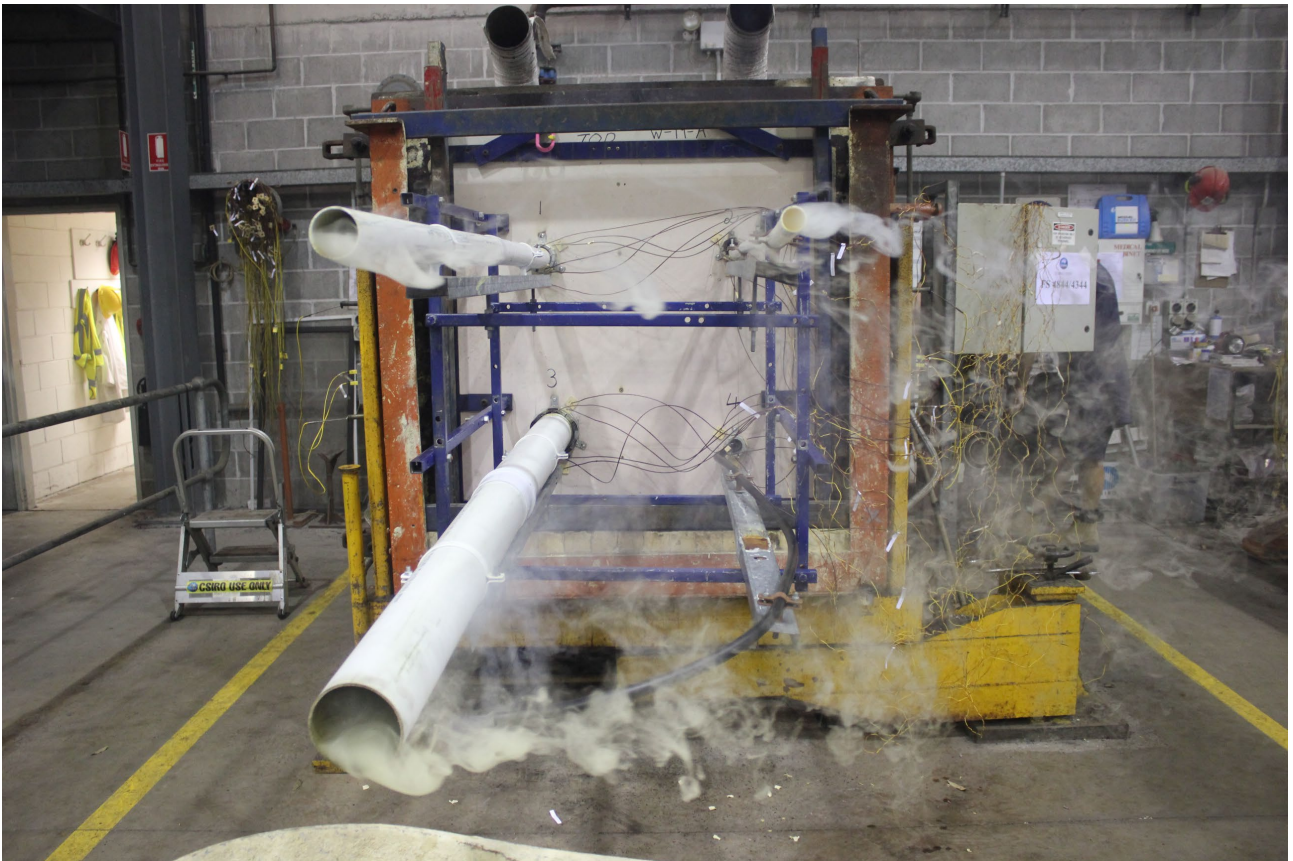
PHOTOGRAPH 7 – SPECIMENS AFTER 60 MINUTES OF TESTING

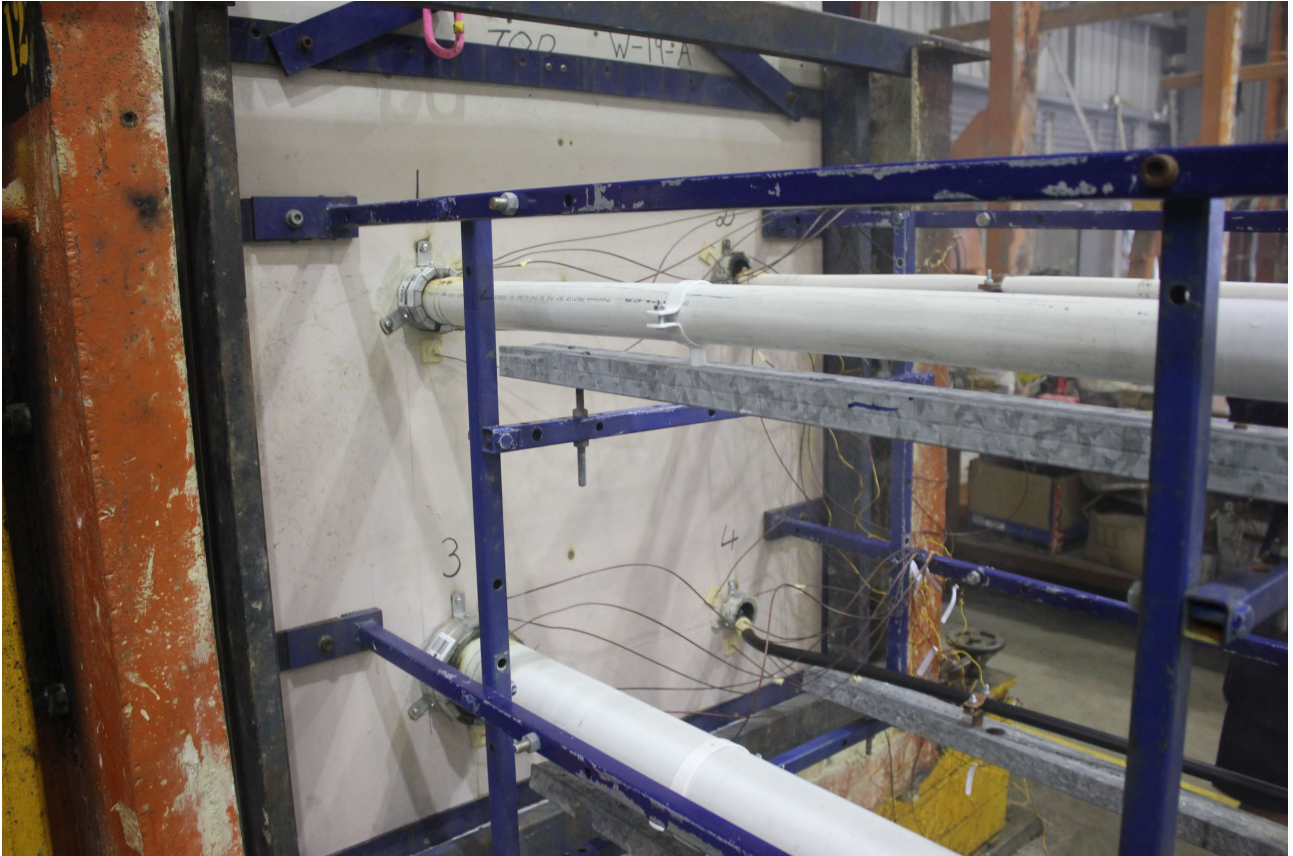
PHOTOGRAPH 8 – UNEXPOSED FACE OF SPECIMENS AT THE CONCLUSION OF TESTING

58 minutes	- The screw heads showing through plasterboard wall.
61 minutes	- <u>Insulation Failure of Specimen 4</u> – maximum temperature rise of 180K is exceeded on the top of pipe 25-mm away from collar on the unexposed face. Test terminated.

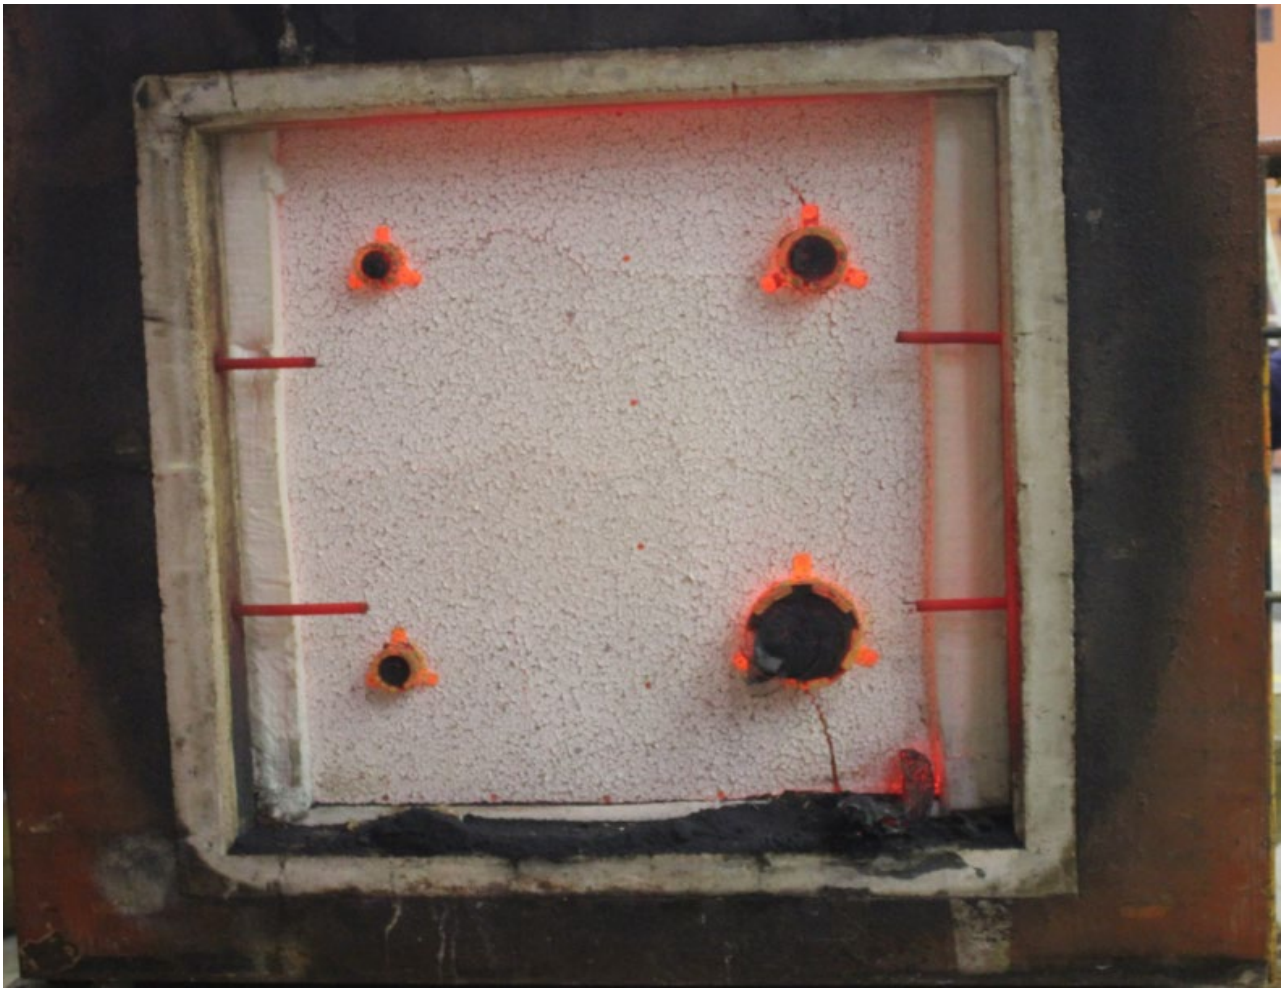
PHOTOGRAPH 9– EXPOSED FACE OF SPECIMENS AT CONCLUSION OF TESTING

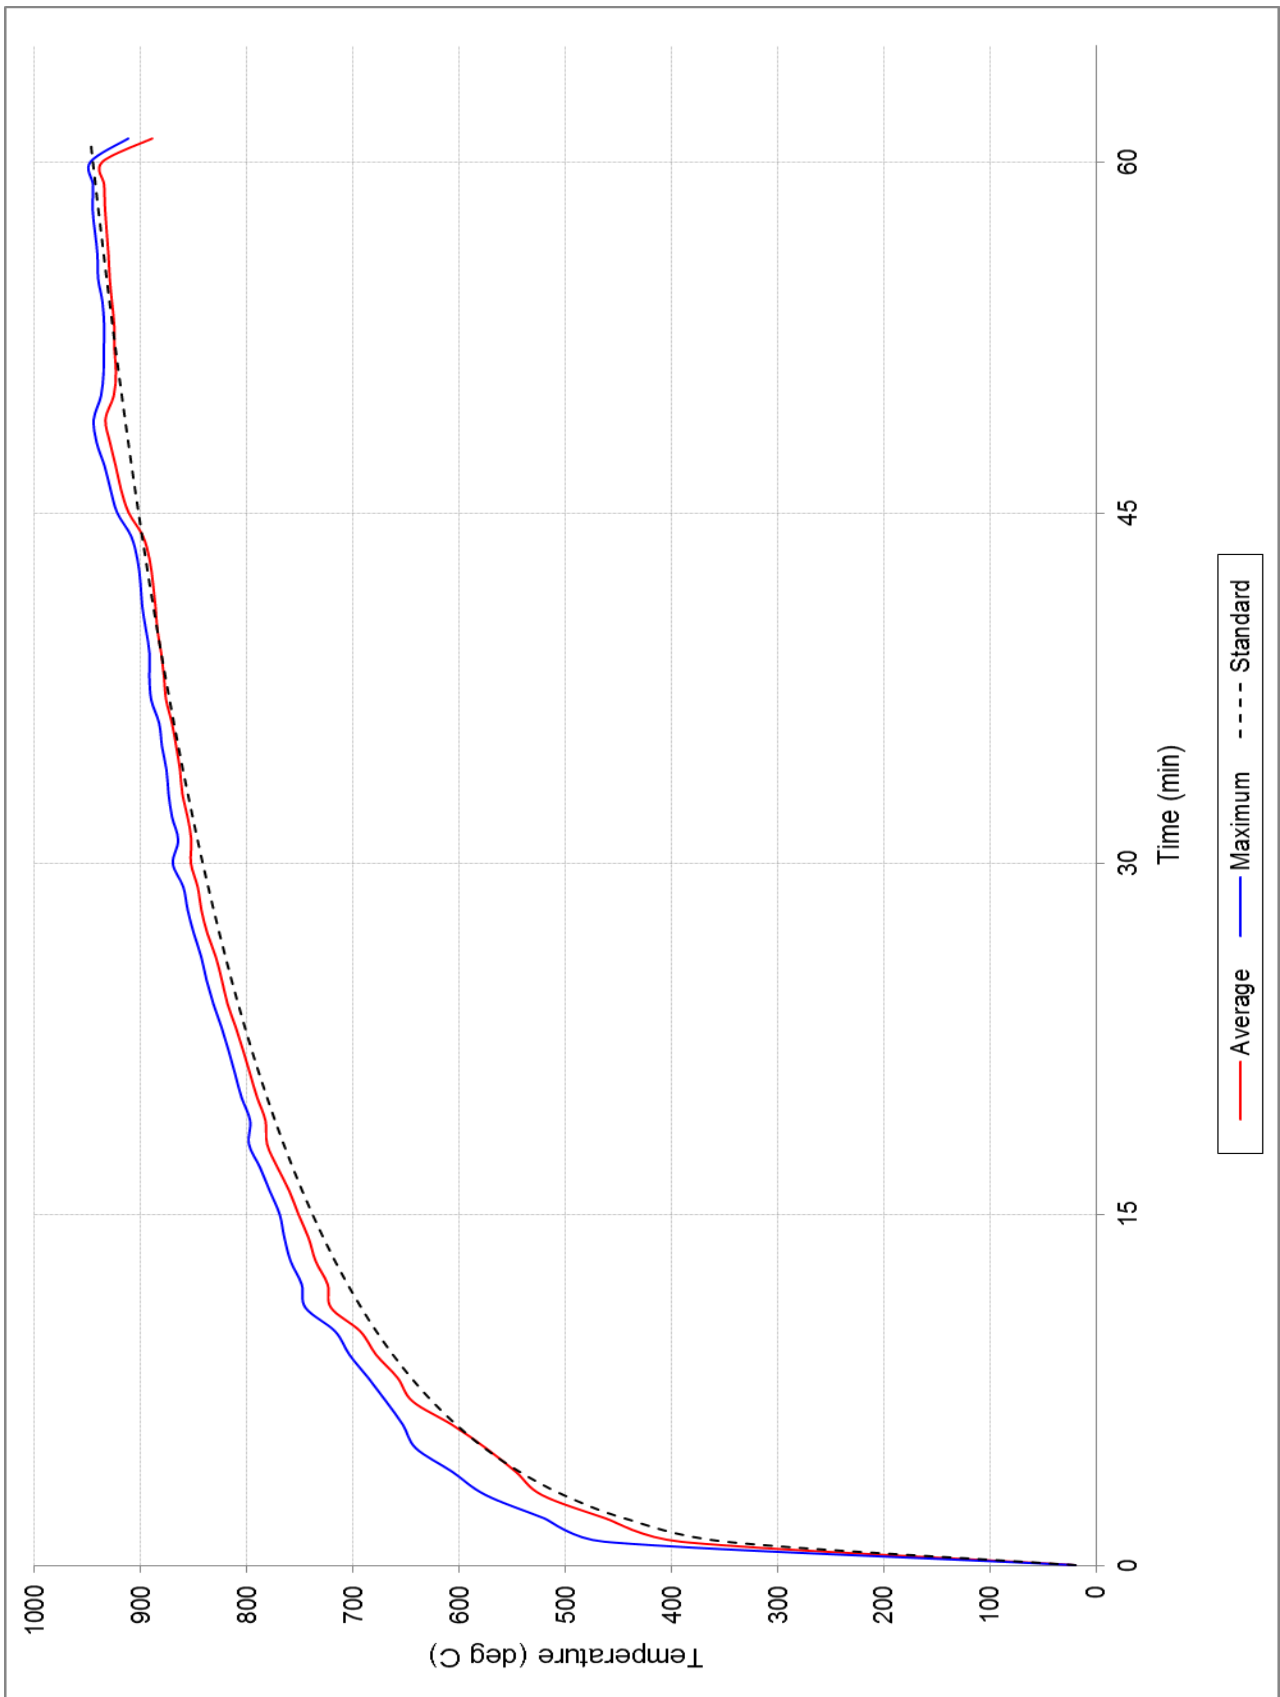
FIGURE 1 – FURNACE TEMPERATURE

Figure 1 shows the standard curves of temperature versus time for heating the furnace chamber and the actual curves of average and maximum temperature versus time recorded during the heating period.

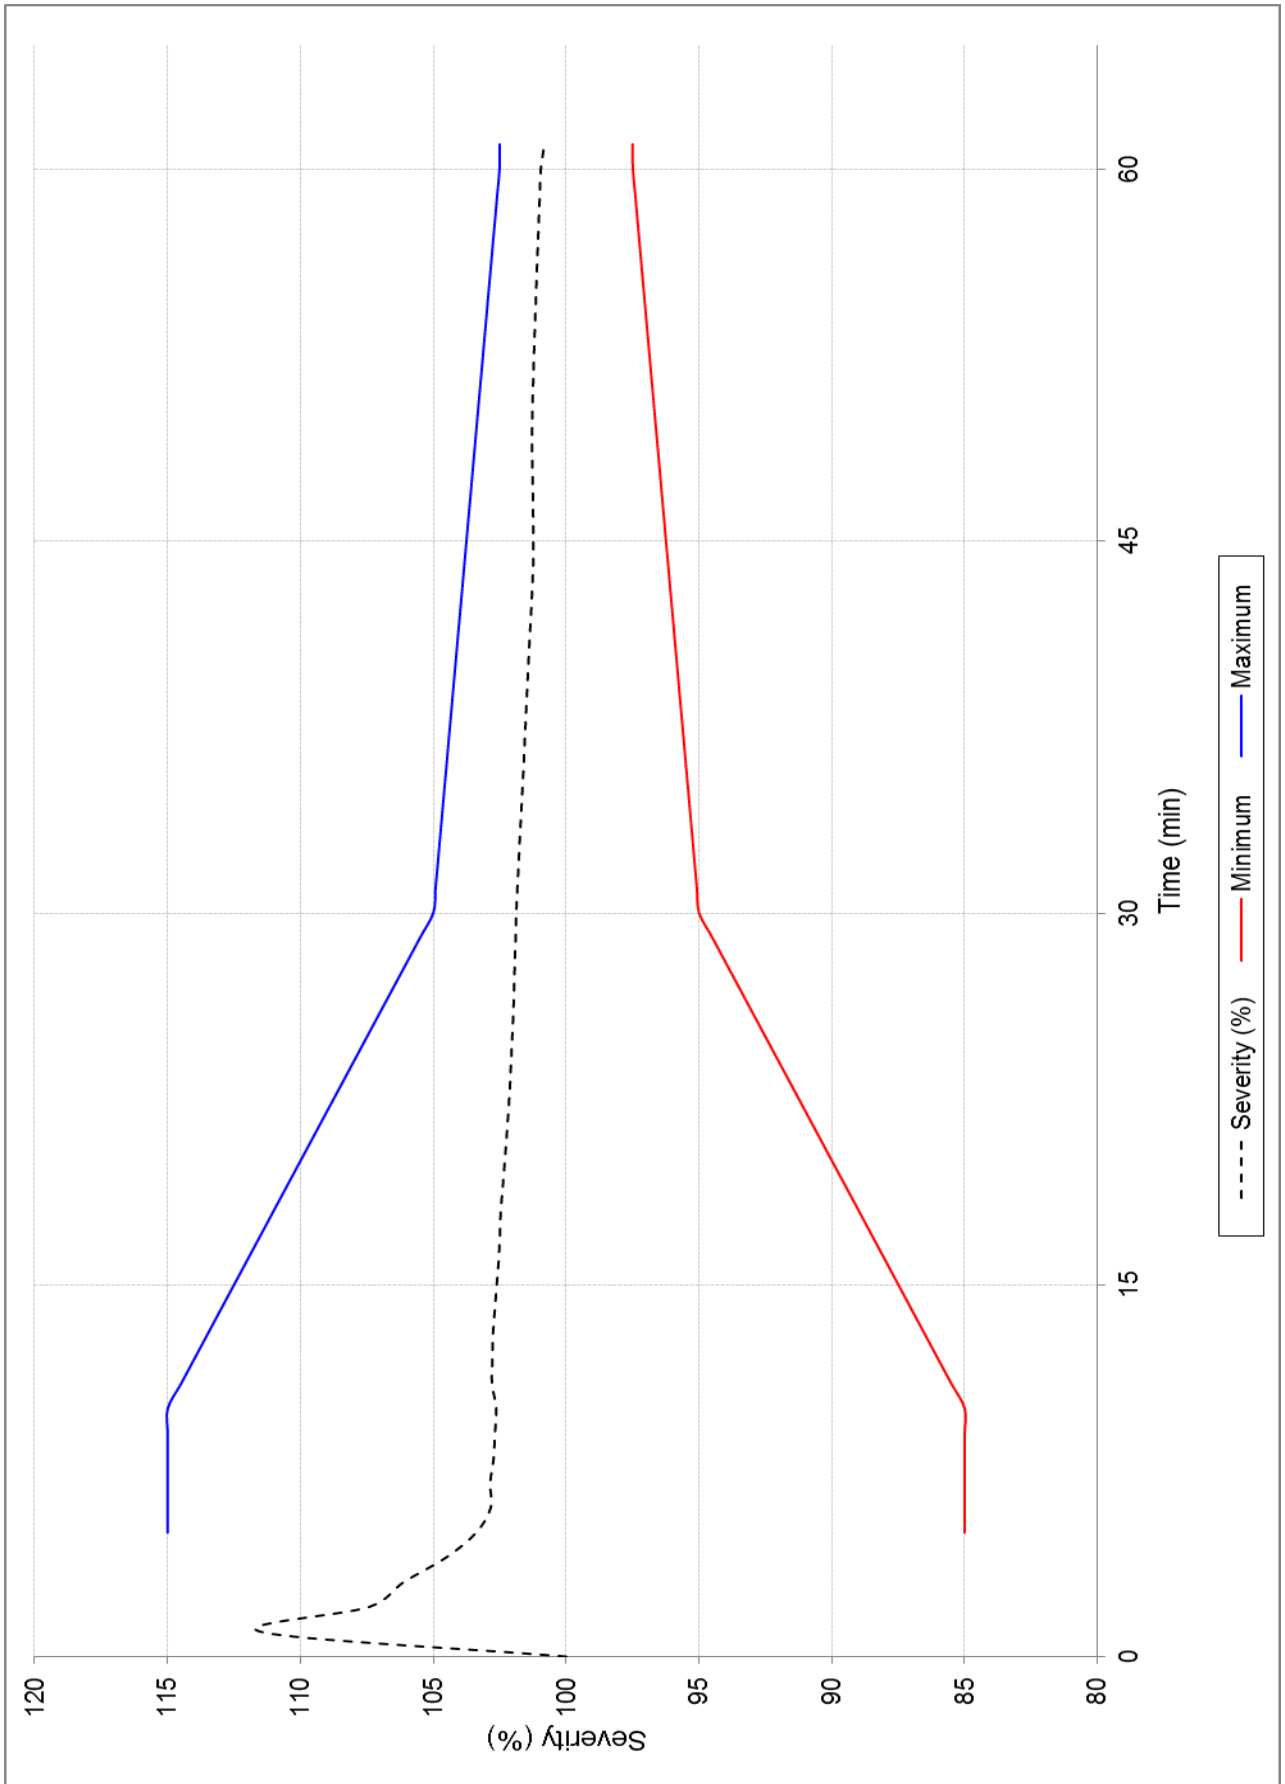
FIGURE 2 – FURNACE SEVERITY

Figure 2 shows the curve of furnace severity versus time during the heating period.

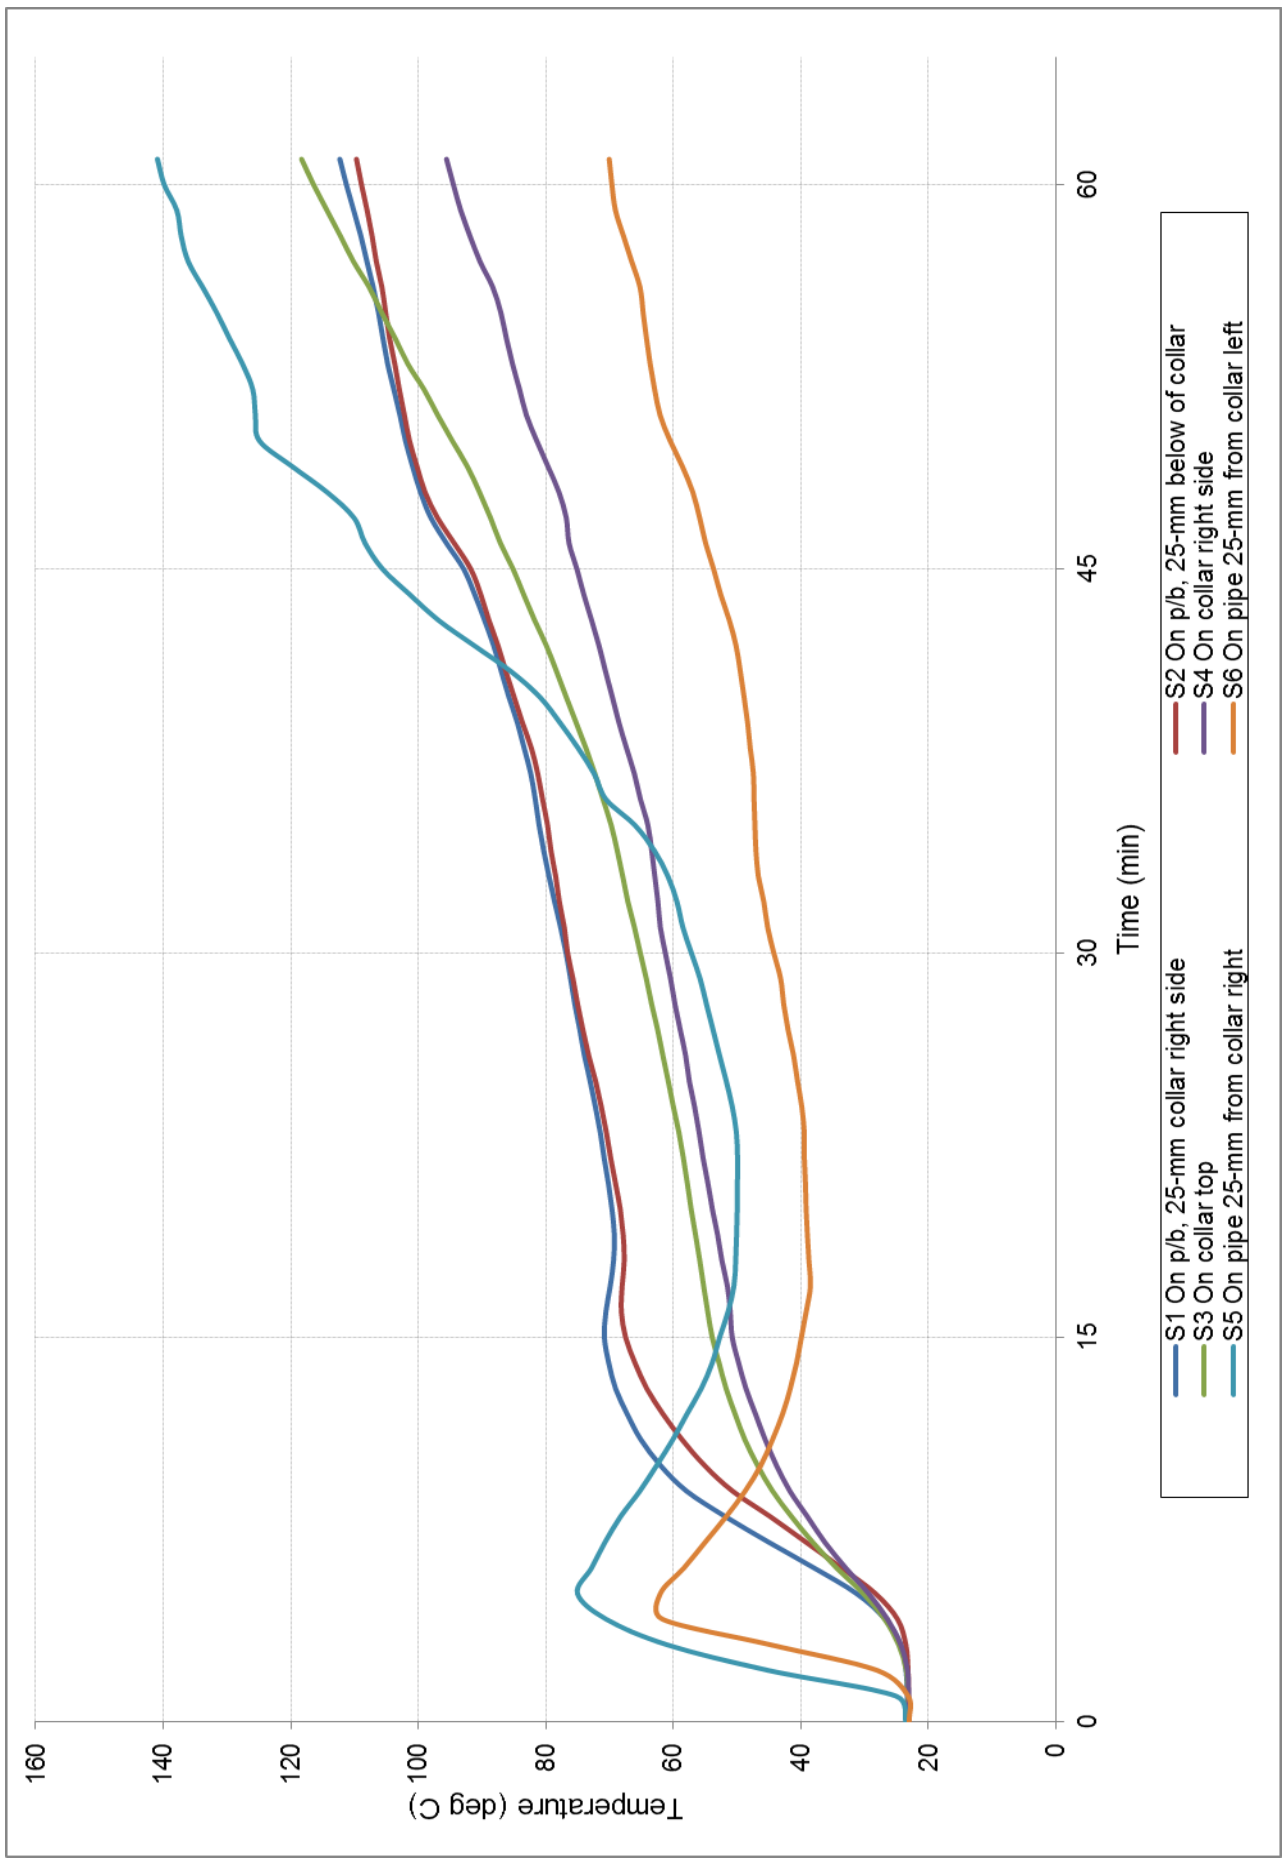
FIGURE 3 - SPECIMEN TEMPERATURE – ASSOCIATED WITH SPECIMEN # 1

Figure 3 shows the curve of temperature versus time associated with Specimen 1.

Structural adequacy	-	not applicable
Integrity	-	no failure at 61 minutes
Insulation	-	no failure at 61 minutes

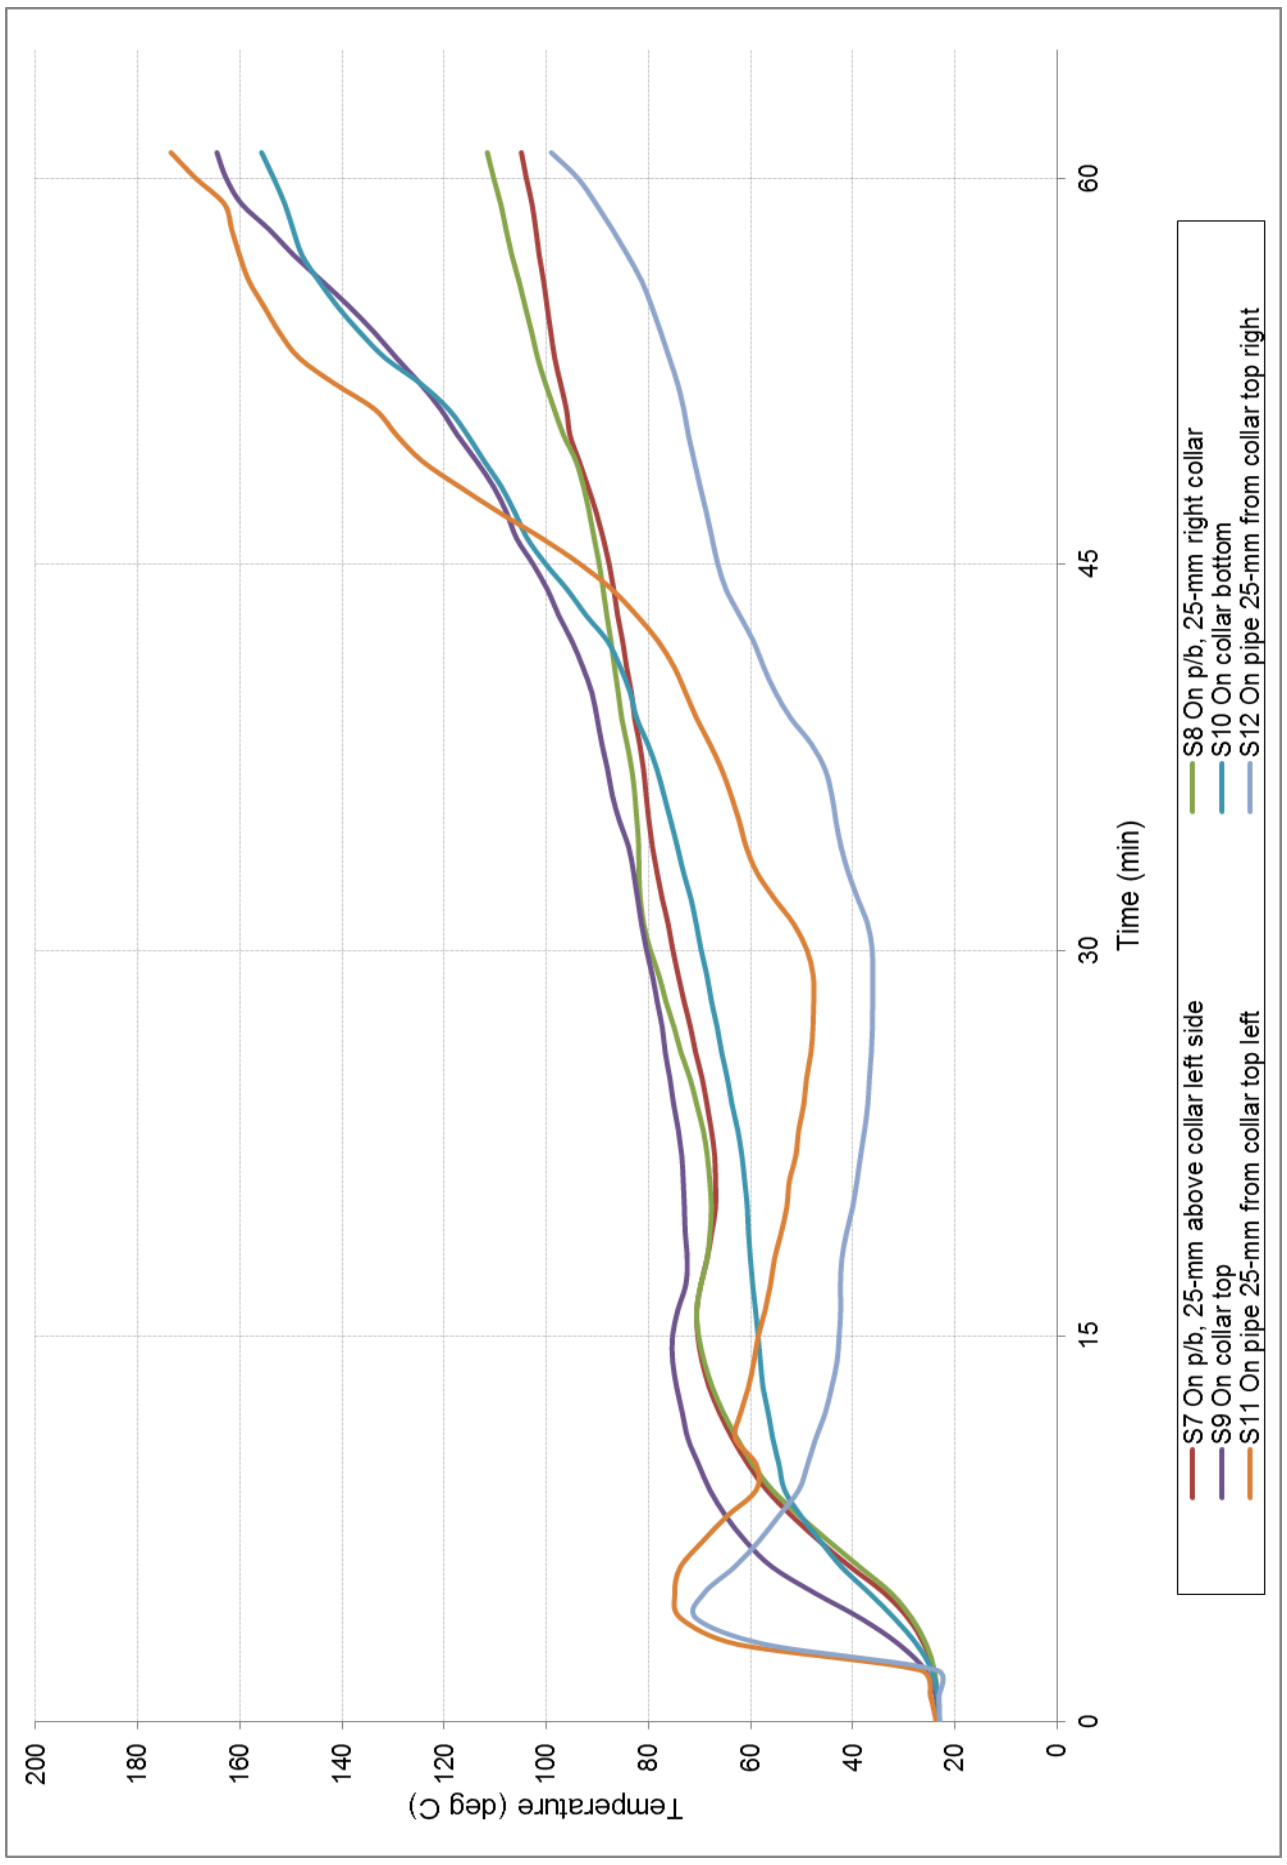
FIGURE 4 - SPECIMEN TEMPERATURE – ASSOCIATED WITH SPECIMEN # 2

Figure 4 shows the curve of temperature versus time associated with Specimen 2.

Structural adequacy	-	not applicable
Integrity	-	no failure at 61 minutes
Insulation	-	no failure at 61 minutes

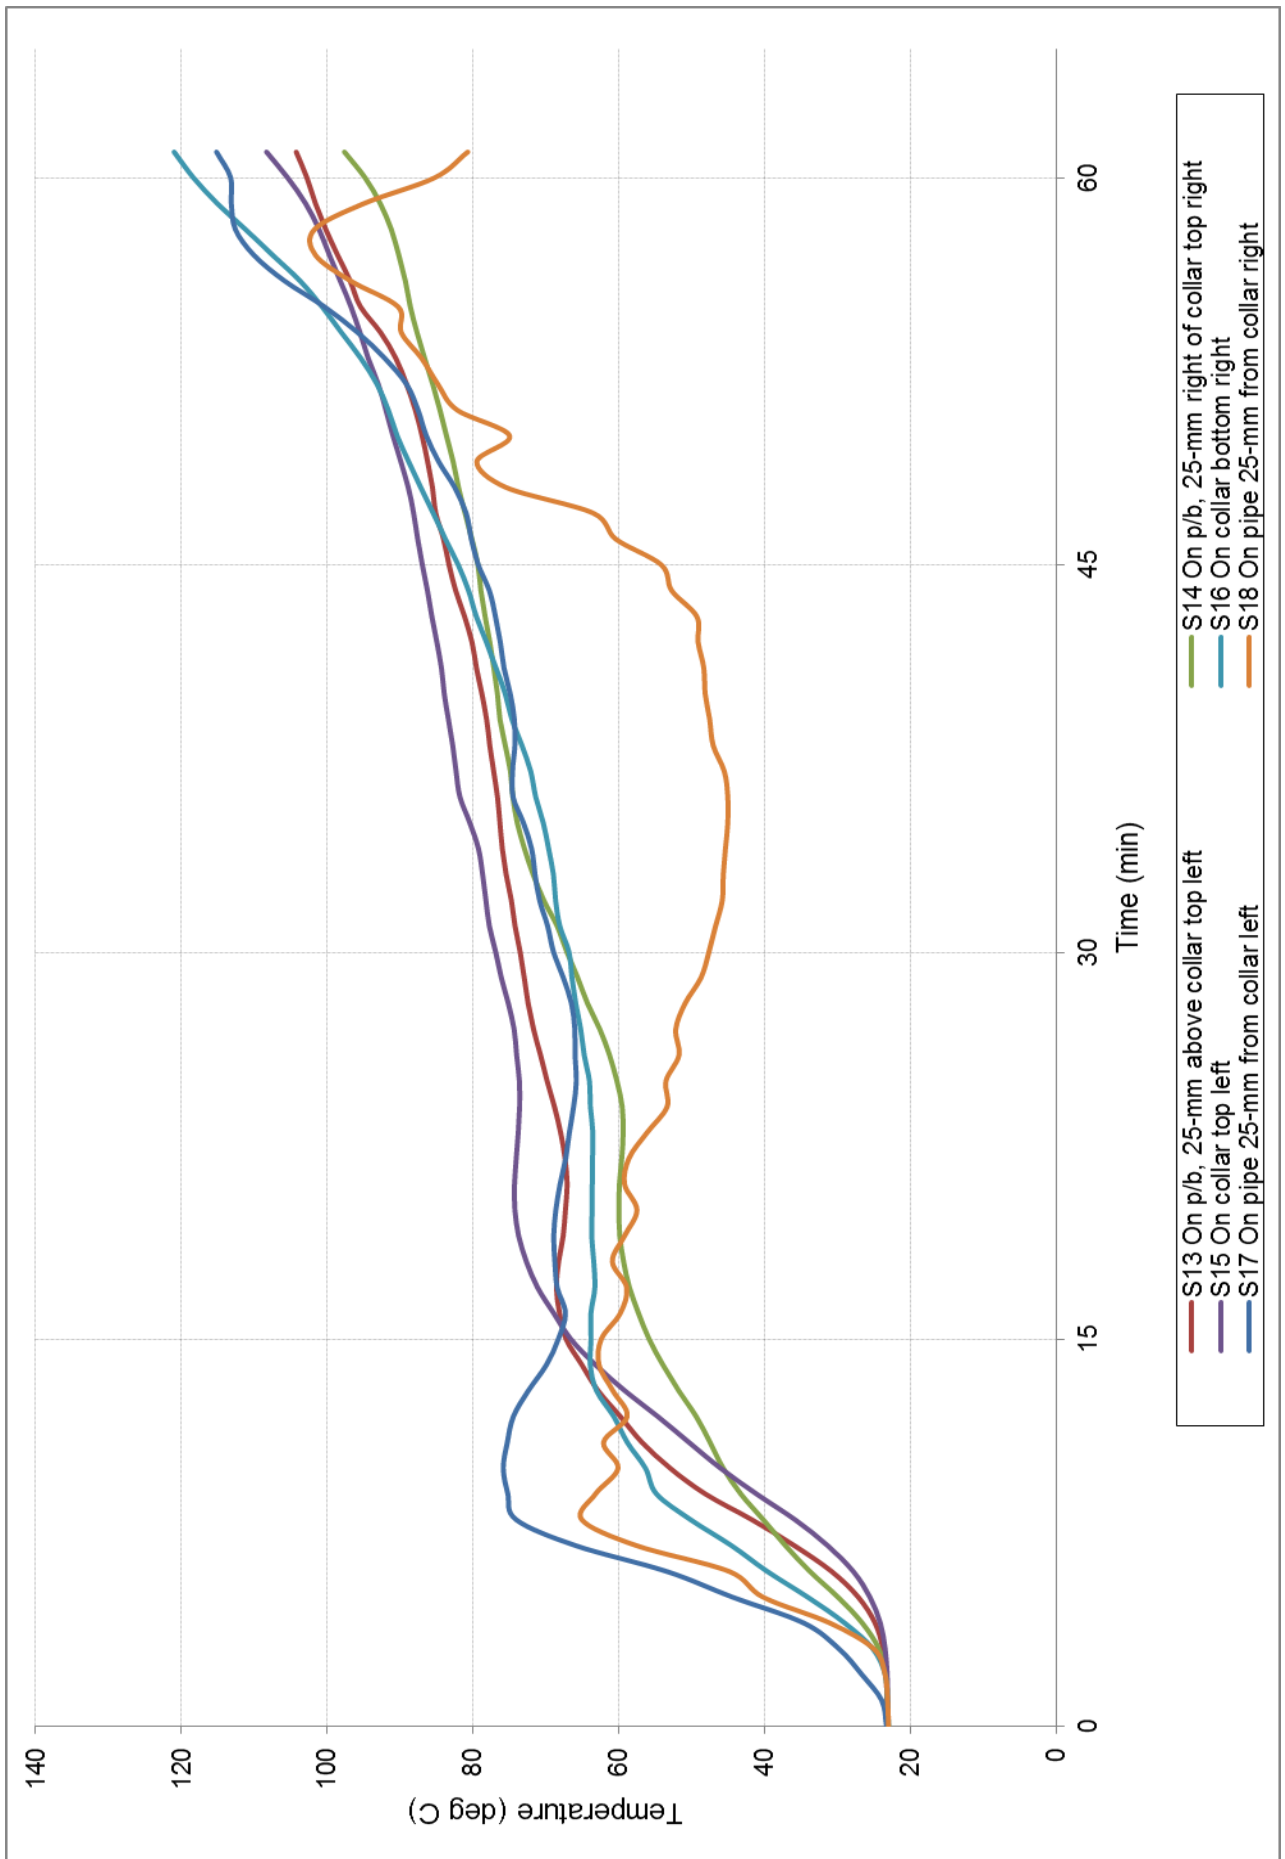
FIGURE 5 - SPECIMEN TEMPERATURE – ASSOCIATED WITH SPECIMEN # 3

Figure 5 shows the curve of temperature versus time associated with Specimen 3.

Structural adequacy	-	not applicable
Integrity	-	no failure at 61 minutes
Insulation	-	no failure at 61 minutes
