Fire-resistance test on fire collars protecting a plasterboard wall penetrated by services

Test Report

Report number: FSP 1985

Sponsored Investigation No. FSP 1985

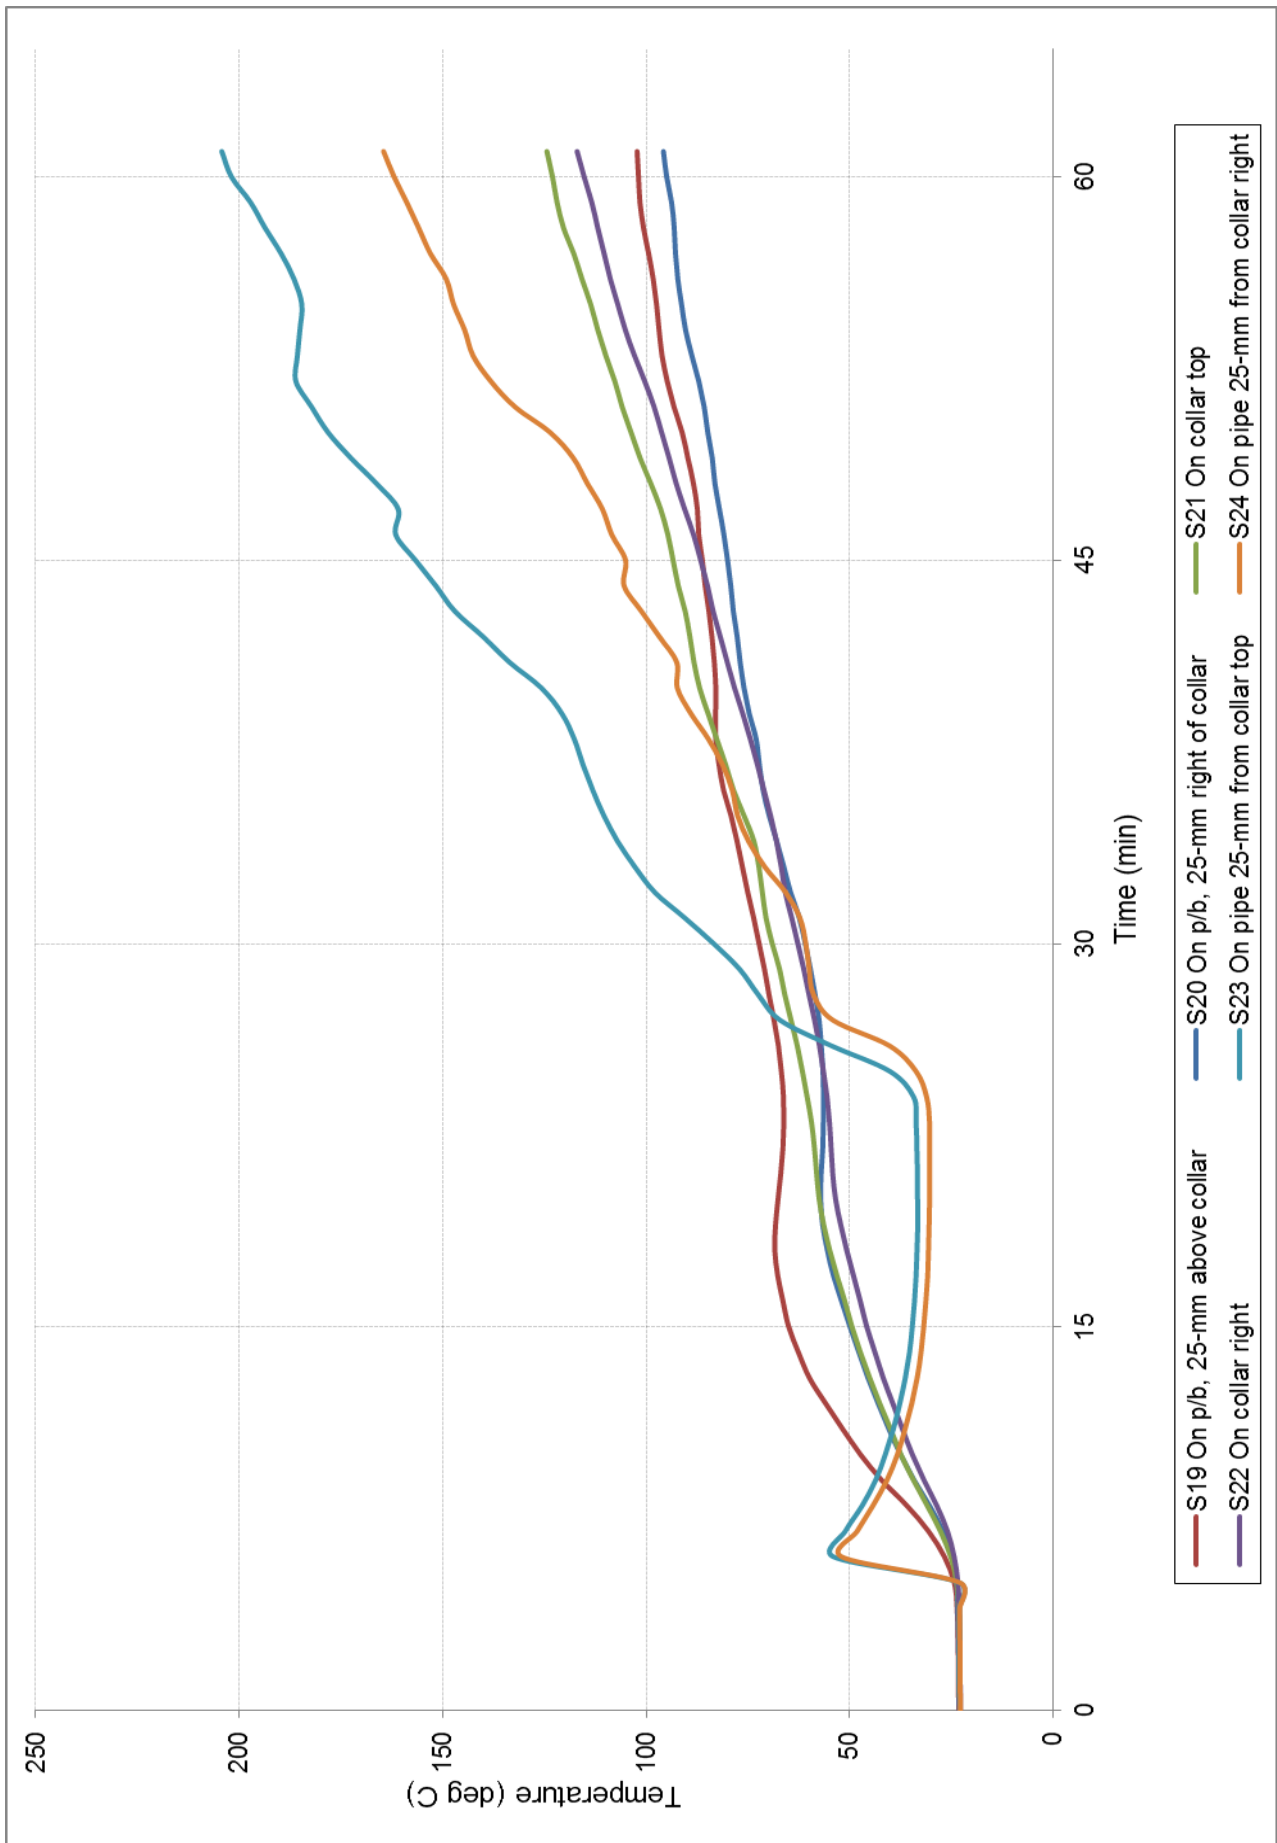
FIGURE 6 - SPECIMEN TEMPERATURE – ASSOCIATED WITH SPECIMEN # 4

58 minutes	- The screw heads showing through plasterboard wall.
61 minutes	- <u>Insulation Failure of Specimen 4</u> – maximum temperature rise of 180K is exceeded on the top of pipe 25-mm away from collar on the unexposed face. Test terminated.

Figure 6 shows the curve of temperature versus time associated with Specimen 4.

Structural adequacy	-	not applicable
Integrity	-	no failure at 61 minutes
Insulation	-	61 minutes

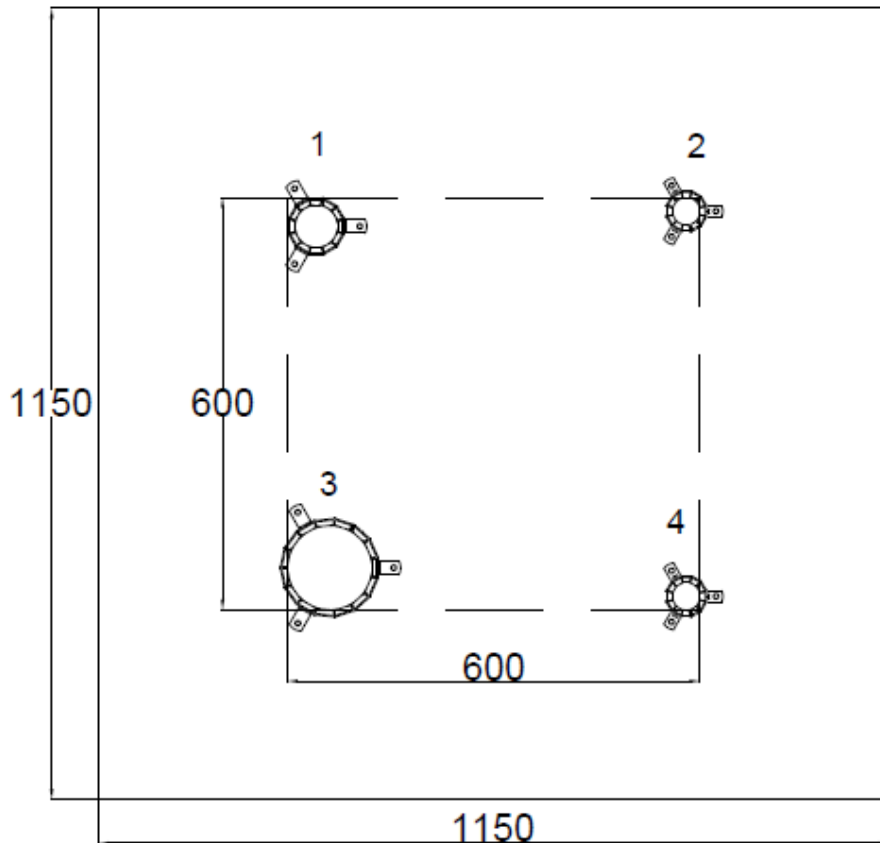
Snap Fire Systems Pty Ltd Test Wall W-19-A Layout Date: 25 FEB 2019

Penetration	Collar Code	Pipe Type	Pipe Diameter (mm)	Sealant
1	50R	PVC	56	Fireban One
2	32R	P-PVC	27	N/A
3	110R	PVC-SC	110	Firesound
4	32R	Pex-B	20	Firesound

DRAWING TITLED "TEST WALL W-19-A LAYOUT" DATED 25 FEBRUARY 2019, BY SNAP FIRE SYSTEMS PTY LTD.

The specimen comprised an 1150-mm x 1150-mm x 90-mm thick wall penetrated by four (4) pipes protected by retrofitted Snap Fire Systems fire collars.

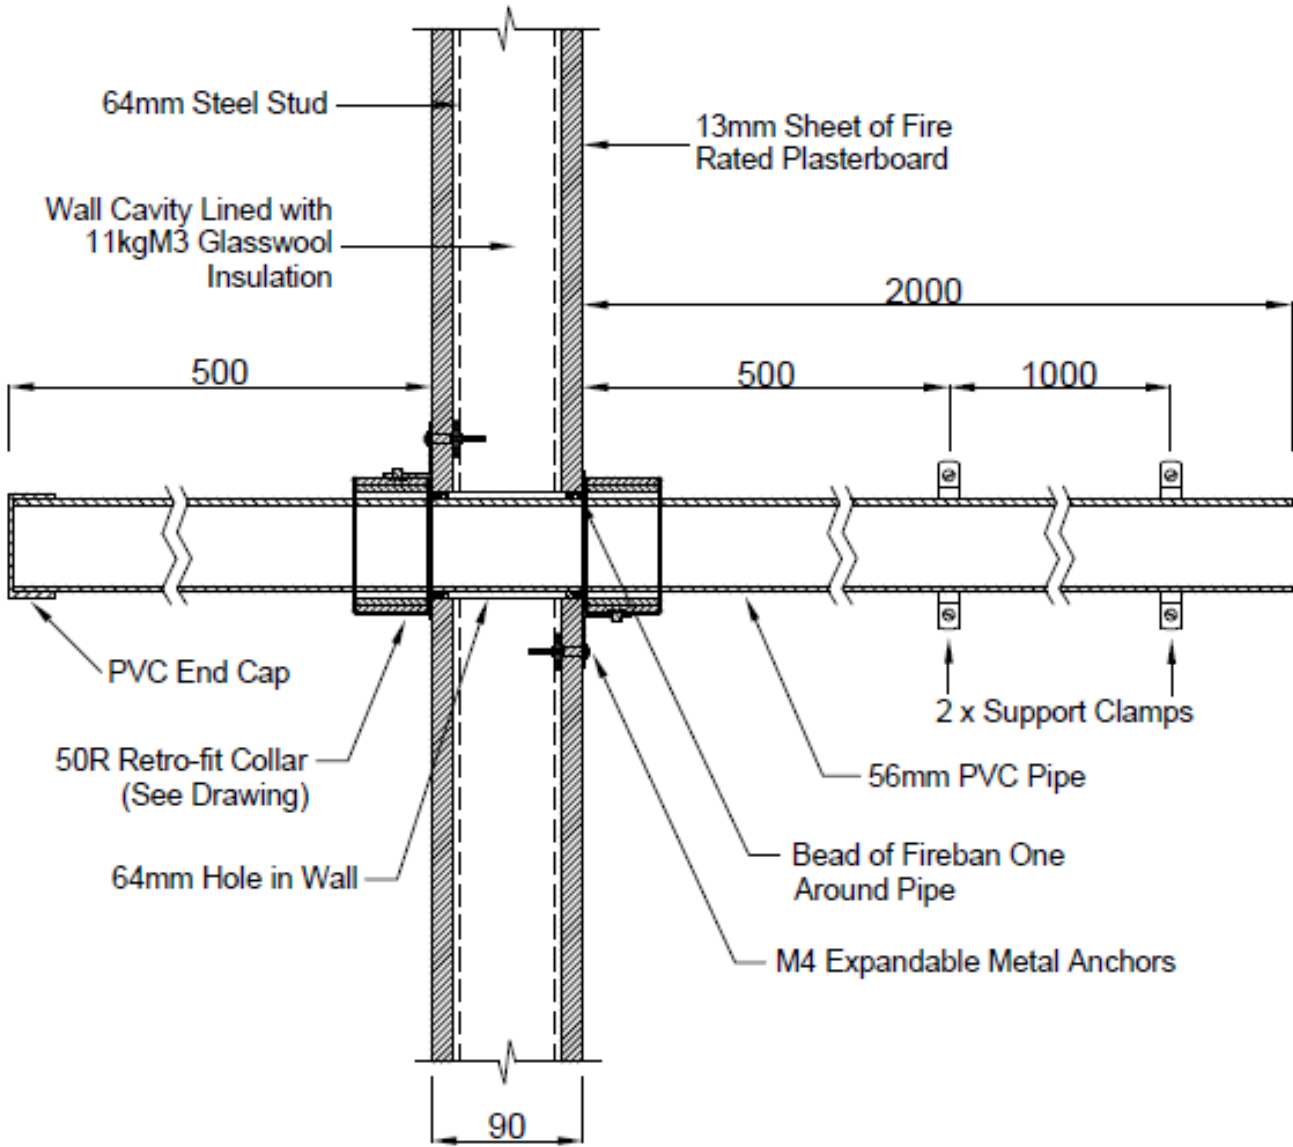
Specimen #1

50 PVC Stack & 50R

DRAWING TITLED "SPECIMEN #1 50 PVC STACK & 50R" DATED 6 FEBRUARY 2019, BY SNAP FIRE SYSTEMS PTY LTD.

The SNAP Retrofit 50R fire collar comprised a 0.75-mm steel casing with a 62-mm inner diameter and a 147-mm diameter base flange. The 47-mm high collar casing incorporated a closing mechanism which comprised two soft Intumesh intumescent wraps lined within the internal circumference of the collar. Intumescent A was 4-mm thick x 43-mm wide x 220-mm long, and Intumescent B was 4-mm thick x 43-mm wide x 200-mm long. Between the strips was a layer of 316 grade stainless steel mesh 210-mm long x 42-mm wide with wire mesh diameter of 0.15-mm, as shown in drawing titled "SNAP 50 Retro", dated 18 January 2019, by Snap Fire Systems Pty Ltd. The Snap collars were surface mounted around the pipe on both the exposed and unexposed face of the wall and fixed through 3 mounting brackets using M4 expandable steel anchors.

The penetrating service comprised a 56-mm diameter PVC pipe, with a wall thickness of 2.45-mm which penetrated the wall through a 64-mm diameter cut-out hole as shown in drawing titled "Specimen #1, 50 PVC Stack & 50R", dated 6 January 2019, provided by Snap Fire Systems Pty Ltd. The pipe projected horizontally, 2000-mm away from the unexposed face of the wall and approximately 500-mm into the furnace chamber. The pipe was supported at nominally 500-mm and 1500-mm from the unexposed face of the plasterboard wall. The pipe was open at the unexposed end and capped with PVC end cap on the exposed end.

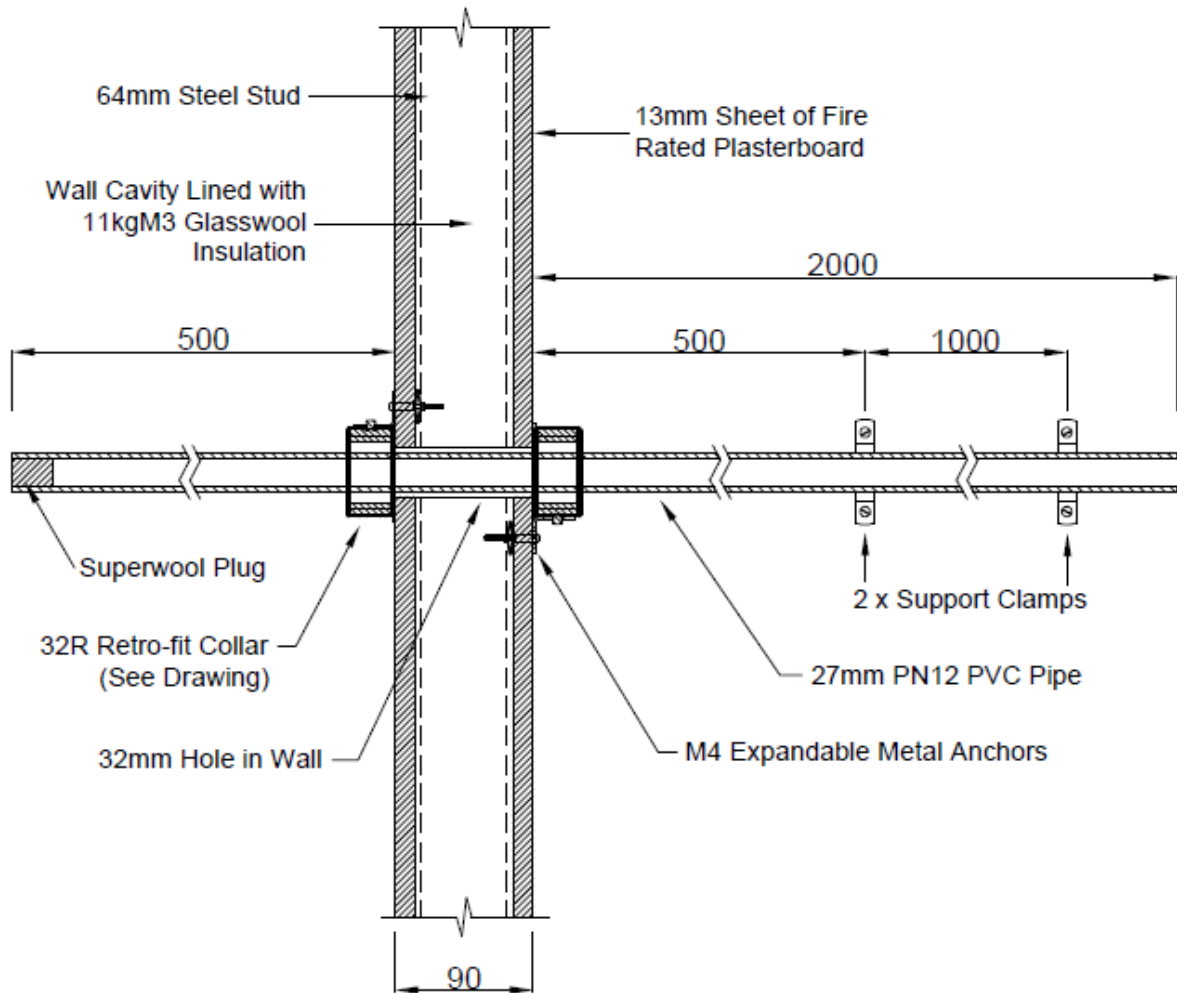
Specimen #2

DN20 PN12 PVC Stack

DRAWING TITLED "SPECIMEN #2 20 PVC STACK & 32R", DATED 6 FEBRUARY 2019, PROVIDED BY SNAP FIRE SYSTEMS PTY LTD.

The 32R Retrofit collar comprised a 0.75-mm steel casing with a 40-mm inner diameter and a 106-mm diameter base flange. The 32-mm high collar casing incorporated a closing mechanism that was comprised of two soft Intumesh intumescent strips lined within the internal circumference of the collar. The inner and outer strips were 4-mm thick x 26-mm wide x 135-mm long, and 4-mm thick x 26-mm wide x 154-mm long, respectively. Between the strips was a layer of 316 stainless steel mesh 135 mm long x 25-mm wide with wire mesh diameter of 0.15-mm, as shown in drawing titled “SNAP 32 Retro”, dated 5 October 2017, by Snap Fire Systems Pty Ltd. The Snap collars were surface mounted around the pipe on both the exposed and unexposed face of the wall and fixed through 3 mounting brackets using M4 expandable steel anchors.

The penetrating service comprised a 27-mm PVC pipe, with a wall thickness of 1.7-mm, penetrating the wall through a 32-mm diameter cut-out hole as shown in drawing titled “Specimen #2, 20 PVC Pipe & 32R” dated 6 February 2019, provided by Snap Fire Systems Pty Ltd. The pipes projected horizontally, 2000-mm away from the unexposed face of the wall and approximately 500-mm into the furnace chamber. The pipes were supported at nominally 500-mm and 1500-mm from the unexposed face of the plasterboard wall. The pipes were open at the unexposed and capped with a Superwool plug on the exposed end.

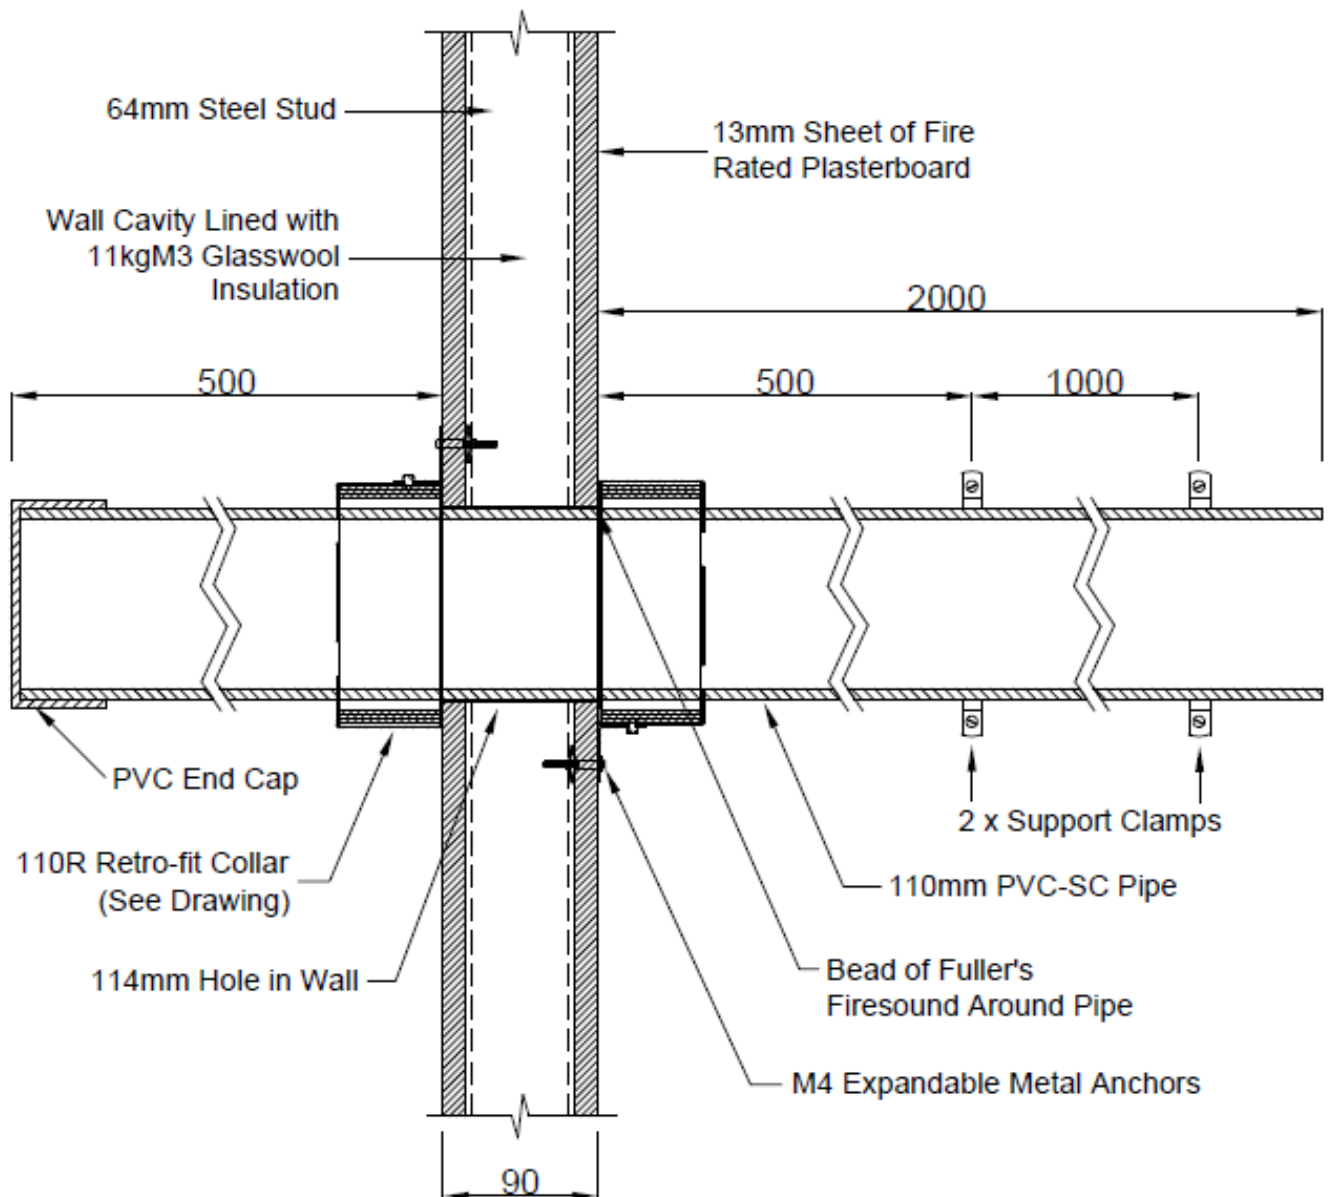
Specimen #3

100 PVC-SC Stack & 110R

DRAWING TITLED "SPECIMEN #3 100 PVC-SC STACK & 110R", DATED 6 FEBRUARY 2019, PROVIDED BY SNAP FIRE SYSTEMS PTY LTD.

The SNAP Retrofit 110R fire collar comprised a 0.75-mm steel casing with a 122-mm inner diameter and a 206-mm diameter base flange. The 62-mm high collar casing incorporated a closing mechanism that was comprised of three soft Intumesh intumescent wraps and wire meshes lined within the internal circumference of the collar. Intumescent A was 2.5-mm thick x 58-mm wide x 424-mm long, Intumescent B was 2.5-mm thick x 58-mm wide x 407-mm long and Intumescent C was 2.5-mm thick x 58-mm wide x 389-mm long. Between intumescent strips A and B was a layer of 304 stainless steel mesh 415-mm long x 58-mm wide and between intumescent strips B and C was a layer of 316 stainless steel mesh 398-mm long x 58-mm wide both had wire mesh diameters of 0.15-mm, as shown in drawing titled “SNAP 110 Retro”, dated 16 January 2019, by Snap Fire Systems Pty Ltd. The Snap collars were surface mounted around the pipe on both the exposed and unexposed face of the wall and fixed through 3 mounting brackets using M4 expandable steel anchors.

The penetrating service comprised a 110-mm PVC-SC pipe, with a wall thickness of 3.46-mm fitted through the collar’s sleeve. The pipe penetrated the wall through a 114-mm diameter opening and projected horizontally 2000-mm away from the unexposed face of the wall and approximately 500 mm into the furnace chamber. The pipe was supported at nominally 500-mm, and 1500-mm from the unexposed face of the plasterboard wall, as shown in drawing titled “Specimen #3, 100 PVC-SC Stack & 110R”, dated 6 February 2019, provided by Snap Fire Systems Pty Ltd. The pipe was open on the unexposed end and capped on the exposed end with a PVC end cap.

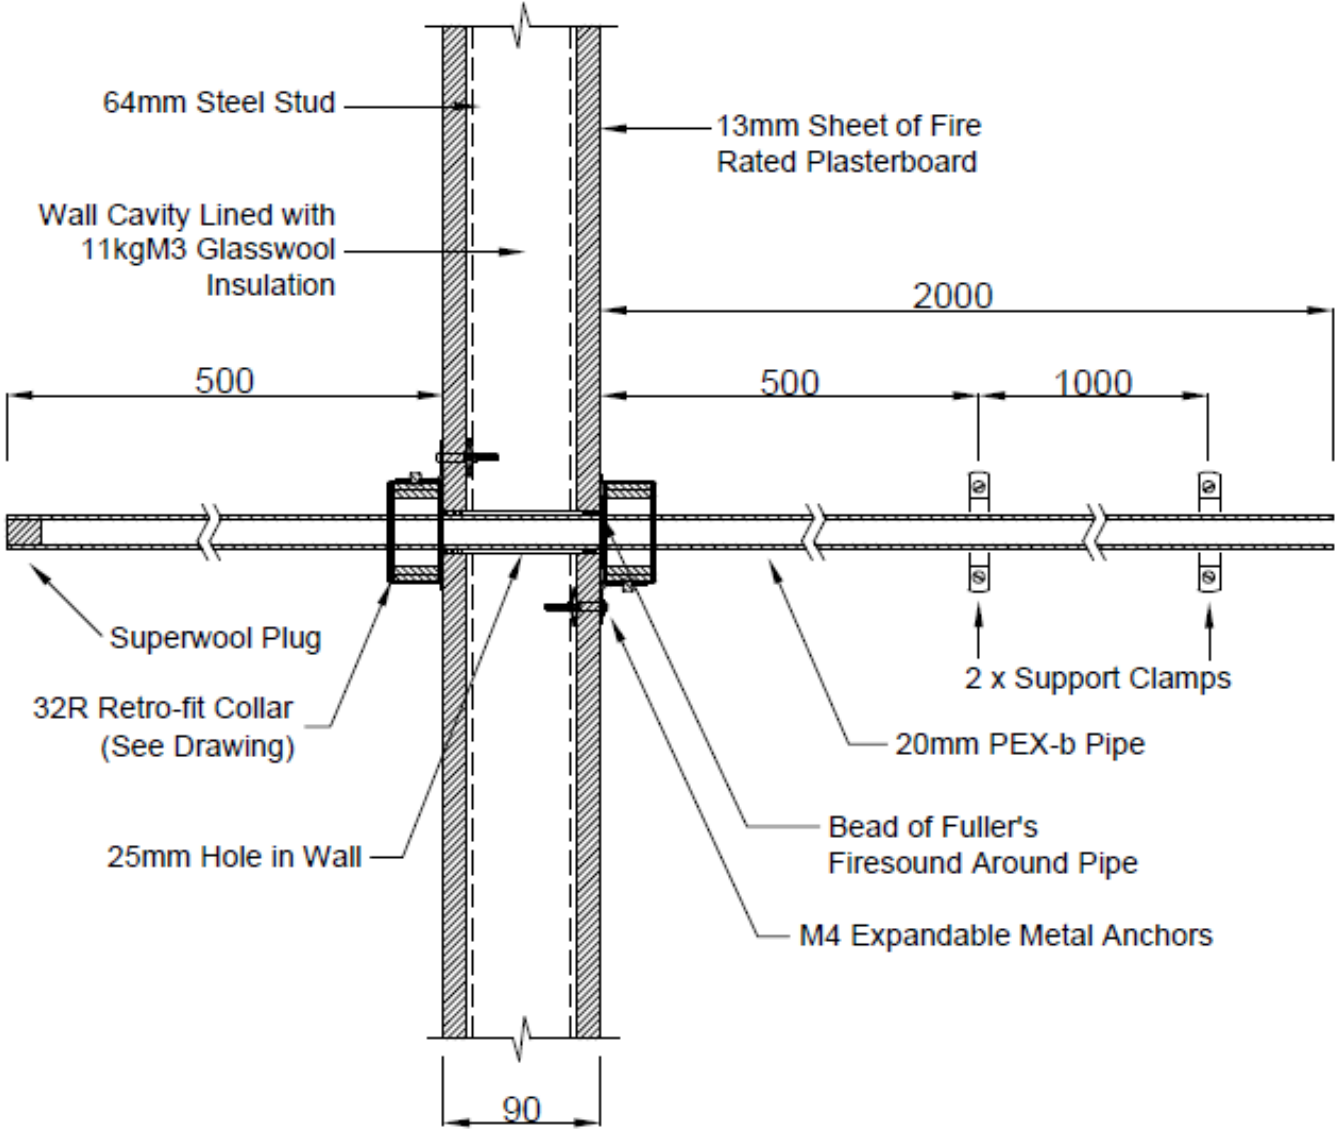
Specimen #4

20 PEX-b Stack & 32R

DRAWING TITLED "SPECIMEN #4 20 PEX-B STACK & 32R", DATED 6 FEBRUARY 2019, PROVIDED BY SNAP FIRE SYSTEMS PTY LTD.

The 32R Retrofit collar comprised a 0.75-mm steel casing with a 40-mm inner diameter and a 106-mm diameter base flange. The 32-mm high collar casing incorporated a closing mechanism that was comprised of two soft Intumesh intumescent strips lined within the internal circumference of the collar. The inner and outer strips were 4-mm thick x 26-mm wide x 135-mm long, and 4-mm thick x 26-mm wide x 154-mm long, respectively. Between the strips was a layer of 316 stainless steel mesh 135 mm long x 25-mm wide with wire mesh diameter of 0.15-mm, as shown in drawing titled “SNAP 32 Retro”, dated 12 January 2017, by Snap Fire Systems Pty Ltd. The Snap collars were surface mounted around the pipe on both the exposed and unexposed face of the wall and fixed through 3 mounting brackets using M4 expandable steel anchors.

The penetrating service comprised a 20-mm PEX-b pipe, with a wall thickness of 2.46-mm, penetrating the wall through a 25-mm diameter cut-out hole as shown in drawing titled “Specimen #4, 20 PEX-b Stack & 32R”, dated 6 February 2019, provided by Snap Fire Systems Pty Ltd. The pipes projected horizontally, 2000-mm away from the unexposed face of the wall and approximately 500-mm into the furnace chamber. The pipes were supported at nominally 500-mm and 1500-mm from the unexposed face of the plasterboard wall. The pipes were open at the unexposed and capped with a Superwool plug on the exposed end.

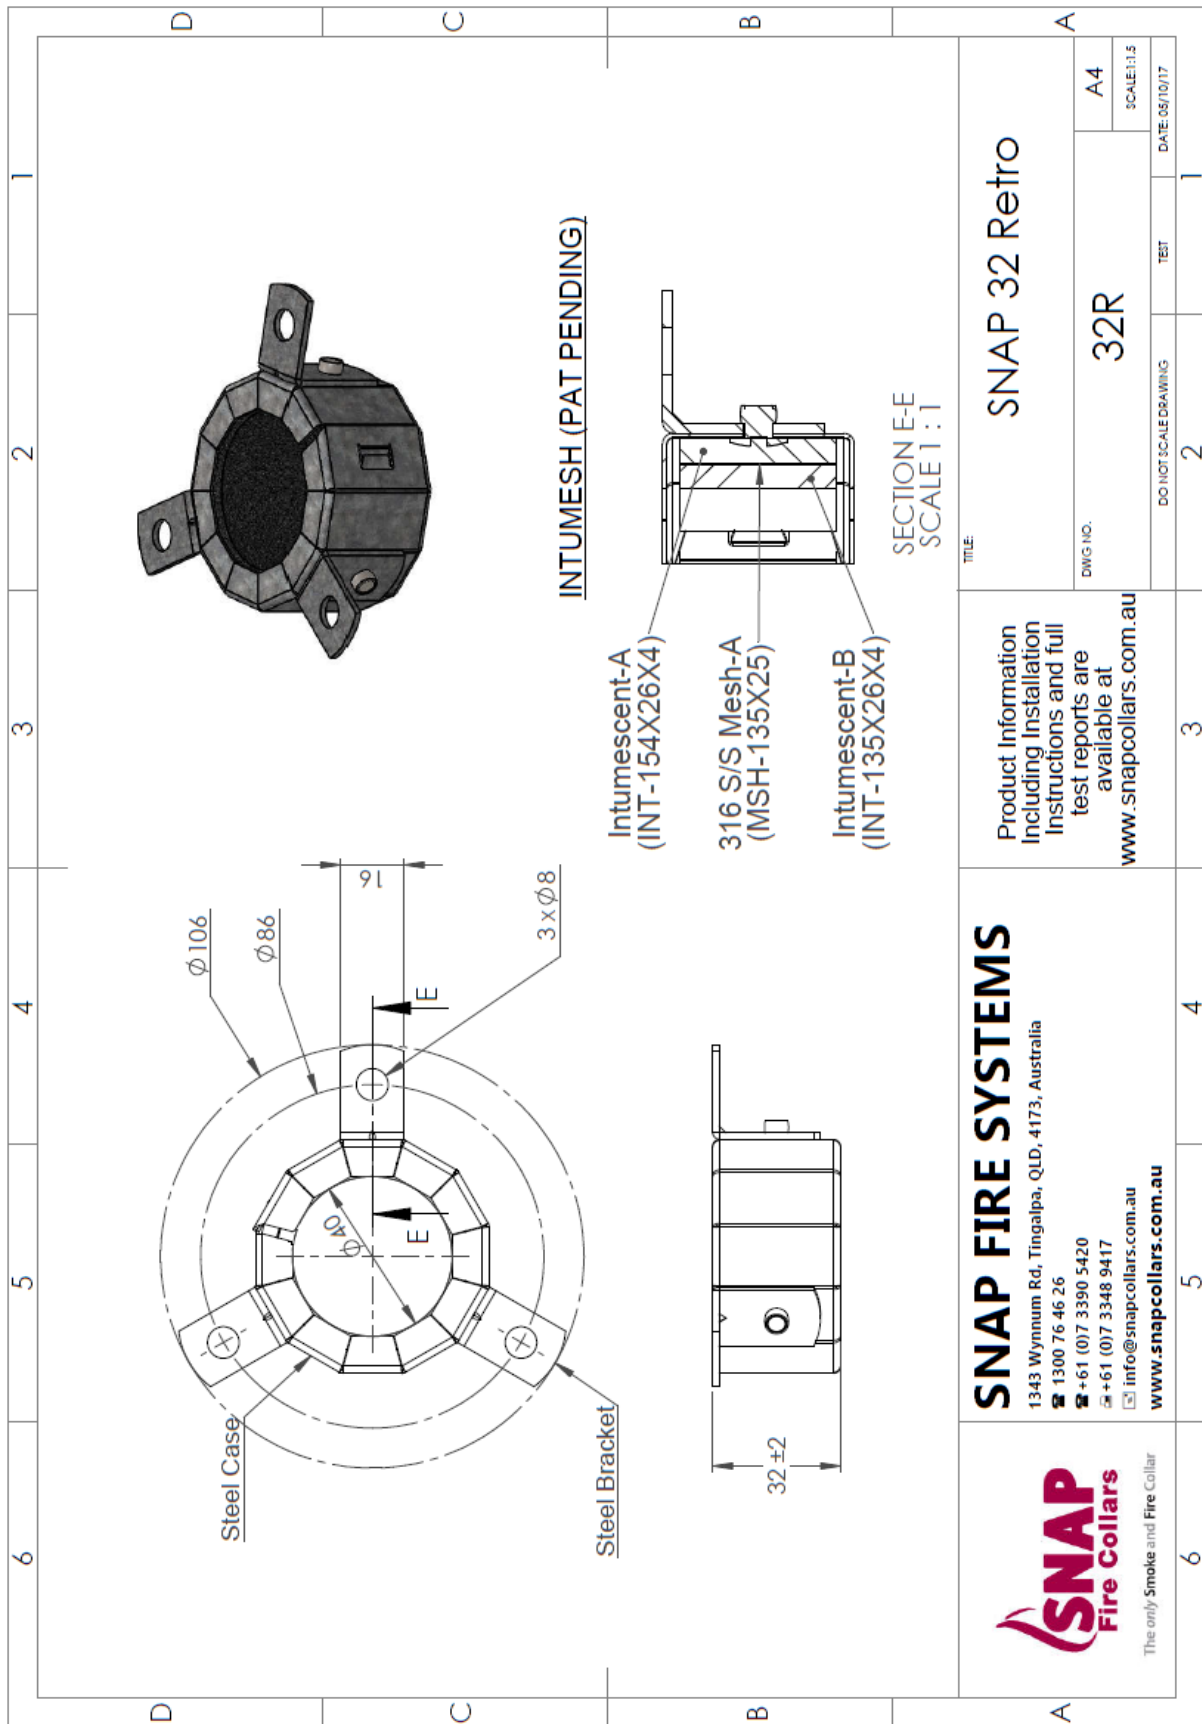
DRAWING NUMBERED 32R, TITLED “SNAP 32 RETRO”, DATED 5 OCTOBER 2017, BY SNAP FIRE SYSTEMS PTY LTD.

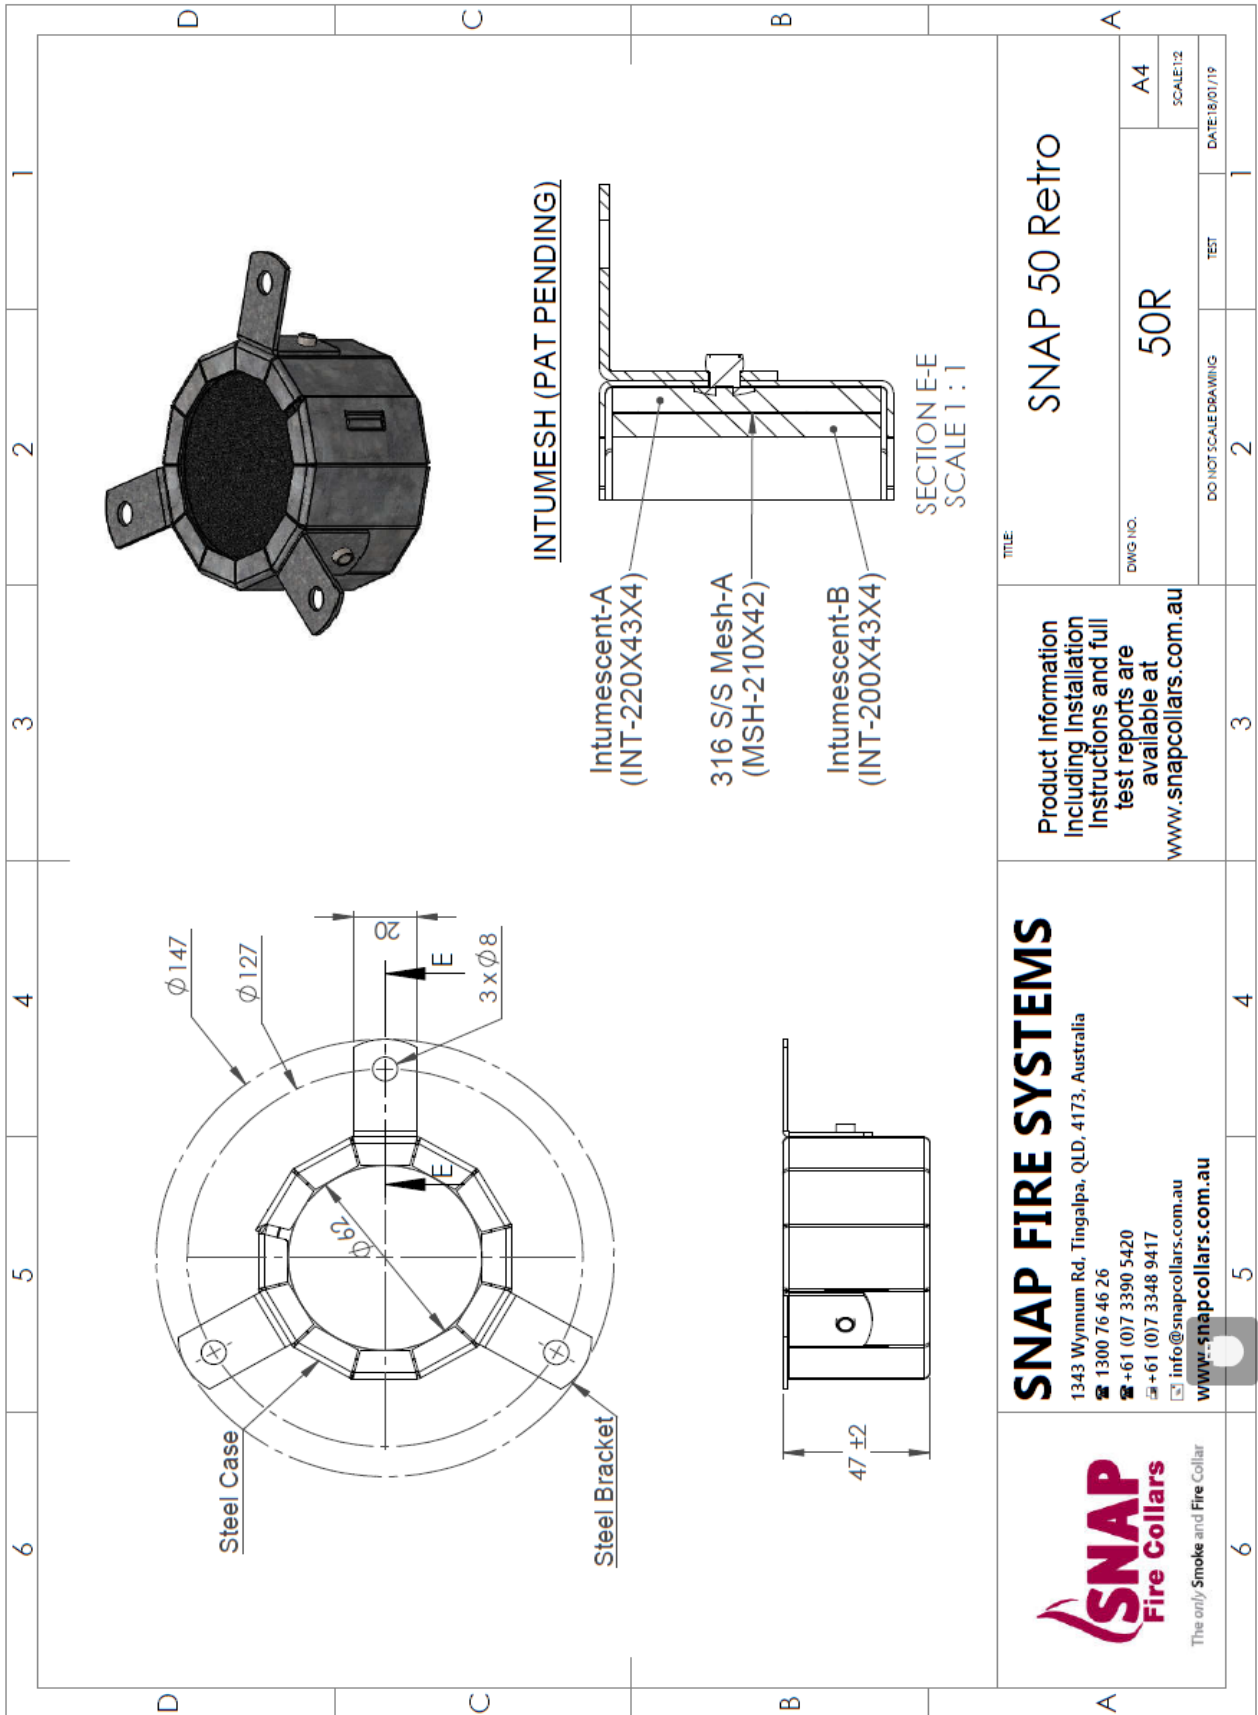
DRAWING NUMBERED 50R, TITLED "SNAP 50 RETRO", DATED 12 JANUARY 2019, BY SNAP FIRE SYSTEMS PTY LTD.

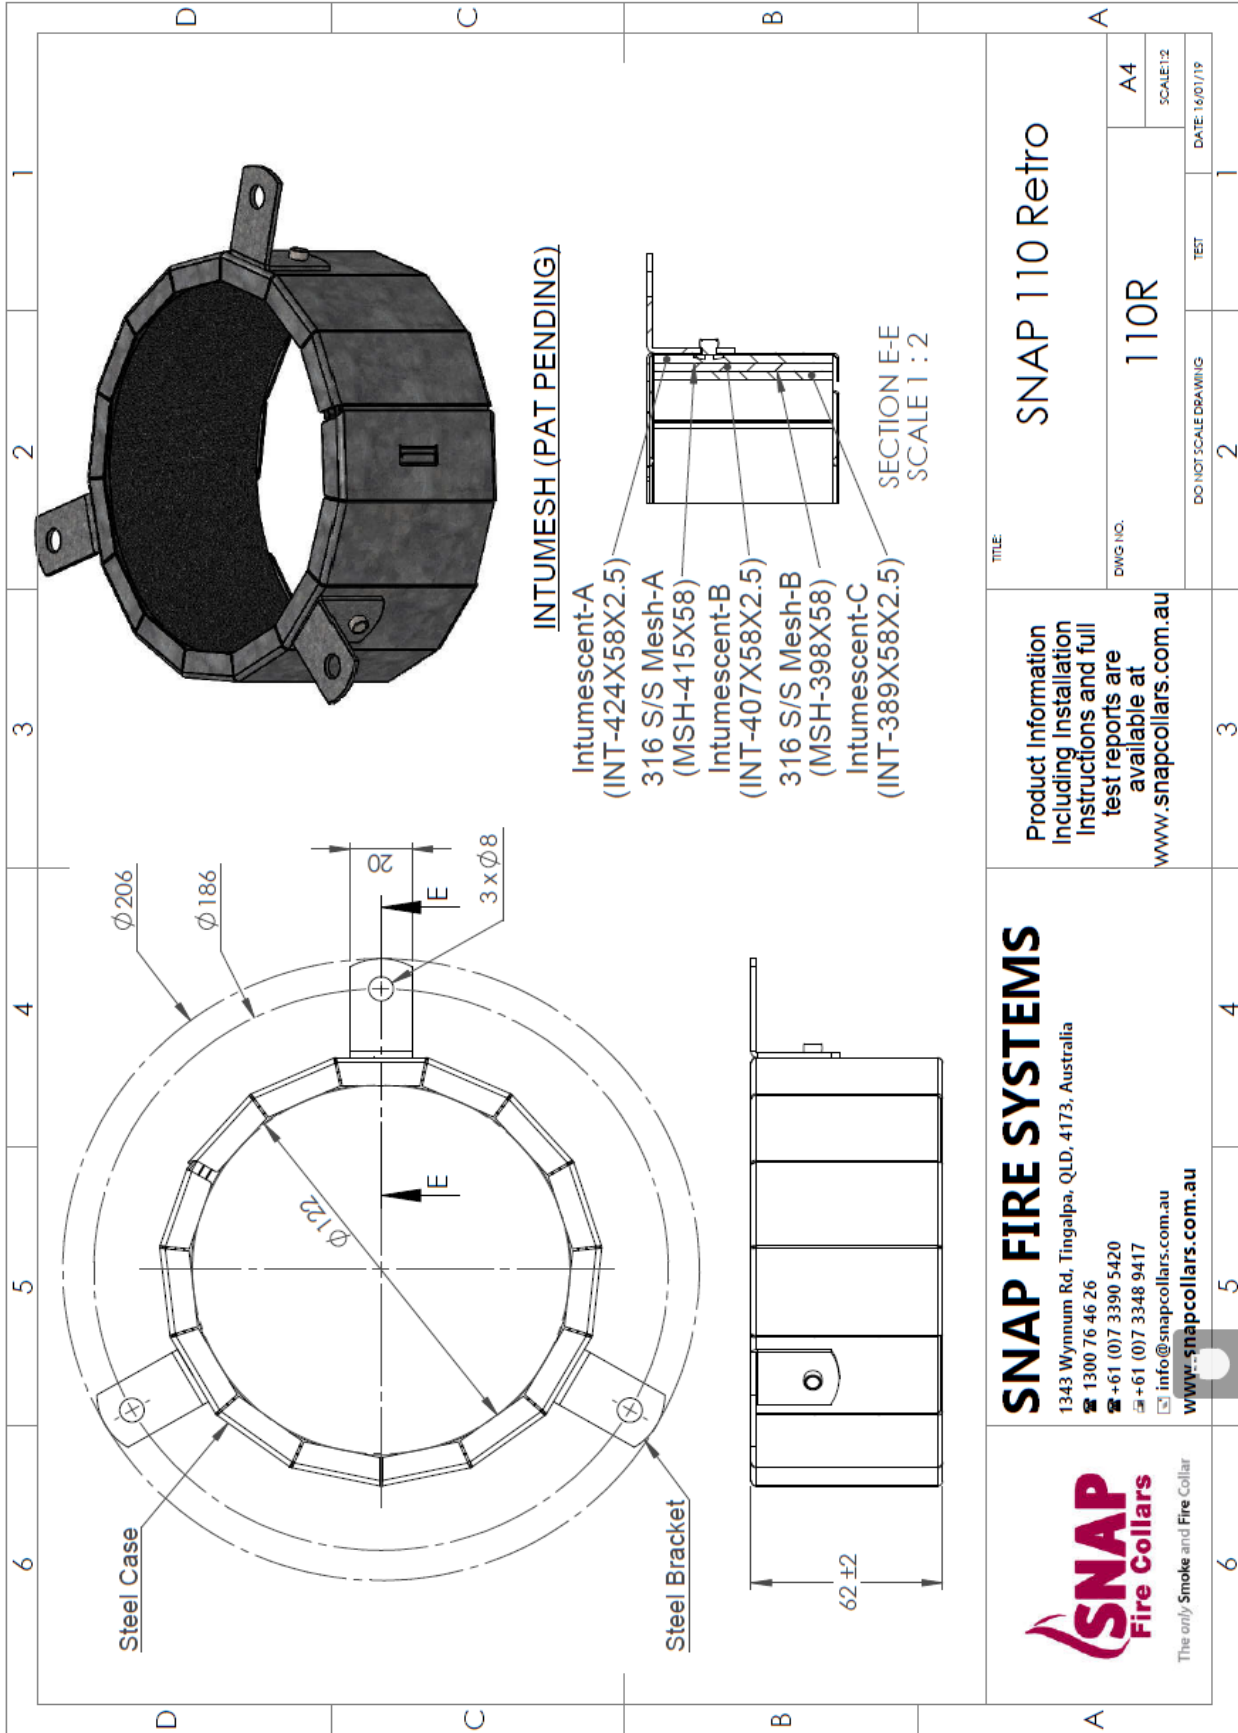
DRAWING NUMBERED 110R, TITLED "SNAP 110 RETRO", DATED 16 JANUARY 2019, BY SNAP FIRE SYSTEMS PTY LTD.
