Fire-resistance test on fire collars protecting a concrete slab penetrated by services

Test Report

Author: Peter Gordon
Report number: FSP 2231
Date: 2 November 2021

Sponsored Investigation No. FSP 2231

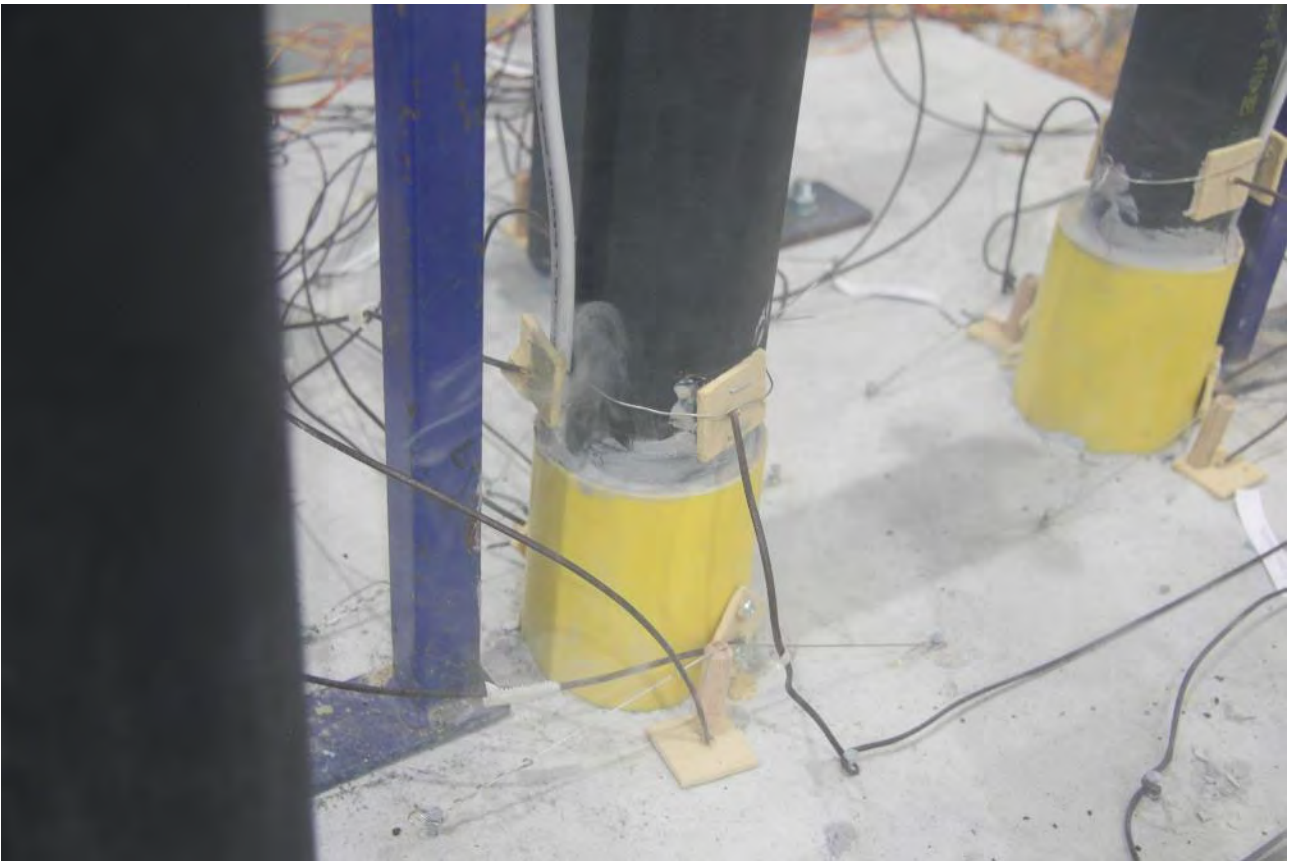
Time	Observation
1 minute -	Smoke is being emitted between the sealant and the pipe lagging at the base of Specimen 3.
2 minutes -	Smoke is being emitted at the base of Specimen 6.
3 minutes -	Smoke is being emitted between the sealant and the pipe lagging at the base of Specimen 4.
5 minutes -	Smoke is being emitted from the end of the pipe and lagging of Specimen 7.
7 minutes -	Smoke has ceased emitting from the base of Specimens 3 and 6.
10 minutes -	Smoke has ceased emitting from Specimen 7.
18 minutes -	The lagging of Specimen 6 has rippled (photograph 5).
21 minutes -	The pipe lagging of Specimens 1, 3, 4 and 7 has been pushed upwards approximately 10-mm, exposing more swollen sealant (photograph 6).
24 minutes -	Moisture has begun pooling around the base of Specimen 6 (photograph 6).
25 minutes -	Steam is venting from a crack in the sealant at the base of Specimen 6 adjacent to thermocouple #38 attached to the power cable (photograph 7).

PHOTOGRAPH 3 – SPECIMEN 3 AT 3 MINUTES INTO THE TEST

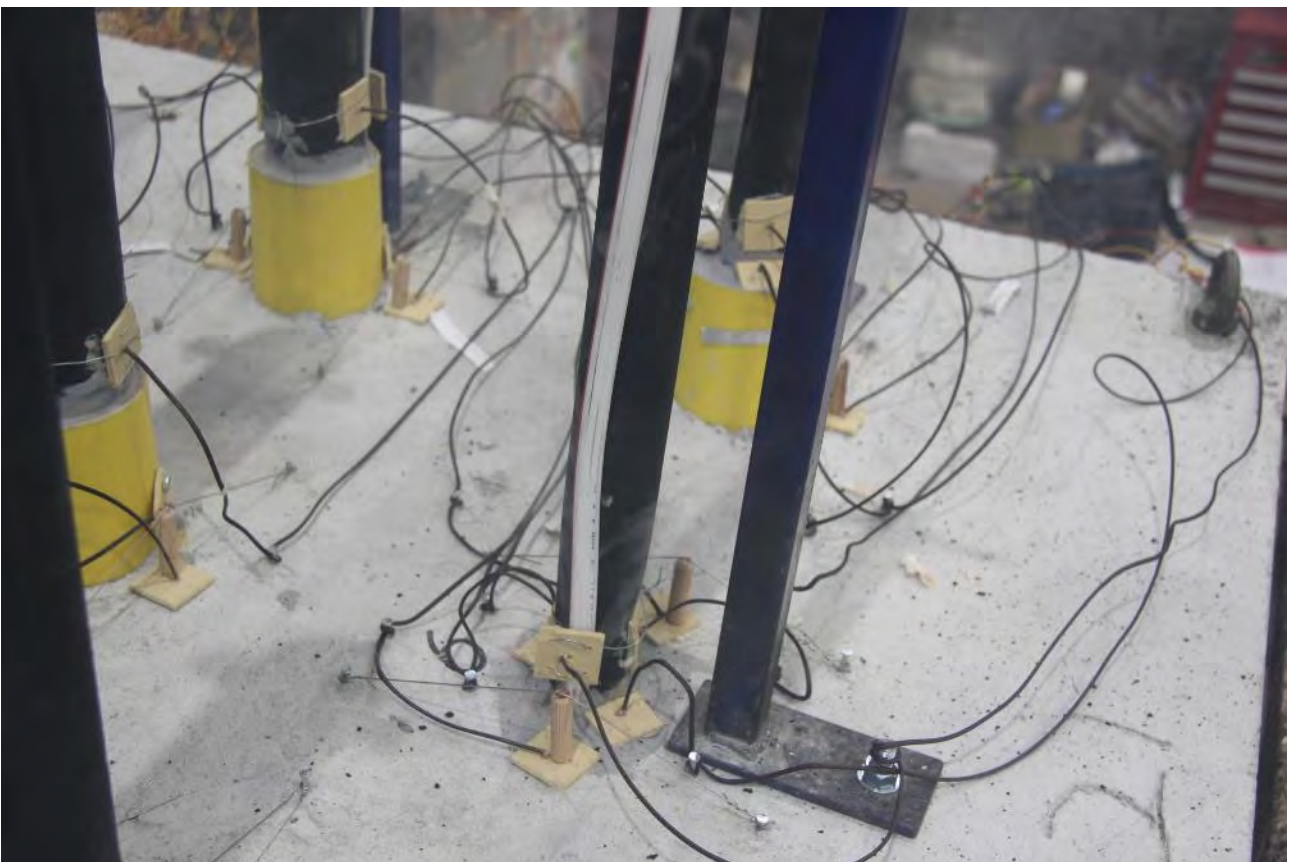
PHOTOGRAPH 4 – SPECIMEN 6 AT 3 MINUTES INTO THE TEST

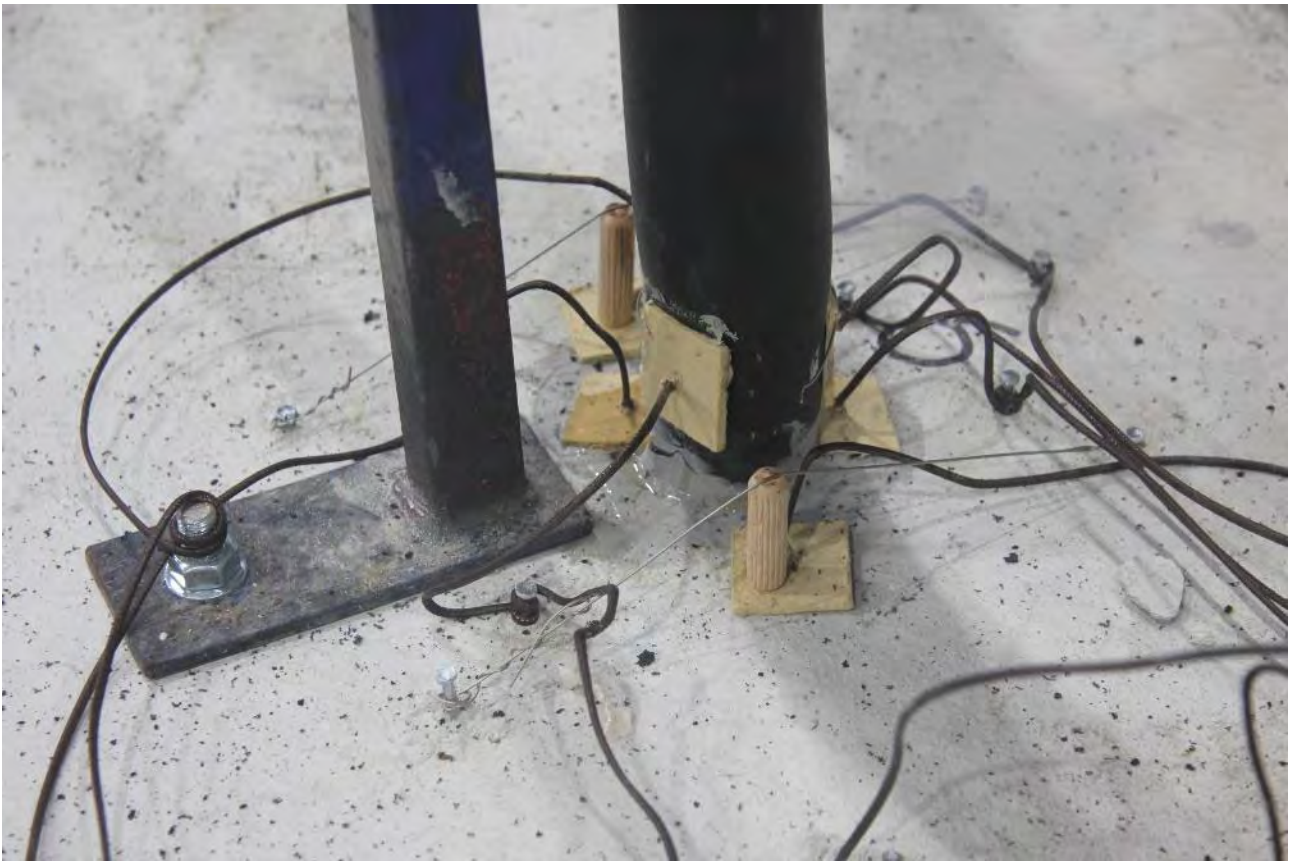
PHOTOGRAPH 7 – SPECIMEN 6 AT 24 MINUTES INTO THE TEST

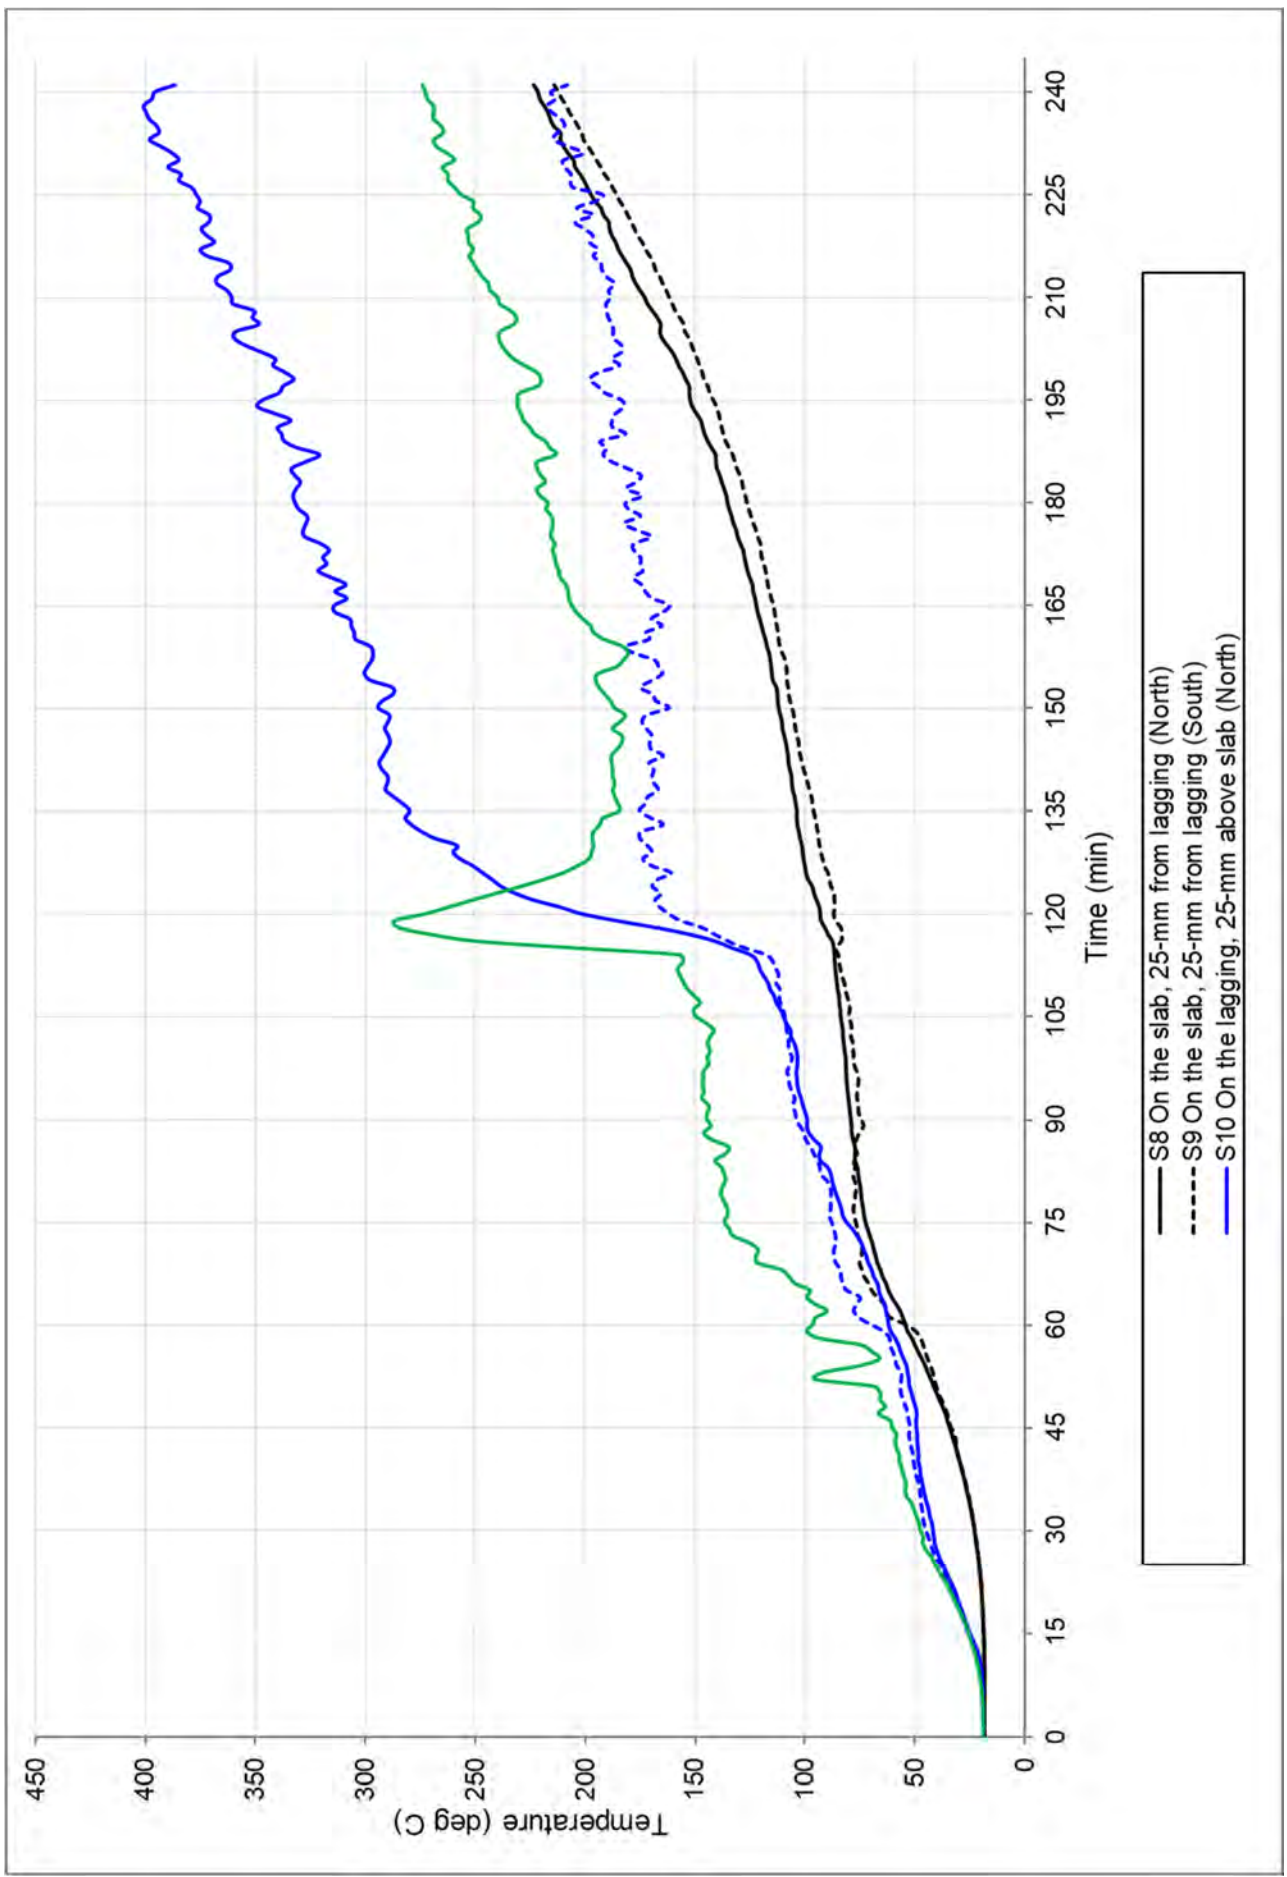
FIGURE 4 – SPECIMEN TEMPERATURE – ASSOCIATED WITH SPECIMEN 2

- 115 minutes - Insulation failure of Specimen 2 - maximum temperature rise of 180K is exceeded on the power cable (Thermocouple #12), approximately 25-mm above the slab.

- 120 minutes - Insulation failure of Specimen 2 - maximum temperature rise of 180K is exceeded on the lagging – north side, 25-mm above the collar casing.
Insulation failure of Specimen 3 - maximum temperature rise of 180K is exceeded on the lagging – north side, 25-mm above the collar casing.

Figure 4 shows the curve of temperature versus time associated with Specimen 2.

Structural adequacy	-	not applicable
Integrity	-	no failure at 241 minutes
Insulation	-	115 minutes

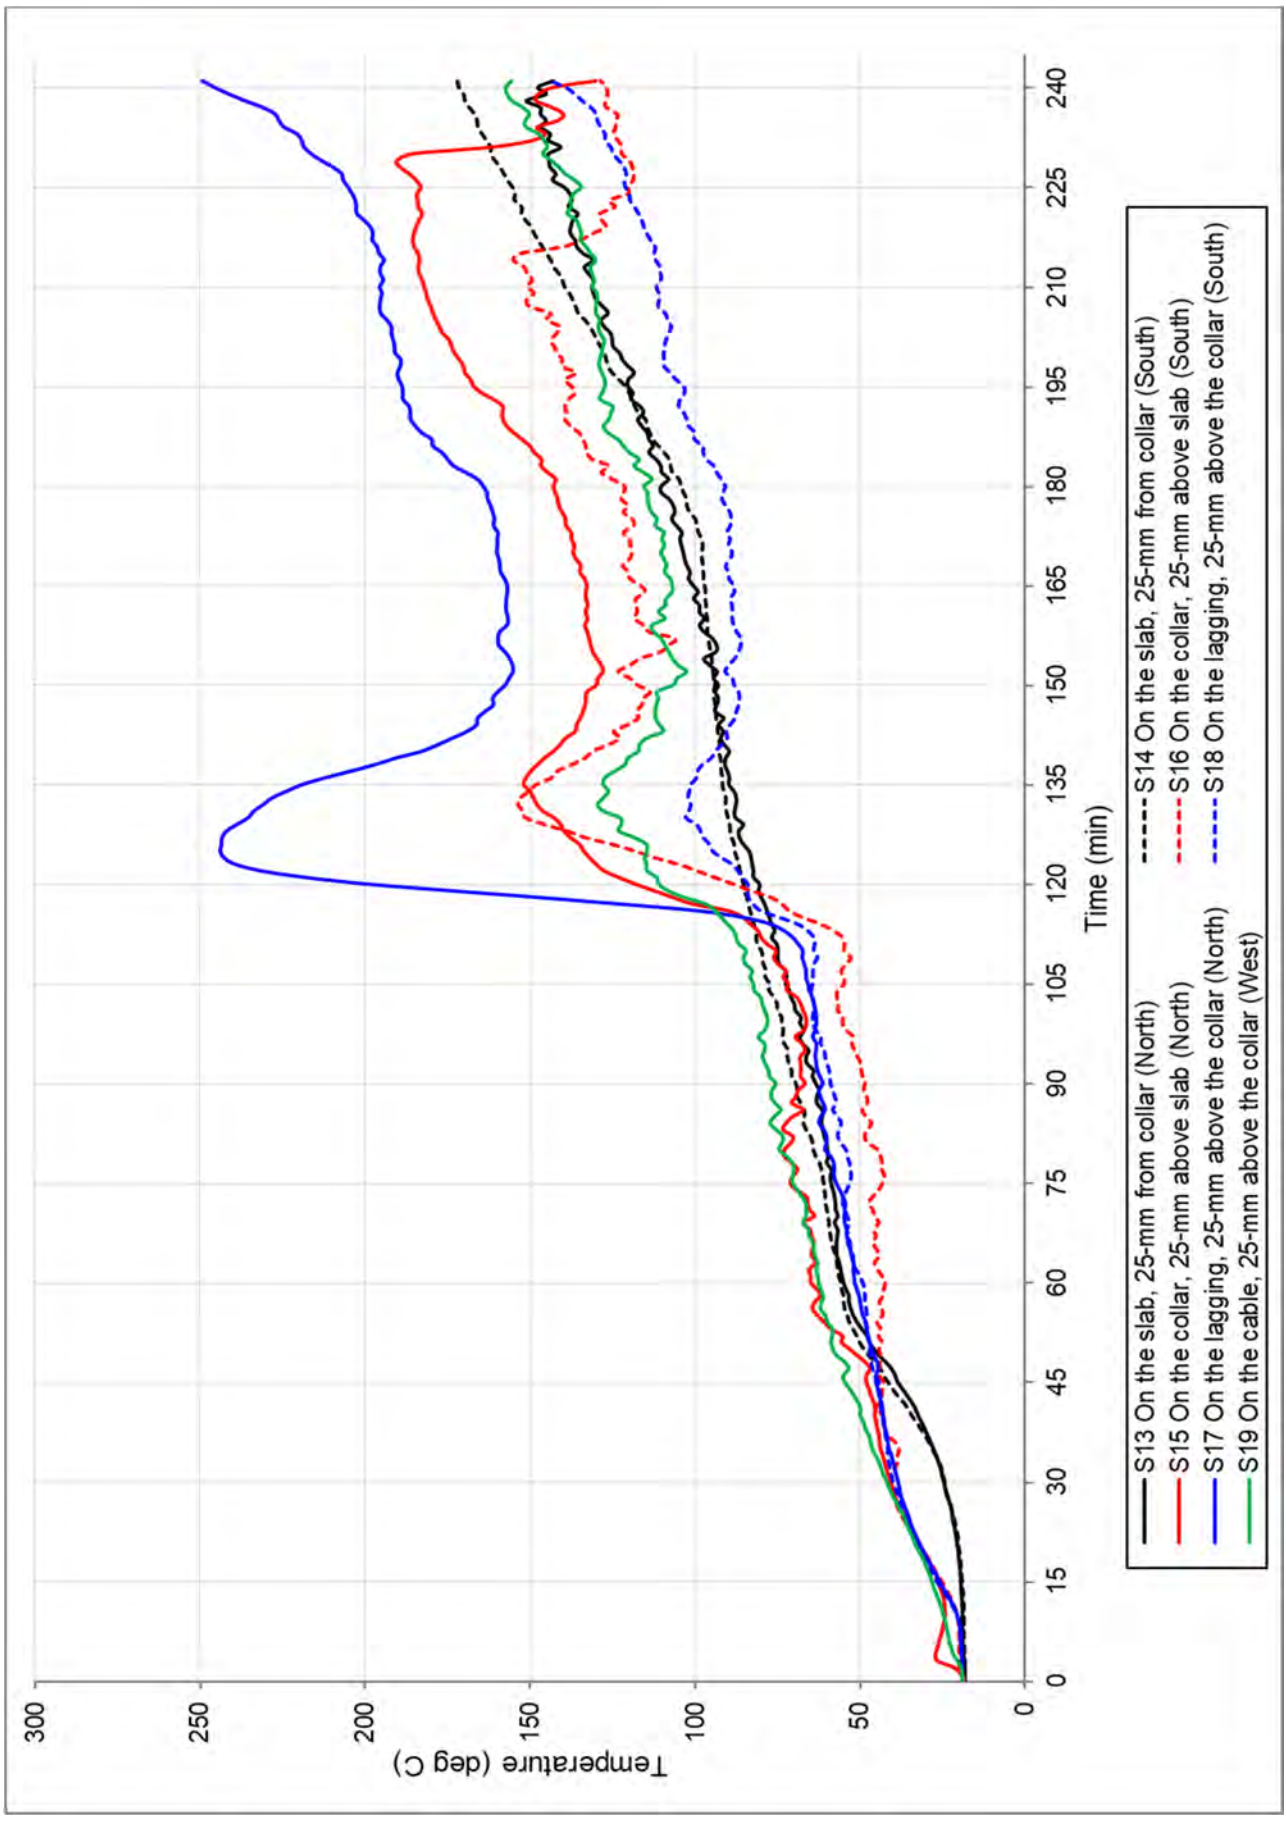
FIGURE 5 – SPECIMEN TEMPERATURE – ASSOCIATED WITH SPECIMEN 3

- 118 minutes - The pipe lagging of Specimen 3 has ruptured with hot gases and smoke venting through a hole approximately 30-mm above the collar casing is visible.

- 119 minutes - The pipe lagging at the base of Specimen 3 has begun to split. Rover applied to the split surface of the lagging, with a maximum temperature of 119°C noted at this time.

Figure 5 shows the curve of temperature versus time associated with Specimen 3.

Structural adequacy	-	not applicable
Integrity	-	no failure at 241 minutes
Insulation	-	120 minutes

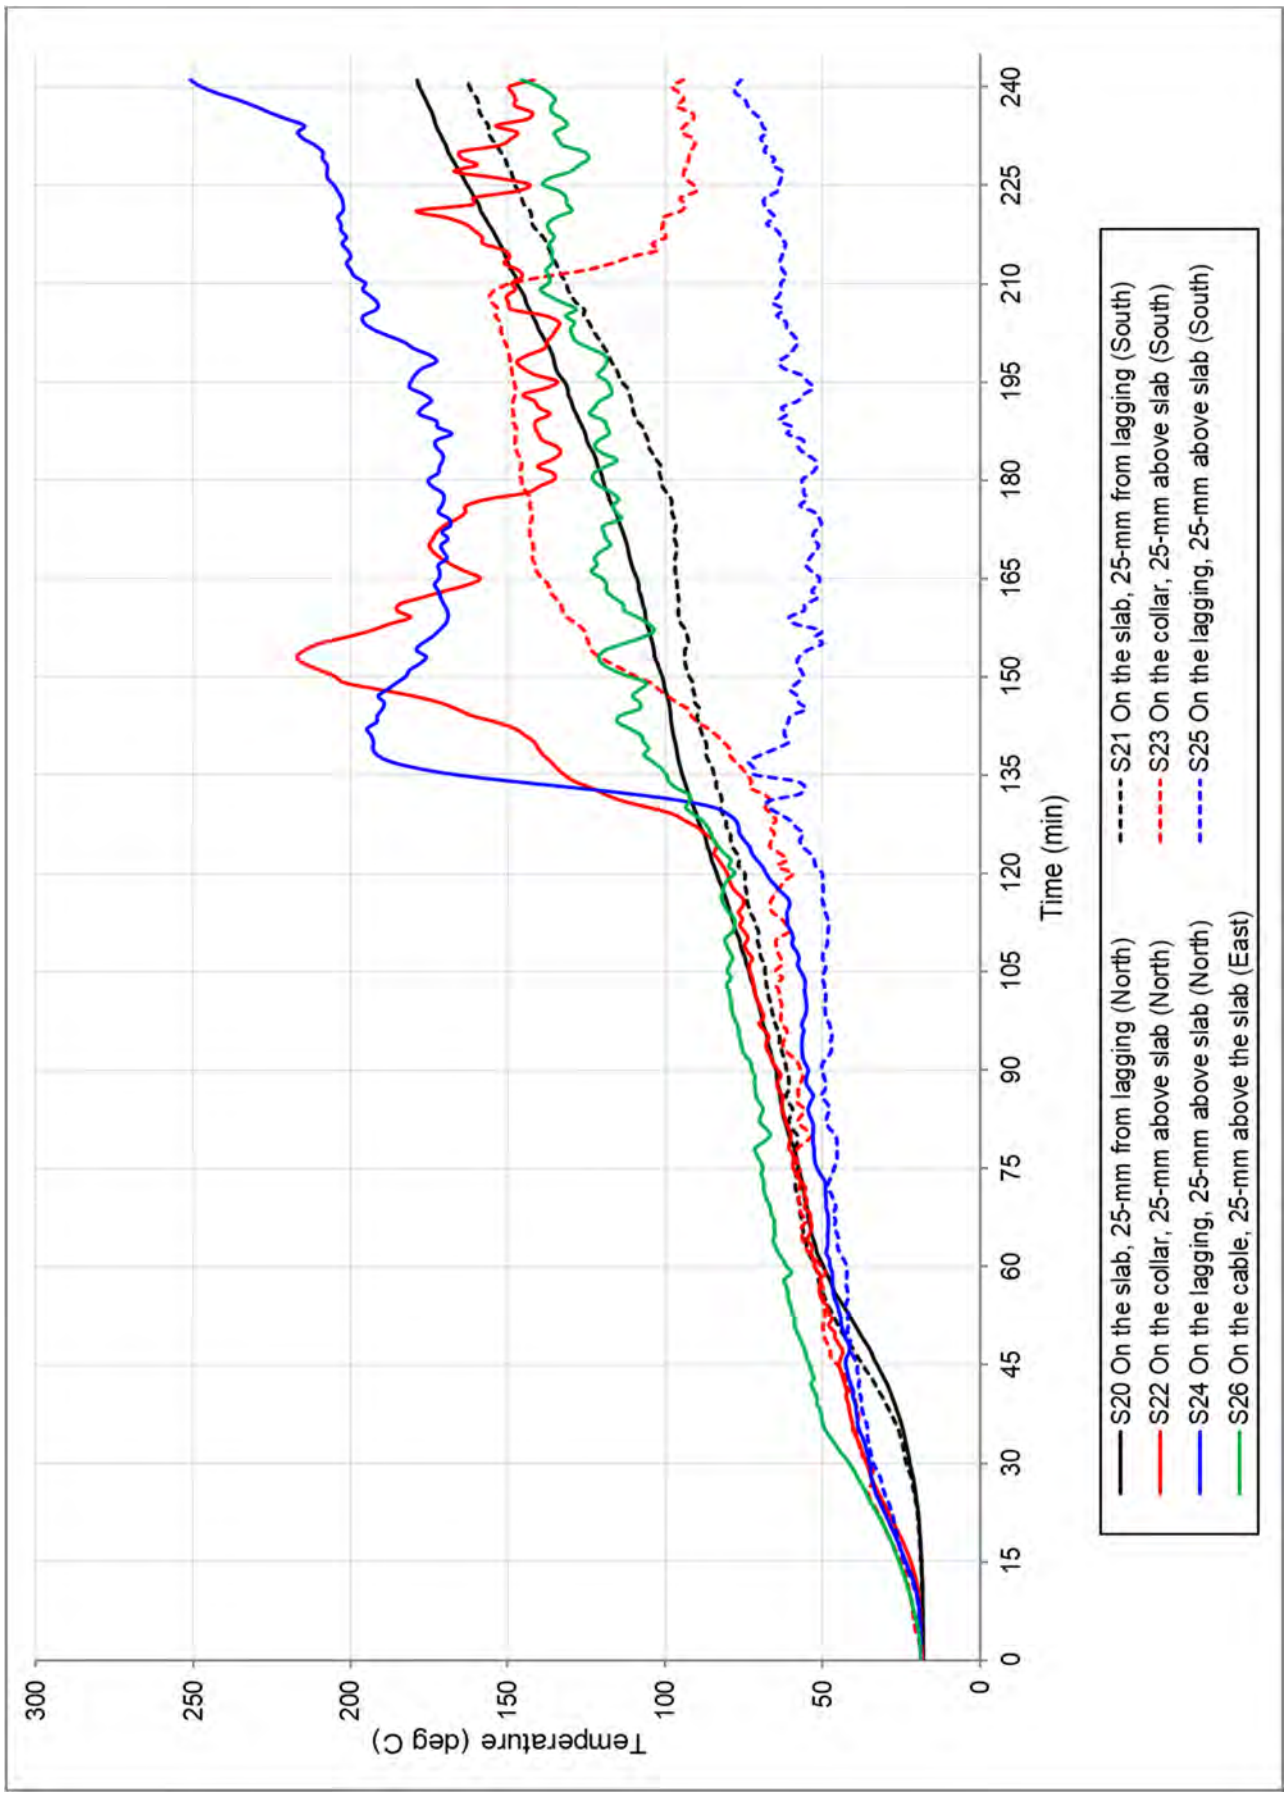
FIGURE 6 – SPECIMEN TEMPERATURE – ASSOCIATED WITH SPECIMEN 4

- 134 minutes - Roving thermocouple applied to the split pipe lagging at the base of Specimen 4 above the collar. A temperature of 352°C degrees was recorded at this time.
Insulation failure of Specimen 4 - maximum temperature rise of 180K is exceeded (roving thermocouple recorded a temperature of 352°C) on the split pipe lagging of the specimen above the collar (photograph 21).

- 152 minutes - The collar sleeve above the concrete slab of Specimen 4 has begun to melt leaving a hole on the north side (photograph 23).
- 189 minutes - Insulation failure of Specimen 6 - maximum temperature rise of 180K is exceeded on the pipe lagging, 25-mm above the concrete slab (north side).

Figure 6 shows the curve of temperature versus time associated with Specimen 4.

Structural adequacy	-	not applicable
Integrity	-	no failure at 241 minutes
Insulation	-	134 minutes

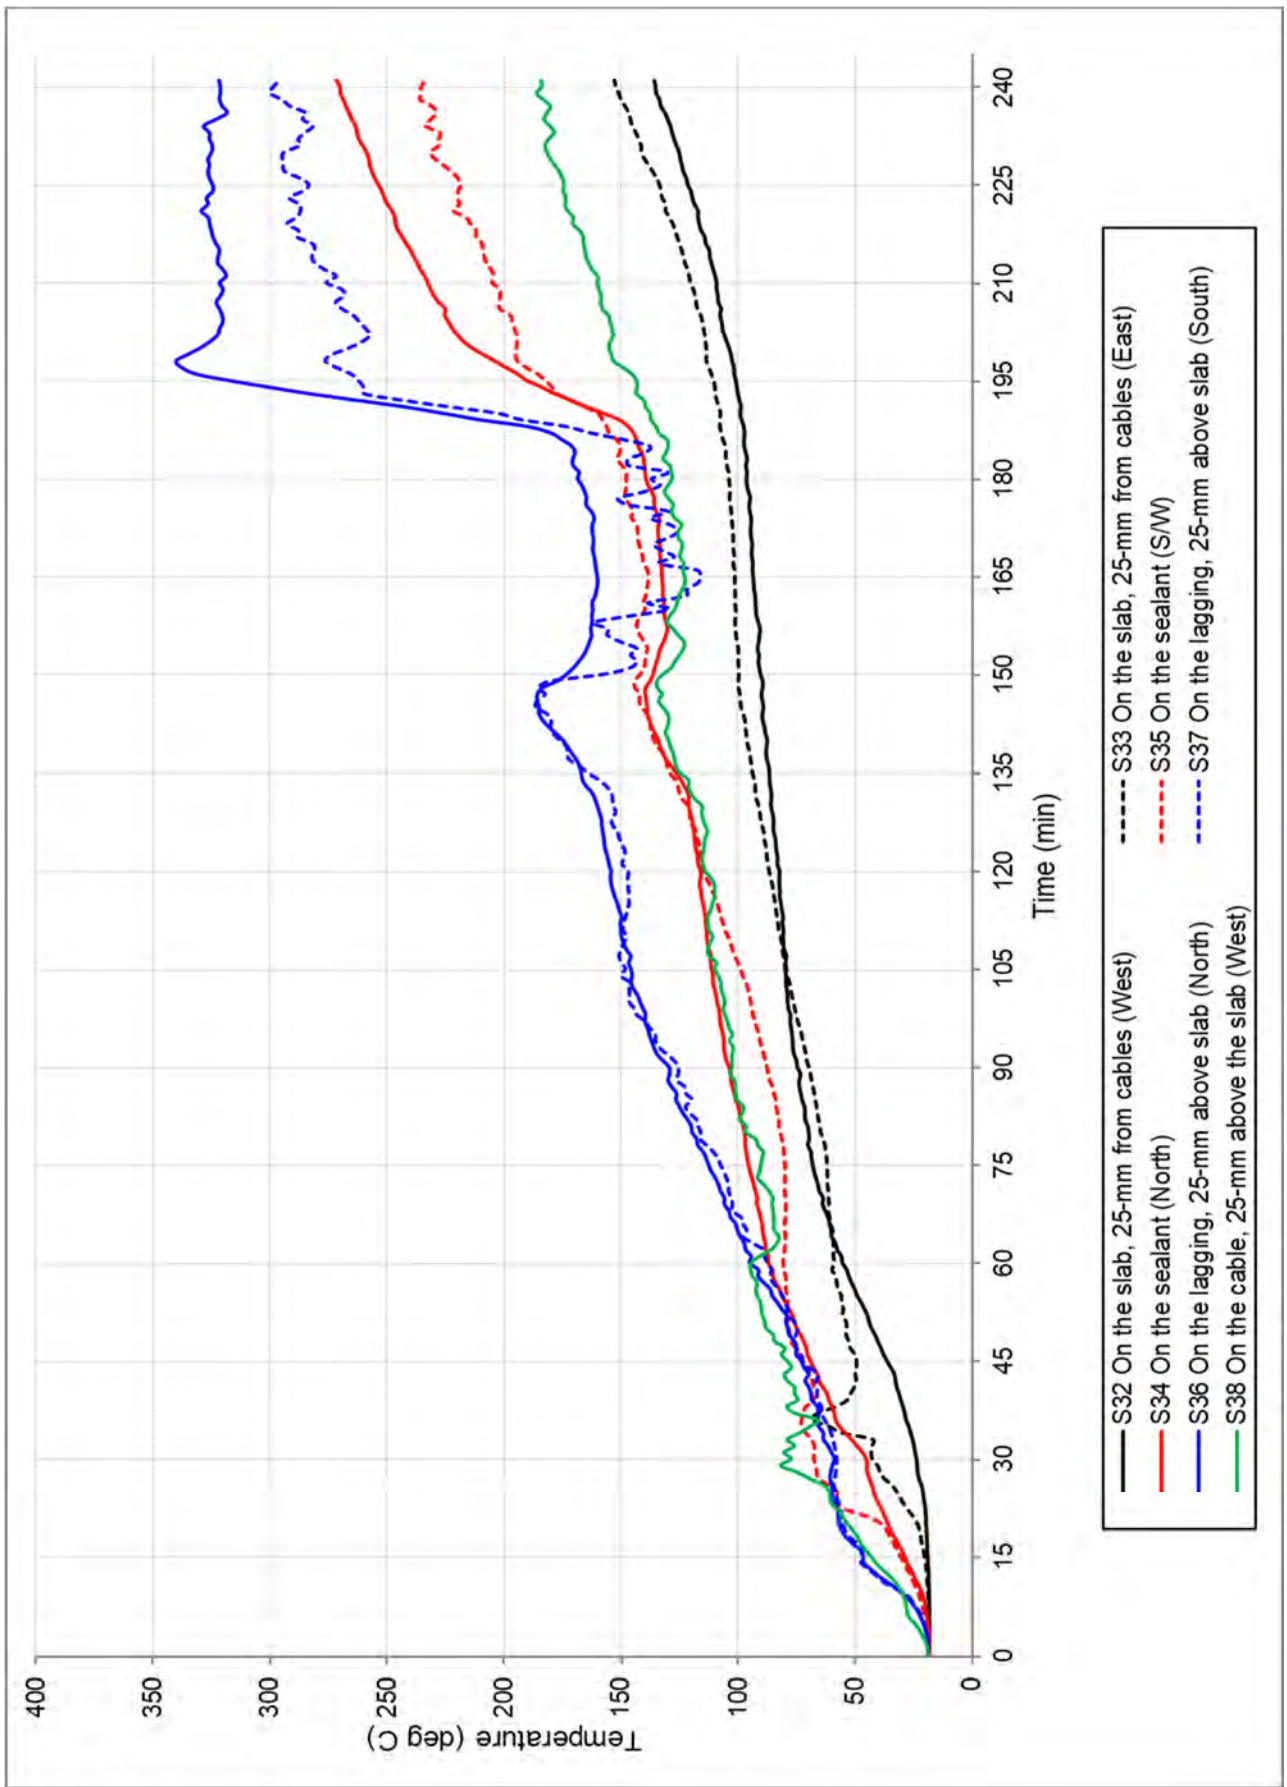
FIGURE 8 – SPECIMEN TEMPERATURE – ASSOCIATED WITH SPECIMEN 6

Figure 8 shows the curve of temperature versus time associated with Specimen 6.

Structural adequacy	-	not applicable
Integrity	-	no failure at 241 minutes
Insulation	-	189 minutes

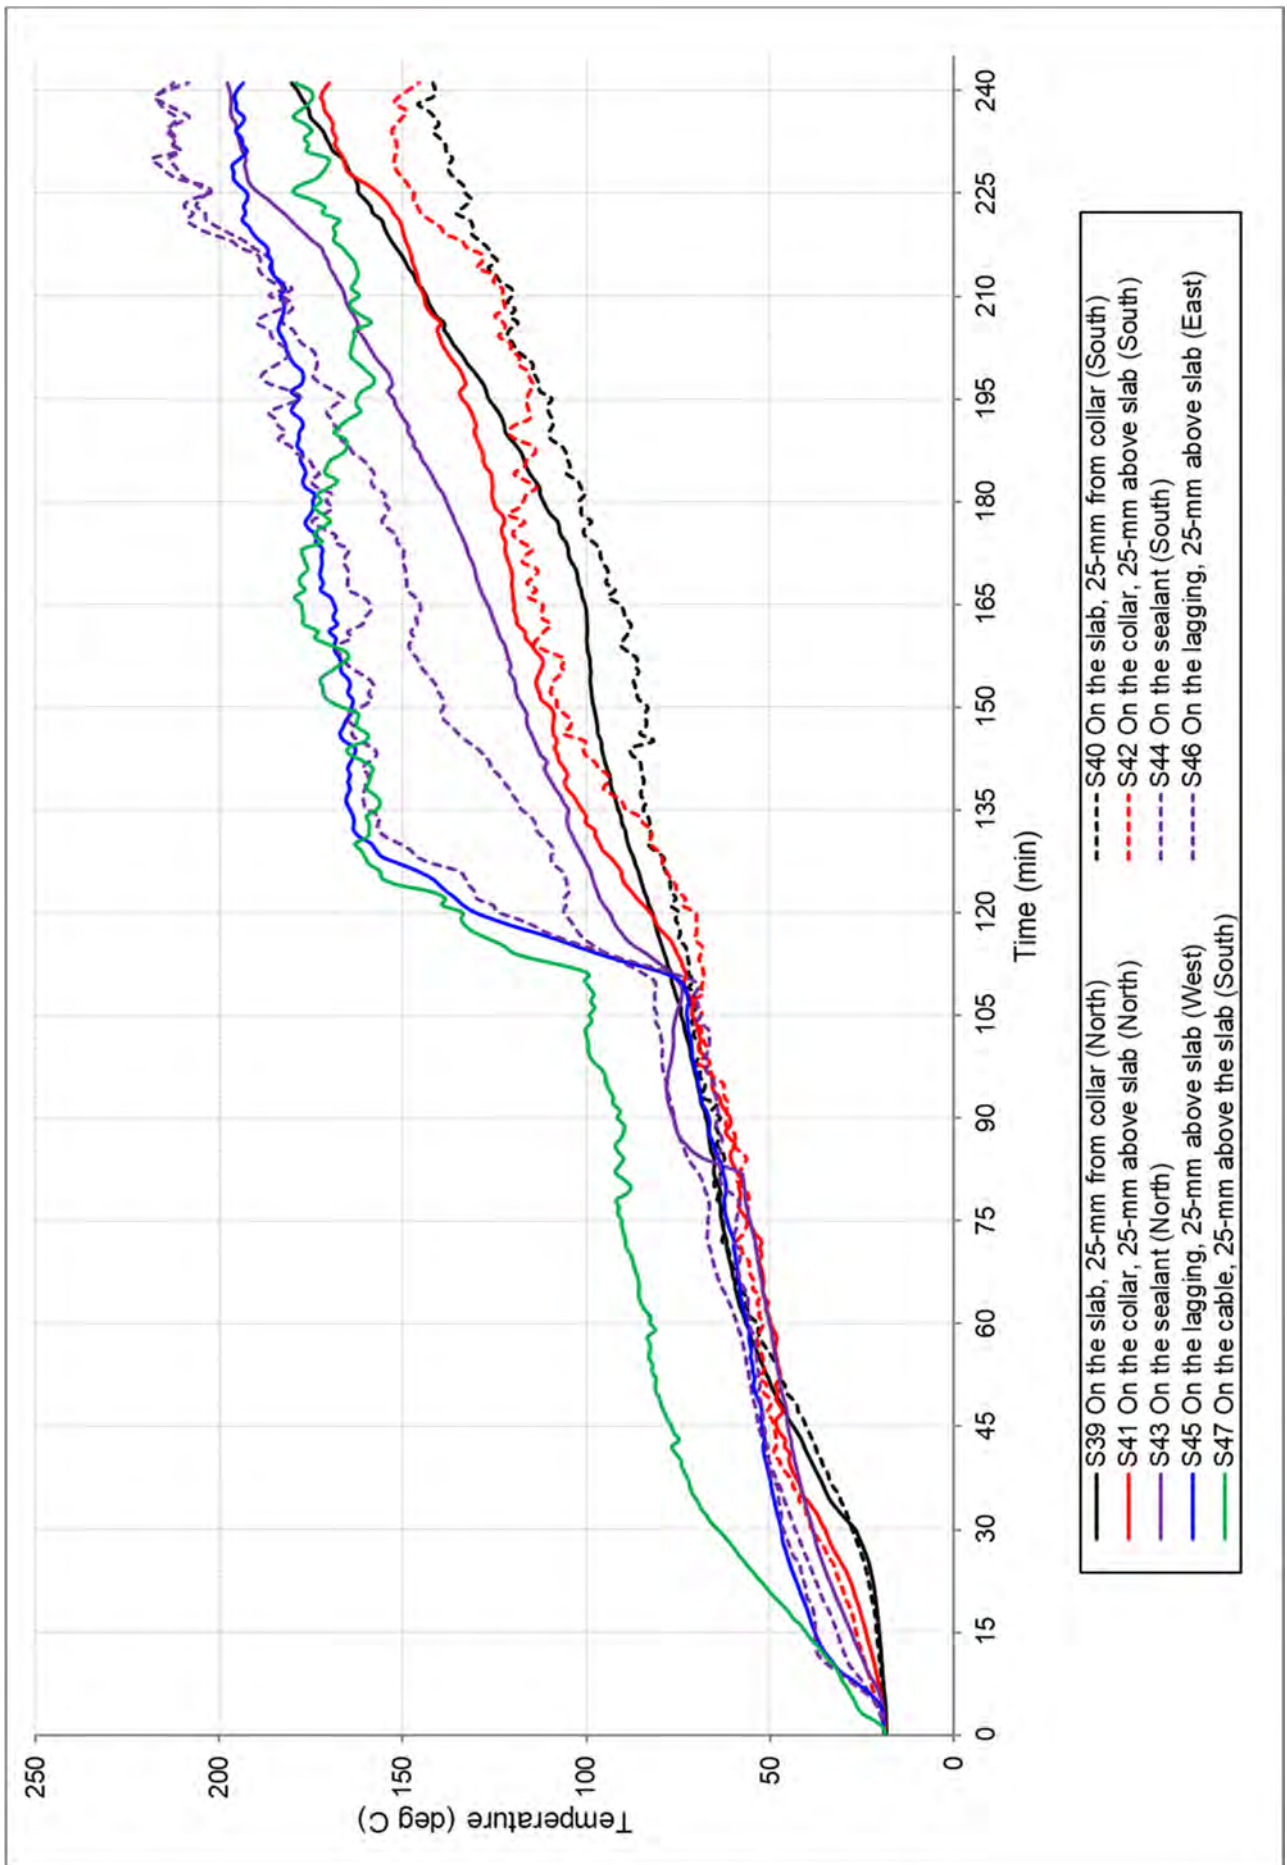
FIGURE 9 – SPECIMEN TEMPERATURE – ASSOCIATED WITH SPECIMEN 7

- 199 minutes - A large amount of smoke is now being emitted from the pipe lagging of Specimens 6 and 7.
- 219 minutes - Insulation failure of Specimen 7 - maximum temperature rise of 180K is exceeded on the pipe lagging, 25-mm above the concrete slab (north side).

Figure 9 shows the curve of temperature versus time associated with Specimen 7.

Structural adequacy	-	not applicable
Integrity	-	no failure at 241 minutes
Insulation	-	219 minutes
