# Fire-resistance test on fire collars protecting a concrete slab penetrated by services

## Test Report

**Author:** Chris Wojcik  
**Report number:** FSP 1692  
**Date:** 14 June 2017

**Client:** Snap Fire Systems Pty Ltd

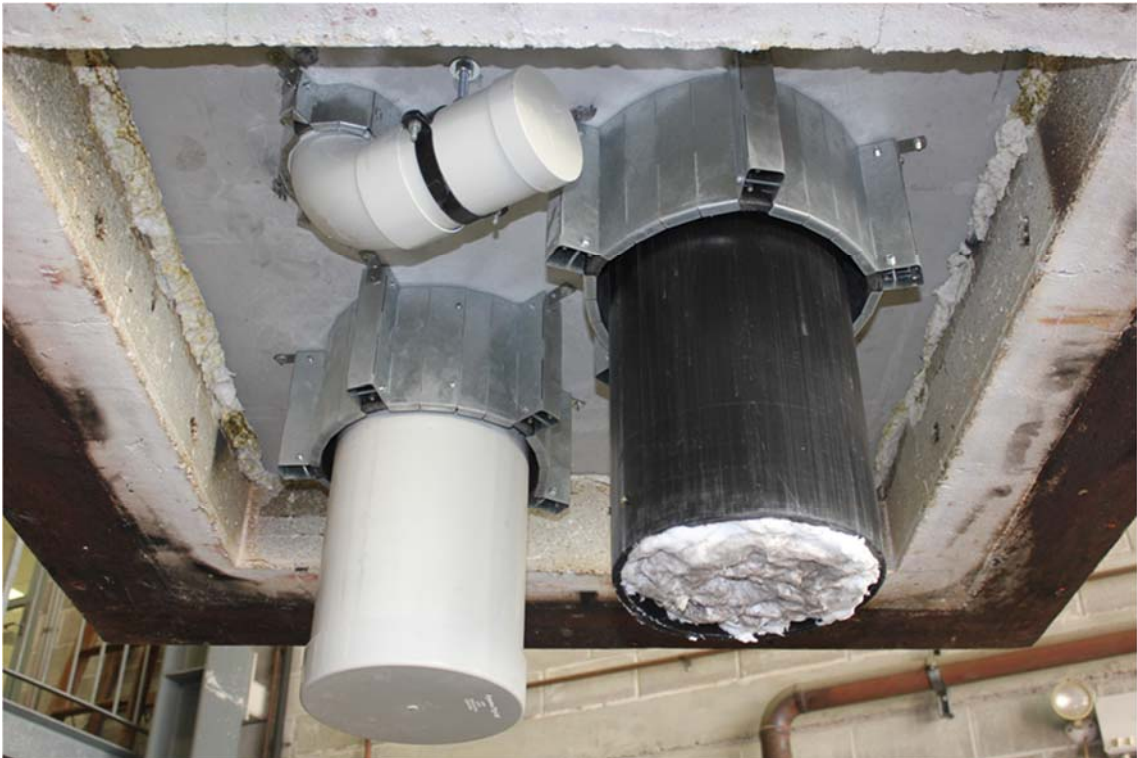
**PHOTOGRAPH 1 – EXPOSED FACE OF SPECIMENS PRIOR TO TESTING**

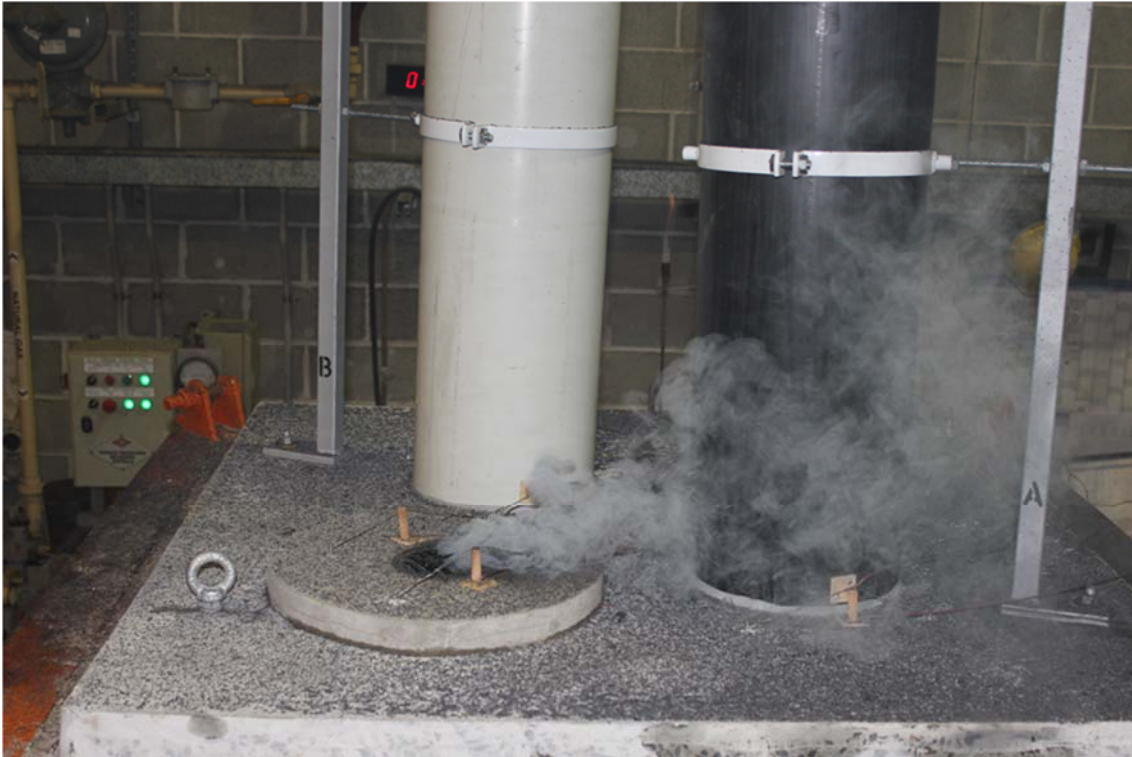
**PHOTOGRAPH 3 – SPECIMENS AFTER 60 MINUTES OF TESTING**

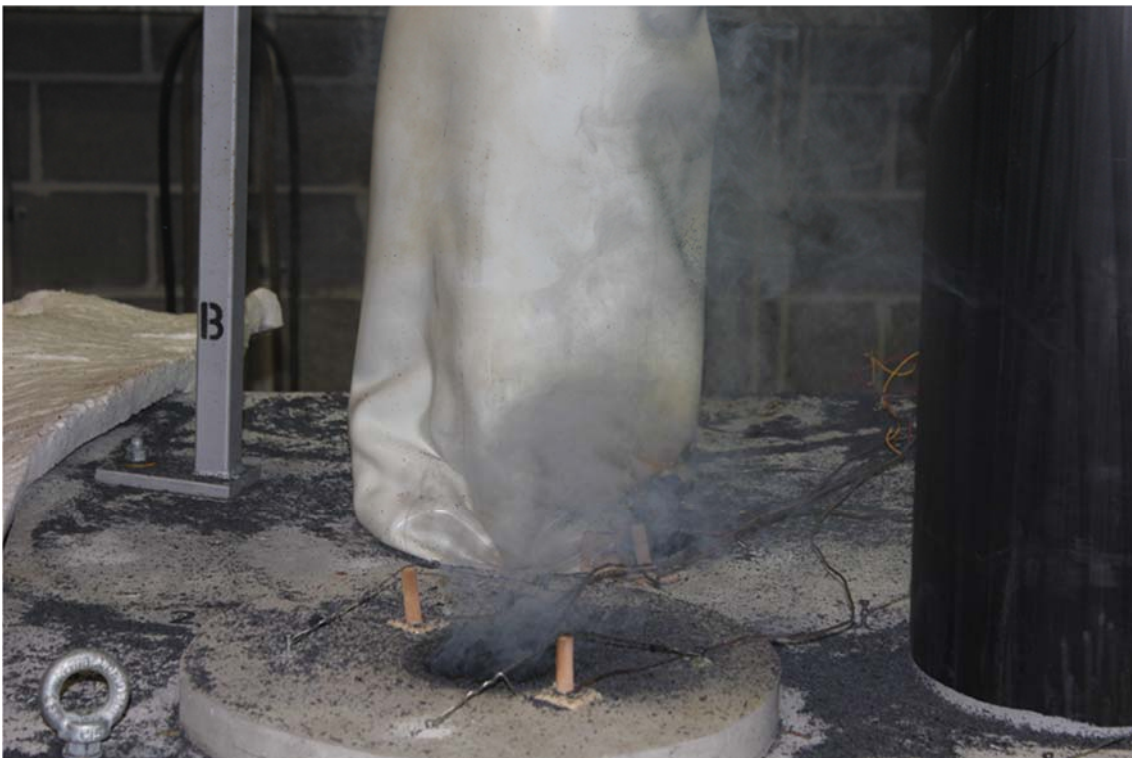
**PHOTOGRAPH 4 – SPECIMENS AFTER 120 MINUTES OF TESTING**

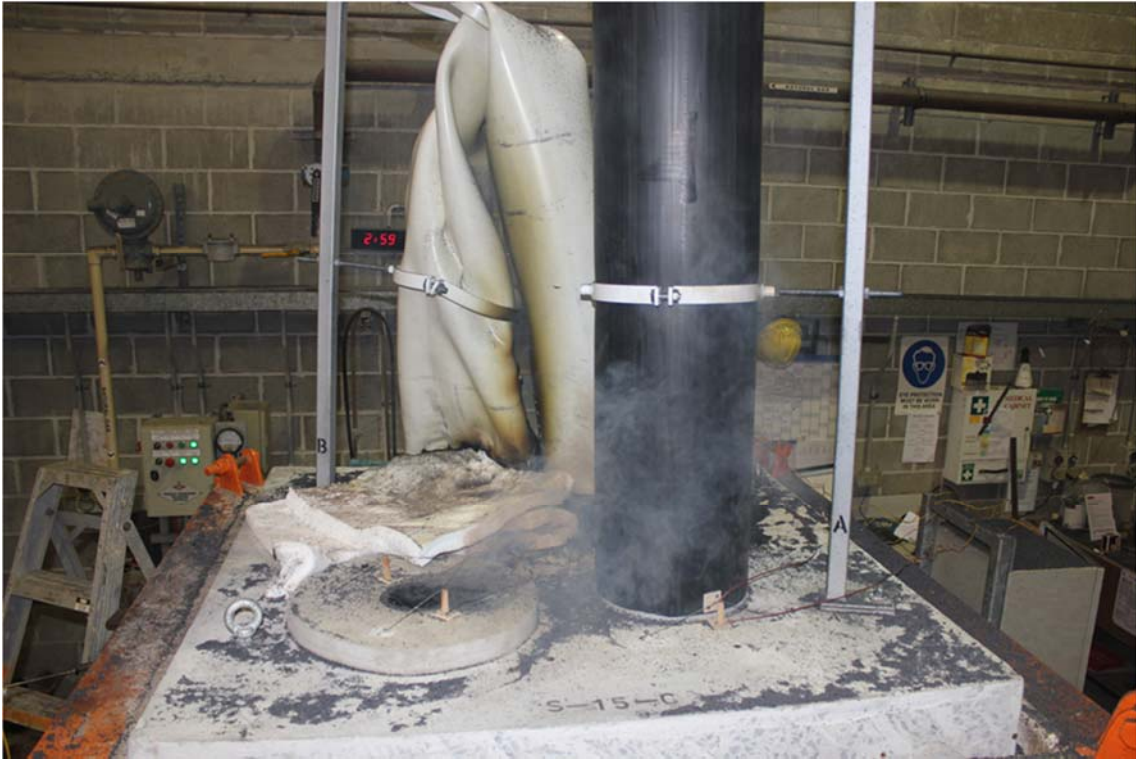
**PHOTOGRAPH 5 – SPECIMENS AFTER 180 MINUTES OF TESTING**

Time	Observation
2 minutes -	Smoke is fluing from Penetration # 2 – floor waste.
5 minutes -	Smoke is fluing from Penetration 3.
8 minutes -	Smoke fluing from Penetration # 3 has decreased.
230 minutes -	Flaming is observed on the unexposed face of Penetration # 2. Flames have spread – affecting Penetration # 3. Test terminated.
