Fire-resistance test on fire collars protecting a plasterboard wall penetrated by services

Test Report

Author: Peter Gordon
Report number: FSP 2024
Date: 22 August 2019

Client: IG6 Pty Ltd as trustee for the IG6 IP Trust

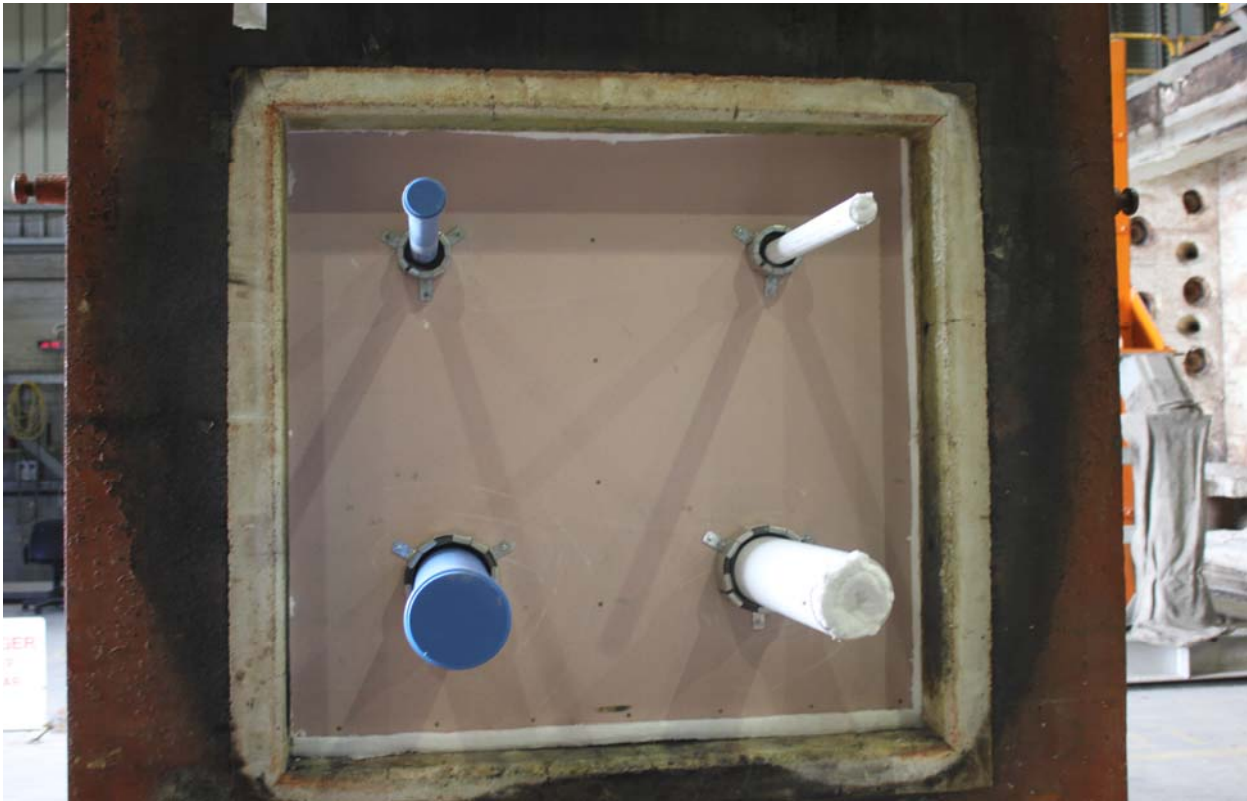
PHOTOGRAPH 1 – EXPOSED FACE OF SPECIMENS PRIOR TO TESTING

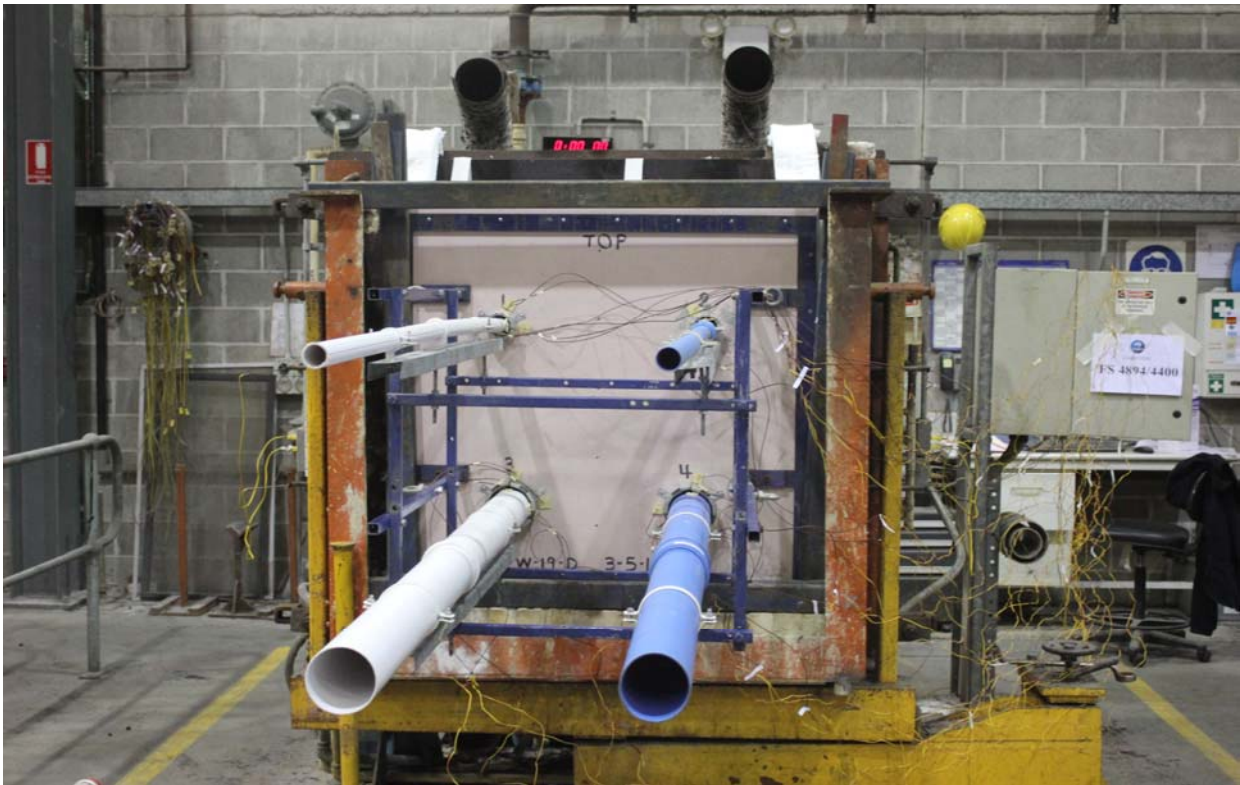
PHOTOGRAPH 2 – UNEXPOSED FACE OF SPECIMENS PRIOR TO TESTING

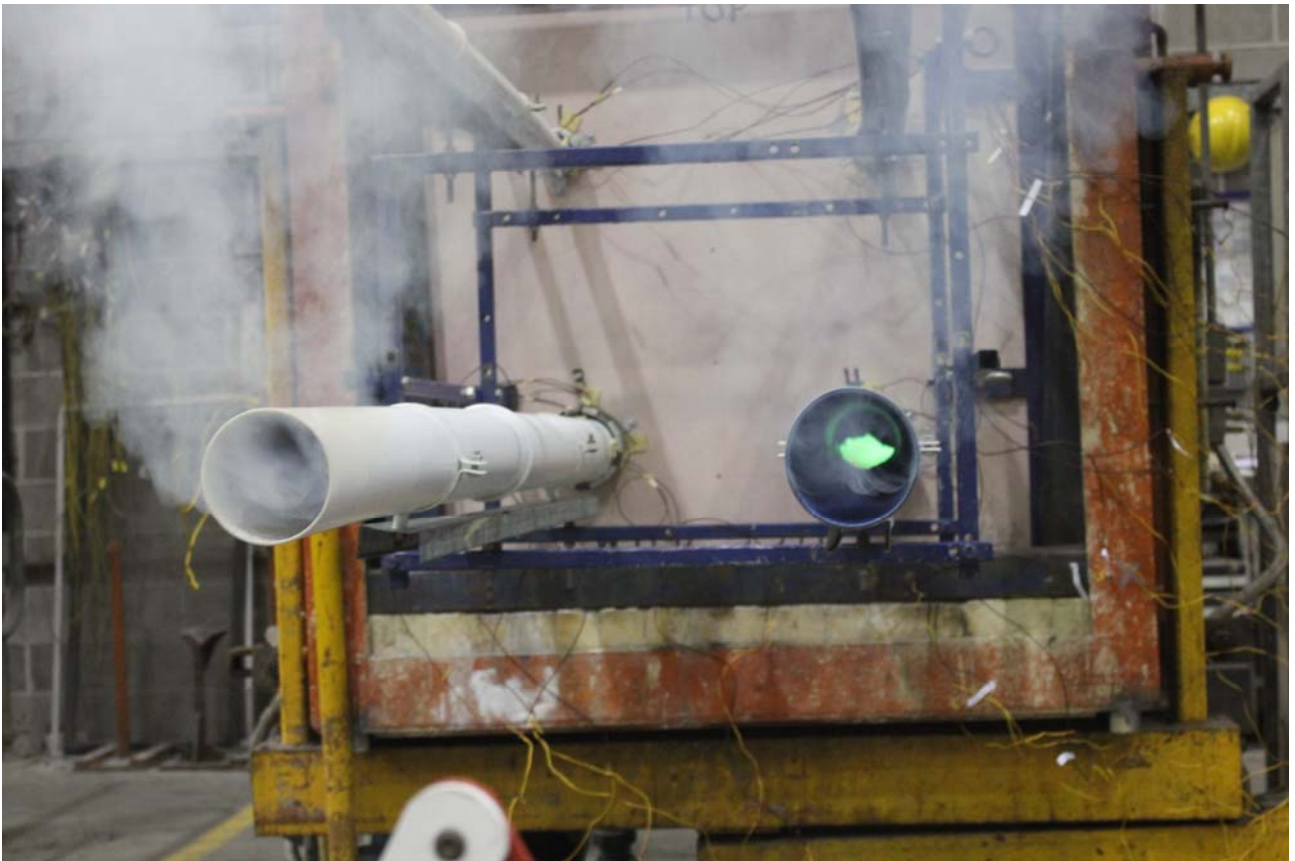
PHOTOGRAPH 3 – SPECIMENS 3 AND 4 AFTER 4 MINUTES OF TESTING

27 minutes -	Light smoke is fluing from the ends of pipes of Specimens 3 and 4.
30 minutes -	Light smoke is being emitted from the base of Specimens 3 and 4.
40 minutes -	Smoke is fluing from the end of the pipe of Specimen 4 has increased.
49 minutes -	Liquid is dripping out from the end of the pipe of Specimen 4.
58 minutes -	The base of the pipe inside the collar of Specimen 4 has melted and smoke has resumed being emitted from the collar.
60 minutes -	A red glow in to the furnace can be seen through the collar. Cotton wool pad test applied between the pipe and collar. No ignition noted at this time.
62 minutes -	Intumescent material from the outside collar of Specimen 4 has begun to swell. Light smoke has resumed fluing from the end of pipe of Specimen 4.
66 minutes -	<u>Insulation Failure of Specimen 4</u> – maximum temperature rise of 180K is exceeded on the plasterboard 25-mm above the collar of Specimen 4. The pipe inside the collar of Specimen 2 has started to melt and a red glow in to the furnace can be seen through the collar.

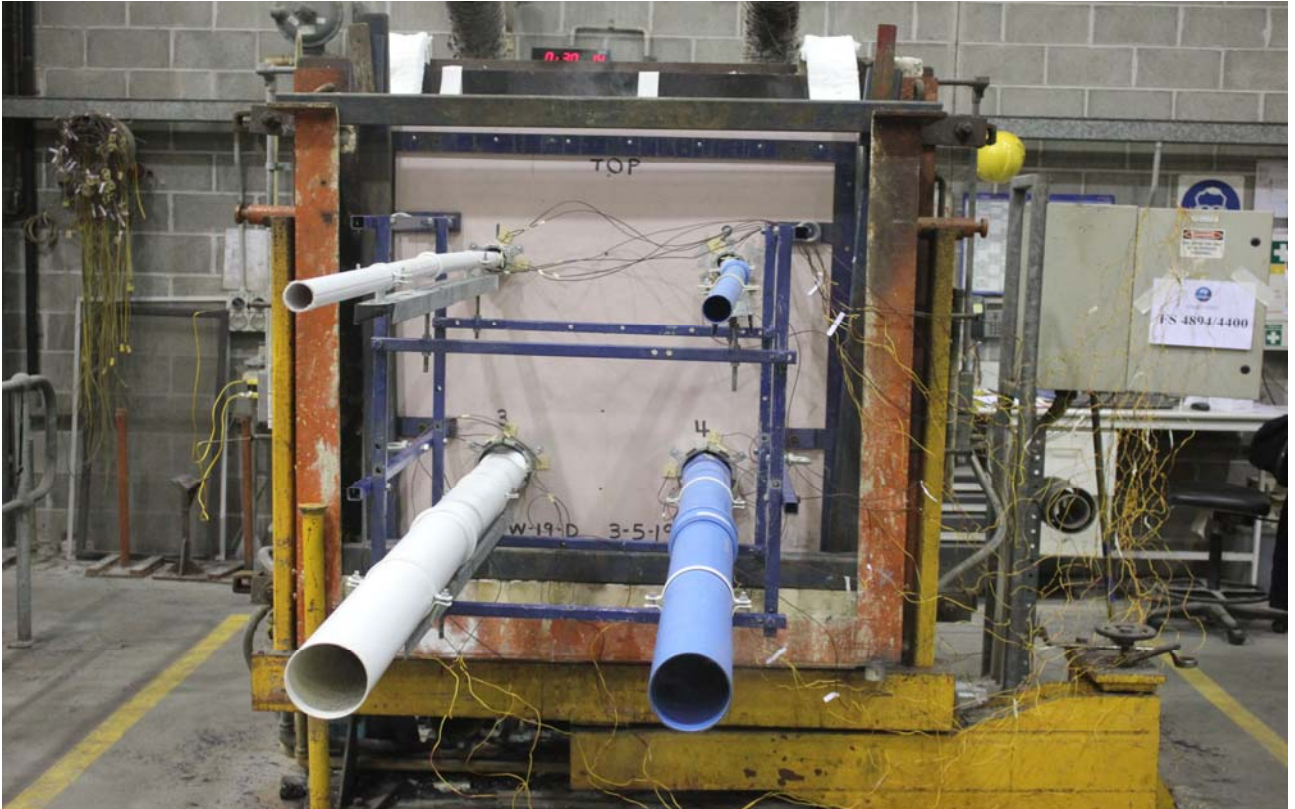
PHOTOGRAPH 4 – SPECIMENS AFTER 30 MINUTES OF TESTING

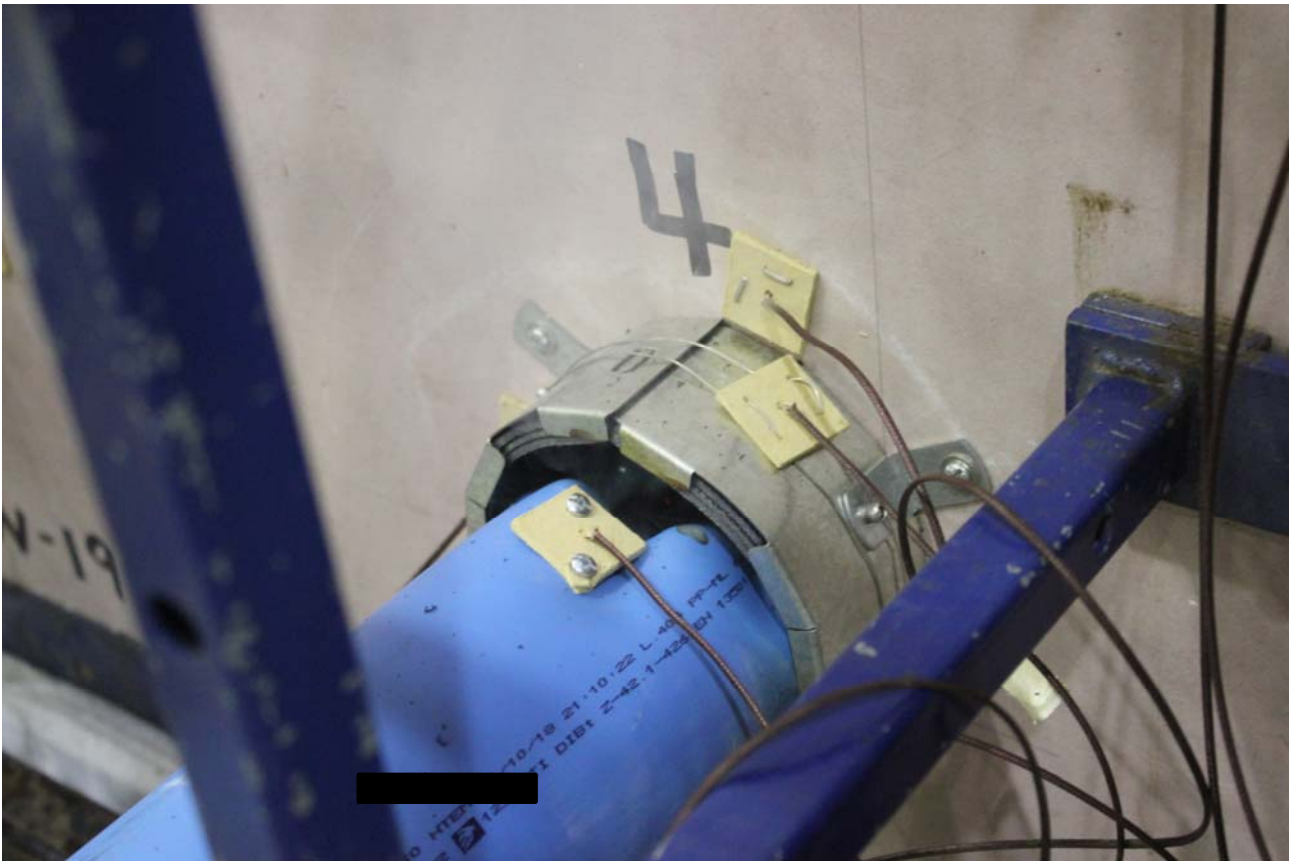
PHOTOGRAPH 5 – SPECIMEN 4 AFTER 58 MINUTES OF TESTING

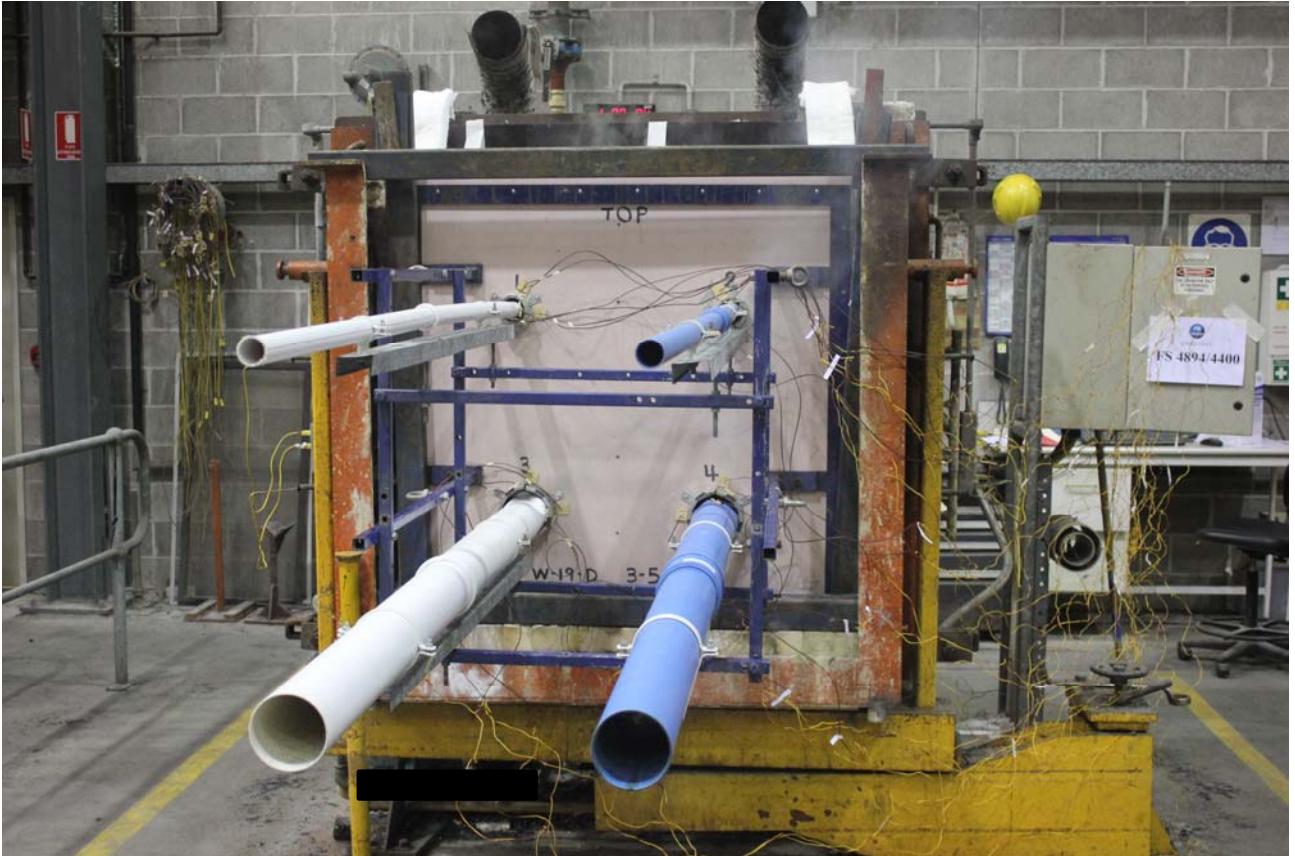
PHOTOGRAPH 6 – SPECIMENS AFTER 60 MINUTES OF TESTING

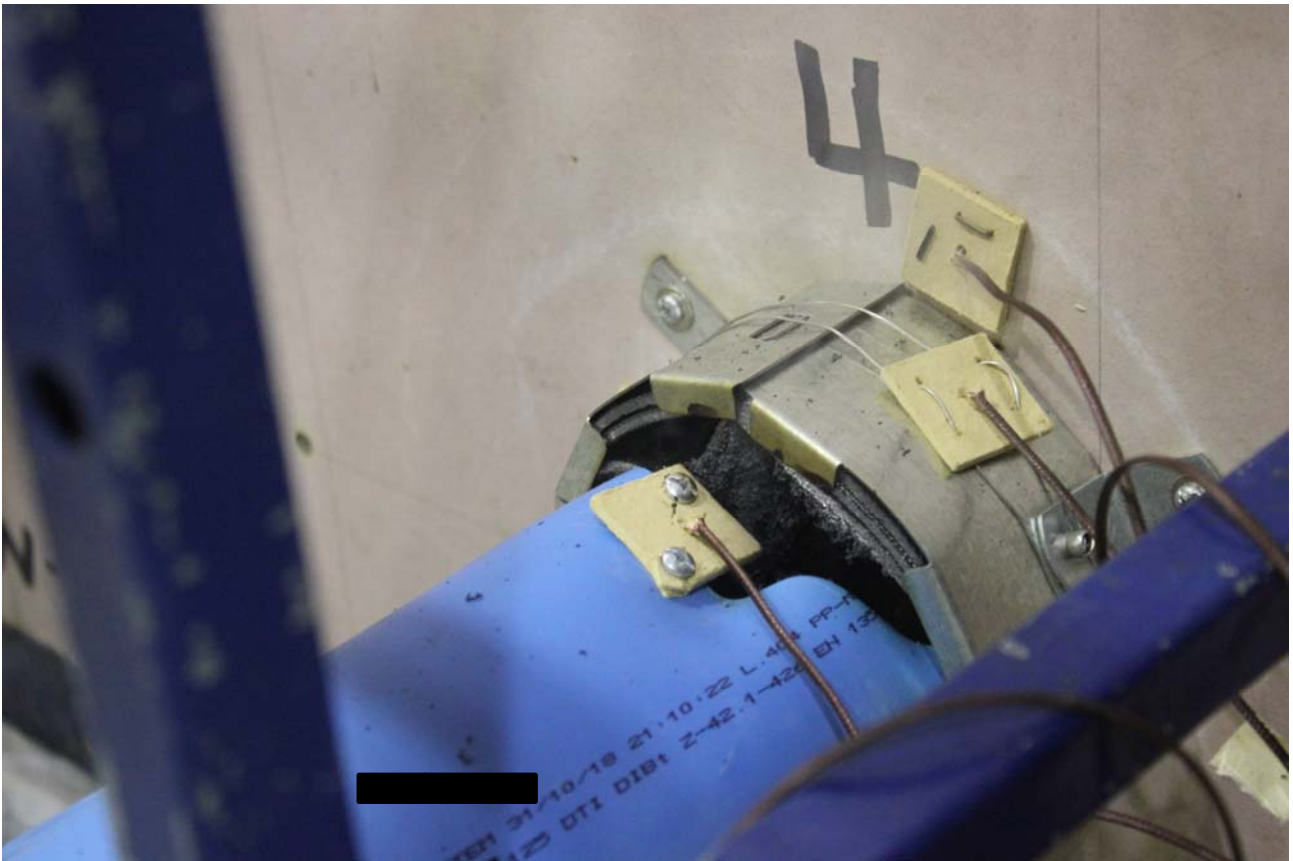
PHOTOGRAPH 7 – SPECIMEN 4 AFTER 62 MINUTES OF TESTING

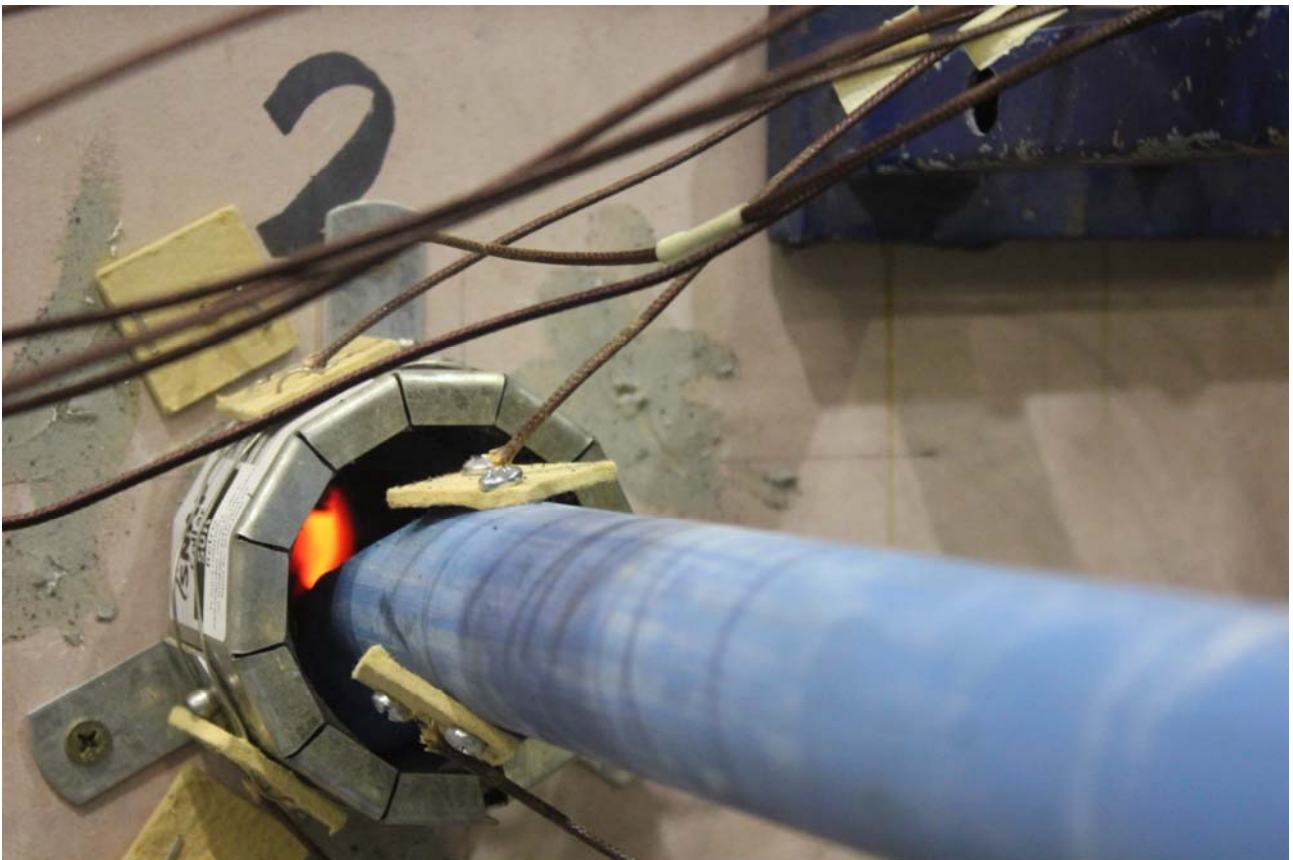
PHOTOGRAPH 8 – SPECIMEN 2 AFTER 68 MINUTES OF TESTING

- 68 minutes - Cotton wool pad test applied between the pipe and collar of Specimen 2. No ignition noted at this time.
- 71 minutes - Insulation Failure of Specimen 2 – maximum temperature rise of 180K is exceeded on top of the pipe 25-mm from the collar of Specimen 2.

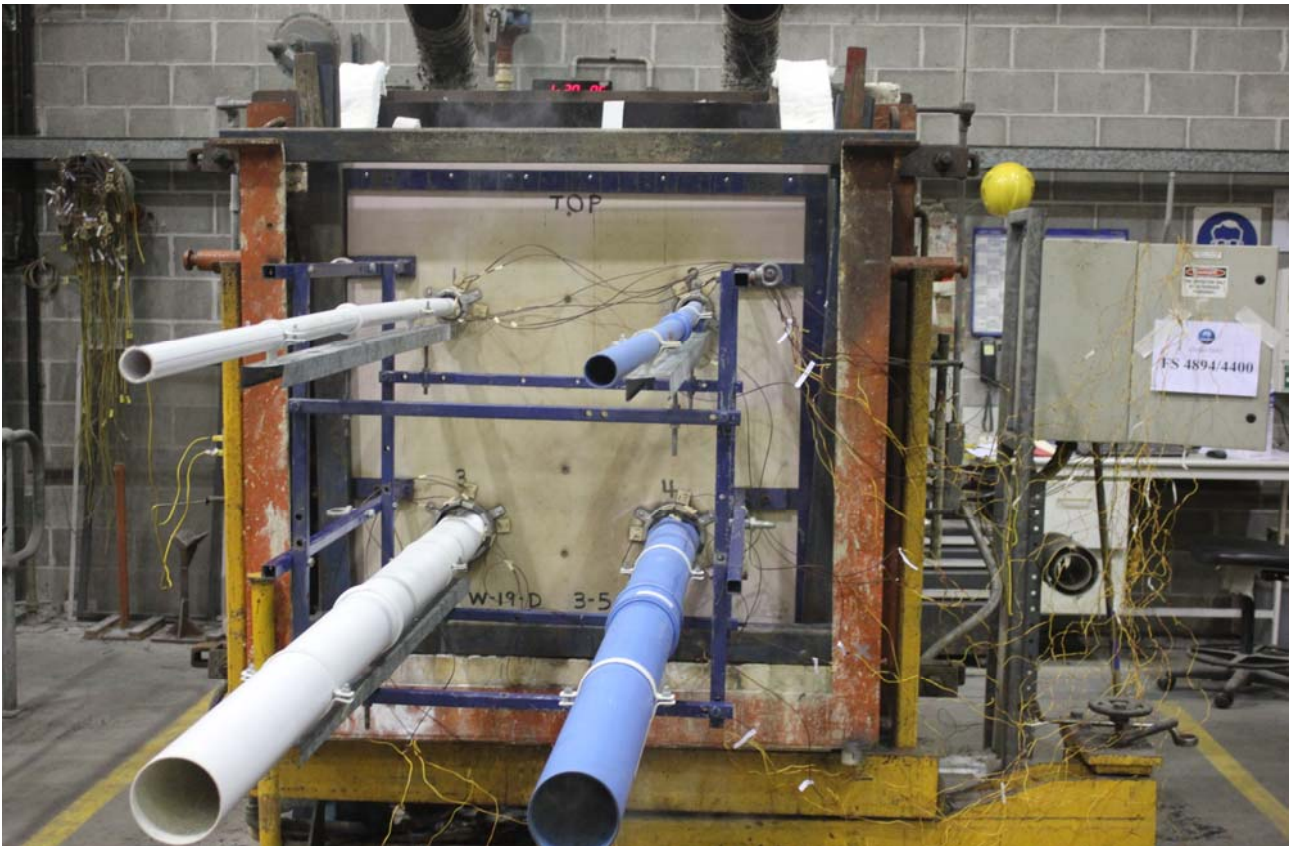
PHOTOGRAPH 9 – SPECIMENS AFTER 90 MINUTES OF TESTING

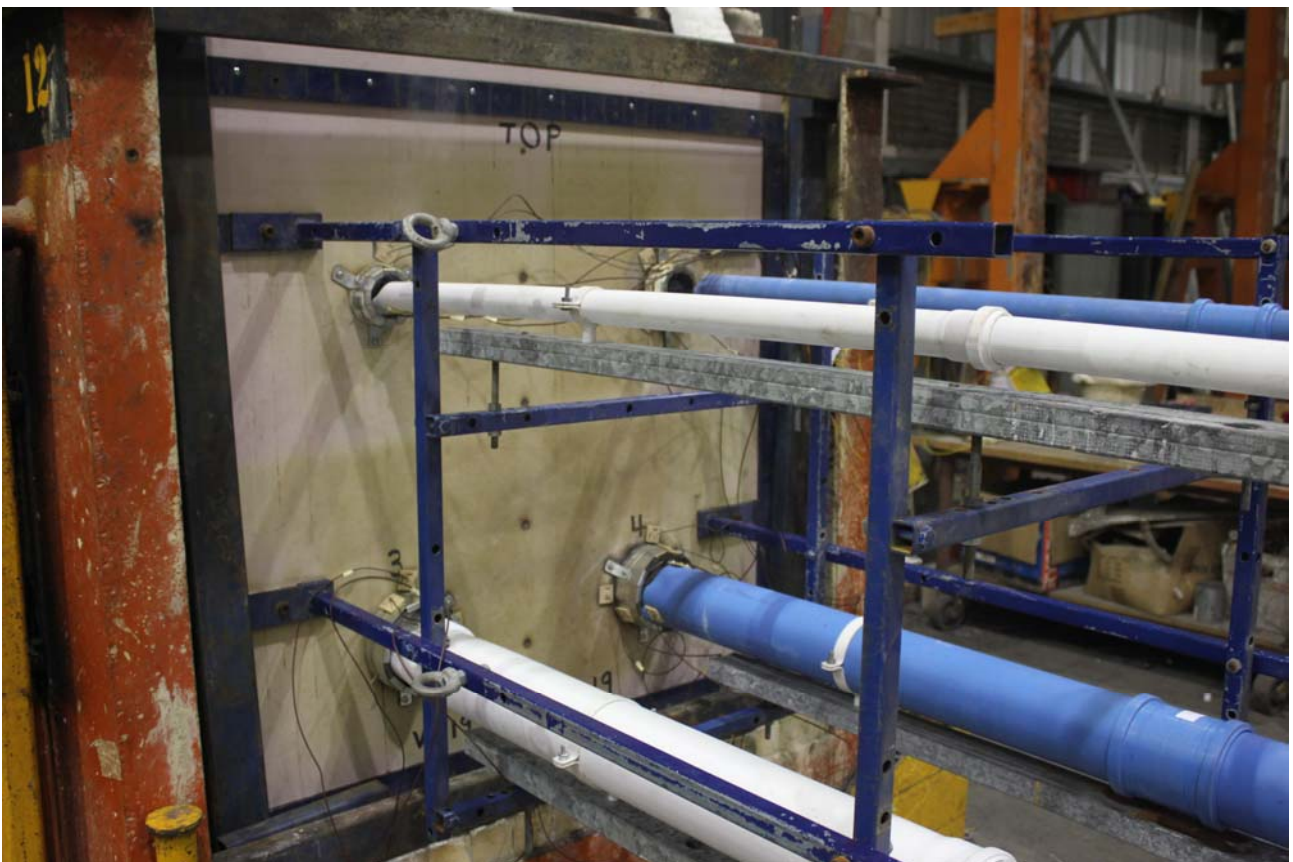
PHOTOGRAPH 10 – SPECIMENS AT CONCLUSION OF TESTING

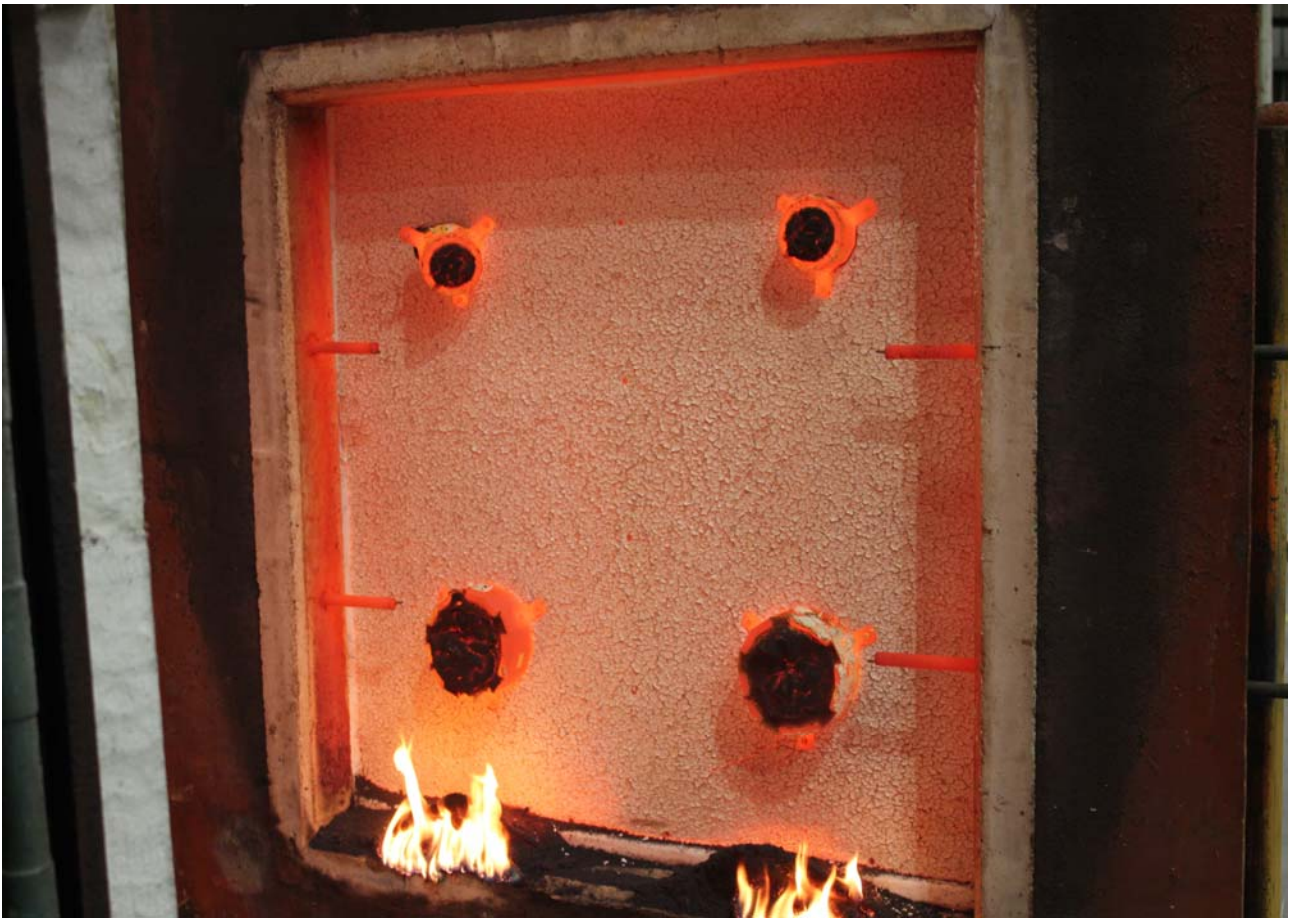
PHOTOGRAPH 11 – EXPOSED FACE OF SPECIMENS AT CONCLUSION OF TESTING

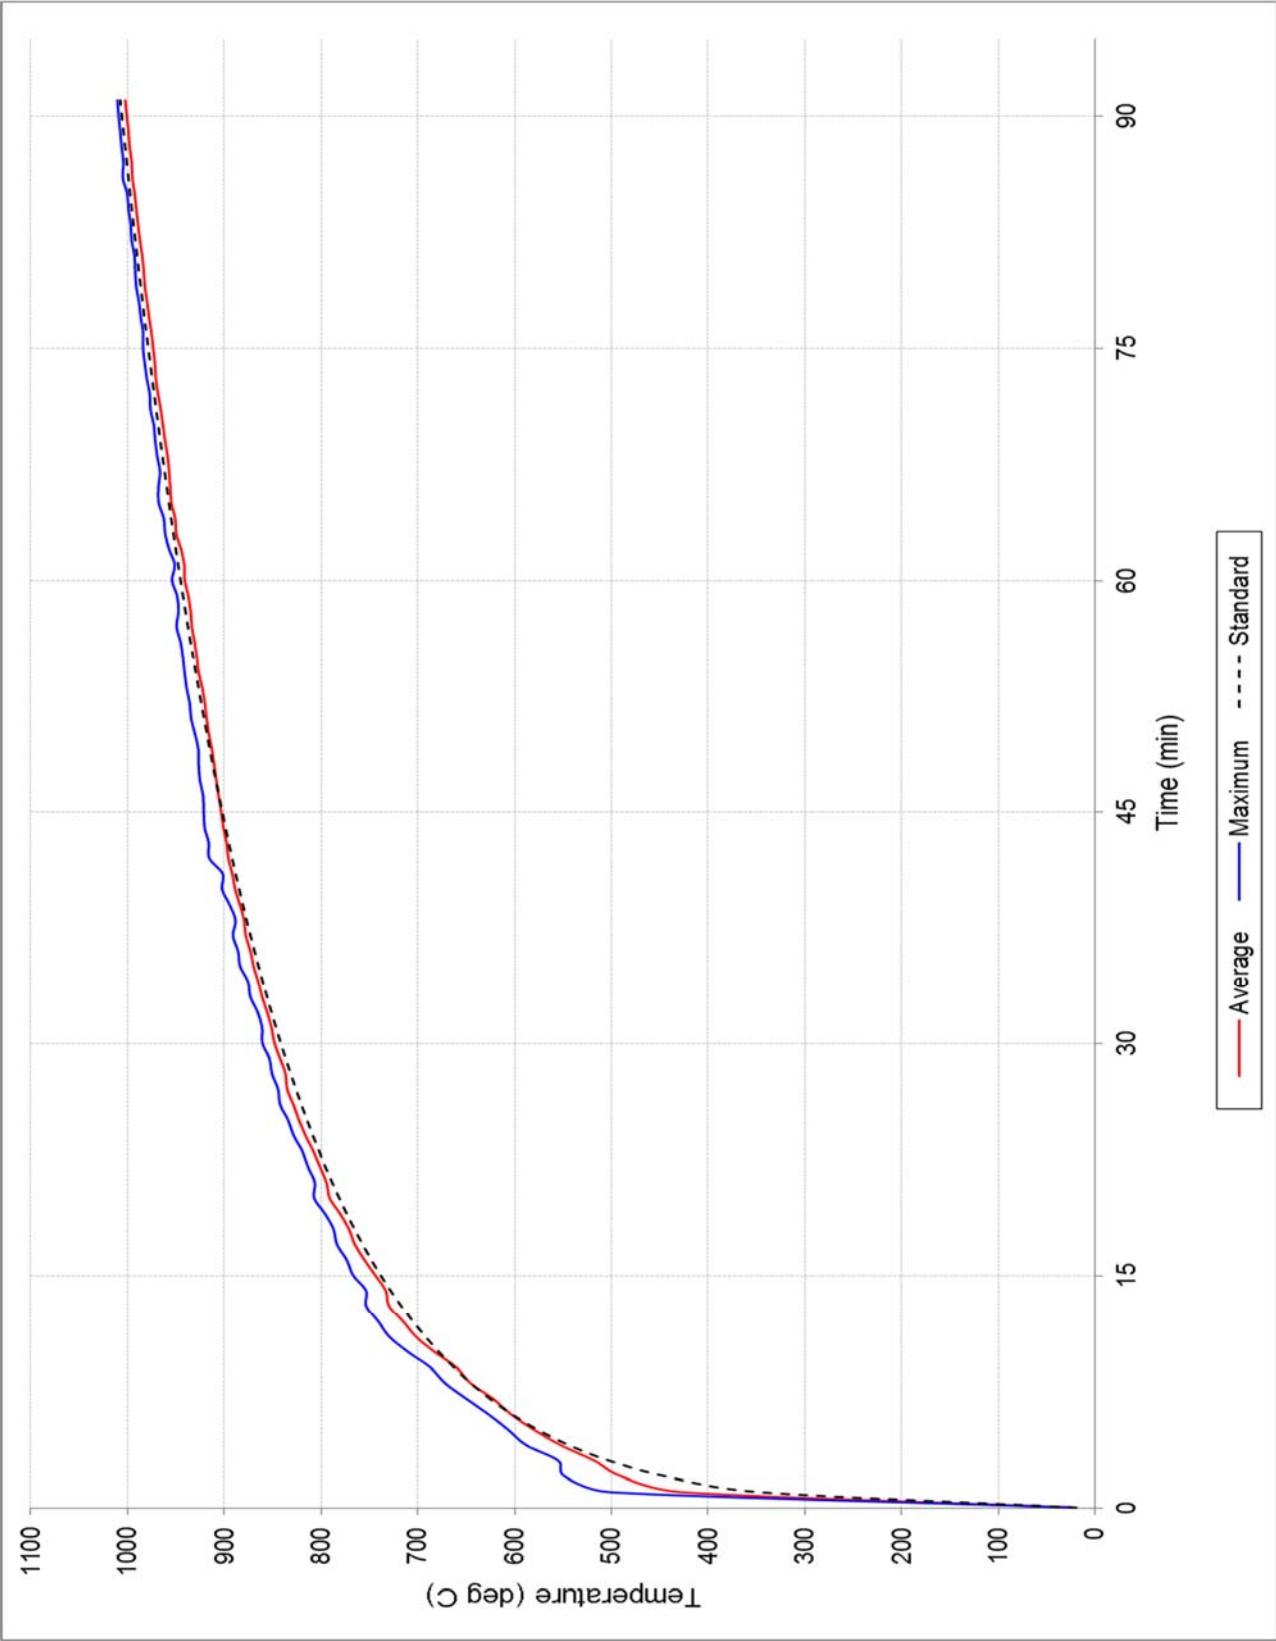
FIGURE 1 – FURNACE TEMPERATURE

Figure 1 shows the standard curves of temperature versus time for heating the furnace chamber and the actual curves of average and maximum temperature versus time recorded during the heating period.

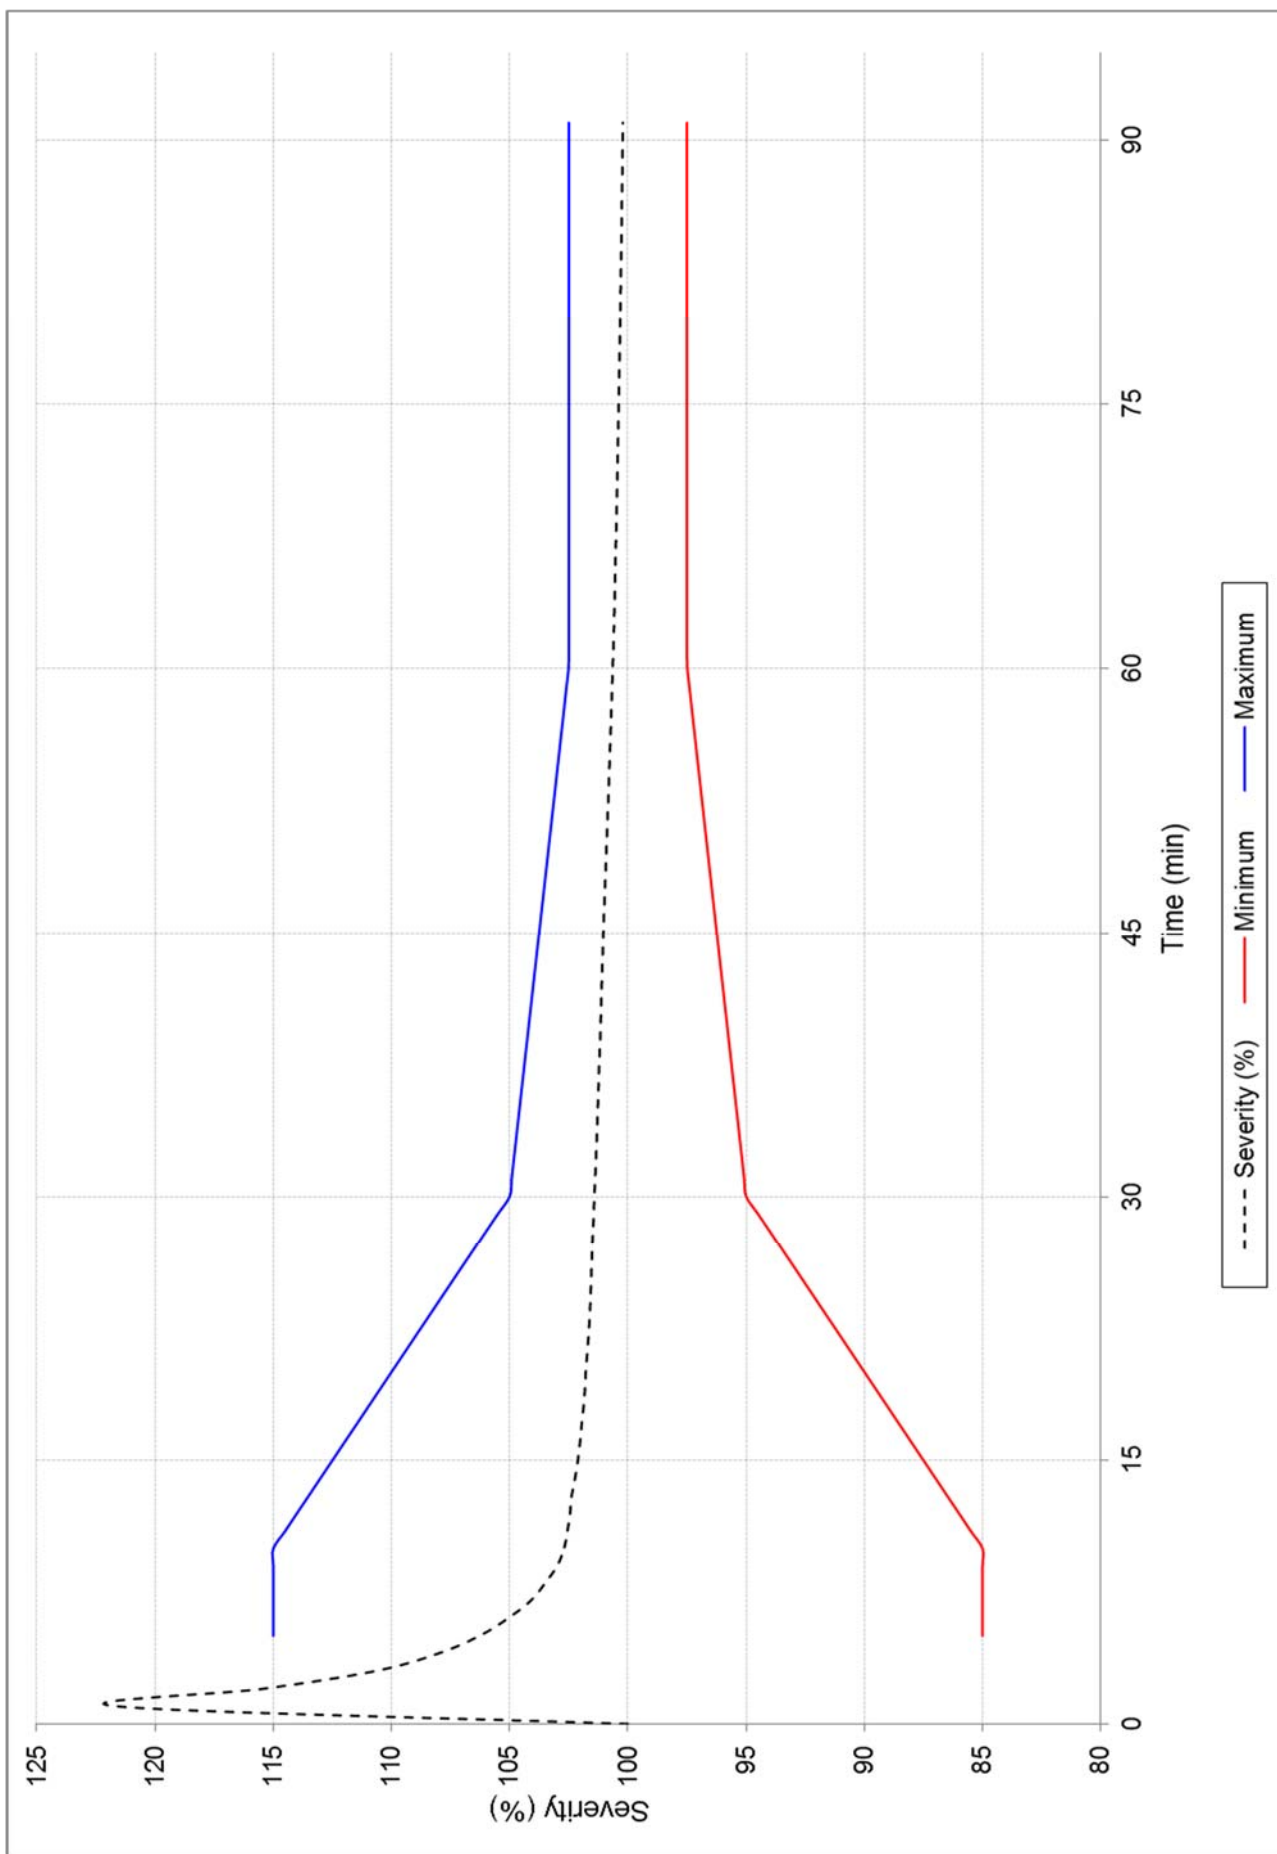
FIGURE 2 – FURNACE SEVERITY

Figure 2 shows the curve of furnace severity versus time during the heating period.

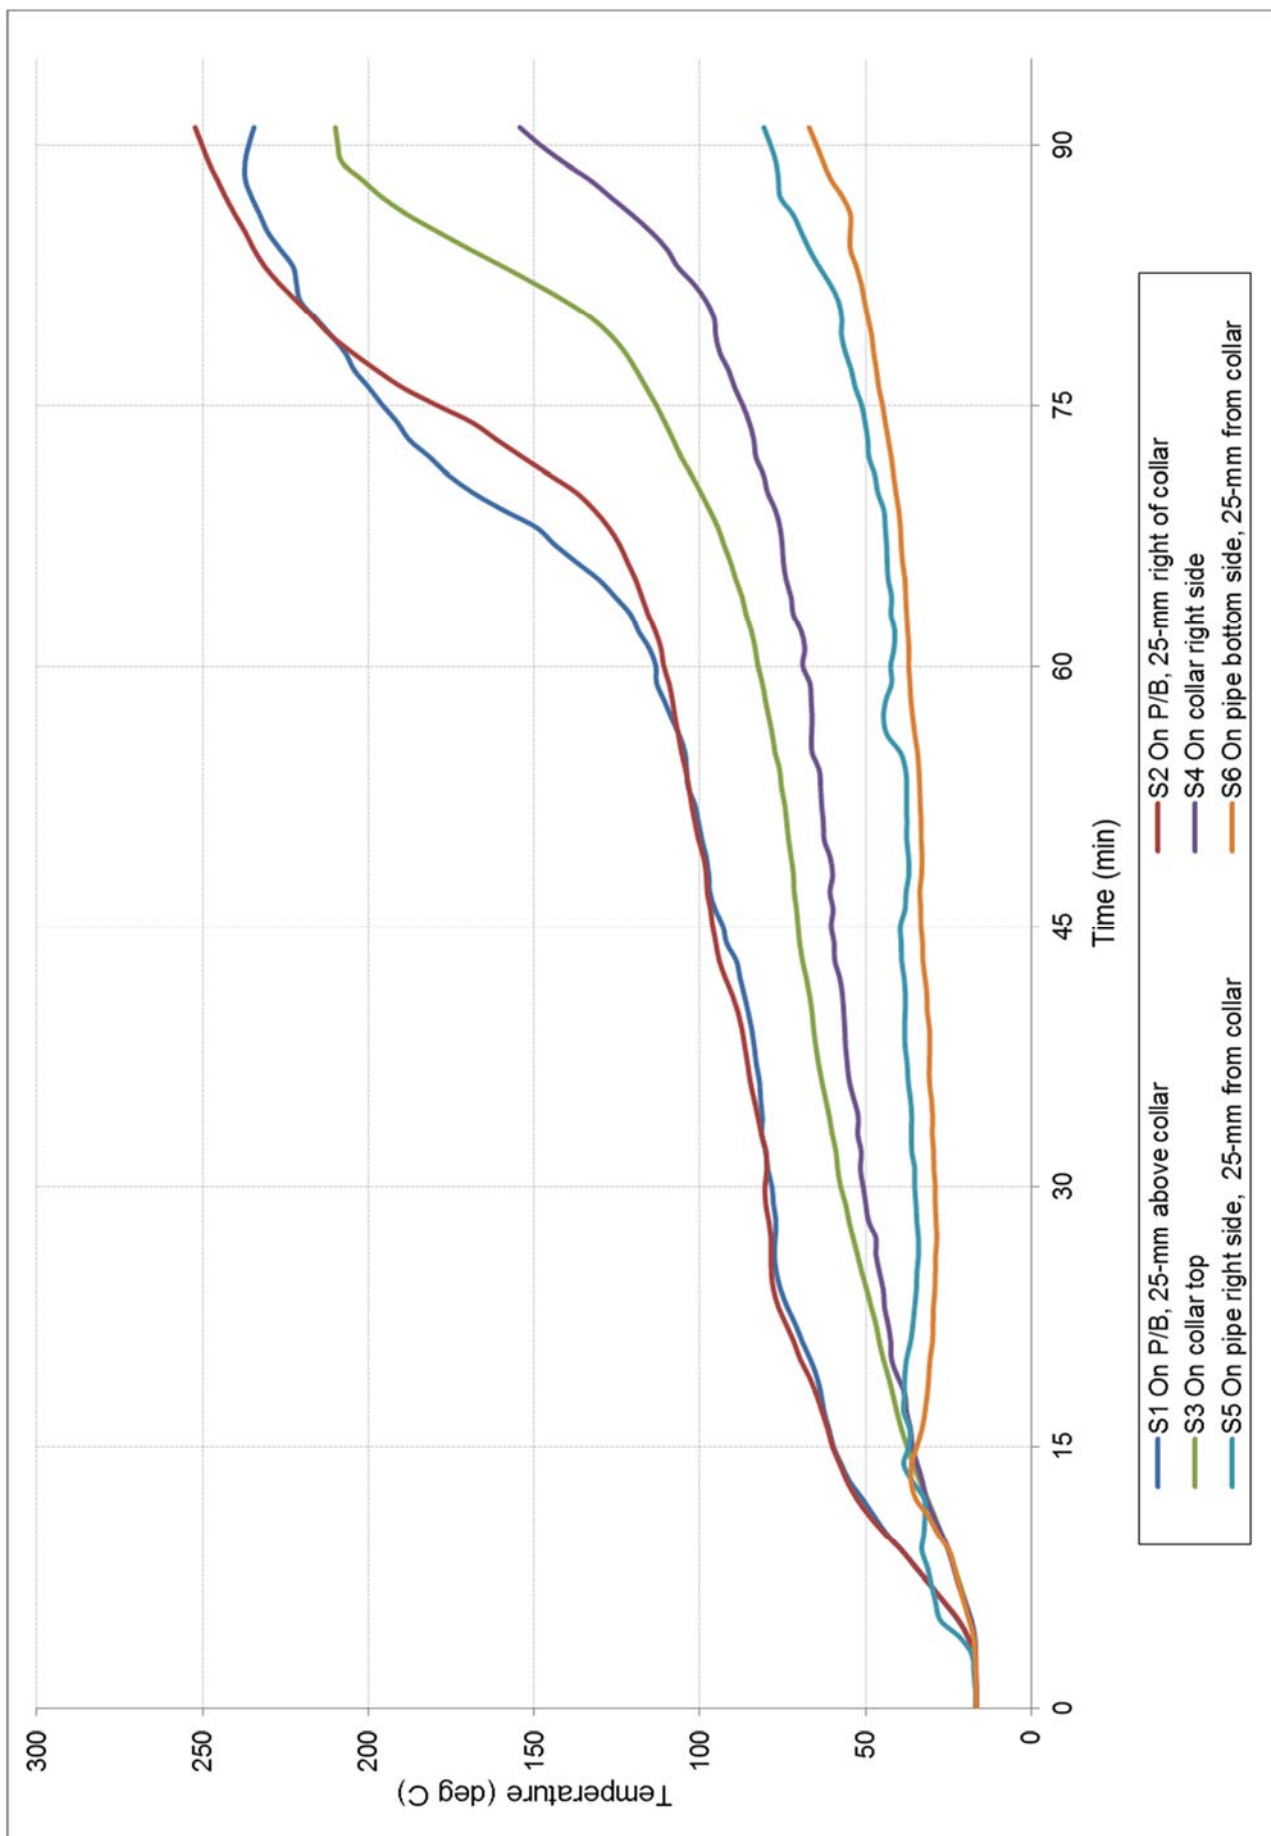
FIGURE 3 - TEMPERATURE VERSUS TIME ASSOCIATED WITH SPECIMEN # 1

- 75 minutes - Cotton wool pad test applied between the pipe and collar of Specimen 2. No ignition noted at this time.
- 76 minutes - Insulation Failure of Specimen 1 – maximum temperature rise of 180K is exceeded on the plasterboard 25-mm above the collar of Specimen 1.

Figure 3 shows the curve of temperature versus time associated with Specimen 1.

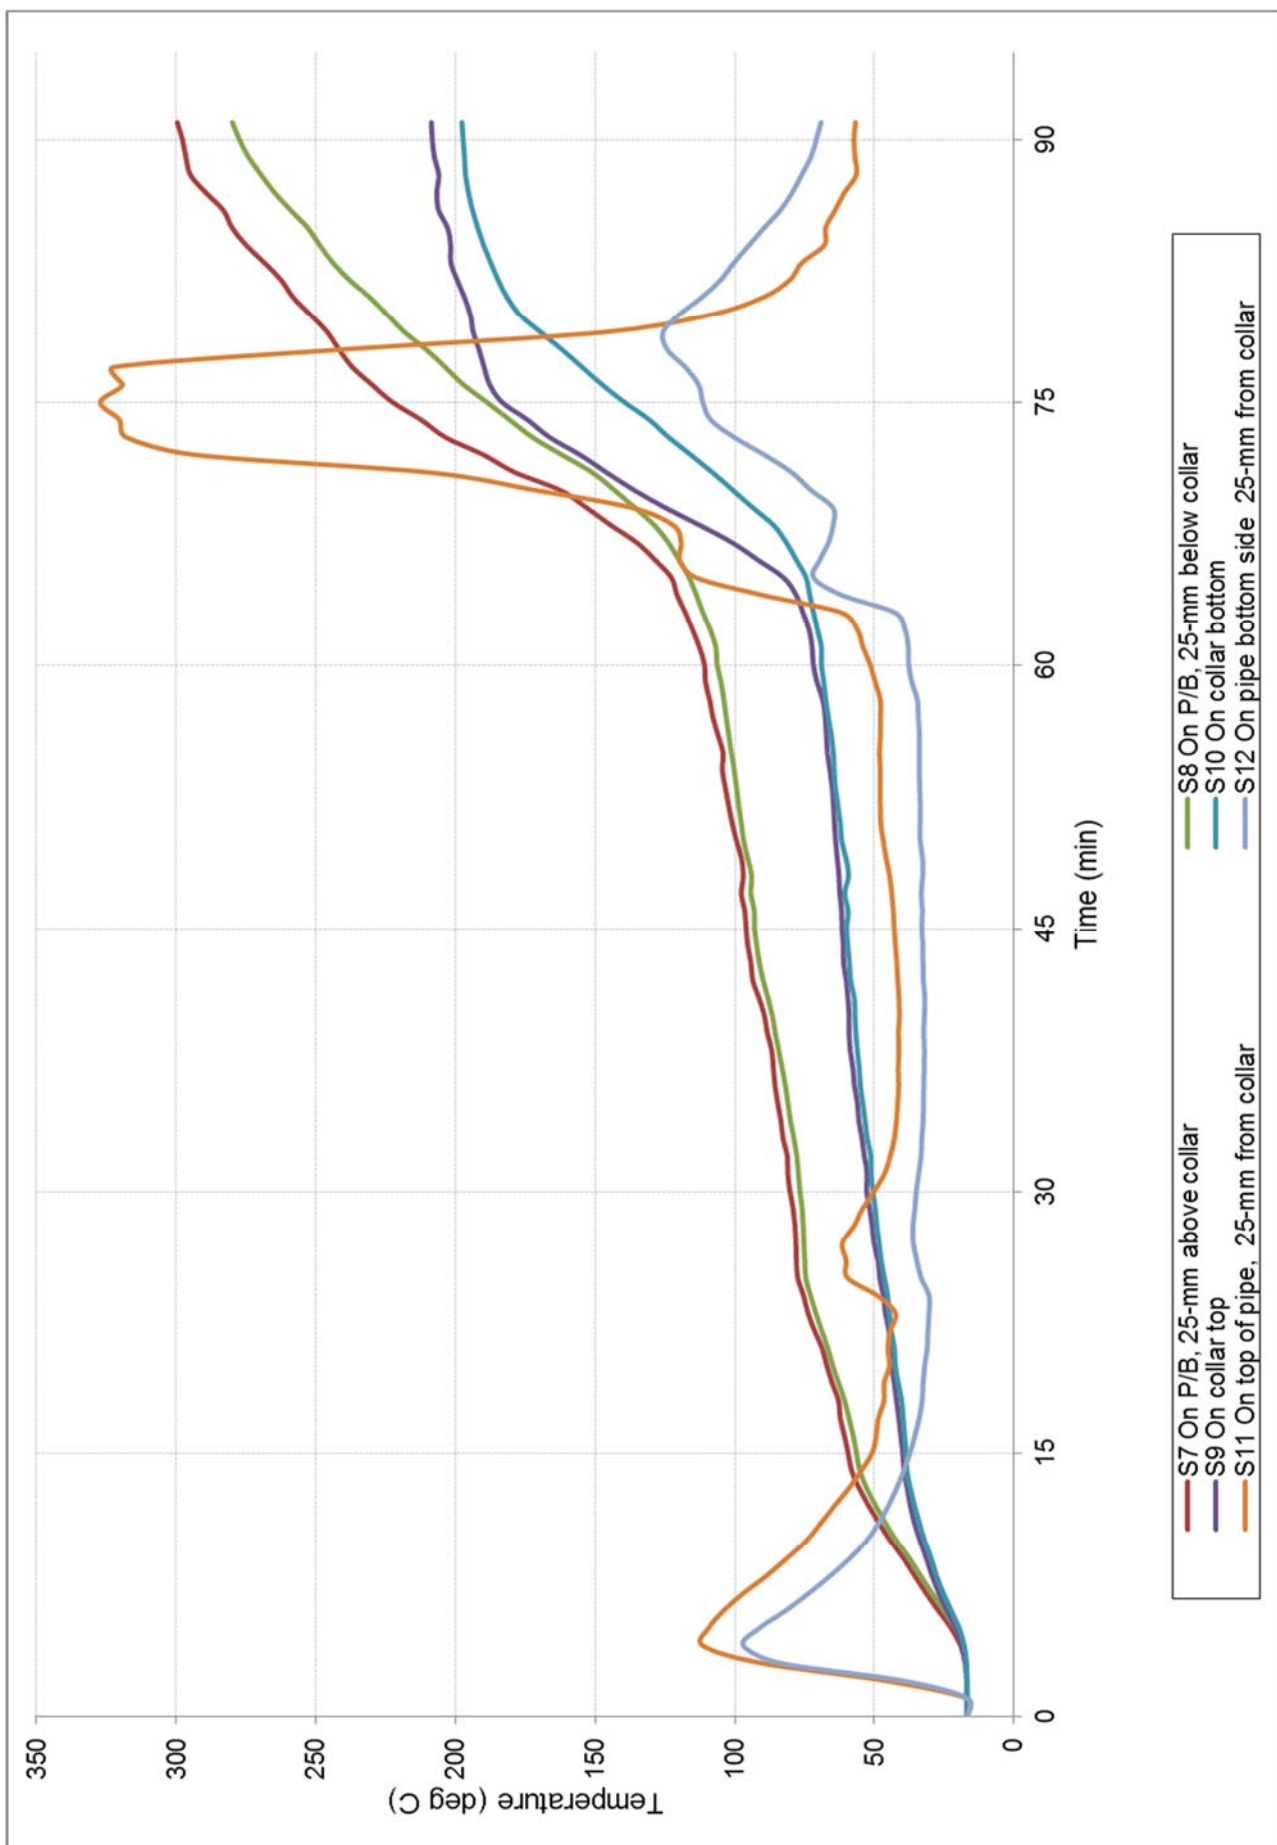
FIGURE 4 - TEMPERATURE VERSUS TIME ASSOCIATED WITH SPECIMEN # 2

Figure 4 shows the curve of temperature versus time associated with Specimen 2.
