Fire-resistance test on fire collars protecting a plasterboard wall penetrated by services

Test Report

Author: Peter Gordon
Report number: FSP 2024
Date: 22 August 2019

Client: IG6 Pty Ltd as trustee for the IG6 IP Trust

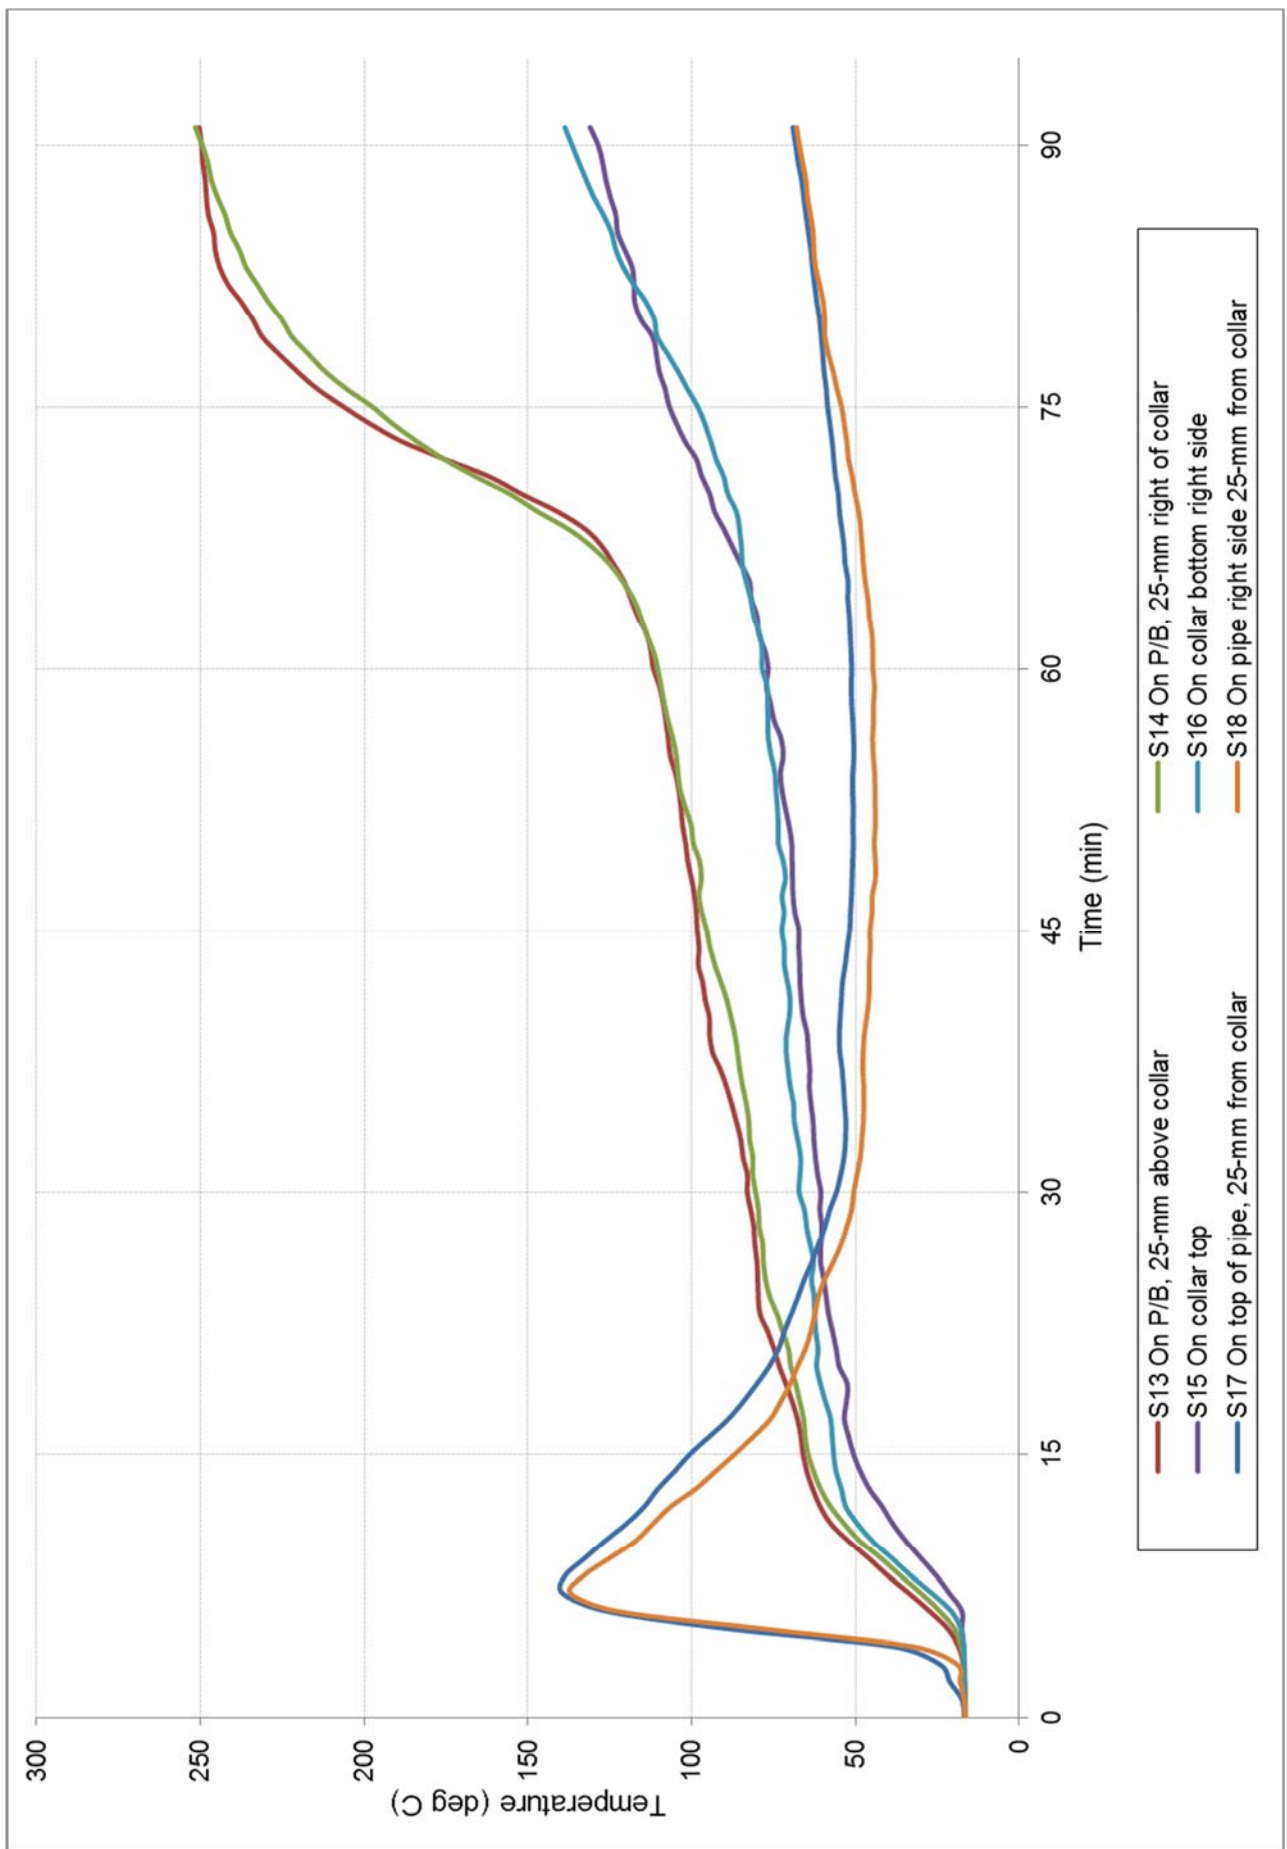
FIGURE 5 - TEMPERATURE VERSUS TIME ASSOCIATED WITH SPECIMEN # 3

- 71 minutes - The unexposed face of the plasterboard wall has begun discolouring with charring around screw heads visible.
- 74 minutes - Insulation Failure of Specimen 3 – maximum temperature rise of 180K is exceeded on the plasterboard 25-mm above the collar of Specimen 3.

Figure 5 shows the curve of temperature versus time associated with Specimen 3.

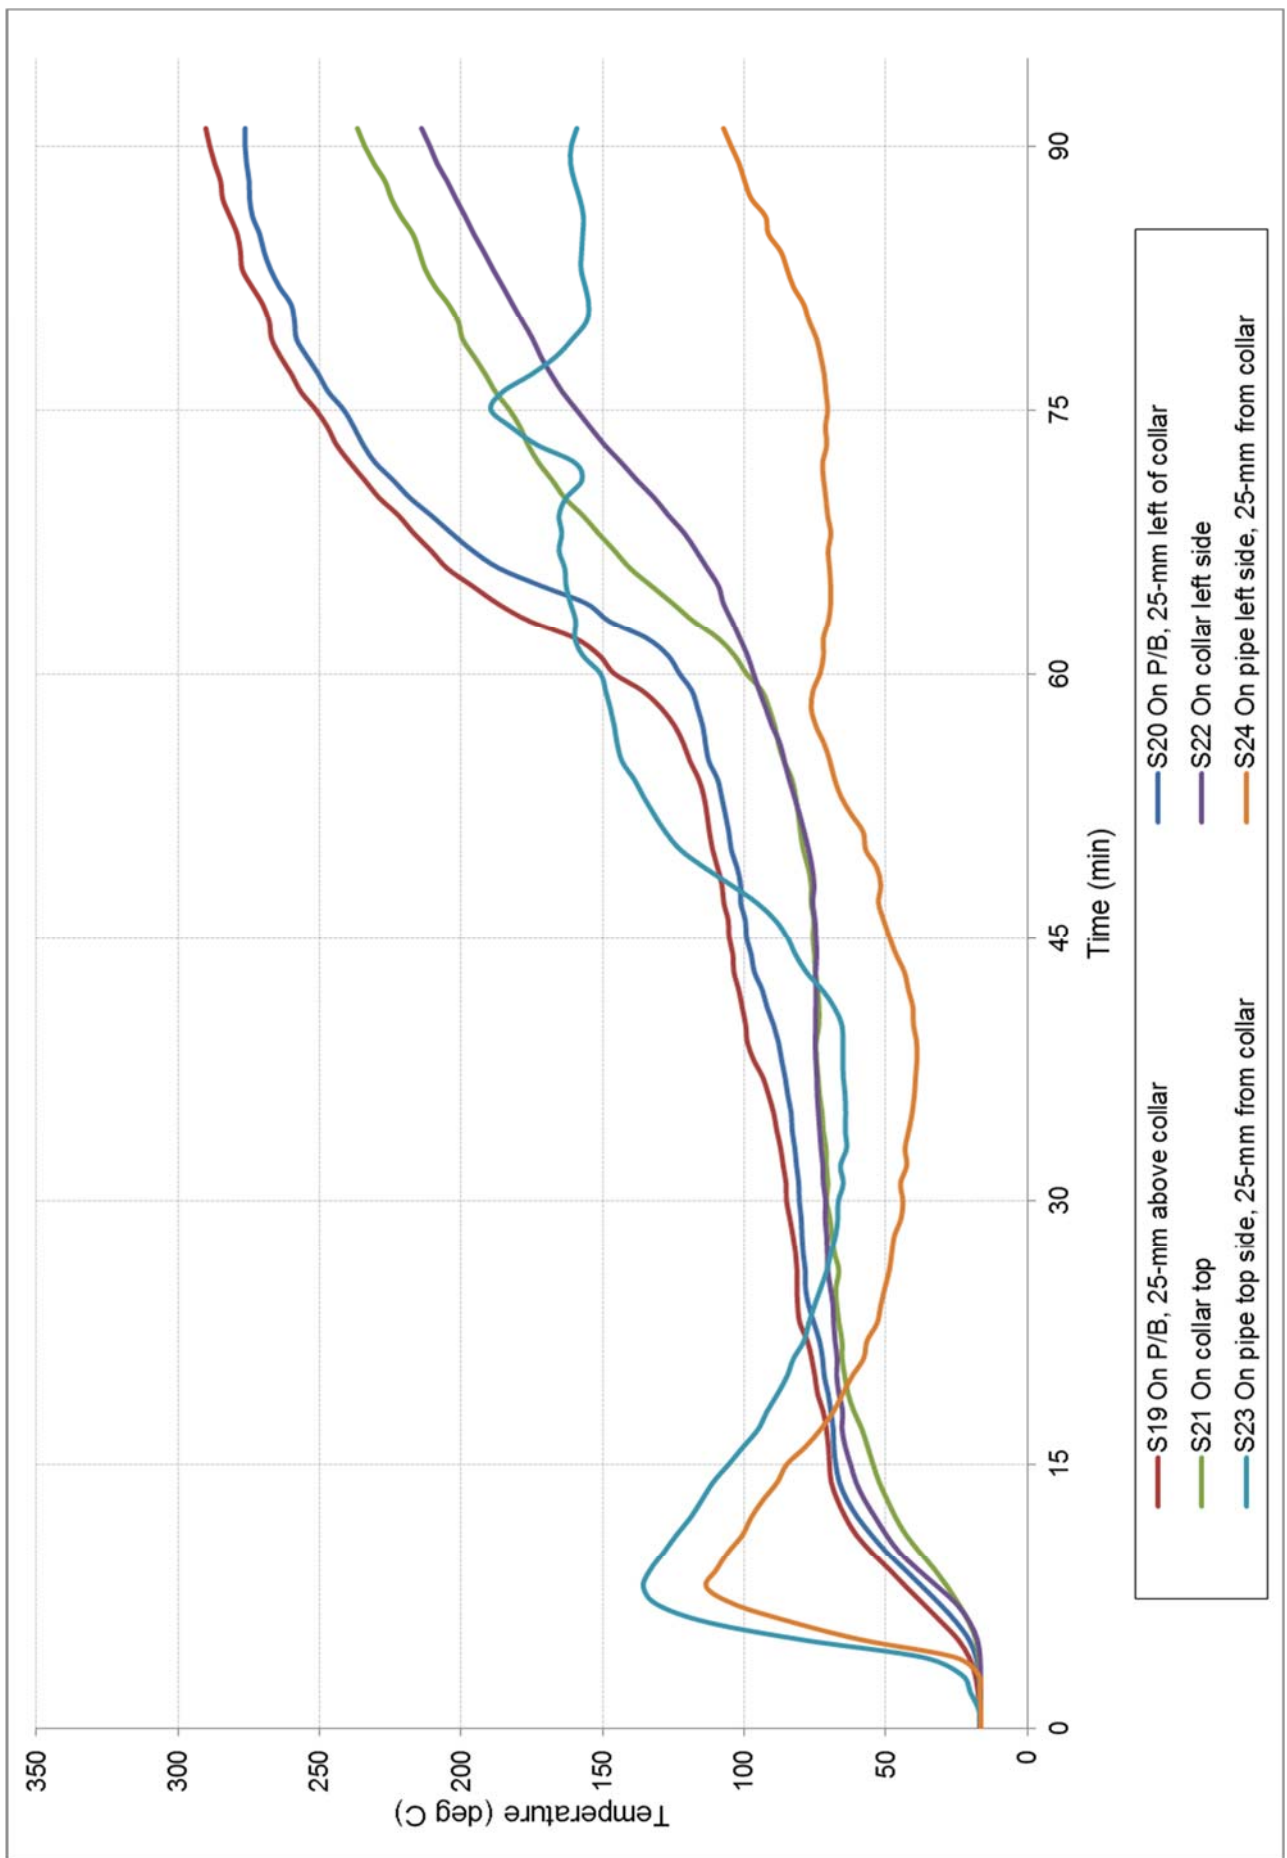
FIGURE 6 - TEMPERATURE VERSUS TIME ASSOCIATED WITH SPECIMEN # 4

Figure 6 shows the curve of temperature versus time associated with Specimen 4.

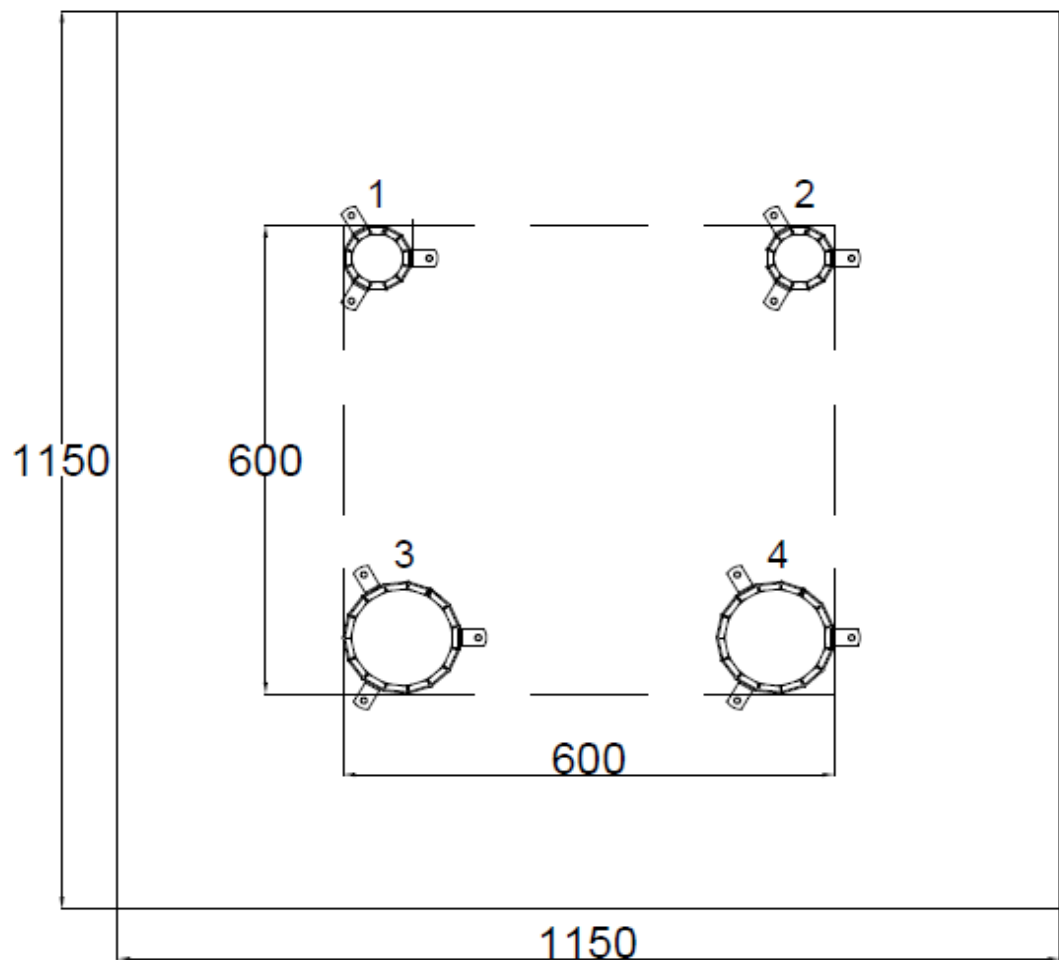
Snap Fire Systems Pty Ltd
Test Wall W-19-D Layout
Date: 26 JUN 2019

Penetration	Collar Code	Pipe Type	Pipe Diameter (mm)	Sealant
1	50R	Raupiano	40	Firesound
2	50R	Triplus	40	Firesound
3	110R	Raupiano	110	Firesound
4	110R	Triplus	110	Firesound

DRAWING TITLED “TEST WALL W-19-D LAYOUT, DATED 26 JUNE 2019, PROVIDED BY SNAP FIRE SYSTEMS PTY LTD.

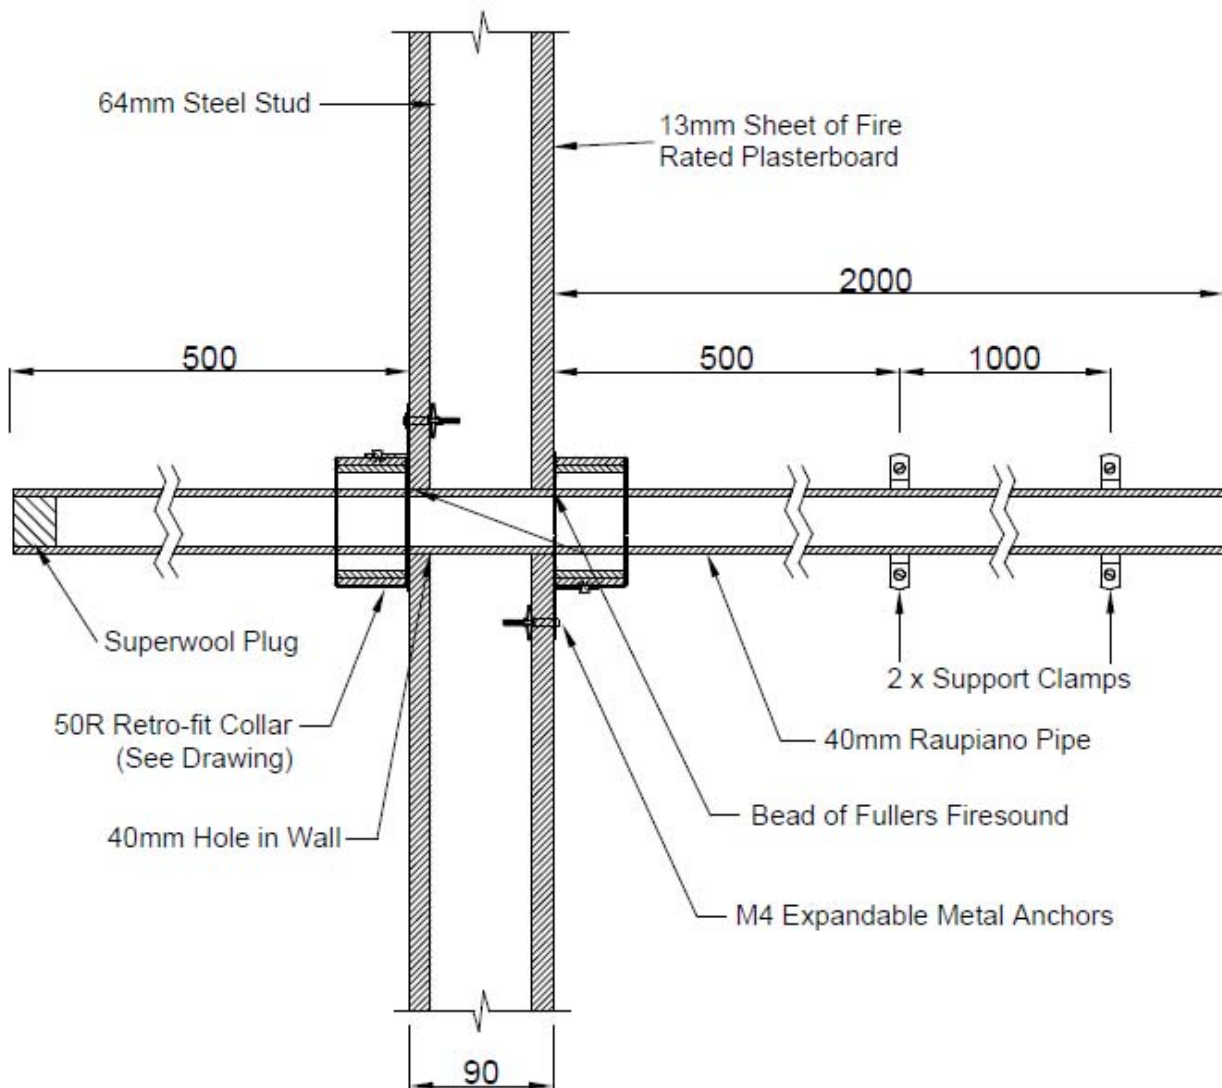
40 Raupiano Stack & 50R

**DRAWING TITLED "SPECIMEN # 1, 40 RAUPIANO STACK PIPE & 50R", DATED 26 JUNE 2019, PROVIDED BY
SNAP FIRE SYSTEMS PTY LTD**

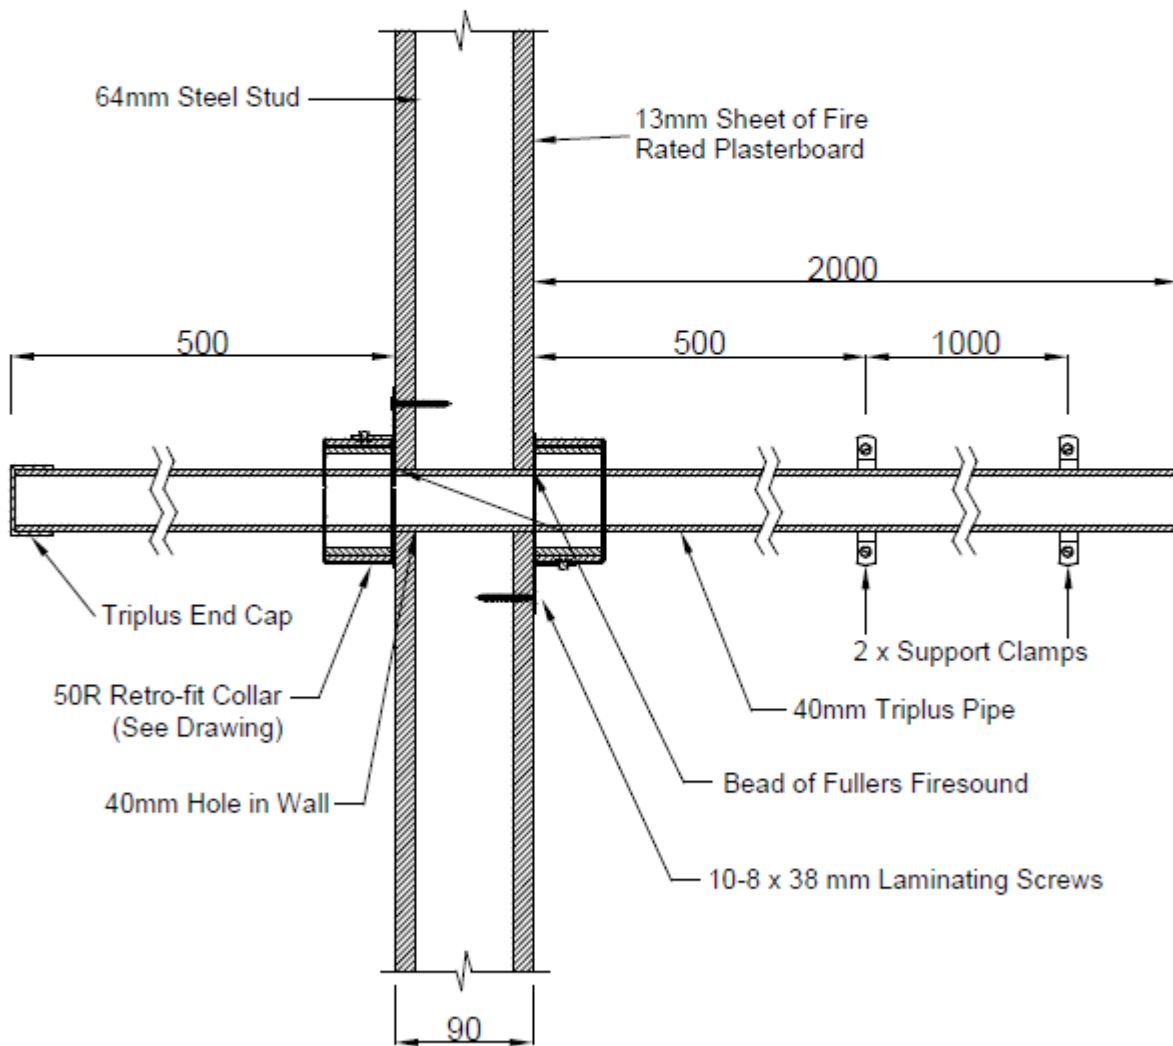
40 Triplus Stack & 50R

DRAWING TITLED "SPECIMEN # 2, 40 TRIPLUS STACK & 50R", DATED 26 JUNE 2019, PROVIDED BY SNAP FIRE SYSTEMS PTY LTD

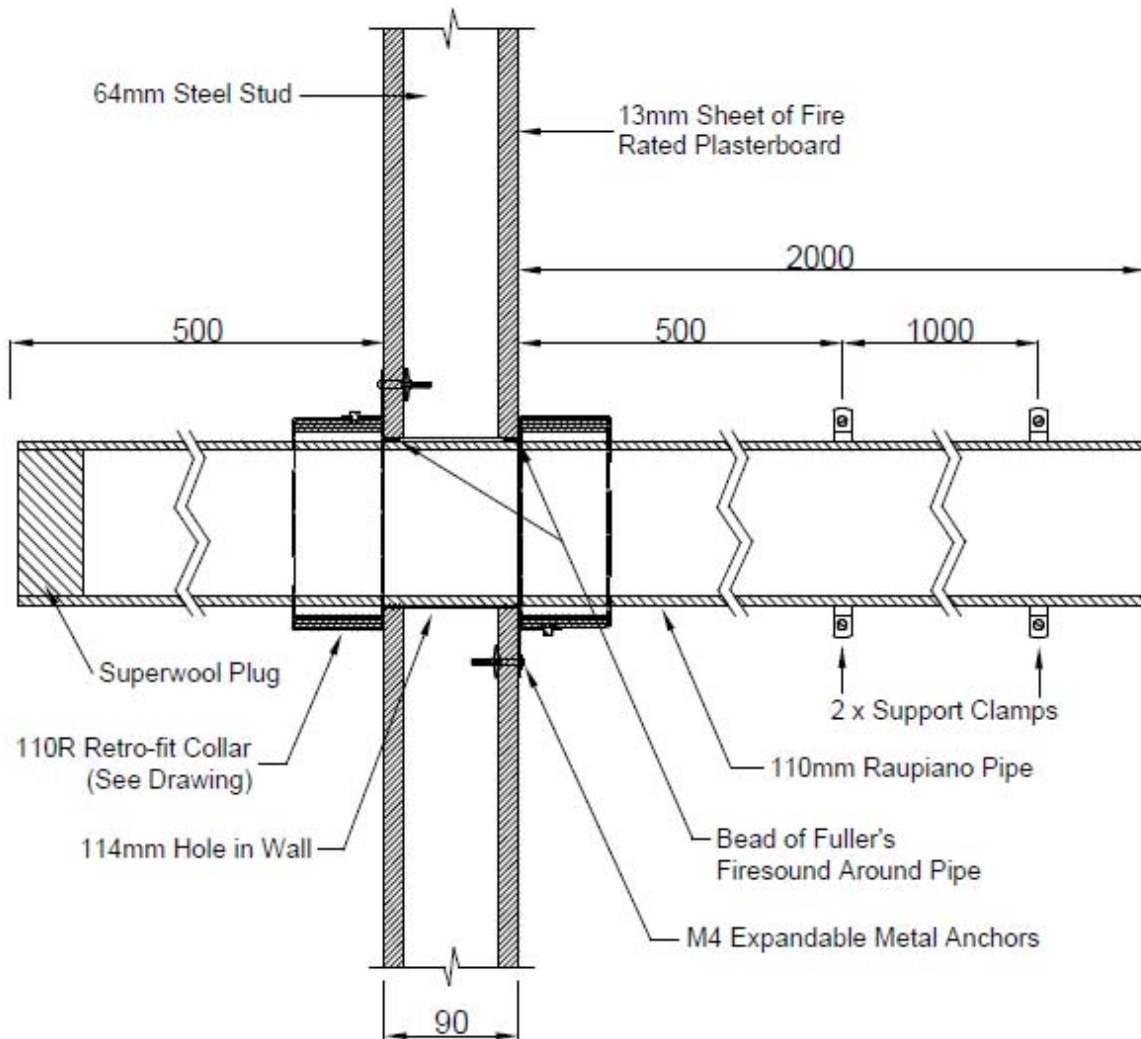
110 Raupiano Stack & 110R

DRAWING TITLED "SPECIMEN # 3, 110 RAUPIANO STACK & 110R", DATED 26 JUNE 2019, PROVIDED BY
SNAP FIRE SYSTEMS PTY LTD

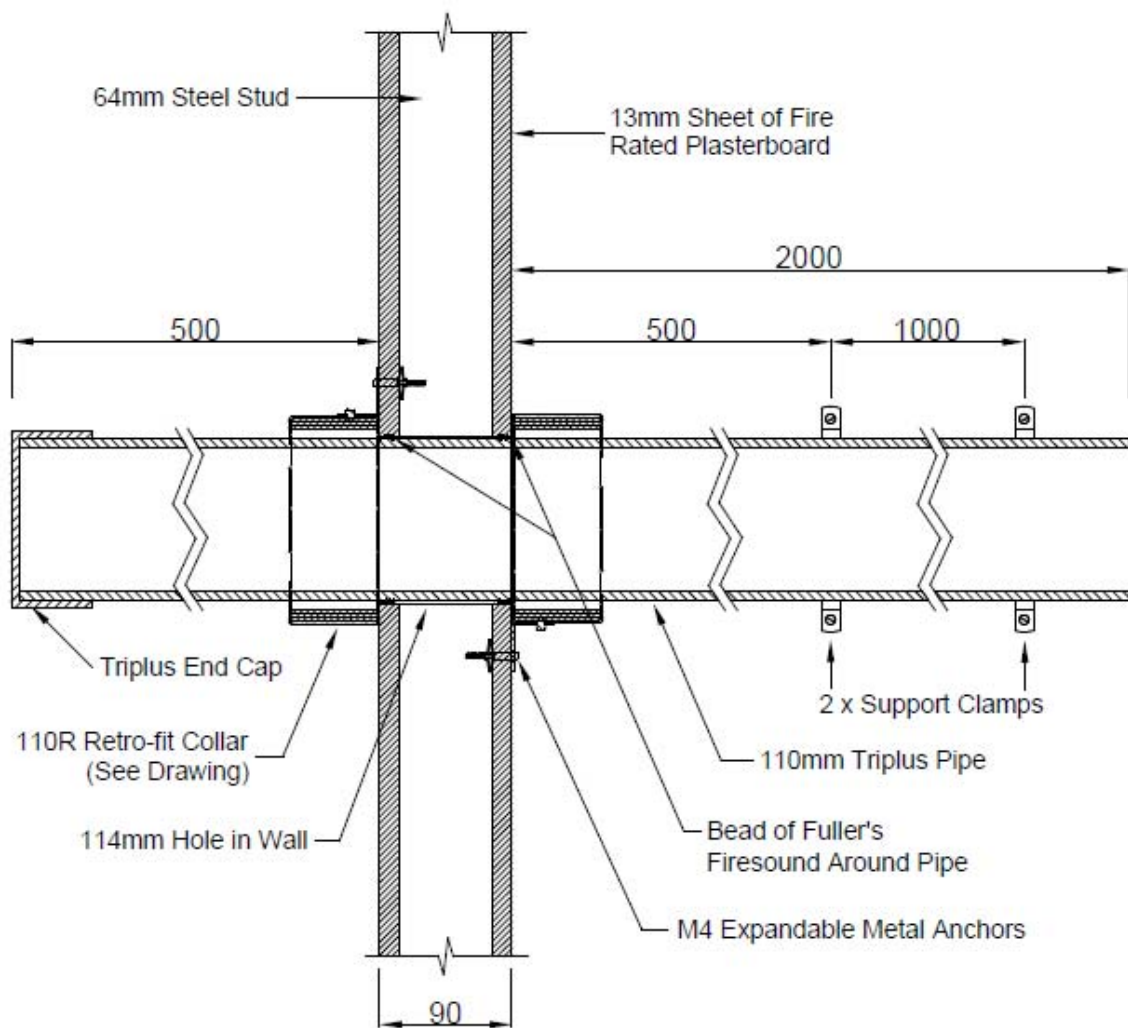
110 Triplus Stack & 110R

DRAWING TITLED "SPECIMEN # 4, 110 TRIPLUS STACK & 110R", DATED 26 JUNE 2019, PROVIDED BY SNAP FIRE SYSTEMS PTY LTD

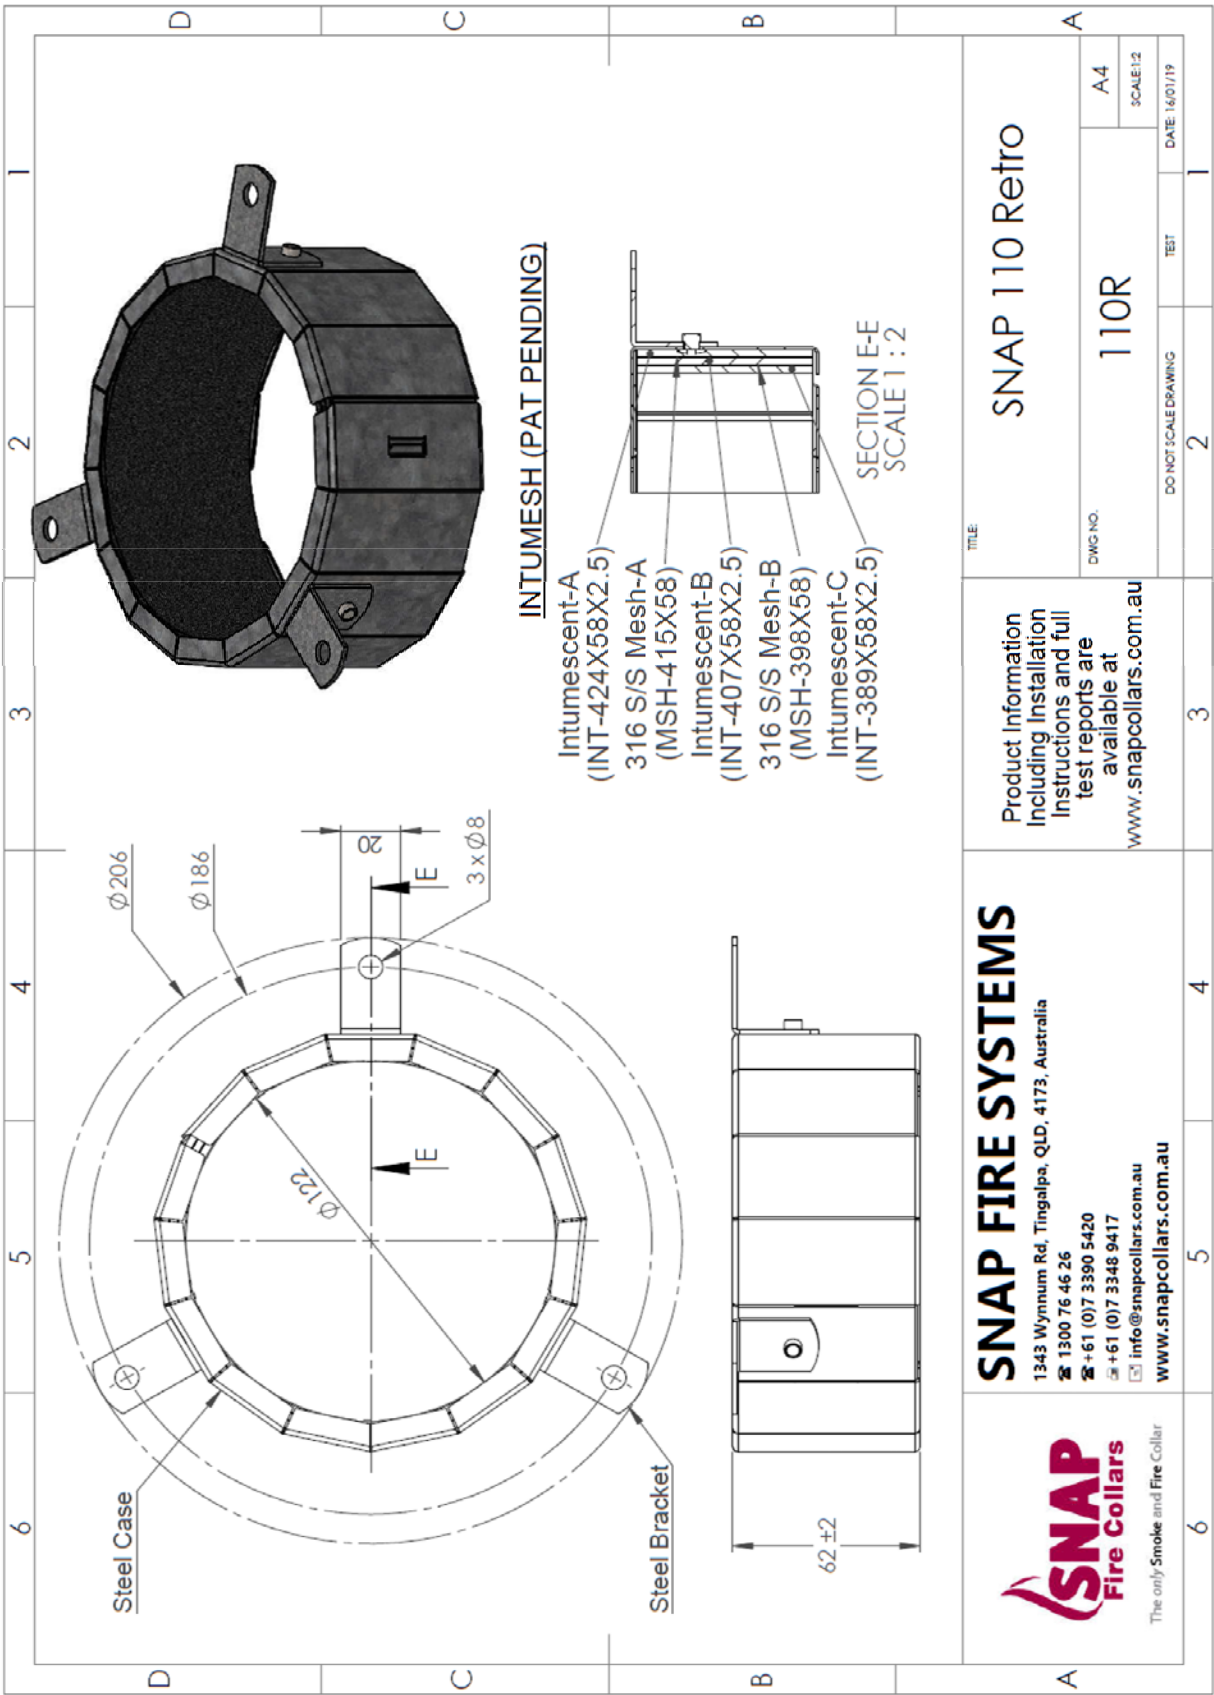
DRAWING NUMBERED 110R, SNAP 110 RETRO, DATED 16 JANUARY 2019, BY SNAP FIRE SYSTEMS PTY LTD.
