# Fire-resistance test on fire collars protecting a plasterboard wall penetrated by services

## Test Report

**Author:** Peter Gordon  
**Report number:** FSP 2090  
**Date:** 9 June 2020  
**Client:** IG6 Pty Ltd as trustee for the IG6 IP Trust

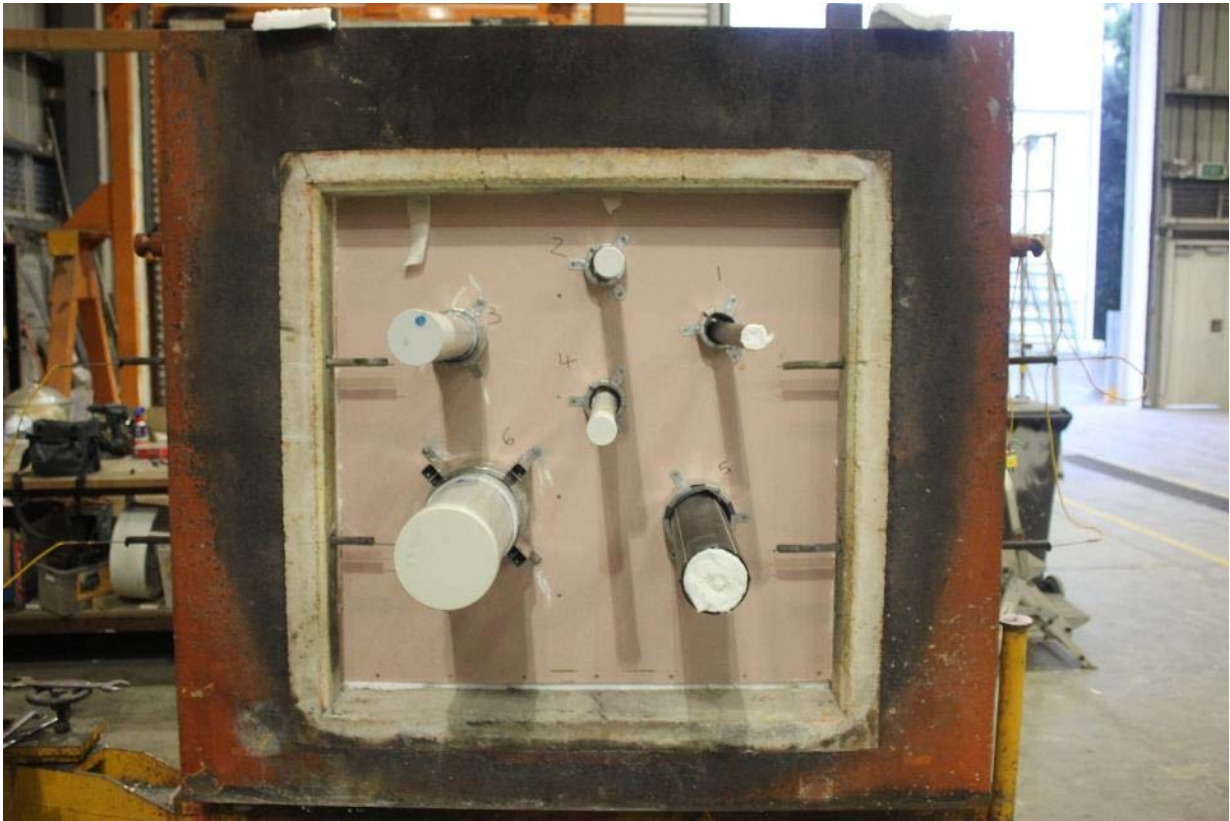
**PHOTOGRAPH 1 – EXPOSED FACE OF SPECIMENS PRIOR TO TESTING**

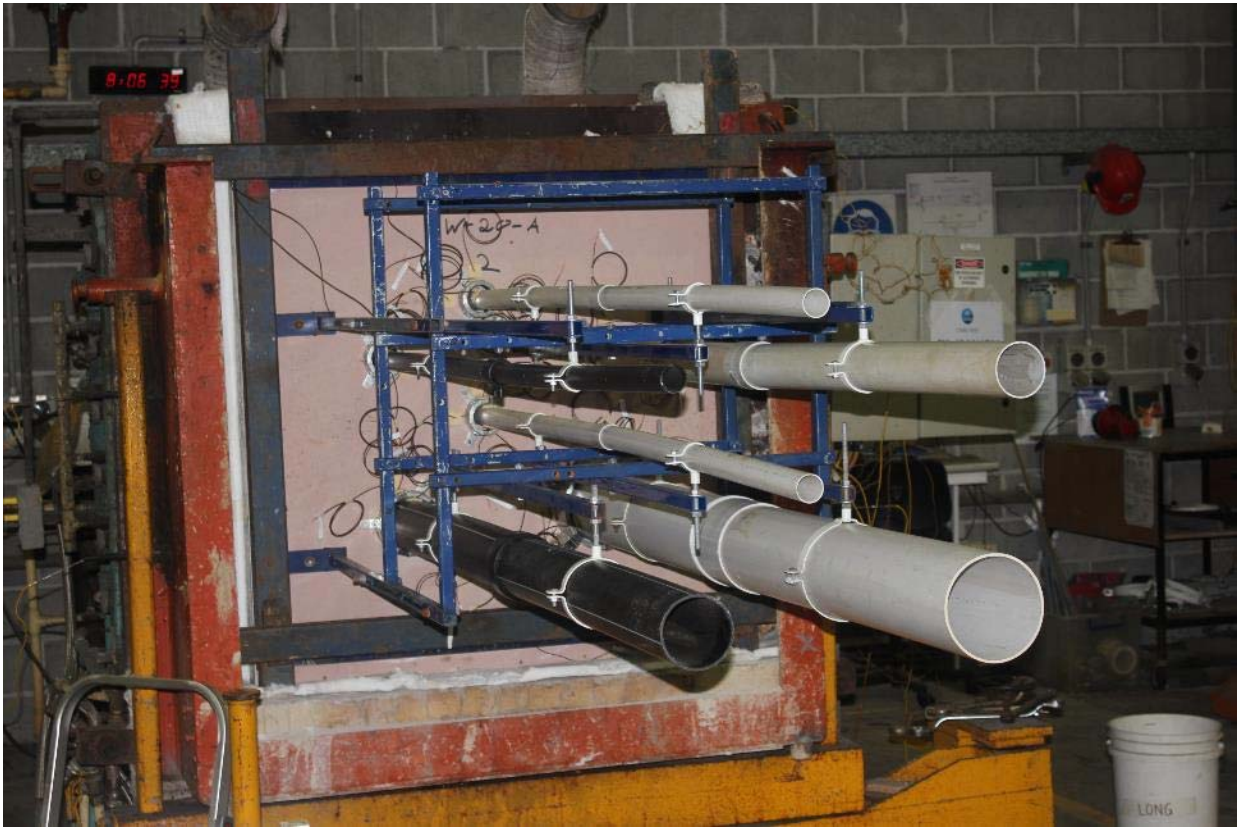
**PHOTOGRAPH 2 – UNEXPOSED FACE OF SPECIMENS PRIOR TO TESTING**

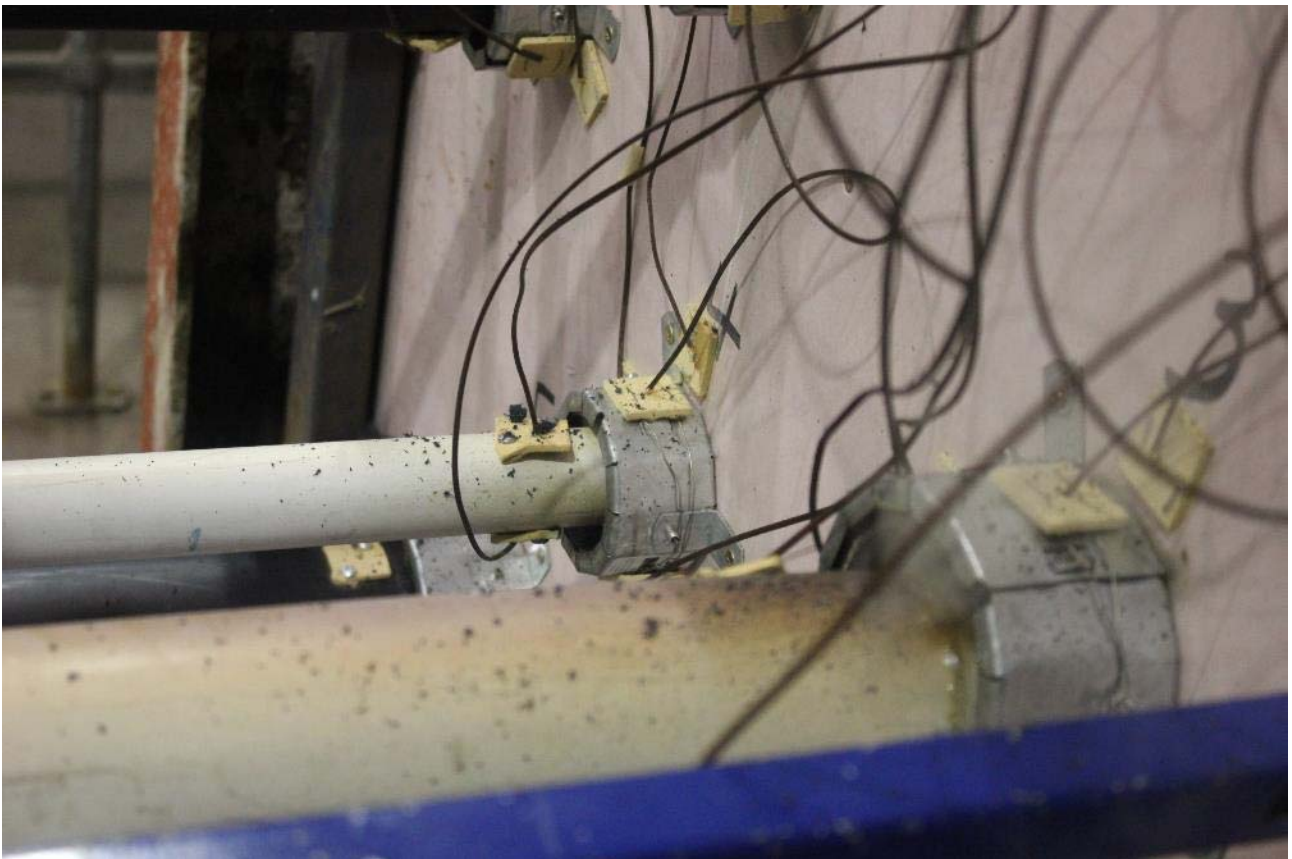
**PHOTOGRAPH 6 – SPECIMENS 3 AND 4 AFTER 49 MINUTES OF TESTING**

23 minutes -	Smoke has resumed being emitted between the collar and pipe of Specimens 1, 2 and 3.
47 minutes -	The base of the pipe of Specimen 4 has begun to discolour. (Photograph 6).
61 minutes -	The base of the pipe of Specimen 2 continues to discolour. (Photograph 7).

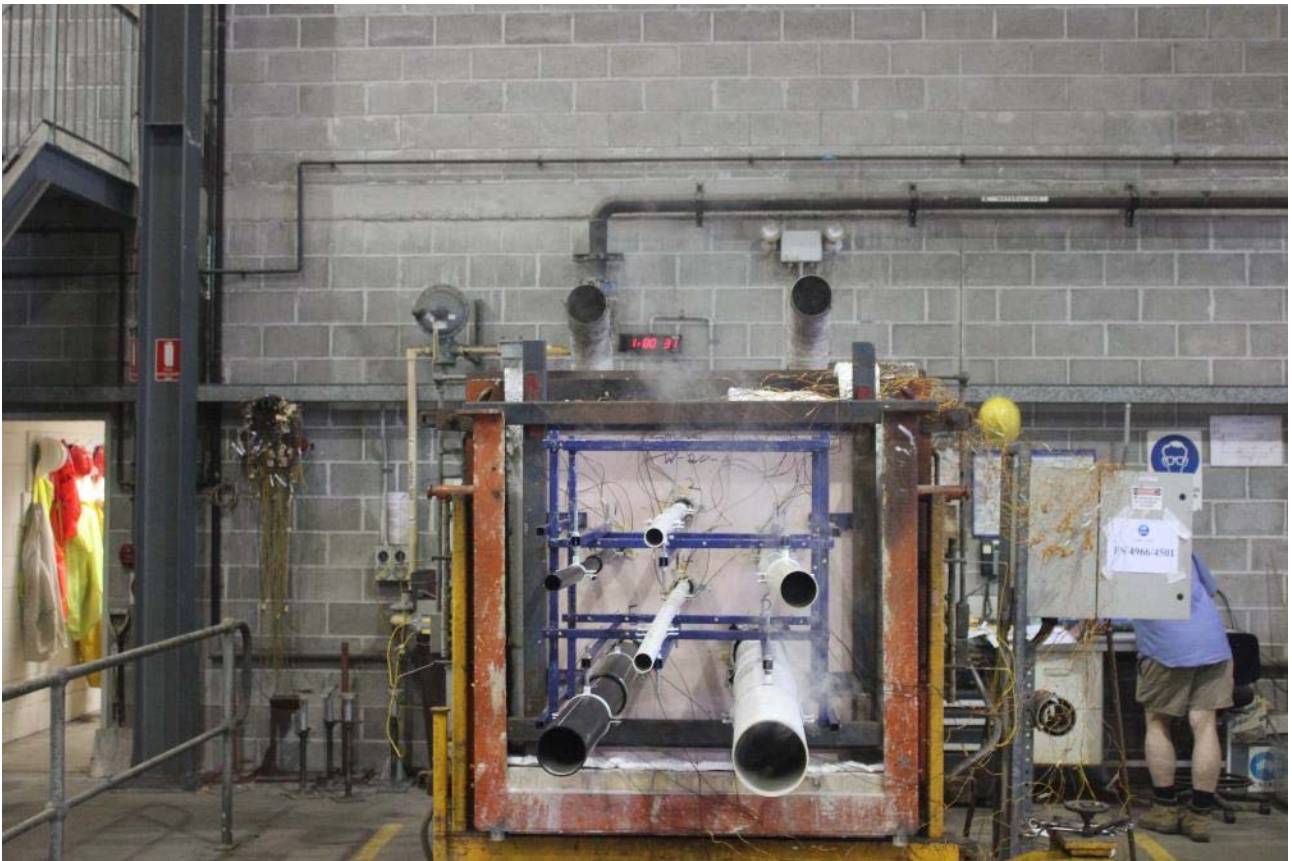
**PHOTOGRAPH 7 – SPECIMENS AFTER 60 MINUTES OF TESTING**

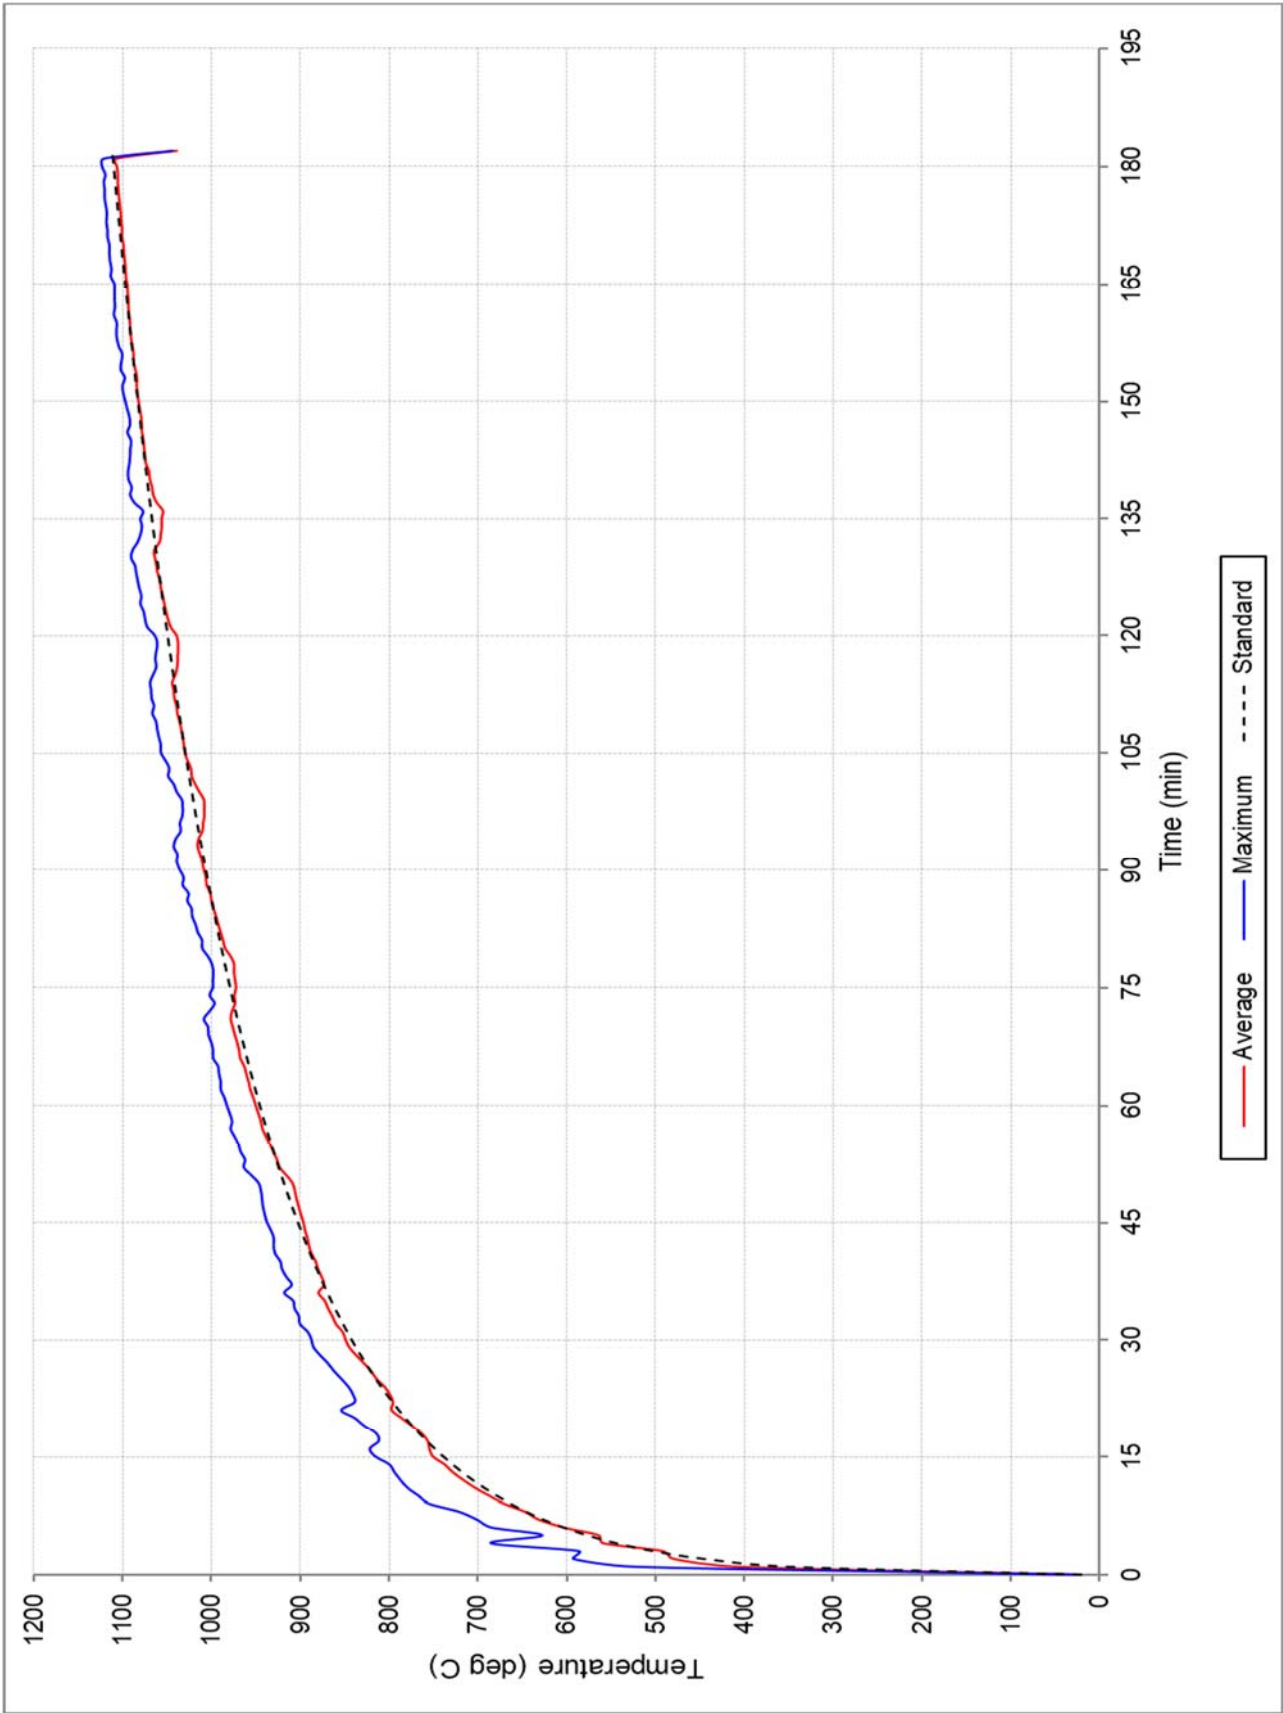
FIGURE 1 – FURNACE TEMPERATURE

Figure 1 shows the standard curves of temperature versus time for heating the furnace chamber and the actual curves of average and maximum temperature versus time recorded during the heating period.

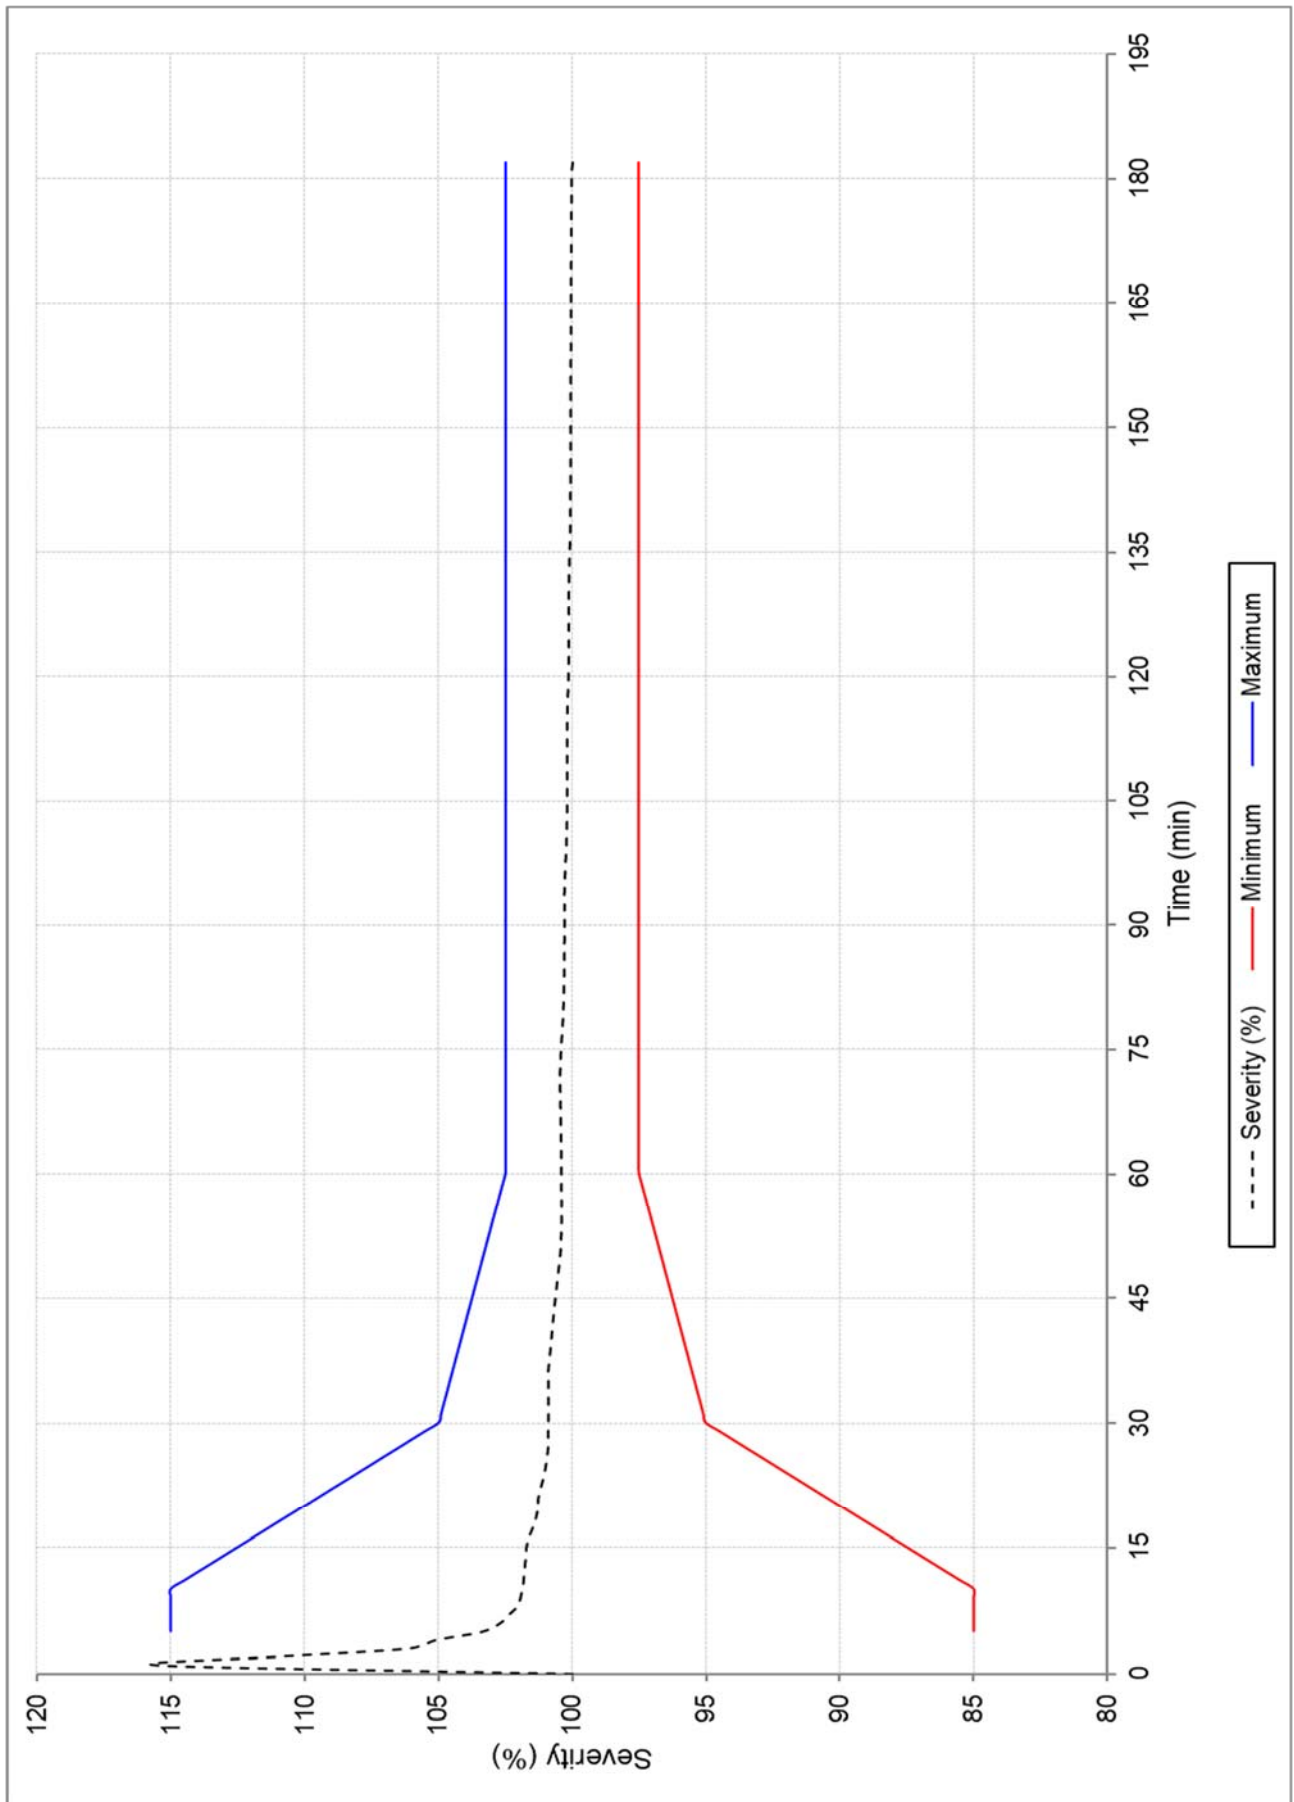
FIGURE 2 – FURNACE SEVERITY

Figure 2 shows the curve of furnace severity versus time during the heating period.

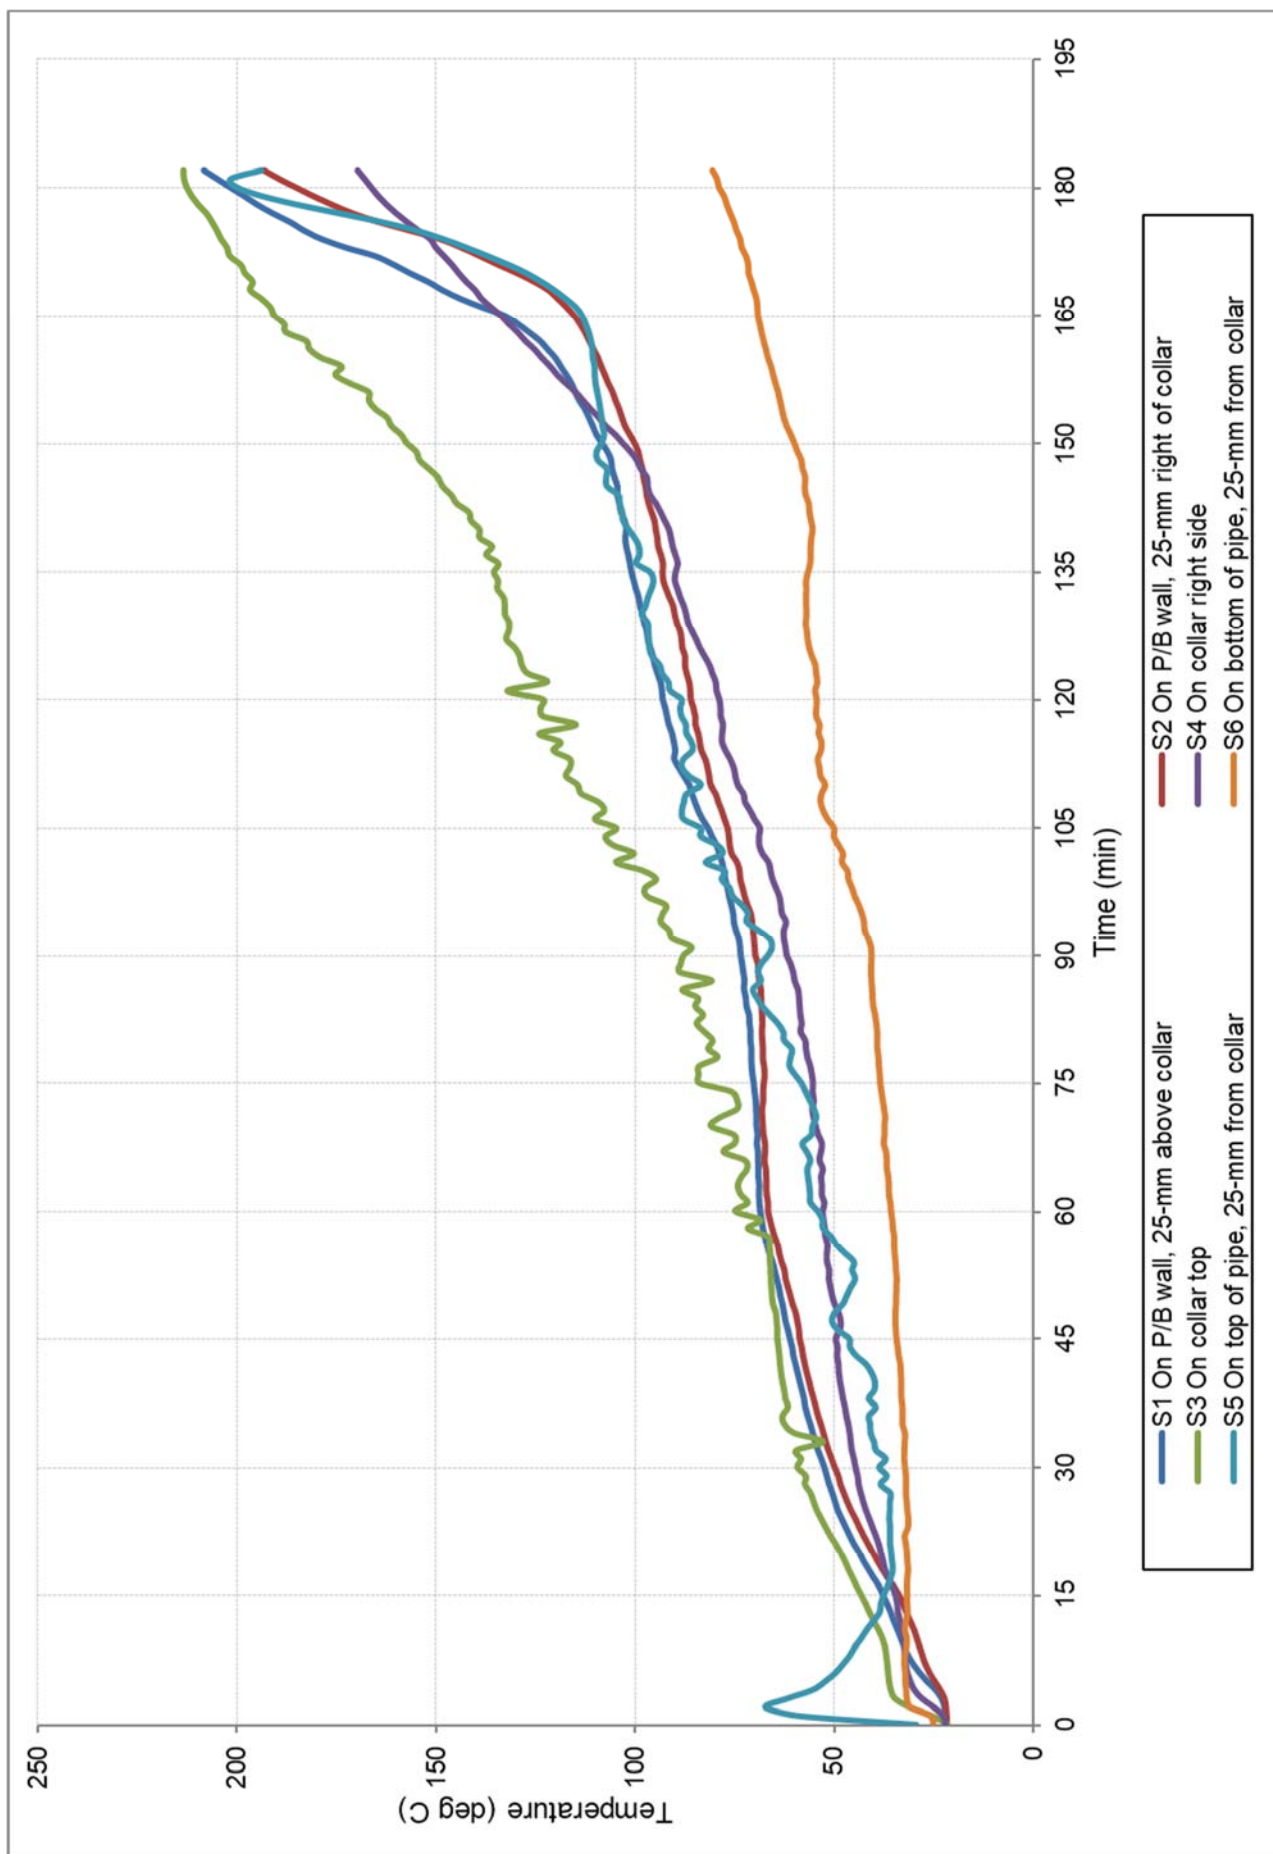
FIGURE 3 - TEMPERATURE VERSUS TIME ASSOCIATED WITH SPECIMEN #1

- 172minutes - Insulation Failure of Specimen 1 – maximum temperature rise of 180K is exceeded on the top of collar 25-mm from the wall of Specimen 1.
- 175 minutes - Intumescent material has filled the inside of collars of all specimens.

Figure 3 shows the curve of temperature versus time associated with Specimen 1.

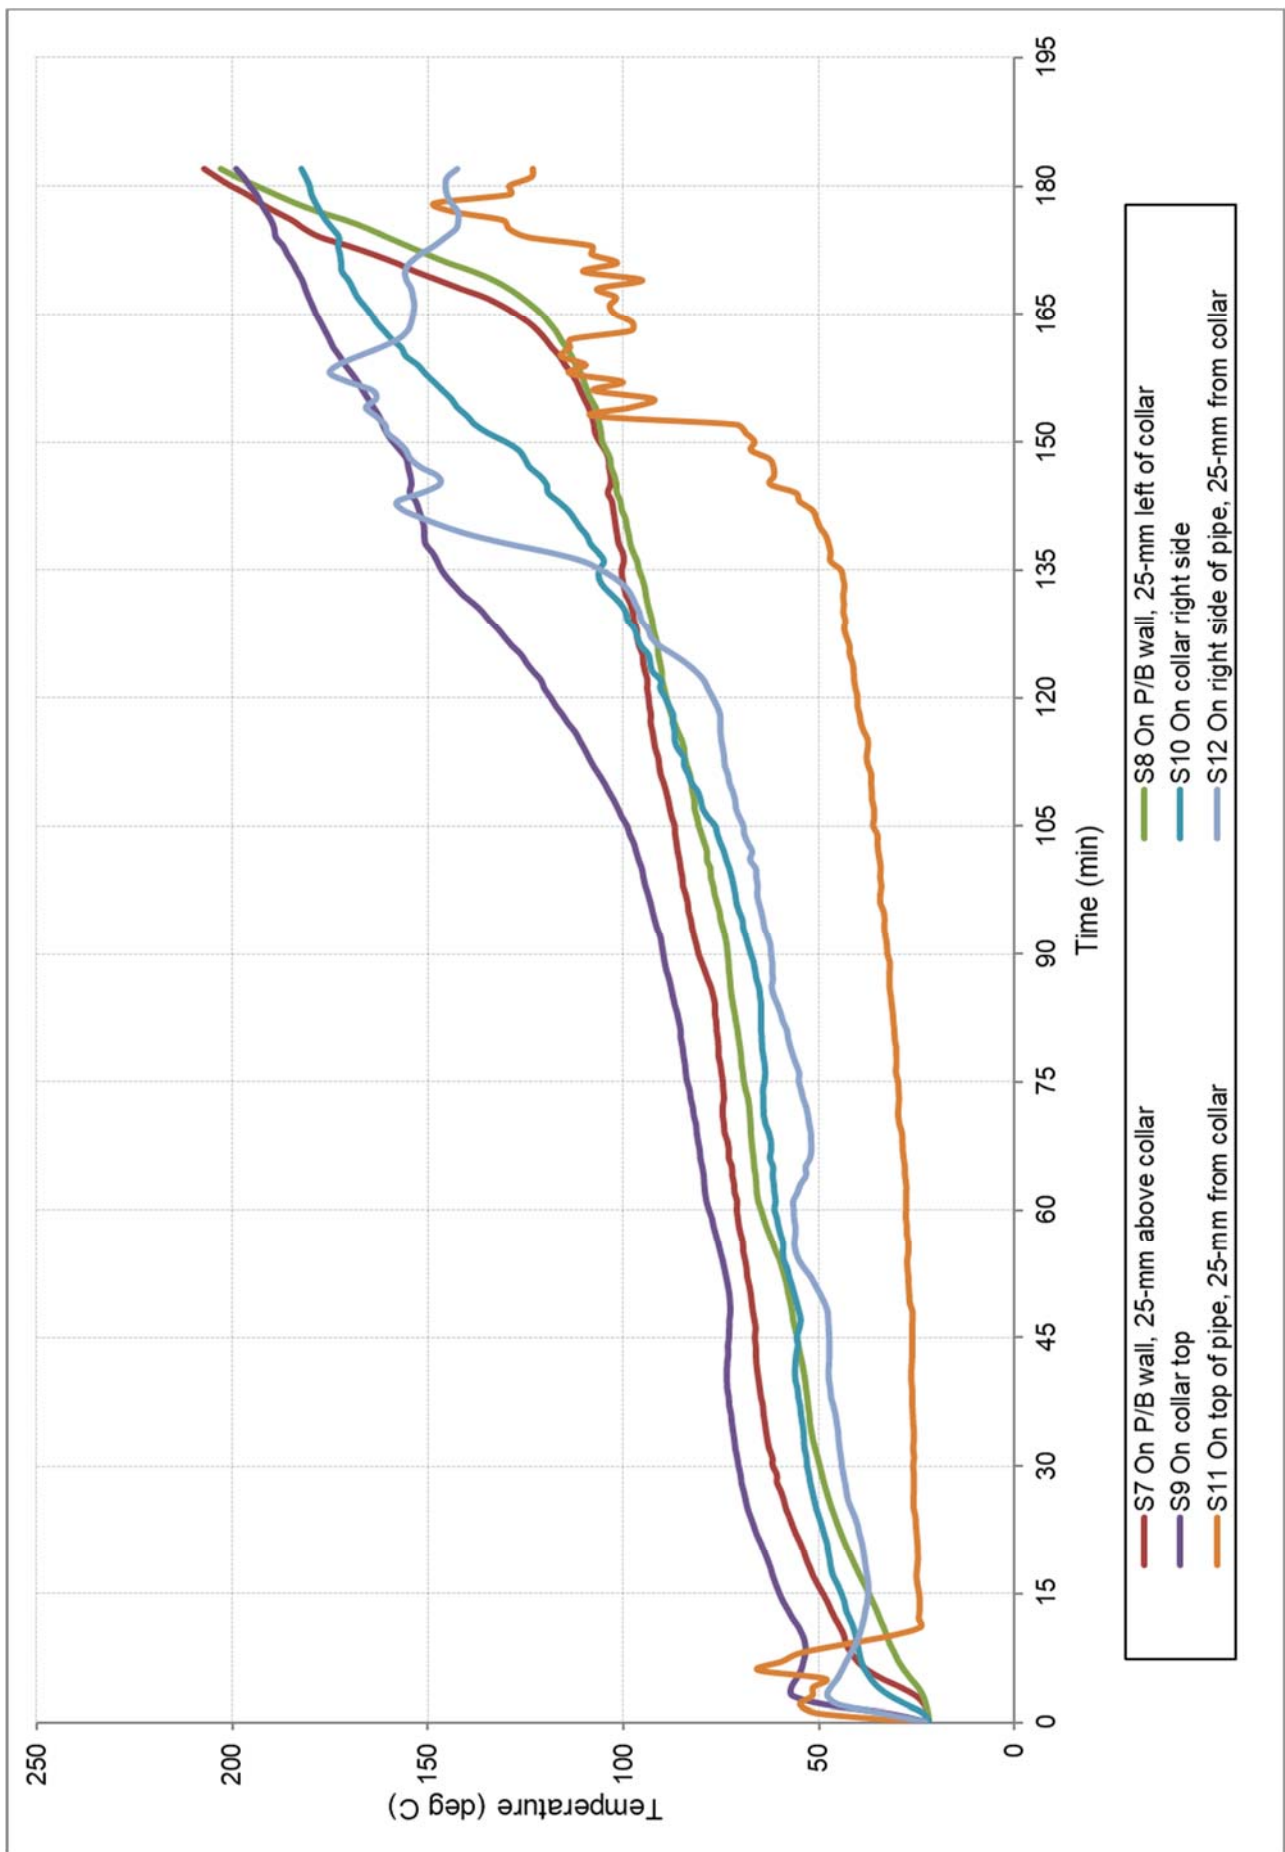
FIGURE 4 - TEMPERATURE VERSUS TIME ASSOCIATED WITH SPECIMEN #2

- 181 minutes - Insulation Failure of Specimen 2 – maximum temperature rise of 180K is exceeded on the plasterboard wall 25-mm above the collar of Specimen 2.  
Test terminated.

Figure 4 shows the curve of temperature versus time associated with Specimen 2.

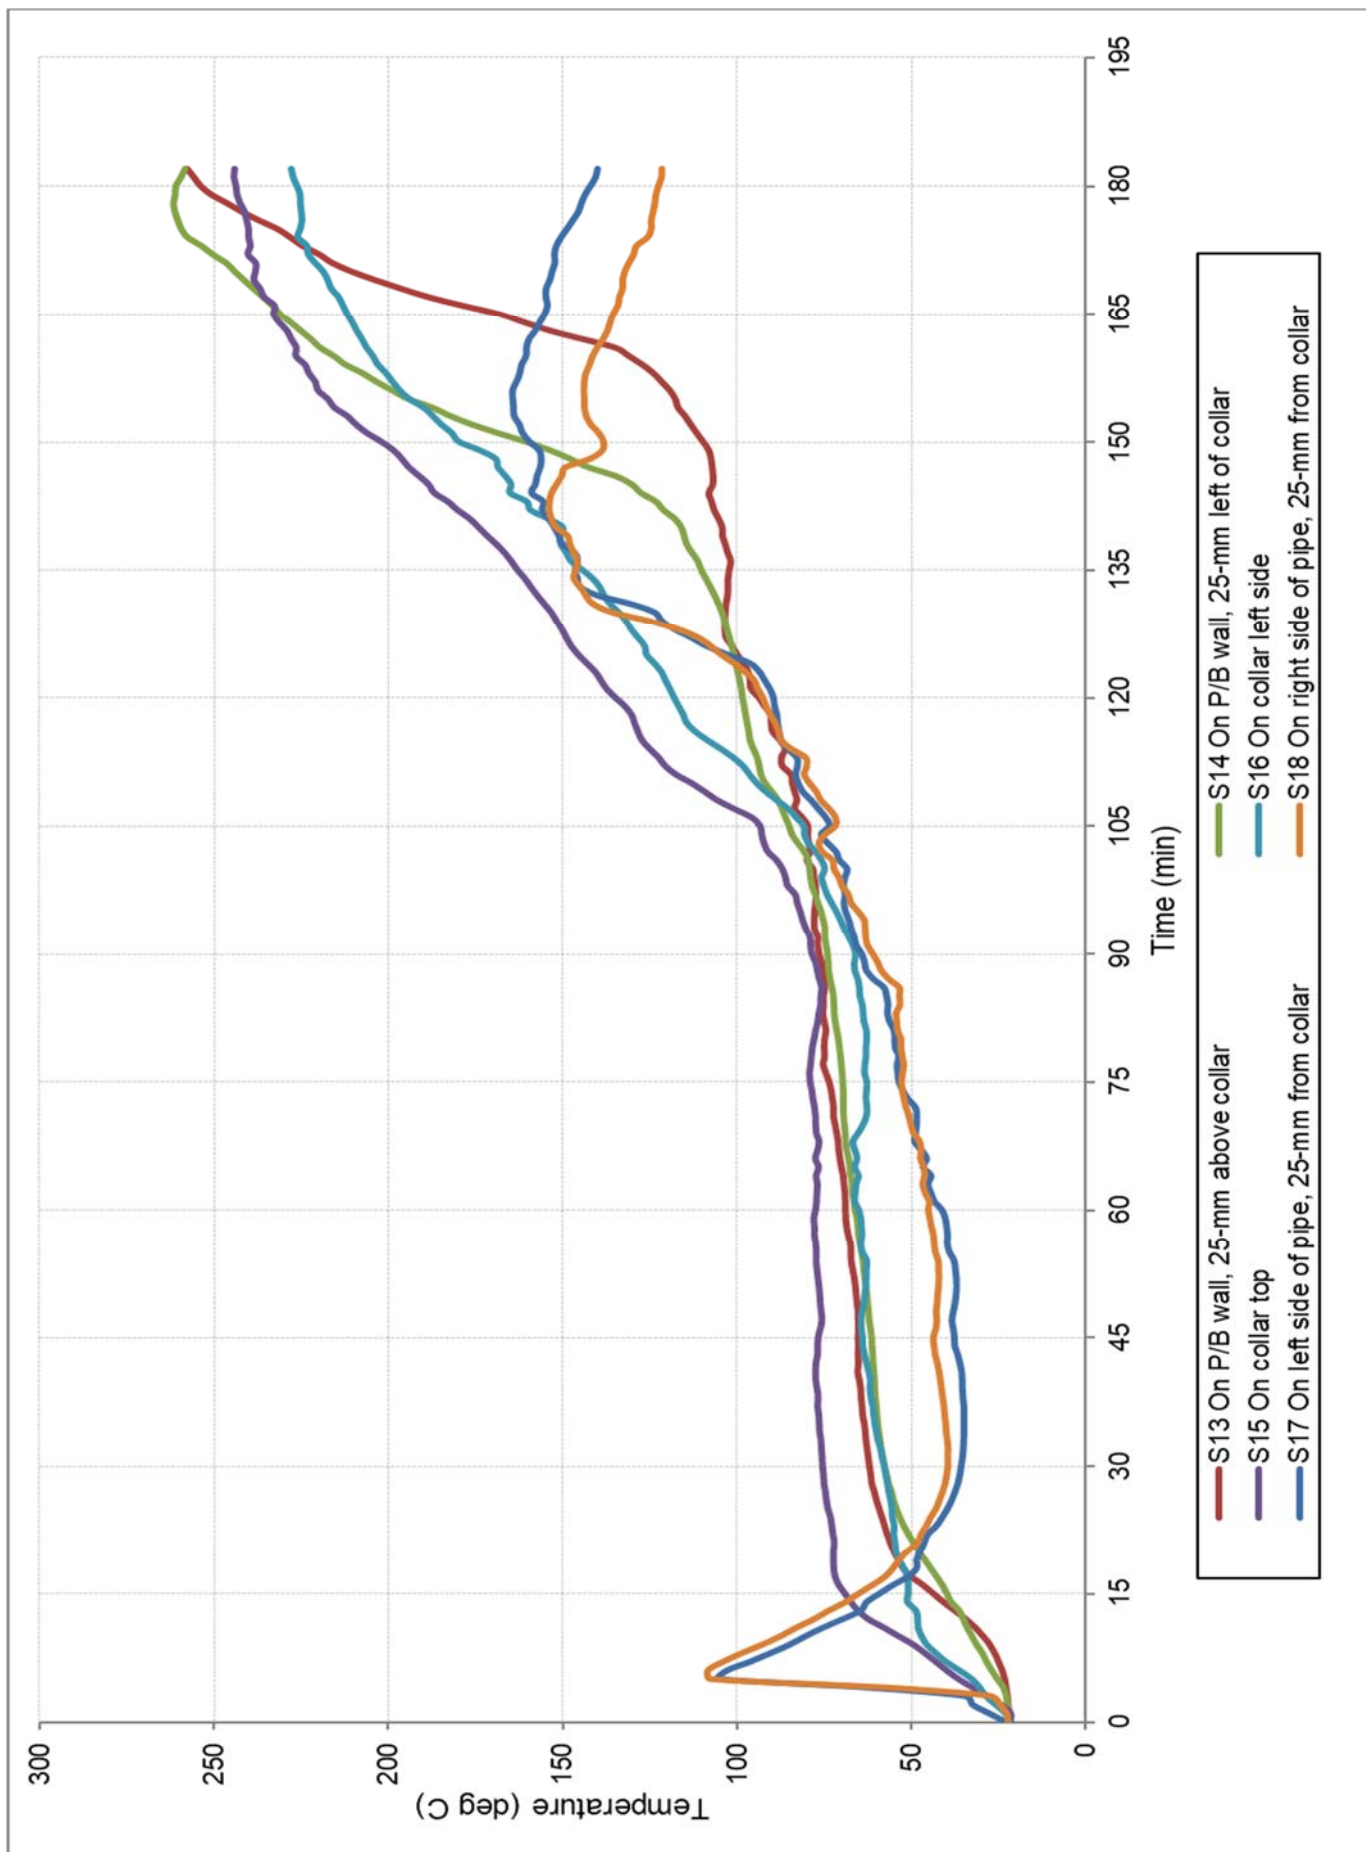
FIGURE 5 - TEMPERATURE VERSUS TIME ASSOCIATED WITH SPECIMEN #3

- 150 minutes - Insulation Failure of Specimen 3 – maximum temperature rise of 180K is exceeded on the top of collar 25-mm from the wall of Specimen 3.

Figure 5 shows the curve of temperature versus time associated with Specimen 3.

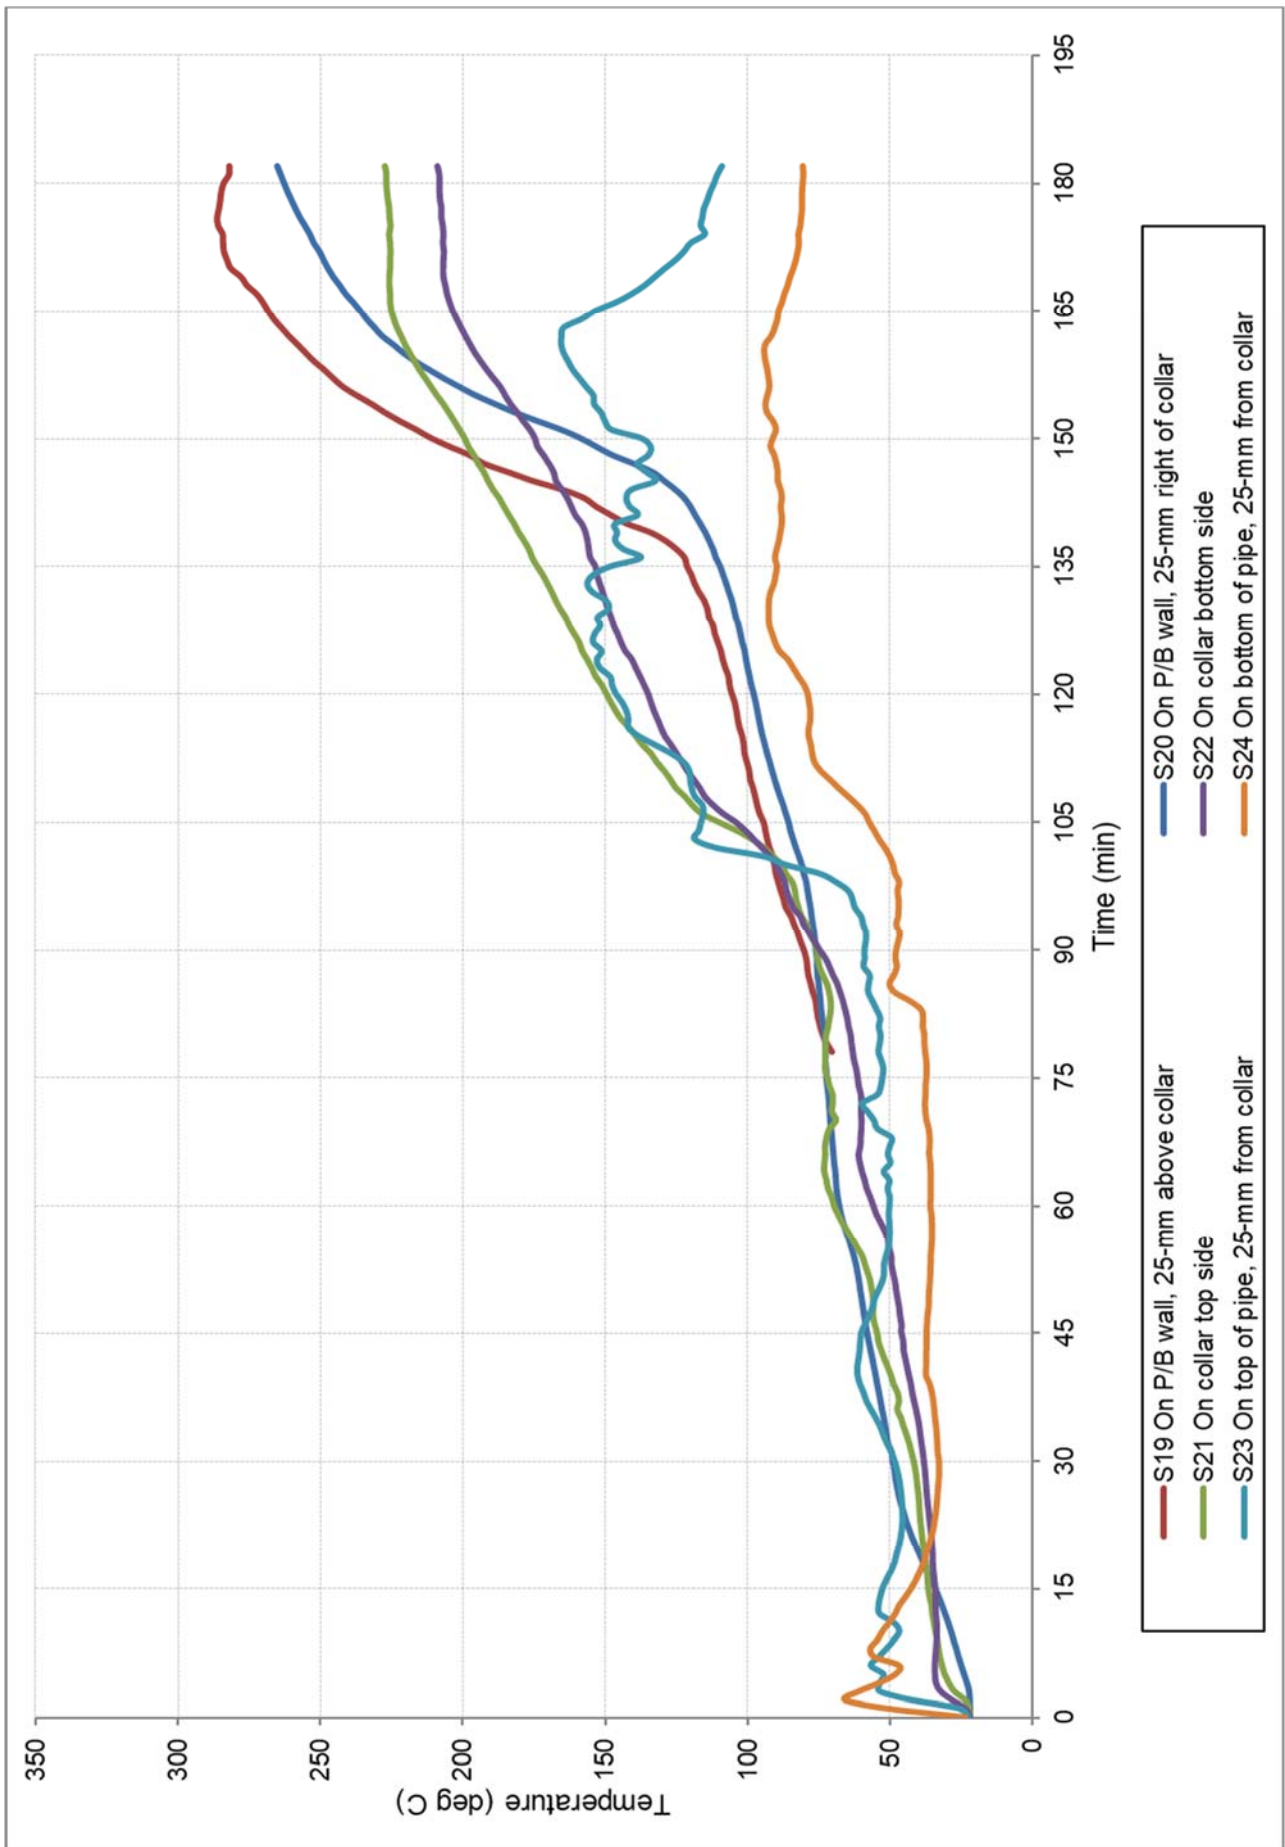
FIGURE 6 - TEMPERATURE VERSUS TIME ASSOCIATED WITH SPECIMEN #4

- 149 minutes - Insulation Failure of Specimen 4 – maximum temperature rise of 180K is exceeded on the plasterboard wall 25-mm above the collar of Specimen 4.

Figure 6 shows the curve of temperature versus time associated with Specimen 4.

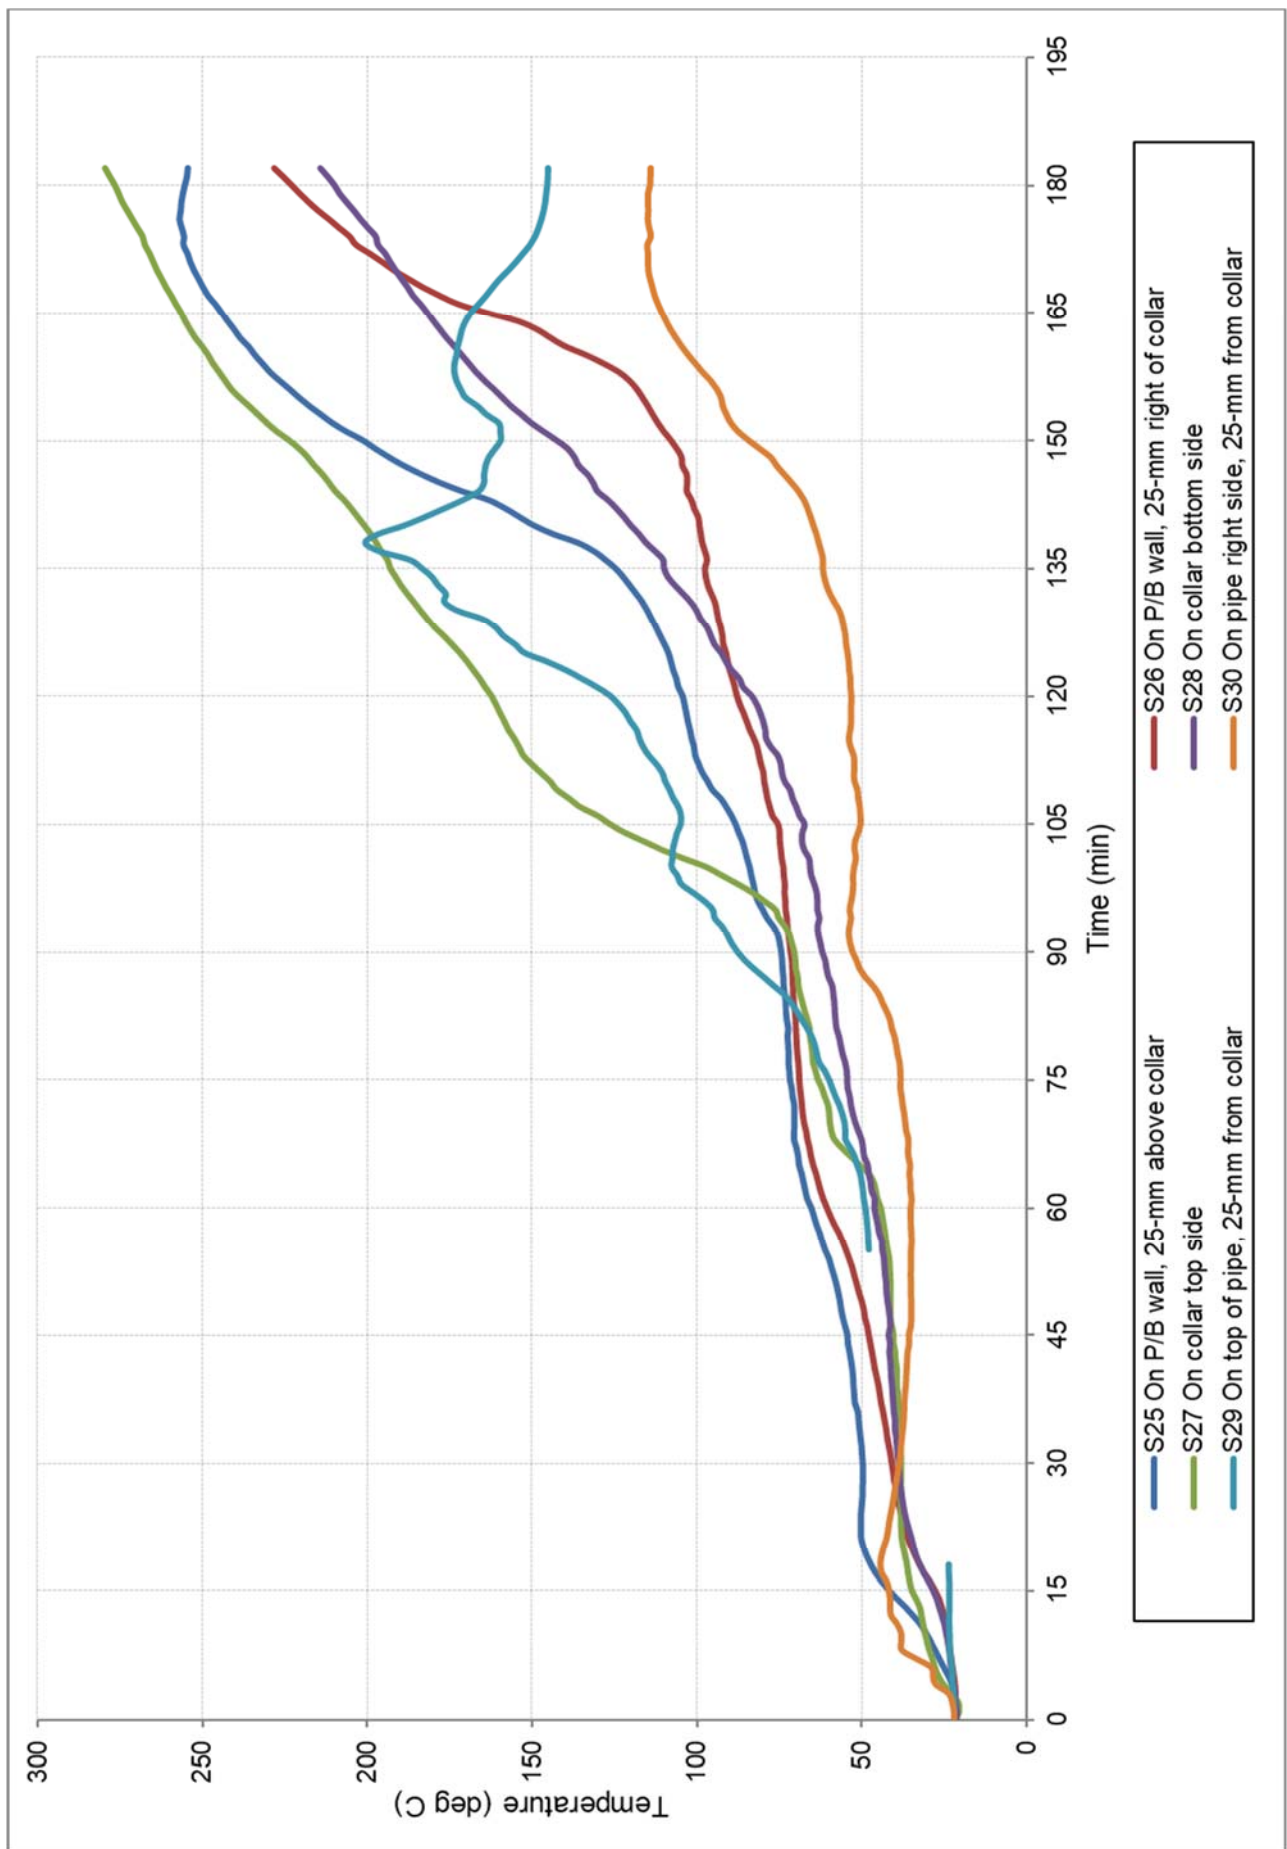
FIGURE 7 - TEMPERATURE VERSUS TIME ASSOCIATED WITH SPECIMEN #5

- 141 minutes - Insulation Failure of Specimen 5 – maximum temperature rise of 180K is exceeded on the top of collar 25-mm from the wall of Specimen 5.

Figure 7 shows the curve of temperature versus time associated with Specimen 5.
