# Fire-resistance test on fire collars protecting a plasterboard wall penetrated by services

## Test Report

**Author:** Peter Gordon  
**Report number:** FSP 2090  
**Date:** 9 June 2020  
**Client:** IG6 Pty Ltd as trustee for the IG6 IP Trust

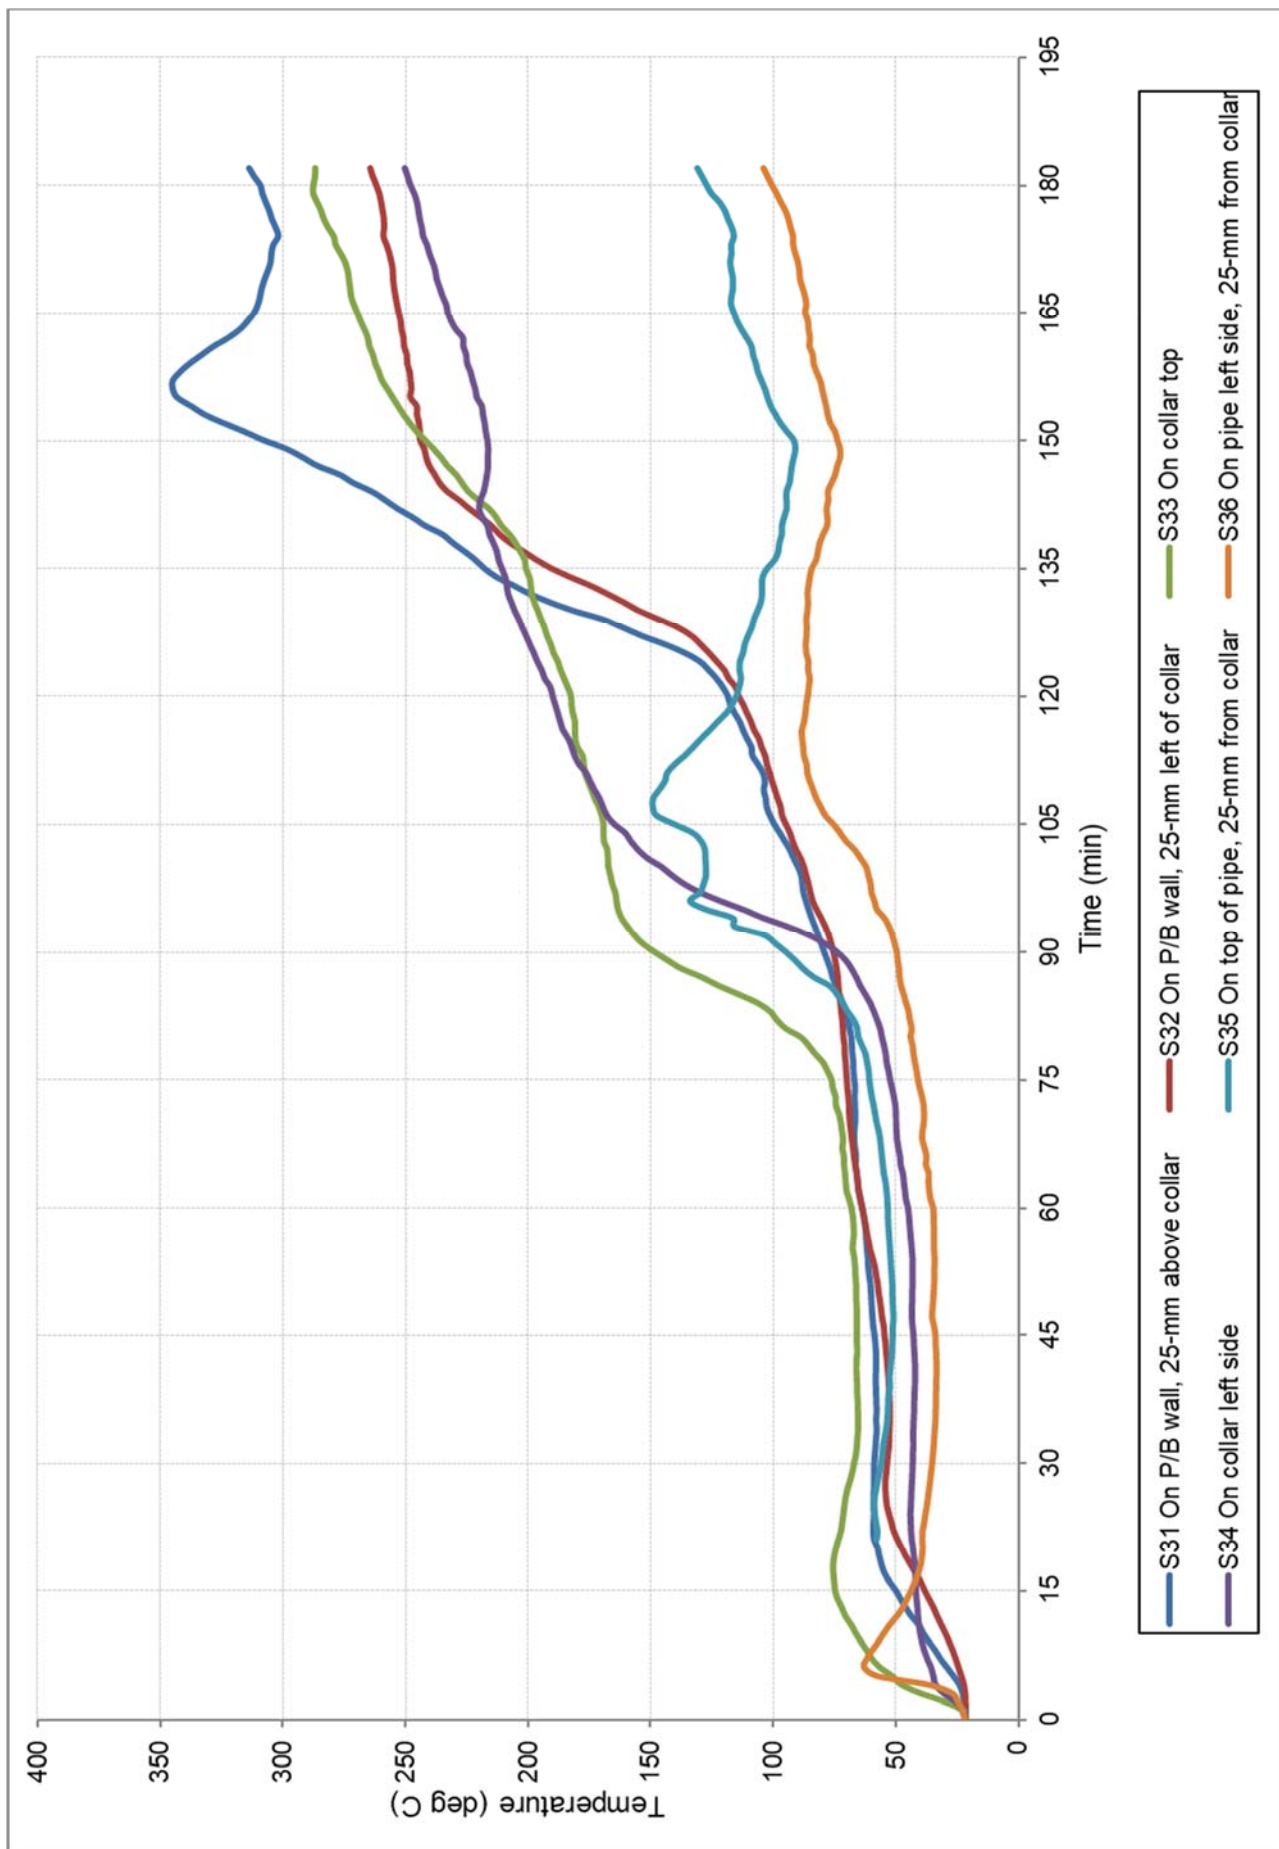
FIGURE 8 - TEMPERATURE VERSUS TIME ASSOCIATED WITH SPECIMEN #6

- 128 minutes - Insulation Failure of Specimen 6 – maximum temperature rise of 180K is exceeded on the left side of collar 25-mm from the wall of Specimen 6.

Figure 8 shows the curve of temperature versus time associated with Specimen 6.

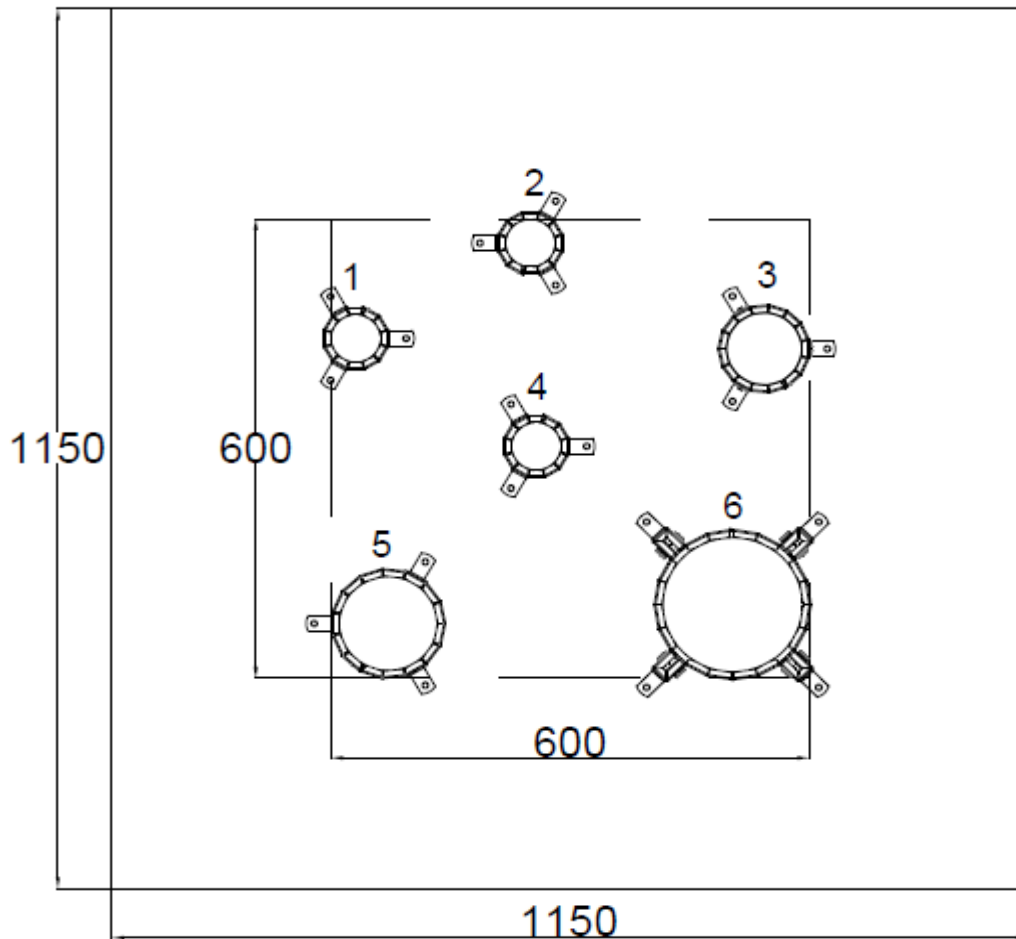
Test Wall W-20-A Layout

Penetration	Collar Code	Pipe Type	Pipe Diameter (mm)
1	50R	HDPE	40
2	50R	PVC	40
3	65-80R	PVC	80
4	50R	PVC	40
5	110R	HDPE	110
6	HP150R	PVC-SC	150

**DRAWING TITLED "TEST WALL W-20-A LAYOUT, DATED 28 JANUARY 2020, PROVIDED BY SNAP FIRE SYSTEMS PTY LTD.**

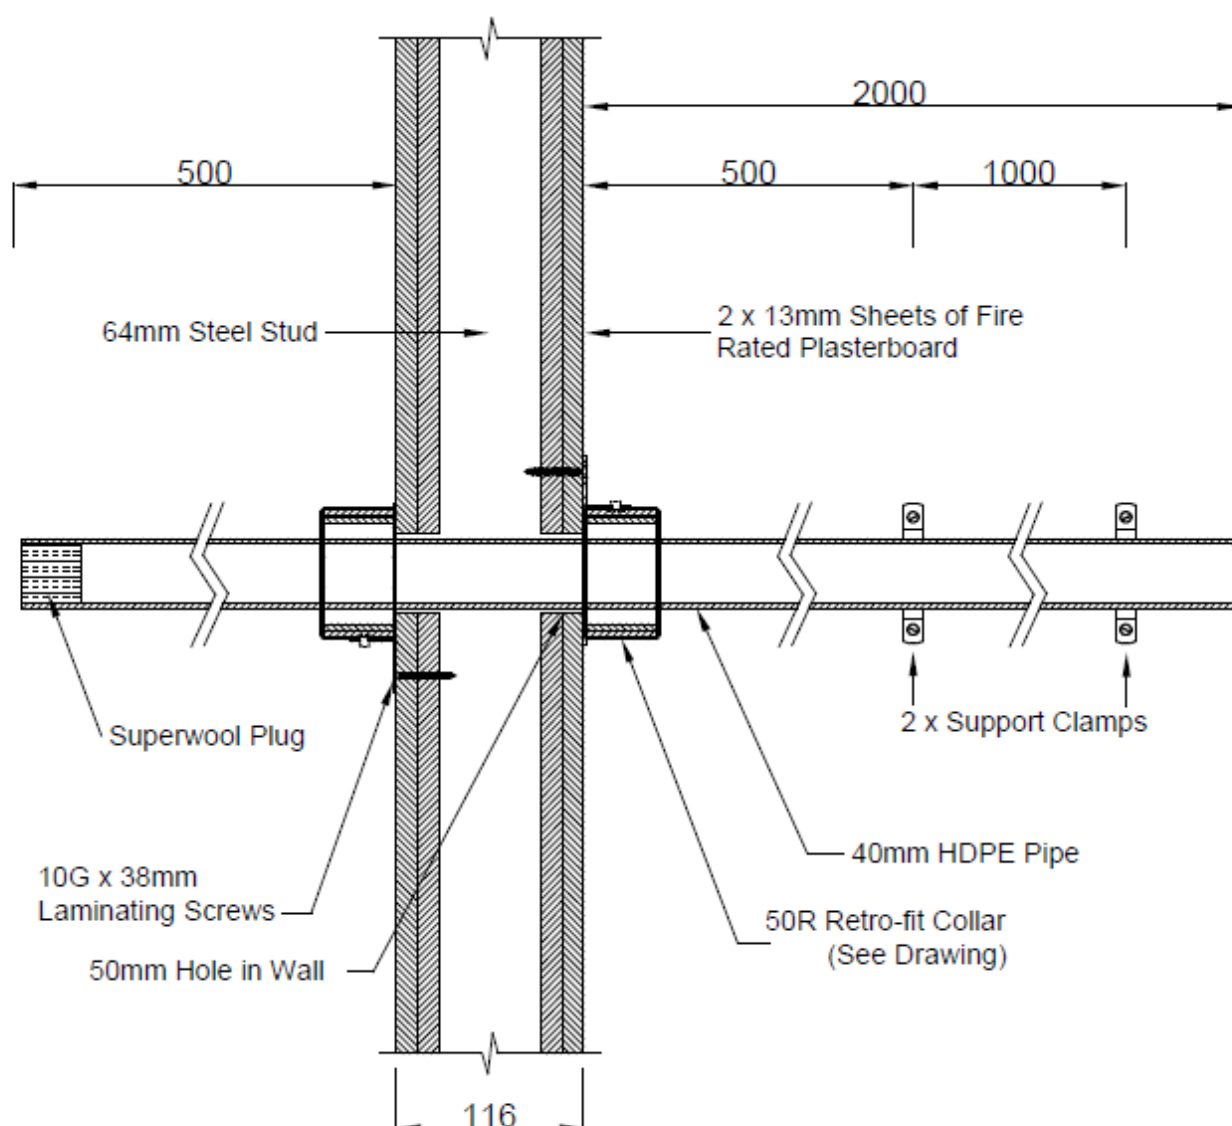
40 HDPE Stack & 50R

DRAWING TITLED "SPECIMEN #1, 40 HDPE STACK & 50R", DATED 29 JANUARY 2020, PROVIDED BY SNAP FIRE SYSTEMS PTY LTD

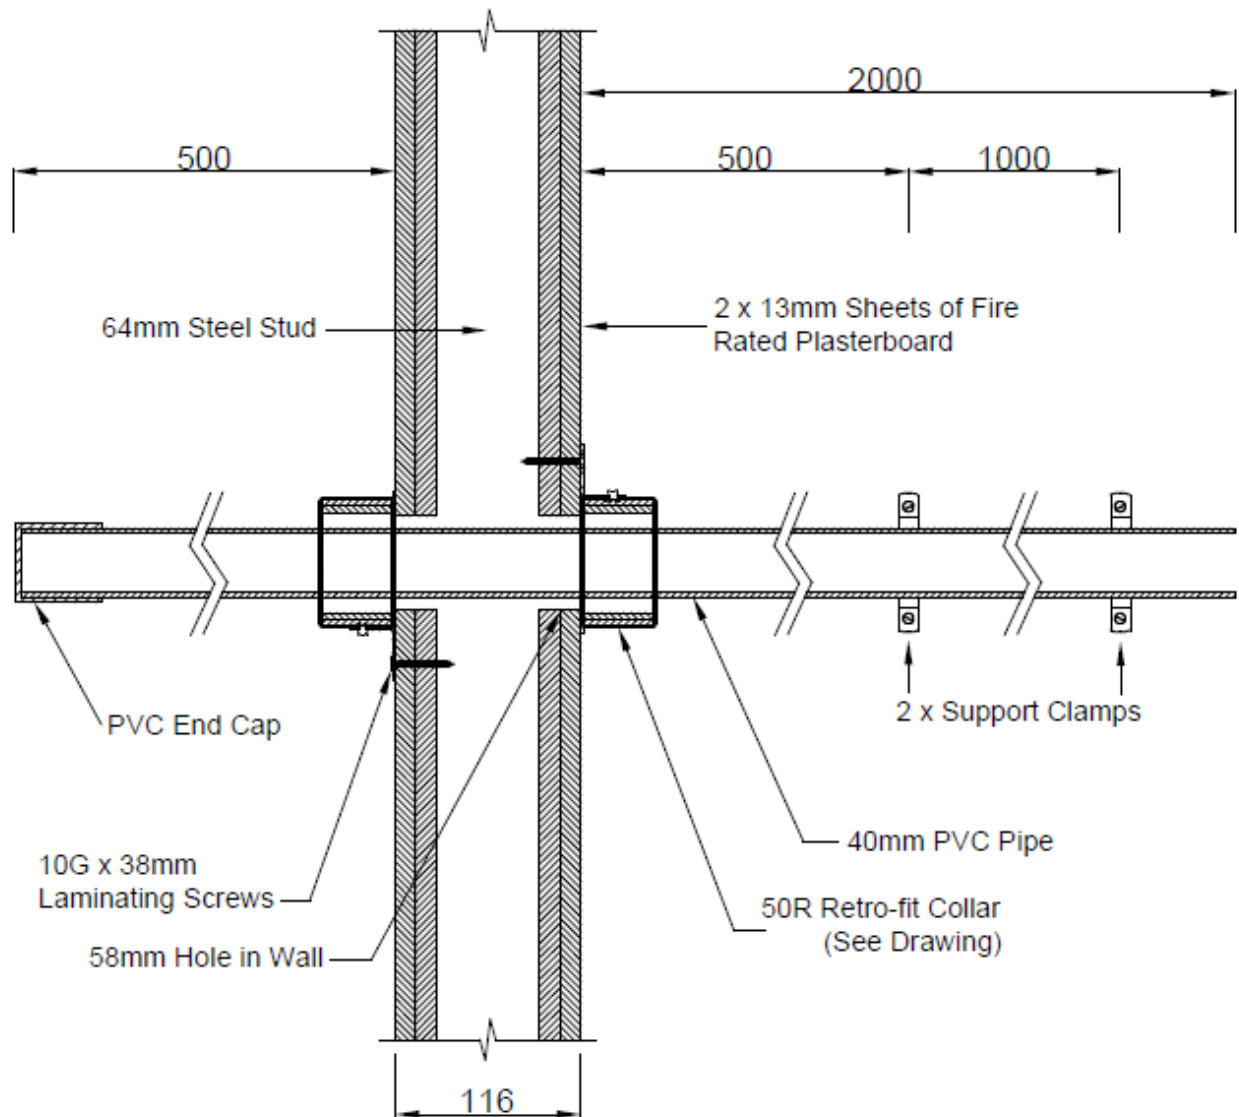
40 PVC Stack & 50R

DRAWING TITLED "SPECIMEN #2, 40 PVC STACK PIPE & 50R", DATED 29 JANUARY 2020, PROVIDED BY SNAP FIRE SYSTEMS PTY LTD

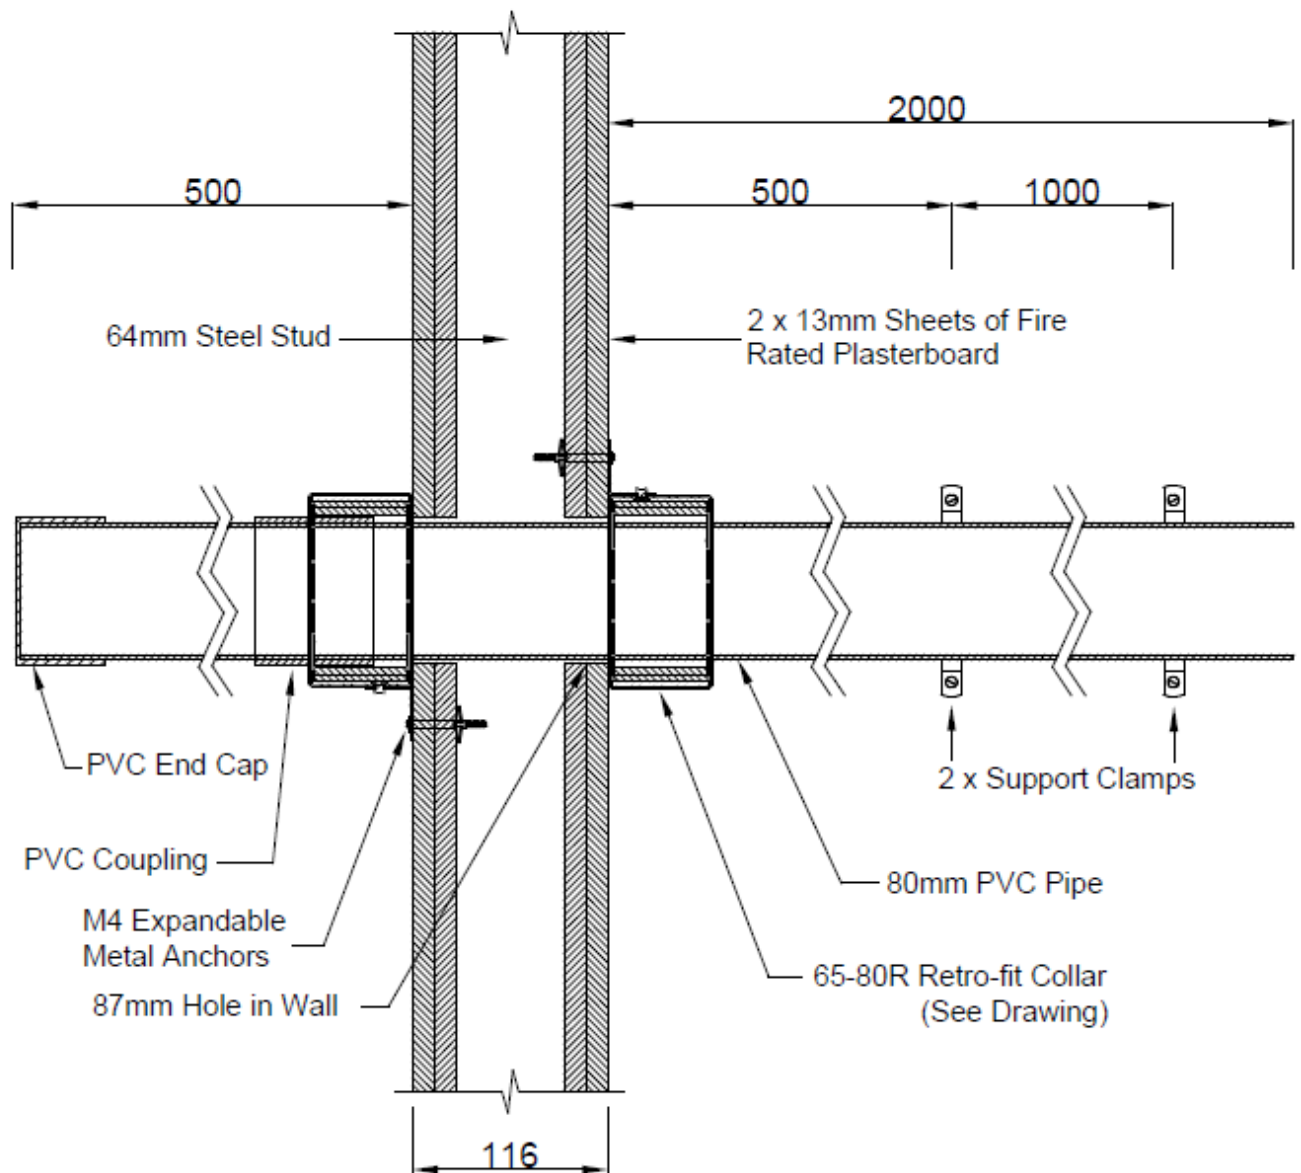
80 PVC Stack + Fitting & 65-80R

DRAWING TITLED "SPECIMEN #3 80 PVC STACK + FITTING & 65-80R", DATED 29 JANUARY 2020, PROVIDED BY  
SNAP FIRE SYSTEMS PTY LTD

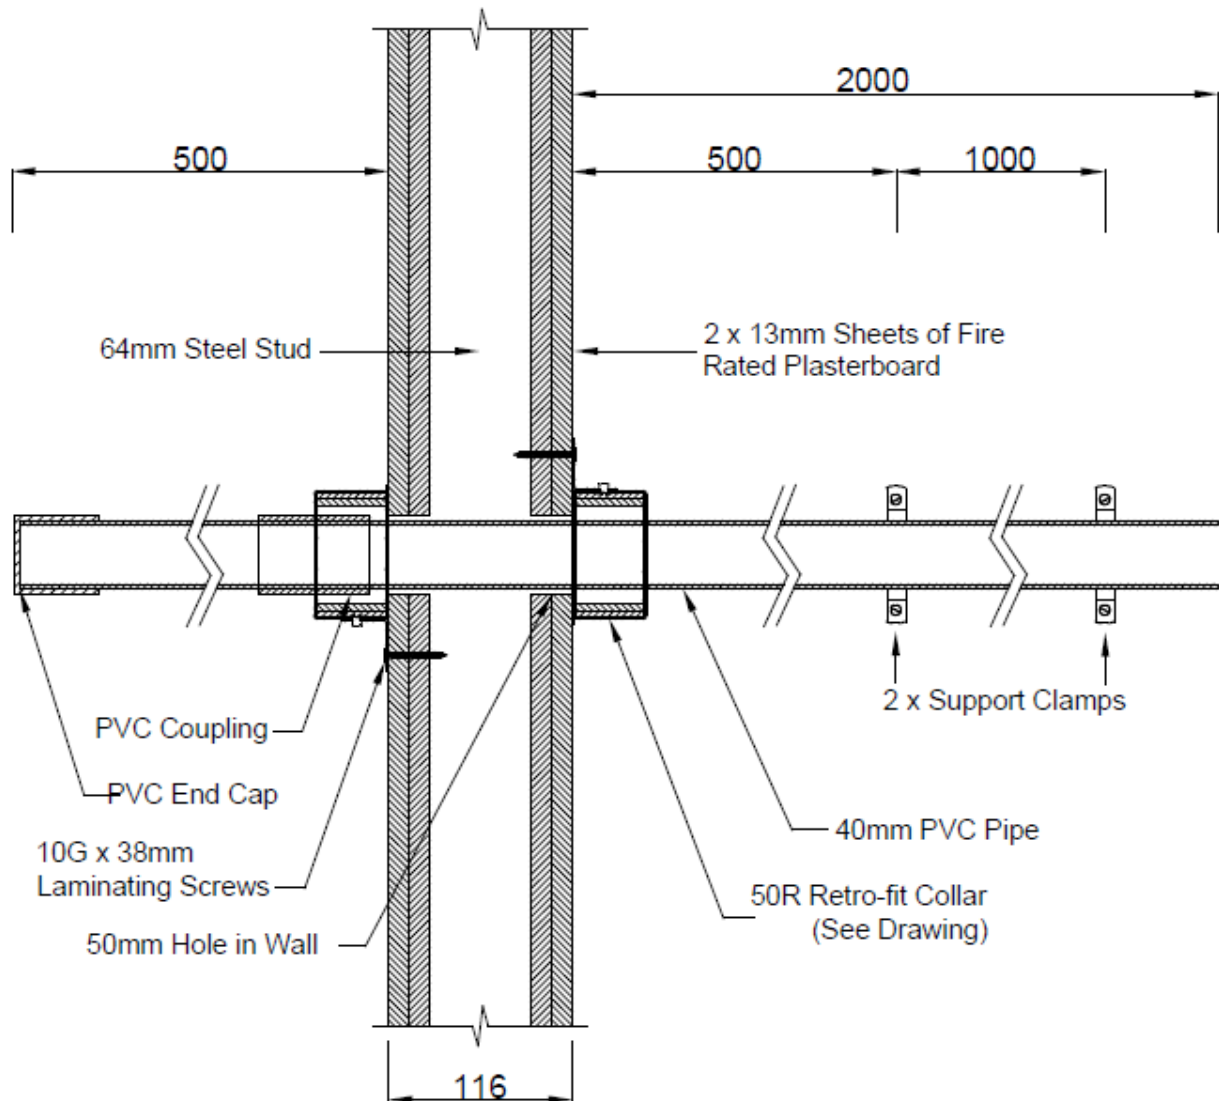
40 PVC Stack + Fitting & 50R

DRAWING TITLED "SPECIMEN #4, 40 PVC STACK + FITTING & 50R", DATED 29 JANUARY 2020, PROVIDED BY  
SNAP FIRE SYSTEMS PTY LTD

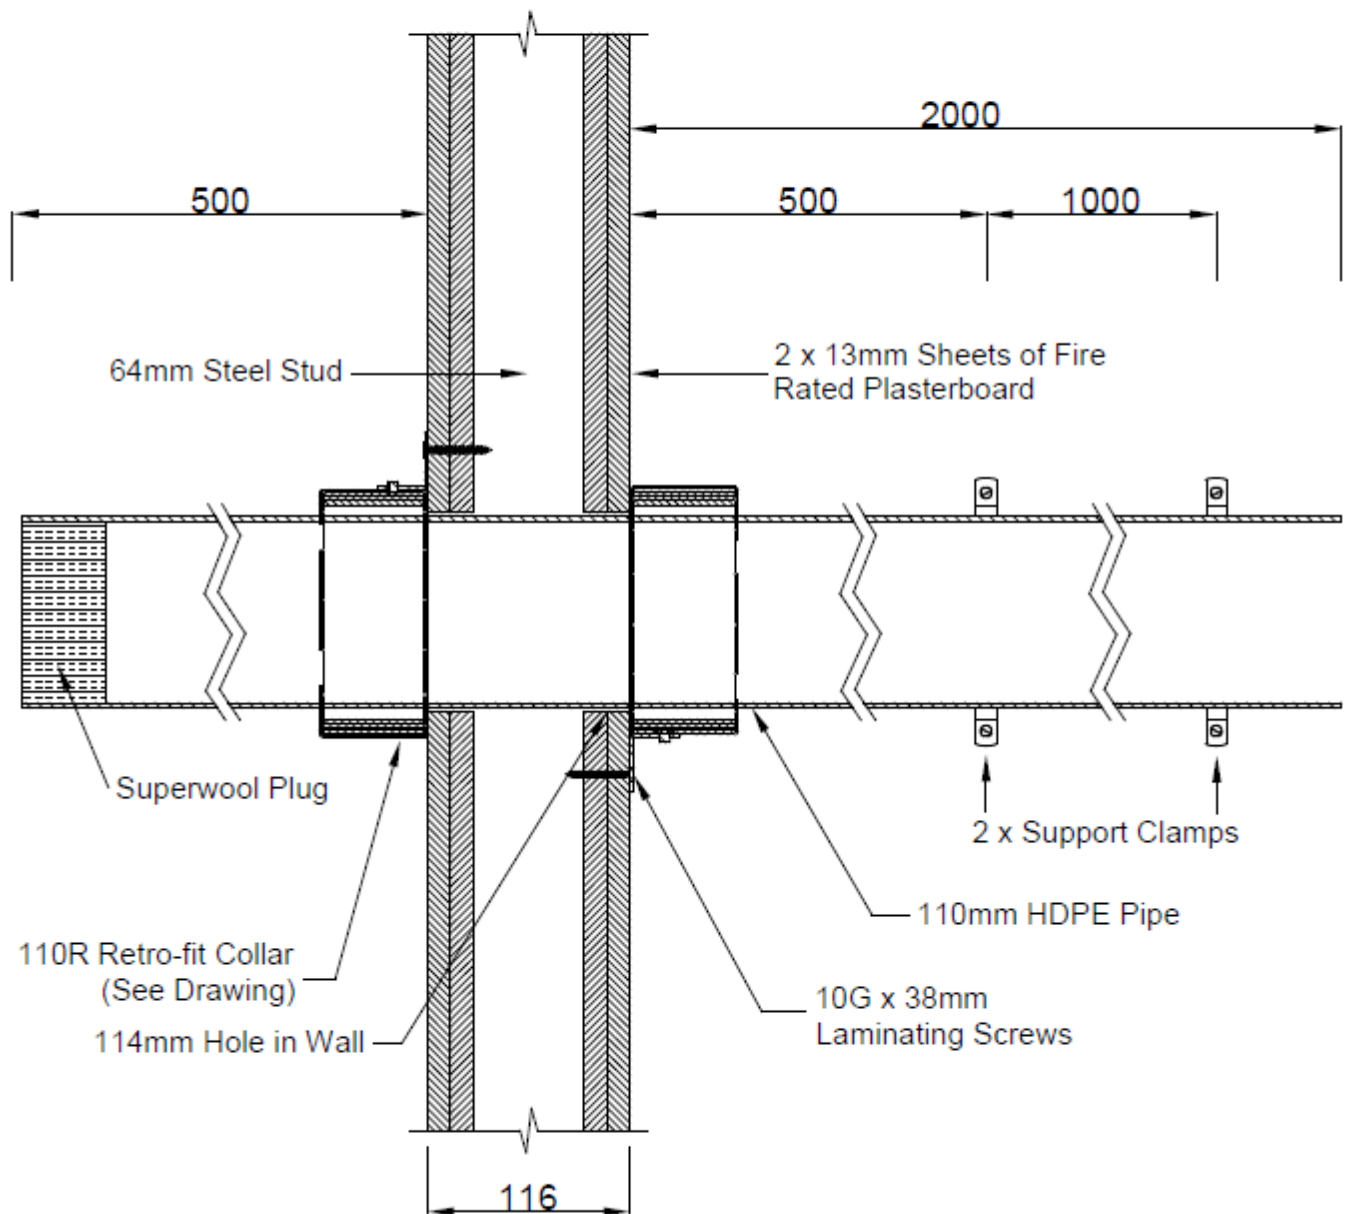
## 110 HDPE Stack & 110R

**DRAWING TITLED "SPECIMEN #5, 110 HDPE STACK & 110R", DATED 29 JANUARY 2020, PROVIDED BY SNAP  
FIRE SYSTEMS PTY LTD**

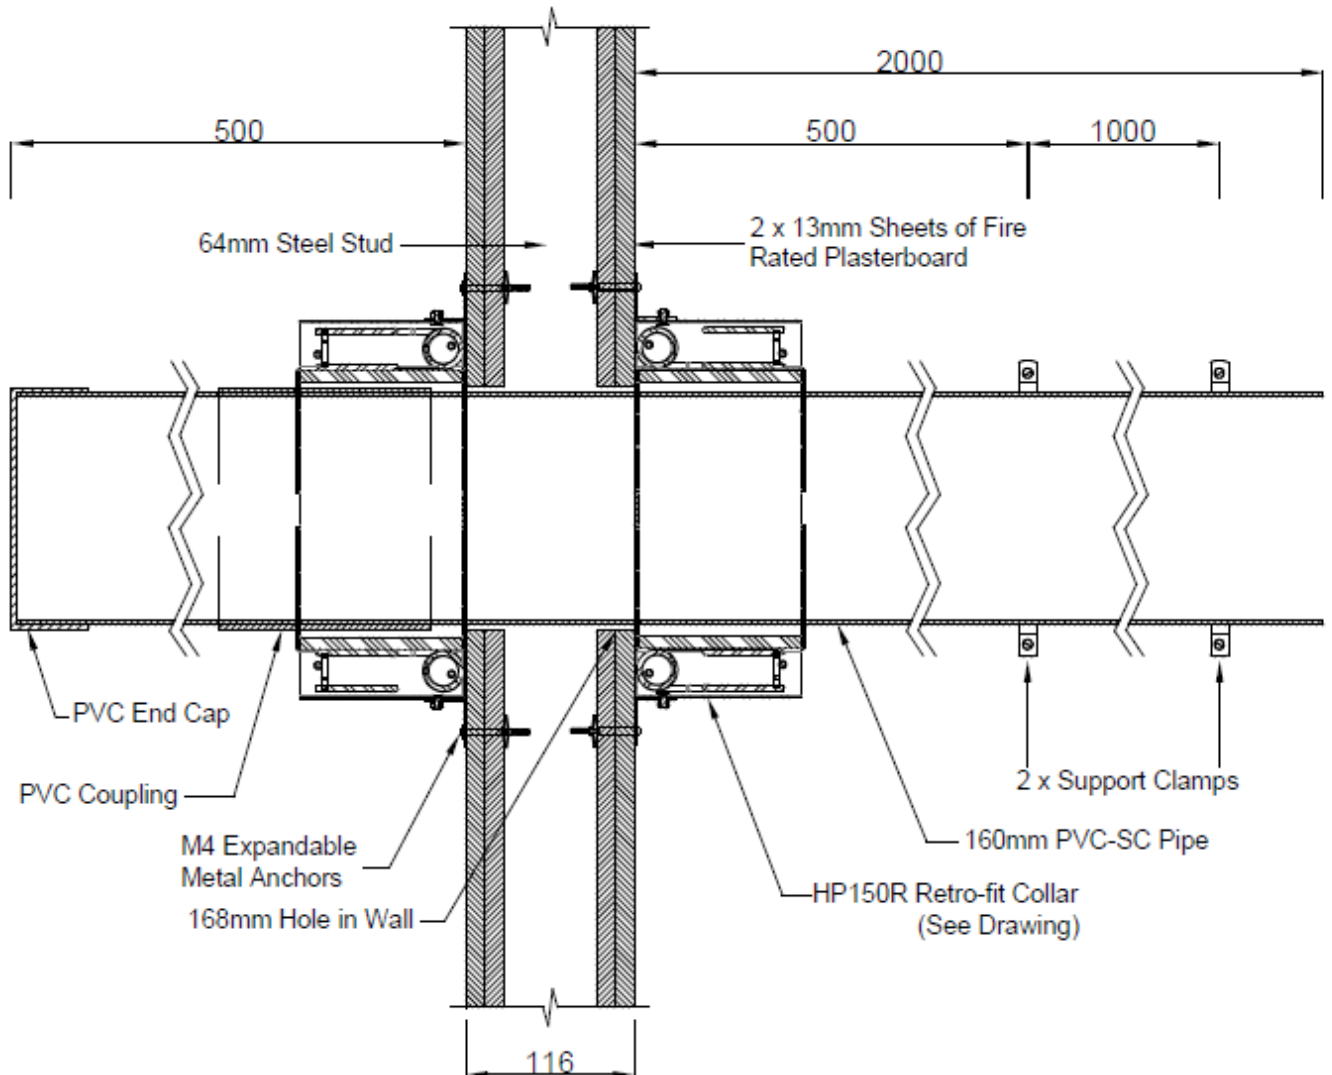
150 PVC-SC Stack + Fitting & HP150R

On top of pipe, 25-mm from collar	S29
	On pipe left side, 25-mm from collar	S30
<b>Specimen 6</b> – 161.8-mm OD Pipemakers pipe (PVC) having a wall thickness of 4.32-mm protected with Snap HP150R Fire collars retro-fitted to both sides of the wall through a 168-mm opening.	On P/B wall, 25-mm above collar	S31
	On P/B wall, 25-mm left of collar	S32
	On collar top	S33
	On collar left side	S34
	On top of pipe, 25-mm from collar	S35
	On pipe left side, 25-mm from collar	S36
Rover		S37
Ambient		S38

DRAWING TITLED "SPECIMEN #6, 150 PVC-SC STACK + FITTING & HP150R", DATED 29 JANUARY 2020,  
PROVIDED BY SNAP FIRE SYSTEMS PTY LTD

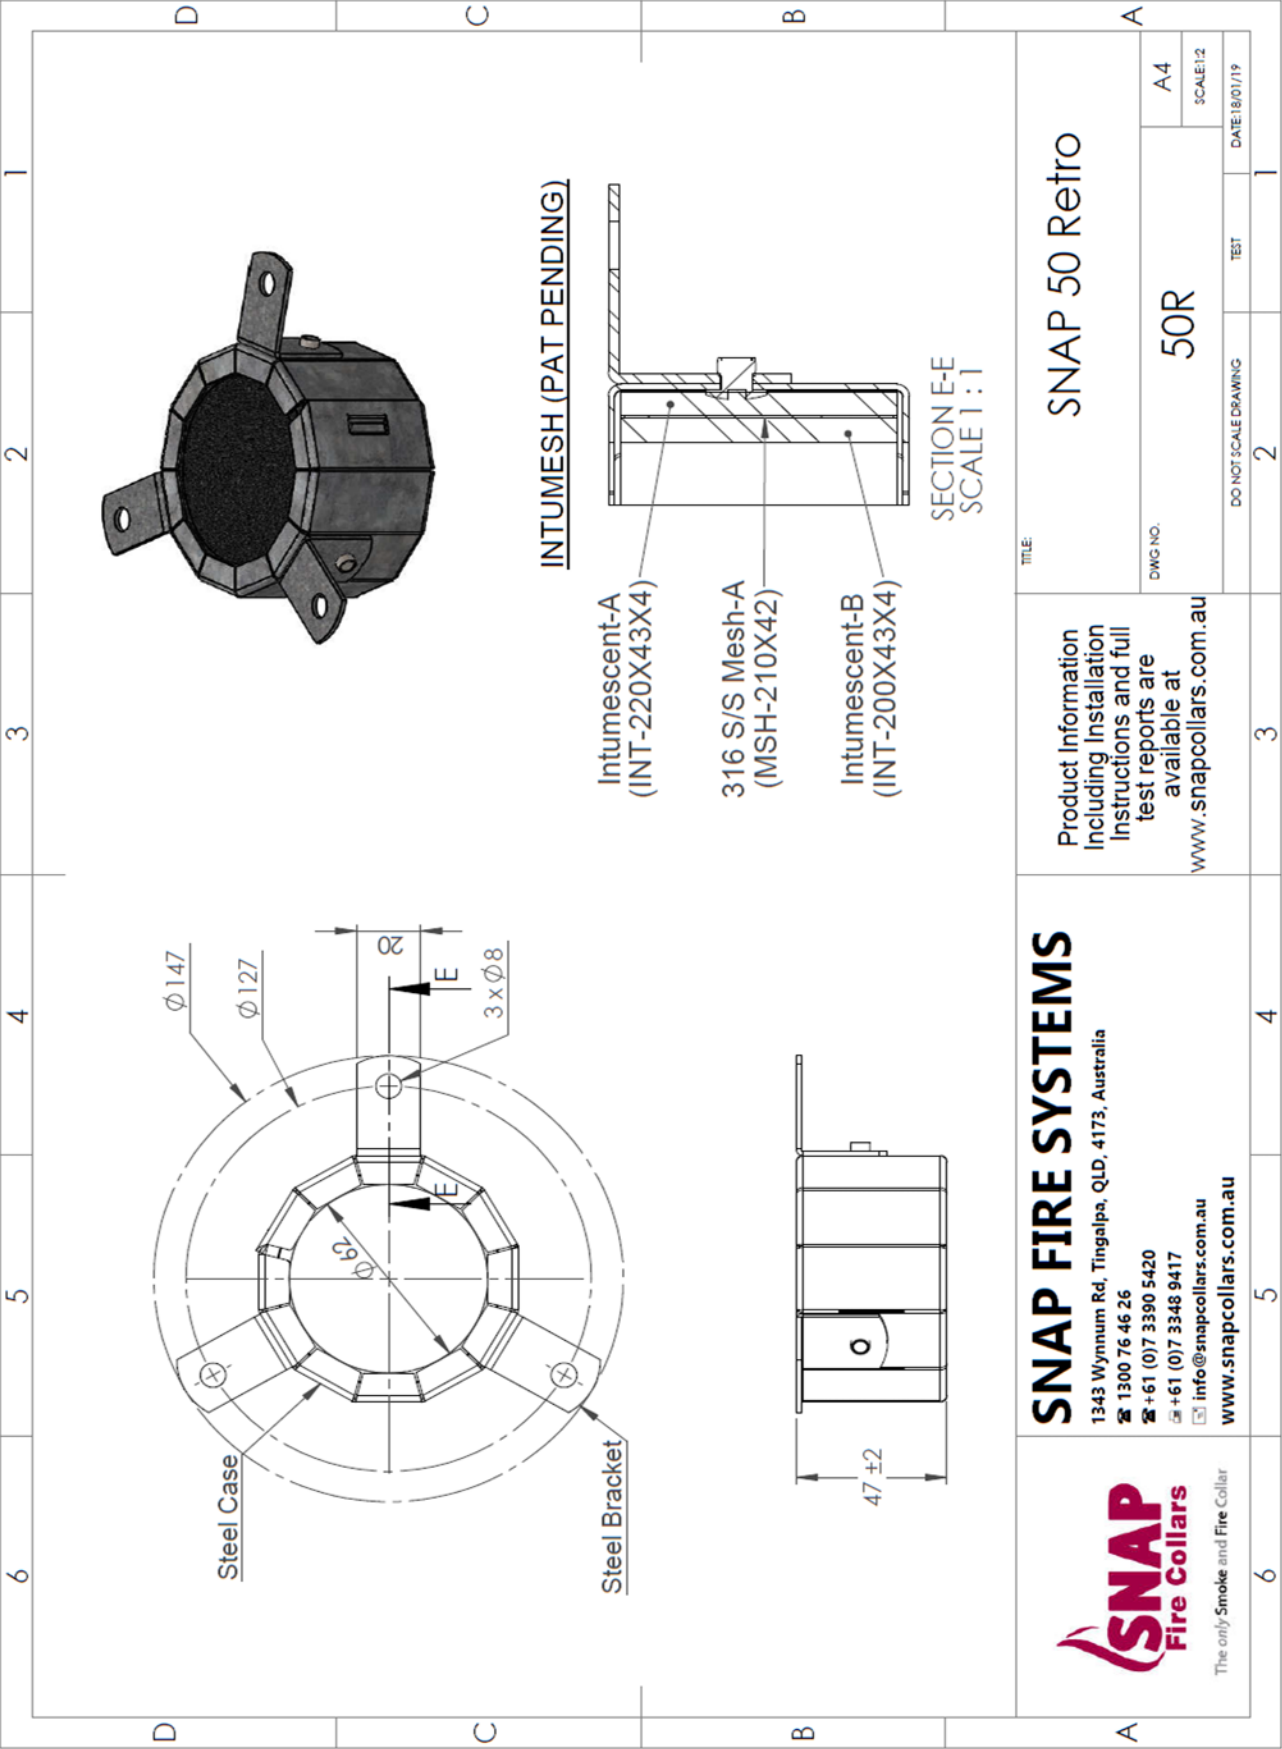
DRAWING NUMBERED 50R, SNAP 50 RETRO, DATED 18 JANUARY 2019, BY SNAP FIRE SYSTEMS PTY LTD.

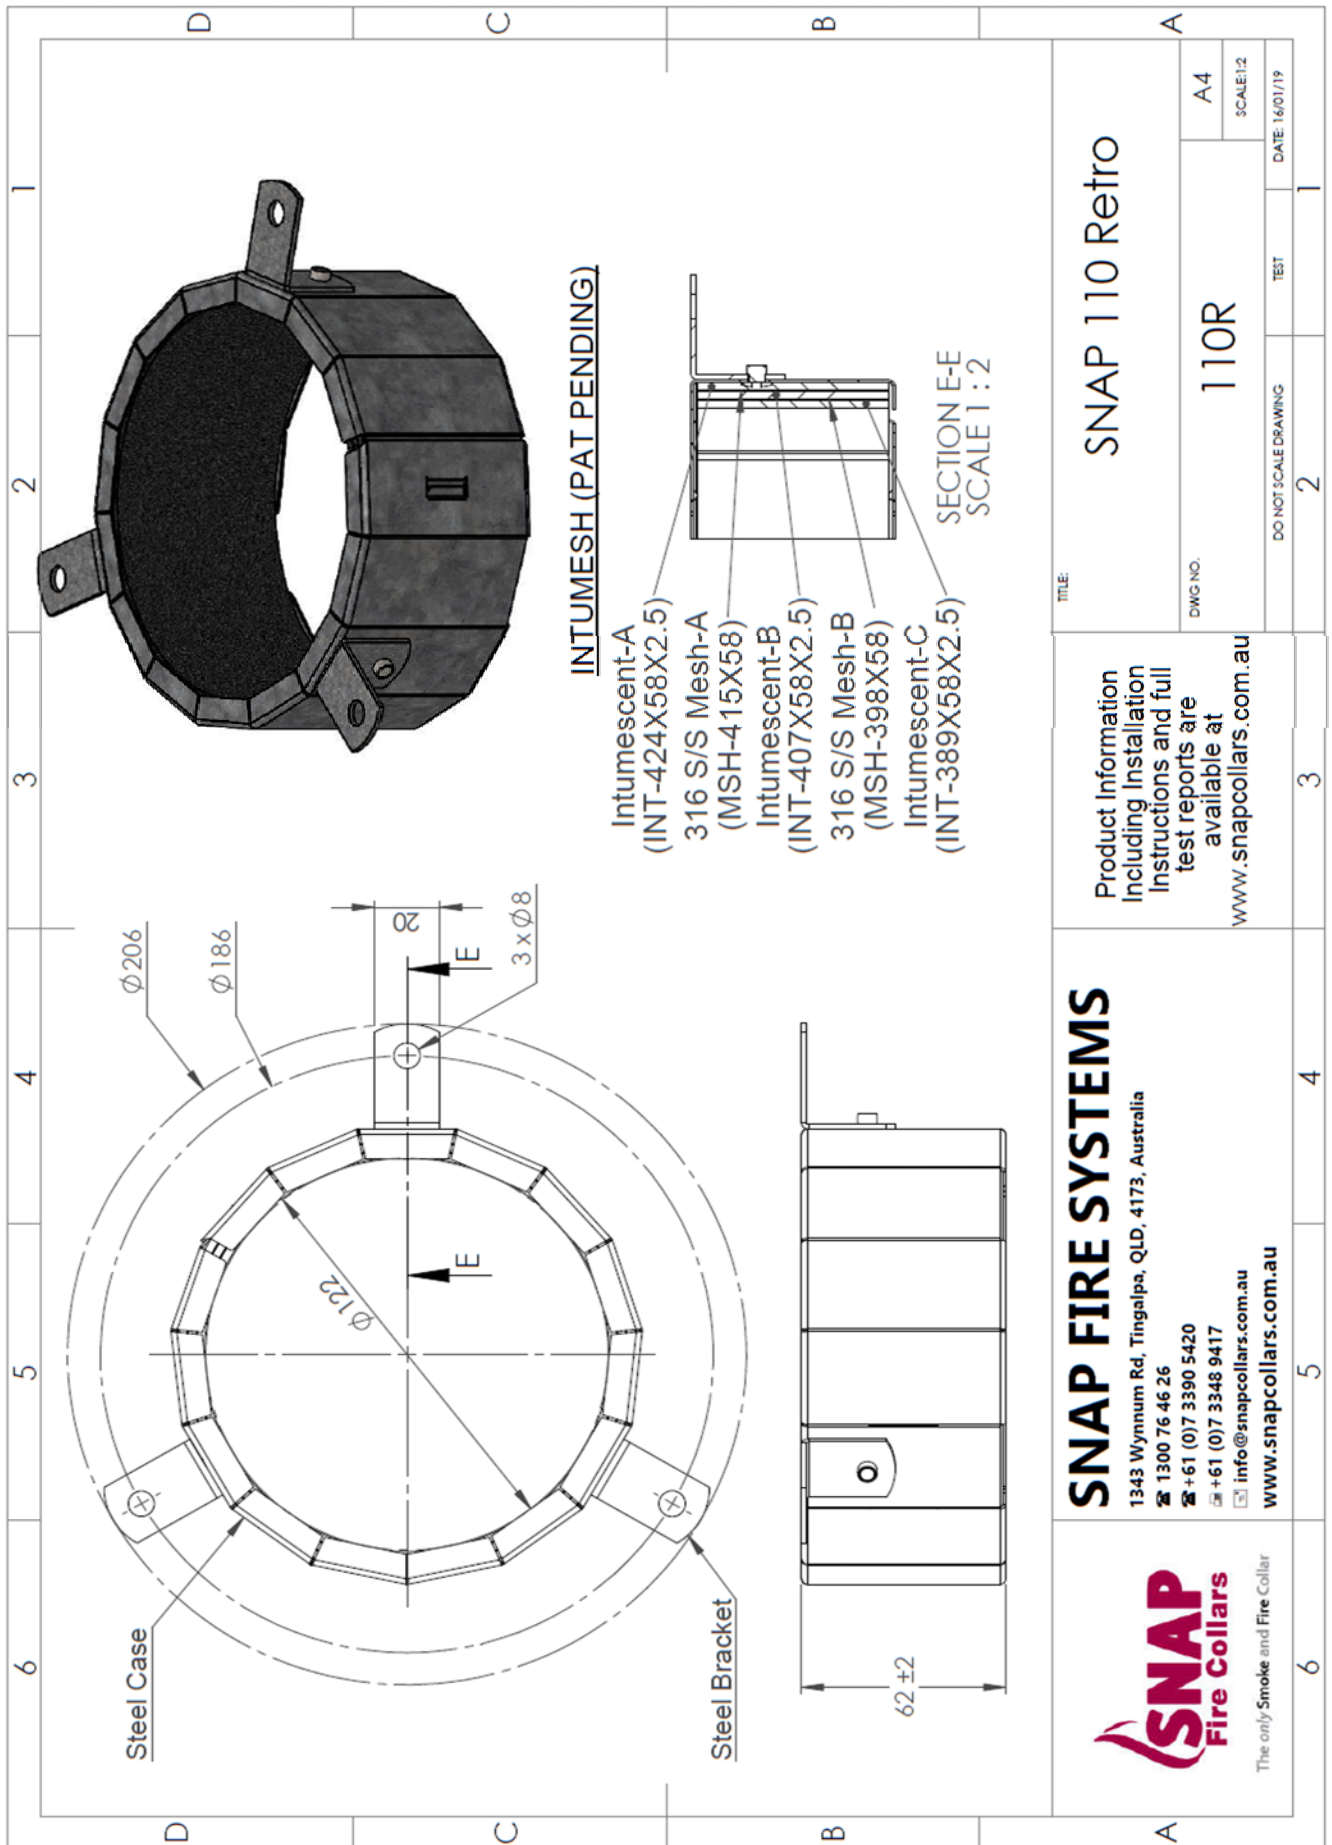
DRAWING NUMBERED 110R, SNAP 110 RETRO, DATED 16 JANUARY 2019, BY SNAP FIRE SYSTEMS PTY LTD.

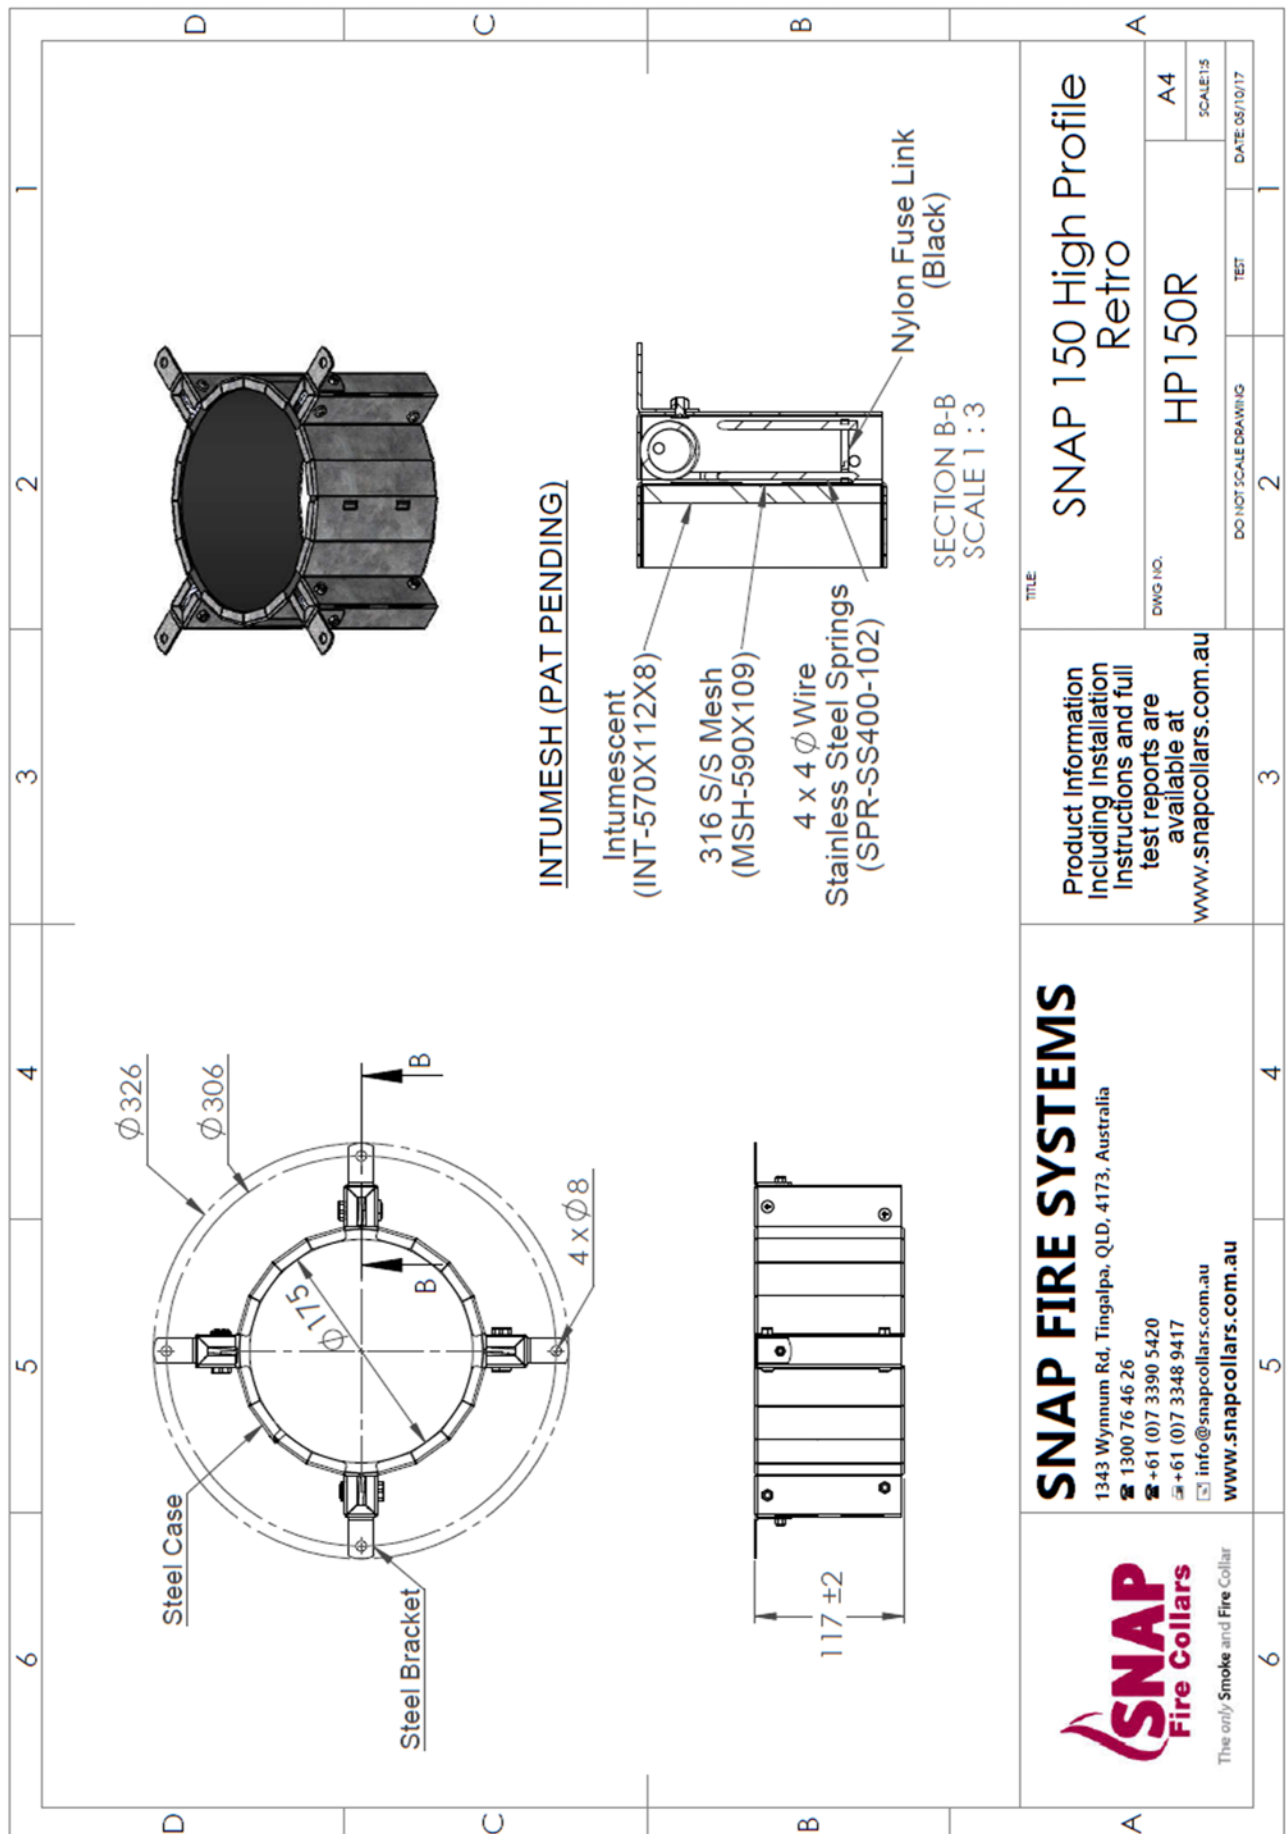
DRAWING TITLED "SNAP 150 HIGH PROFILE RETRO", DATED 5 OCTOBER 2017, BY SNAP FIRE SYSTEMS PTY LTD.
