Fire-resistance test on retrofit fire collars protecting a Hebel PowerPanel wall penetrated by services

Test Report

Author: Peter Gordon
Report number: FSP 2118
Date: 1 September 2020
Client: IG6 Pty Ltd as trustee for the IG6 IP Trust

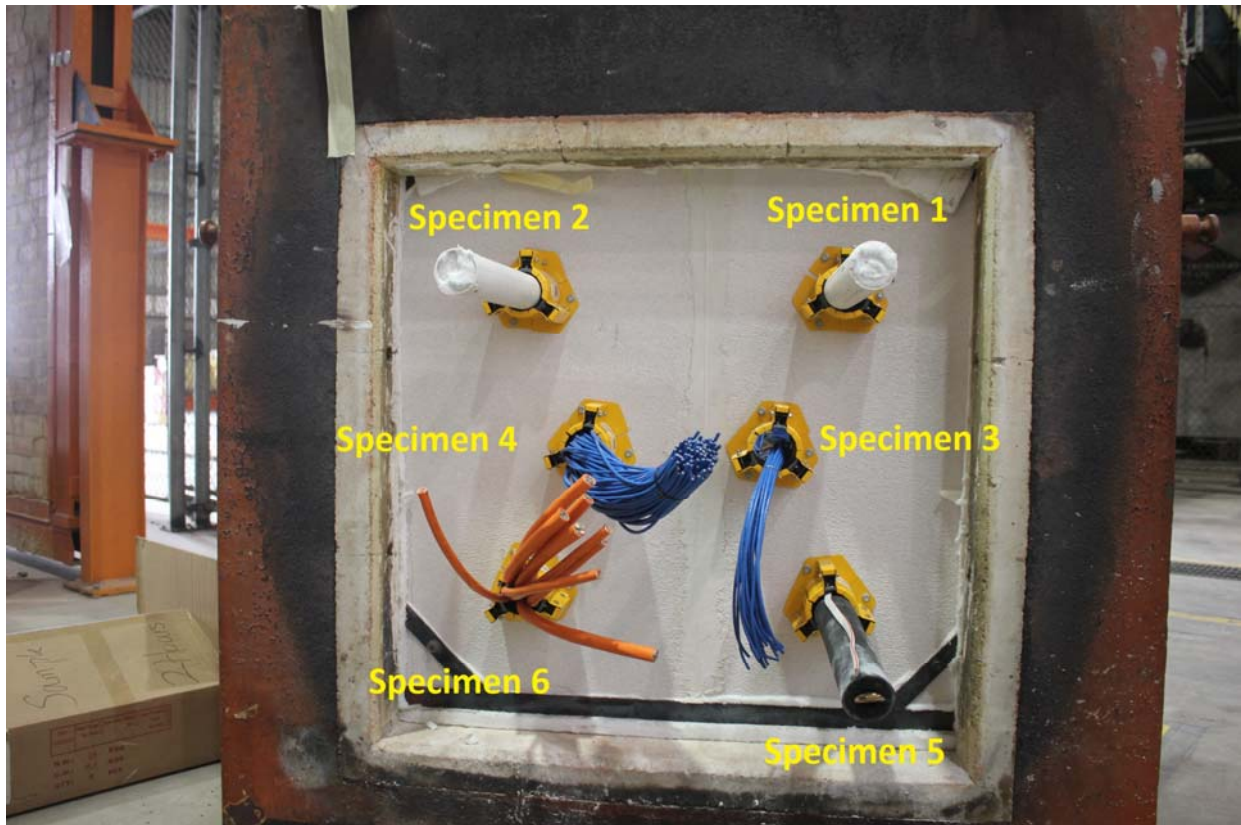
PHOTOGRAPH 1 – EXPOSED FACE OF SPECIMENS PRIOR TO TESTING

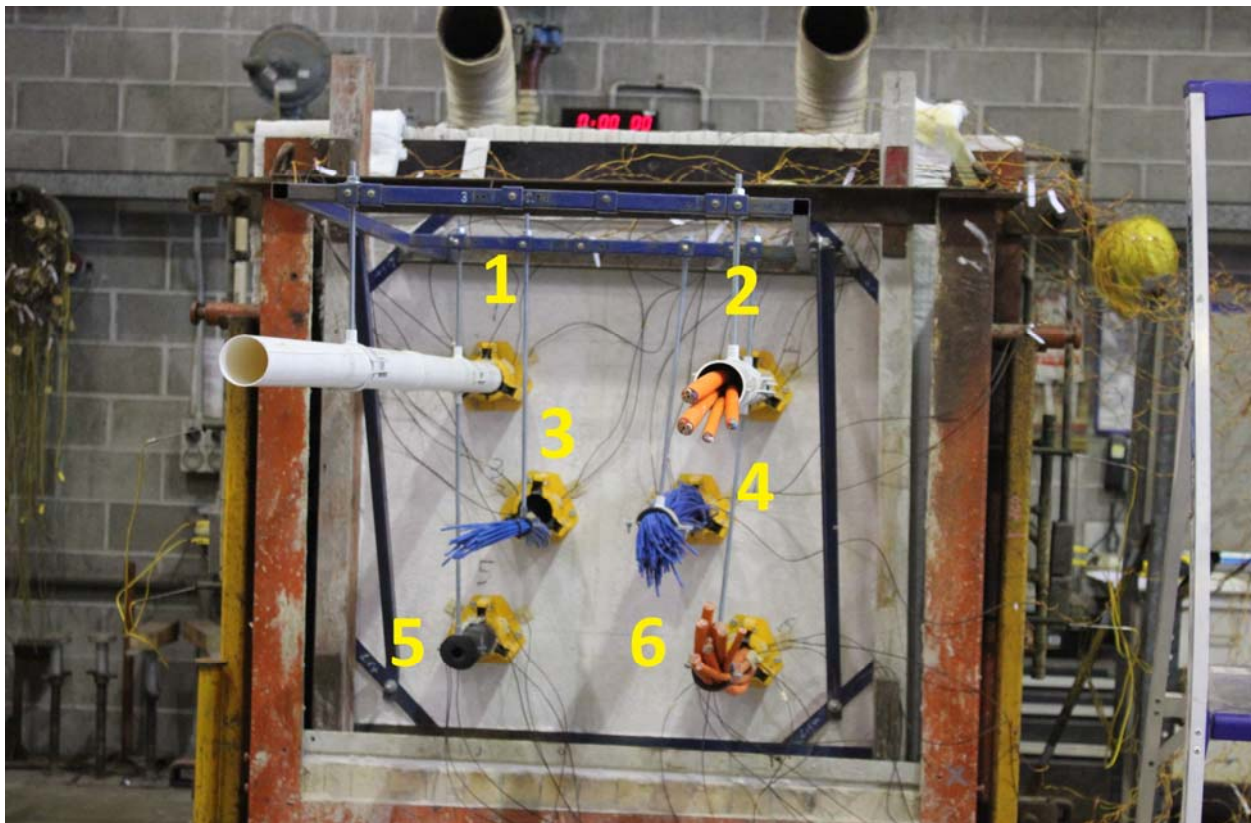
PHOTOGRAPH 2 – UNEXPOSED FACE OF SPECIMENS PRIOR TO TESTING

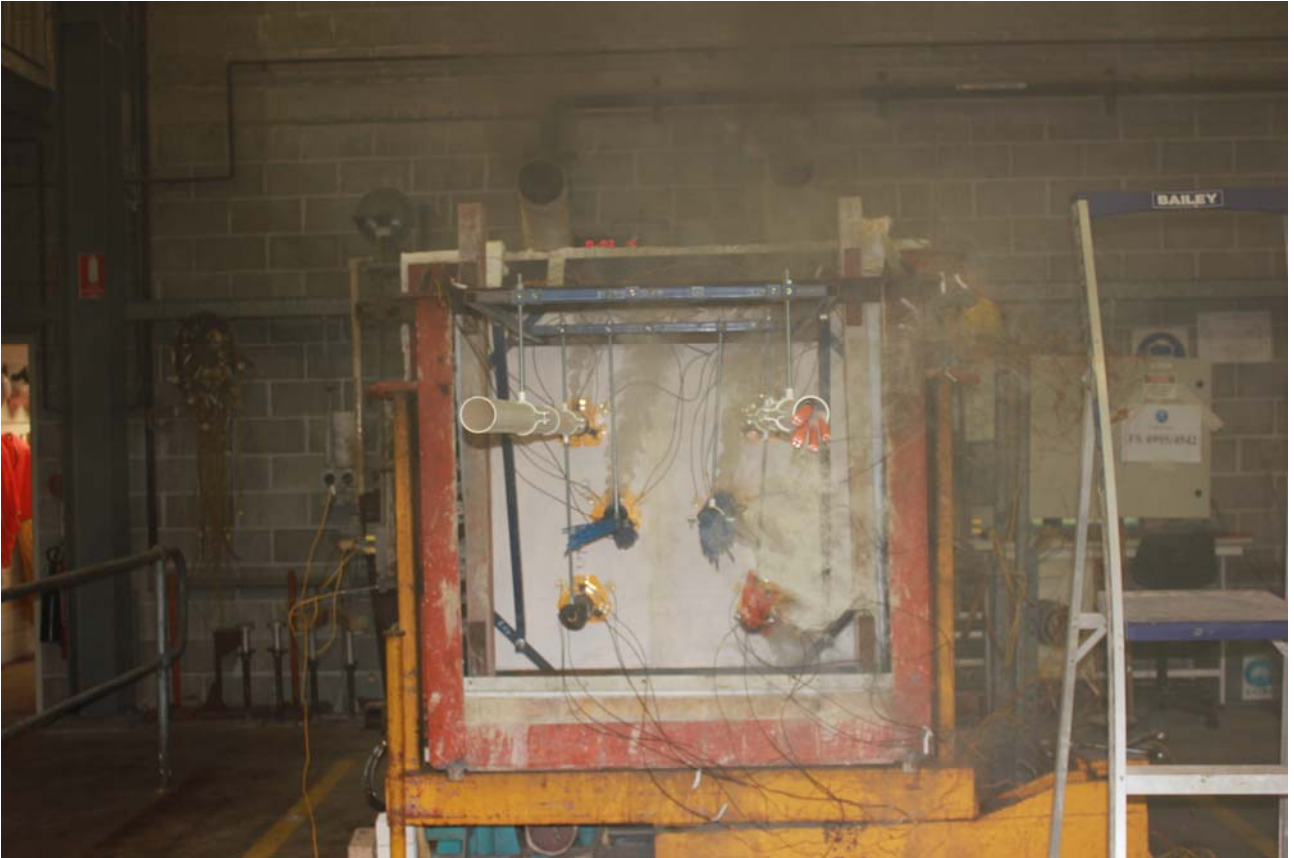
PHOTOGRAPH 3 – SPECIMENS AFTER 3 MINUTES OF TESTING

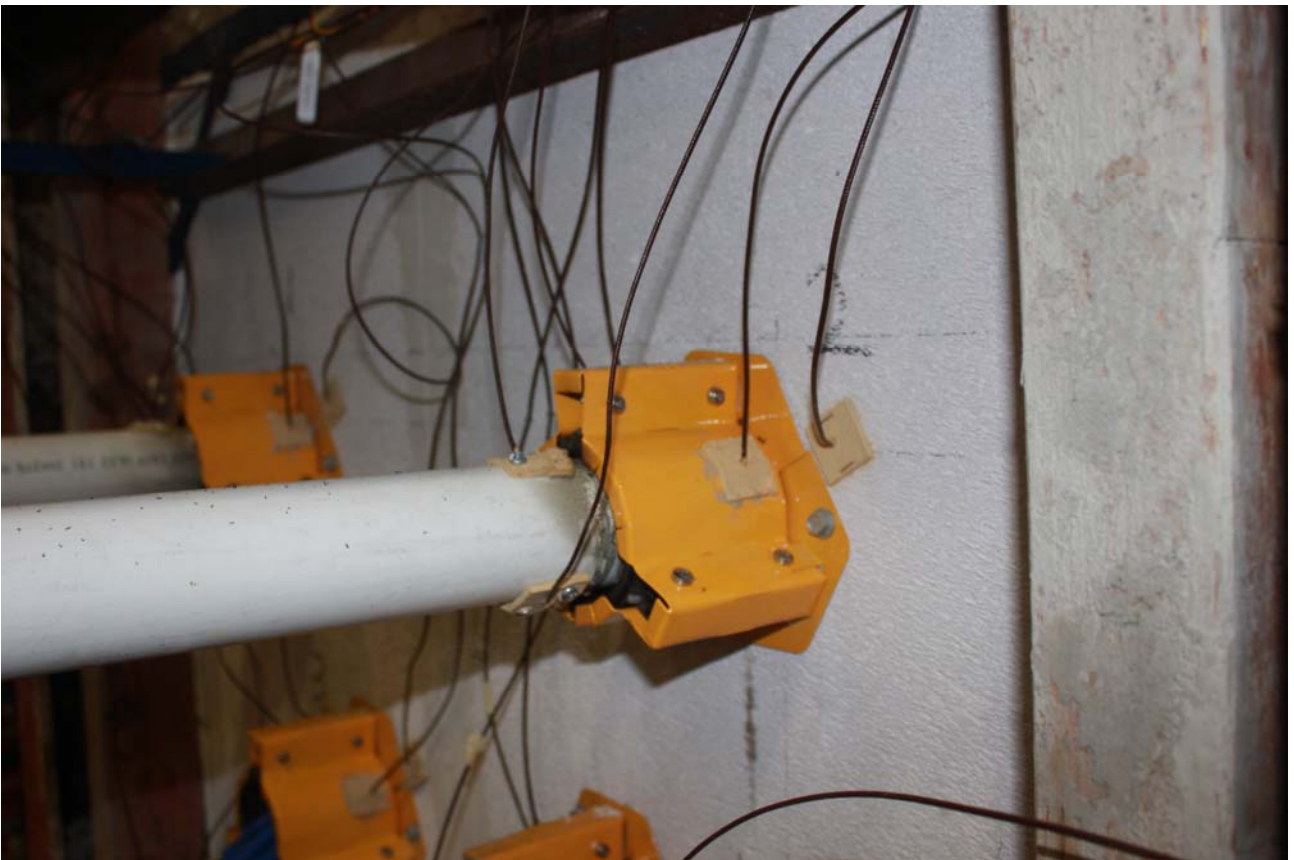
PHOTOGRAPH 4 – SPECIMENS 1 AND 2 AFTER 8 MINUTES OF TESTING

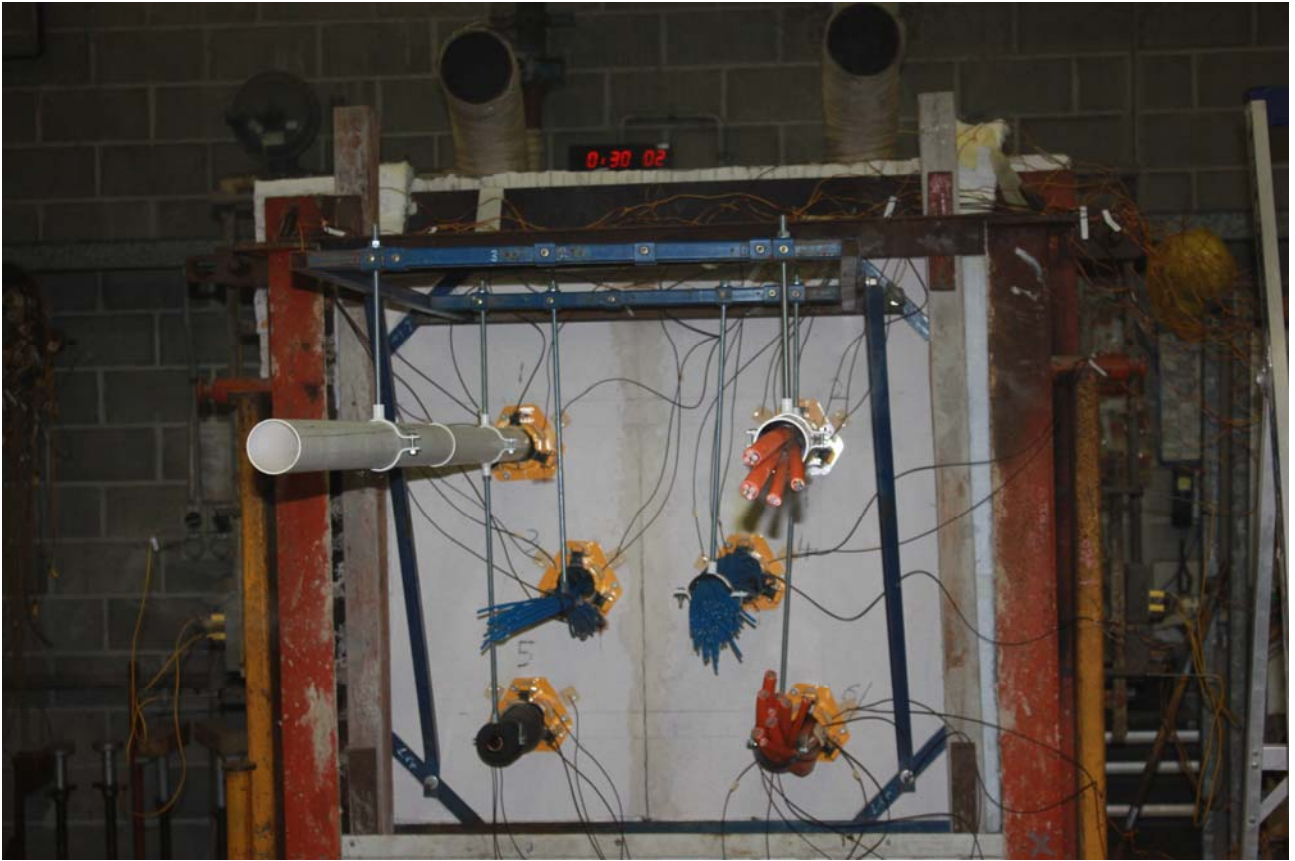
PHOTOGRAPH 5 – SPECIMENS AFTER 30 MINUTES OF TESTING

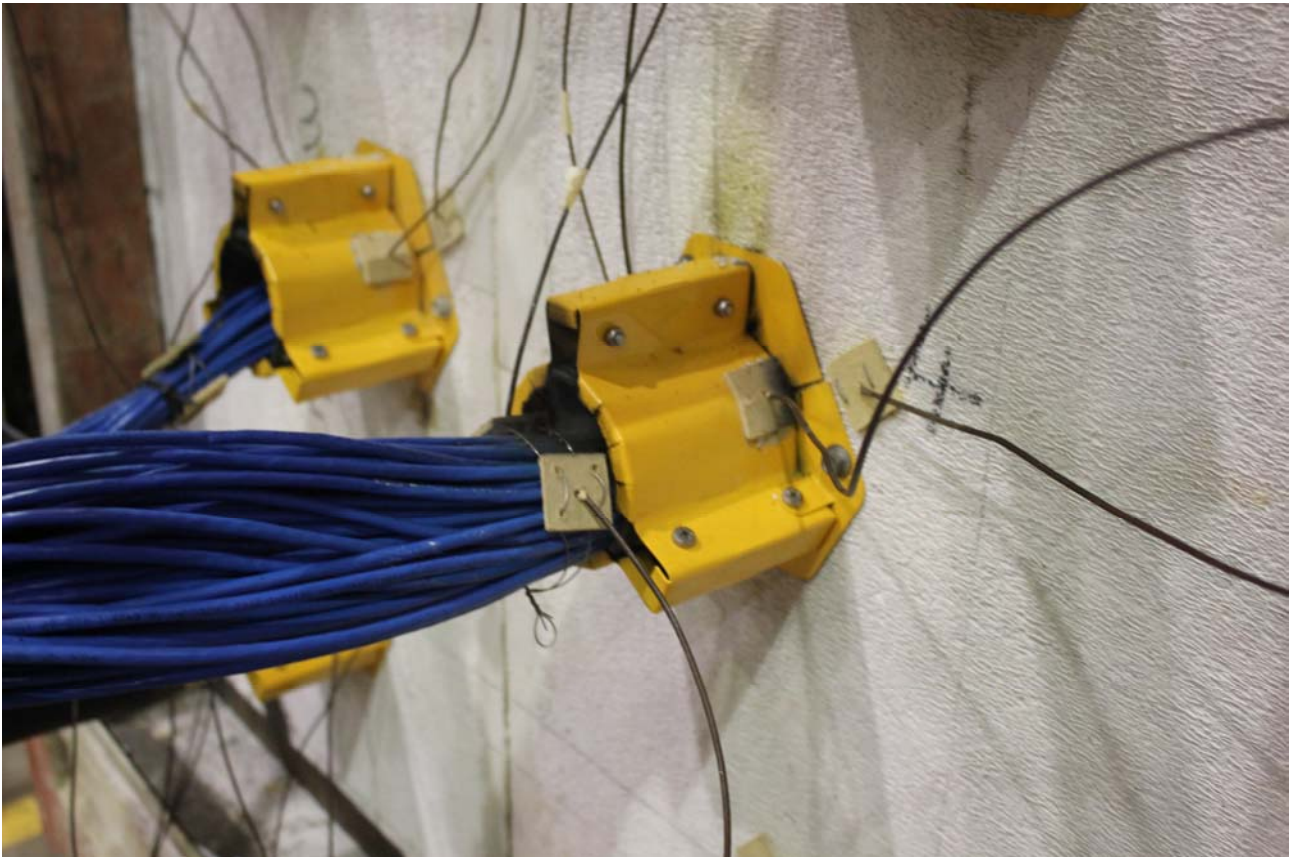
PHOTOGRAPH 6 –SPECIMENS 3 AND 4 AFTER 49 MINUTES OF TESTING

- 49 minutes - The blue sheath on the cables of Specimen 4 has begun to discolour. Horizontal cracks have begun to form on the wall adjacent to Specimens 3 and 4 (photograph 6).

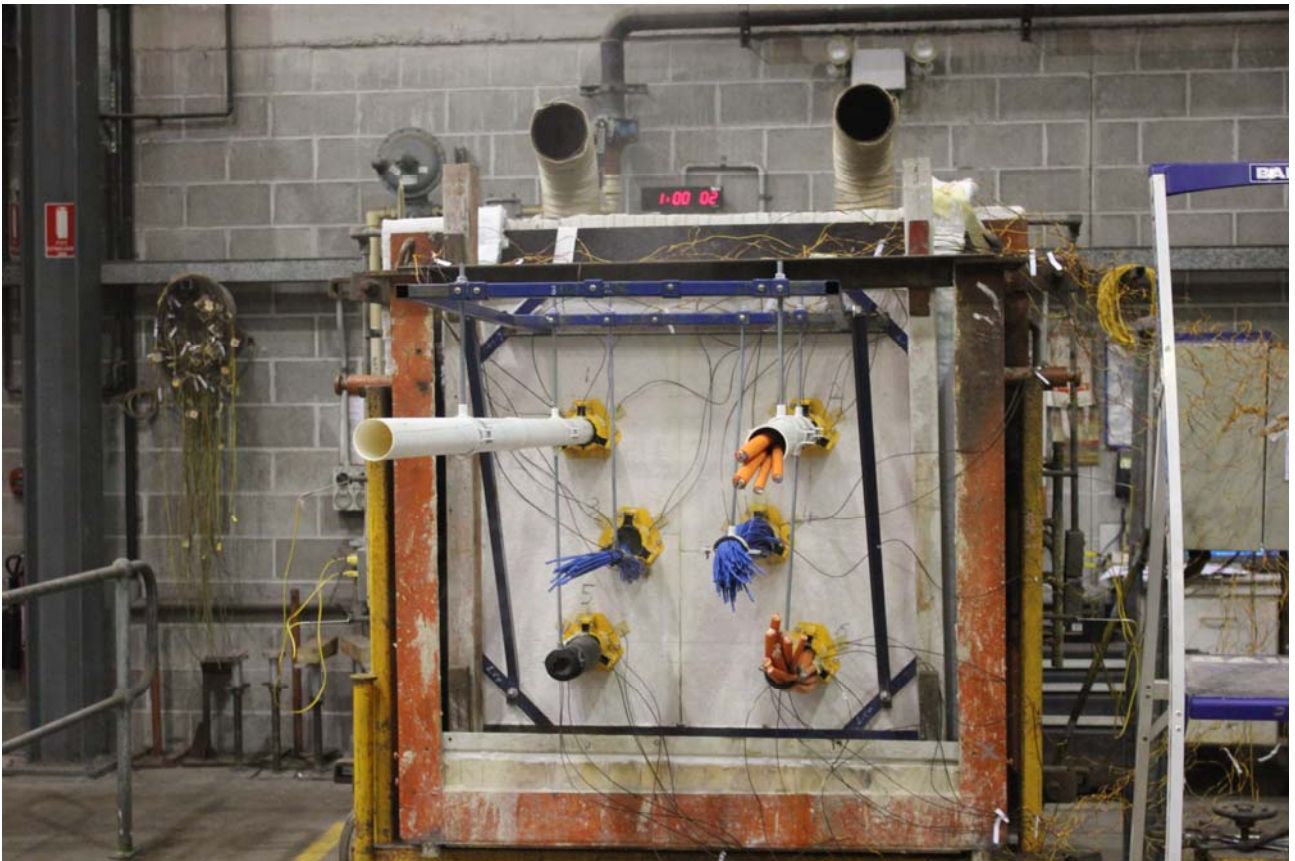
PHOTOGRAPH 7 – SPECIMENS AFTER 60 MINUTES OF TESTING

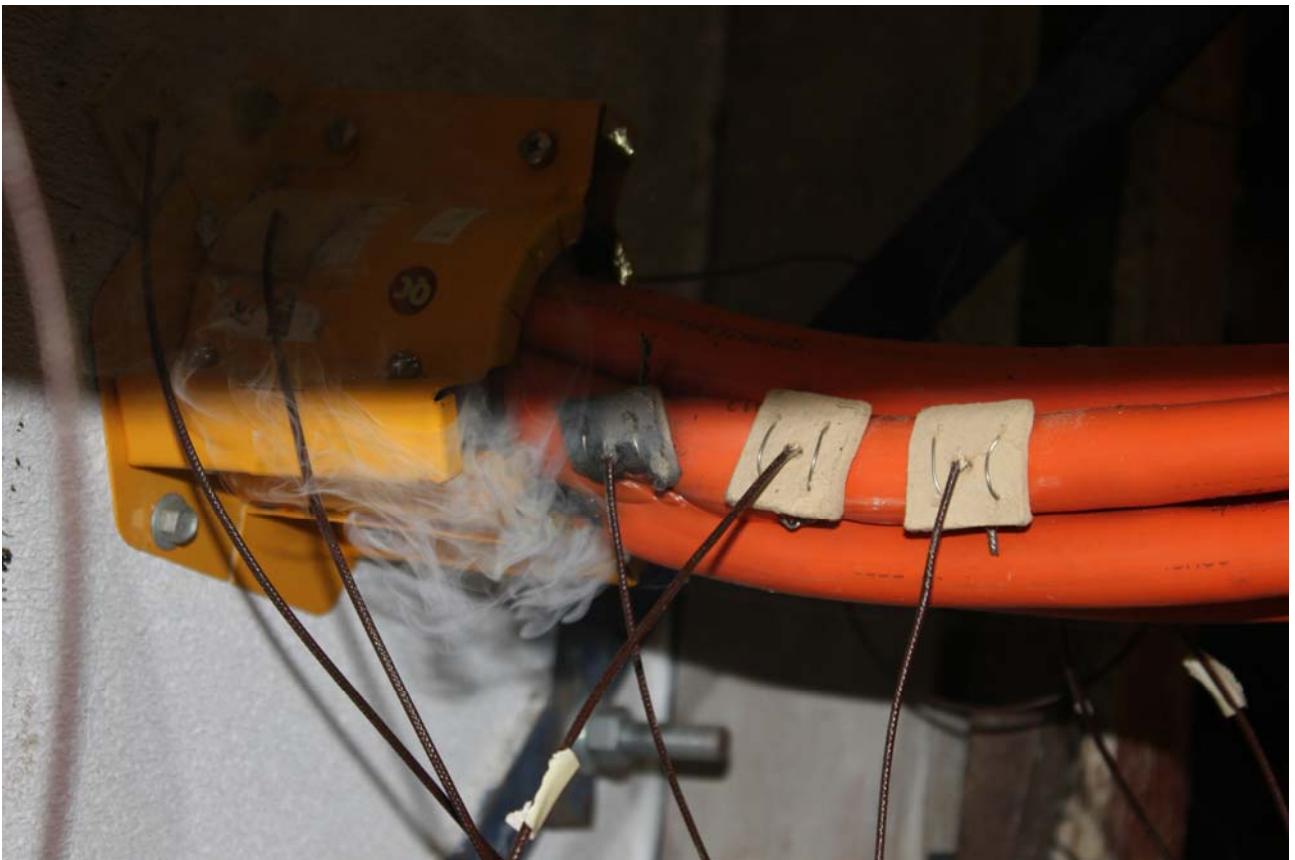
PHOTOGRAPH 8 – SPECIMEN 6 AFTER 73 MINUTES OF TESTING

- 72 minutes - Smoke is being emitted between the collar and pipe of all specimens.
- 73 minutes - The sheath on the 16-mm² cable of Specimen 6 adjacent to the collar has begun to discolour (photograph 8).

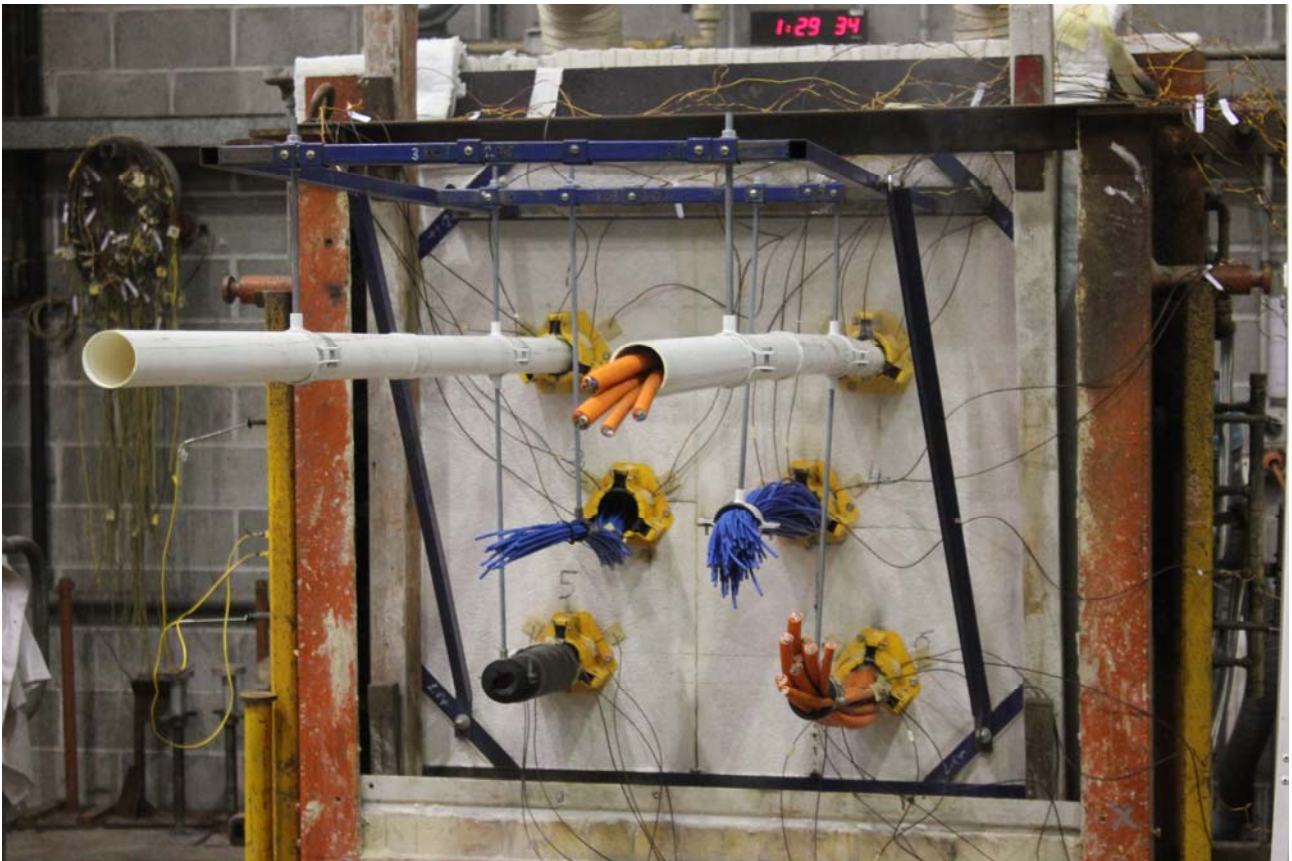
PHOTOGRAPH 9 – SPECIMENS AFTER 89 MINUTES OF TESTING

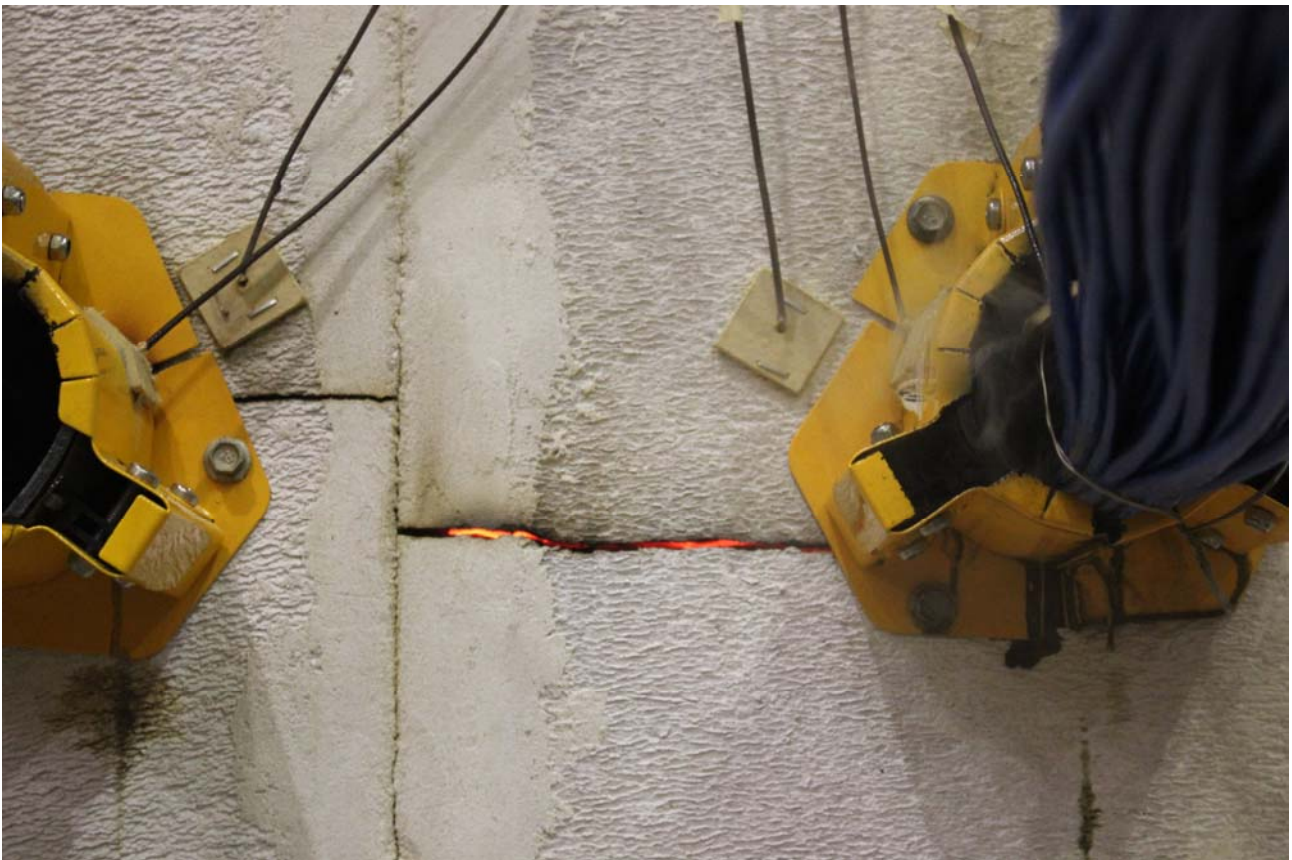
PHOTOGRAPH 10 – THE WALL ADJACENT TO SPECIMENS 3 AND 4 AFTER 97 MINUTES OF TESTING

- 93 minutes - The sheath on the 16-mm² and 6-mm² cables of Specimen 6 adjacent to the collar have begun to melt.
- 97 minutes - The horizontal crack in the wall adjacent to Specimen 4 has widened with the glow of the furnace visible (photograph 10). Cotton pad test applied above the crack on the wall – no ignition noted at this time.

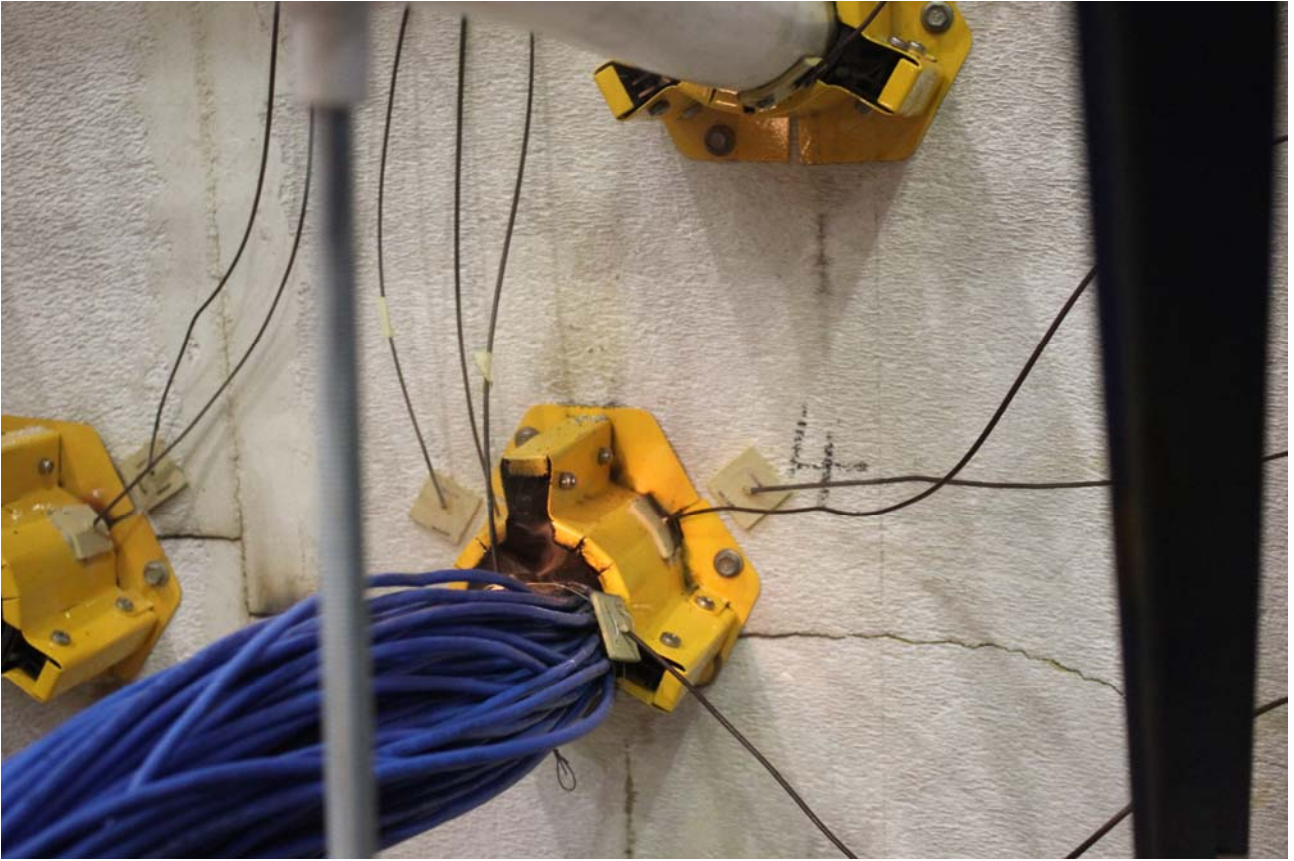
PHOTOGRAPH 11 – SPECIMEN 4 AFTER 105 MINUTES OF TESTING

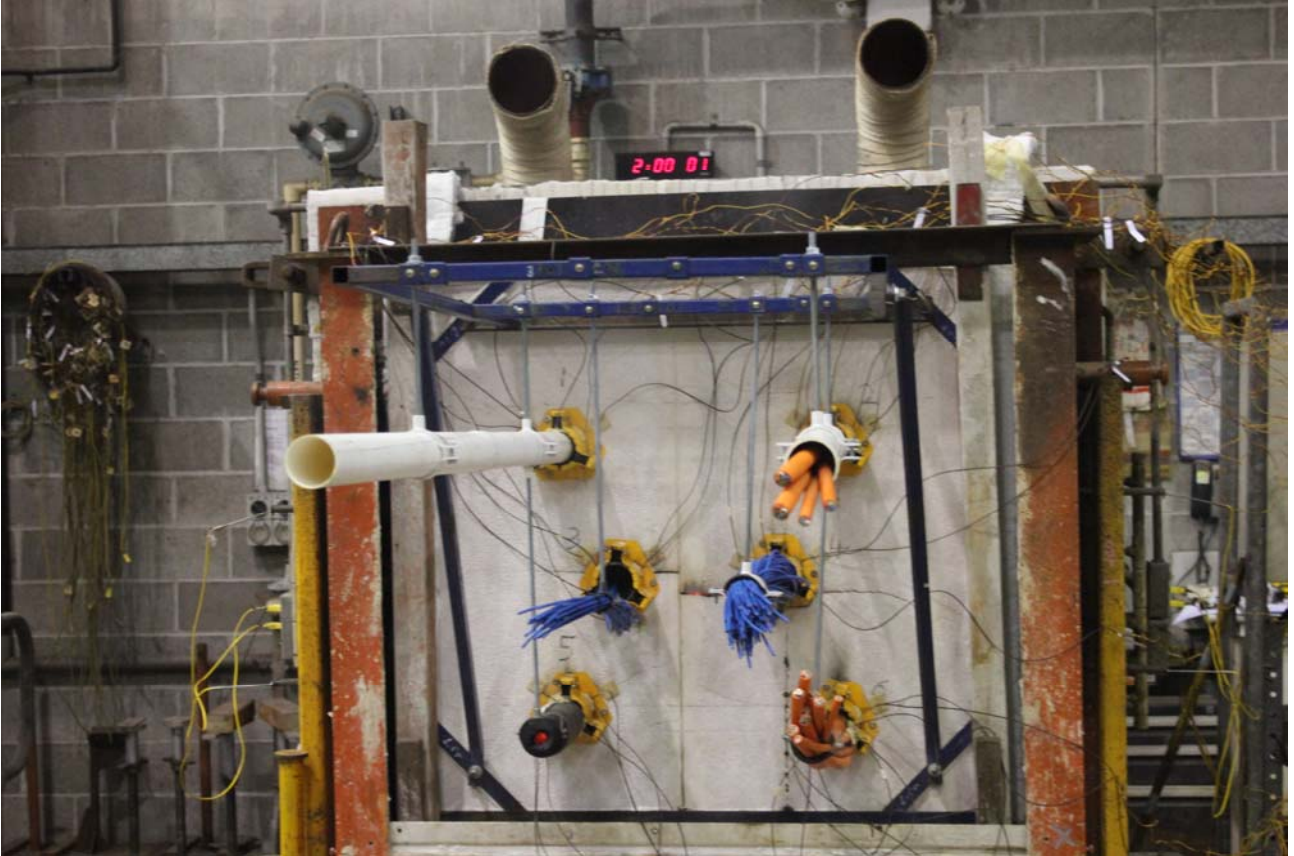
PHOTOGRAPH 12 – SPECIMENS AFTER 120 MINUTES OF TESTING

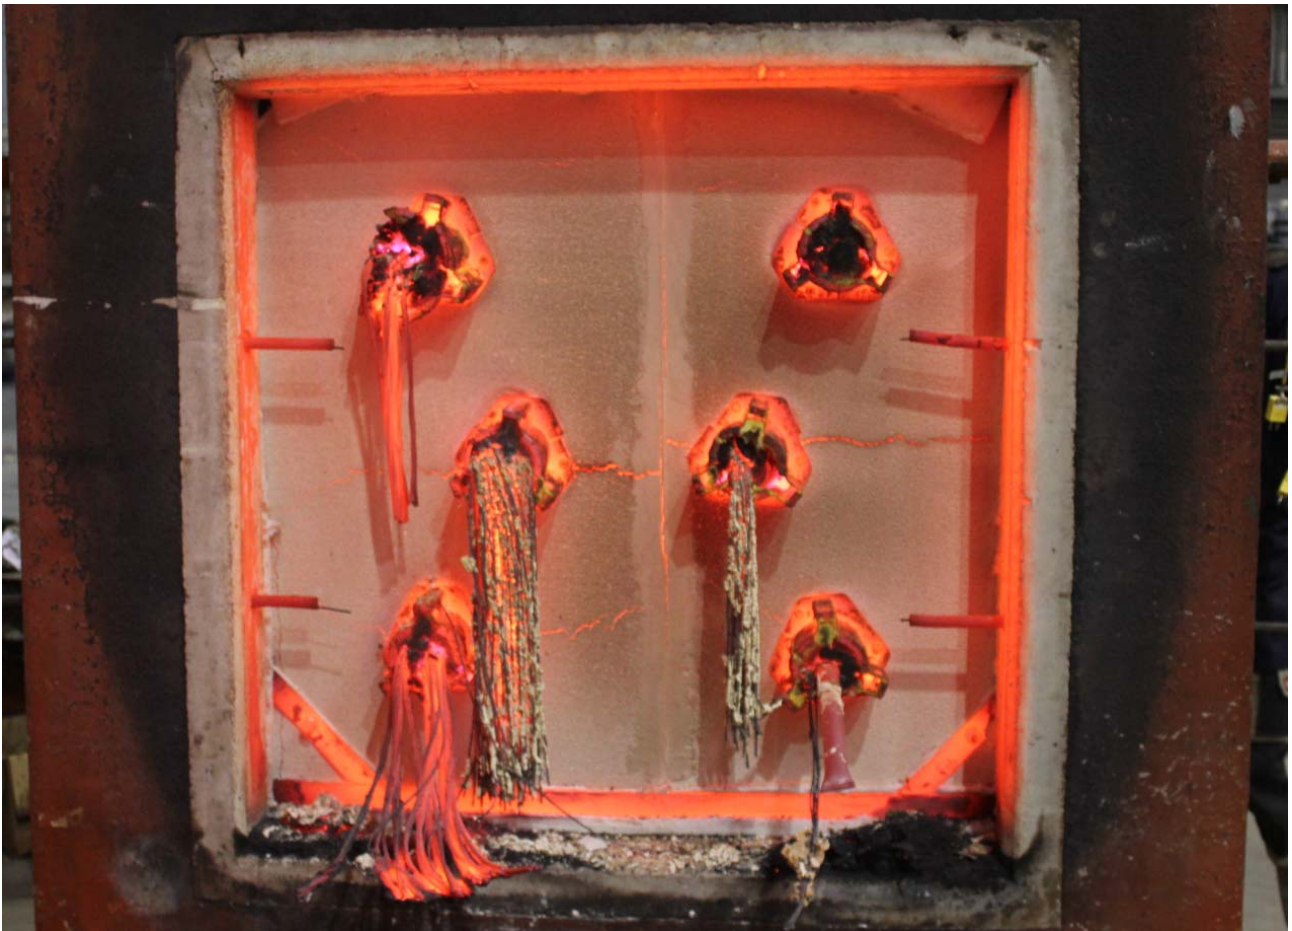
PHOTOGRAPH 13 – EXPOSED FACE OF SPECIMENS AT CONCLUSION OF TESTING

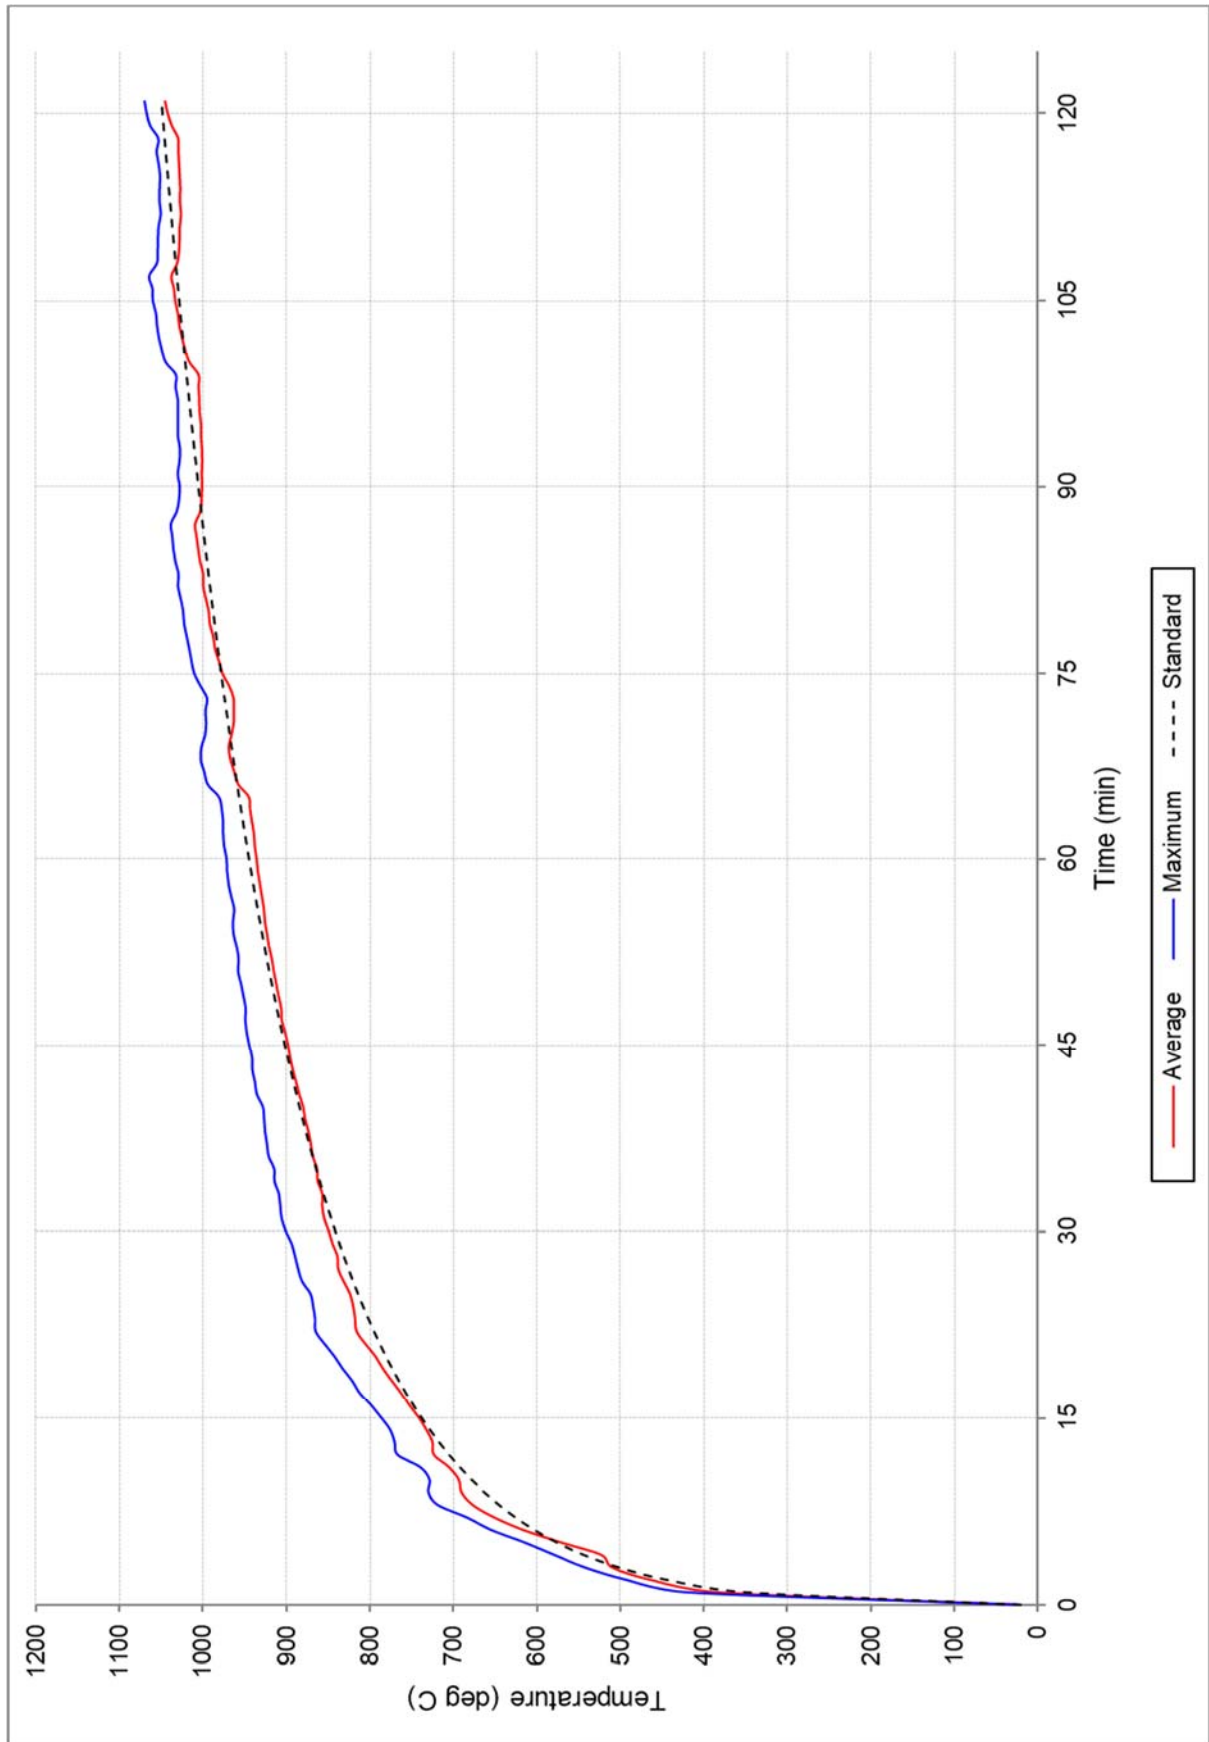
FIGURE 1 – FURNACE TEMPERATURE

Figure 1 shows the standard curves of temperature versus time for heating the furnace chamber and the actual curves of average and maximum temperature versus time recorded during the heating period.

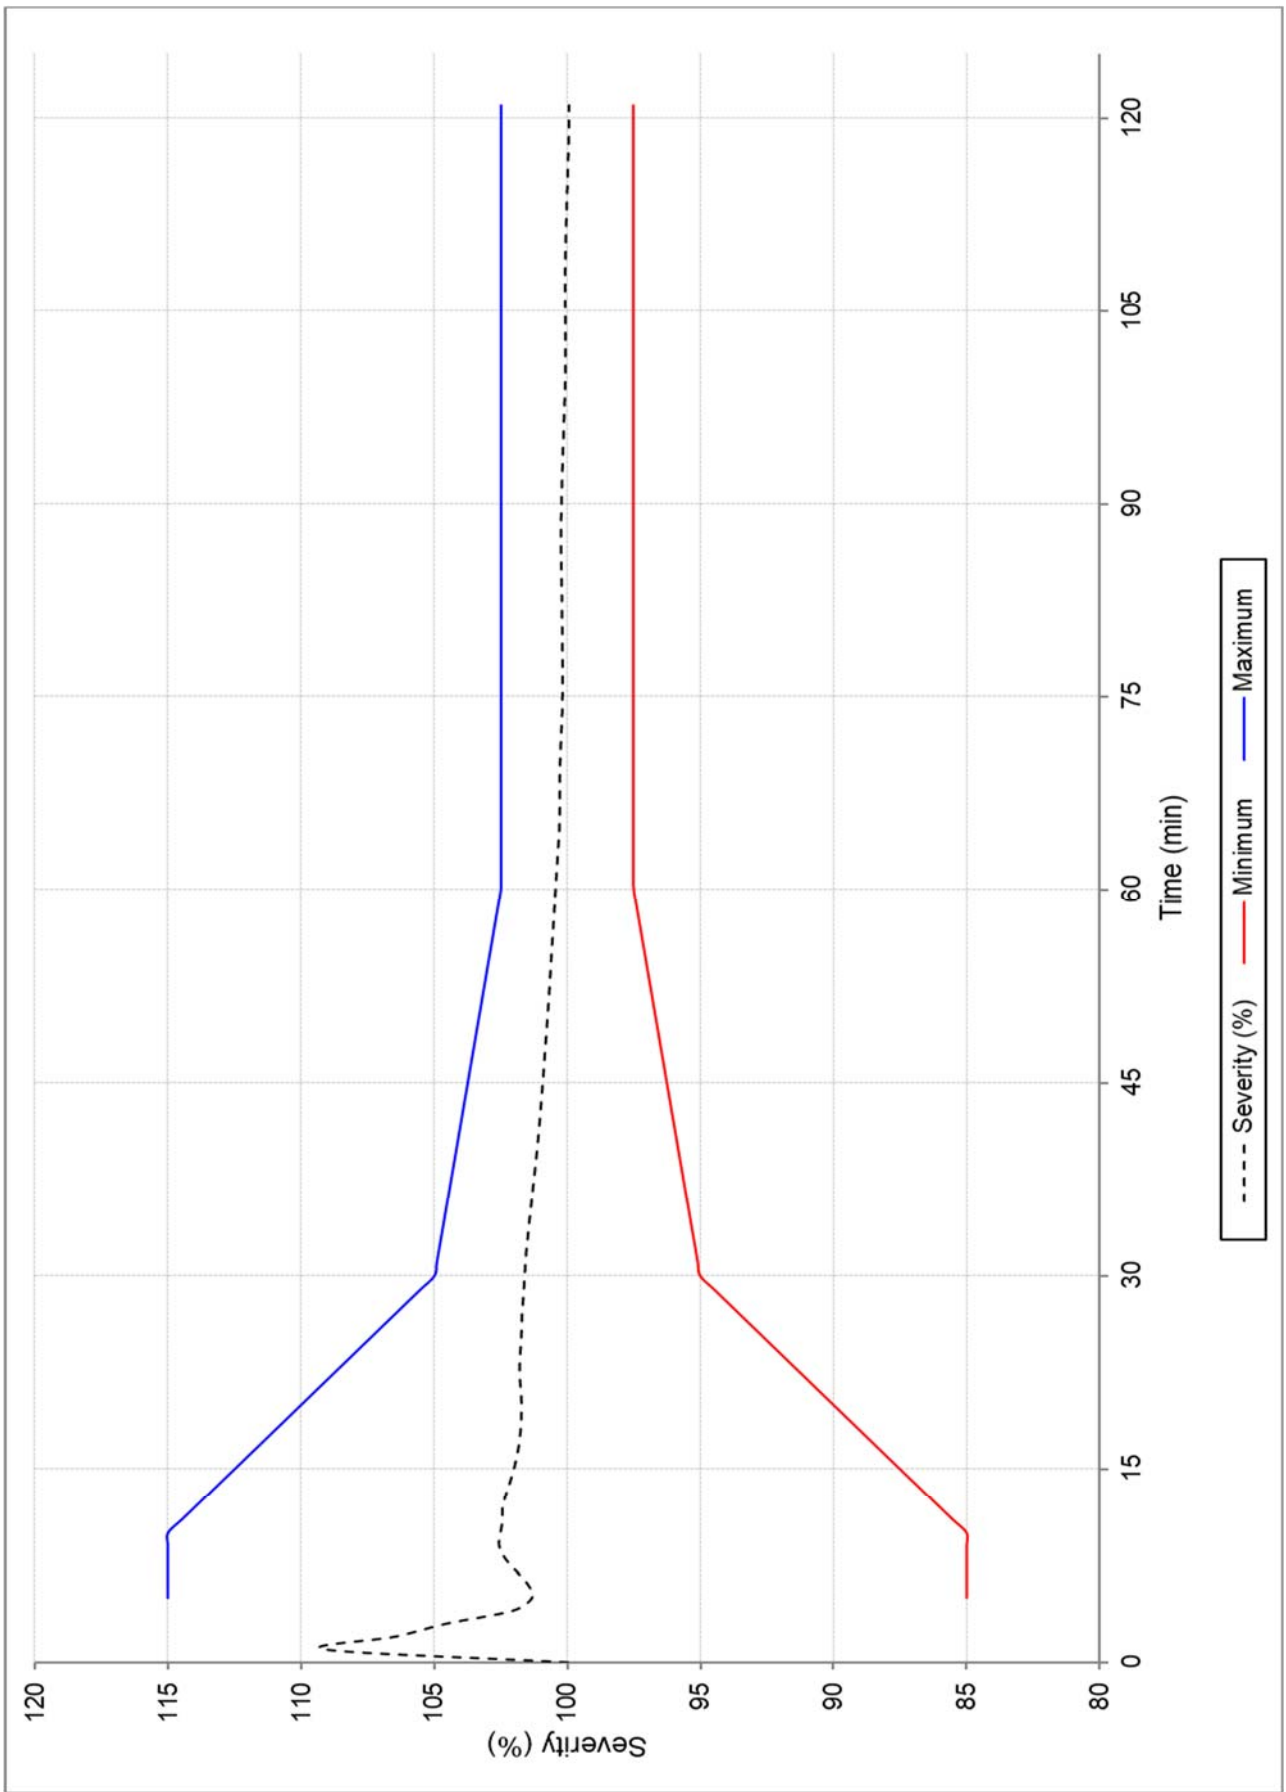
FIGURE 2 – FURNACE SEVERITY

Figure 2 shows the curve of furnace severity versus time during the heating period.

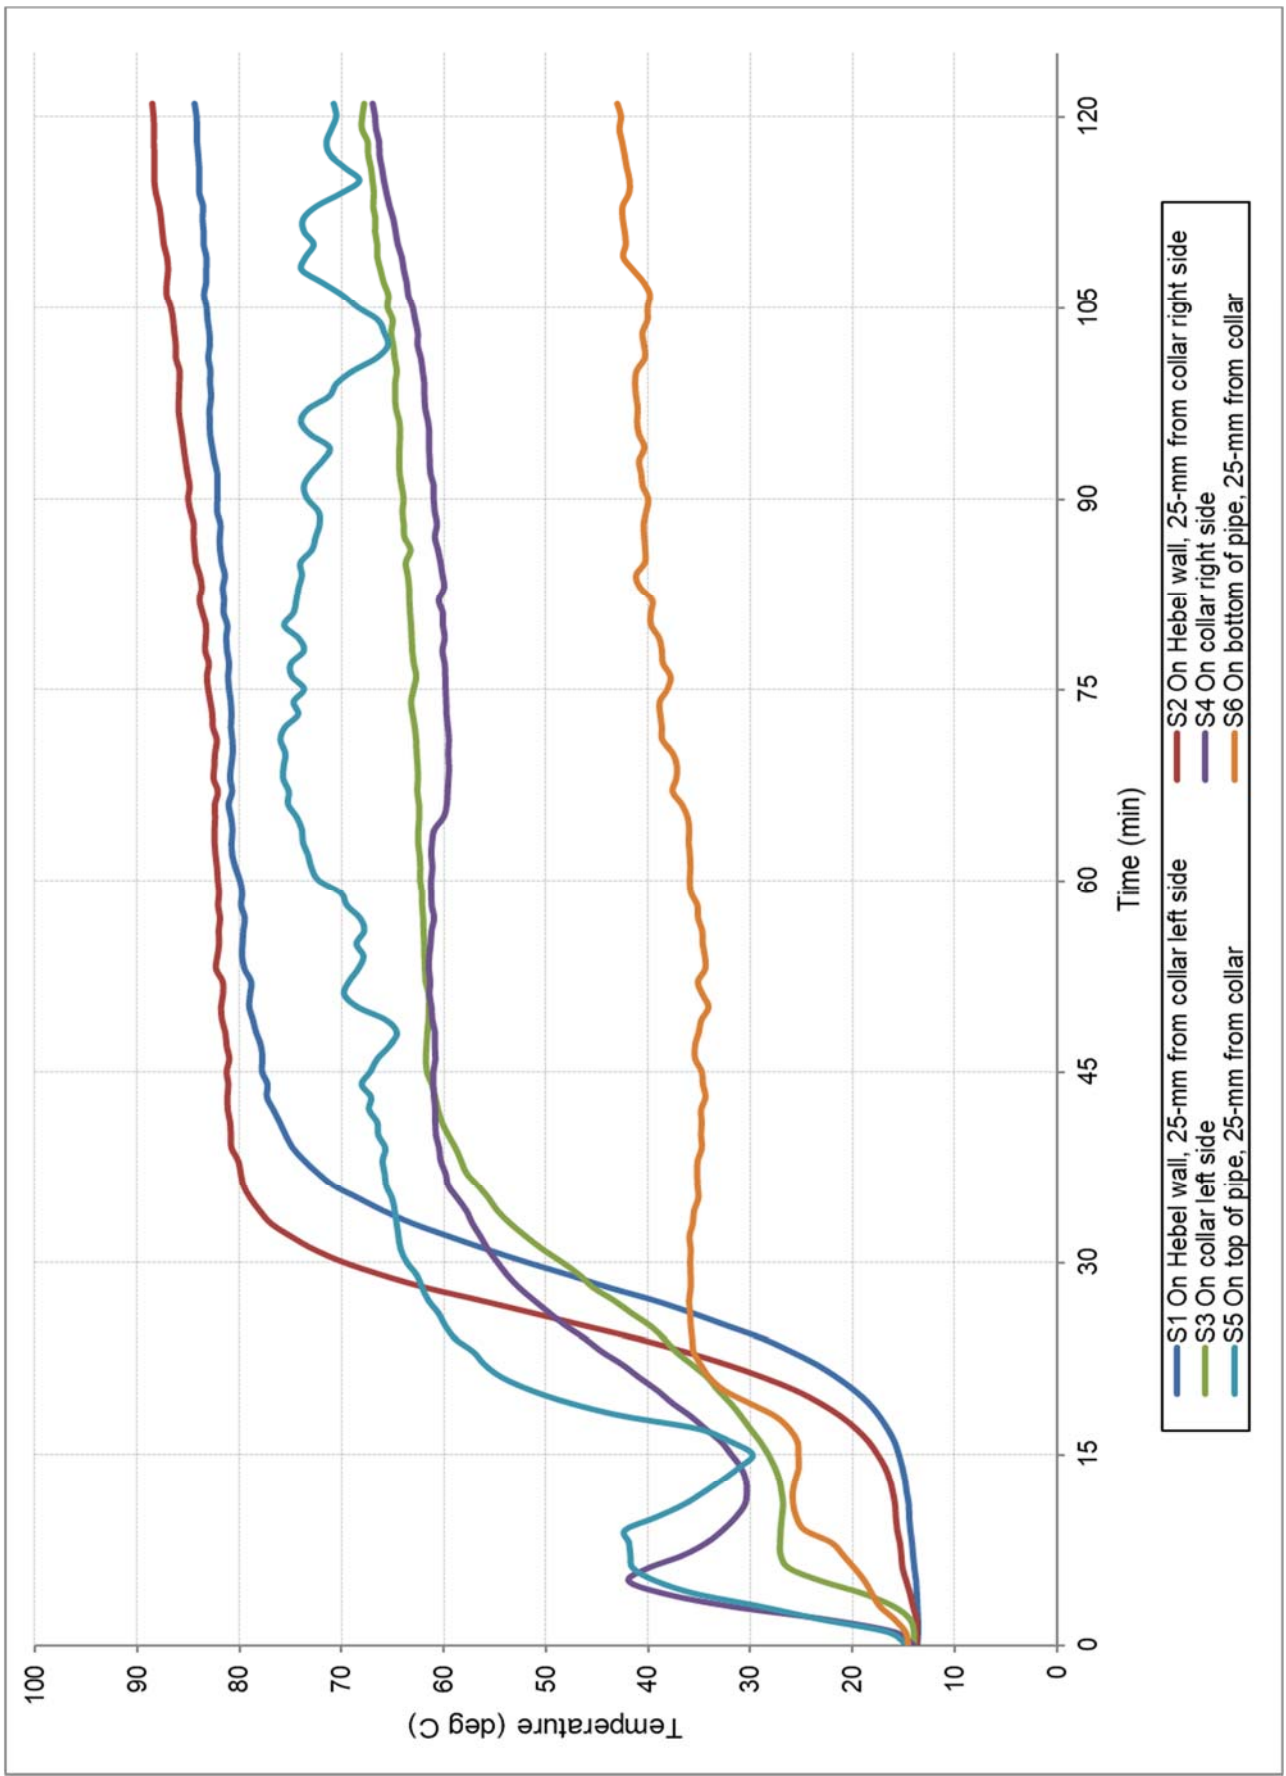
FIGURE 3 - TEMPERATURE VERSUS TIME ASSOCIATED WITH SPECIMEN #1

Figure 3 shows the curve of temperature versus time associated with Specimen 1.
