Fire-resistance test on retrofit fire collars protecting a Hebel PowerPanel wall penetrated by services

Test Report

Author: Peter Gordon
Report number: FSP 2118
Date: 1 September 2020
Client: IG6 Pty Ltd as trustee for the IG6 IP Trust

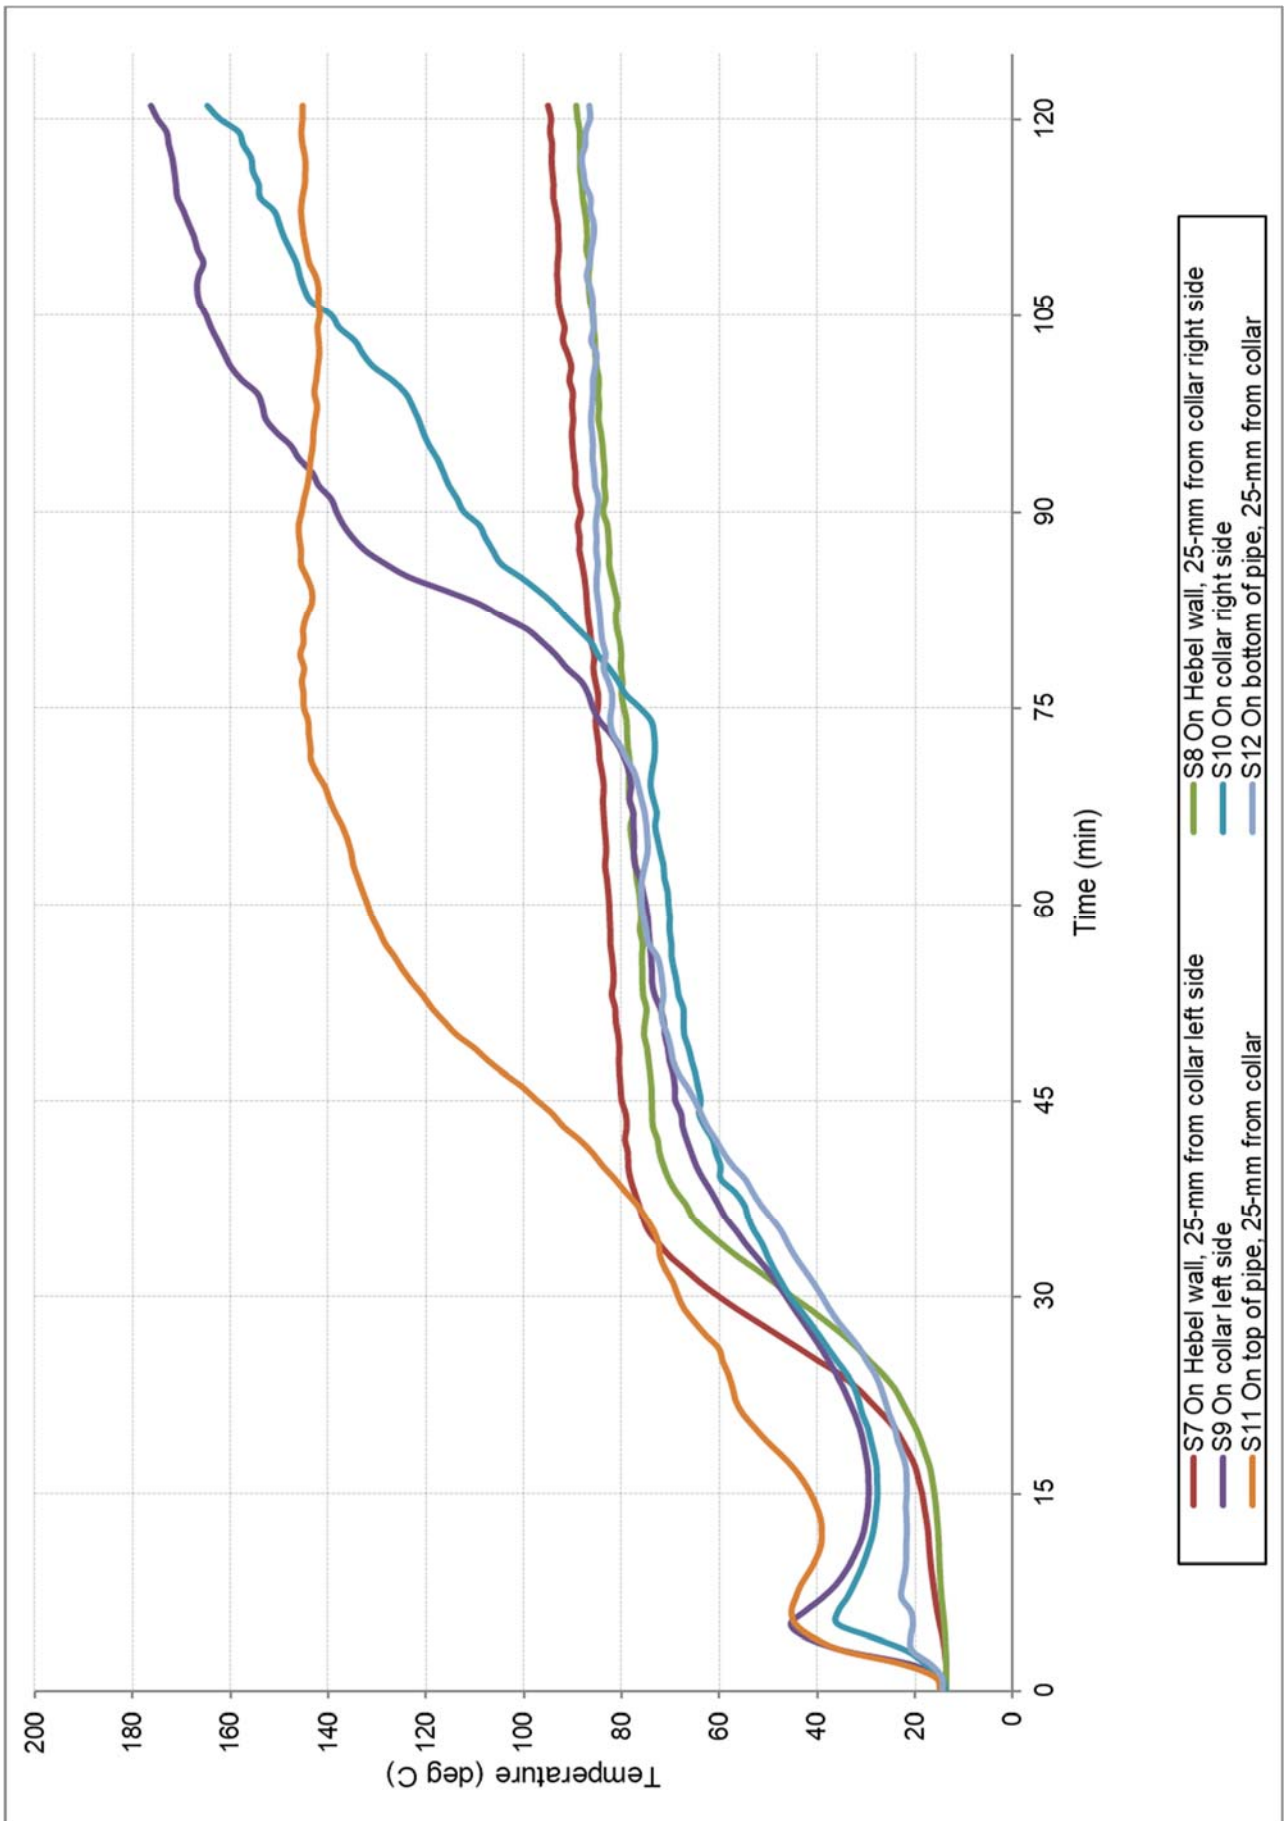
FIGURE 4 - TEMPERATURE VERSUS TIME ASSOCIATED WITH SPECIMEN #2

Figure 4 shows the curve of temperature versus time associated with Specimen 2.

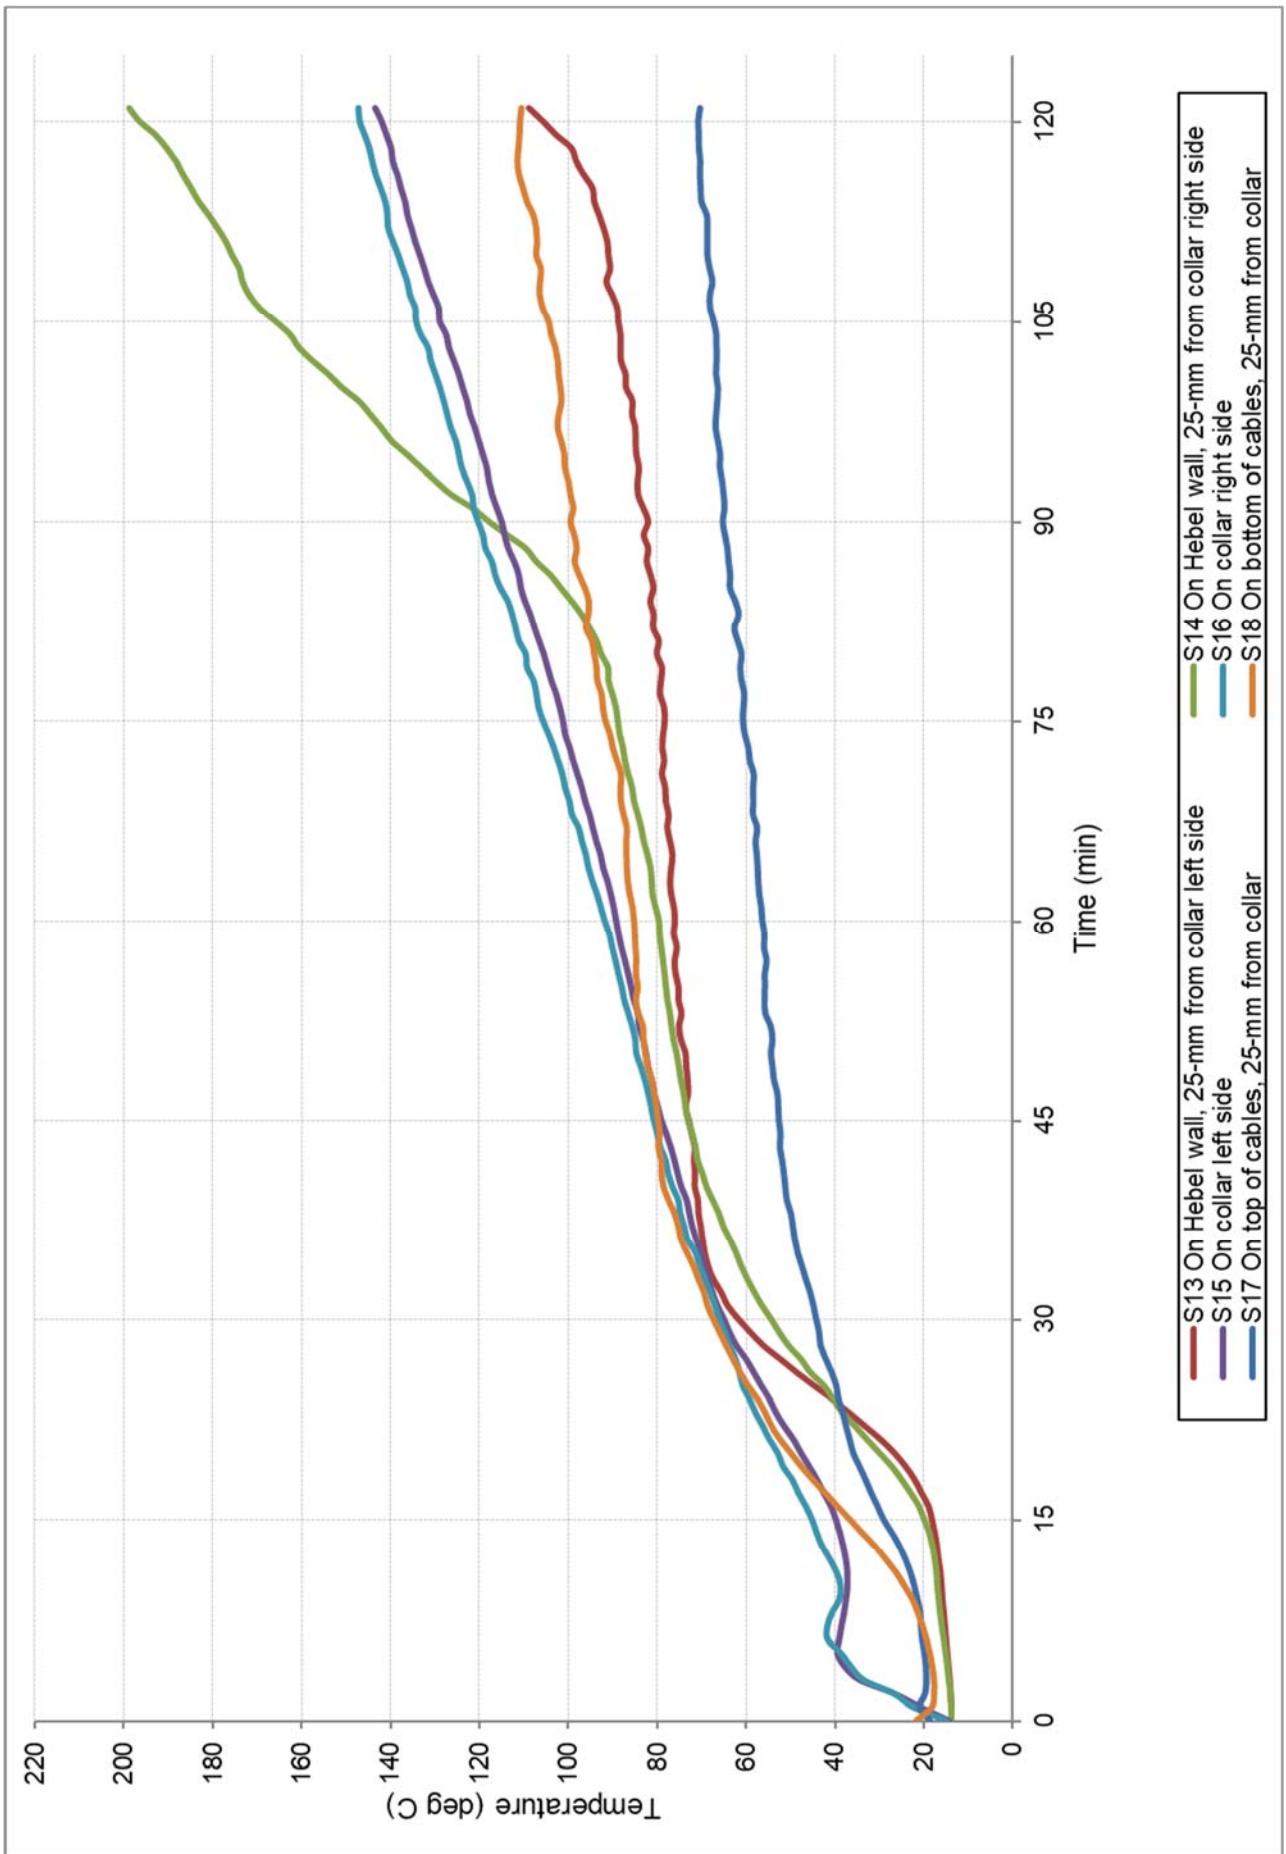
FIGURE 5 - TEMPERATURE VERSUS TIME ASSOCIATED WITH SPECIMEN #3

- 120 minutes - Insulation failure of Specimen 3 – maximum temperature rise of 180K is exceeded on the Hebel wall 25-mm from the right hand side of the collar of Specimen 3.

Figure 5 shows the curve of temperature versus time associated with Specimen 3.

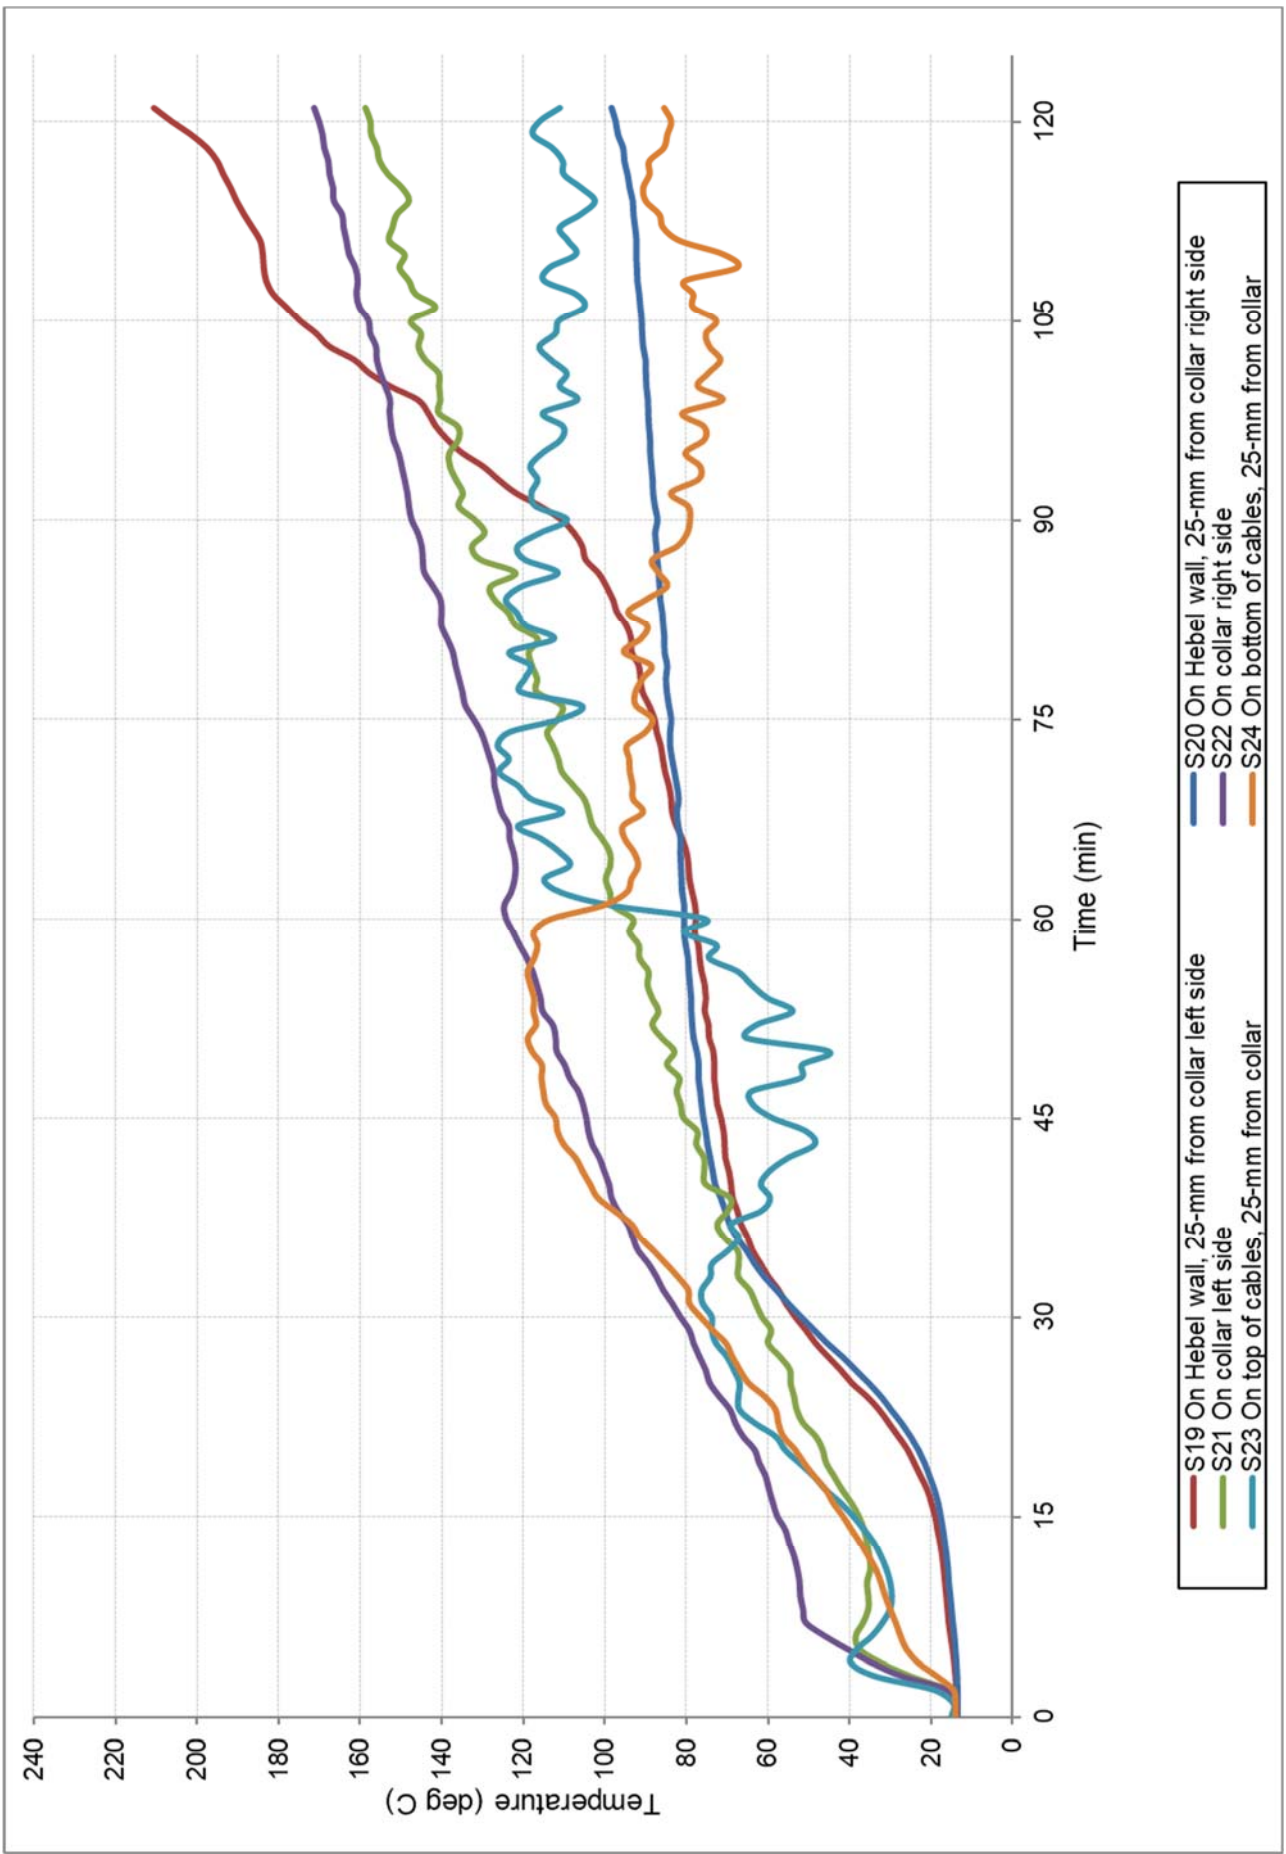
FIGURE 6 - TEMPERATURE VERSUS TIME ASSOCIATED WITH SPECIMEN #4

- 117 minutes - Insulation failure of Specimen 4 – maximum temperature rise of 180K is exceeded on the Hebel wall 25-mm from the right hand side of the collar of Specimen 4.

Figure 6 shows the curve of temperature versus time associated with Specimen 4.

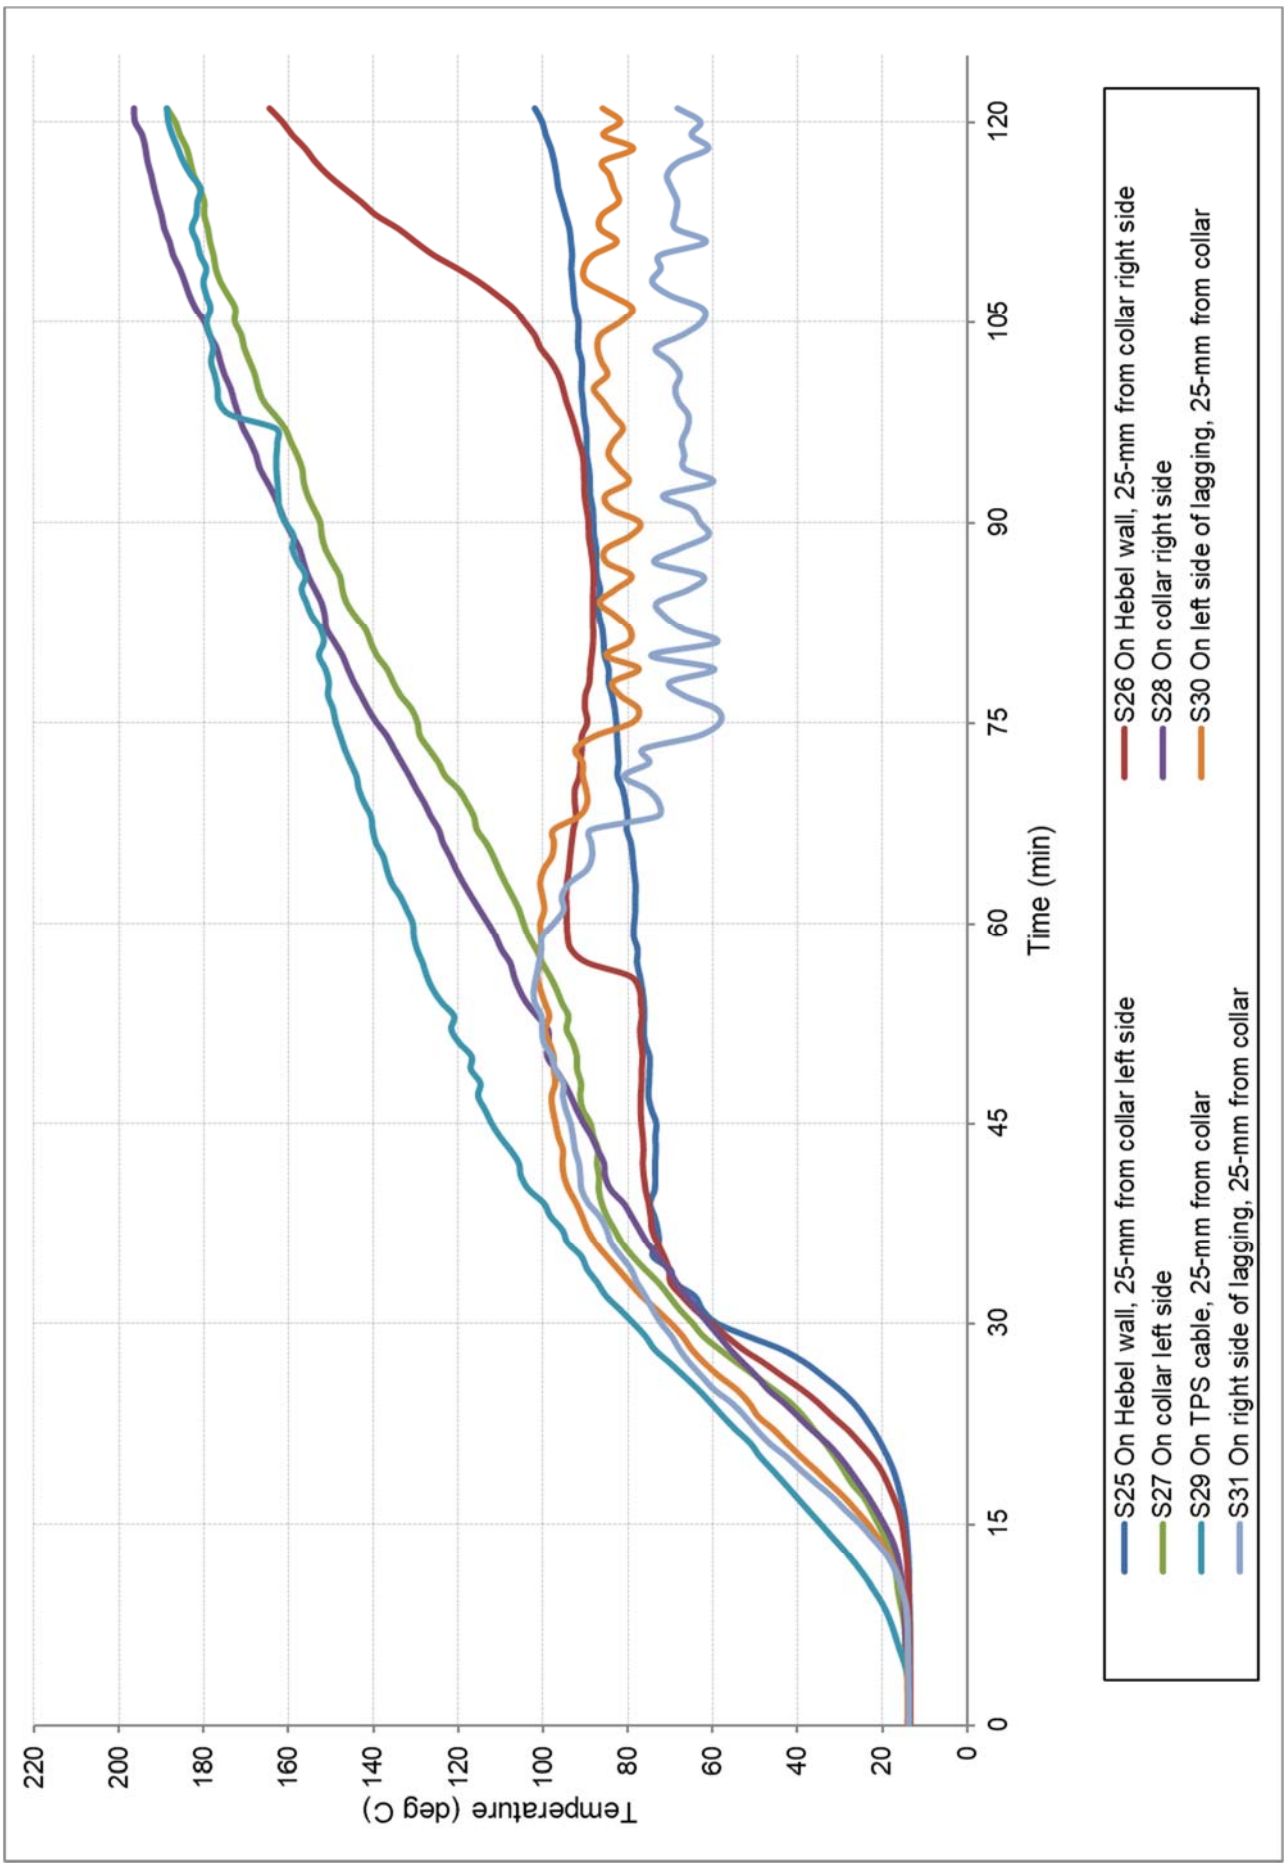
FIGURE 7 - TEMPERATURE VERSUS TIME ASSOCIATED WITH SPECIMEN #5

Figure 7 shows the curve of temperature versus time associated with Specimen 5.

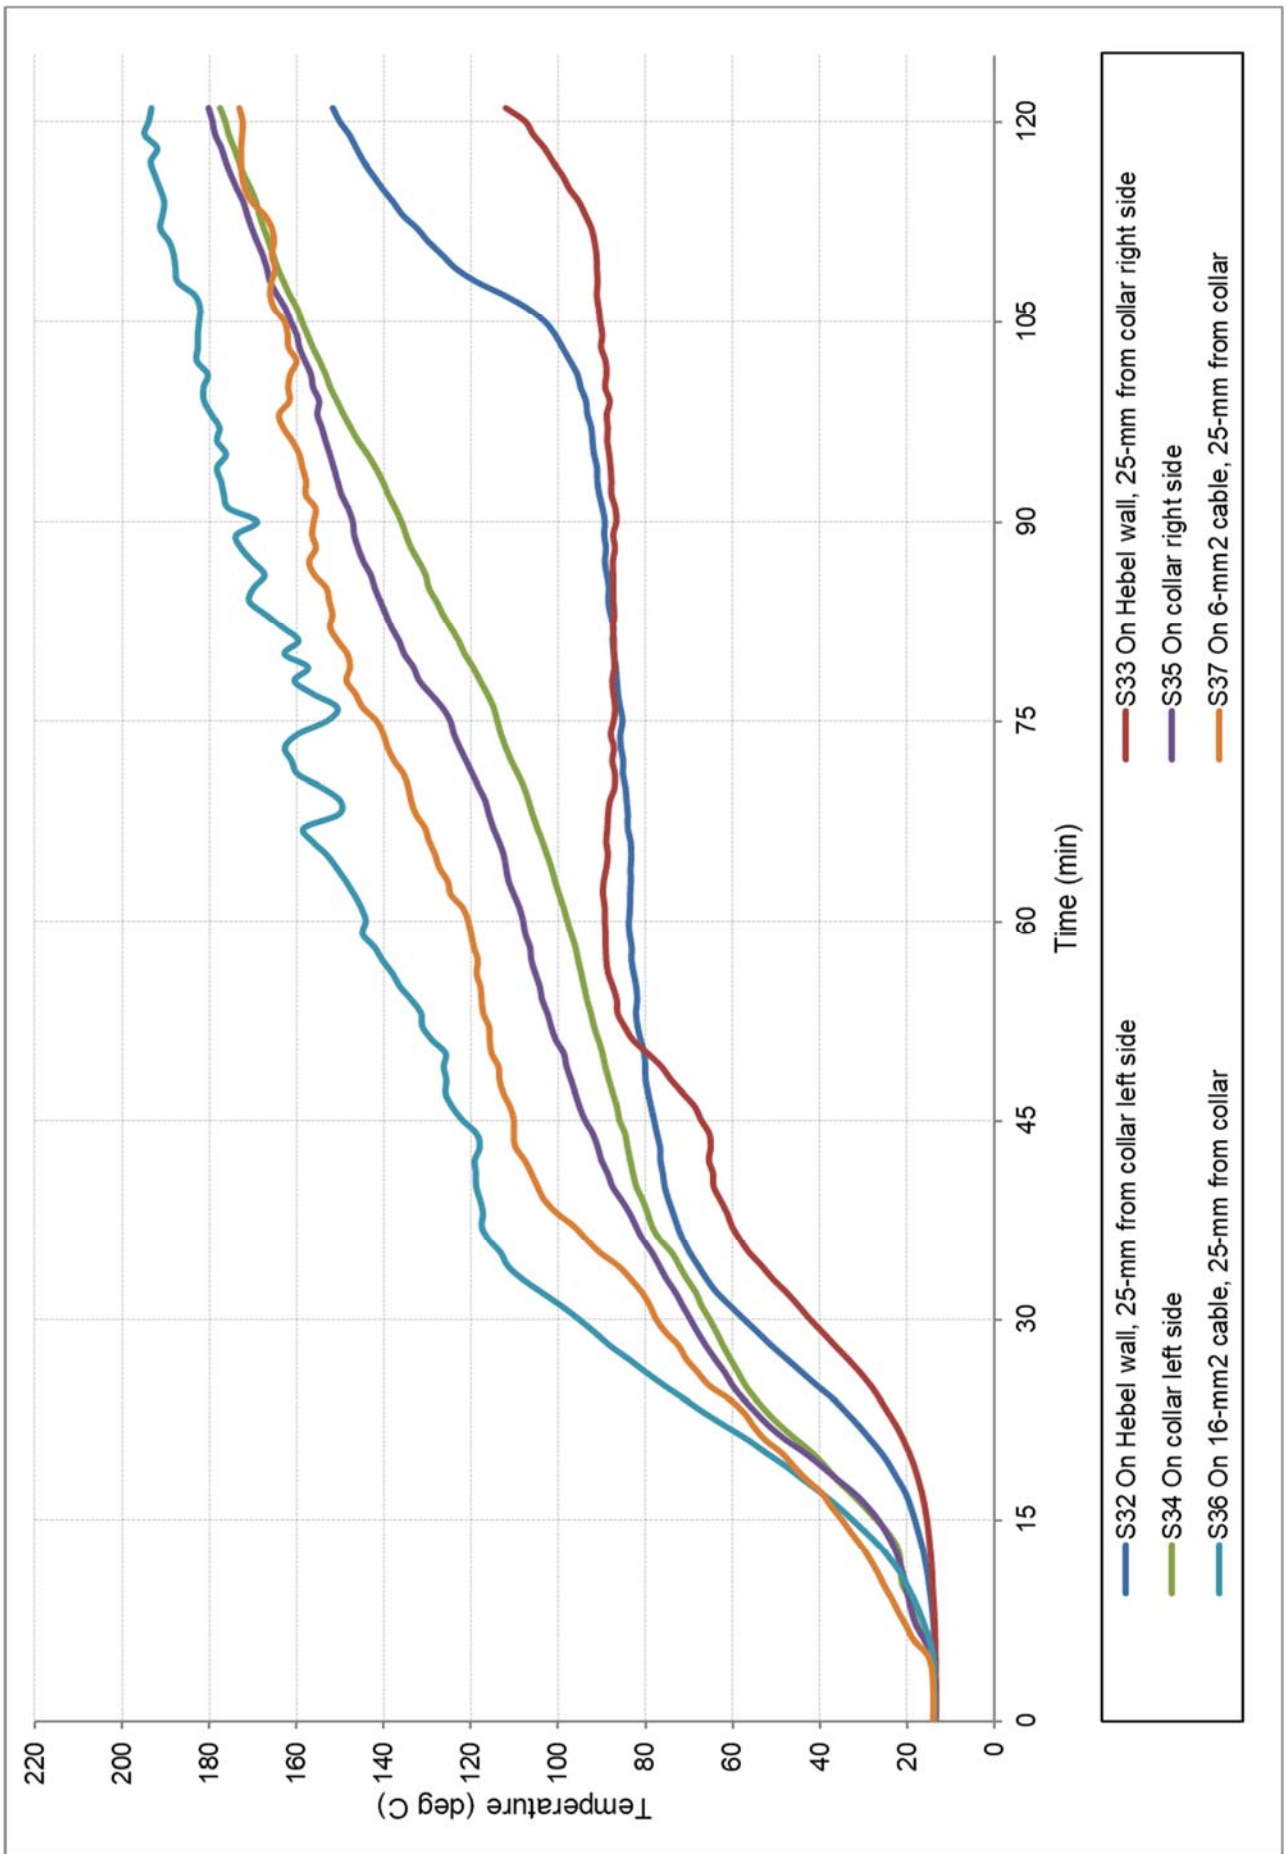
FIGURE 8 - TEMPERATURE VERSUS TIME ASSOCIATED WITH SPECIMEN #6

- 119 minutes - Insulation failure of Specimen 6 – maximum temperature rise of 180K is exceeded on the 16-mm² power cables 25-mm from the collar of Specimen 6.

Figure 8 shows the curve of temperature versus time associated with Specimen 6.

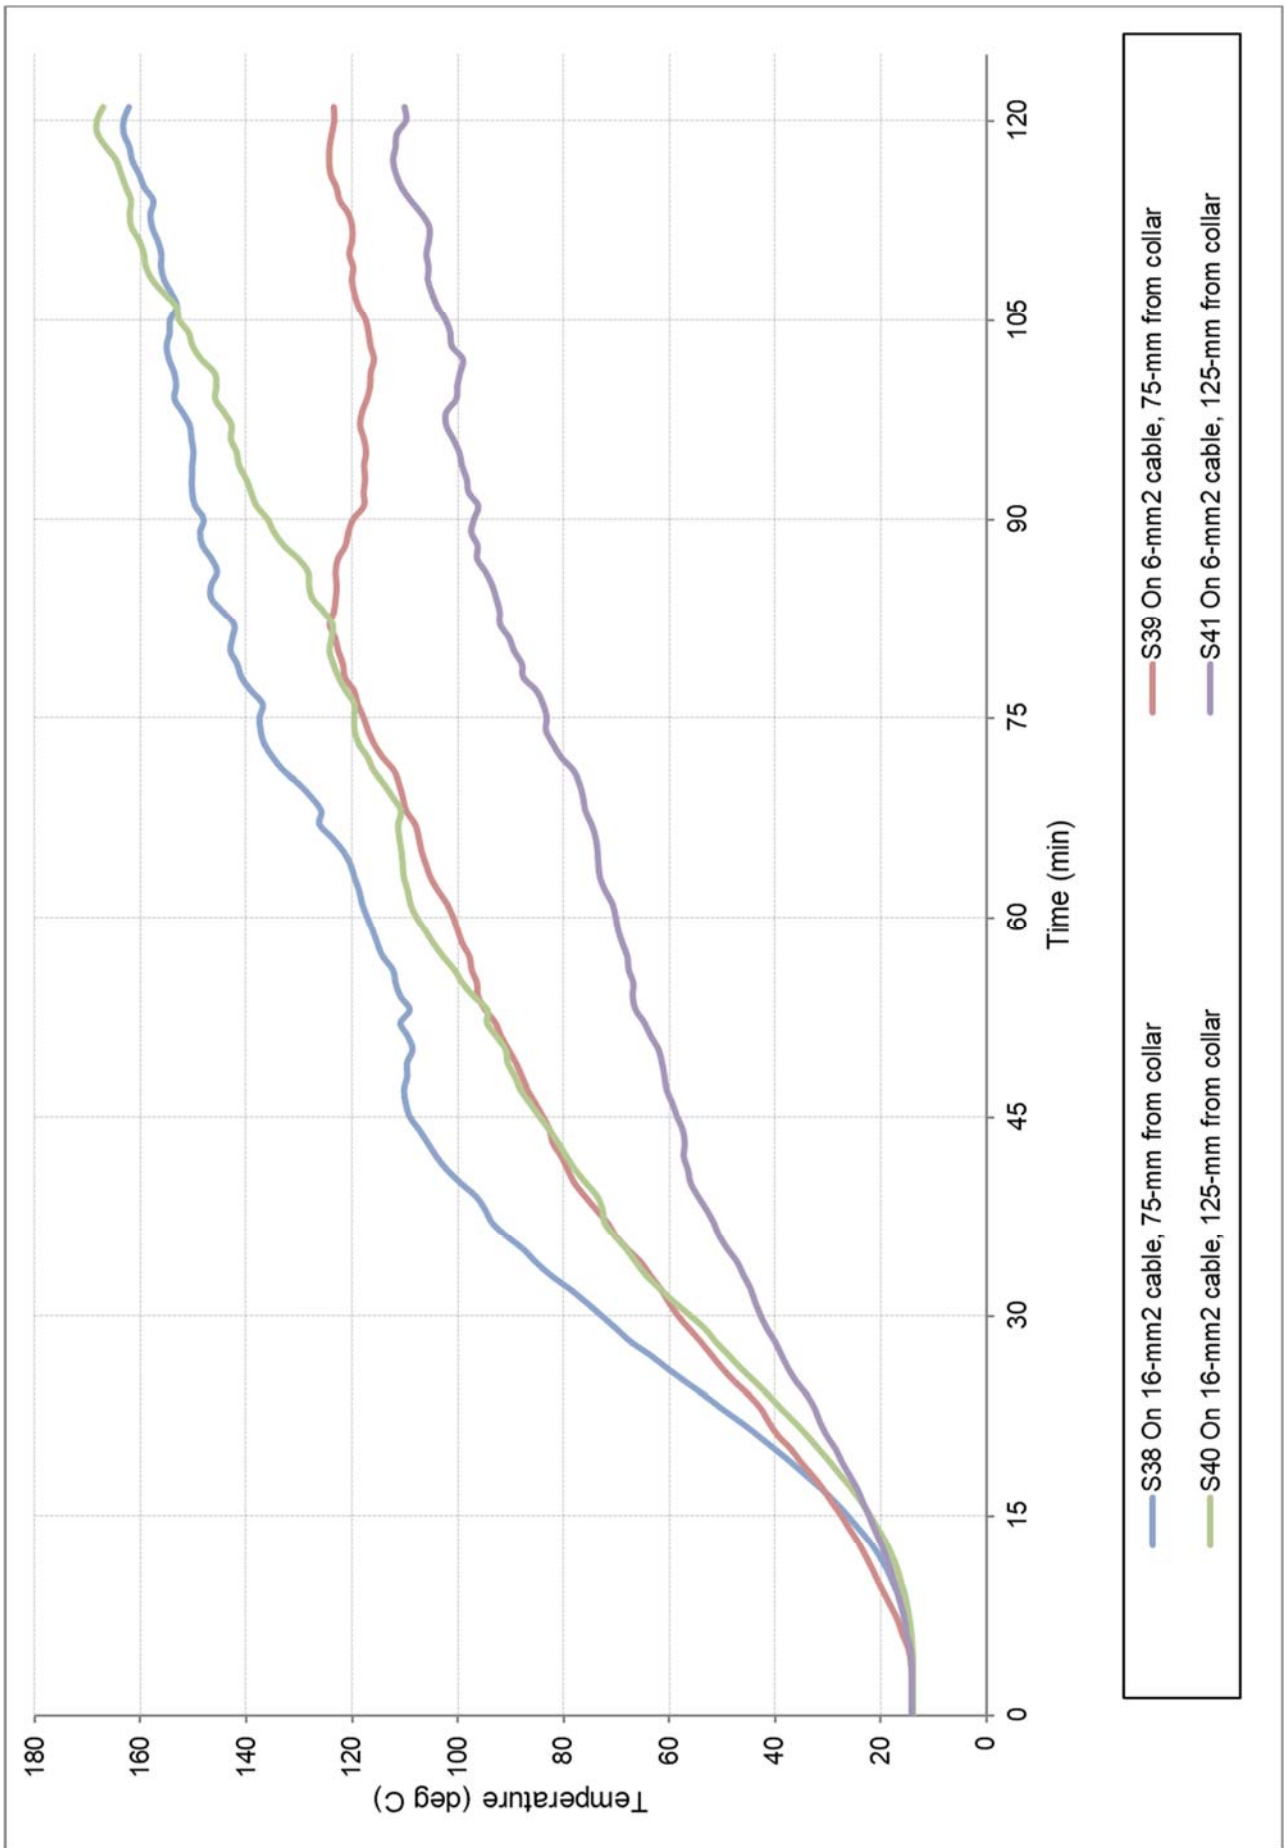
FIGURE 9 - TEMPERATURE ASSOCIATED WITH EXTRA THERMOCOUPLES ON SPECIMEN #6

SPECIMEN	T/C Position	T/C designation
Specimen 6 - SNAP MS70R Multi Services Retrofit fire collars protecting a bundle six 16-mm ² 3C+E and three 6-mm ² 3C+E power cables.	On Hebel wall, 25-mm from collar left side	S32
	On Hebel wall, 25-mm from collar right side	S33
	On collar left side	S34
	On collar right side	S35
	On 16-mm ² cable, 25-mm from collar	S36
	On 6-mm ² cable, 25-mm from collar	S37
Additional Thermocouples placed on cables of Specimen 6.	On 16-mm ² cable, 75-mm from collar	S38
	On 6-mm ² cable, 75-mm from collar	S39
	On 16-mm ² cable, 125-mm from collar	S40
	On 6-mm ² cable, 125-mm from collar	S41
Rover		S42
Ambient		S43

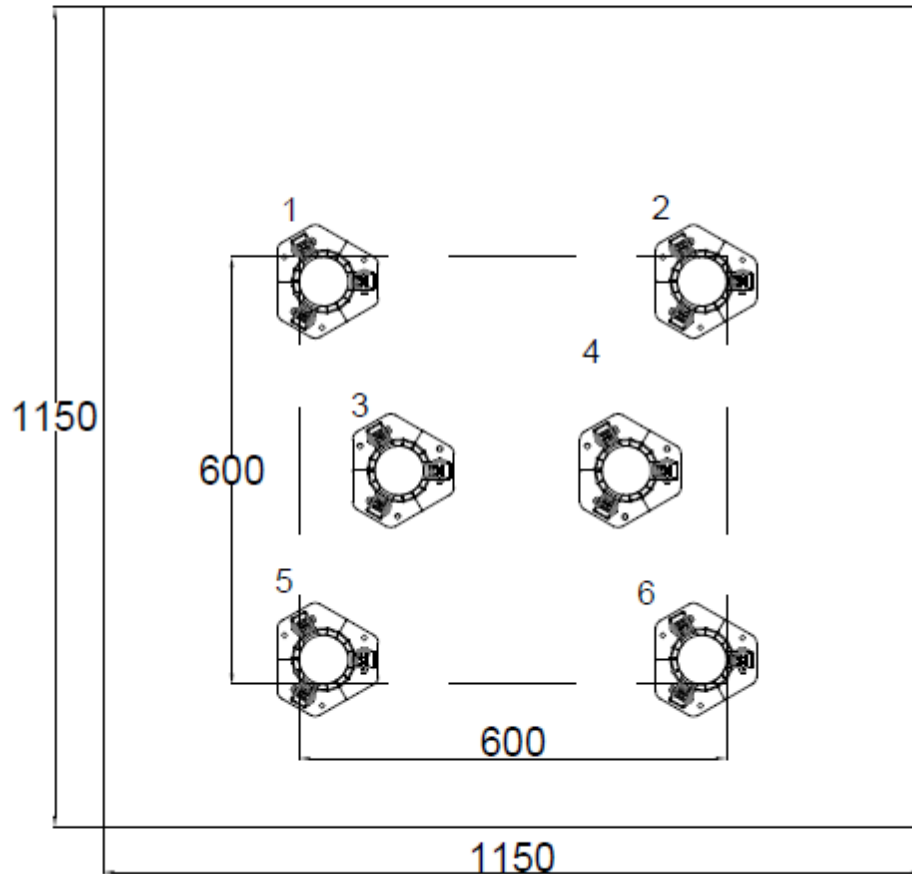
Test Wall W-20-F Layout

Penetration	Collar Code	Pipe Type	Pipe Diameter
1	MS70R	PN6 Pressure PVC	50
2	MS70R	Medium Duty PVC Conduit with Orange Power Cables	50, 2x(16mm ² 3C+E) & 2x(6mm ² 3C+E)
3	MS70R	20xCat5e Cables	
4	MS70R	100xCat5e Cables	
5	MS70R	Copper Tube with F/R lagging and TPS cable	1in(19mm Lagging) & 2.5mm ² 3C
6	MS70R	Orange Power Cables	3x(6mm ² 3C+E) & 6x(16mm ² 3C+E)

DRAWING TITLED "TEST WALL W-20-F LAYOUT, DATED 9 JUNE 2020, PROVIDED BY SNAP FIRE SYSTEMS PTY LTD.

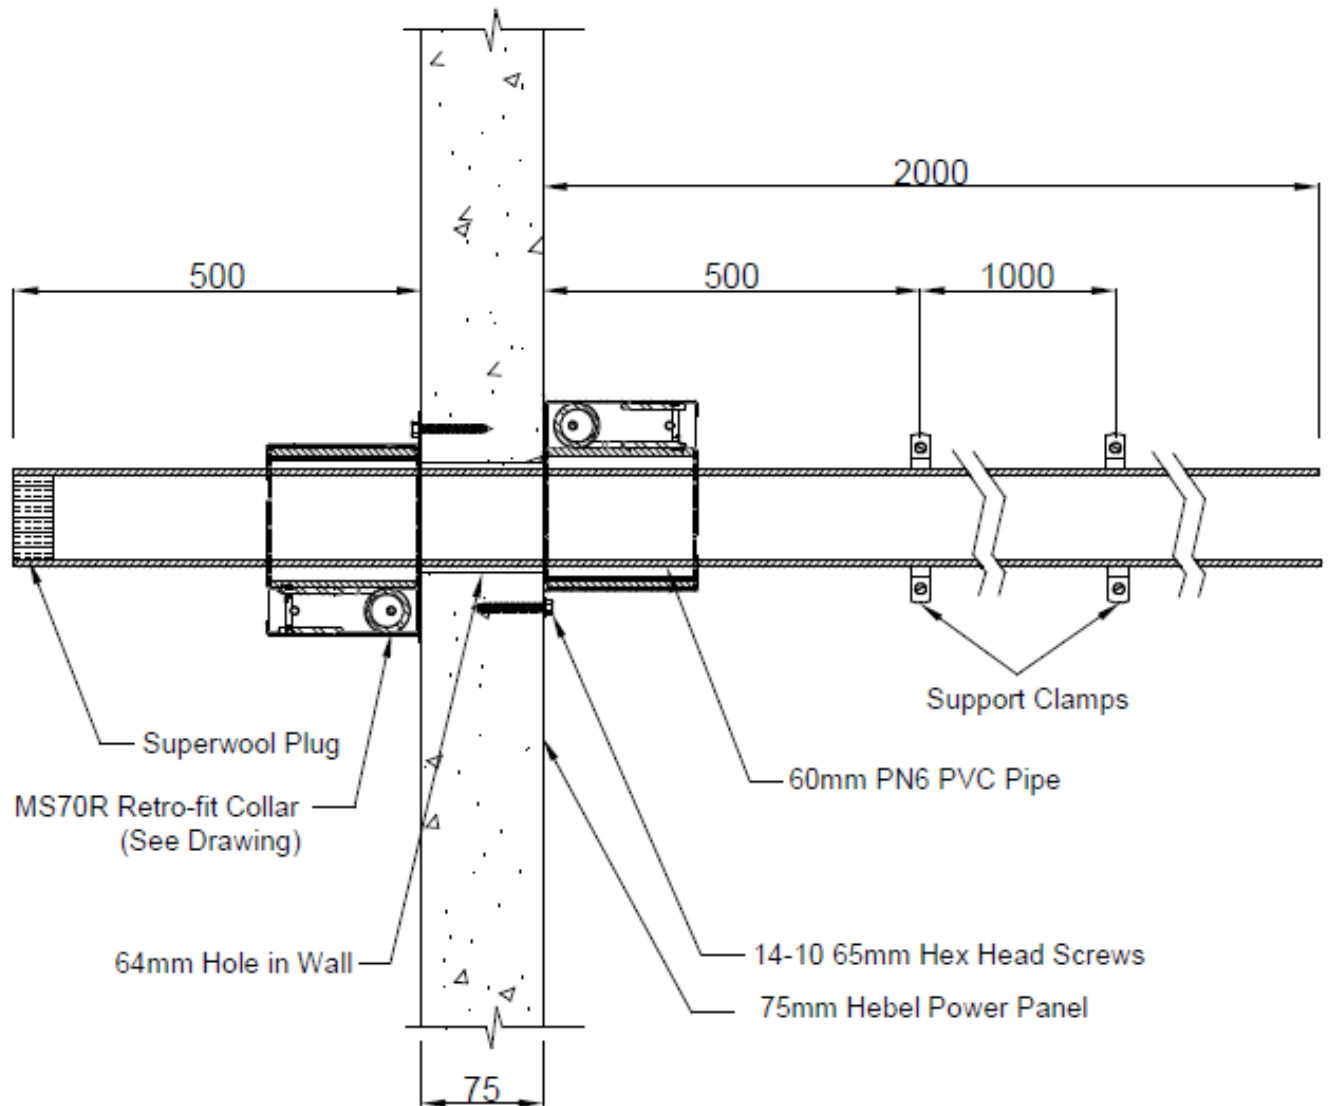
50 PN6 PVC Pipe & MS70R Collar

DRAWING TITLED "SPECIMEN #1 50 PN6 PVC PIPE & MS70R COLLAR", DATED 9 JUNE 2020, PROVIDED BY SNAP FIRE SYSTEMS PTY LTD

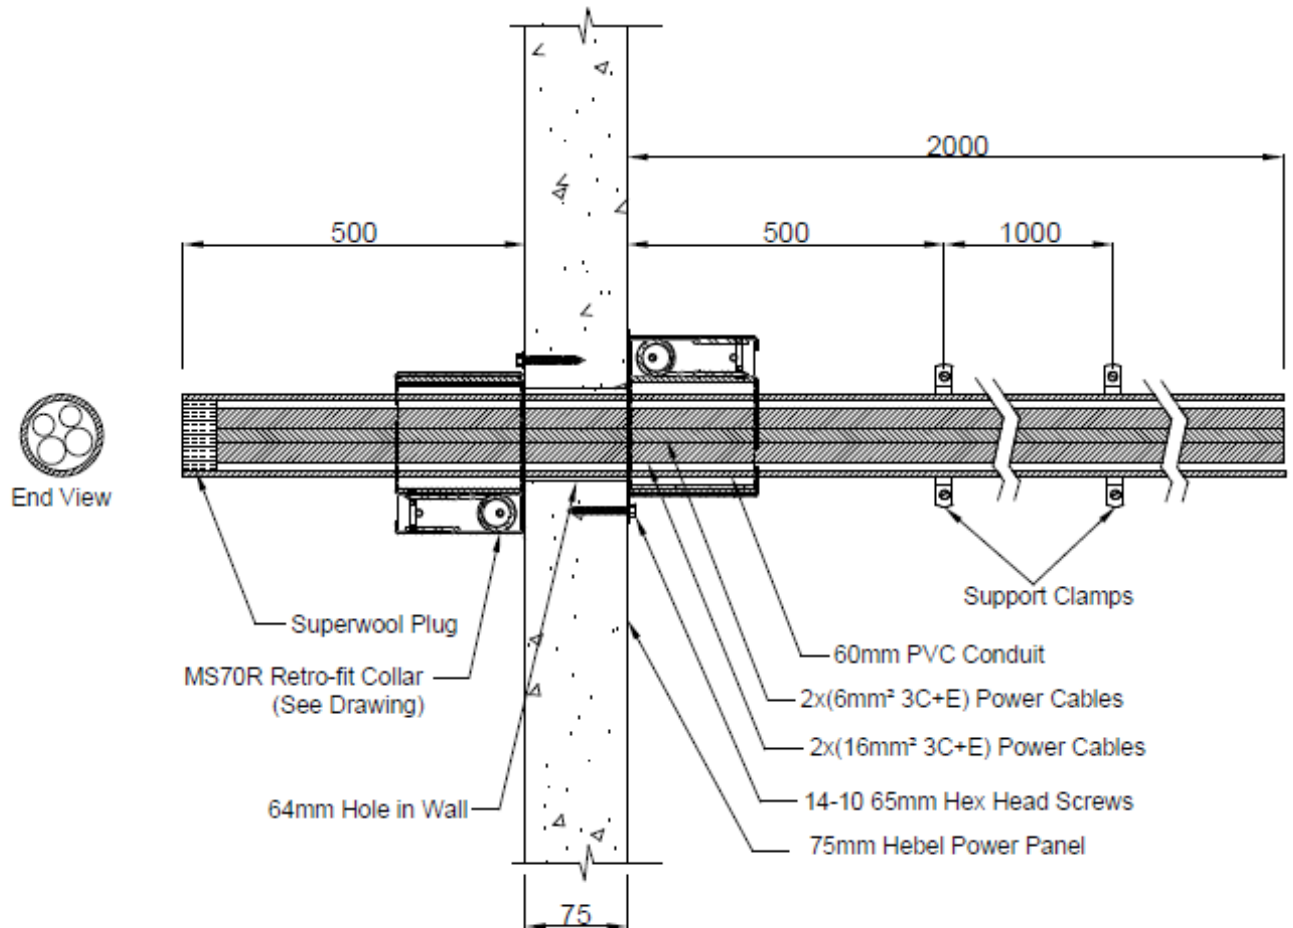
50 PVC Conduit with 16mm² 3C+E &
6mm² 3C+E Power Cables & MS70R Collar

DRAWING TITLED "SPECIMEN #2 50 PVC CONDUIT WITH 16MM² 3C+E & 6MM² 3C+E POWER CABLES & MS70R COLLAR", DATED 9 JUNE 2020, PROVIDED BY SNAP FIRE SYSTEMS PTY LTD

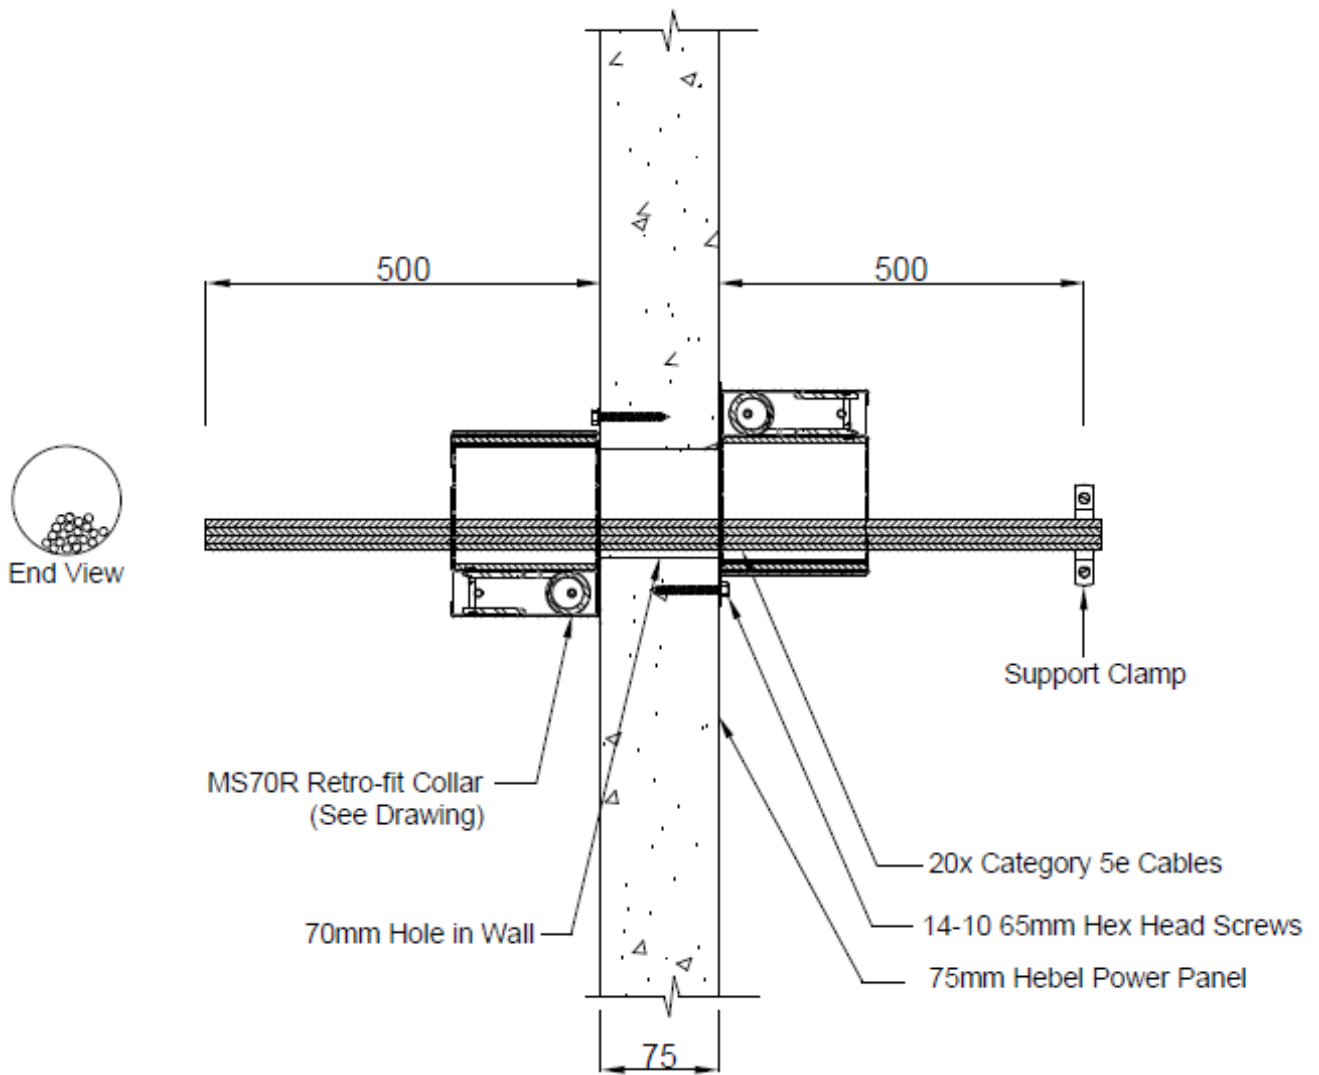
20% Full of Cat5e Cables & MS70R Collar

**DRAWING TITLED "SPECIMEN #3 20% FULL OF CAT5E CABLES & MS70R COLLAR", DATED 9 JUNE 2020,
PROVIDED BY SNAP FIRE SYSTEMS PTY LTD, PROVIDED BY SNAP FIRE SYSTEMS PTY LTD**

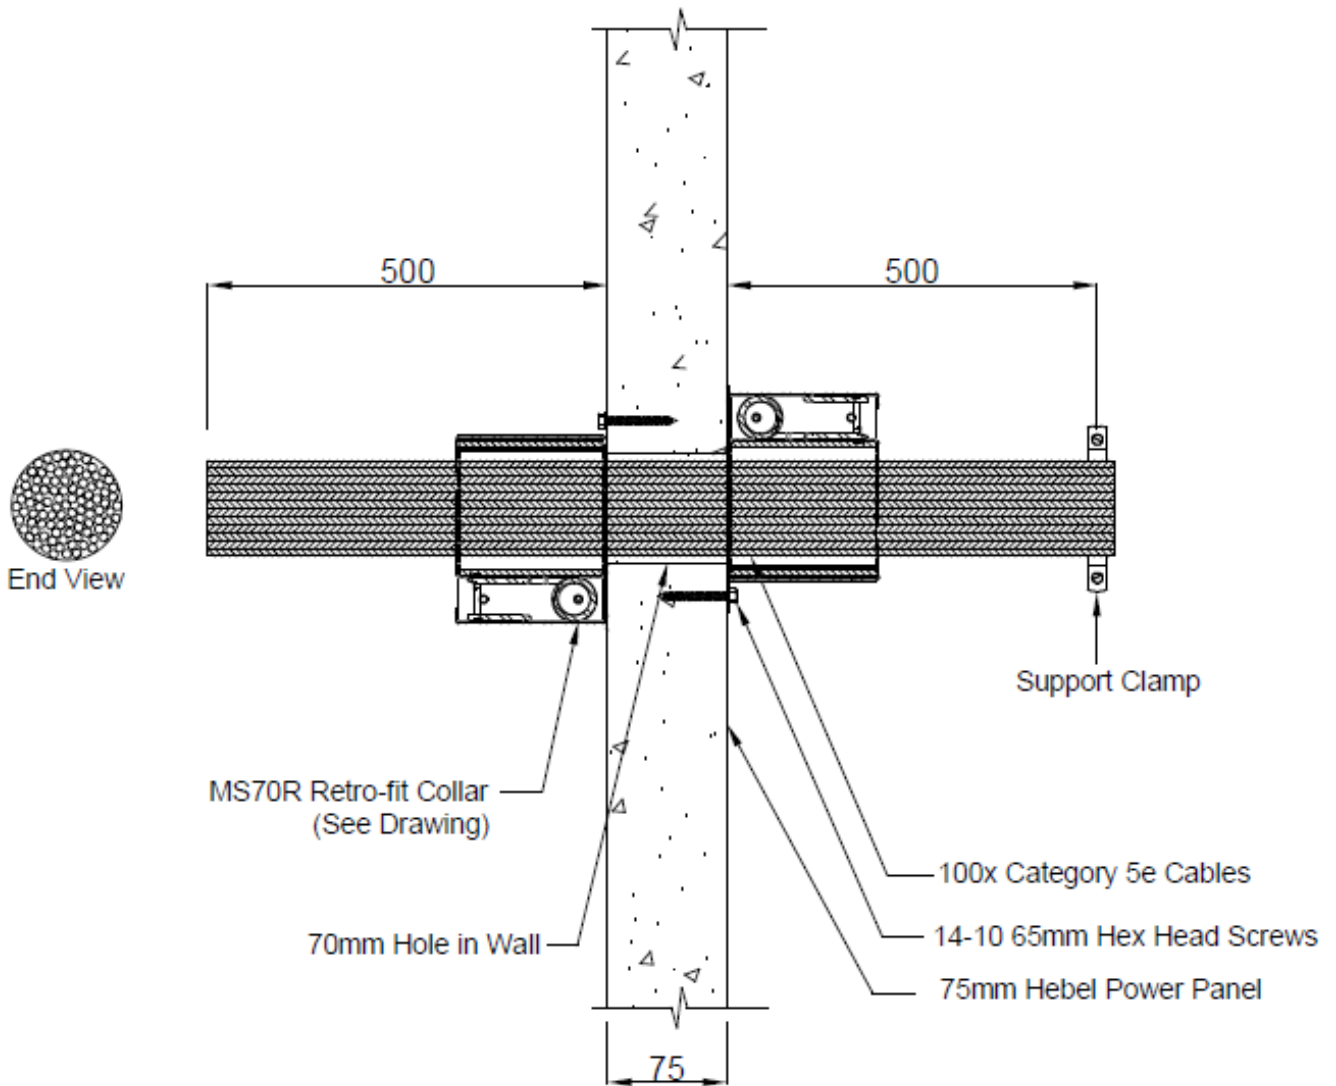
100% Full of Cat5e Cables & MS70R Collar

DRAWING TITLED "SPECIMEN #4 100% FULL OF CAT5E CABLES & MS70R COLLAR", DATED 9 JUNE 2020,
PROVIDED BY SNAP FIRE SYSTEMS PTY LTD, PROVIDED BY SNAP FIRE SYSTEMS PTY LTD

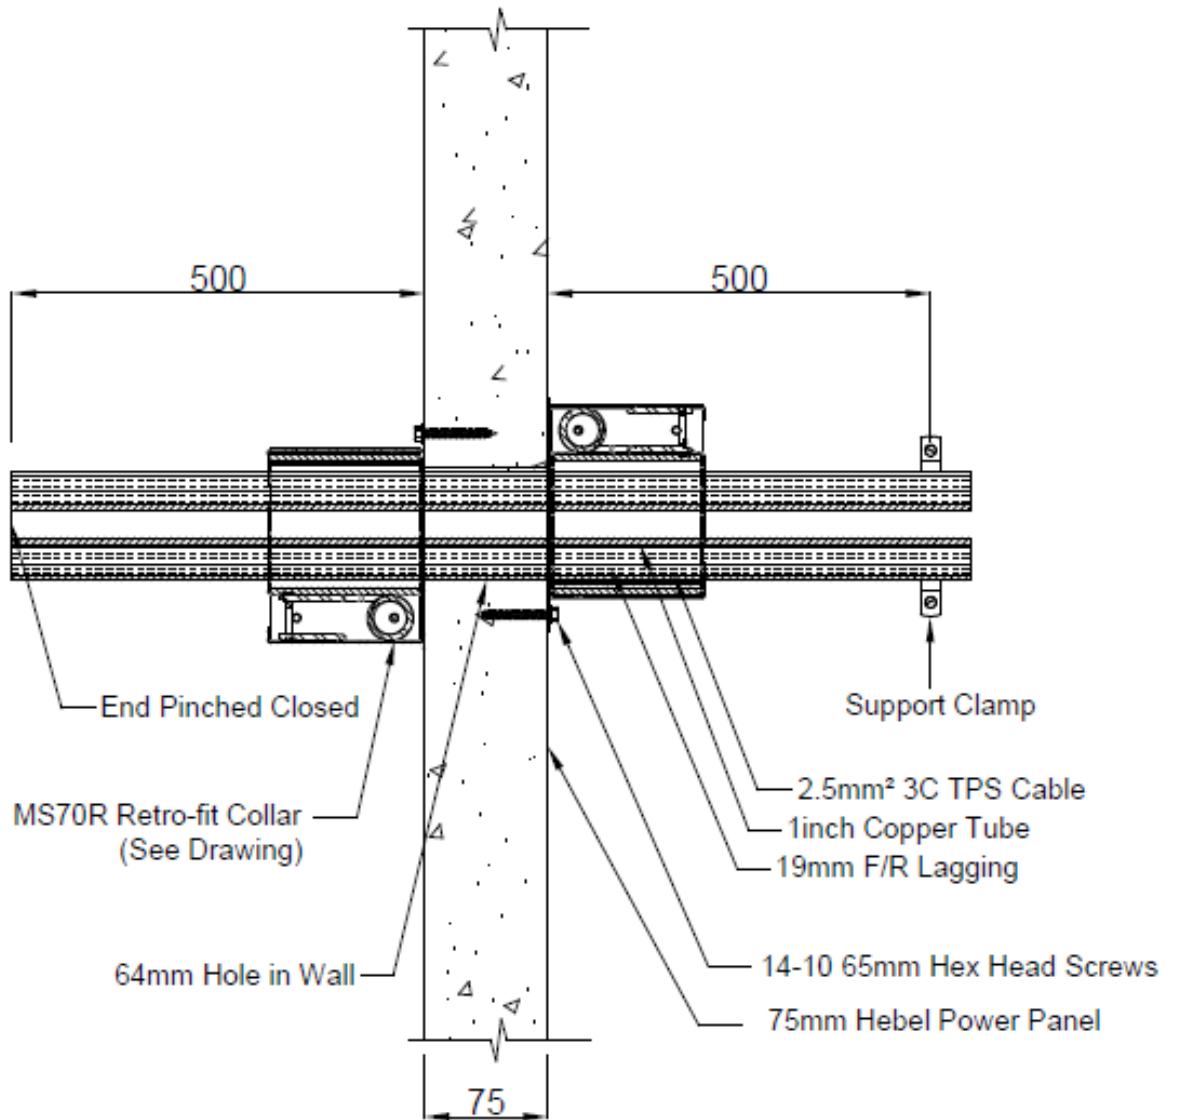
1inch Copper Tube with 19mm F/R Lagging,
2.5mm² 3C TPS Cable & MS70R Collar

DRAWING TITLED "SPECIMEN #5 1 INCH COPPER TUBE WITH 19MM F/R LAGGING, 3C TPS CABLE & MS70R COLLAR", DATED 9 JUNE 2020, PROVIDED BY SNAP FIRE SYSTEMS PTY LTD
