Fire-resistance test on retrofit fire collars protecting a Hebel PowerPanel wall penetrated by services

Test Report

Author: Peter Gordon
Report number: FSP 2118
Date: 1 September 2020
Client: IG6 Pty Ltd as trustee for the IG6 IP Trust

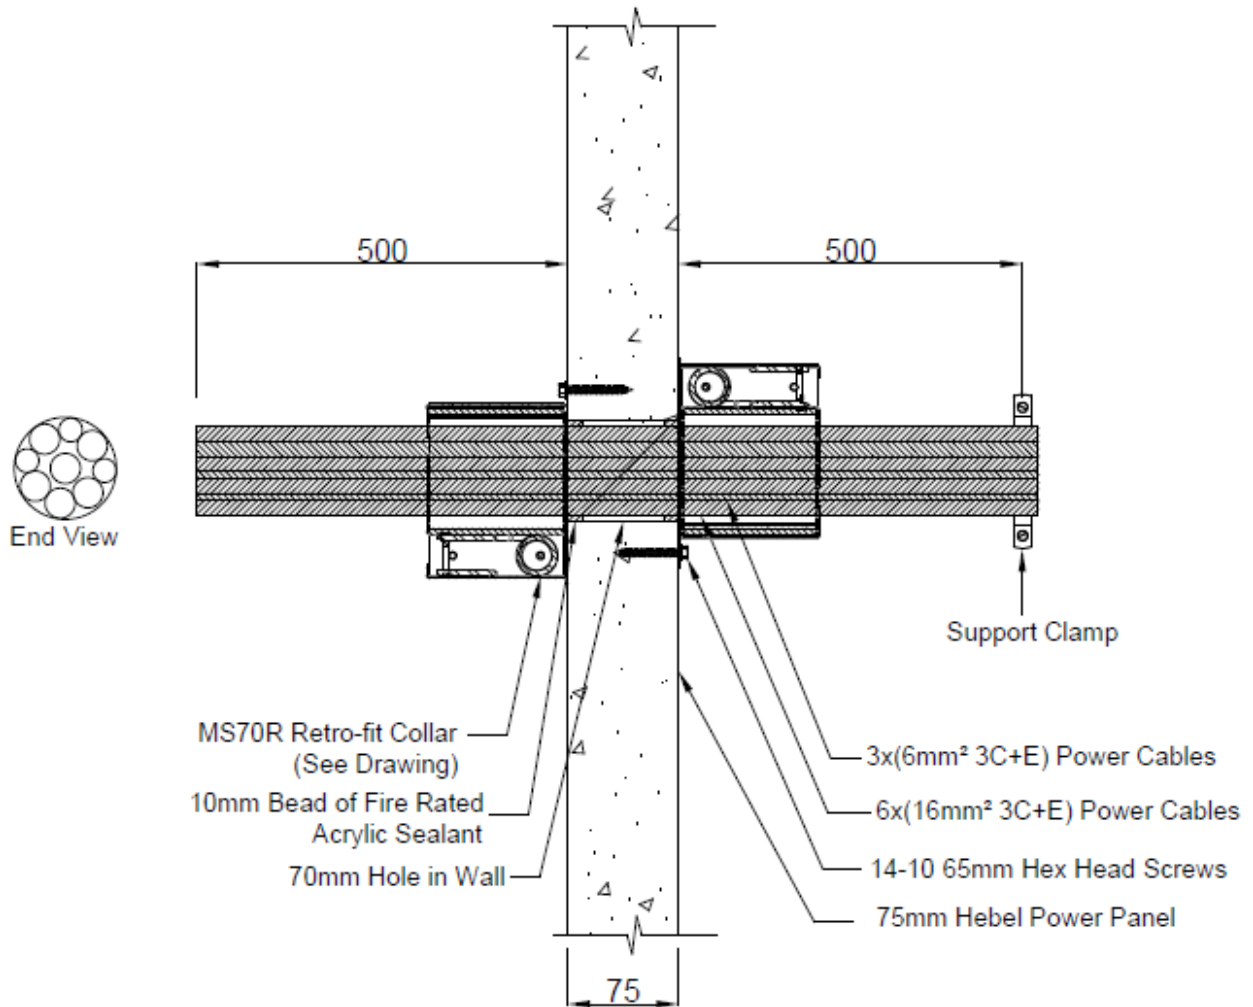
16mm² 3C+E & 6mm² 3C+E Power Cables & MS70R Collar

DRAWING TITLED "SPECIMEN #6 16MM² 3C+E & 6MM² 3C+E POWER CABLES & MS70R COLLAR", DATED 9 JUNE 2020, PROVIDED BY SNAP FIRE SYSTEMS PTY LTD
