# Fire-resistance test on retrofit fire collars protecting a plasterboard wall penetrated by services

## Test Report

**Author:** Peter Gordon  
**Report number:** FSP 2126  
**Date:** 8 September 2020  
**Client:** IG6 Pty Ltd as trustee for the IG6 IP Trust

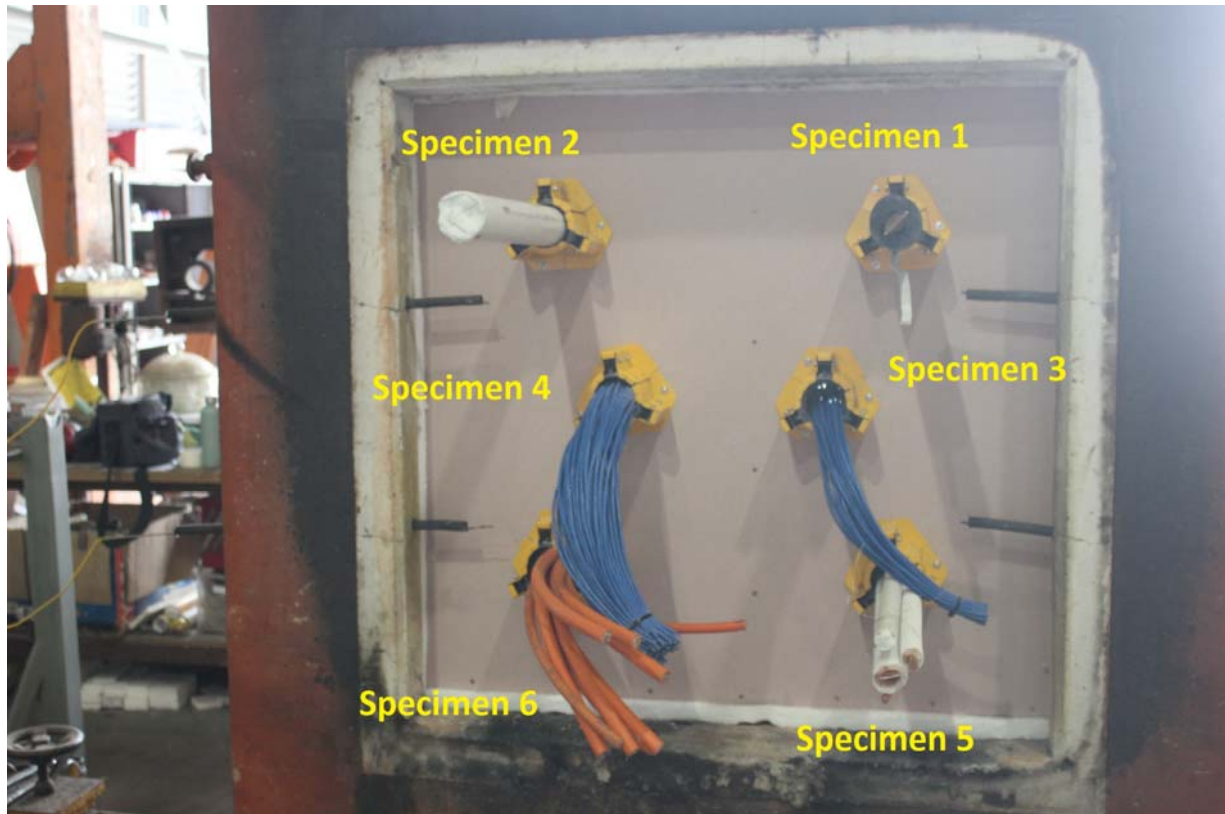
**PHOTOGRAPH 1 – EXPOSED FACE OF SPECIMENS PRIOR TO TESTING**

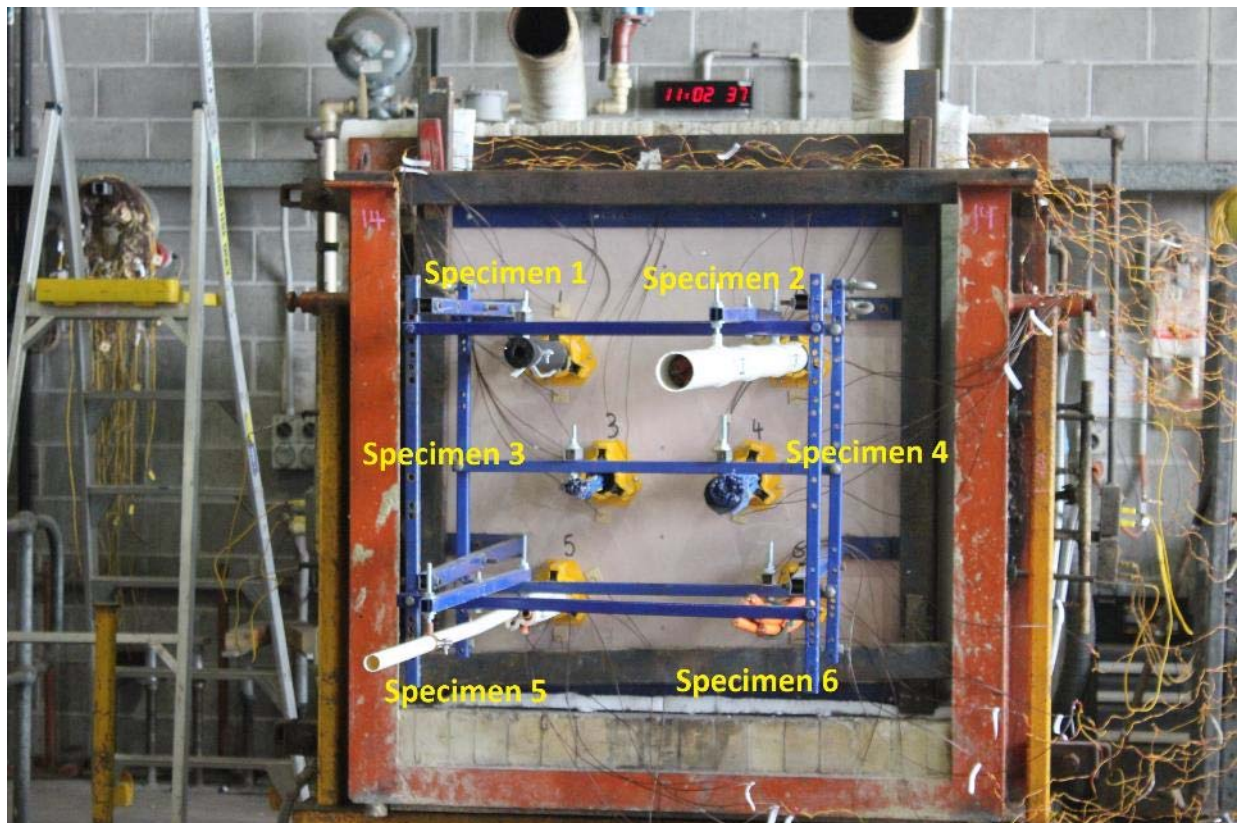
**PHOTOGRAPH 2 – UNEXPOSED FACE OF SPECIMENS PRIOR TO TESTING**

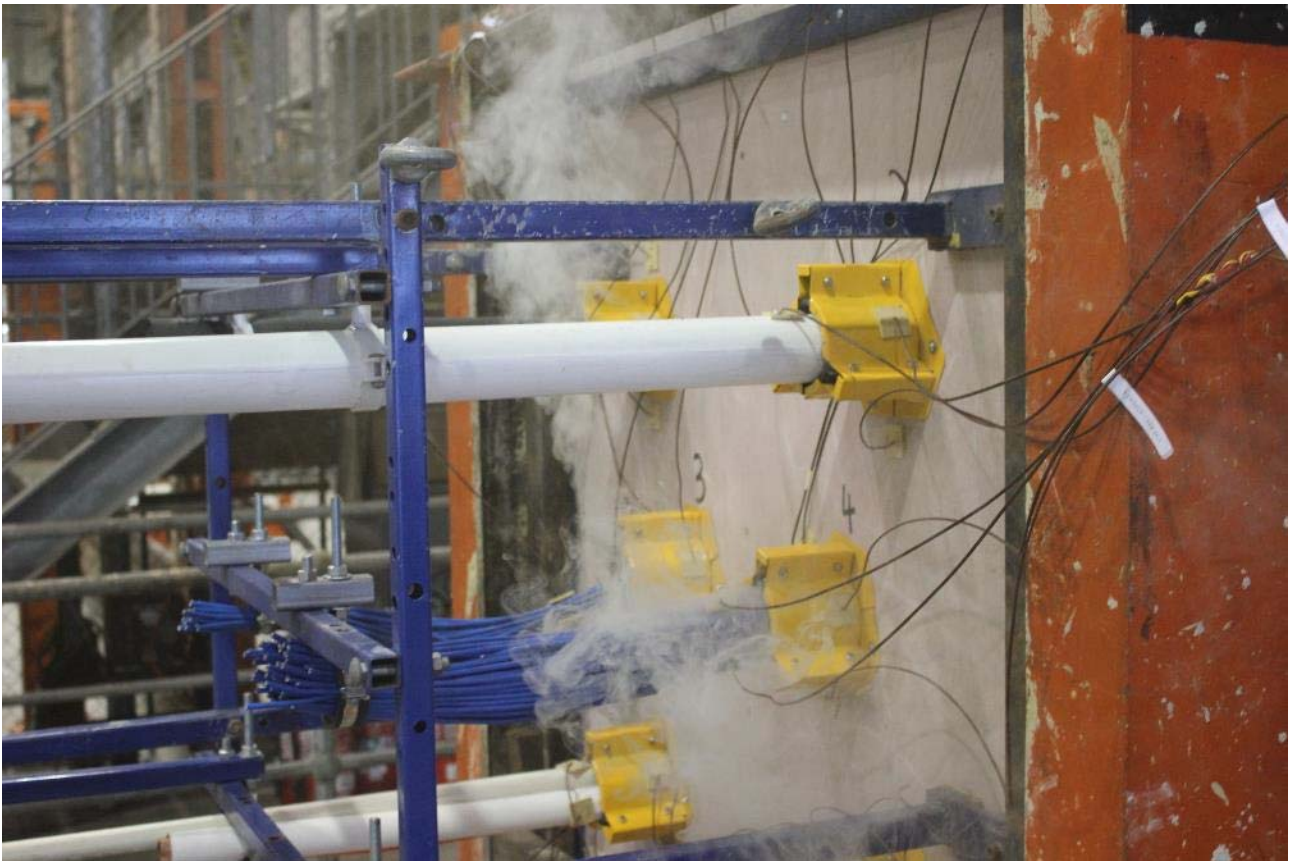
**PHOTOGRAPH 3 – SPECIMENS AFTER 2 MINUTES OF TESTING**

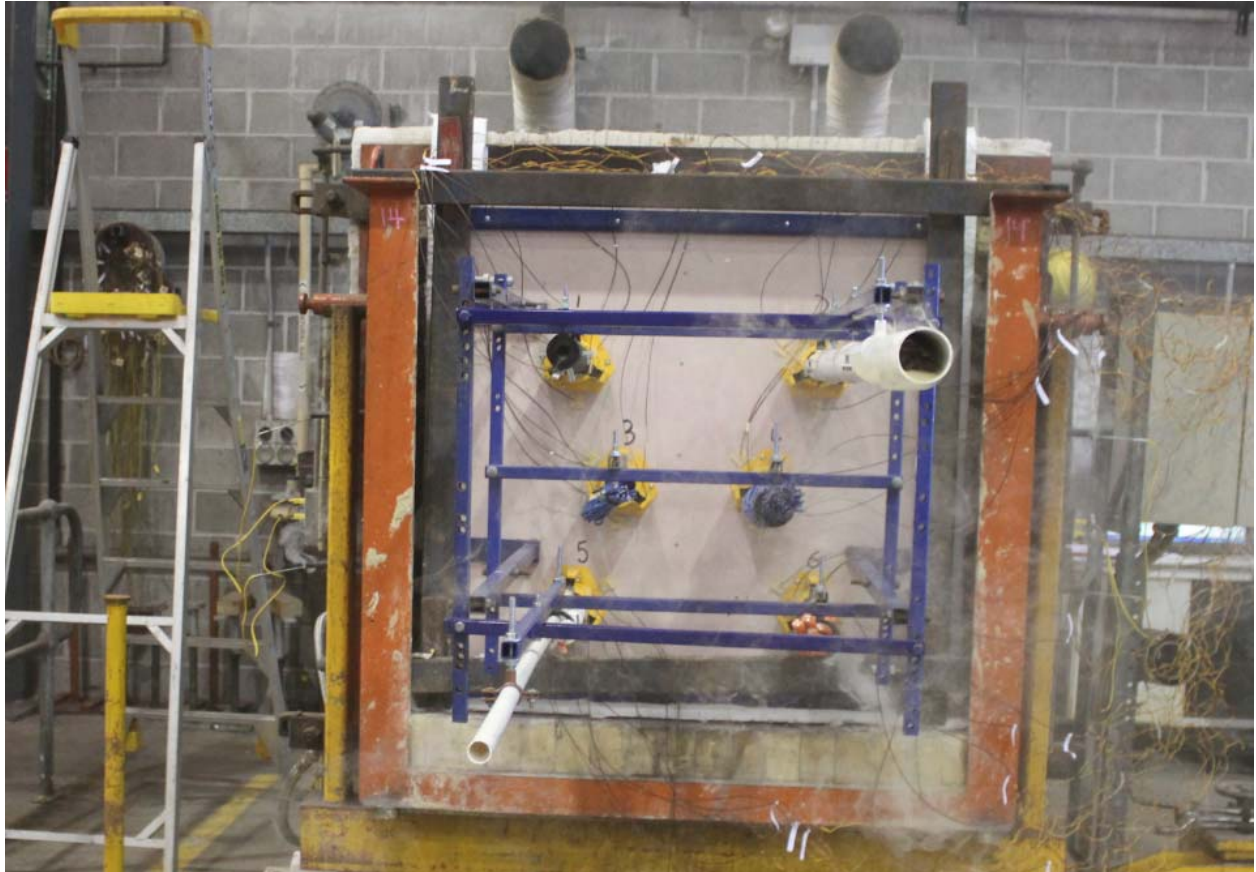
**PHOTOGRAPH 4 – SPECIMENS AFTER 4 MINUTES OF TESTING**

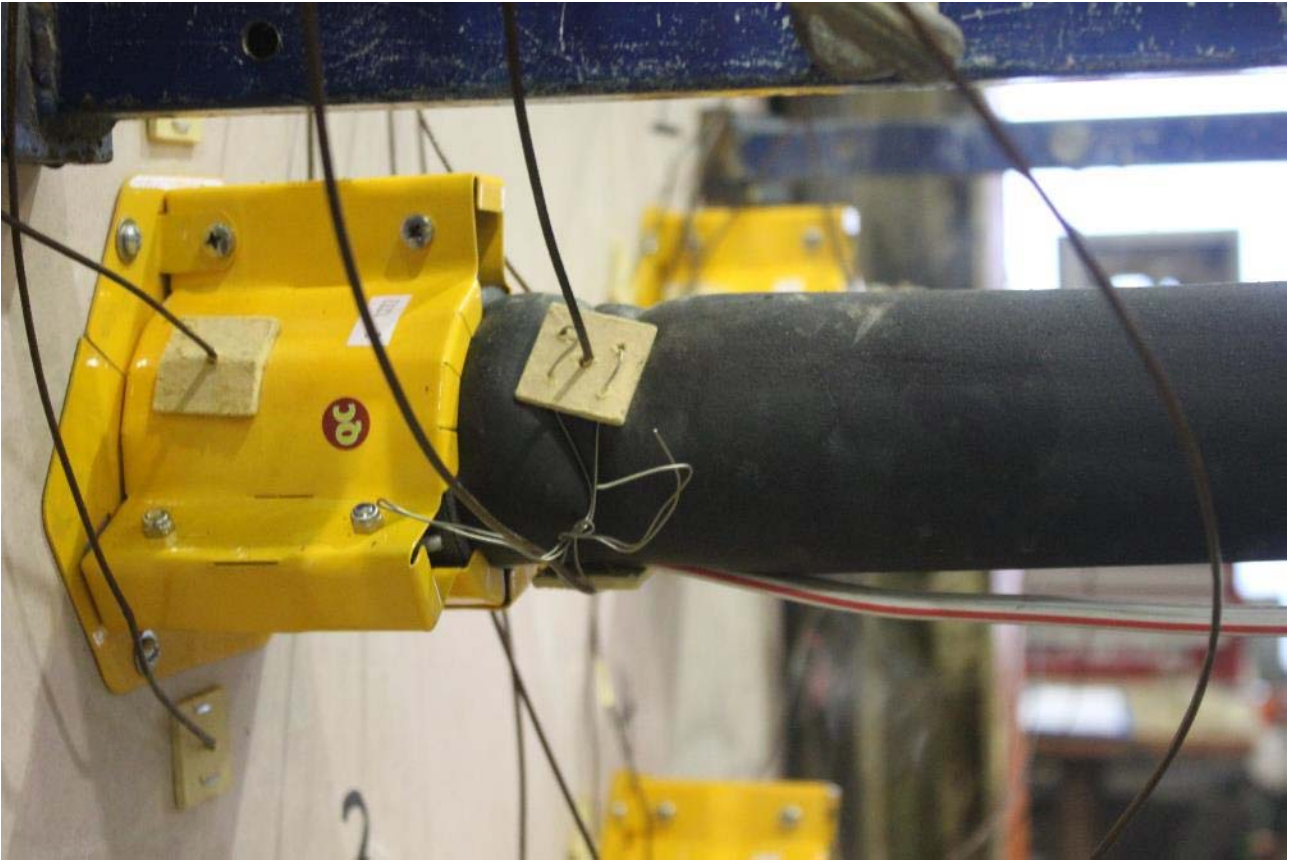
**PHOTOGRAPH 5 – SPECIMEN 1 AFTER 18 MINUTES OF TESTING**

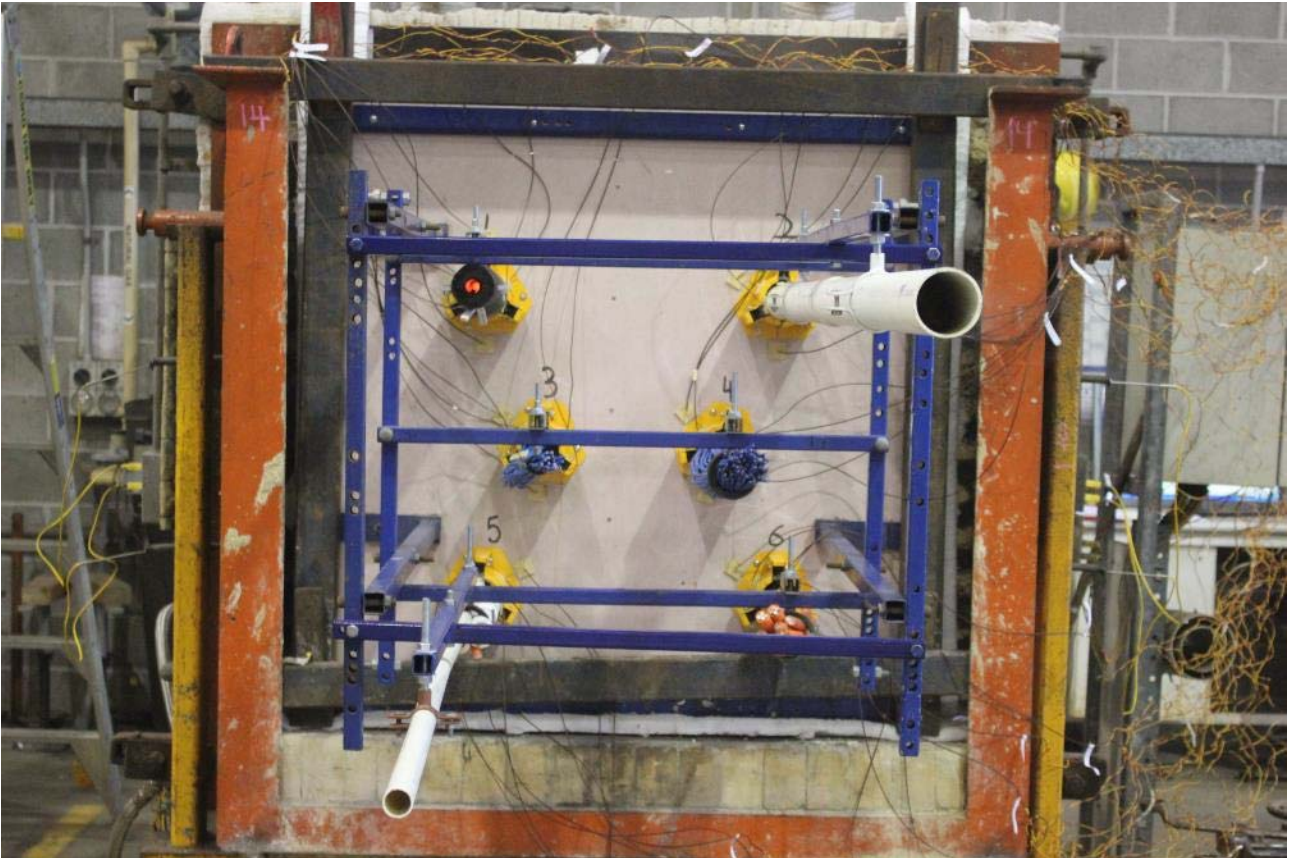
**PHOTOGRAPH 6 – SPECIMENS AFTER 30 MINUTES OF TESTING**

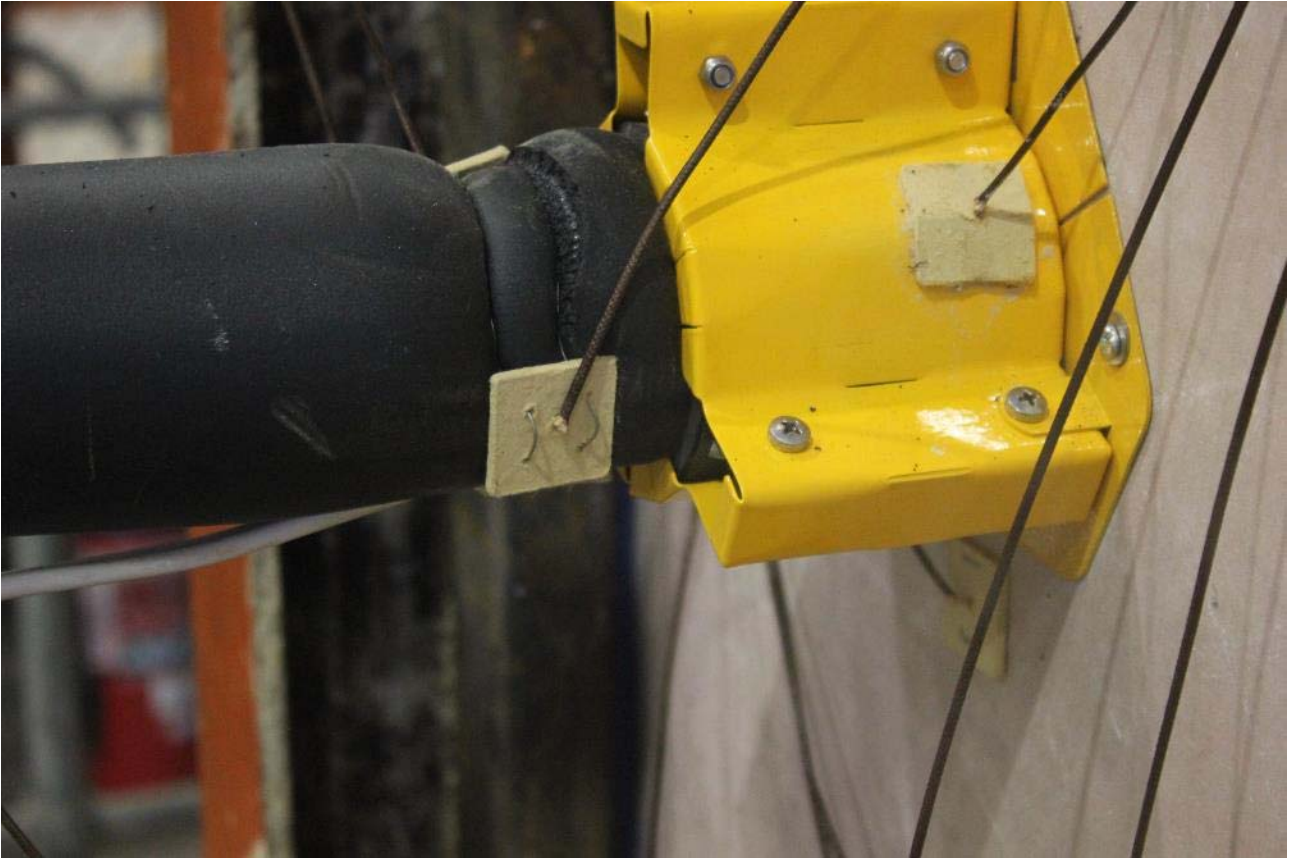
**PHOTOGRAPH 7 – SPECIMEN 1 AFTER 32 MINUTES OF TESTING**

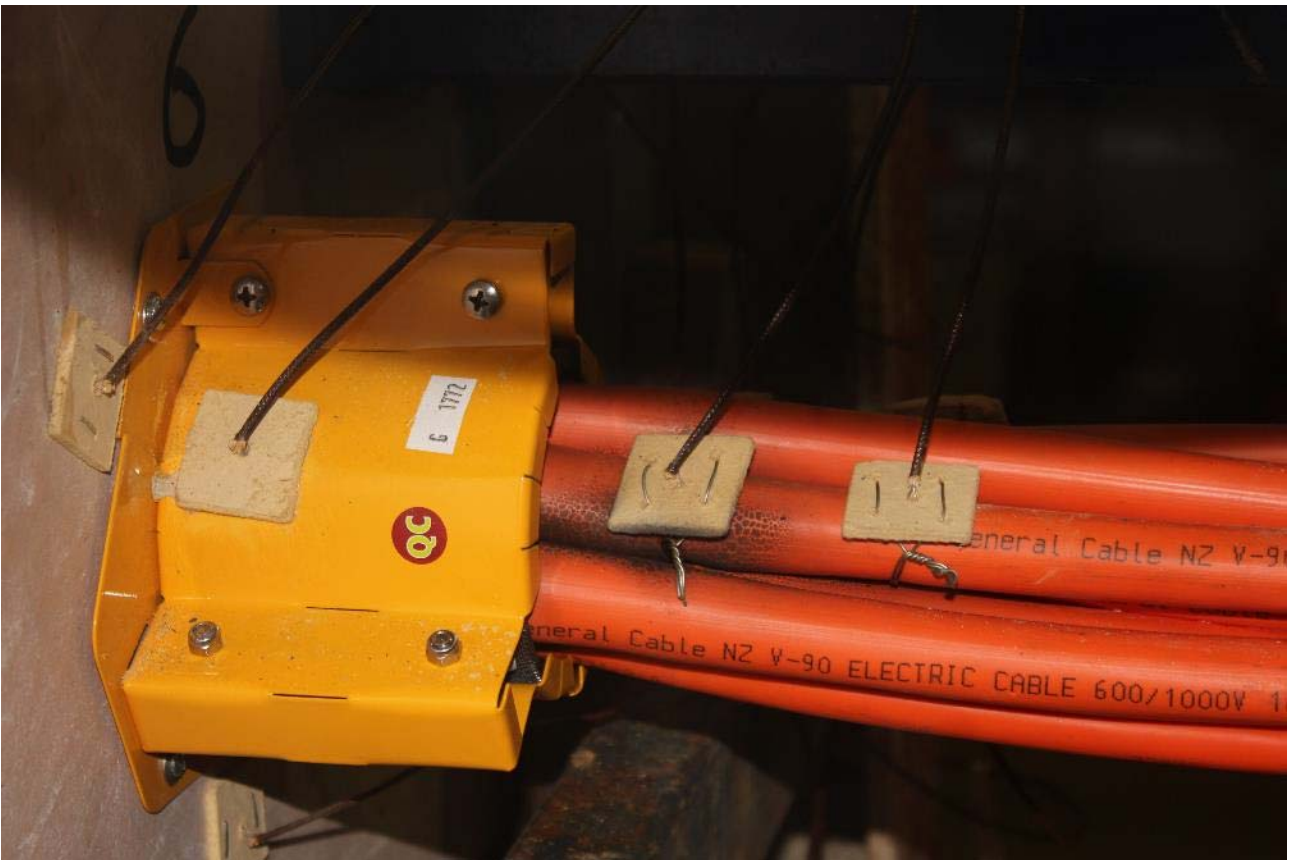
**PHOTOGRAPH 8 – SPECIMEN 6 AFTER 40 MINUTES OF TESTING**

- 36 minutes - Light smoke has resumed fluing from the PVC pipe of Specimen 2.
- 40 minutes - The orange sheath on the cables – top right of Specimen 6 adjacent to the collar has begun to discolour (Photograph 8).

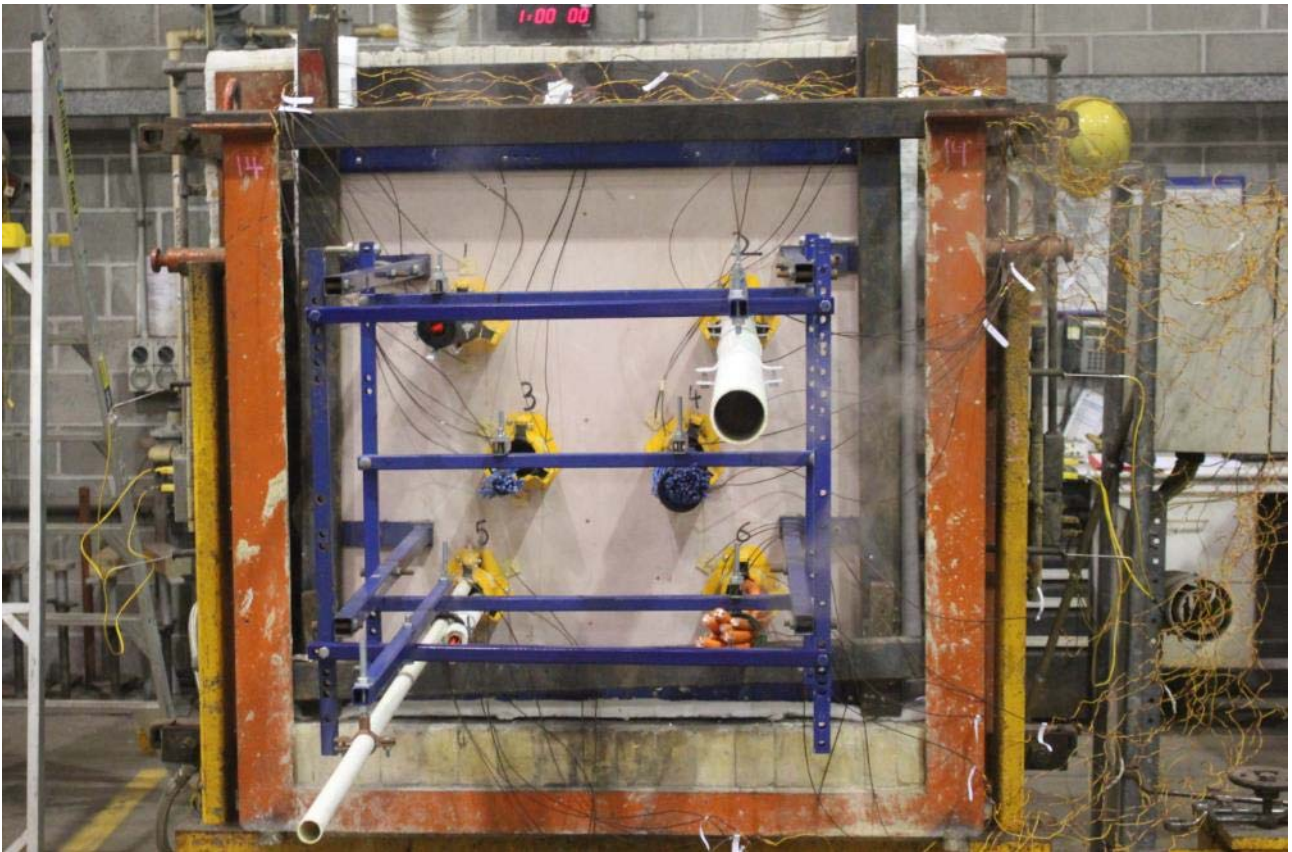
**PHOTOGRAPH 9 – SPECIMENS AFTER 60 MINUTES OF TESTING**

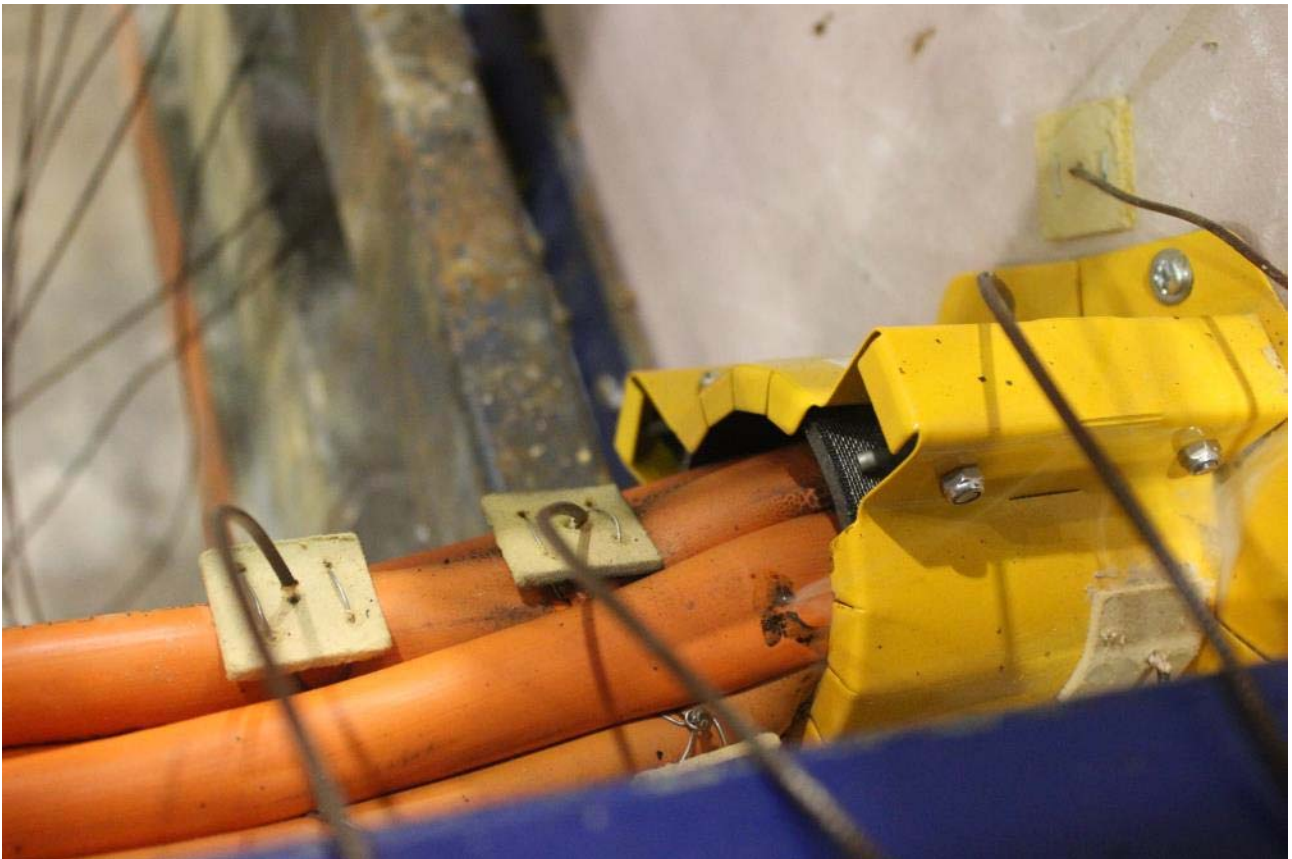
**PHOTOGRAPH 10 – SPECIMEN 6 AFTER 62 MINUTES OF TESTING**

- 45 minutes - The lagging of the pair coil has begun to melt and shrink with thermocouple #32 on the ¾ lagging no longer in full contact.
- 62 minutes - The orange sheath on the 16-mm<sup>2</sup> cable – top right of Specimen 6 adjacent to the collar has begun to split (Photograph 10).

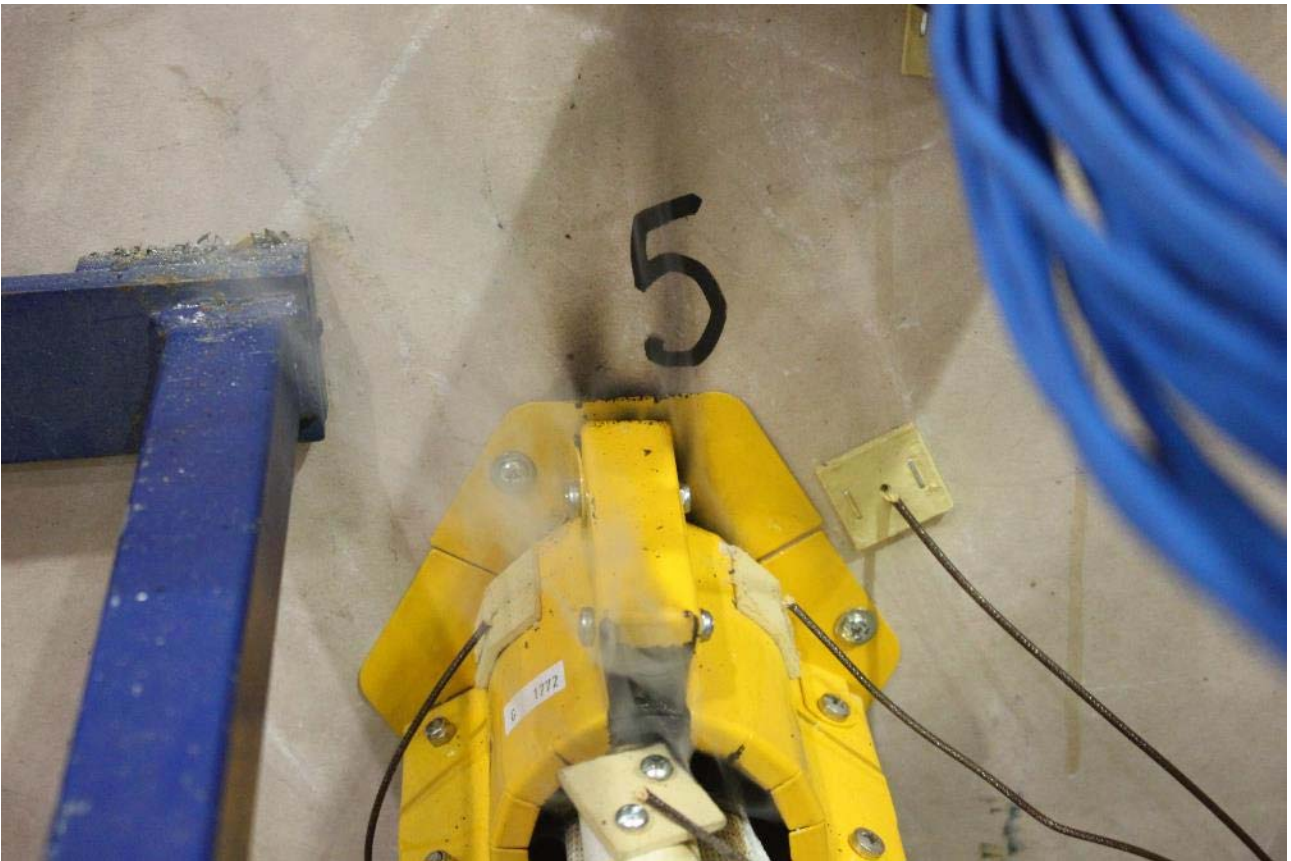
**PHOTOGRAPH 11 – SPECIMEN 5 AFTER 75 MINUTES OF TESTING**

- 75 minutes - Smoke staining is visible on the plasterboard wall above Specimen 5 (Photograph 11).
- 82 minutes - The level of smoke being emitted from all the specimens has increased.

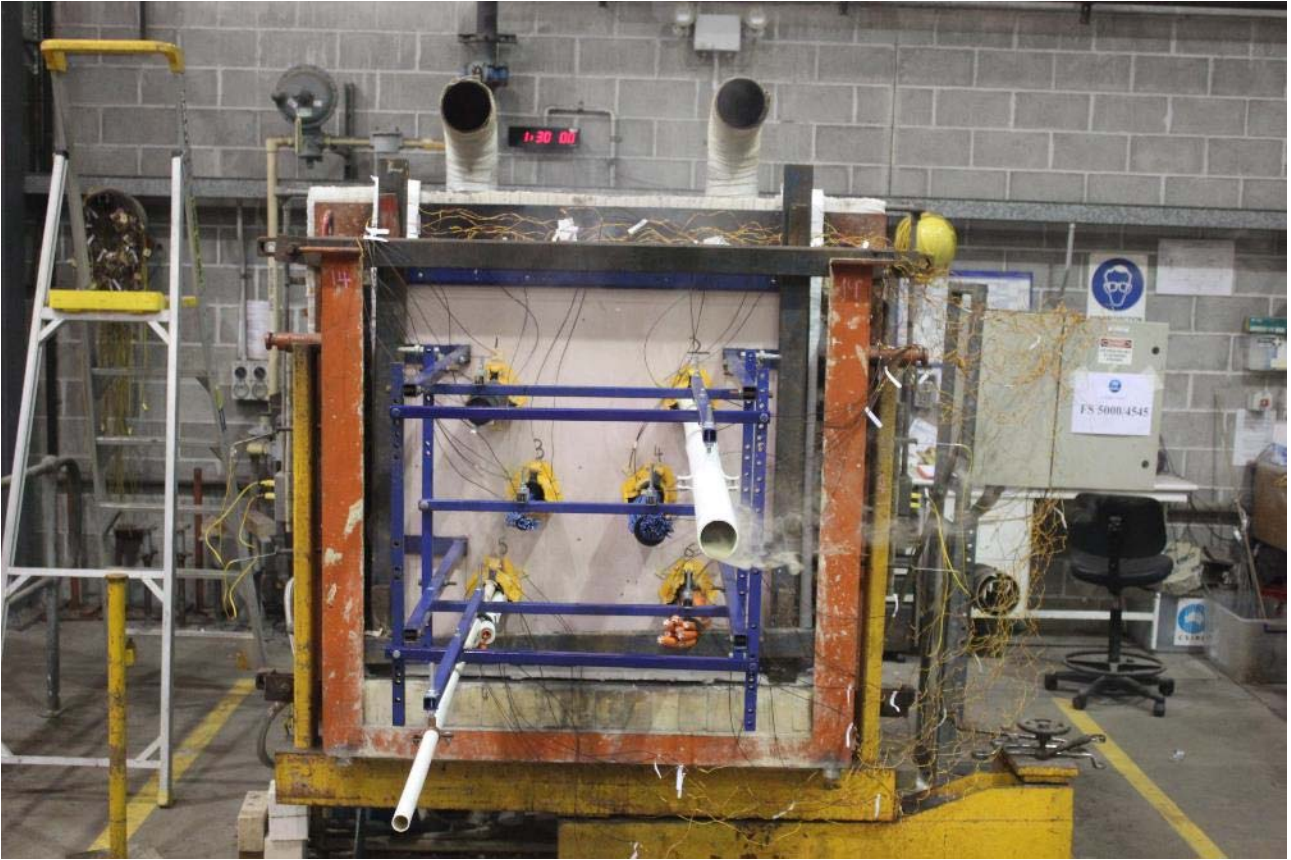
**PHOTOGRAPH 12 – SPECIMENS AFTER 90 MINUTES OF TESTING**

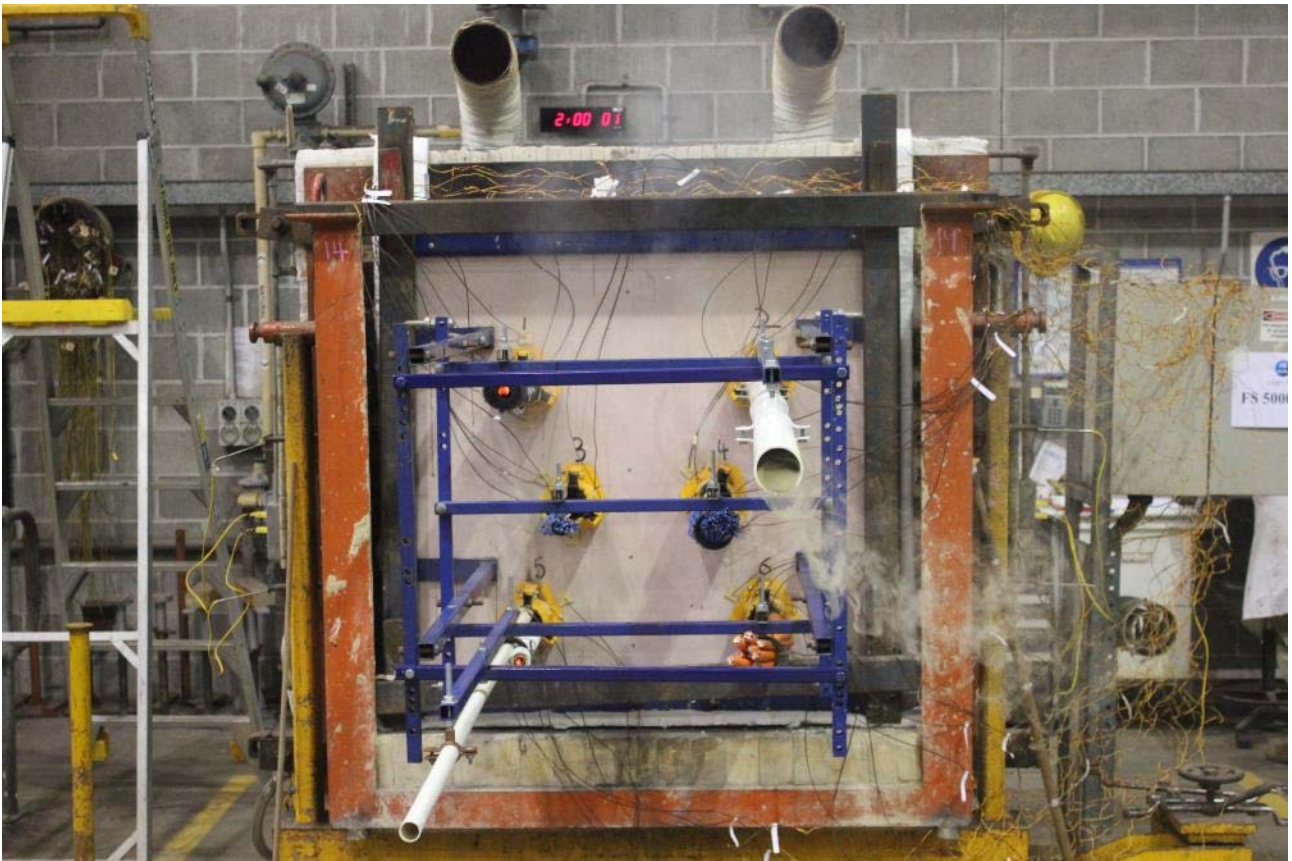
**PHOTOGRAPH 13 – SPECIMENS AFTER 120 MINUTES OF TESTING**

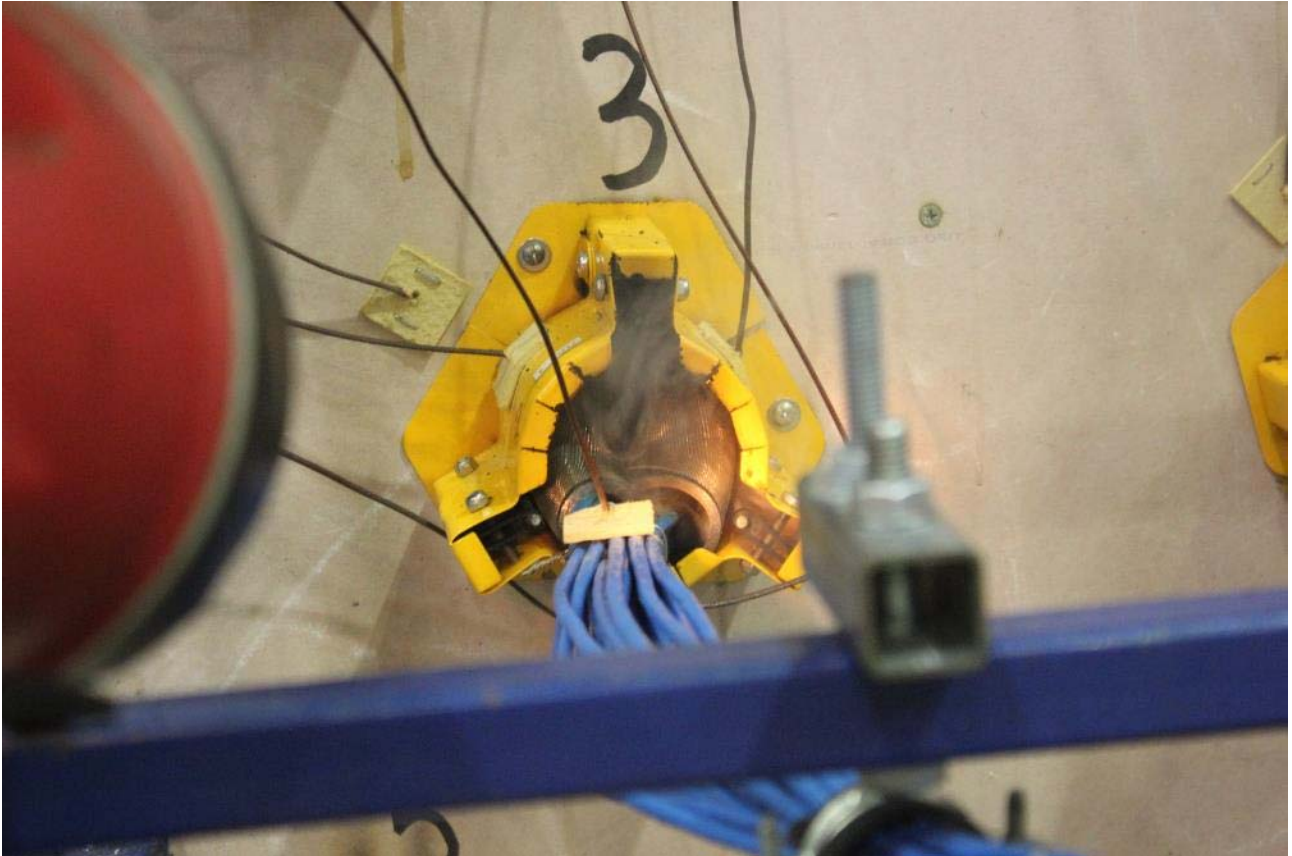
**PHOTOGRAPH 14 – SPECIMEN 3 AFTER 138 MINUTES OF TESTING**

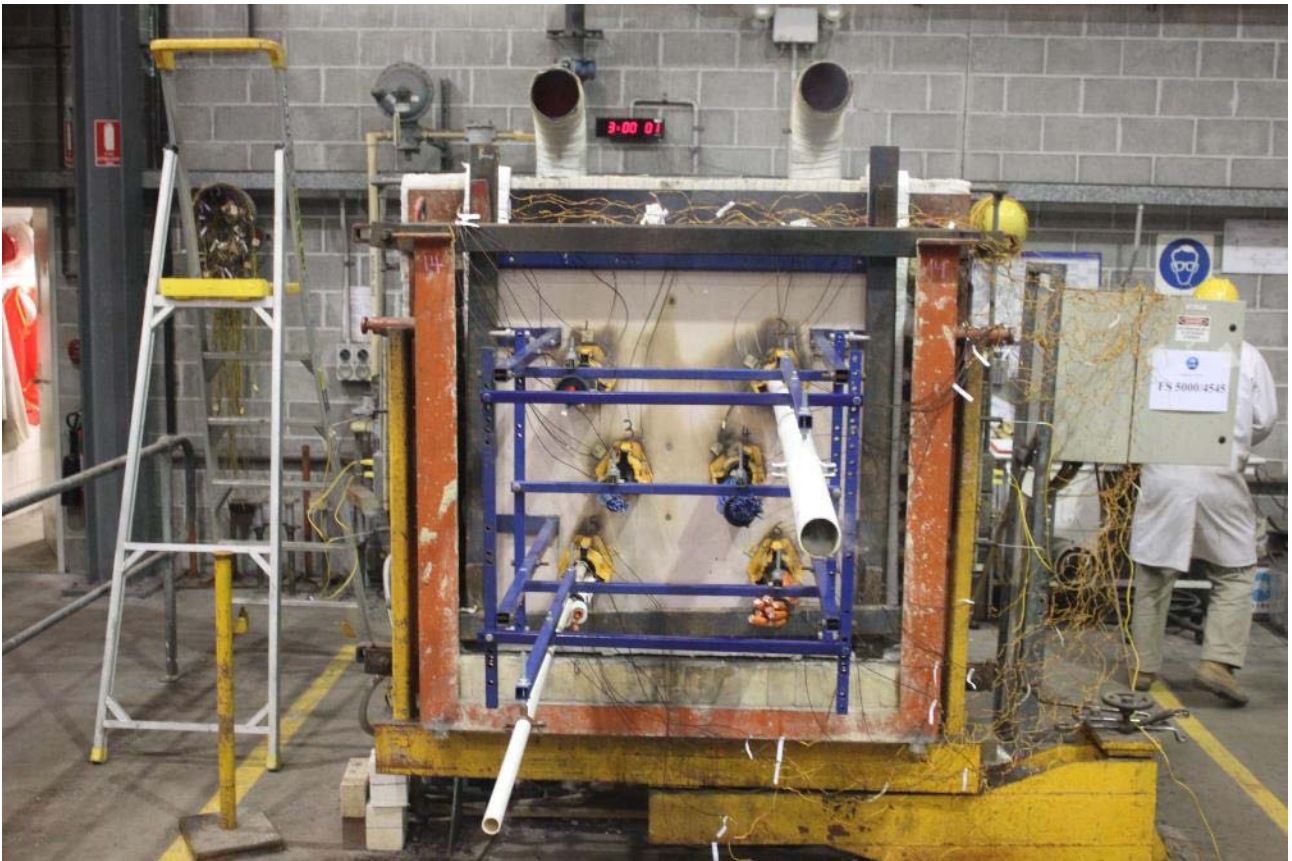
**PHOTOGRAPH 15 – SPECIMENS AFTER 180 MINUTES OF TESTING**

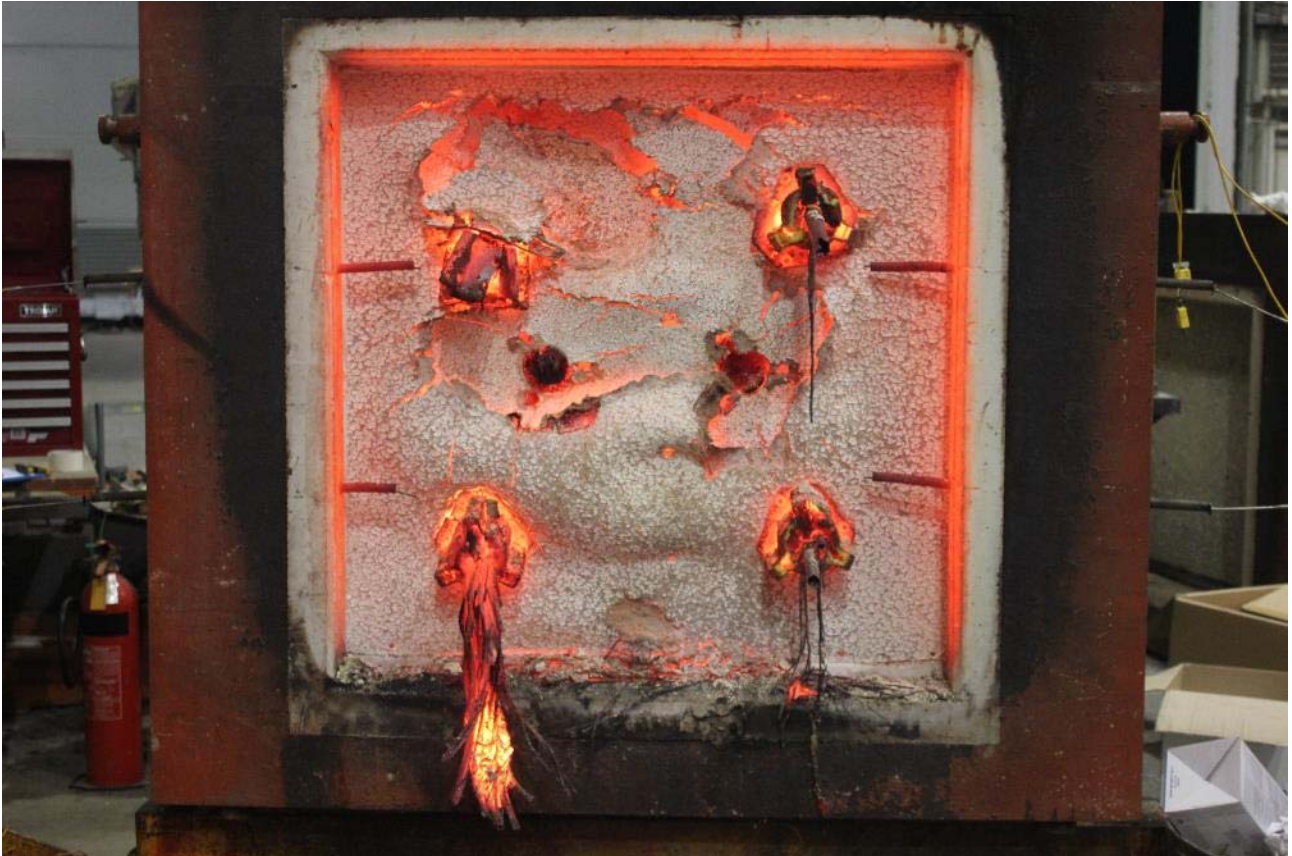
**PHOTOGRAPH 16 – EXPOSED FACE OF SPECIMENS AT CONCLUSION OF TESTING**

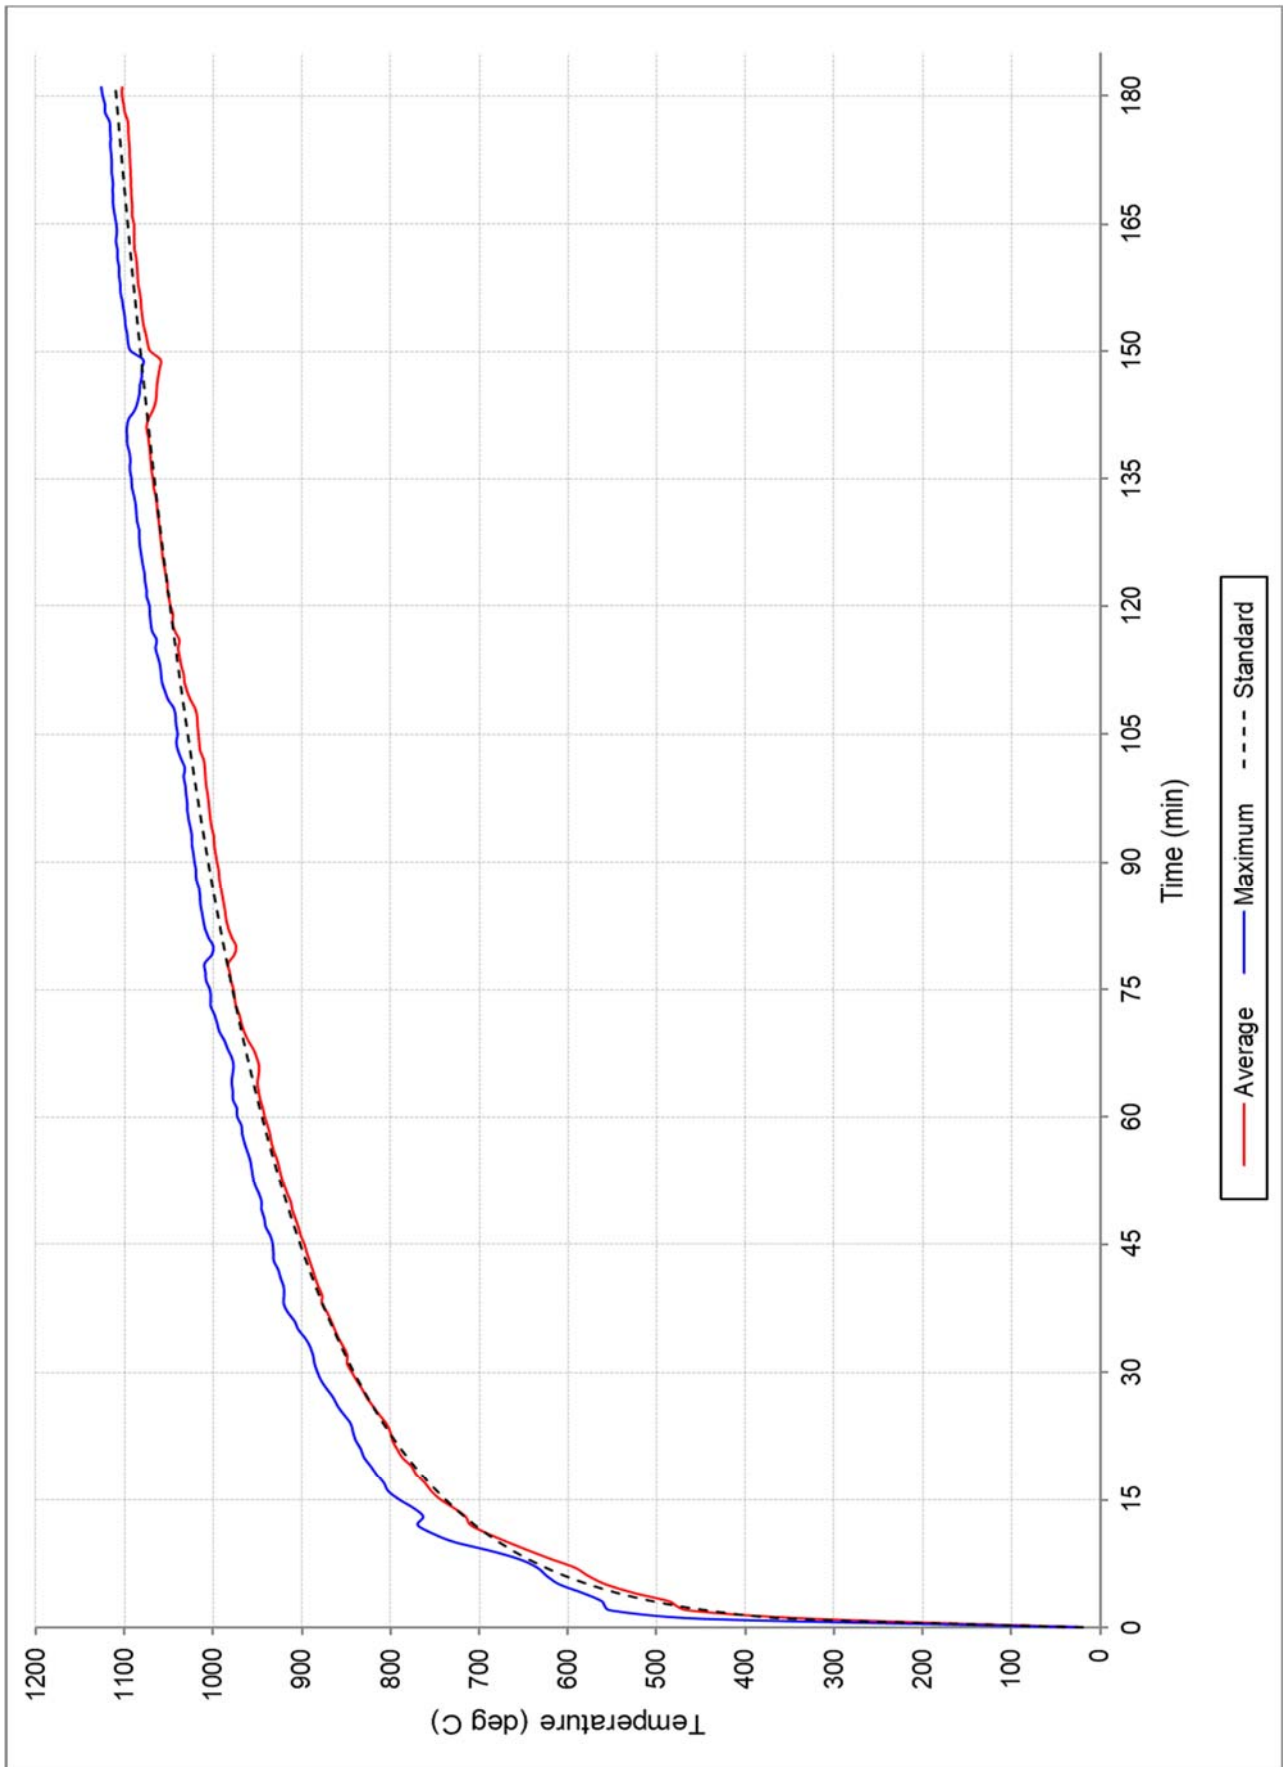
FIGURE 1 – FURNACE TEMPERATURE

Figure 1 shows the standard curves of temperature versus time for heating the furnace chamber and the actual curves of average and maximum temperature versus time recorded during the heating period.

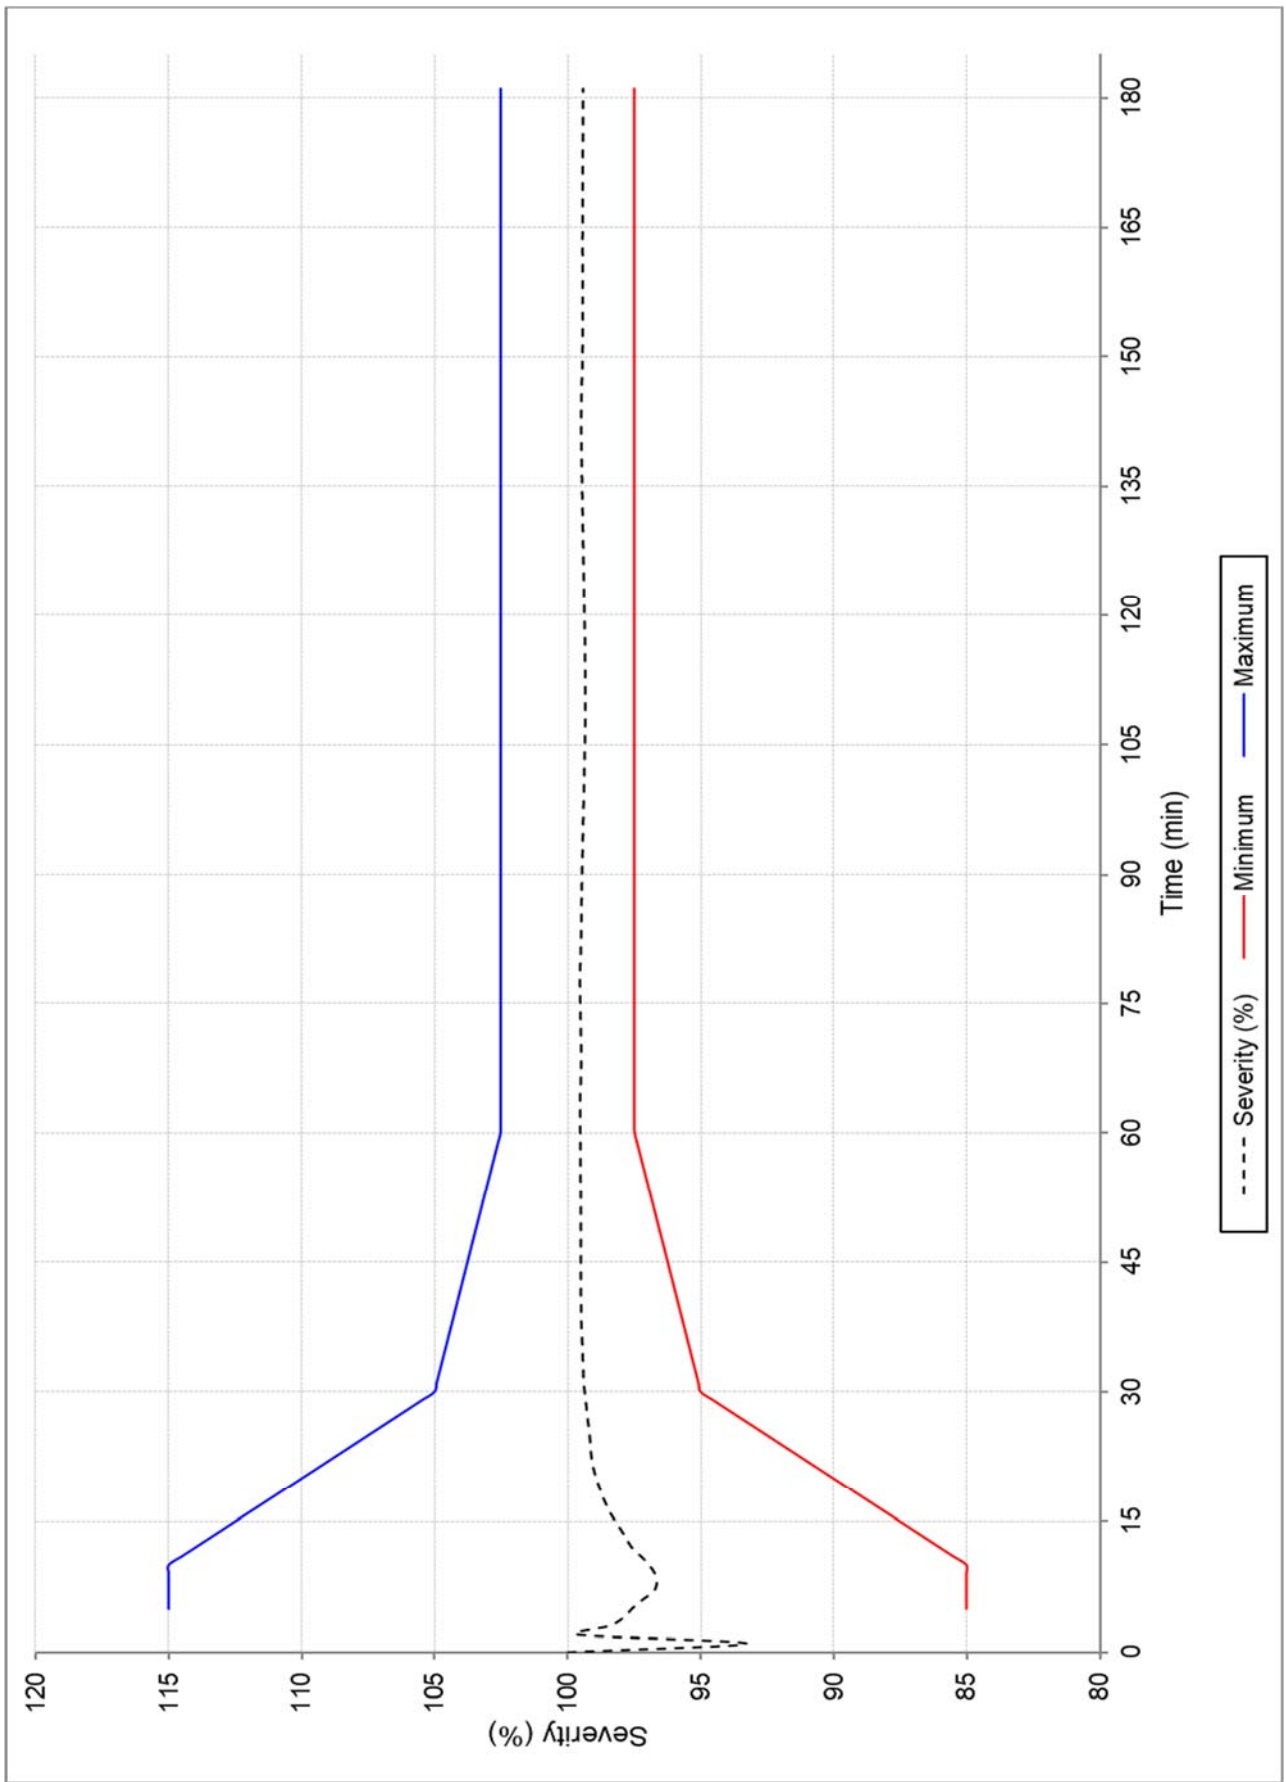
FIGURE 2 – FURNACE SEVERITY

Figure 2 shows the curve of furnace severity versus time during the heating period.
