# Fire-resistance test on retrofit fire collars protecting a plasterboard wall penetrated by services

## Test Report

**Author:** Peter Gordon  
**Report number:** FSP 2126  
**Date:** 8 September 2020  
**Client:** IG6 Pty Ltd as trustee for the IG6 IP Trust

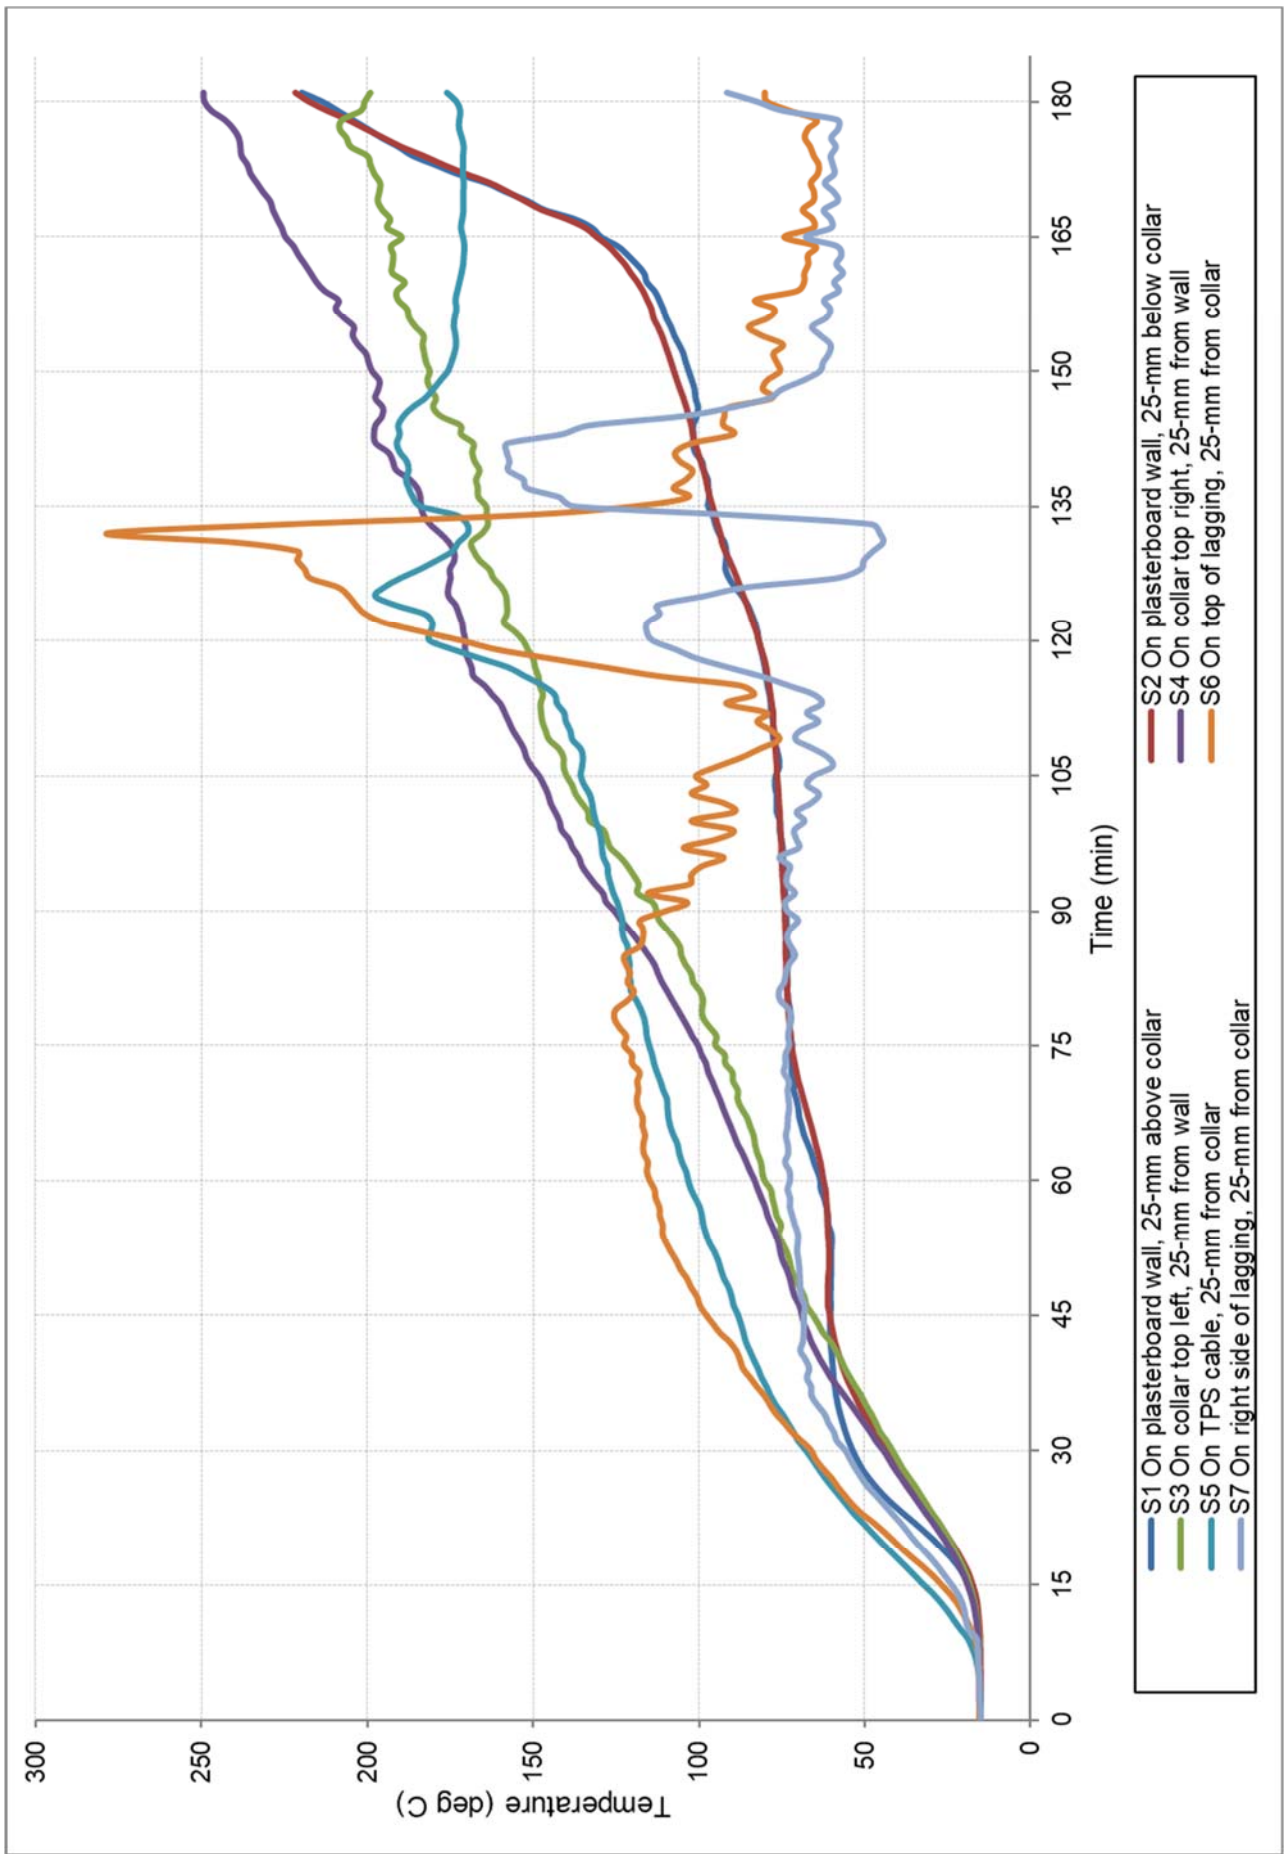
FIGURE 3 - TEMPERATURE VERSUS TIME ASSOCIATED WITH SPECIMEN #1

Figure 3 shows the curve of temperature versus time associated with Specimen 1.

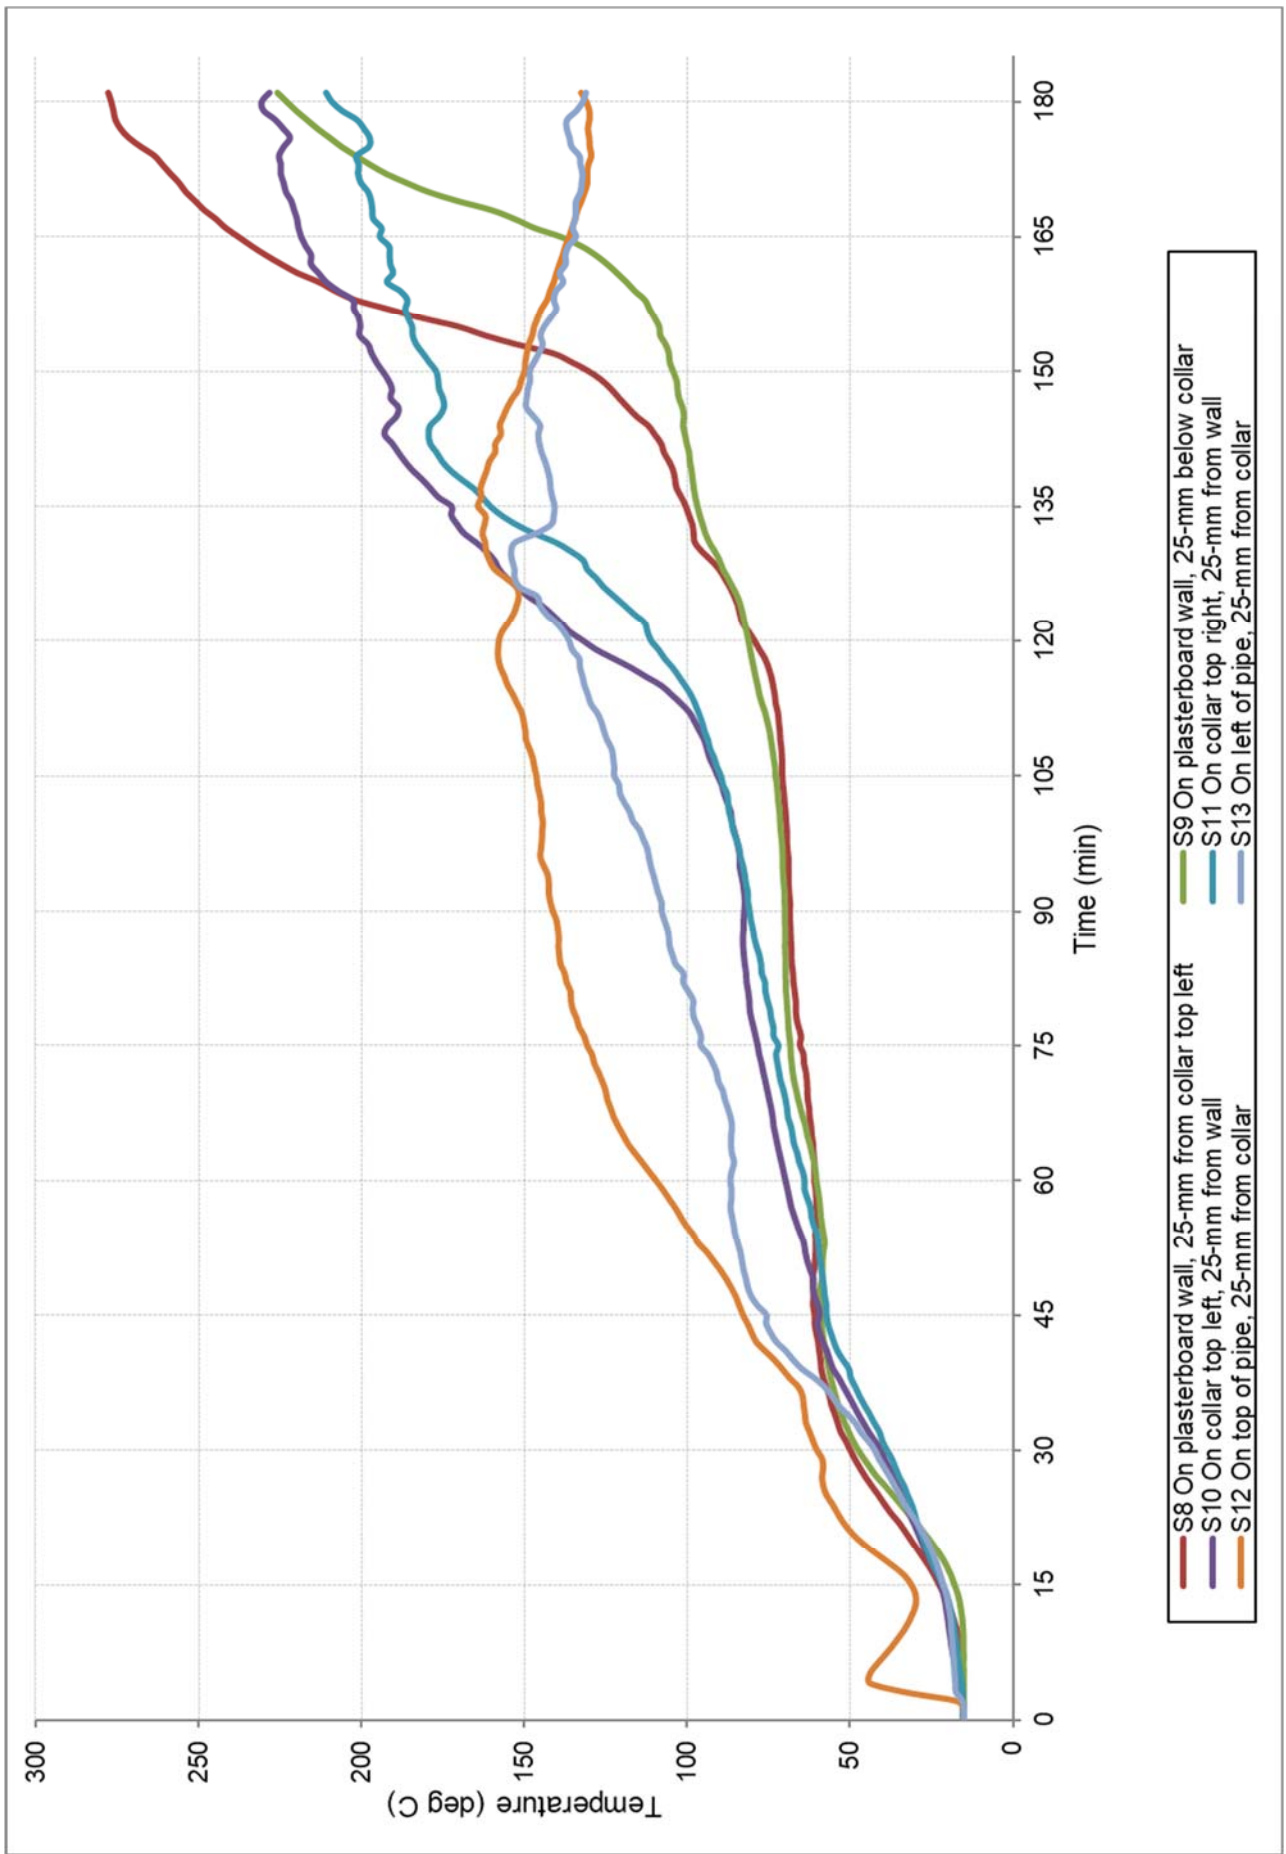
FIGURE 4 - TEMPERATURE VERSUS TIME ASSOCIATED WITH SPECIMEN #2

Figure 4 shows the curve of temperature versus time associated with Specimen 2.

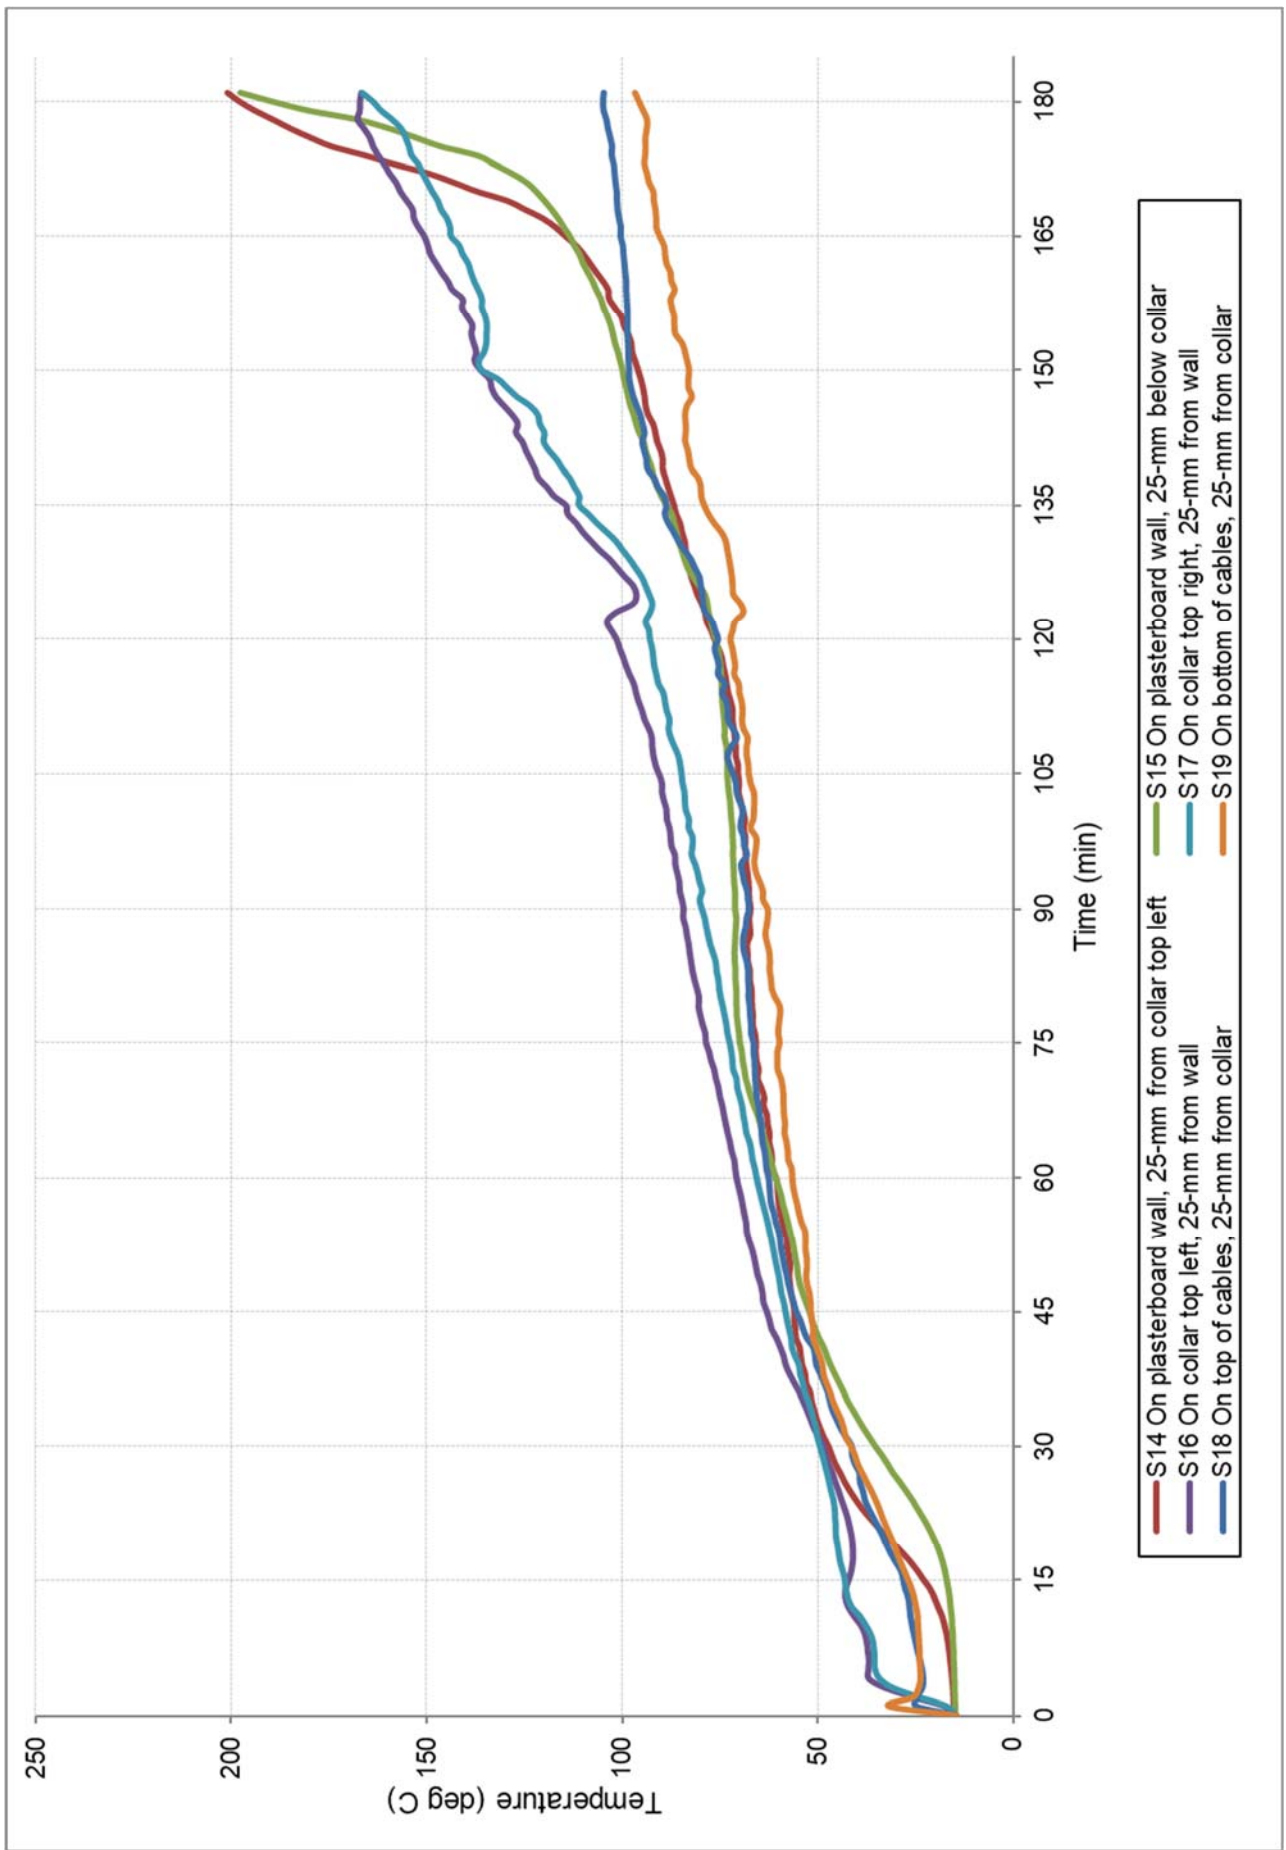
FIGURE 5 - TEMPERATURE VERSUS TIME ASSOCIATED WITH SPECIMEN #3

- 180 minutes - Insulation Failure of Specimen 3 – maximum temperature rise of 180K is exceeded on the plasterboard wall 25-mm above the collar.
- 181 minutes - Test terminated.

Figure 5 shows the curve of temperature versus time associated with Specimen 3.

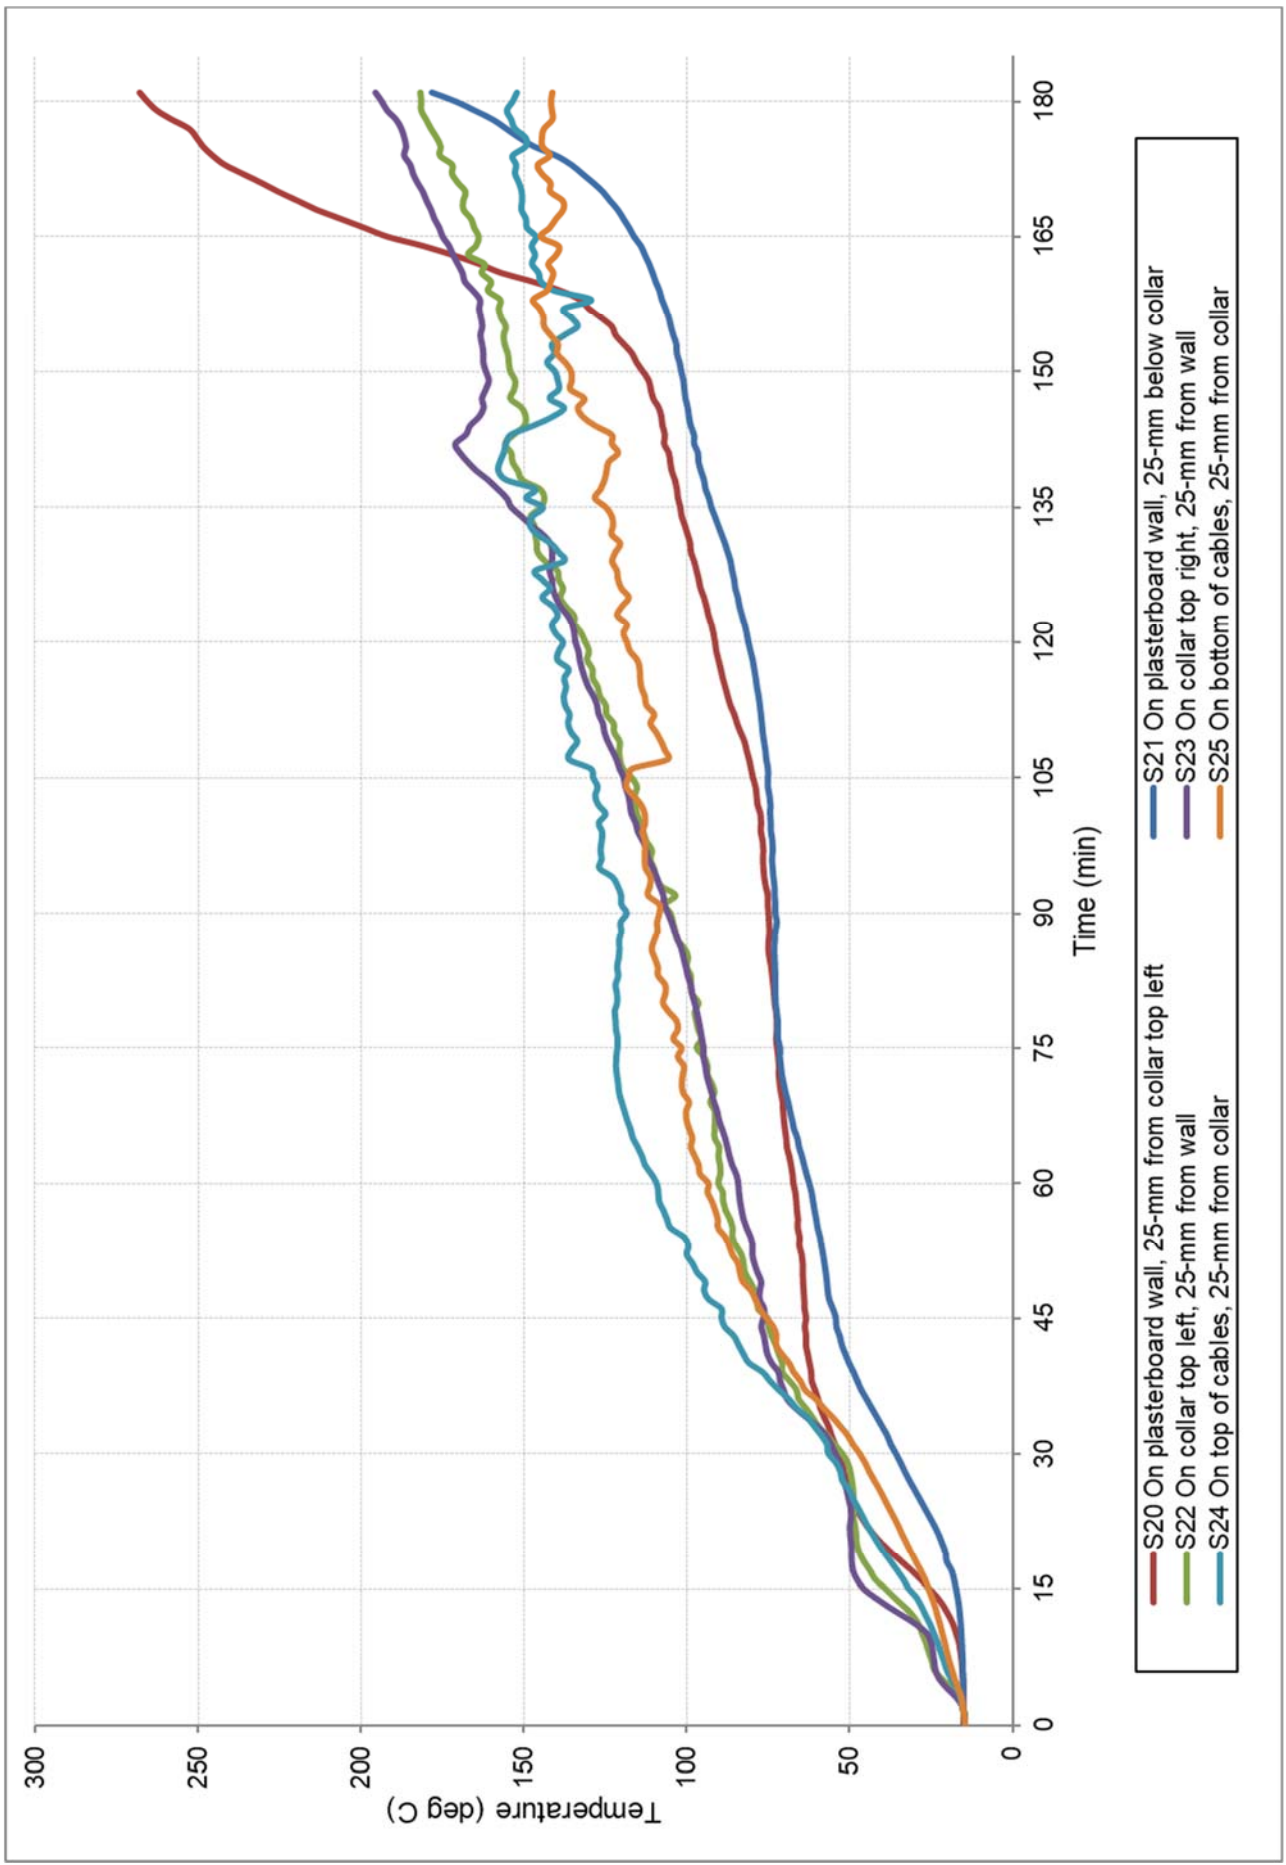
FIGURE 6 - TEMPERATURE VERSUS TIME ASSOCIATED WITH SPECIMEN #4

- 166 minutes - Insulation Failure of Specimen 4 – maximum temperature rise of 180K is exceeded on the plasterboard wall 25-mm above the collar.
- 175 minutes - Insulation Failure of Specimen 5 – maximum temperature rise of 180K is exceeded on the plasterboard wall 25-mm above the collar. The plasterboard wall continues to char around specimens.

Figure 6 shows the curve of temperature versus time associated with Specimen 4.

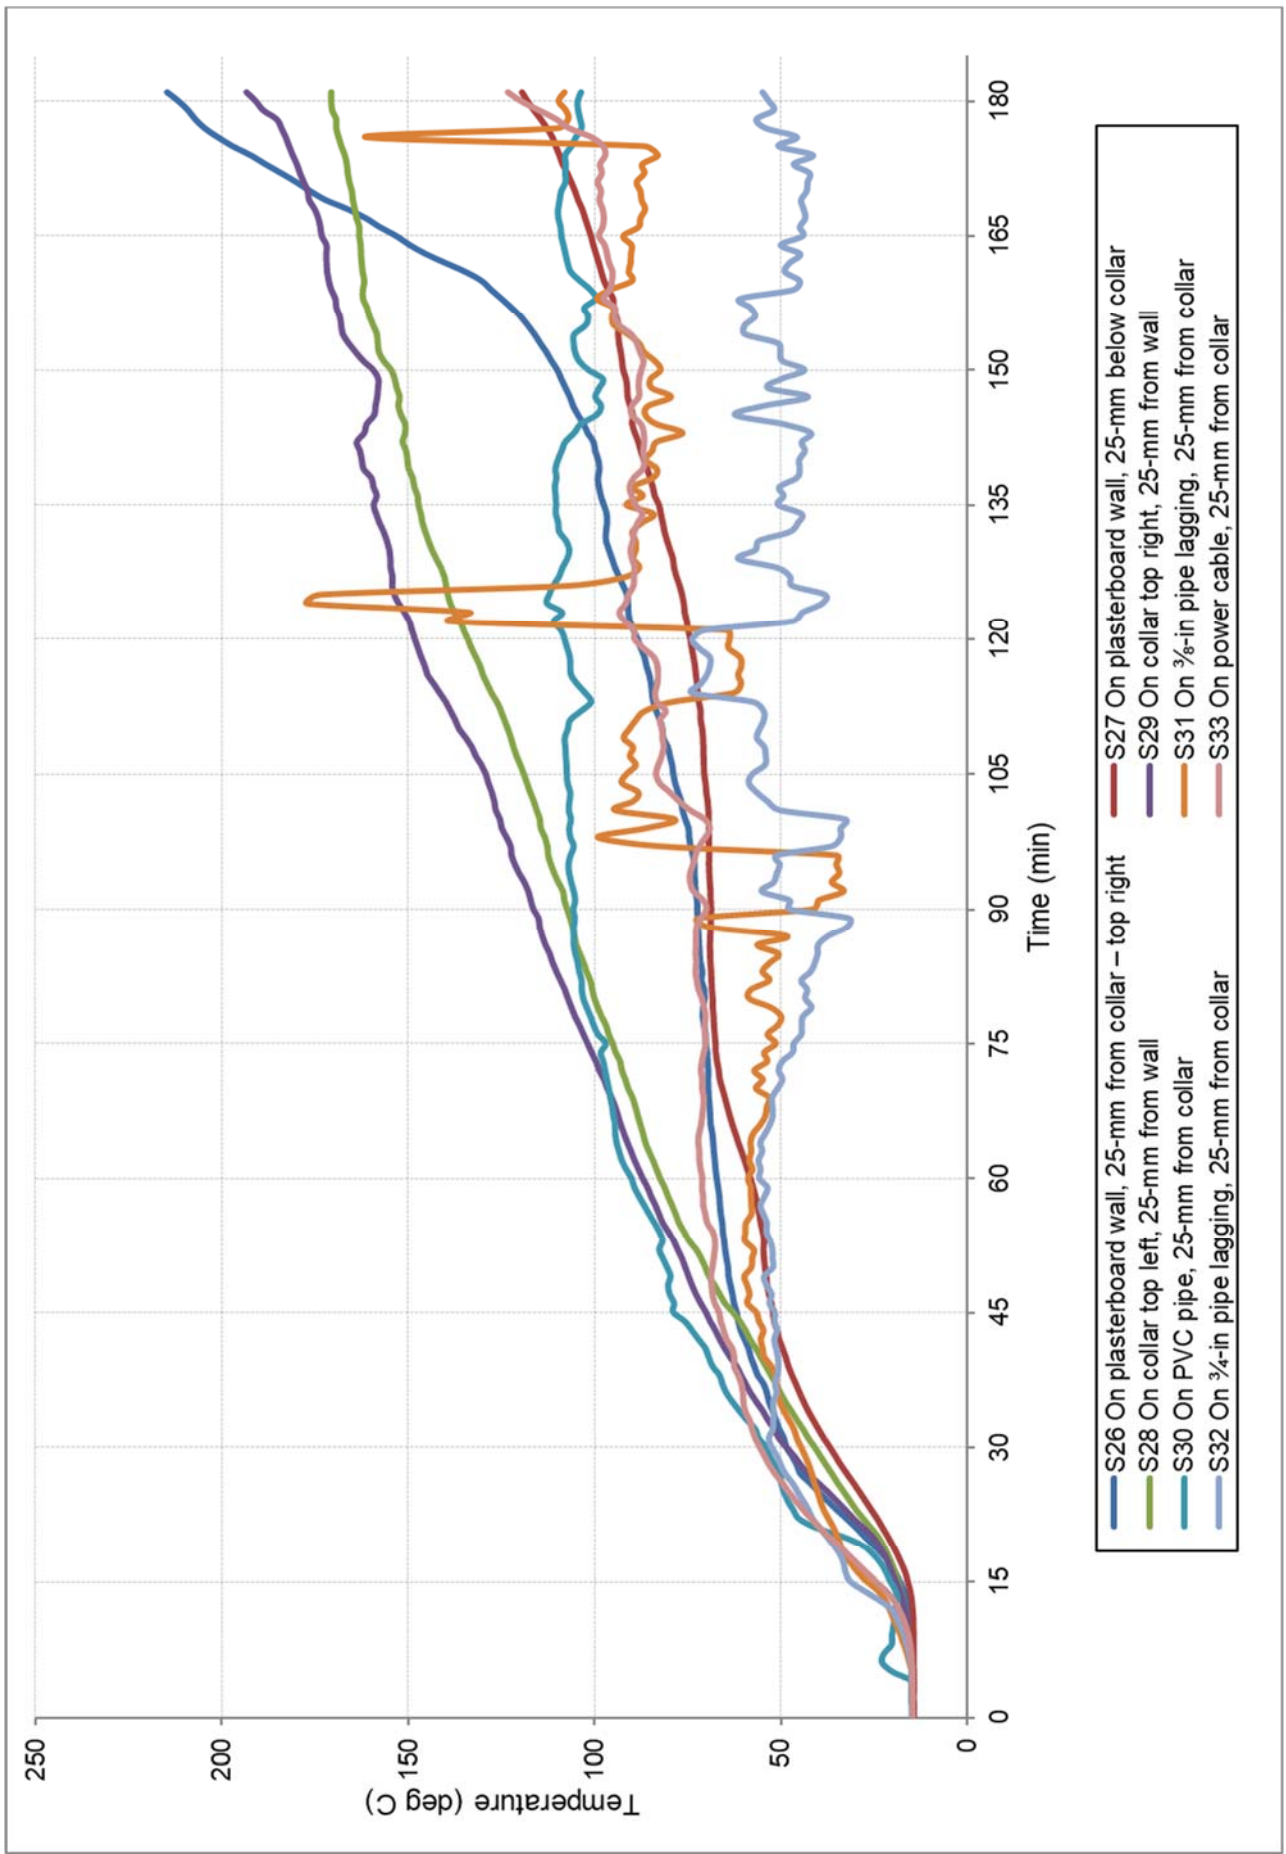
FIGURE 7 - TEMPERATURE VERSUS TIME ASSOCIATED WITH SPECIMEN #5

Figure 7 shows the curve of temperature versus time associated with Specimen 5.

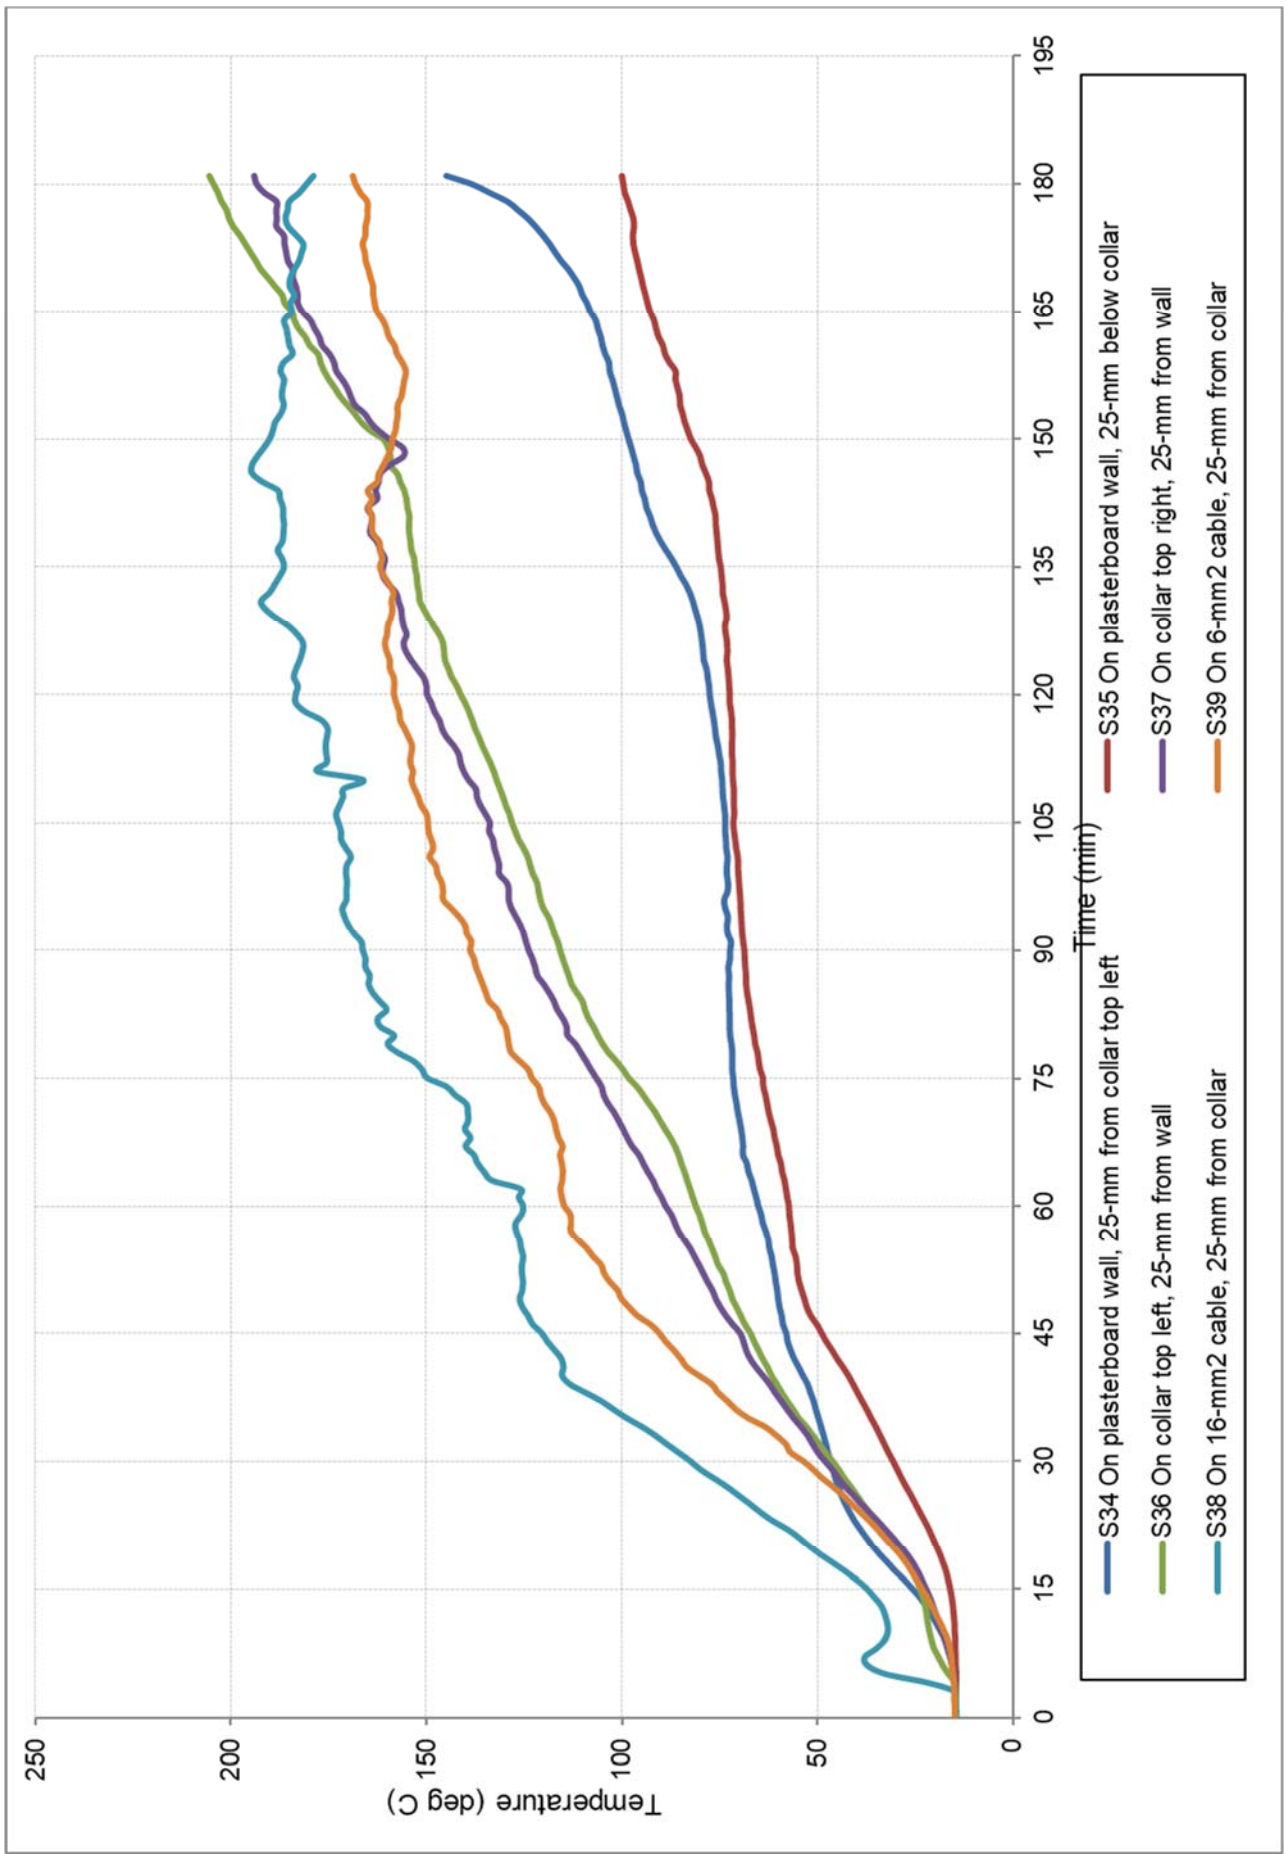
FIGURE 8 - TEMPERATURE VERSUS TIME ASSOCIATED WITH SPECIMEN #6

Figure 8 shows the curve of temperature versus time associated with Specimen 6.

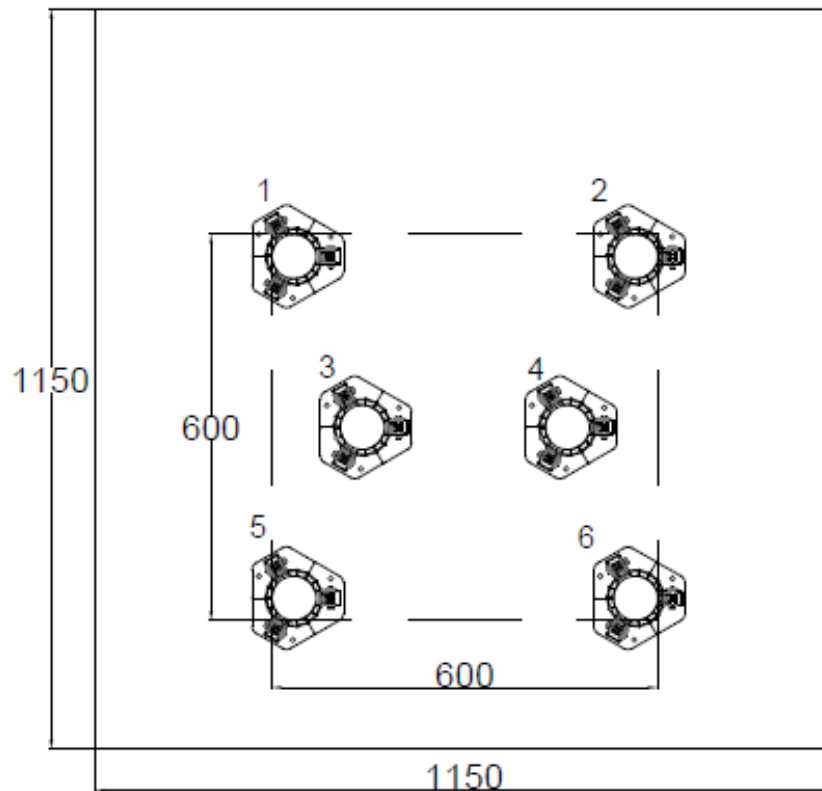
Test Wall W-20-G Layout

| Penetration | Collar Code | Pipe Type | Pipe Diameter |
| 1 | MS70R | Copper Tube with F/R lagging and TPS cable | 1in(19mm Lagging) & 2.5mm <sup>2</sup> 3C |

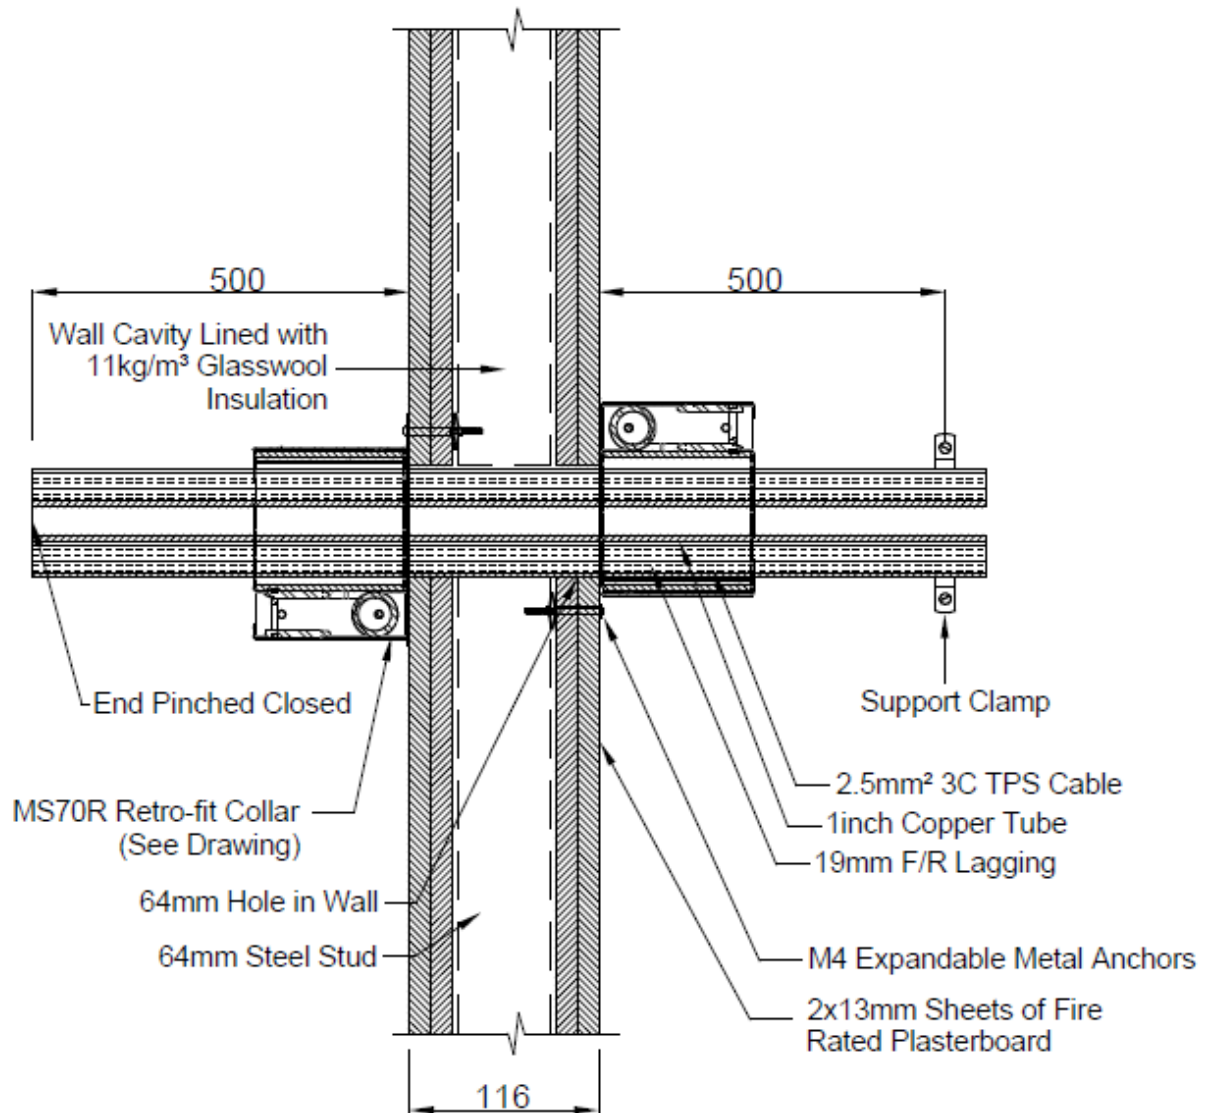
1inch Copper Tube with 19mm F/R Lagging,  
2.5mm<sup>2</sup> 3C TPS Cable & MS70R Collar

**DRAWING TITLED "SPECIMEN # 1 1INCH COPPER TUBE WITH 19MM F/R LAGGING, 3C TPS CABLE & MS70R COLLAR", DATED 11 JUNE 2020, PROVIDED BY SNAP FIRE SYSTEMS PTY LTD**

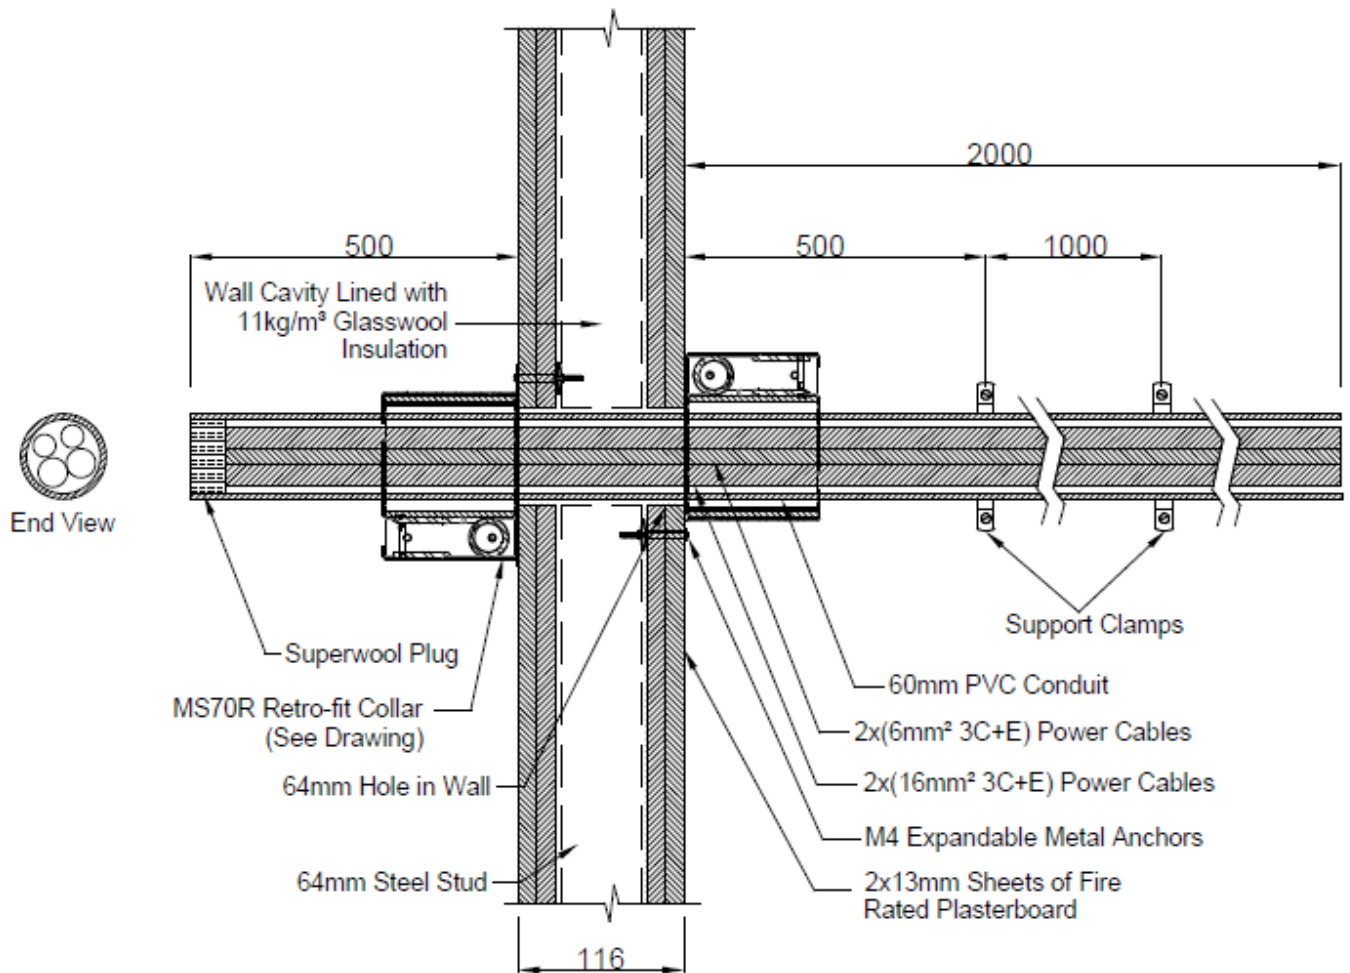
50 PVC Conduit with 16mm<sup>2</sup> 3C+E &  
6mm<sup>2</sup> 3C+E Power Cables & MS70R Collar

**DRAWING TITLED "SPECIMEN #2 50 PVC CONDUIT WITH 16MM<sup>2</sup> 3C+E & 6MM<sup>2</sup> 3C+E POWER CABLES & MS70R COLLAR", DATED 11 JUNE 2020, PROVIDED BY SNAP FIRE SYSTEMS PTY LTD**

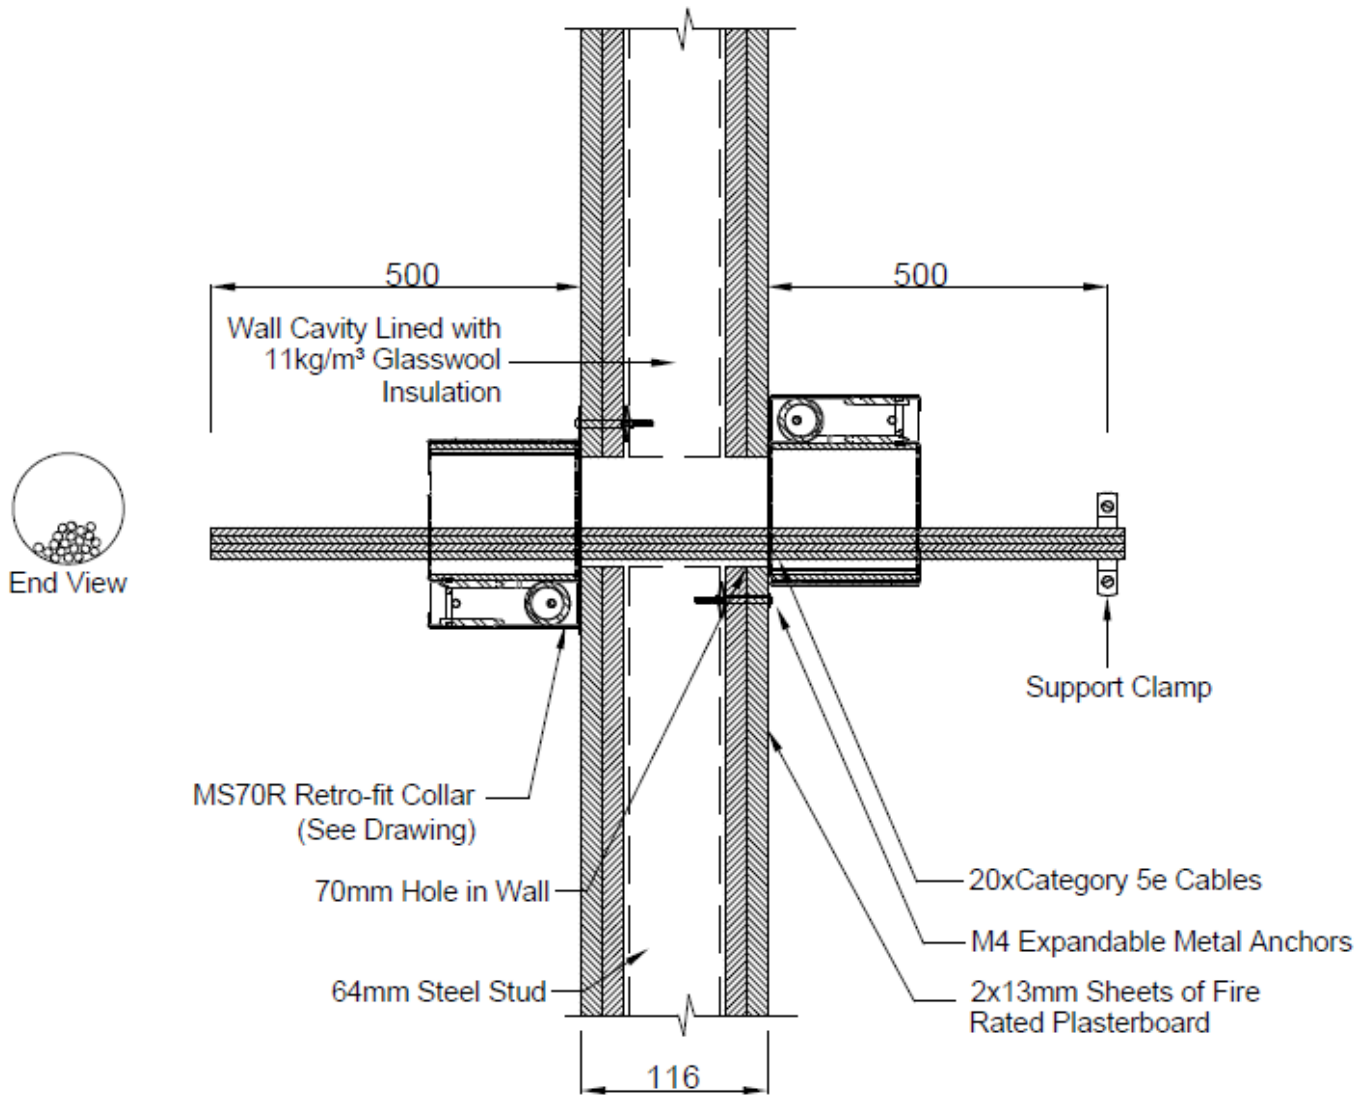
20% Full of Cat5e Cables & MS70R Collar

**DRAWING TITLED "SPECIMEN #3 20% FULL OF CAT5E CABLES & MS70R COLLAR", DATED 11 JUNE 2020,  
PROVIDED BY SNAP FIRE SYSTEMS PTY LTD, PROVIDED BY SNAP FIRE SYSTEMS PTY LTD**

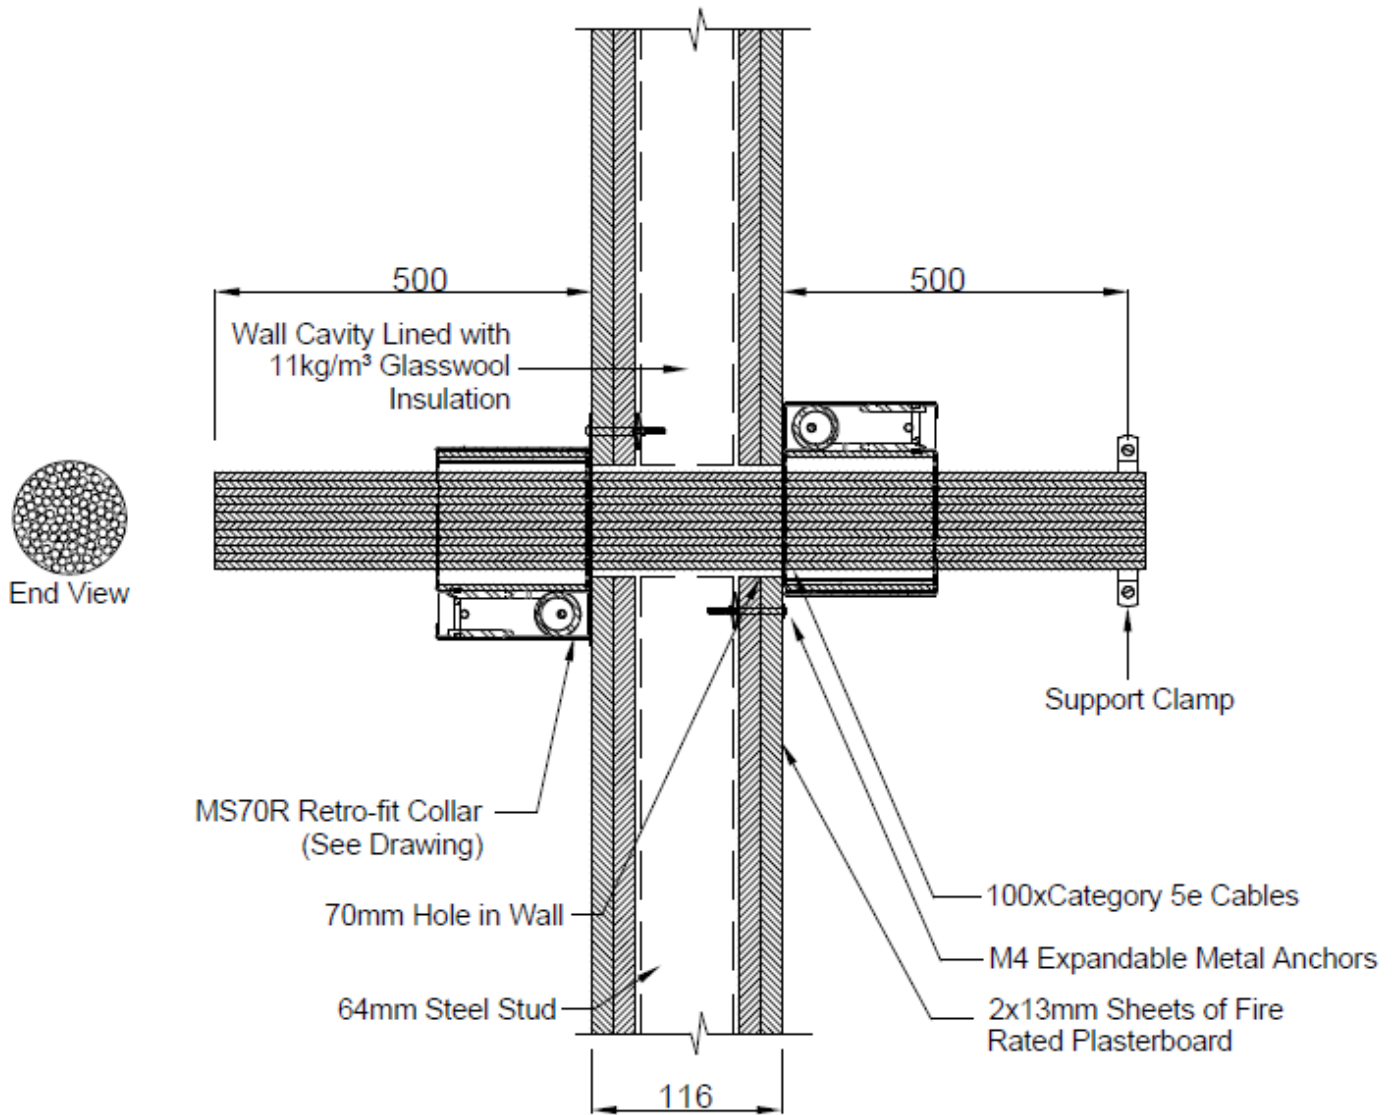
100% Full of Cat5e Cables & MS70R Collar

**DRAWING TITLED "SPECIMEN #4 100% FULL OF CAT5E CABLES & MS70R COLLAR", DATED 11 JUNE 2020, PROVIDED BY SNAP FIRE SYSTEMS PTY LTD, PROVIDED BY SNAP FIRE SYSTEMS PTY LTD**

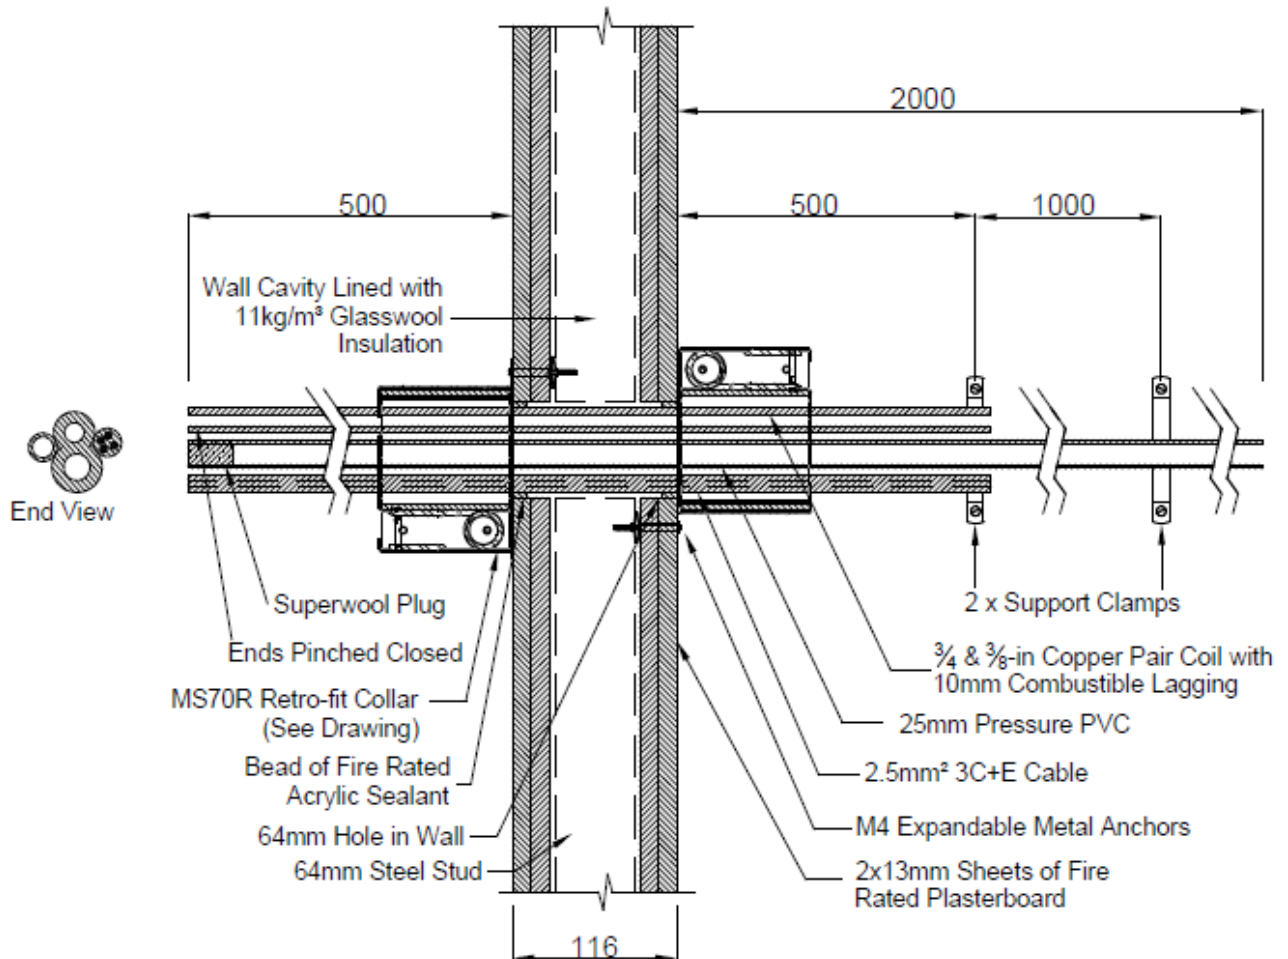
$\frac{3}{4}$ -in &  $\frac{3}{8}$ -in Insulated Copper Pair Coil, 25mm Pressure PVC,  
2.5mm<sup>2</sup> 3C+E Cable & MS70R

**DRAWING TITLED "SPECIMEN #5  $\frac{3}{4}$ -IN &  $\frac{3}{8}$ -IN INSULATED COPPER PAIR COIL, 25-MM PRESSURE PVC, 2.5MM<sup>2</sup> 3C+E CABLE & MS70R", DATED 11 JUNE 2020, PROVIDED BY SNAP FIRE SYSTEMS PTY LTD**
