# Fire-resistance test on retrofit fire collars protecting a plasterboard wall penetrated by services

## Test Report

**Author:** Peter Gordon  
**Report number:** FSP 2126  
**Date:** 8 September 2020  
**Client:** IG6 Pty Ltd as trustee for the IG6 IP Trust

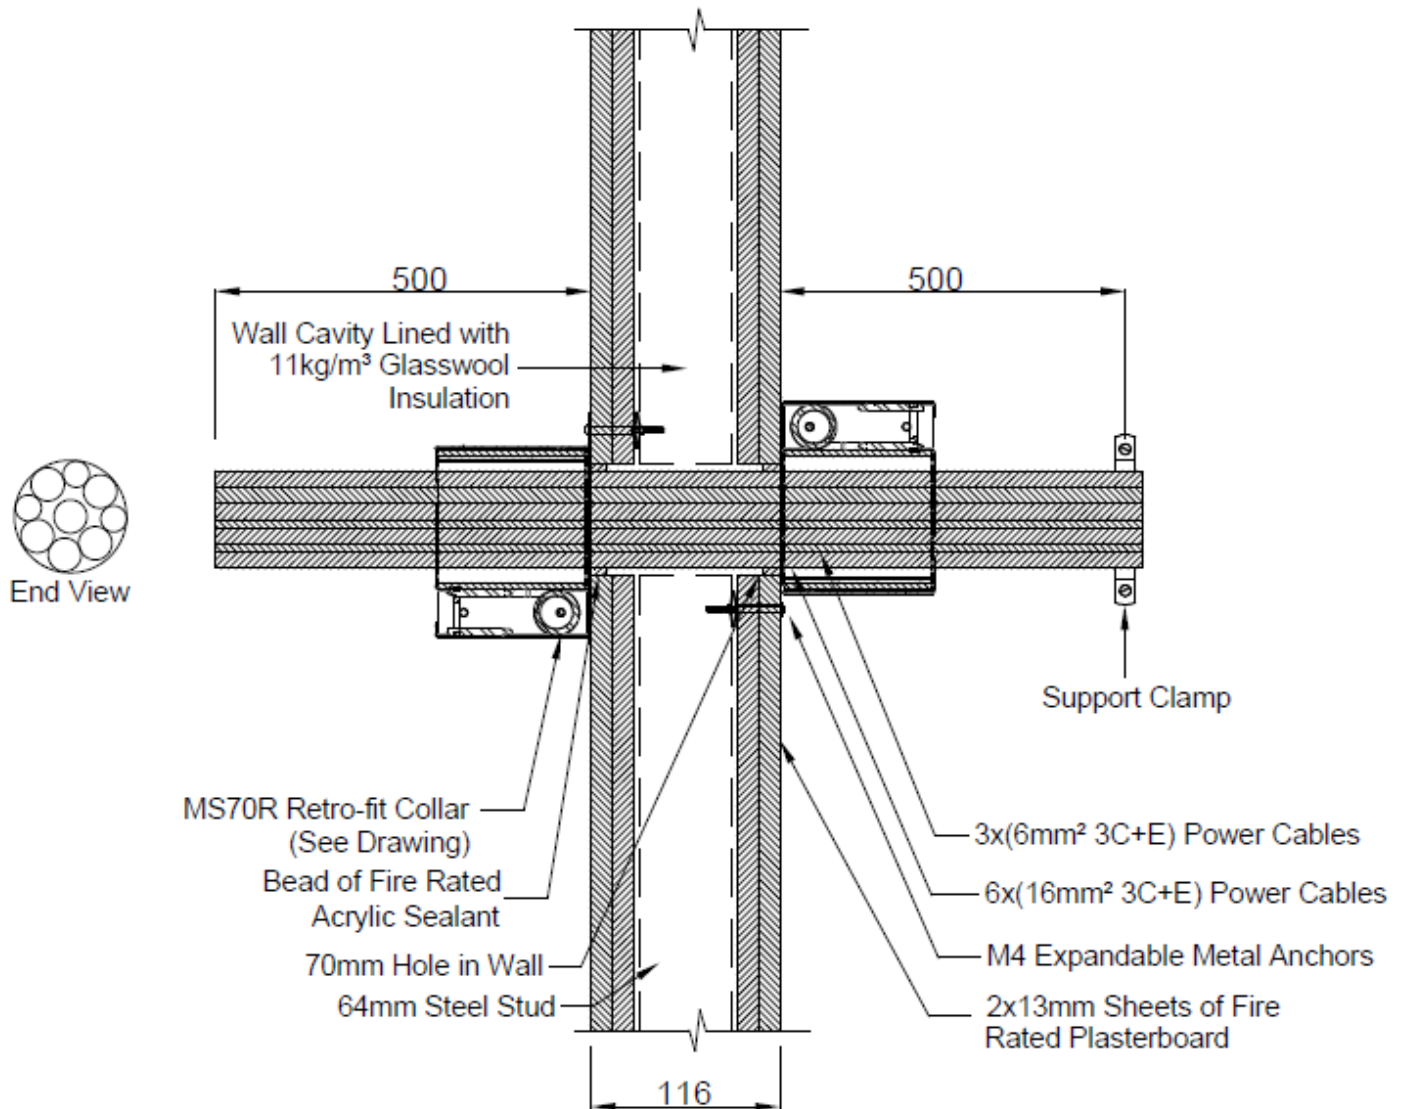
16mm<sup>2</sup> 3C+E & 6mm<sup>2</sup> 3C+E Power Cables | & MS70R Collar

DRAWING TITLED "SPECIMEN #6 16MM<sup>2</sup> 3C+E & 6MM<sup>2</sup> 3C+E POWER CABLES & MS70R COLLAR", DATED 11 JUNE 2020, PROVIDED BY SNAP FIRE SYSTEMS PTY LTD

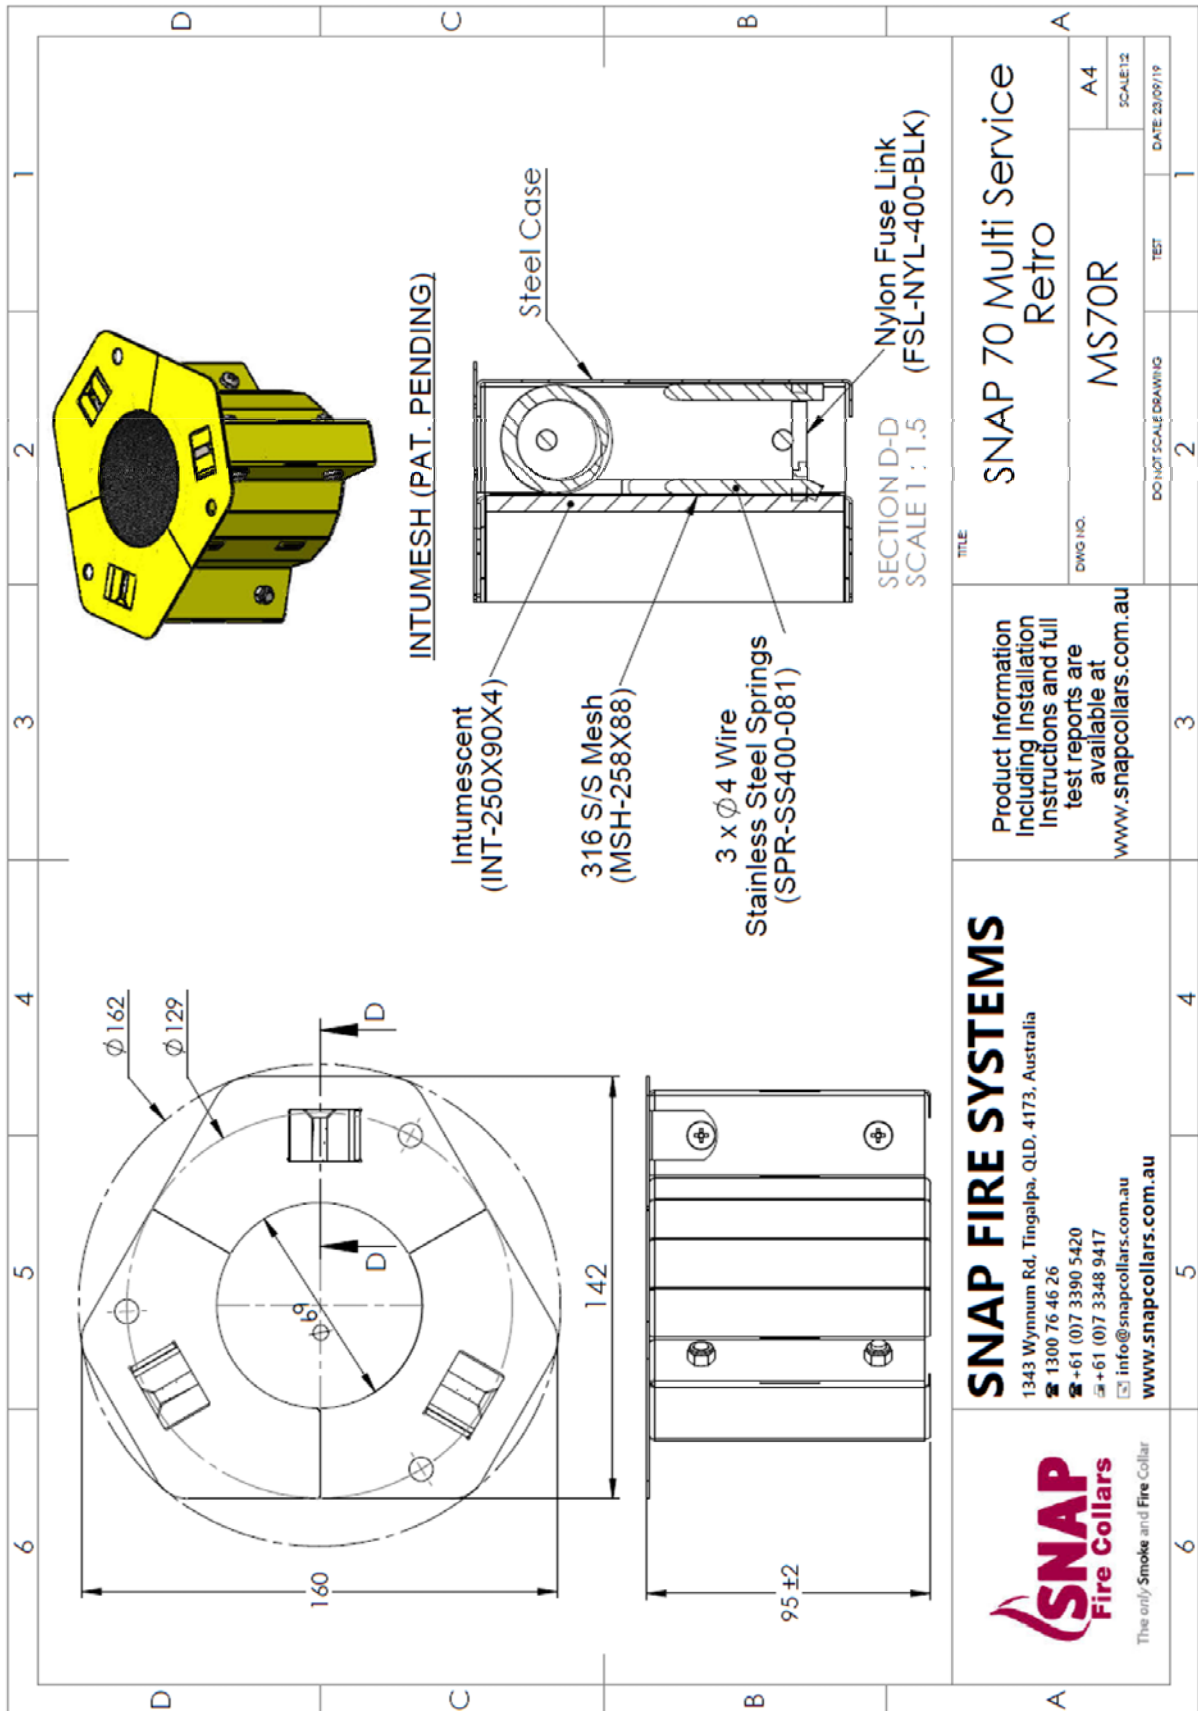
DRAWING TITLED “SNAP 70 MULTI SERVICE RETRO”, DATED 23 SEPTEMBER 2019, BY SNAP FIRE SYSTEMS.
