Fire-resistance test on retrofit fire collars protecting a plasterboard wall penetrated by services

Test Report

Author: Peter Gordon
Report number: FSP 2267
Date: 24 June 2022
Client: IG6 Pty Ltd

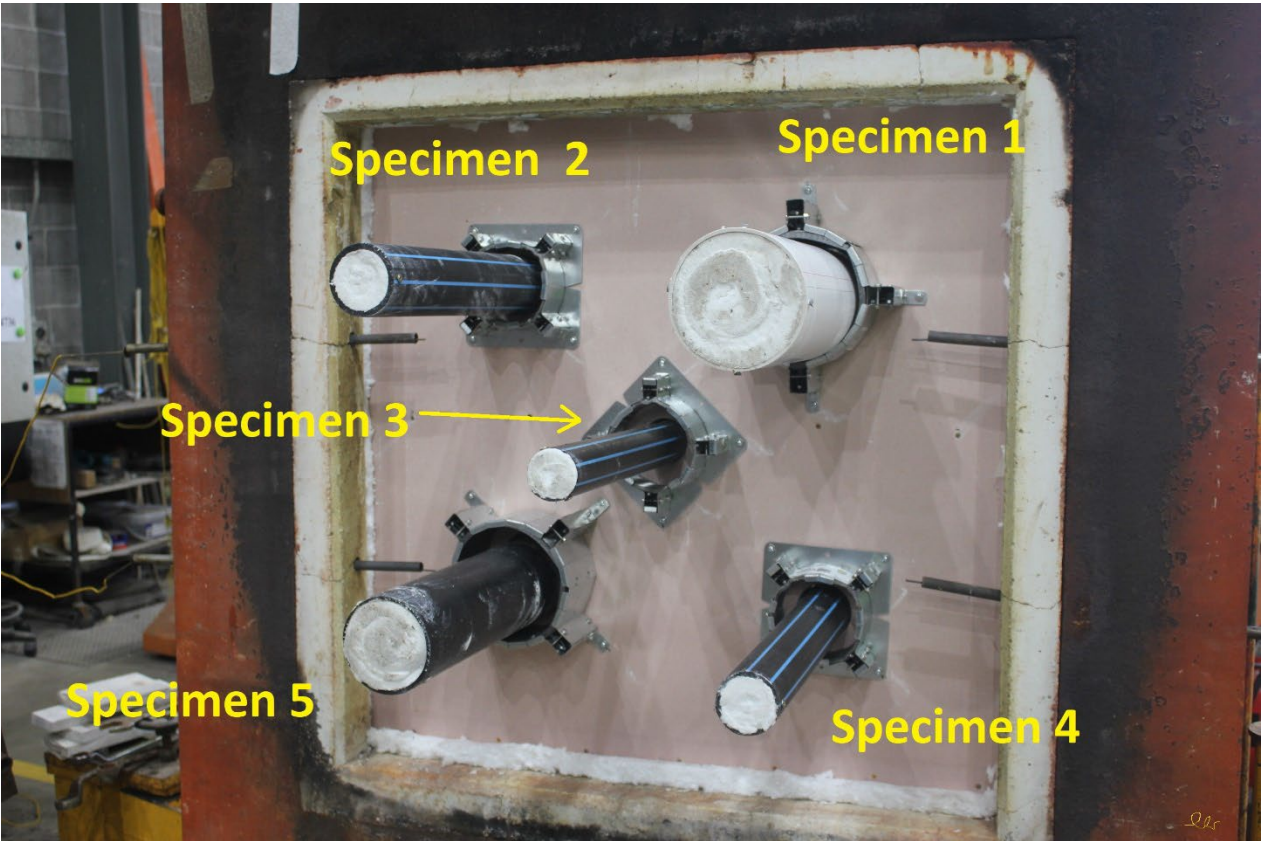
PHOTOGRAPH 1 – EXPOSED FACE OF SPECIMENS PRIOR TO TESTING

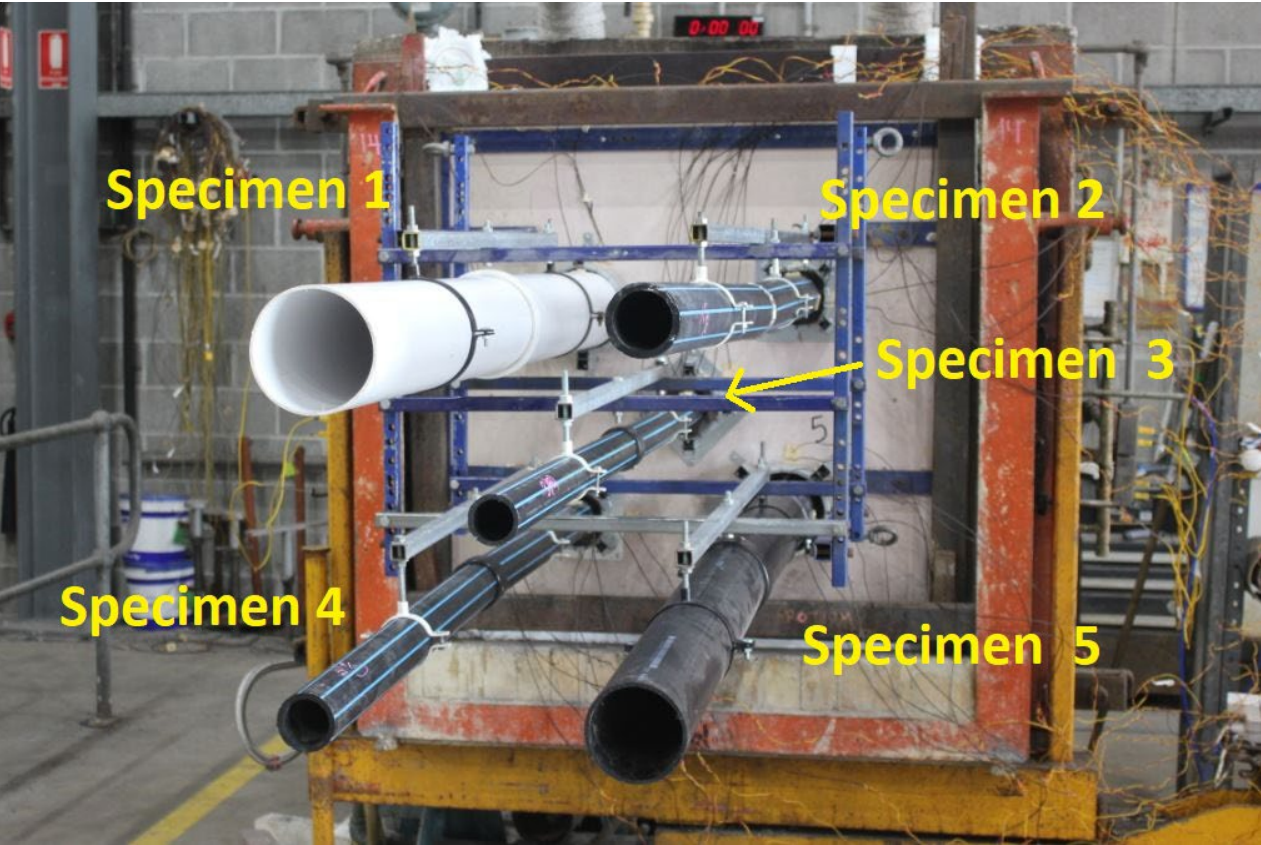
PHOTOGRAPH 2 – UNEXPOSED FACE OF SPECIMENS PRIOR TO TESTING

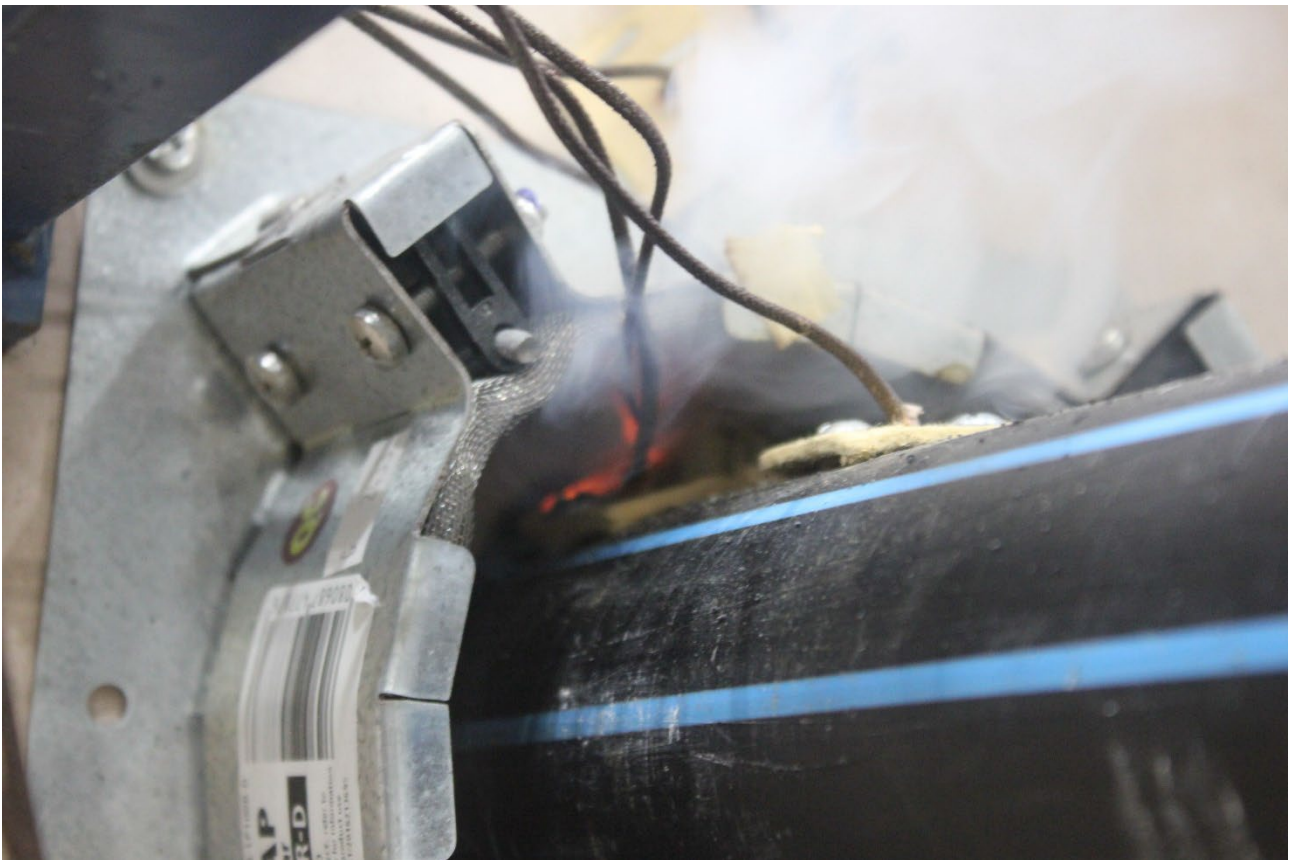
PHOTOGRAPH 14 –SPECIMEN 4 AFTER 147 MINUTES OF TESTING

- 147 minutes - Flaming observed on the pipe inside the collar of specimen 4. Cotton pad test applied over the pipe and collar above the flaming at the base of specimen 4, no ignition of cotton pad noted at this time.

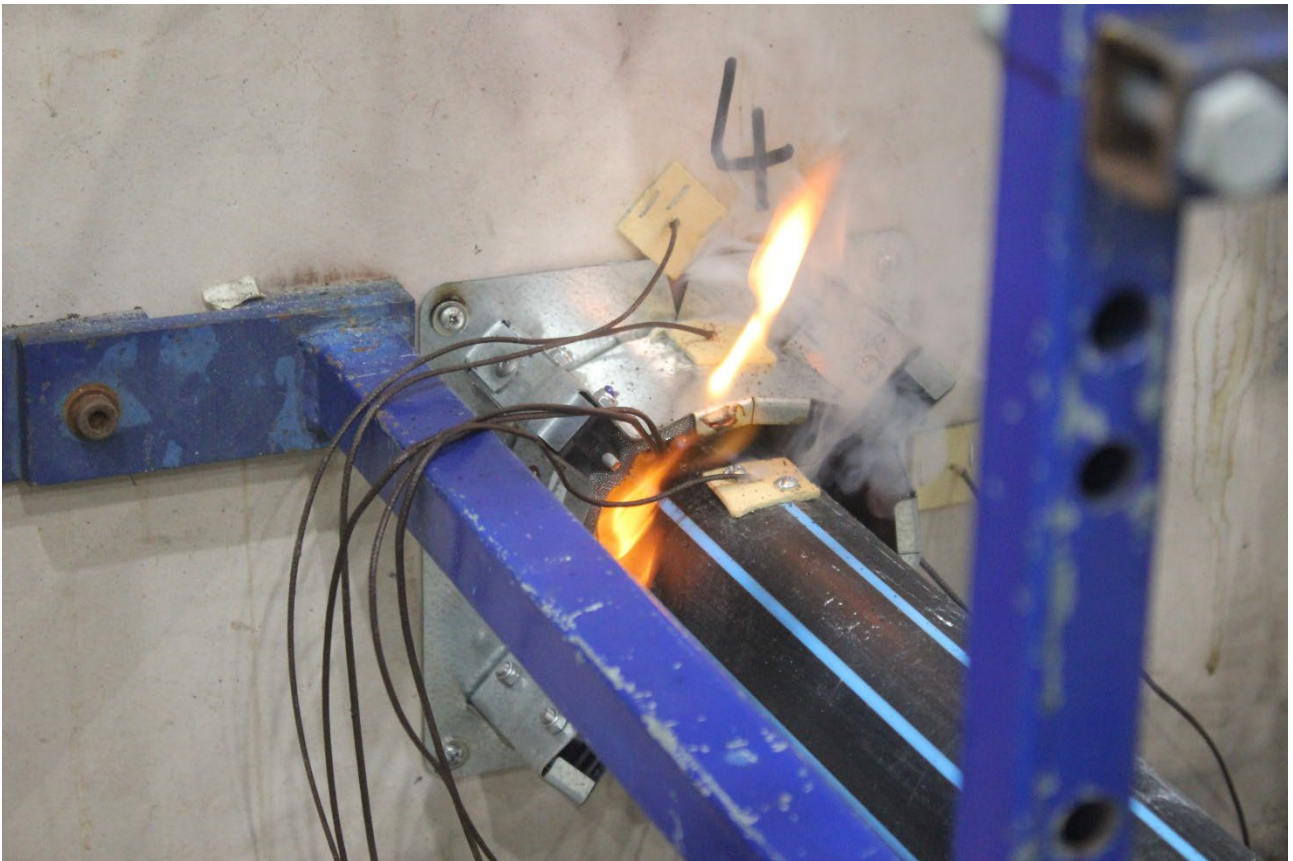
PHOTOGRAPH 15 –SPECIMEN 4 AFTER 150 MINUTES OF TESTING

- 150 minutes - Integrity failure of specimen 4 - Cotton pad test applied over the top of the pipe adjacent to the flaming inside the collar of specimen 4, ignition of cotton pad noted at this time.

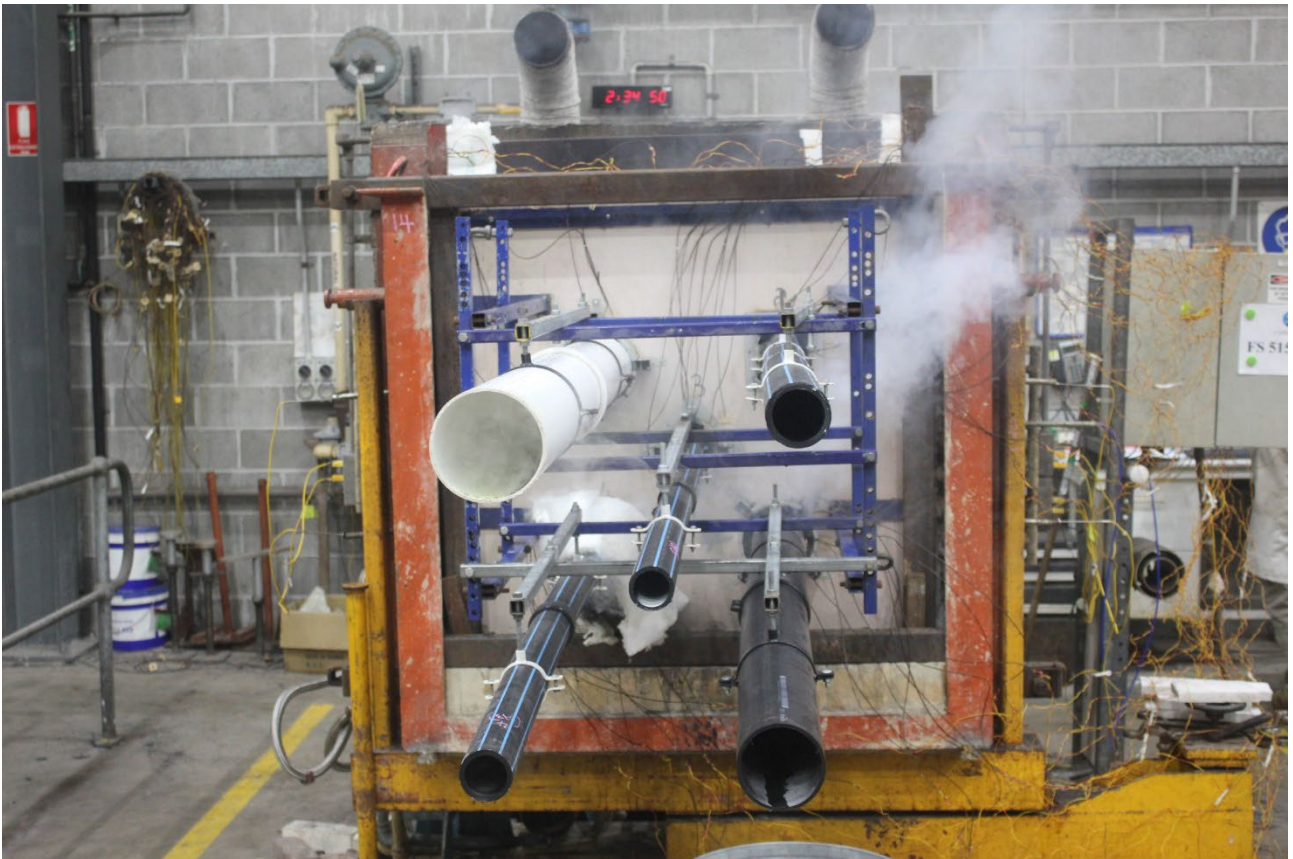
PHOTOGRAPH 17 – SPECIMEN 5 AFTER 165 MINUTES OF TESTING

- 161 minutes - The top of the pipe inside the collar of specimen 5 has softened and begun to distort.
- 165 minutes - A loud clicking noise and the release of a nylon fuse of specimen 3 was noted at this time. The level of smoke being emitted from the collar at the base of specimen 5 has intensified (Photograph 17).

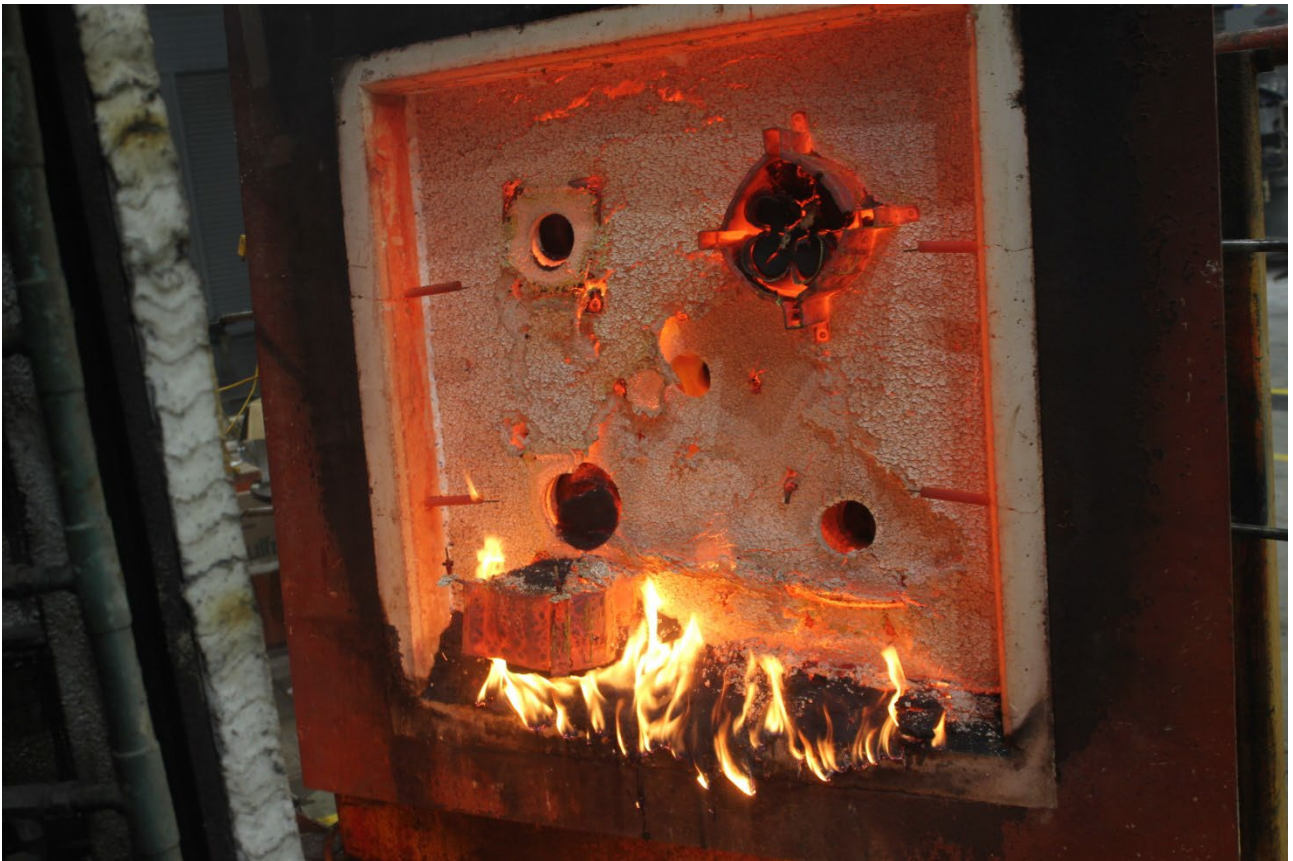
PHOTOGRAPH 19 – EXPOSED FACE OF SPECIMENS AT CONCLUSION OF TESTING

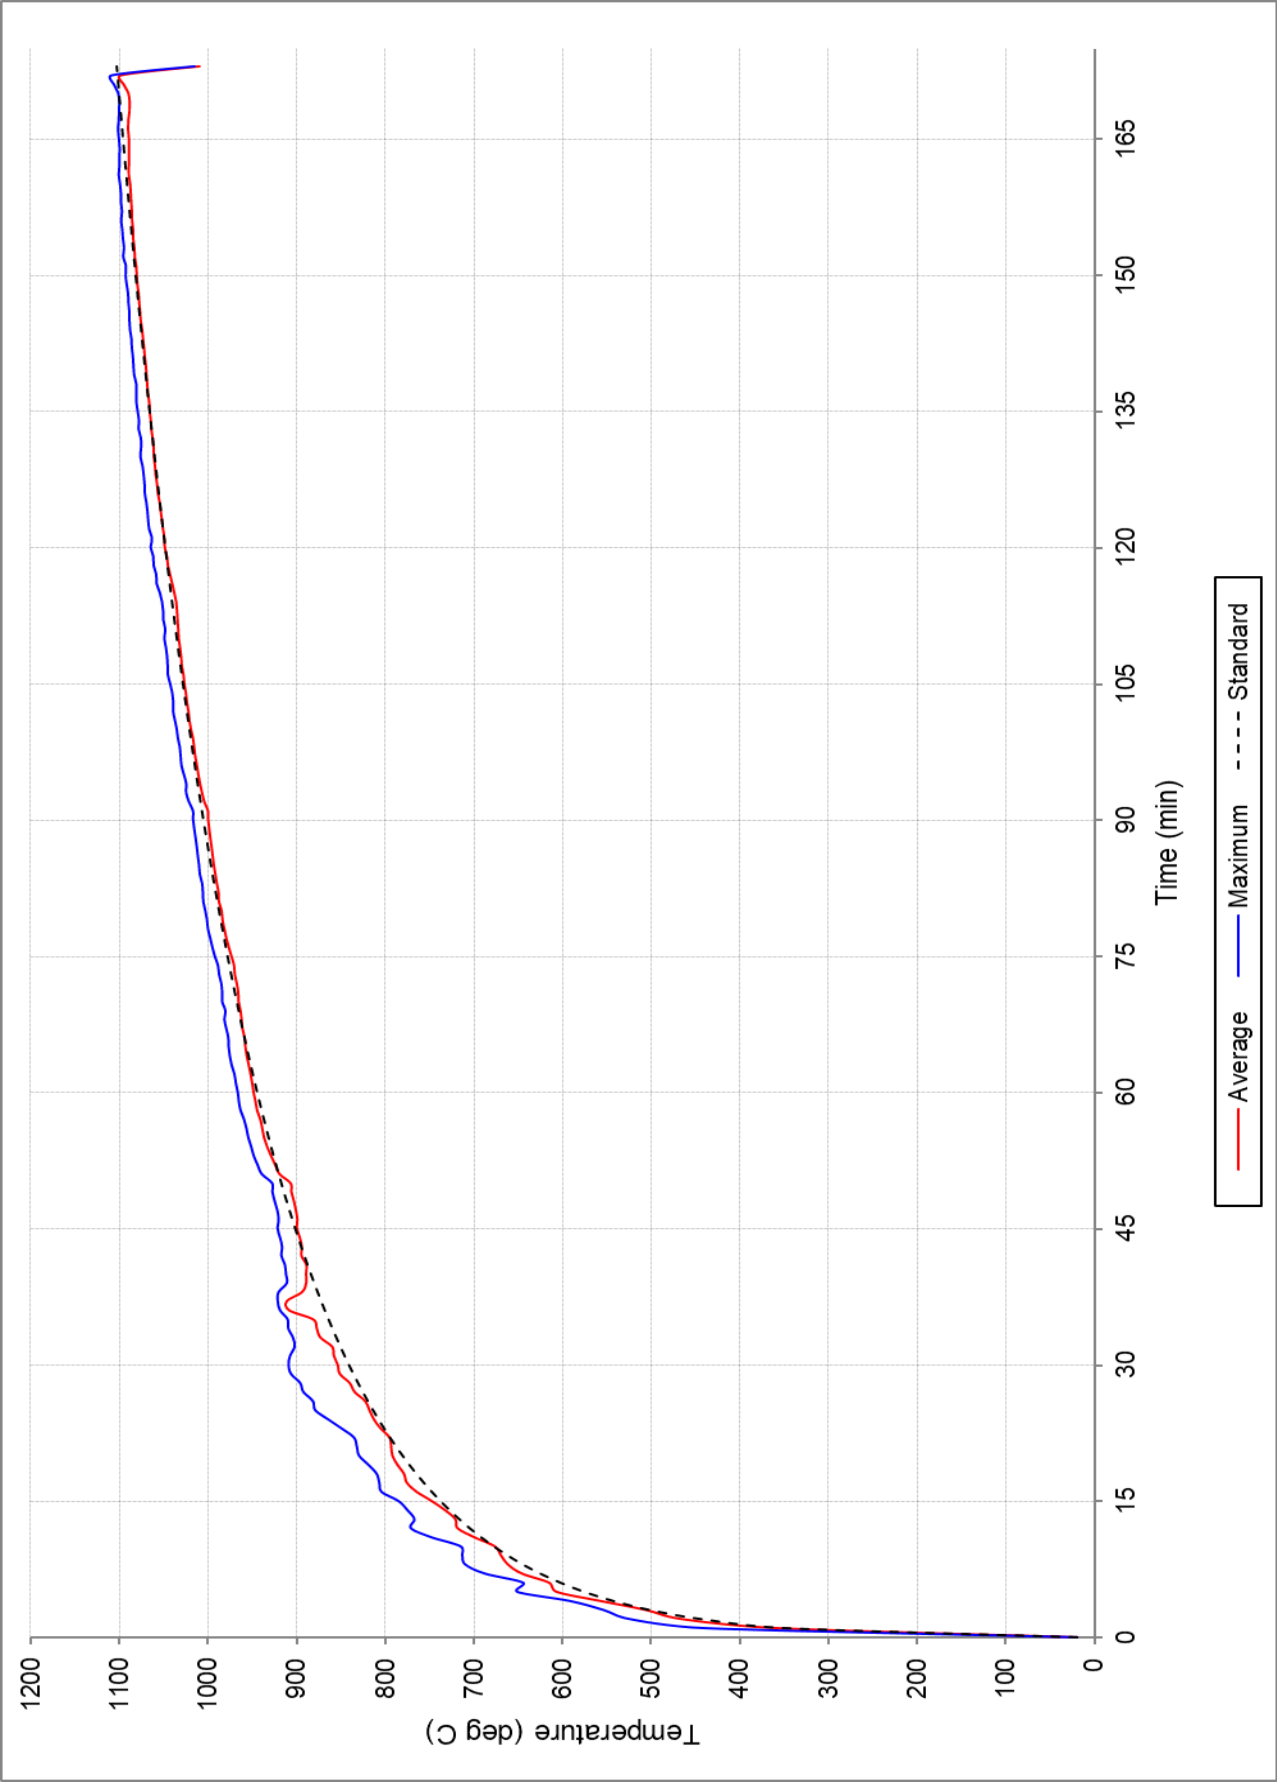
FIGURE 1 – FURNACE TEMPERATURE

Figure 1 shows the standard curves of temperature versus time for heating the furnace chamber and the actual curves of average and maximum temperature versus time recorded during the heating period.

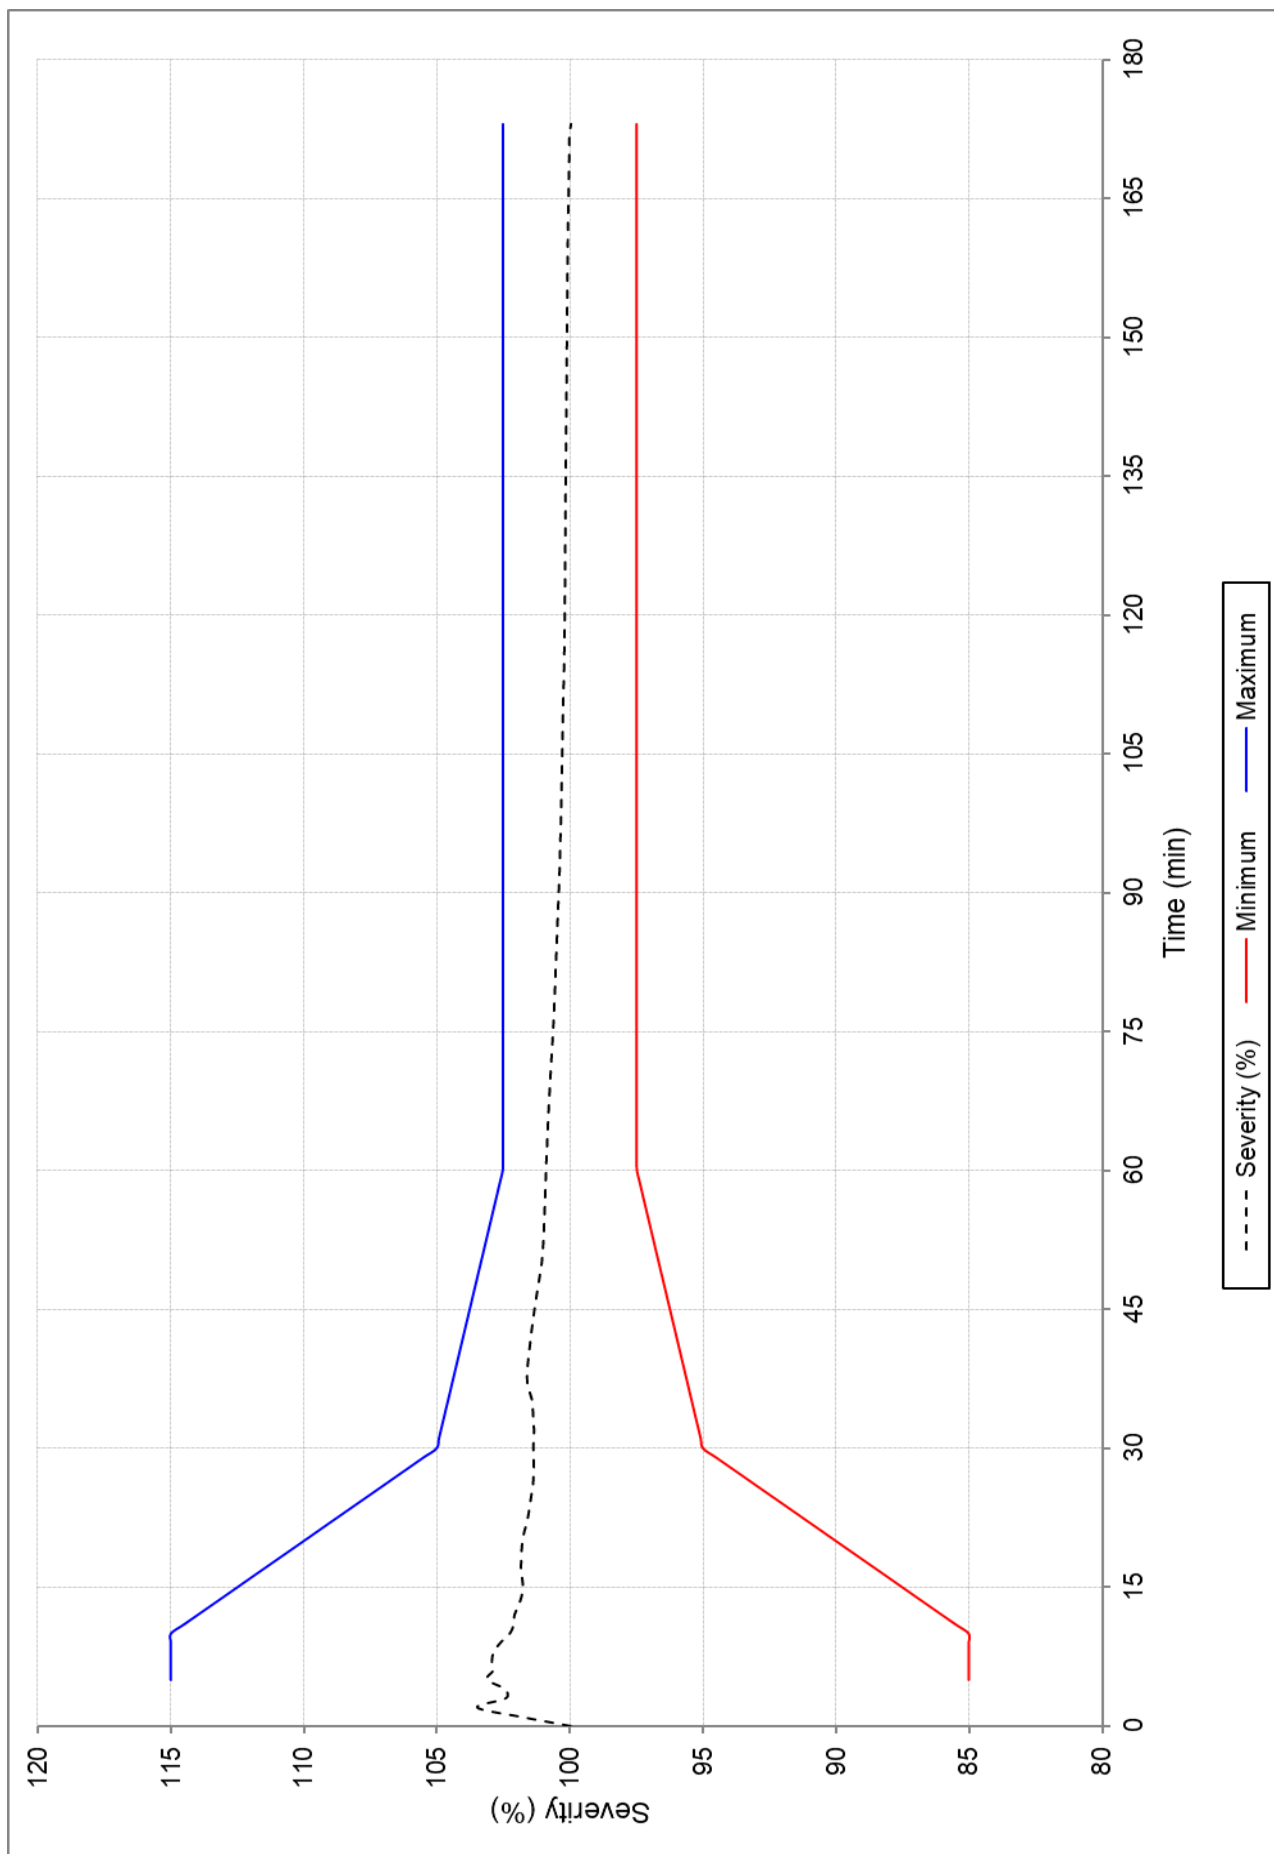
FIGURE 2 – FURNACE SEVERITY

Figure 2 shows the curve of furnace severity versus time during the heating period.

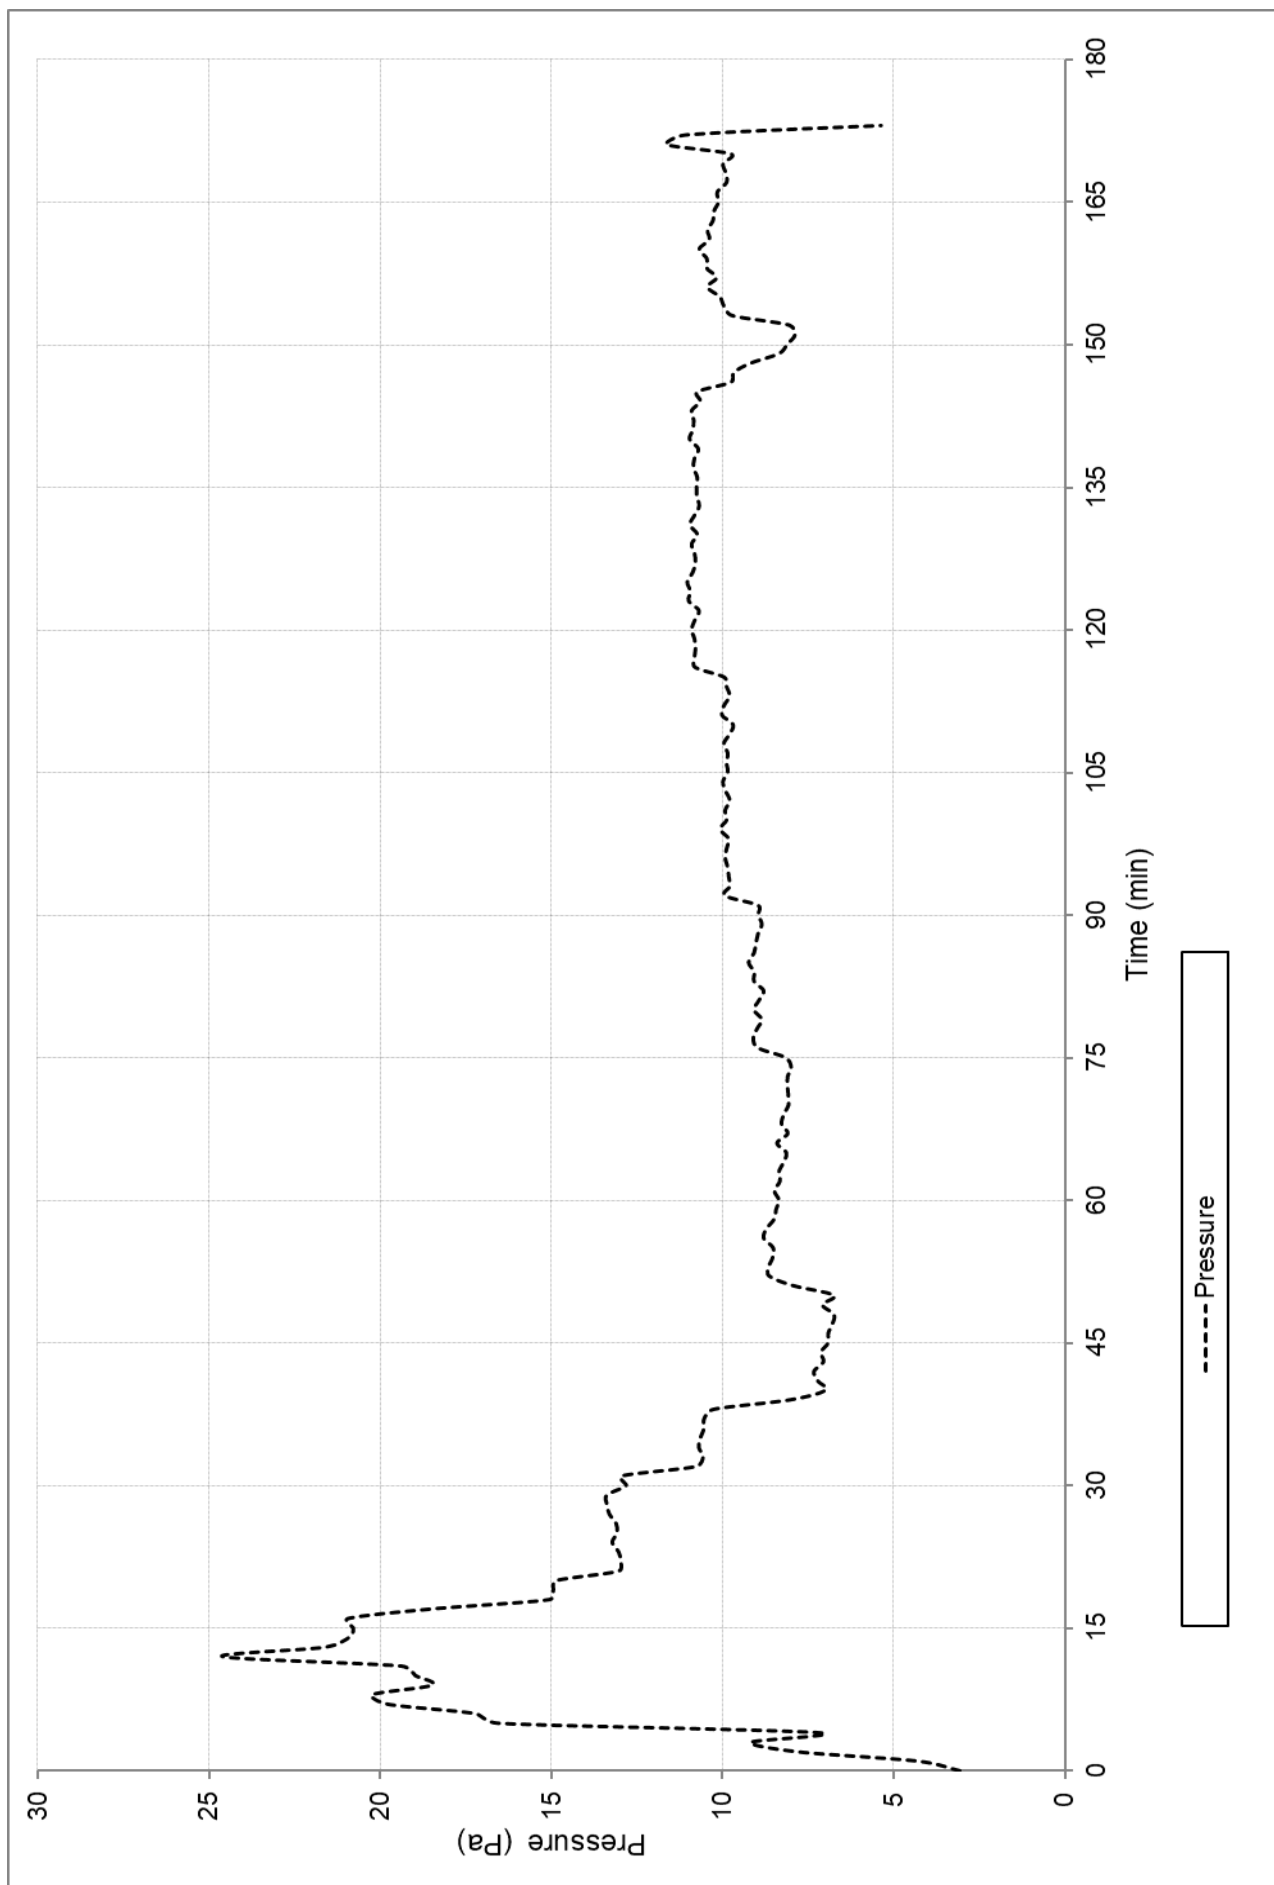
FIGURE 3 – FURNACE PRESSURE

The furnace pressure was outside of the tolerances of the requirements of AS 1530.4-2014 after the first 32 minutes of the test as shown in Figure 3. The test laboratory confirms that this departure in furnace pressure would not have significantly affected the results of this test.

Figure 3 shows the curve of furnace pressure versus time during the heating period.

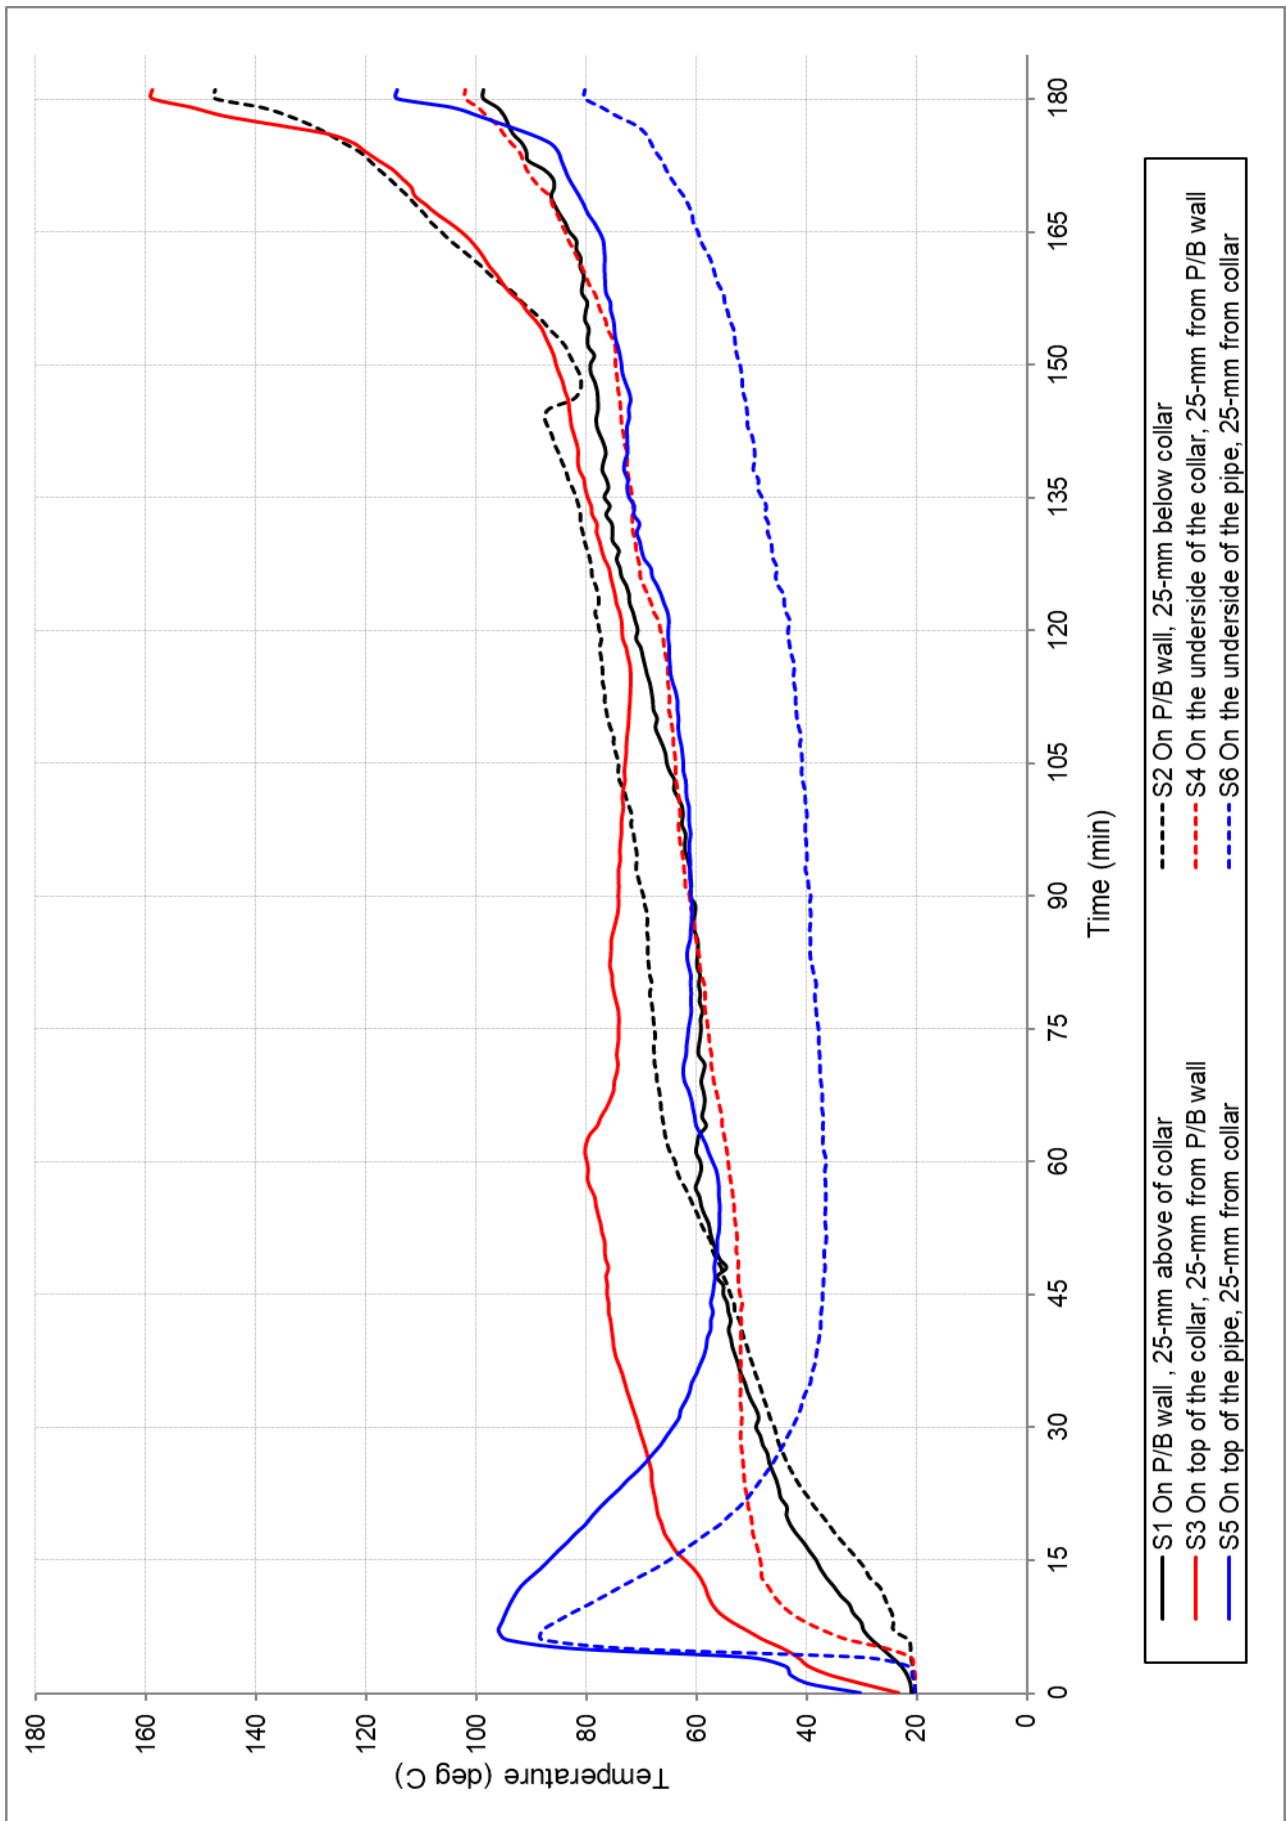
FIGURE 4 - TEMPERATURE VERSUS TIME ASSOCIATED WITH SPECIMEN #1

Figure 4 shows the curve of temperature versus time associated with Specimen 1.

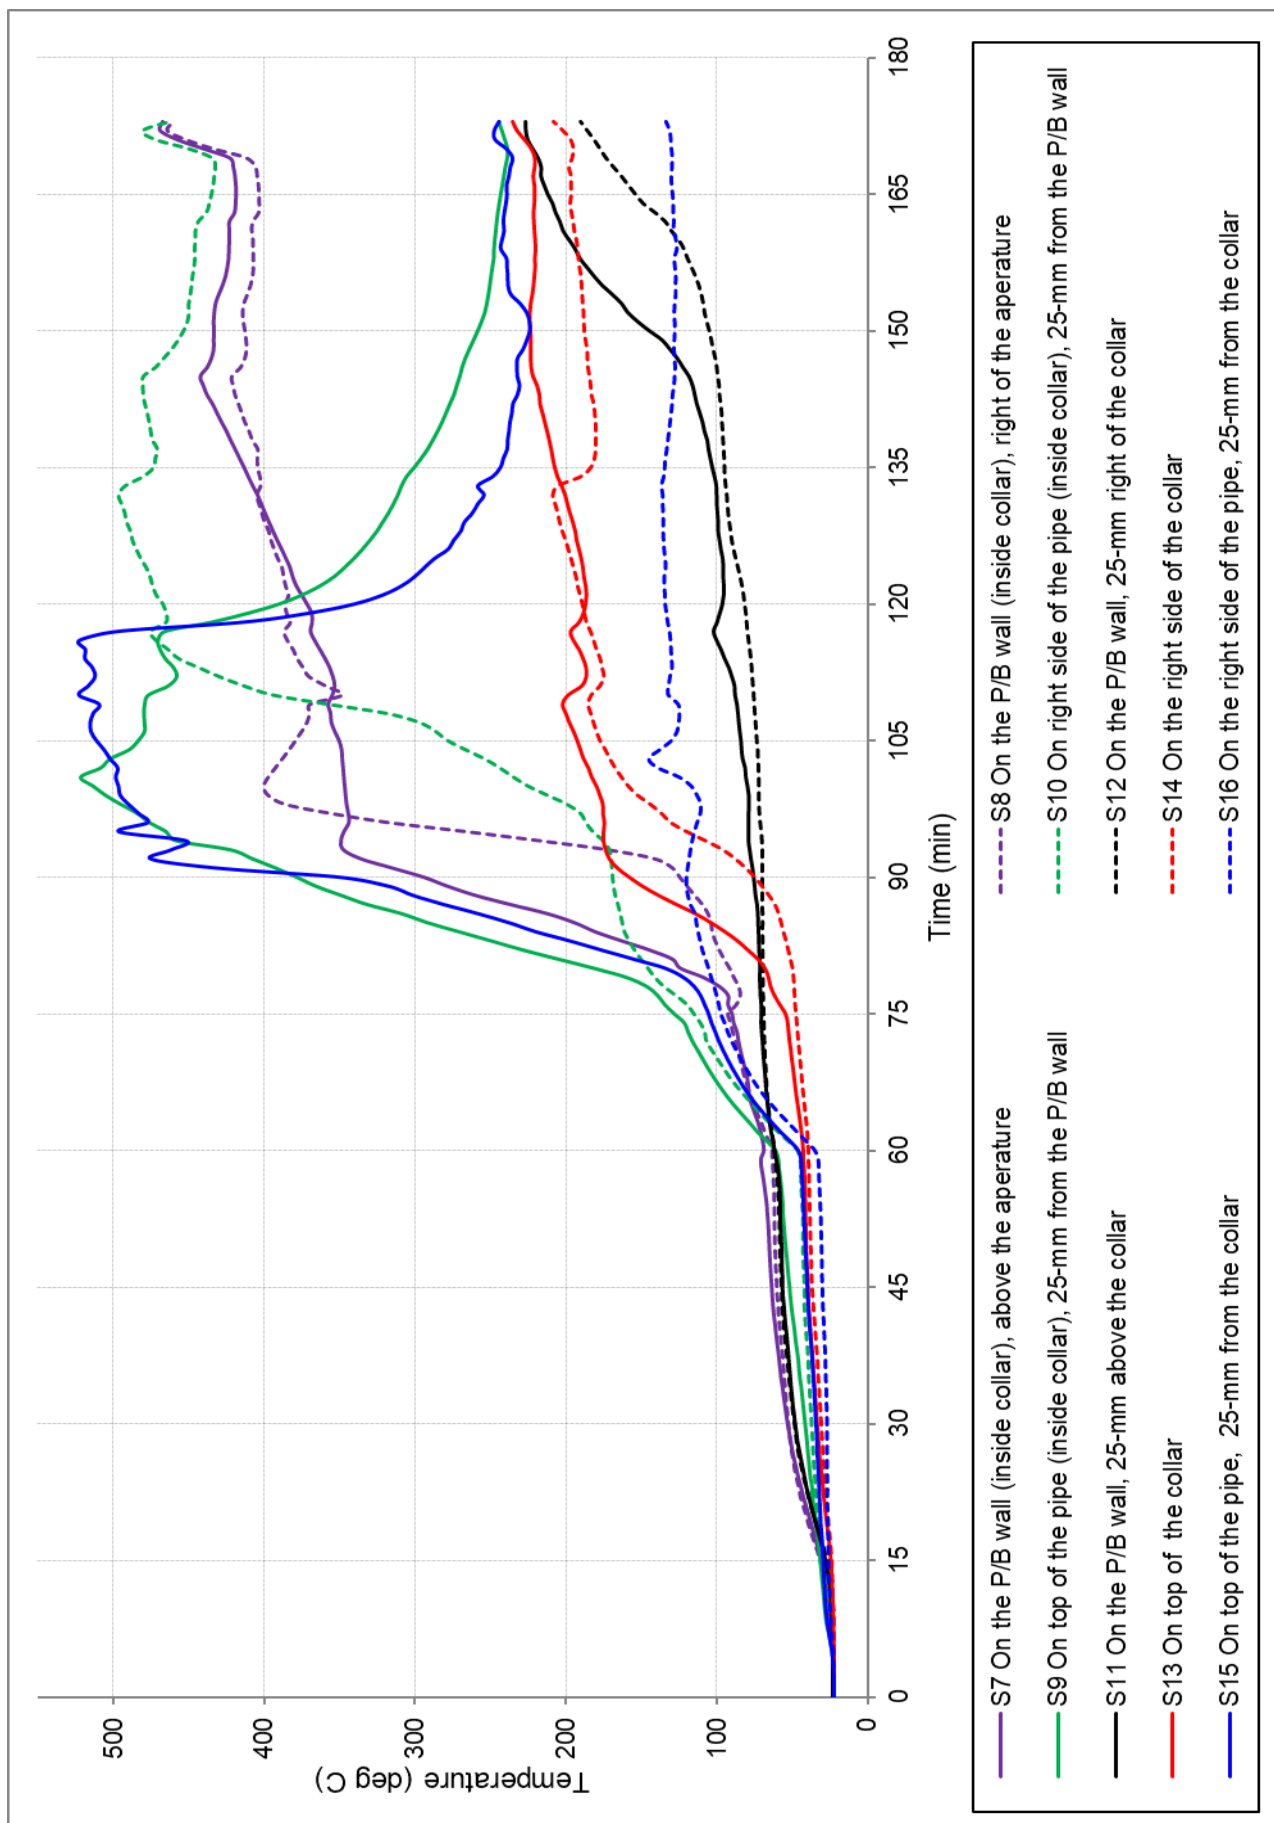
FIGURE 5 - TEMPERATURE VERSUS TIME ASSOCIATED WITH SPECIMEN #2

Figure 5 shows the curve of temperature versus time associated with Specimen 2.

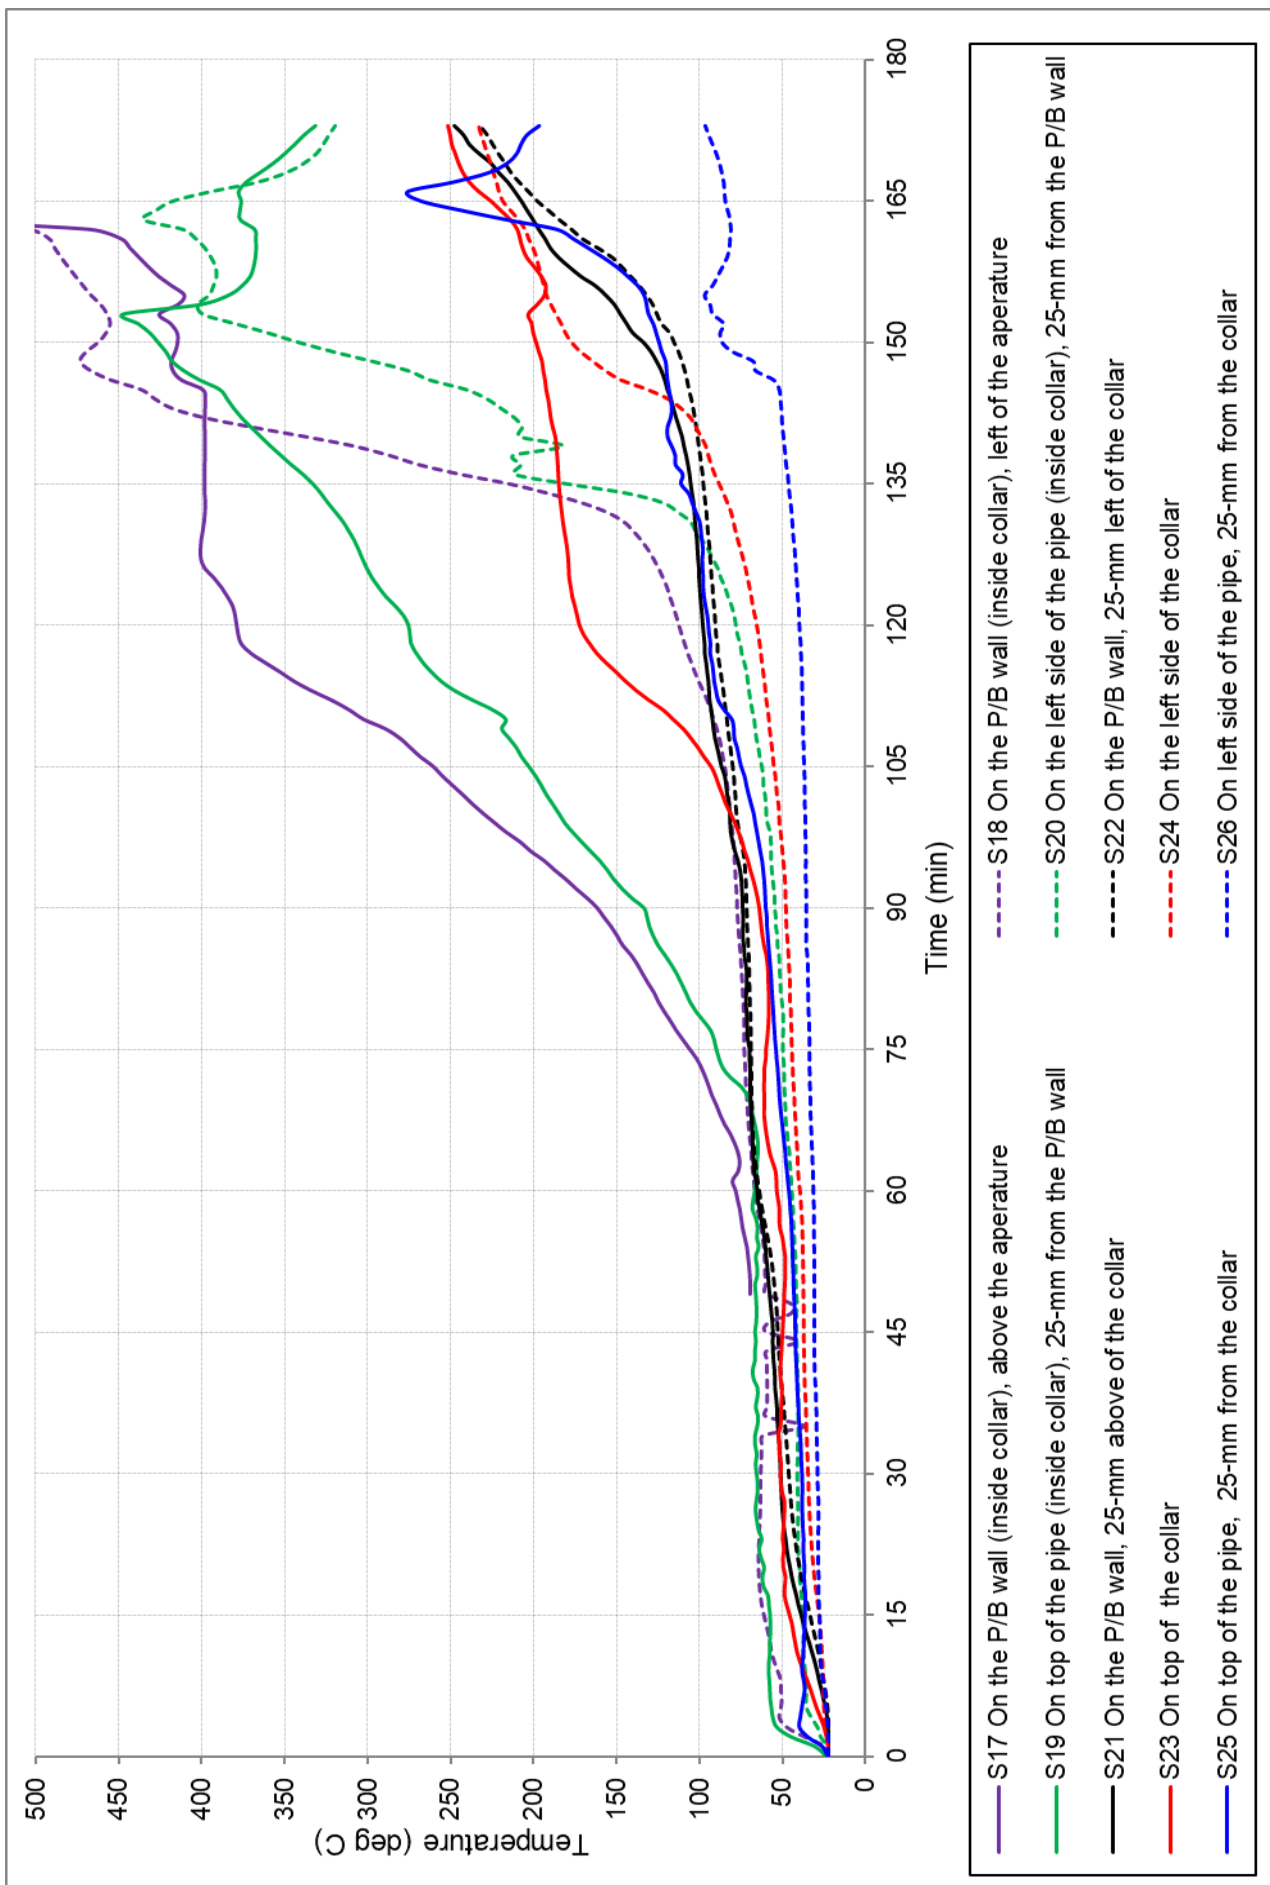
FIGURE 6 - TEMPERATURE VERSUS TIME ASSOCIATED WITH SPECIMEN #3

Figure 6 shows the curve of temperature versus time associated with Specimen 3.
