Fire-resistance test on retrofit fire collars protecting a plasterboard wall penetrated by services

Test Report

Author: Peter Gordon
Report number: FSP 2267
Date: 24 June 2022
Client: IG6 Pty Ltd

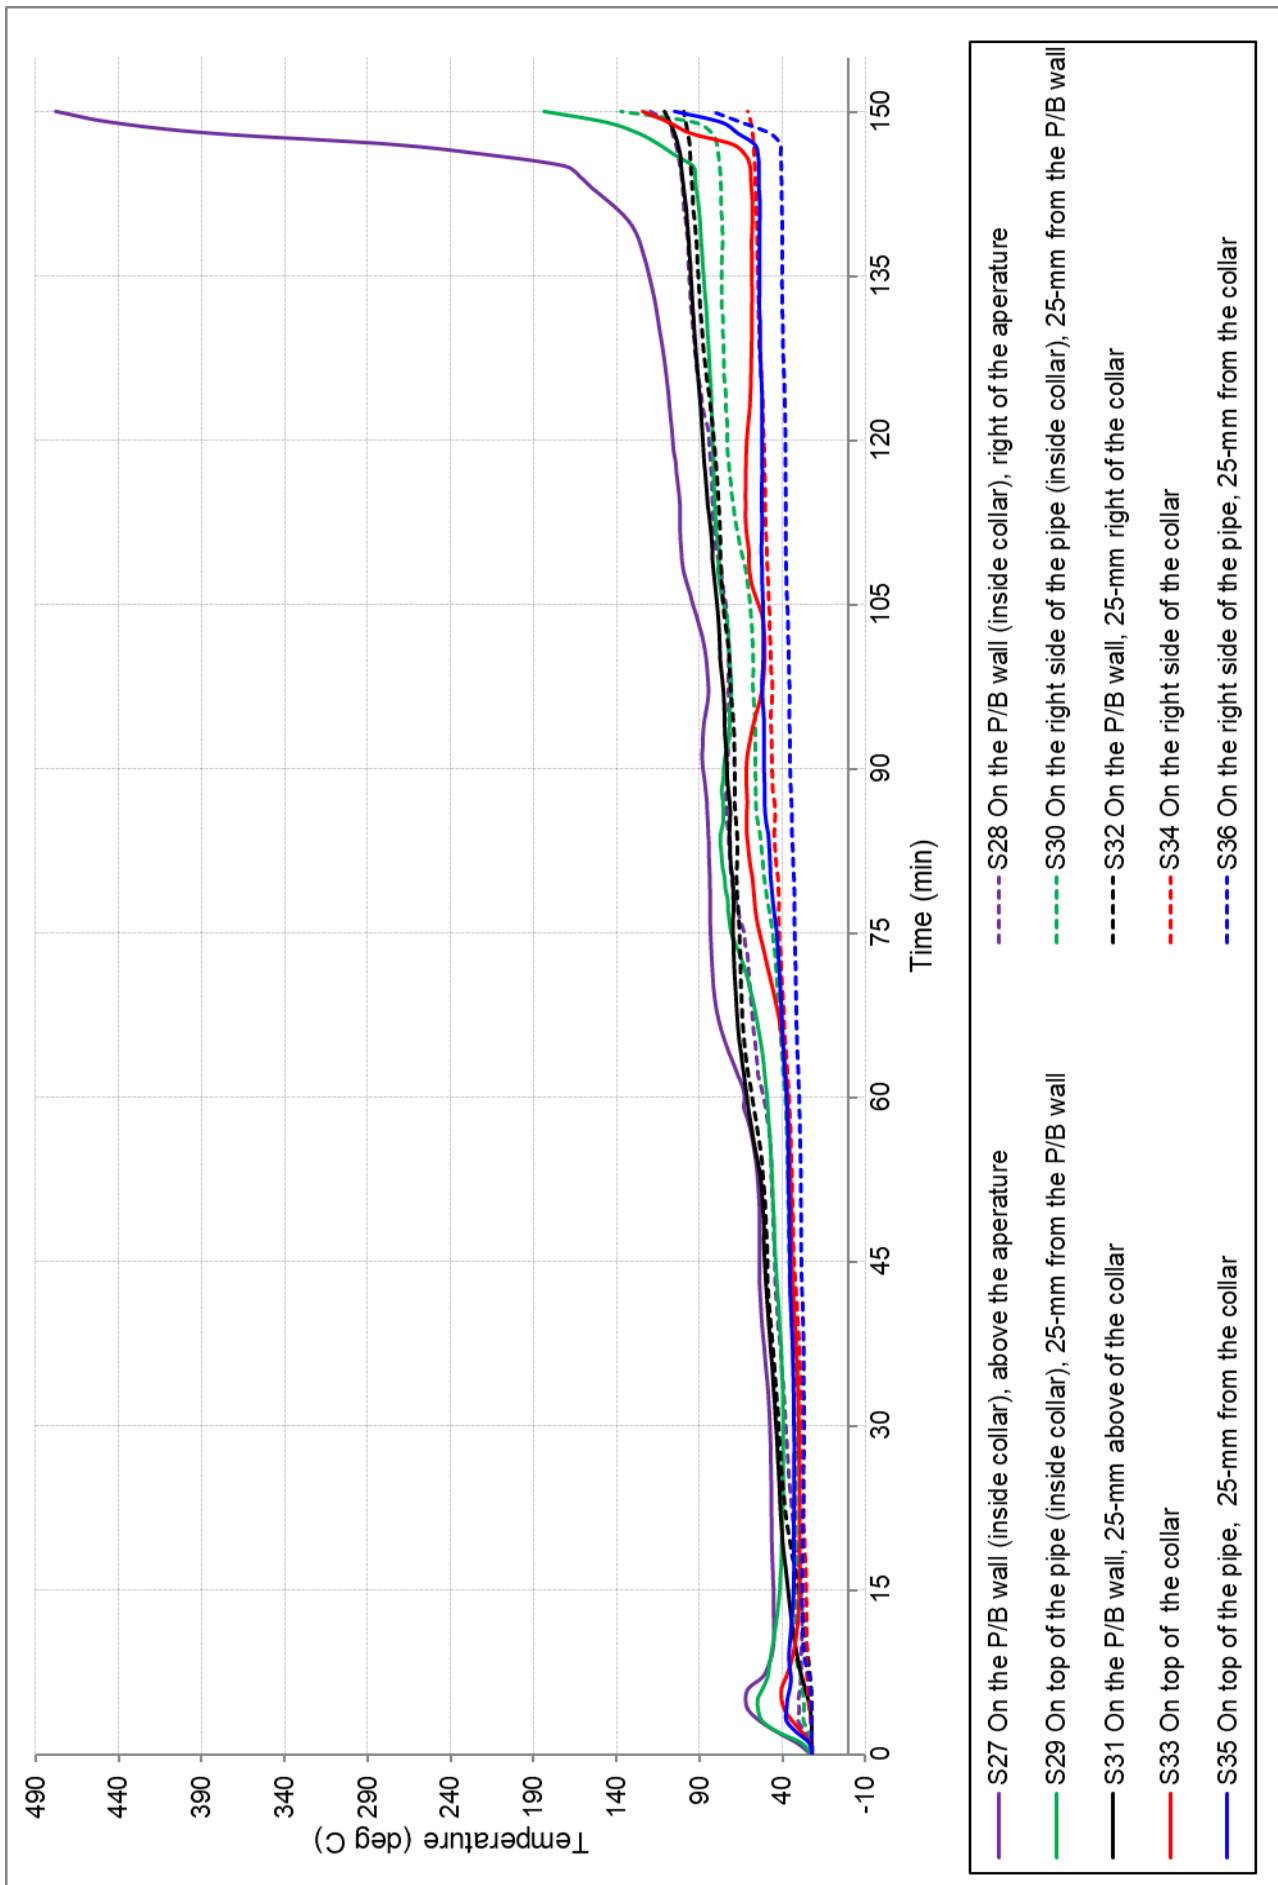
FIGURE 7 - TEMPERATURE VERSUS TIME ASSOCIATED WITH SPECIMEN #4

Figure 7 shows the curve of temperature versus time associated with Specimen 4.

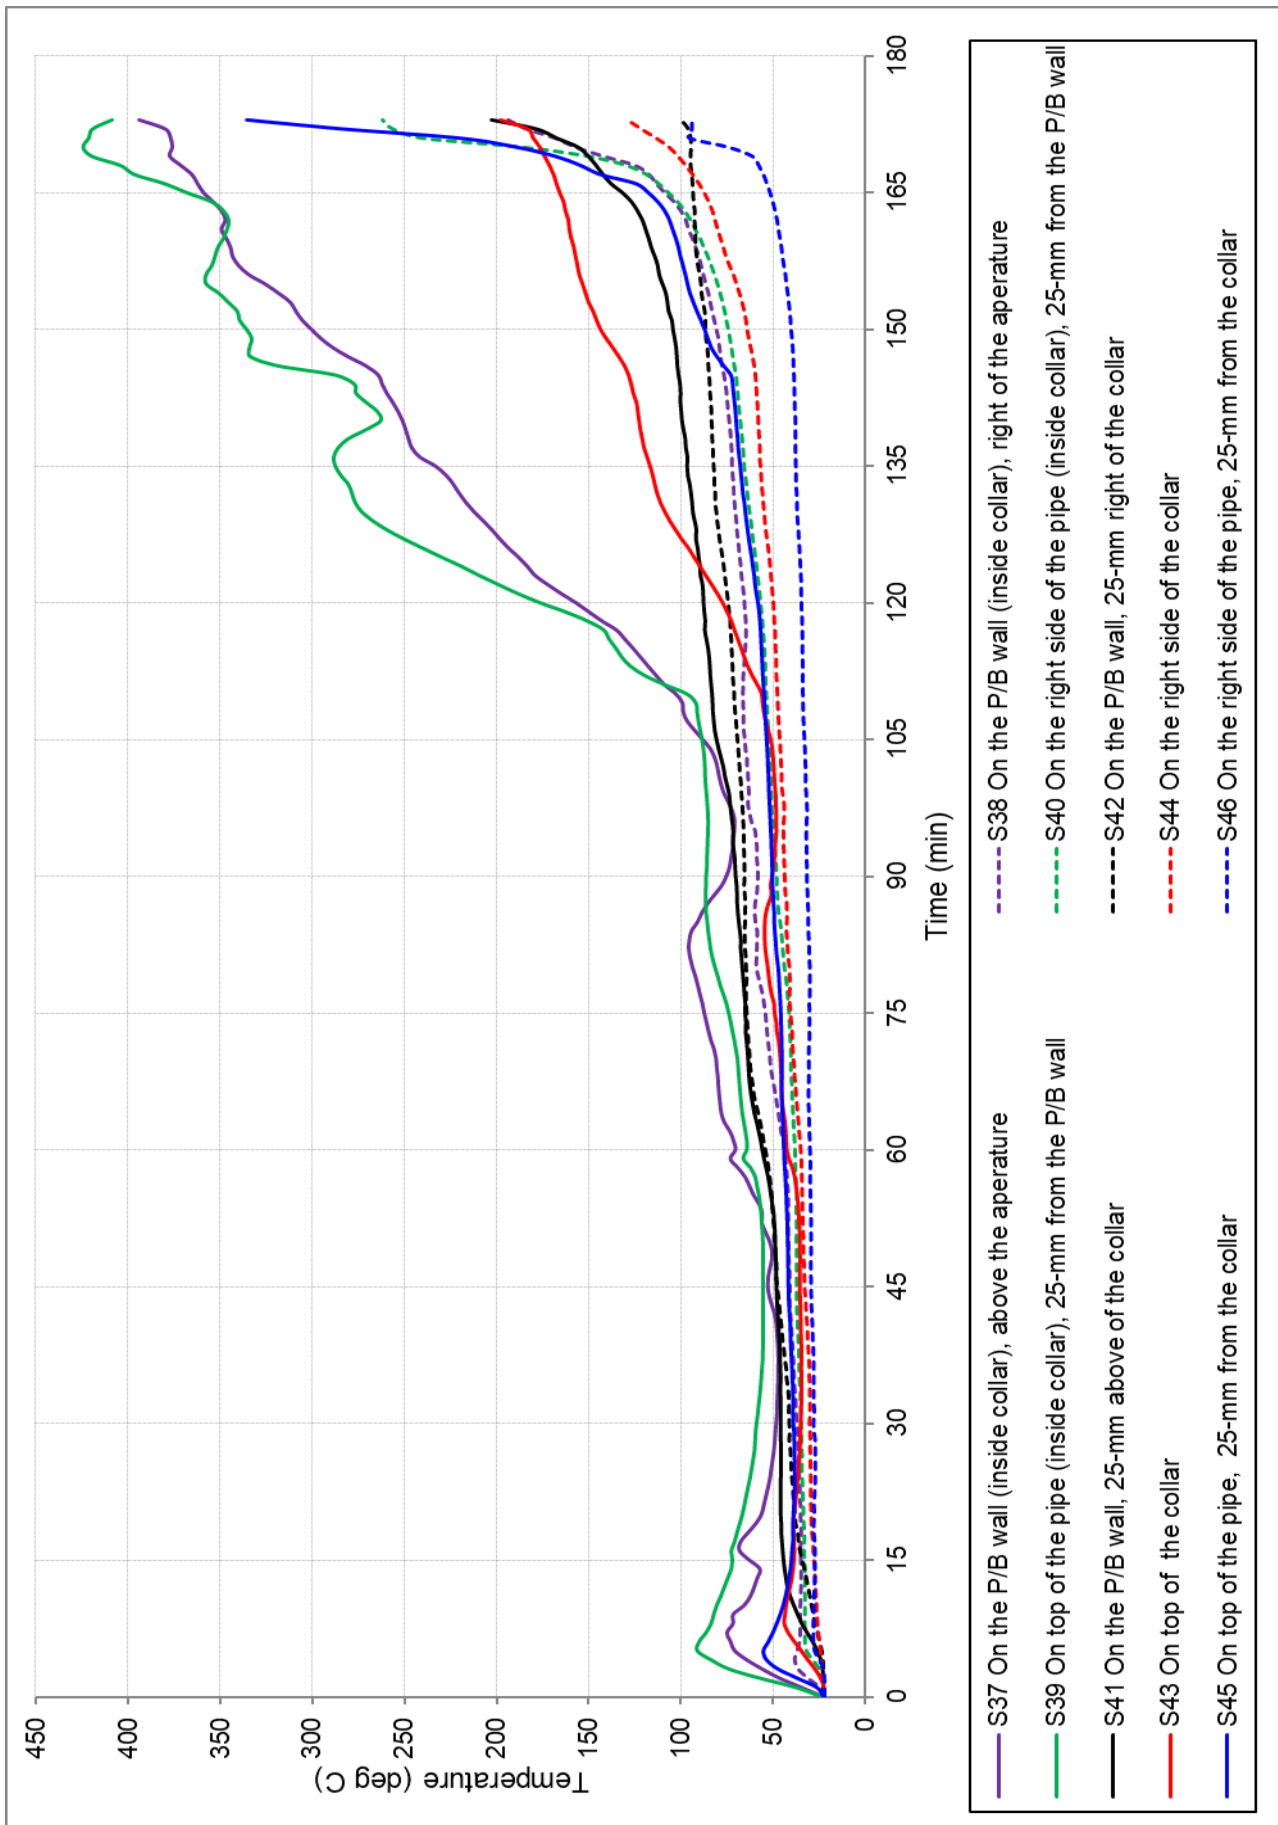
FIGURE 8 - TEMPERATURE VERSUS TIME ASSOCIATED WITH SPECIMEN #5

Figure 8 shows the curve of temperature versus time associated with Specimen 5.

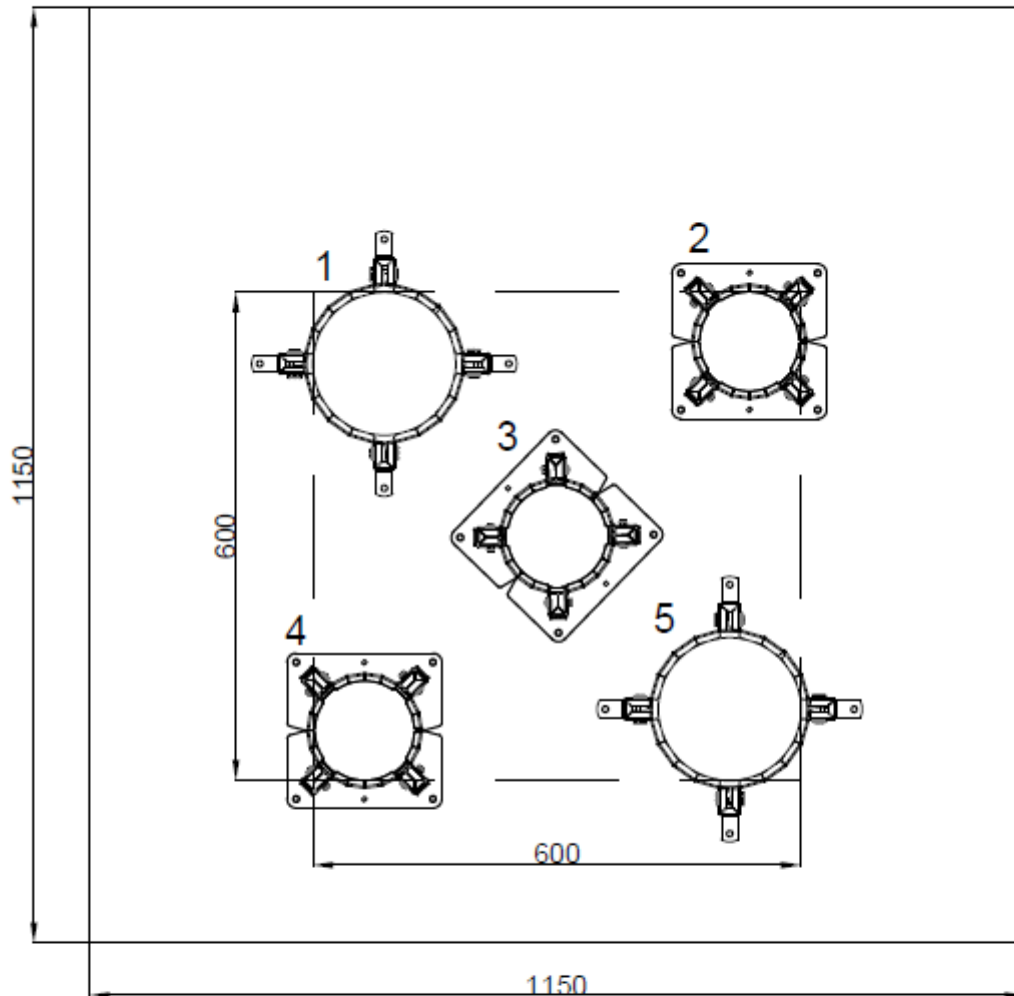
Test Wall W-21-A3 Layout

Penetration	Collar Code	Pipe Type	Pipe Diameter
1	HP150R	Raupiano	160
2	LP100R-D	PN16 PE100	90
3	LP100R-D	PN16 PE100	63
4	LP100R-D	PN16 PE100	75
5	HP150R	HDPE	125

DRAWING TITLED 'TEST WALL W-21-A3 LAYOUT, DATED 23 NOVEMBER 2021, BY SNAP FIRE SYSTEMS PTY LTD.

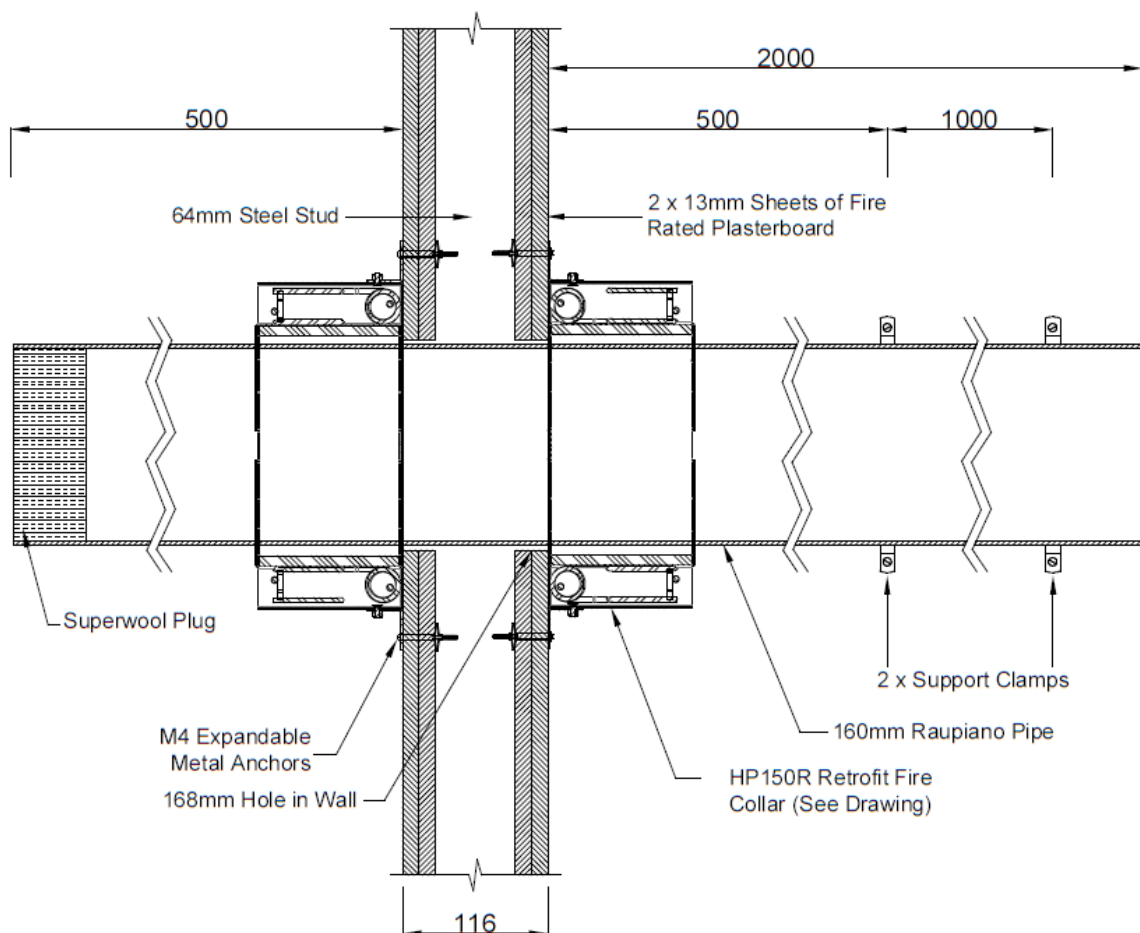
160 Raupiano Stack & HP150R

DRAWING TITLED 'SPECIMEN #1 160 RAUPIANO STACK & HP150R', DATED 25 OCTOBER 2021, BY SNAP FIRE SYSTEMS PTY LTD.

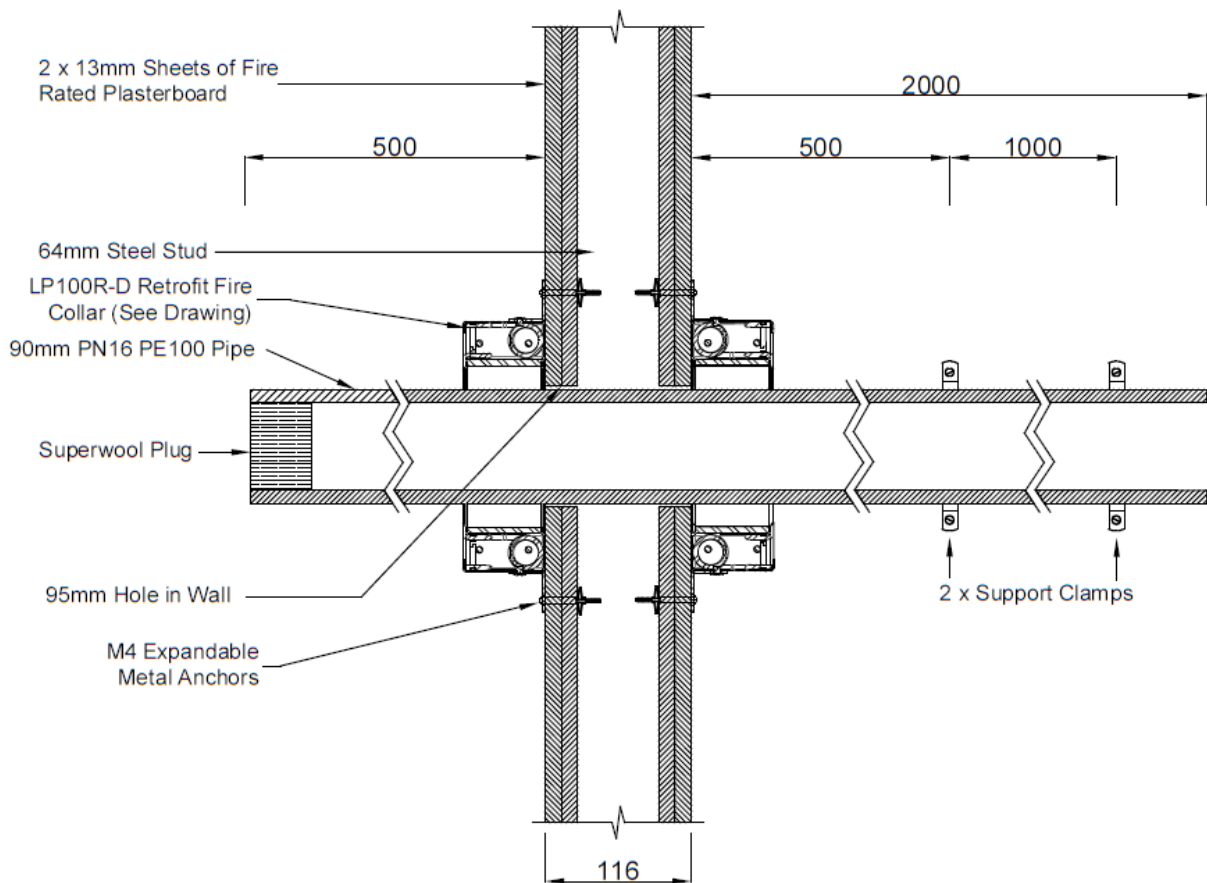
90 PN16 PE100 Pipe & LP100R-D

DRAWING TITLED 'SPECIMEN #2 90 PN16 PE100 PIPE & LP100R-D', DATED 28 JANUARY 2022, BY SNAP FIRE SYSTEMS PTY LTD

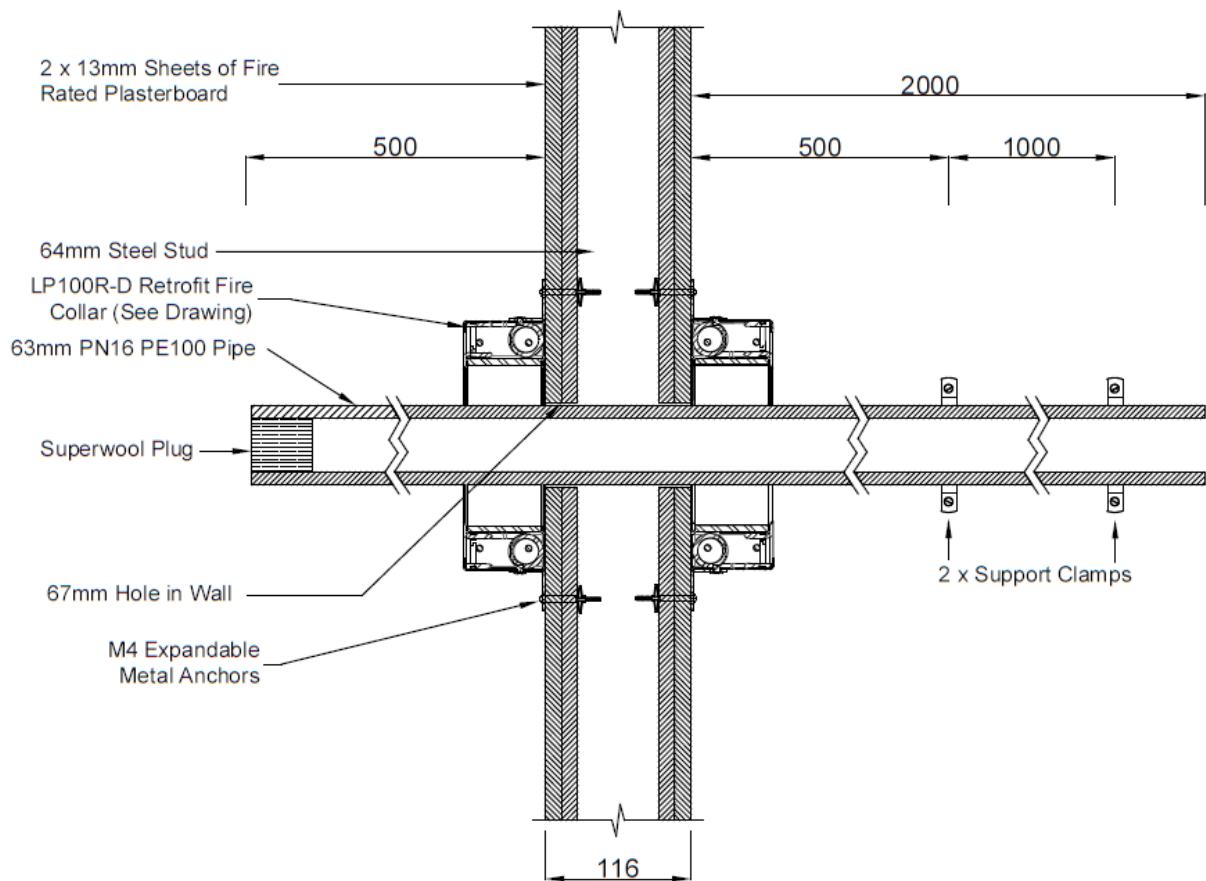
63 PN16 PE100 Pipe & LP100R-D

DRAWING TITLED 'SPECIMEN #3 63 PN16 PE100 PIPE & LP100R-D', DATED 28 JANUARY 2022, BY SNAP FIRE SYSTEMS PTY LTD

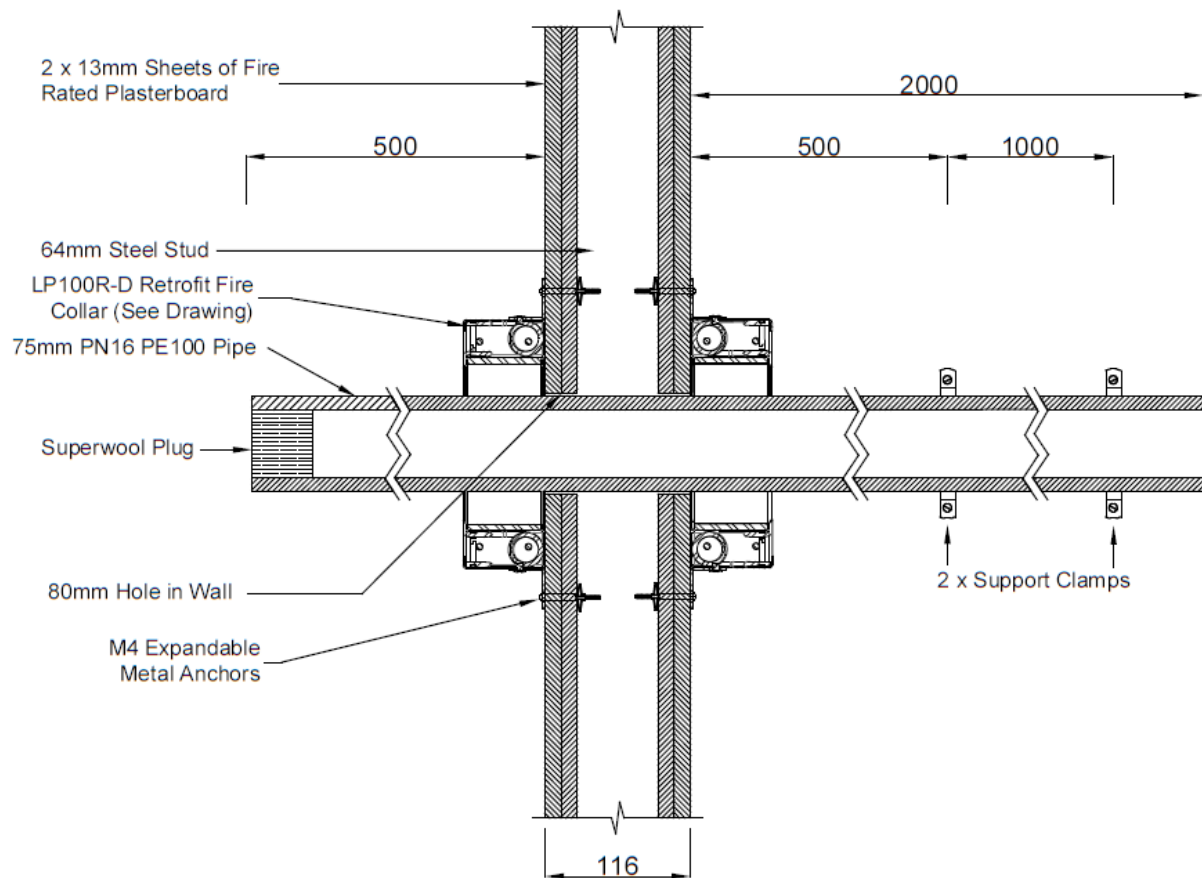
75 PN16 PE100 Pipe & LP100R-D

DRAWING TITLED 'SPECIMEN #4 75 PN16 PE100 PIPE & LP100R-D', DATED 28 JANUARY 2022, BY SNAP FIRE SYSTEMS PTY LTD

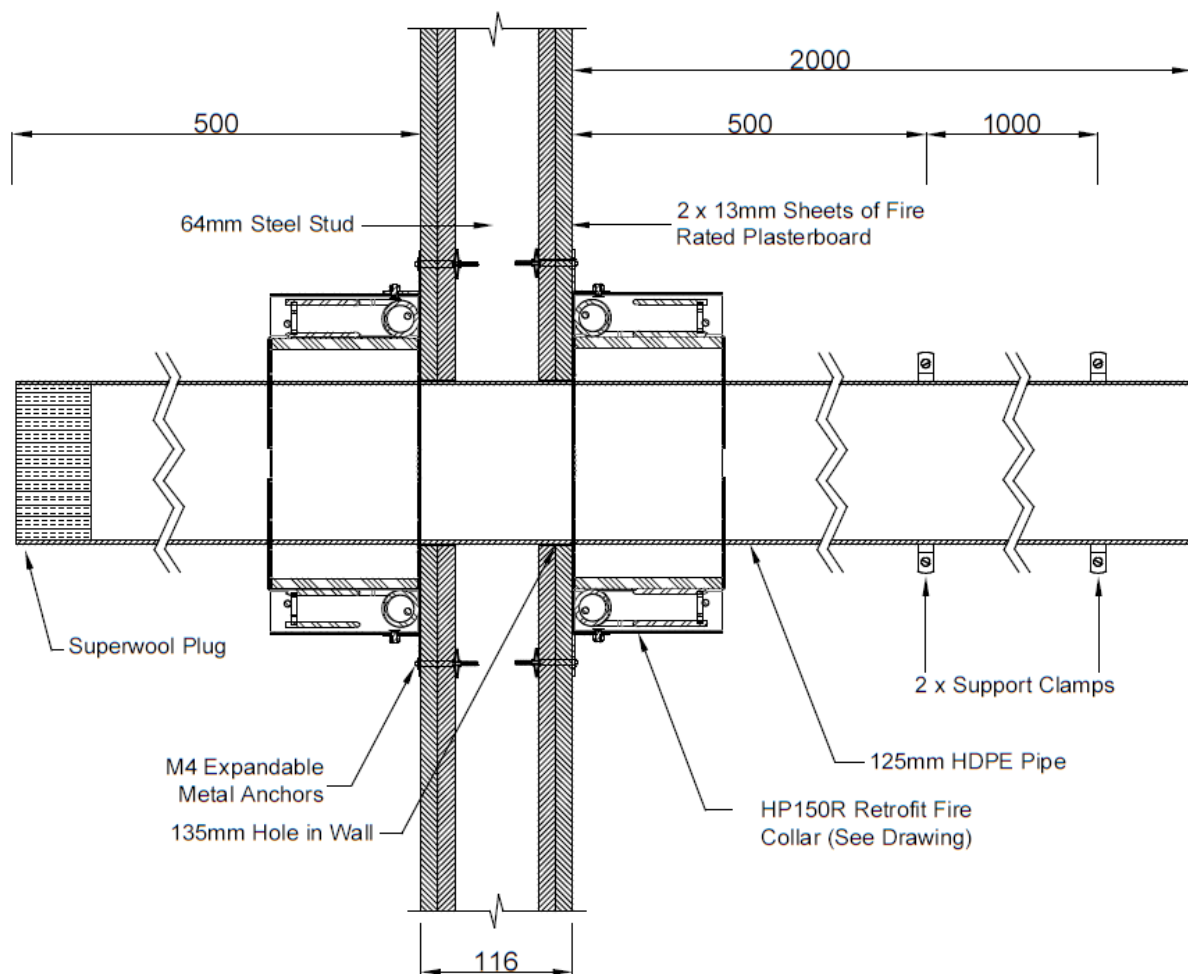
125 HDPE Stack & HP150R

DRAWING TITLED 'SPECIMEN #5 125 HDPE STACK & HP150R', DATED 23 NOVEMBER 2021, BY SNAP FIRE SYSTEMS PTY LTD

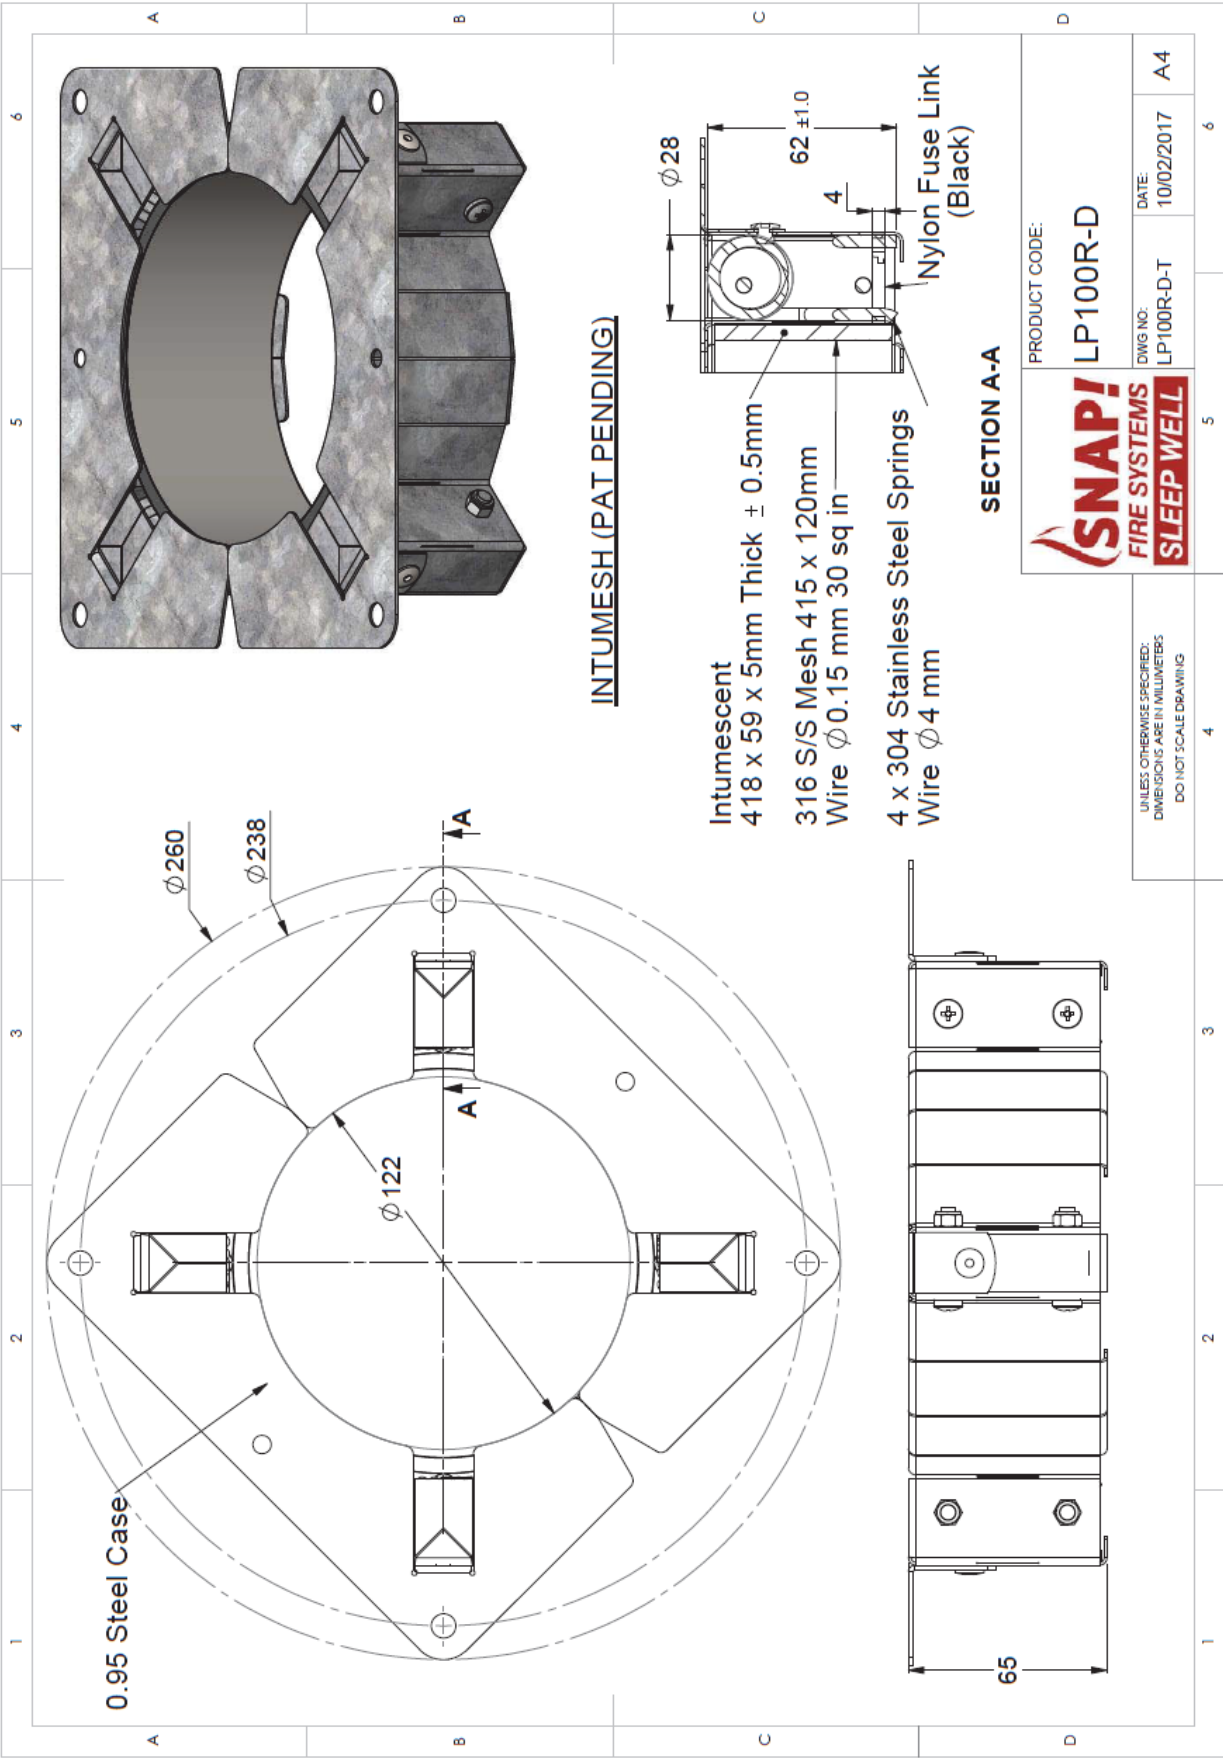
DRAWING NUMBERED LP100R-D-T, DATED 10 FEBRUARY 2017, BY SNAP FIRE SYSTEMS PTY LTD

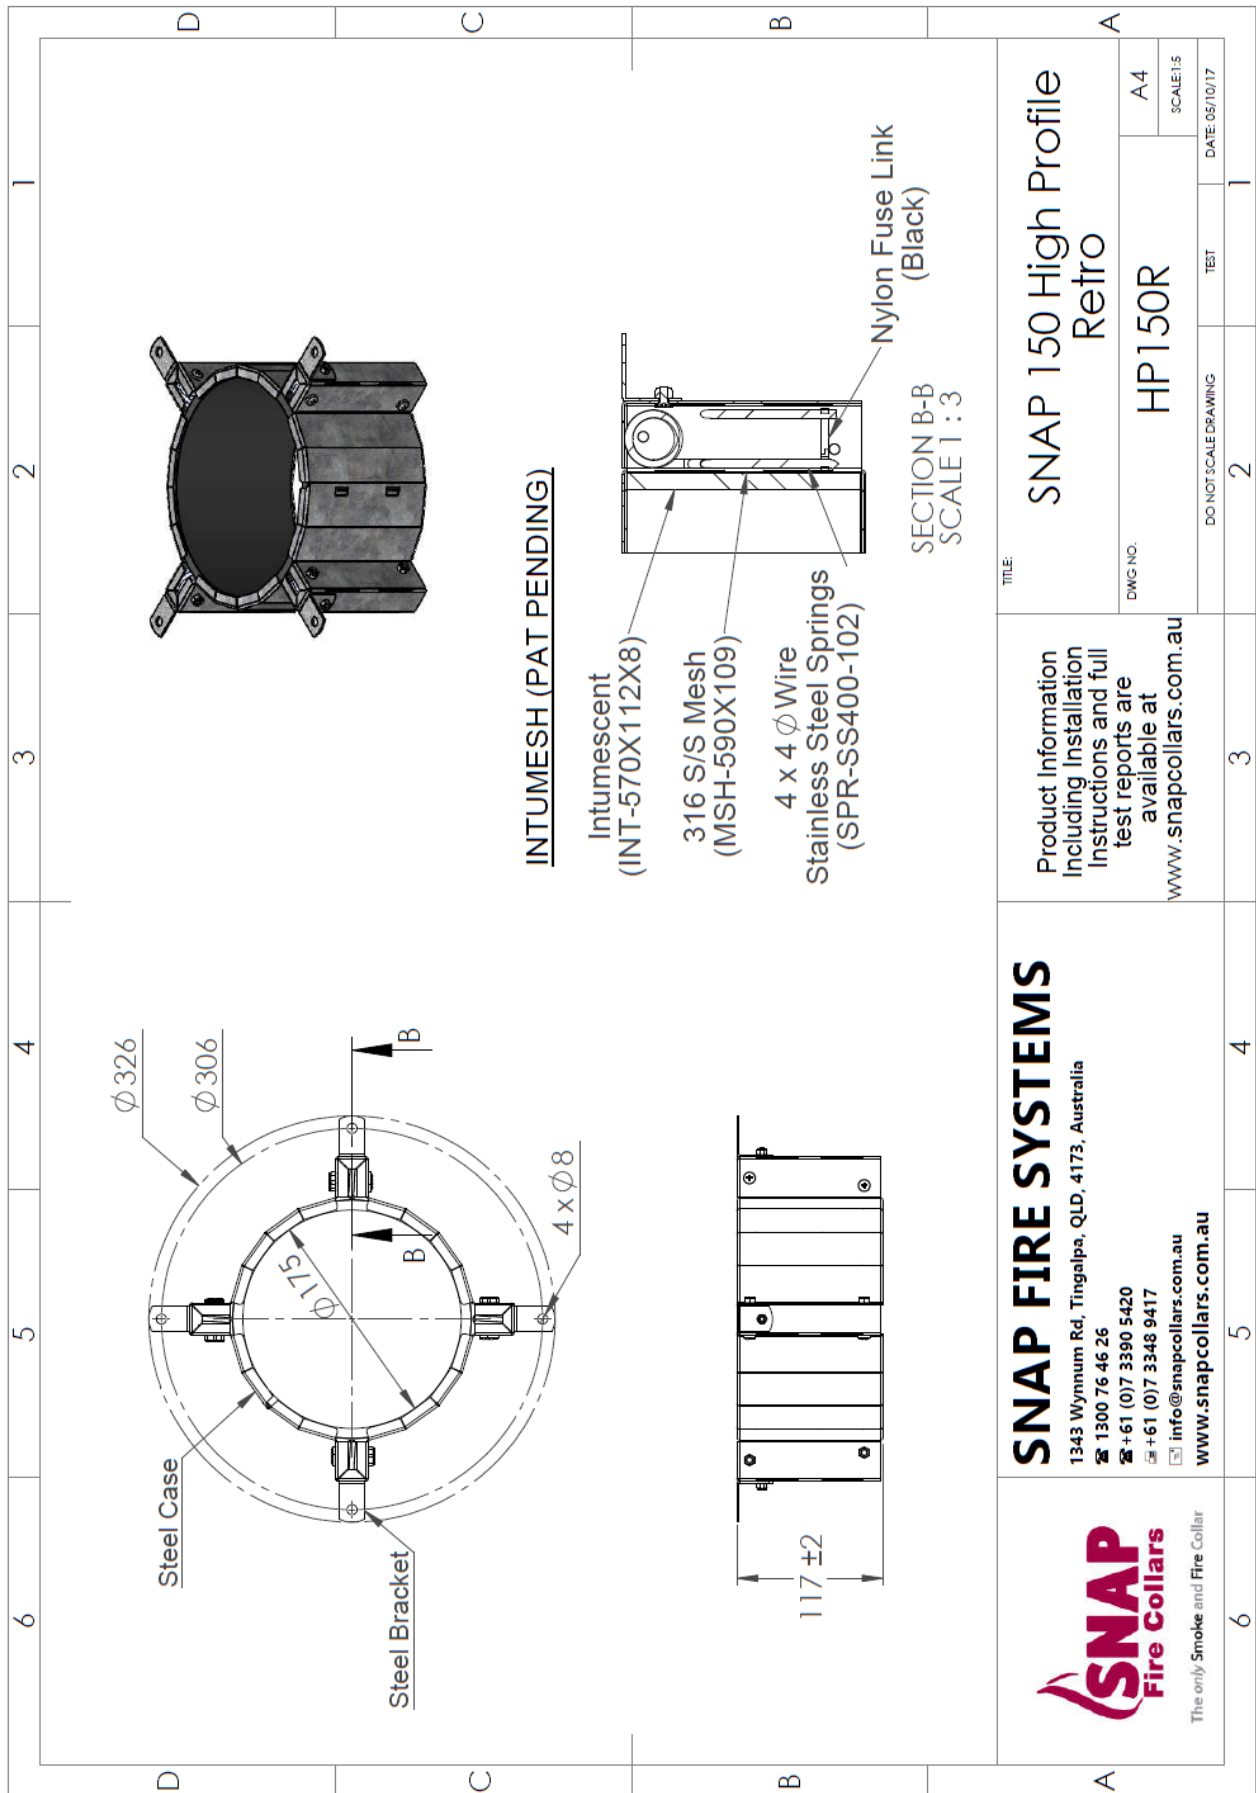
DRAWING 'SNAP 150 HIGH PROFILE RETRO', DATED 5 OCTOBER 2017, BY SNAP FIRE SYSTEMS PTY LTD
