# Fire-resistance test on fire collars protecting a concrete slab penetrated by services

## Test Report

**Author:** Peter Gordon  
**Report number:** FSP 2203  
**Date:** 13 October 2021

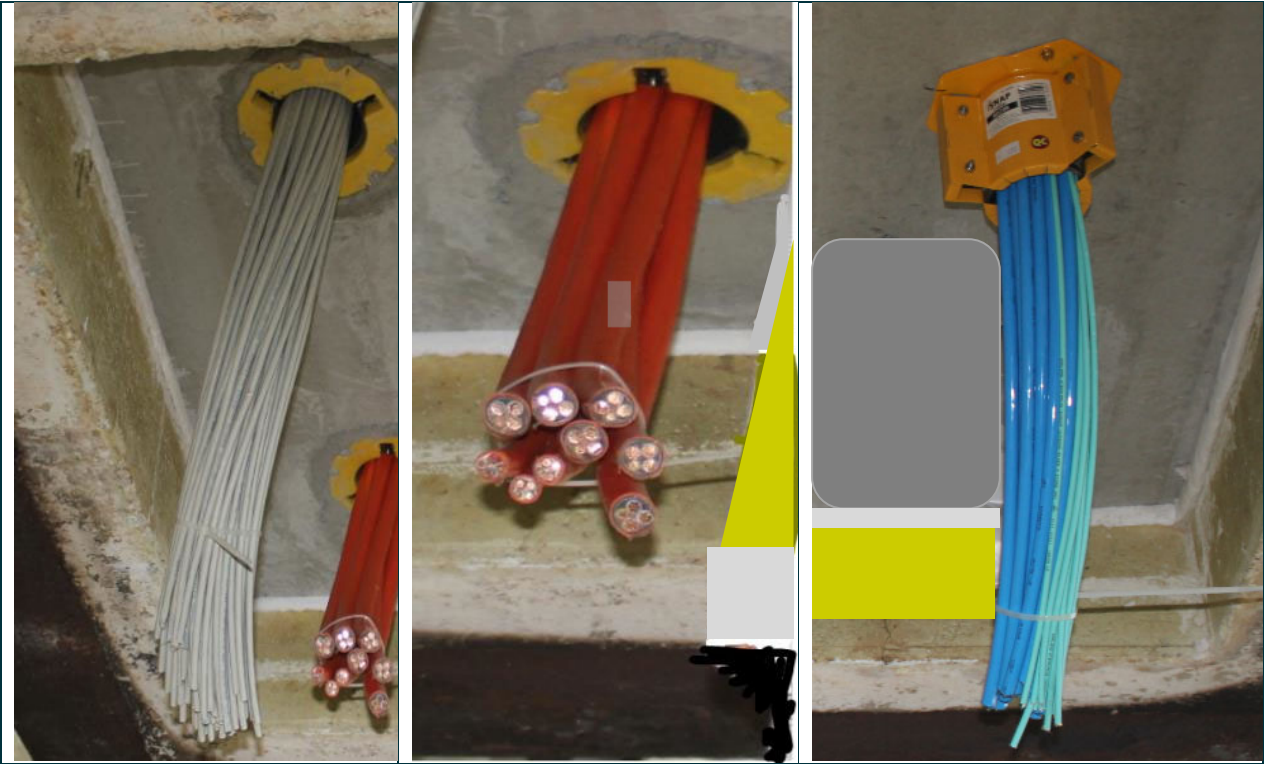
PHOTOGRAPH 1 – EXPOSED FACE OF SPECIMEN 1, 2, AND 5 PRIOR TO TESTING

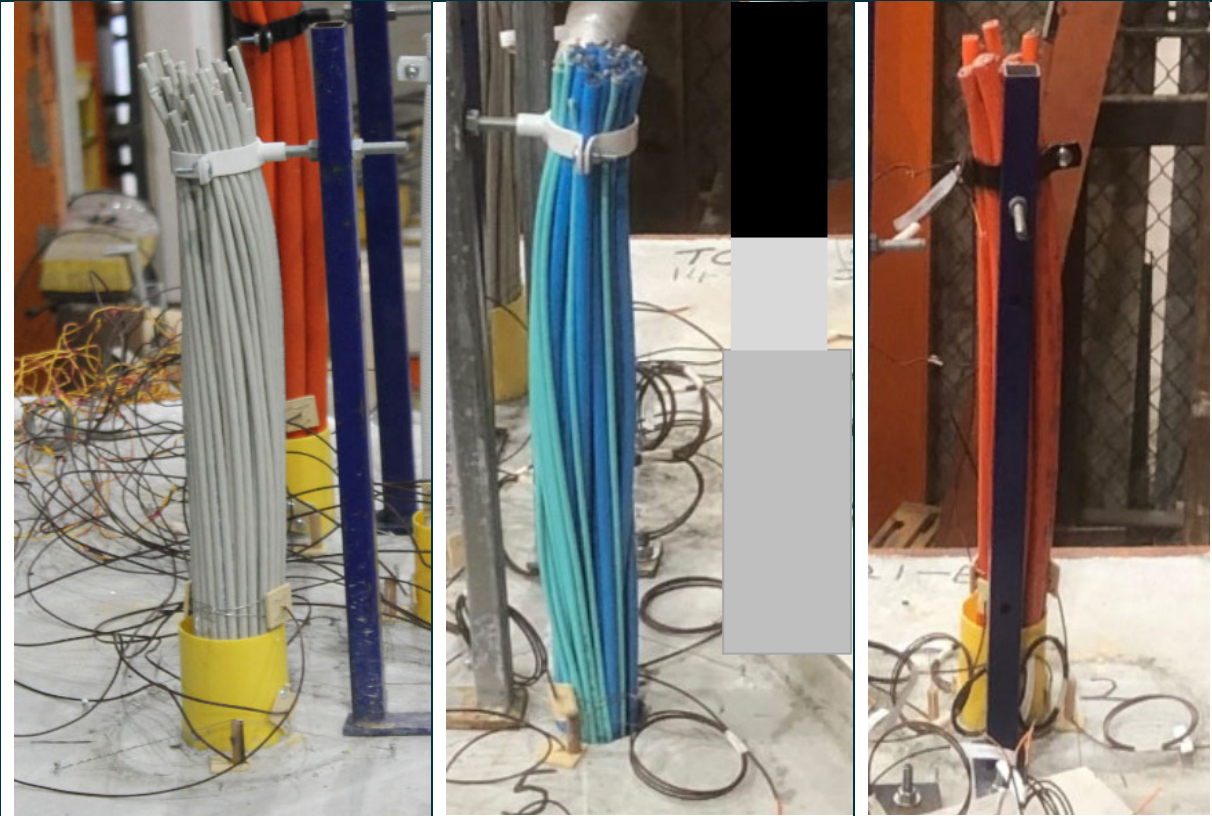
PHOTOGRAPH 2 – UNEXPOSED FACE OF SPECIMEN 1, 2, AND 5 PRIOR TO TESTING

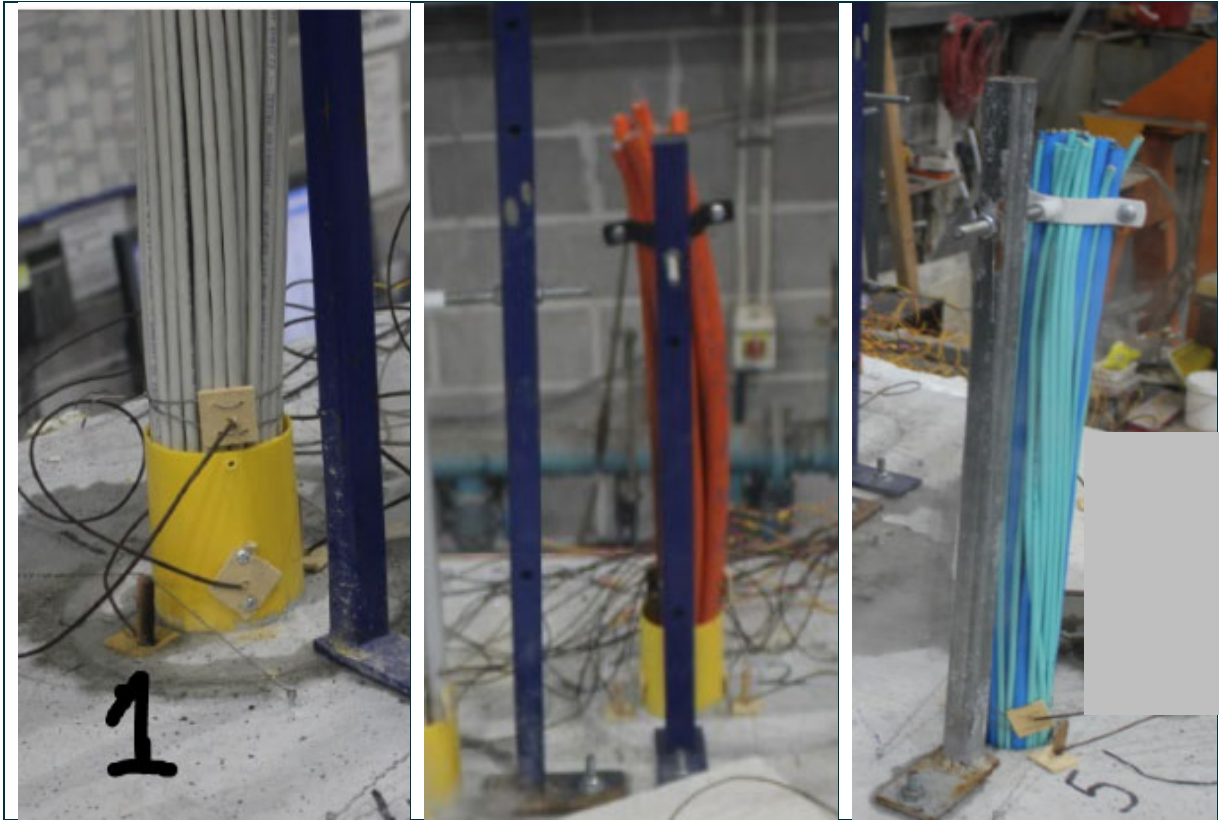
**PHOTOGRAPH 3 – SPECIMENS 1, 2 AND 5 AT 30 MINUTES INTO THE TEST**

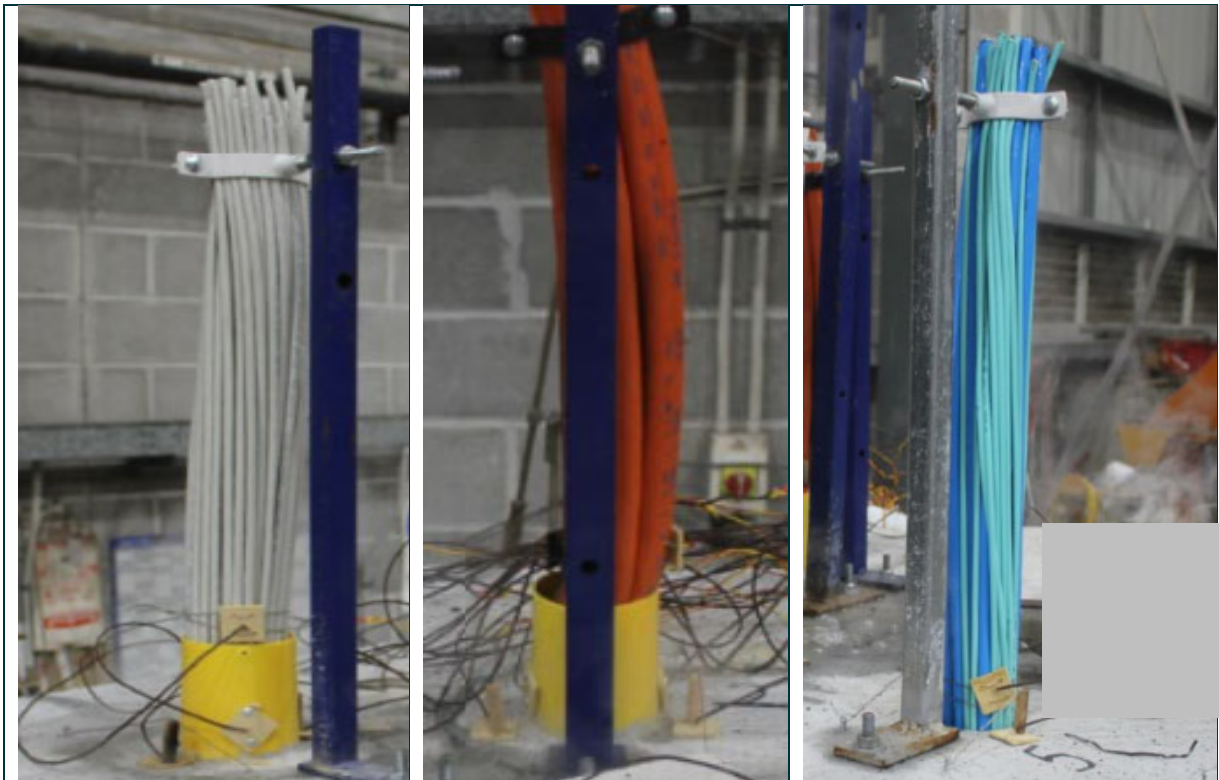
**PHOTOGRAPH 4 – SPECIMENS 1, 2 AND 5 AT 60 MINUTES INTO THE TEST**

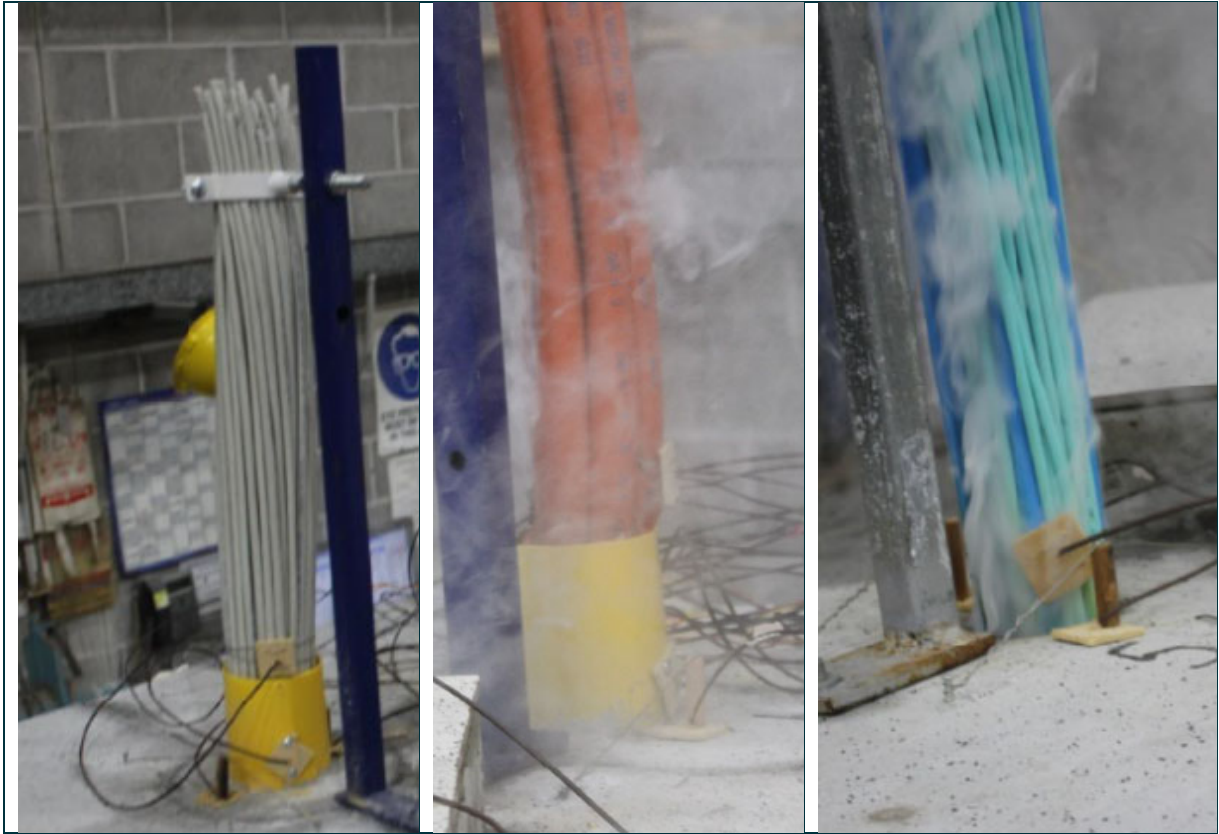
**PHOTOGRAPH 5 – SPECIMENS 1, 2 AND 5 AT 90 MINUTES INTO THE TEST**

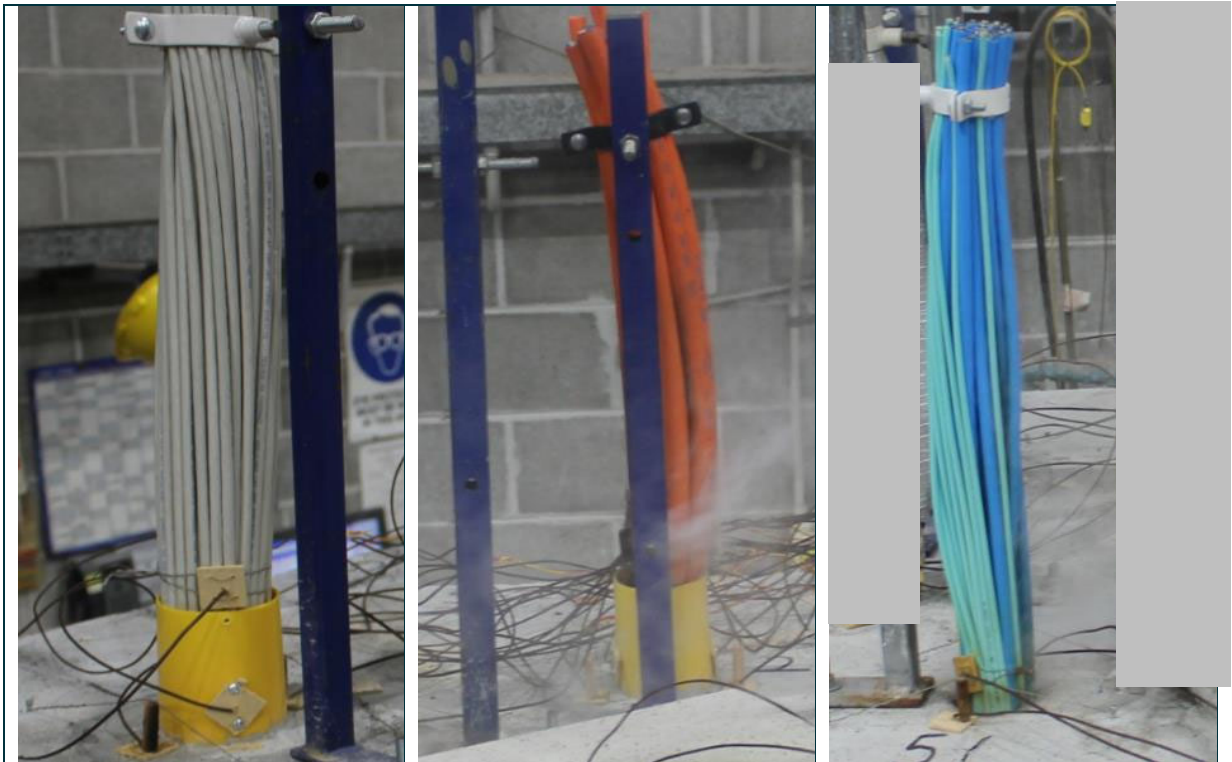
**PHOTOGRAPH 6 – SPECIMENS 1, 2 AND 5 AT 120 MINUTES INTO THE TEST**

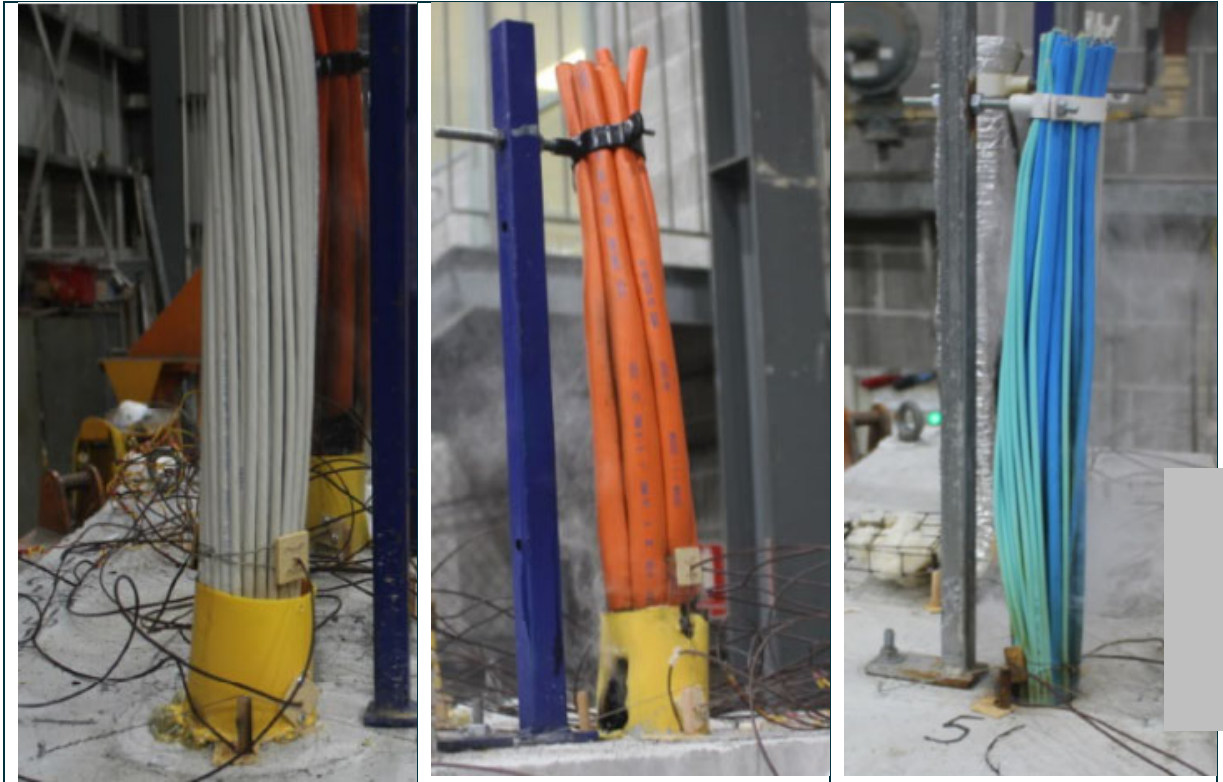
**PHOTOGRAPH 7 – SPECIMENS 1, 2 AND 5 AT 180 MINUTES INTO THE TEST**

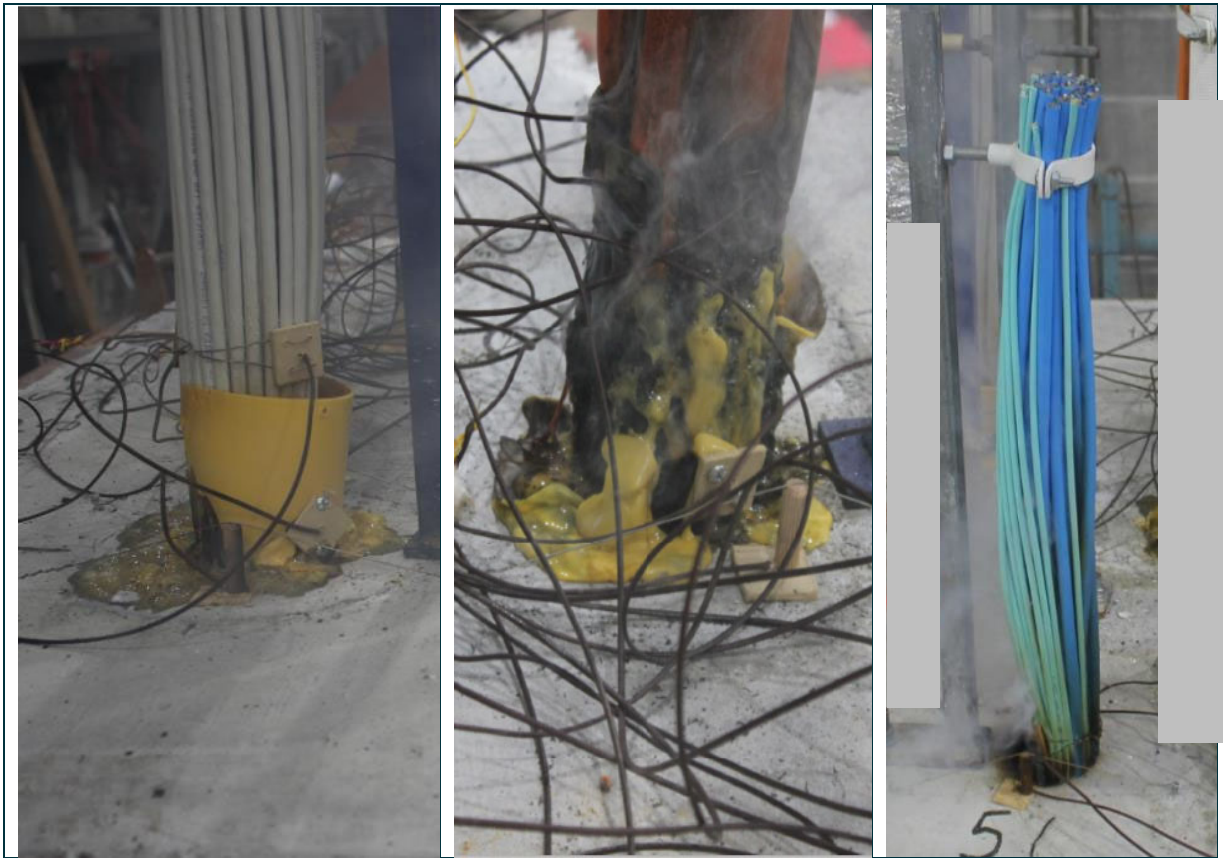
**PHOTOGRAPH 8 – SPECIMENS 2 AND 5 AT 240 MINUTES INTO THE TEST**

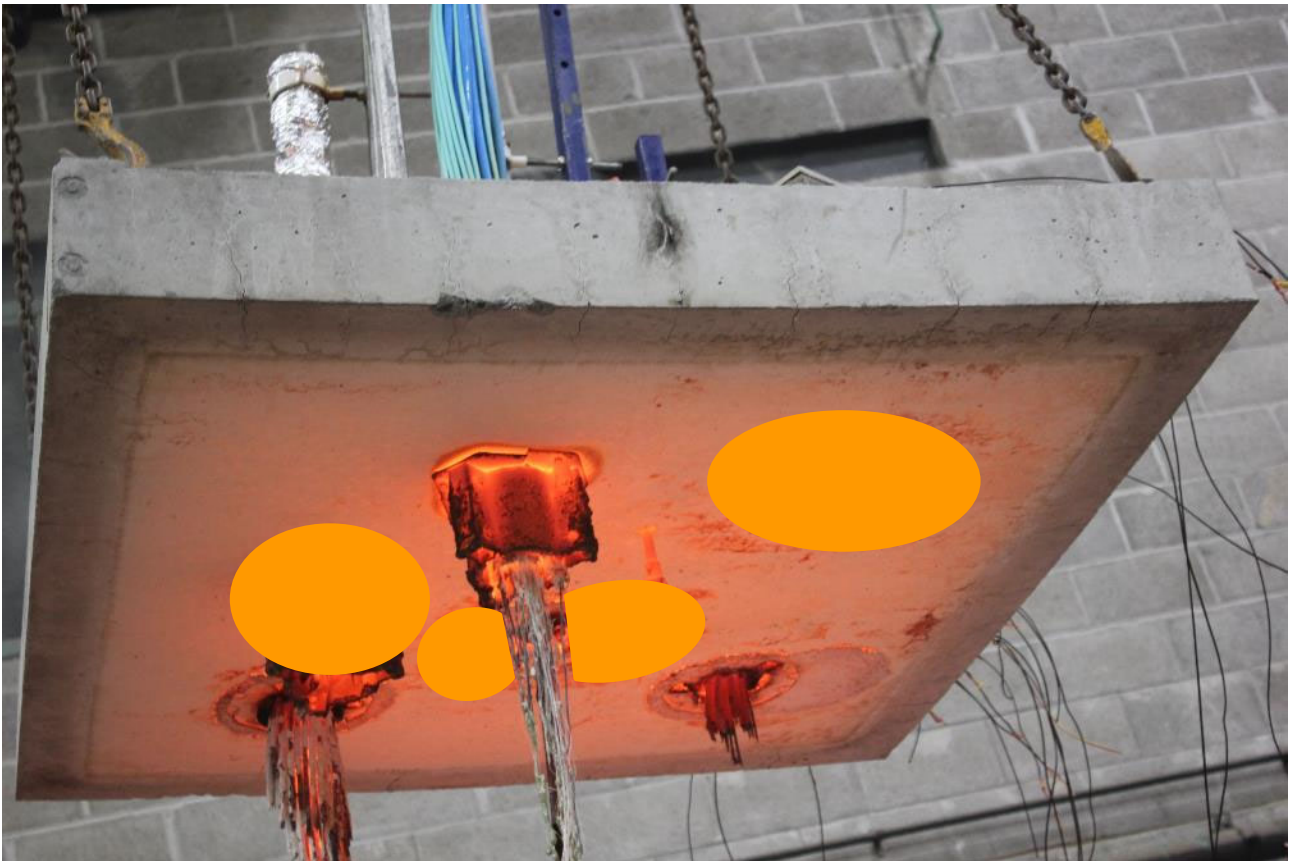
**PHOTOGRAPH 9 – EXPOSED FACE OF SPECIMENS AT THE CONCLUSION OF TESTING**

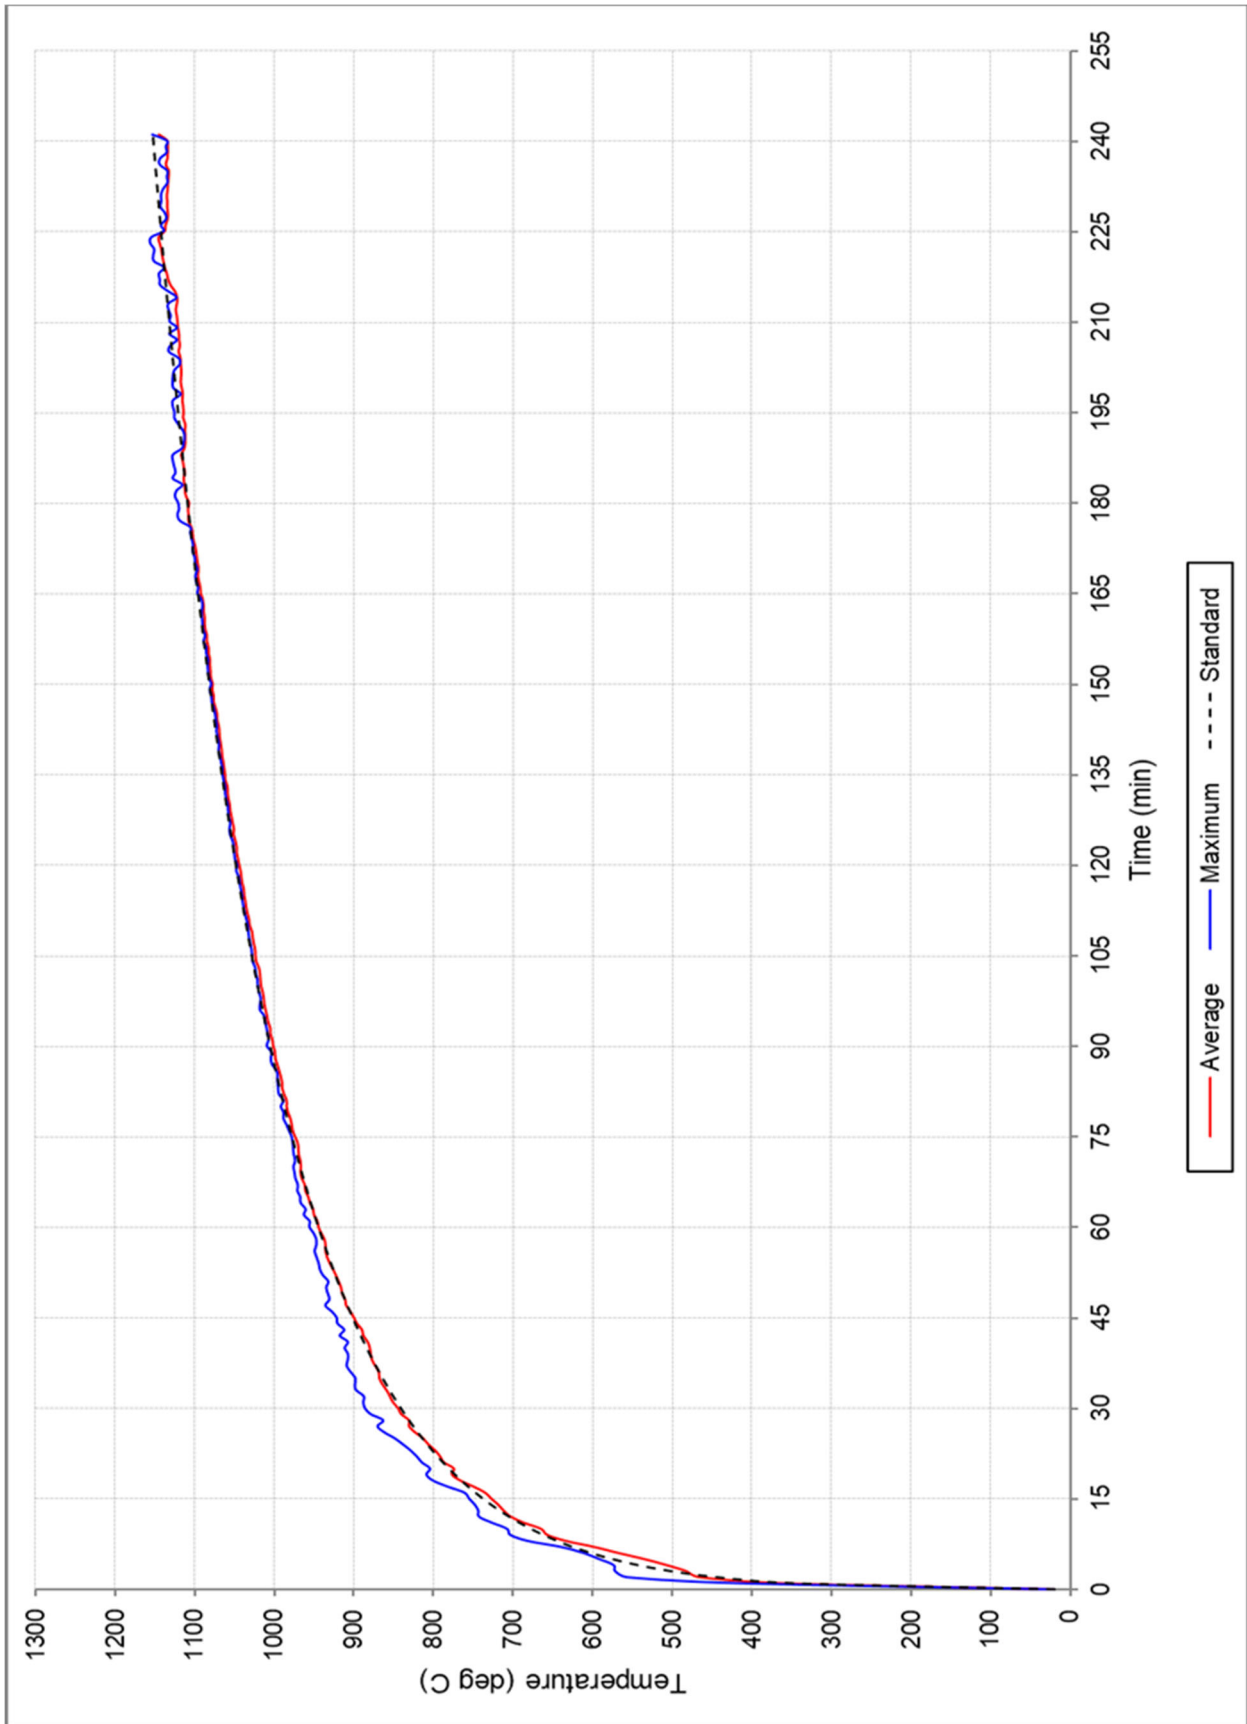
FIGURE 1 – FURNACE TEMPERATURE

Figure 1 shows the standard curves of temperature versus time for heating the furnace chamber and the actual curves of average and maximum temperature versus time recorded during the heating period.

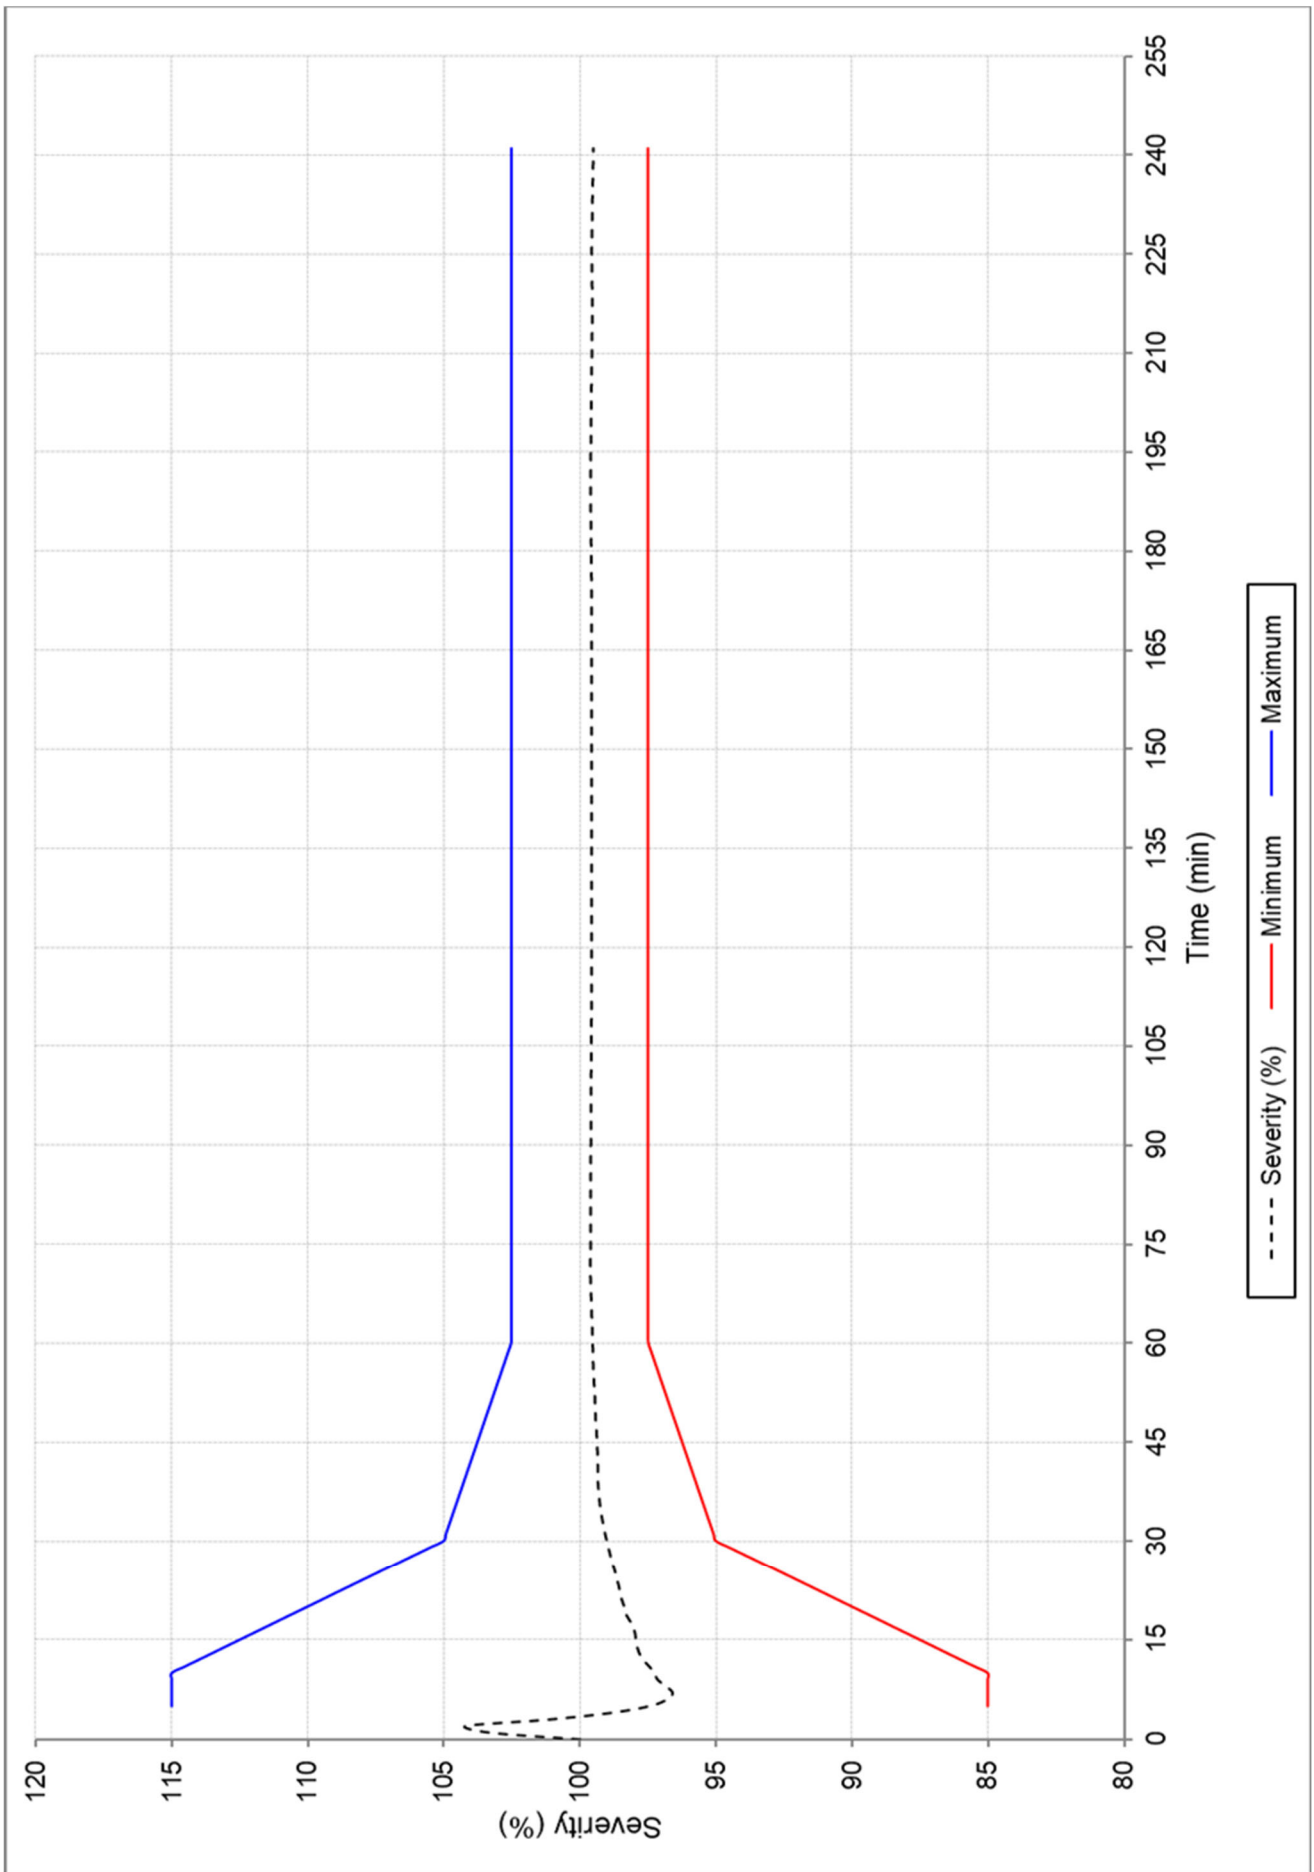
FIGURE 2 – FURNACE SEVERITY

Figure 2 shows the curve of furnace severity versus time during the heating period.

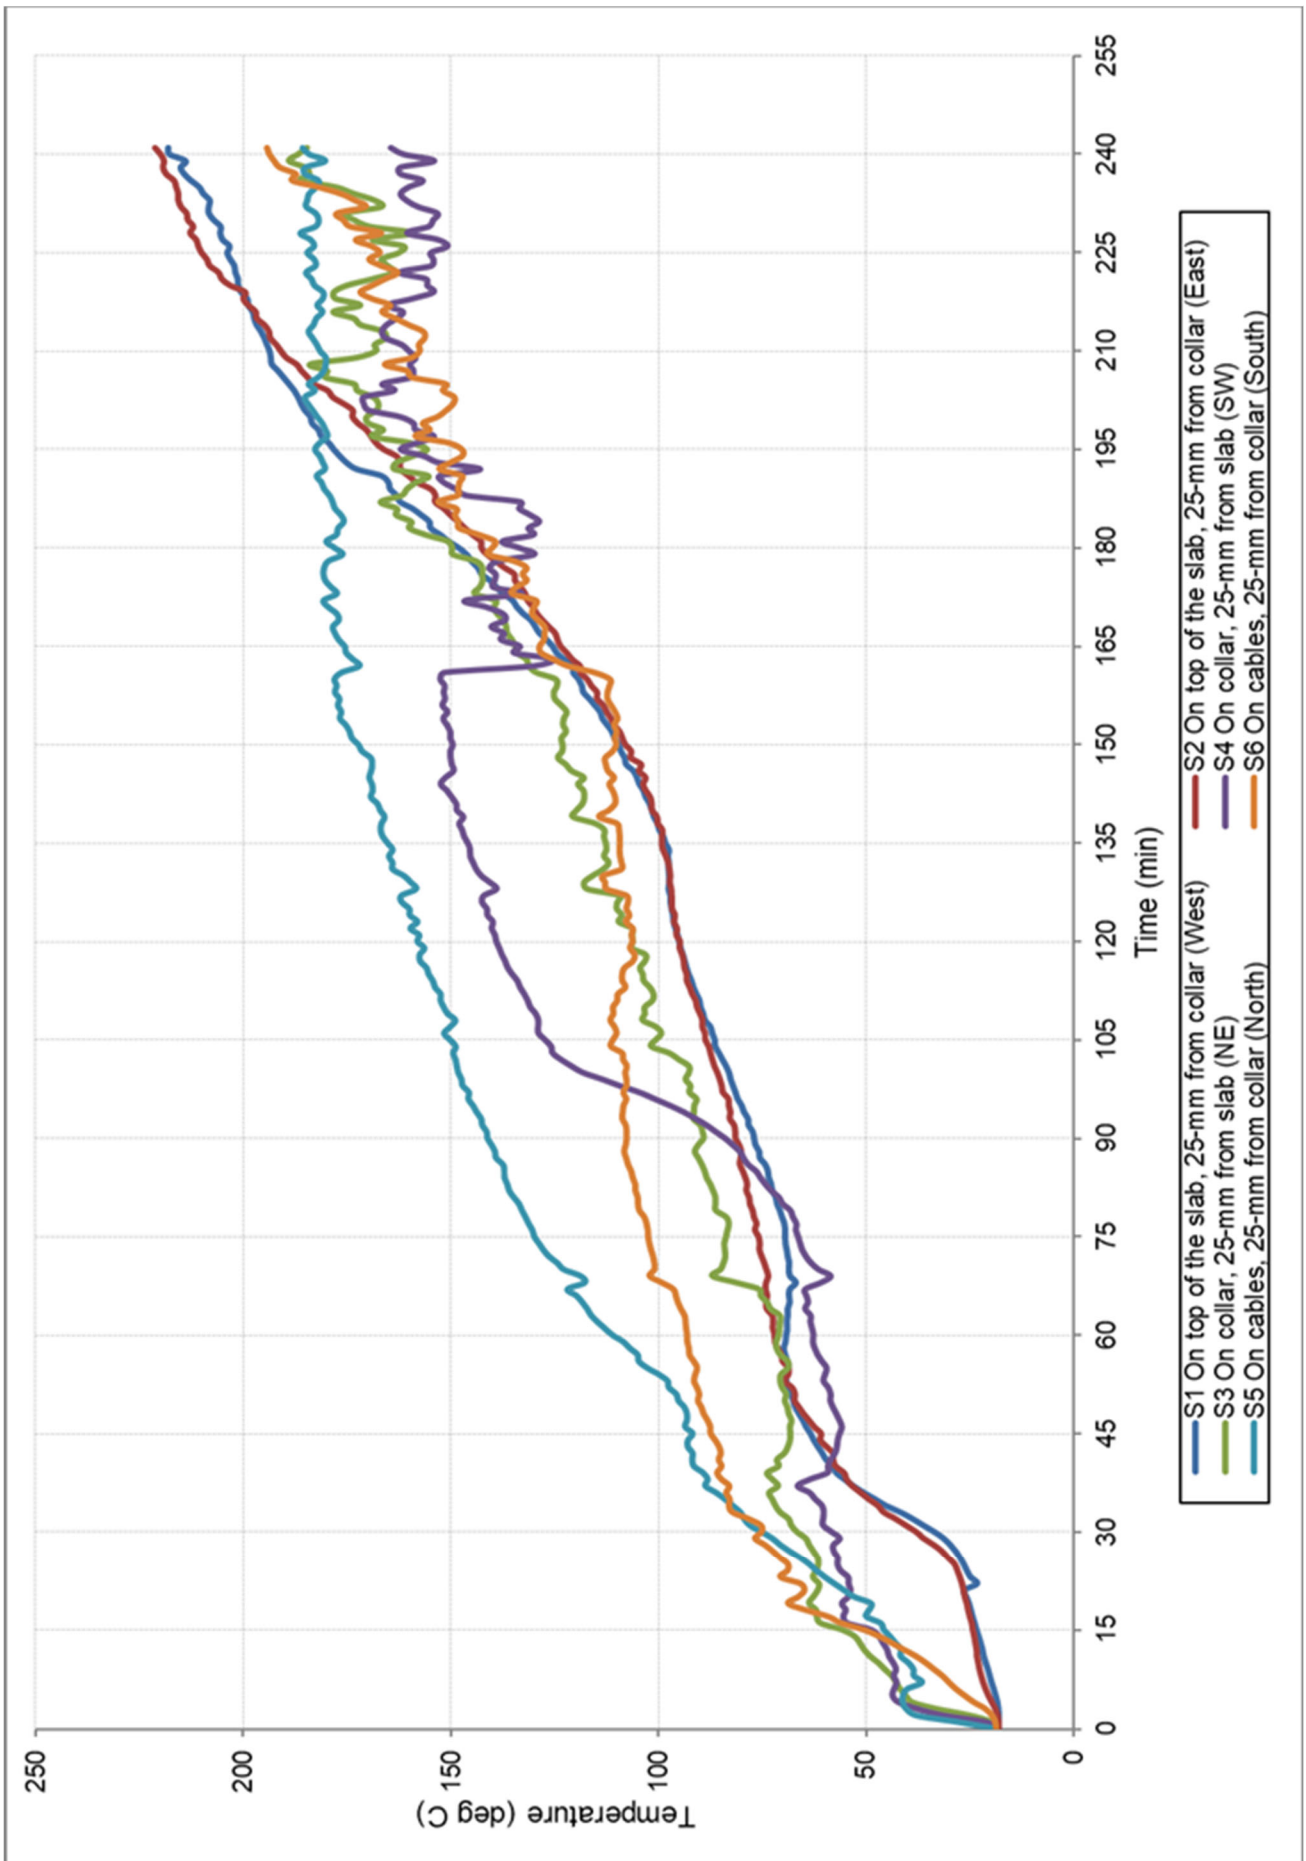
FIGURE 3 – SPECIMEN TEMPERATURE – ASSOCIATED WITH SPECIMEN 1

Figure 3 shows the curve of temperature versus time associated with Specimen 1.

Structural adequacy	-	not applicable
Integrity	-	no failure at 241 minutes
Insulation	-	217 minutes

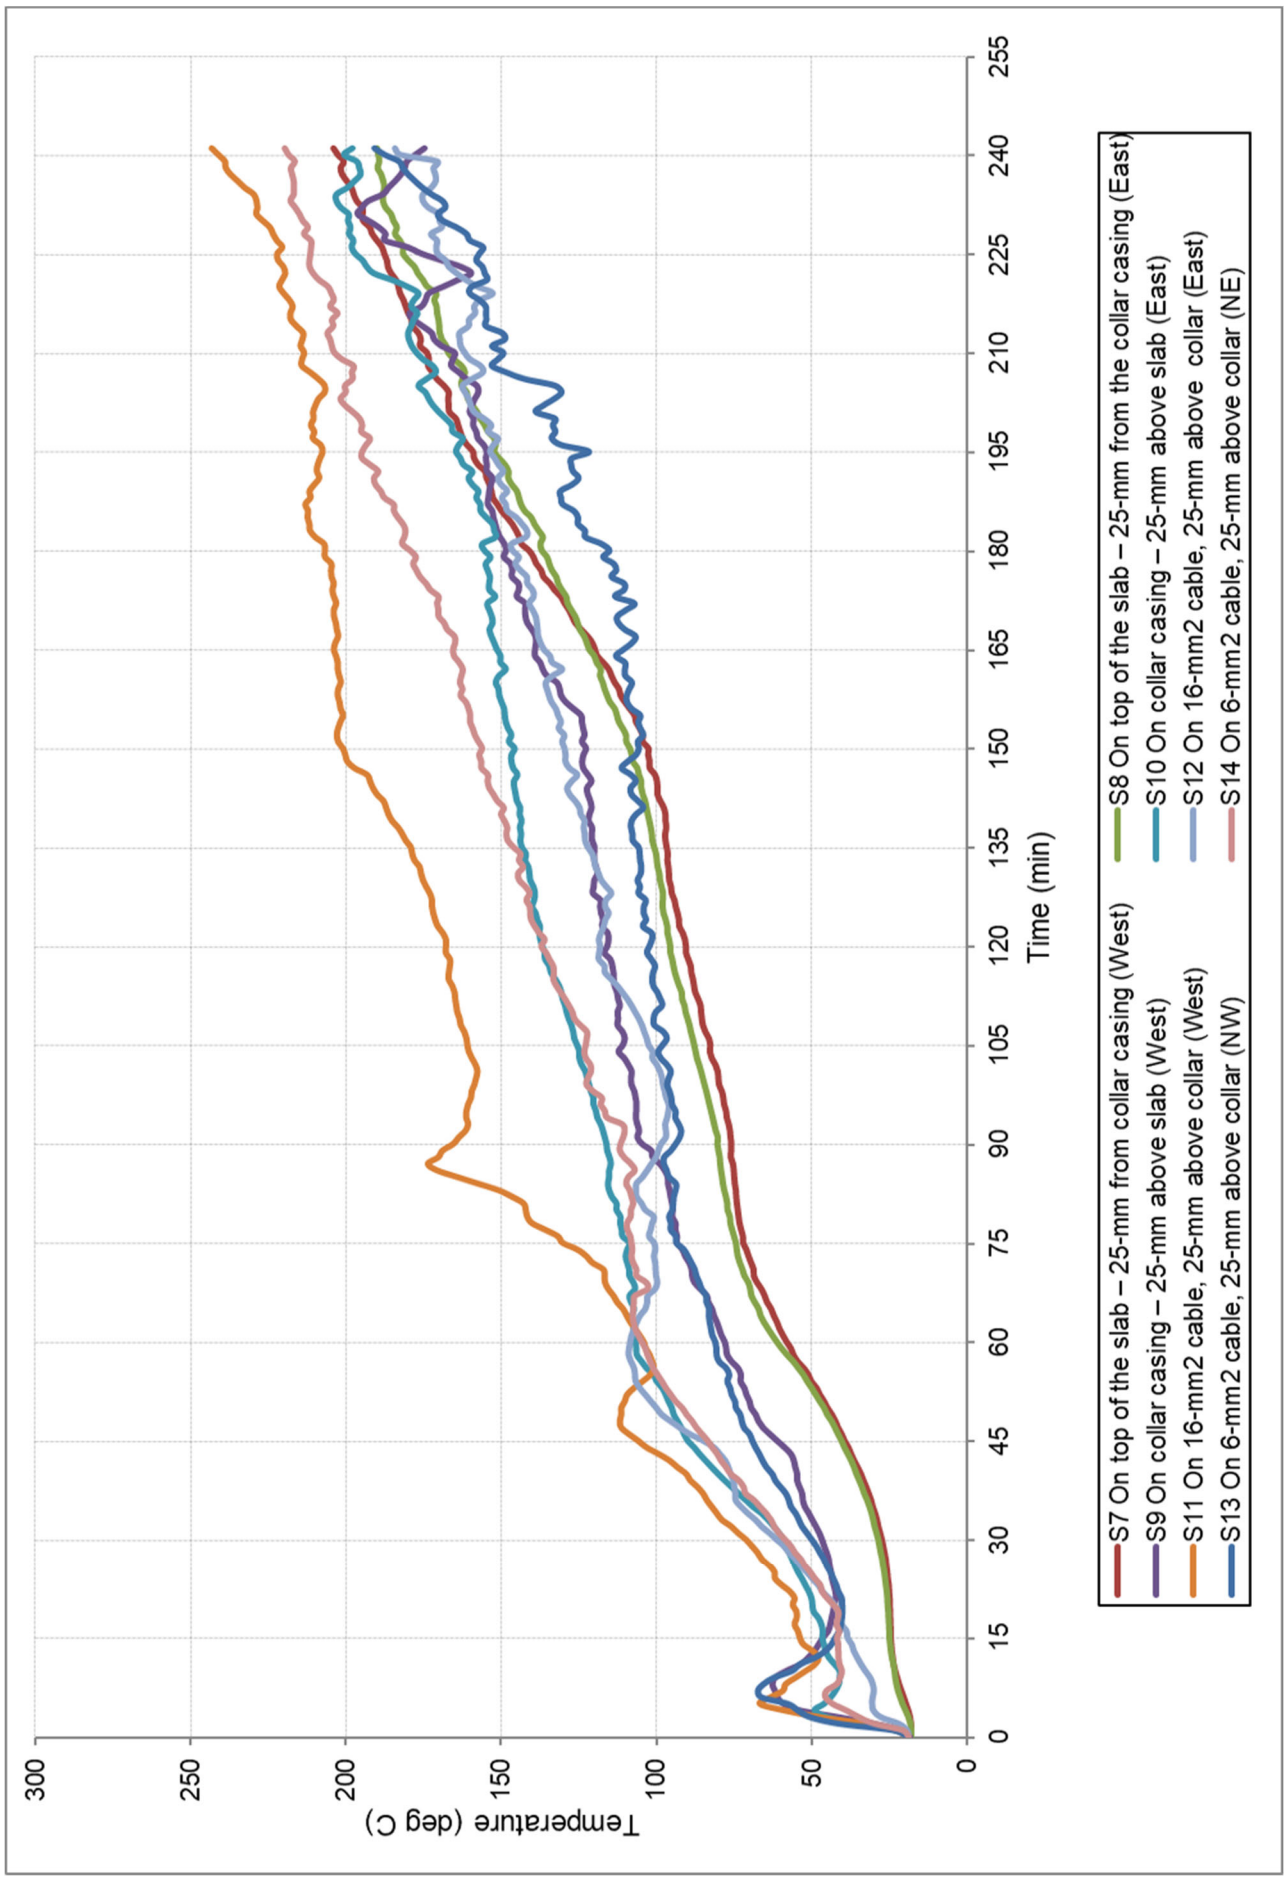
FIGURE 4 – SPECIMEN TEMPERATURE – ASSOCIATED WITH SPECIMEN 2

Figure 4 shows the curve of temperature versus time associated with Specimen 2.

Structural adequacy	-	not applicable
Integrity	-	no failure at 241 minutes
Insulation	-	148 minutes

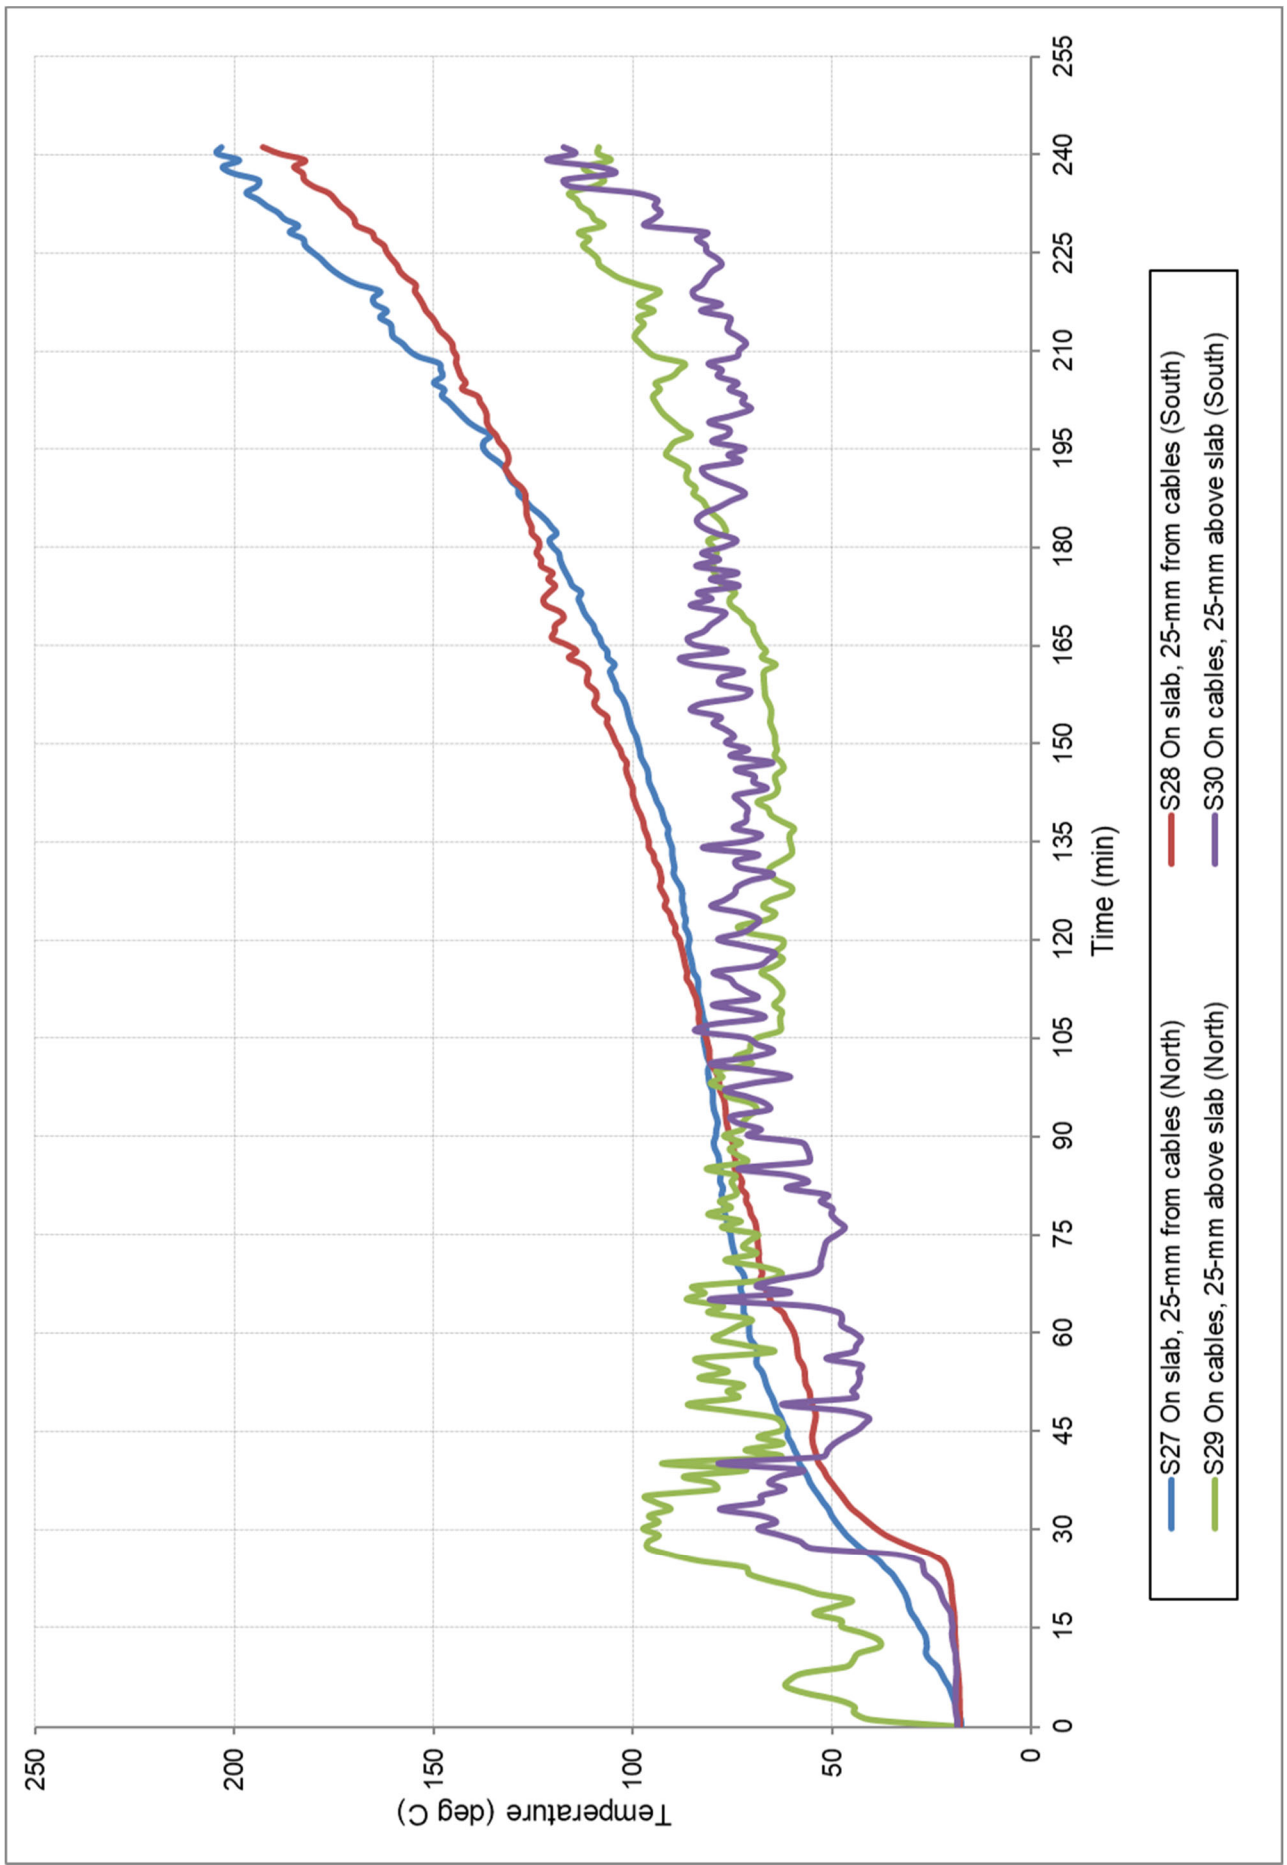
FIGURE 5 – SPECIMEN TEMPERATURE – ASSOCIATED WITH SPECIMEN 5

Figure 5 shows the curve of temperature versus time associated with Specimen 5.

Structural adequacy	-	not applicable
Integrity	-	no failure at 241 minutes
Insulation	-	237 minutes

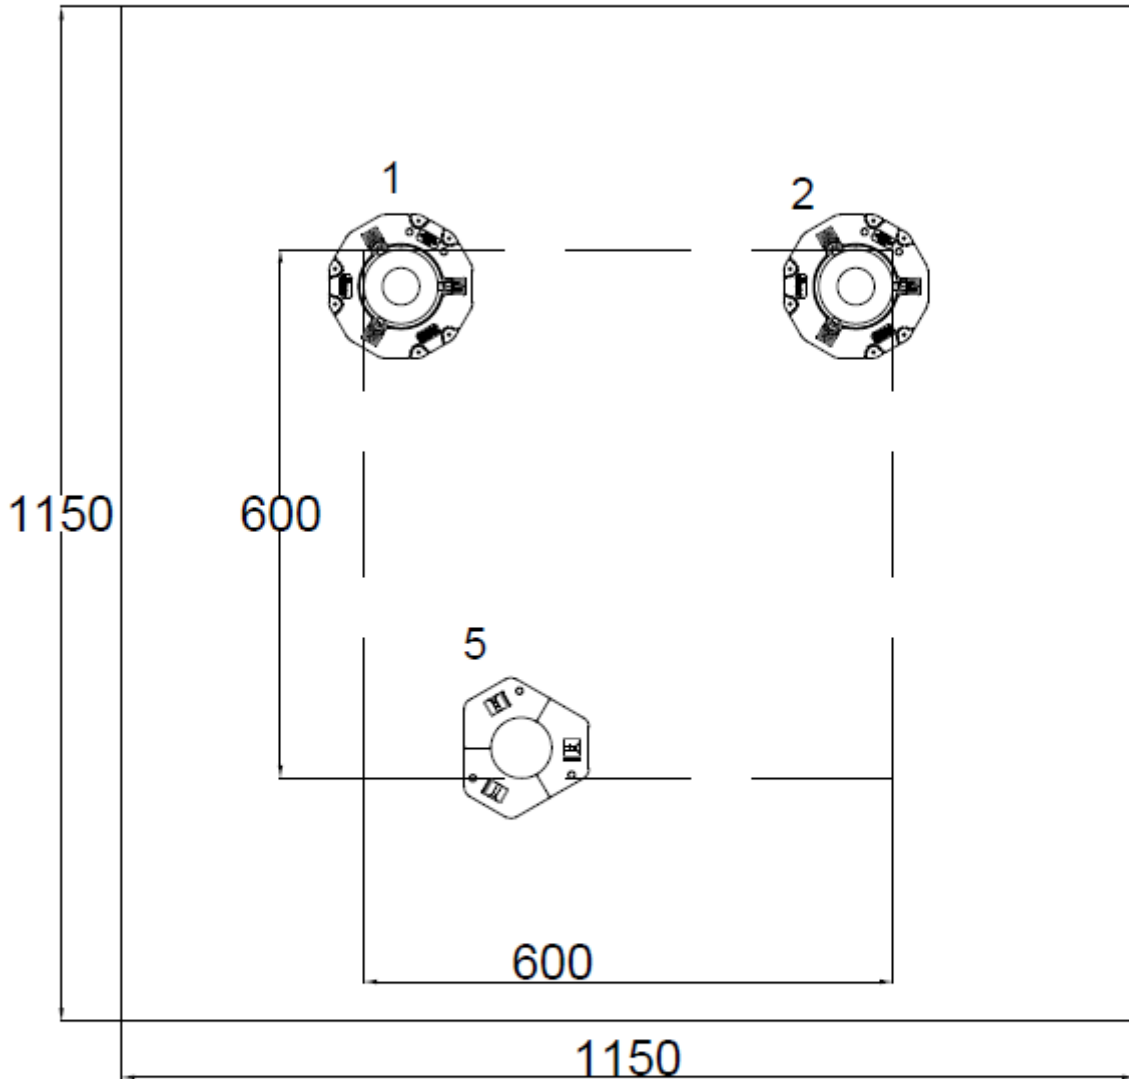
Penetration	Collar Code	Pipe Type	Pipe Diameter
1	MS70C	Cat7 Cables	80x7mm
2	MS70C	Orange Power Cables	3x(6mm <sup>2</sup> 3C+E), 6x(16mm <sup>2</sup> 3C+E)
5	MS70R	Optical Fibre Bundle	20x11mm & 10x5mm

**DRAWING TITLED 'TEST SLAB S-21-B LAYOUT', DATED 17 MAY 2021, BY SNAP FIRE SYSTEMS PTY LTD**
