# Fire-resistance test on fire collars protecting a concrete slab penetrated by services

## Test Report

**Author:** Peter Gordon  
**Report number:** FSP 2203  
**Date:** 13 October 2021

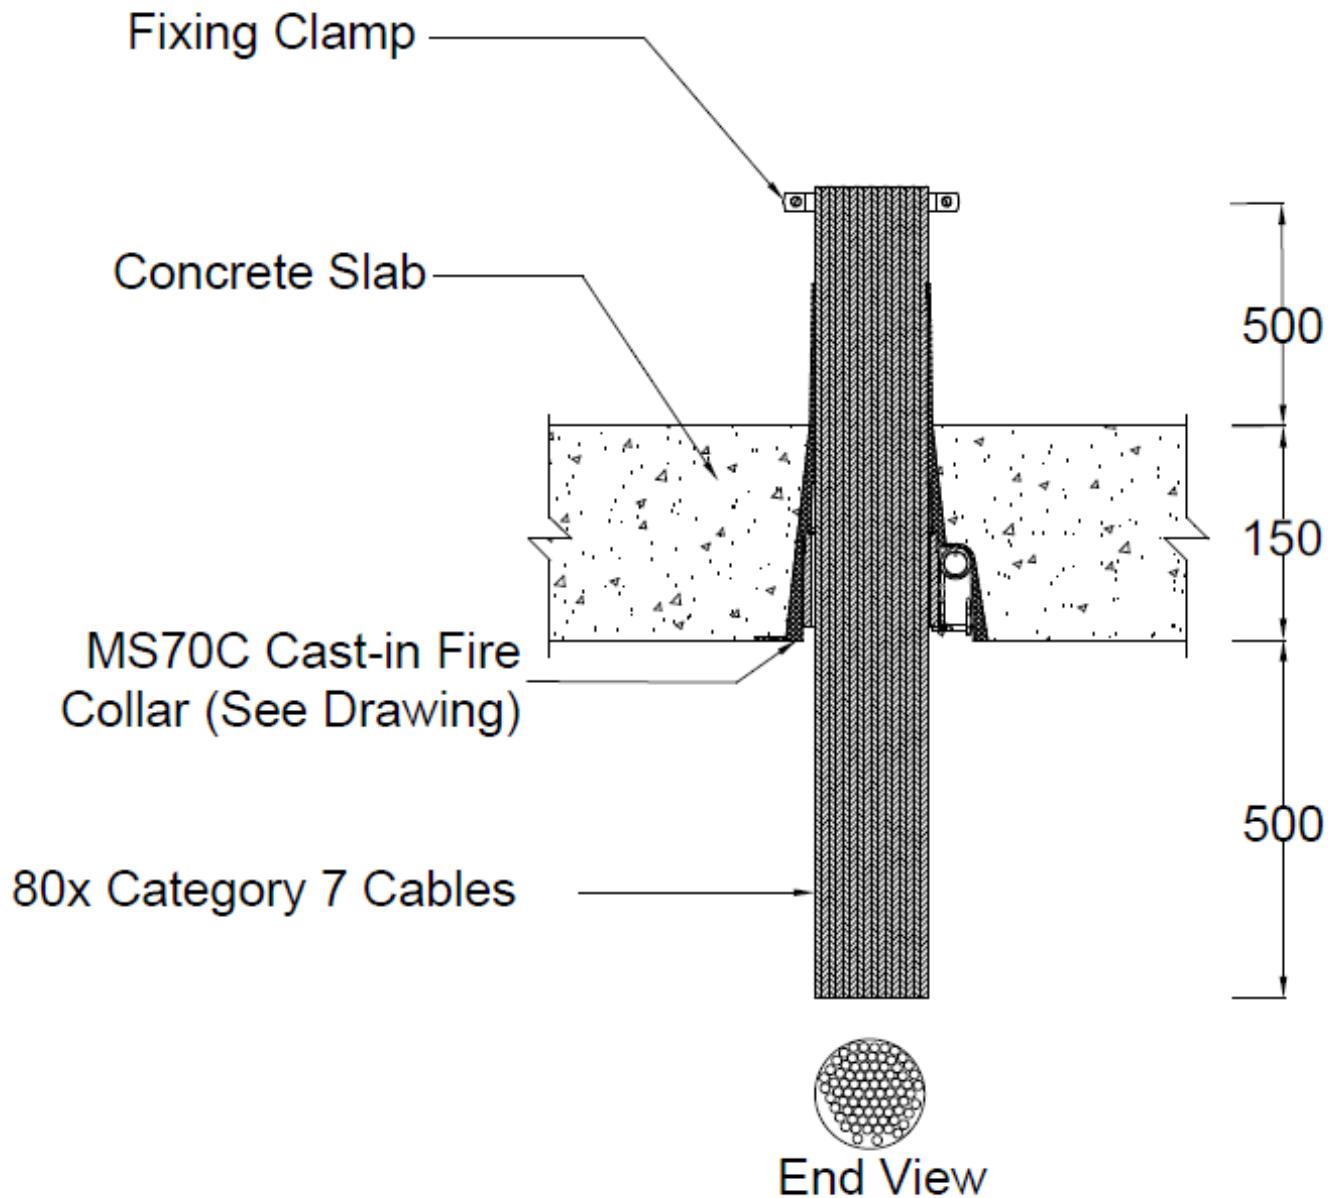
100% Full of Cat7 Cables & MS70C

DRAWING TITLED 'SPECIMEN #1 100% FULL CAT 7 CABLES & MS70C & UL100FWS', DATED 17 MAY 2021, BY SNAP FIRE SYSTEMS PTY LTD

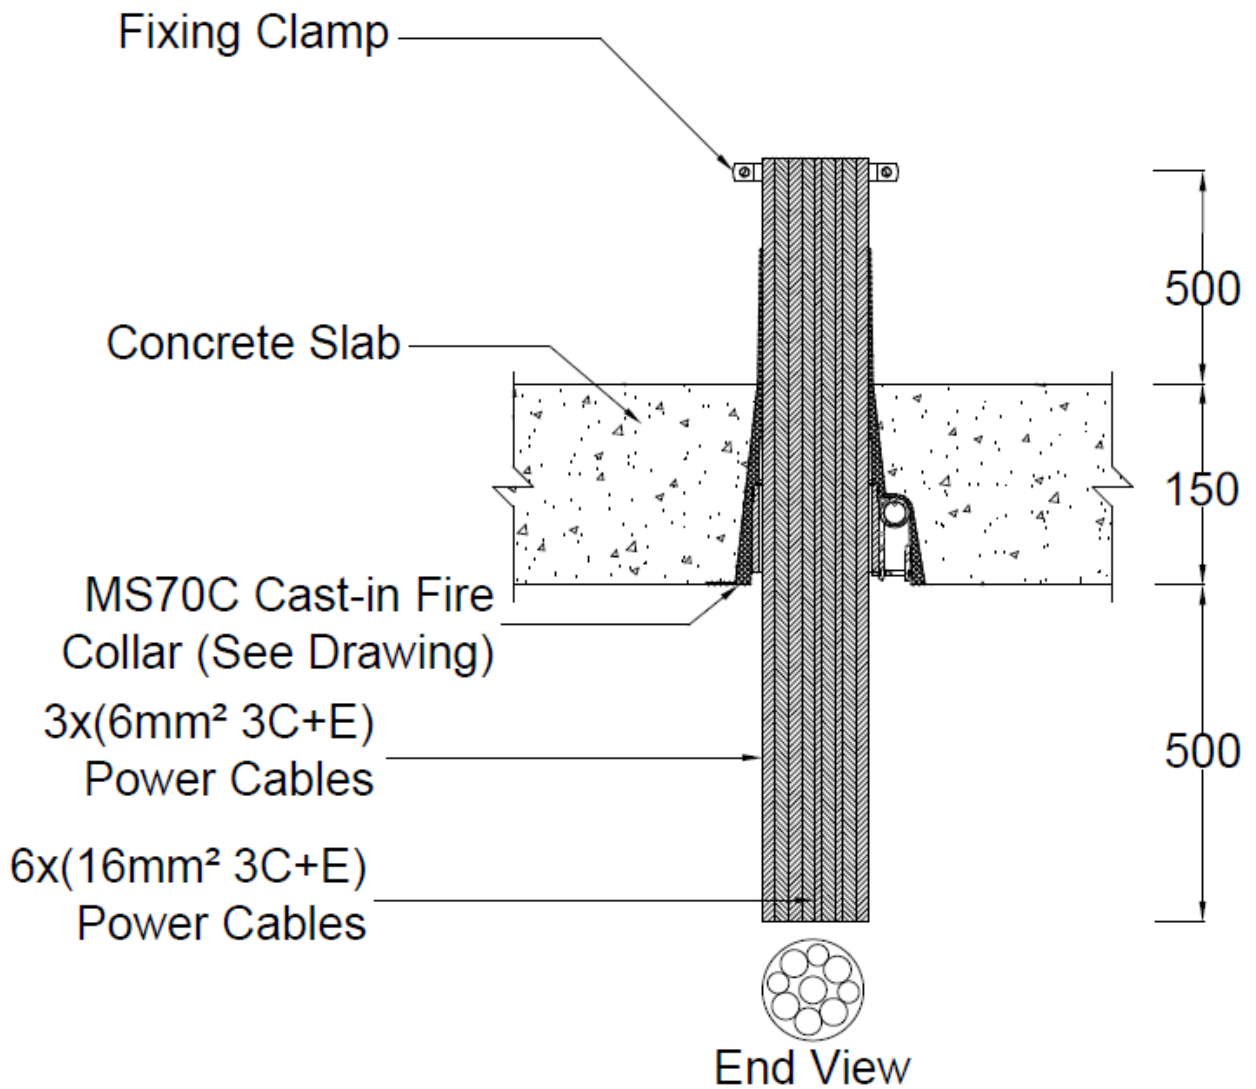
16mm<sup>2</sup> 3C+E & 6mm<sup>2</sup> 3C+E Power Cables &  
MS70C

DRAWING TITLED 'SPECIMEN #2 16MM<sup>2</sup> 3C+E & 6-MM<sup>2</sup> 3C+E POWER CABLES & MS70C', DATED 6 APRIL 2021,  
Y SNAP FIRE SYSTEMS PTY LTD

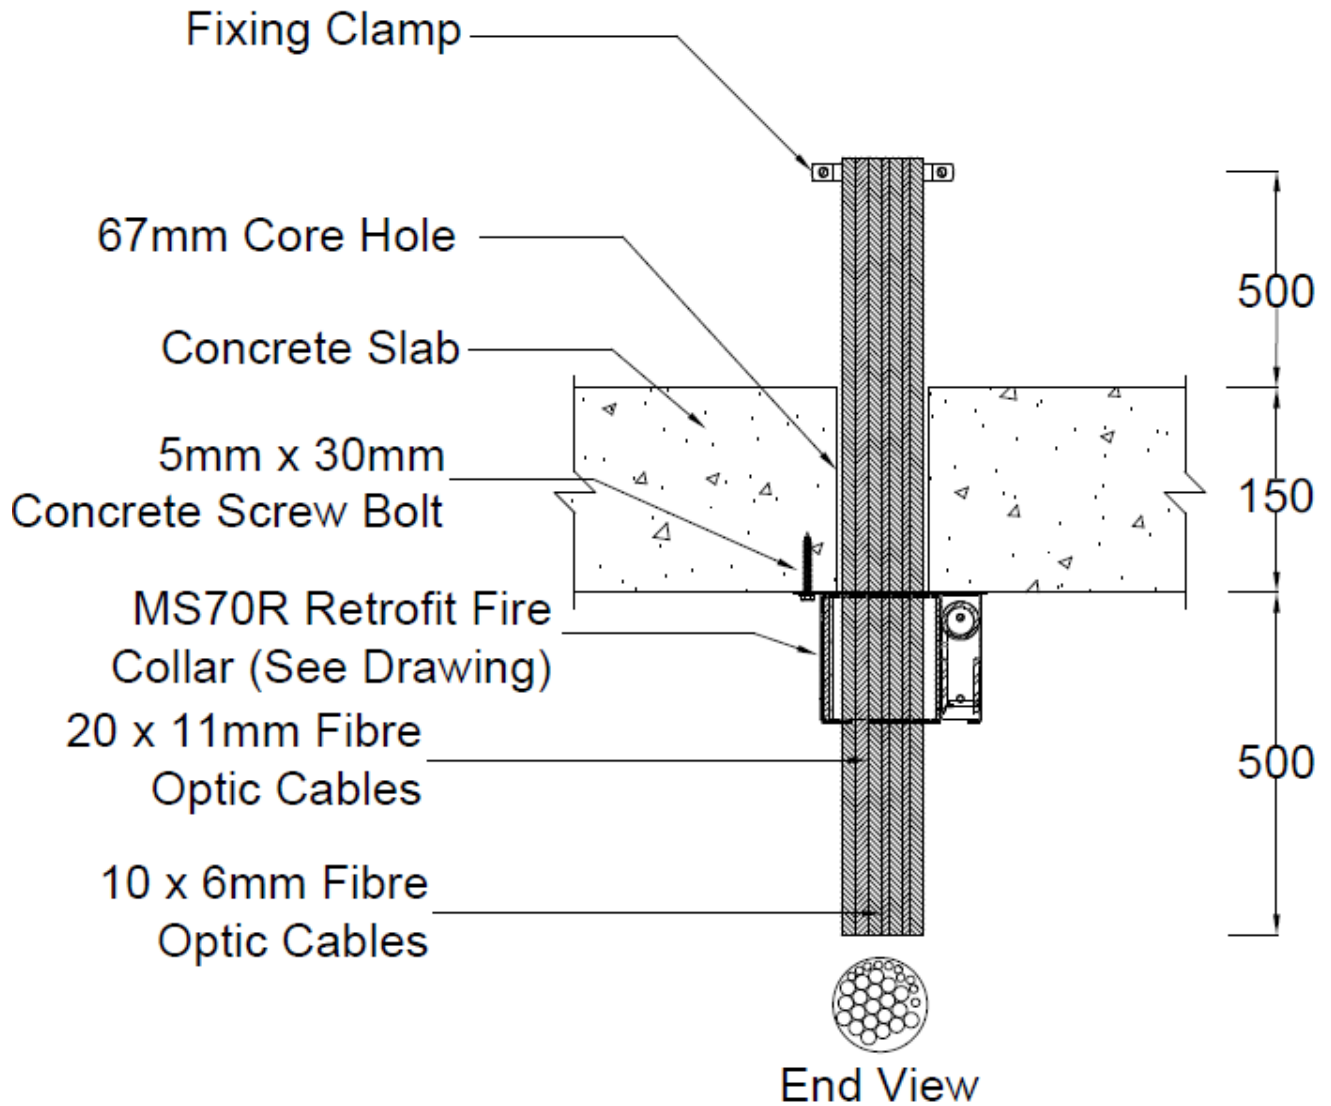
Fibre Optic Cables & MS70R

DRAWING TITLED 'SPECIMEN #5 FIBRE OPTICAL CABLES & MS70R', DATED 17 MAY 2021,  
BY SNAP FIRE SYSTEMS PTY LTD

On 6-mm <sup>2</sup> cable, 25-mm above collar (NE)	S14	
Specimen 5 – A SNAP MS70R Multi Service Retrofit fire collar protecting a bundle of Optic Fibre cables penetrating a 67-mm diameter aperture.	On slab, 25-mm from cables (North)	S27
	On slab, 25-mm from cables (South)	S28
	On cables, 25-mm above slab (North)	S29
	On cables, 25-mm above slab (South)	S30
Rover		S35
Ambient		S36

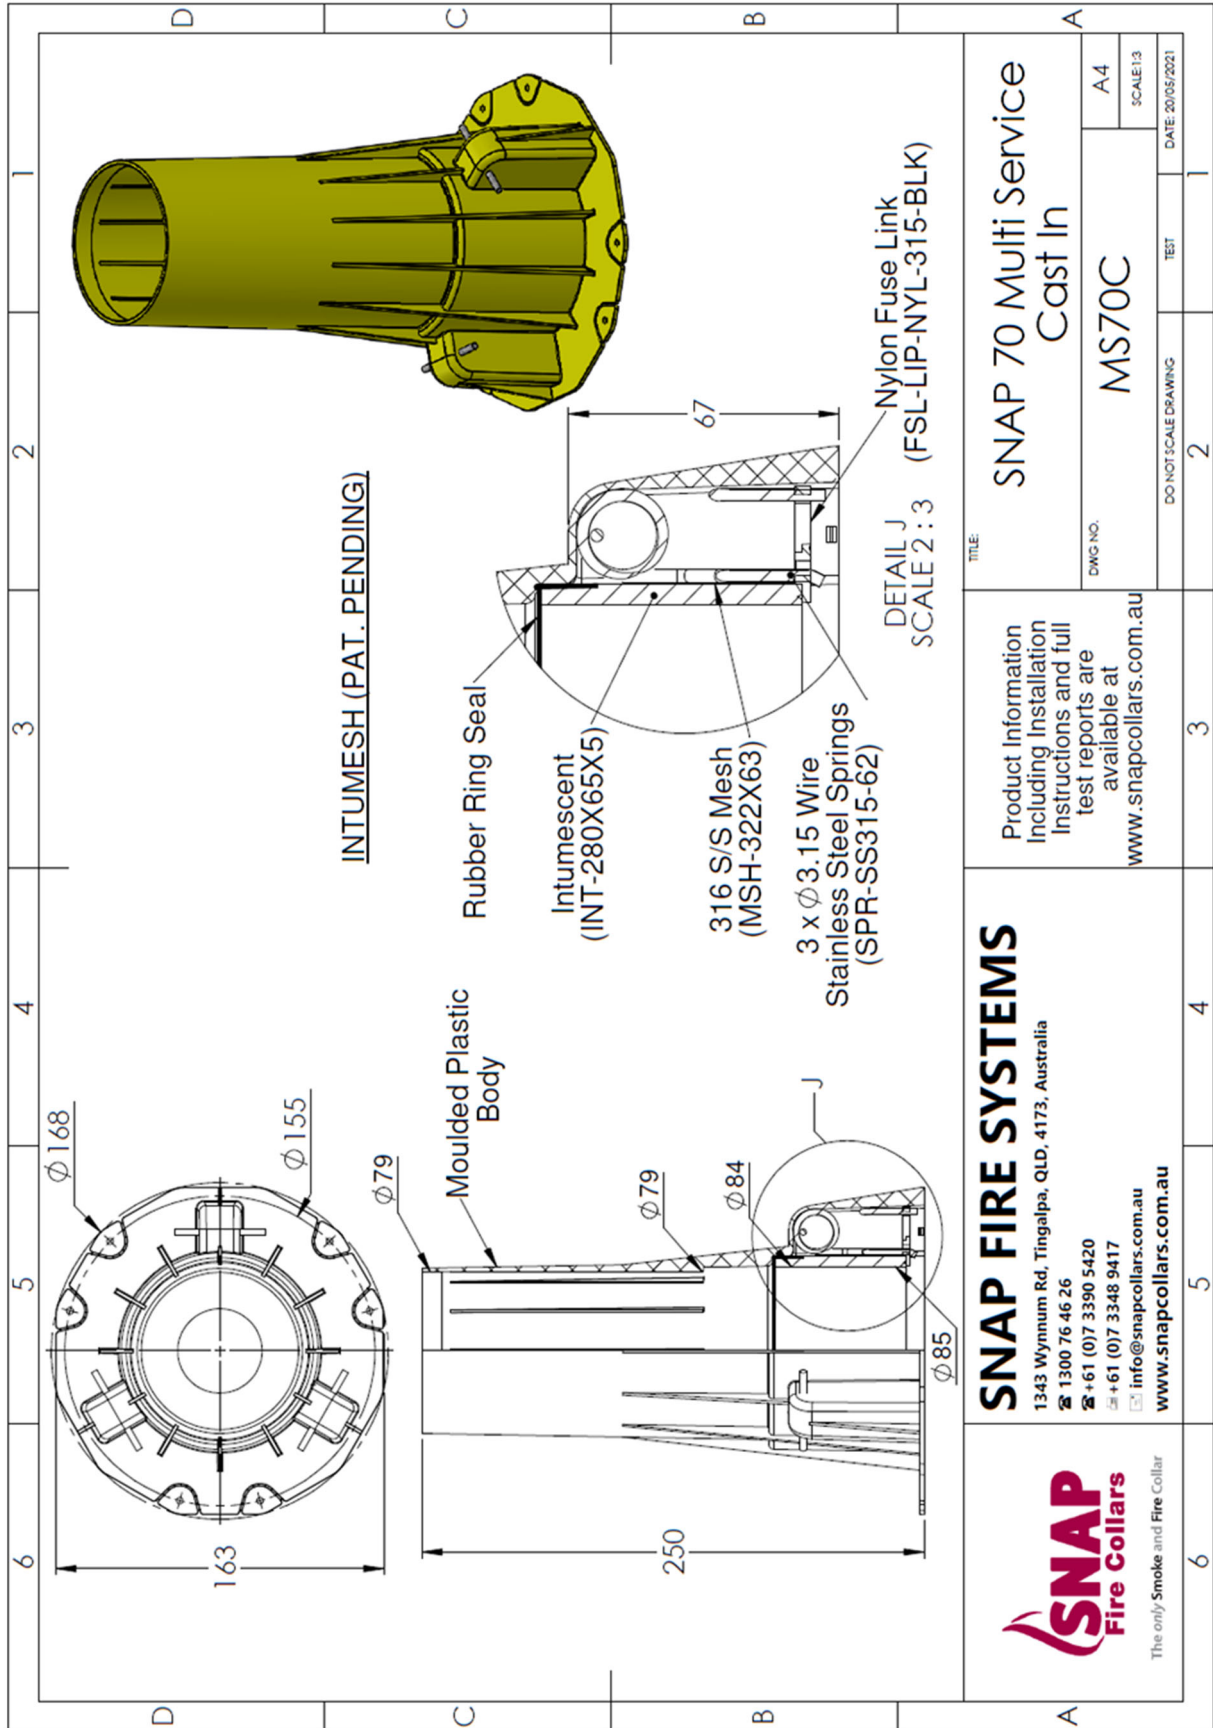
DRAWING TITLED 'SNAP 70 MULTI SERVICE CAST IN', DATED 20 MAY 2021, BY SNAP FIRE SYSTEMS PTY LTD

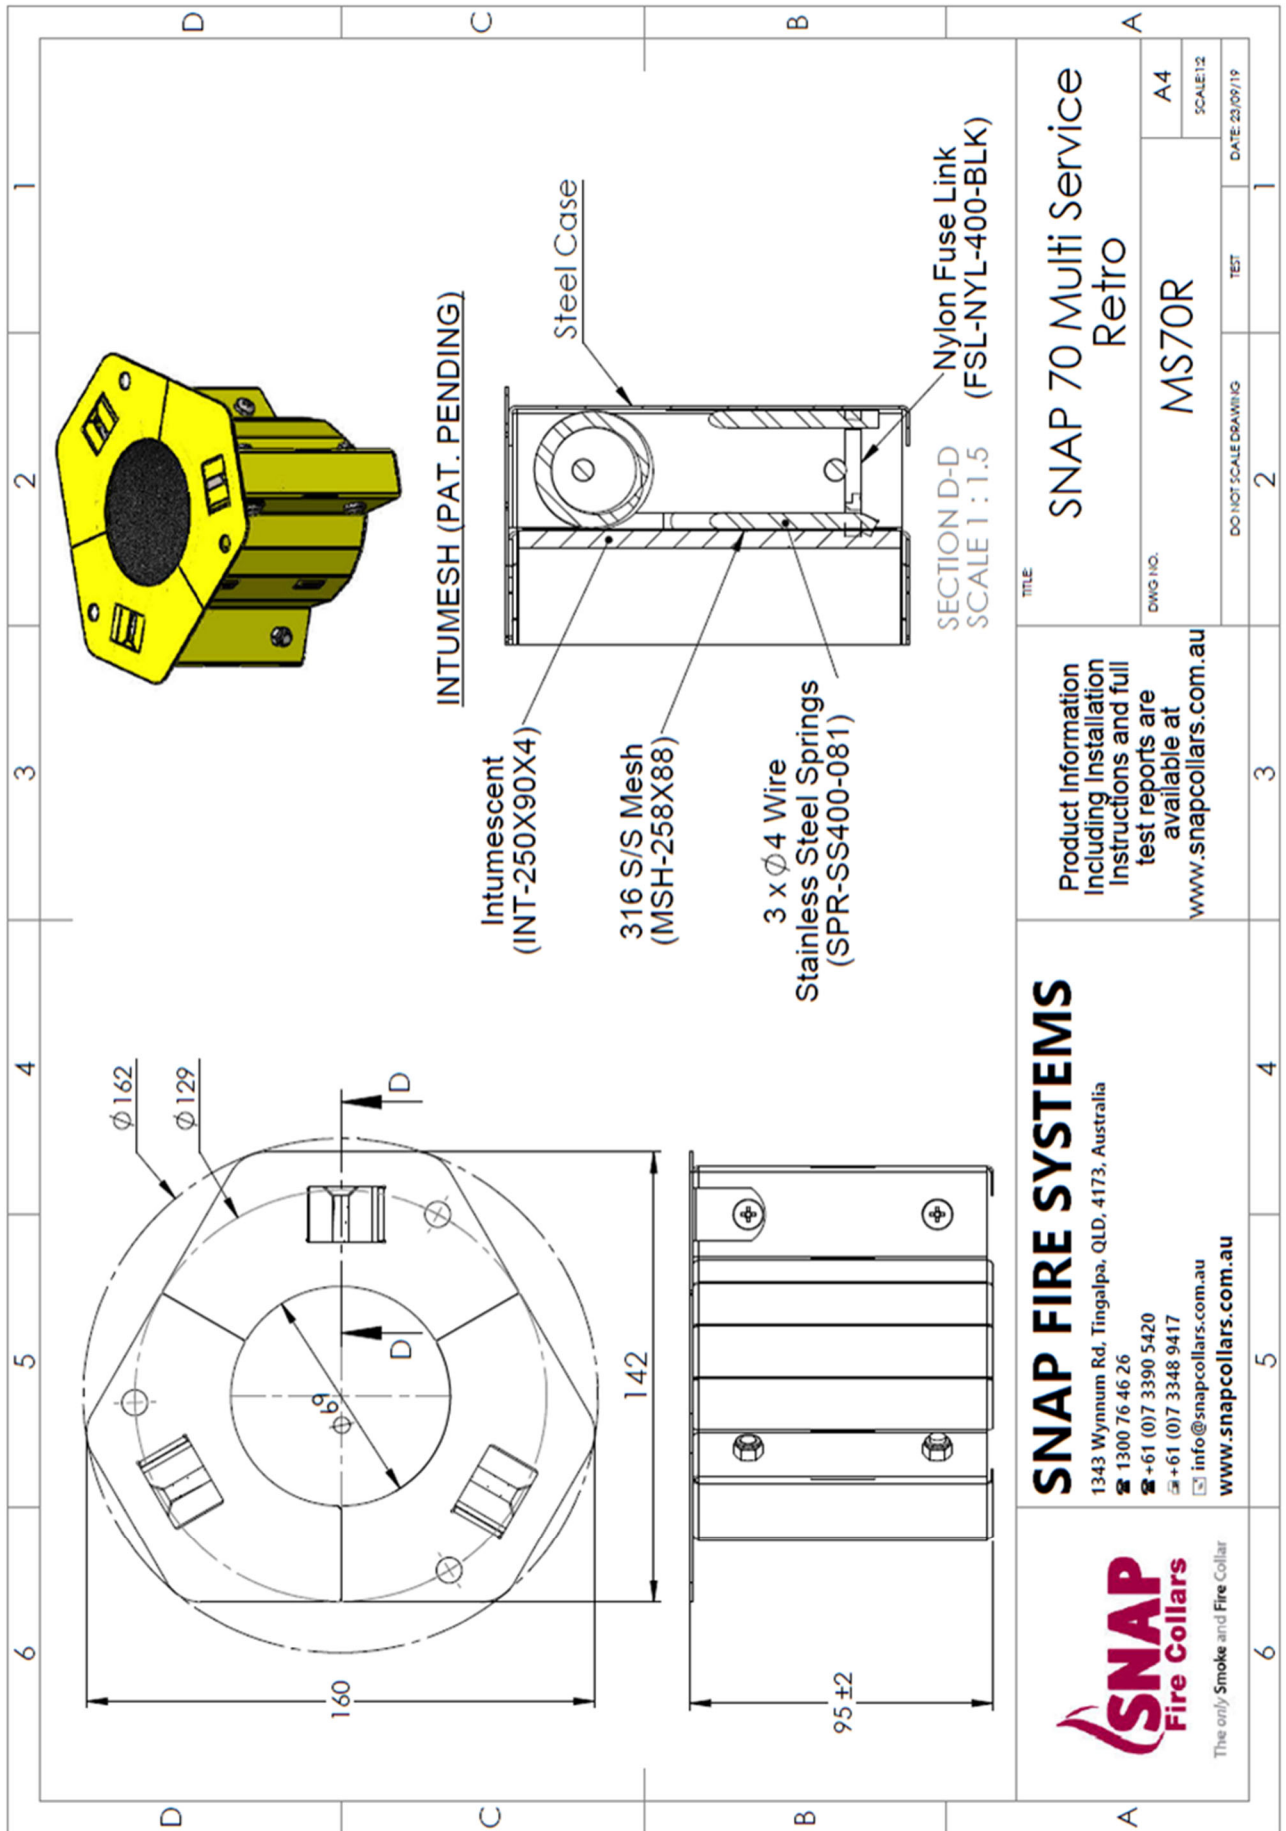
DRAWING TITLED 'SNAP 70 MULTI SERVICE RETRO', DATED 23 SEPTEMBER 2019, BY SNAP FIRE SYSTEMS PTY LTD
