**FIRE-RESISTANCE TEST ON
FIRE COLLARS PROTECTING A CONCRETE SLAB
PENETRATED BY SERVICES**

Report number FSP 1367a

SPONSORED INVESTIGATION No. FSP 1367a
**FIRE-RESISTANCE TEST ON FIRE COLLARS PROTECTING A
CONCRETE SLAB PENETRATED BY SERVICES**

The sponsor identified the specimen as Snap Cast-in Fire Collars protecting a concrete slab penetrated by six Polyethylene pipes.

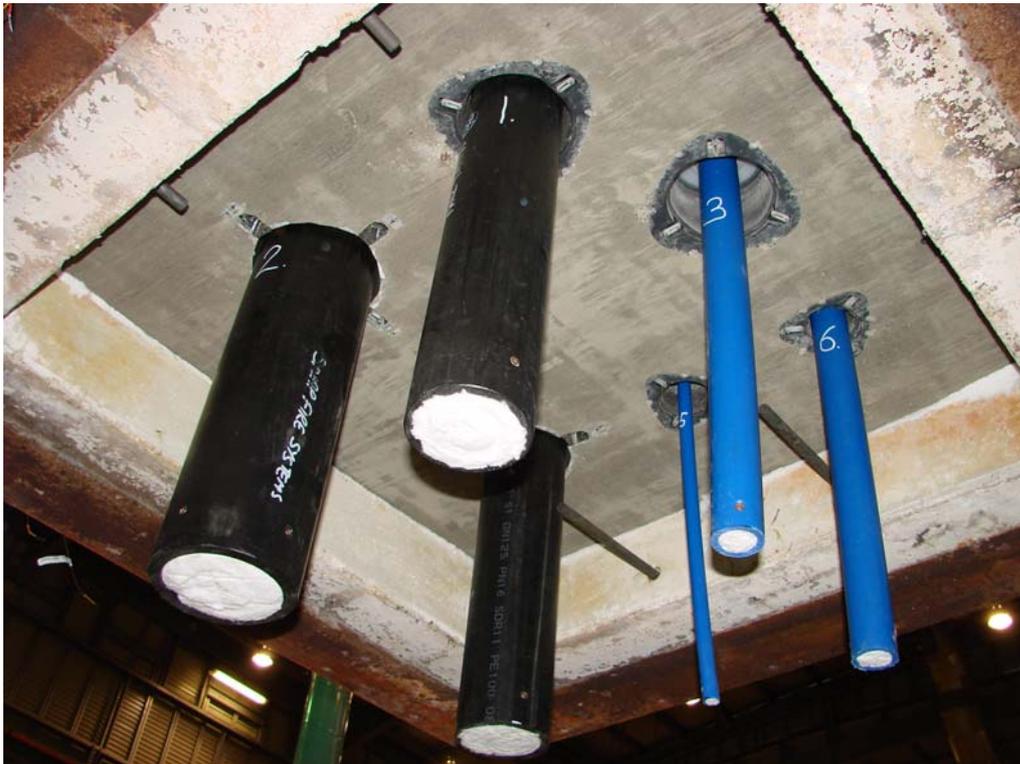
Photograph 1 – Exposed face of the specimen prior to testing

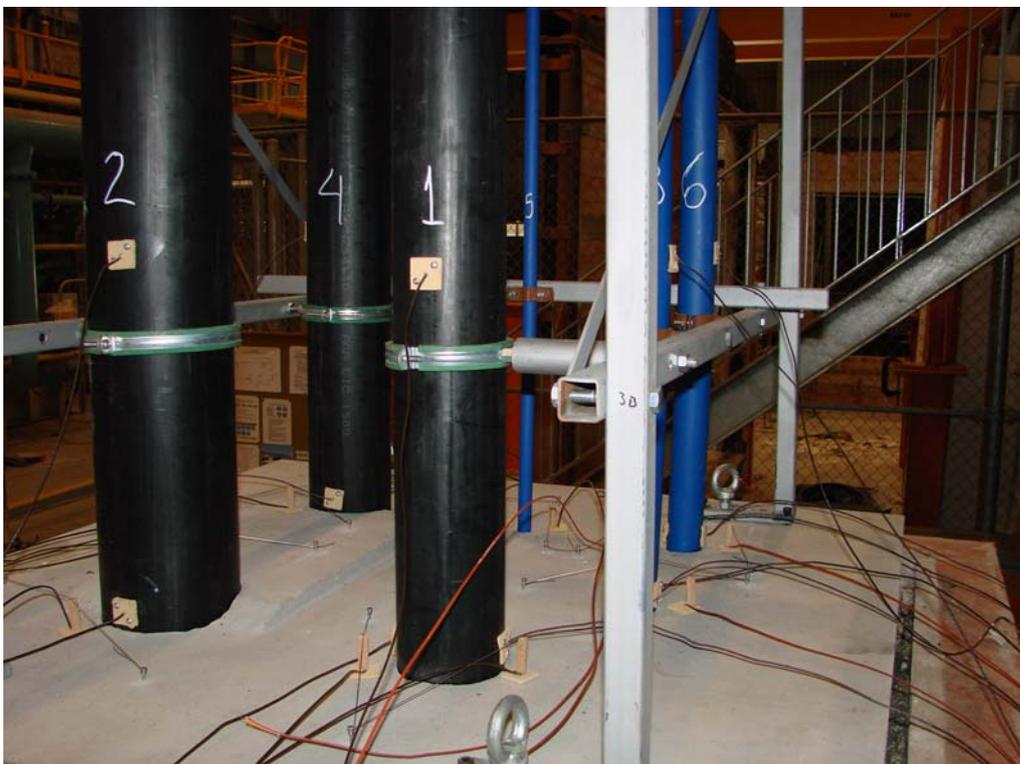
Photograph 2 – Unexposed face of the specimen prior to testing

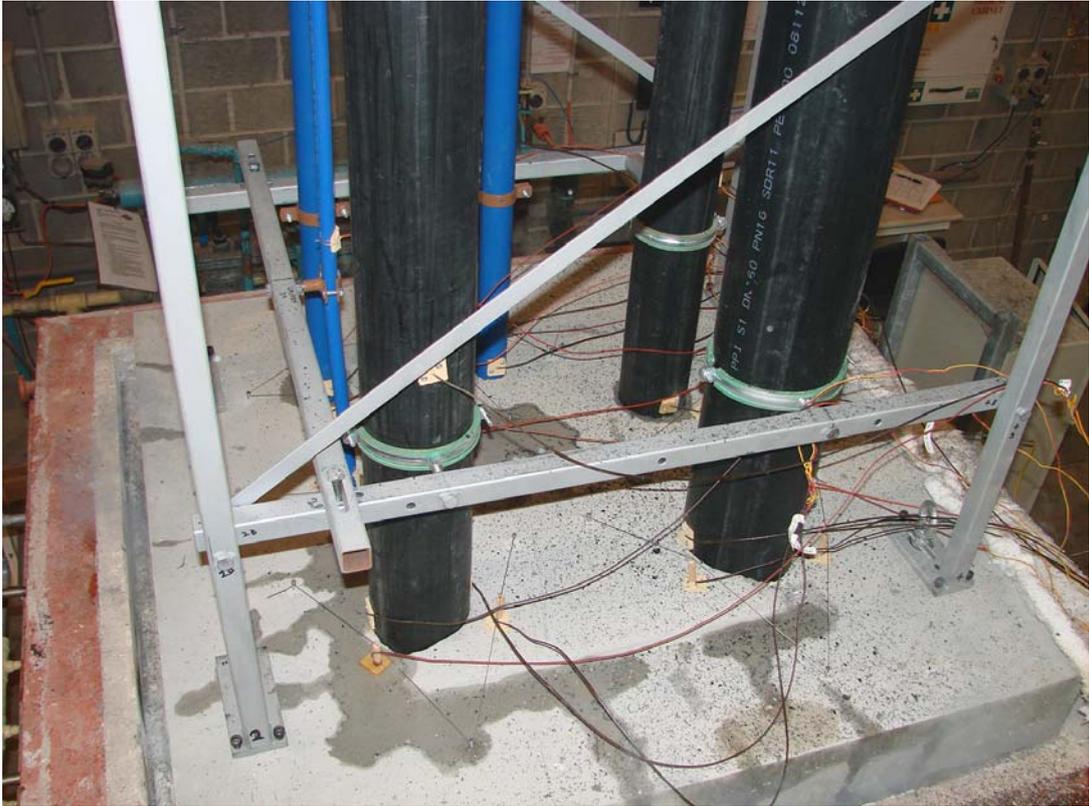
Photograph 3 – Specimen after 60 minutes of testing

- 60 minutes - No apparent change to the specimen.
- 103 minutes - Pipe #2 starts to deform at its base (photograph 4).
- 127 minutes - Pipe #4 starts to deform at its base (photograph 6).

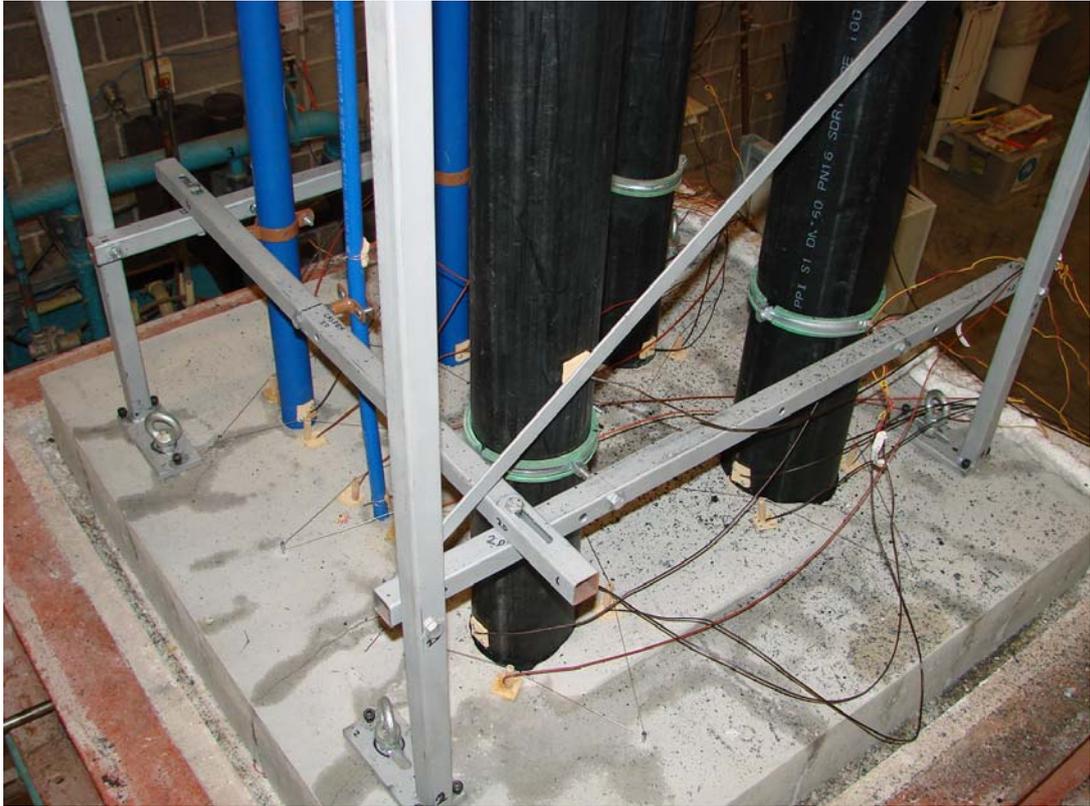
Photograph 5 – Specimen after 120 minutes of testing

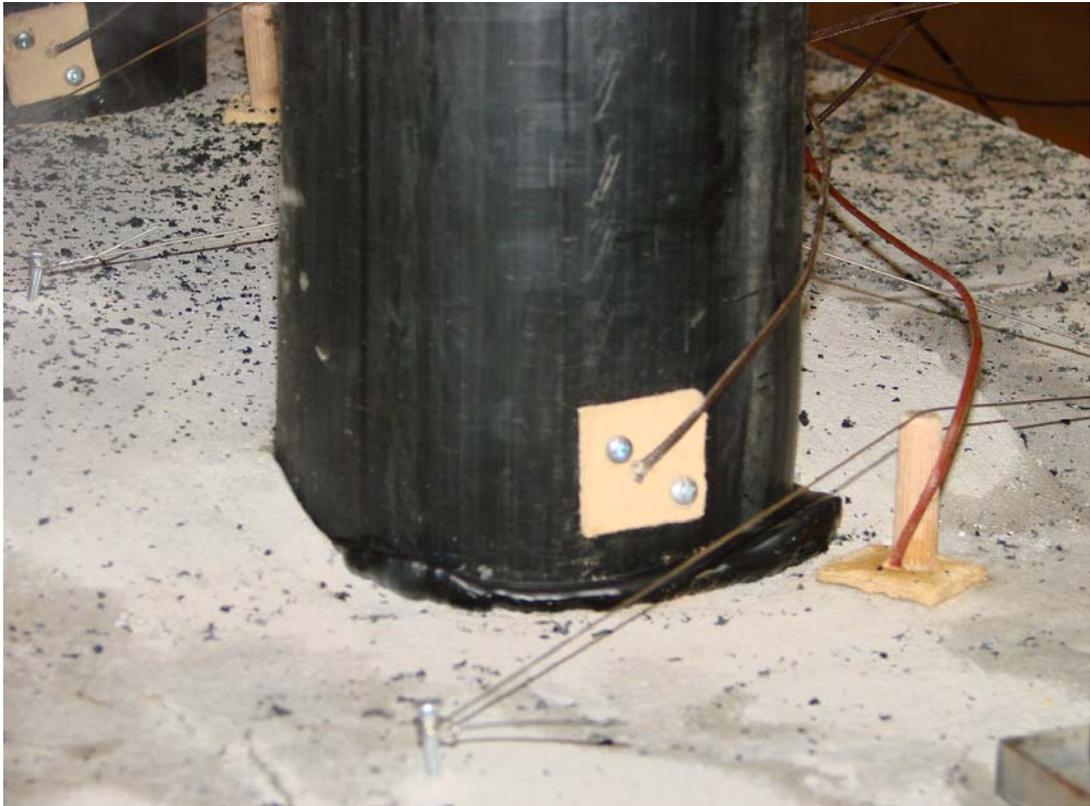
Photograph 6 – Pipe #4 at 127 minutes of testing.

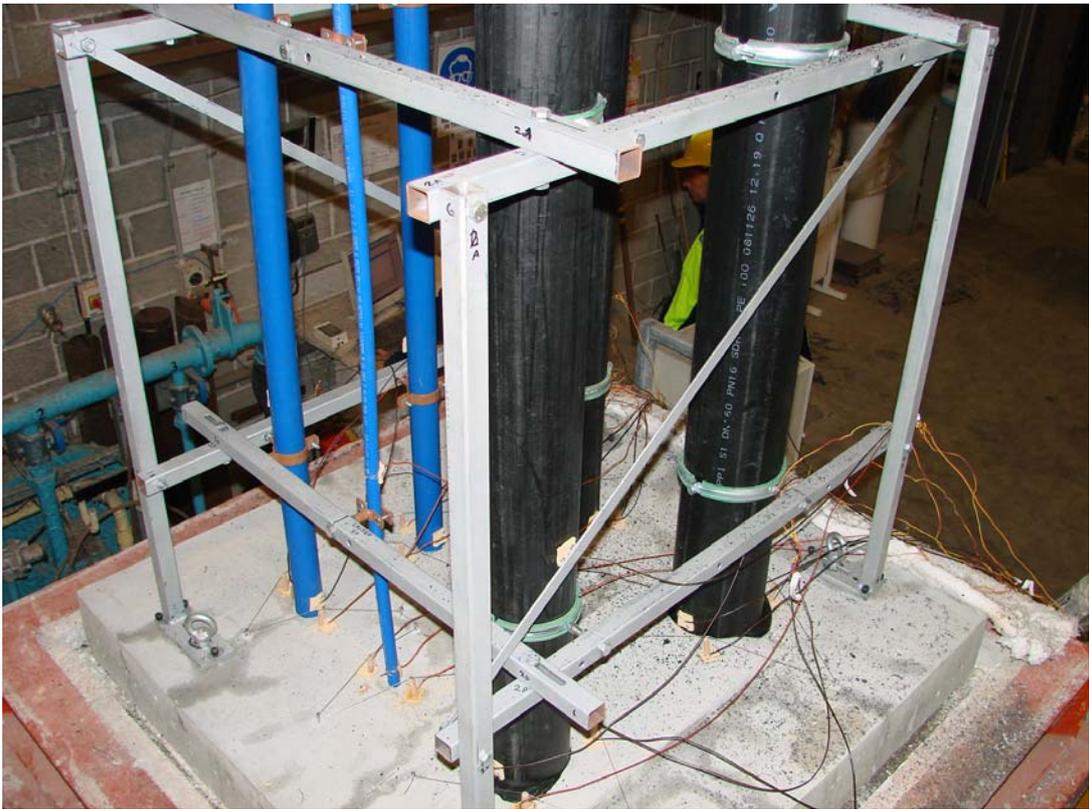
Photograph 7 – Specimen at 180 minutes of testing

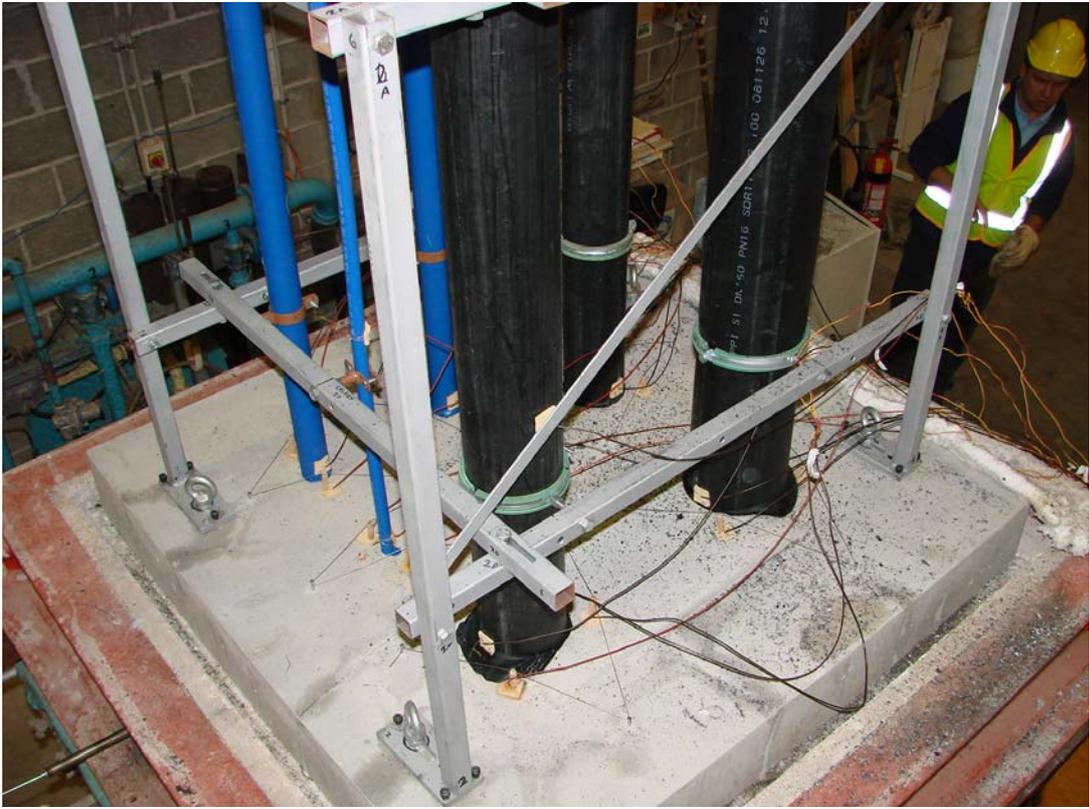
Photograph 8 – Specimen at the conclusion of testing

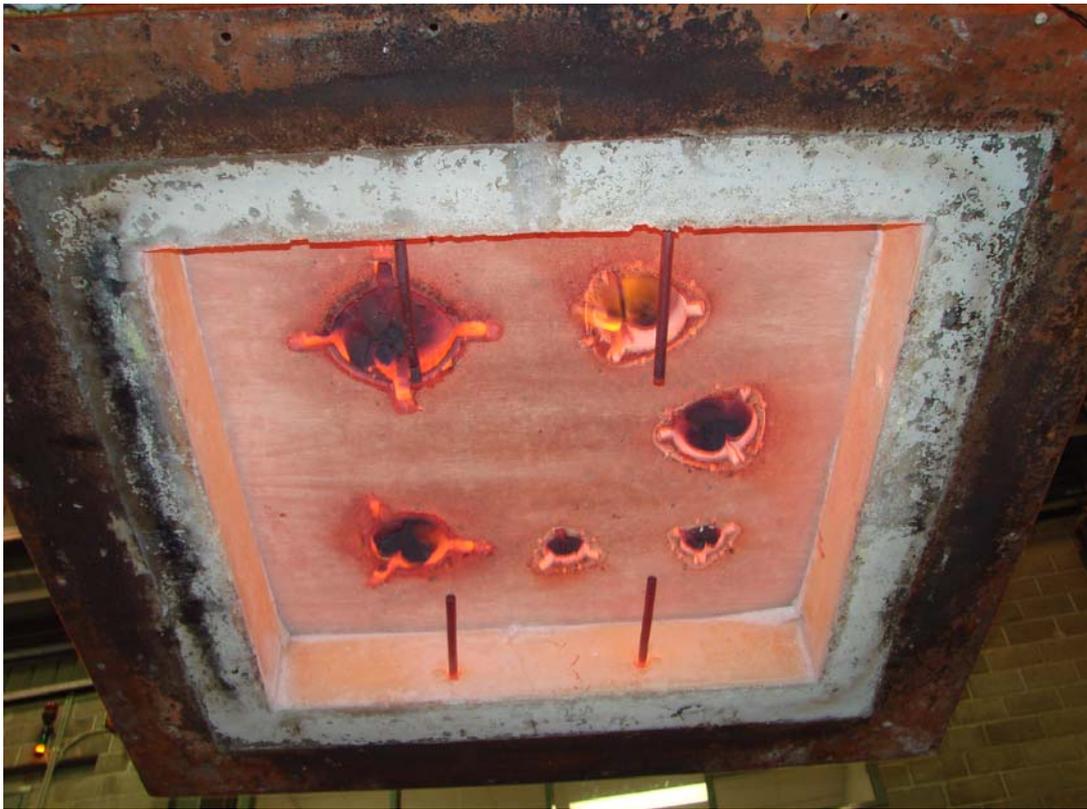
Photograph 9 – Exposed face after the conclusion of testing
